**DOT/FAA/AR-xx/xx**

# **Research for the Electrical Wiring Interconnection System Program**

October 2007

Final Report

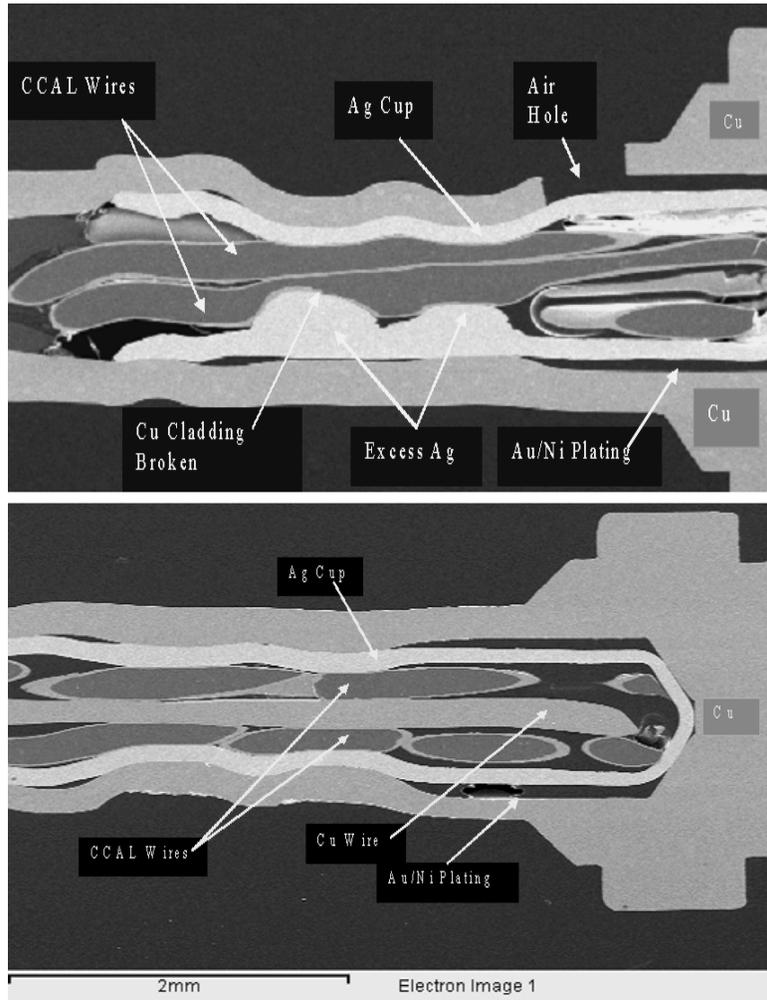
FIGURE 9. SEM PHOTOGRAPHS OF STRIPPED CCAL AIRCRAFT WIRING IN LENGTH-SECTIONED, CRIMPED CONNECTORS

stripped wire surfaces to provide multiple Ag/Cu electrical contacts and a nearly continuous mechanical seal to protect the cut wire ends from contaminants that could enter the connector through the hole designed to allow air to escape during the crimping process. The excess Ag apparent in the upper connector in Figure 9 caused the Cu cladding to fail producing a direct electrical contact between the Ag surface of the connector and Al core of the CCAL wire as shown in figure 10.

(Au)/Ni plated as indicated in figures 9 and 11 and as determined by the representative EDS line scan across a CCAL wire in contact with the interior wall of a length-sectioned connector as shown in figure 12.

Consequently, the analyses of the crimped connectors in figures 9 – 13 indicate that the design of the connectors includes multiple mechanical contacts/seals to prevent the corrosive contaminants present in the aircraft environment from entering a properly crimped connector to react with the cut ends of the CCAL wires. Even bare CCAL wires with Cu:Al interfaces exposed by damage during improper stripping procedures would be protected from galvanic corrosion by the crimped connector. The continuous nature of the interfaces between the CCAL wiring/Ag cup and Ag cup/connector body should ensure good electrical contact between the aircraft wiring and crimped connector.

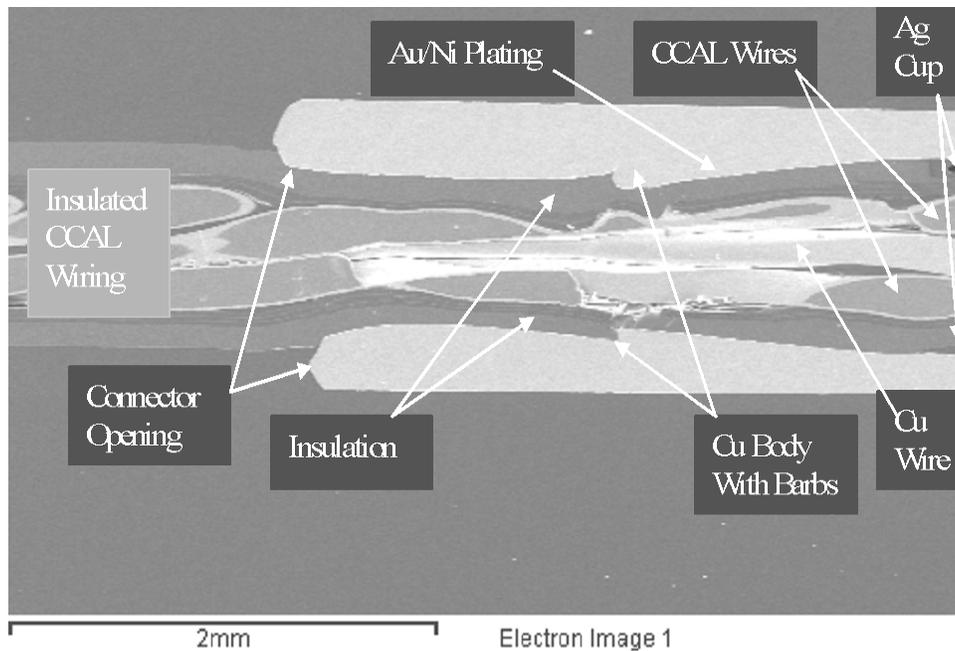
FIGURE 11. SEM PHOTOGRAPH OF INSULATED PORTION OF CCAL AIRCRAFT WIRING IN LENGTH-SECTIONED, CRIMPED CONNECTOR

In contrast to the connector sections securing the stripped wire ends, the representative SEM photograph in figure 11 shows that the surface of the connector section securing the insulated CCAL wiring contains a reversed barb. The barb is forced into the insulation during the crimping process to form a mechanical seal that protects the stripped wire surfaces in the silver cup (figure 9) from the contaminants that would enter through the connector opening. To prevent internal corrosion of the connector, the entire internal surface of the connector is gold

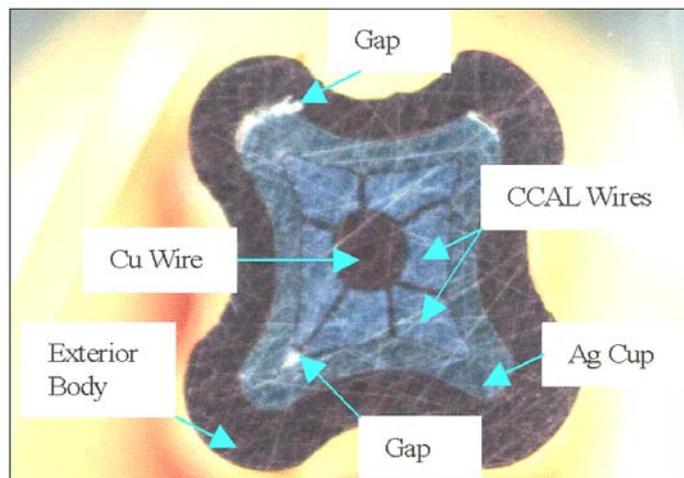
FIGURE 13. MICROSCOPE PHOTOGRAPH OF THE CCAL AIRCRAFT WIRING IN CROSS-SECTIONED, CRIMPED CONNECTOR

To view the shape of the crimped CCAL wires, the connector was cross-sectioned and photographed with a microscope as shown in figure 13. The photograph was taken with side lighting to highlight any gaps between the CCAL wiring and Ag cup and between the Ag cup and the exterior body of the connector. The photograph shows that the 7 CCAL wires are no longer circular conforming to the crimped shape of the connector. In contrast to the CCAL wires, the centered Cu wire retains its circular shape during the crimping process. Except for a small gap in one corner in figure 13, there is continuous contact between the CCAL wiring and Ag surface for the entire circumference of the crimped cup. There is also continuous contact between the Ag cup and exterior body of the crimped connector except for one, possibly two, gaps in the crimped corners.

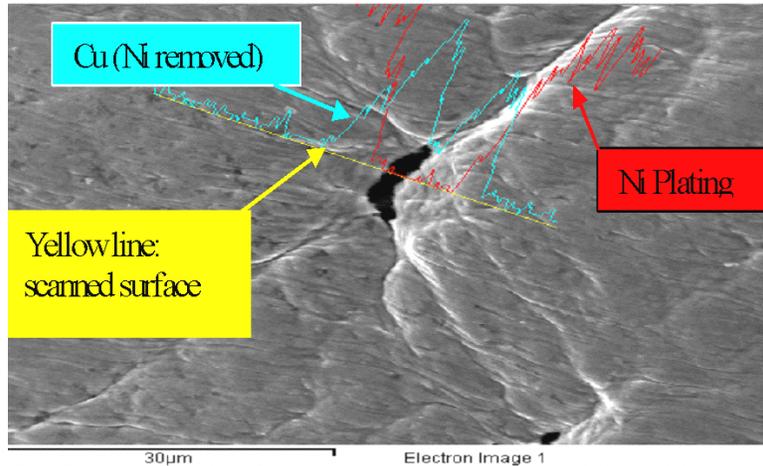
FIGURE 14. SEM PHOTOGRAPH AND EDS LINE SCAN OF HOLE IN NICKEL PLATING ON BENT CCAL WIRE

To test the ruggedness of the CCAL aircraft wiring during non-approved stripping procedures and tight bends, the insulation was stripped from the 24 AWG aircraft wiring using common wire strippers (24 AWG gap) and the exposed CCAL wires were bent around a 1/8 inch metal rod. The sharp bending caused several breaks in the Ni plating of the bent wire. The EDS line scan performed on the damaged Ni plating was transposed on the SEM photograph in figure 14 to show Al was not detected near or in the hole.

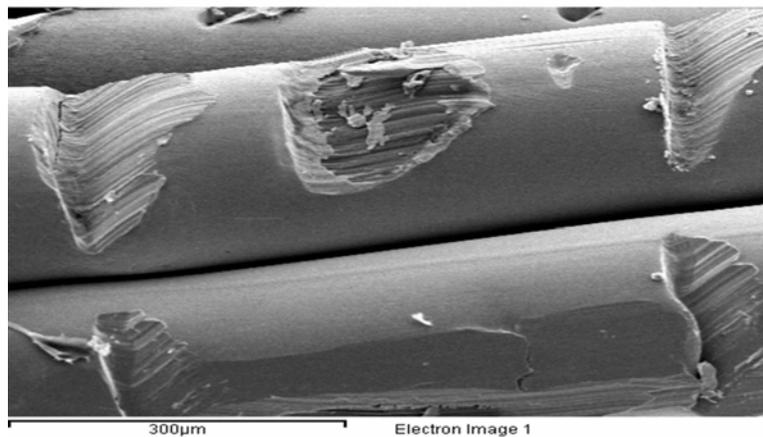
FIGURE 15. SEM PHOTOGRAPH OF STRIPPED 24 AWG AIRCRAFT WIRING

The aircraft wiring stripped of its insulation shown in figure 15 had the expected gouges in its CCAL wire surfaces that were produced when the insulation was cut/removed with a common stripping tool. EDS analyses of the gouges detected Al indicating the damage was deeper than the 17 µm total thickness of the Ni plating/Cu cladding layer.

Although the gouges in figure 15 were expected, the damage to the CCAL wires caused when the stripping tool was used to pull the insulation along/off the wires was not expected. The SEM photograph in figure 16 (with transposed EDS line scan) shows two different types of damage to the CCAL wire surfaces. The first level of damage changes the physical appearance/decreases the thickness of the Ni plating (Cu detected by EDS in figure 16) as the stripping tool is pulled along the surface of the wire. The second level of damage is more severe and occurs when Cu cladding is removed completely from the Al surface leaving behind large holes in the Cu cladding (Al detected by EDS and drawing marks on Al surface are visible in figure 16).

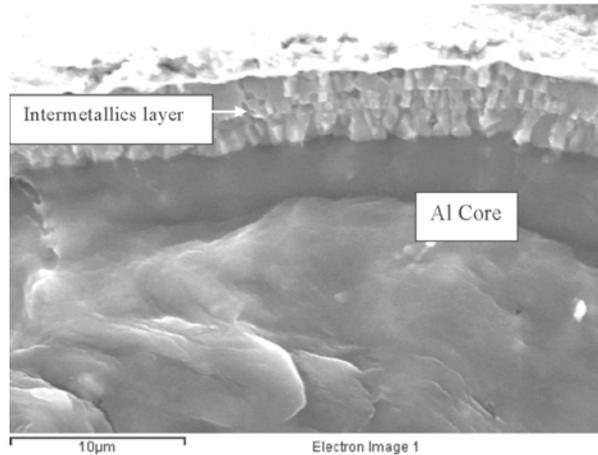
FIGURE 21. SEM PHOTOGRAPH OF 350°C HEATED/BROKEN CCAL WIRE

To determine the effects of the intermetallics formation on the fatigue resistance of the CCAL wire, the wire heated 350°C for 4 hours was placed on the fatigue tester (Appendix A). However, the initial 90° bending of the heated CCAL wire caused the wire to break. The SEM photograph of the broken wire in figure 21 shows that the intermetallics layer separated from the Al core greatly reducing the fatigue resistance of the heated CCAL wire. Reported research (2)

demonstrated an inversely proportional relationship between breaking load and intermetallic layer thickness.

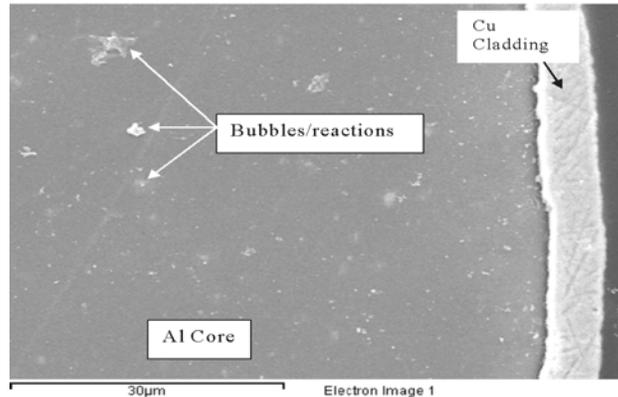
FIGURE 22. SEM PHOTOGRAPH OF CROSS – SECTIONED CCAL WIRE AFTER 3 HOUR 1% NACL SOLUTION TEST

minimal effect on the overall corrosion rates. The effects of electrochemical corrosion on the CCAL wire ends appeared to be inhibited by the formation of a protective film on the Al surface that contained Al, O and Cl. The larger white deposits on the Al core surface in figure 22 are located where the bubbles escaped through the film.

As opposed to the 1% NaCl aqueous test in figure 22, the commercial CCAL wire ends exposed to the 20 ppm NaCl underwent severe corrosion at the Cu:Al interface as evidenced by the accumulation of Al oxide/hydroxide crystals ( no Cl detected) at the interface in figure 24. The 20 ppm NaCl solution did not form a protective layer as in figure 22 as evidenced by the removed (with respect to Cu cladding), furrowed Al core surface in figure 24. As opposed to the NaCl produced crystals present on the Cu:Al interface, the 20 ppm NaOH galvanic corrosion produced a deep crevice at, and deep furrows extending from, the Cu:Al interface in figure 24.

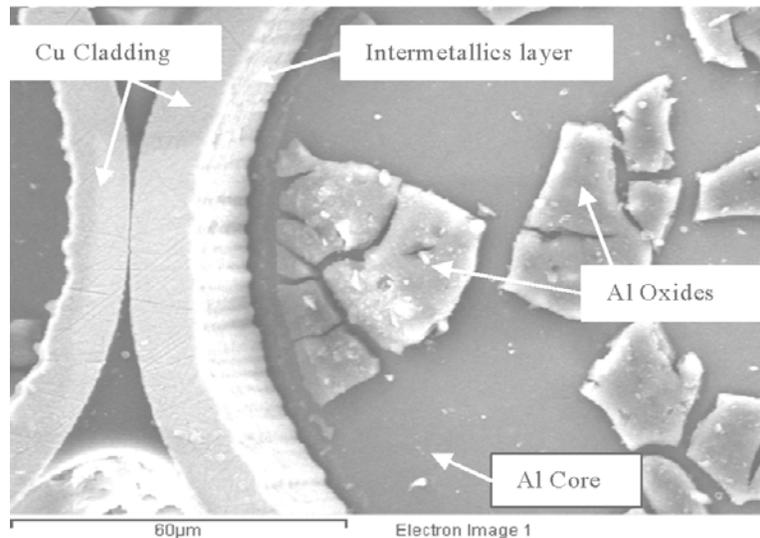
FIGURE 25. SEM PHOTOGRAPH OF CROSS-SECTIONED CCAL AIRCRAFT WIRING AFTER 2 DAY EXPOSURE TO 200 PPM NAOH SOLUTION

To study the effects of Ni plating and the pure Cu wire at the center of the 24 AWG aircraft wiring (figure 4) on the electrochemical reactions of exposed Al surfaces, different pieces of CCAL aircraft wiring were suspended in an epoxy casting material, cross-sectioned and exposed to 200 ppm NaOH solution for 2 days. The corroded surfaces were then washed off with distilled water and analyzed using SEM/EDS. The inner Cu wire, Ni plating and Cu claddings of the CCAL wires did not show any signs of corrosion. However, significant amounts of the Al cores had been corroded from the interior of the CCAL wires and Al oxides were present on the lowered Al core surfaces as shown by the SEM photograph in figure 25.

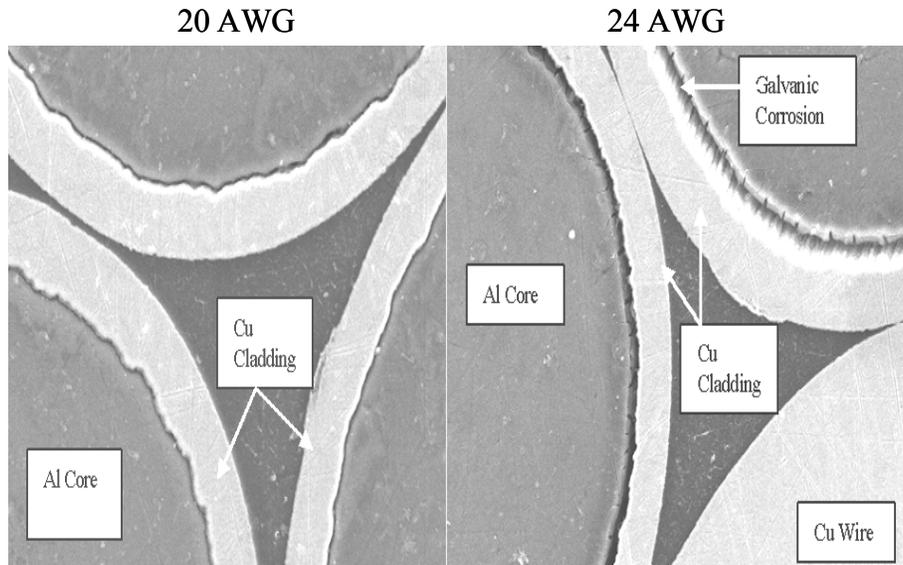
FIGURE 26. SEM PHOTOGRAPHS OF CROSS-SECTIONED CCAL AIRCRAFT WIRING AFTER 6 DAYS WITH 20 PPM NAOH SOLUTION

For the first study, pieces of the 20 and 24 AWG CCAL aircraft wiring were suspended in an epoxy casting material, cross-sectioned and exposed to 20 ppm NaOH for 6 days. The corroded surfaces were then washed off with distilled water and analyzed using SEM/EDS. The Al surfaces of the CCAL wires in the 20 AWG wiring underwent much less corrosion than those of the CCAL wires in the 24 AWG wiring (centered Cu wire) as shown in figure 26.

A higher magnification SEM photograph of the 24 AWG CCAL wire in figure 26 was recorded as shown in figure 27 and shows that the 20 ppm NaOH galvanic corrosion at the Al:Cu interface is similar in appearance to the 20 ppm NaOH corrosion in figure 24, i.e., crevice at Al:Cu interface and furrows in Al surface. The Cu:Al interface in figure 27 is much more uneven than in figure 24 due to the thicker intermetallics layer in the CCAL aircraft wiring compared to the commercial CCAL wires.

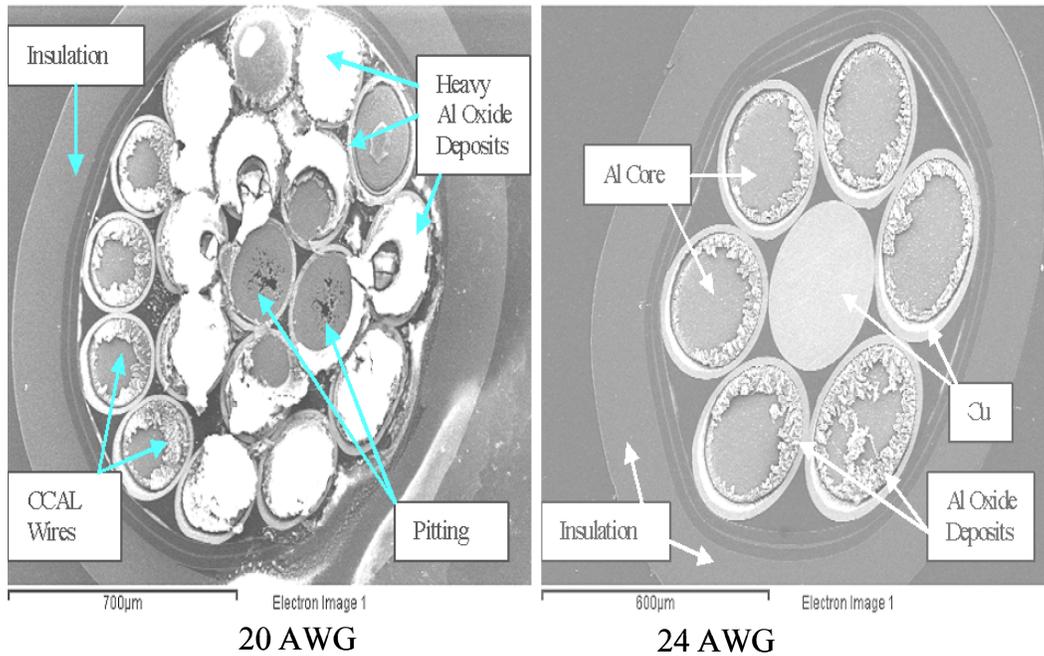
FIGURE 28. SEM PHOTOGRAPHS OF CROSS-SECTIONED CCAL AIRCRAFT WIRING AFTER 4 DAYS WITH 20 PPM NaCl SOLUTION

Since the first study using 1% NaCl in deionized water formed a protective gel on the exposed ends of the commercial CCAL wires, a 20 ppm NaCl solution was used to corrode cross-sectioned pieces of the 20 and 24 AWG CCAL aircraft wiring suspended in an epoxy casting material for 4 days. The corroded surfaces were then washed off with distilled water and blown dry (to remove any heavy deposits) before SEM/EDS analysis. The corrosion of the Al surfaces was less concentrated on the Al:Cu interfaces for the 20 AWG wiring than for the 24 AWG wiring as shown in figure 28.

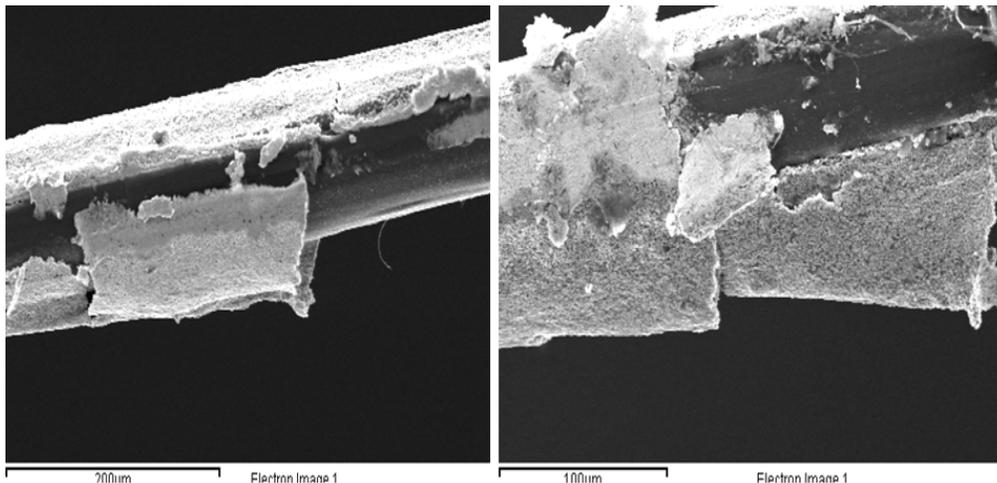
FIGURE 32. SEM PHOTOGRAPHS OF PBO FIBERS COATED WITH AG FILM AFTER 3 TEST CYCLES – NO CNF PRESENT

Since both the fatigue resistance and tensile strength tests indicated that CNF help anchor the coating to the PBO surface and improve the flexibility of the formed Ag coating, SEM/EDS analyses of the Ag coated PBO wires that failed after less than 12 cycles and the two PBO wires that exceeded 24 cycles without failure (table 1) on the fatigue test rig were performed. The SEM/EDS analyses focused on the physical changes that occurred at the Ag coating:PBO interface that could account for the improved film adhesion in the presence of CNFs. The SEM photographs of the failed Ag coated PBO wire without CNF present (failed after 3 cycles) in figure 32 show that the PBO wire surface is smooth and the Ag coating left the entire circumference of the PBO filament in sections.

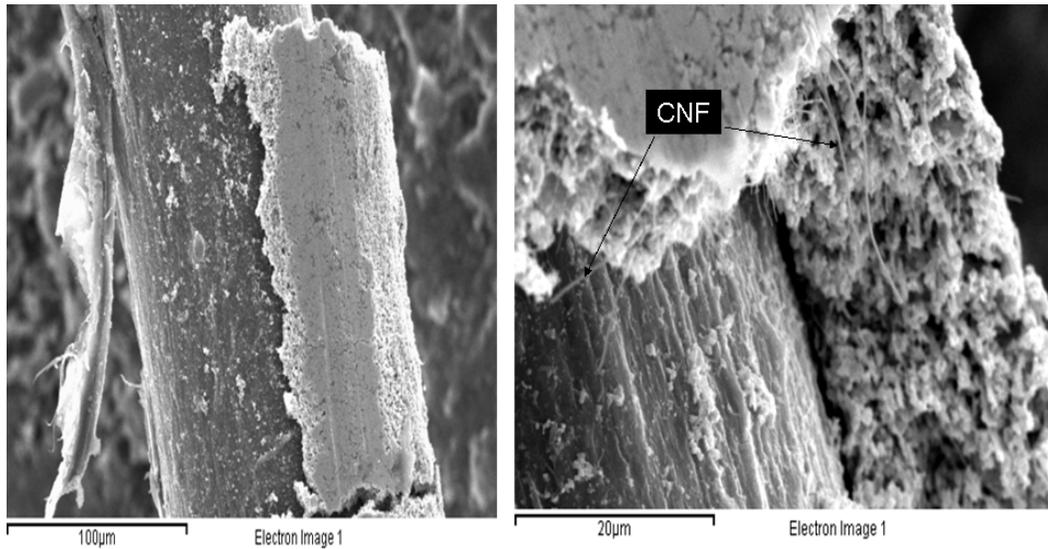
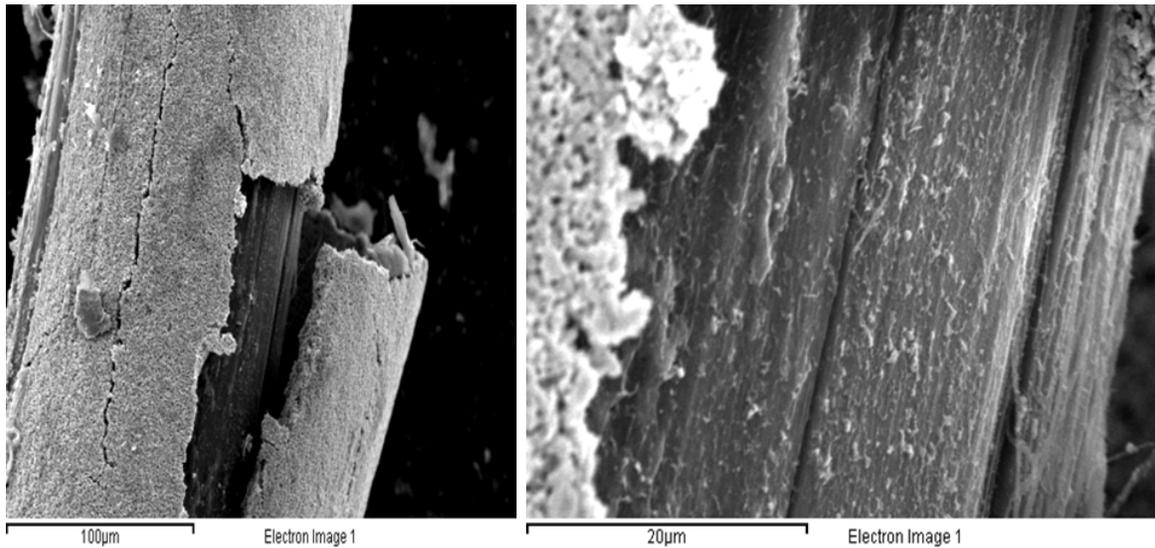
surface and the increased surface smoothness likely accounts for the reduction in the number of cycles prior to film failure, i.e., 12 cycles for coated versus 4 for infiltrated.

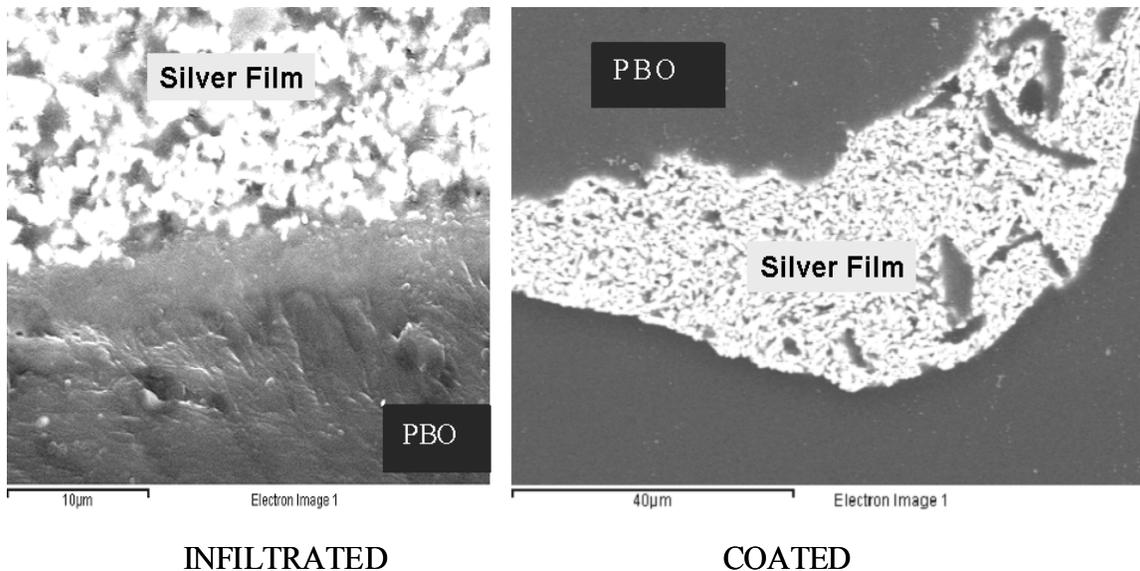
FIGURE 35. SEM PHOTOGRAPHS OF CROSS-SECTIONED PBO FIBERS (10% CNF) WITH AG FILM (5% CNF) AFTER 24 TEST CYCLES

of the Ag films that was undamaged after 24 cycles of the bending fatigue test. The cross-sectioned Ag films indicate there are voids in the films, which may also contribute to the flexibility of the films.

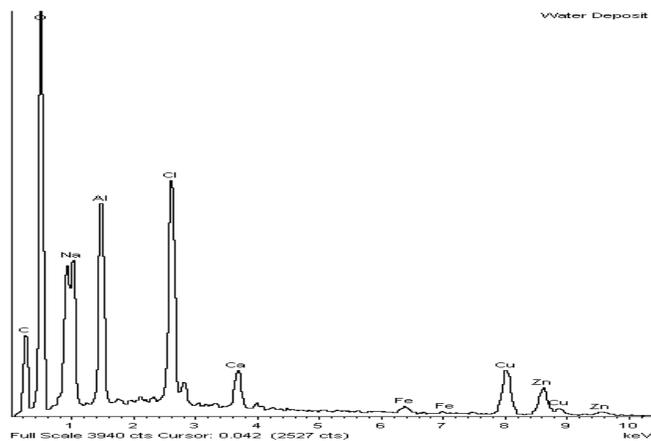
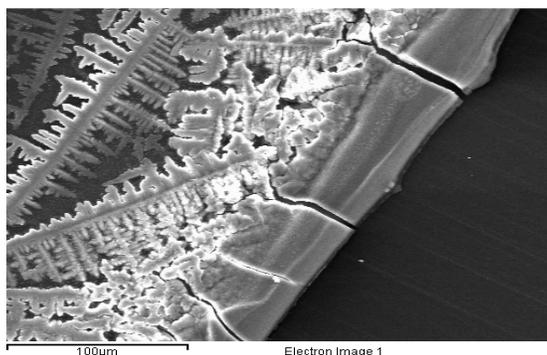
the dehumidifier water. The first type includes aluminum (Al), Cu (Cu), zinc (Zn) and iron (Fe) representing construction metals of the dehumidifier. The second type are carbon (C), calcium (Ca), chlorine (Cl), oxygen (O) and sodium (Na) representing species from the surrounding area that were deposited on the dehumidifier coils by the air flow and washed into the condensed water reservoir. The thin deposit with distinct areas of different crystal structures formed by the evaporating dehumidifier water shown in figure 37 indicates that the species are present in ppm levels and have a wide range of water solubilities [most likely, low solubility organics/carbonates (metal, C, O) and high solubility chlorides (metal, Cl)]. The dissolved metal species present in the dehumidifier water are most likely responsible for directing the water-insoluble polymer onto the powered Cu wires, i.e., the dissolved metal species combine with the dissolved Cu species produced during electrolysis to cross-link the dissolved PVAL producing the water-insoluble polymer on the Cu wires.

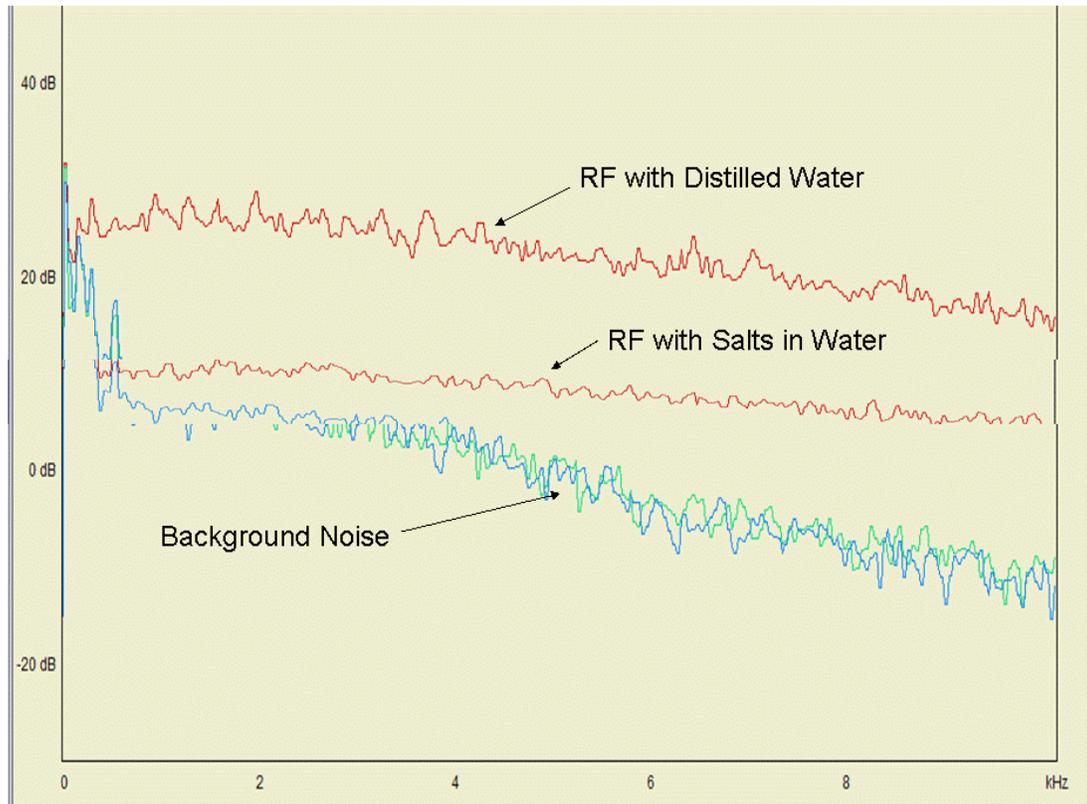
FIGURE 38. BACKGROUND NOISE AND RF PRODUCED BY ELECTROLYSIS OF DIFFERENT WATER SOLUTIONS

be dissolved into the PVAL repairing solution and not in the water used to detect damaged insulation. In every case, seconds after a drop of 10% PVAL solution was added to the water layer undergoing electrolysis, the RF output decreased to a level equal to the background noise in figure 38, a water-insoluble film formed on the positively charged wire and the current flow decreased from greater than 0.5 A to less than 15 mA.

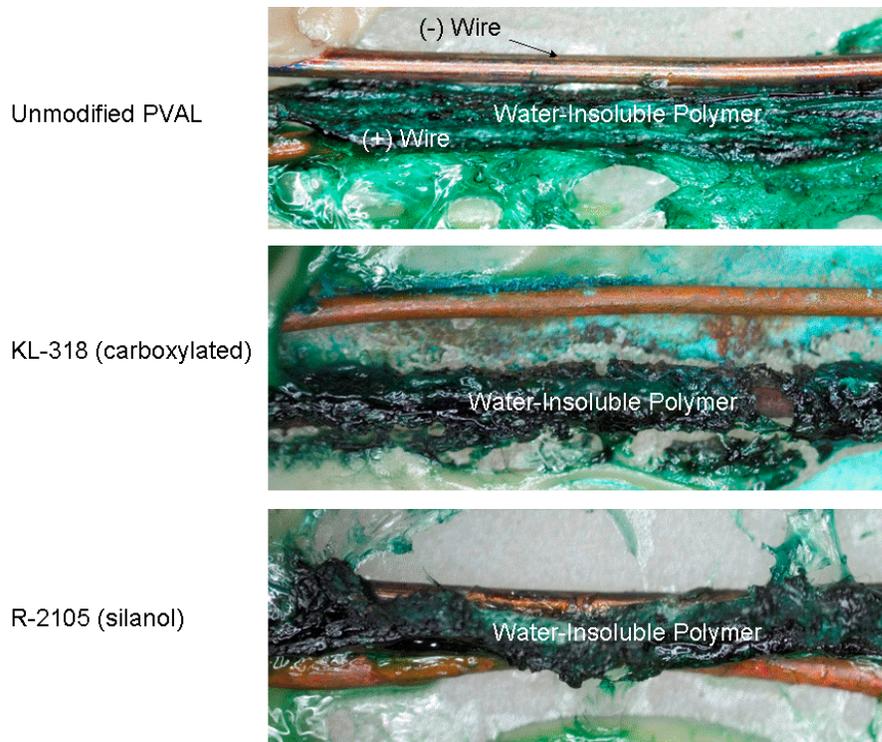
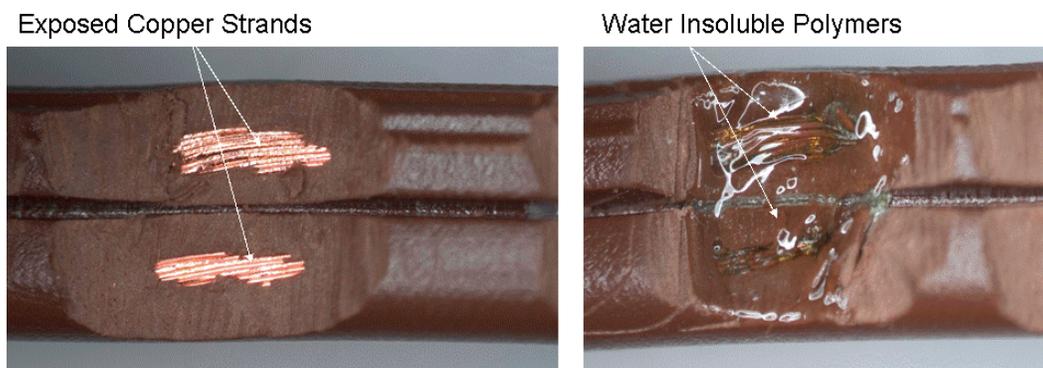
Based on the research to date, the unmodified 10% PVAL (80% hydrolysis) solution prepared with distilled water containing  $\text{CuCl}_2$  (0.05%) or Elmer's School glue (1%) was selected as the best candidate (least viscous solution, most adherent/flexible film) for development into a sprayable self-repairing solution. As further evaluation of the PVAL solution, the insulation of a lamp cord was cut away with a razor blade and the damaged cord was plugged into an 115Vac, 20A outlet. When a drop of distilled or tap (salts) water was placed on the exposed Cu strands, within seconds the produced dendrites [1] shorted the circuit causing the circuit breaker to open. When the test was repeated with the candidate PVAL solution, a clear water-insoluble layer formed immediately on both exposed wires as shown in figure 40 and the current flow rapidly fell to below 3 mA.

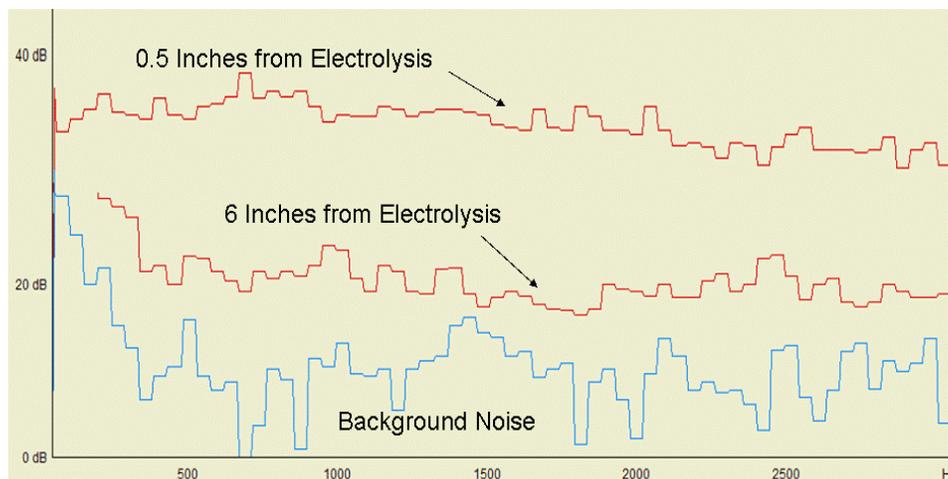
FIGURE 41. EFFECTS OF DISTANCE ON RF DETECTED BY CU COIL ANTENNA

The wound Cu wire coil described in Appendix B was placed directly above the Cu pair with the coil held vertically (open end toward wires) and was slowly moved from 0.5 to 12 inches above the Cu wire pair during electrolysis (static heard on AM radio). The overlaid spectra shown in figure 41 are representative of the spectrum analyzer outputs as the Cu coil antenna was moved from 0.5 inches to 6 inches away from the Cu wire pair. The RF detected by the spectrum analyzer decreased dramatically with increasing distance and equaled the background noise by 9 inches. Consequently, the wound Cu coil antenna and the radio (static not heard at 12 inches) had similar capabilities for detecting the RF produced by electrolysis.

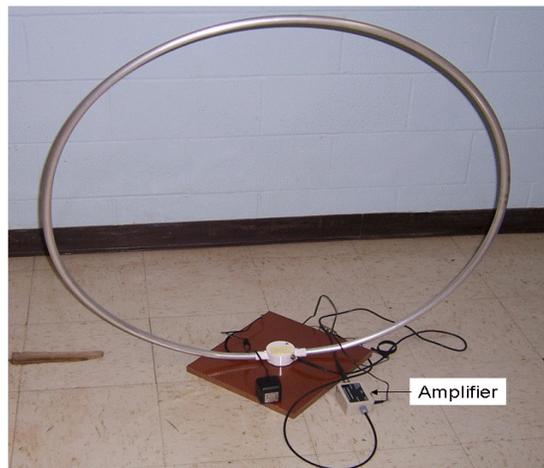
FIGURE 42. LOOP ANTENNA FOR LOW FREQUENCY RF

A commercial loop antenna designed to detect low frequency RF is shown in figure 42. The loop is 48 inches in diameter and comes with an amplifier and connectors allowing its use with the computer based spectrum analyzer. Although cumbersome, the antenna is portable and was used more to evaluate the possibility of detecting RF from outside the aircraft than inclusion into a portable, self-repair maintenance procedure. As opposed to the Cu coil antenna, the RF detection capabilities of the loop antenna did not change significantly when moved 12 inches from the Cu pair undergoing electrolysis. The overlaid spectra in figure 43 are representative of the spectrum analyzer outputs as the loop antenna was moved in steps of 12 inches from the Cu pair. The overlaid spectra in figure 43 also includes the spectrum analyzer outputs when the Cu pair undergoing electrolysis was placed on a steel plate and then covered with either an aluminum or steel pan. Since it could not be confirmed visually, electrolysis during the covered tests was confirmed by the static detected by the radio placed 6 inches from the covered wire pair.

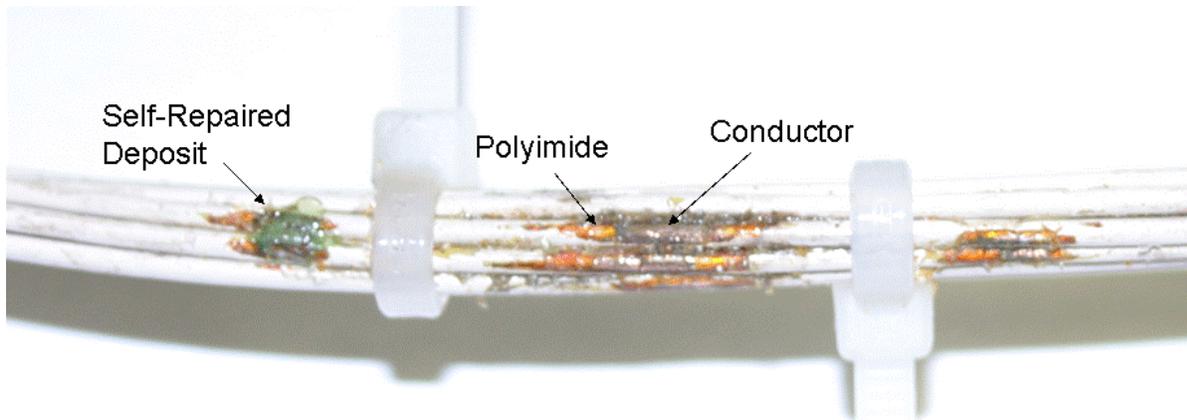
FIGURE 44. BUNDLE OF WIRING WITH DAMAGED AND SELF-REPAIRED INSULATION

To make the evaluation of the self-repairing repair method more realistic, 10 lengths (each 1 foot long) of 24 AWG aircraft wiring were bundled together using wire wraps as shown in figure 44. The insulations of several wires were damaged with a razor blade and

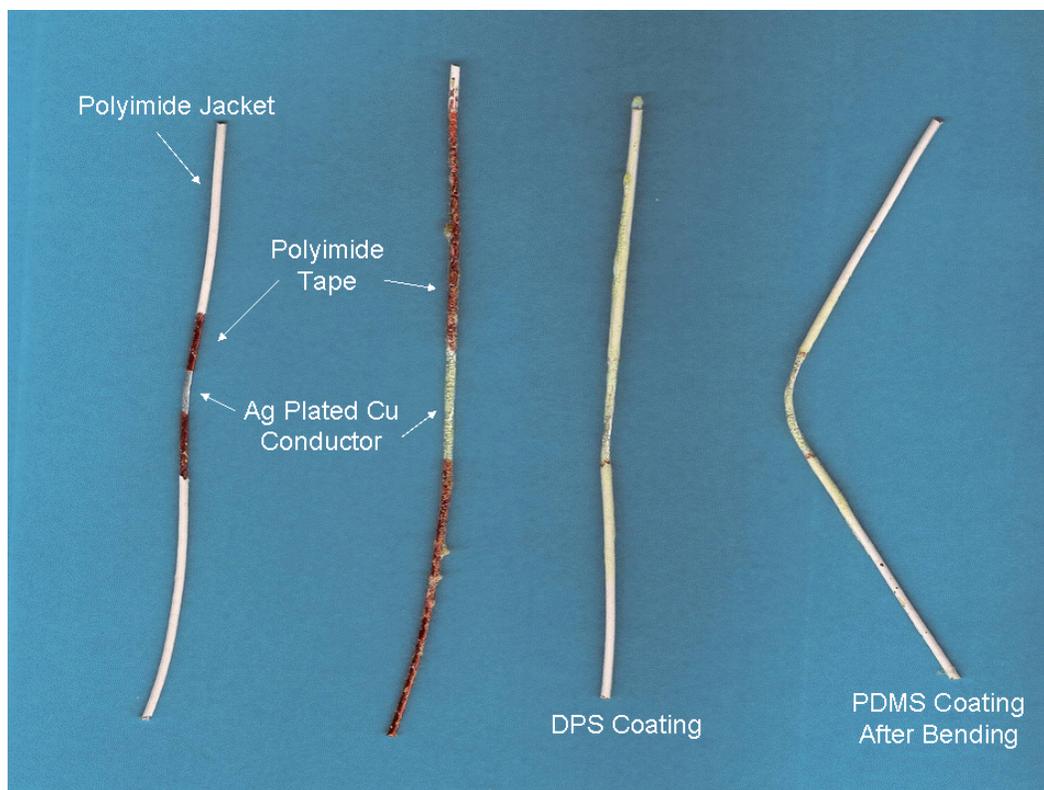
FIGURE 46. DAMAGED STANDARD HOOKUP WIRES BEFORE AND AFTER COATING WITH REPAIR SOLUTIONS

To initially test the insulation repair capabilities of the modified polyimide solutions for wire applications, two standard hookup wires (M81381/11-20-9 “C”) with an aromatic polyimide jacket were damaged to partially or completely expose a polyimide tape (brown) wrapped around a metal conductor wire (white: Ag plated Cu) as shown in figure 46. When the damaged wire was coated with a polyimide resin:DPS in figure 46, the coating was adherent to the polyimide jacket, inner polyimide tape and exposed metal conductor. However, repeated bending produced cracks in the repair coating. The second damaged wire was coated with a polyimide resin:PDMS system. Again the modified polyimide film was adherent to all of the exposed surfaces of the damaged wire, but in contrast to the DPS system, the film remained intact after multiple bends as shown in figure 46. Therefore, the initial results indicate that the modified polyimide resin solutions are suitable for coating wires as well as flat surfaces and the adherence/flexibility of the modified polyimide coating can be defined by the silanes selected to modify the polyimide resin.

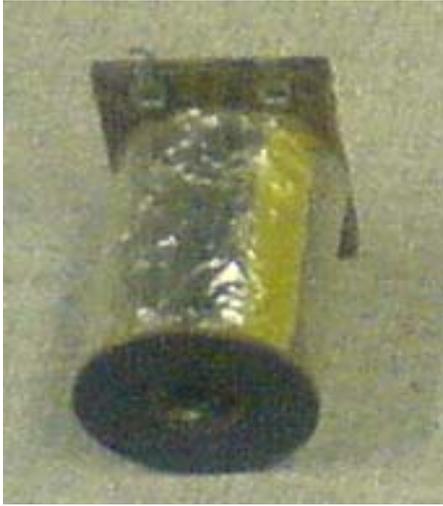
FIGURE F-1. PICTURE OF A COMMERCIAL COIL

Two basic types of coils were studied during the research. The first type of coil is shown in figure F-1 and was purchased or wound with a coil winder in the laboratory. For the laboratory version, fine gauge copper wire was wrapped around plastic tubing to produce the several hundred turn coils. Fine gauge wire with a large number of turns provides stronger signals than coarse gauge wire with a low number of turns. The commercial coils were not flexible but had the advantage that they could be affixed directly to the connector. The second type of coil is an “on-site wound” ten turn coil produced by winding an insulated wire with stripped ends around the wires to be monitored as shown in figure f-2.

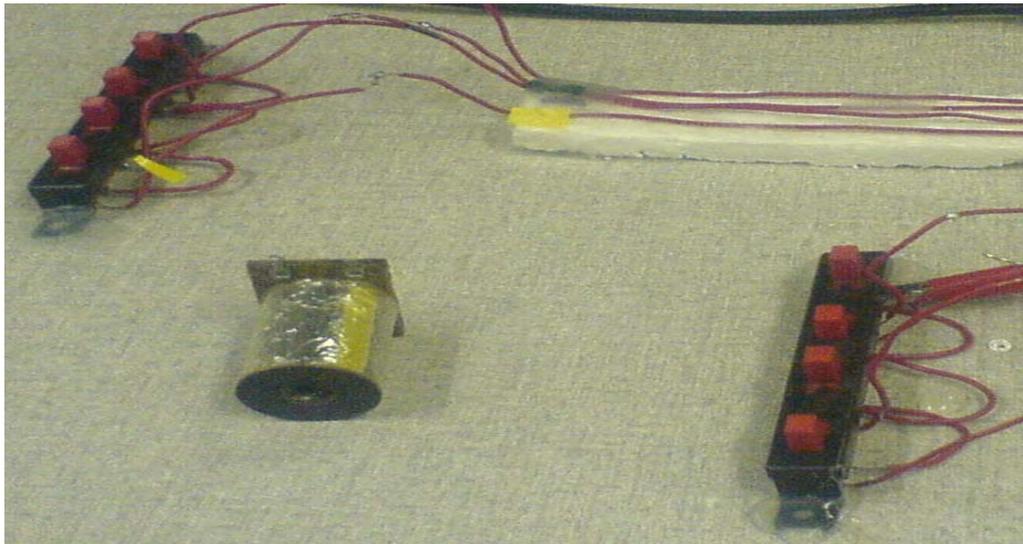
FIGURE F-3. SWITCHES USED TO CHANGE THE SIGNAL PASSING THROUGH THE FOUR WIRES

Wires approximately 2 feet long were soldered onto each connector pin and were labeled to identify each type of degradation. The ends of the wires were connected to switches to help in easy switching and avoid movement of any wires during the measurements as shown in figure F-3. For the prewound coils (laboratory wound and commercial shown in figure f-1), the ends of the four wires on the two sides of each connector were fed through the coils’ center tubes before attaching to the switches. For the third set of tests, insulated wires were tightly wound around the four wires on the two sides of each connector (as shown in figure F-2) after the wires had been attached to the switches. The experimental set-up used to perform the connector degradation tests (performed one connector pin pair at a time) is shown in figure F-4.
