ADS - 19

STRUCTURAL DESIGN FOR FUEL CONTAINMENT UNDER SURVIVABLE CRASH CONDITIONS

General Dynamics | Convair, San Diego, Calif.

FEDERAL AVIATION AGENCY

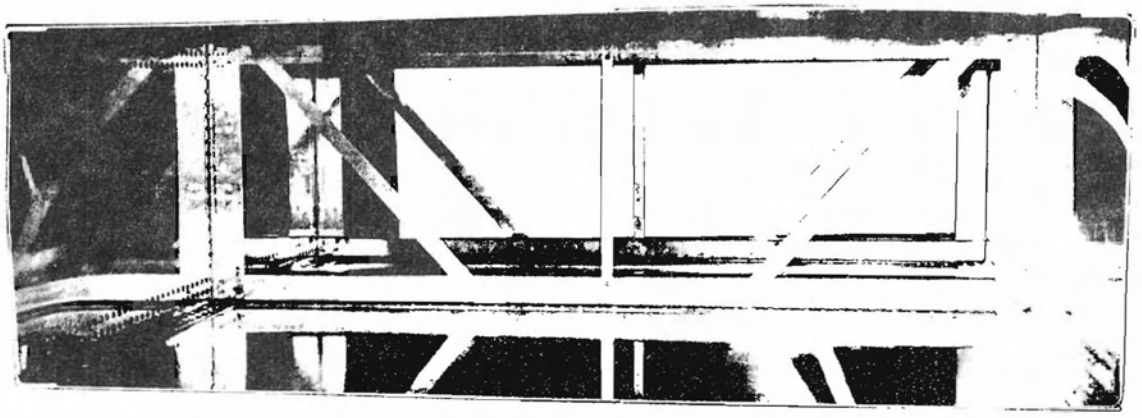
Figure B-10. Test Tank No. 1. This was a light, simple tank specimen measuring 16" x 48" x 72". Filled with water, 48" chord simulated 60" chord fuel filled tank.

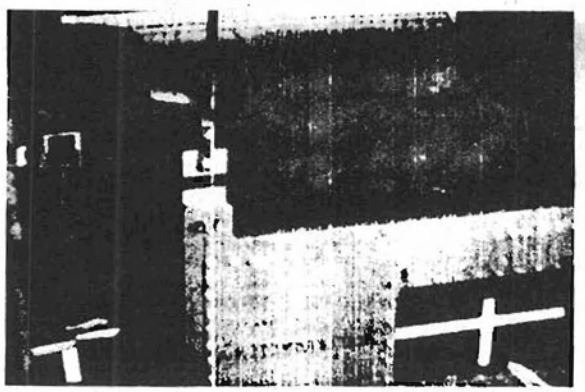
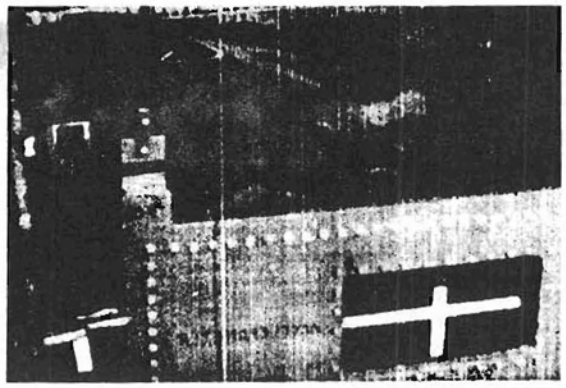
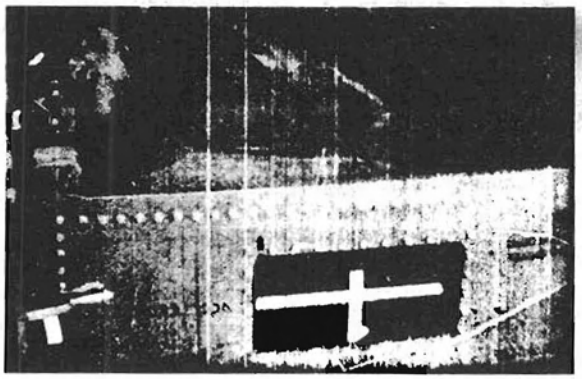
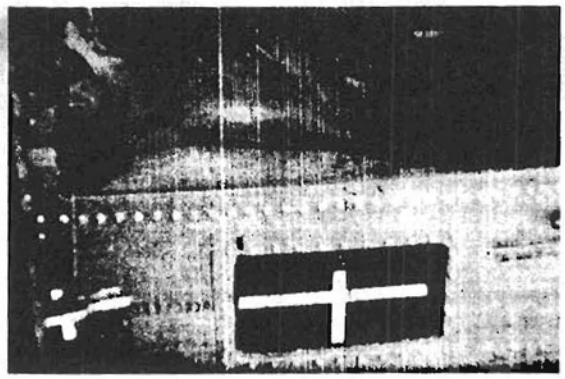
Figure B-11. Drop No. 4, Log Impact, Tank No. 1. Max. velocity 25.4 fps, peak load 34,100 lb.

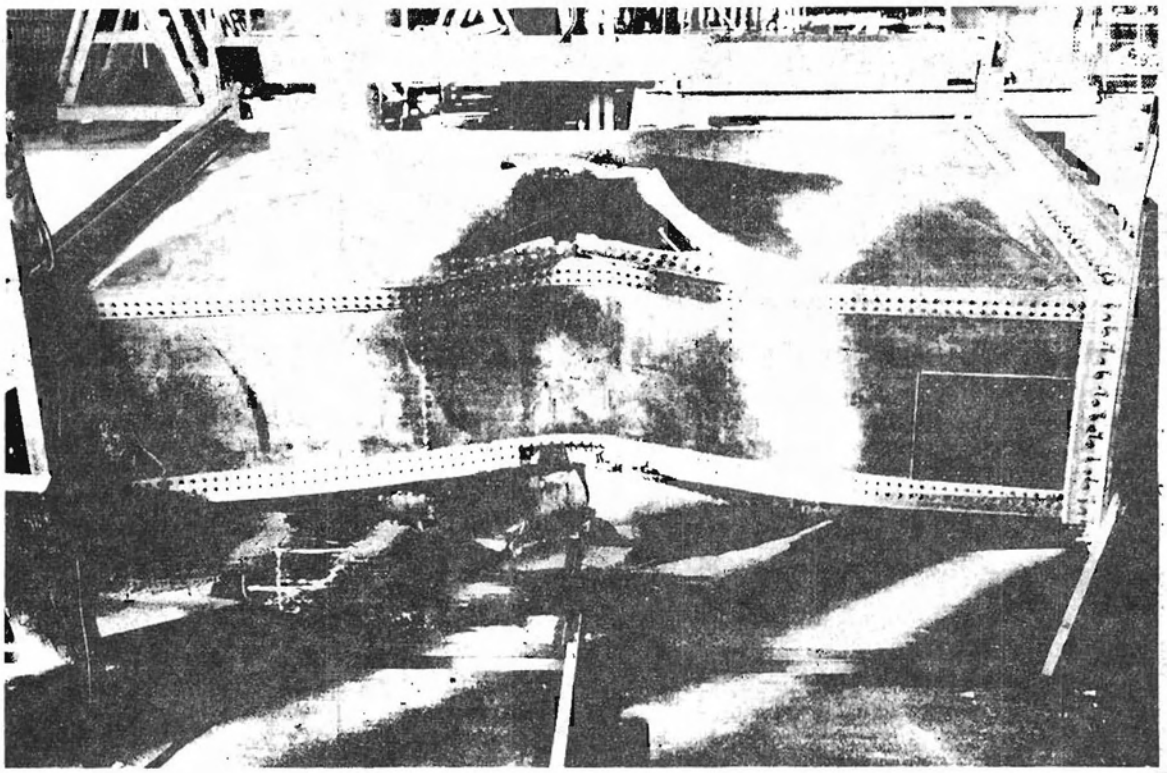
Figure B-12. Failure of No. 1 Test Tank. Result of Drop No. 4 — log impact test, 10-ft. drop height, impact load 34,100 lb.

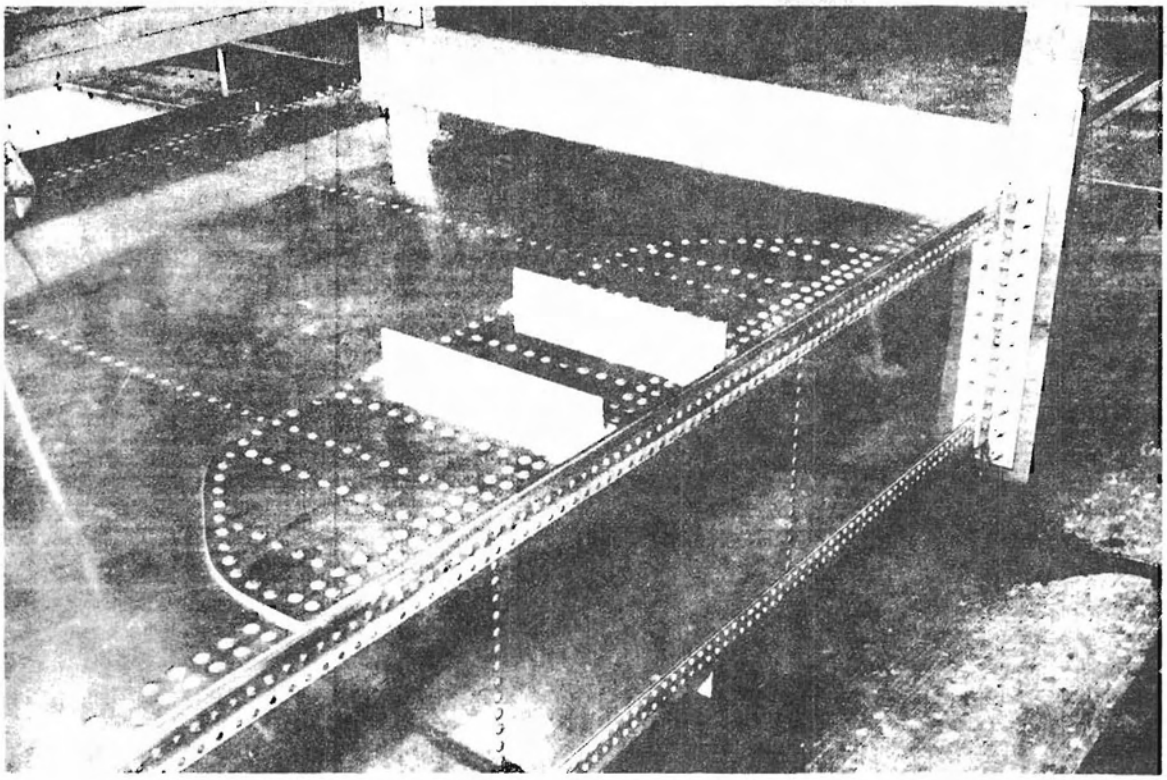
Figure B-13. Test Tank No. 2. Specimen was identical to Tank No. 1 except for skin stiffening on upper and lower surfaces.

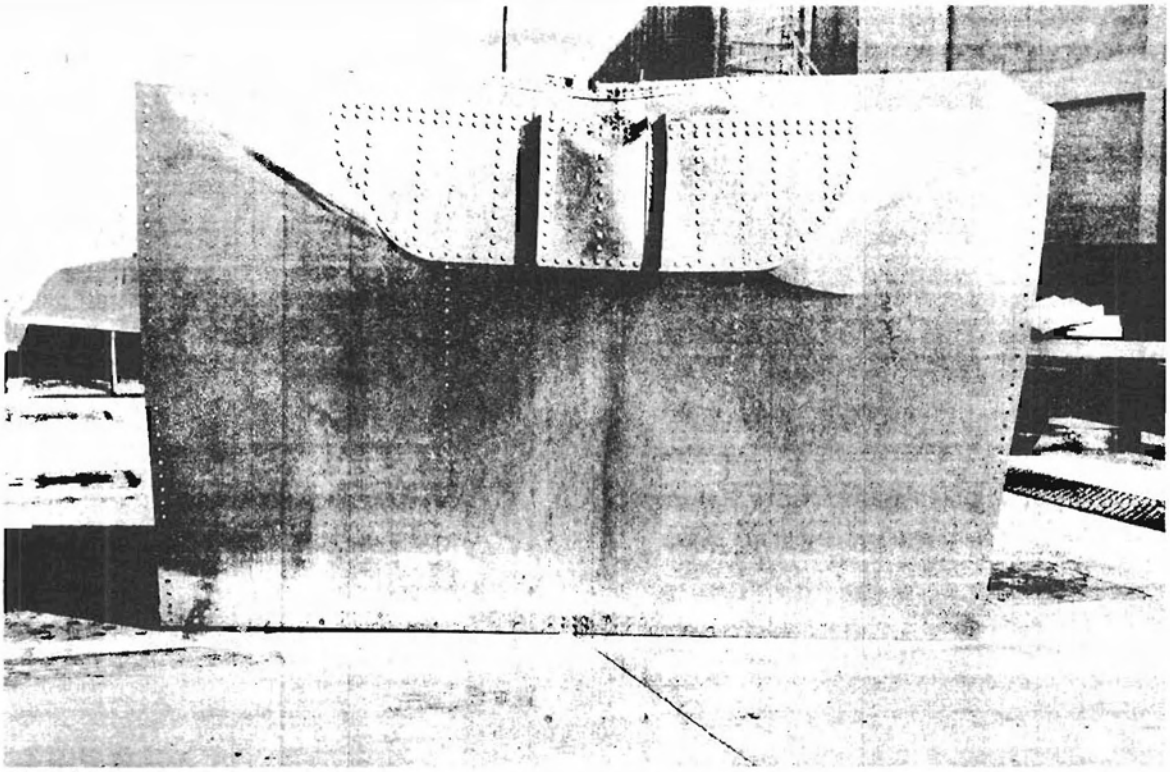
Figure B-14. Failure of Tank No. 2. Failure of upper surface after Drop 10, log impact — 6-ft. drop height, impact load 52,700 lb.

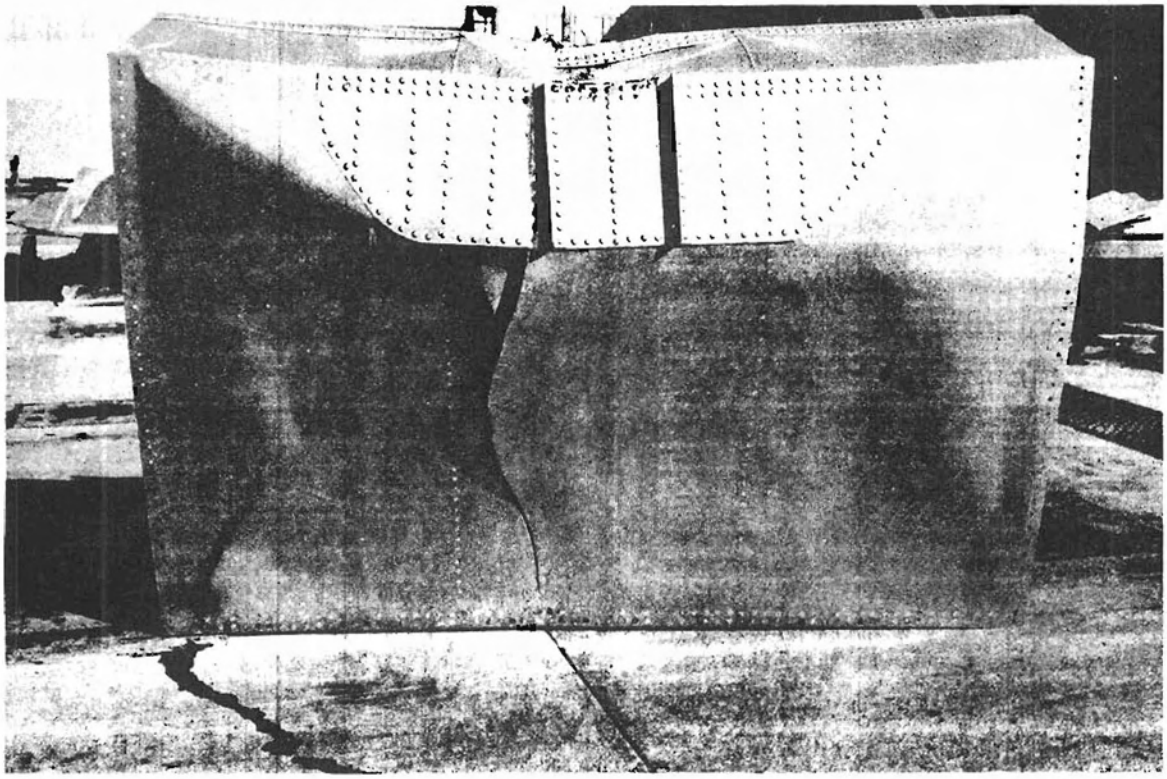
Figure B-15. Failure of Tank No. 2. Lower surface shown; note bending failure of doubler.

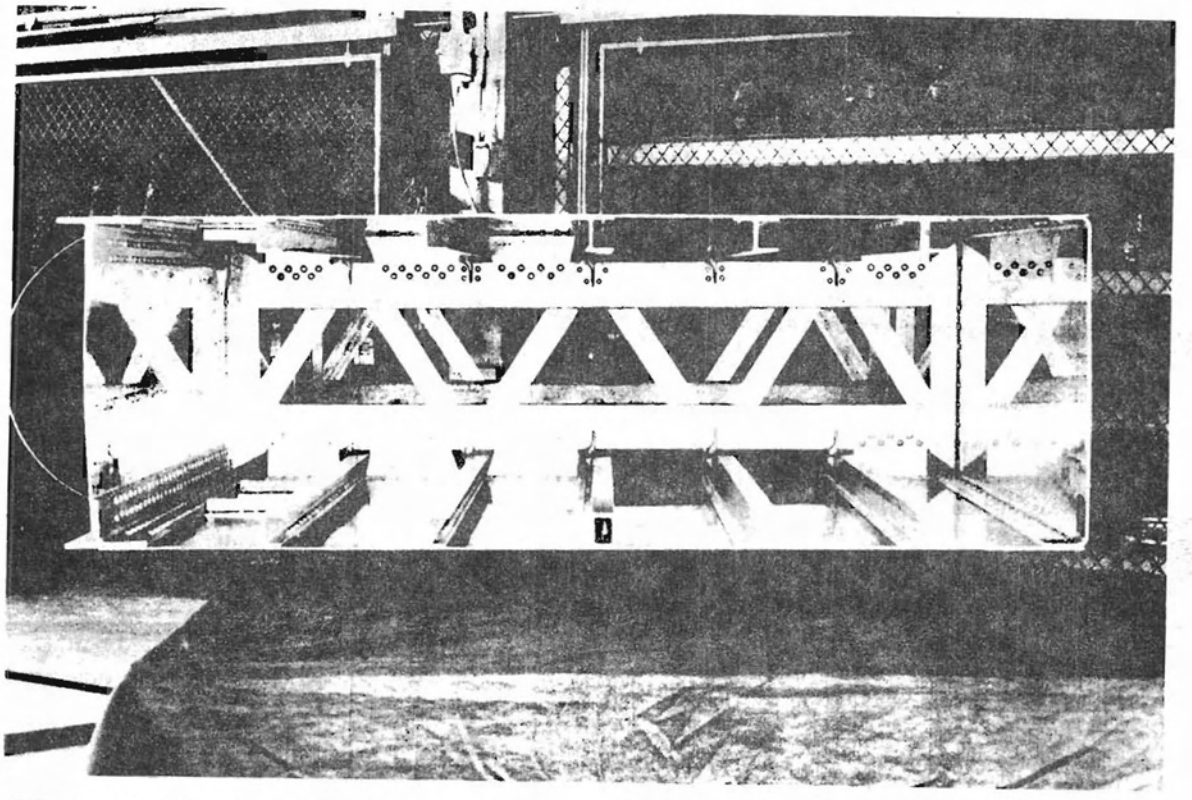
Figure B-16. Test Tank No. 3. Tank structure was similar to wing of existing jet transport.

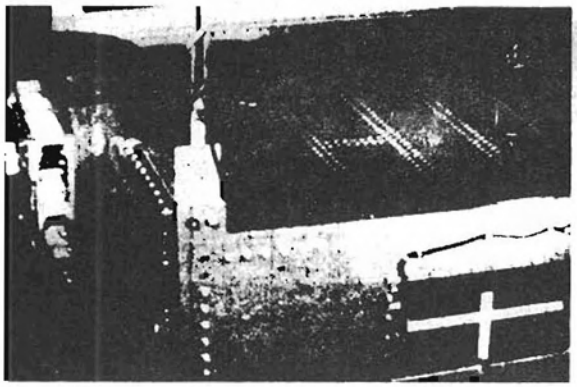
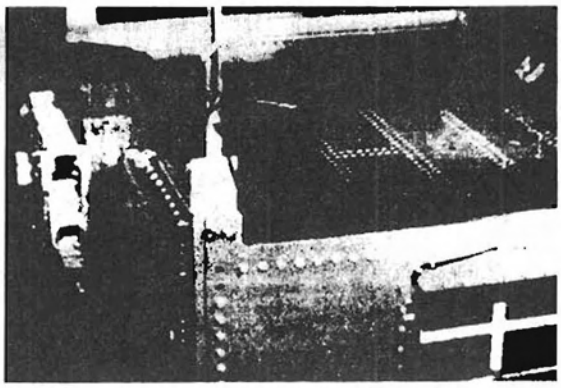
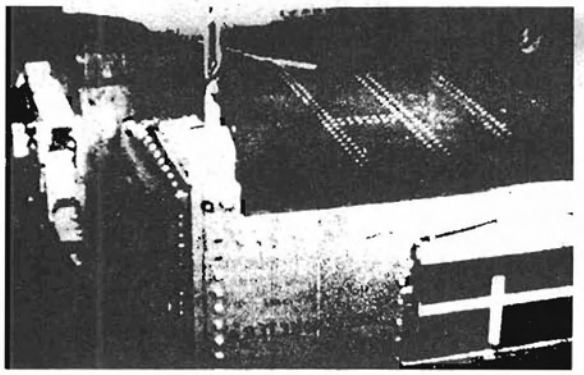
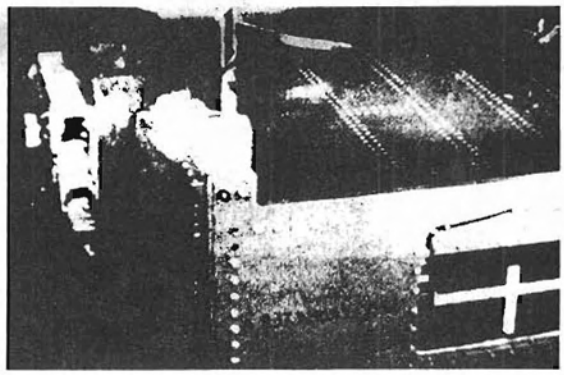
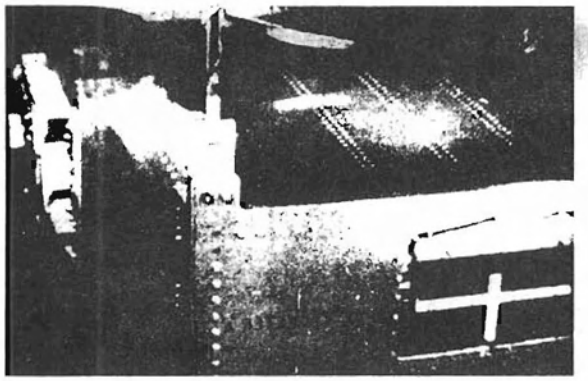
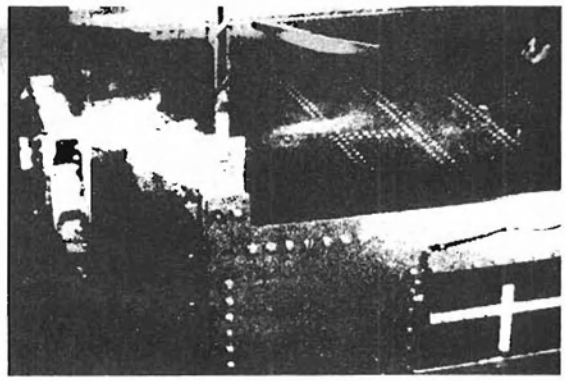
Figure B-17. Drop No. 12. Log impact, Tank No. 3, max. velocity 17.9 fps, peak load 70,070 lb.

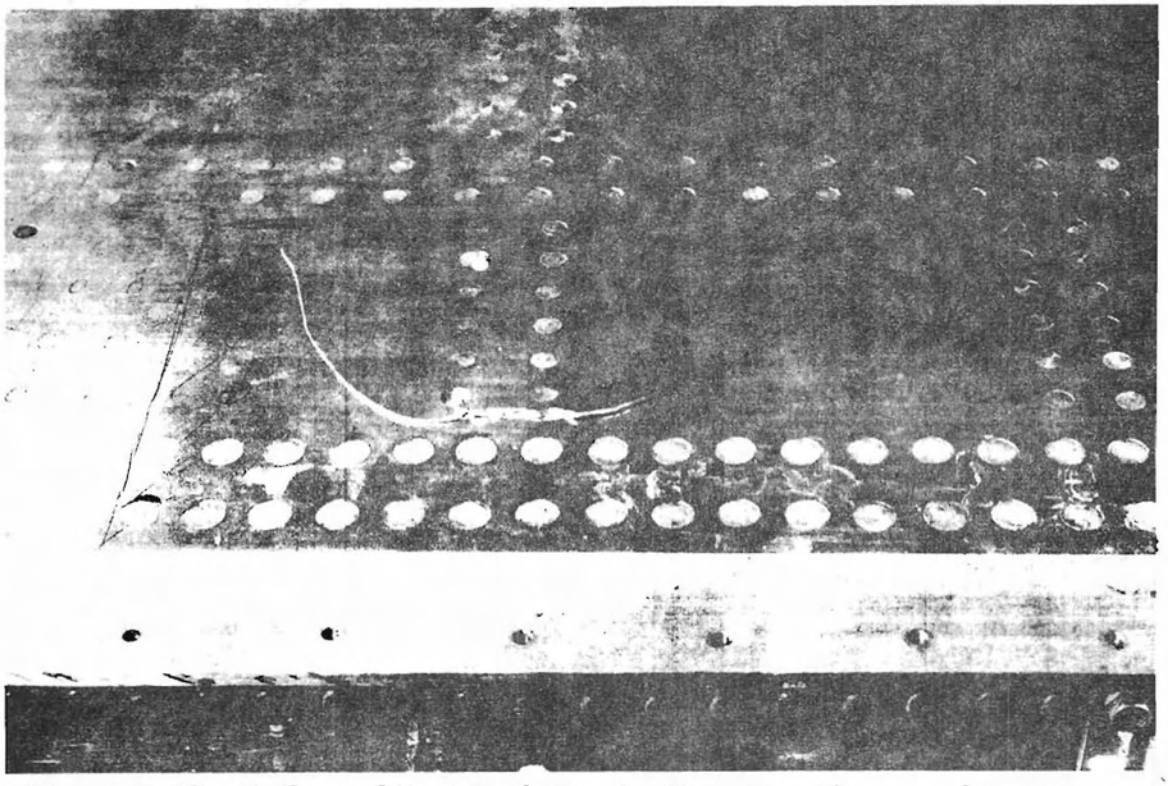
Figure B-18. Failure of Test Tank No. 3. Drop No. 12 upper skin rupture at front spar resulted from log impact test from 5-ft. drop height. Similar fracture appeared at other rib, lower skin did not fail. Impact load was 70,070 lb.

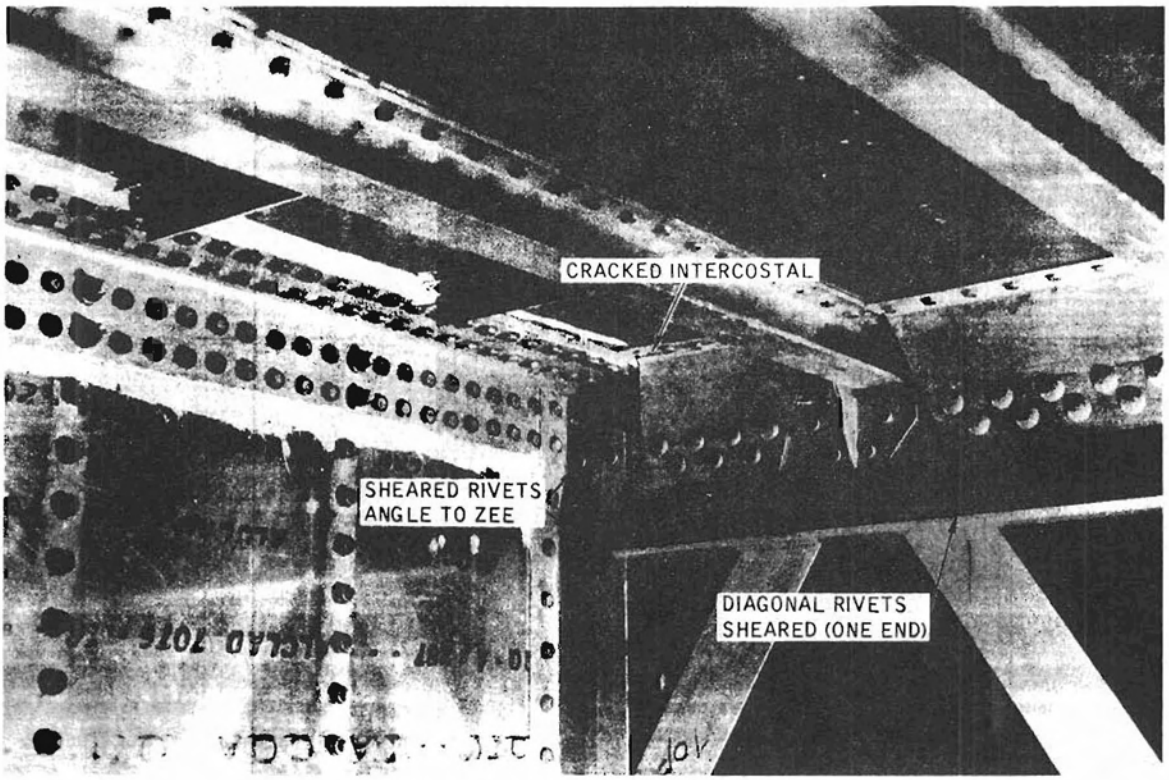
Figure B-19. Internal Failure of Test Tank No. 3.

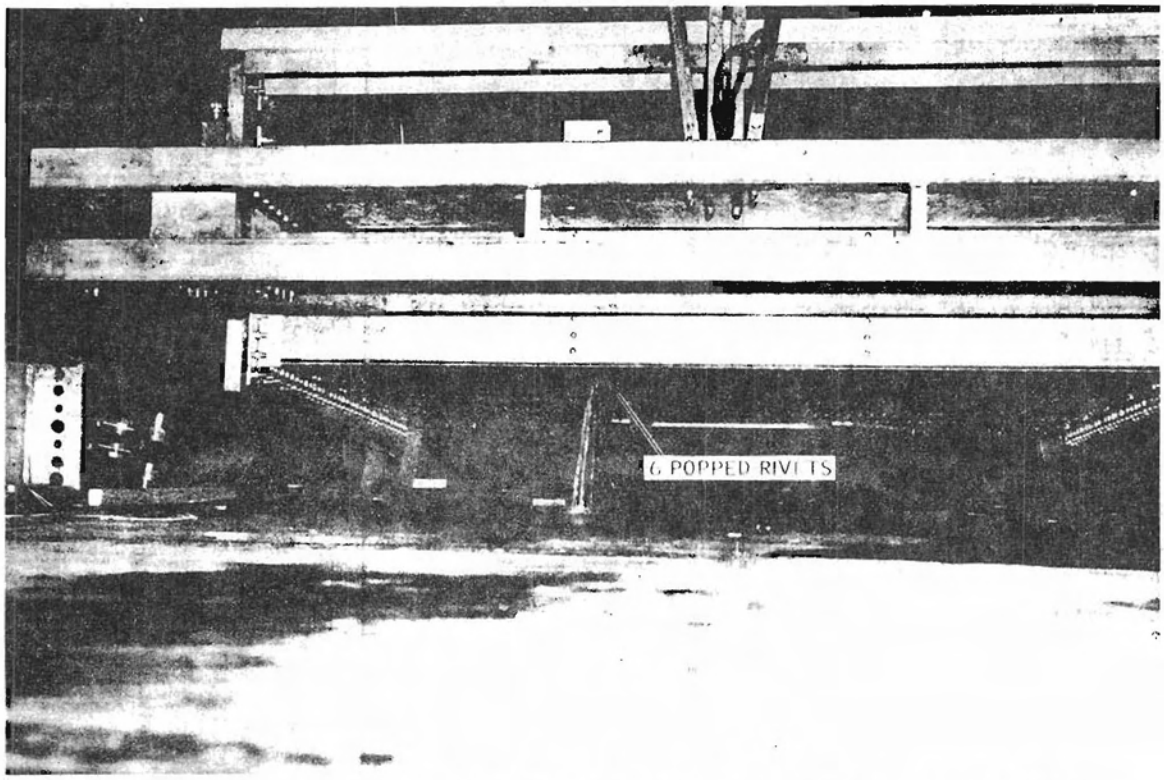
Figure B-20. External Damage to Test Tank No. 4. Tank was rebuilt from Tank No. 3. Steel rivets were added internally and skin doublers were added to the upper and lower surfaces (Figure B-24). Six rivets popped during Drop No. 18 — a 40-g arrested stop.

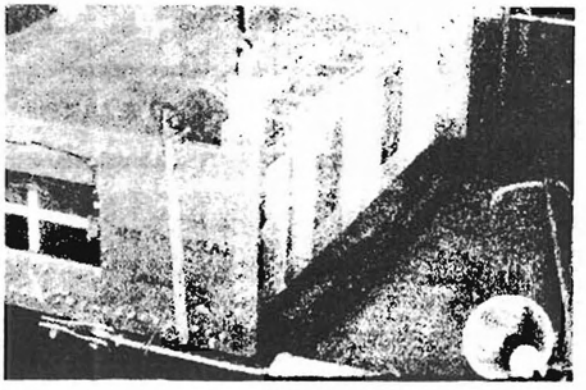
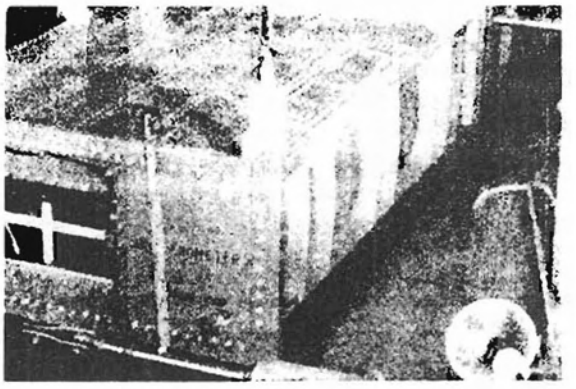
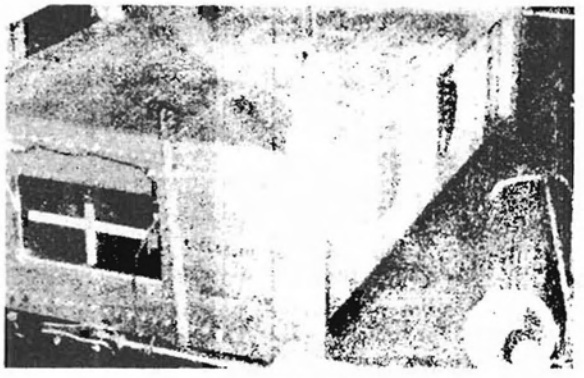
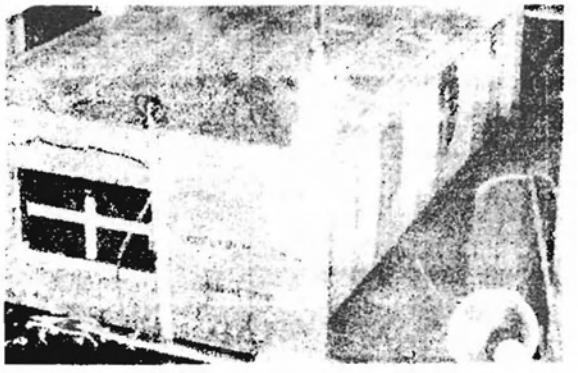
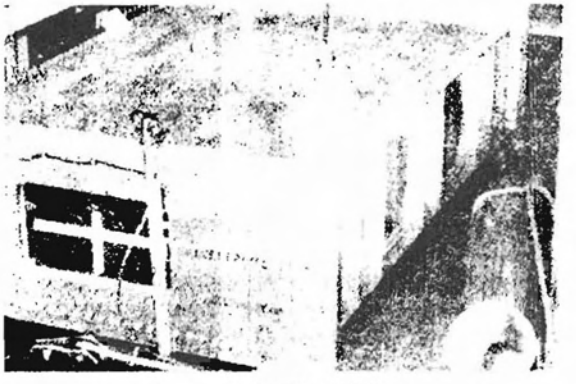
Figure B-21. Drop No. 18. 40-g arrested stop, Tank No. 4, impact velocity 48.4 fps, peak load 97,600 lb.

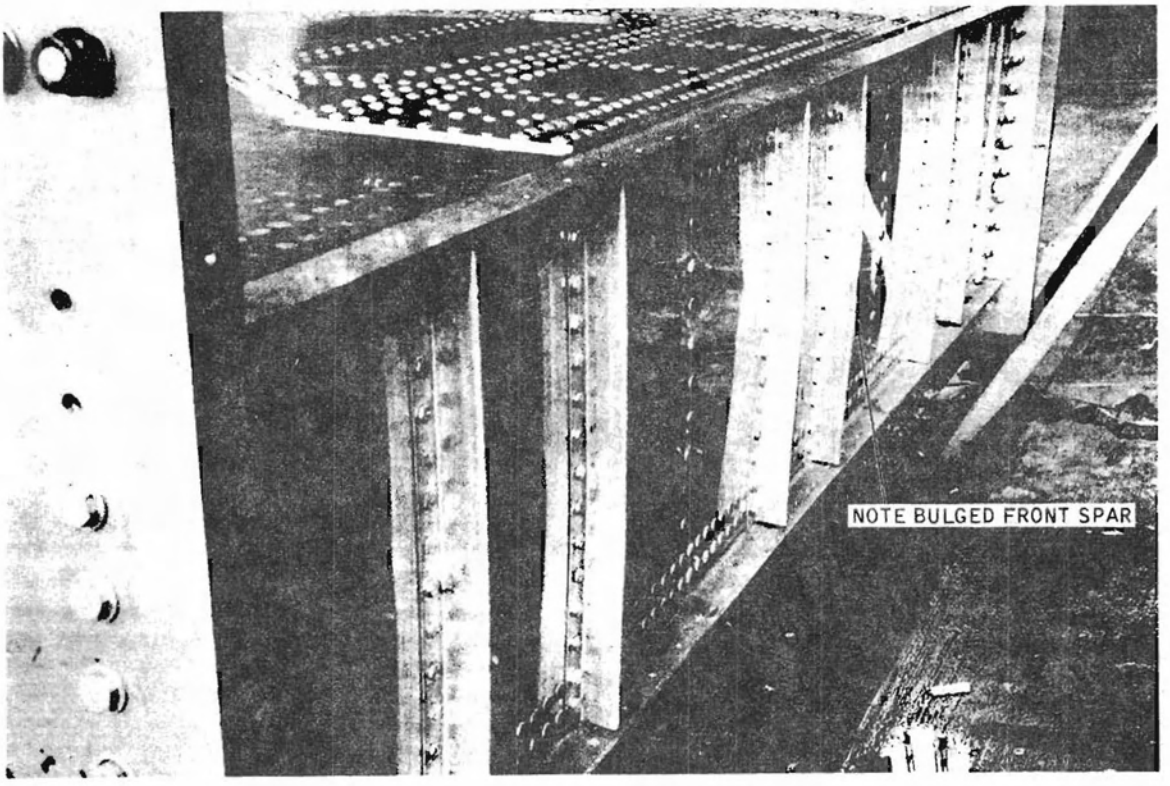
Figure B-22. Further External Damage to Tank No. 4. This shows bulge of front spar as a result of Drop No. 18 — a 40-g arrested stop. Only leakage was that shown in Figure B-20.

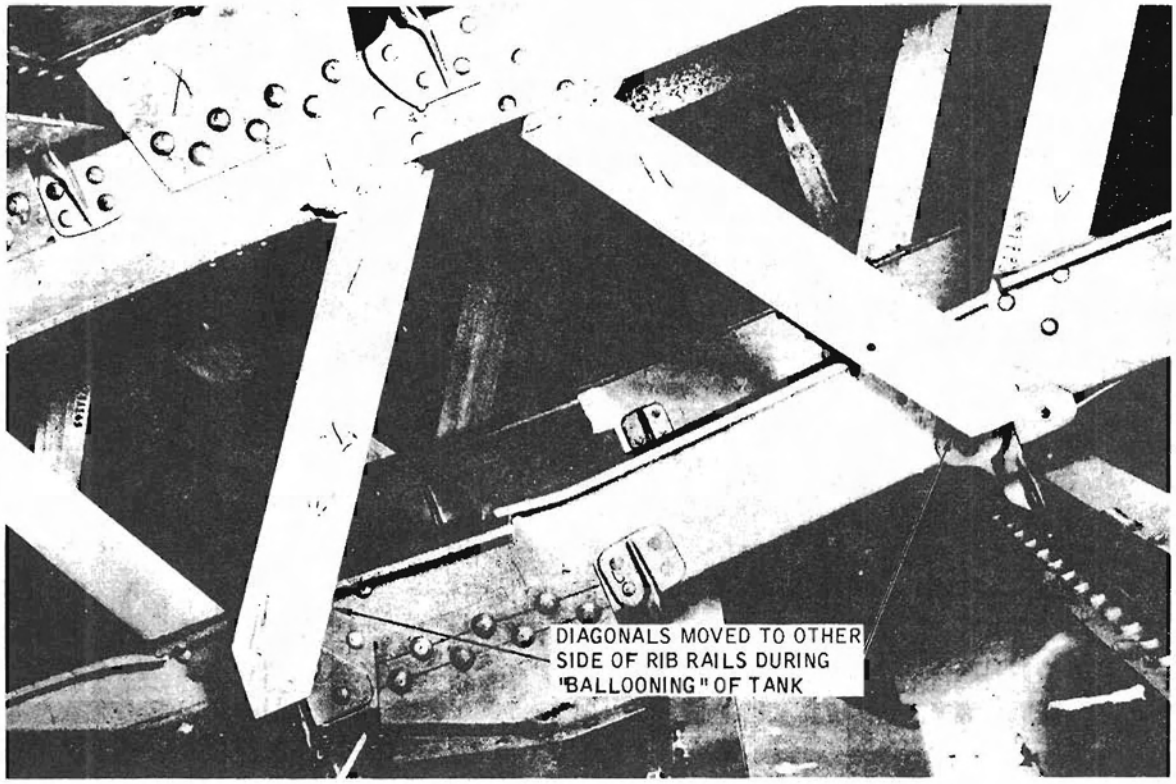
Figure B-23. Internal Damage to Tank No. 4. This shows further damage resulting from 40-g arrested stop. Note extreme deflections that must have occurred to allow two diagonals to switch from inboard to outboard side of rib rails.

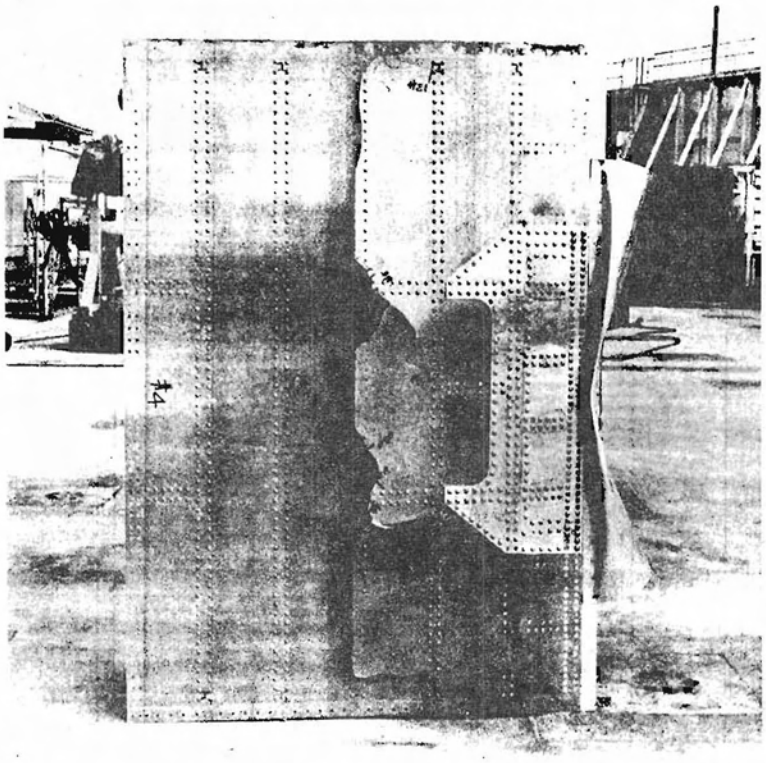
Figure B-24. Complete Failure of Test Tank No. 4. The six popped rivets shown in Figure B-20 were replaced and a log impact series of tests was begun. This shows progressive failure resulting from Drops 19, 20 and 21. Initial skin failure was 2-in. crack at an aft end of third-bay intercostal. Max. impact load was 94,100 lb.

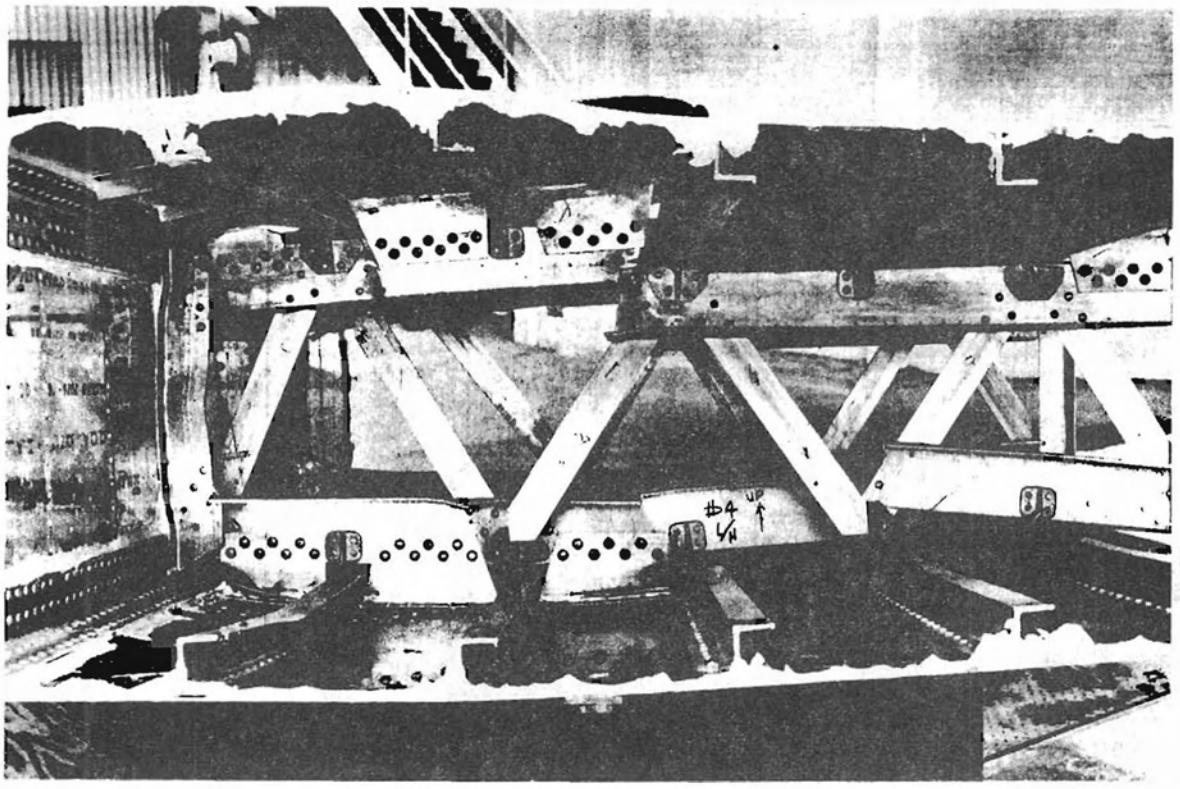
Figure B-25. Final Internal Damage to Tank No. 4

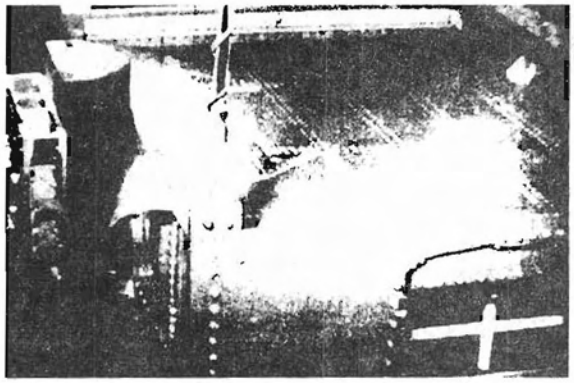
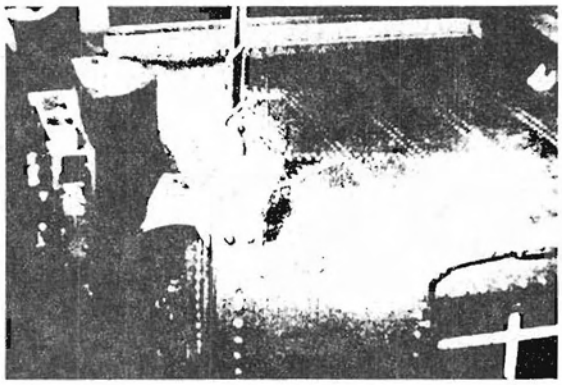
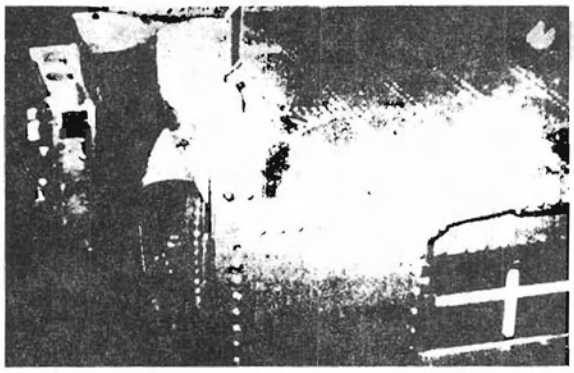
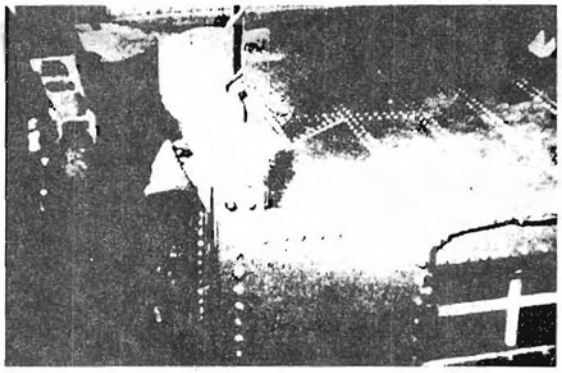
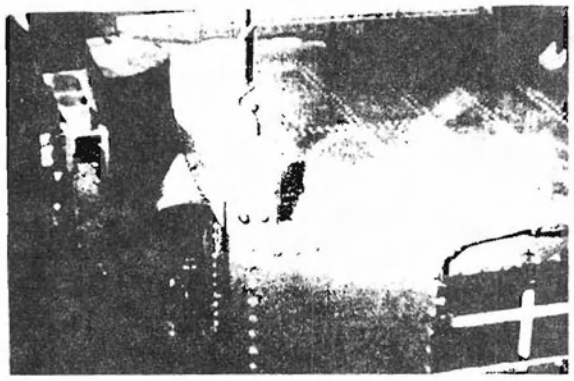
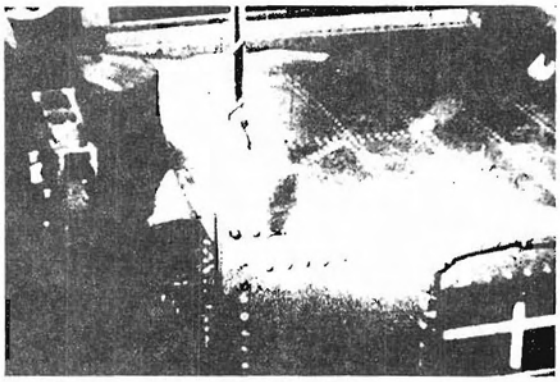
Figure B-26. Drop No. 19. Log impact, Tank No. 4, impact velocity 17.9 fps, peak load 70,200 lb.

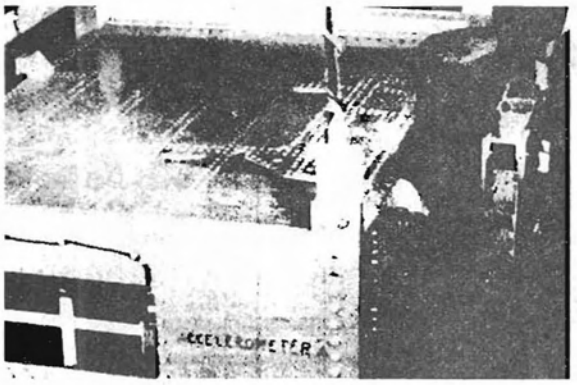
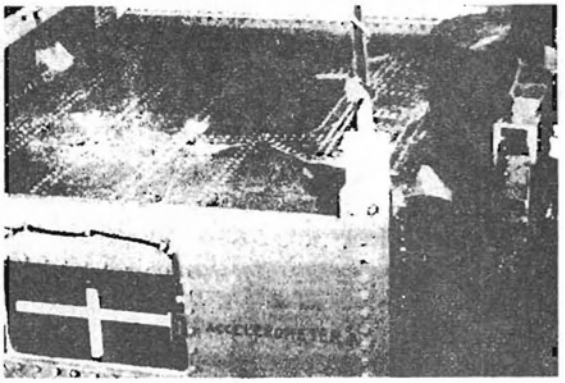
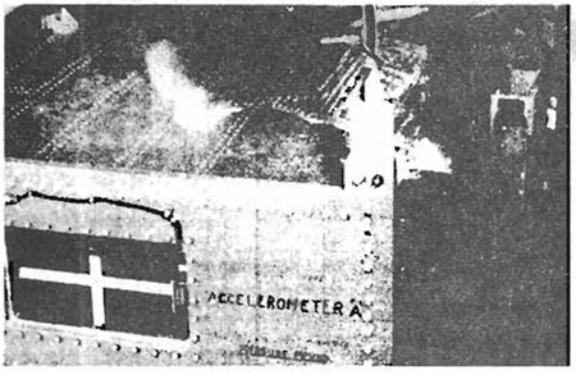
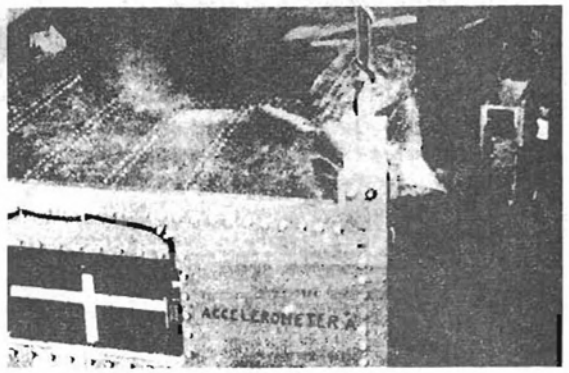
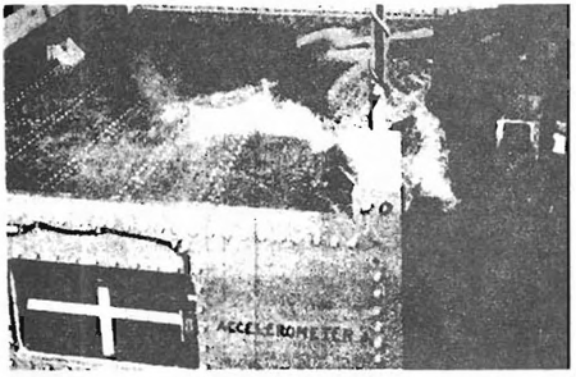
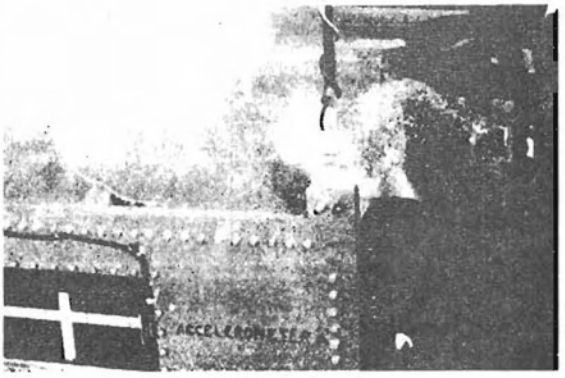
Figure B-27. Drop No. 21. Log impact, Tank No. 4, impact velocity 24 fps, peak load 94,100 lb.

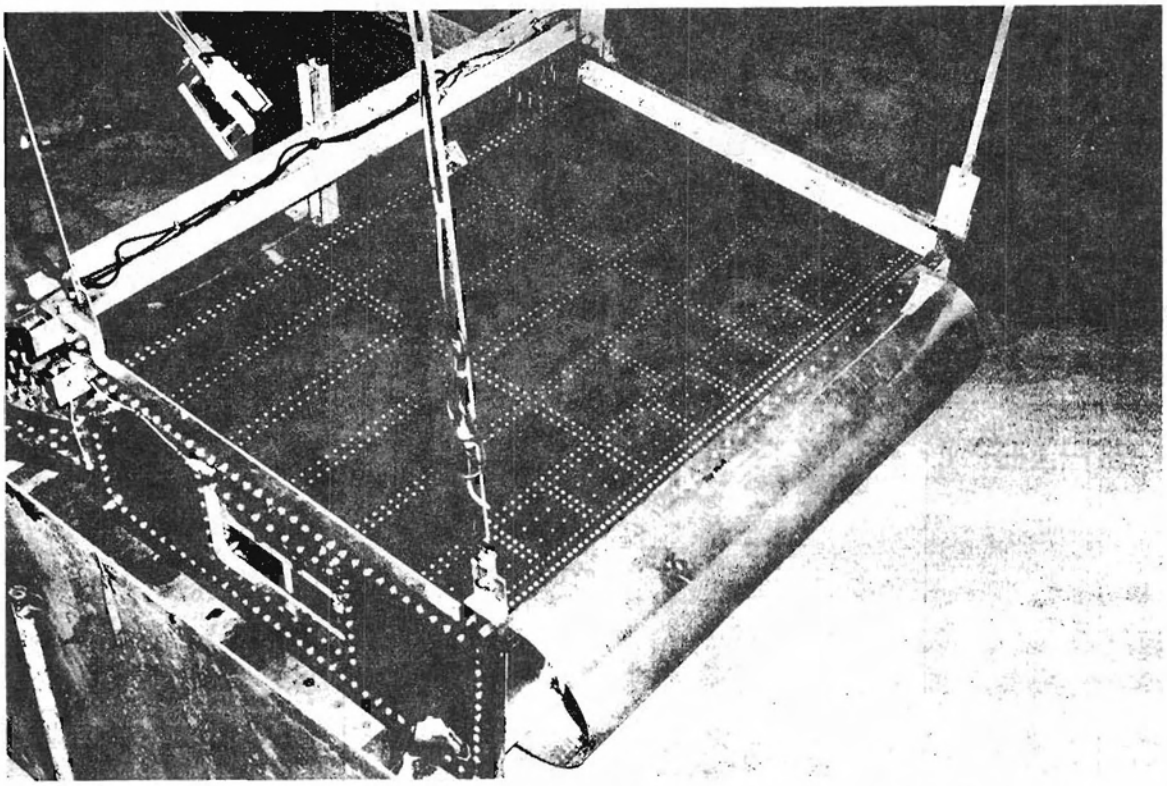
Figure B-28. Test Tank No. 6. Tests tanks 5 and 6 were identical and incorporated better features of previous tanks, plus web-type ribs.

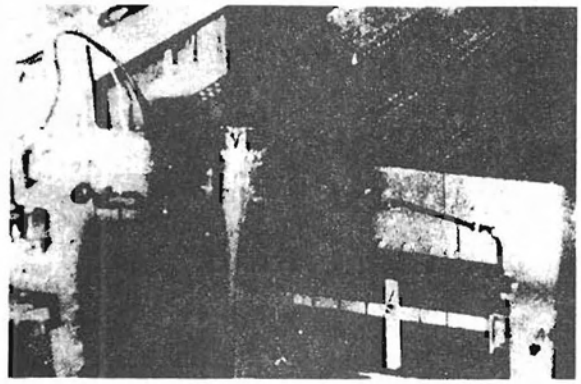
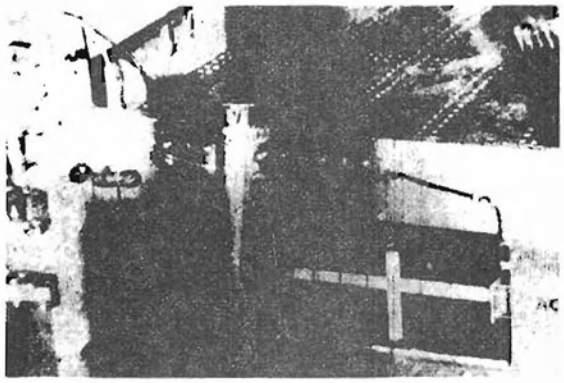
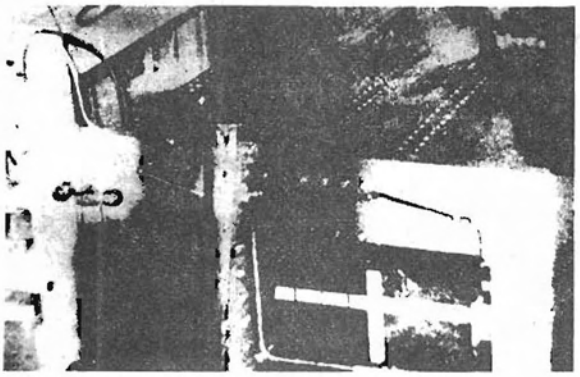
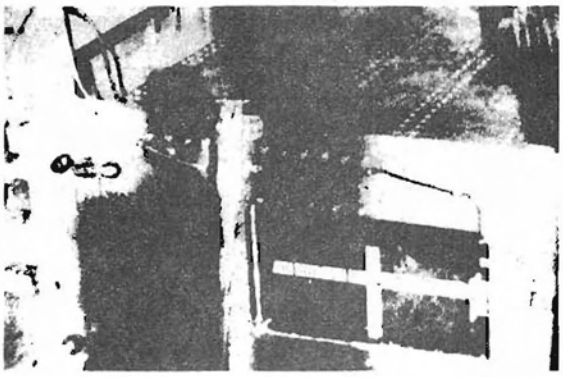
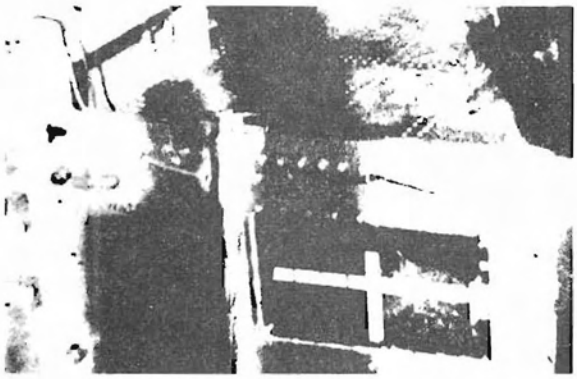
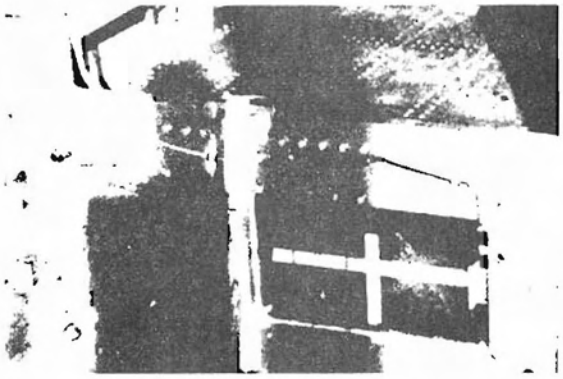
Figure B-29. Drop No. 25. Log impact, tank No. 5, impact velocity 27.8 fps, peak load 97,000 lb.

Figure B-30. Upper Skin Fracture, Tank No. 5. Result of Drop No. 25: log impact test from drop height of 12 ft.; impact load was 97,000 lb.

Figure B-32. Front Spar of Tank No. 5. Result of Drop 25, most fuel leakage was from this fracture.

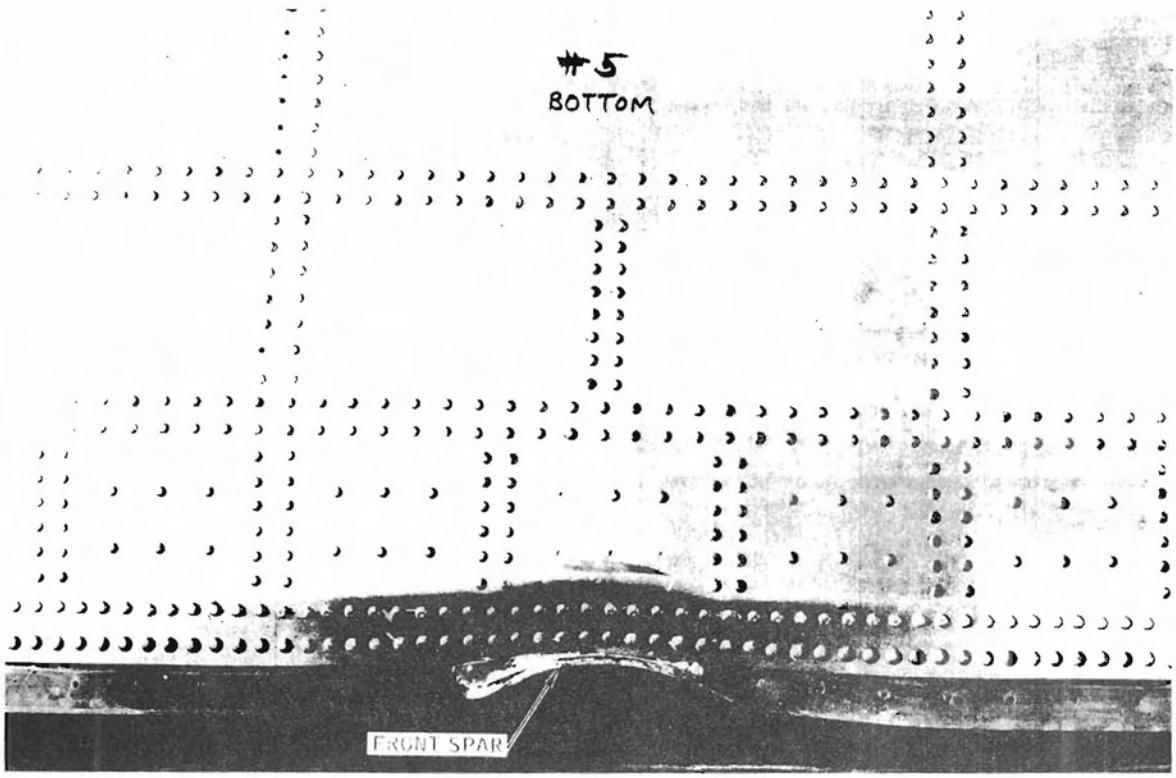
Figure B-31. Lower Surface of Tank No. 5. Results of Drop 25, impact load was 97,000 lb.

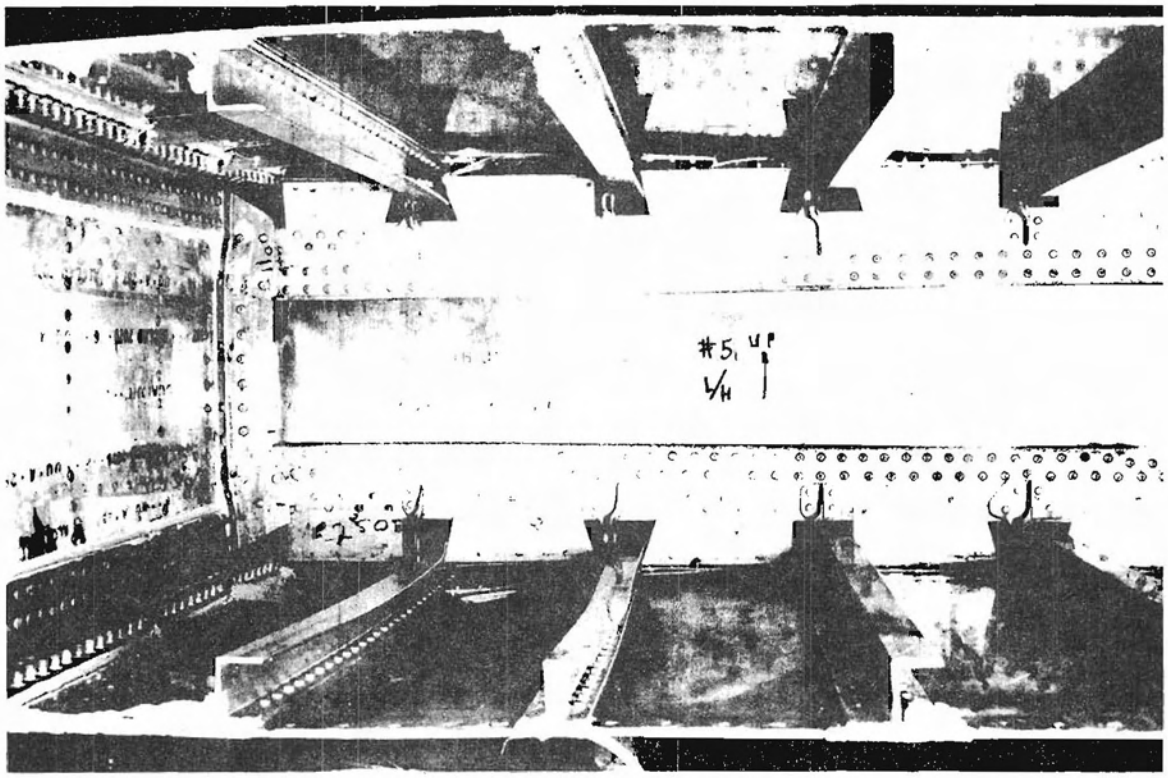
Figure B-34. Internal Damage to Tank No. 5. Results of Drop 25, log impact test, max. impact load was 97,000 lb.

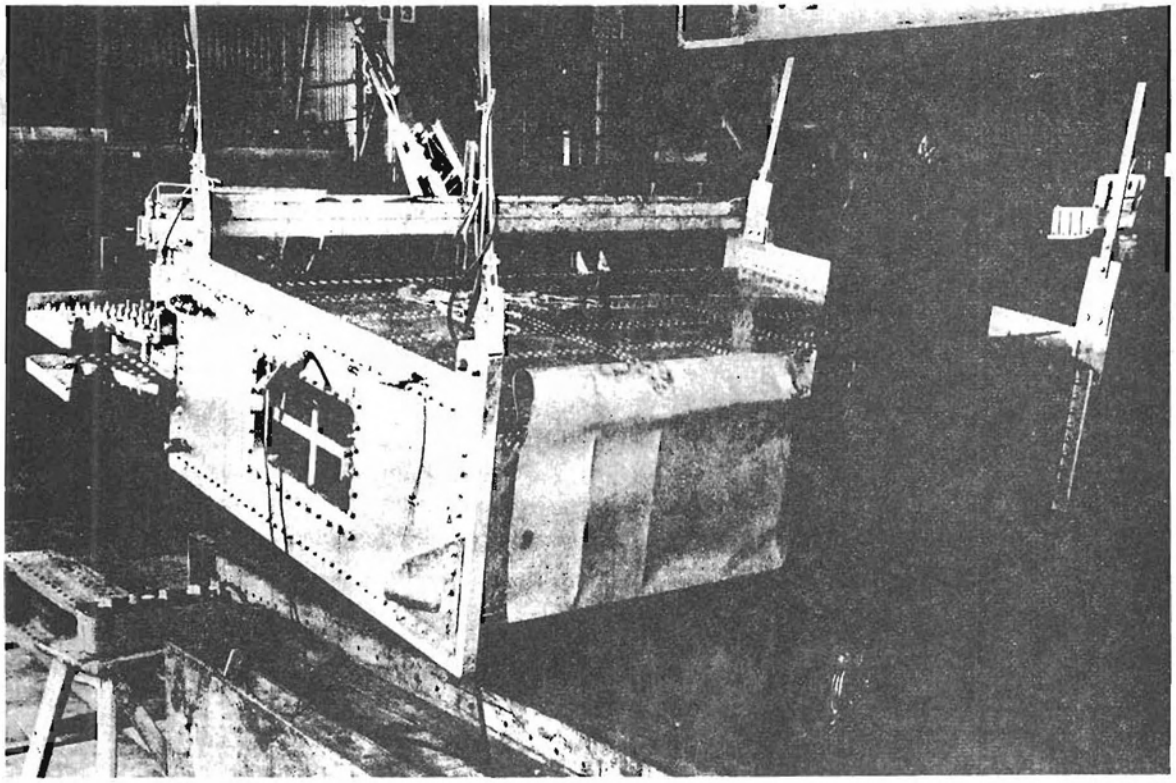
Figure B-35. Test Tank No. 6. Tank is shown prior to Drop 47 after sustaining a series of sand and sand-rock pile tests and after having broken several poles. This tank eventually broke a 17.4-in. diameter piling.
