ADS - 19

STRUCTURAL DESIGN FOR FUEL CONTAINMENT UNDER SURVIVABLE CRASH CONDITIONS

General Dynamics | Convair, San Diego, Calif.

FEDERAL AVIATION AGENCY

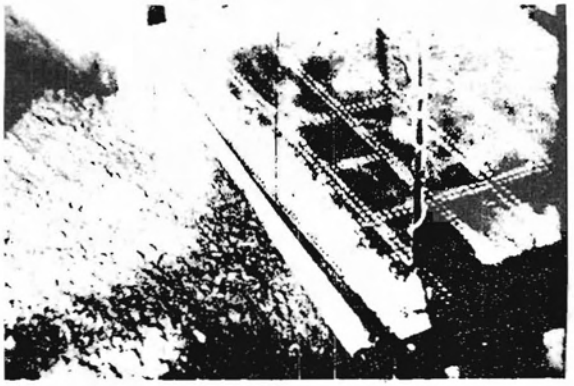
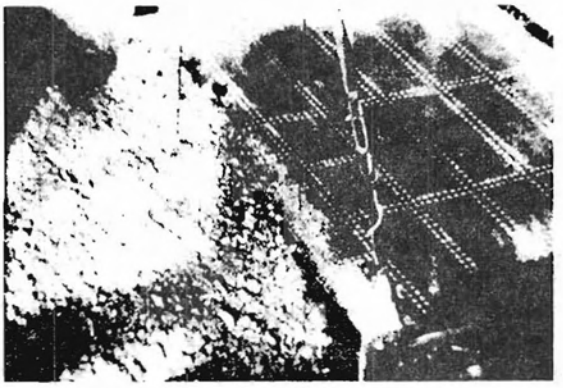
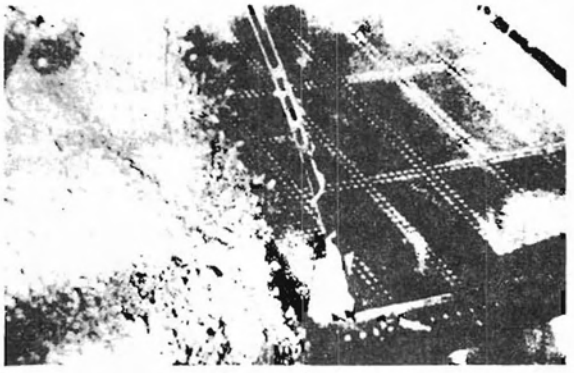
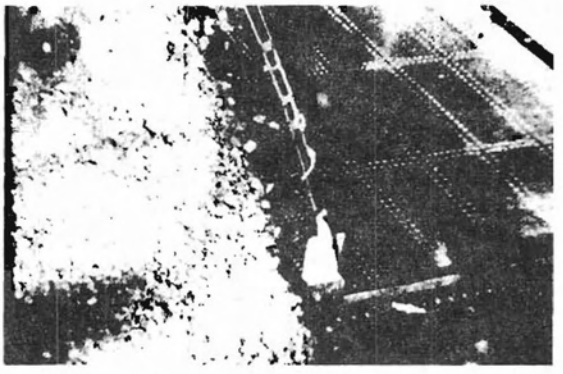
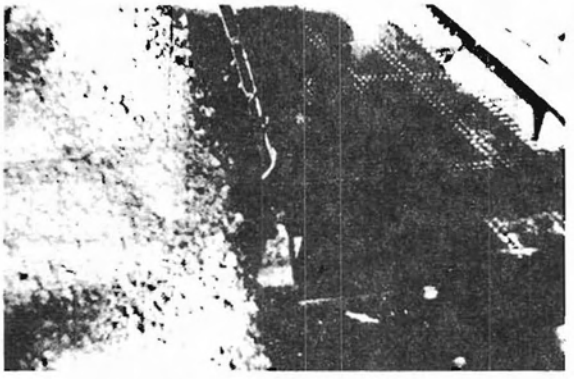
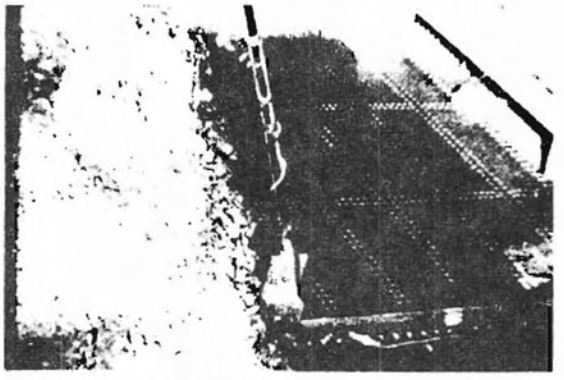
Figure B-36. Drop No. 39. Tank No. 6, 30-degree sand/rock pile, 40.1-fps impact velocity.

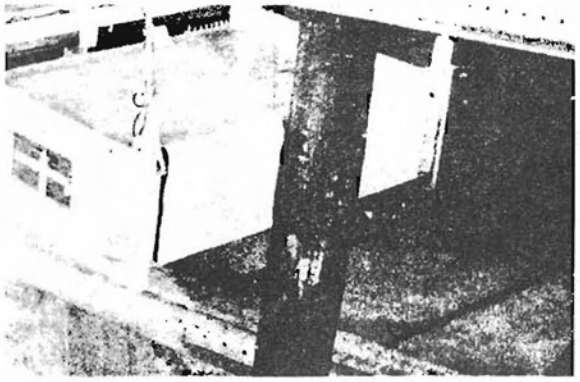
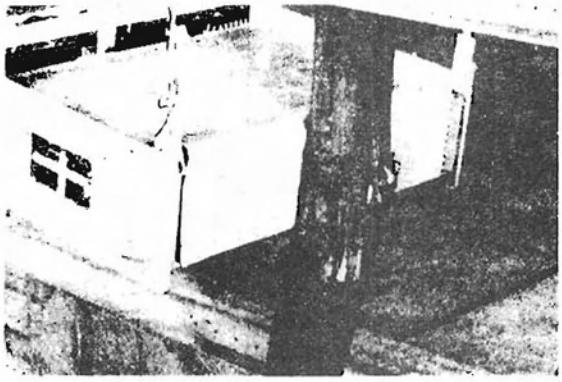
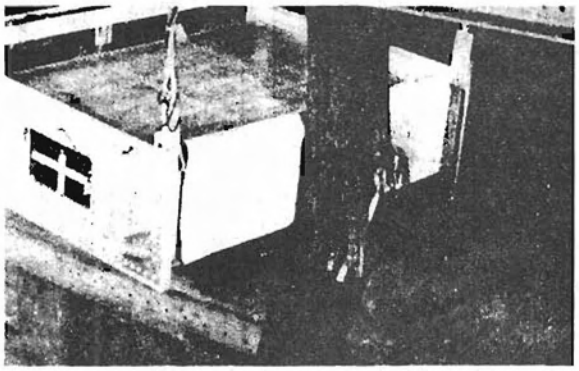
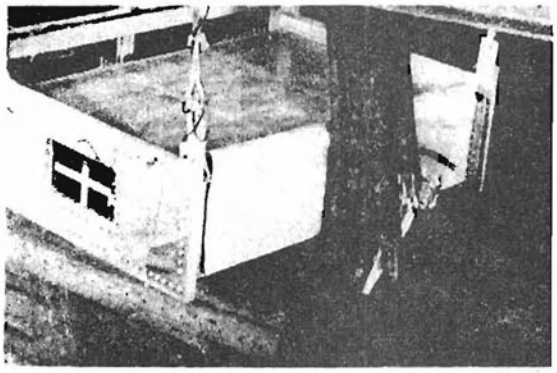
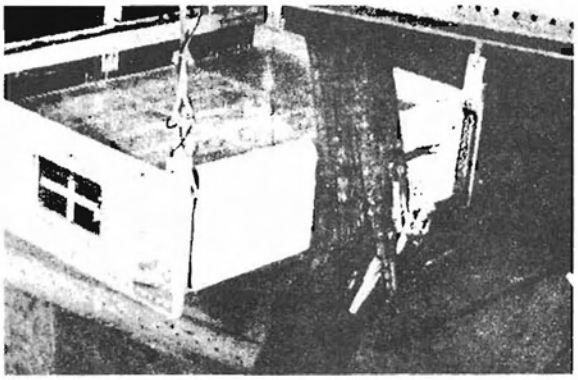
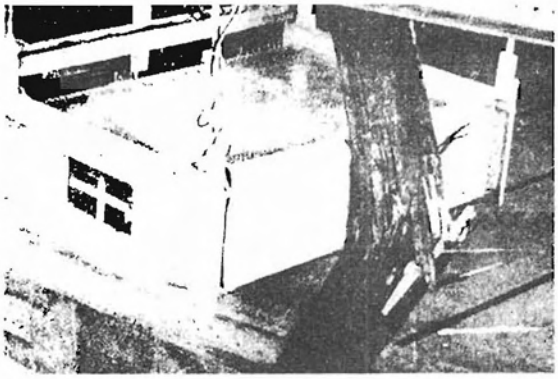
Figure B-37. Drop No. 50. Tank No. 6, 16-in. diameter pole, 41-6 fps impact velocity.

Note 4. The outstanding leg of the most forward intercostals began to crack during Drop No. 49. The cracks progressed slowly through Drop No. 52.

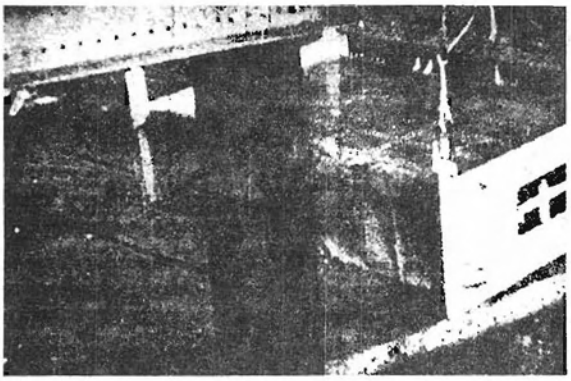
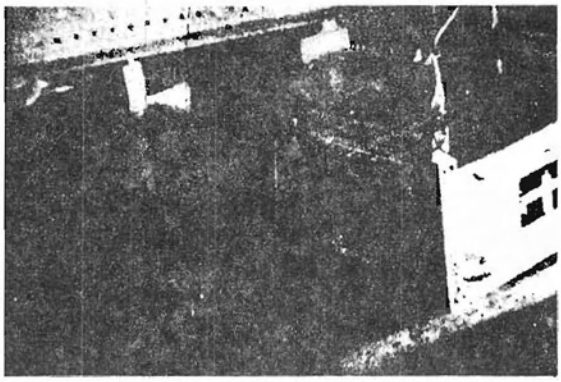
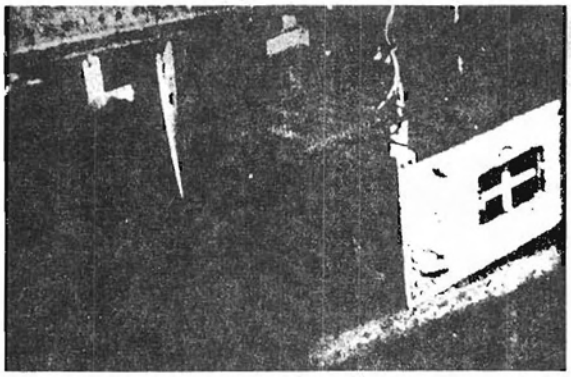
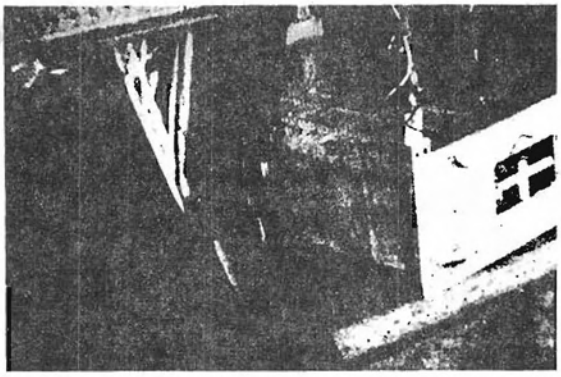
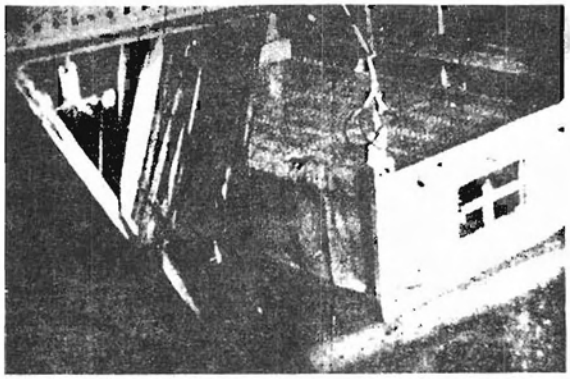
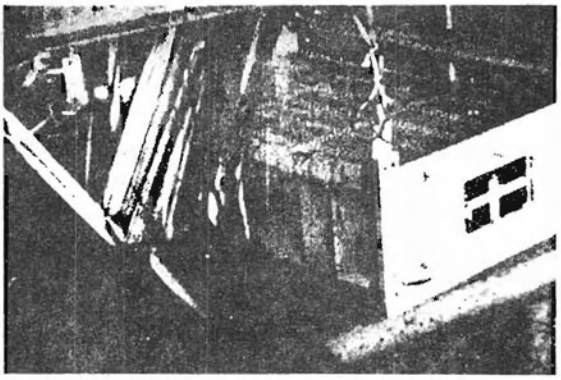
Figure B-38. Drop No. 52. Tank No. 6, 17.4-in. diameter piling, 47.4-fps impact velocity.

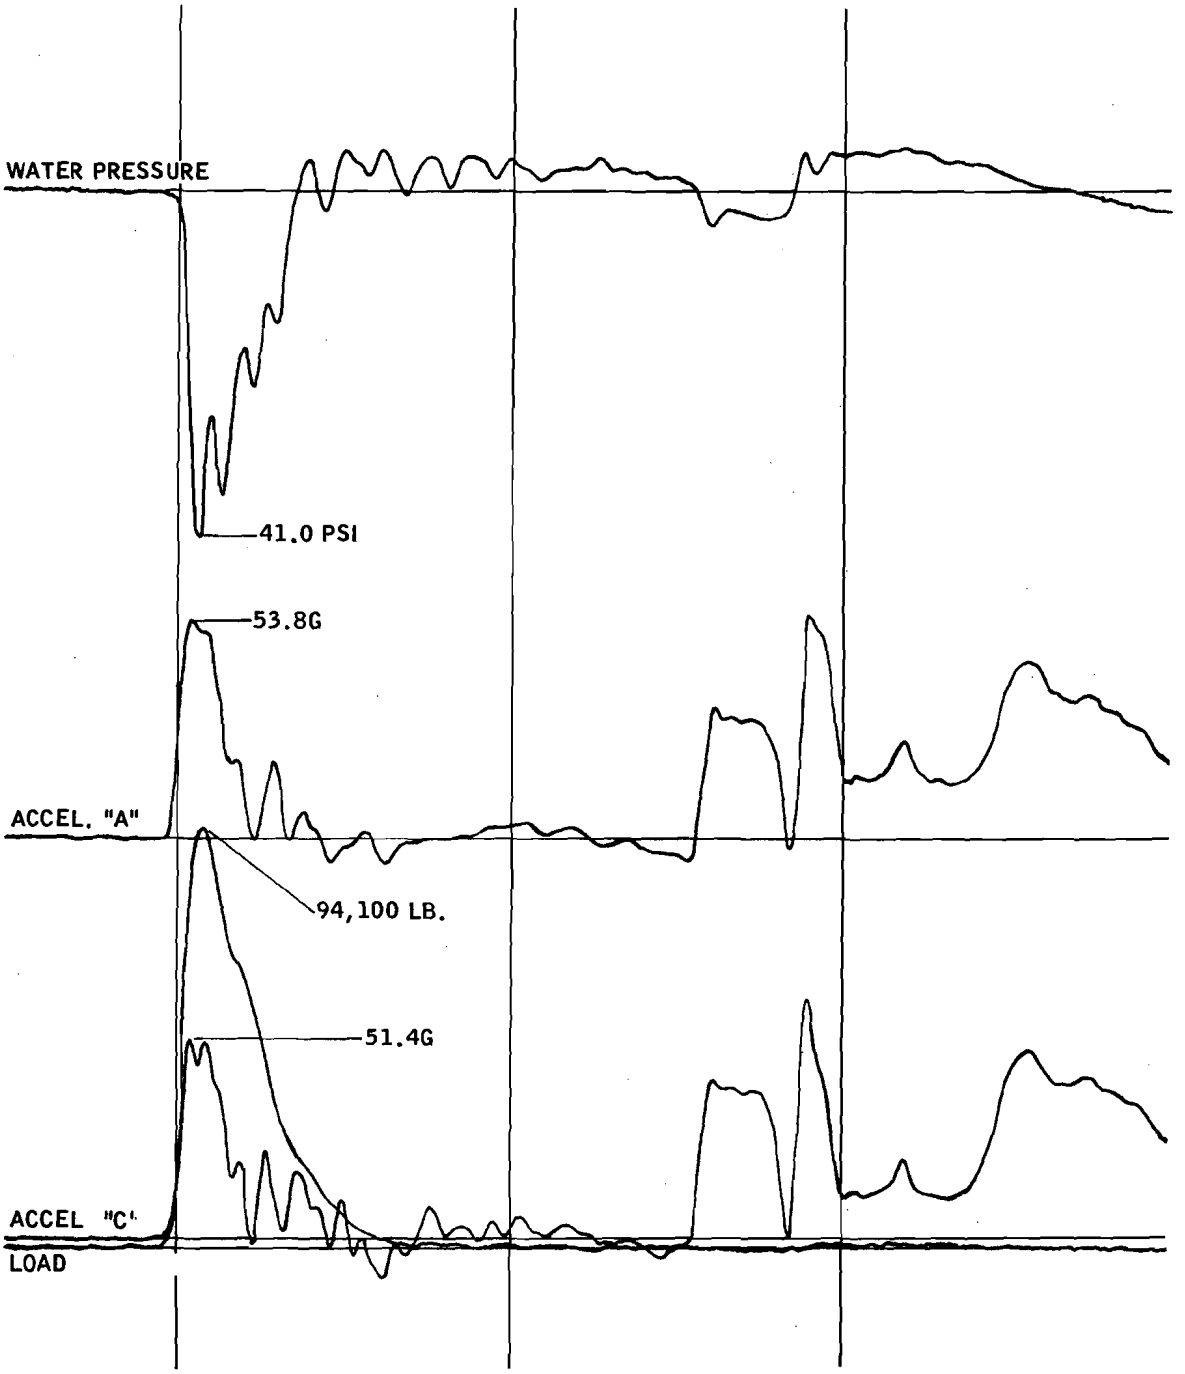
Figure B-45. Drop No. 21, 9-ft. Log Impact

Note 2. Figure B-24 shows progressive skin failure resulting from three successive drop tests. Drop No. 19 caused cracks approximately 2 in. long at the aft end of the intercostals supporting the third skin bay. Drop No. 20 extended the cracks somewhat and Drop No. 21 extended the cracks from tip to tip.

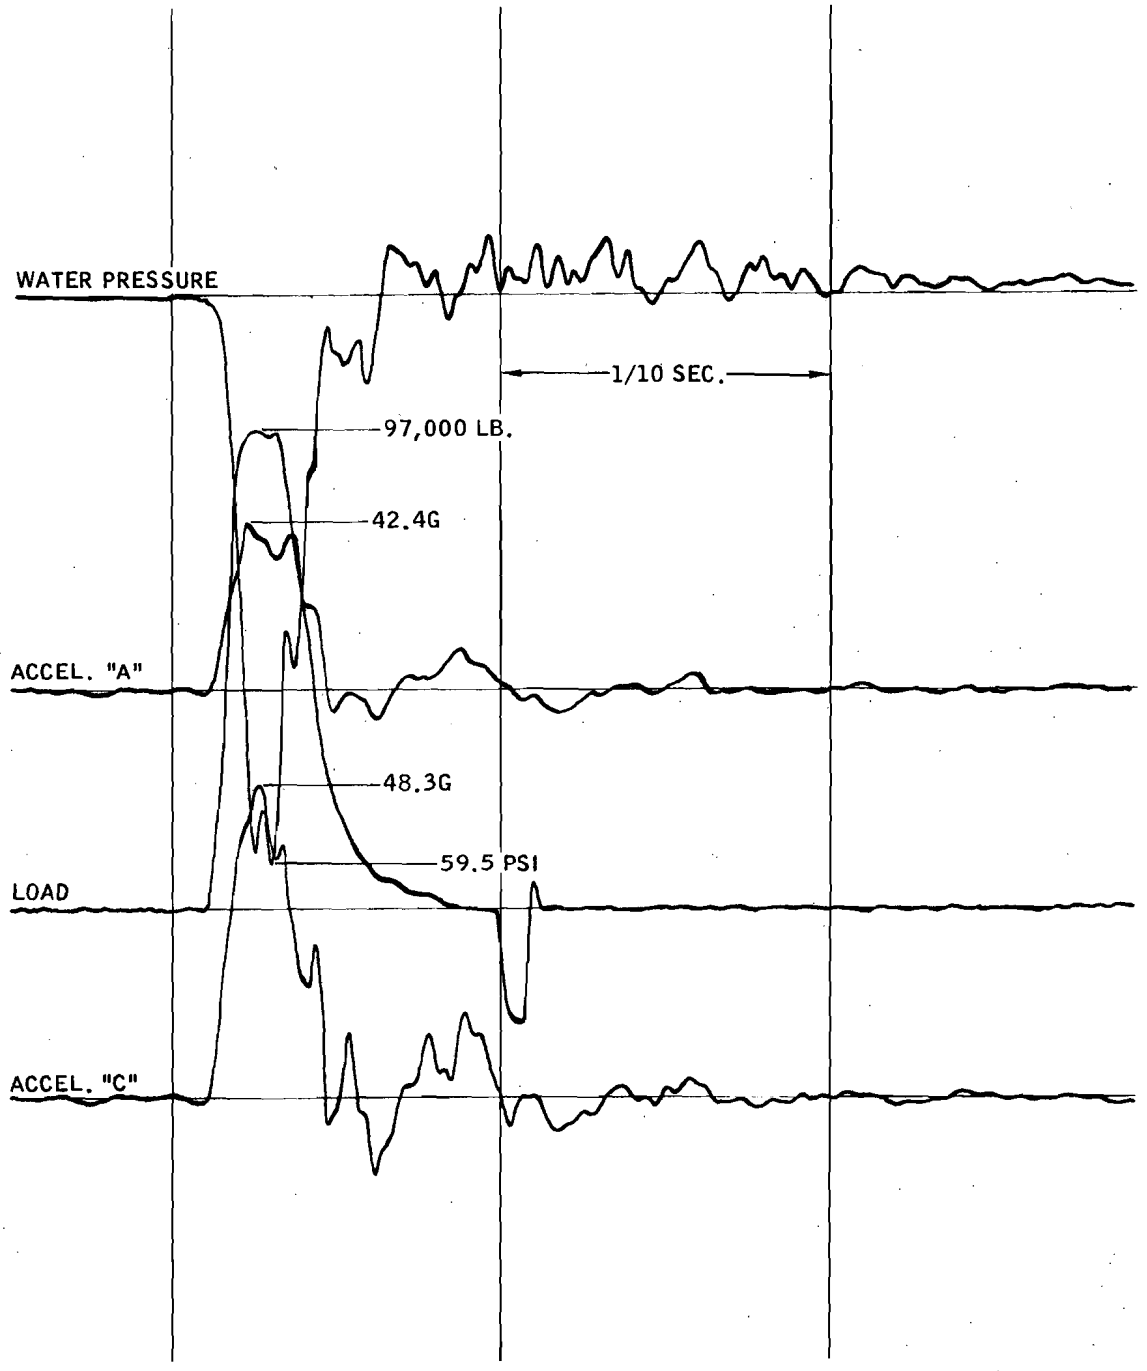
Figure B-46. Drop No. 25, 12-ft. Log Impact

25	5	Log Impact	12	2,786	27.8	97,000	34.8	42.4	43.3	59.5	Tank ruptured
26	6	Ground* Impact (Dry Sand)	5	2,880 (3/4 full)	17.9	--	--	5.7	6.0	5.1	No damage
