FULL-SCALE DYNAMIC CRASH TEST OF A LOCKHEED CONSTELLATION MODEL 1649 AIRCRAFT

TECHNICAL REPORT

OCTOBER 1965

Aviation Safety Engineering and Research
Division of Flight Safety Foundation, Inc.
Phoenix, Arizona

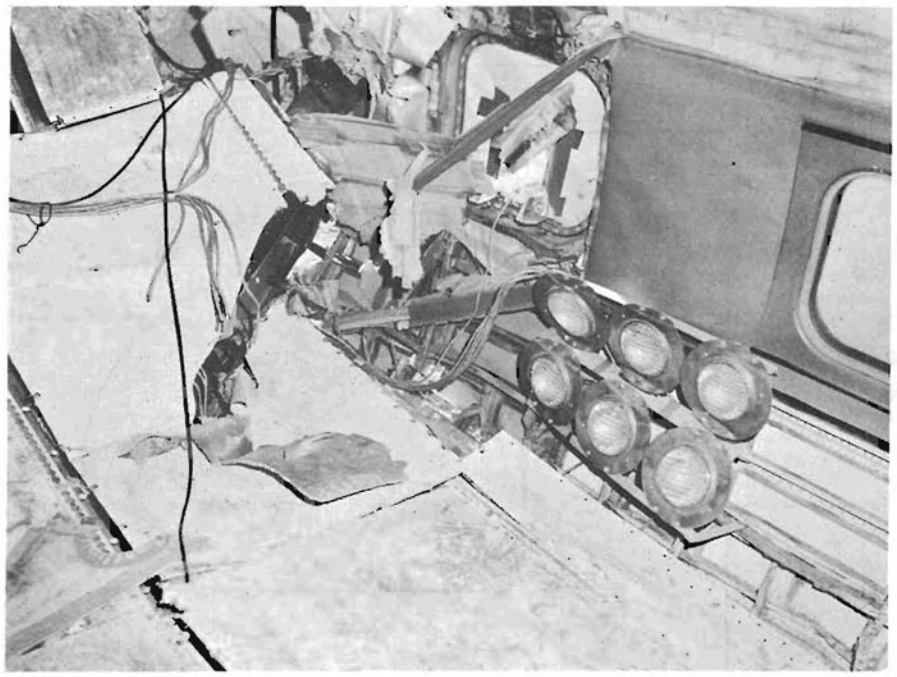
FIG. 33 FLOOR DAMAGE, FORWARD MAIN CABIN LOOKING FORWARD TOWARD COCKPIT

The fuselage broke across the forward cabin just aft of the main door, between fuselage station 370 and fuselage station 380 as shown in Figures 30 through 33. The nose gear impacted the bottom of the aircraft just forward of the break. The displacement of the forward fuselage section due to the fuselage break combined with the upward displacement of the floor caused by the nose gear impact produced a sharp break in the continuity of the cabin floor at this point.

Further aft, several floor panels were broken up, and numerous failures occurred in the lower structural members in the cargo hold. The seat tracks on the left side were broken at approximately fuselage station 400, and the floor bent upward approximately 15 degrees as shown in Figure 33. Though the forward main cabin door was jammed, the fuselage break near the door left an opening large enough to permit exit (Figure 30). Exit through the gap would have been hazardous, however, due to jagged metal edges. Vertical space in the cargo hold, normally 3 feet, was reduced to about 6 inches at the location of the

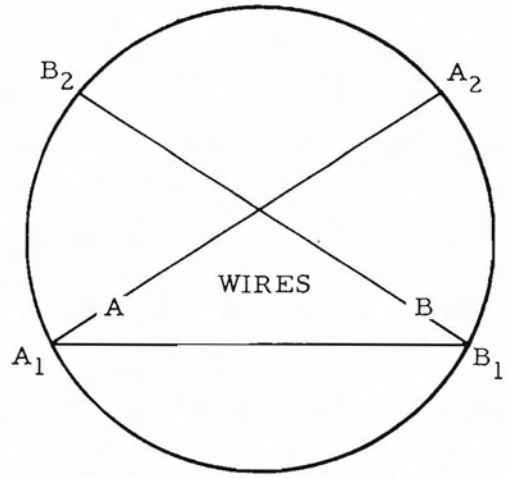
FORWARD LOCATION
POSTCRASH

WIRE A. EXPANDED LENGTH 154.2"
DISTANCE BETWEEN A_1 AND A_2 147.45"
WIRE B. EXPANDED LENGTH 151.00"
DISTANCE BETWEEN B_1 AND B_2 148.2"

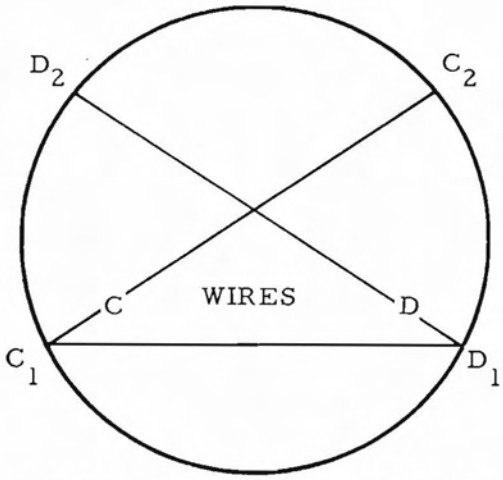
AFT LOCATION
POSTCRASH

WIRE C. EXPANDED LENGTH
BROKEN AFTER 121.50"
DISTANCE BETWEEN C_1 AND C_2 113.75"
WIRE D EXPANDED LENGTH 118.5
DISTANCE BETWEEN D_1 AND D_2 116.5

FIG. 35 RESULTS OF FUSELAGE VOLUME REDUCTION EXPERIMENTS

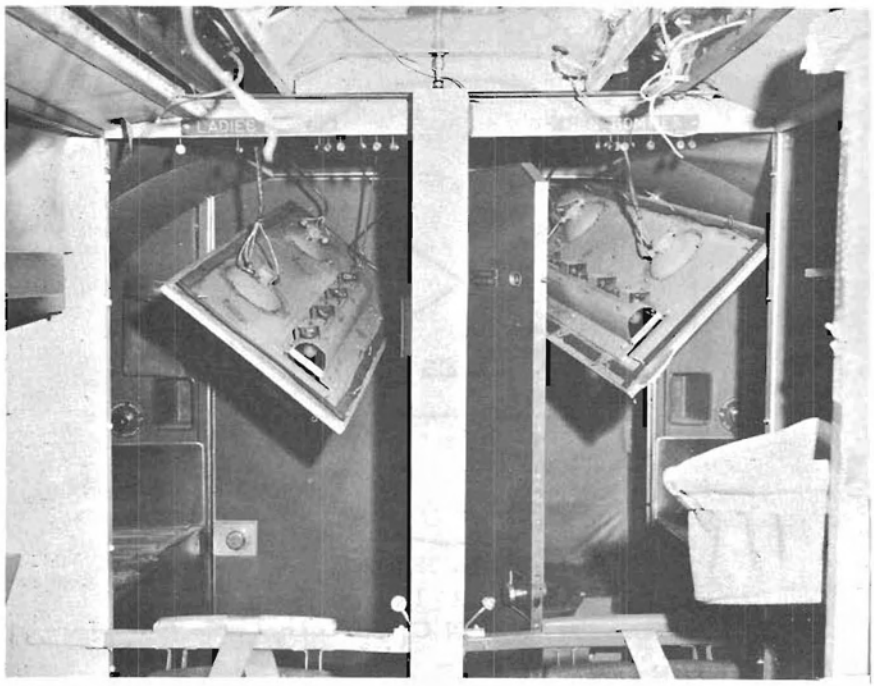
FIG. 37 AFT LAVATORY OVERHEAD LIGHT PANELS, POSTCRASH

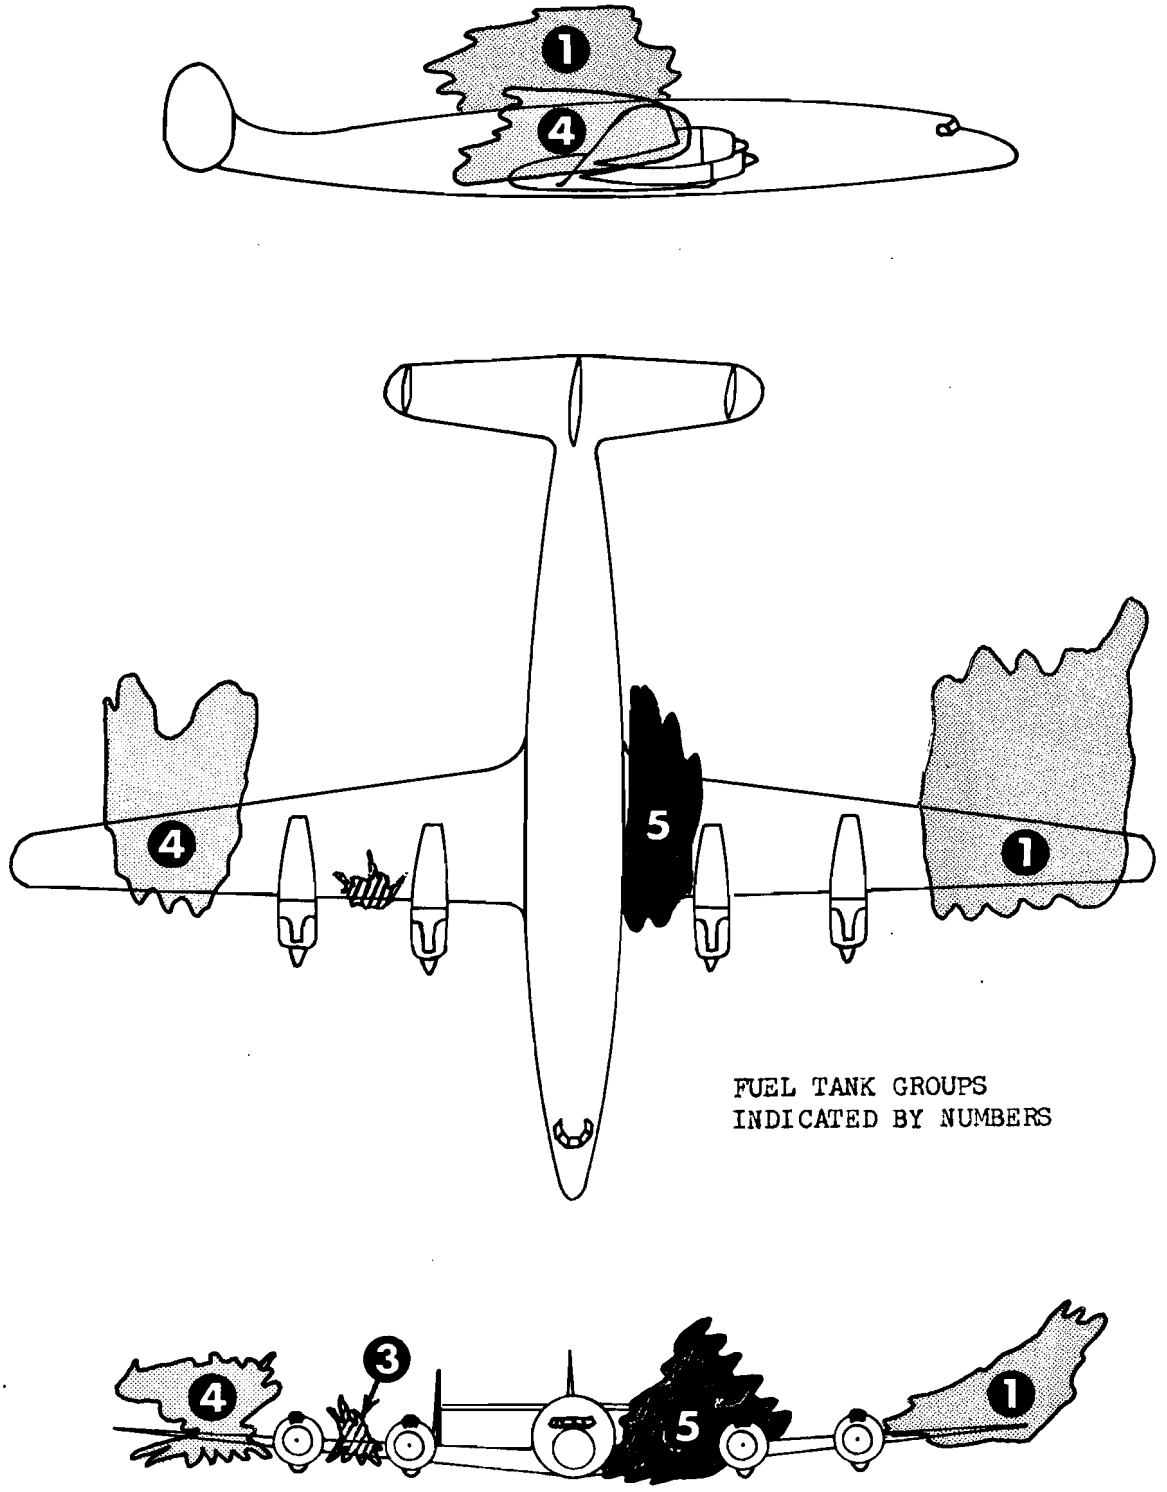
FIG. 40 FUEL SPILLAGE OCCURRING 1.00 SECONDS AFTER IMPACT WITH MAIN GEAR BARRIERS

Initial impact and subsequent course of the aircraft through the barriers caused the wings to fail or disintegrate, spilling the simulated fuel. Figures 40, 41, 42, and 43 present a kinematic of the fuel spillage during the crash.

The No. 1 fuel tank was ruptured when the outer portion of the left wing impacted against the earthen barrier. The complete destruction of the tank caused the entire volume of simulated fuel to be released in a heavy mist. As the aircraft contacted and slid forward up the 6 degree slope, the wing was partially separated from the fuselage at the root. This failure opened up the No. 5 fuel tank allowing its simulated fuel to be completely expelled in a mist cloud by the time the aircraft came to rest on the 20 degree slope. Traces of the simulated fuel were found 15 feet ahead of the aircraft.

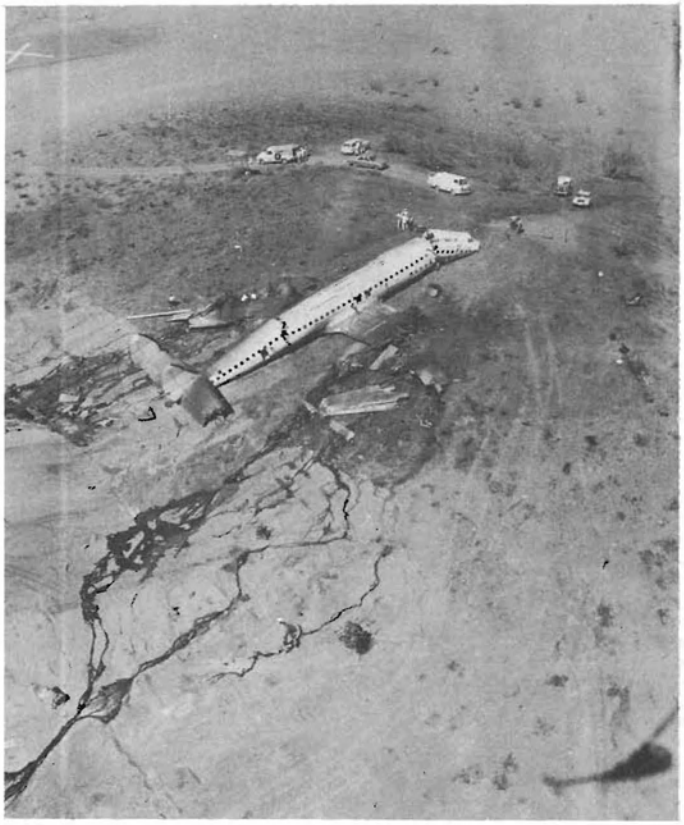
FIG. 44 AERIAL PHOTOGRAPH OF THE CRASH SCENE ILLUSTRATING THE WING FAILURES AND SPILLAGE PATTERN

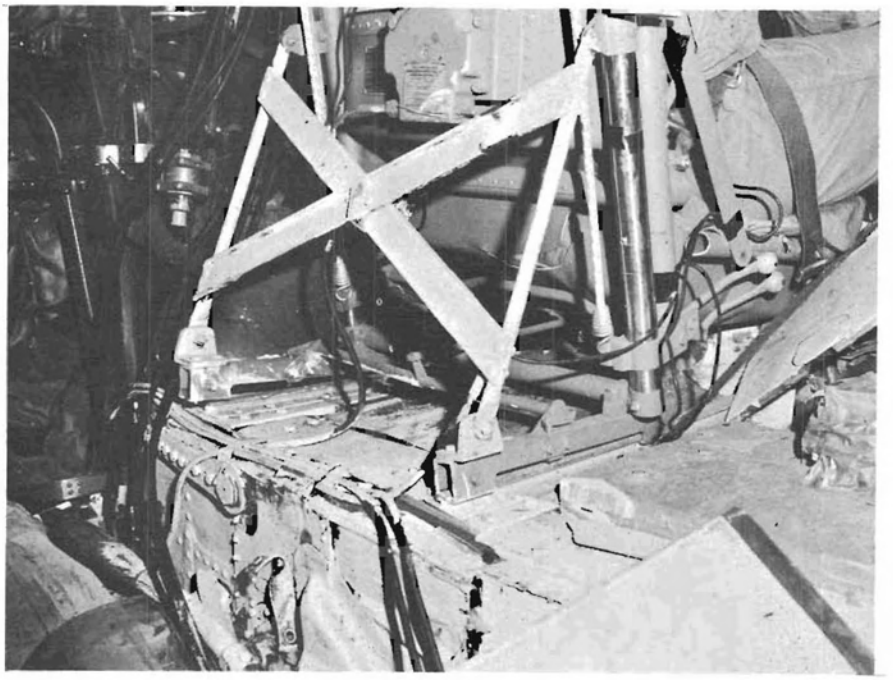
FIG. 50 PILOT'S CREW SEAT FLOOR ATTACHMENTS, POSTCRASH

forward attachment points. The left aft seat leg was completely torn free of the floor track and the right aft leg remained partially attached as shown in Figure 50. The aft attachments failed by outward bending of the flanges as illustrated in Figure 51. The tubular seat pan frame was broken on the right side at a point near its attachment to the seat back frame, as shown in Figure 52. Figure 53 shows that the sheet metal seat pan was also torn along the back beginning at the tube failure and progressing to the left approximately 11 inches. The right hand diagonal seat pan support strap was broken free from the seat pan. The bolt hole at this attachment failed (hole tearout), allowing the bolt to tear through 3/4 inch of the seat side tubing before the attaching bolt failed. The loss of the vertical support, which had been provided by the diagonal support strap, allowed the seat pan to bend downward and contact the floor. (The floor was also buckled upward at this location.) The forward edge of the seat pan was resting on the floor after the crash. The pilot's lap belt and shoulder harness remained in place and attached, and the shoulder harness inertia reel was locked. The restraint provided kept the pilot dummy well positioned in the seat. The seat back was bent forward 20 to 30 degrees, due to the shoulder harness load, as shown in Figure 54. The bending failure occurred about one-third of the way up from the seat pan at the location of the attachment of the diagonal seat pan support straps.

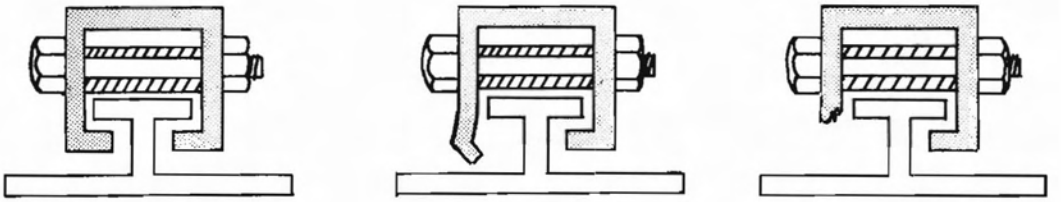
FIG. 51 SEAT TRACK ATTACHMENT FAILURES

The third crew seat was torn free of the floor tracks due to failure of the attachment grips as illustrated in Figure 51. This allowed the seat and its occupant to travel forward and to the left until they contacted the bulkhead at fuselage station 260. The seat and dummy came to rest blocking the cockpit door as shown in Figure 59. The dummy was well restrained in the seat by the diagonal shoulder harness and lap belt throughout the crash. The back of the seat was bent forward, approximately 5 degrees. The complete failure of the attachment of this seat to the floor was attributed in part to a high localized load caused by the nose gear structure which was embedded under the fuselage just beneath the seat. Figures 60 and 61 show the seat tracks and the track grips.

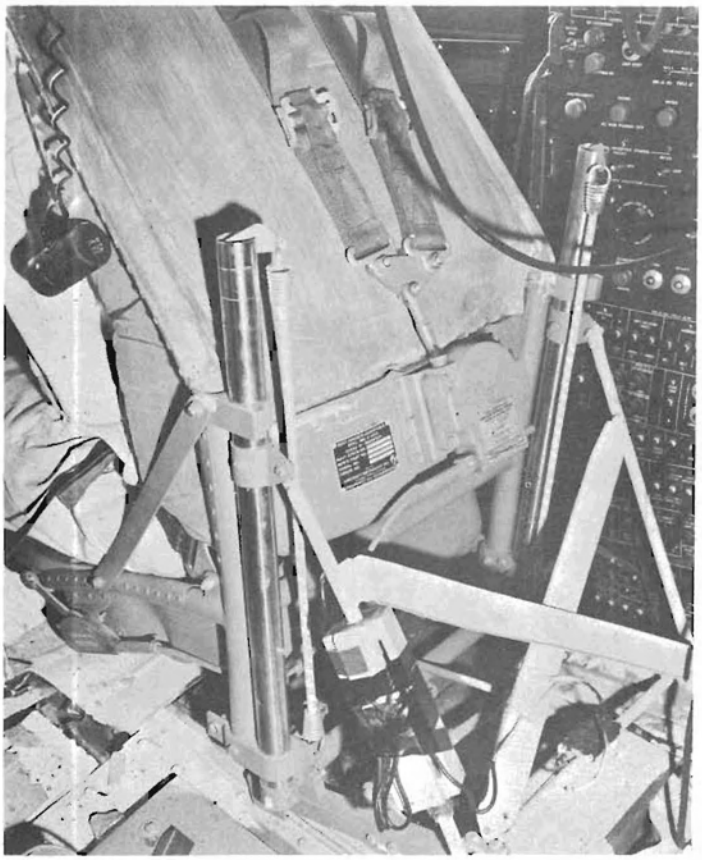
FIG. 57 BENDING FAILURE OF COPILOT'S SEAT BACK

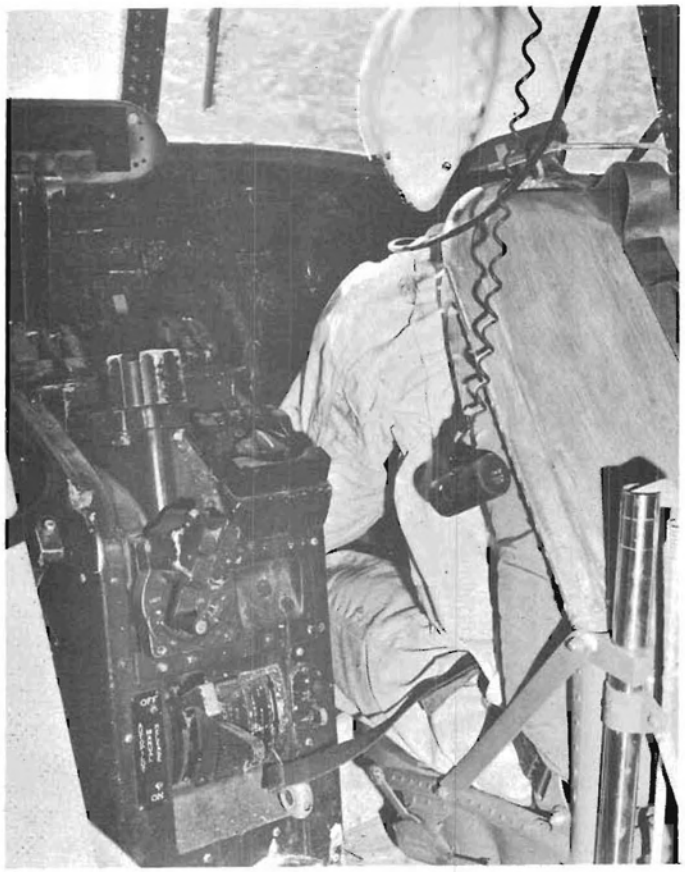
FIG. 58 POSITION OF COPILOT DUMMY, POSTCRASH

The copilot dummy remained well positioned with respect to the seat, but rotated forward as shown in Figure 58, enough to contact the instrument panel with the helmet visor and perhaps the dummy's forehead. The helmet was still in place, although the visor was broken, and the top of the helmet was severely indented due to contact with the upper cockpit structure. The energy absorbing liner shows 1/16 inch permanent deformation around the crown pad and one localized deep dent forward of the crown pad. The copilot's right leg was caught between the right rudder pedal and the right cabin structure. Both of the copilot dummy's legs were extended straight forward past the rudder pedals.

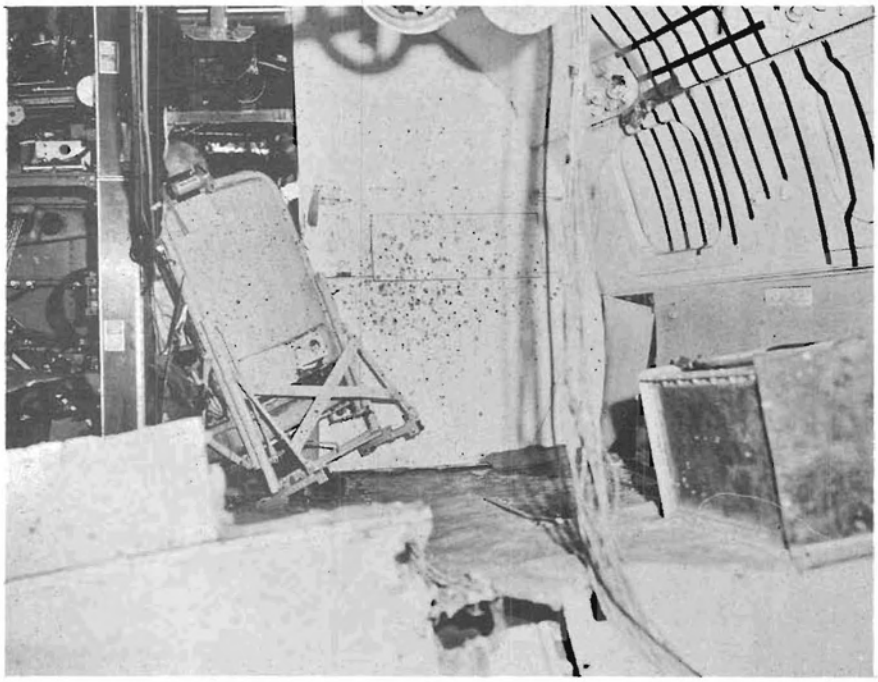
FIG. 59 POSTCRASH RESTING POSITION OF THIRD CREW MEMBER AND SEAT

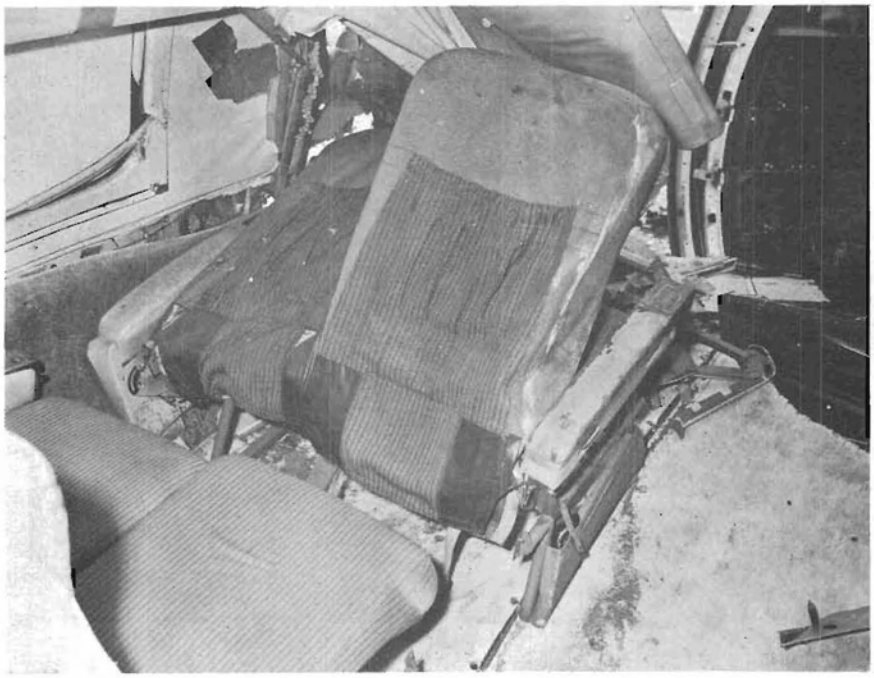
The forward and center seats remained in place during the crash, but the aft seat came loose from the floor-tracks and rotated backwards. The forward seat was deformed toward the aisle due to loads applied by the fuselage side wall which was deformed inwardly just aft of the fuselage break. Figure 66 shows the deformation and seat positions.

FIG. 66 BACK OF FORWARD CONSTELLATION SEAT AFTER REMOVAL OF CENTER SEAT DUMMIES

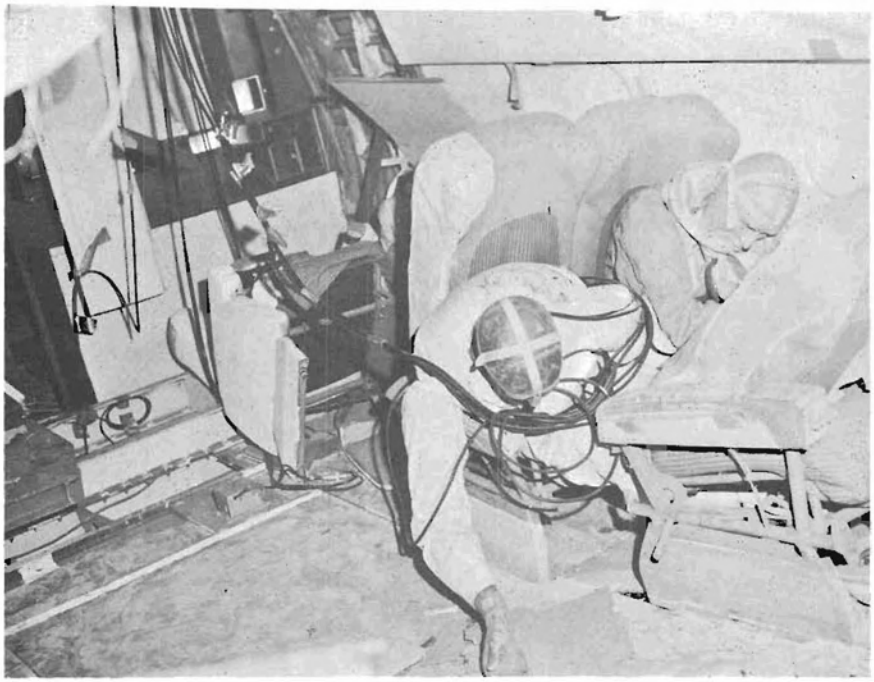
FIG. 67 POSTCRASH VIEW OF CENTER CONSTELLATION SEATS AND OCCUPANTS

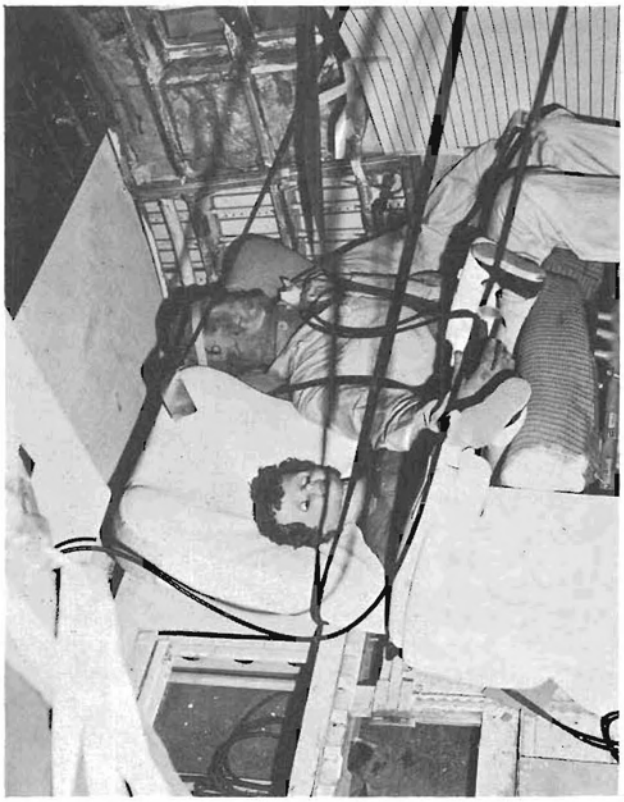
FIG. 69 VIEW SHOWING 90-DEGREE ROTATION OF AFT CONSTELLATION SEAT AND OCCUPANTS

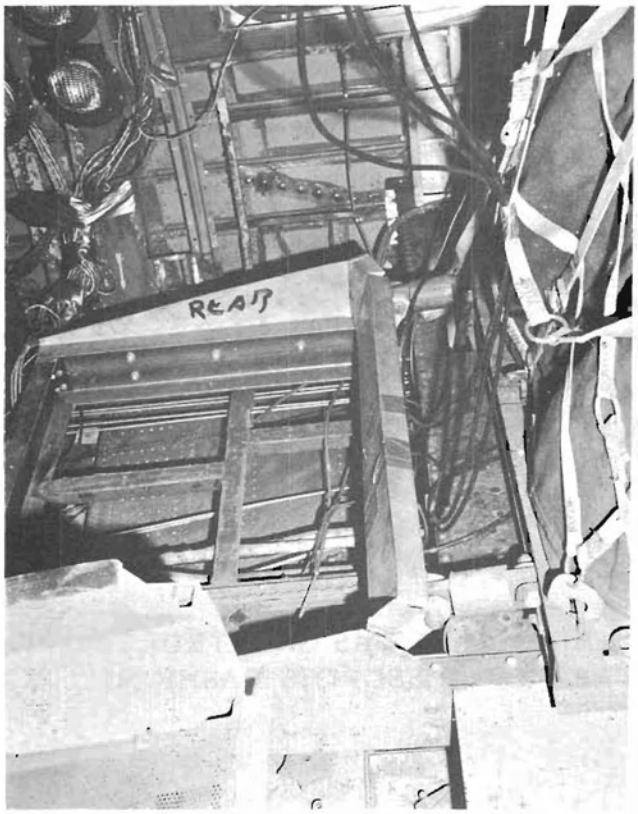
FIG. 77 FORWARD DEFORMATION OF LONGITUDINAL LOAD LINK ATTACHMENT

During the crash, neither pallet nor cargo separated from its original tiedown, however, both of the longitudinal restraint installations of the cargo pallets deformed approximately 2 inches forward as shown in Figure 77. The flexible nets survived the crash with no load ring deformation, and no failures occurred in either of the cargo tiedown systems. The rigid cargo stack slid forward on the pallet approximately 4 inches while the crushable cargo remained in place and parallelogrammed forward ten inches. An illustration of the cargo action is shown in Figure 78.

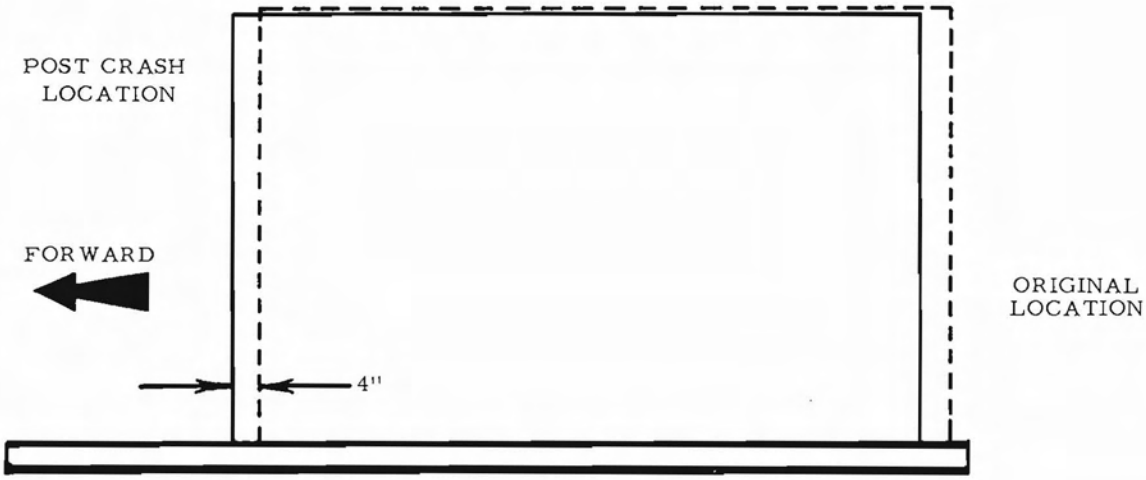
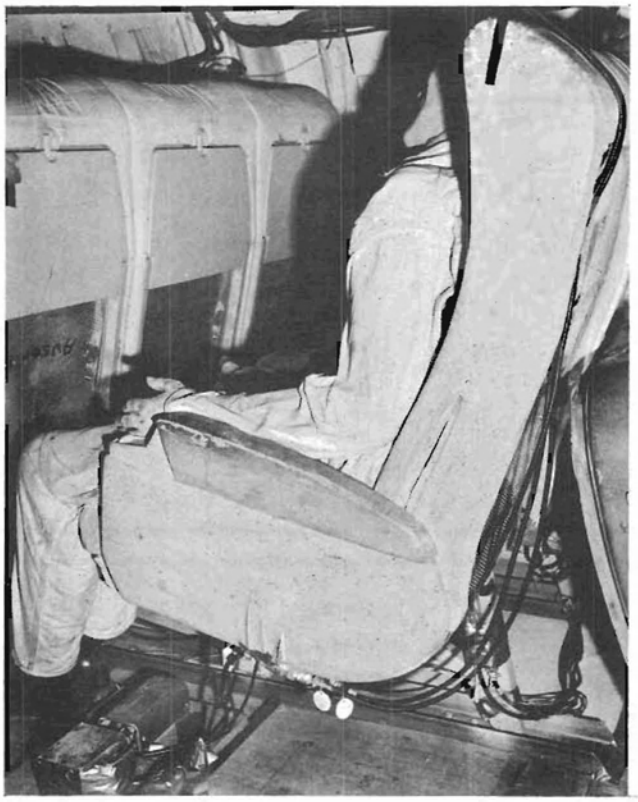
PALLET #2
POSTCRASH CARGO SHIFT
CRUSHABLE CARGO

PALLET #1
POSTCRASH CARGO SHIFT
RIGID CARGO

FIG. 78 FORWARD MOVEMENT EXPERIENCED IN CARGO LOADS

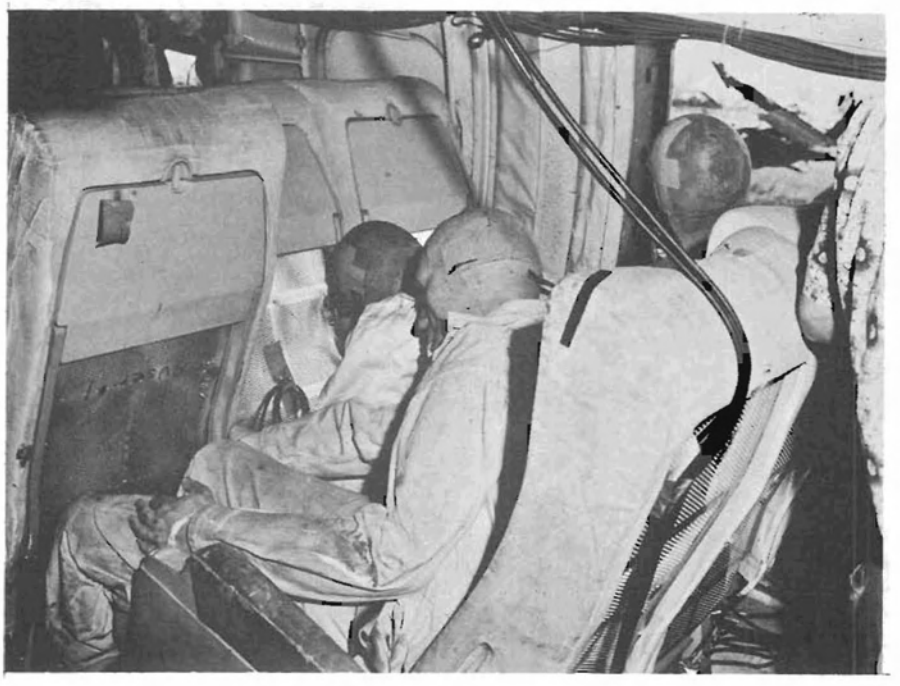
FIG. 81 POSTCRASH POSITION OF FORWARD FACING SEAT DUMMIES

The inboard seat back of the unoccupied triple seat remained in its original upright position. The other two seat backs were broken over as shown in Figures 80 and 81. None of the plastic food trays attached to the back of the seat showed any damage. A maximum vertical seat leg force of approximately 1000 pounds tension was measured for this seat, as shown in Appendix 6.

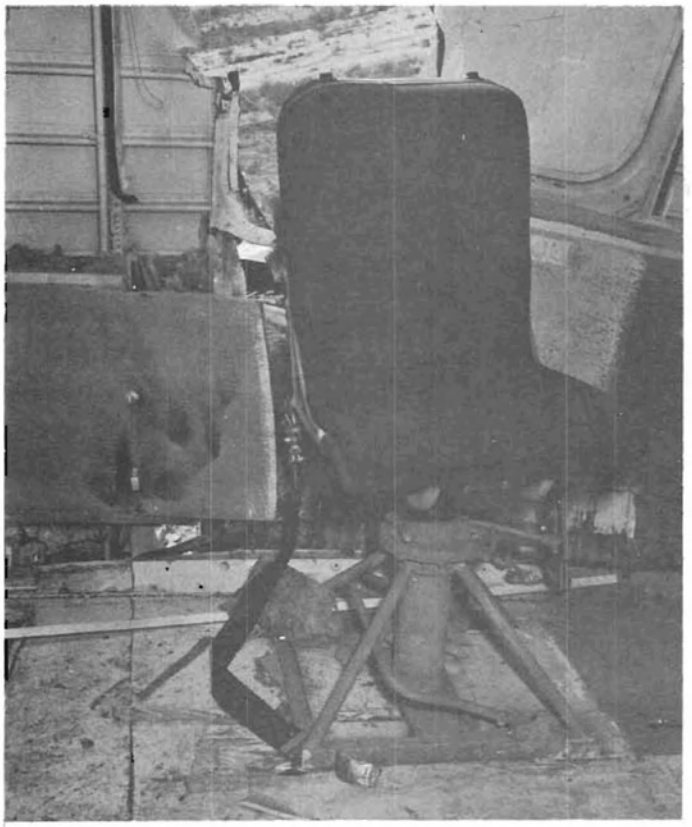
The side facing seat remained attached to the aircraft floor and sustained no gross structural failure. The lap belt remained attached, but this minimal restraint allowed the dummy's head and shoulders to move forward (laterally) so that the dummy's head struck the galley partition, 24 inches forward of the seat as shown in Figure 93. The dummy moved forward (with respect to the aircraft) on the seat 6 inches, remaining only partially on the seat pan. The right leg of the dummy swung around toward the dummy's right (forward in the airplane) about 35 degrees. Vertical loading caused slight downward bending of the forward edge of the tubular seat pan frame as shown in Figure 94. This was the only permanent deformation of the structure of this seat. The lap belt load, developed in the side facing seat reached a maximum of approximately 1200 pounds (one side). This is consistent with the lap belt loads developed in forward facing seats.

FIG. 93 SIDE FACING SEAT OCCUPANT, POSTCRASH POSITION, VIEWED FROM AISLE

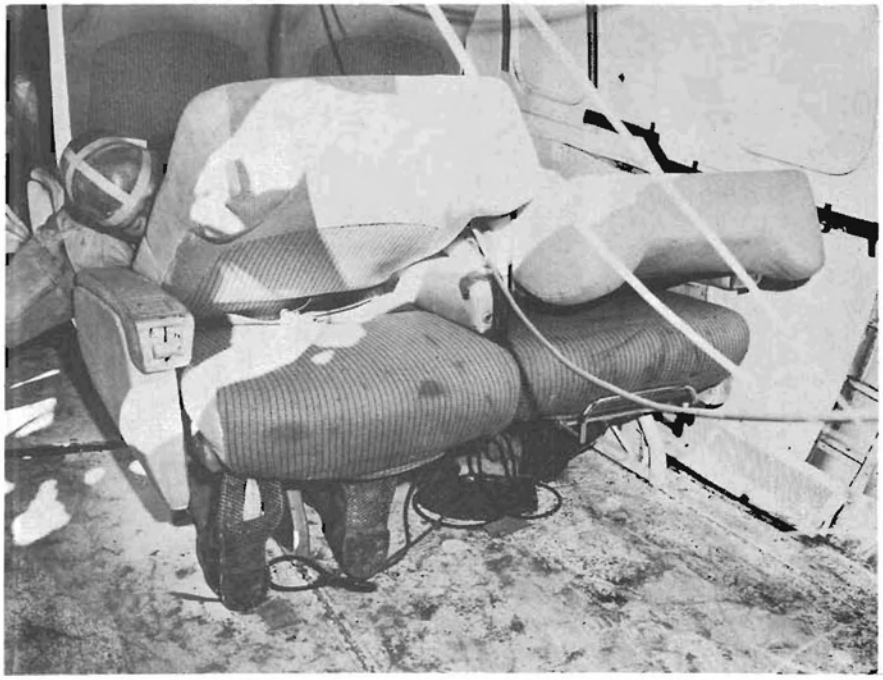
The postcrash position of both dummies occupying the rear seat of this experiment is shown in Figure 96. The dummy in the aisle seat was resting with its face and upper shoulders against the forward seat back. The dummy slid forward in the seat approximately 11 inches and both legs were jammed under the forward seat with the right leg on the aisle side of the seat leg (see Figures 96 and 97). This forward movement was allowed by failure of the AN 1032 bolt used to attach the left end of the lap belt to the seat. The dummy next to the wall was found with its face against the lower forward seat back and both legs jammed under the forward seat up to the knees. The lap belt on this dummy was still attached. Figure 97 shows the dummies in contact with the forward seat along the right hand side of each respective forward seat back, indicating a left lateral load. Both seats remained attached to the floor. The accelerations of the aft passenger seat, along with the dummy pelvic accelerations and the lap belt load, were consistent with those of the other experiments aboard the aircraft. The acceleration levels were on the order of 10G's. The lap belt loads are not considered valid because of the failure of the lap belt attachment during the test, at an unknown time. Both of the seat pan tubular frames on the rear seats broke where the longitudinal members join the lateral support tubing. The forward edges of both seat bottoms deflected downward to within one to two inches from the floor, and the forward edge of the aisle seat contacted the floor. The left hand wall side showed no lateral deformation.

FIG. 96 POSTCRASH VIEW OF AFT CONSTELLATION SEATS SHOWING JAMMED POSITION OF DUMMY LEGS AND FORWARD SEAT BACK BREAKOVER

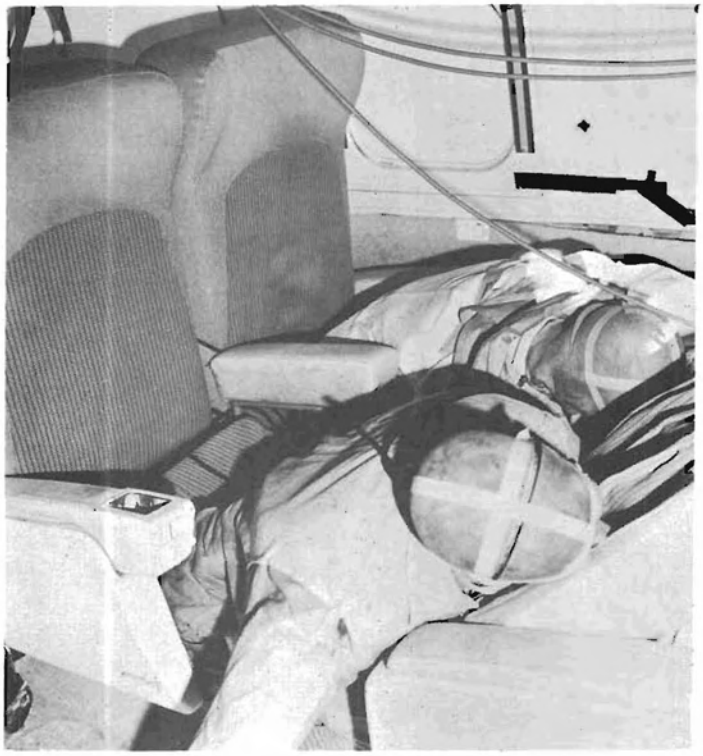
FIG. 97 VIEW SHOWING UPPER BODY CONTACT WITH FORWARD SEAT BACKS OF AFT CONSTELLATION SEAT EXPERIMENT

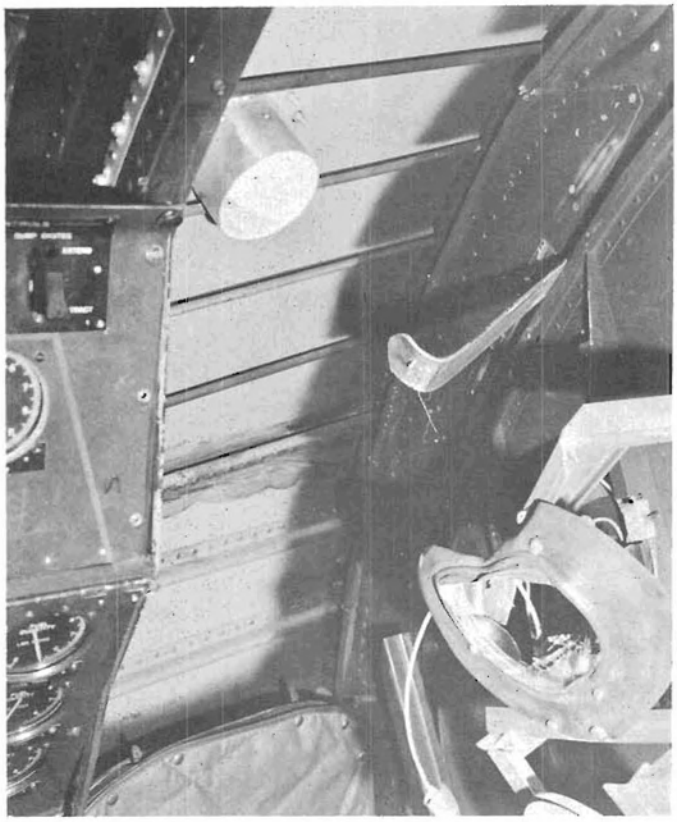
FIG. 106 POSTCRASH VIEW OF COCKPIT CRASH LOCATOR BEACON EJECTION DEVICE. NOTICE THE DAMAGE WHICH OCCURRED WHEN THE AFT END OF THE EJECTOR TUBE BLEW OUT.

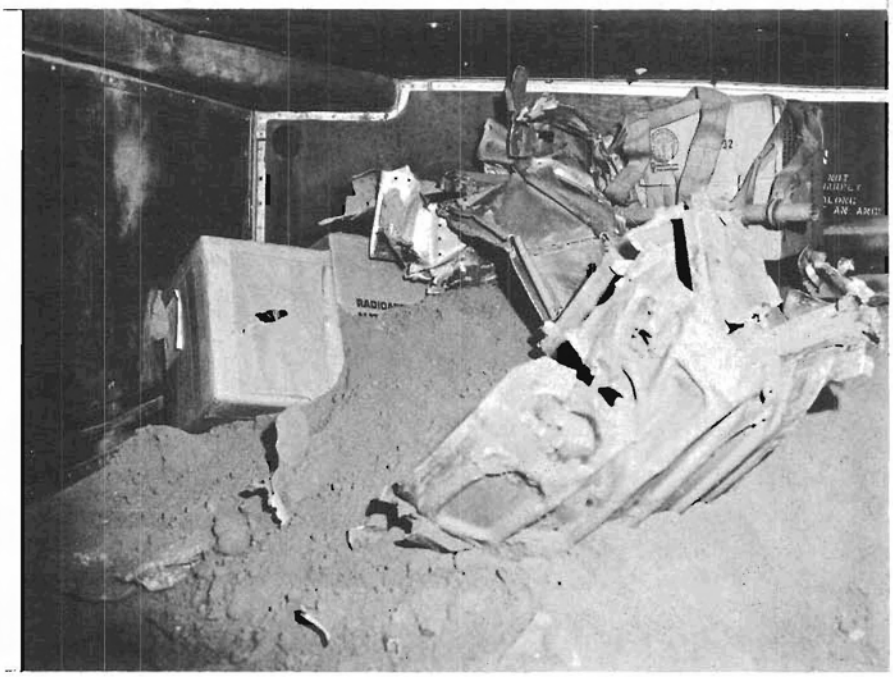
A post crash view of the radioactive materials shipping containers is presented in Figure 110. Even though the cargo compartment volume was reduced by approximately 50 percent, the actual damage occurring to the cargo appeared to be small. CARI personnel removed the containers for further evaluation.

FIG. 109 STORAGE OF SHIPPING CONTAINERS FOR RADIOACTIVE MATERIALS PRIOR TO THE CRASH
