DOT/FAA/AR-09/4

Effects of Disbonds, Lightning Strikes, and Low-Velocity Impact Damage on Adhesively Bonded Composite Joints

December 2009

Final Report

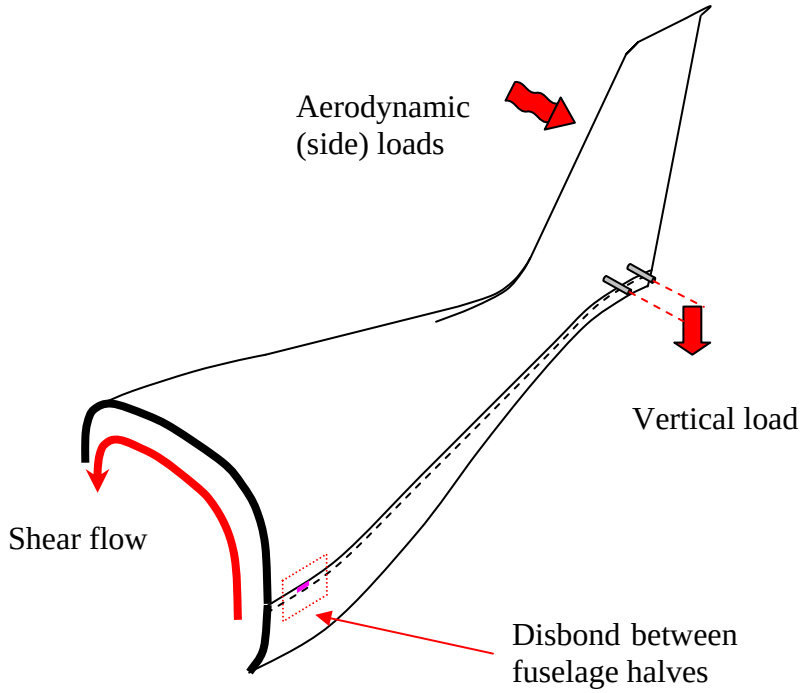
Figure 1. Typical General Aviation Fuselage Component Showing Disbond

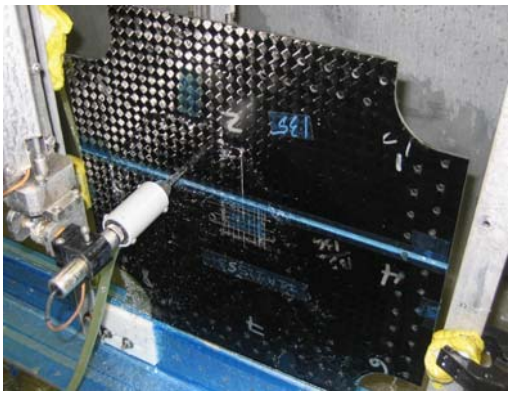
Figure 13. A TTU Scan of a PFS Test Specimen

The impacted specimens were subjected to through-transmission ultrasonic (TTU) NDI that generate C-scans to quantify the damaged planar areas using image-analysis software (figure 13). A TTU C-scan provided a projection of damage that was incurred on both adherends, the adhesive layer, and the adhesive/adherend interfaces. Therefore, care was exercised when interpreting the failure mechanism. Additional inspections, such as microscopy, x-ray, and thermal imaging, may be required to quantify the damage on adhesive, adherends, and interfaces.

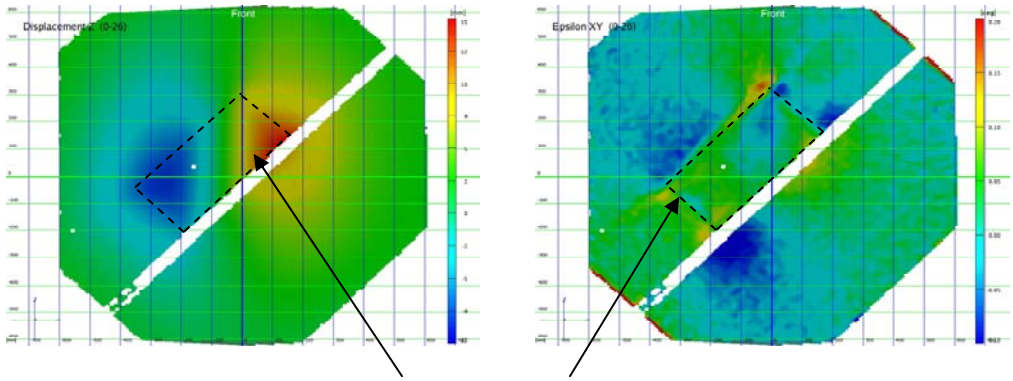
Figure 25. Photogrammetry Data for Specimen With Rectangular Defect

For the specimens with 1- by 2-inch-rectangular disbonds (1-inch overlap), the reduction in static strength was approximately 26%. Specimens with 2- by 2-inch-square defects indicated a 27% reduction in static strength, and specimens with 2- by 4-inch-rectangular defects, prior to and after drilling fastener holes, indicated a 40% reduction in static strength. Since the maximum shear stresses of the joint occurred at the edges of the overlap, the defects closer to the edge of the overlap significantly affected the adhesive stress distribution and the elastic trough (figure 24). For specimens with square or rectangular disbonds that spread across the overlap, complete load redistribution occurred around the defect. In such cases, the undesirable stress concentrations of the joint adjacent to the four corners of the defects (figure 25) can cause premature failure or disbond and delamination initiation during cyclic loading.

The photogrammetry data indicated severe stress concentrations around the boundaries of rectangular defects and damage propagation prior to failure (appendix A), based on the NDI methodology outlined in reference 5. Failure modes of the specimens indicated delamination (adherend) failure due to significant out-of-plane buckling that caused secondary peel stresses adjacent to the disbond boundaries. Mode I fracture toughness obtained from double-cantilever beam tests indicated that the fracture toughness of EA9394 adhesive is 3.7 in-lbf/in^2 [7], which was about three times higher than the composite laminate. This caused the interlaminar (adherend) failure, rather than adhesion failure, of composite joints of all PFS specimens, see figure 26.

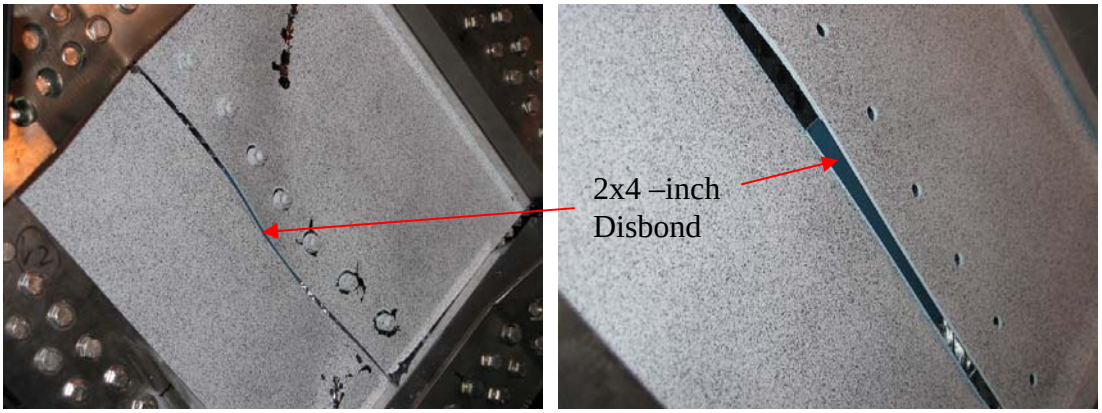
Figure 26. Failure Modes of PFS Specimens With 2- by 4-Inch (Rectangular) Defects

Fastener installation (fail-safe or repair) completely restores the strength of the joints with 2- by 4-inch-rectangular defects. In addition to carrying the in-plane shear loads, fasteners are able to restrict the out-of-plane loading on the overlap region, especially around the defects, and increase the through-the-thickness strength of the bonded region. Also, the fasteners keep both adherend plates intact and significantly minimize peel stresses. For specimens without fasteners, the out-of-plane buckling caused a significant peel stress, and the failure mode was a direct result of the high peel stresses at the disbond corners, as shown in figure 26. Since the fastener holes were drilled within the elastic trough region of these specimens, they had no effect on the static strength of the joint.

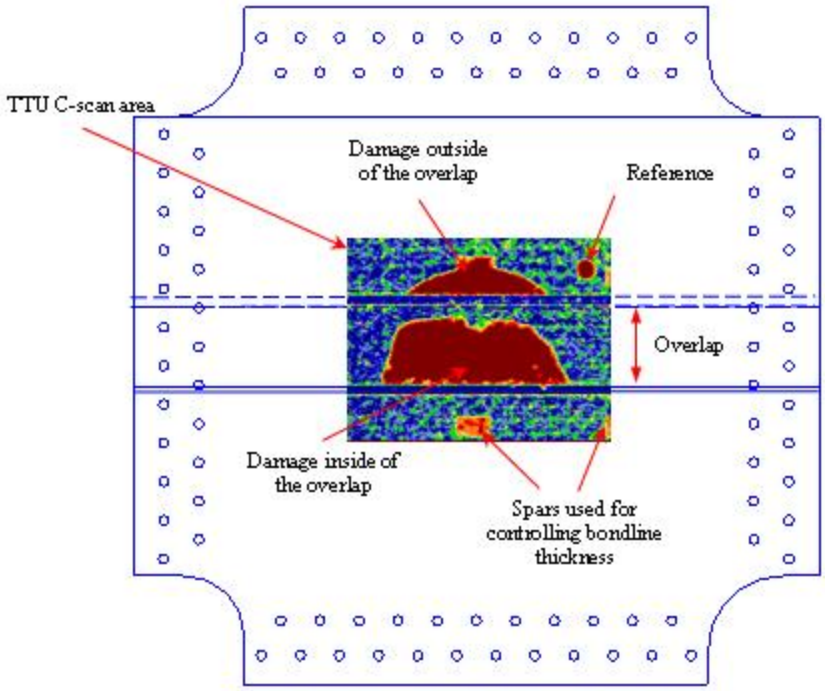
Except for the 0.25-inch impactor, PFS specimens with a 2-inch overlap indicated approximately 9% residual strength reduction due to impact damages (figure 31). Postimpact TTU C-scans of PFS specimens were made to evaluate the extent of damage. A typical result with explanations is shown in figure 32. The 0.25-inch impactor penetrated through most of the joint and caused extensive localized ply failure on the opposite side (figure 33). See appendix A for a complete description of figure 33. As the impactor diameter increased, the residual indention reduced, resulting in barely visible impact damages on the side of the impact for 1- and 2-inch impactors. However, the back side localized fiber failure was evident for all cases, and the overall damage areas seem to be the same for a given energy level and support fixture (figures 30 and 33). During impact, the free edge on the impact side undergoes compression, while the free edge on the opposite side undergoes tension in the Mode I (opening mode through-the-thickness) loading direction. For a short overlap length, the impact damage spreads across the overlap region and through a large area of the bonded region. For a given impactor diameter, an increase in overlap length minimizes the free-edge peel (tensile) stresses and reduces the damage propagation along this edge under high Mode I (peel) loading (figure 34). Also, the damage area toward the free edge, under compression, forms a bell-shaped curve, especially for large support fixtures, indicating that the free-edge stresses are reduced away from the impact location as the overlap length increases. A similar shape is observed for damage incurred by smaller impactors for the energy level investigated. As shown in figure 34, the support fixture greatly influences impact damage shape and size. The small fixture increases the overall system stiffness and restricts large deflections. Thus, the energy is dissipated through severely fractured adhesive layers and adherends.

Figure 32. Postimpact TTU C-Scan of PFS Specimen

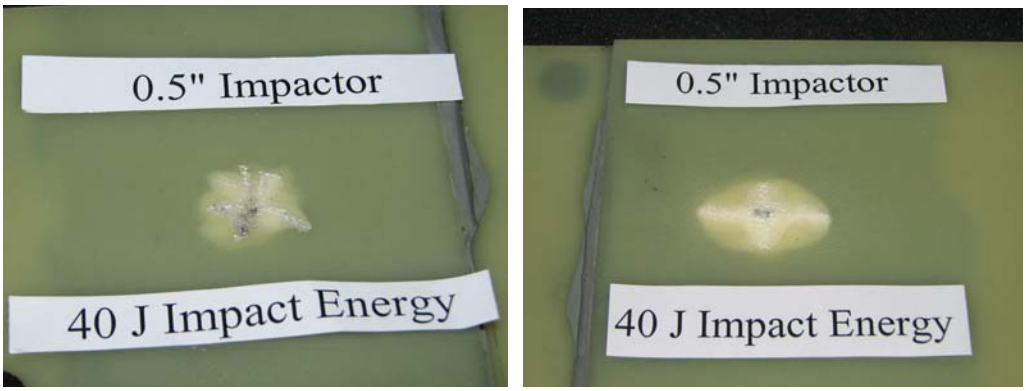
Figures 45 through 53 show the damage induced on the impact side (left) and back sides (right) of FGSW, CFPW, and CFUT SLS specimens for impact energy of 354 in-lbf (40 J) using impactors with diameters of 0.5, 0.75, and 1.0 inch, respectively. Due to the translucent nature of glass fibers, the damage on FGSW specimens can be seen with the naked eye.

Figure 45. Impact Damage Induced on FGSW With 0.5-Inch Impactor

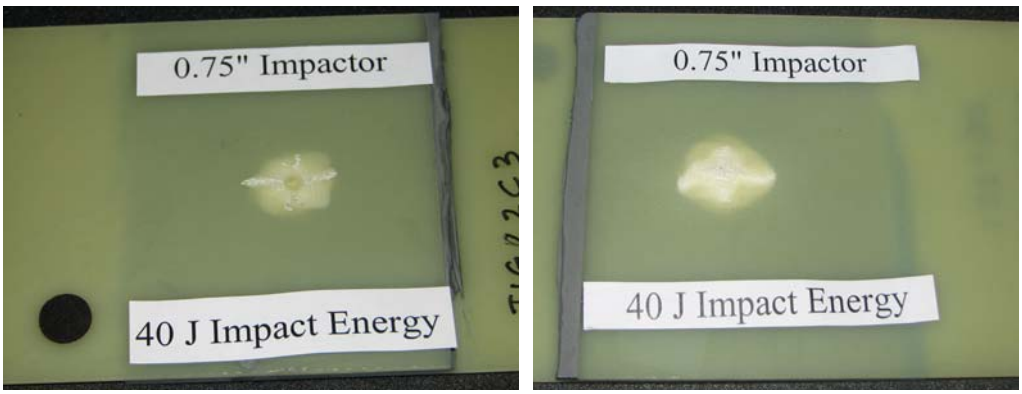
Figure 46. Impact Damage Induced on FGSW With 0.75-Inch Impactor

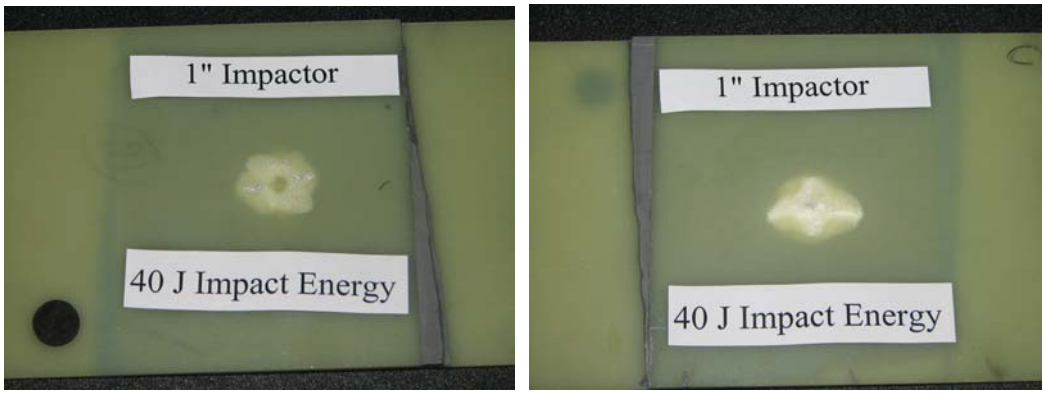
Figure 47. Impact Damage Induced on FGSW With 1.00-Inch Impactor

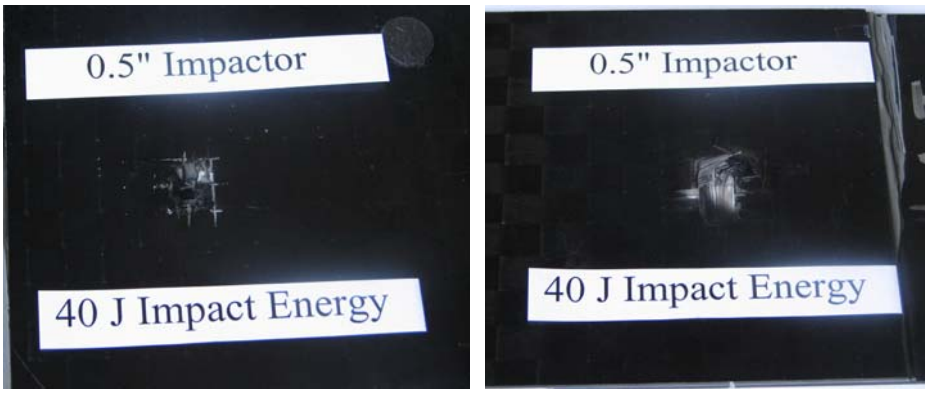
Figure 48. Impact Damage Induced on CFPW With 0.5-Inch Impactor

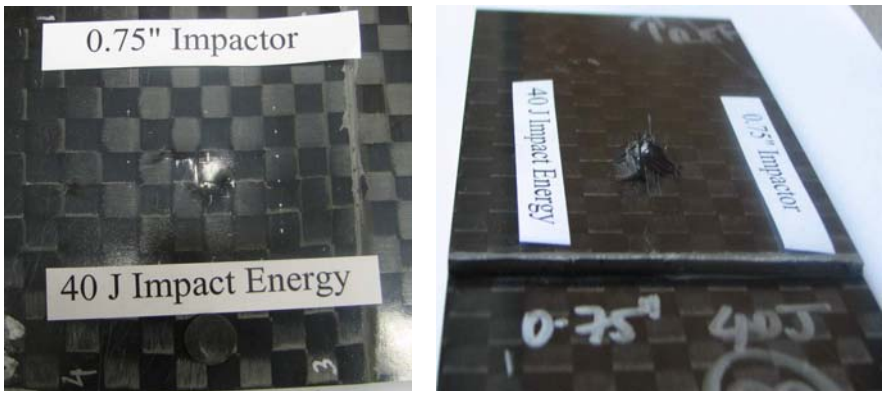
Figure 49. Impact Damage Induced on CFPW With 0.75-Inch Impactor

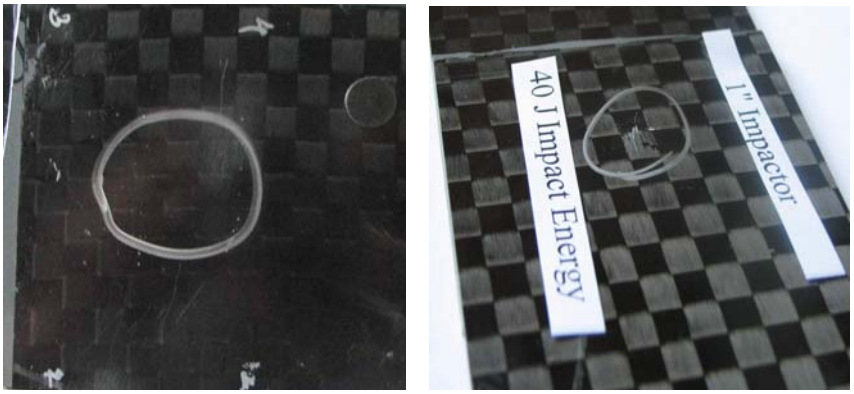
Figure 50. Impact Damage Induced on CFPW With 1.00-Inch Impactor

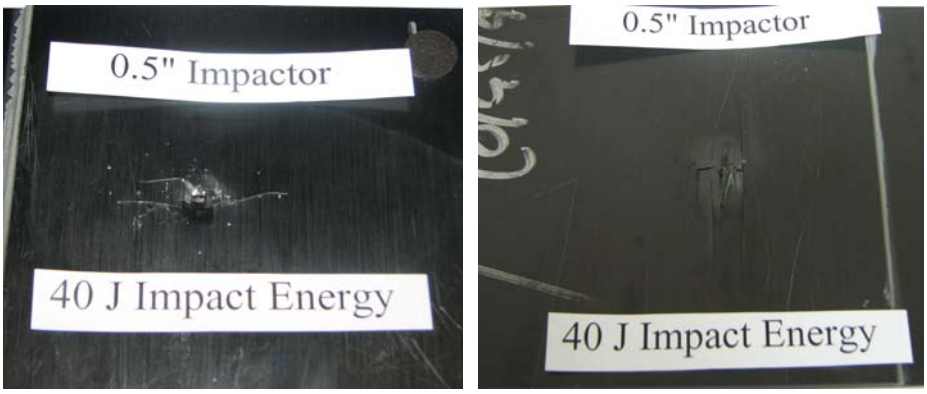
Figure 51. Impact Damage Induced on CFUT With 0.5-Inch Impactor

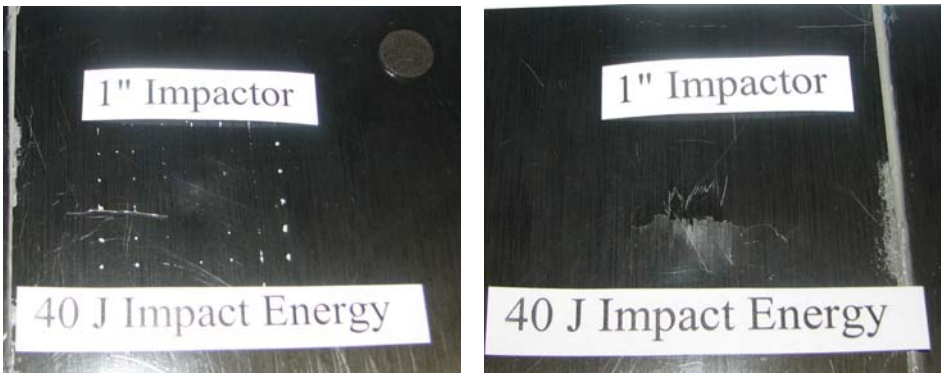
Figure 53. Impact Damage Induced on CFUT With 1.00-Inch Impactor

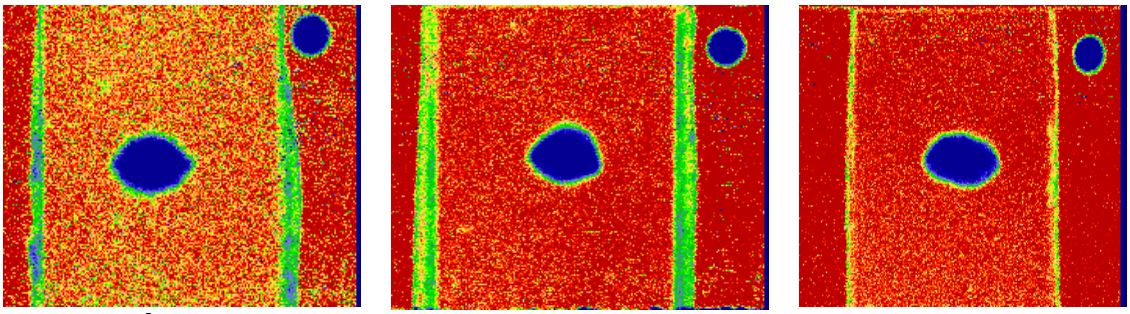
1-Inch Impactor 0.75-Inch Impactor 0.5-Inch Impactor

Figures 54 through 56 show the TTU C-scan images of the damage induced on woven FGSW, CFPW, and CFUT specimens for impact energy of 354 in-lbf (40 J) using impactors with diameters of 0.5, 0.75, and 1.0 inch, respectively. These image areas represent the projected damage that consists of delamination, matrix cracking, and fiber breakage on several layers of composite adherend, as well as damages within the bondline and the interface. The difference in response behavior FGSW (fiberglass) and carbon CFPW laminates is striking. The FGSW seems to be unaffected by impactor diameter.

Figure 54. Ultrasonic C-Scan of FGSW (354 in-lbf)

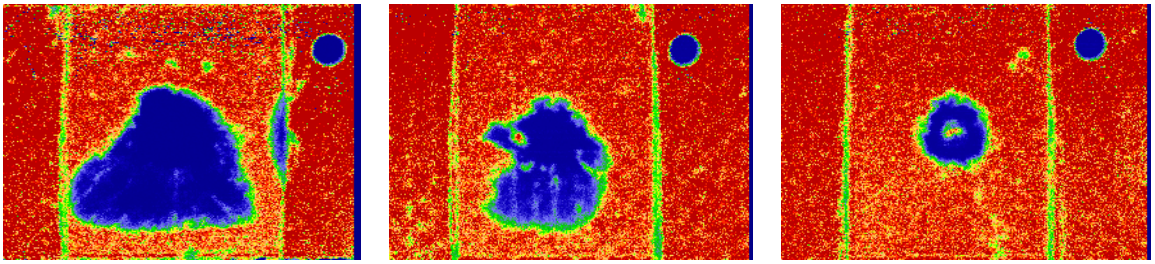
1-Inch Impactor 0.75-Inch Impactor 0.5-Inch Impactor

Figure 55. Ultrasonic C-Scan of CFPW (354 in-lbf)

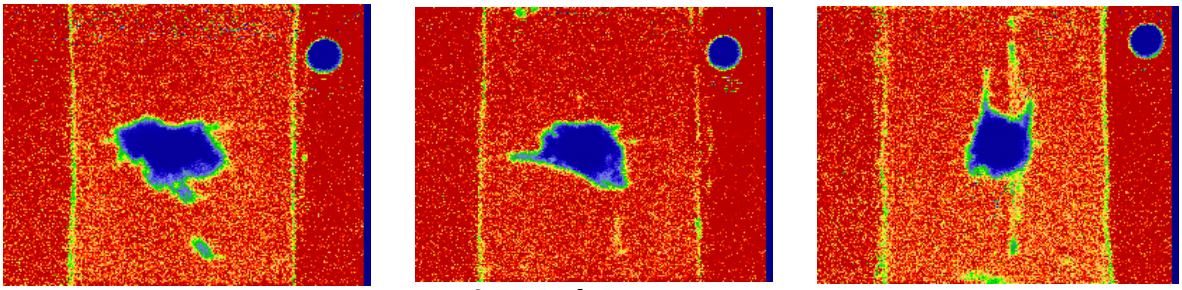
1-Inch Impactor 0.75-Inch Impactor 0.5-Inch Impactor

Figure 56. Ultrasonic C-Scan of CFUT (354 in-lbf)

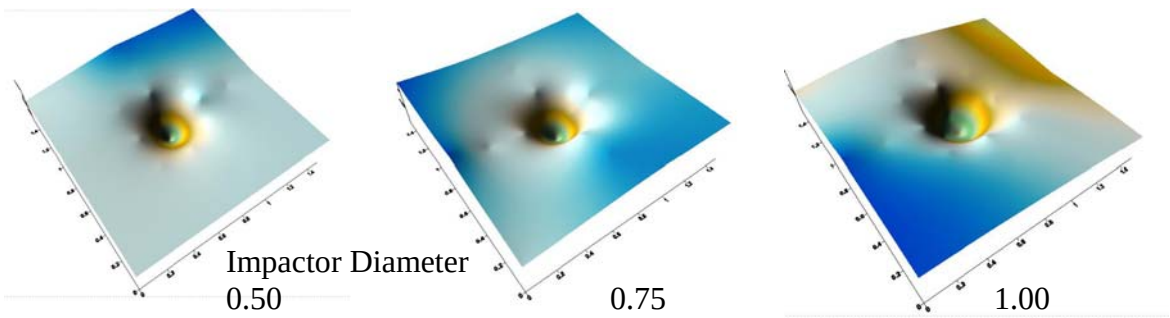
Figures 60 through 62 show (not to scale) the residual indentation induced on the test specimens on woven glass/epoxy, carbon plain weave, and carbon unitape test specimens at 40 J impact energy induced by impactors with diameters of 0.5, 0.75, and 1.0 inch, respectively. Measured residual indentation values are tabulated in appendix B.

Figure 60. Residual Indentation for FGSW (354 in-lbf)

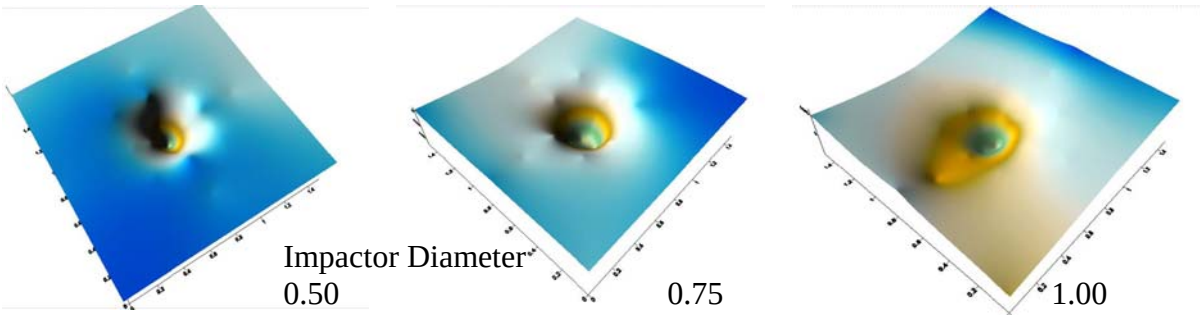
Figure 61. Residual Indentation for CFPW (354 in-lbf)

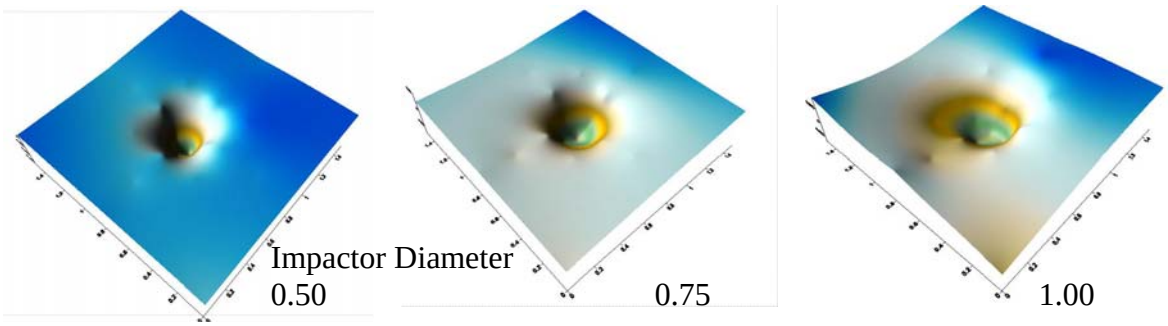
Figure 62. Residual Indentation for CFUT (354 in-lbf)

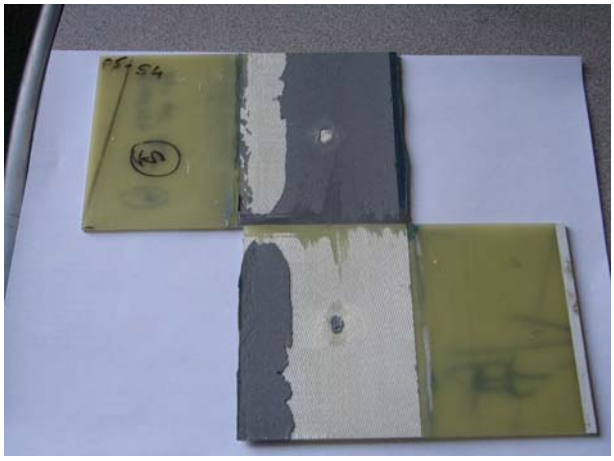
Figures 63 through 65 show typical failure modes observed for FGSW, CFPW, and CFUT SLS specimens. The primary failure mode for all residual strength tests on lap joints was adherend failure (mostly first ply).

Figure 63. Typical Failure Mode Observed for FGSW SLS Specimens

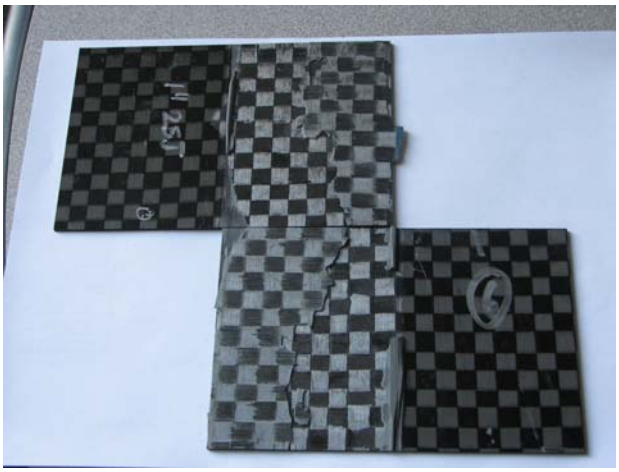
Figure 64. Typical Failure Mode Observed for CFPW SLS Specimens

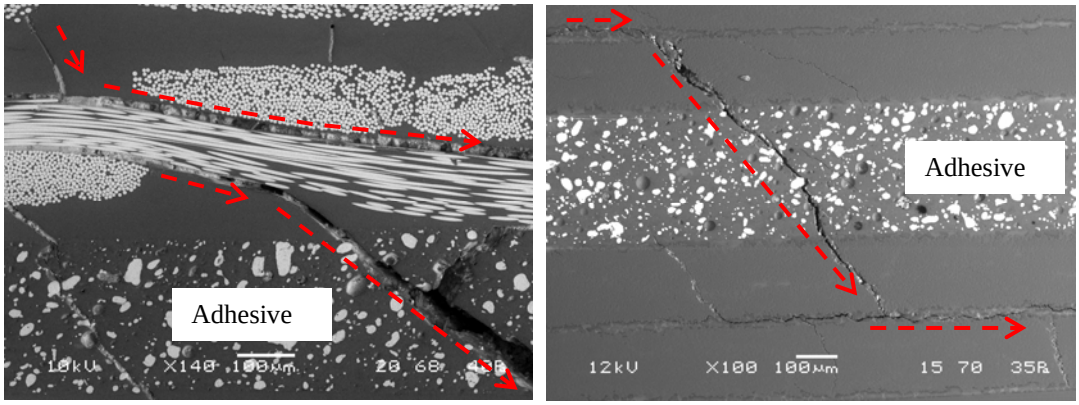
(a) Fabric adherend, CFPW (b) Unidirectional tape adherend, CFUT

Figure 75. Transverse Crack Propagation

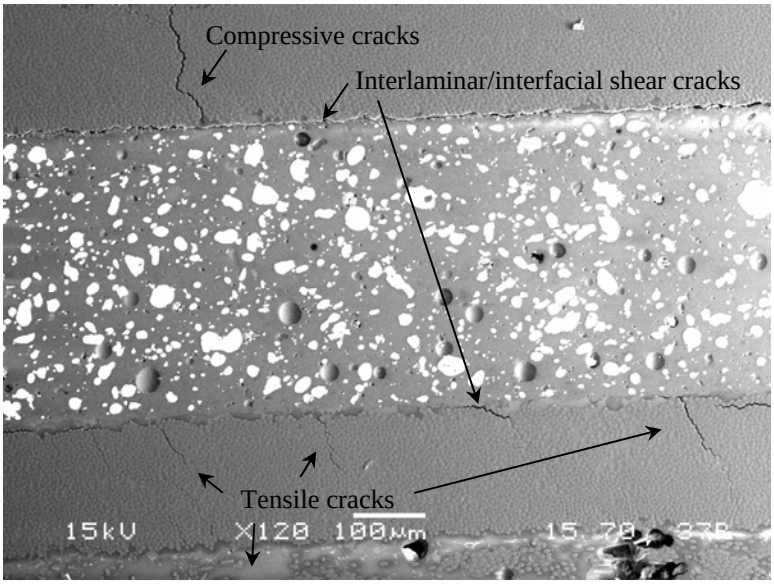
Figure 76. Fracture Due to Bending

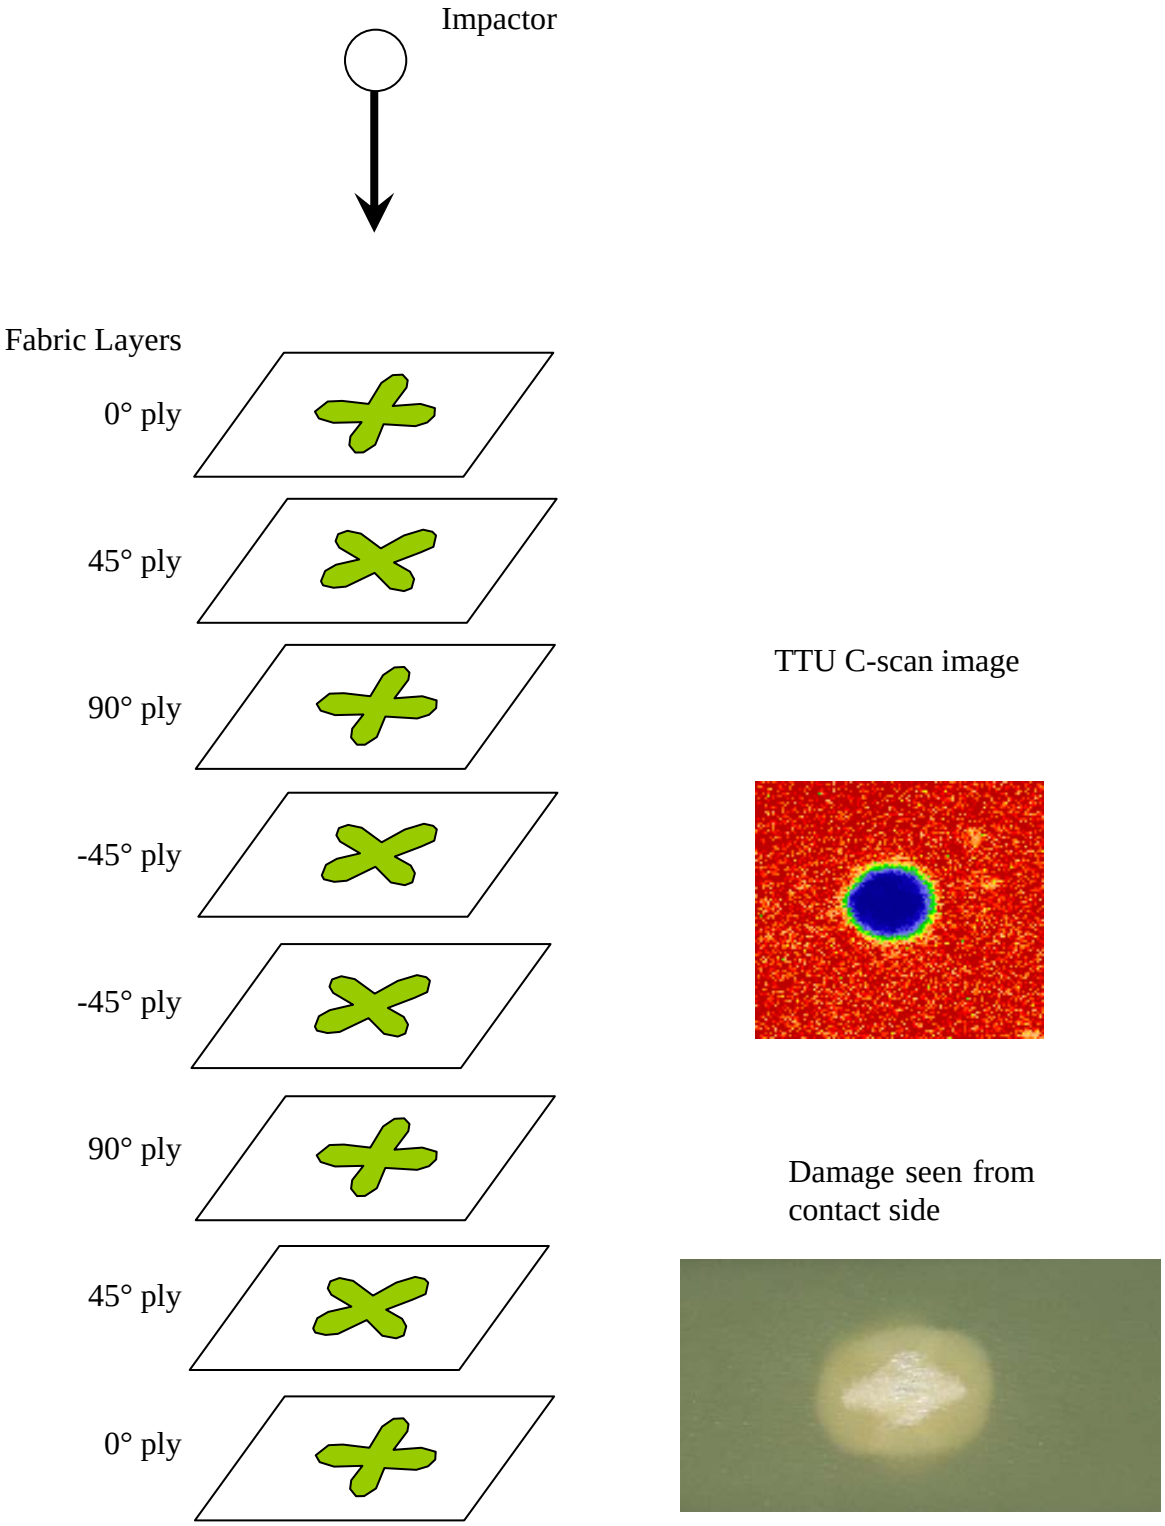
quasi-isotropic, i.e., $[0°/45°/90°/-45°]_s$, these cross-shaped damage zones, possibly concentrated in a 45° radial spacing along fiber directions at each layer through-the-thickness and smaller cracks in between, result in an observed circular damage shape in the FGSW specimens. In addition to cracks, localized contact stress results in fiber breaks and transverse cracks on the first few plies that result in cracks through-the-thickness of these plies. At these crack tips, where they meet the lower ply, high peel stress was created at the ply interface that resulted in interfacial cracks or delamination. Because of the matrix cracks along the fiber directions, the delamination propagated along the fiber directions of adjacent plies. Because the adjacent fabric plies in the case of FGSW are oriented 45° apart, the delamination may have spread in a circular pattern, as shown in figure 77, i.e., matrix cracks in adjacent layers coalesce within the small layer of matrix material between plies. Additional microscopic analysis may be required to verify this conjecture.

Figure 77. Orientation of Matrix Crack Concentrations of Glass Fabric Layers (Top Adherend) Due to Impact

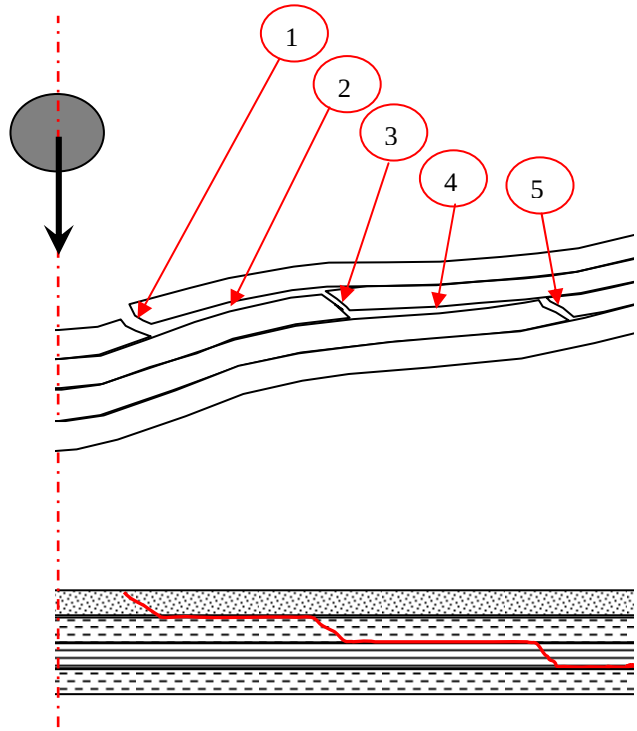
The conical or pine tree-shaped damage can be attributed to fiber breakage and delamination or debonding caused by transverse and interlaminar shear forces, as shown in figure 78. Transverse cracks, due to transverse shear, tend to be at an angle with respect to midsurface. When these transverse cracks met the bottom ply that had a different fiber orientation, they tended to propagate along the fibers, i.e., in-plane rotation of crack propagation direction to align with fiber direction, until bending of fibers caused a tensile failure or fiber break. Fracture due to fiber break continued though the matrix material of the next ply until arrested and realigned by fibers running perpendicular to the fracture orientation. For the cases of fabric materials, this phenomenon can occur within a layer, as shown in figure 75(a). As shown in this figure, the transverse crack continues on the bottom side of the fiber, although the crack path is offset along the fiber direction. For CFUT, there was a considerable amount of transverse cracks due to its low transverse tensile strength. Thus, these cracks passed through layers without difficulty. Consequently, the damage was contained within a small area, except for the outermost layer that resulted in long longitudinal cracks. However, for CFPW, interlaced or woven fiber architecture functioned as a crack arrest mechanism within the layer and resulted in large interlaminar fractures. Thus, the CFPW damage area was considerably larger compared to CFUT. FGSW that had a ductile matrix system and flexible fibers compared to the CFPW system resulted in smaller damages that were contained within the impact area by larger residual deformation and a high concentration of small cracks within the pine tree-shaped impact damage zone.

1. Transverse crack (0° ply)
2. Delamination
3. Transverse crack (±45° ply)
4. Delamiantion
5. Fiber break (0° ply)

Figure 78. Fracture Propagation on First Few Layers of Adherend Due to Impact

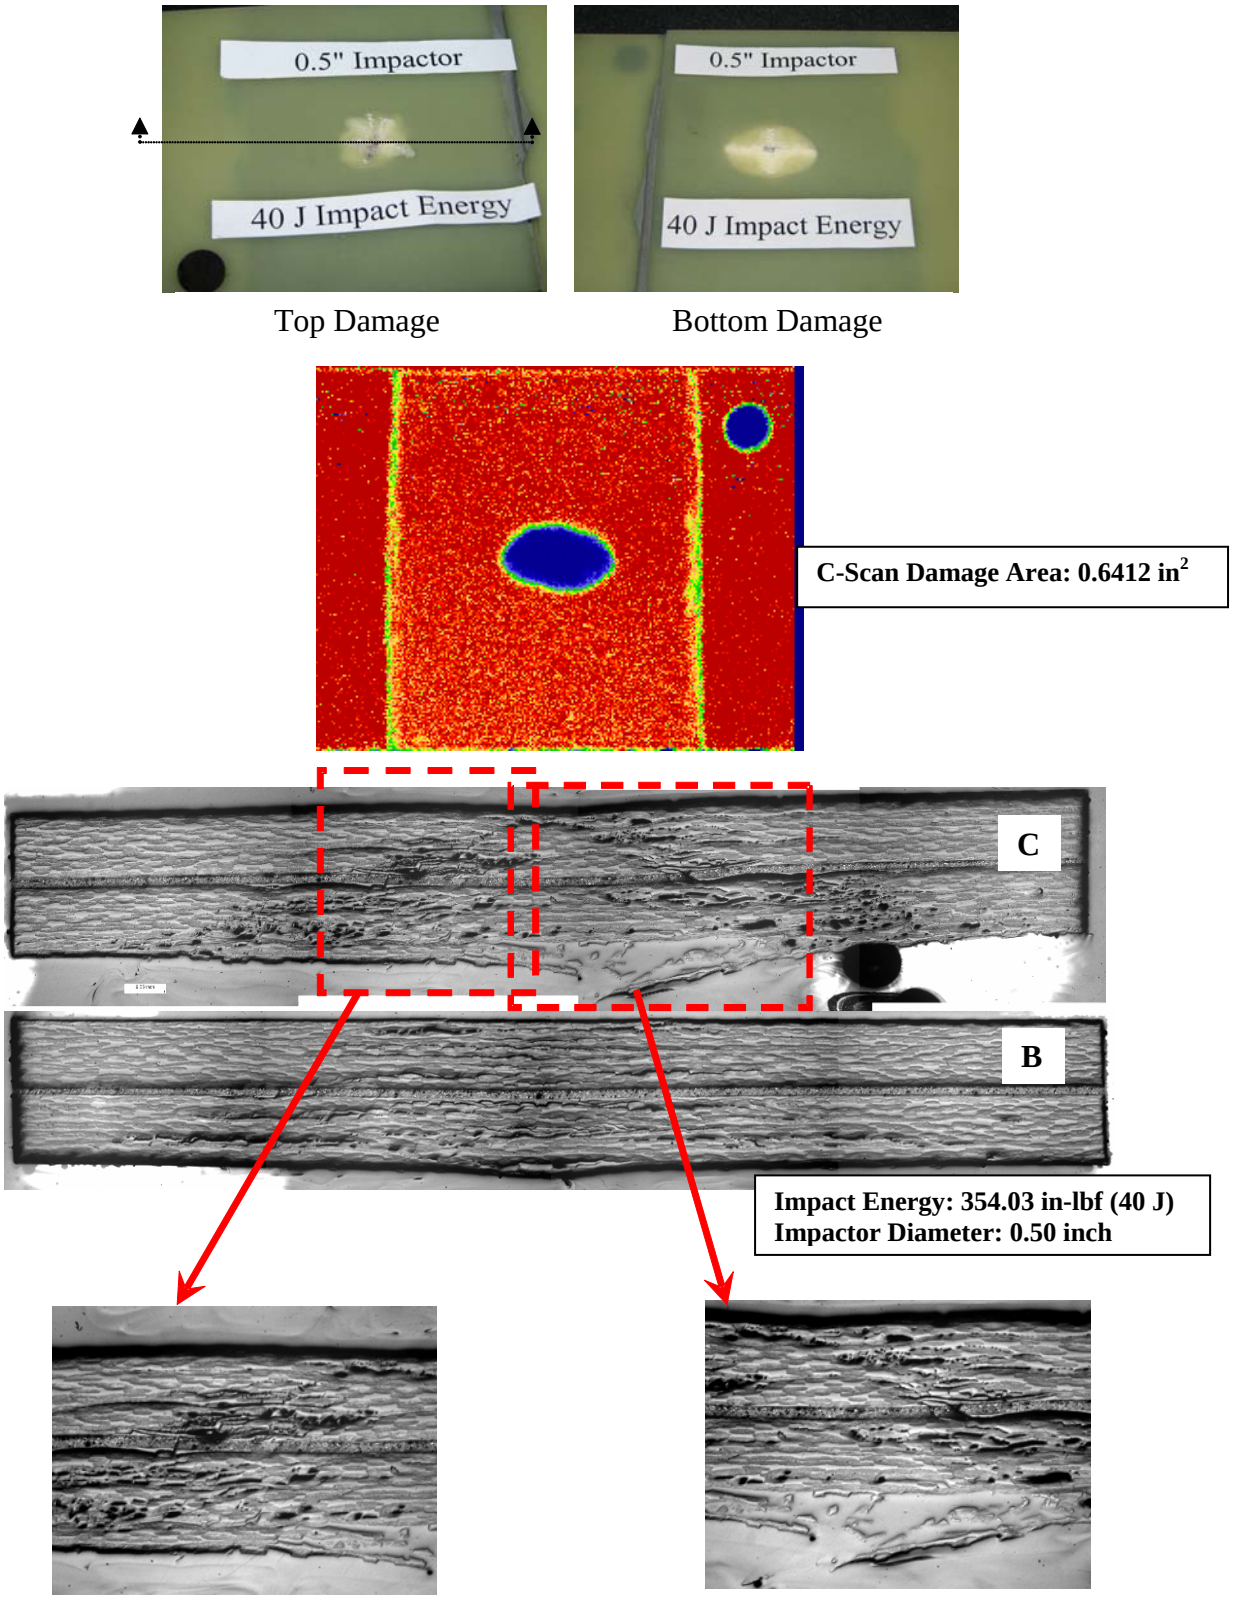
Figures 79 though 90 show photomicrographs of the impacted SLS specimens with different impactors for several different energy levels. These figures show visual damage on the impacted and opposite sides of the specimen (top), TTU C-scan image of the damage area (center), and photomicrographs of the specimen (bottom). These specimens are dissected along the impact point to investigate through-the-thickness damage. The cutting planes were chosen so that one of the two specimen surfaces represents the centerline of the impact, while the other surface is one blade thickness (0.08 inch) away. Photomicrographic image that matches the centerline is labeled as C, while the surface that is offset due to blade thickness is labeled as B. Since overall damage distribution is conical, offset (B) images show less damage than centerline (C) images.

Figure 79. Photomicrograph of FGSW—I1G83C3: 0.50-Inch Impactor and 354.03 in-lbf

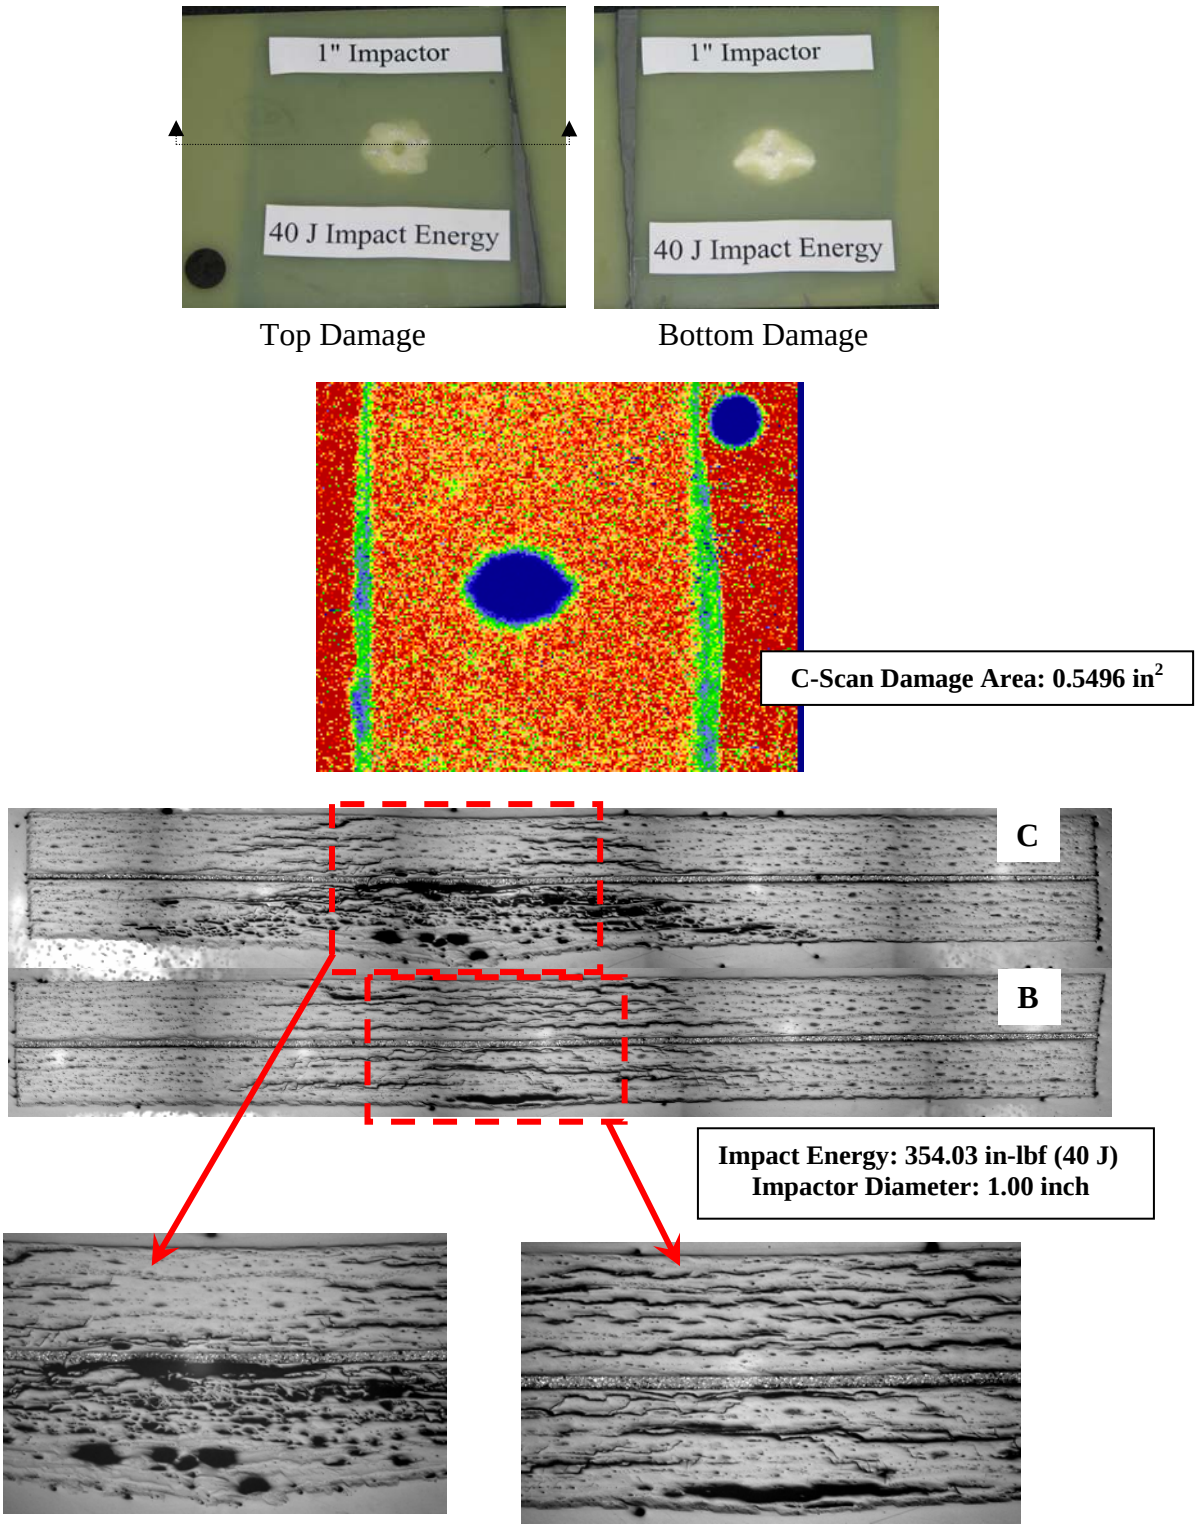
Figure 80. Photomicrograph of FGSW—I1G61C3: 1.00-Inch Impactor and 354.03 in-lbf

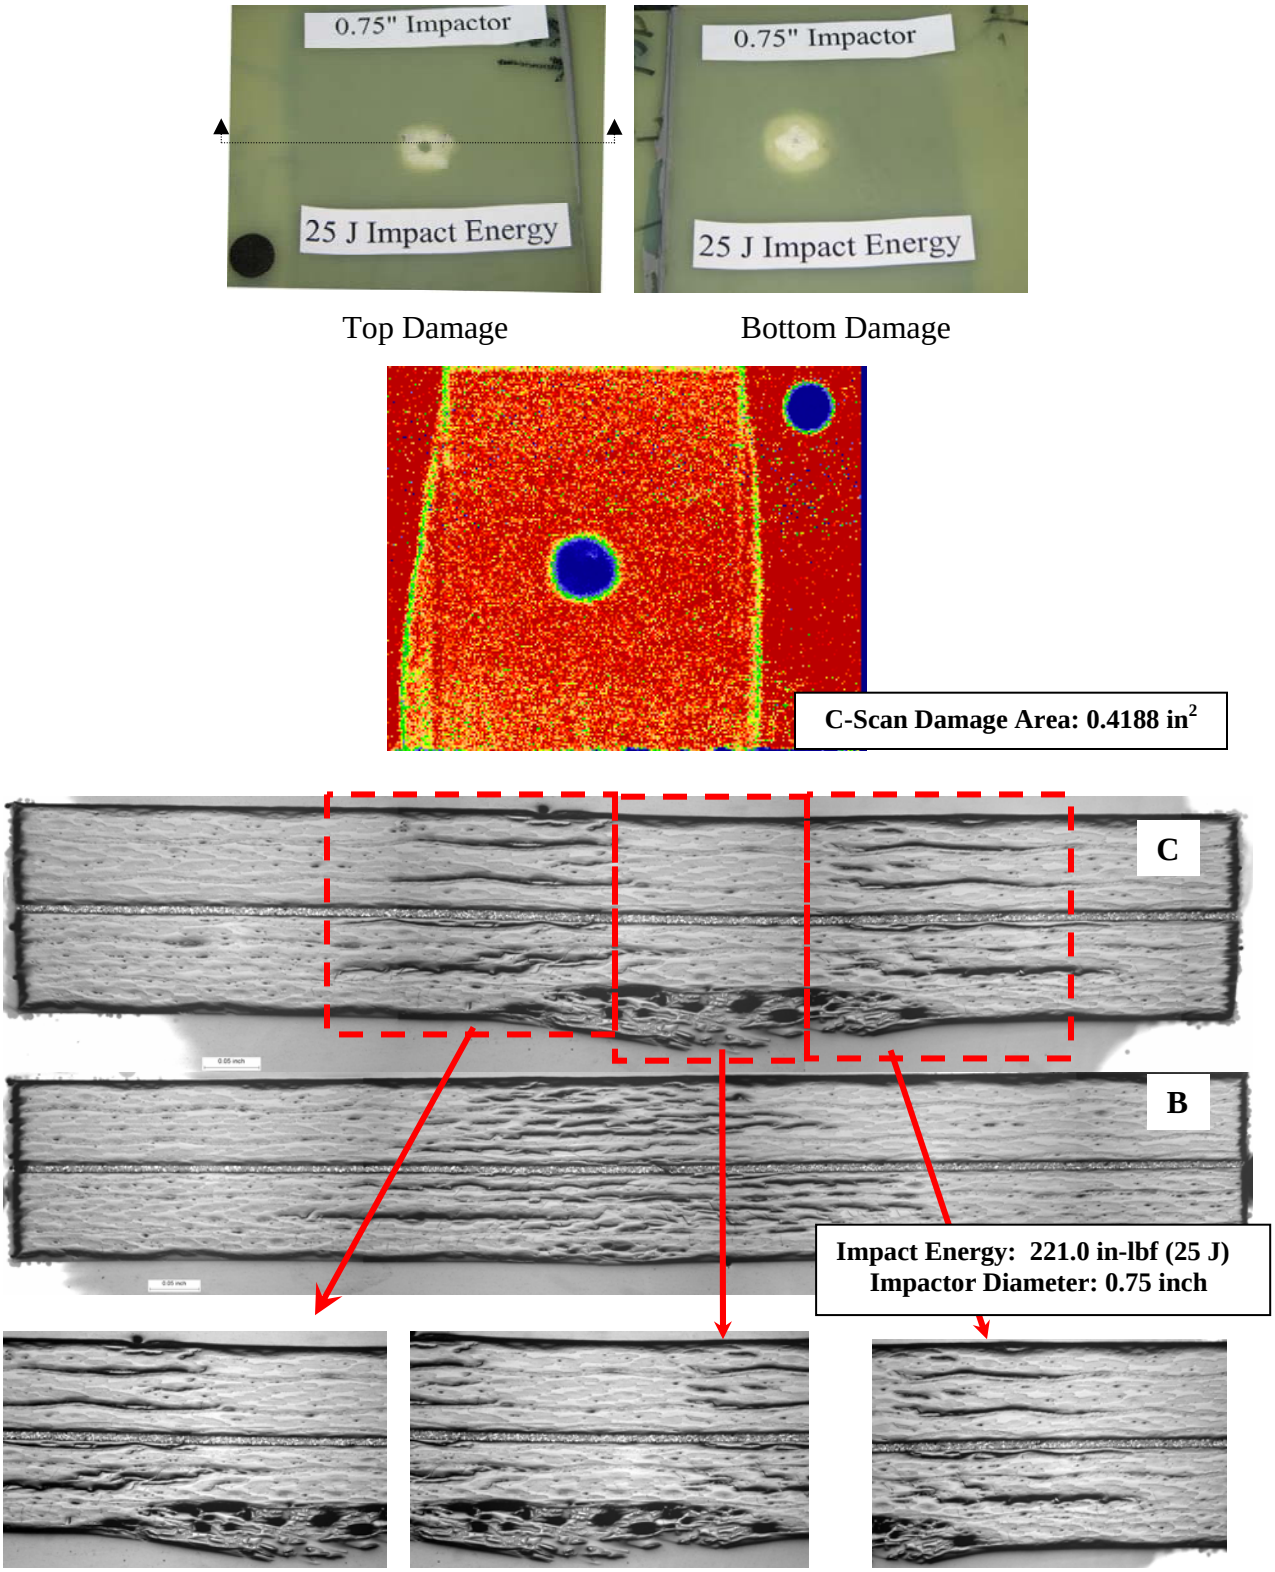
Figure 81. Photomicrograph of FGSW—I1G42B2: 0.75-Inch Impactor and 221.0 in-lbf

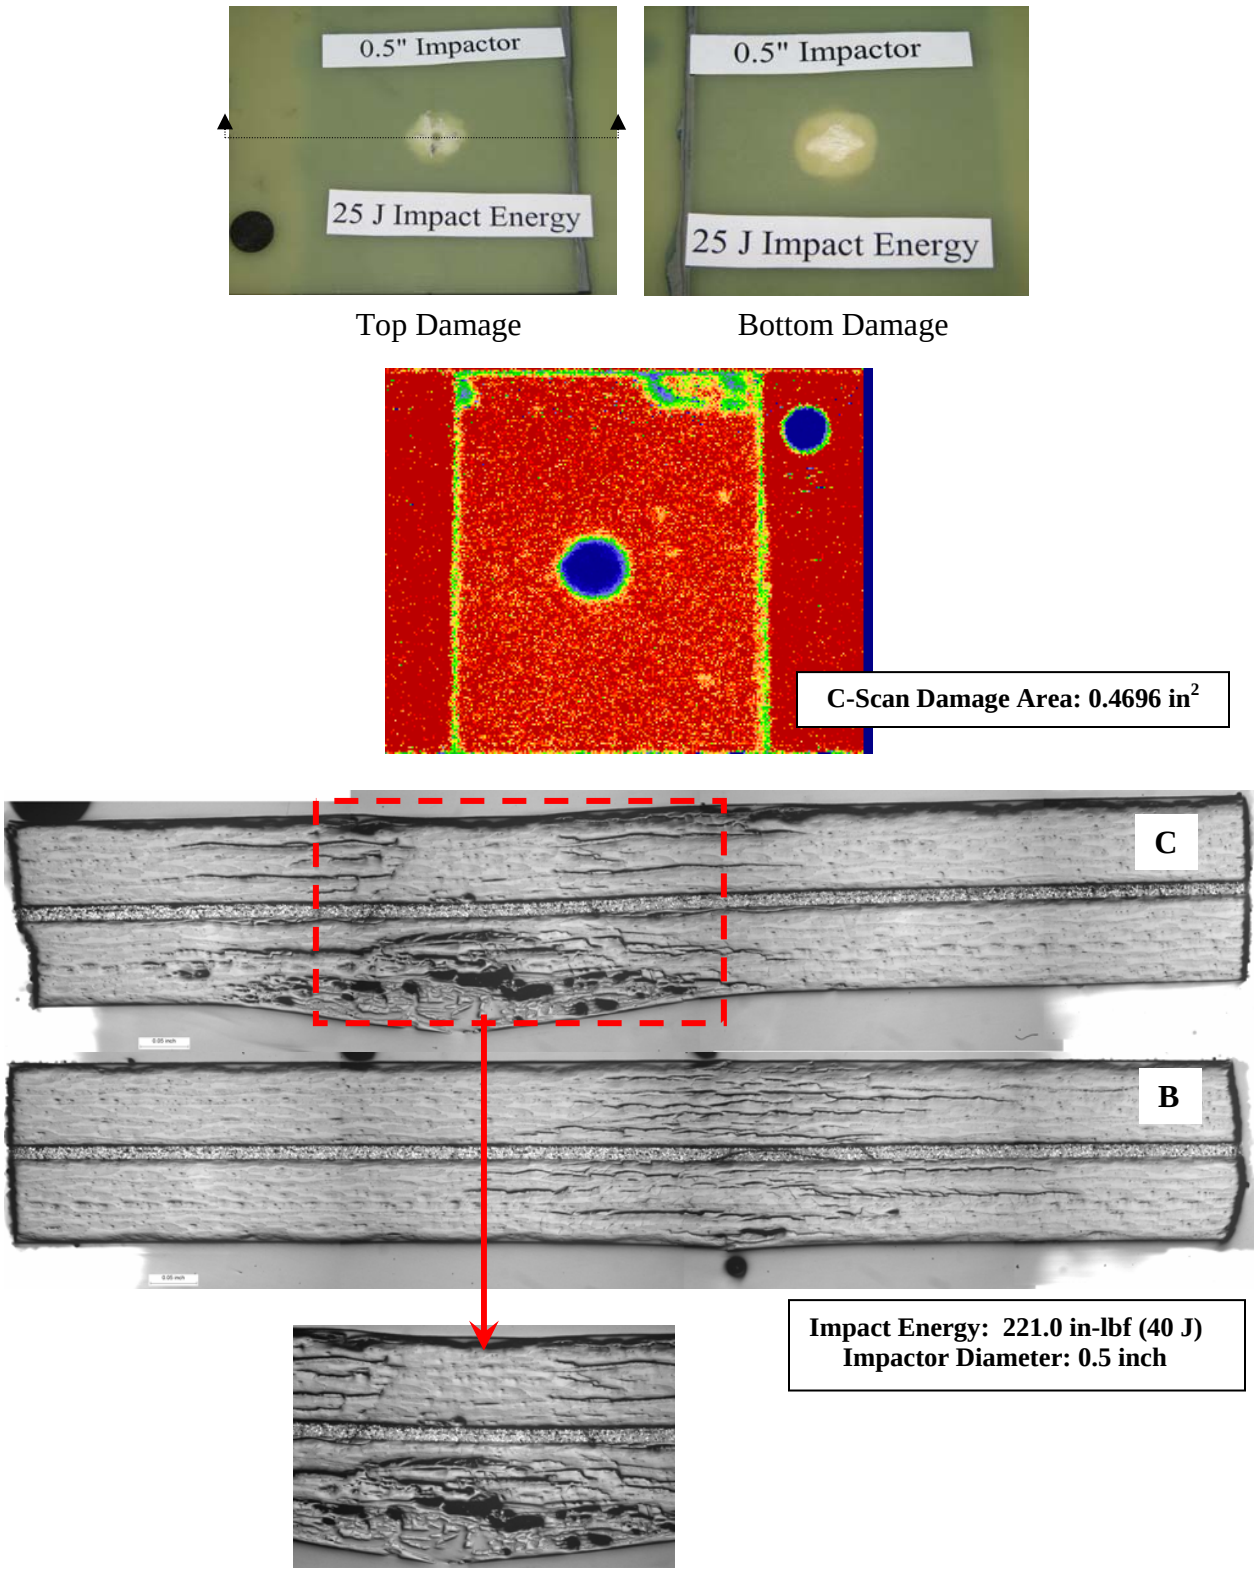
Figure 82. Photomicrograph of FGSW—I1G73B5: 0.5-Inch Impactor and 221.0 in-lbf

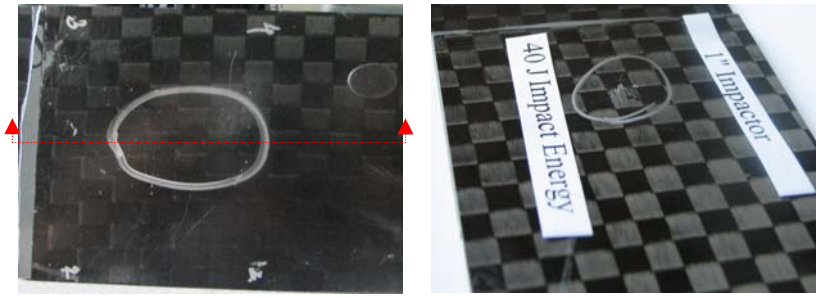
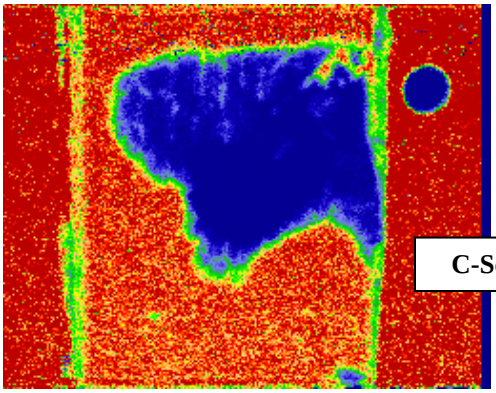
Top Damage Bottom Damage

C-Scan Damage Area: 5.098 in^2

The delaminations along 0° and 90° layers on the impacted side of the FGSW specimens are clearly shown in figures 81 and 82 (C images) and the small cracks are clearly seen on the surface offset by the blade thickness (B images). Pine tree-shaped damage zone is clearly visible in FGSW specimens. Thus, photomicrographs reconfirm the circular damage shape observed
