DOT/FAA/AR-09/4

Effects of Disbonds, Lightning Strikes, and Low-Velocity Impact Damage on Adhesively Bonded Composite Joints

December 2009

Final Report

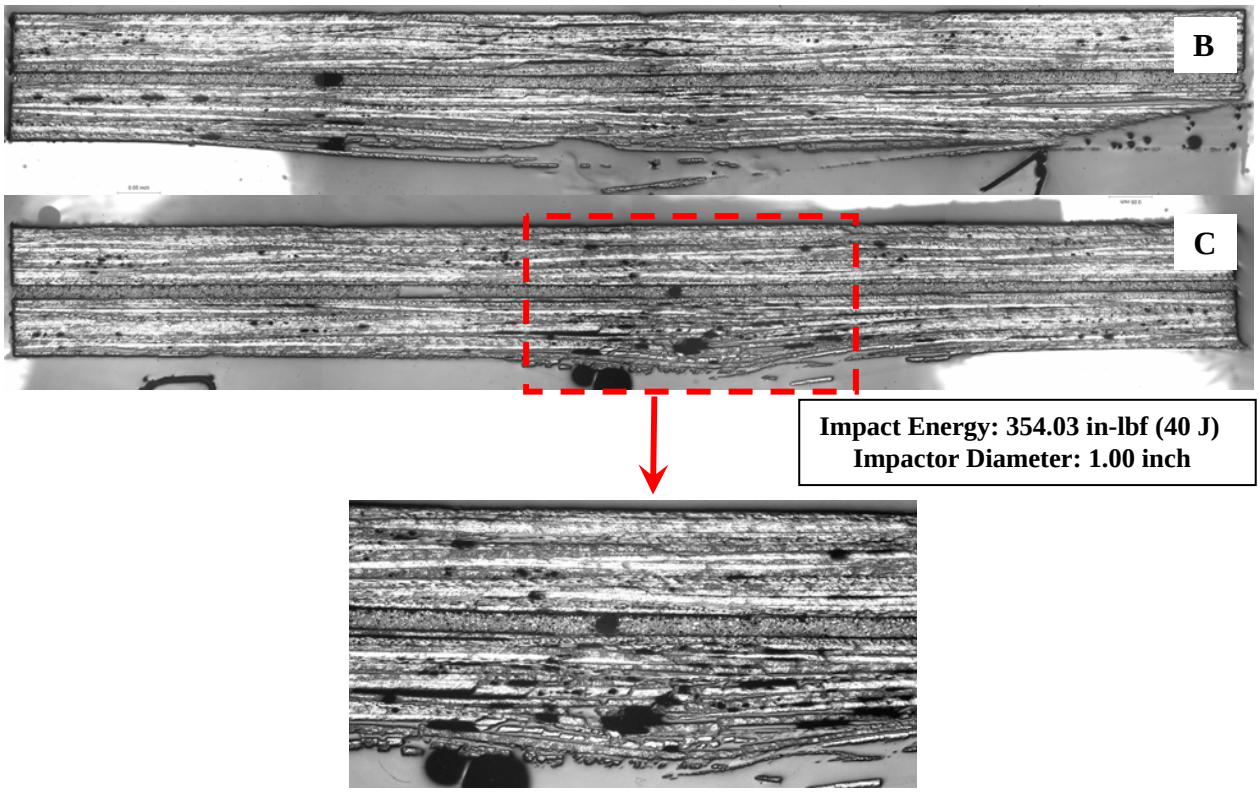
Figure 83. Photomicrograph of CFRP—I1P11C3: 1-Inch Impactor and 354.03 in-lbf

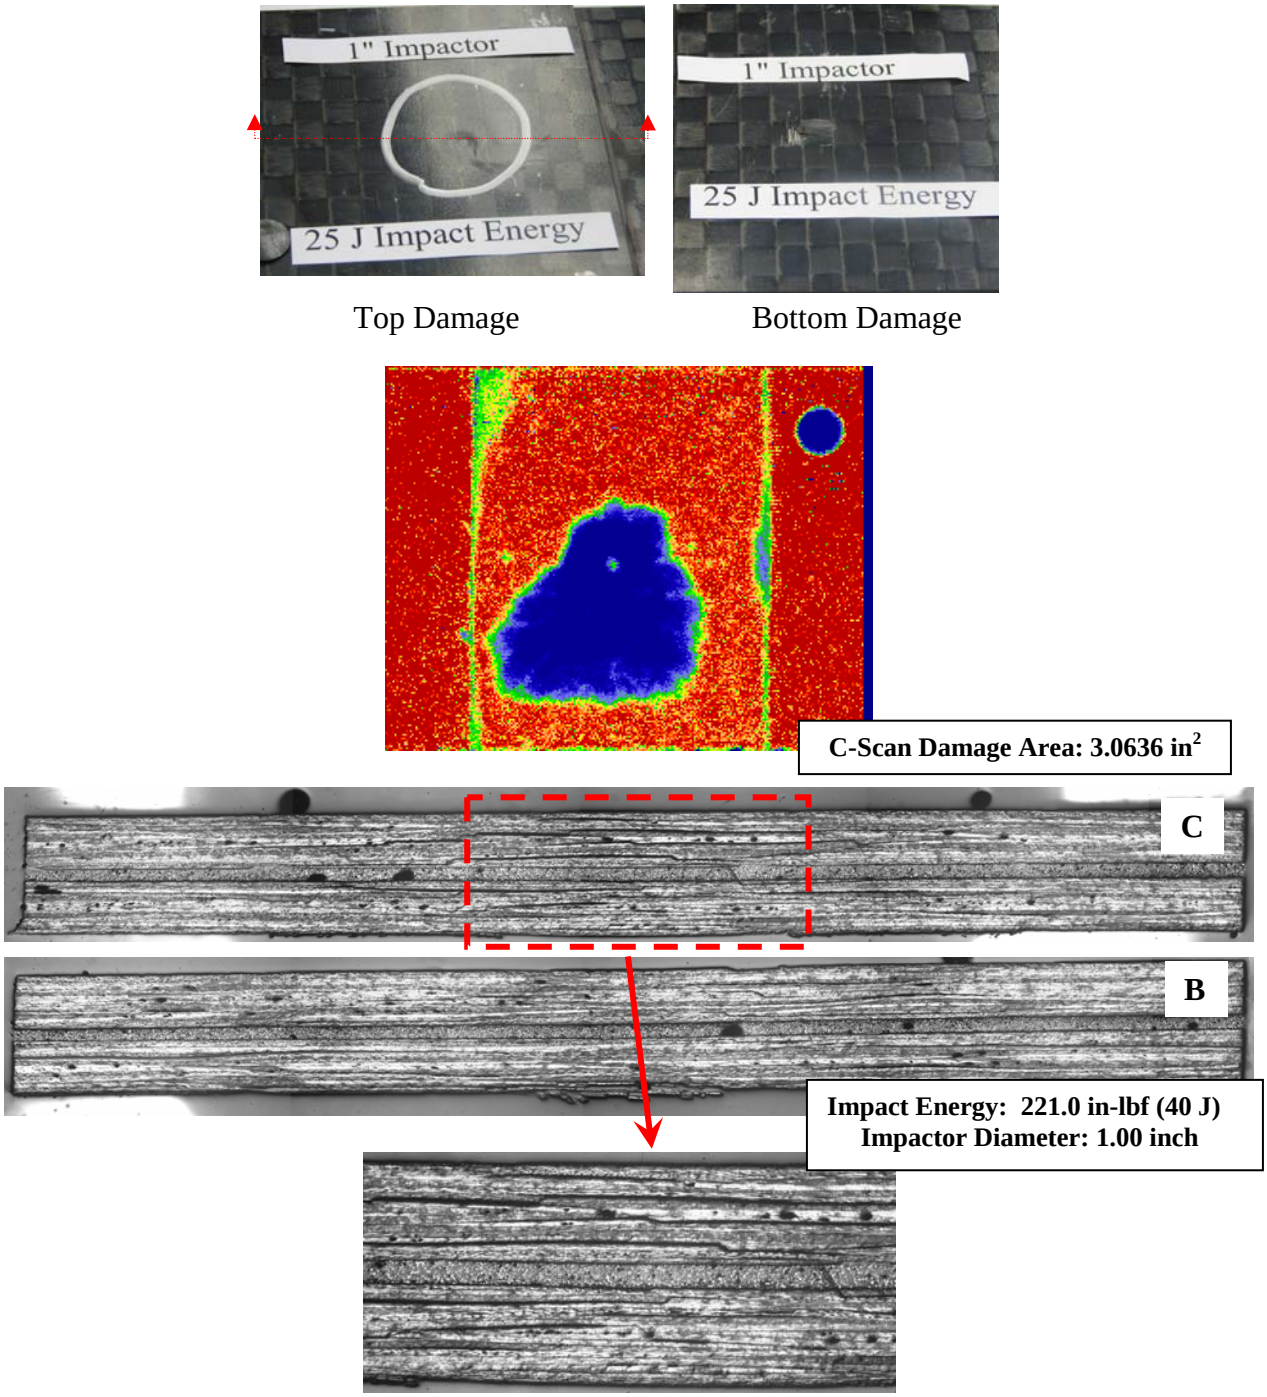
Figure 84. Photomicrograph of CFRP—I1P61B2: 1-Inch Impactor and 221.0 in-lbf

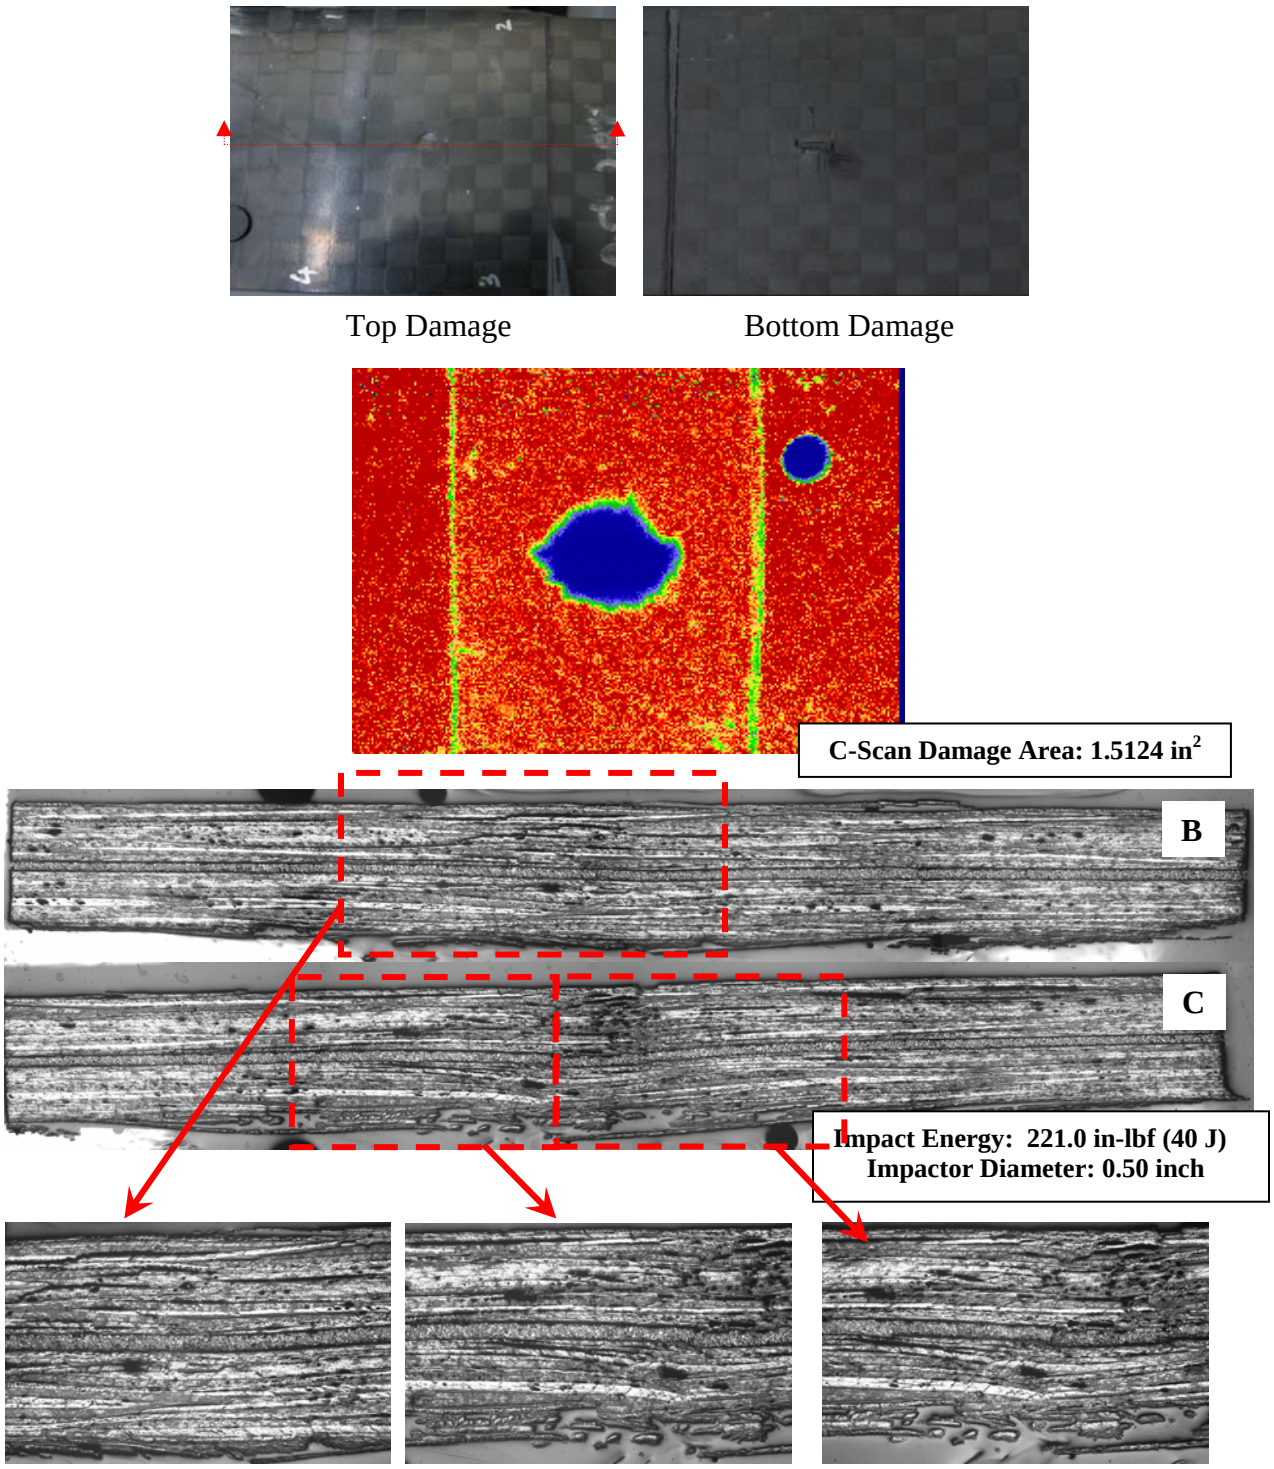
Figure 85. Photomicrograph of CFRP—I1P43B4: 0.5-Inch Impactor and 221.0 in-lbf

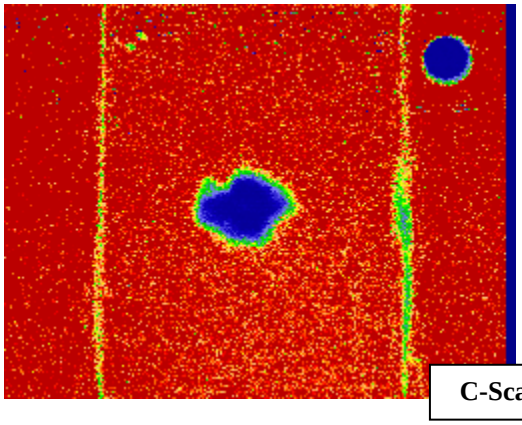
C-Scan Damage Area: 0.7528 in^2

Figures 83 through 85 show large interlaminar delaminations in CFPW specimens. These figures also showed that, for these specimens, the tensile fiber failure is limited to the bottom-most plies compared to specimens from the other two material systems. The damage area shown on the C-scan images is primarily due to large delaminations shown in the photomicrographs. Figures 86 through 90 show a substantial amount of transverse matrix cracks and relatively short delaminations in CFUT specimen that are concentrated within the pine tree-shaped damage zone. These fracture areas are projected in TTU C-scan images, including some of the longitudinal cracks in the outer-most ply that propagate out of the primary damage zone. There is a considerable amount of fractures across the adhesive layer that emanates from the transverse matrix crack of adjacent 0° plies. In addition, some compressive and tensile cracks propagated to cause multiple adhesive/adherend failures (interfacial failures).

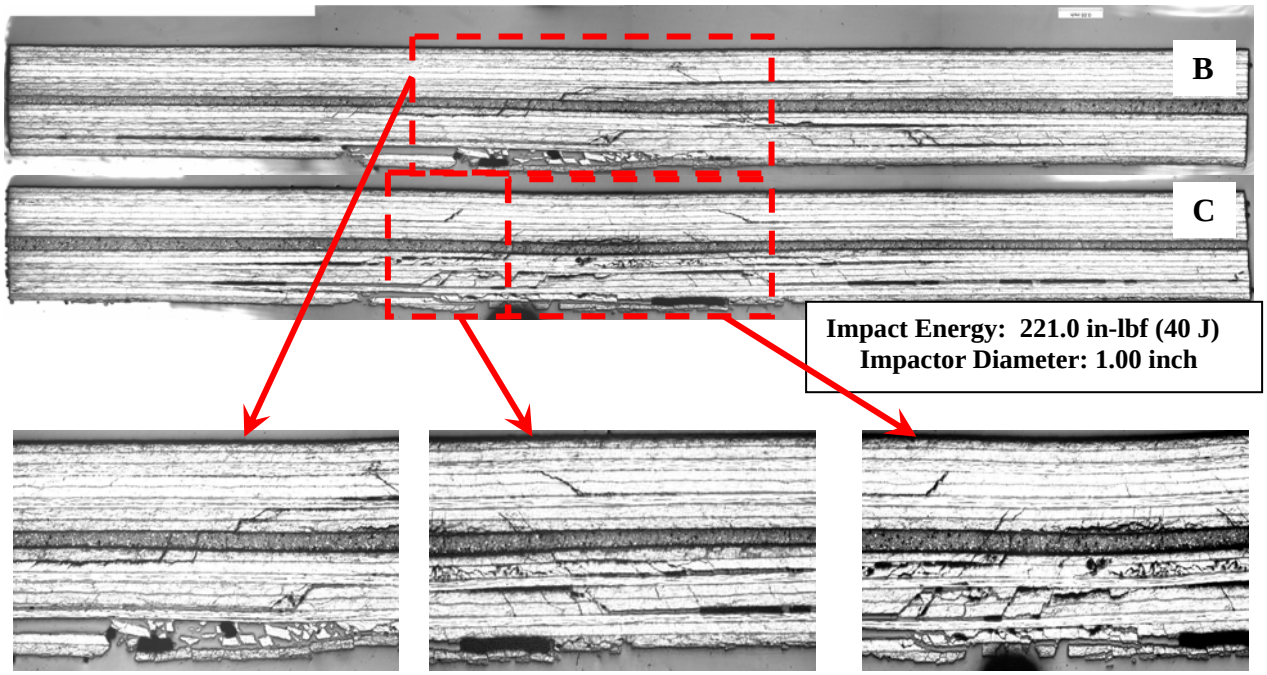
Figure 86. Photomicrograph of CFUT—I1U21B3: 1-Inch Impactor and 221.0 in-lbf

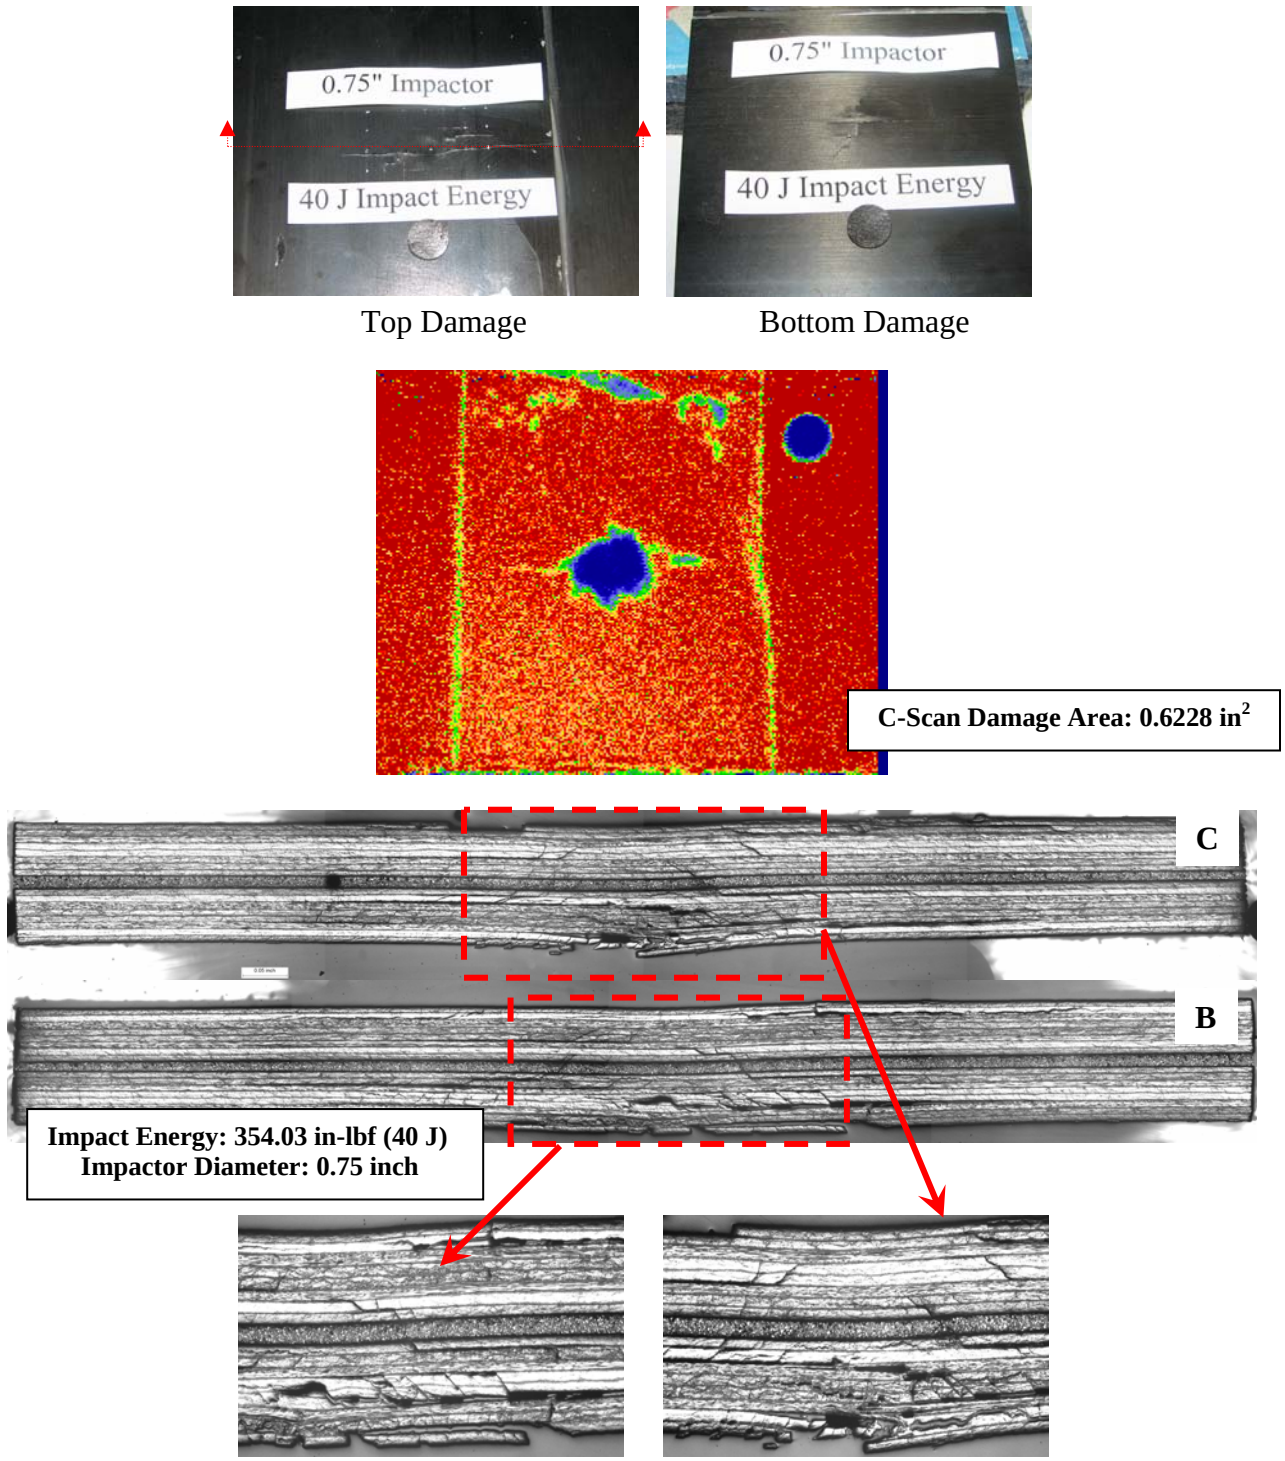
Figure 87. Photomicrograph of CFUT—I1U12B1: 0.75-Inch Impactor and 354.03 in-lbf

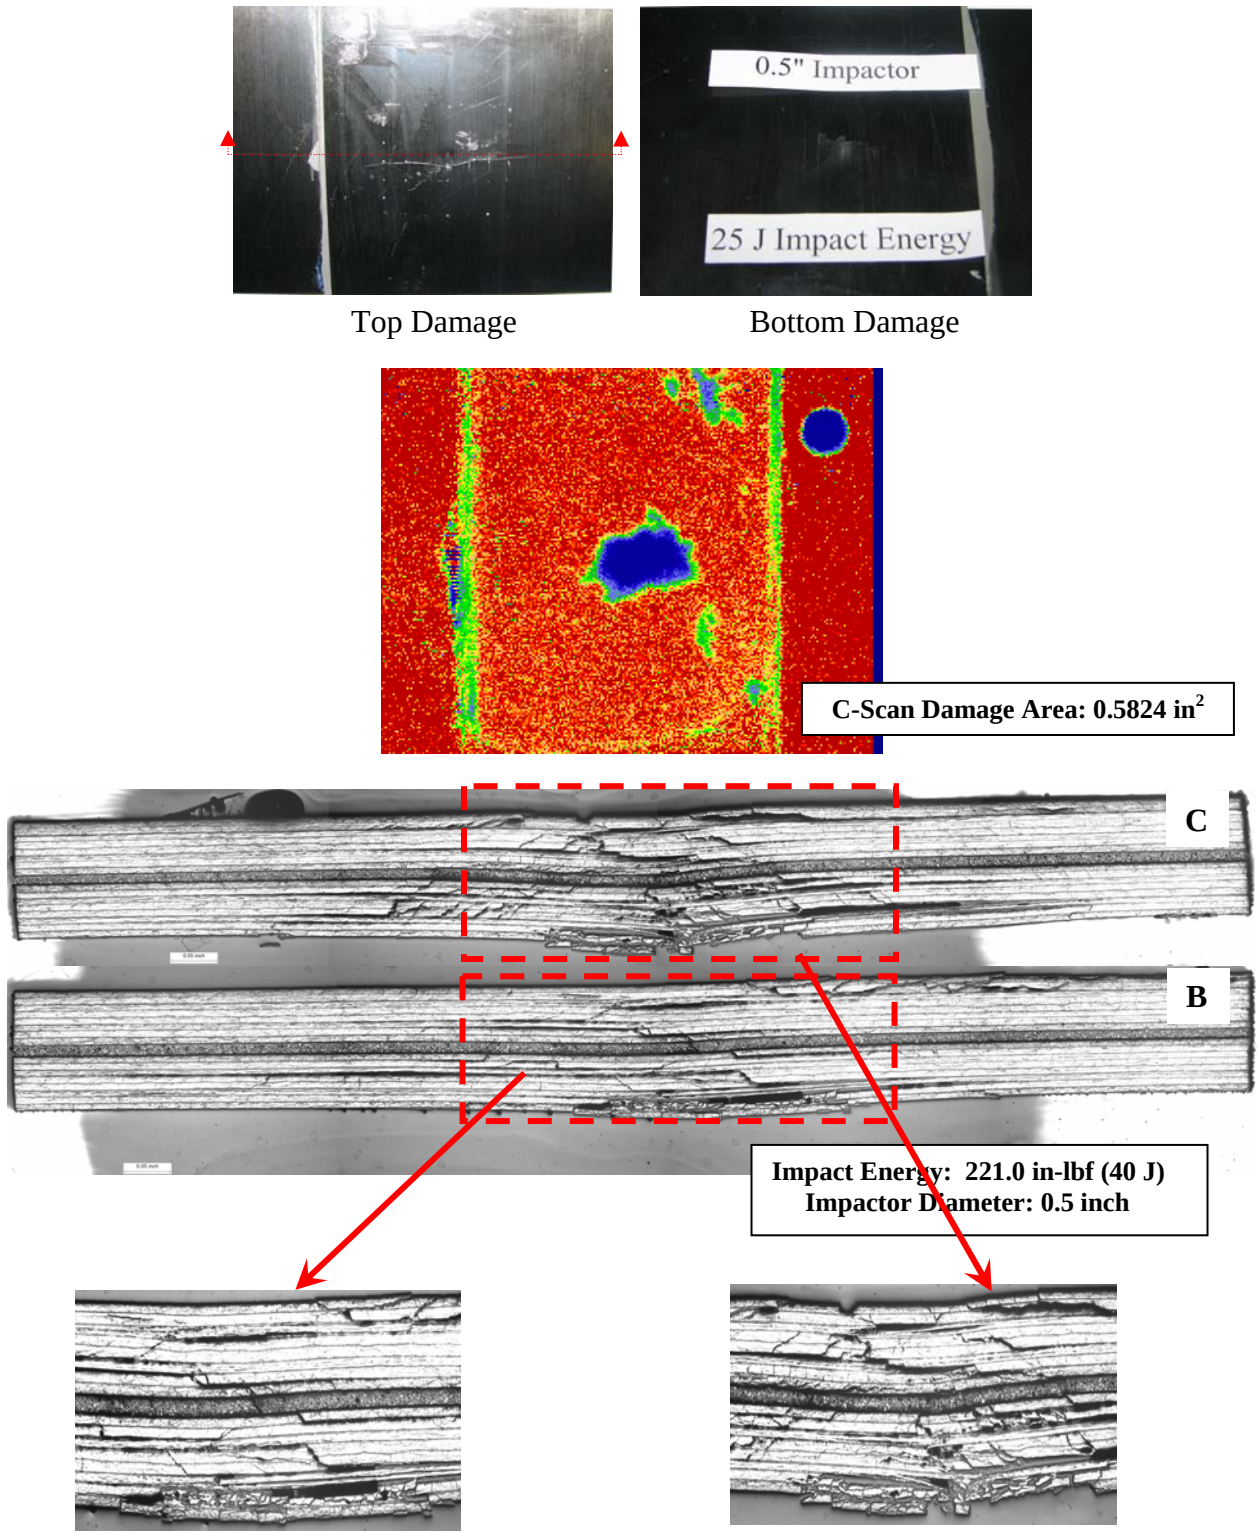
Figure 88. Photomicrograph of CFUT—I1U73B2: 0.5-Inch Impactor and 221.0 in-lbf

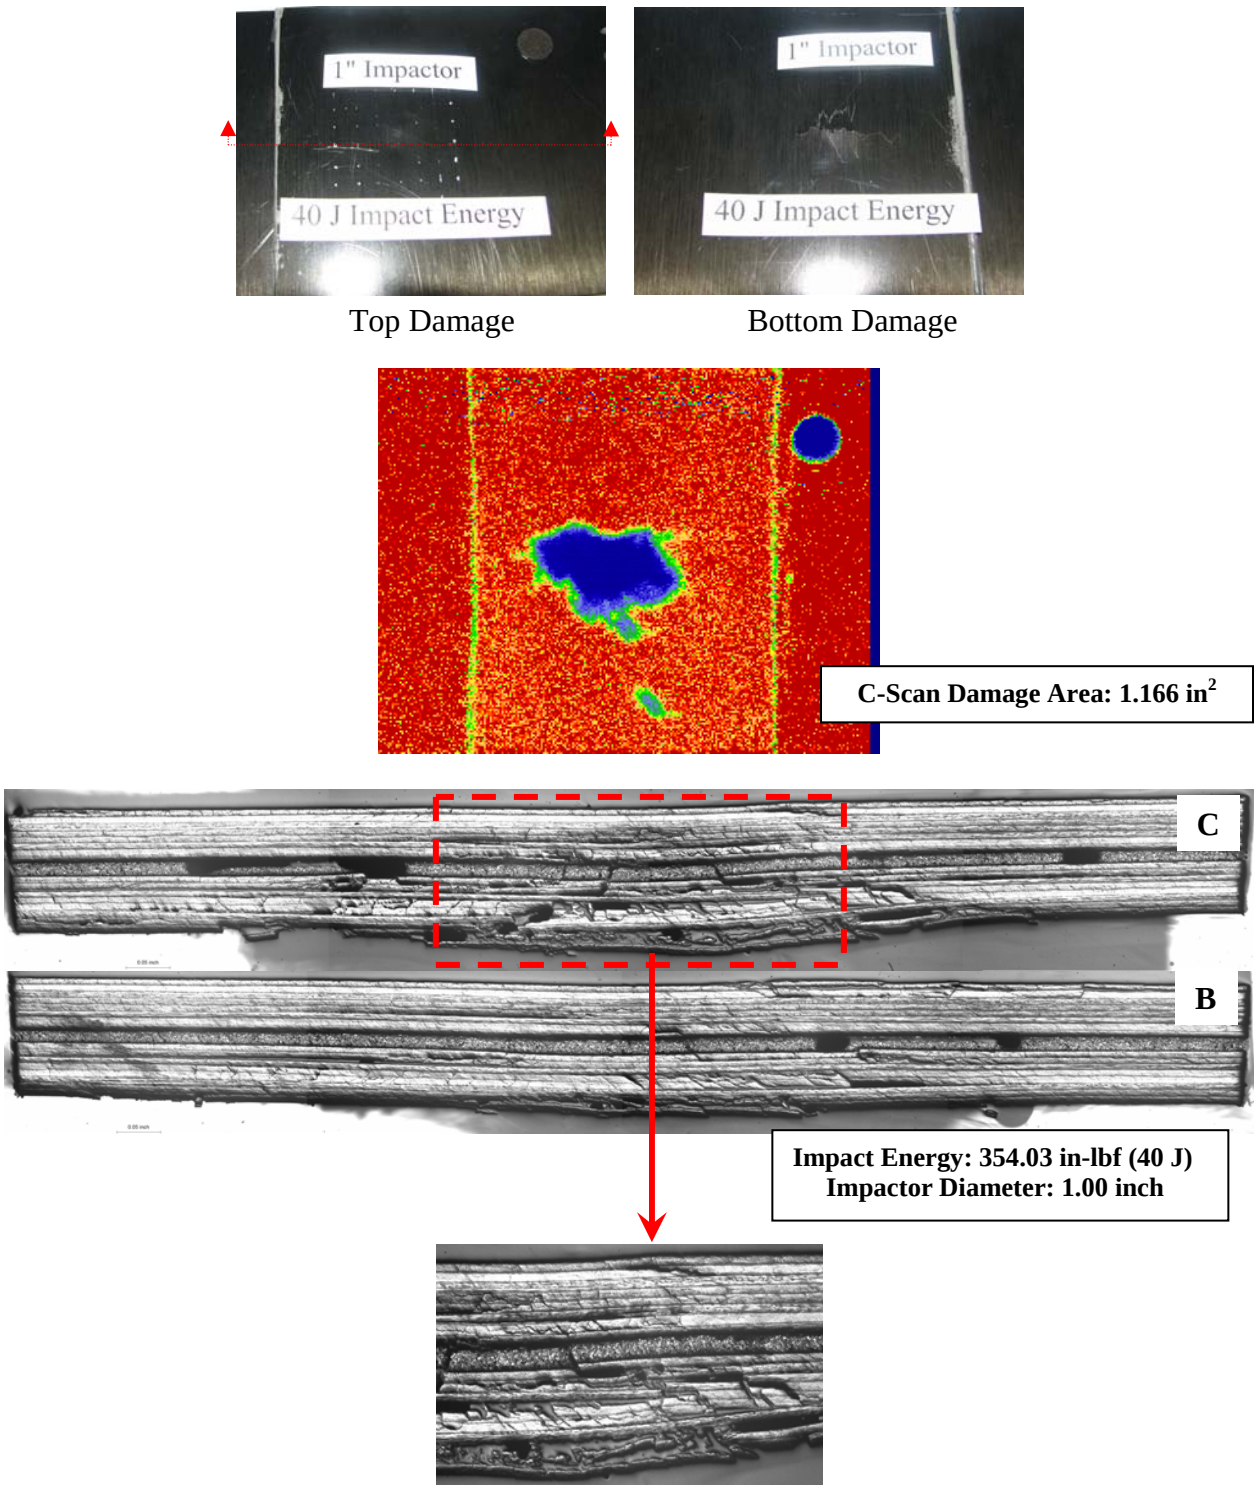
Figure 89. Photomicrograph of CFUT—I1U31C2: 1-Inch Impactor and 354.03 in-lbf

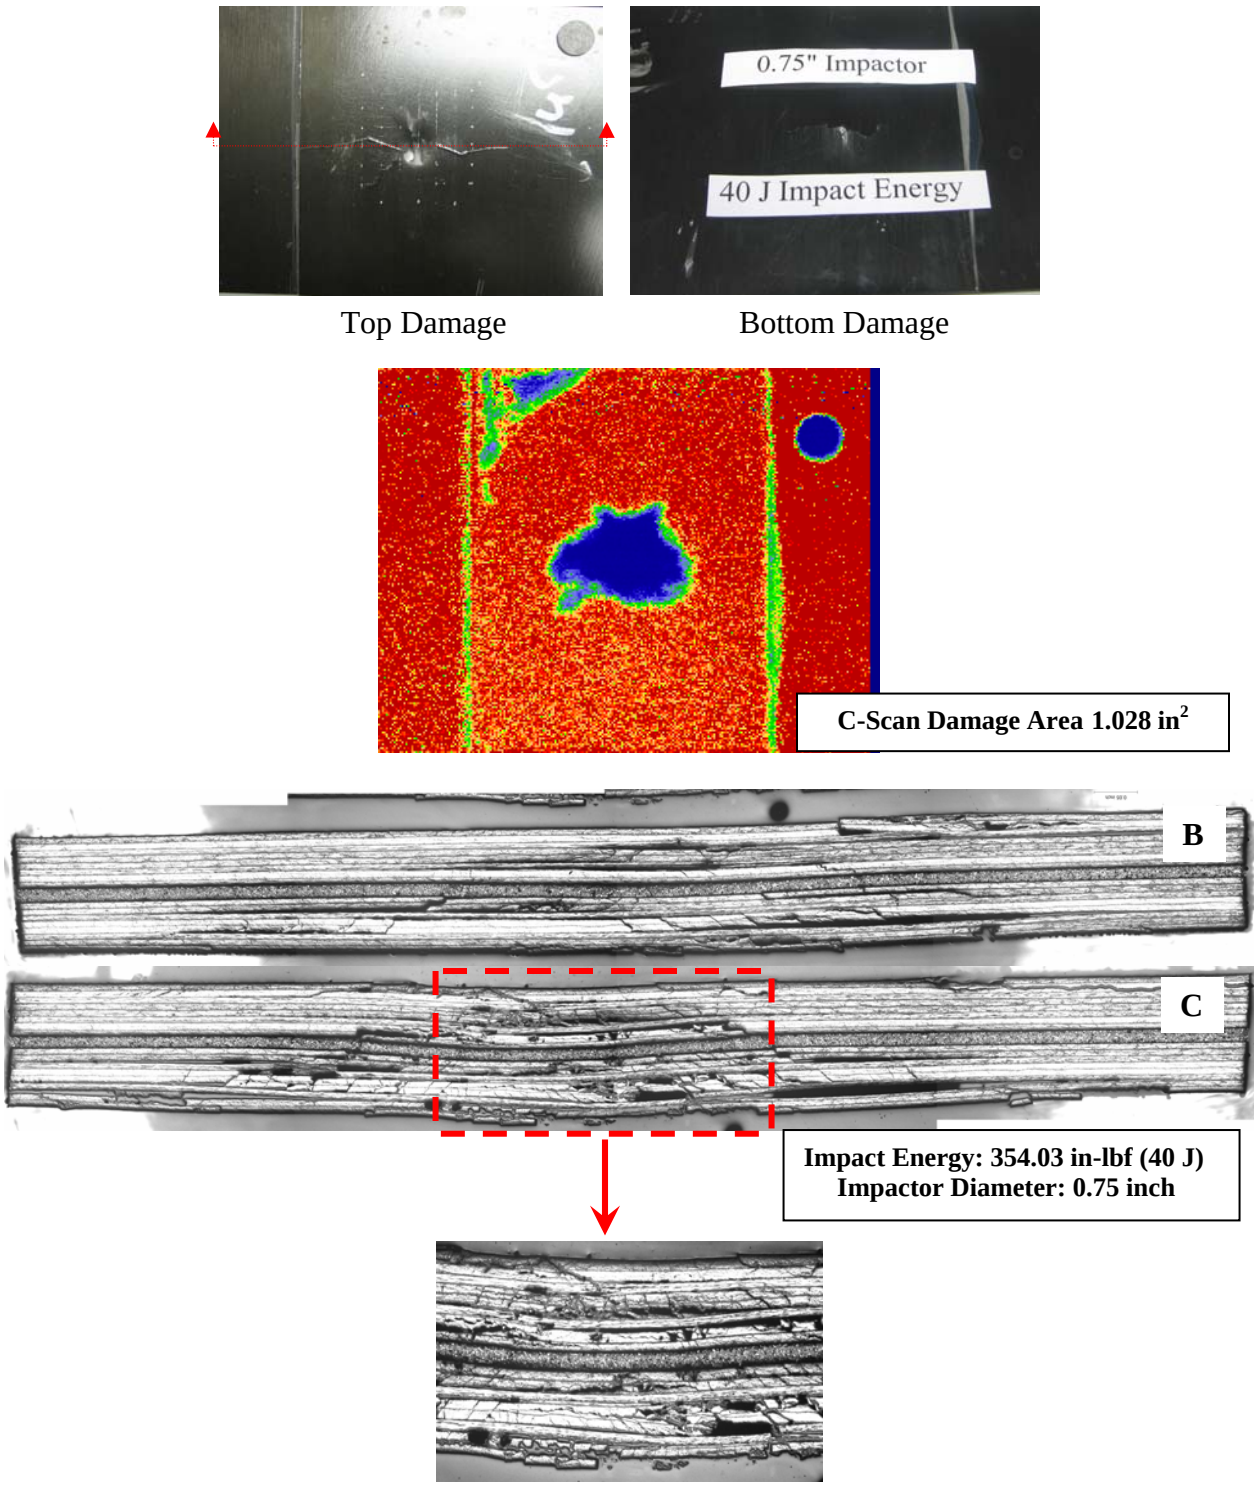
Figure 90. Photomicrograph of CFUT—I1U42C2: 0.75-Inch Impactor and 354.03 in-lbf
