DOT/FAA/AR-95/13

Structural Integrity Evaluation of the Lear Fan 2100 Aircraft

May 1996

Final Report

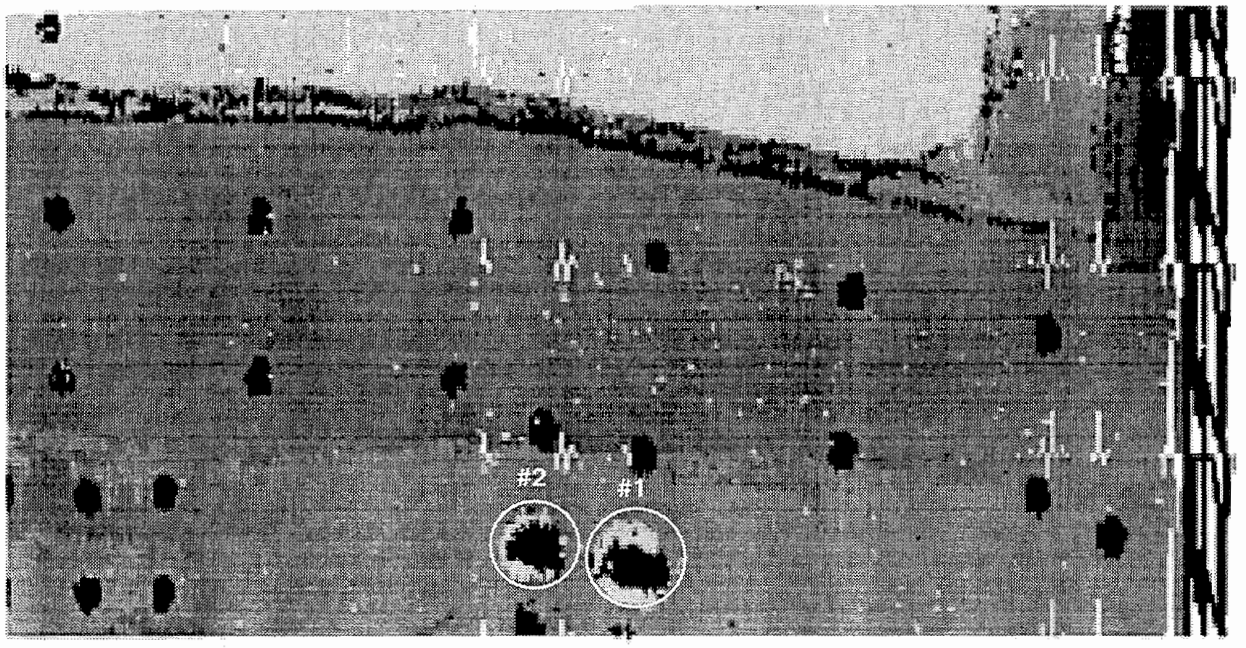
Defects identified by ultrasonic evaluation for the upper wing skins are summarized in figure 3, and the gray scale images of the MAUS data are shown in figures 4 through 13. Numbers next to defects shown in the MAUS images correlate with the defect numbers shown in figure 3 for the left and right wing skins, respectively. A total of 19 delaminations around the fastener heads were identified (5 on the left wing and 14 on the right wing) by the MAUS, all

FIGURE 4. MAUS IMAGES OF DEFECT NOS. 1 AND 2 ON THE UPPER LEFT WING SKIN.

were verified by A-Scan. The majority of these delaminations were located around fasteners connecting the upper skins to the aft spars. One area of minor porosity was identified by the MAUS, located between wing stations Yw=28 and Yw=40, extending over the entire skin of the left wing in the chord direction, but could not be verified by A-Scan. Lack of verification by A-Scan indicates that MAUS equipment is more sensitive than conventional ultrasonic inspection equipment, which cannot detect defects that produce an ultrasonic attenuation less than 3dB.

Thermographic inspection was performed on all defects and suspect areas identified by the MAUS. All delaminations around upper wing skin fasteners that were identified by ultrasonic inspection were also detected by thermography. However, the majority of these defects appeared to be slightly smaller than ultrasonic inspection data indicated. Thermographic inspection of the splice between upper and side fuselage skins produced no indications of disbond, even in the area that ultrasonic inspection identified as worse than other splice areas. In addition, thermographic inspection could not detect the area of mild porosity on the left wing that was detected by the MAUS. These results indicate that thermographic inspection equipment used is not as sensitive as conventional ultrasonic equipment.

The majority of the defects detected on the upper wing skins were delaminations around fastener holes. This type of damage is usually produced during assembly of the composite structure. Assembly induced damage was investigated in detail in reference 8, where an analysis method was developed to evaluate the criticality of the damage. The defects detected during the inspection were evaluated using this method. The results of the analytical evaluation are presented in section 5.

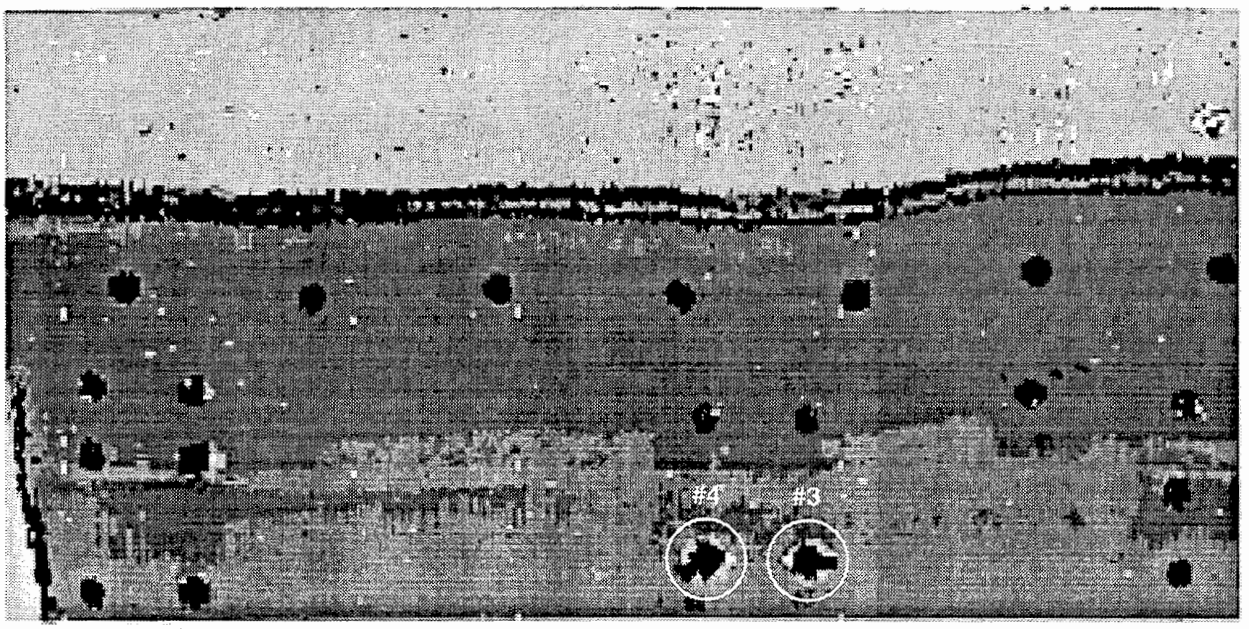
FIGURE 5. MAUS IMAGES OF DEFECT NOS. 3 AND 4 ON THE UPPER LEFT WING SKIN.

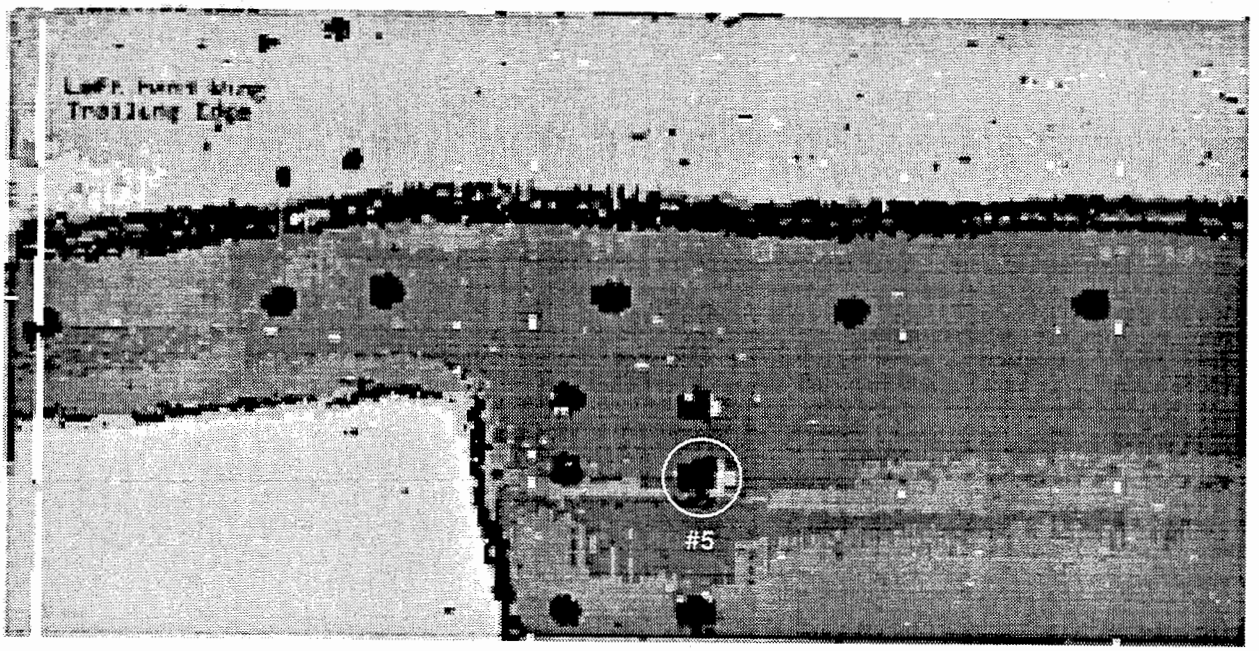
FIGURE 6. MAUS IMAGE OF DEFECT NO. 5 ON THE UPPER LEFT WING SKIN.

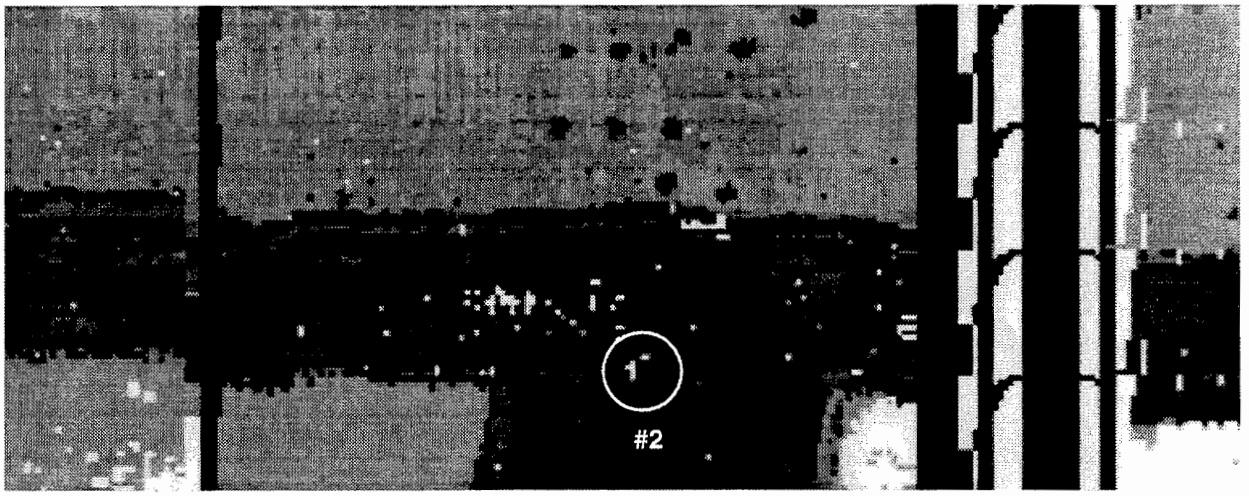
FIGURE 8. MAUS IMAGE OF DEFECT NO. 2 ON THE UPPER RIGHT WING SKIN.

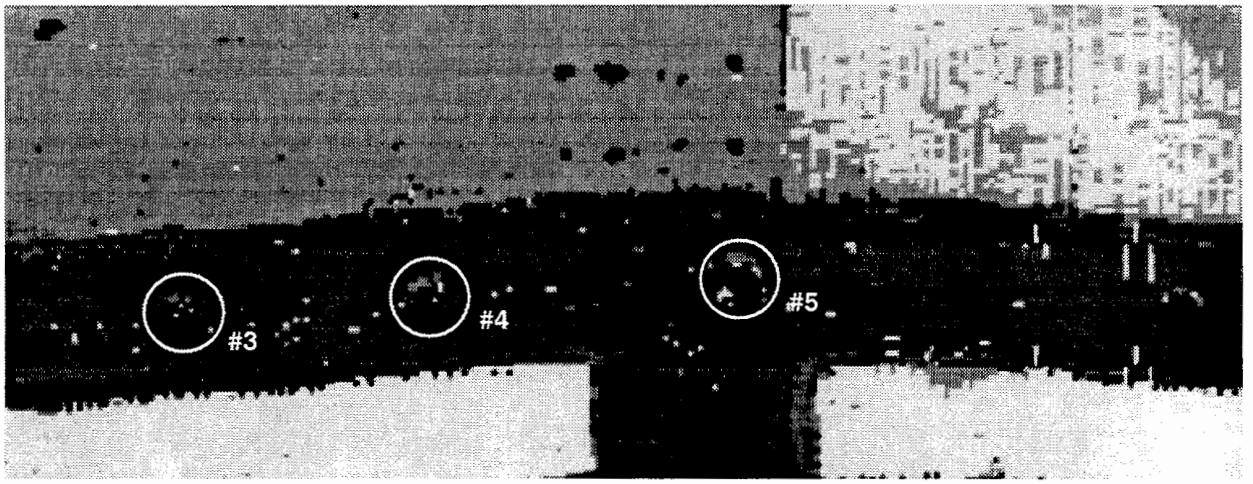
FIGURE 9. MAUS IMAGES OF DEFECT NOS. 3, 4 AND 5 ON THE UPPER RIGHT WING SKIN.

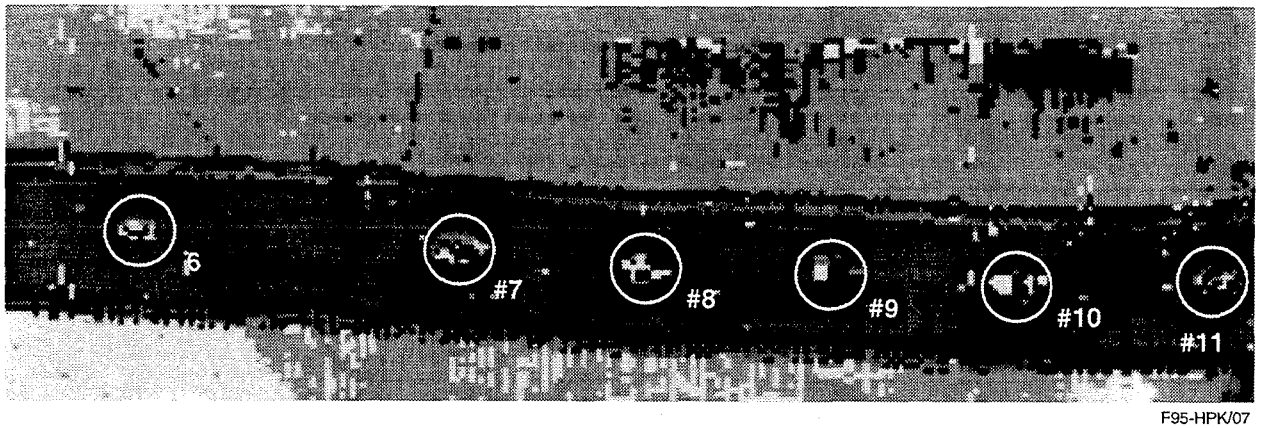
FIGURE 10. MAUS IMAGES OF DEFECT NOS. 6 THROUGH 11 ON THE UPPER RIGHT WING SKIN.

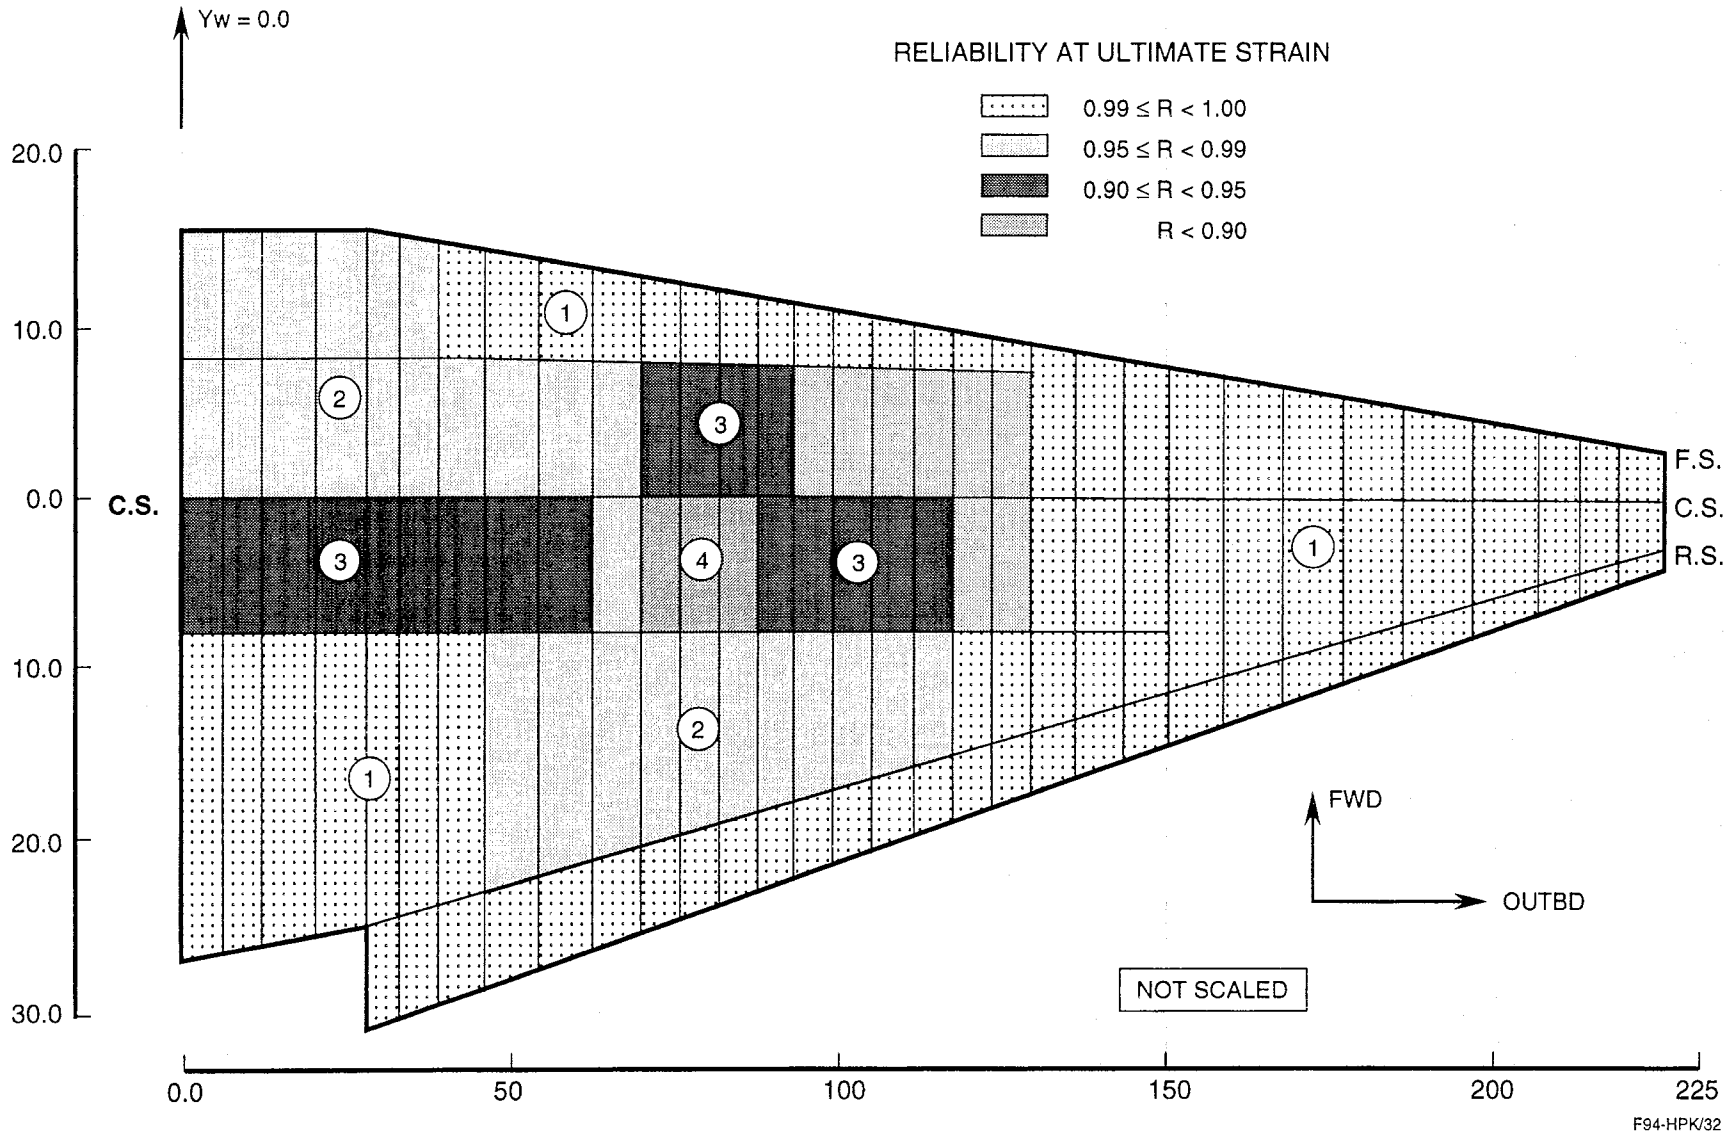
FIGURE 27. RELIABILITY OF IMPACT DAMAGED UPPER WING SKIN, LOW IMPACT THREAT, AVERAGE STRAIN.

The results shown in table 2 indicate that the upper skin under the average limit strain has very high reliability against low impact threat. The reliability exceeds 0.99 for the entire skin with a minimum of 0.99725 for initial failure and 0.99790 for final failure. The reliability remains relatively high for the majority of the skin under ultimate strain, except for a region aft of the center spar between Yw 69 and 87 where the reliability falls below 0.90. It may be noted that the worst case ultimate strain in the area with low reliability exceeds 3000 micro. The distribution of the damaged structural reliability for structural failure under the average ultimate strain is depicted in figure 27. The figure shows that the reliability in the wing tip area is high and decreases towards the aircraft centerline. Also, the reliability decreases from the leading and trailing edges towards the center spar. That is, the reliability distribution follows closely with the strain distribution within the upper wing skin. This same distribution trend was observed for all results of the impact damage tolerance evaluations.

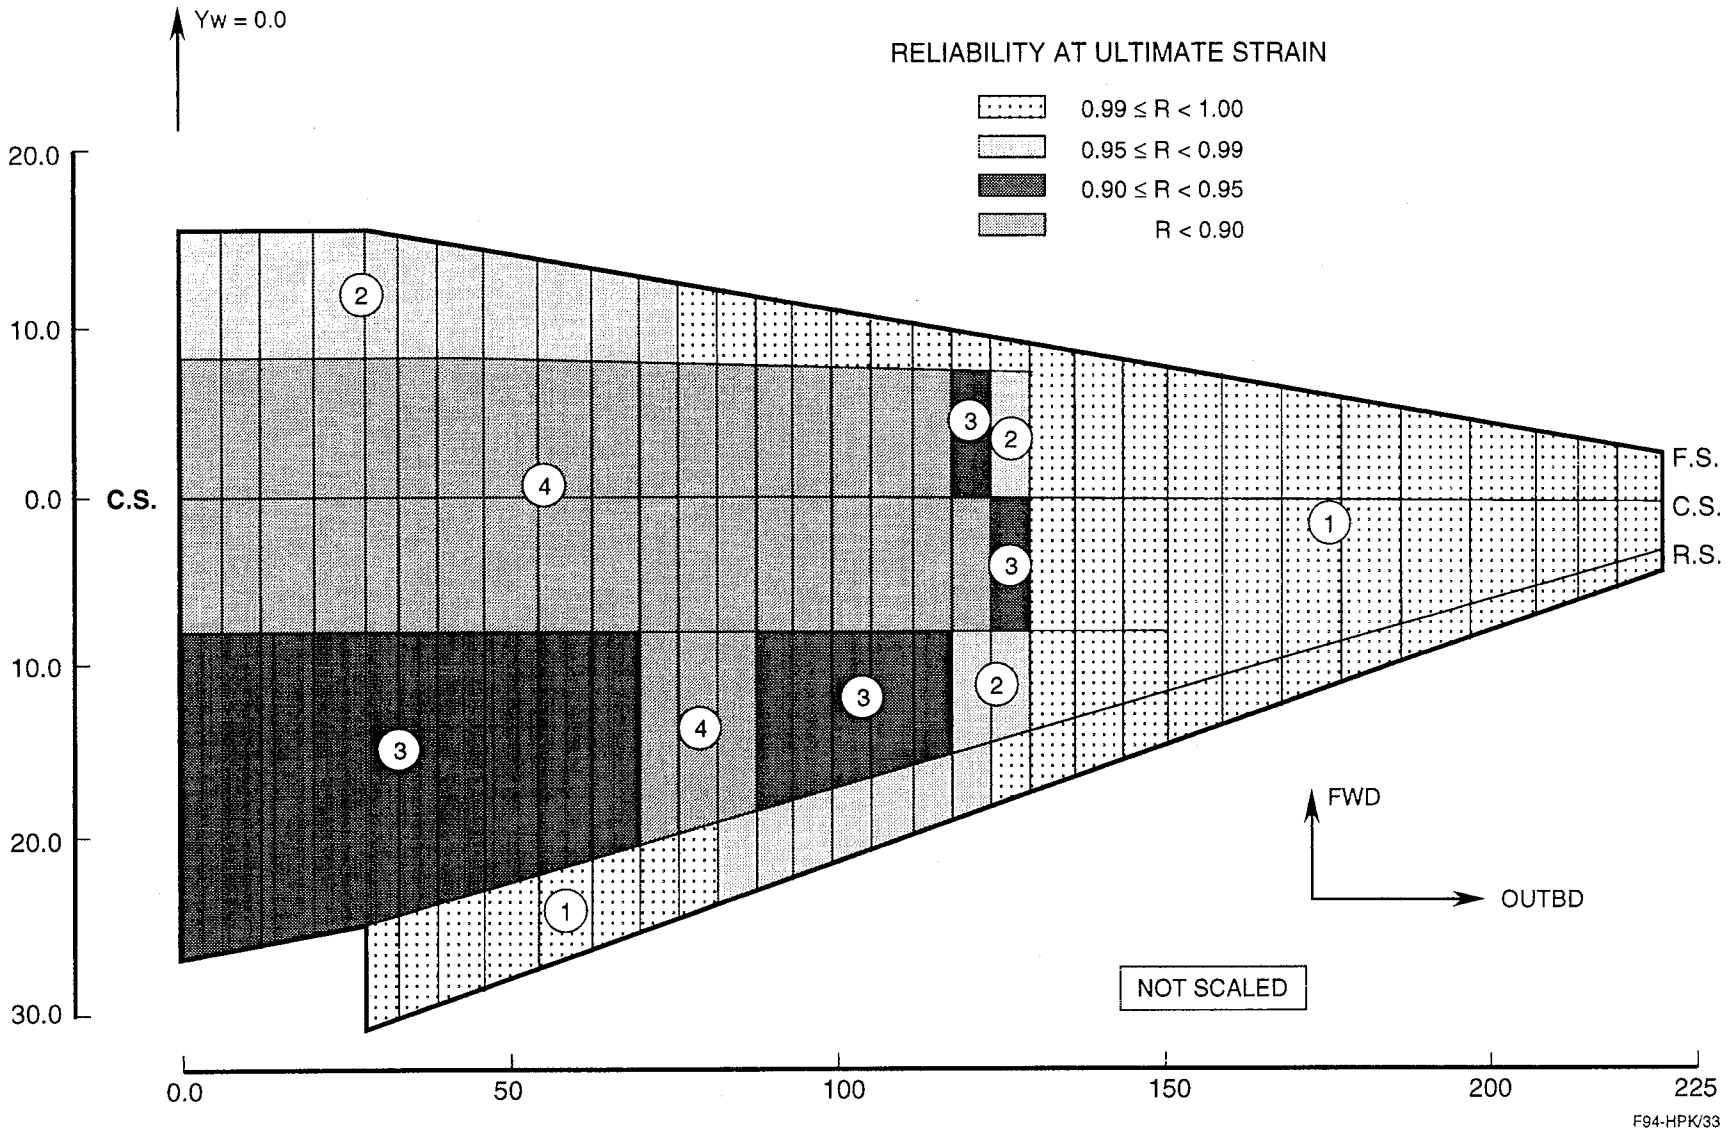
FIGURE 28. RELIABILITY OF IMPACT DAMAGED UPPER WING SKIN, MEDIUM IMPACT THREAT, AVERAGE STRAIN.

The results of impact damage tolerance evaluation for the upper wing skin with average strain against medium impact threat are summarized in table 3, and the reliability distribution for structural failure at ultimate strain is shown in figure 28. Table 3 indicates that the structural reliability against medium threat is high at limit strains. The minimum reliability in subdivision 87 is 0.97588 for initial failure and 0.99203 for structural failure. That is, the skin reliability exceeds 0.99 under limit applied strain. Figure 28 shows that the reliability exceeds 0.99 for the area outboard of Yw 129. The reliability decreases inboard of Yw 129. It becomes lower than 0.90 inboard of Yw 123 immediately aft and forward of the center spar, as shown by region 4 of figure 28.

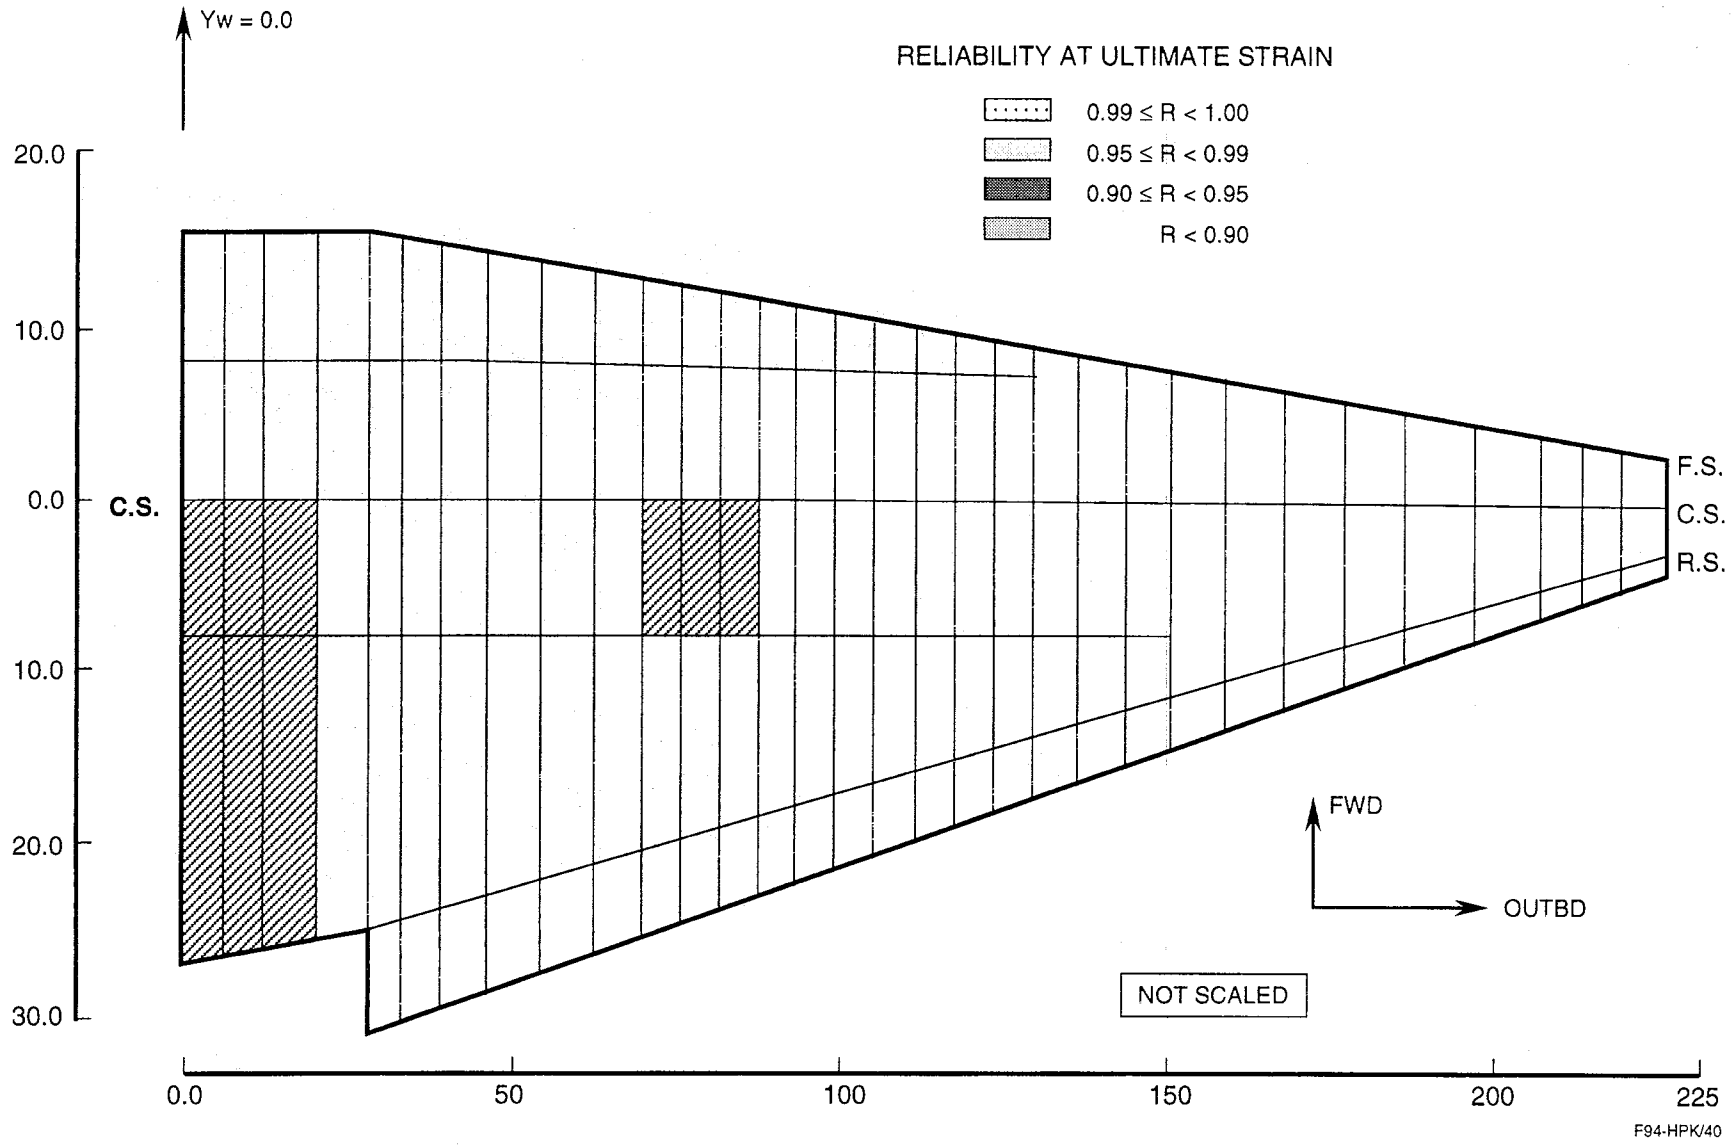
FIGURE 35. CRITICAL IMPACT DAMAGE LOCATIONS OF THE UPPER WING SKIN.

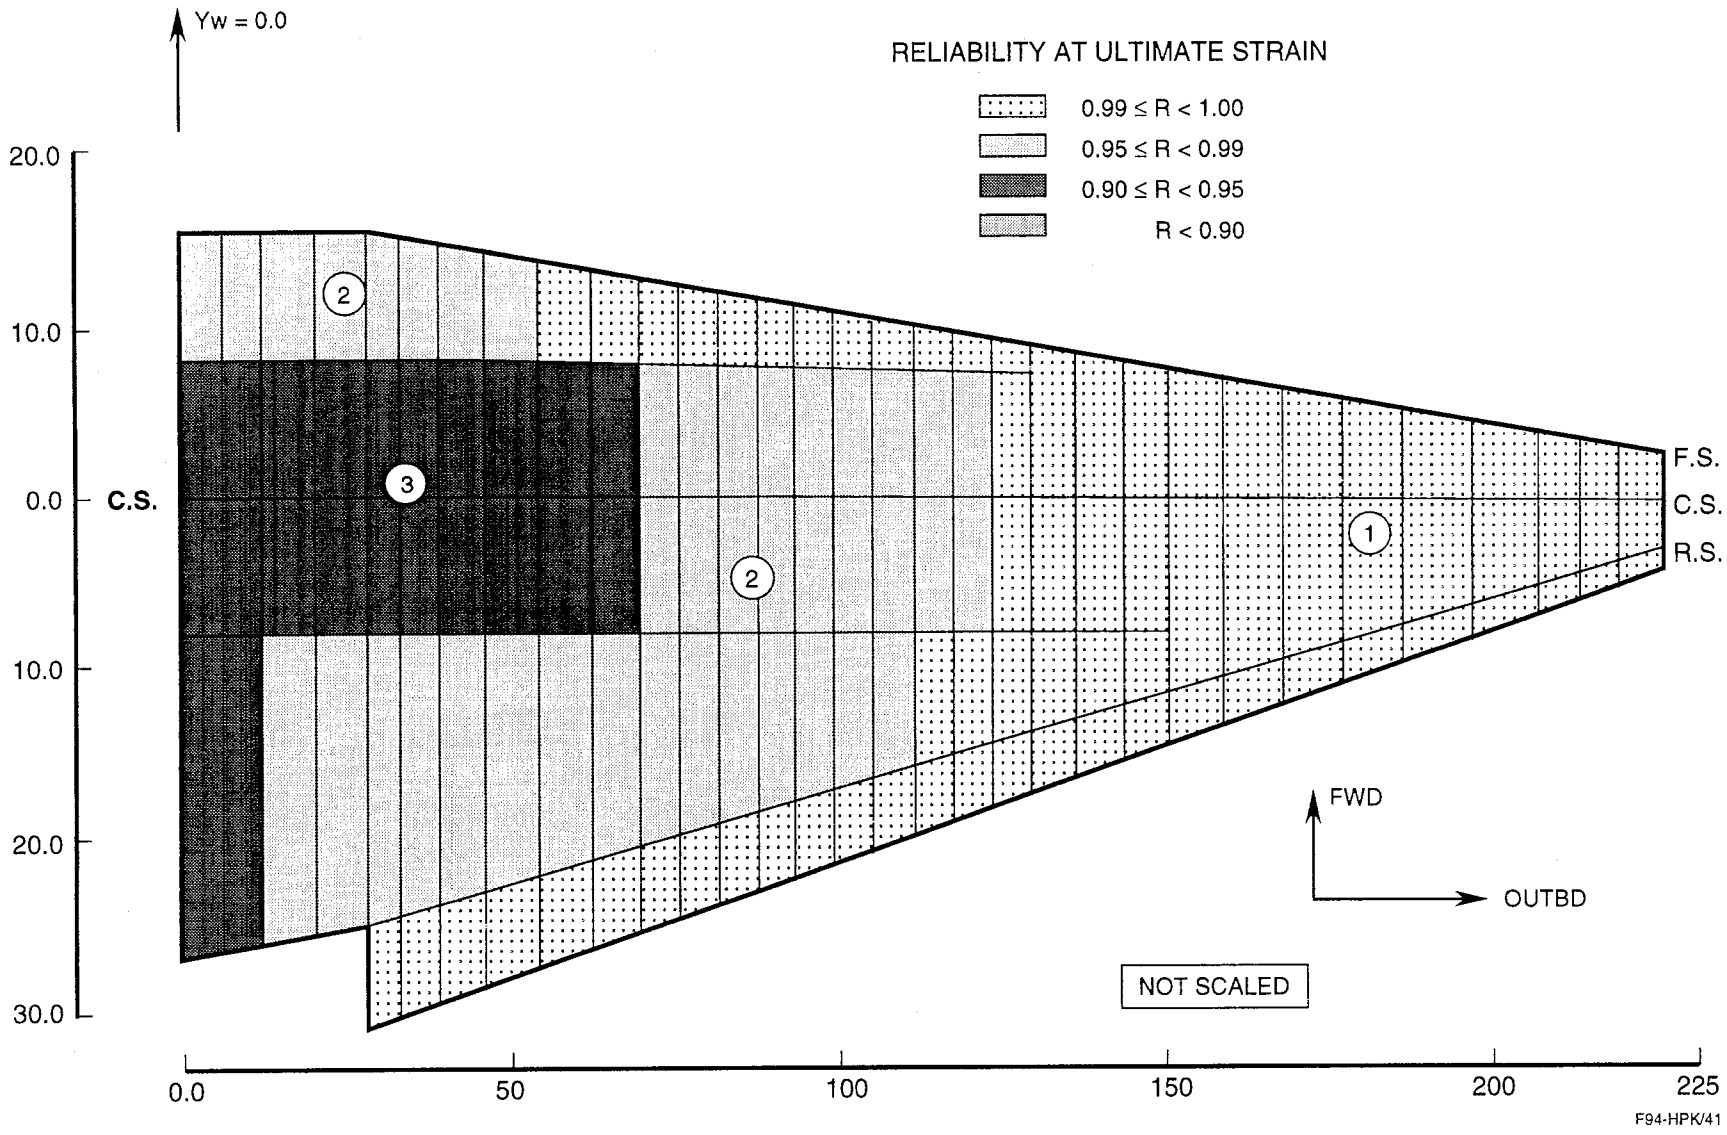
FIGURE 36. RELIABILITY OF UPPER WING SKIN WITH 2.0-IN.-DIAMETER ASSEMBLY INDUCED DAMAGE, S_r = 0.15, MAXIMUM STRAIN.

The minimum reliabilities at limit and 1.25 times limit strains exceed 0.99 and the minimum reliability at ultimate strain is 0.92825. Figure 36 shows the reliability distribution within the upper wing skin with 2.0-in.-diameter assembly induced damage under maximum ultimate strain. The figure shows that the reliability exceeds 0.90 for the entire wing skin. These results indicate that the baseline assembly induced damage is less severe as compared to the impact threats.

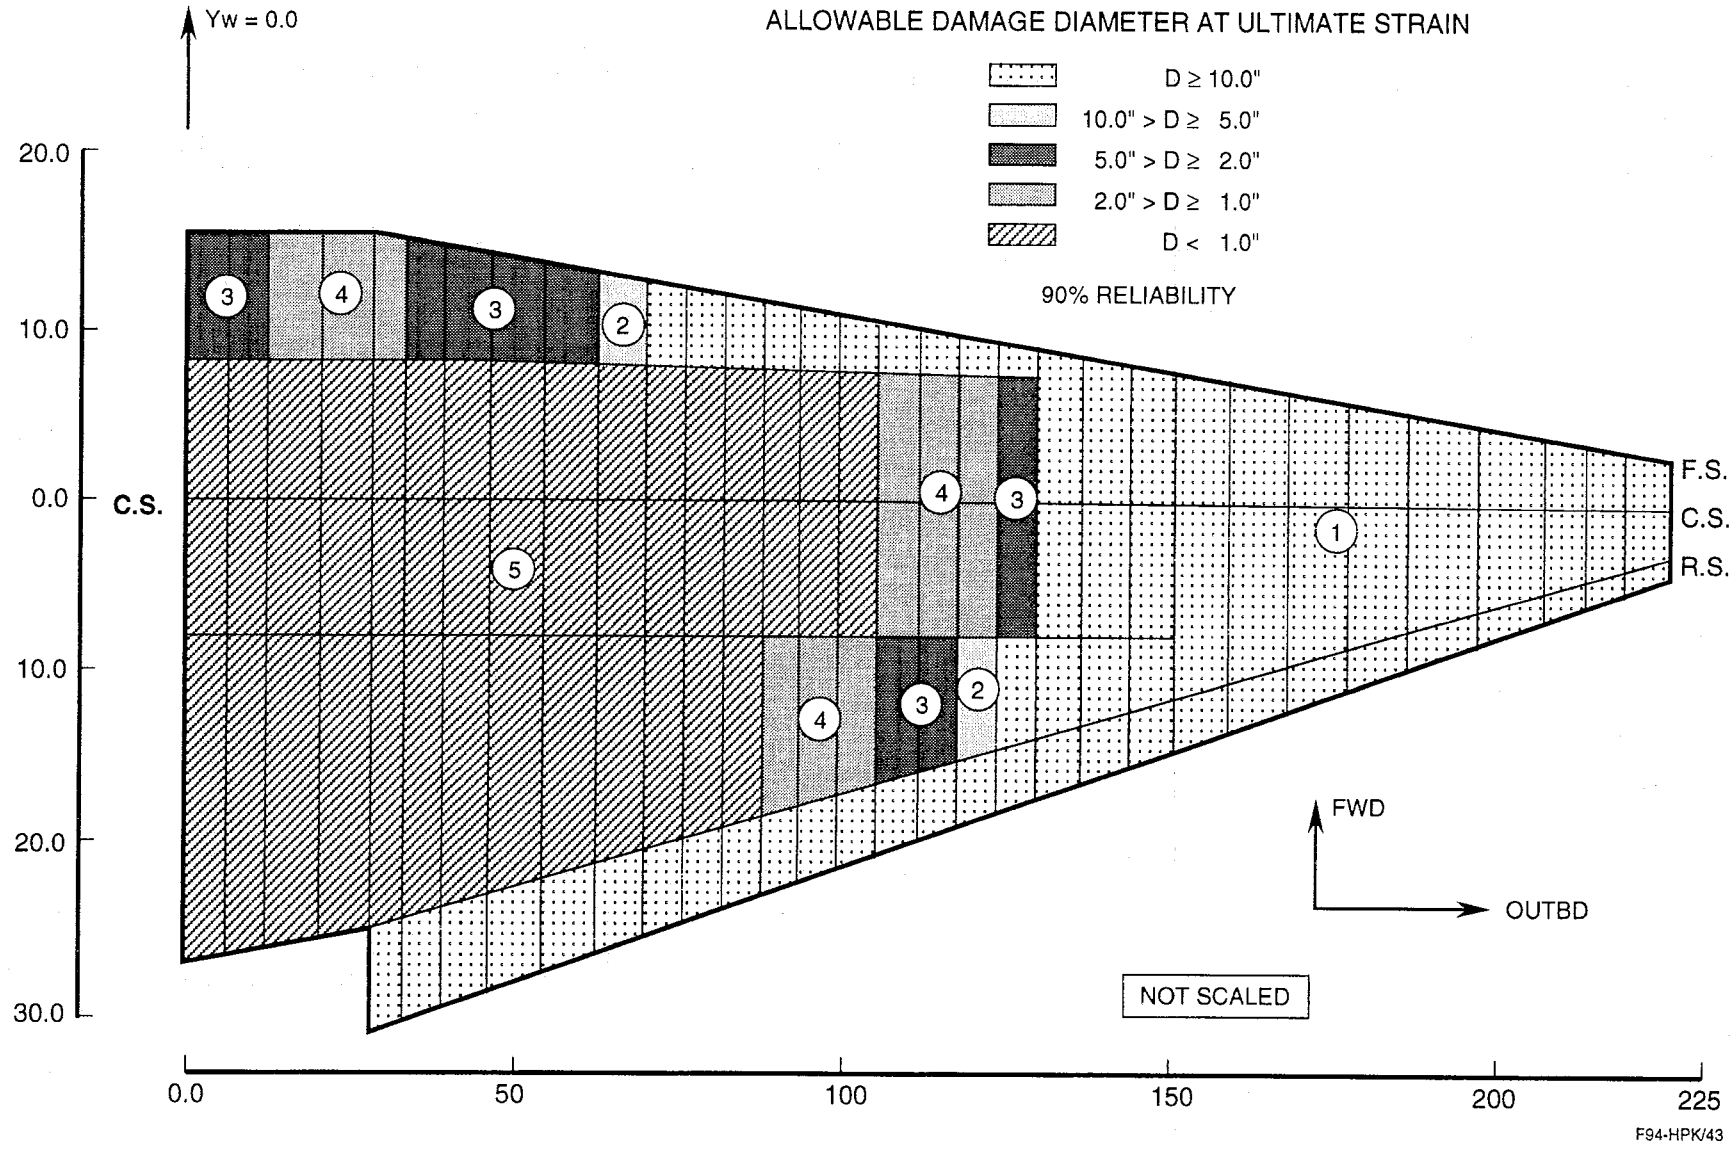
Similar results for reduced stiffness retention ratio are summarized in tables 13 and 14 and are shown in figures 38 and 39. Table 13 shows the results for a stiffness retention ratio (Sr) of 0.01. This level of damage is usually induced by a poor assembly process due to severe overtorque or fastening composite parts with large unshimmed gaps. The results shown in table 13 indicate that the minimum allowable damage diameter is approximately 0.4 in. for the 0.90 reliability requirement in the most critical area of the wing skin. For a 0.99 reliability requirement, no damage of this type will be tolerated in the critical area, as the minimum allowable damage diameter is smaller than the fastener hole diameter of 0.25-in. The distribution of the allowable damage size is shown in figure 38. This figure shows that the allowable damage

FIGURE 38. ALLOWABLE ASSEMBLY INDUCED DAMAGE DIAMETER IN THE UPPER WING SKIN, 90% RELIABILITY, S_r = 0.01, MAXIMUM STRAIN.

size is still large in the wing tip area. However, the allowable damage diameter is smaller than 2.0-in. for a large portion of the skin inboard of Yw 123.

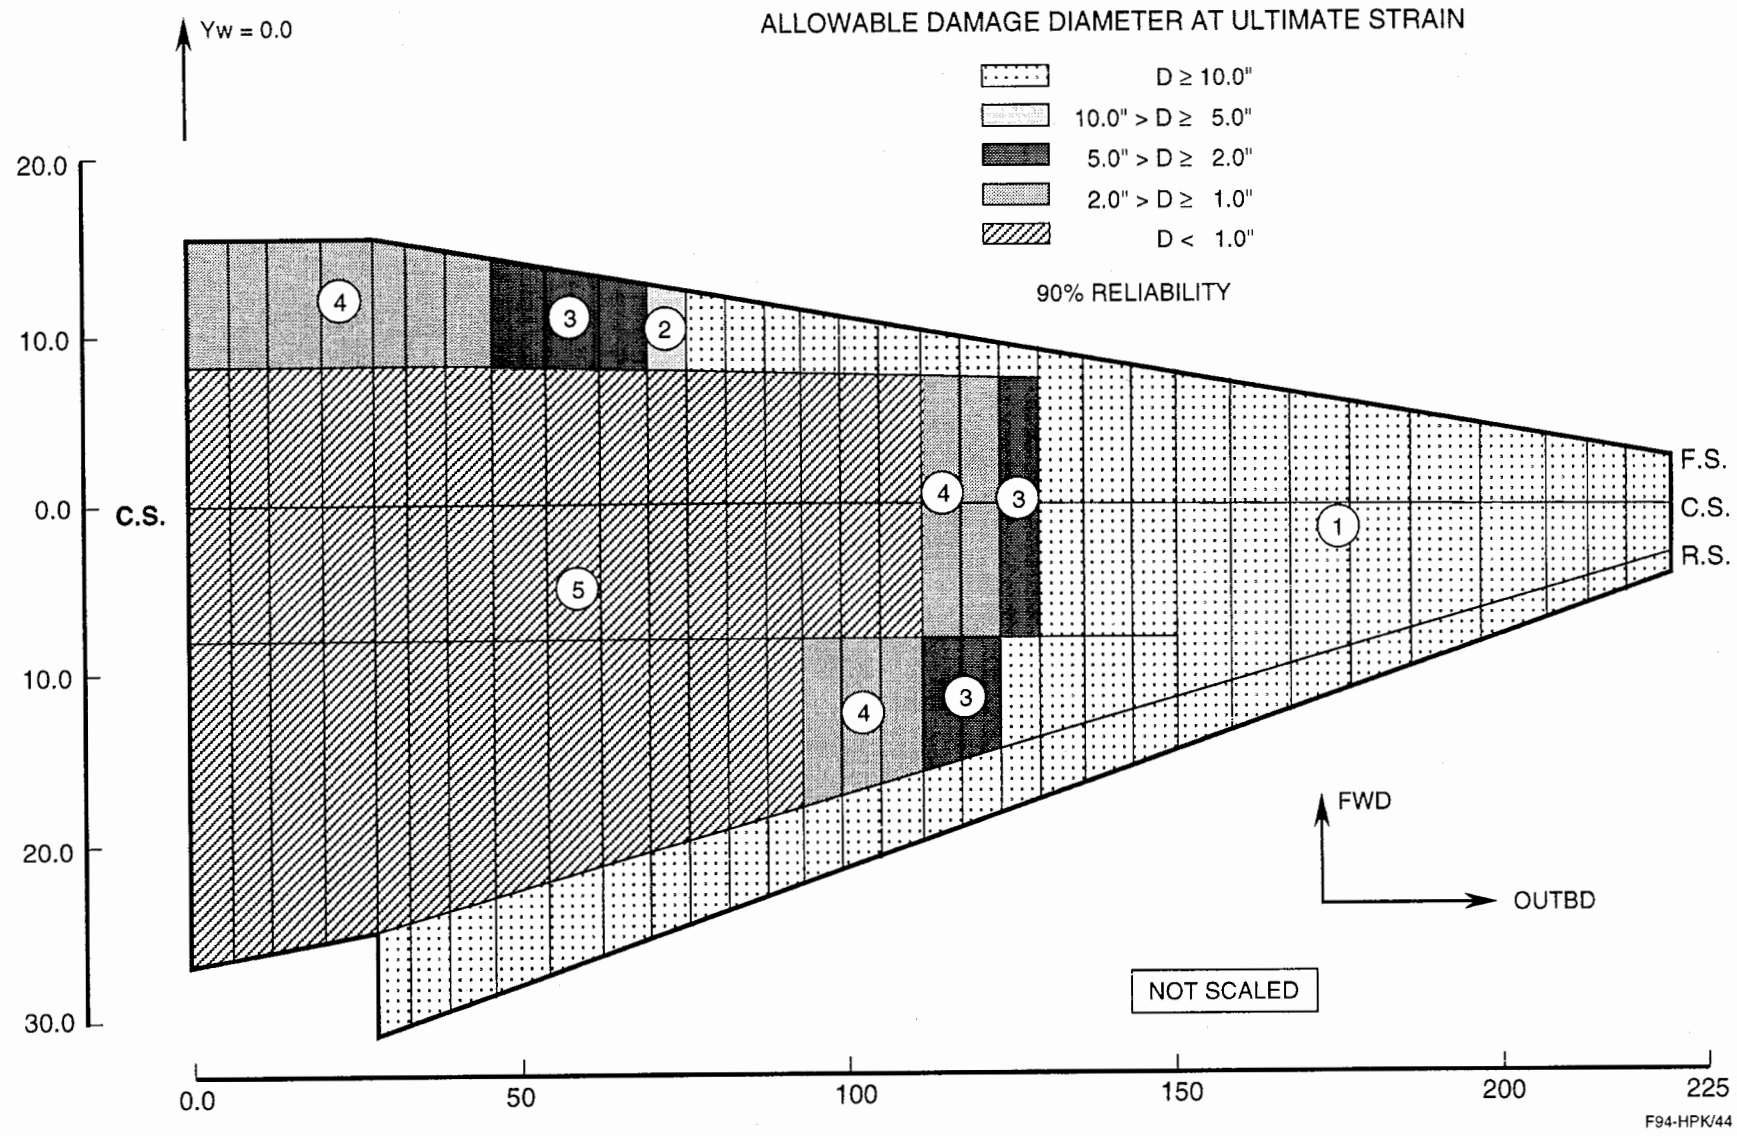
FIGURE 39. ALLOWABLE ASSEMBLY INDUCED DAMAGE SIZE IN THE UPPER WING SKIN, 90% RELIABILITY, S_r = 0.001, MAXIMUM STRAIN.

Table 14 shows results for Sr=0.001, which represents damage induced by a very poor assembly procedure with nearly visible fastener pull-through. As expected, the results show a very significant reduction in the allowable damage size in the critical locations of the wing skin. The minimum allowable damage diameter for a 0.90 reliability, is 0.375-in. in subdivisions 137 and 138. The 0.90 reliability damage size distribution is shown in figure 39. As shown in the figure, the allowable damage diameter is smaller than 1.0 in. for a large portion of the skin inboard of Yw 111.

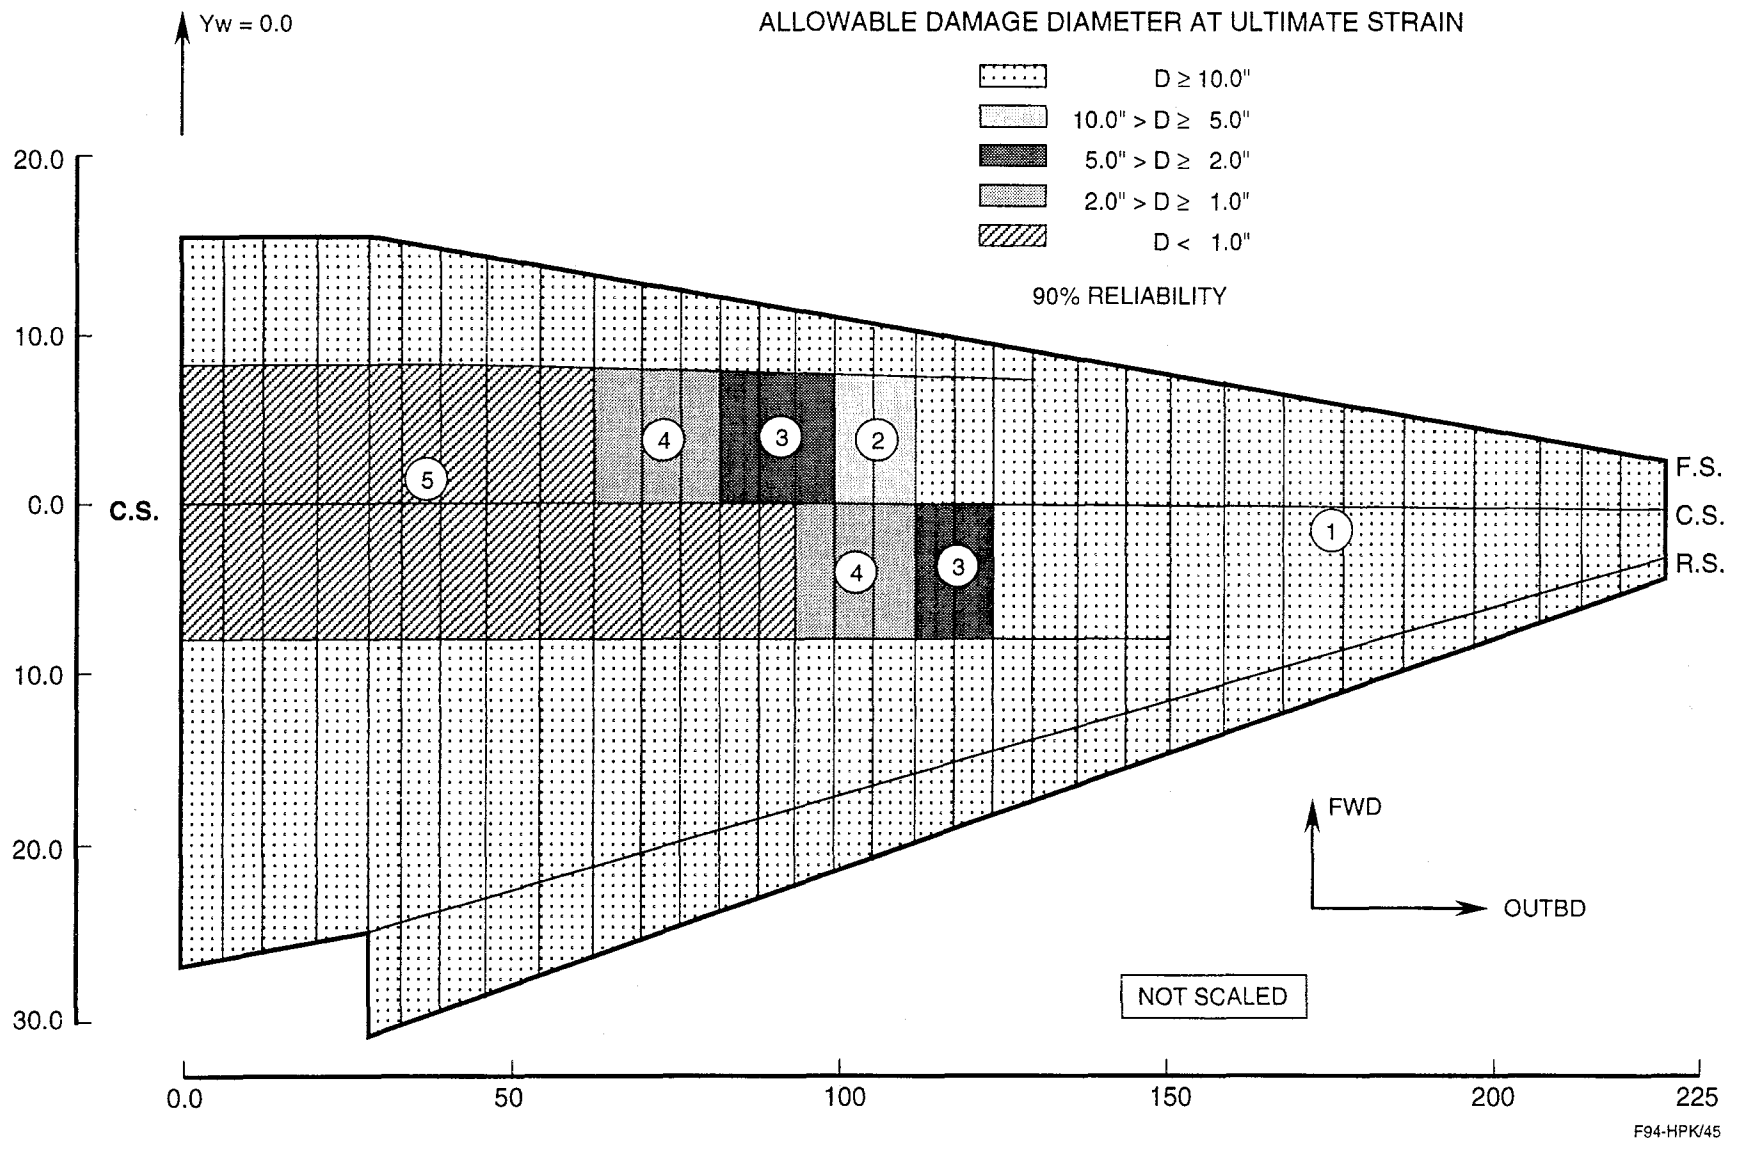
Table 15 and figure 40 show the results of allowable damage size for the wing skin under average ultimate strain in each subdivision with Sr=0.01, for comparison purposes. These results show that a large portion of the skin is capable of tolerating large size damage. However, the allowable damage diameter is smaller than 1.0 in. for portions of the inboard area near the center spar.

FIGURE 40. ALLOWABLE ASSEMBLY INDUCED DAMAGE SIZE IN THE UPPER WING SKIN, 90% RELIABILITY, S_r = 0.01, AVERAGE STRAIN.

The results of the assembly induced damage tolerance evaluation for the Lear Fan 2100 upper wing skin show that the structure is capable of tolerating damage induced by normal assembly operation. This is evident by the defects detected on the E009 aircraft. However, NDI after final assembly is needed to assure that the structures are properly assembled, because the results of the evaluation indicate that poor assembly operation may degrade the integrity of the

structure. Local structural failure under ultimate strains may be initiated at locations with severe assembly induced damage.
