DOT/FAA/AR-95/49

A Study of the Continued Fire Worthiness of Aircraft Seat Cushion Fire-Blocking Layers

March 1997

Final Report

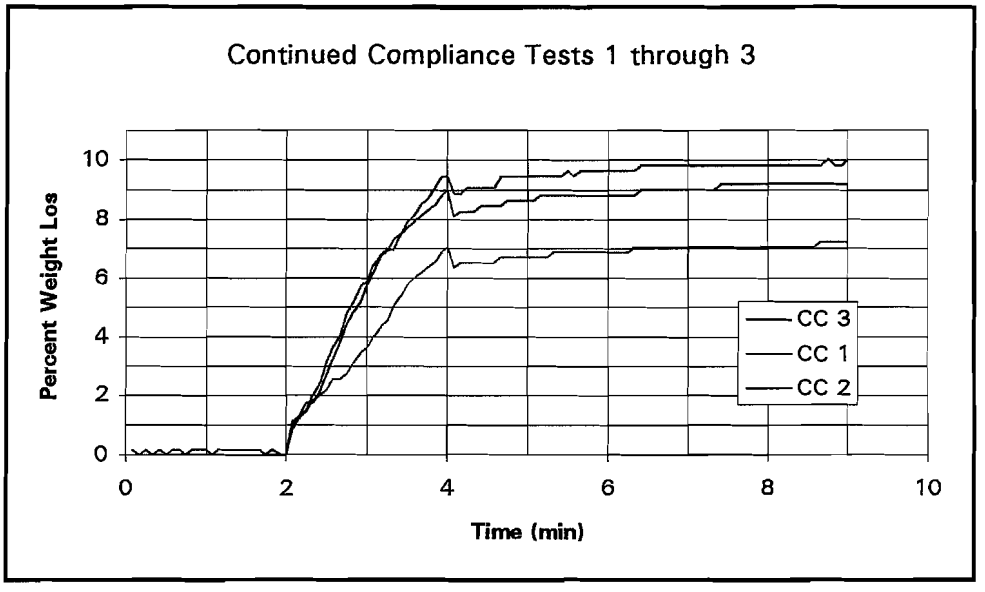
FIGURE 1. PERCENT WEIGHT LOSS PROFILES, TESTS 1 THROUGH 3

Stock Test Results. The weight loss profiles of the stock tests are shown in figures 1 and 2. The eight stock tests resulted in five tests exceeding 10 percent weight loss. The stock cushion tests did result in several instances where burn lengths exceeded the 17 inch (43.2 cm) requirement. In either case, the standard pass/fail criteria has no relevance in the stock configuration tests, which are expected to have higher test values. The data scatter was wide for both stock test series A and B, as seen in tables 4 and 5. Excluding test number five, no unusual fire behavior was observed during the testing.

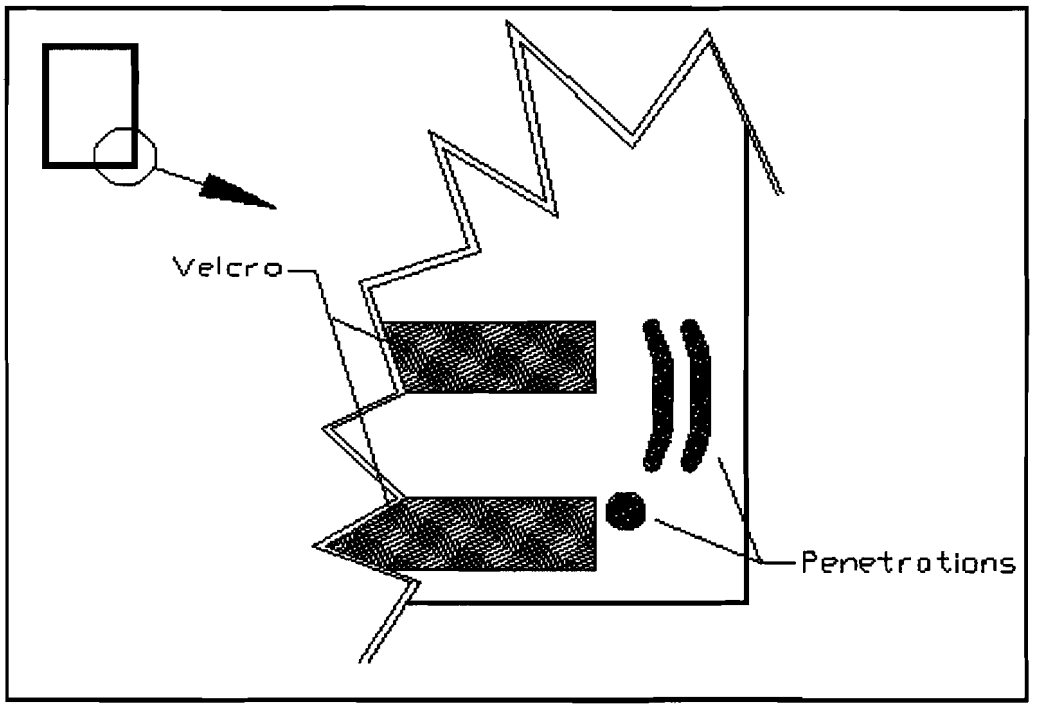
FIGURE 3. TEST NUMBER FIVE FIRE-BLOCKING LAYER PENETRATIONS
(vertical cushion, cutaway view of rear facing corner closest to burner cone)

Test number five resulted in a weight loss of 27.47 percent. Excessive damage resulted from penetrations in the vertical cushion FBL. The three penetrations were located on the back side bottom corner closest to the burner (see figure 3). They consisted of two, four-inch by one-half-inch (10.2-cm by 1.27-cm) vertical, parallel slashes with a separation of one inch (2.54-cm); and a one-inch (2.54-cm) -diameter hole located approximately two inches (5.08 cm) below and one inch (2.54 cm) to the side, opposing the burner, from the vertical slashes. During the portion of the test when the oil burner was turned off, burning originated from the backside of the cushion. This behavior was solely due to the FBL penetrations.

Test number five demonstrated the effect of FBL penetrations. The two, four-inch by one-half-inch (10.2-cm by 1.27-cm) slashes plus the one-inch (2.54 cm) -diameter circle, provide a total penetration area of 4.78 square inches (30.8 square centimeters). Several other cushions also had penetrations in differing spatial orientations which negated propagational behavior as seen in test number five. These penetrations, found in cushions tests 9, 11, and 33, were characterized as one-inch (2.54-cm) or less diameter holes being mechanically created by vibration and friction

from contacting rivet heads or other such features in the stock seat frame. The orientation of the burner flame to the penetration played the obvious factor regarding fire development.

Penetrations to the FBL must be considered very carefully beyond the scope of a standardized test. During this work, some threshold phenomena is evident when considering the successful or failed combustion of a seat cushion. The penetration orientation with respect to a flame, the surface area of the penetration, the seat cushion material(s) and construction, and the dynamics of the flame exposure impact this threshold behavior. In the case of test number five, the penetrations were not subject to direct flame contact. However, the size of the penetrations allowed acceptable ventilation inside the fire-blocking layer resulting in combustion of the foam cushion. The danger of penetrations is demonstrated by test number five. Yet, tests 9, 11, and 33 demonstrated smaller insignificant penetrations.

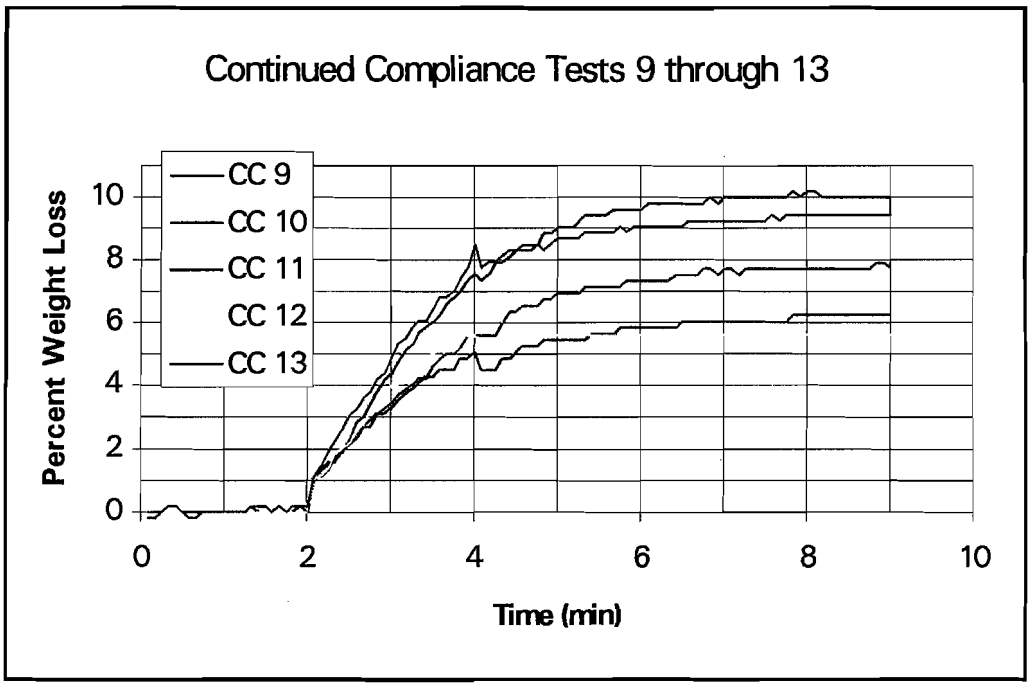
FIGURE 4. PERCENT WEIGHT LOSS PROFILES, TESTS 9 THROUGH 13

Modified Test Results. The weight loss profiles of the modified tests are shown in figures 4 through 9. The 30 modified shaped cushion tests yielded one failure and that was for a weight loss greater than 10 percent (see table 4). There were no differences noted in the test performance based on the lack of or the presence of the strapping affixed to the horizontal cushions for flotation purposes.

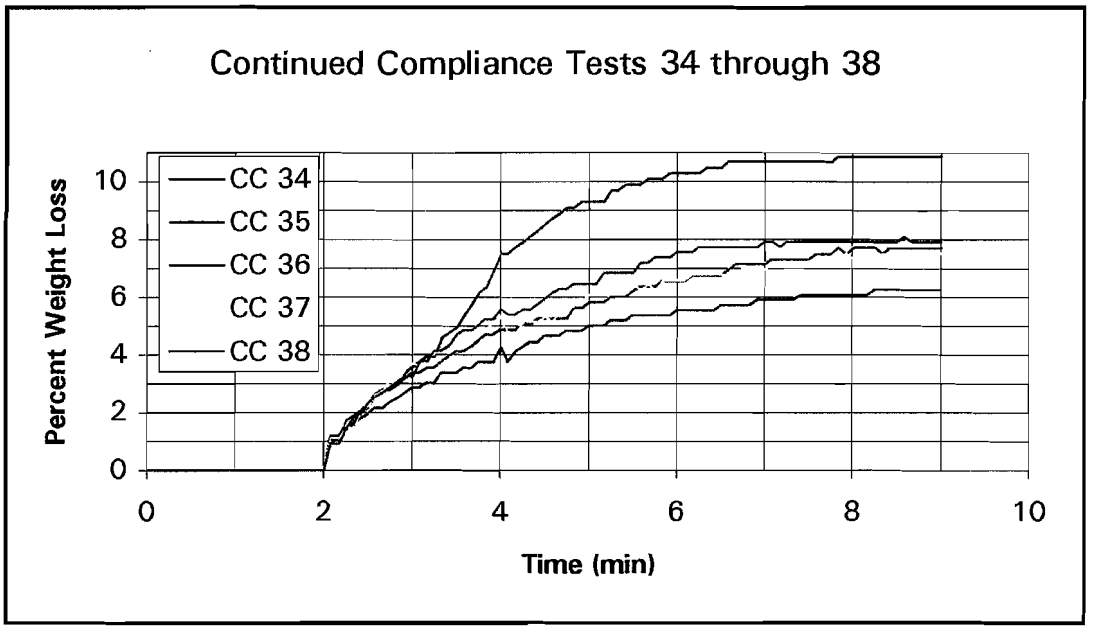
FIGURE 9. PERCENT WEIGHT LOSS PROFILES, TESTS 34 THROUGH 38

The percent weight loss was 10.87 for test number 36. This test was one of the final four tests performed which had reused vertical cushions. In review of this test, the final weight loss was mainly affected by the involvement of the reused vertical cushion. Had the vertical cushion been in an untested condition, the entire cushion set would have been expected to pass in the same manner as the other 29 tests.

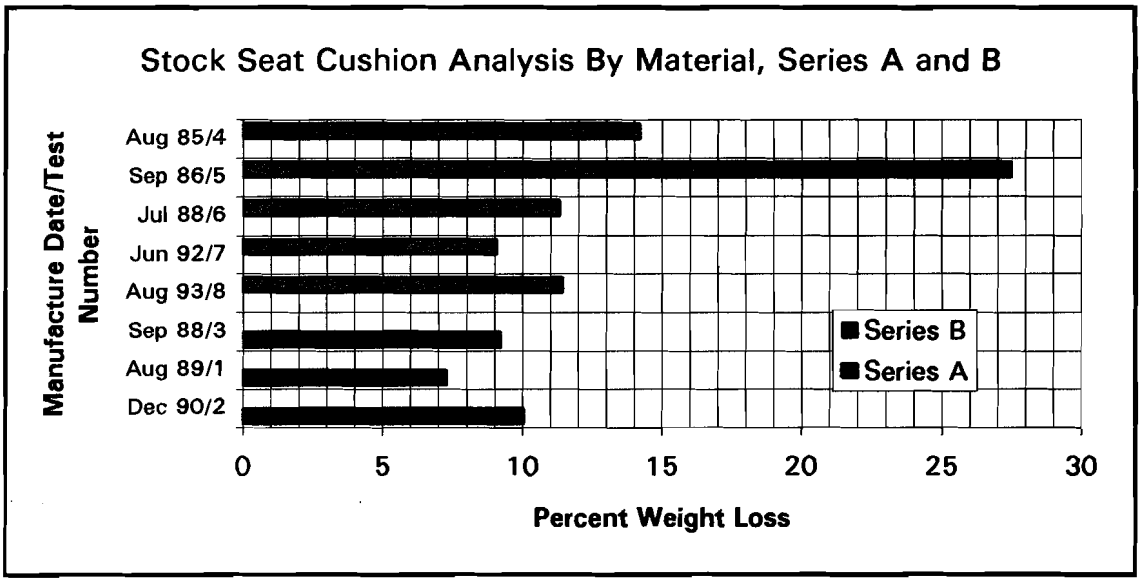
FIGURE 10. TEST RESULTS BY MATERIAL, SERIES A AND B

Overall Test Results Comparison. The overall breakdown of all tests based on percent weight loss is given in table 6. Figures 10 through 15 illustrate the test results comparatively.

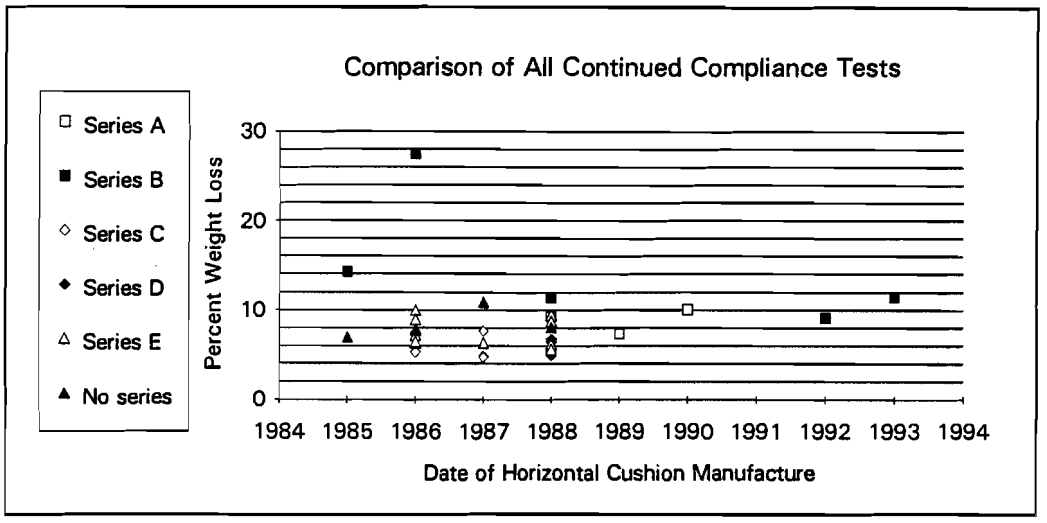
FIGURE 15. COMPARISON OF ALL CONTINUED COMPLIANCE TESTS

2. The modified cushion test results, as seen in table 4 and figures 14 and 15, show that the worn fire-blocking layers maintained fire endurance with respect to Part 25, Appendix F, Part II.

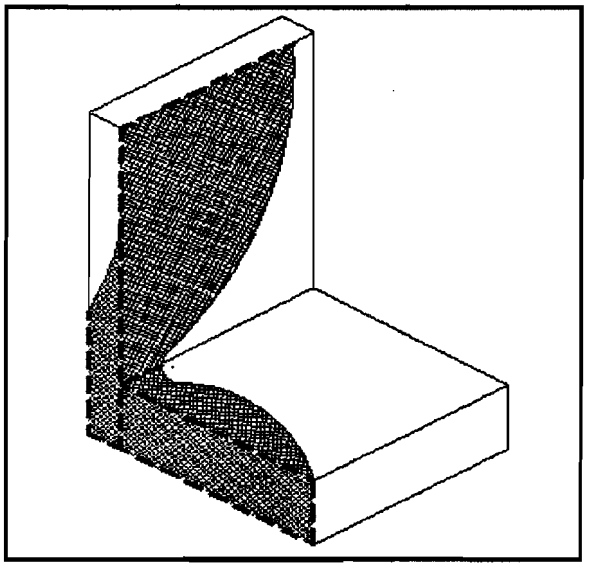
FIGURE 16. TYPICAL BURN PATTERN RESULTING FROM SEAT TEST
(typically damaged areas are cross-hatched)

The seat cushion tests, for the most part, followed a generic sequence of events. Upon flame impingement, the vertical edge of the horizontal cushion facing the burner lost its dress cover due to combustion. The flame also contacted the upper and lower horizontal cushion surfaces of the horizontal cushion near the burner cone. The burner flame also tracked in an upward arc across the front, vertical face of the vertical cushion. The arc started from the intersection of the horizontal and vertical cushions, close to the burner, and swept upward further away from the flame source. A typical burn pattern is shown in figure 16.

The dress cover material was consumed in these areas as well. The fire-blocking materials subjected to the oil burner flame were only affected in the flame contact zone and the immediate vicinity of the burner jet. The FBLs underwent a thermal degradation which resulted in a black, charred, brittle state. In many instances, a crack formed on the vertical cushion edge which received the direct flame contact. This crack had no further negative effect in the combustion of the cushion. Excluding the vertical edge facing the burner cone, the mechanical integrity of the FBL materials were never compromised due to flame impingement.
