DOT/FAA/AR-95/54

Transport Water Impact and Ditching Performance

March 1996

Final Report

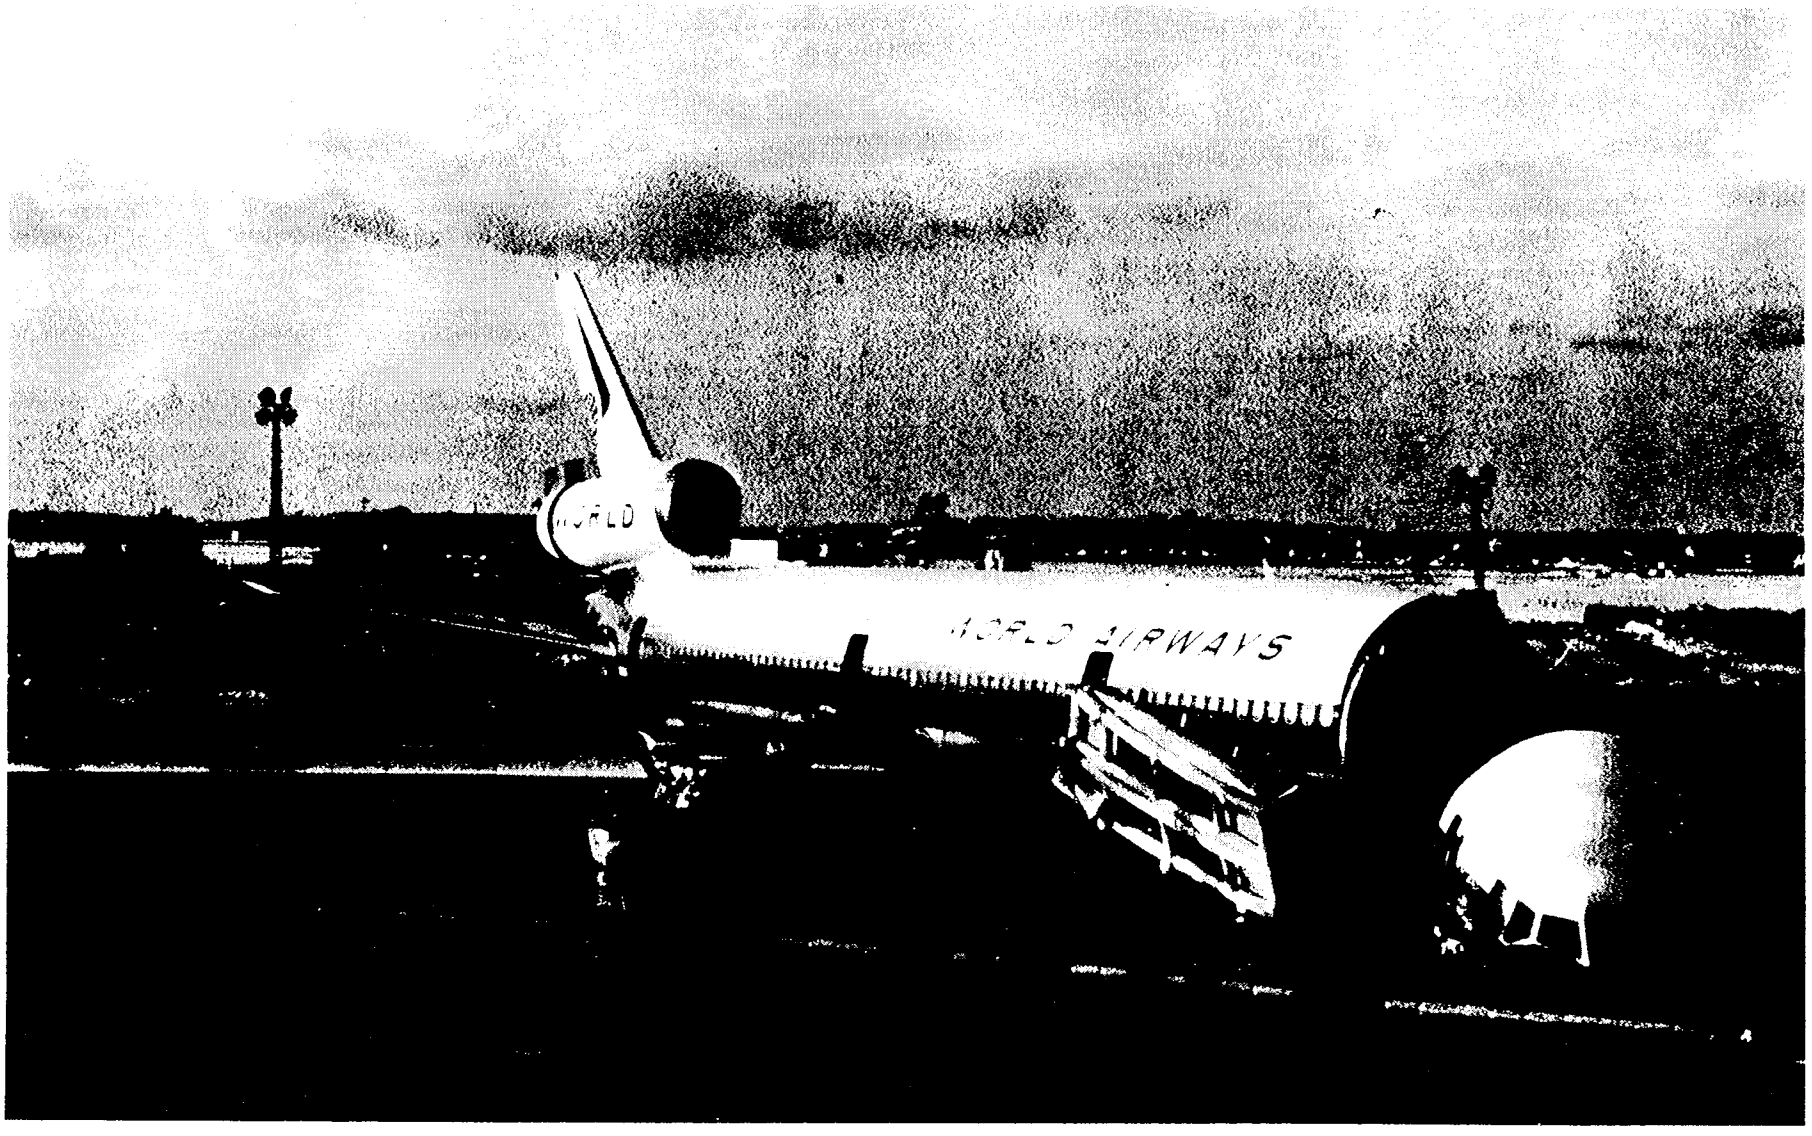
Upon crossing the end of the runway, the airplane came to rest with a slightly nosedown attitude in water which came up to the wings. A section of the nose up to the first row of the cabin seats separated along a fracture line (figure 1) and remained attached to the fuselage only by control cables and electric wire bundles. The pressure bulkhead was crushed along the fuselage bottom centerline, and the main cabin floor beams from fuselage station (FS) 392 to 475 failed due to the downward displacement. The pressure bulkhead at the forward end of the nose gear was crushed as well, leading to the failure of the extended nose gear. The main landing gear were extended and remained undamaged. The airplane's three engines remained attached to their respective pylons, although the No. 3 engine's rear mount was broken. There was no substantial mechanical damage to the engine.

The overall impact forces experienced by the passengers as the aircraft came to rest in the water did not jeopardize occupant survival except in the area of the fuselage separation. The failure of the main cabin floor beams in this area led to floor displacement and subsequent seat track fractures. Three seat modules in the first passenger row, consisting of three left, two center, and three right seats, separated from the floor. This led to the disappearance and presumed death of two of the three passengers seated in this row. The third passenger seated in this row was able to climb back into the main cabin. The cabin aft of the structural separation remained intact.

FIGURE 1. WORLD AIRWAYS DC-10 AFTER COMING TO REST IN BOSTON HARBOR

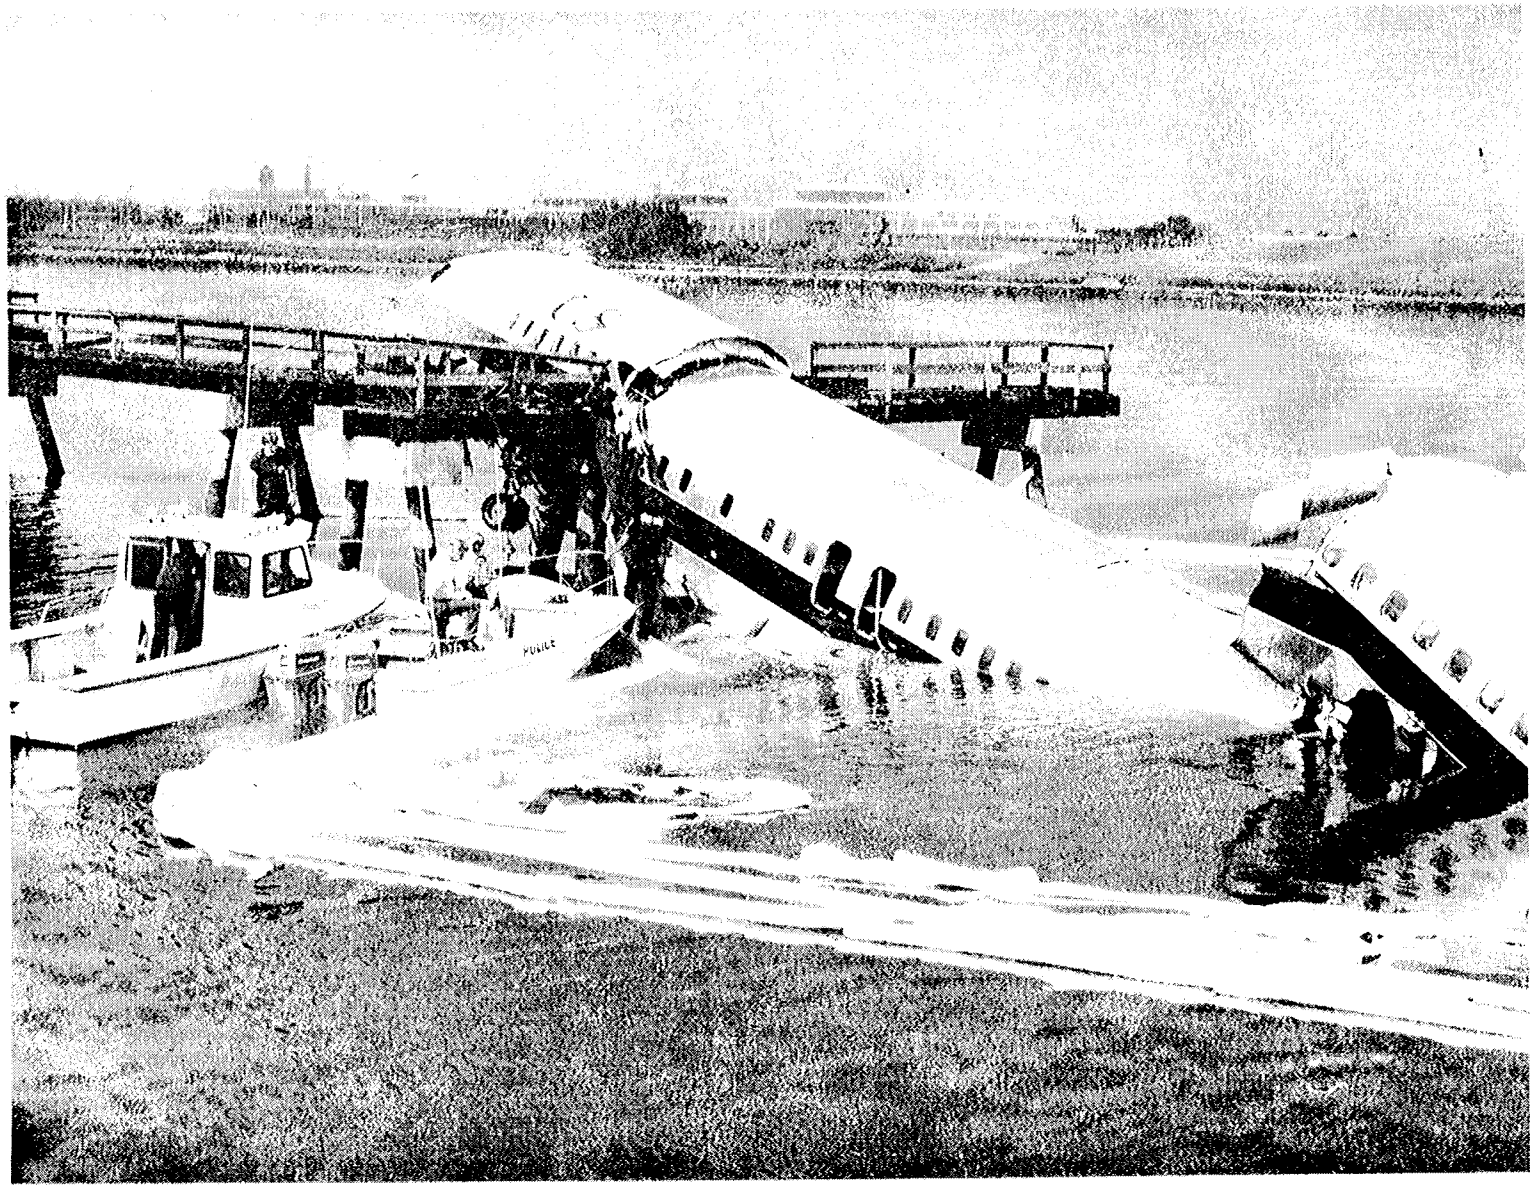
Decelerative forces were not great enough to cause any seat dislocations or seat belt/shoulder harness separations. The only seat damage was caused by fuselage crush and subsequent floor displacement.

Floor displacement was the primary cause of two fatalities. Timber from the wooden approach light pier structure penetrated the fuselage and forced the floor section and surrounding seats upwards, crushing four passengers against the ceiling. Two passengers in row 21 were killed by asphyxia caused by compression of the chest and two passengers in row 22 sustained serious multiple injuries. A piece of wood also penetrated the forward cockpit bulkhead, but did not produce any seat dislocations and caused only minor injury to the captain. The airplane was equipped with eight exits (figure C-3): the L-1 main boarding door, the L-2 aft entry door, the R-1 forward galley door, the R-2 aft galley door, and four overwing exits. All exit doors, with the exception of the L-1 and L-2, were used during evacuation. The L-1 door could not be opened by the lead flight attendant, and the L-2 door was closed when water began entering the cabin. The R-1 slide was successfully deployed. The flight attendant disarmed the R-2 slide before the door was opened to prevent the slide from blocking the exit area. Both the left and right overwing exits operated successfully during evacuation.

FIGURE 3 US AIR B737-400 AFTER COMING TO REST ON LIGHTING STANCHION IN BOWERY BAY

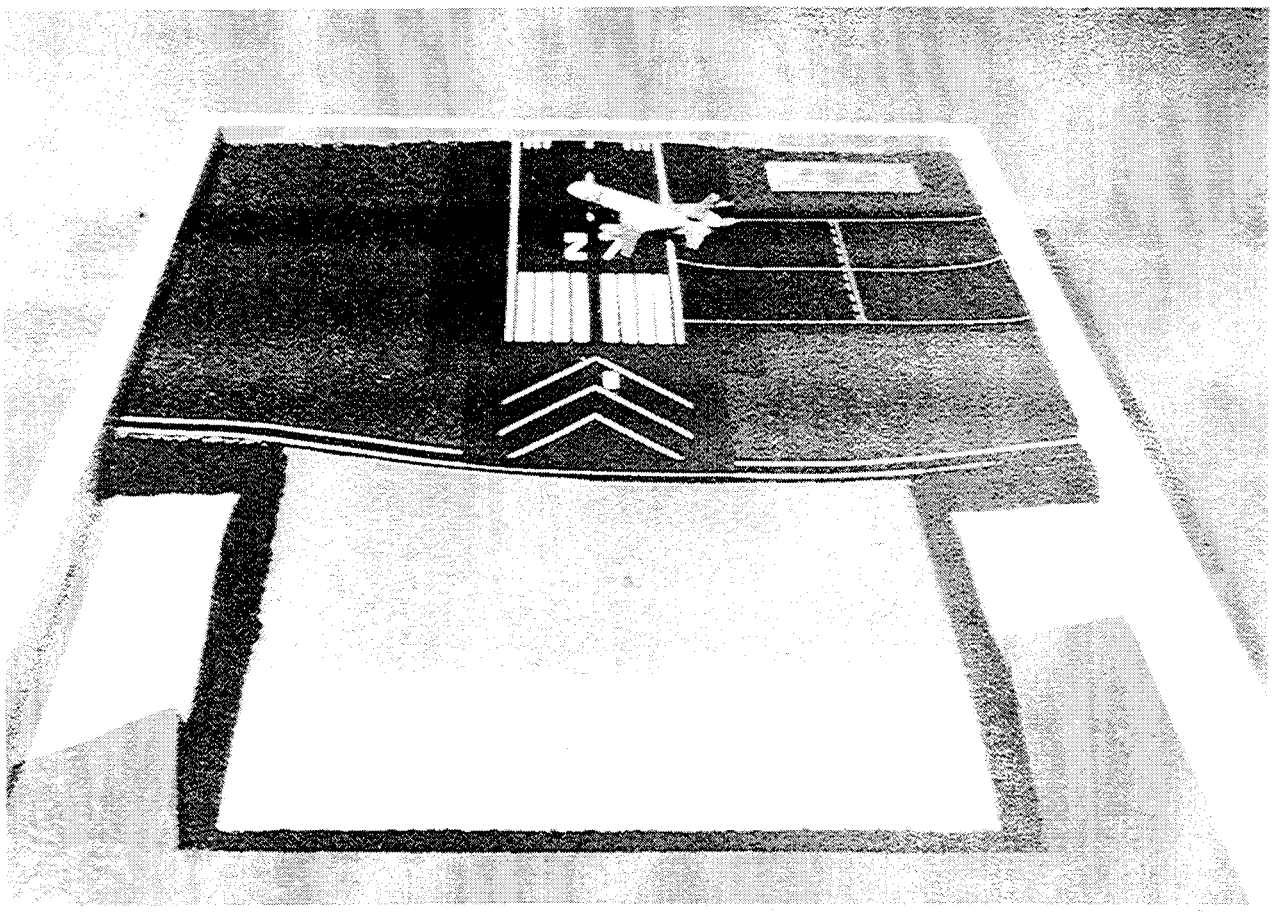
Allowing the airplane to gradually slide into water, as in the JFK accident, should result in minimal aircraft damage and a successful emergency evacuation of all occupants using the available flotation devices. Runway overrun areas leading into water which avoid sudden drop-offs and allow for a smooth transition into the water can reduce impact forces and prevent fuselage separations. Evidence to support this is provided by both the FAA and airport engineers. As stated in FAR Part 139.307 (a)(1), "No slope from the edge of the full-strength surfaces downward to the existing terrain shall be steeper than 2:1," thus preventing vertical drop-offs. Boston-Logan Airport Engineers have looked into the feasibility of developing sloped runway safety areas that decelerate the aircraft through the use of gravel. The model of such a sloped overrun area, developed by Boston-Logan Airport Engineers, is shown below in figure 4.

FIGURE 4. INCLINED SAFETY AREA (ISA) MODEL DEVELOPED BY BOSTON-LOGAN AIRPORT ENGINEERS

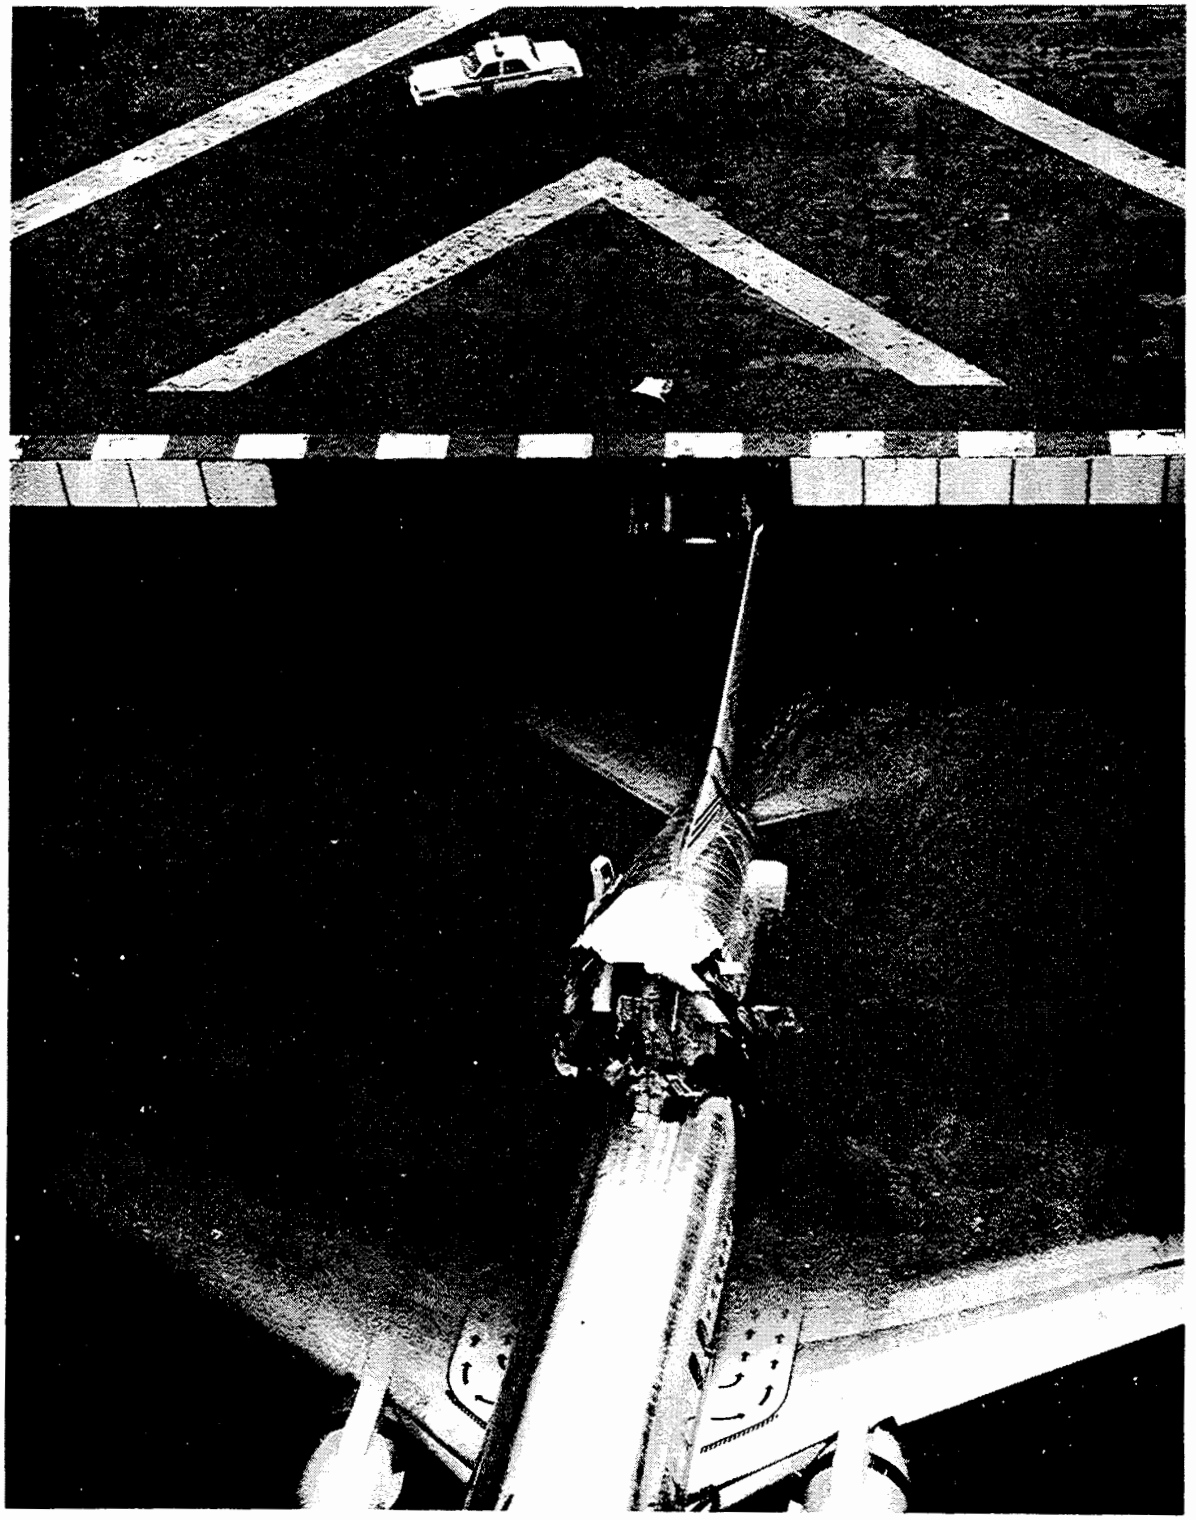
The drop into the water and the presence of obstructions immediately beyond the runway increase the potential for excessive impact forces on the airplane. The LaGuardia accident included both of these hazards. Upon crossing the end of the runway, the airplane encountered a drop of approximately 10 feet into the water and a concrete/wooden pier structure positioned within 50 feet of and in line with the end of the runway. The fuselage separated in two locations. In contrast, the JFK accident involved a very gradual slope into the water resulting in no fuselage separations. Although there was an approach lighting pier located directly beyond the runway, the landing gear remained on the ground and the pilot was able to swerve the airplane to avoid it.

FIGURE 5. LAGUARDIA AIRPORT RUNWAY DROP-OFF TO WATER

NTSB made the following recommendations to the Port Authority of New York and New Jersey. Survey the 1,000 by 500 foot surface area contiguous to the departure ends of the runways at the LaGuardia Airport in order to minimize hazards to airplanes that do not stop on the runways.
