Full-Scale Tests on Rubblized Pavement Test Items at the National Airport Pavement Test Facility

May 2010

DOT/FAA/AR-TN10/9

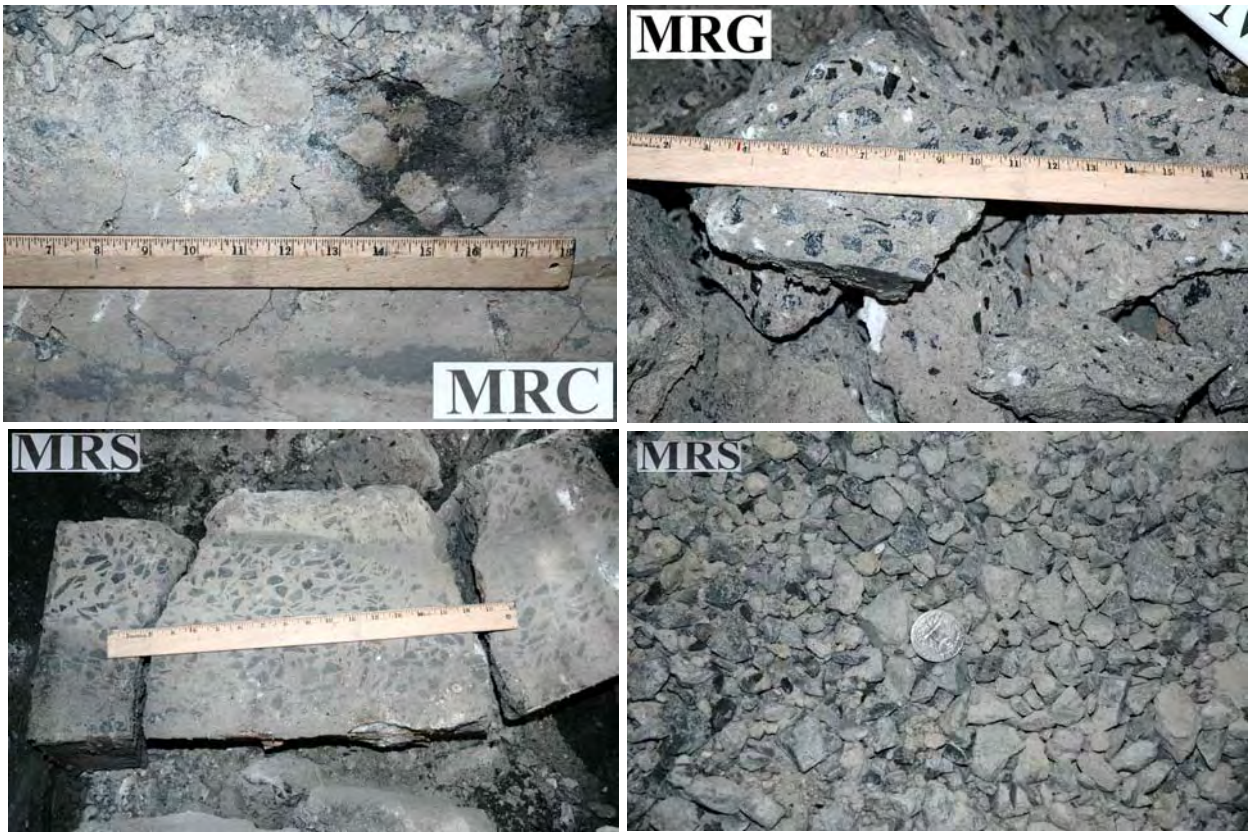
Figure 7. Visual Observations From the Test Pits in Rubblized Test Items

TEST PITS IN RUBBLIZED TEST ITEMS. After the three test items were rubblized, a 4-foot-long by 4-foot-wide test pit was saw-cut in each test item for visual examination of the rubblized concrete (extent of fractures from rubblization process, particle sizes, etc.). Figure 7 shows fracture patterns and particle sizes in test items MRC, MRG, and MRS, respectively. In general, the top 2 to 3 inches in all the test items were rubblized into dust and stones with a top particle size of 1 inch (figure 7). The particle size in the bottom 9 inches ranged from 4 to 15 inches with larger particle sizes in MRS. The test pits showed that the rubblization process induced cracks/fractures for the entire depth of the slabs and that the cracks were tightly held.

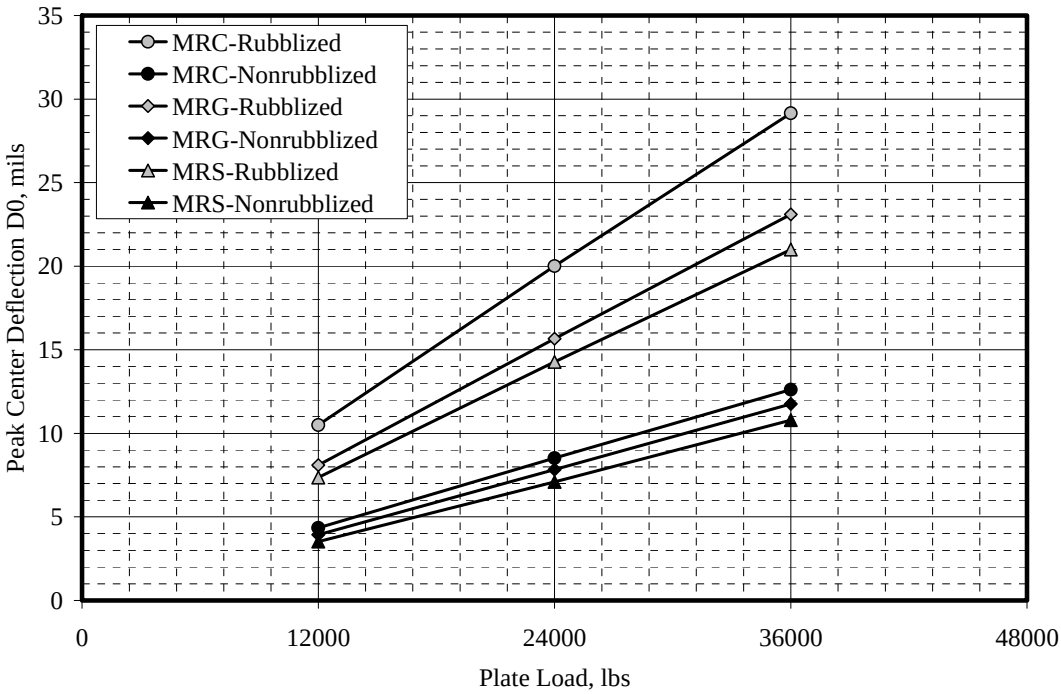
Figure 8. Mean Peak D0s From Uniformity Tests

UNIFORMITY OF PAVEMENT STRUCTURES. HWD tests were performed using the FAA Kuab HWD equipment on a 10-foot grid to study the uniformity of the pavement structures, see figure 5. Tests were performed with a 12-inch-diameter plate at three different load levels: 12,000, 24,000, and 36,000 lb. The results showed that the pavement structure within each test item was fairly uniform. For peak center deflection (D0), the coefficient of variation (COV) ranged between 20 and 25 percent. For deflection D7 (at 72-inch offset from the center of load plate, and an indicator of subgrade condition), the COVs were approximately 10 percent. Figure 8 shows that the mean D0s for the rubblized test items were larger than the D0s for the nonrubblized test items. Also, among the rubblized test items, MRC showed the highest deflections, followed by MRG, and then by MRS. This order was counter to expectations because MRC had a crushed aggregate subbase course and would normally be expected to be of higher stiffness than the MRG pavement built directly on the subgrade. Pretraffic measurements of subgrade strength in the test pits showed that water had migrated from the crushed aggregate subbase into the subgrade of MRC and softened approximately the top 3 inches of the subgrade. The subgrade surface in the MRC test pits had strength of approximately 4 CBR, whereas the strength 1 foot below the surface was approximately 8 CBR. The subgrade surface in the MRG and MRS test pits ranged from 7 to 8 CBR, as constructed. The order of failure, discussed in the next section, also followed the order of the HWD deflection magnitudes.

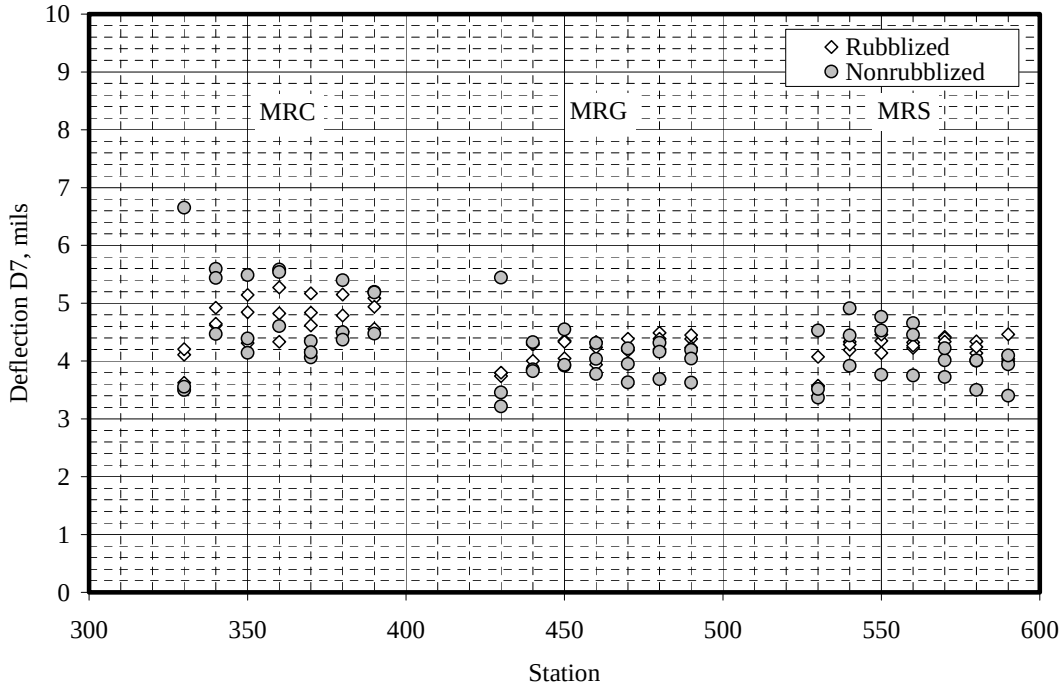
Figure 9. Deflections D7 From Uniformity Tests

Figure 9 shows deflection D7 (at 72-inch offset from center of plate) that is indicative of subgrade stiffness. Figure 9 is further indication that the subgrade of MRC was of lower stiffness than the subgrade of MRG and MRS.

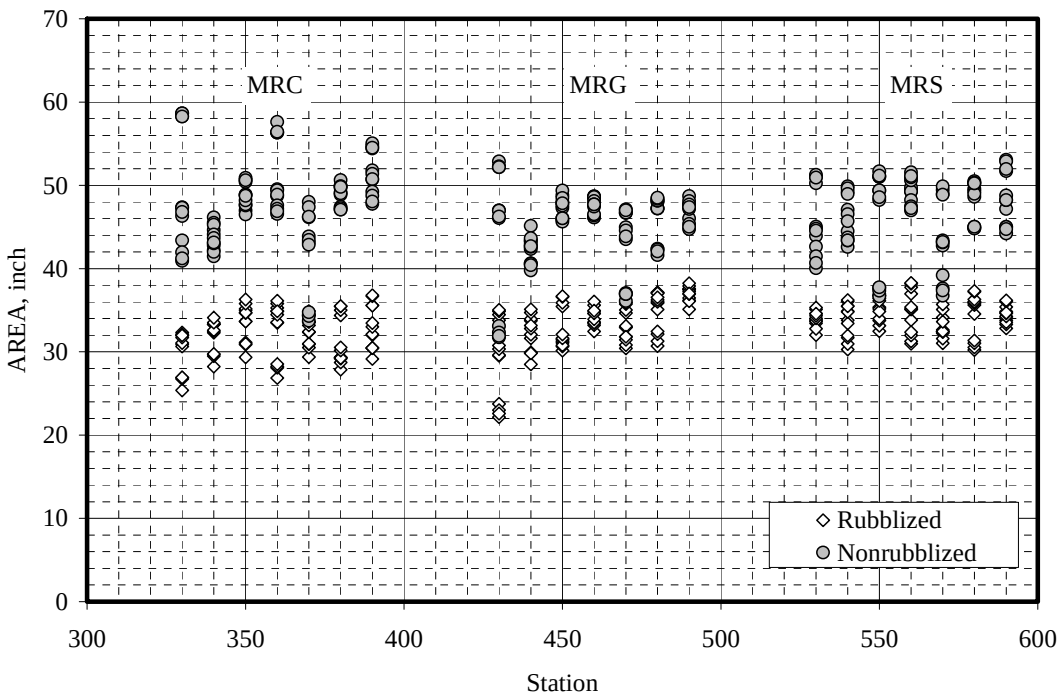
Figure 10. The AREA From Uniformity Tests

AREA is the area of deflection basin normalized with D0 and is a deflection basin shape factor [3]. Figure 10 shows the AREA for rubblized and nonrubblized test items. The magnitude of the AREA term is a fairly good indicator of layer behavior (bound or unbound). Higher AREA values indicate bound material, and lower AREA values indicate unbound material.

The rubblized test items show lower AREA values (mean AREA = 33.2 inches) compared to nonrubblized test items (mean AREA = 46.6 inches).

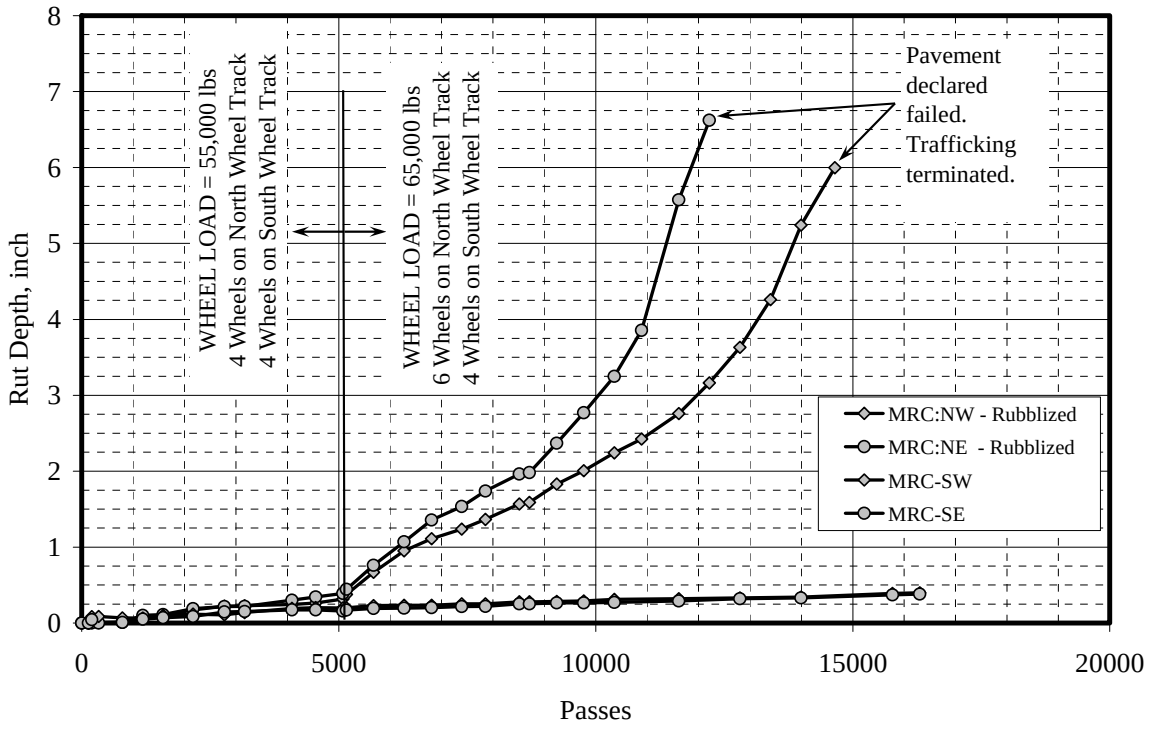
Figure 13. Straightedge Rut Depth Measurements in the Test Item MRC

Figures 13 through 15 show the straightedge rut depth measurements for test items MRC, MRG, and MRS, respectively. Traffic tests started on July 7, 2005, and continued until October 6, 2005, following the schedule in table 1. The temperature of the asphalt varied between 66° and 85°F (19° and 29°C) during the test period. The average temperature of the asphalt was approximately 78°F (26°C).

Except at the MRS-SW location, all test items showed similar rut depths during the first 5,082 passes (55,000-lb wheel load, four-wheel landing gear configuration). In particular, there was no discernible difference between the performance of the rubblized and nonrubblized pavements. It was also visually observed that the surface deflections of the rubblized pavements under load were negligible, and the response of the rubblized pavements appeared to be very similar to the

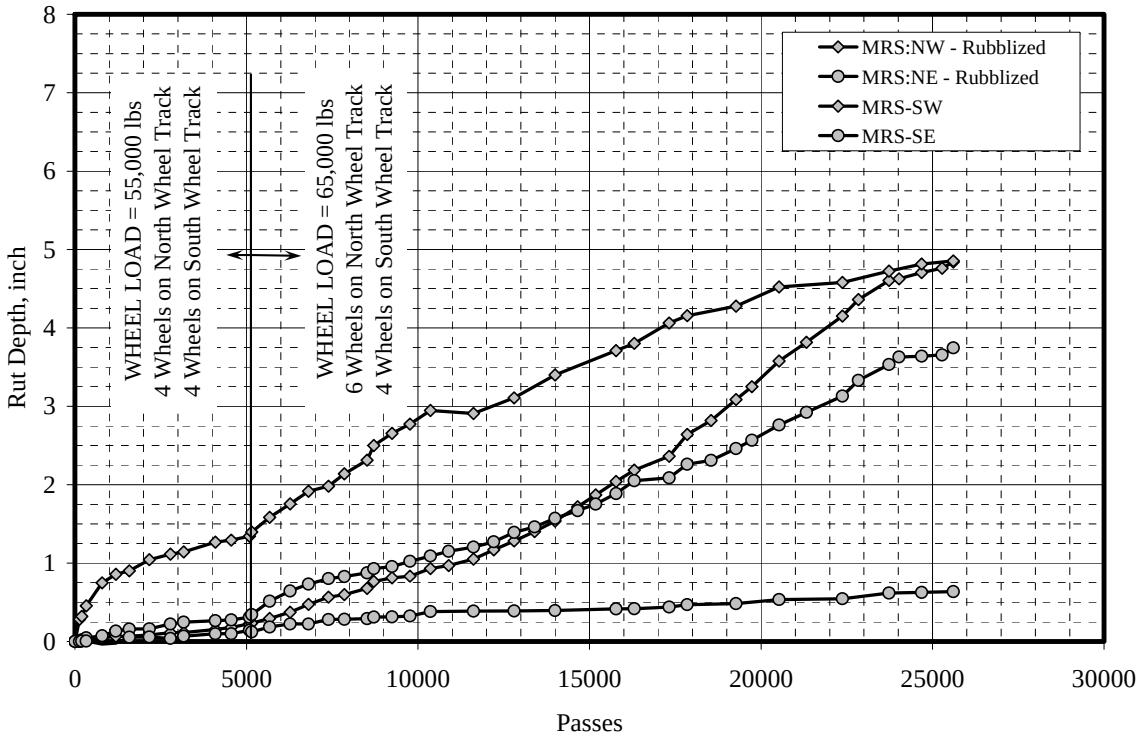
Figure 15. Straightedge Rut Depth Measurements in the Test Item MRS

At the MRS-SW location (nonrubblized), a test pit (5′ x 4′) was opened in the concrete slab (for subgrade evaluation) prior to placing the HMA overlay. The concrete that was used to refill the test pit was severely broken and a depression formed at this location during the placement and compaction of the HMA overlay. This severely weak area caused significant local accumulation of rutting early in the traffic tests.

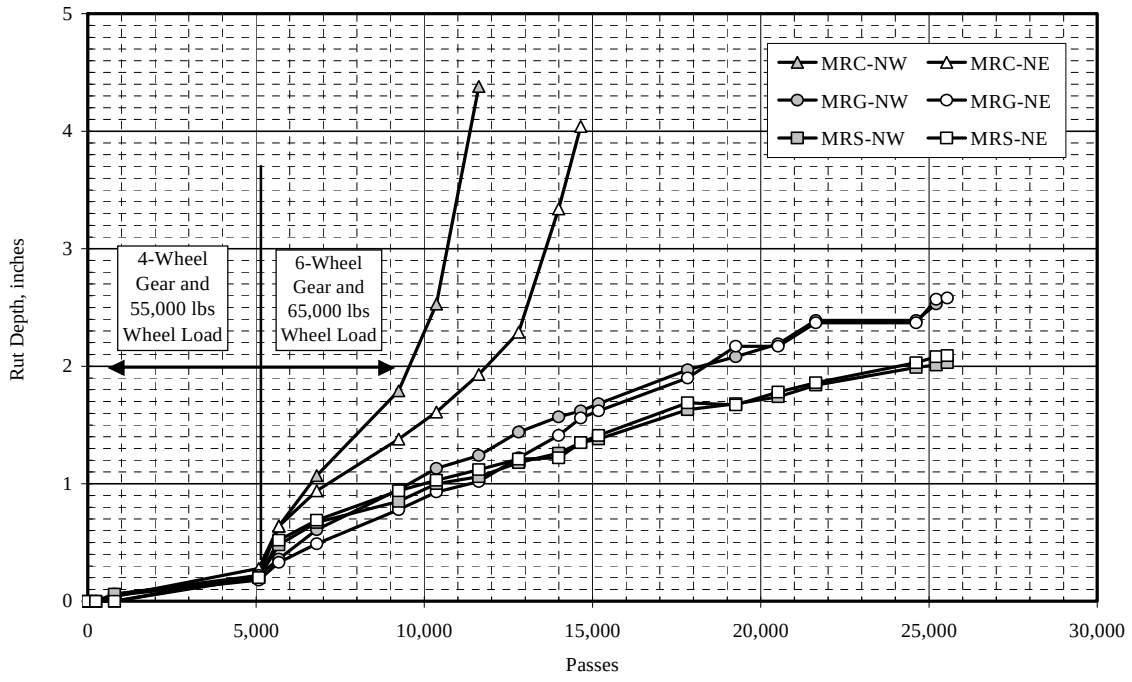
Figure 17. Rut Depths in the Rubblized Concrete Test Items From Transverse Surface Profiles

After approximately 10,000 passes in MRC, 13,000 passes in MRG, and 15,000 passes in MRS, significant upheaval in the HMA layer at the longitudinal joints just outside the traffic path was observed in the rubblized test items. After this number of passes, the rut depth measurements are exaggerated because the straightedge was resting on top of the upheavals outside the traffic path. More accurate rut depth measurements have been computed from the surface profile measurements (figure 17). Maximum rut depths from the transverse profiles at the end of trafficking were 4 inches on MRC-N, 2.5 inches on MRG-N, and 2 inches on MRS-N.

Significant structural upheaval was also observed outside the wheel track on MRC-N, but neither the straightedge measurement nor the transverse profile measurements could separate the contributions of the underlying structural response and the asphalt upheaval movement. Measurements of the transverse profiles of the structural layer interfaces are presented in the Layer Profile section from trench data. These measurements give a more definitive estimate of the true structural response of the rubblized pavement structures. The NE end of MRC was the first area of the rubblized pavements to show signs of failure (figure 18). This failure was not representative of the structural performance of the test item as a whole because one of the preoverlay test pits (for subgrade evaluation) was located where the pavement failed. A weakened support system resulted because the replaced subbase aggregate material could not be compacted to the same density as in the original construction. A depression in the pavement surface was observed at this location after about 400 load repetitions. The depression migrated longitudinally toward the east until it was about 15 feet long, but the structure continued to support the full traffic load until it appeared to be in danger of suffering complete structural collapse at 11,814 passes. The weakened area did not migrate back into the west half of the test item, and the declared structural life of MRC-NW of 14,256 passes is believed to be a true representation of the structural performance of the test item. Also, MRC-NW did not appear to be in danger of complete structural collapse as had MRC-NE. Trafficking in MRG and MRS was terminated after 25,608 passes. From visual inspection at the end of trafficking, MRG-N appeared to be suffering from structural upheaval outside the wheel track, but MRS-N did not.

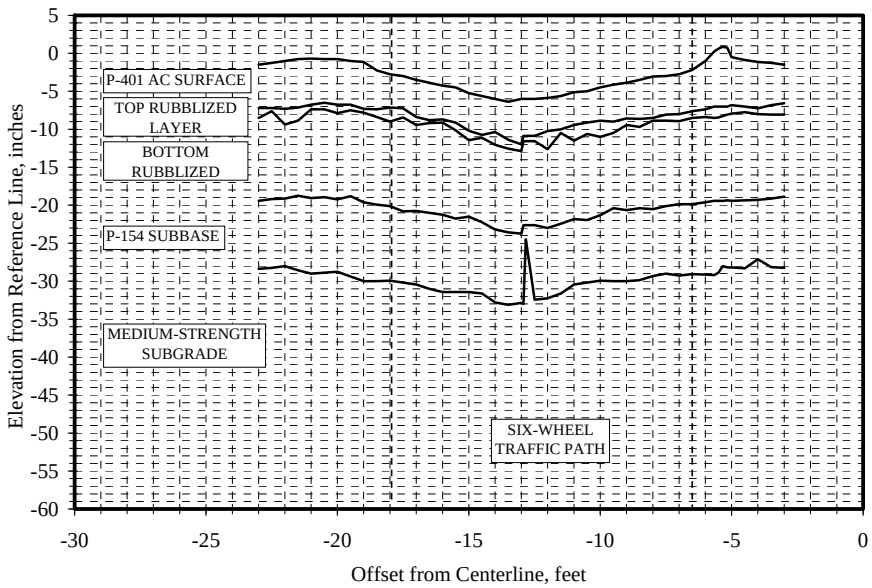
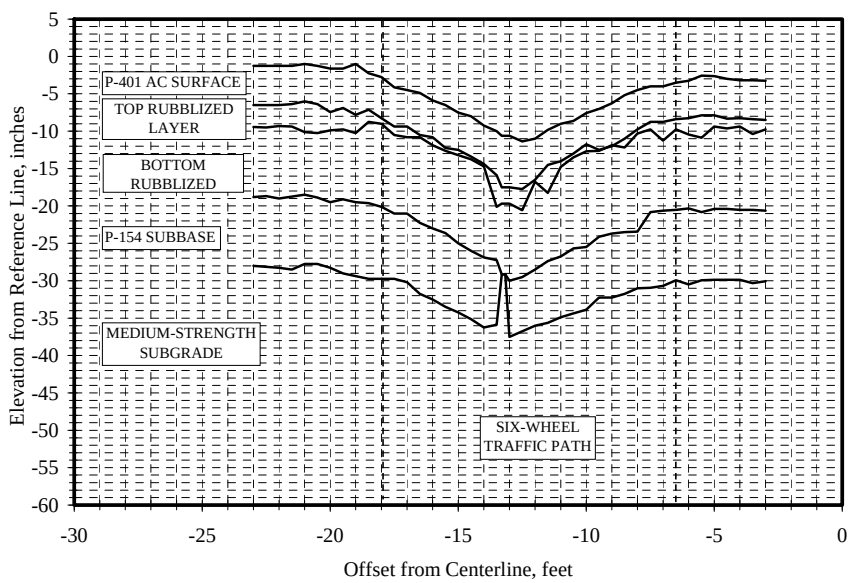
Figure 19. Pavement Layer Profiles From Trenches in Test Item MRC

The figure shows that the HMA surface and the top rubblized layer (top 3 inches of finely rubblized material) contributed to rutting. Shear failure in the subgrade resulted in significant upheaval outside the traffic path. Subgrade penetration into the subbase was observed. Significant shoving in the HMA layer was also observed.

In test item MRC, the top 3 to 4 inches of subgrade had reduced strength (CBR 3 to 4) because of moisture migration from the P-154 subbase into the subgrade. This weak layer of subgrade allowed higher vertical deflection in the pavement structure, which resulted in a faster rate of interlock deterioration between the rubblized concrete pieces and ultimate failure of the pavement structure. As shown in figures 20 and 28 (for MRG) and figures 21 and 29 (for MRS), the rubblized layer did not experience severe deterioration since the support system and the HMA overlay provided sufficient confinement and allowed limited vertical movement. This resulted in longer pavement structural life. Also, the rubblization process did not induce cracking in the underlying econocrete layer (as observed during the posttraffic test).

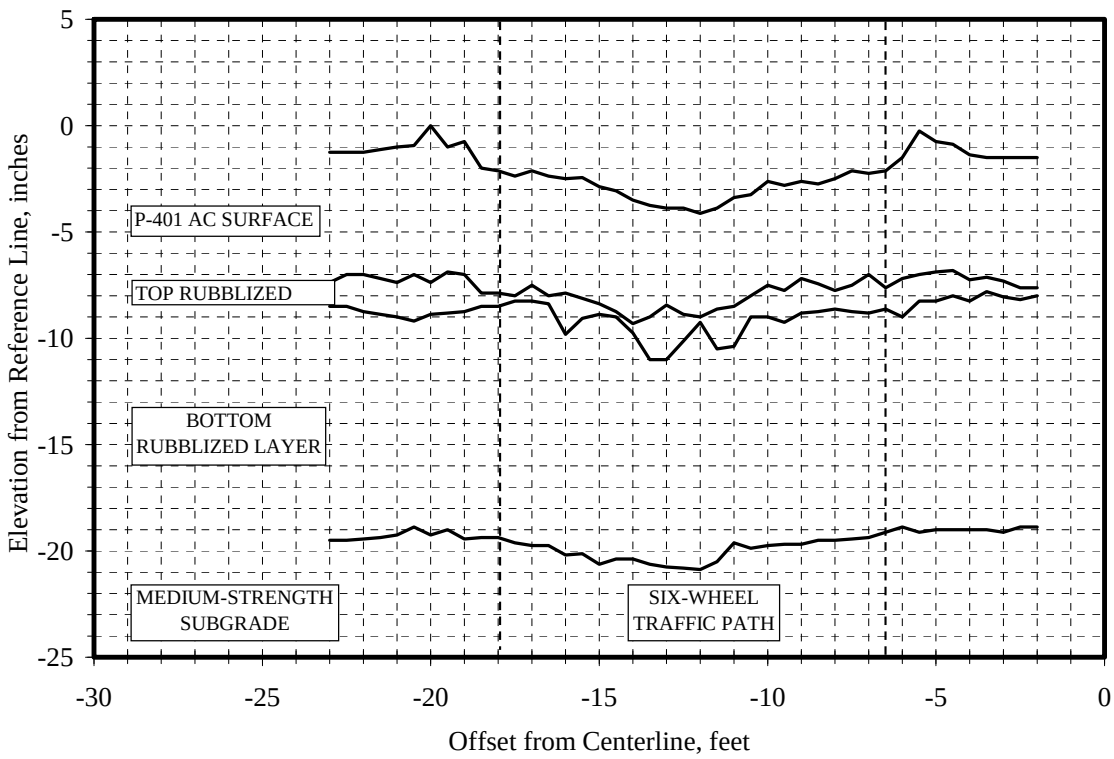
Figure 20. Pavement Layer Profiles From Trench in Test Item MRG

Figures 20 and 21 show the pavement layer profiles for test items MRG and MRS, respectively. The figures show that most of the rutting was contributed by the top 3 inches of the thin rubblized layer and the HMA overlay. The top 3 inches of rubblized layer are mainly composed of loose dust and stones with a top size of 1 inch. The bottom 9 inches of rubblized layer were 4 to 15 inches of tightly locked concrete pieces. A significant amount of shoving in the HMA layer was observed that resulted in significant upheaval just outside the traffic path. The subgrade in test item MRG (figure 20) showed indications of shear failure, as evidenced by the subgrade upheaval outside the traffic path.

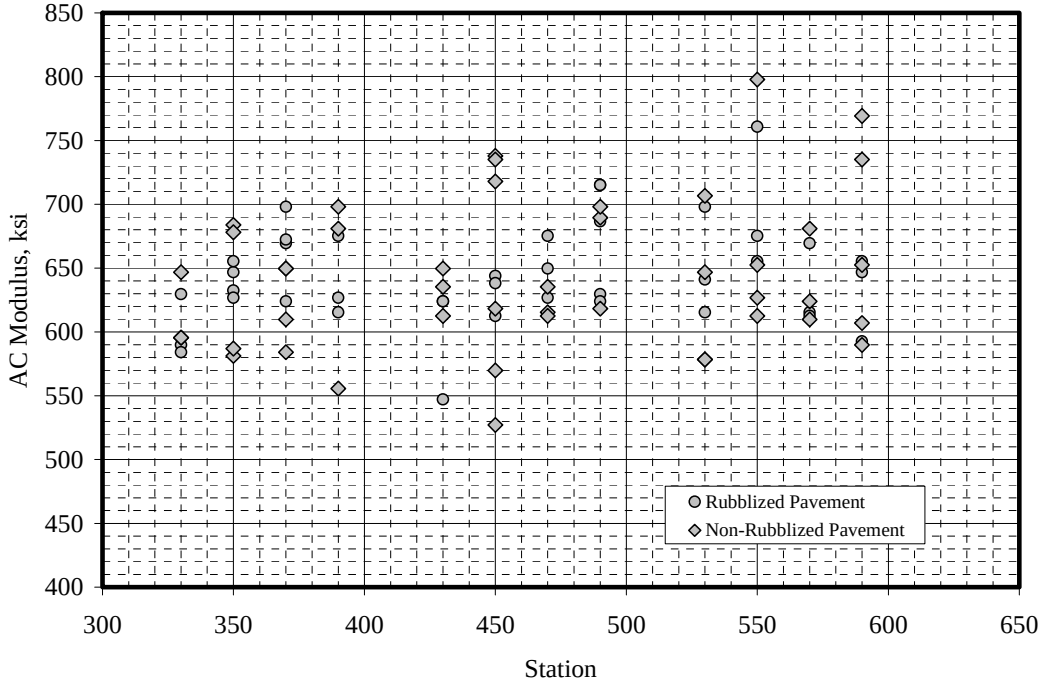
Figure 31. P-401 Asphalt Concrete Surface Modulus From PSPA Tests

be found in references 4 and 5. Figure 31 shows the P-401 asphalt concrete surface modulus obtained from PSPA tests.

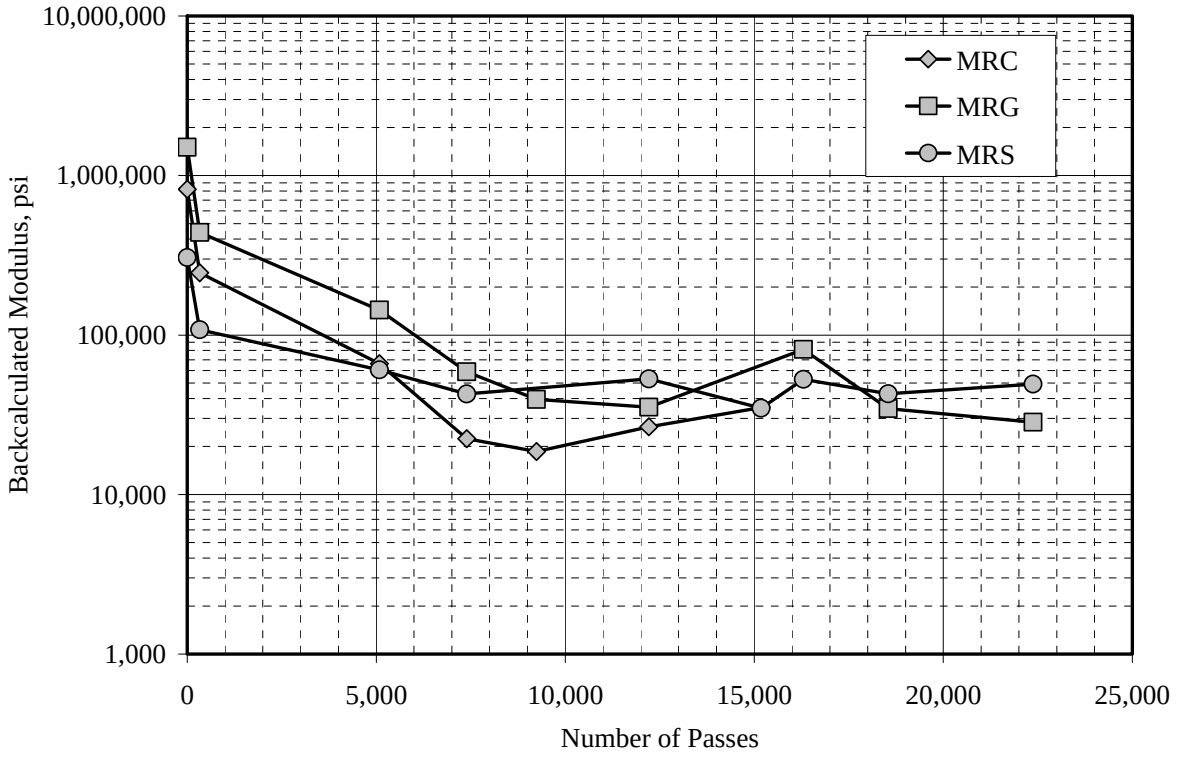
Figure 32. Changes in the Modulus of Rubblized Concrete During the Traffic Tests

Figure 32 shows that the rubblized concrete modulus reduces to approximately 30 percent of the initial modulus value after 330 passes for all three test items. The pavement performance, as indicated by rut depth, does not show a decline of this magnitude. In fact, for the first 5,083 passes, the maximum rut depth in all three test items is about 0.25 inch. After 5,083 passes, the modulus drops to approximately 20,000 psi for MRC, 40,000 psi for MRG, and 50,000 psi for MRS. These results indicate that backcalculated modulus may not be a good predictor of pavement performance when applied to a flexible pavement design procedure.

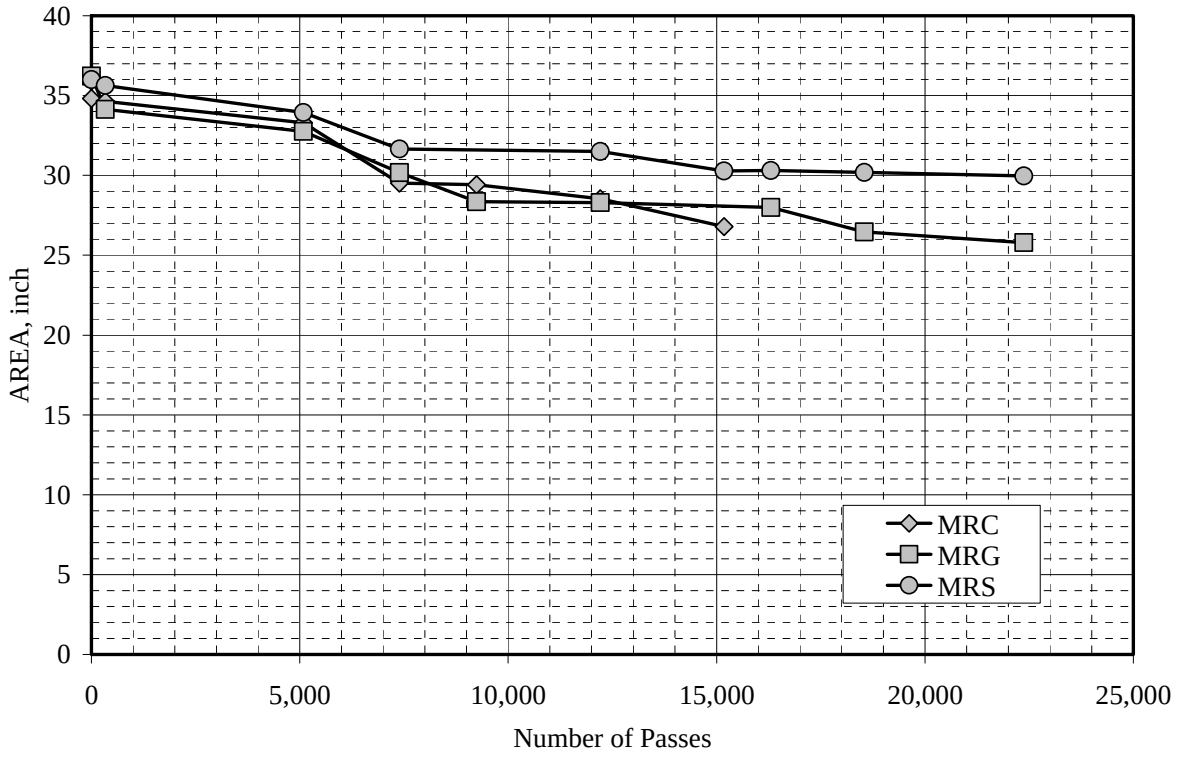
Figure 34. Changes in the Deflection Basin Shape Factor AREA During the Traffic Tests

For the first 5068 passes (at a 55,000-lb wheel load), all three test items showed similar rut depths. The AREA values (figure 34) also suggest similar behavior. The AREA values for test item MRC are somewhat overstated after about 7000 passes because the HWD tests could not be performed in the NE area of the test item due to large rut depths, as that part of the test item deteriorated toward failure.

At the end of trafficking, the AREA values were reduced by approximately 29 percent of the initial value for MRG and reduced by 17 percent for MRS. The rubblized concrete in the MRG and MRS trenches (figures 28 and 29) showed no significant signs of deterioration at the end of trafficking.
