FIRE CONTAINMENT CHARACTERISTICS OF AIRCRAFT CLASS D CARGO COMPARTMENTS

March 1983

Final Report

DOT/FAA
CT-82/156

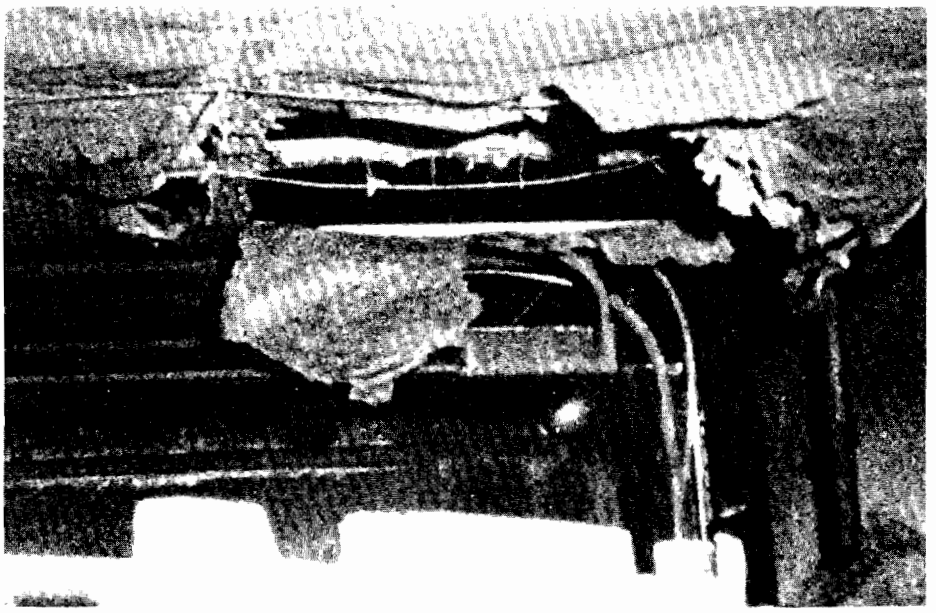
FIGURE 7. NOMEX™ LINER AFTER FIRE TEST

Four tests were conducted with Nomex™ ceiling liners. For reasons unrelated to the study, no fire resulted in the first test. The fire penetrated the Nomex™ ceiling liner in the remaining three tests. Burnthrough occurred zero to forty seconds after smoke detector activation. Figure 7 shows the damage to the Nomex™ liner after test 2. The fire intensity cycled noticeably in tests 2 and 10. As the oxygen was consumed the fire subsided, allowing the oxygen level to rise again due to entrained air. When it reached a critical level, rapid burning of the combustible material resumed. Overpressurization of the compartment resulted from this rapid burning and forced smoke back against the flow of above-ceiling air and out the inlet. In an aircraft this would be analogous to smoke being forced into the pressurized cabin instead of out the overboard vents. This occurred three or four times during tests 2 and 10 (figure 7).

1. Nomex ceiling liners burned through in each case. Burnthrough occured 0 to 40 seconds after smoke detection.

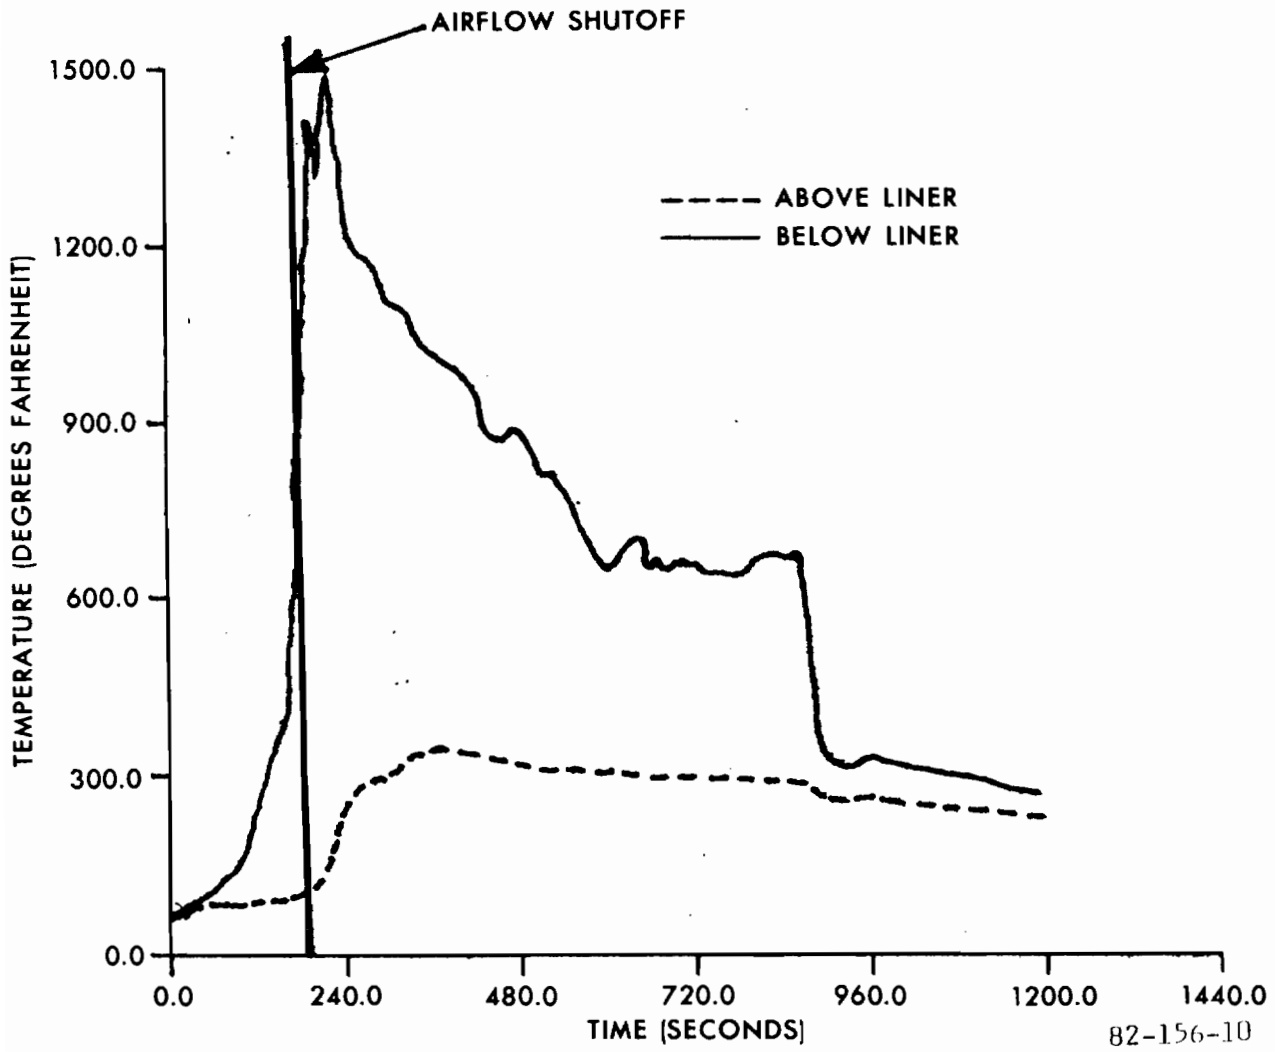
FIGURE 9. TEMPERATURE ABOVE AND BELOW FIBERGLASS LINER

Three tests were conducted using a fiberglass ceiling liner. Cargo compartment temperatures similar to the tests with the Nomex liner resulted, but the fire never burned through the fiberglass liner. However, large quantities of smoke were present above the ceiling. Some of the reasons for smoke collecting above the ceiling were: the burning of the resin on the backface of the fiberglass, the permeable nature of the fiberglass cloth after the resin burned away, and the natural leakage through cracks and joints in the drop ceiling structure. There was no evidence of the cycling of the fire observed in tests 2 and 10. It should be noted that both the Nomex and the fiberglass easily passed the vertical and 45-degree bunsen burner tests required for class D cargo compartment liners. Figures 8 and 9 illustrate the effectiveness of the two different lining materials as a fire barrier. Temperatures above the ceiling liner are compared with those below the liner. Although the below-ceiling temperatures were similar, the temperature above the fiberglass liner never exceeded 400° F, while the temperature above the Nomex liner reached 1150° F. At approximately 800 seconds into the Nomex test, the above ceiling temperature exceeded the temperature below the liner. The Nomex liner no longer existed at this point. Figure 10 is a plot of oxygen concentration versus time for tests 7 and 10. The fiberglass liner was able to maintain an oxygen concentration of less than 10 percent for 10 minutes. While this did not extinguish the fire, it did reduce the initial flare up, resulting in a small fire with very little spread. The oxygen concentration during the Nomex test dropped to a minimum concentration of 10 percent but rose again to 18 percent as the liner burned away and fresh air was entrained.

2. The polyester resin used with the fiberglass ceiling liner was partially burned away but the glass cloth remained intact for all tests.

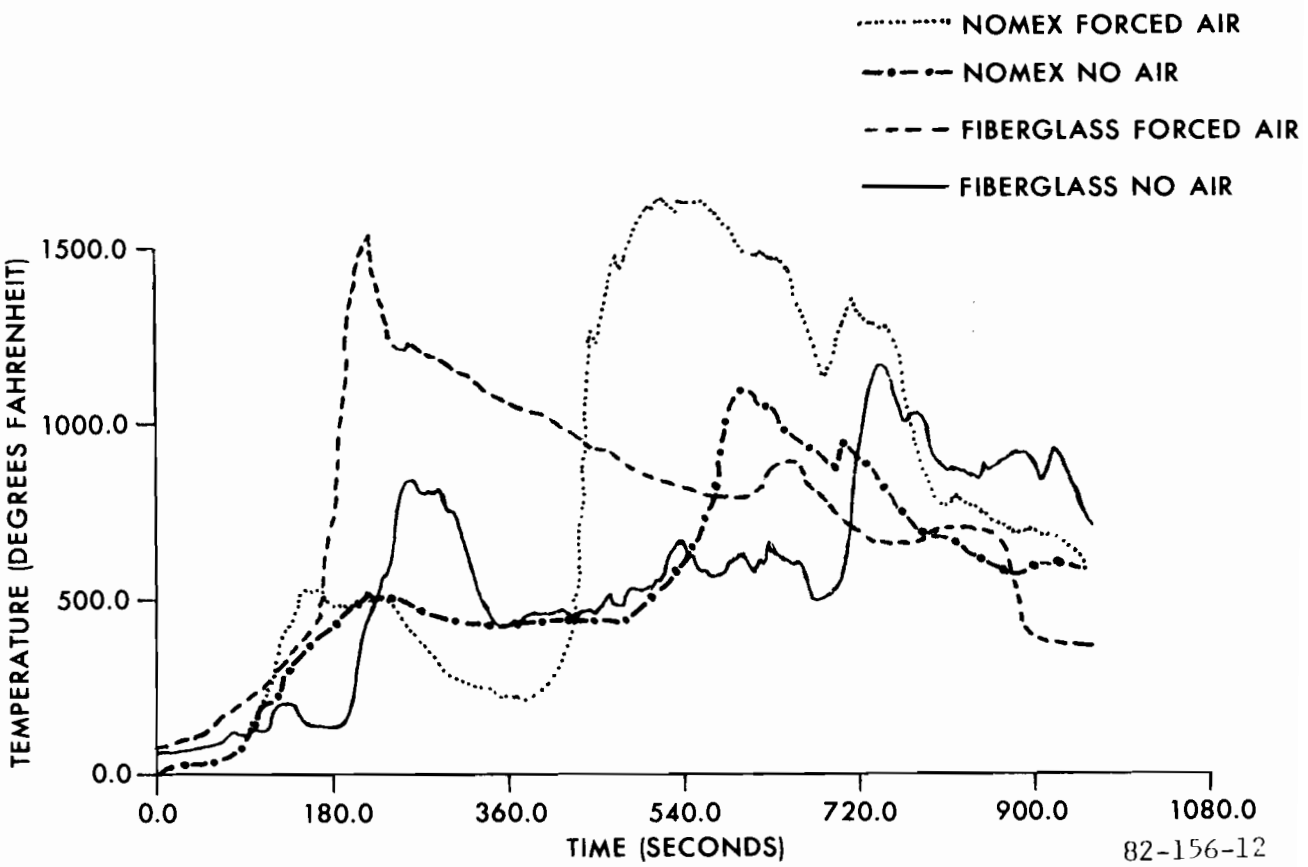
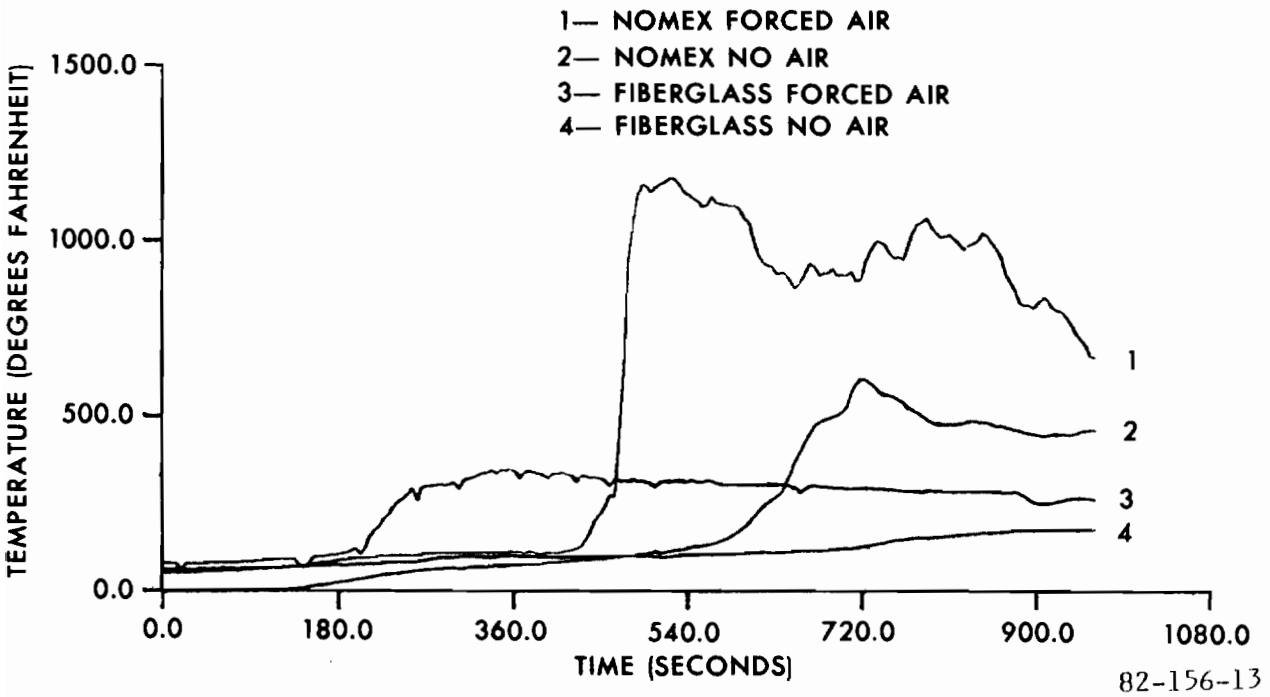
Figures 11 and 12 show the effect of forced ventilation on fire growth and intensity. The temperature below the ceiling increased earlier and became hotter with both liner types when forced ventilation was used. The most severe fire in terms of above-ceiling temperatures was during test 10 using the Nomex ceiling liner and forced ventilation. Temperatures above the ceiling increased earliest in the test using the fiberglass ceiling liners and forced ventilation but the temperature leveled off before reaching 400° F. The fire in the test using the Nomex liner and no forced ventilation took longer to develop, but eventually reached

700° F above the ceiling as the liner burned away. In test 9, using the fiberglass ceiling liner and without forced ventilation, the temperature above the liner never exceeded 200° F.

Forced ventilation, in some cases, produded a flaming condition leading to a self-sustaining fire, whereas without ventilation a fire may be limited to a smoldering condition and self-extinguishment.

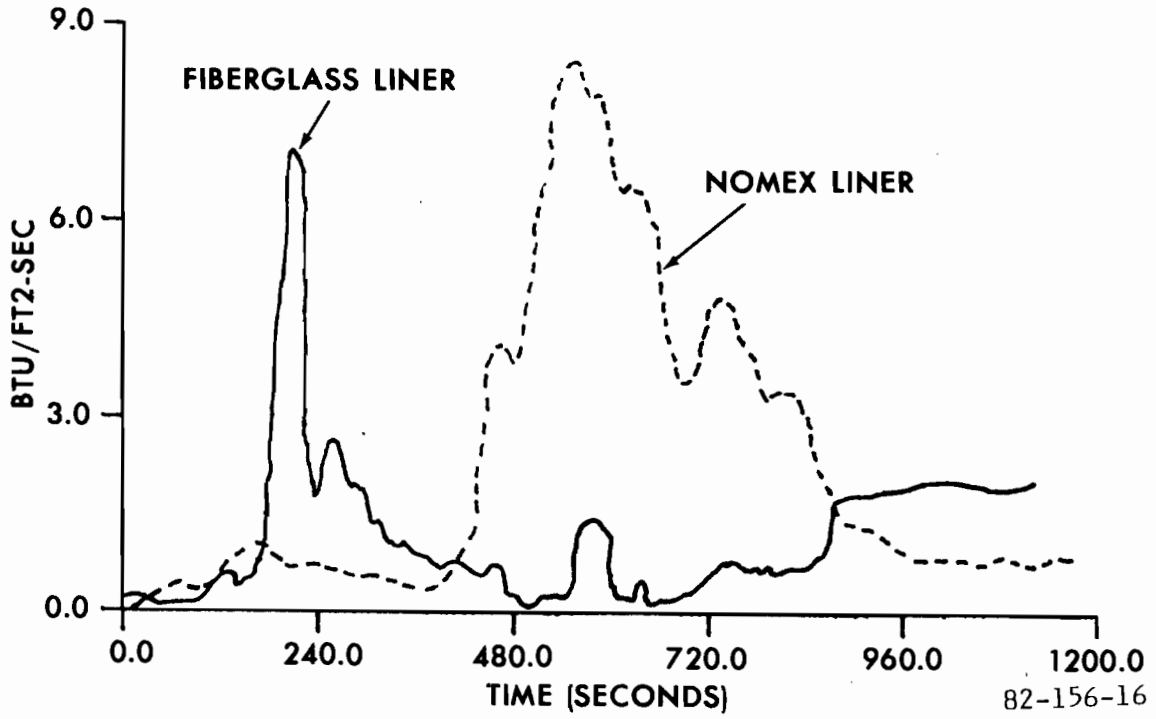
FIGURE 15. HEAT FLUX ON CEILING LINERS

Maximum heat flux levels recorded on the ceiling were in the range of 6.0 to 8.6 BTU/ft^2-second for the tests that developed beyond a smoldering condition. Figure 15 shows the heat flux incident on the ceiling liner for test 7 and 10 using fiberglass and Nomex ceiling liners, respectively.

3. Typical cargo fires can produce maximum temperatures of 1800° F and maximum heat flux of 8.6 BTU/ft^2-sec at the ceiling liner. The peak fire conditions are only slightly lower on the upper sidewall liner when the fire is adjacent to the sidewall.
