DOT/FAA/CT-85/36

Crash Dynamics Program Transport Seat Performance and Cost Study Benefit Study

Mark R. Cannon
Richard E Zimmermann

Final Report

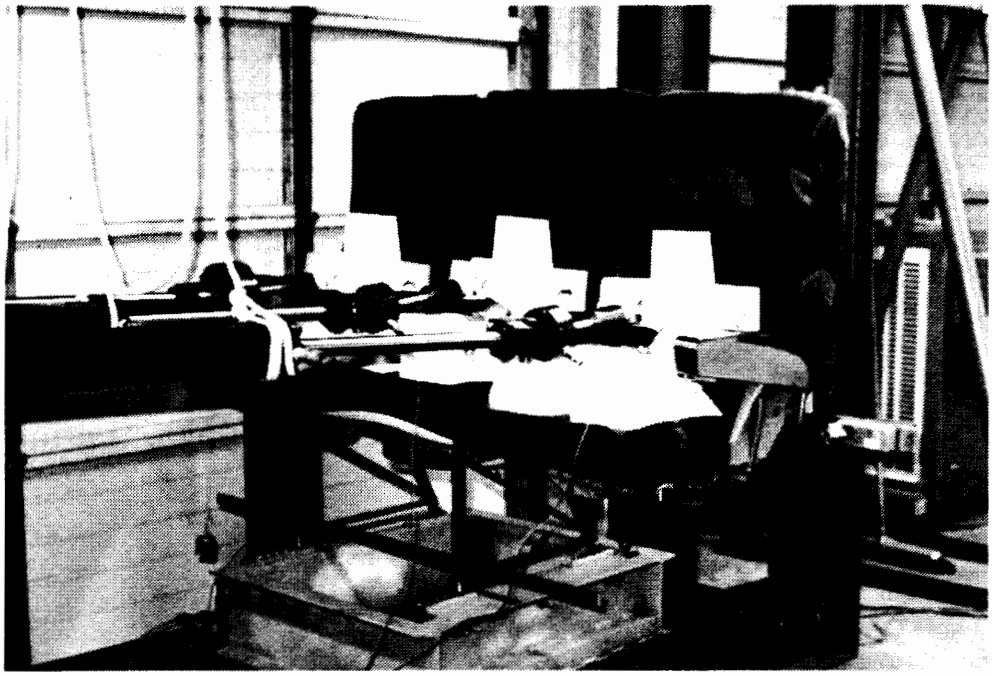
Figure 16. Forward static test arrangement.

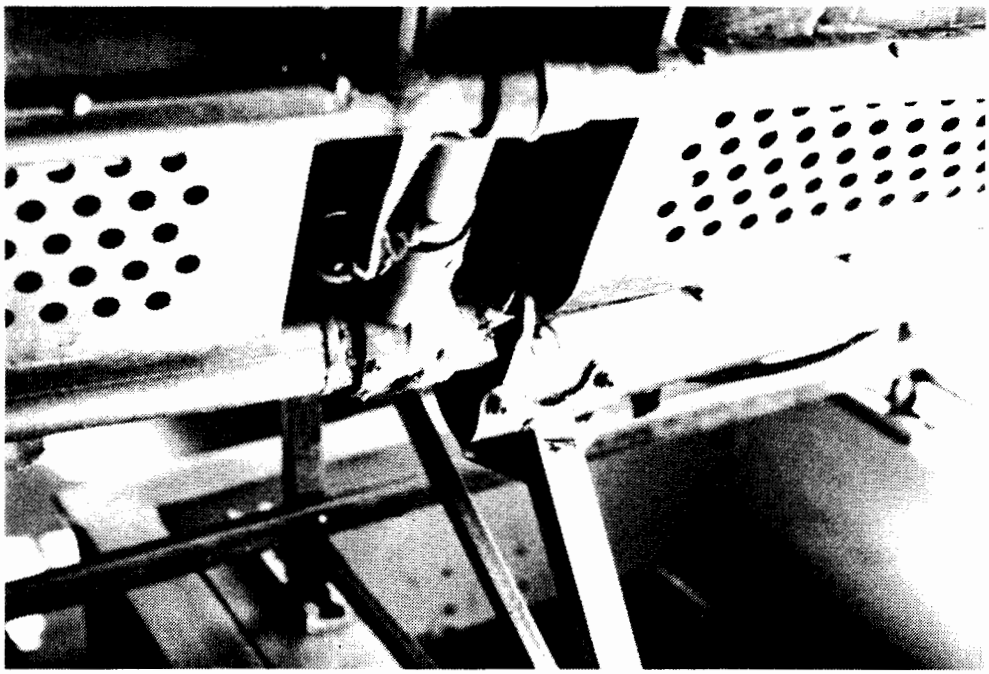
Figure 17. Forward static test failure location of standard seat (Example 1).

Results from the forward static tests showed the standard seat built in the early 1970's had an ultimate strength of 11.2 G, while one of the newer seats failed at 9.1 G. Failure locations of two of the standard seats are shown in figures 17 and 18. In figure 17, the rear lateral seat pan tube ruptured at the outboard rear leg attach point. The seat in figure 18 failed at the fitting which attaches the outboard rear leg to the seat pan tube.

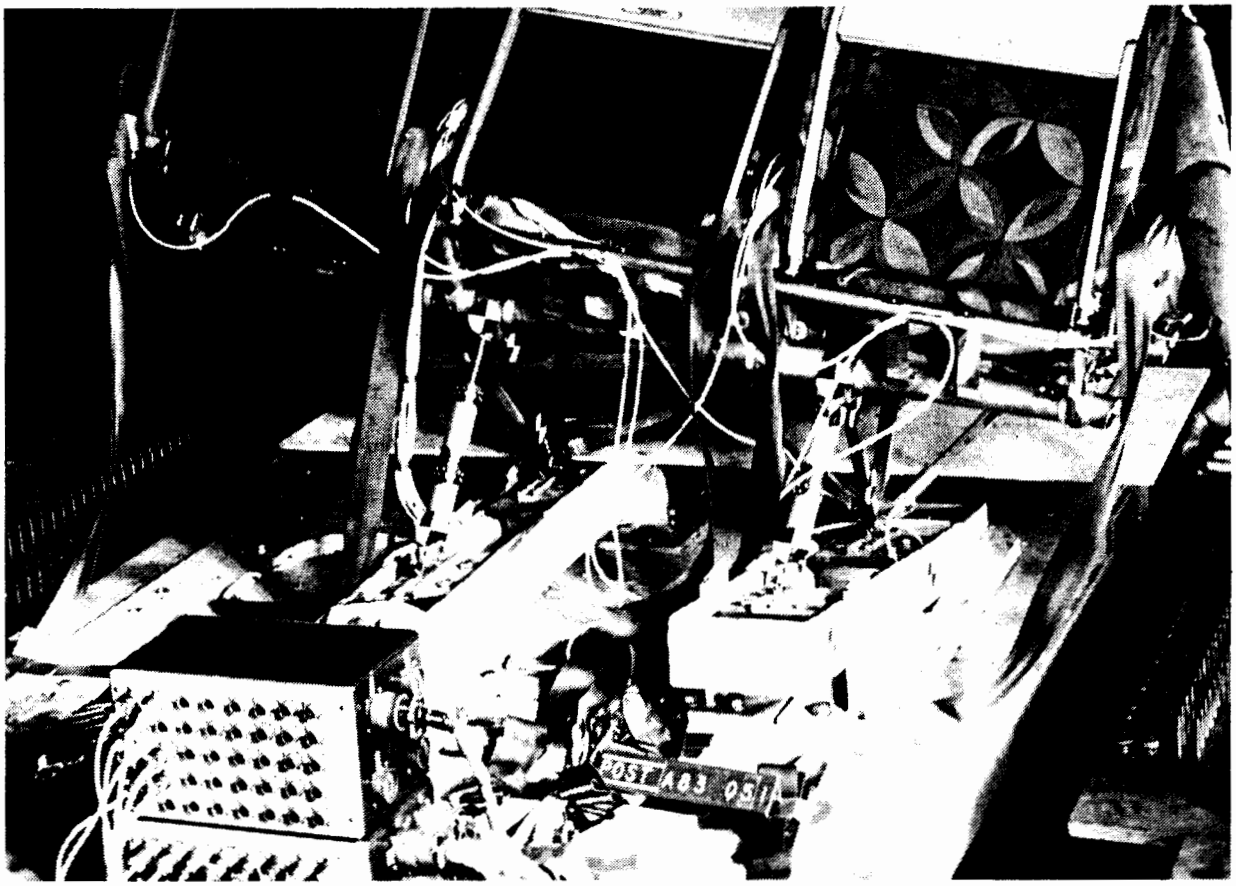
results were desired. To study the seats' reaction to floor deformation, the inboard track was pitched down 10 degrees and the outboard track was rolled out 10 degrees prior to the dynamic tests (figure 19). All of the standard seats failed the dynamic tests with floor deformation such that the seats be came completely detached from the floor tracks on the test fixture (figure 20). Conversely, the modified seats remained affixed to the floor track and used only half of their available energy absorption capability (figure 21). After completion of the static and dynamic verification tests, new modified and standard seats were placed aboard the Boeing 720 CID aircraft (figure 22). Additional seat experiments were installed by NASA and the FAA. The NASA experiments consisted of a standard and modified triple passenger seat, and the FAA experiment was a new, state-of-the-art, composite, triple-passenger seat.

Figure 20. Standard seat after dynamic testing.
