Analysis of the T63-A-700 Engine used in Alcohol Turbine Fuel Extender Test

John S. Glaeser
Depot Engineering and RCM Support Office
U.S. Army Aviation Systems Command
Naval Air Station, Corpus Christi, Texas

August 1990

DOT/FAA/CT-TN90/18

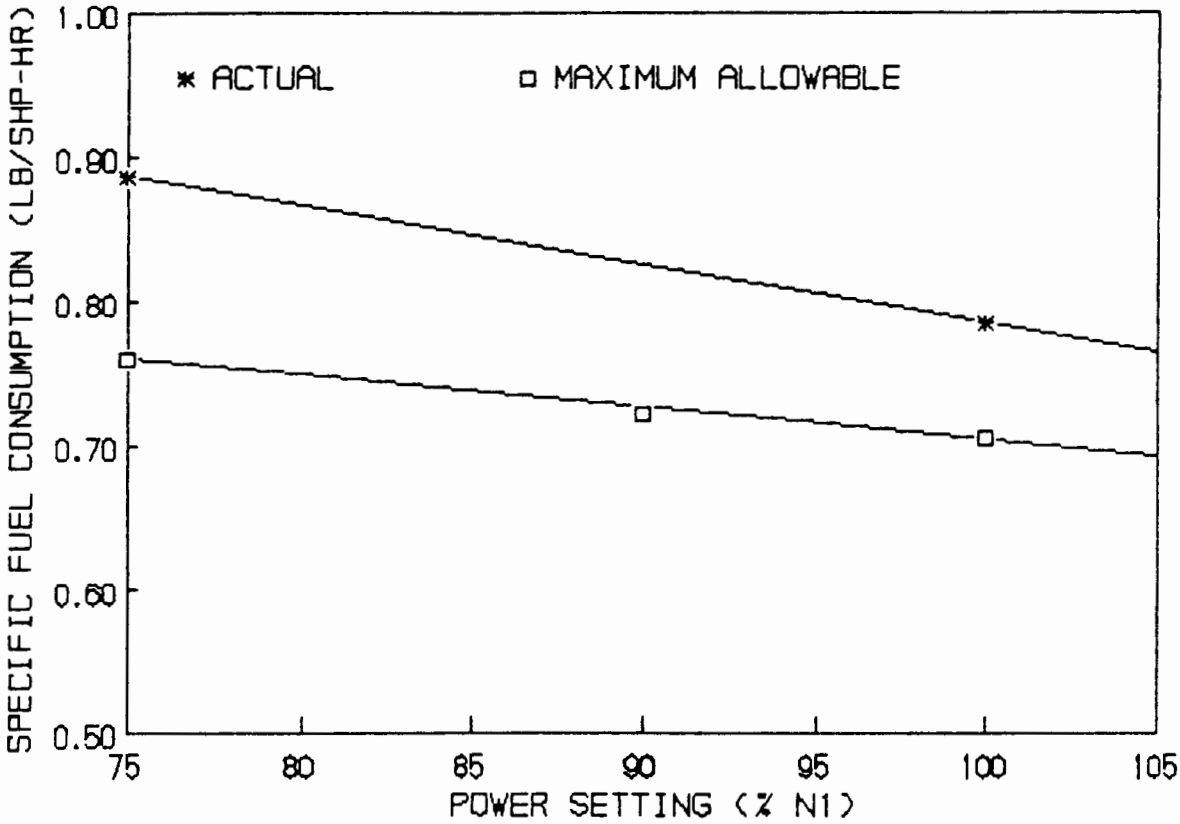
The specific fuel consumption for the engine was consistently higher than the maximum allowable (figure 1).

FIGURE 1. FUEL CONSUMPTION COMPARISON

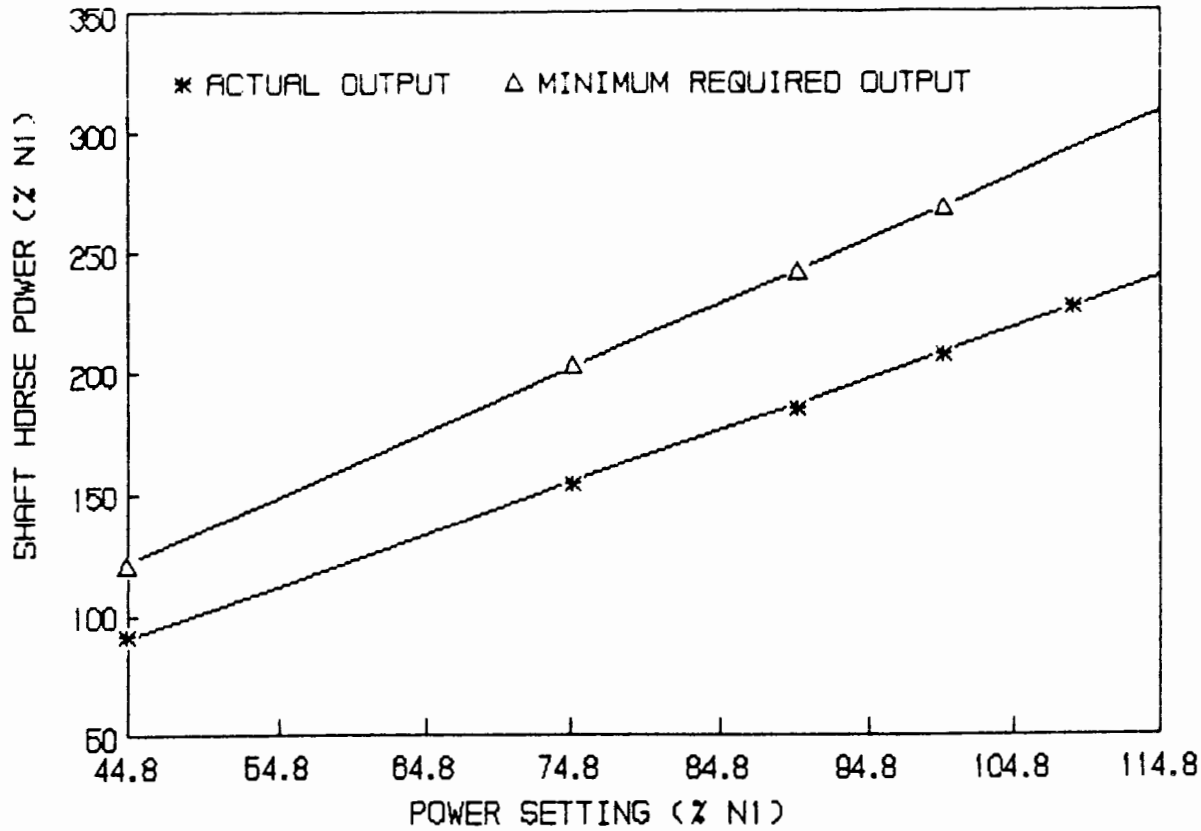
The engine was operated through all ranges of power settings. Table 2 reflects the test run parameters. At all power settings, the shaft horsepower (referred to standard day, sea level conditions) was lower than the minimum specified in TM55-2840-231-23, Aviation Unit and Intermediate Maintenance Manual, Engine Assembly (figure 2).

FIGURE 2. OUTPUT POWER COMPARISON

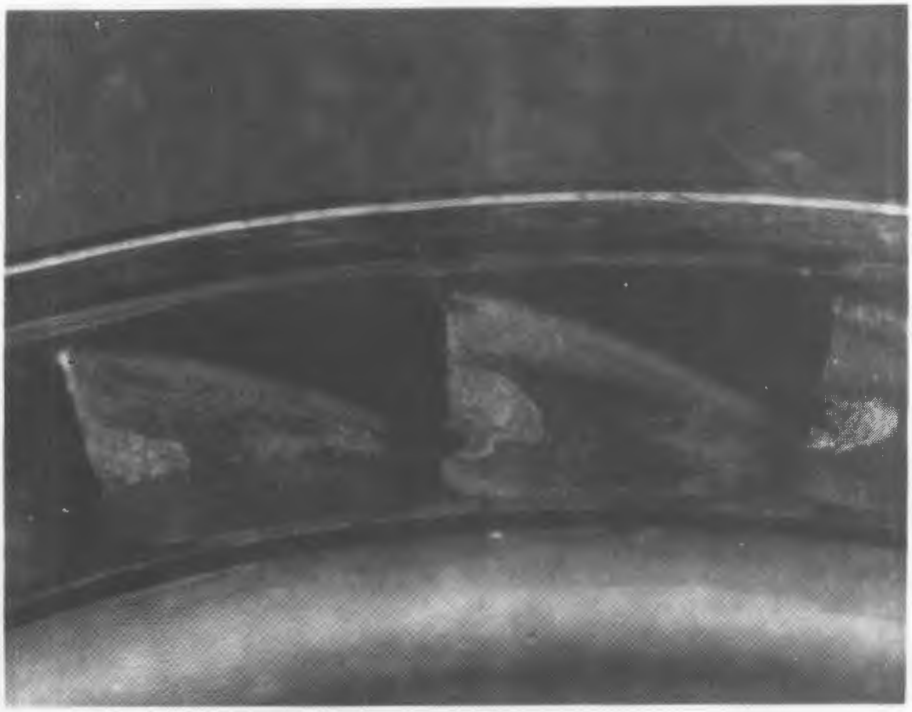
It was concluded that the vanes on the first stage gas producer burned during a series of hot or hung starts using extender fuels. The inefficiency of both the fuel nozzle and the fuel control unit using alcohol blends during starting operations caused the overtemperatures.

The engine disassembly revealed several discrepancies in the hot section. The first stage gas producer nozzle vanes had burned trailing edges. One 3-vane section of the nozzle was burned more heavily than the remainder of the vanes (figure 3).

FIGURE 3. THE AFFECTED TRAILING EDGES

Assuming that the alcohol blends contributed to the hot section damage during starting operations, it follows that consideration should be given to using only jet fuel to start gas turbine engines. Extender fuels would be introduced after the engine reached normal operating conditions. This would require additional testing to confirm the above assumption. The Federal Aviation Administration Technical Center reported that the incidence of hung starts was reduced by starting the test engine on either neat Jet-A or neat JP-4.

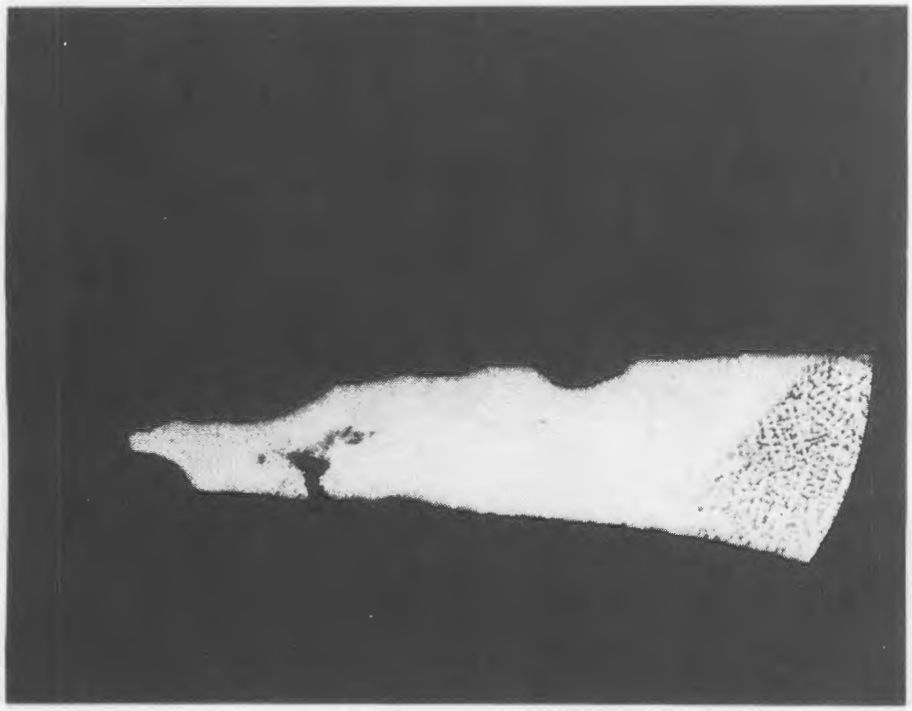
First stage gas producer nozzle - The nozzle was analyzed at the CCAD Metallurgical Laboratory. An examination of the burned cross-section confirmed incipient melting in this area of the nozzle (figure 4). The number of engine hours at the time the nozzle started to burn is unknown. The type of fuel in use and the engine operating parameters when this failure commenced is also unknown; however, the following hypothesis is probable. The inspection of the fuel nozzle and the fuel control unit installed in this engine revealed that they were operating normally. The fuel atomization pattern for this nozzle was proper for normal operating conditions. However, the alcohol fuel mixtures may have altered the flame pattern during starting and low power requirements, particularly during hot and/or hung starts. In addition, the flame speed when operating on alcohol fuels is slower, and it is possible the flame front extended beyond the burner can. This further compounds the overtemperature problem during a hot or a hung start.

FIGURE 4. TRAILING EDGE SHOWING INCIPIENT MELTING
