Magneto-Optic Imaging Inspection of Selected Corrosion Specimens

July 1992

DOT/FAA/CT-TN92/20

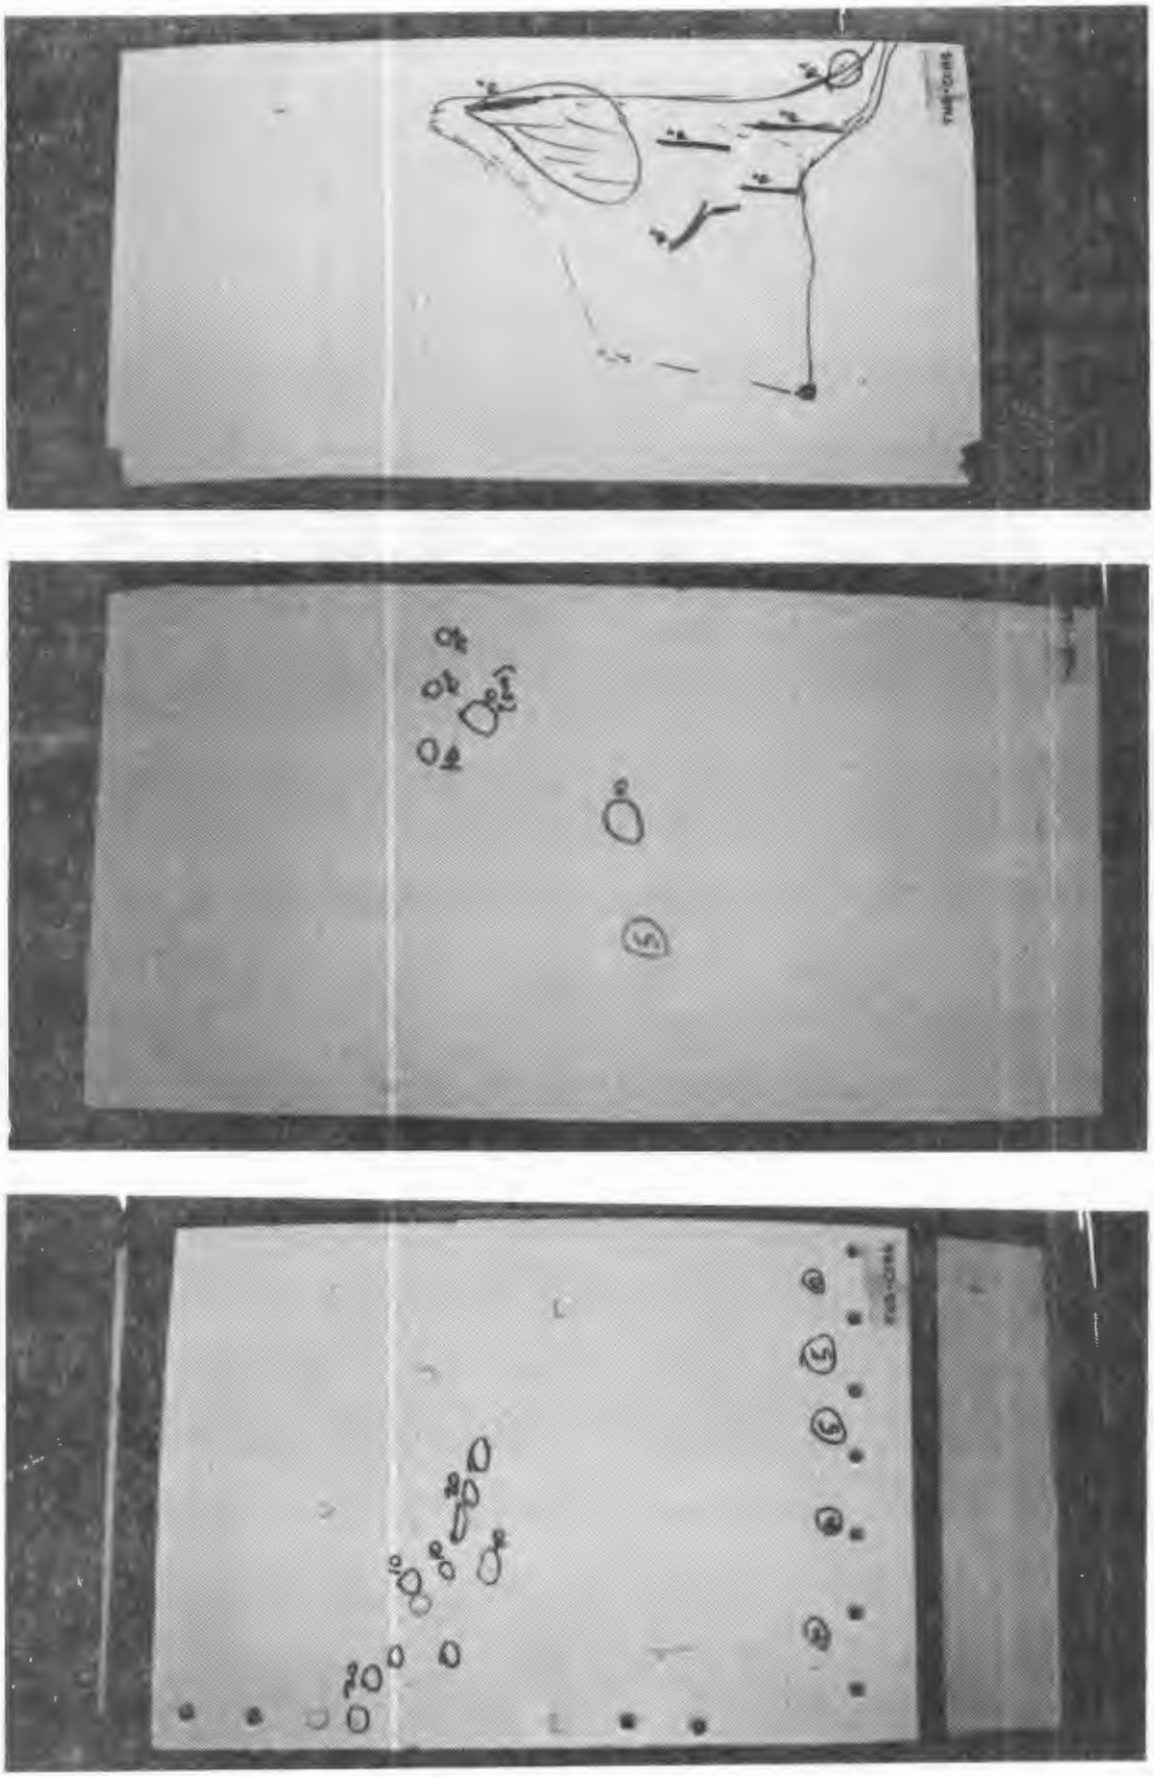
Six test panels were provided by Boeing. The panels, taken from actual aircraft, measured approximately 6 by 18 inches with thickness of 0.040 inch. Each panel contained at least one row of flush rivets which attached plates of varying sizes (representing internal structure) to the back of the panel. Figure 1 shows examples of several panels with notations indicating corrosion detected by MOI.

test piece perturbs the magnetic field and distorts the magneto-optic image. (A similar effect is introduced by magnetic material in the case of eddy current scanning.) The extent of corrosion was recorded on each panel surface, using an erasable marker. Personnel were requested to use the marker to circumscribe corrosion having a depth of 10 percent or greater of panel thickness, and to estimate and mark whether its depth was 10 percent, 20 percent, or 30 percent and greater (Figure 1).

Figure 1 Examples of test panels containing subsurface corrosion, detected by MOI.

Figure 2 Model 301-1 in operation on a test panel.

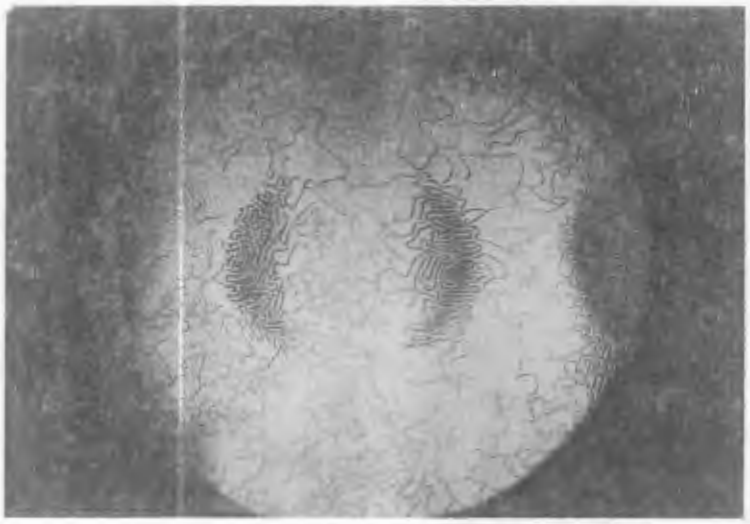
Figure 1. Image of Boeing Reference Standard 127-XXX. Note how the flat-bottomed hole gives a sharper "edge" type image, while a real corroded image gives a diffuse "area" type image.

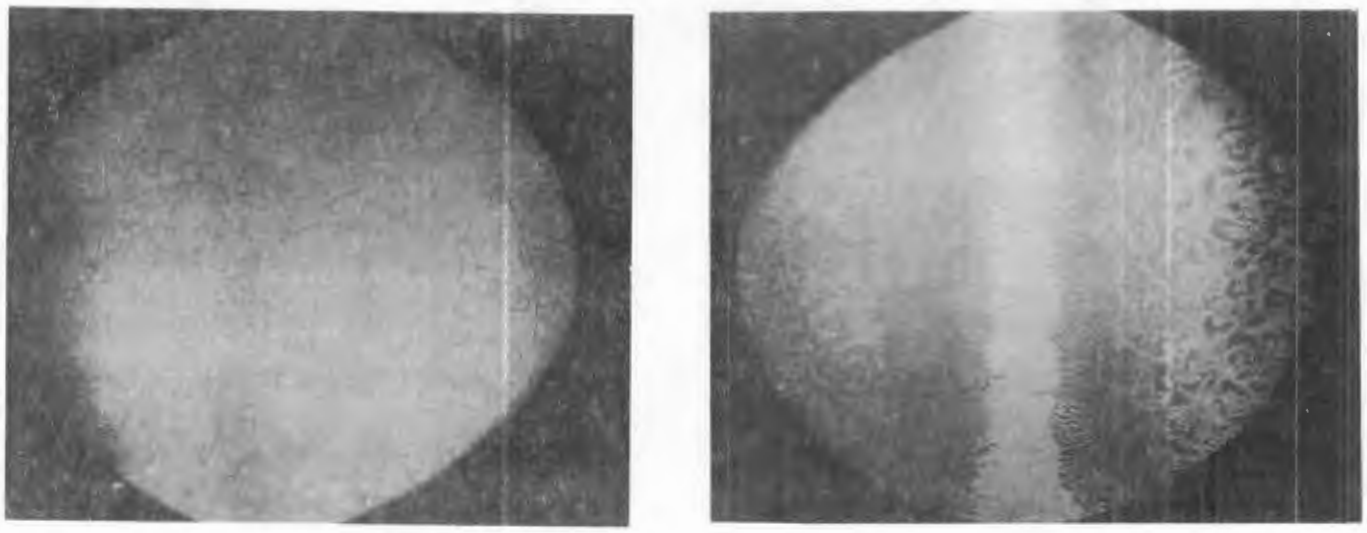
WARNING: IF THE FREQUENCY SETTING IS TOO LOW, A BRIGHT LINE ON A DARKER BACKGROUND WHICH IS CENTERED ON THE IMAGE AREA, WILL APPEAR (see Figure 2b). THIS IS NOT AN IMAGE OF CORROSION, AND GENERALLY DOES NOT MOVE WHEN THE IMAGING HEAD IS SCANNED. THE FREQUENCY MUST BE INCREASED UNTIL THIS FEATURE IS MINIMIZED OR ELIMINATED. WHEN LOWER FREQUENCIES ARE USED, IMAGES OF THE SUBSTRUCTURE MAY BECOME VISIBLE. HOWEVER, THE REGULAR PATTERN EXHIBITED BY THIS SUBSTRUCTURE EASILY DISTINGUISHES IT FROM THE GENERALLY IRREGULAR CORROSION IMAGES.

Figure 2. The appearance of the image for a correct and typical setup condition for corrosion, shown in the figure on the left, and the appearance of the image when the frequency is set too low, shown on the right. The dark side bands are a result of too deep a penetration of the eddy current excitation.

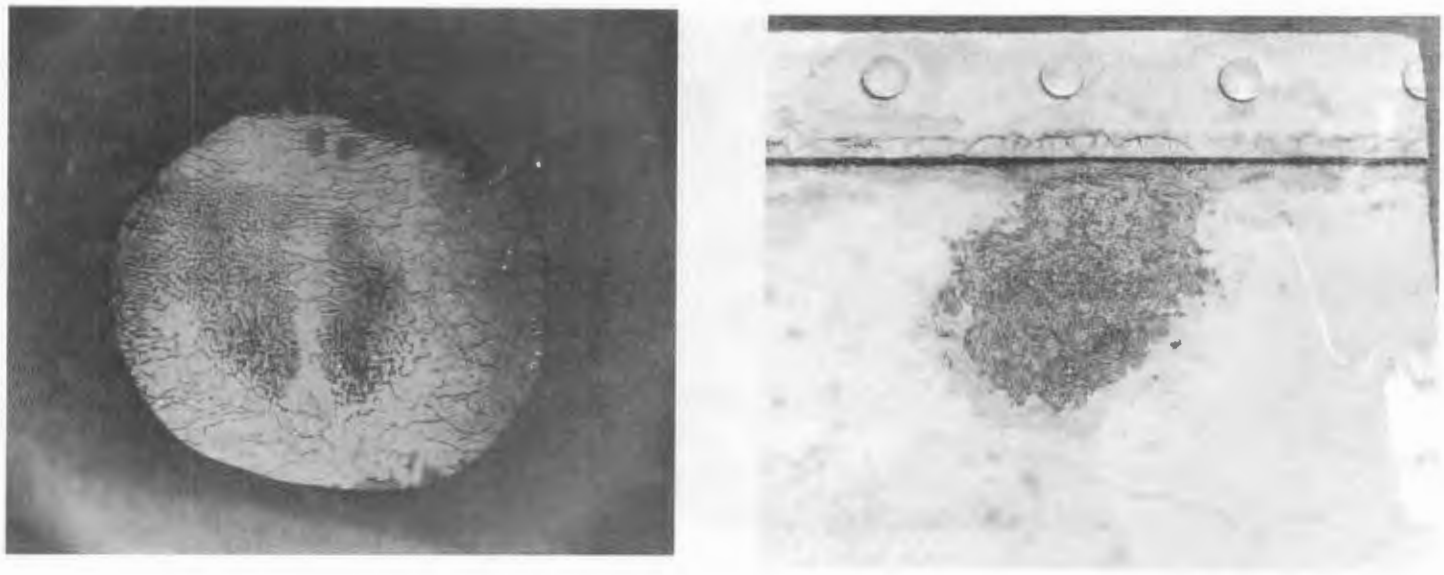
Figure 3. An image of corrosion, left, in an aluminum panel removed from an older airplane, right. The image is bookmatched or mirrored from the actual photo of the corrosion because it was obtained from the opposite side of the panel.
