DOT/FAA/DS-89/2

JOINT SEALANTS FOR AIRPORT PAVEMENTS

Phase I: Laboratory and Field Investigations

Final Report

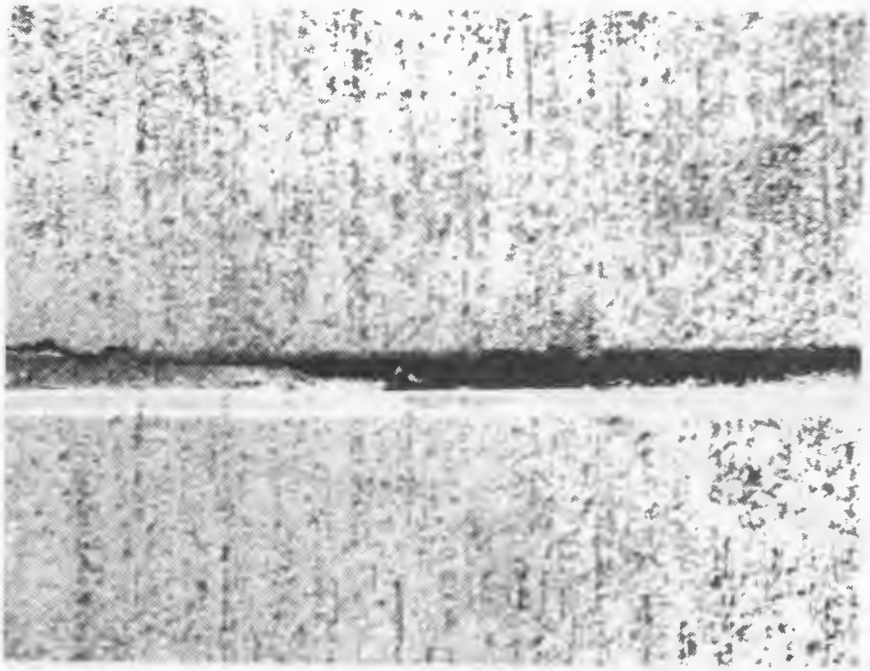
Damages from jet fuel and hydraulic fluid were found on parking aprons and maintenance areas where aircraft are fueled and serviced (Figure 2). Even though a particular sealant was specified as "jet-fuel resistant," the sealant was found damaged by these fluids. For example, at Los Angeles International Airport, after only 2 years, a "jet-fuel resistant" seal showed signs of deterioration by jet fuel (Figure 3). Hydraulic fluid appears to affect sealants just as much as jet fuel. Figure 4 shows an example of a jet-fuel resistant seal that has been

FIGURE 3. JET-FUEL DAMAGE OF JOINT SEAL ON PARKING APRON AT LOS ANGELES INTERNATIONAL AIRPORT.

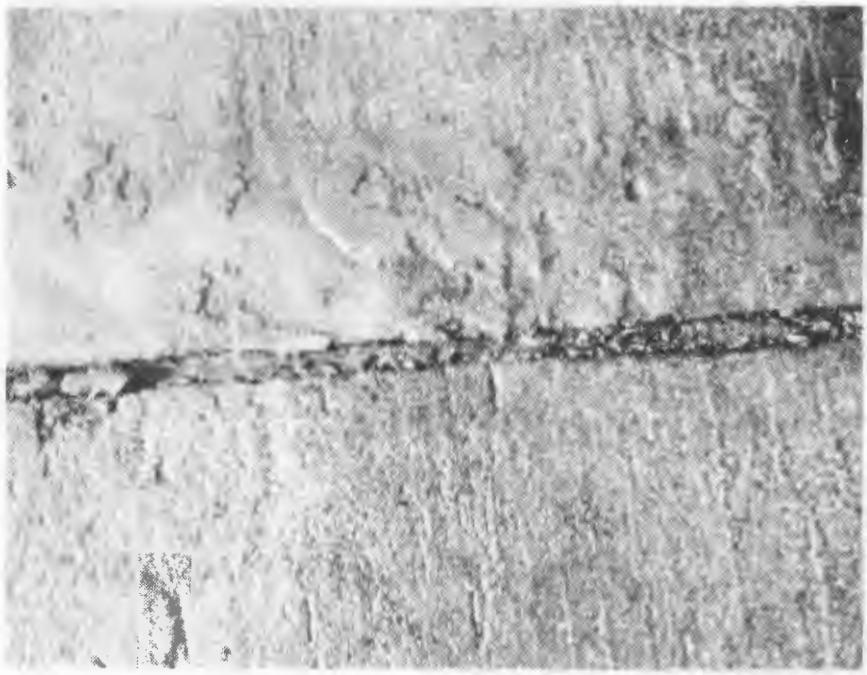
almost completely deteriorated by hydraulic fluid. Current specifications for joint sealants require jet-fuel resistance, but not hydraulic fluid resistance.

FIGURE 4. HYDRAULIC FLUID DAMAGE OF JOINT SEAL ON PARKING APRON AT LOS ANGELES INTERNATIONAL AIRPORT.

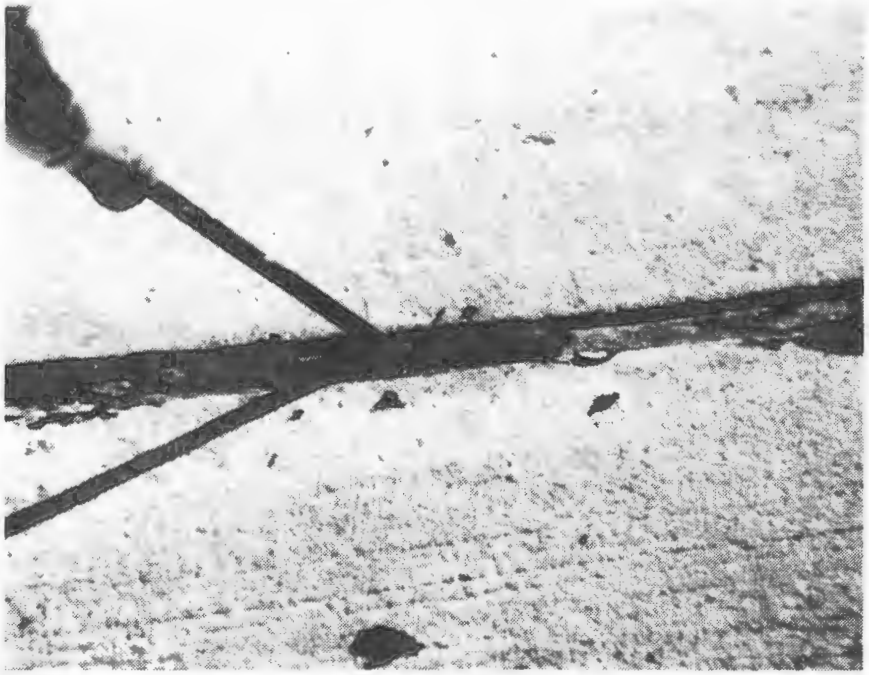
Adhesion loss occurs when the bonding between the sealant material and the walls of the joint fails. An example of adhesion failure is shown in Figure 5. Adhesion loss can be caused by improper cleaning during installation, inadequate materials, and improper shape factor (References 7, 10). Adhesion loss was found in varying degrees of severity at all of the airports and in every area of the airports (i.e., parking apron, taxiway, etc).

FIGURE 5. ADHESION LOSS OF JOINT SEAL AT ATLANTA HARTSFIELD INTERNATIONAL AIRPORT.

An important factor in installing seals successfully is a clean joint. All dirt, old sealant residue, or any loose material must be removed before installing a joint seal. The recommended method of joint cleaning is sandblasting (Reference 10).

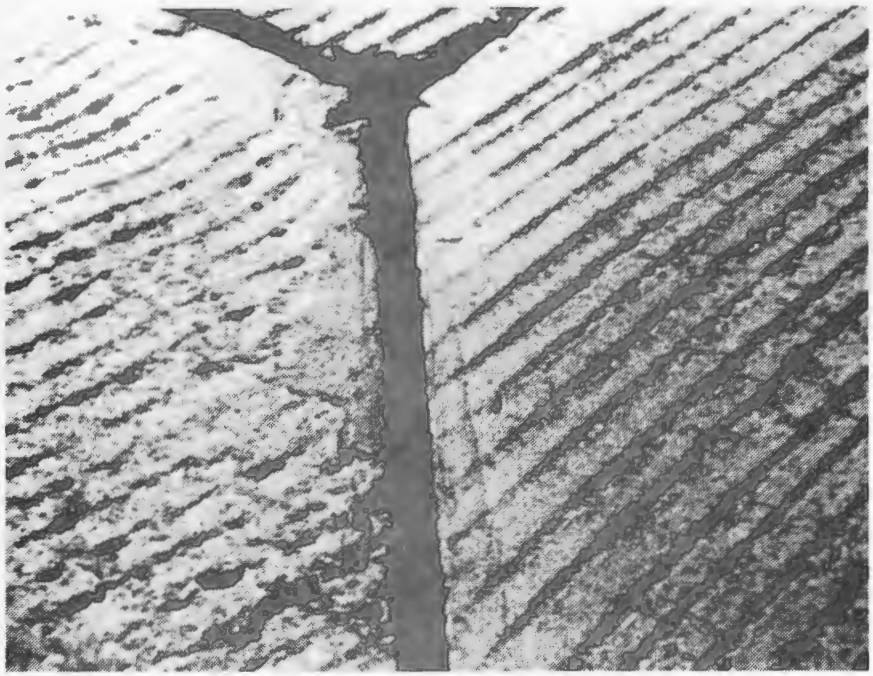
Cohesion loss occurs when the sealant material fails from tensile forces while maintaining a bond between the sealant and joint wall (Figure 6). This type of defect can be caused by inadequate material and an improper shape factor (depth/width ratio) for the material (References 7, 10). Cohesion failure was found in every area of the airports surveyed. Research has found that elastomeric low modulus silicone and elastomeric sealants need different shape factors to lower the stresses in the sealant. The shape factor for the sealant material, if too large, can induce increased stresses in the sealant and lead to cohesion failure. The material capabilities may also be inadequate for the required joint movement, regardless of the shape factor, if the maximum allowable strain for the material is exceeded.

FIGURE 6. COHESION LOSS OF JOINT SEAL AT ATLANTA HARTSFIELD INTERNATIONAL AIRPORT.

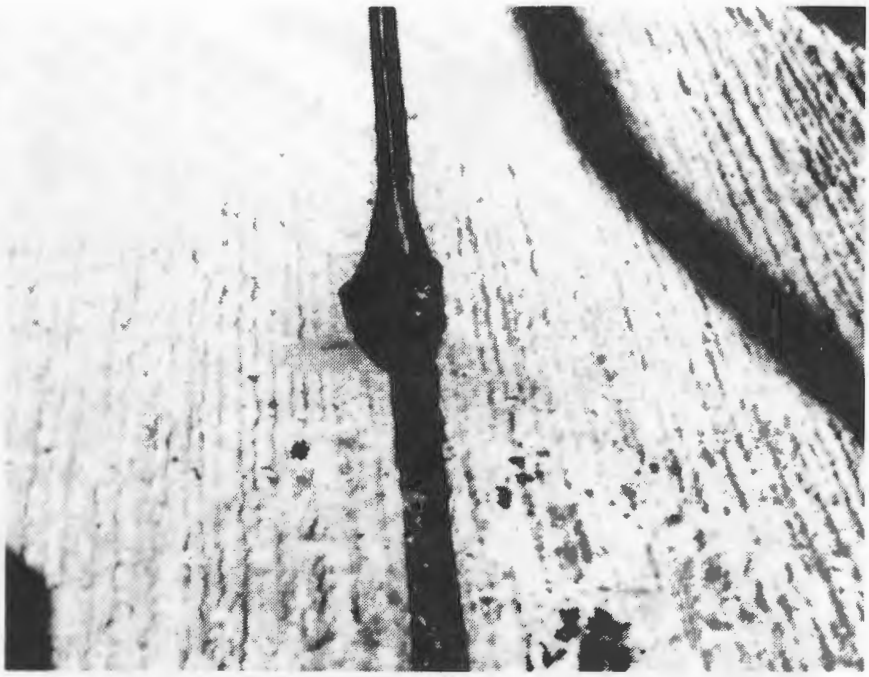
Compression set in a preformed compression seal occurs when it loses its resiliency and permanently retains its deformed shape. Figure 8 shows an example of a preformed seal with compression set. Such a seal can no longer expand as a joint increases in width and the seal against the joint walls is lost. This allows water and incompressibles to enter the joint which can result in damage to the pavement system. This defect is probably caused by poor seal material or poor adhesive/lubricant. (An adhesive/lubricant is used to aid installation of the seal and adhesion.)

FIGURE 8. COMPRESSION SET OF PREFORMED COMPRESSION SEAL AT ATLANTA HARTSFIELD INTERNATIONAL AIRPORT.
