Report No. FAA-RD-71-75

# AN INVESTIGATION OF METHODS TO CONTROL POST-CRASH FUEL SPILL FROM INTEGRAL FUEL TANKS

DECEMBER 1971

FINAL REPORT

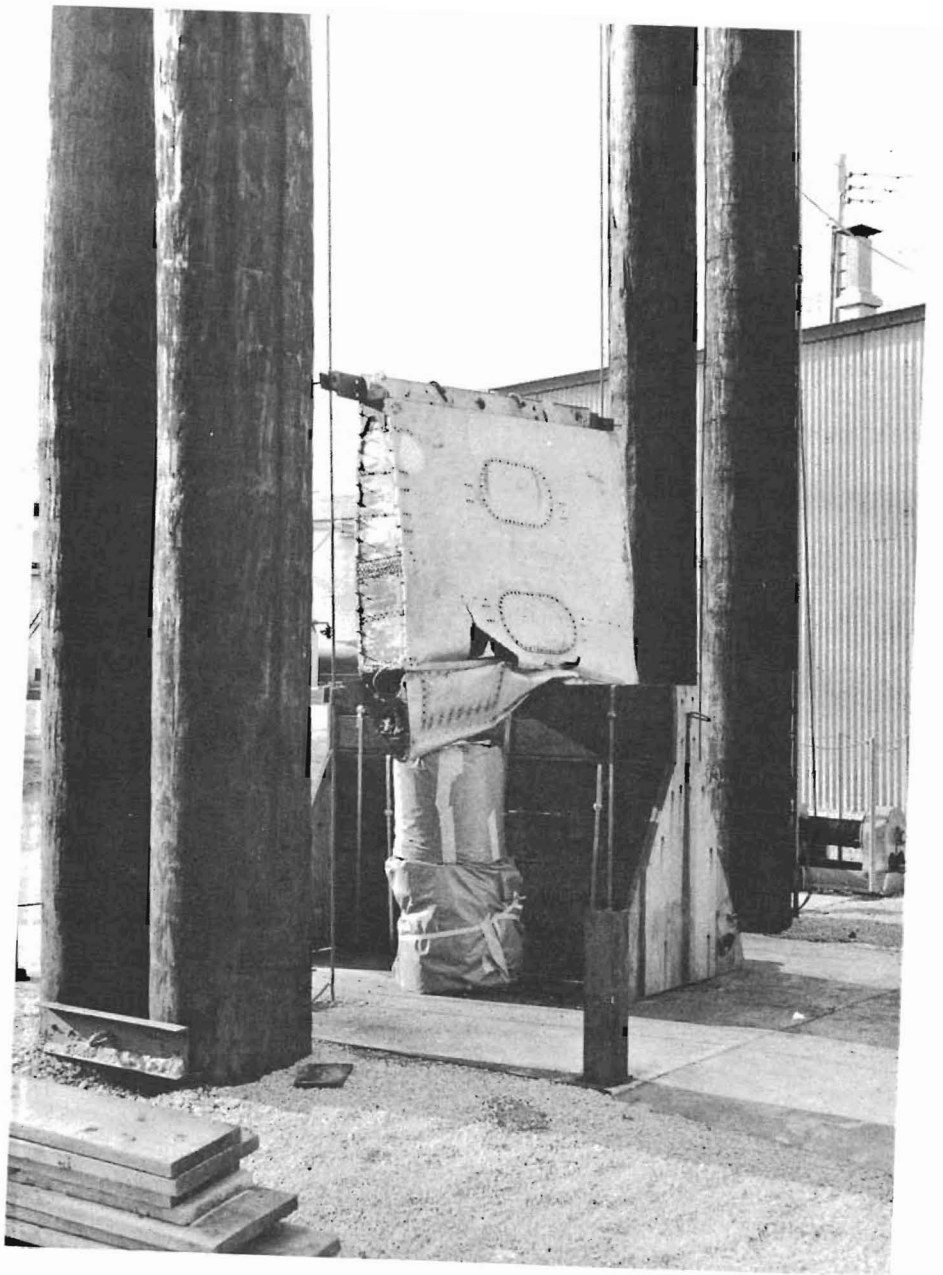
FIGURE 2 DROP TOWER BUCKLING TEST ON DC-7 WING TANK SECTION

Buckling Test - The buckling test was conducted on the simulated wing sections with a 15-foot drop and on the aircraft wing sections with a 40-foot drop. The buckling obstacle was a vertical stack of railroad ties approximately 7 inches wide. Crushable corrugated fiberboard columns were used each side of the obstacle to limit penetration to approximately one-half the depth of the forward fuel cavity. Guide plates were attached to the forward and trailing edges of the test sections and to the vertical cables to insure impact at the approximate center and at an angle of 90° to the front spar of the wing section and to the forward surface of the simulated wing section. See Figures 2 and 3.

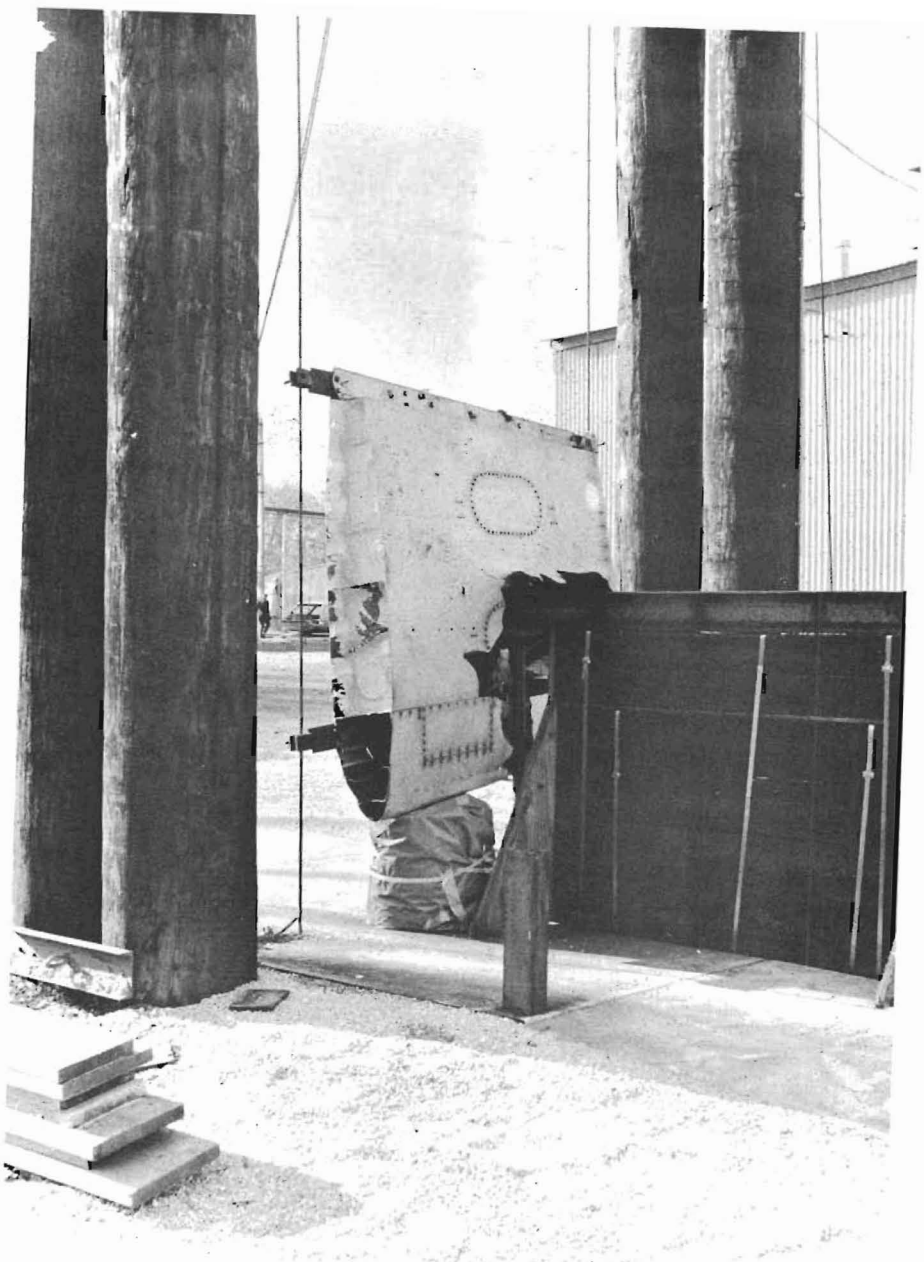
FIGURE 4 DROP TOWER SLASHING TEST ON DC-7 WING TANK SECTION

Slashing Test - The slashing test was conducted on the aircraft wing sections only. The drop height was 20 feet. The slashing obstacle is the buckling obstacle with a 4-inch "I" beam attached to the top and extending beyond the end of the ties approximately 12 inches. The guide plates were attached to the wing so as to insure impact at the center lower half of the leading edge. Impact was normal to the wing bottom causing slashing of the wing bottom one-half to two-thirds the depth of the forward fuel tank. Depth of penetration was controlled by corrugated fiberboard columns located each side of the impact obstacle. See Figures 4 and 5.

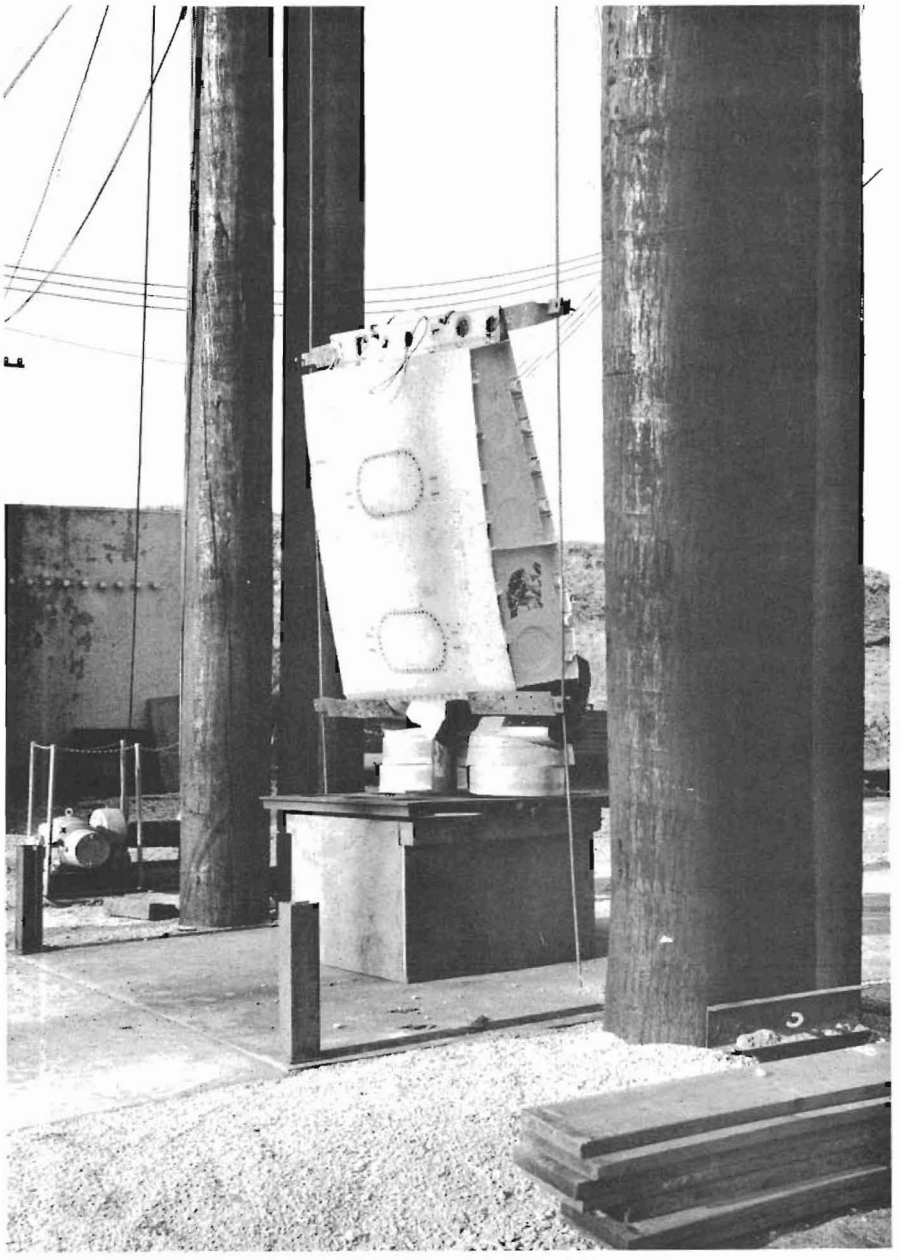
FIGURE 6 DROP TOWER PENETRATION ON DC-7 WING TANK SECTION

Penetration Test - The penetration test was conducted on the simulated wing sections with a 10 foot drop and on the aircraft wing sections with a 20 foot drop. The penetration obstacle was a 22-inch length of 4-inch pipe welded to a base plate and having a 2½-inch pipe placed inside and extending 7 inches above the 4-inch pipe. Guide plates were attached to the wing section so as to cause impact to occur on an axis extending through the front lower edge and the aft upper edge of the fuel cavity. The DC-7 wing tank sections had an impact angle of approximately 75° so that the penetrating obstacle fractured the lower forward wing spar before entering the fuel cavity. However, because of the comparatively small size of the simulated wing sections, the impact angle was set at 90° to the forward surface to insure impact and penetration. Corrugated fiberboard columns were used to limit penetration damage to the forward fuel cavity only. See Figures 6 and 7.

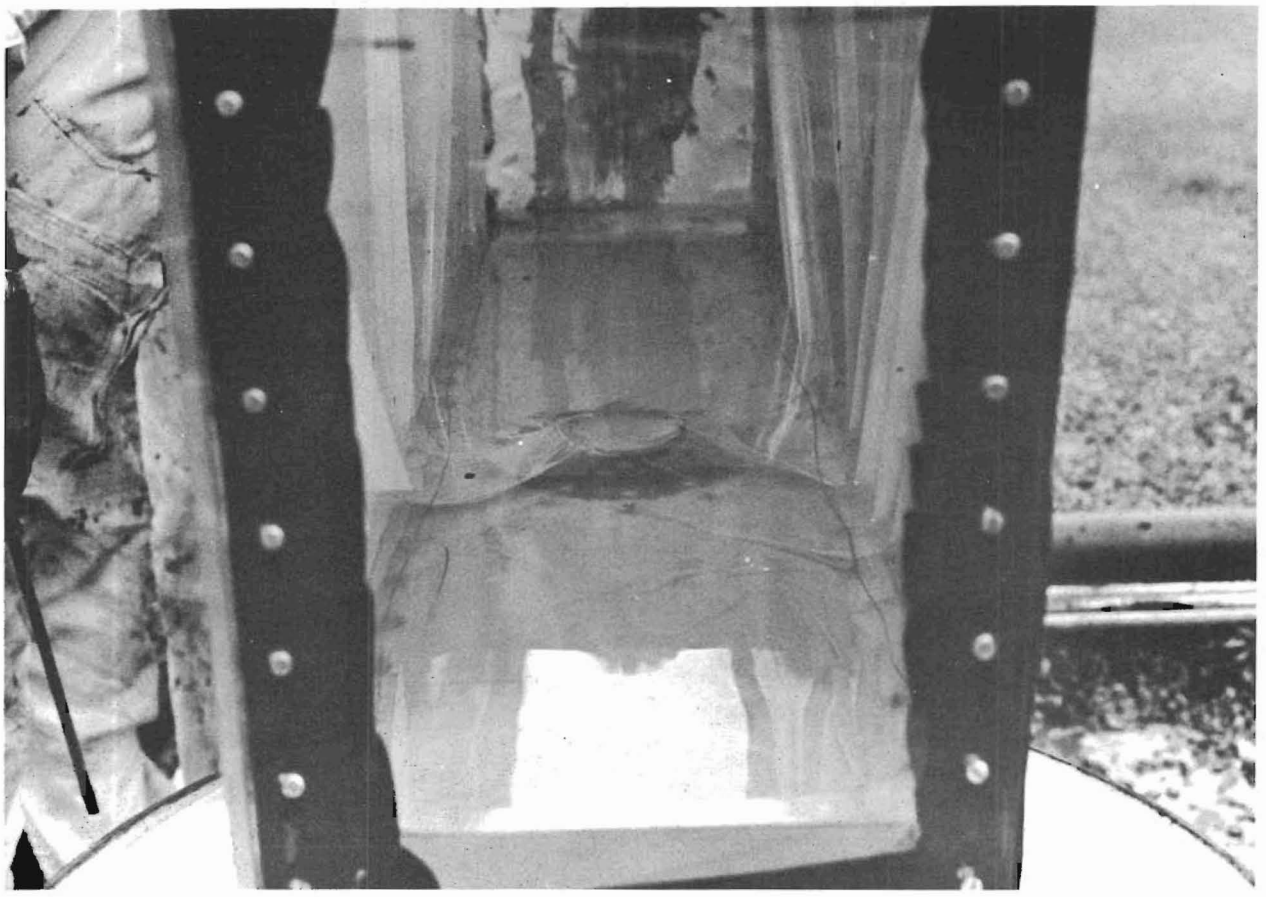
FIGURE 10 FUEL FLOW TEST SHOWING CURTAIN POSITION AFTER SUBSTANTIAL LOSS OF FLUID

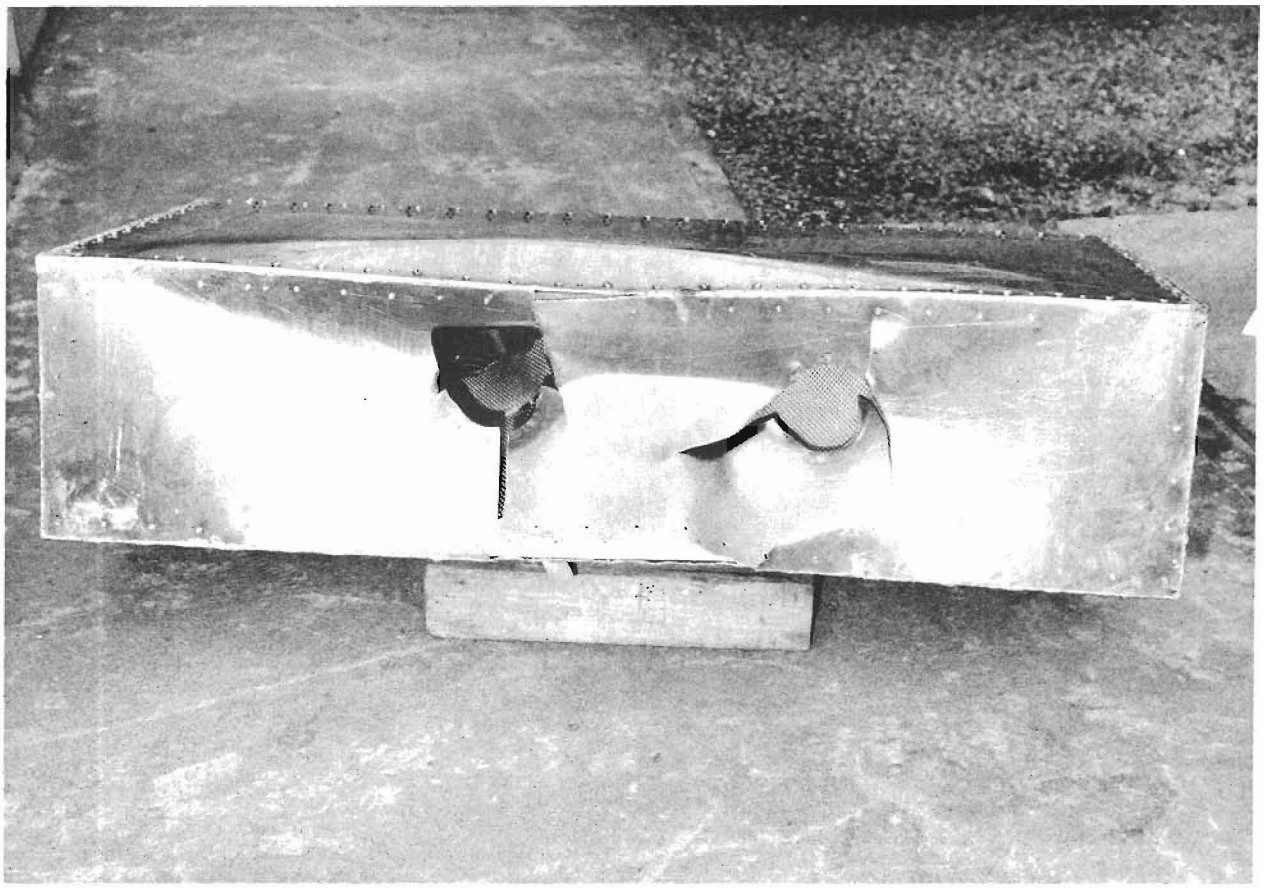
FIGURE 13 PENETRATION TEST ON SIMULATED WING SECTION (OUTSIDE VIEW)

Penetration Test - The pipe penetrated the structure but did not pierce the liner. There was no loss of test fluid. The test structure was dropped a second time with impact occurring approximately 12 inches from the first impact area. Depth of penetration was deeper than the previous drop. There was no damage to the liner in the area of the second impact; however, a jagged piece of structure at the original impact area cut the fabric and the liner (2-inch cut). Fluid loss on the second drop was 6 gpm. A 4-inch diameter hole was punched in the structure on the first drop and a 5-inch diameter hole on the second drop. The welded seams, top and bottom edge of the leading surface, failed between the two impact areas during the second drop. Instrumentation recorded 15 G's during both drop tests. Figures 13 and 14 show the results of the above penetration test performed on a structure with the leading surface fairing removed and seams welded.

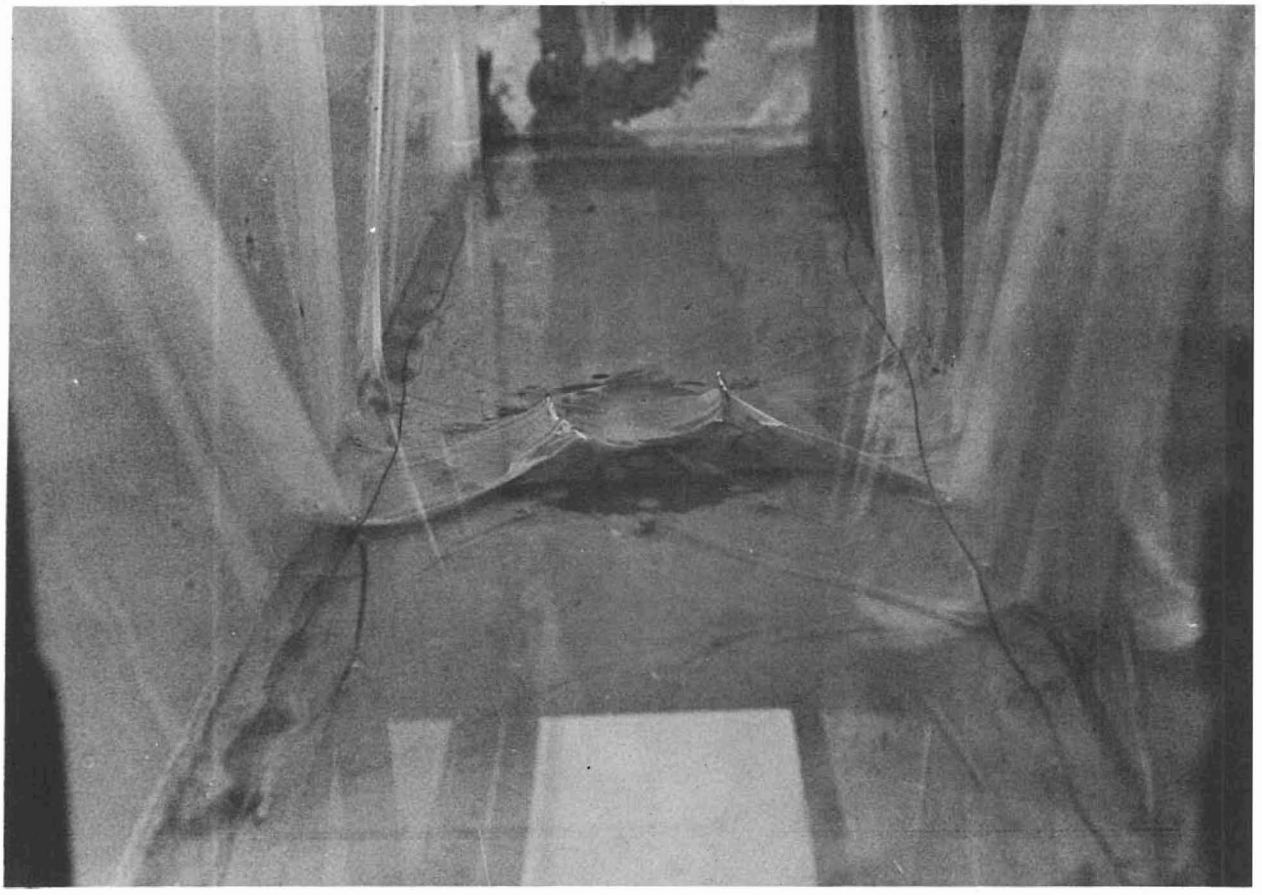
A second 0.002-inch thick polyethylene film was installed as before and the curtain positioned so as to lay relatively close to the front, bottom, and top surface of the structure. Position was maintained by securing the top and bottom leading edges with piano wire across the full width of the tank. Upon release of the quick disconnect there was full flow for approximately 2 minutes and 30 percent flow for an additional 2 minutes. Figure 15 shows the curtain in position over the wound, also shown are the piano wires used to maintain curtain position prior to test.

FIGURE 15 FUEL FLOW TEST SHOWING CURTAIN IN POSITION OVER WOUND

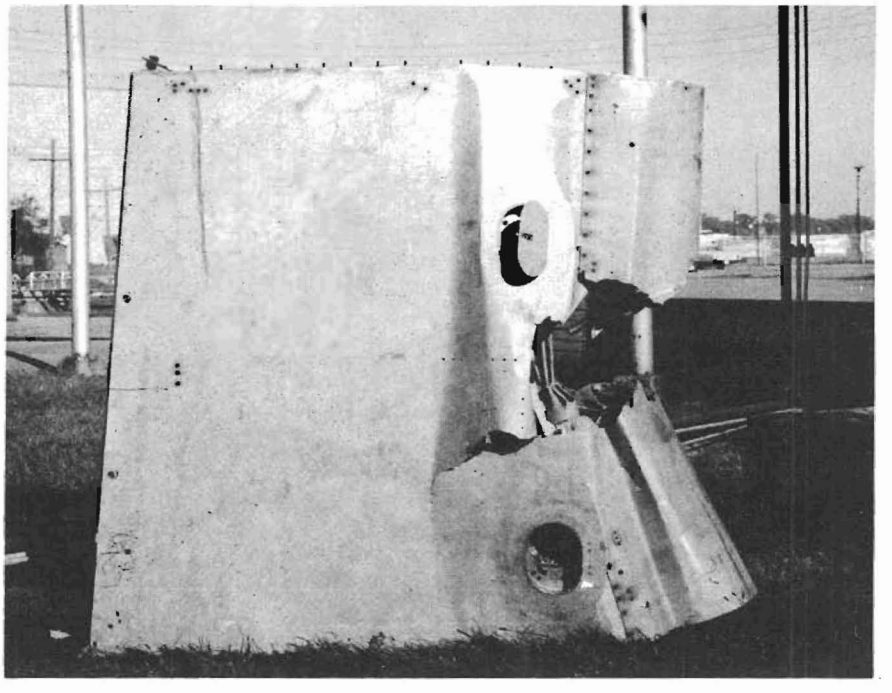
| Test No. | Obstacle | Containment Method No. | Rate of Fluid Loss | Splash Distance | Weight Empty | G's | Comments |
|---|---|---|---|---|---|---|---|
| 1 | Buckling | Control | 102 gpm | - | 190 lb. | 350 | The wing section impacted squarely on the obstacle. The lower skin fractured loose from the forward edge of the tank 26 inches from the impact point on one side and 12 inches on the other side. The obstacle penetrated 7 inches beyond the forward wing spar. The top skin split open approximately 20 inches each side of a 14-inch opening made by the obstacle. The top skin split 19 inches back from the forward wing spar. The upper two-thirds of the forward wing spar fractured at the point of impact. |

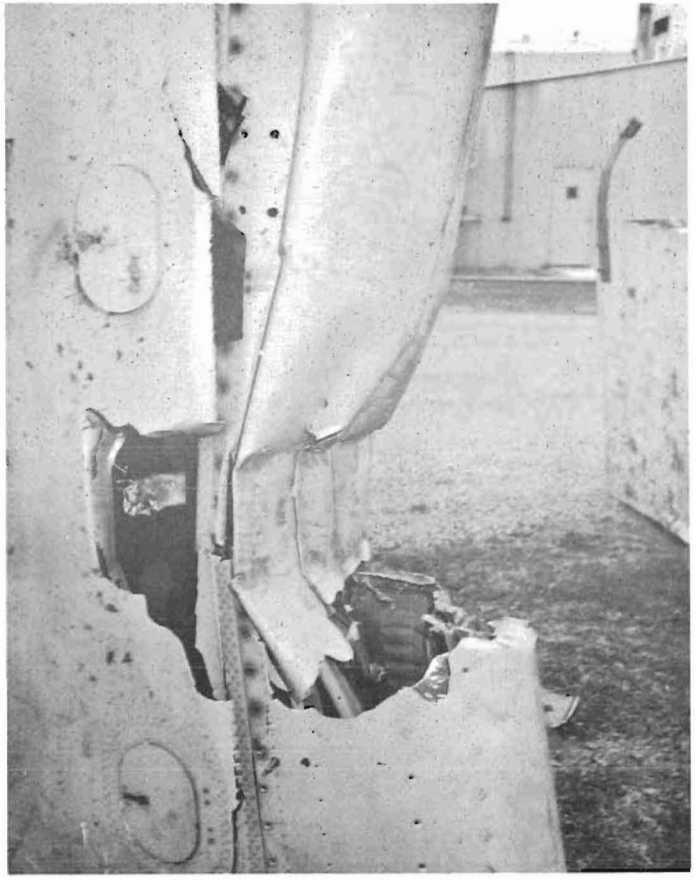
Containment Method No 2

| Test No. | Obstacle | Containment Method No. | Rate of Fluid Loss | Splash Distance | Weight Empty | G's | Comments |
|---|---|---|---|---|---|---|---|
| 2 | Buckling | 2 | See comments | | 190 lb. | 110 | The wing section impacted squarely on the obstacle. Fluid loss was rated as a heavy flow approximately 25 gpm during the first minute, and approximately 6 gpm during the second minute after impact. Thirty-six gallons of fluid remained in the tank. The lower skin had complete fracture from the forward spar. The center of the forward spar was pushed back 3 inches. The top skin split in the aft direction 15 inches from the forward spar at the center of the wing. There was no damage to the liner, with the exception of a 1/8-inch hole 4 inches down from the top of the liner in one side. The water splashed 19-1/2 feet perpendicular to the bottom side of the wing, and 17 feet perpendicular to the top side of the wing. |

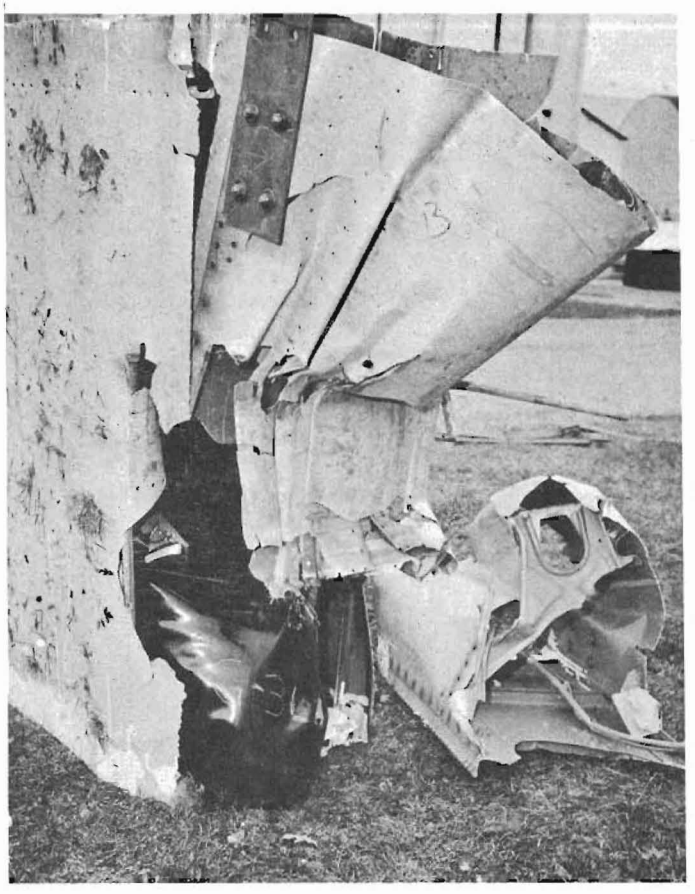
Containment Method No 3

| Test No. | Obstacle | Containment Method No. | Rate of Fluid Loss | Splash Distance | Weight Empty | G's | Comments |
|---|---|---|---|---|---|---|---|
| 3 | Buckling | 3 | 408 gpm | 25' | 180 lb. | 38 | The forward spar fractured at the center. The top and bottom wing surfaces broke loose at the forward spar. The upper wing surface had a 7 by 12-inch hole at the point of impact while the bottom skin had a 30-inch long opening to the fuel cavity at the spar. The curtain was torn at the forward spar dumping the test fluid. |

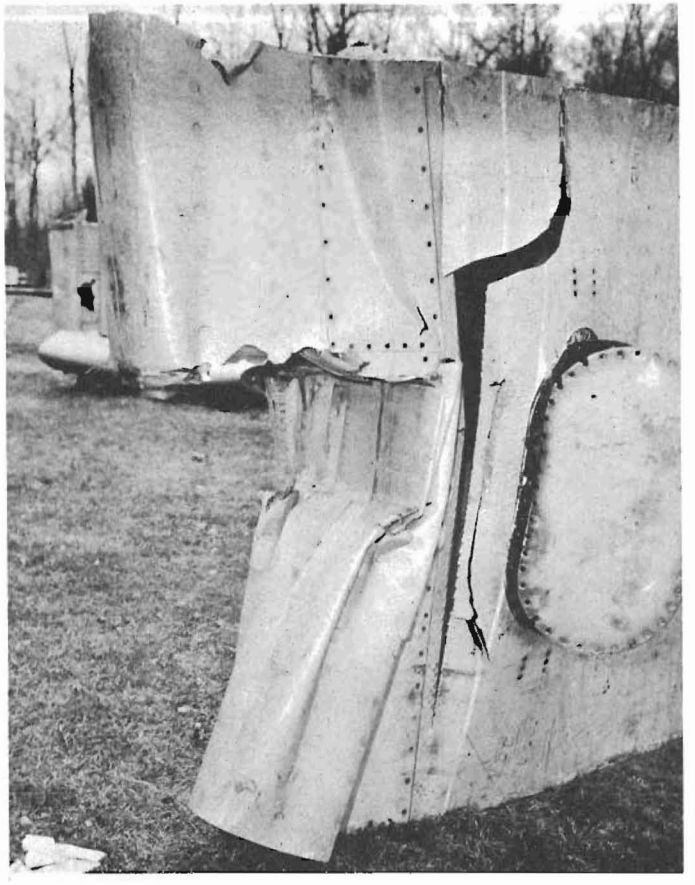
Containment Method No 4

| Test No. | Obstacle | Containment Method No. | Rate of Fluid Loss | Splash Distance | Weight Empty | G's | Comments |
|---|---|---|---|---|---|---|---|
| 4 | Buckling | 4 | 408 gpm | 32' | 260 lb. | 37 | The top and bottom wing surfaces were broken loose at the forward spar. One-half of the forward spar and leading edge were completely loose from the remainder of the wing. The liner had two 2-inch diameter holes and one 3/4-inch diameter hole in the impact area. The end of the liner was torn out on the end where the spar and leading edge were torn away. |

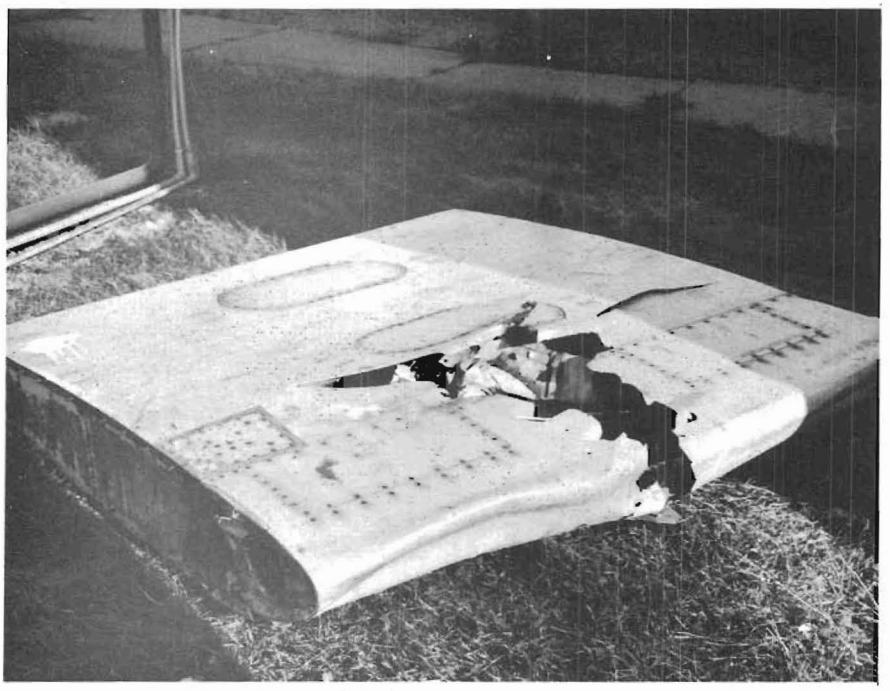
| Test No. | Obstacle | Containment Method No. | Rate of Fluid Loss | Splash Distance | Weight Empty | G's | Comments |
|---|---|---|---|---|---|---|---|
| 6 | Slashing | Control | 185 gpm | - | 190 lb. | 170 | The wing section lower edge impacted the I-beam which sliced to 8 inches behind the forward wing spar. A 10 by 17-inch section of the wing spar was pushed in. The lower wing skin had a 4 foot tear. The forward access door frame was broken, and the door had 10-inch and 9-inch tears. |

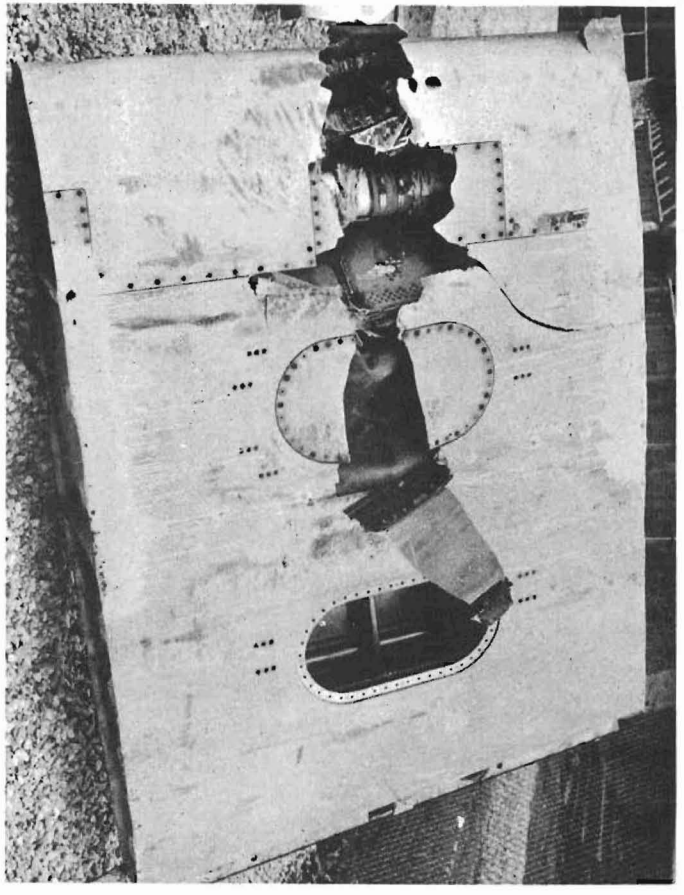
Containment Method No 2

| Test No. | Obstacle | Containment Method No. | Rate of Fluid Loss | Splash Distance | Weight Empty | G's | Comments |
|---|---|---|---|---|---|---|---|
| 7 | Slashing | 2 | See comments | 25' | 190 lb. | 78 | The wing section lower edge impacted the I-beam which sliced a tear 20 inches long by 4-9 inches wide in the tank section of the wing. The forward spar had complete fractures in two places. The liner had a 3/4-inch tear in the lower forward edge. Rate of fluid loss was approx 20 gpm for the first 45 secs., 6 gpm for the next 1.5 minutes, diminishing to .25 gpm thereafter. Thirty-eight gallons of water remained in the tank after 5 min. |

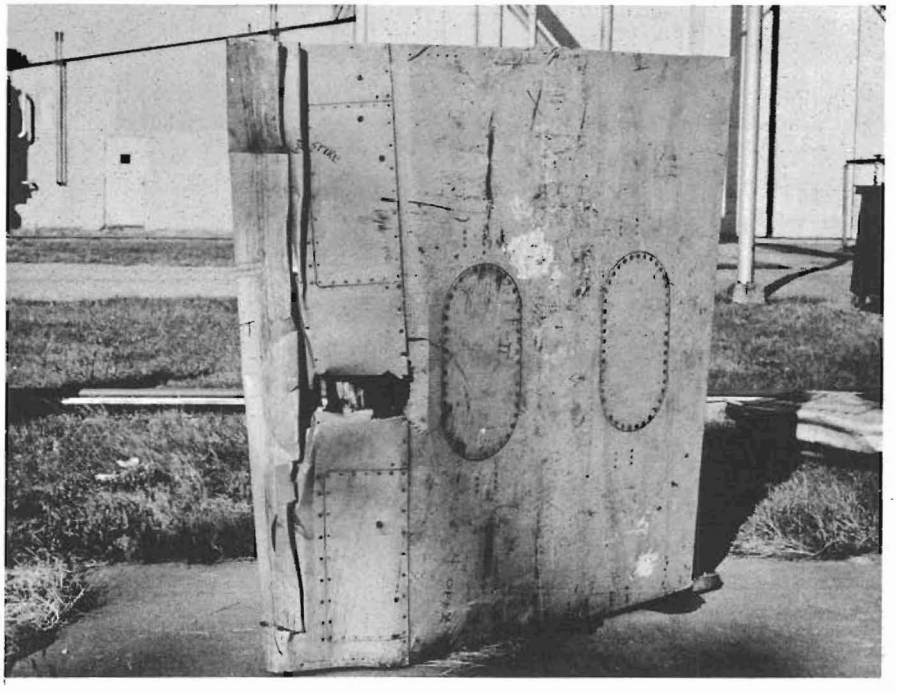
| Test No. | Obstacle | Containment Method No. | Rate of Fluid Loss | Splash Distance | Weight Empty | G's | Comments |
|---|---|---|---|---|---|---|---|
| 11 | Penetration | Control | 163 gpm | - | 190 lb. | 100 | The wing section impacted the obstacle 4 inches below the wing centerline. There was a 4 by 7-inch hole at the impact point. The forward spar fractured the full length adjacent to the lower wing surface. The lower skin pulled loose 12 inches at the side on the forward corner of the tank. The top of the nose fairing broke loose along the entire length of its joint to the tank. |

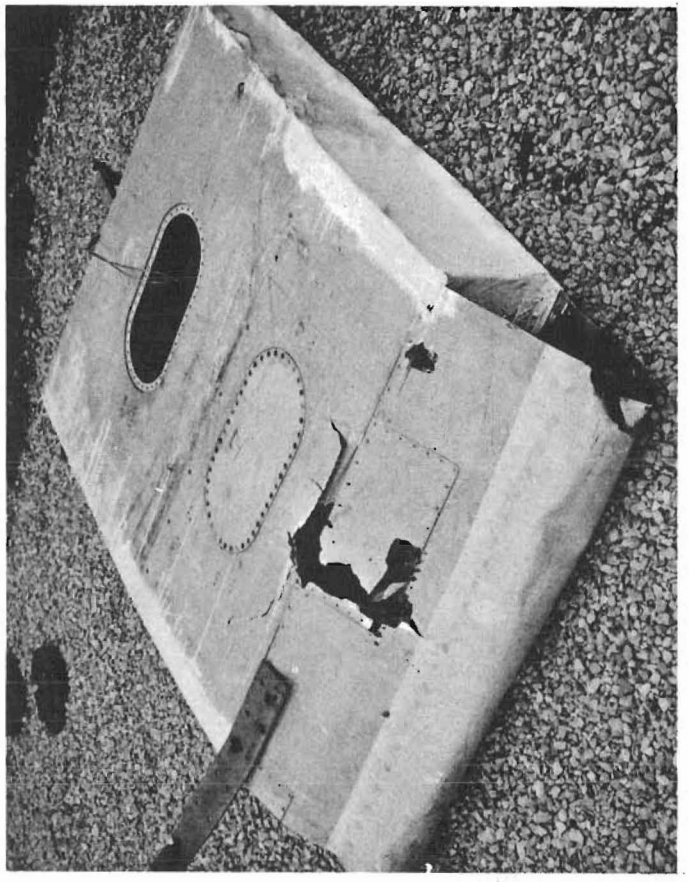
Containment Method No 2

| Test No. | Obstacle | Containment Method No. | Rate of Fluid Loss | Splash Distance | Weight Empty | G's | Comments |
|---|---|---|---|---|---|---|---|
| 12 | Penetration | 2 | See comments | 12' | 190 lb. | 123 | The wing section impacted the obstacle 3 inches back from the leading edge of the wing on the underside. There was a 9 by 12-inch hole at the impact point. There was an 18-inch tear at the bottom of the main spar with additional skin cracks for a total length of 27 inches. There was an 11-inch vertical tear in the forward spar. Approximately 43 gallons of test fluid were dumped within .5 minutes. No additional fluid loss occurred. 25 gallons of water were retained in the containment liner. There was a 4-inch abraded area on the cloth reinforcement, but no hole in the liner. |

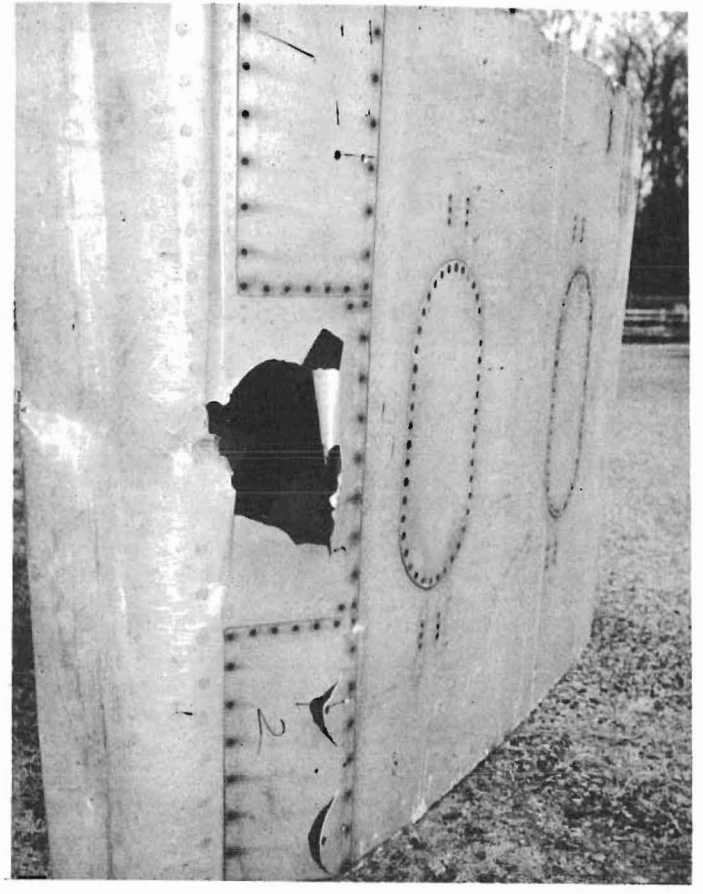
Containment Method No 3

| Test No. | Obstacle | Containment Method No. | Rate of Fluid Loss | Splash Distance | Weight Empty | G's | Comments |
|---|---|---|---|---|---|---|---|
| 13 | Penetration | 3 | 136 gpm | 21' | 230 lb. | 26 | The top surface of the wing broke loose adjacent to and forward of the front spar. A 7 x 10-inch hole was punched in the spar. A 12 by 12-inch "X" tear occurred in the curtain. |
