Report No. FAA-RD-72-83

WING LEADING EDGE FUEL TANK IMPACT TESTS

OCTOBER 1972

FINAL REPORT

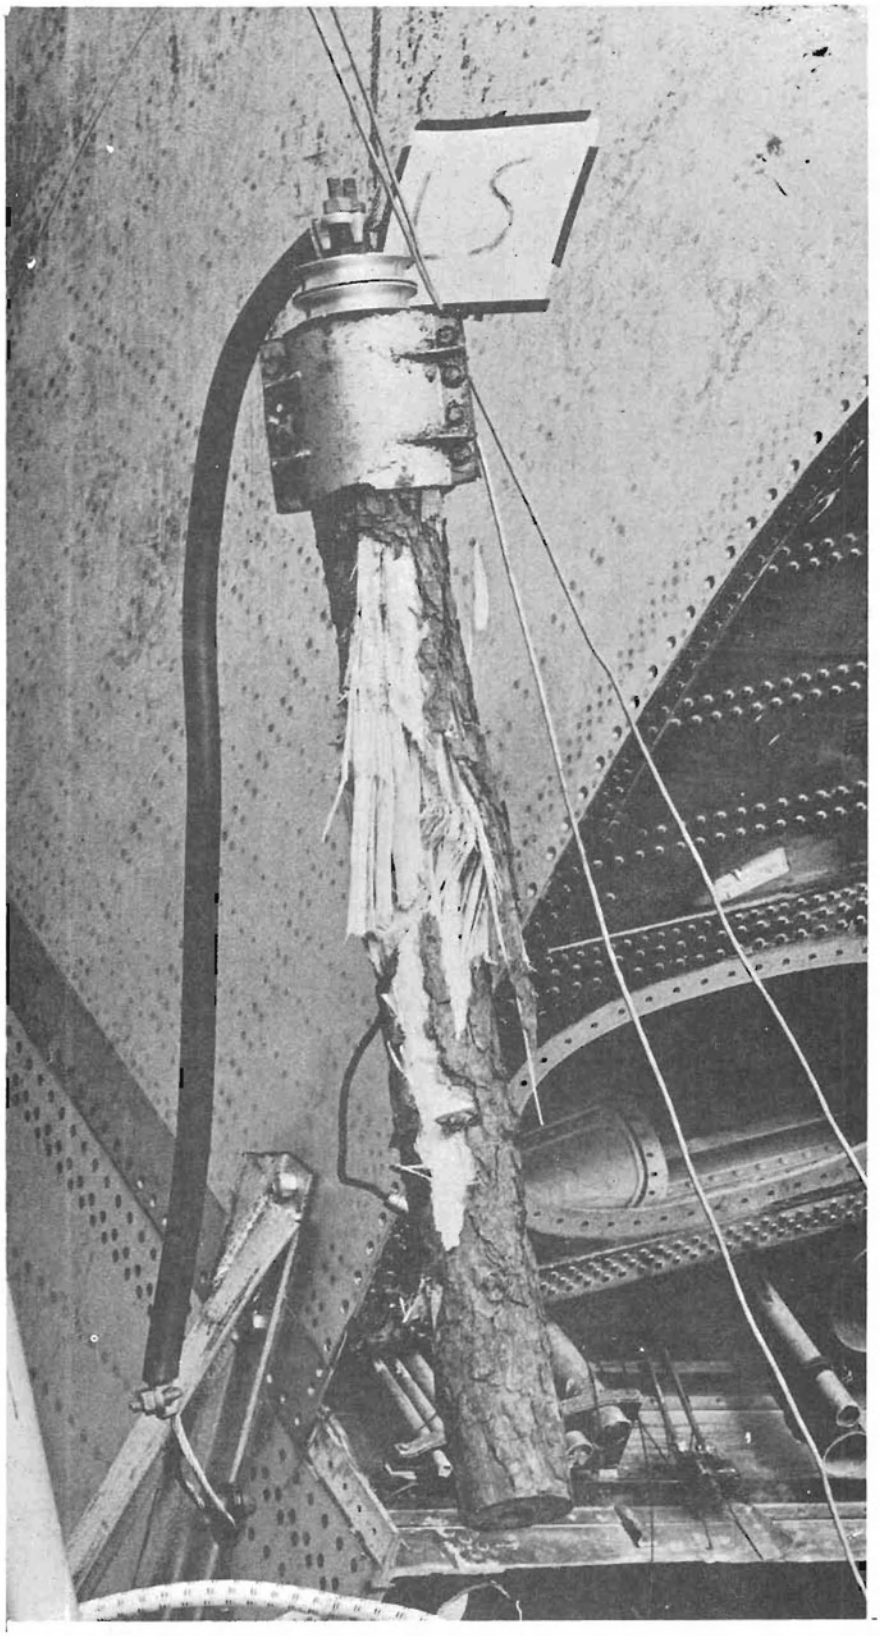
FIGURE 1. LOG FAILURE - TEST 2

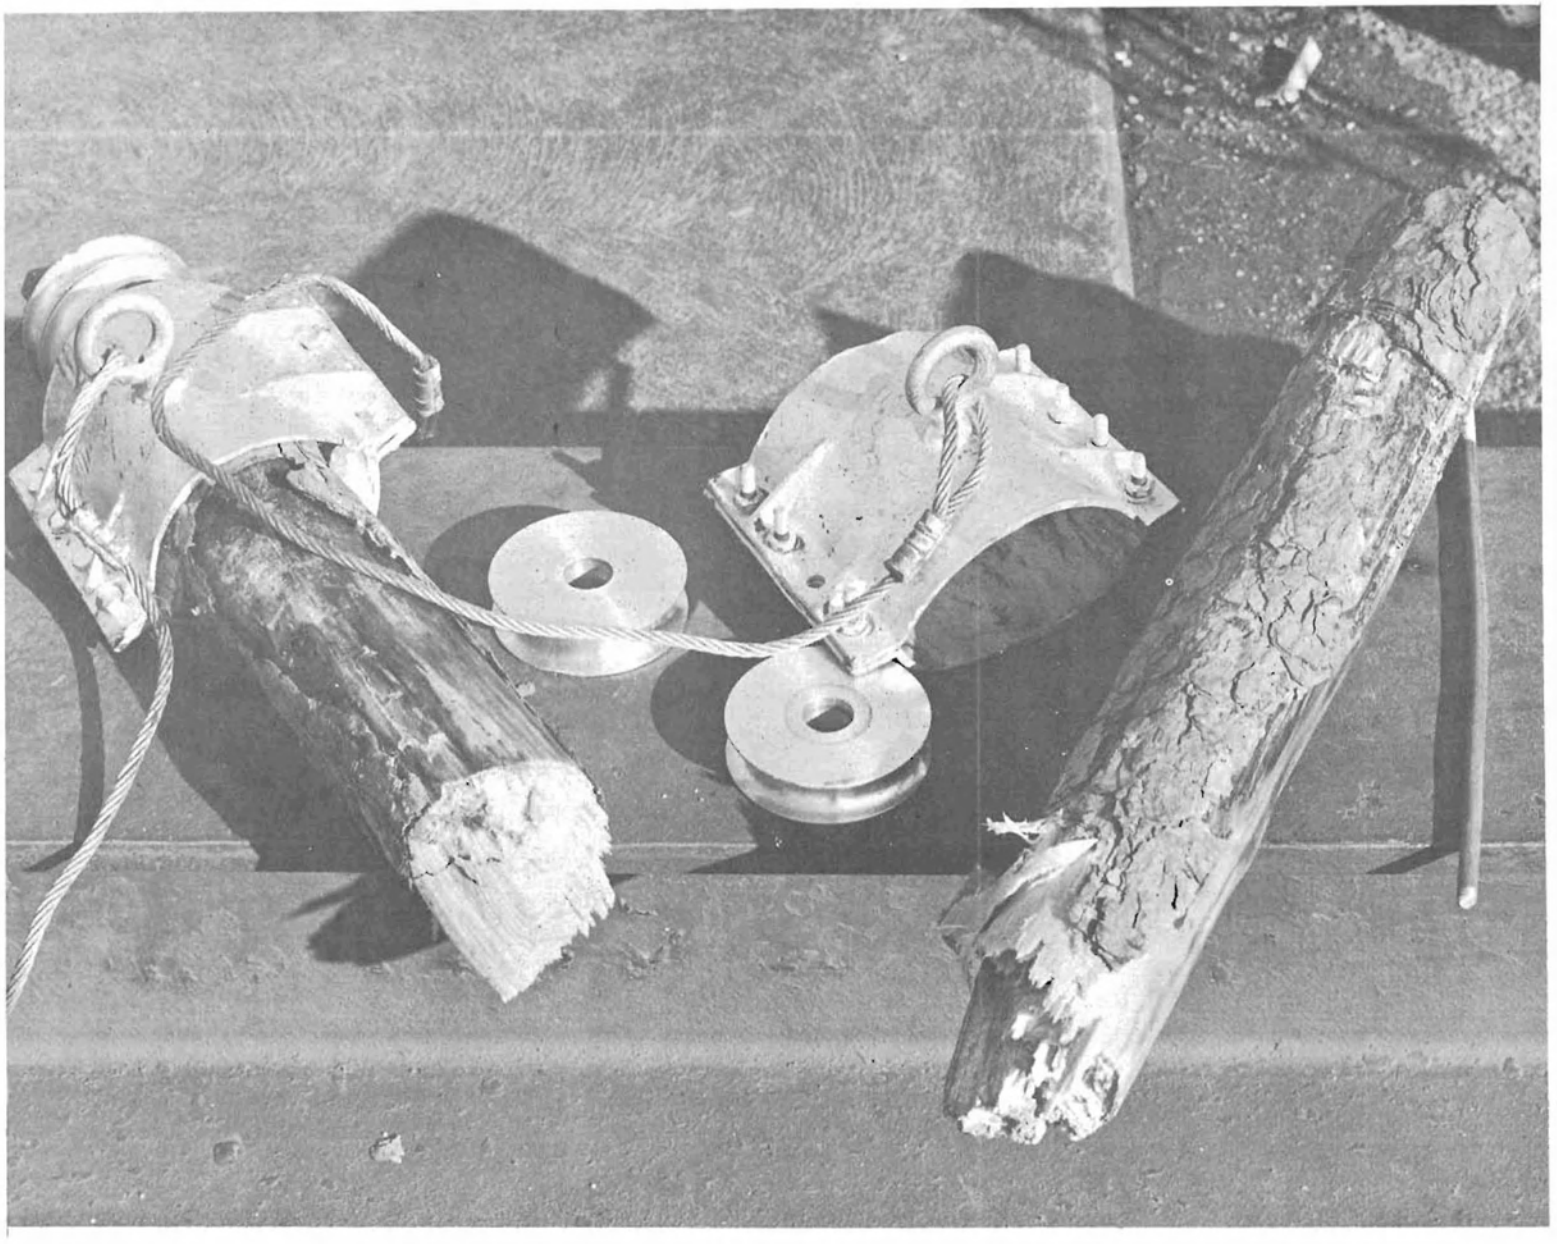
FIGURE 2. LOG FAILURE - TEST 4

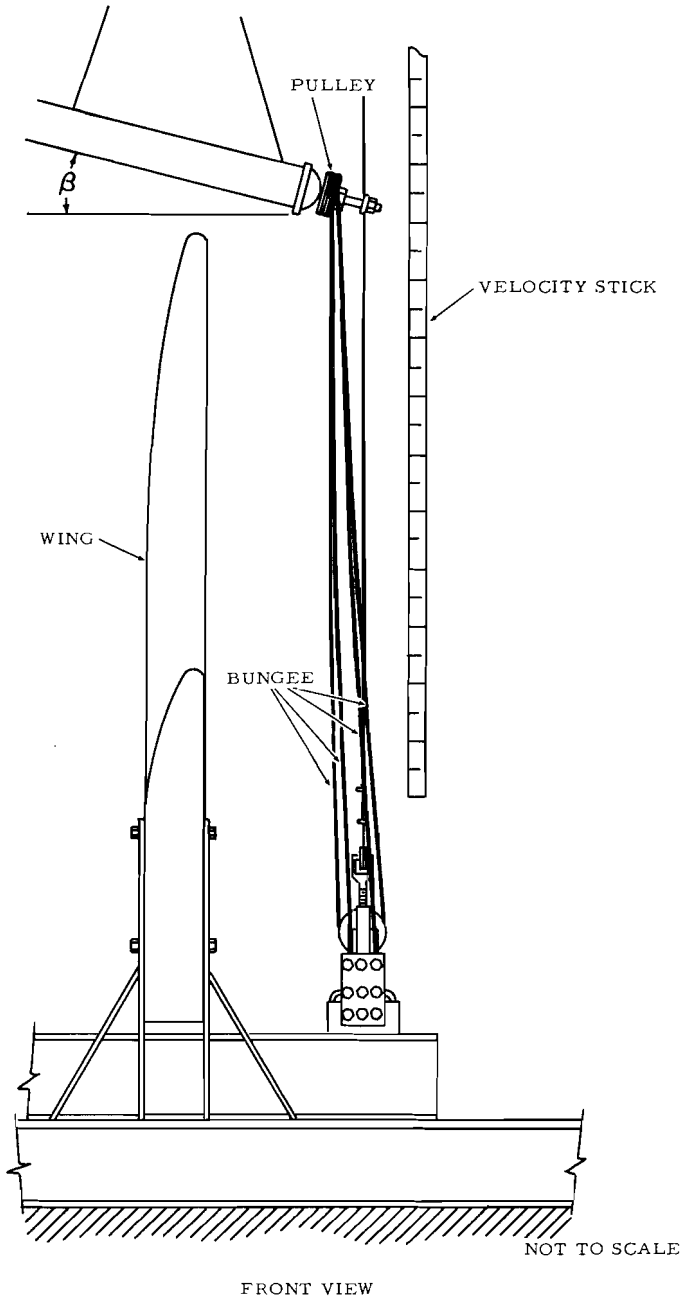
FIGURE 3. ANGLE OF IMPACT - ANGLE IRON TESTS

to consistently control its dimension and material specifications. However, the V-shaped cross section of the angle iron makes positive control at impact difficult. Referring to Figure 3, the angle of impact Ø, may vary causing inconsistent test results. The most acceptable test obstacle was the pipe which, because of its cylindrical shape and conformance to a material specification, would be expected to produce quite consistent test results. The pipe used in this test program caused severe damage at approximately 100 mi/h. If this were considered too severe, the wall thickness of the pipe could always be decreased while keeping the outside diameter the same, thus reducing the severity of the test. The wall thickness of the pipe used was 0.203 inch, but tubing with the same outside diameter is available in wall thicknesses ranging from 0.049 to 0.750 inch. Also the pipe can be procured in a variety of diameters. However, for the same dimensions and material specifications, the variations in strength would be minimal for equal lengths of pipe, thereby imparting the same impact load for the same impact speed.

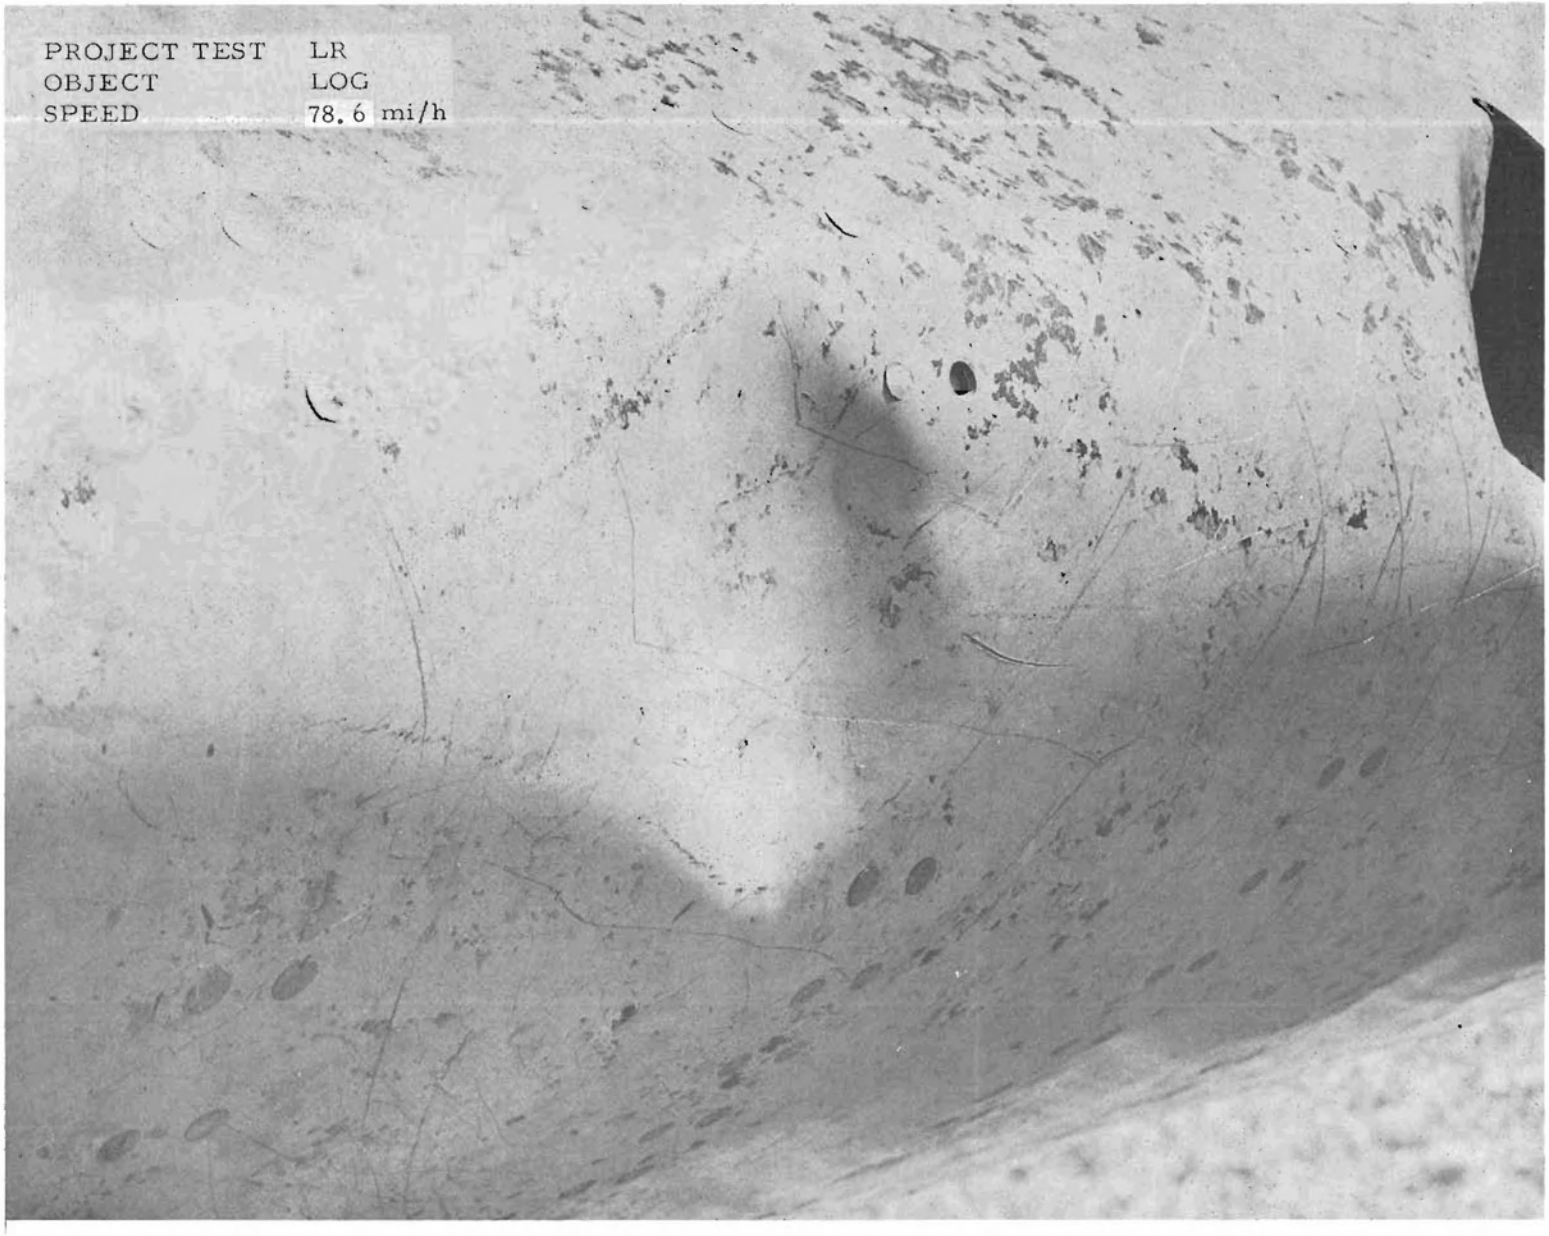
FIGURE 6. DAMAGE TO WING - TEST 1, 78.6 MI/H - LOG

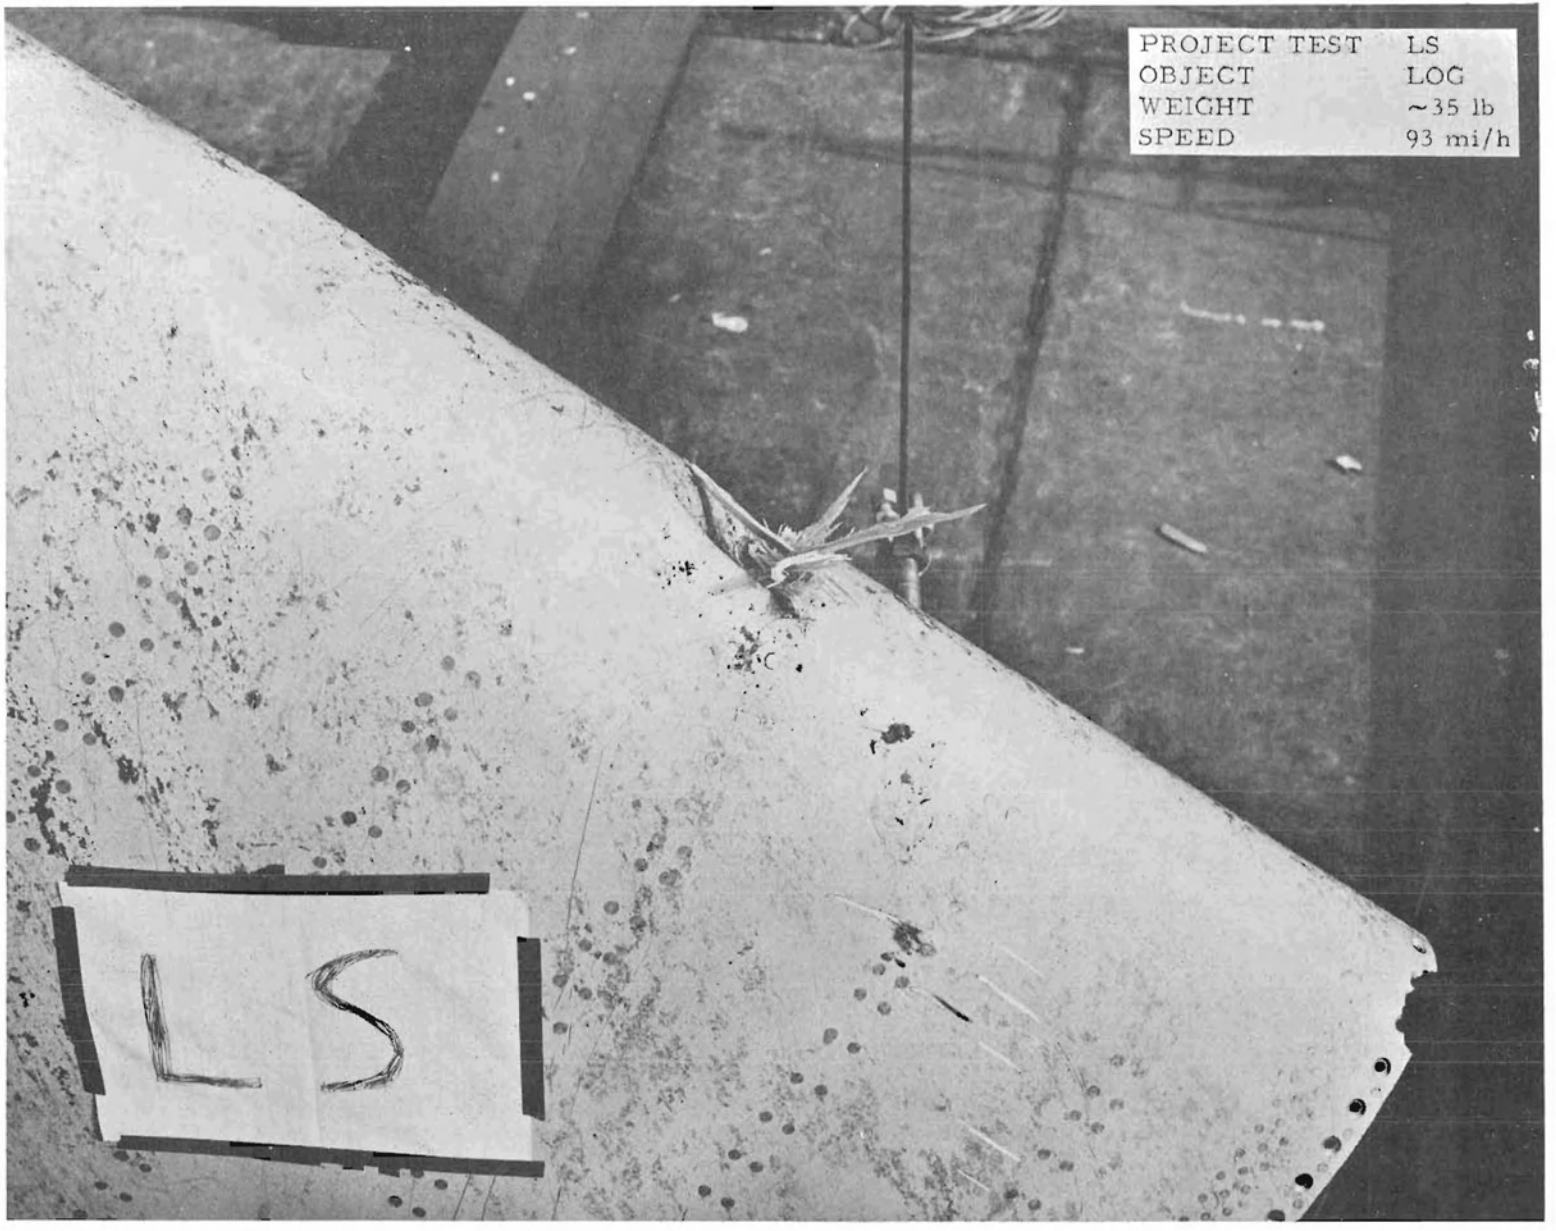
FIGURE 7. DAMAGE TO WING - TEST 2, 93.0 MI/H - LOG

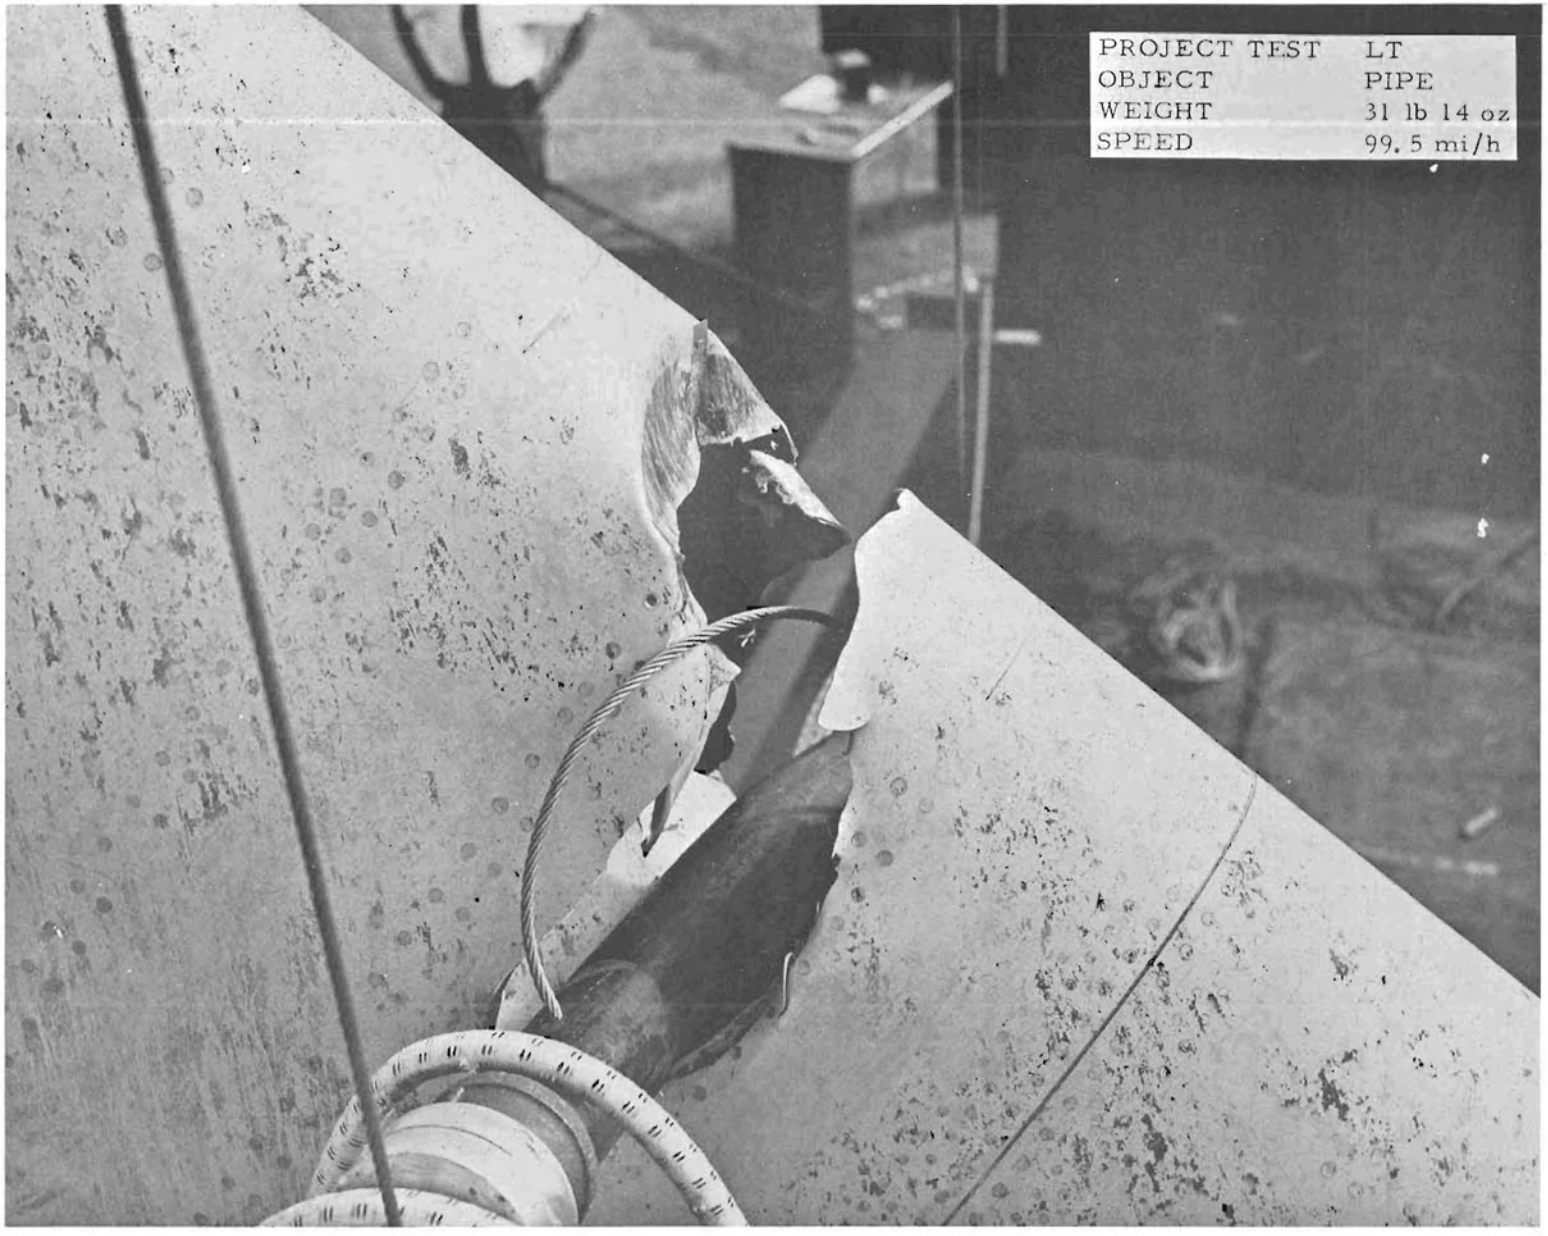
FIGURE 8. DAMAGE TO WING - TEST 3, 99.5 MI/H - PIPE

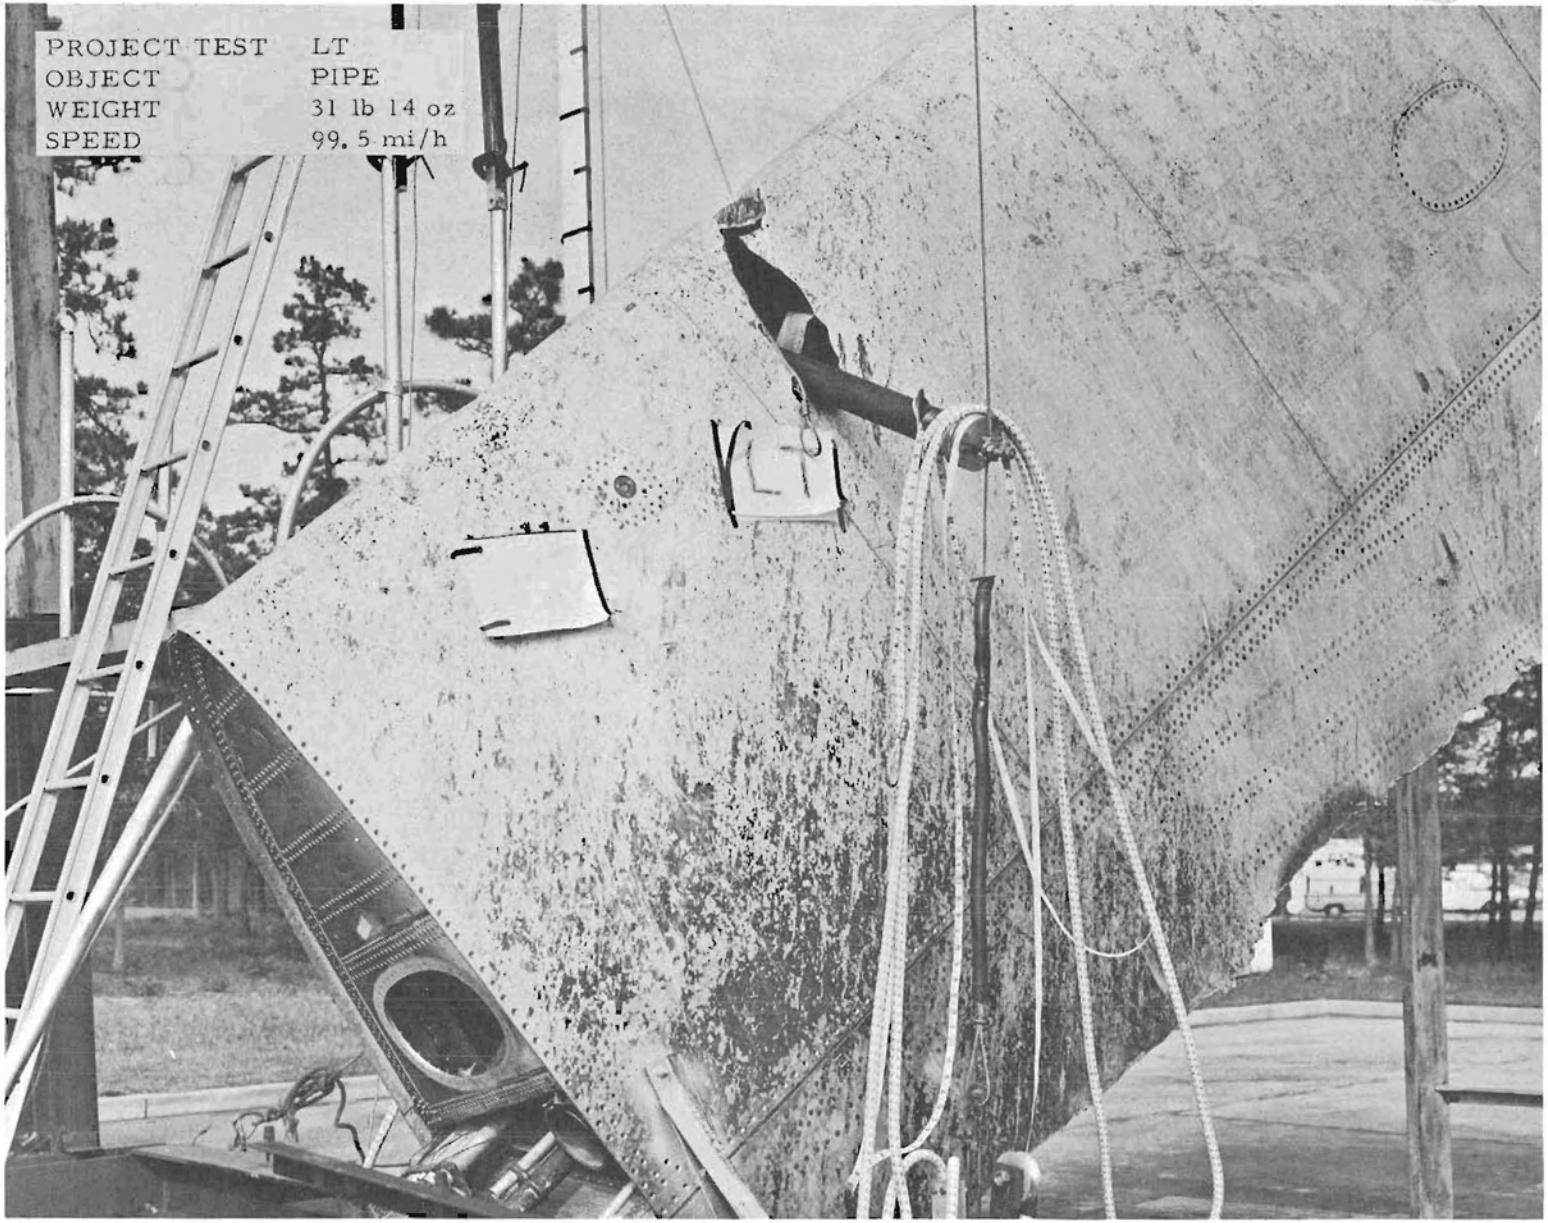
FIGURE 9. DAMAGE TO WING - TEST 3, 99.5 MI/H - PIPE

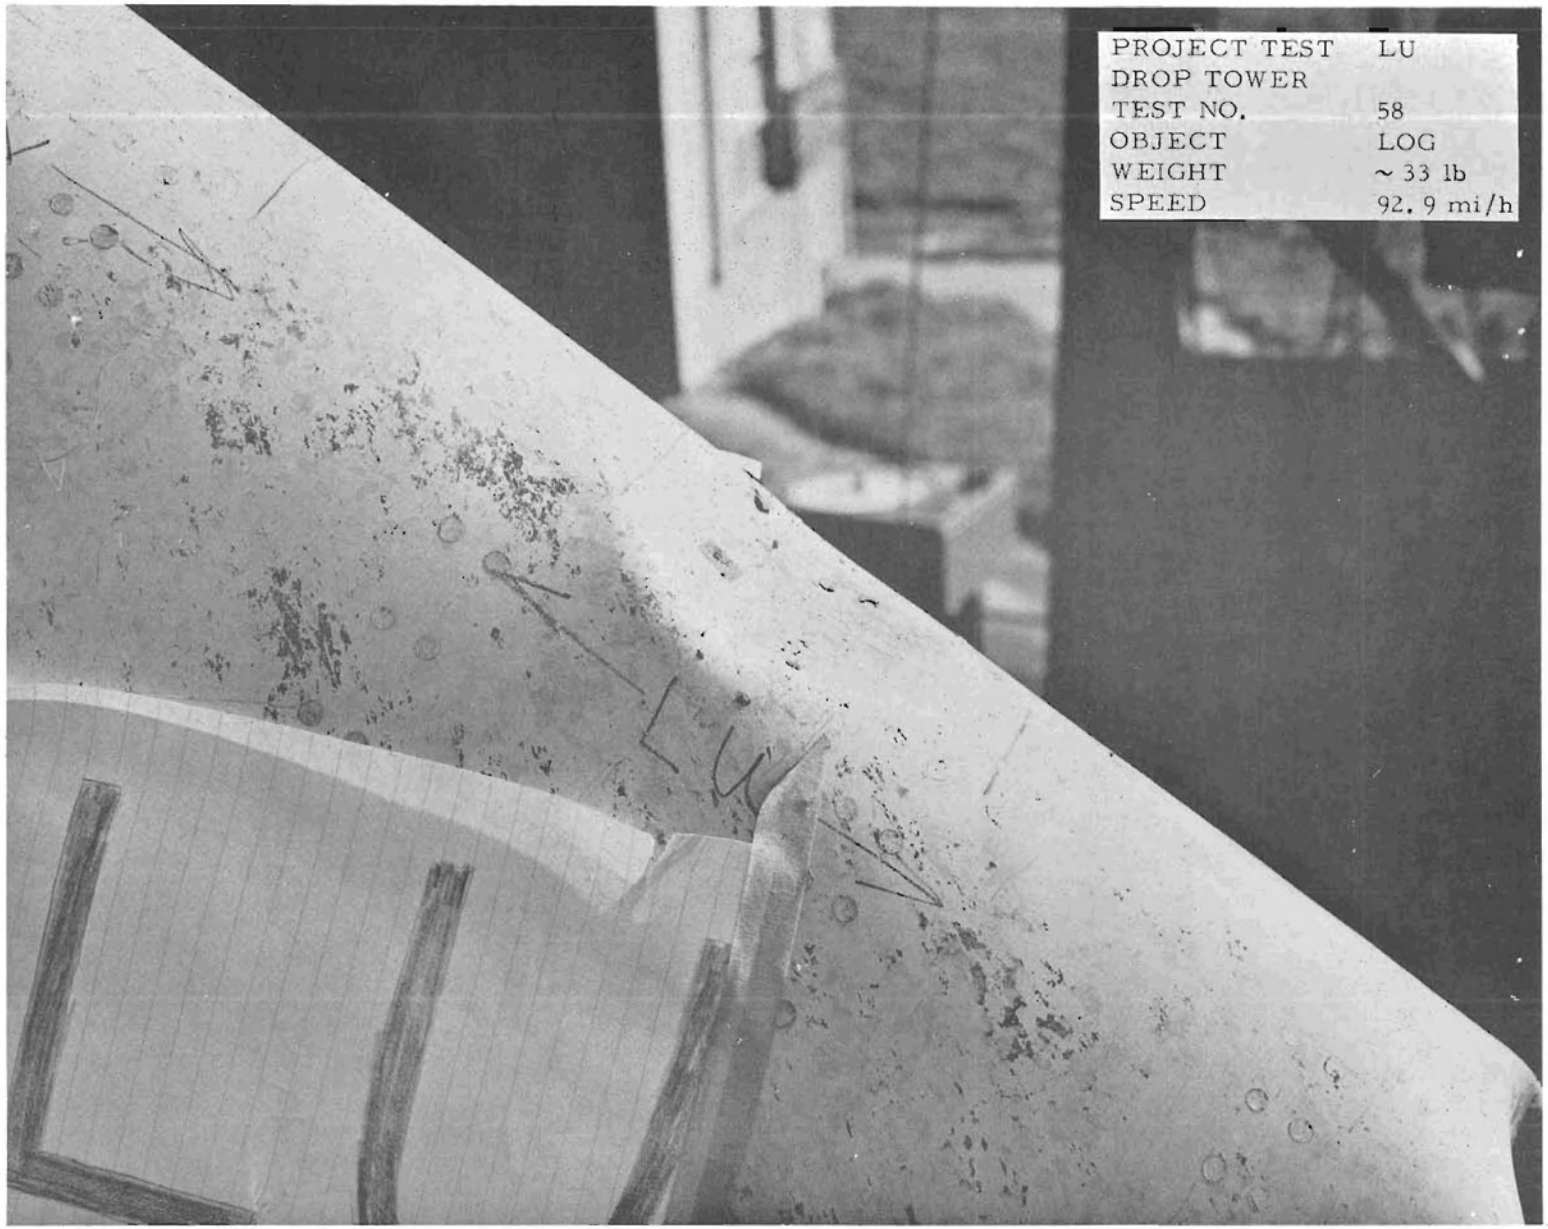
FIGURE 10. DAMAGE TO WING - TEST 4, 92.9 MI/H - LOG

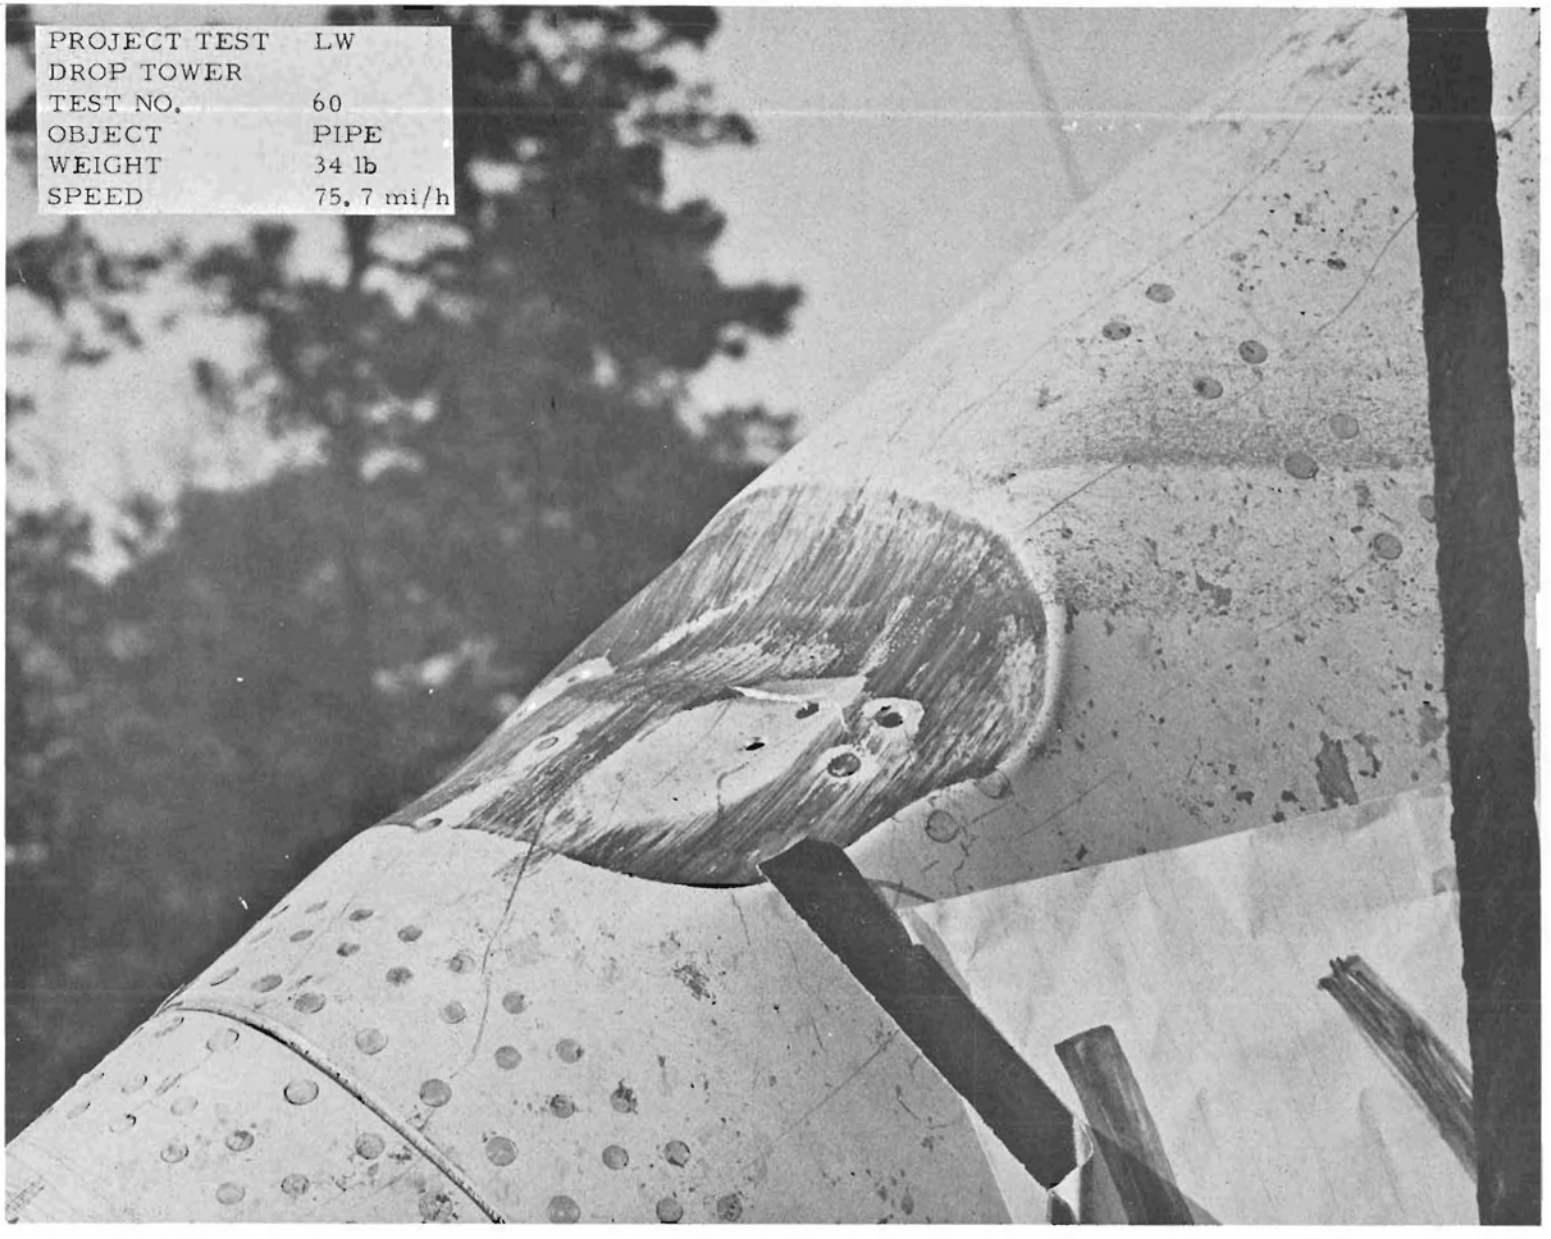
FIGURE 12. DAMAGE TO WING - TEST 6, 75.7 MI/H - PIPE

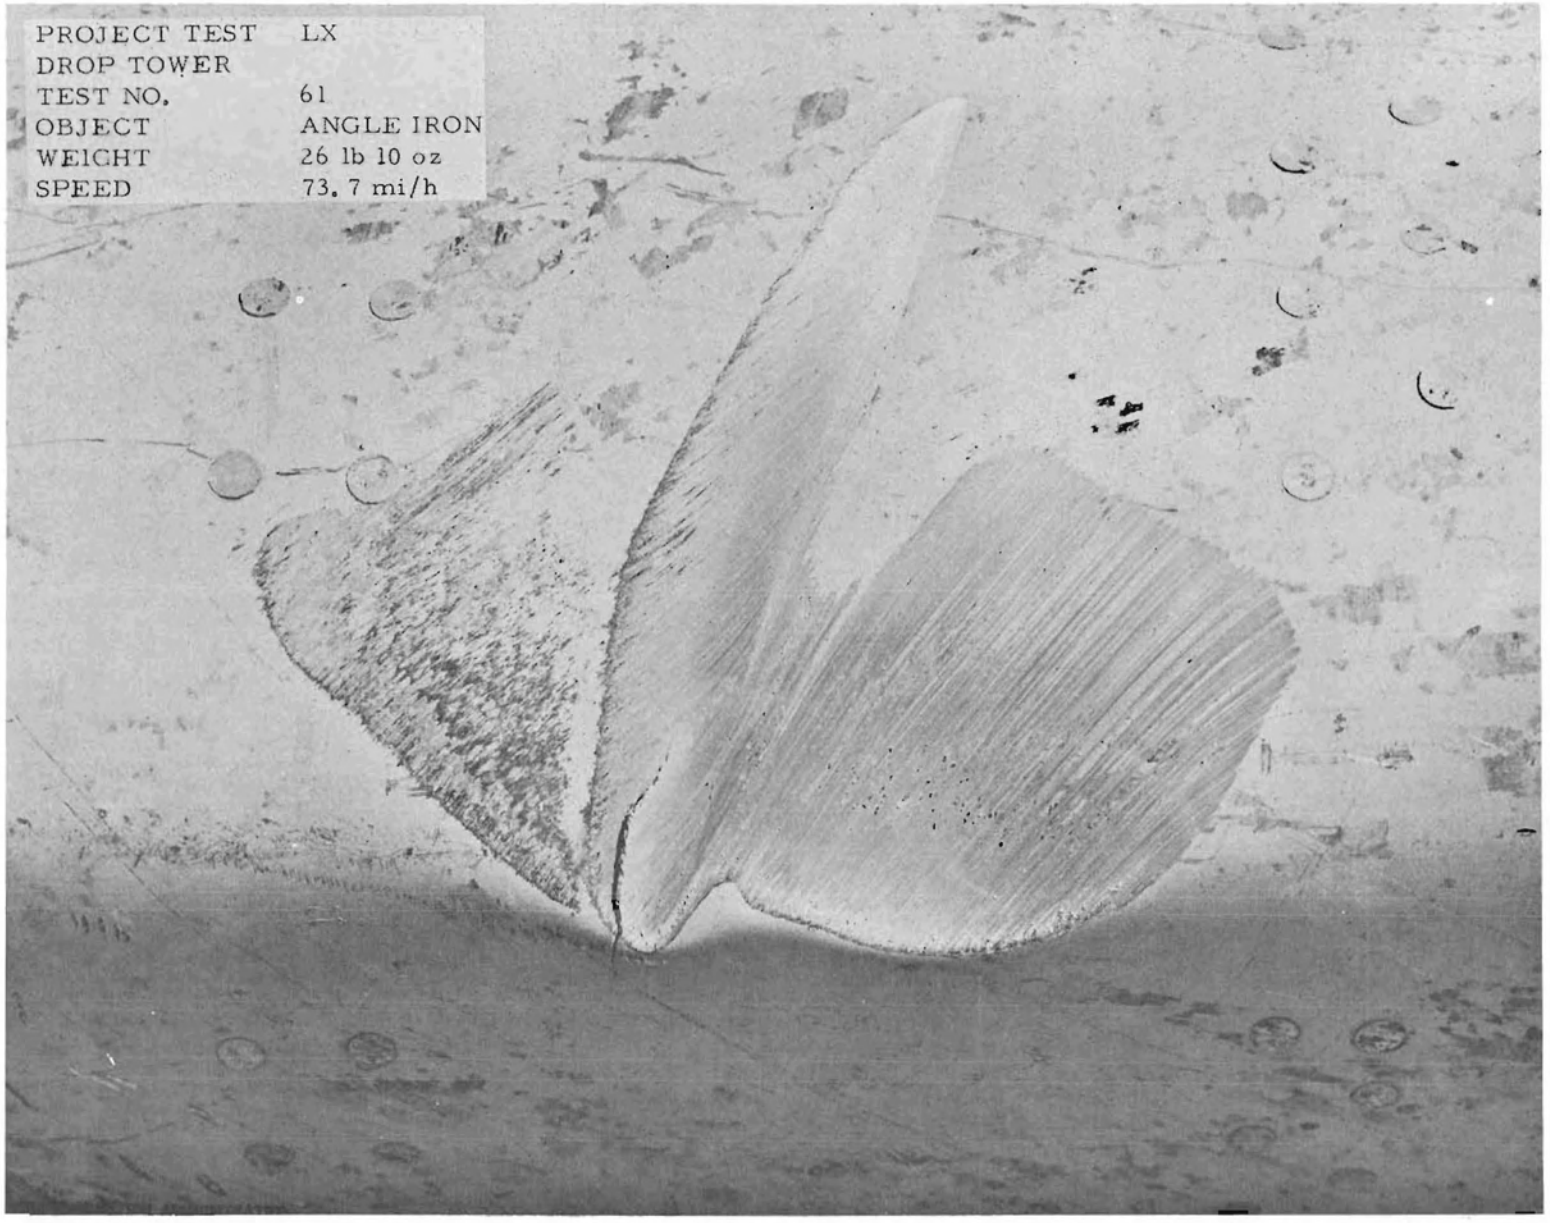
FIGURE 13. DAMAGE TO WING - TEST 7, 73.7 MI/H - ANGLE IRON

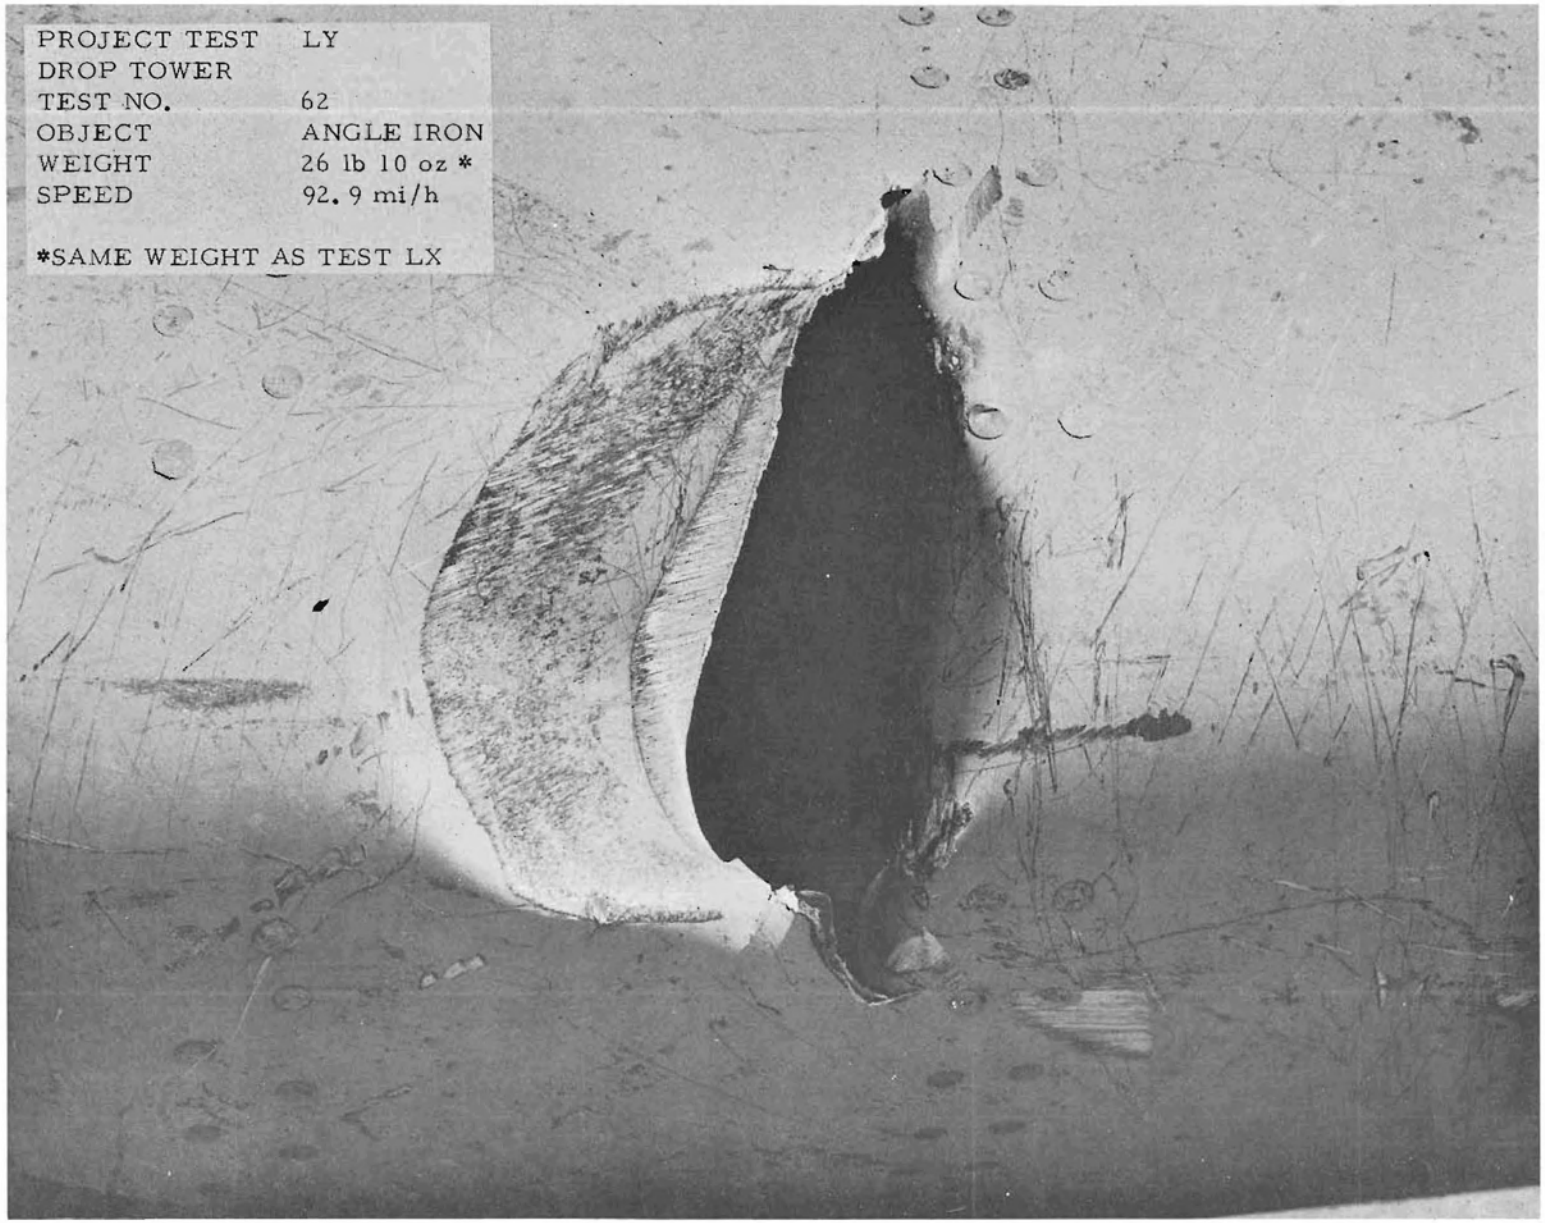
FIGURE 14. DAMAGE TO WING - TEST 8, 92.9 MI/H - ANGLE IRON

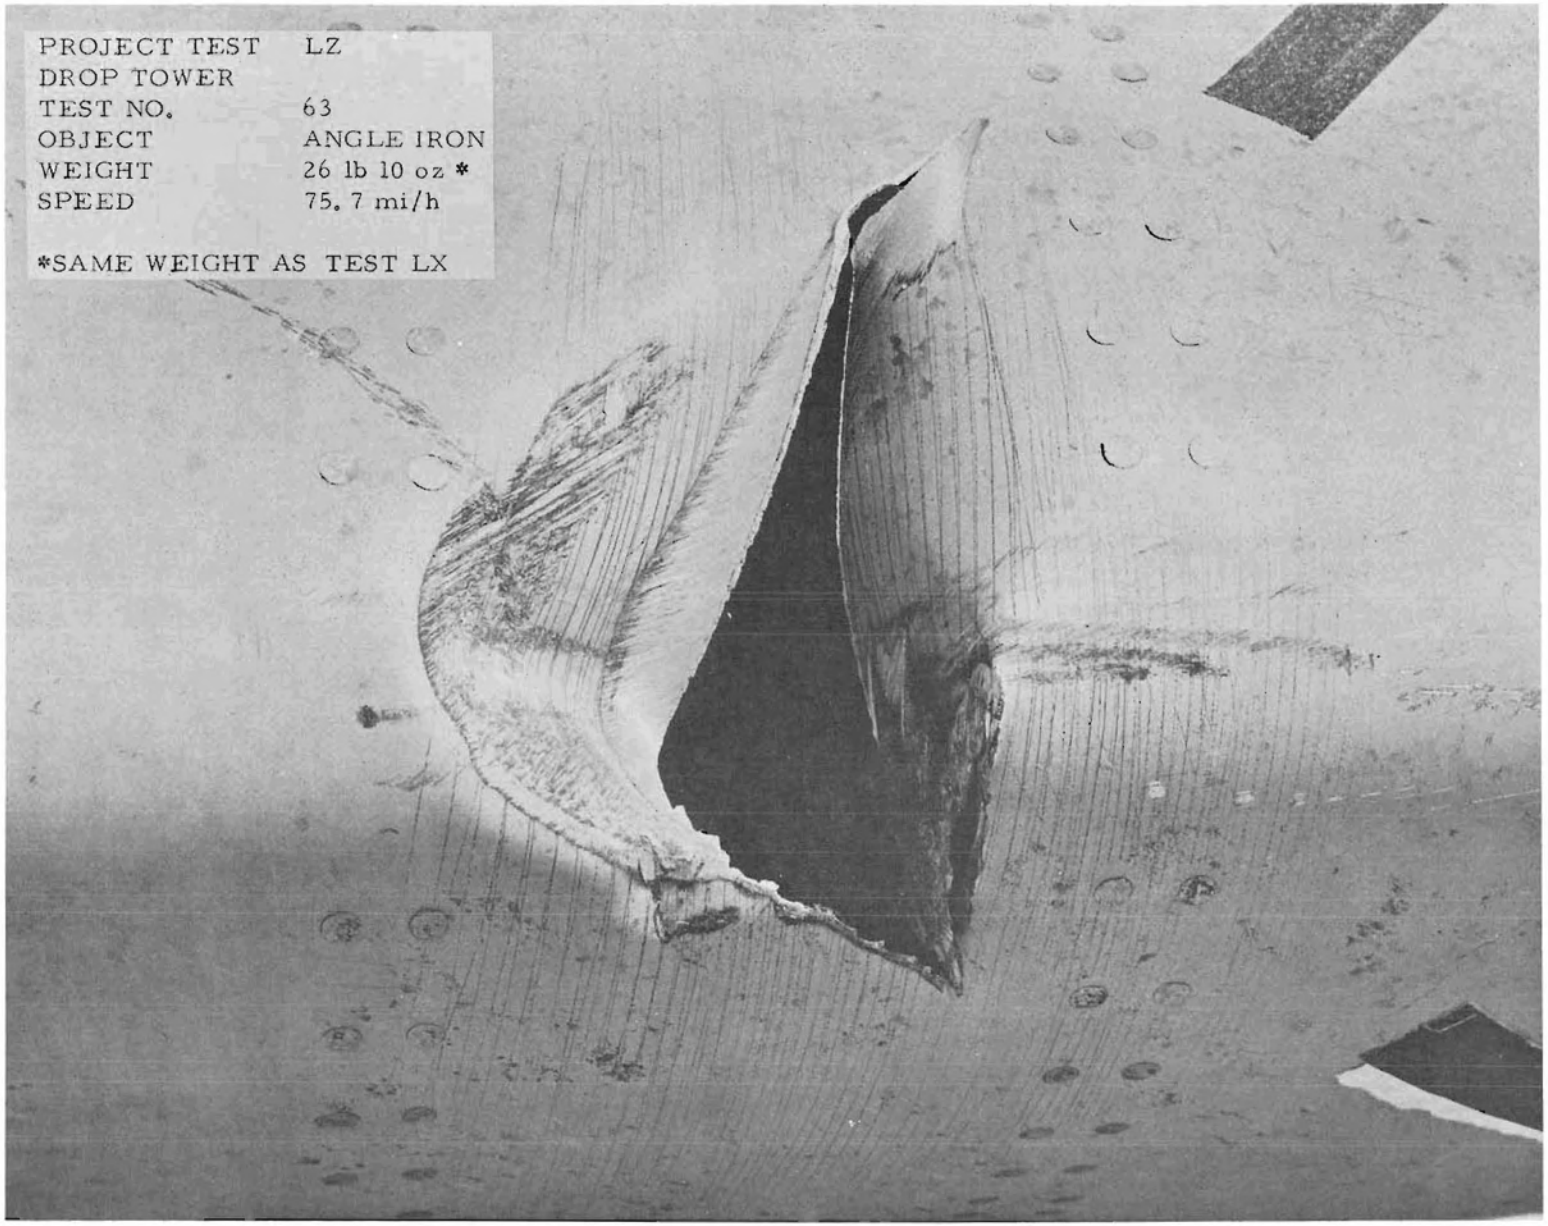
FIGURE 15. DAMAGE TO WING - TEST 9, 75.7 MI/H - ANGLE IRON
