Report No. FAA-RD-72-83

WING LEADING EDGE FUEL TANK IMPACT TESTS

OCTOBER 1972

FINAL REPORT

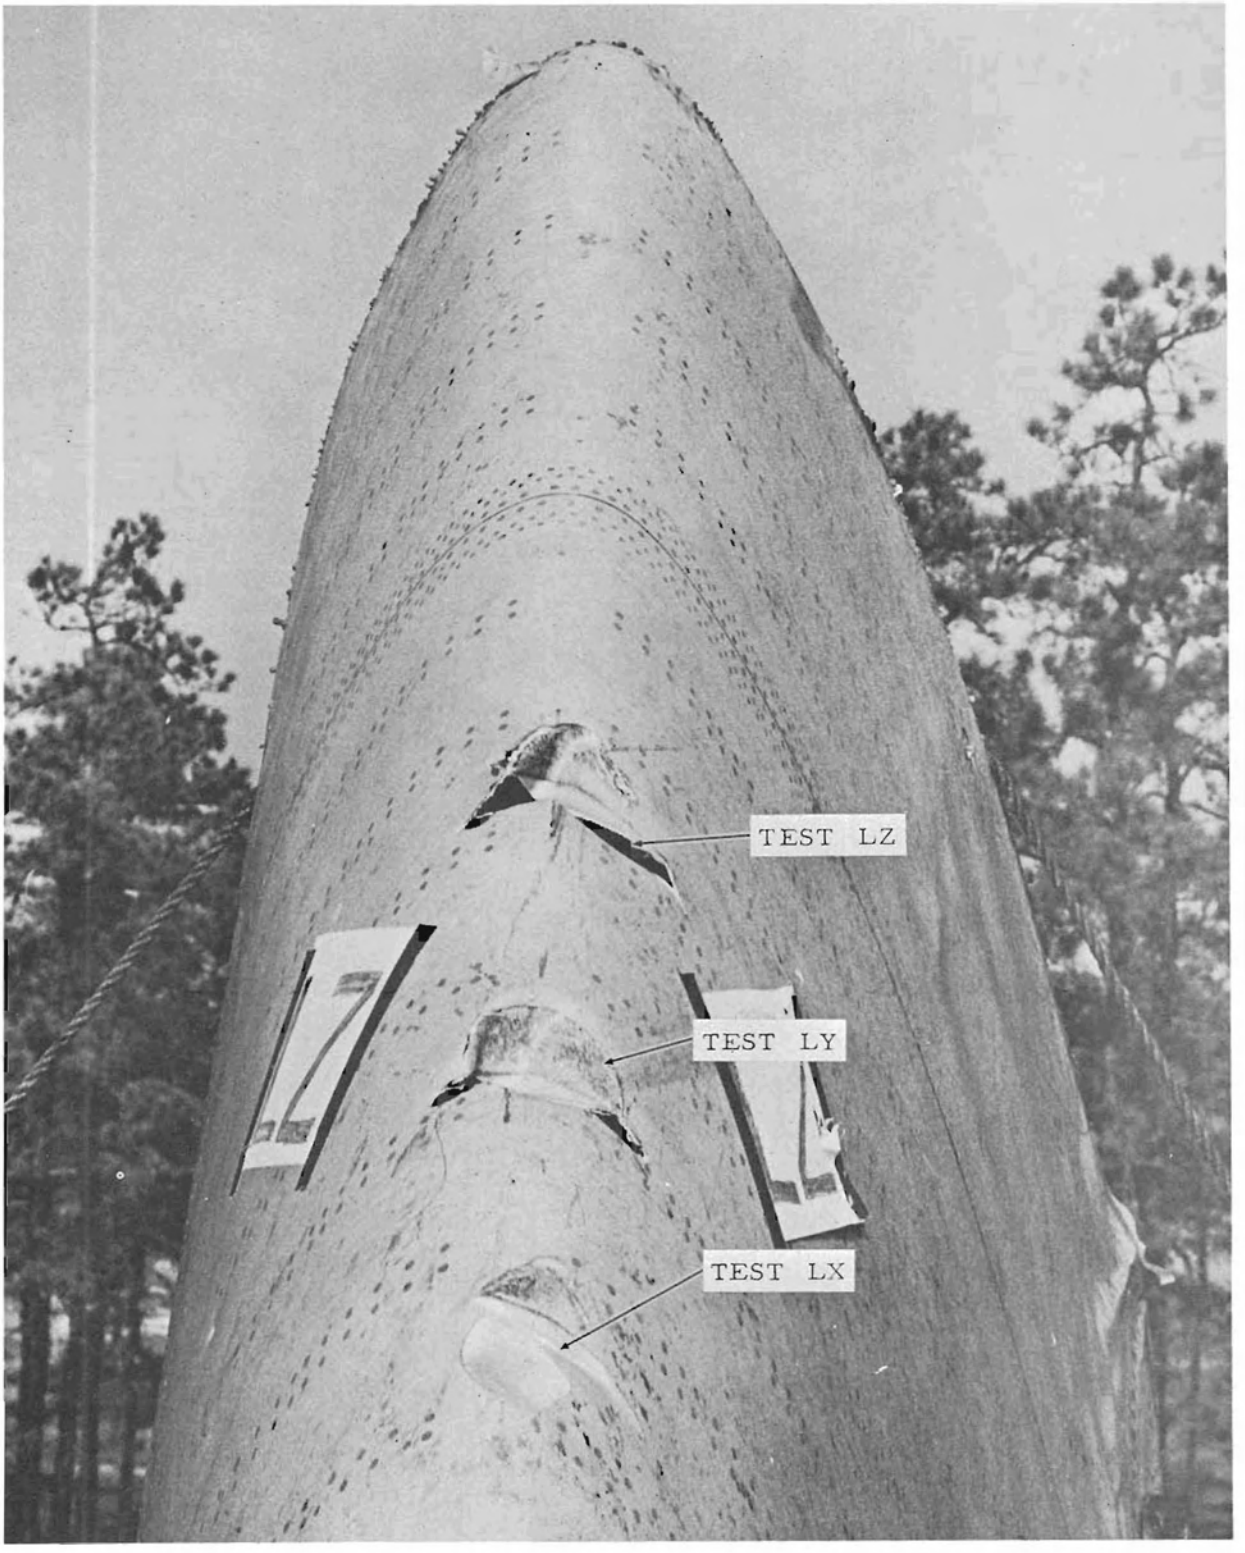
FIGURE 16. DAMAGE TO WING - TEST 7, 8, 9 - ANGLE IRON

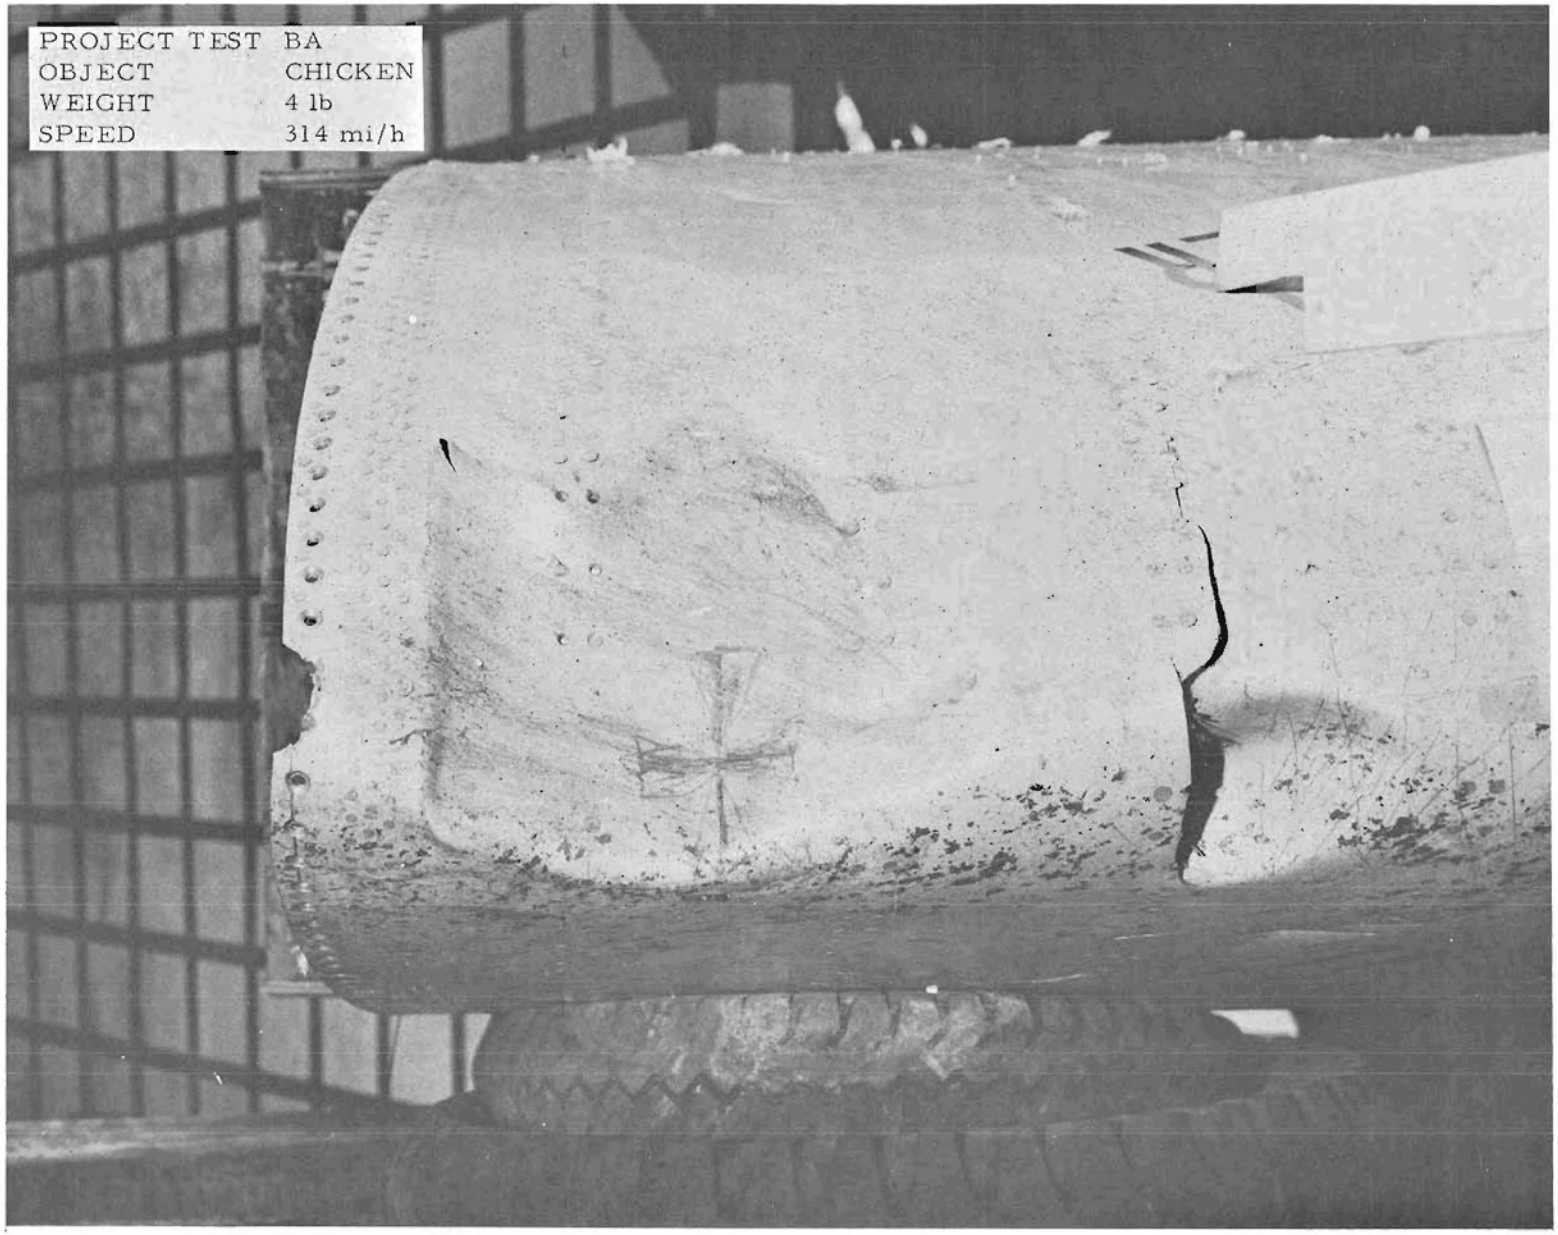
FIGURE 17. DAMAGE TO WING - TEST 10, 314 MI/H - CHICKEN

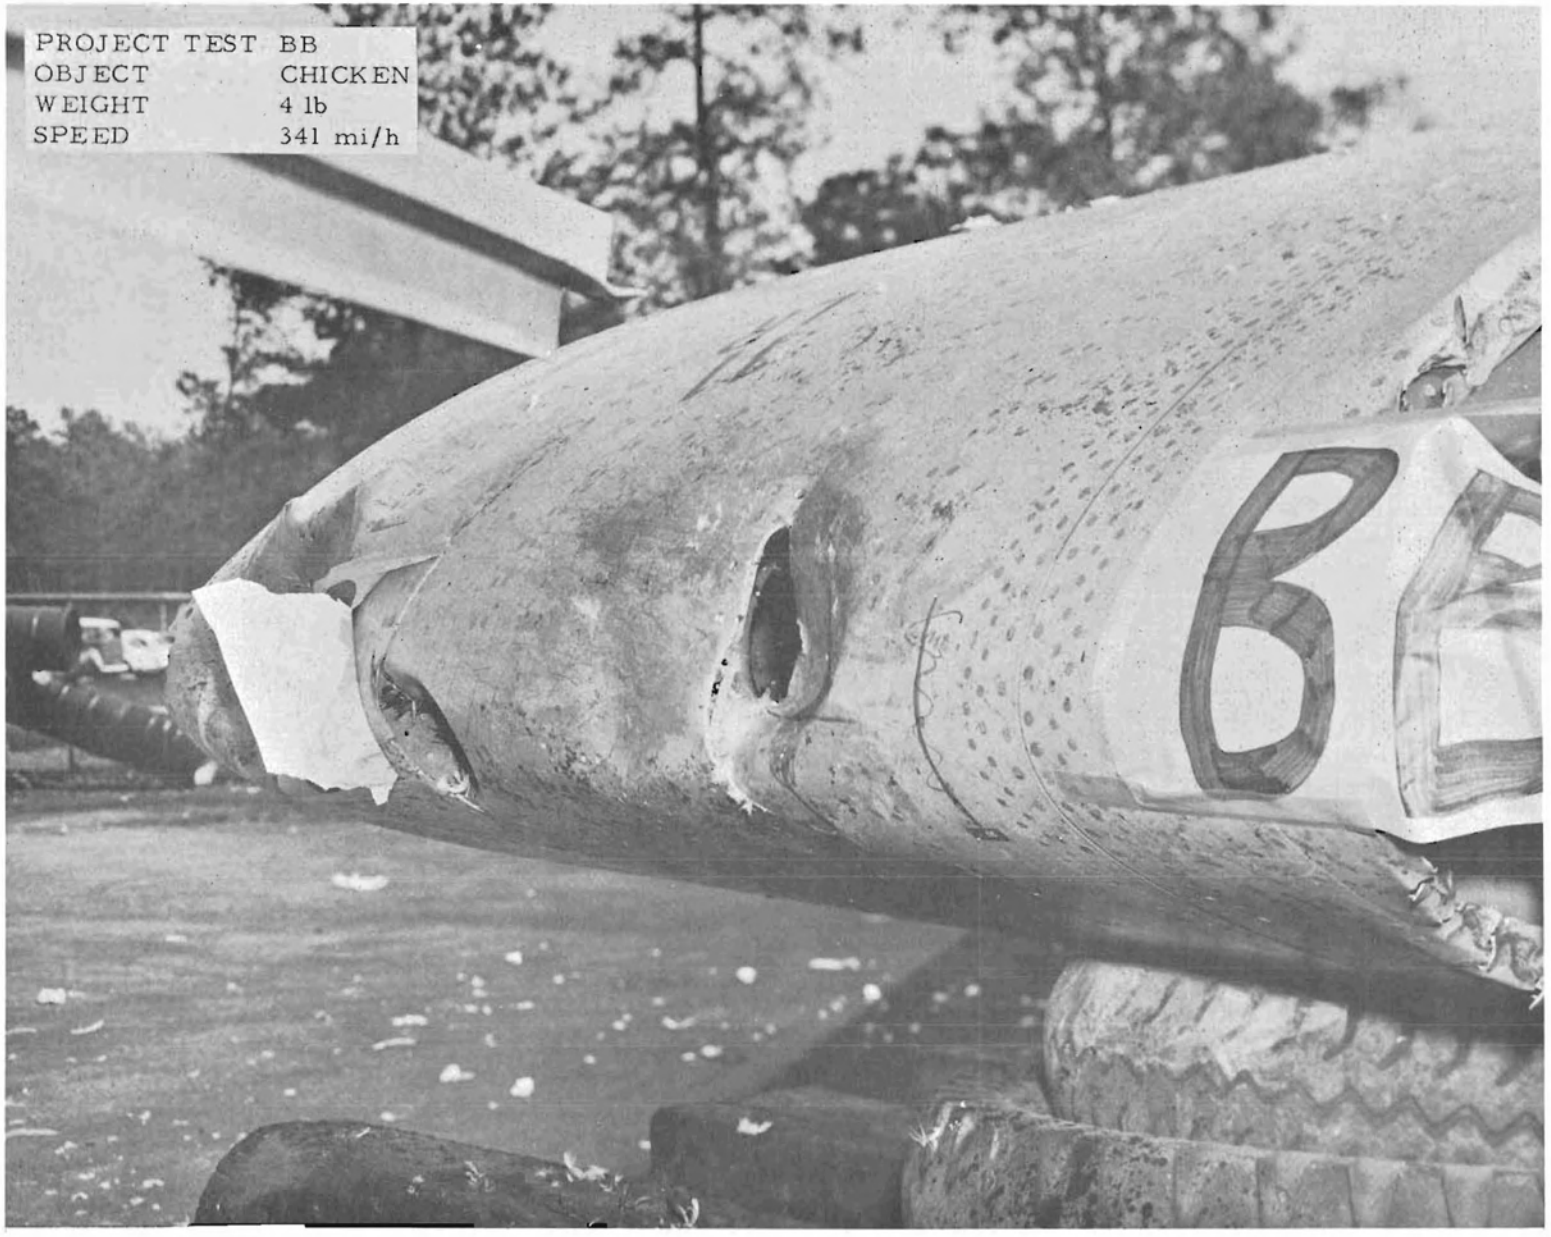
FIGURE 19. DAMAGE TO WING - TEST 11, 341 MI/H - CHICKEN
