FAA RD-75-118

ANALYSIS OF THE EFFECT OF CONCORDE AIRCRAFT NOISE ON HISTORIC STRUCTURES

July 1975

Final Report

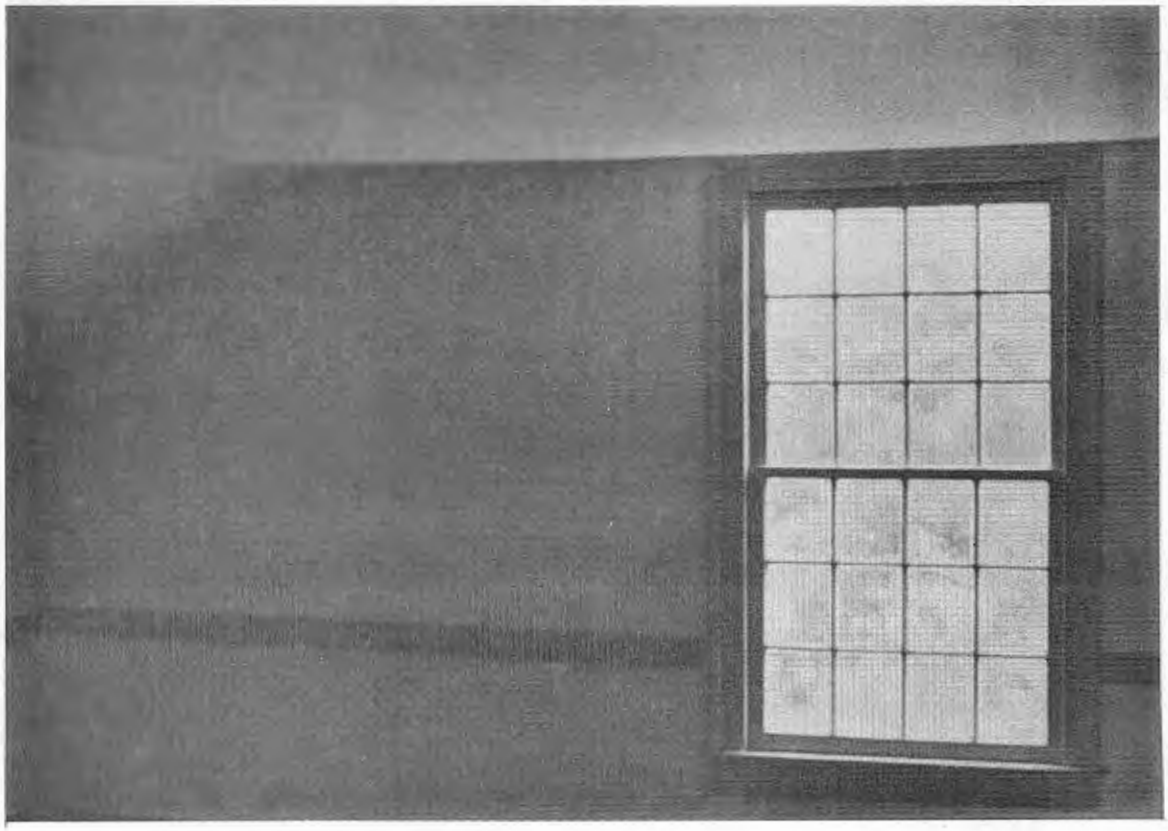
FIGURE III-2
Original Plaster in Garret Room
of Sully Plantation

Figure III-2 shows a typical Sully window, the one in the garret room. Note that it is a "twelve-over-twelve" consisting of twenty-four 8- by 10- by 1/16-inch lites. Some of the other windows at Sully have different configurations with fewer of the same size lites but the twelve-over-twelve is most typical. Among all the windows at Sully there are 324 lites. Approximately half are original; the rest have been replaced with "reproduction glass." This replacement glass (costing $1.45 per lite) is made in the old way, by pouring molten glass onto a flat surface rather than rolling it. This process results in an uneven surface where the thickness varies between 1/16 inch and 1/8 inch. In the process of restoring the structure all the old lites which could be saved were removed and then re-installed in fresh putty without glazier points. This emission of glazier points was done to eliminate stress concentrations when the glass is subjected to aircraft noise. All the lites at Sully had a transparent plastic Scotchtint film cemented to their surface to aid in reflecting sunlight. This thin film does not add appreciably to the strength of the lite but it will hold the pieces in place if a light becomes cracked.

Observation of the lites at Sully disclosed that at least four of them were cracked. These lites have only 1/10 the strength of healthy lites, since it takes much less pressure to run an existing crack than to start a new one.

Present overflights near Sully already cause some vibration of the windows. During our visit to Sully we noted that the lites in the garret room window vibrated sufficiently to be easily detectable

The probability of breaking lites which are already cracked is considerably greater since they have only 1/10 the strength of healthy lites. The probability of a cracked lite failing during an overflight is .0013. This corresponds to a probability of breakage of .19 for a year of overflights. For the four lites observed cracked

the probability is thus 80 percent that one of them will break during a year of overflights. Since already cracked lites have a risk of breaking, it would be appropriate to replace them with healthy lites. Apparently this already is the policy at Sully since about half of the lites have already been replaced.

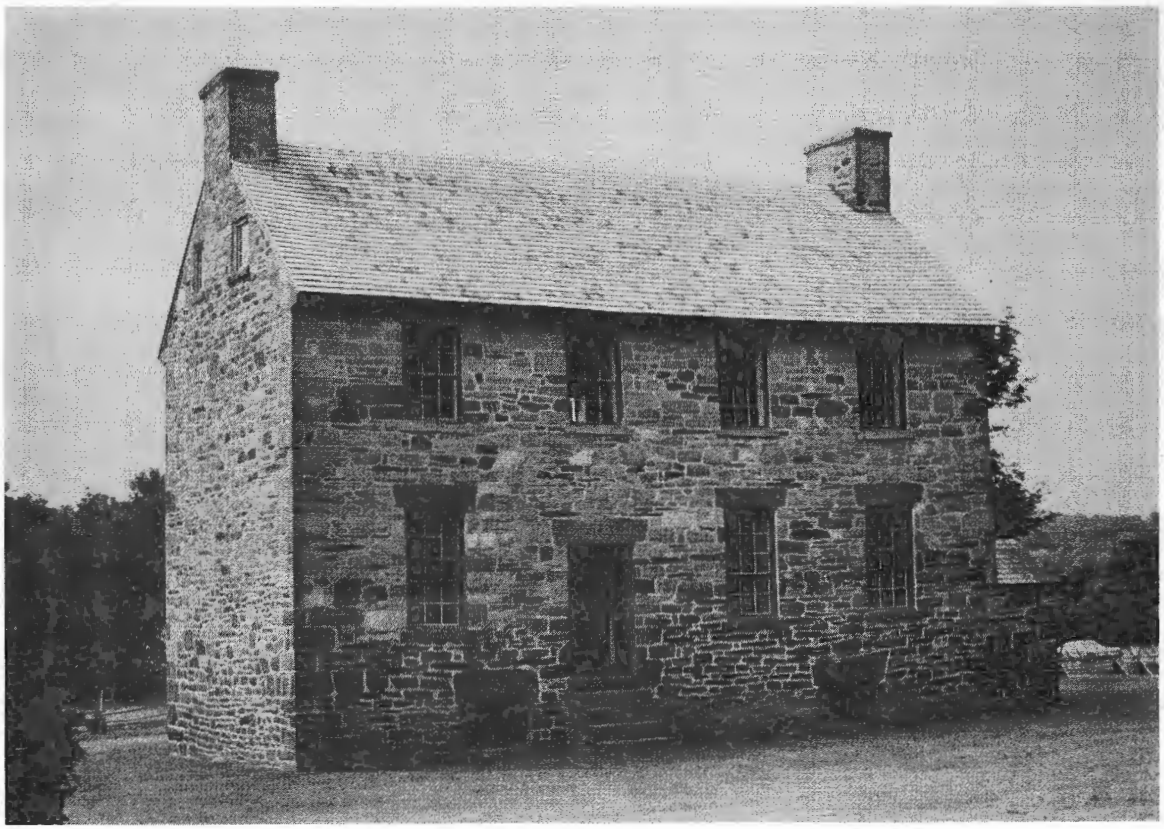
FIGURE VI-1
Stone House in Restored Condition

The Stone House was constructed in the 1820's probably as a tavern to serve the Warrenton Turnpike. With the advent of railroads and a canal system, the Stone House's function as a tavern was short-lived. Figure VI-1 shows the Stone House in its restored condition.

The chimneys at the Stone House are in sound condition and have short unsupported lengths. The probability of chimney failure will be smaller than that of glass.

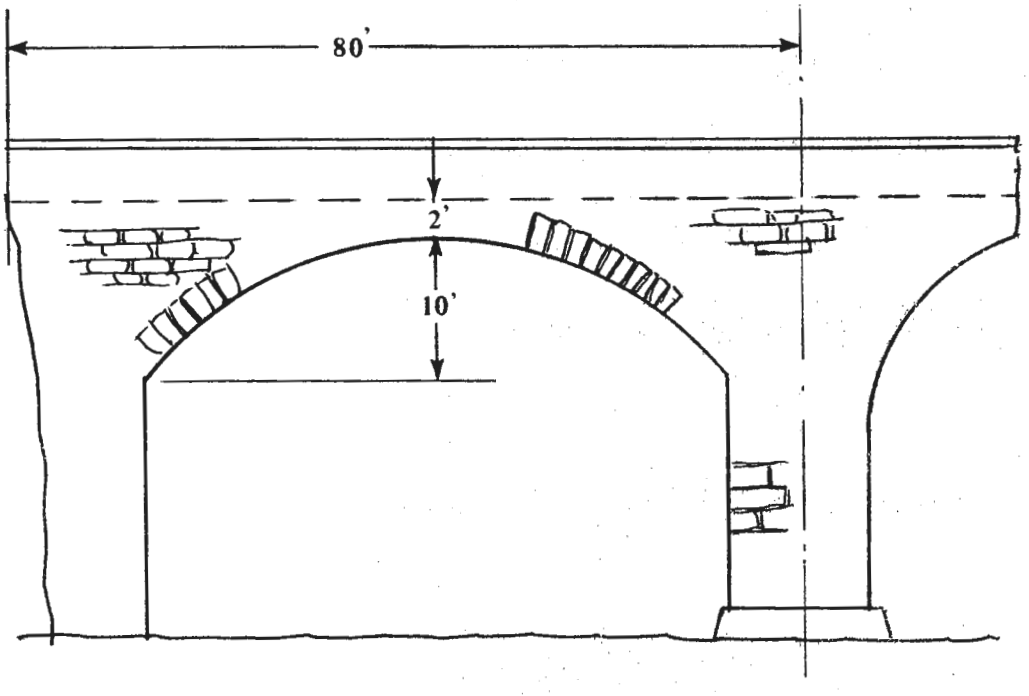
FIGURE VI-4
Stone Bridge

The sound level at the Stone Bridge due to Concorde is estimated to be 74 dB(A), or .0021 psf (A weighted). Based on the spectrum of Concorde noise, this would cause an overpressure of .0157 psf at the bridge structure.

The historical data available for this bridge indicates that the Union Army had considerable difficulty in destroying the bridge after their retreat. Hence, the probability of damage to the bridge due to aircraft noise is extremely small.

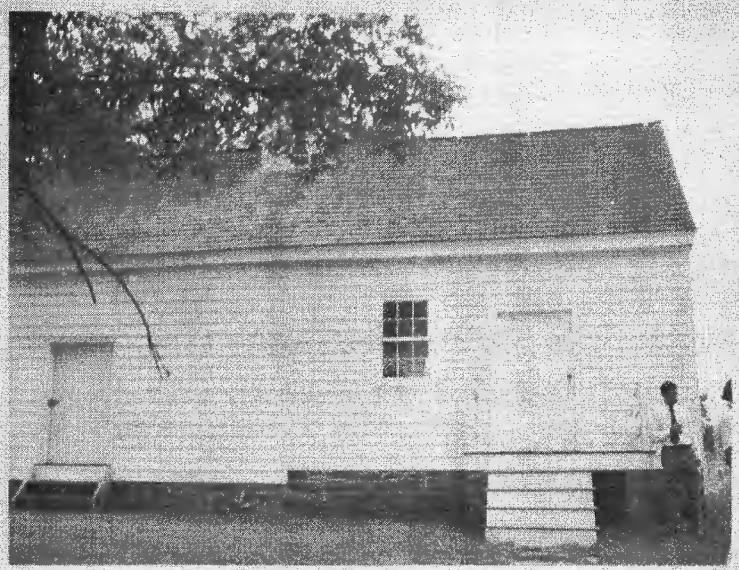
FIGURE VI-5
Dogan House

The effective factor of safety for glass breakage is 13 for healthy glass and 9.74 for cracked glass. There are only about 50 lites in Dogan House, and the probability of glass breakage is 3.6×10^{-34} per year for healthy glass, and 7.2×10^{-18} per year for cracked glass.

The probability for chimney breakage will be even smaller.

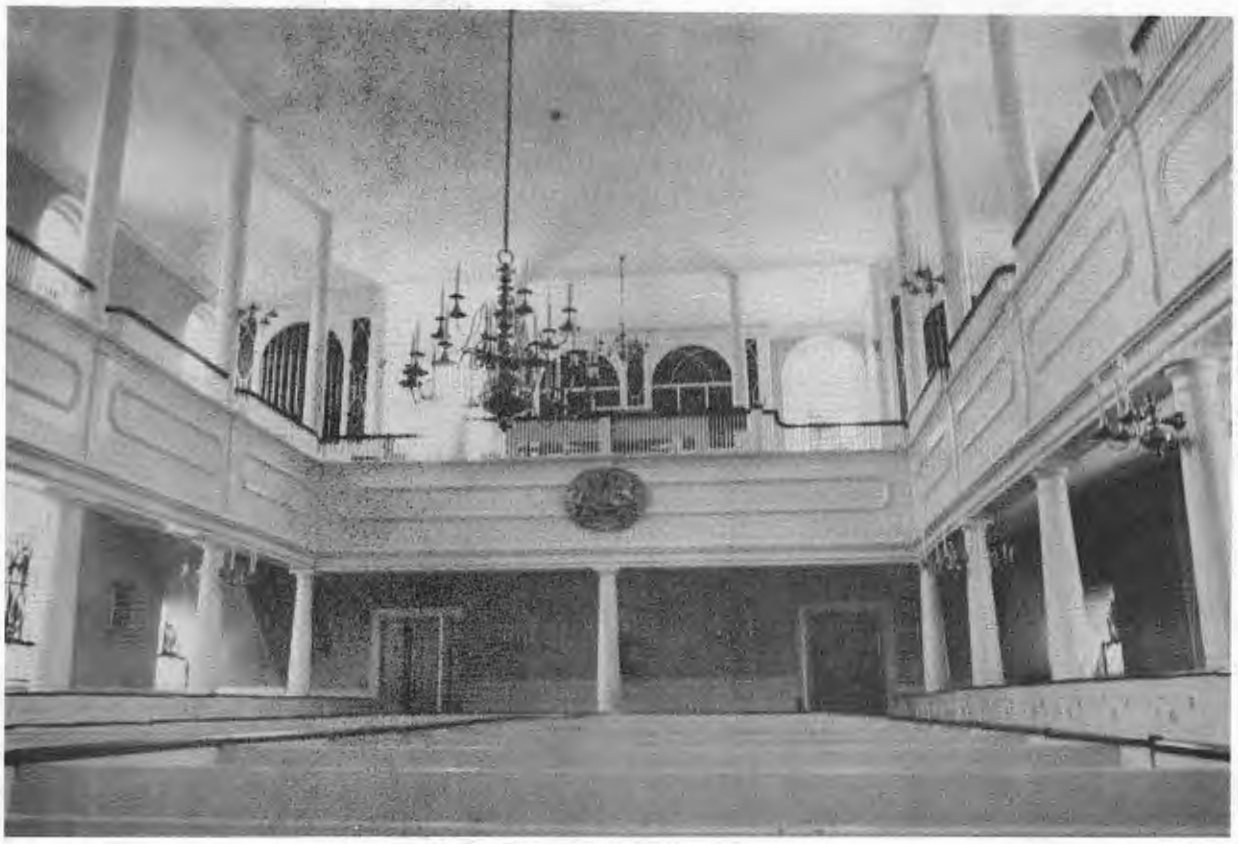
FIGURE VII-2
Interior of Saint George's Church

Parts of the church most likely to be damaged by vibrations due to airborne sound are its stained glass windows and the ceiling plaster. Of the 23 stained glass windows in the church, nine are considered to be very valuable and irreplaceable. They are made of Tiffany glass, dating to the mid-19th Century. All nine Tiffany windows are located on the main level of the church hall. The ceiling was recently replastered over the original plaster, the new plaster held in place by metal lathing. Several long cracks are already visible in the new plaster.

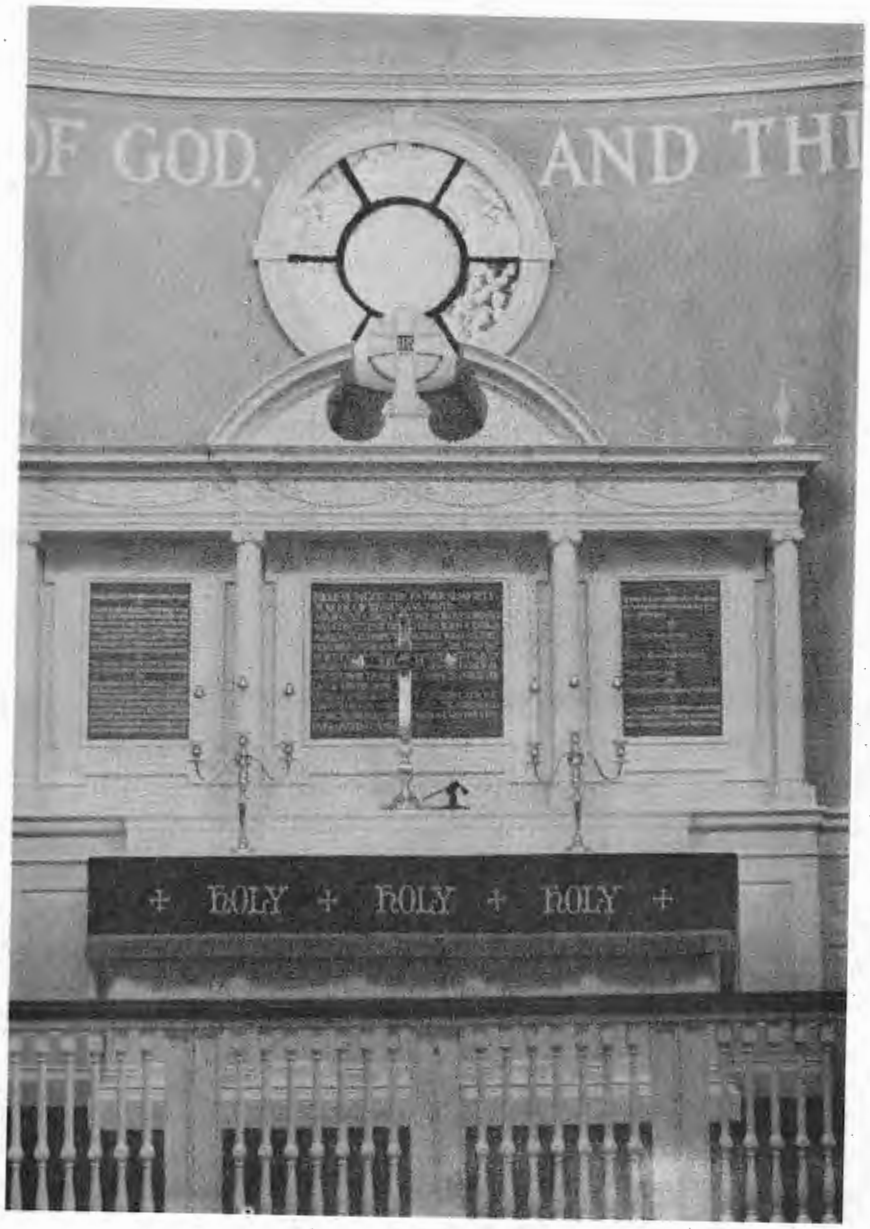
FIGURE VII-4
Round Window in Recess Chancel
of Saint George's Church

Presently, the church still has the original plaster on the walls and nine original Tiffany stained glass windows one of which is shown in Figure VII-3. Over the altar is a round window containing the likeness of a gilt dove bearing a gilt olive branch in his beak. (See Figure VII-4.)
