TECHNICAL DEVELOPMENT REPORT NO. 374

Bird Impact Tests of the Douglas Model DC-8 Airplane Eyebrow And Clear-View Windows

January 1959

FEDERAL AVIATION AGENCY
TECHNICAL DEVELOPMENT CENTER
INDIANAPOLIS, INDIANA

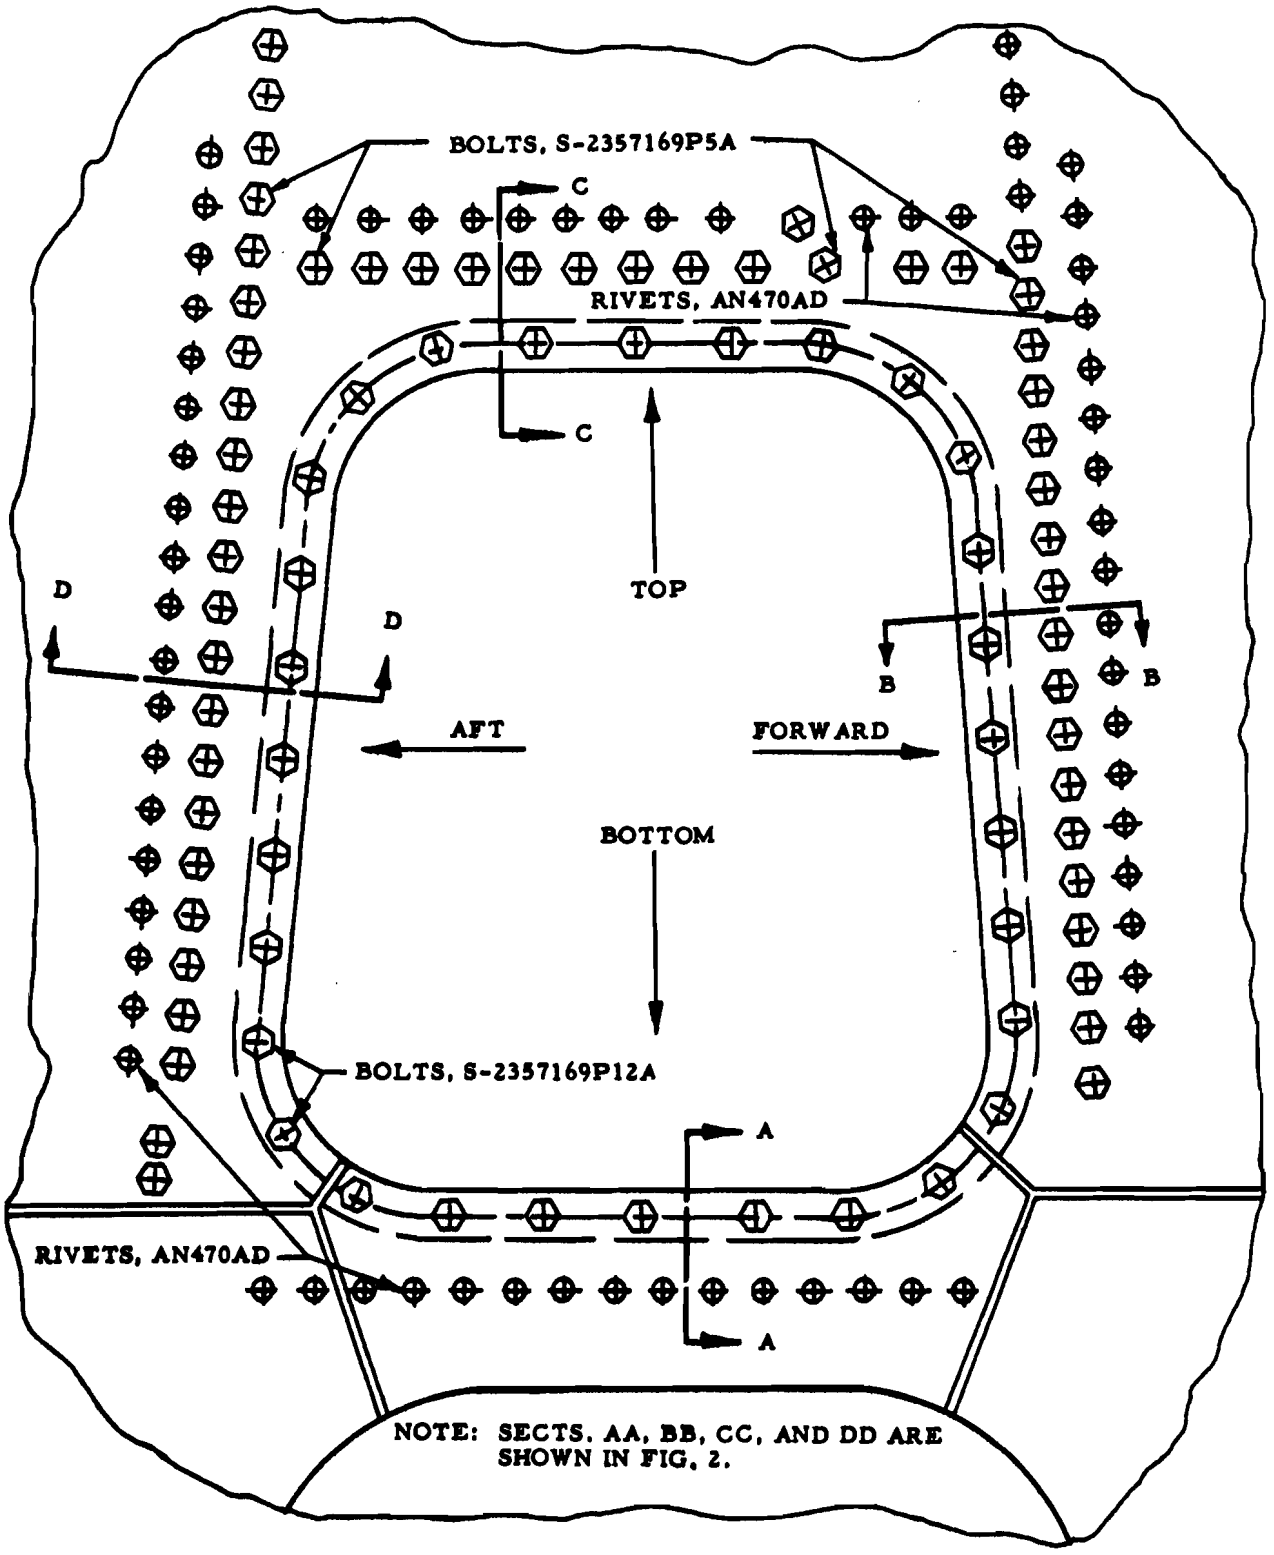
FIG. 1 EYEBROW WINDOW INSTALLATION EXTERIOR VIEW COPILOT'S SIDE

bolting sill leaving an air space between the exterior and interior panels. This mounting arrangement and the sectional dimensions of the panels are shown in Figs. 1 and 2.

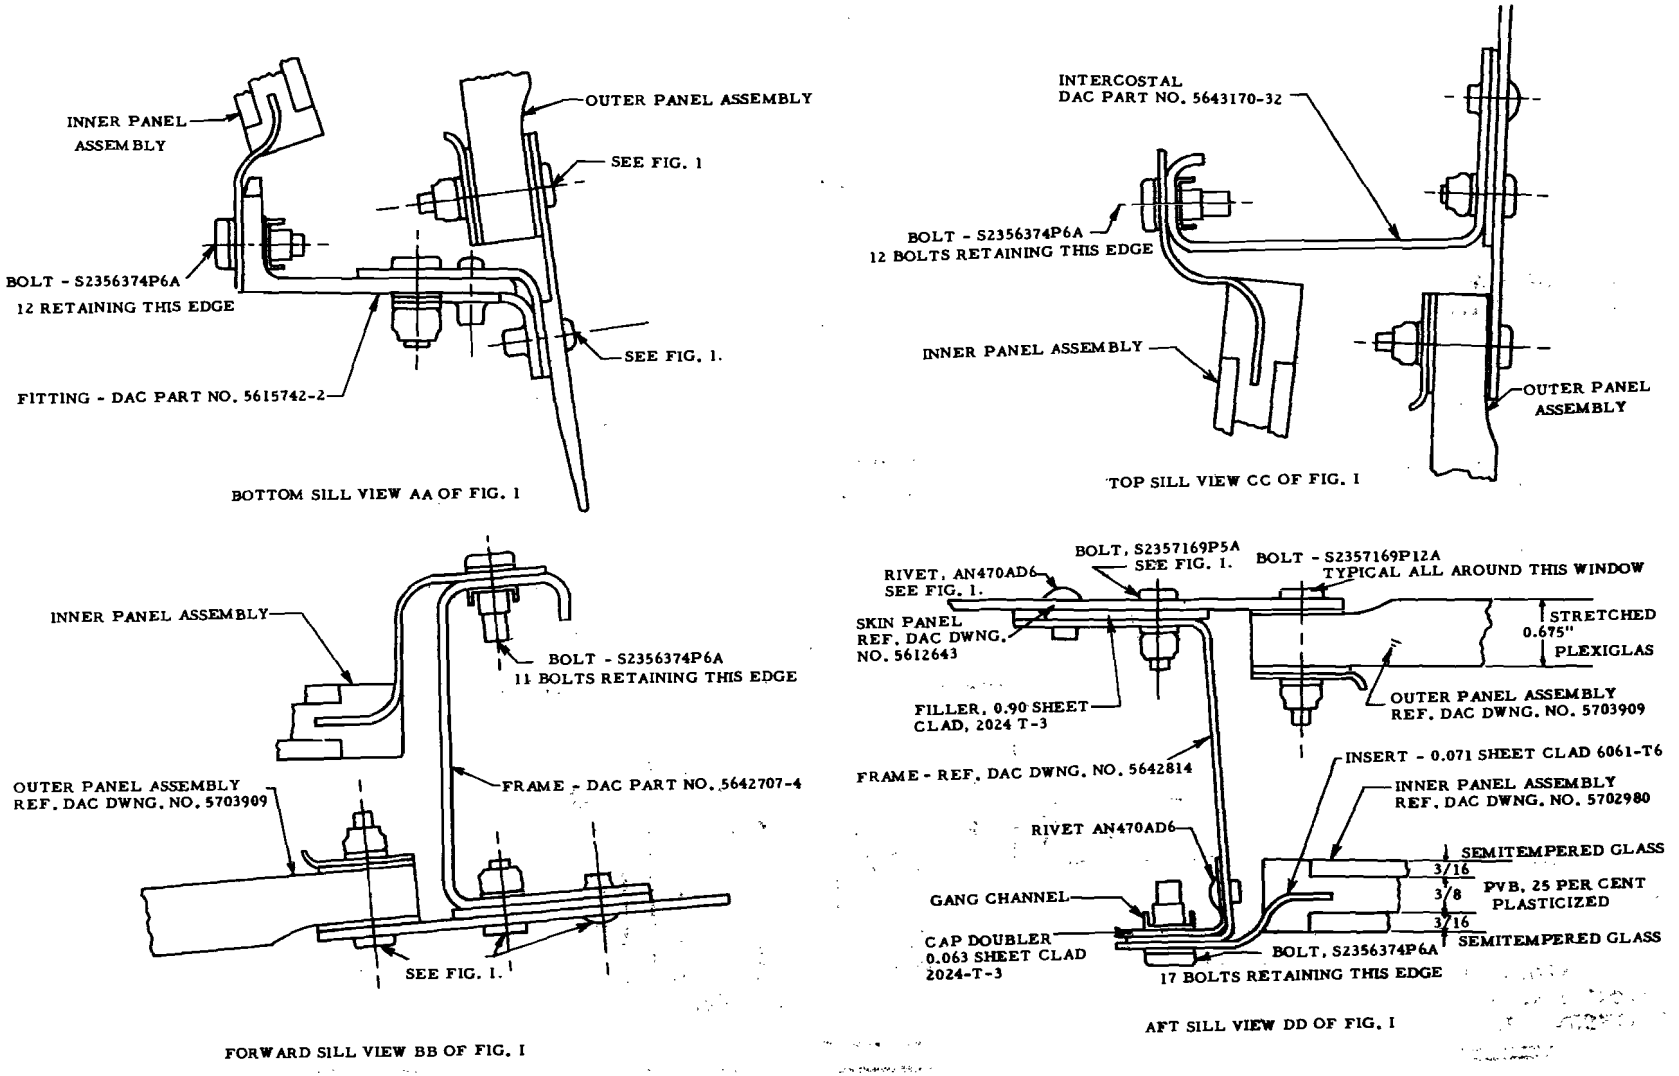
FIG. 2 SECTIONAL VIEW OF EYEBROW WINDOW
REF. DAC DRAWING NO. 5653470

* MODIFICATIONS ARE GIVEN WITH REFERENCE TO THE AFT SILL OF TEST NO. 3-21, SHOWN IN FIG. 2

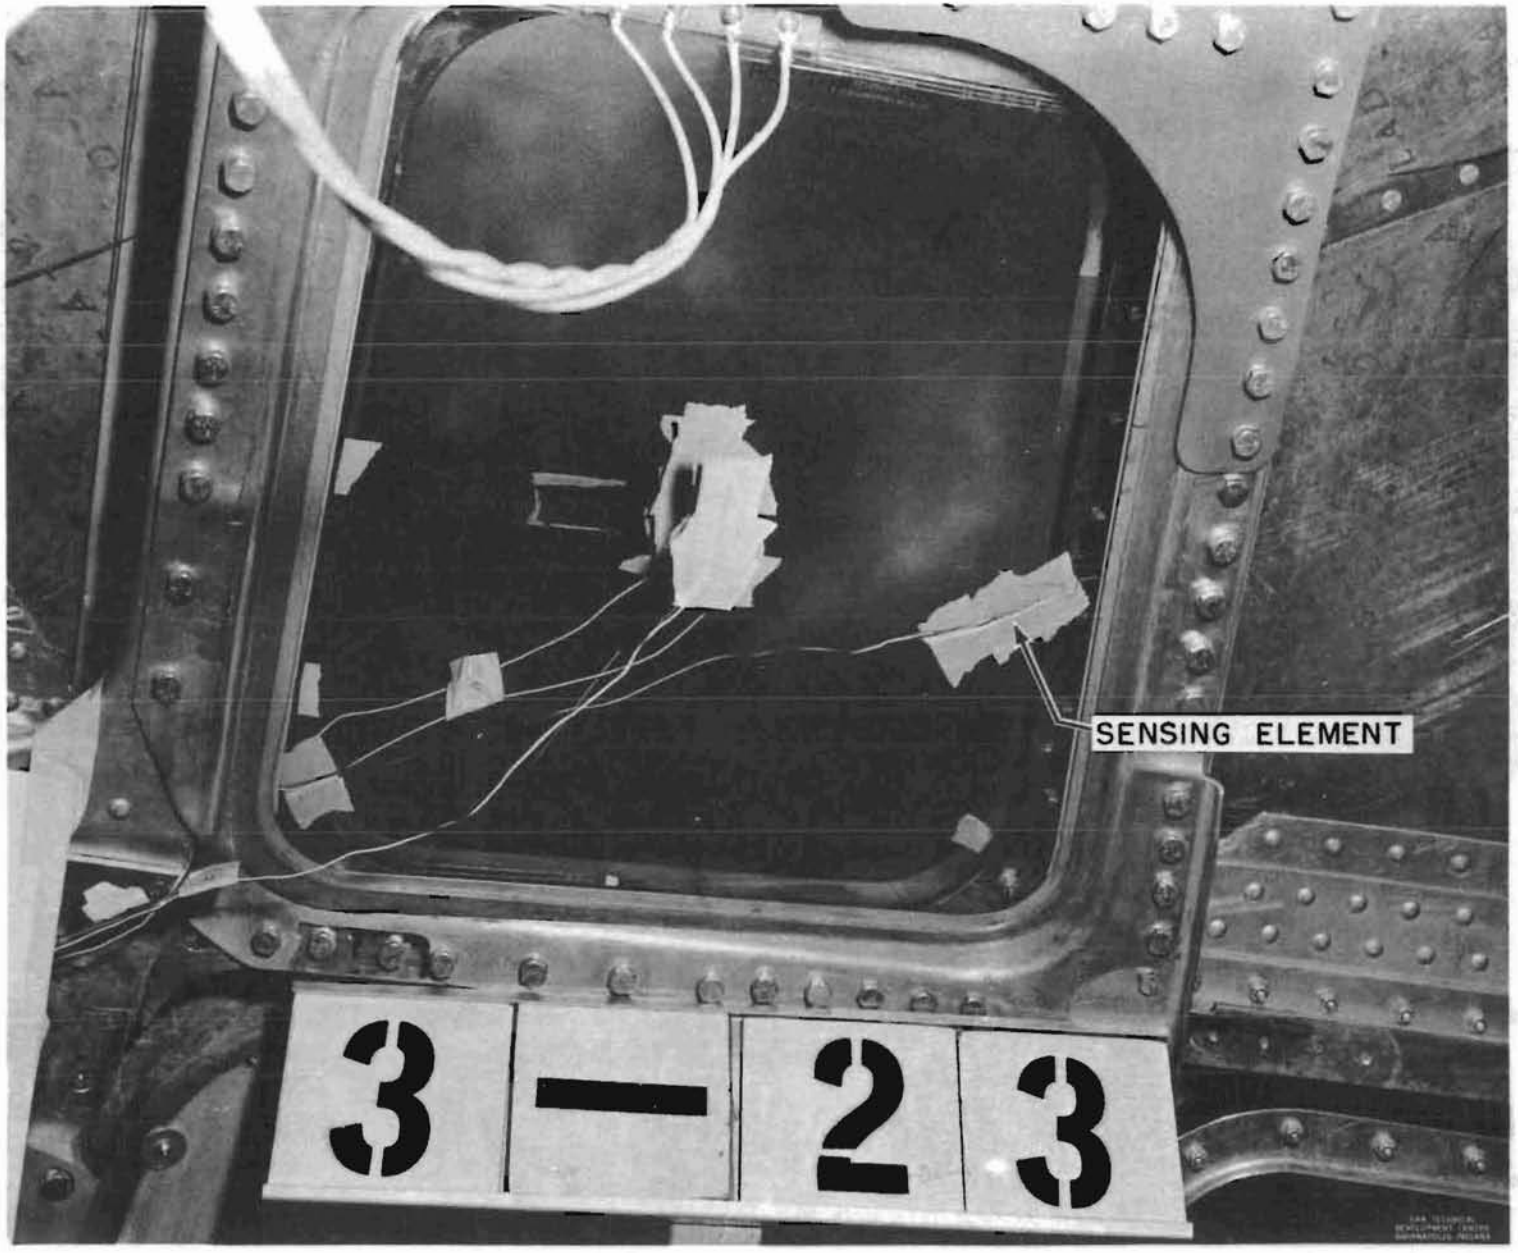
FIG. 8 THERMOCOUPLE LOCATIONS FOR THE EYEBROW WINDOW

Eyebrow window temperatures were obtained prior to each test from thermocouples attached to the faces of the exterior and interior panels by means of masking tape. The thermocouples were placed at the geometric center of the outer and inner faces of the exterior stretched Plex-55 panel and the interior glass-vinyl-glass panel assembly. Also, one thermocouple was placed on the outside face of the glass-vinyl-glass panel assembly directly opposite the sensing-element control. The location of these thermocouples is shown in Fig. 8.

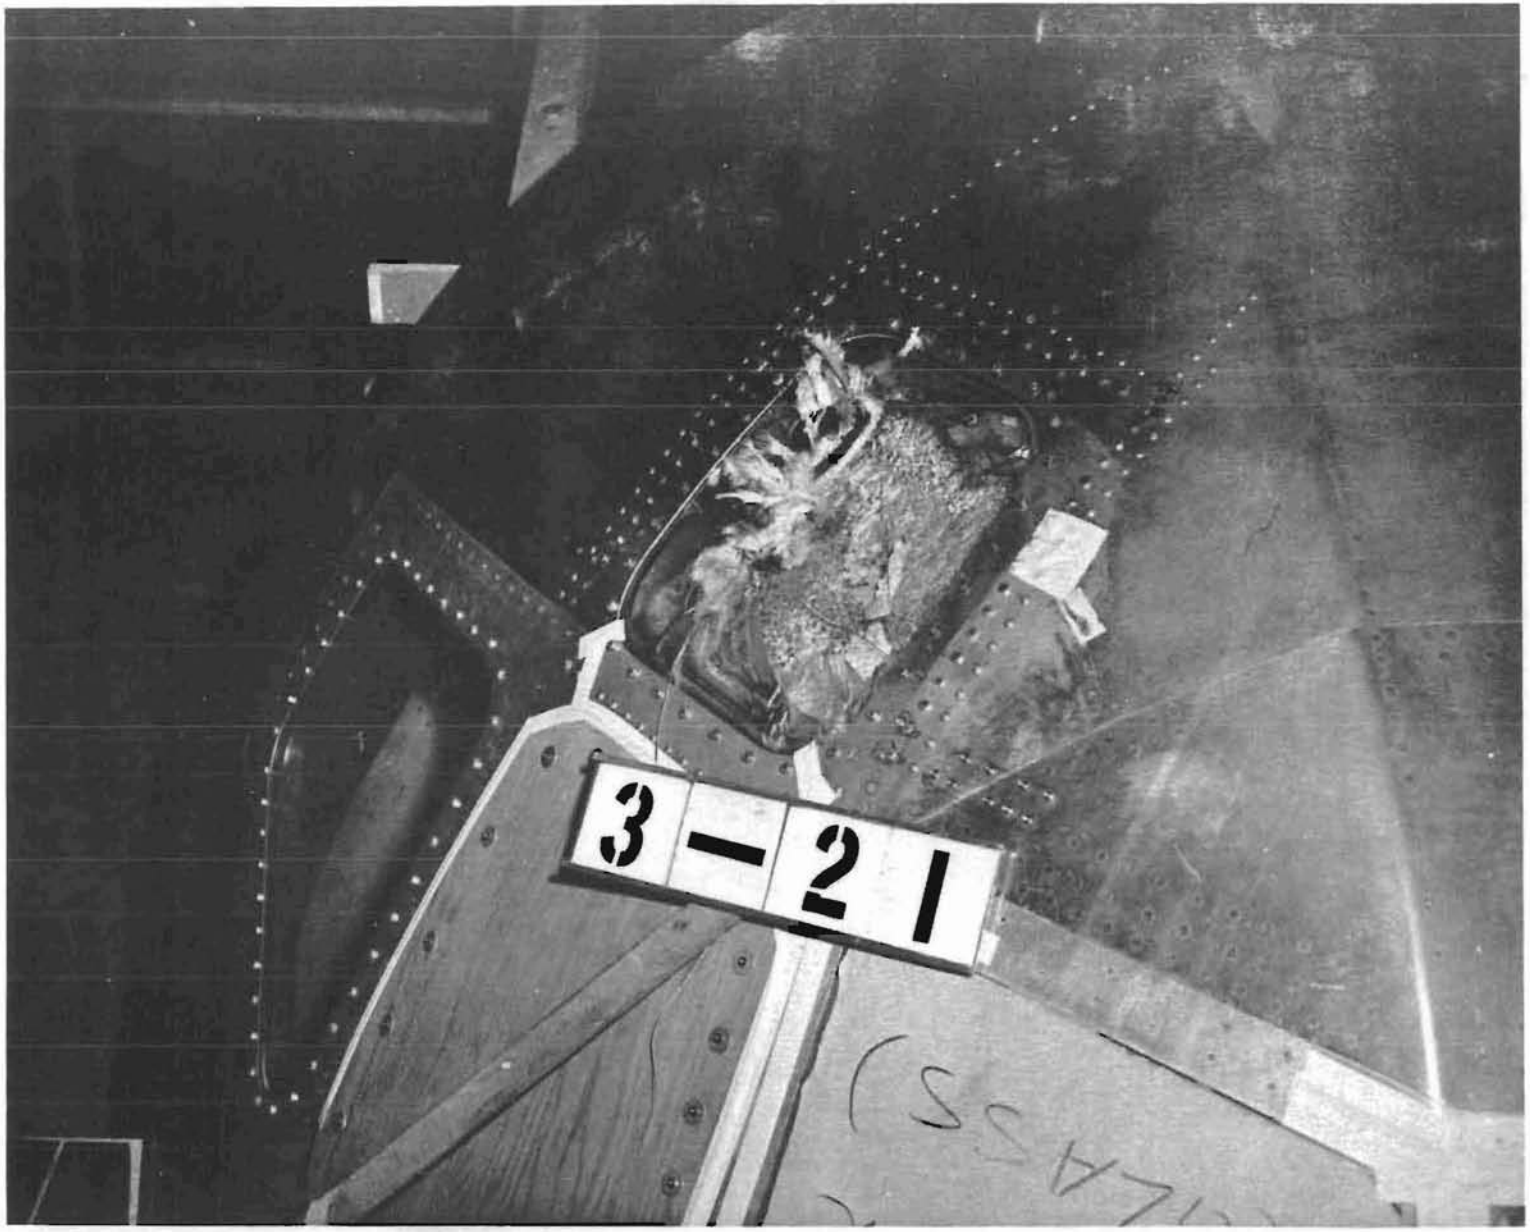
FIG. 10 TEST 3-21 - COPILOT EYEBROW WINDOW, EXTERIOR VIEW - PROJECTILE VELOCITY 388 MPH

The projectile struck on the horizontal centerline of the copilot's eyebrow window about 2 inches aft of the forward window sill. The exterior stretched Plex-55 panel was shattered by the impact as shown in Fig. 10. None of the bird carcass penetrated the interior window, but part of the carcass entered the cockpit area to the rear of the pilot as the aft sill-frame, DAC Part No. 5642814, fractured in two places. This

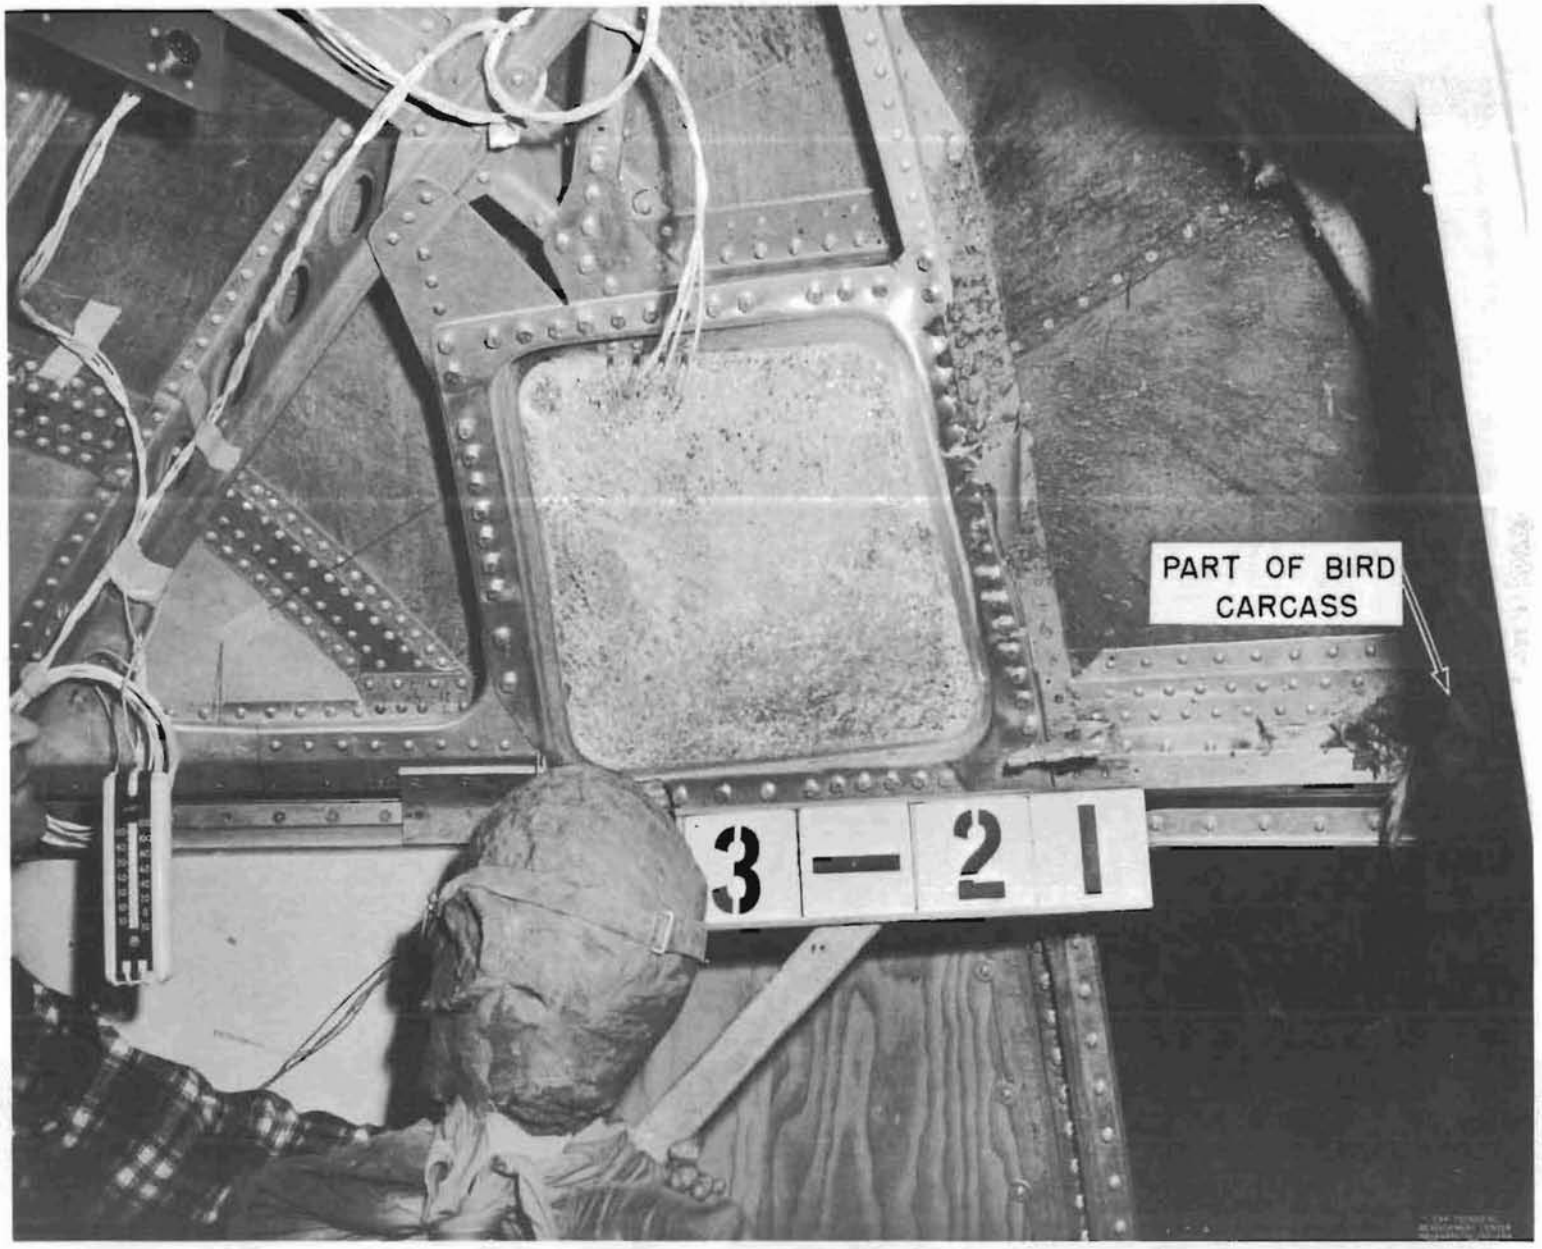
FIG. 11 TEST 3-21 - COPILOT EYEBROW WINDOW, INTERIOR VIEW - PROJECTILE VELOCITY 388 MPH

failure is shown in Figs. 11 and 12. That part of the carcass which entered the cockpit through the void caused by the fractures in the frame generally followed the contour of the fuselage aft of the window. This is shown in Fig. 11. Relative to flying window fragments, the strike position for this test was critical but only a few particles of glass struck the upper right side of the pilot's head. None of these particles penetrated the clay, but merely adhered to it. The copilot, after the test, is shown in Fig. 13.

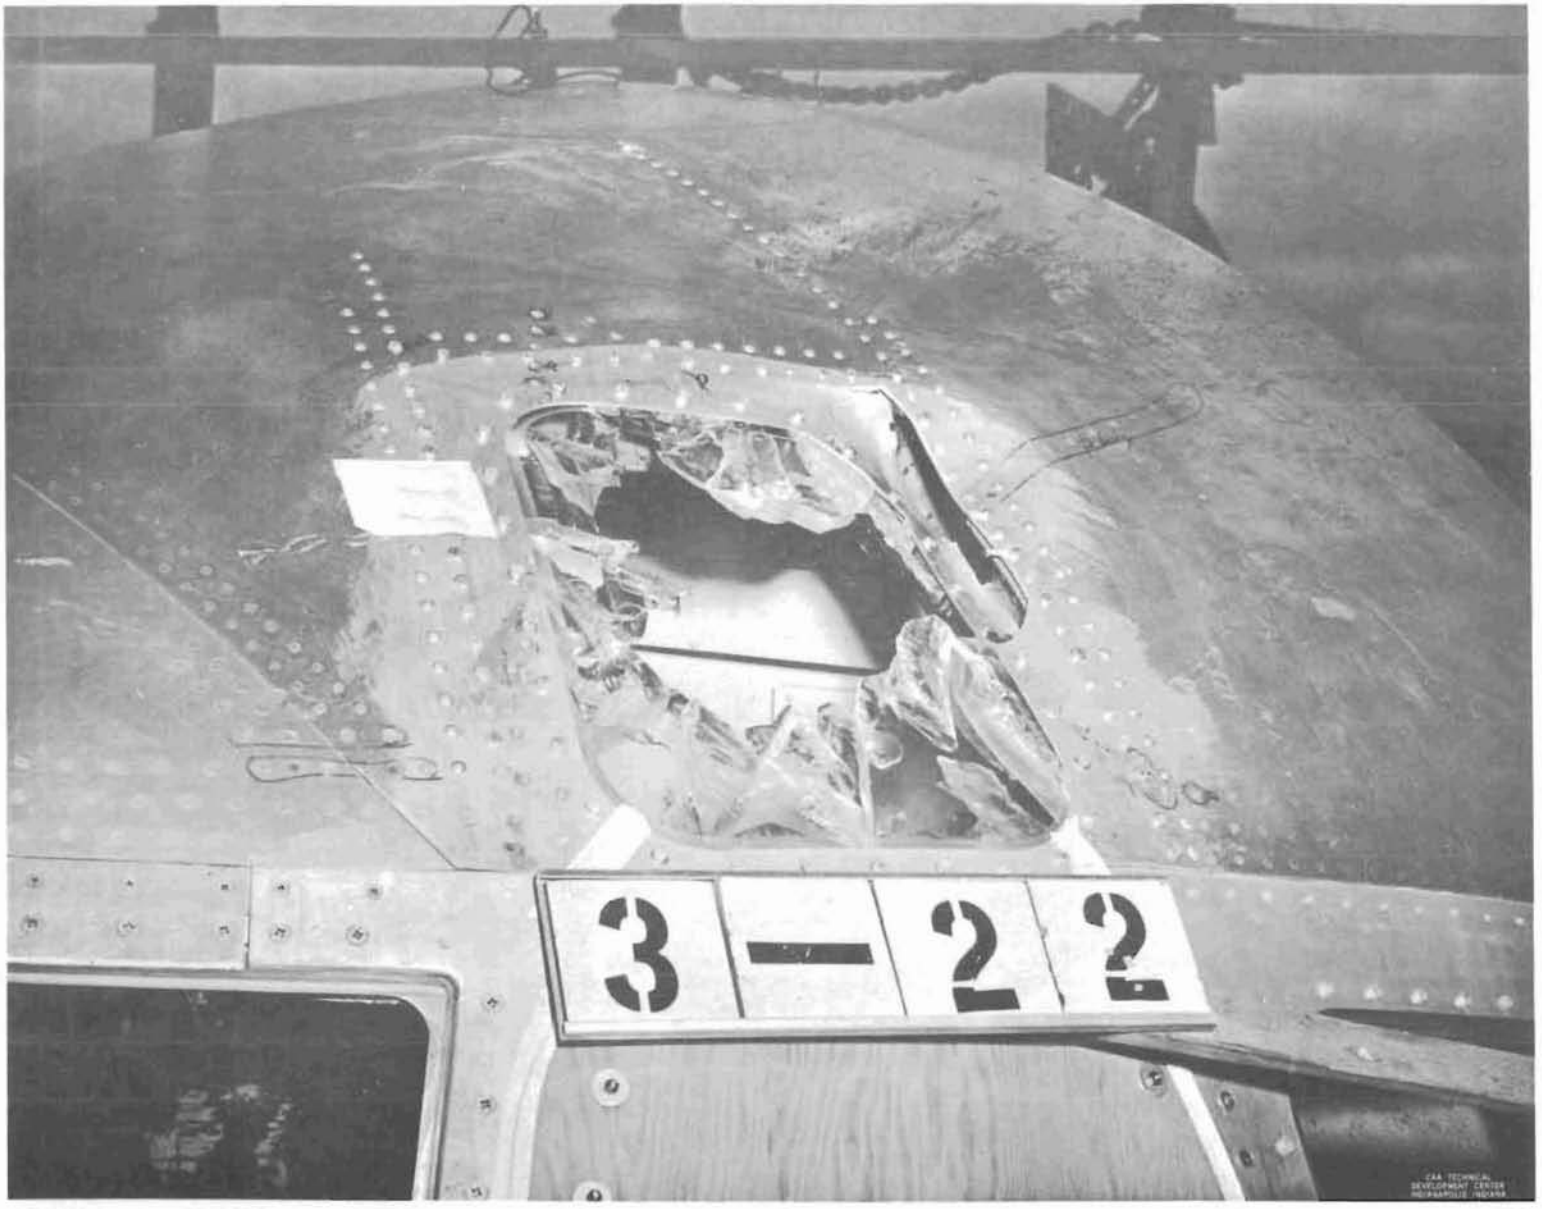
FIG. 14 TEST 3-22 - PILOT EYEBROW WINDOW, EXTERIOR VIEW - PROJECTILE VELOCITY 413 MPH

Prior to this test, which involved the pilot's eyebrow window, the aft sill-frame, DAC Part No. 5642814, was increased in strength as shown in Fig. 4. The projectile struck approximately 2 inches above the horizontal centerline of the window and immediately forward of the aft sill. This is a critical strike position relative to impact strength of the window arrangement. The exterior panel was shattered by the impact (see Fig. 14), and the aft sill retaining the panel fractured in one place and bent aft from the upper support intercostal sill, as shown in Figs. 15 and 16. The interior panel was not penetrated. When the sill-frame, DAC Part No. 5642814, modified as described previously, for the interior panel again fractured, part of the bird carcass entered the cockpit to the rear of the pilot similar to Test 3-21. This is shown in Figs. 15 and 16. A few particles of glass from the inner face of the interior window impinged upon the top and left side of the pilot's head. None penetrated the clay or was directed toward the pilot's eye area. The pilot, after being exposed to this test, is shown in Fig. 17.

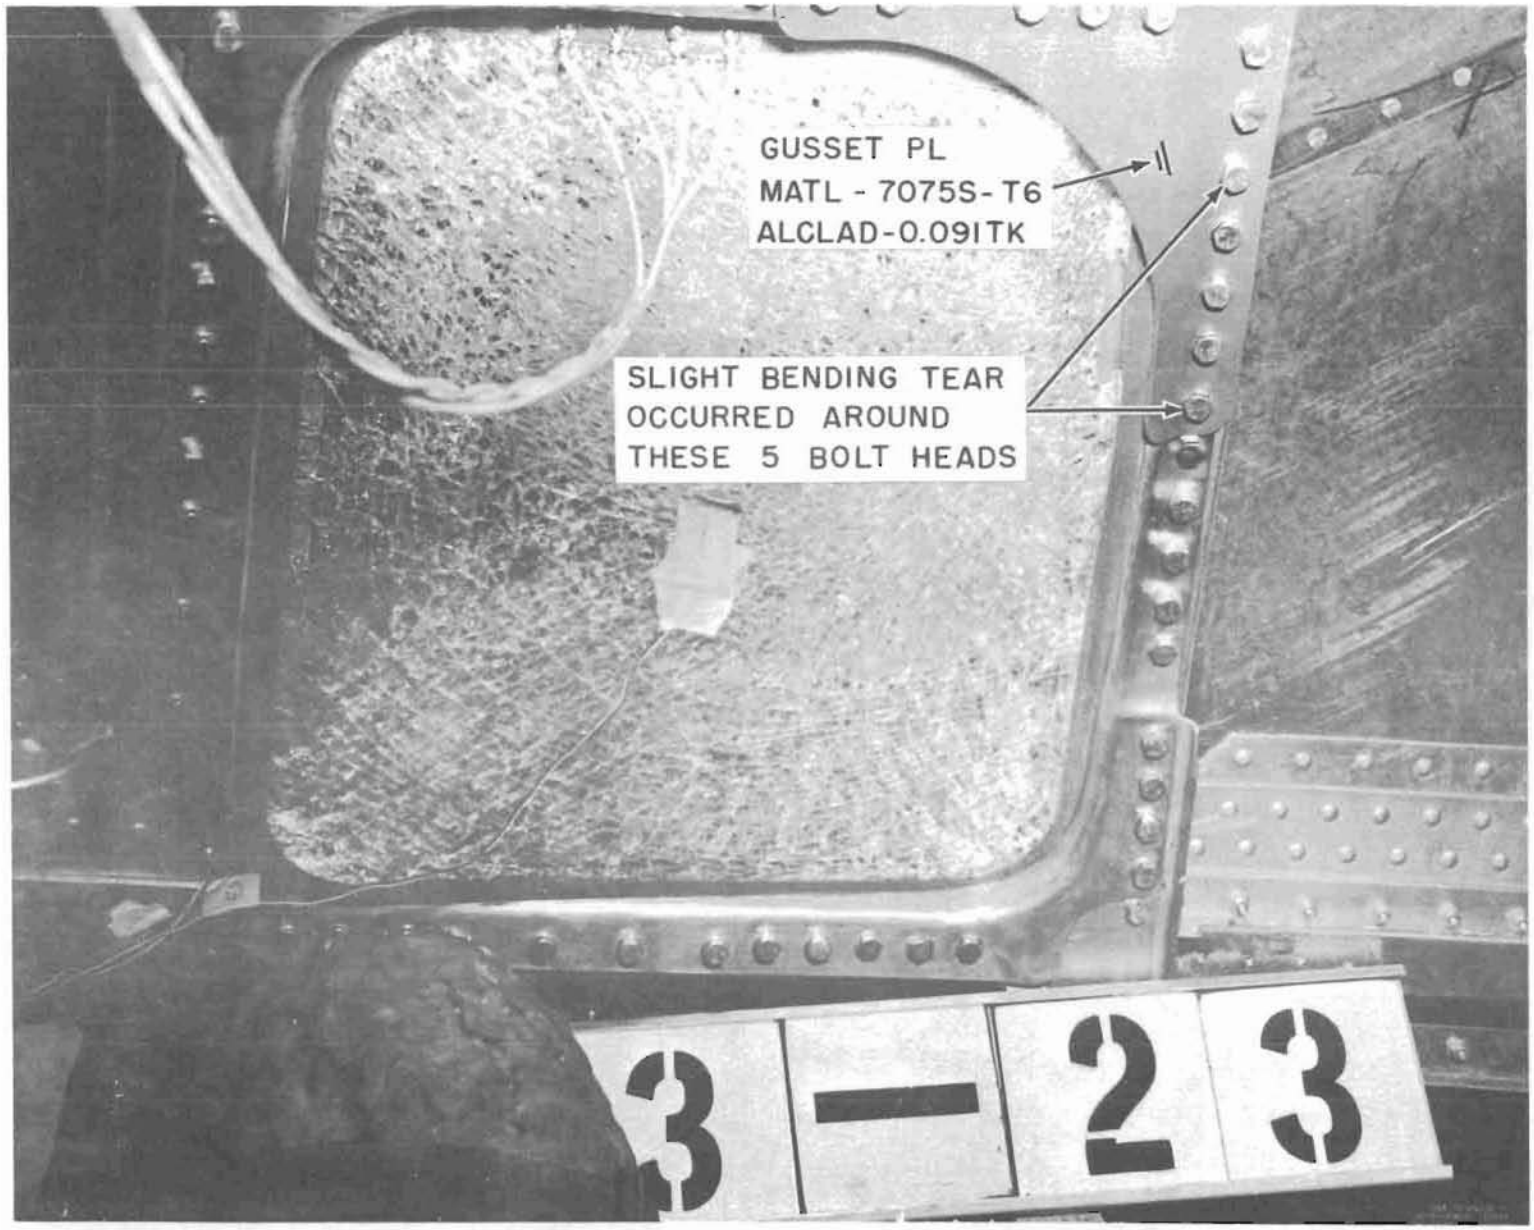
FIG. 18 TEST 3-23 - COPILOT EYEBROW WINDOW INTERIOR VIEW - PROJECTILE VELOCITY 397 MPH

Prior to this test, which involved the copilot's eyebrow window, the aft sill-frame, DAC Part No. 5642814, was increased further in strength by replacement with a DAC fabricated 0.125-inch-thick frame as shown in Fig. 5, and the addition of a steel reinforcing axle. Also, the upper aft corner retaining arrangement for the interior window panel was strengthened by the addition of a 0.091-inch-thick, 7075S-T6 gusset, as shown in Fig. 18. The bird carcass projectile struck slightly above and approximately 4 inches aft of the target point. There was no penetration of the window and no fracture of the 0.125-inch 7075-T6 aft sill-frame retaining the interior window. See Fig. 18. The frame had a 3/8-inch-deep permanent set pocket centered approximately 5 3/4 inches below the upper sill heel line causing the frame heel to roll 1/4-inch aft. A slight bending tear occurred around five bolt heads retaining the gusset and aft window edge. See Fig. 18. The exterior panel was shattered as shown in Fig. 19. Relatively few particles of glass impinged upon the copilot's head, predominantly on the top and upper right side. Only a few particles penetrated the clay. See Fig. 20.

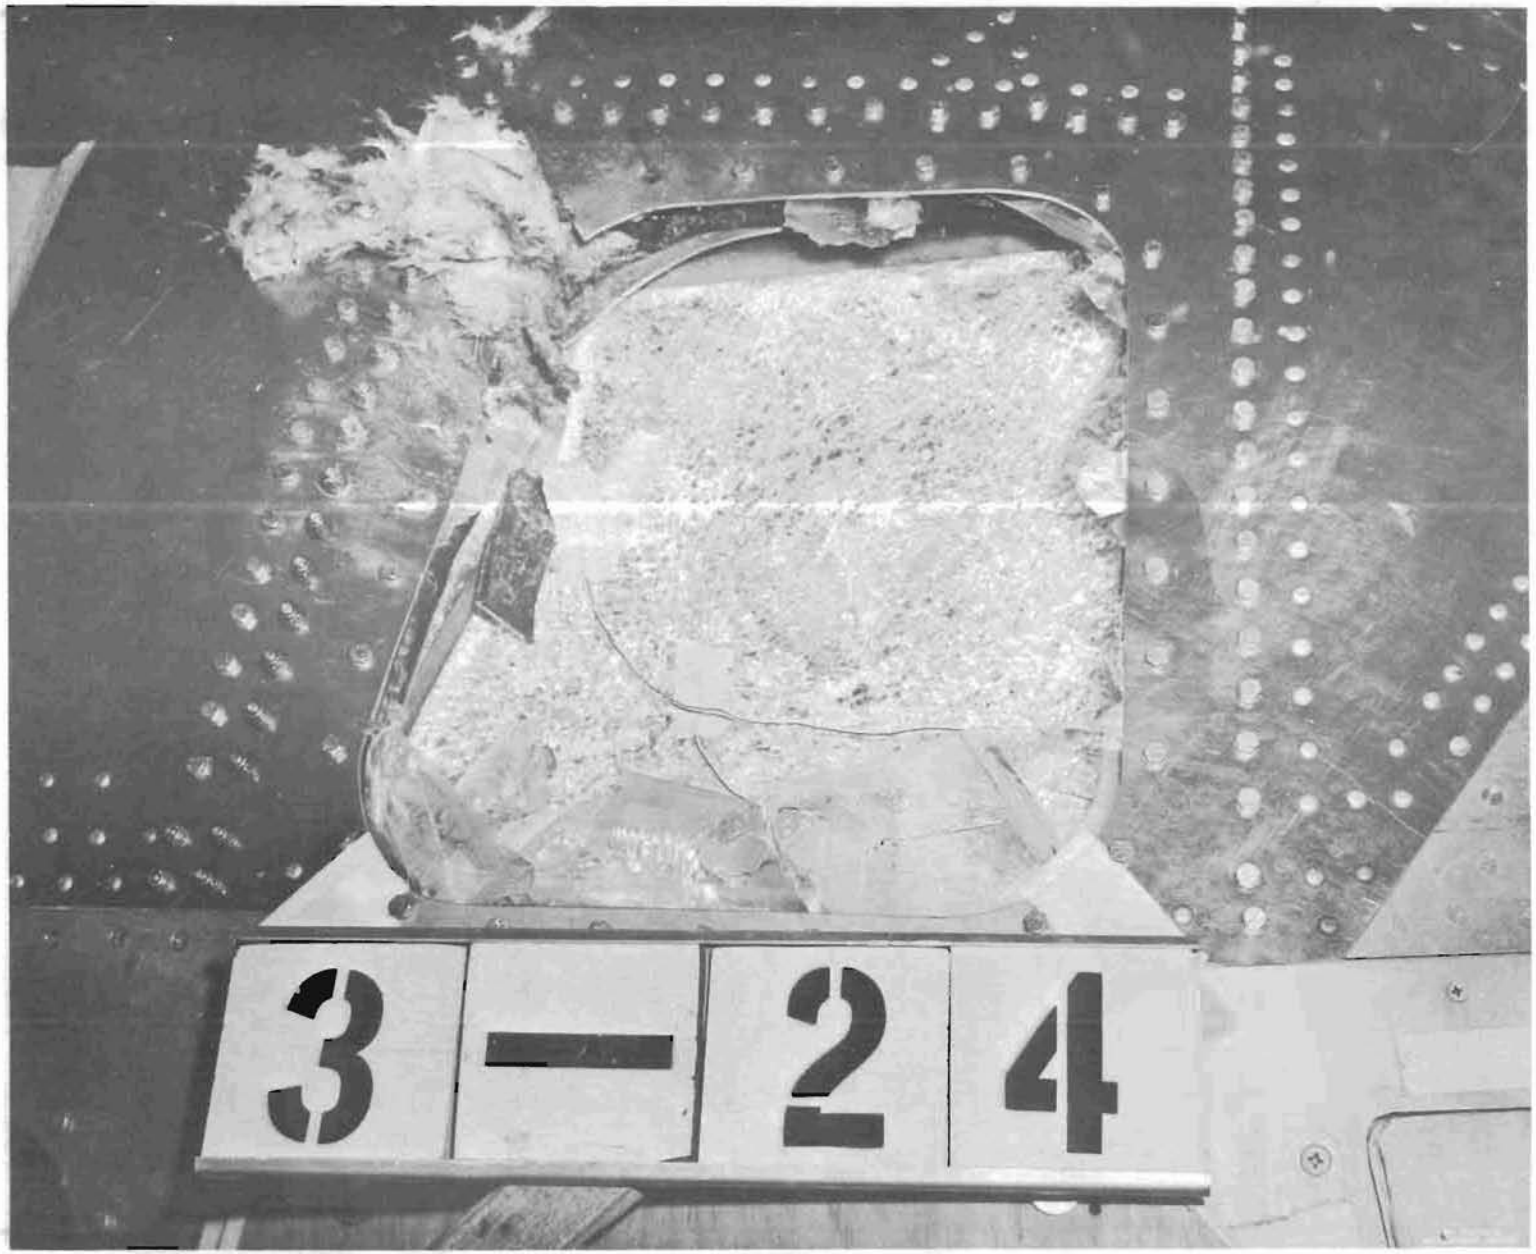
FIG. 21 TEST 3-24 - PILOT EYEBROW WINDOW, EXTERIOR WINDOW - PROJECTILE VELOCITY 432 MPH

Prior to this test, which involved the pilot's eyebrow window, the aft sill-frame, DAC Part No. 5642814, was modified further by using all DAC fabricated increased gauge parts as shown in Fig. 6, including the upper aft corner gusset plate which had a material change from 7075S-T6 alclad to 2024S-T3 alclad. The carcass struck just forward of the target point, which was the window centroid. Upon impact, the exterior stretched Plex panel

shattered and the skin and bolts retaining the panel were damaged, as shown in Fig. 21. There was no penetration of the interior panel although the vinyl interlayer delaminated for a 6-inch length along the aft sill, resulting in a slight tear in the vinyl. In addition, some bending tear occurred around the washers under the five lower bolt heads retaining the upper aft gusset plate. These two points of damage are shown in Fig. 22. Only a few particles of glass impinged upon the pilot's head. None penetrated the clay but merely adhered to it. The pilot is shown in Fig. 23.

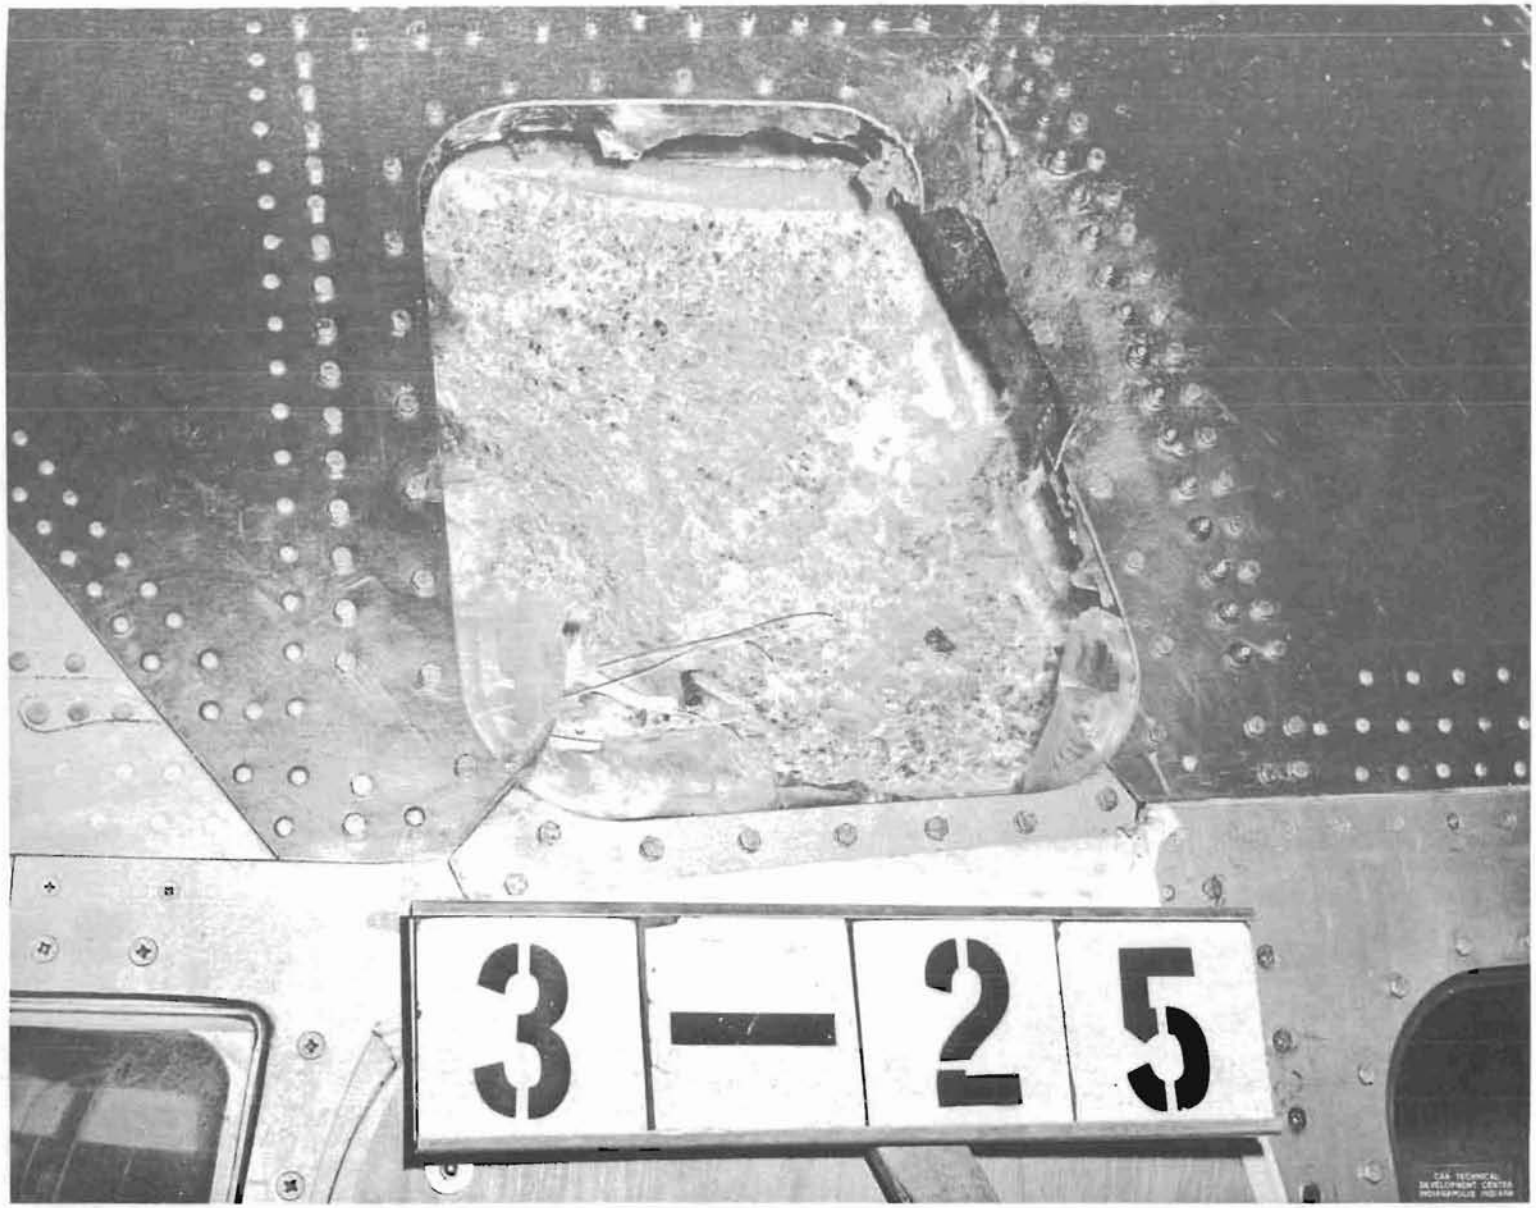
FIG. 24 TEST 3-25 - PILOT EYEBROW WINDOW, EXTERIOR VIEW - PROJECTILE VELOCITY 485 MPH

This test involved the pilot's eyebrow window. Modifications to the window supporting structure were identical to those of the preceding test. The carcass struck 3 inches forward and 2 inches below the target point. The exterior stretched Plex-55 panel was shattered and five bolts helping to retain the outer window failed in tension and bending as shown in Fig. 24. There was no penetration of the interior panel. See Fig. 25. A bending tear occurred around the 5 lower bolts bearing against the reinforcing gusset plate and around 11 bolts bearing against the aft window bolting edge. This is shown in Fig. 26. The interior panel vinyl interlayer delaminated for a length of 9 inches along the inner surface of the aft edge metal insert. The band between the metal insert and vinyl along the outer surface of the aft edge of the panel remained intact. A few particles of glass impinged upon the upper and back left side of the pilot's head. One sliver of glass about 1/4-inch long by 1/8-inch square at the large end penetrated the clay approximately 1/16-inch in this area. See Fig. 26A.

b. The upper and aft metal insert edge of the interior window is strengthened to equal that obtained by incorporating a 0.091-inch-thick 2024S-T3 gusset plate, as shown in Figs. 24 and 26.

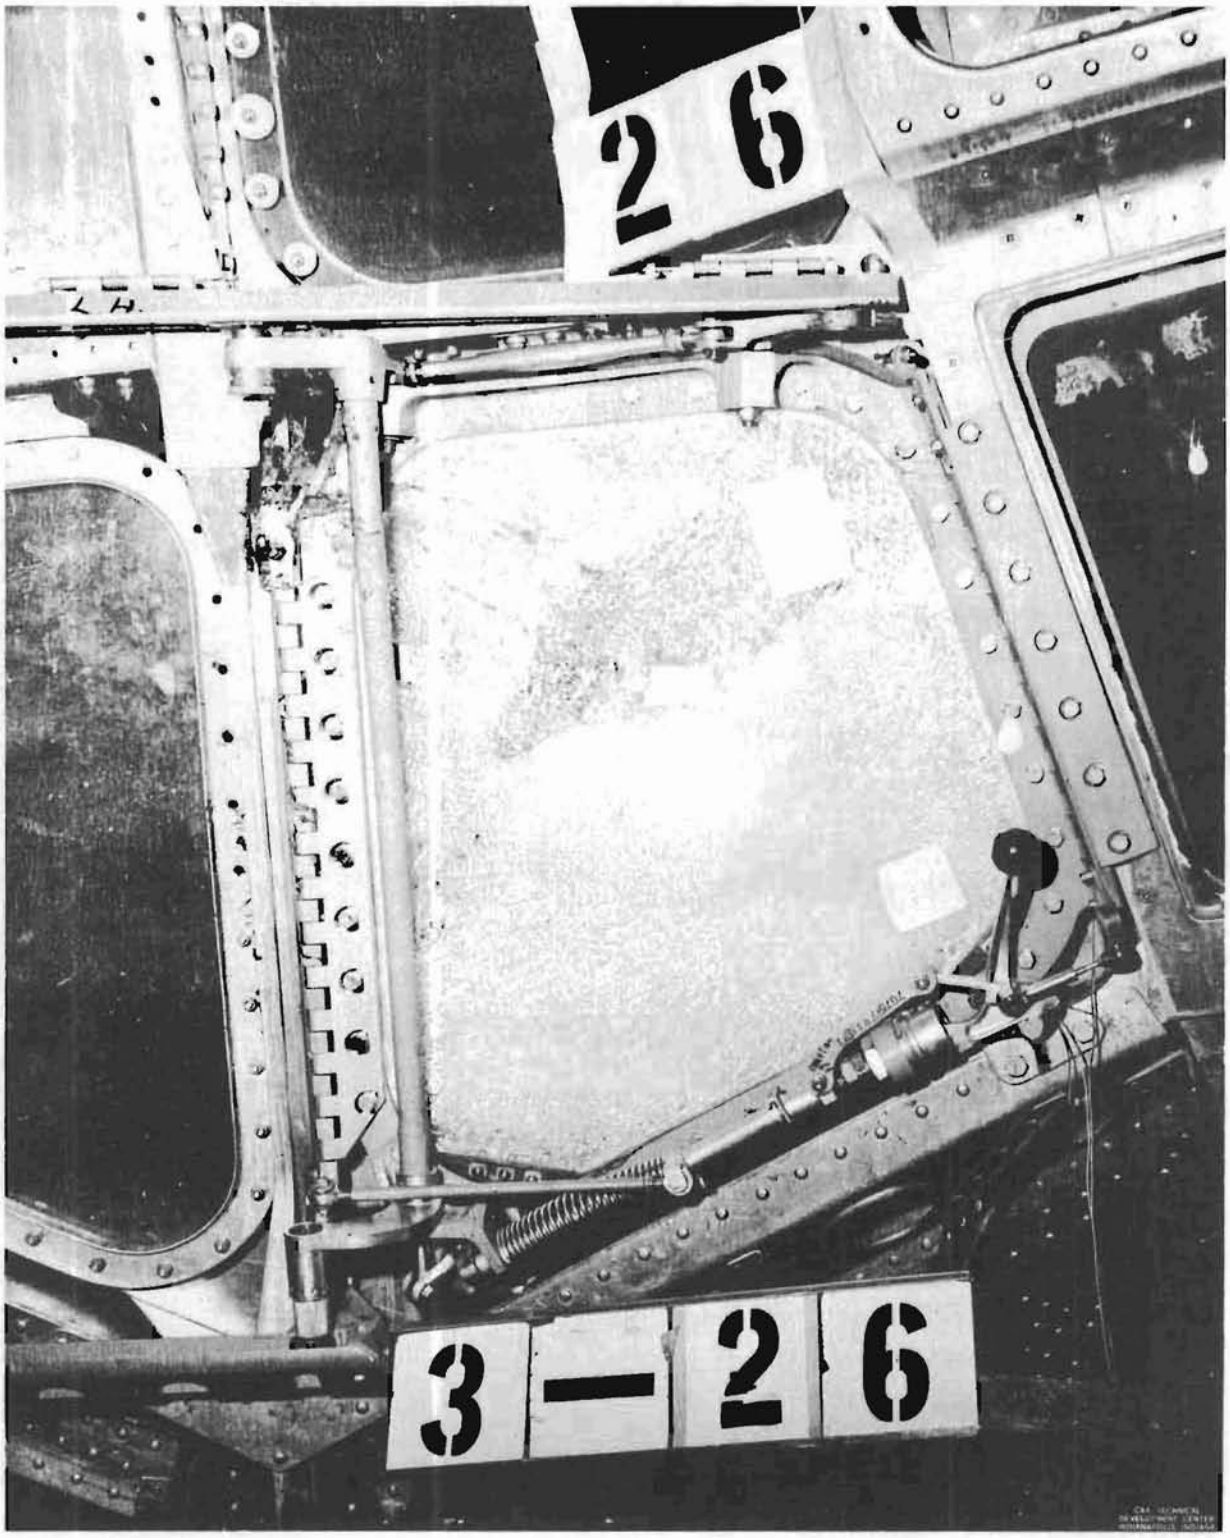
FIG. 28 TEST 3-26 - PILOT CLEAR-VIEW WINDOW, INTERIOR VIEW - PROJECTILE VELOCITY 430 MPH

This test involved the pilot's clear-view window. The bird carcass struck the target point shattering the exterior stretched Plex-55 panel and the hydraulic pressure rolled back the aft sill doubler plate, as shown in Fig. 27. Eighteen fasteners retaining the doubler plate failed by forming tuliped heads which allowed them to pull through the doubler material. This action allowed a relatively small part of the bird carcass to enter the cockpit area aft of the pilot position. There was no penetration of the interior window as shown in Fig. 28. The amount and velocity of the glass particles departing from the inner face of the interior window was low. None of these particles penetrated either the pilot's head or clothing although a few particles of bird carcass impinged upon the pilot as shown in Fig. 29. The latching mechanism for the window remained fastened and was operable immediately after the test.
