TECHNICAL DEVELOPMENT REPORT NO. 374

Bird Impact Tests of the Douglas Model DC-8 Airplane Eyebrow And Clear-View Windows

January 1959

FEDERAL AVIATION AGENCY
TECHNICAL DEVELOPMENT CENTER
INDIANAPOLIS, INDIANA

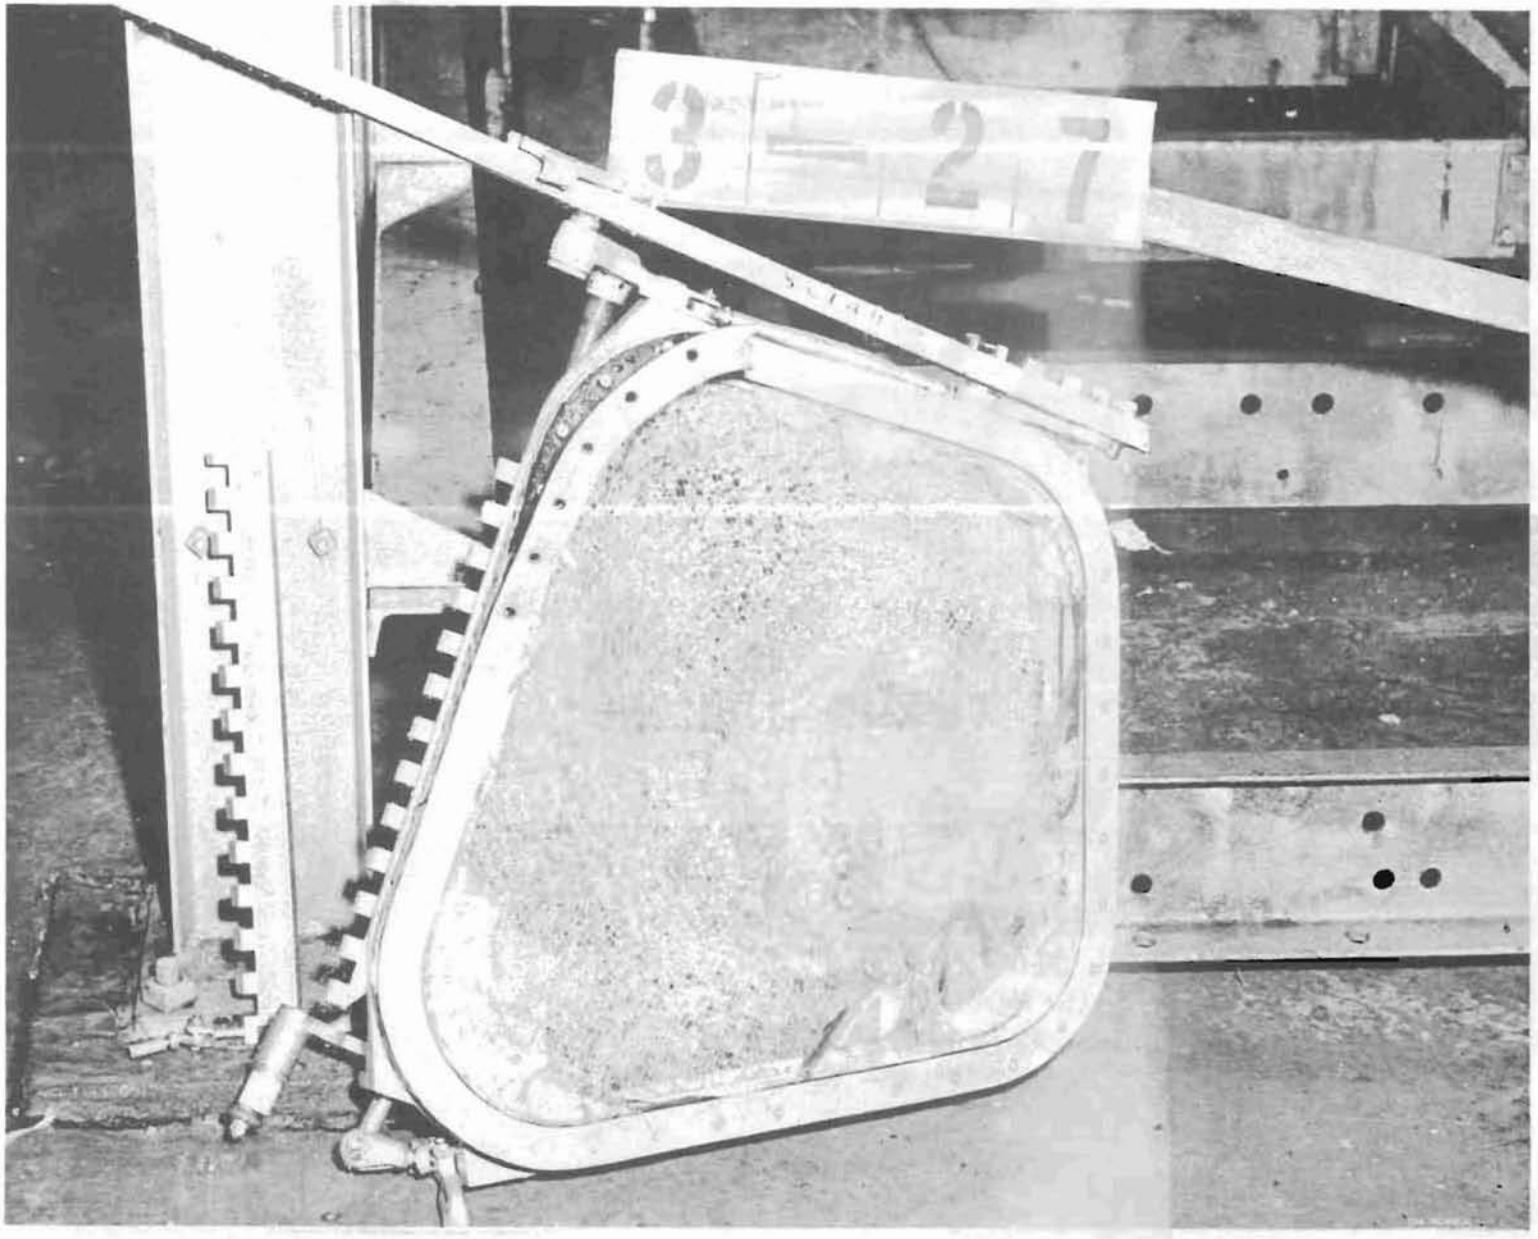
FIG. 30 TEST 3-27 - COPILOT CLEAR-VIEW WINDOW, EXTERIOR PANEL - PROJECTILE VELOCITY 485 MPH

This test involved the copilot's clear-view window. The bird carcass hit approximately 3 inches forward of the target point. Upon impact, the exterior panel shattered and the interior panel remained intact, as shown in Fig. 30. The force of the impact loaded the aft window hook in such a manner that the 0.130-inch steel hinge pin failed in shear. As expected, the high-speed movies of the test indicated that failure occurred initially at the upper end of the hinge and progressed rapidly

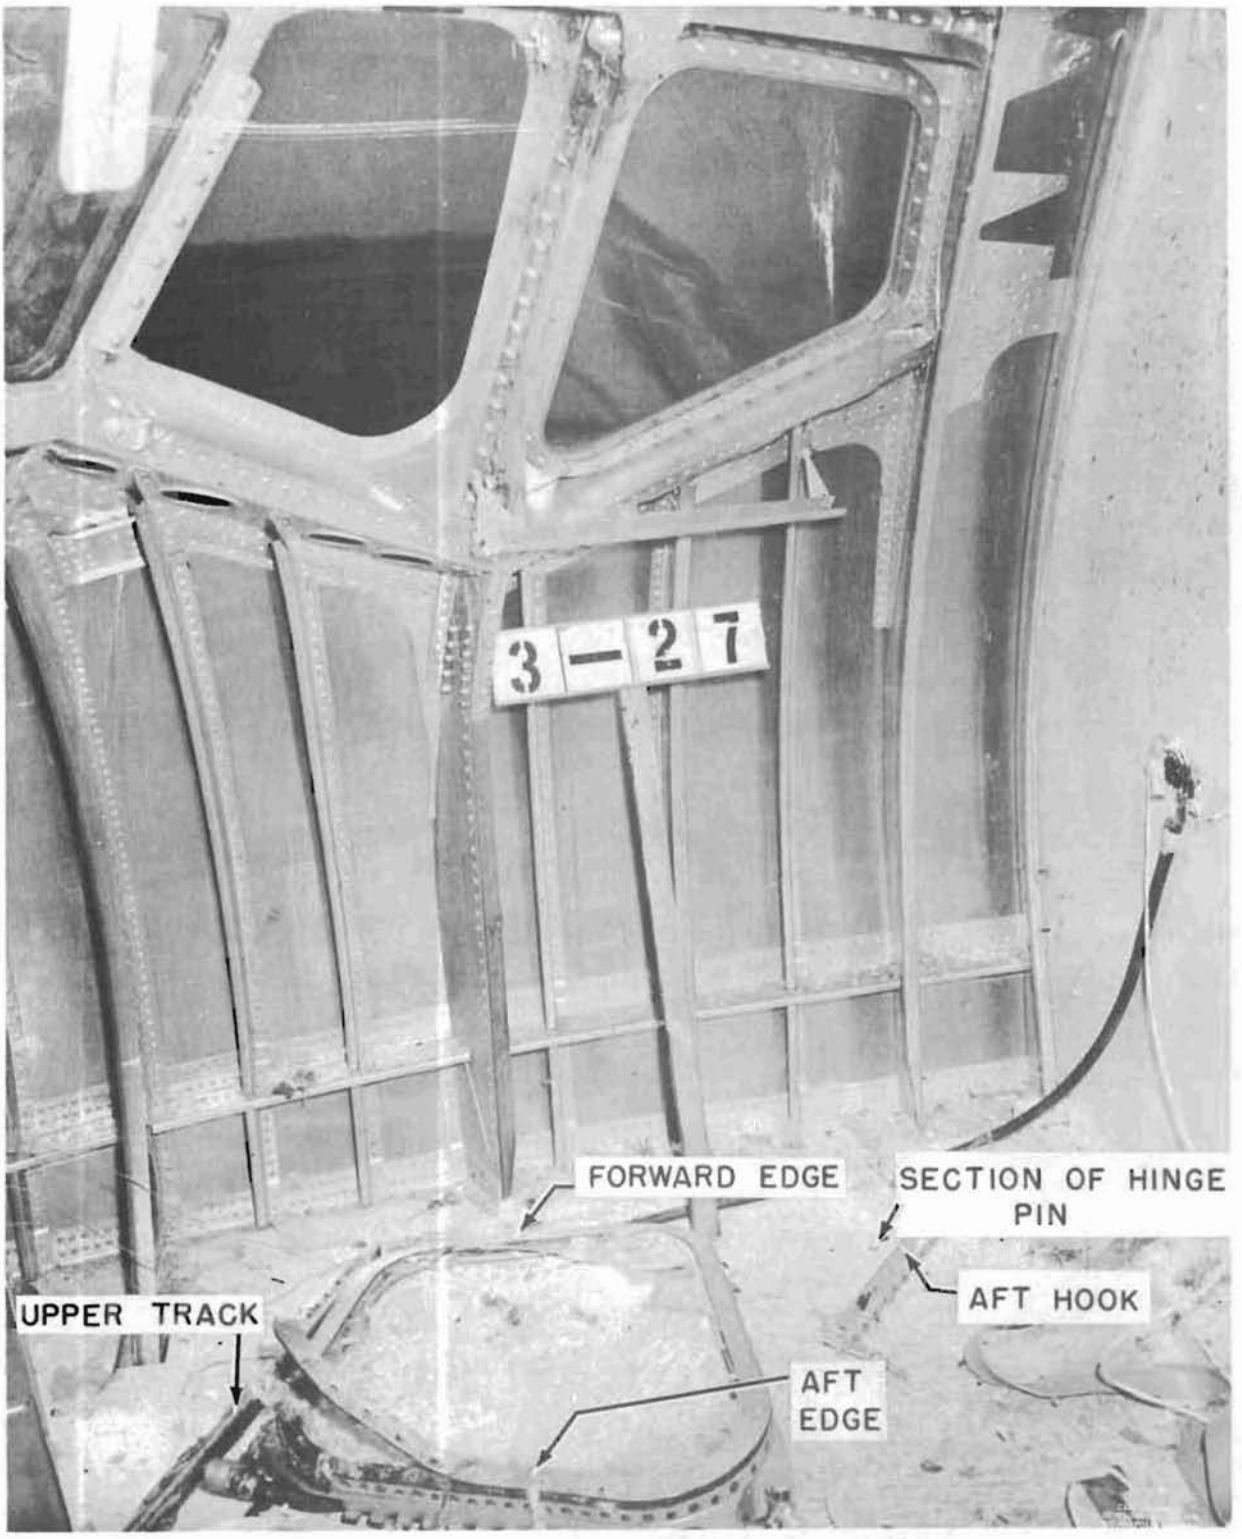
FIG. 32 TEST 3-27 - COPILOT CLEAR-VIEW WINDOW, EXTERIOR VIEW - PROJECTILE VELOCITY 485 MPH

downward zipper fashion. This allowed the upper sill hook to unlatch and the window was forced inward striking the copilot a severe blow on the right side of the head, as shown in Fig. 31. The hook hinge halves were not damaged, however. The final disposition of the window and associated parts is shown in Fig. 32.

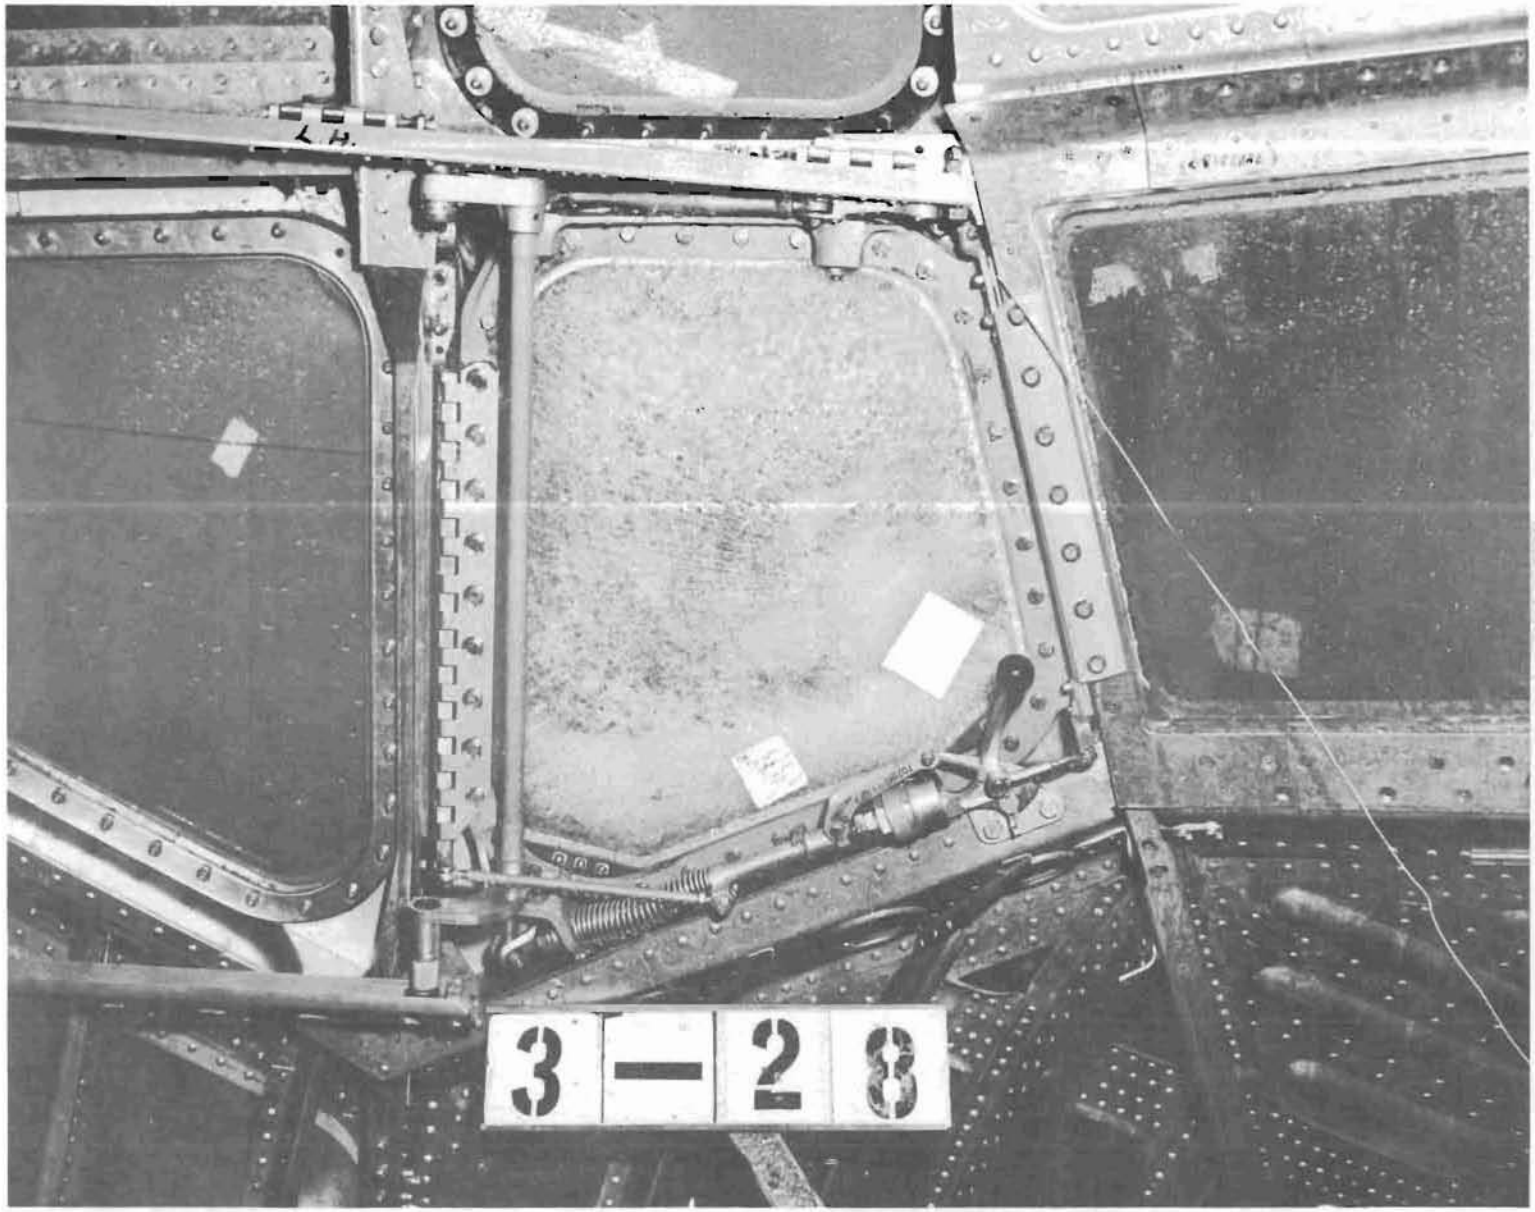
FIG. 34 TEST 3-28 - PILOT CLEAR-VIEW WINDOW, INTERIOR VIEW - PROJECTILE VELOCITY 481 MPH

Prior to this test, which involved the pilot's clear-view window, the hinge pin for the aft window latch was increased in size to 0.180-inch diameter, as shown in Fig. 3. The bird carcass hit approximately 2 inches below and 3 inches forward of the target point. The exterior panel shattered completely and the aft doubler plate facing was rolled back slightly as 13 fasteners failed. This is shown in Fig. 33. A small amount of bird carcass extruded through the opening at the upper aft corner of the window. That part of the carcass which extruded into the cockpit passed to the rear of the pilot. There was no penetration of the interior panel, as shown in Fig. 34. High-speed movies of this test indicated that flying glass from this panel was noticeably greater in both quantity and velocity compared with Test No. 3-26. None of the glass penetrated the pilot's head or clothing and none was directed toward the pilot's eye area. The track and latches were all functional. After impact, the window was opened and moved aft to check operation. See Fig. 34A.

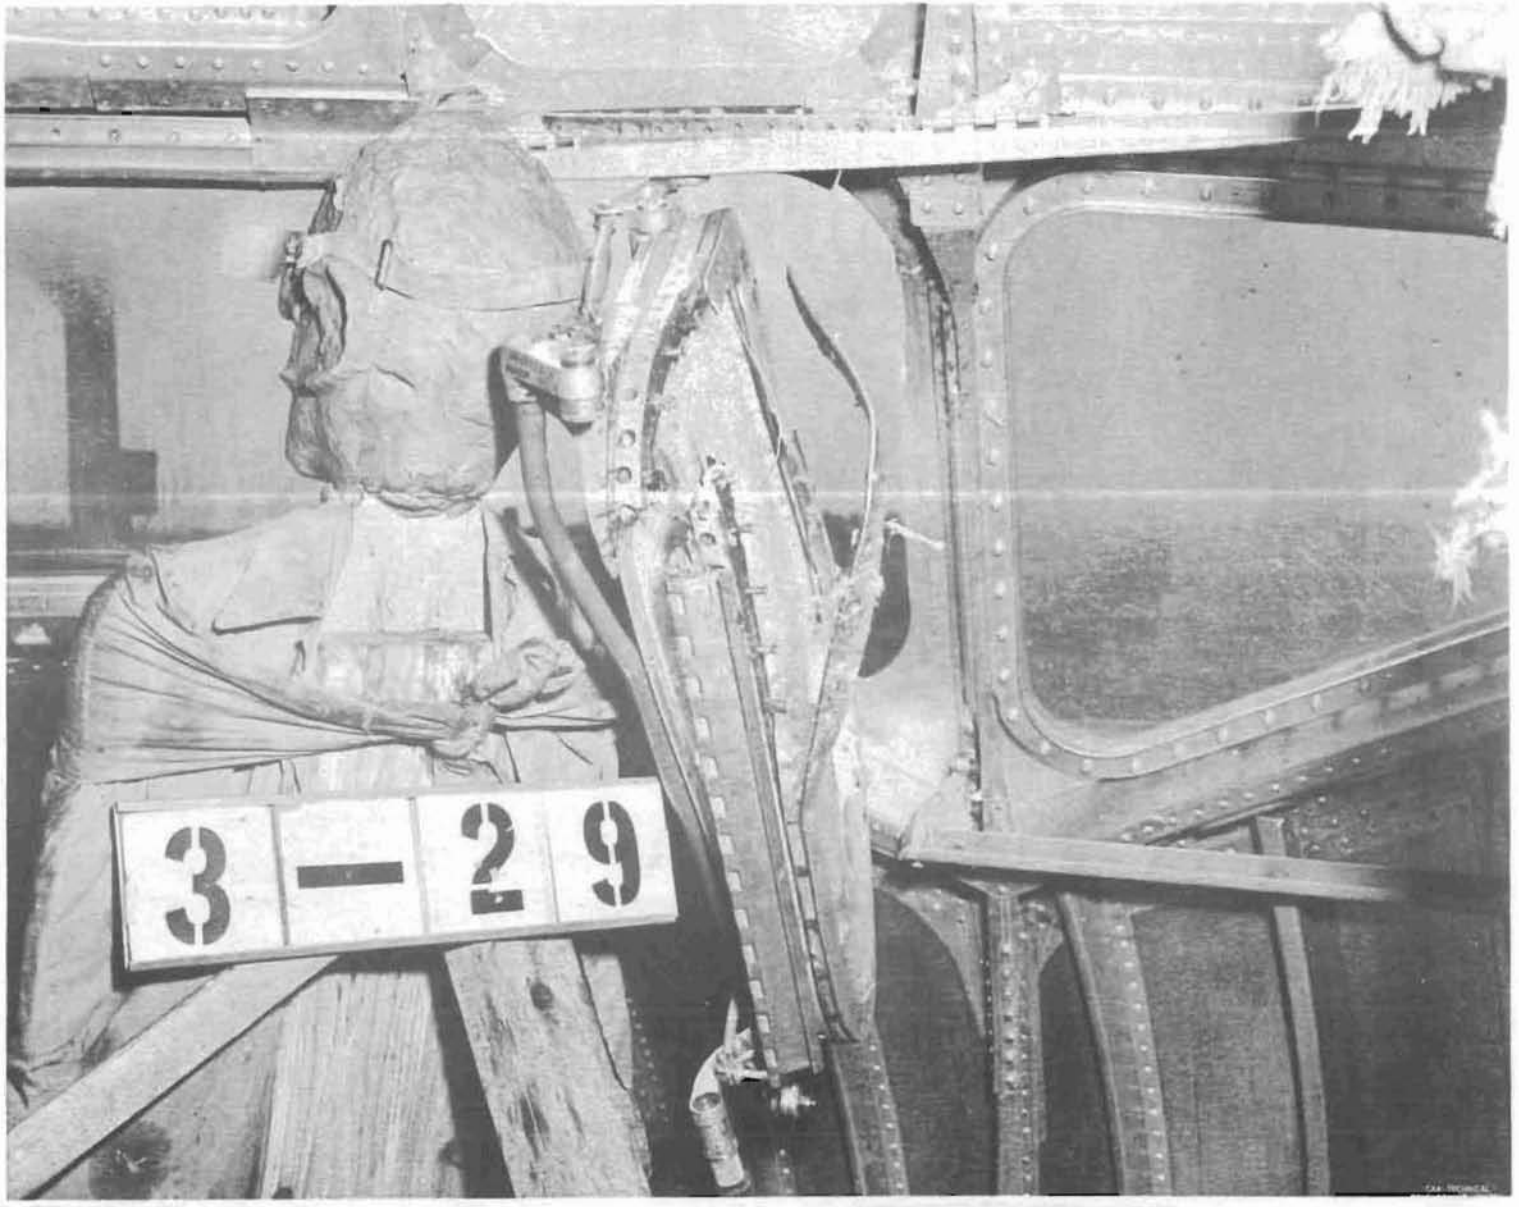
FIG. 35 - TEST 3-29 - COPILOT CLEAR-VIEW WINDOW - PROJECTILE VELOCITY 486 MPH

Prior to this test, which involved the copilot's clear-view window, the successful operation of the aft full-length latch suggested a possibility of the elimination of the upper sill latching hook, and DAC Part No. 3641243 was removed. Upon impact the two support points at the forward and aft latches were not sufficient to contain the bending of impact which resulted in fracture of the window frame. The window was forced open, hitting the copilot on the side of the head. See Fig. 35. High-speed movies of the test indicated that hydraulic pressure from bird carcass fluids forced the window inward at the upper aft corner. The excessive bending resulted in fracture of the window frame, as shown in Fig. 35, thereby allowing the aft hook to become disengaged. Inspection of the side of the copilot's head showed no large indentations in the clay, thereby indicating that the window frame had lost most of its kinetic energy at the time of contact. As shown in Fig. 36, the aft doubler facing was not damaged as severely as in tests in which the window remained locked in position.
