**DOT/FAA/AR-04/28**

# **Turbine Engine Fan Disk Crack Detection Test**

September 2004

Final Report

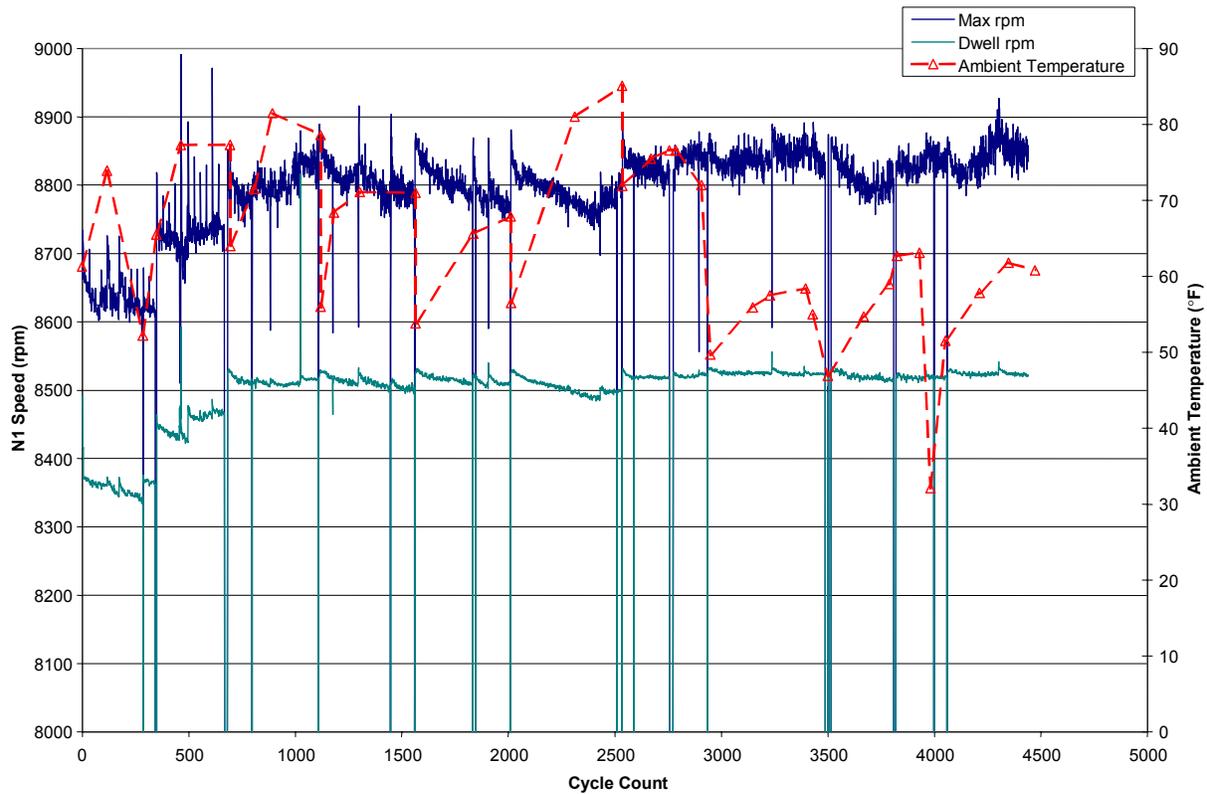
FIGURE 14. N1 SPEED VS CYCLE COUNT

After the first 285 cycles at approximately 2500-8500 rpm, the T2 simulator setting was changed so that the airflow limiter allowed a higher N1 rpm. The target speed for the airflow limiter was 8800 rpm. However, the T2 simulator temperature was raised in small increments (5°F) to prevent overshooting the desired rpm. The T2 temperature was increased to 40°F after approximately 695 cycles and maintained at that temperature until the conclusion of the test. Figure 14 shows the peak and sustained rpm values throughout the seeded fault testing (courtesy of Hood Technologies). Several spikes are noticeable. A broken T2 simulator wire caused the first spike in the rpm. The N1 speed reached as high as 9050 by one participant's estimation. Several other less severe spikes occurred on start-up. Figure 15 shows the distribution of the maximum N1 rpm for all cycles after the T2 simulator was set to 40°F. The mean peak N1 speed was 8816 with a standard deviation of 31.2 rpm. The ambient temperatures are also plotted in figure 14, but no trends indicating a relationship in N1 speed variation and ambient temperature are evident.

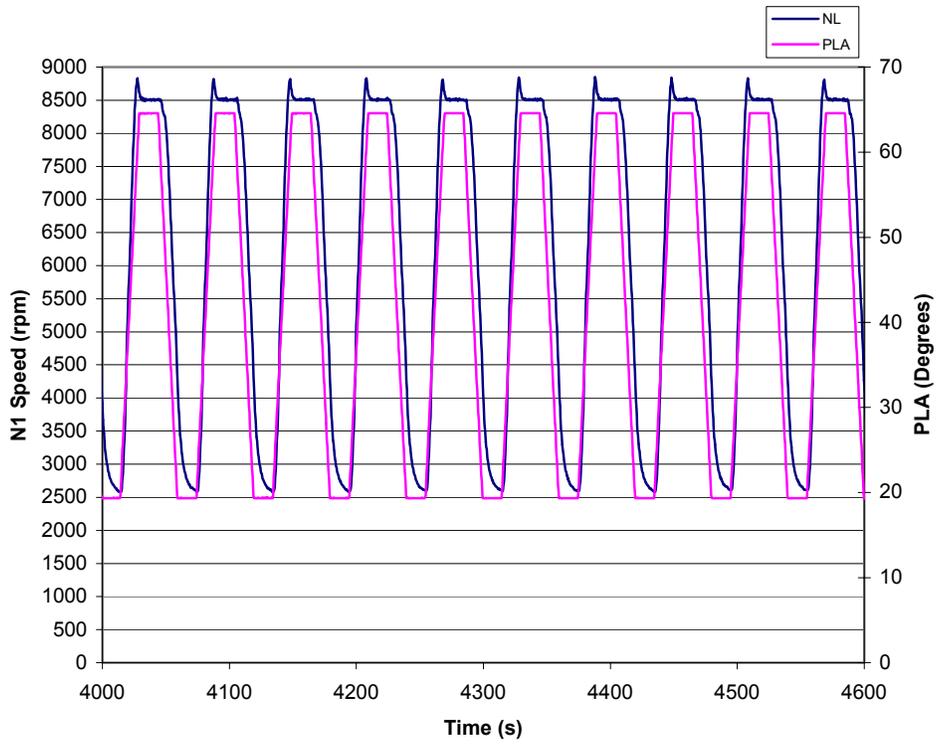
FIGURE 16. SAMPLE ENGINE POWER CYCLE DATA

Smaller spikes were present in every engine throttle cycle (figures 16 and 17). This overshoot was a consequence of the method chosen to control rpm speeds. The airflow limiter allowed an overshoot of the N1 and N2 speeds by an average of 300 rpm before invoking the rpm limit. Figures 16 and 17 show N1 and PLA values for typical engine cycles during the seeded fault testing. The data presented was extracted from the data file named 04\_03\_03a.txt. The overshoot of N1 rpm occurred even when the throttles were advanced slowly.
