**FULL-SCALE DYNAMIC CRASH TEST  
OF A  
DOUGLAS DC-7 AIRCRAFT**

**TECHNICAL REPORT**

**APRIL 1965**

**Aviation Safety Engineering and Research  
Division of Flight Safety Foundation, Inc.  
Phoenix, Arizona**

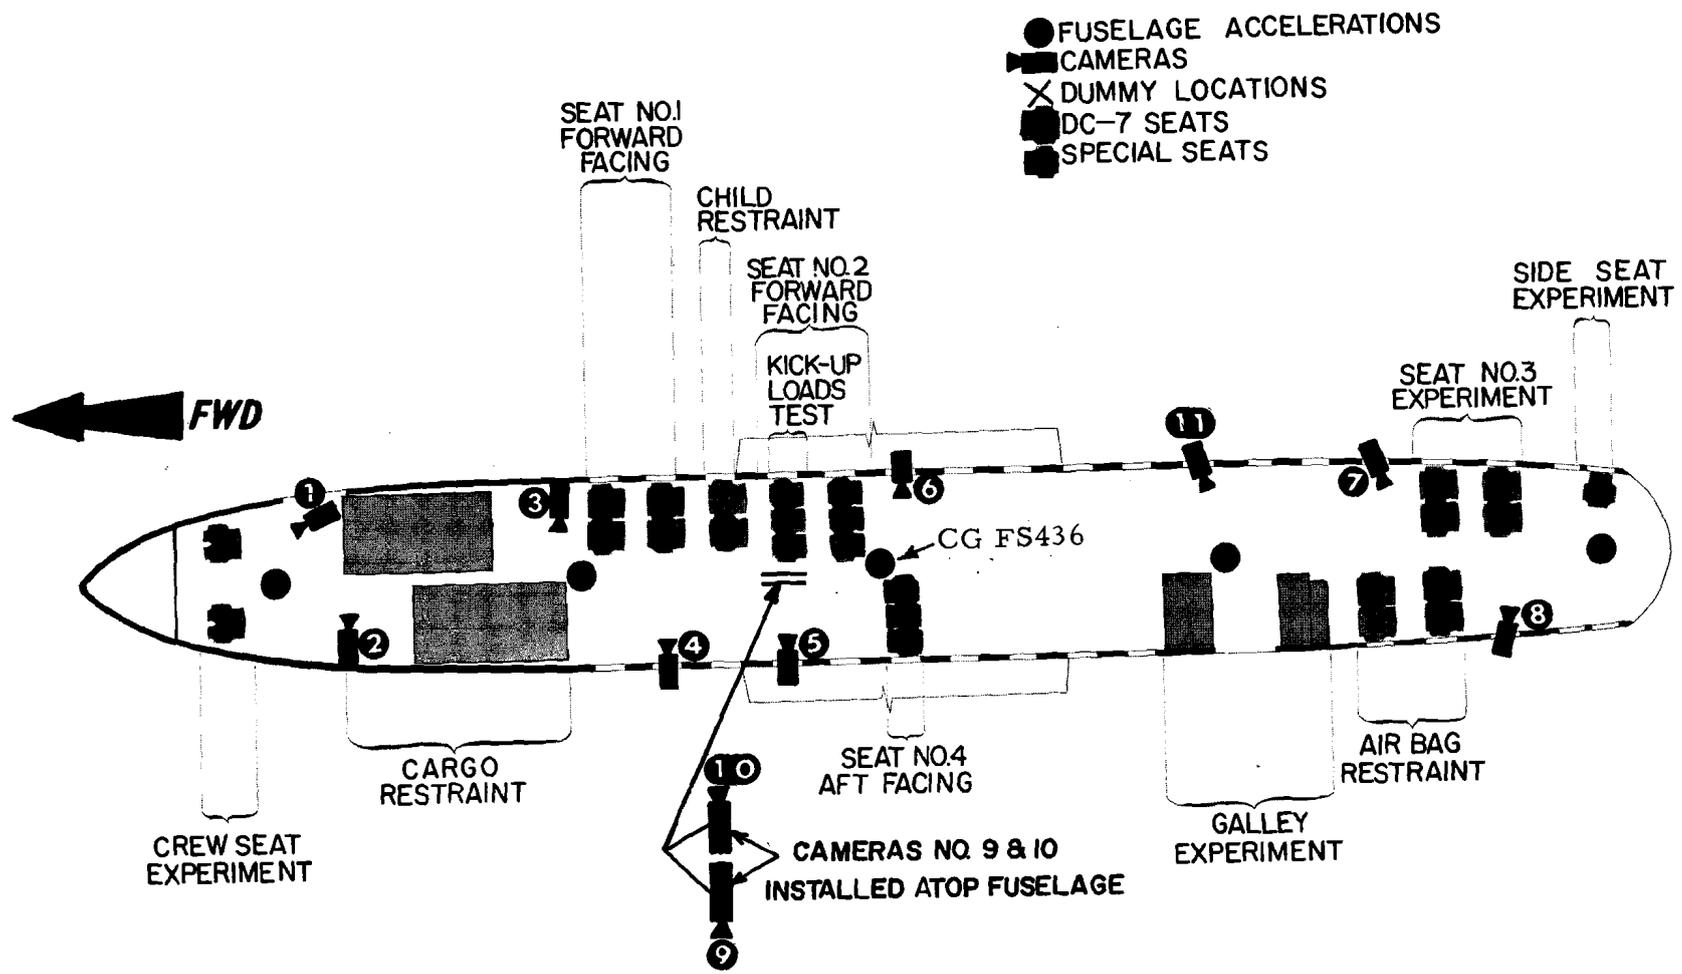
FIG. 21 ONBOARD EXPERIMENT AND CAMERA LOCATIONS

Only partial data was obtained from two of the onboard cameras, Nos. 3 and 4 in Figure 21. Both of these camera mounts failed, allowing the cameras to point away from the intended fields of view. Camera No. 3 was located in the aircraft near the structural failure at fuselage station 300 and its mount failed when the fuselage broke. The mount for camera No. 4 was struck by a part of the propeller from No. 3 engine which passed through the fuselage at that point.

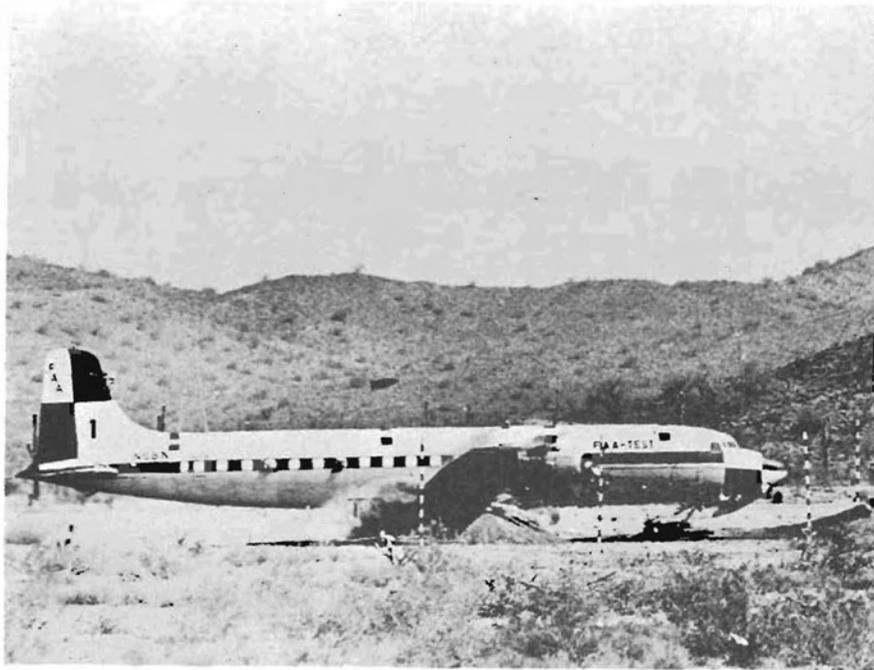
FIG. 22 NOSE AND MAIN GEAR CONTACT WITH BARRIERS

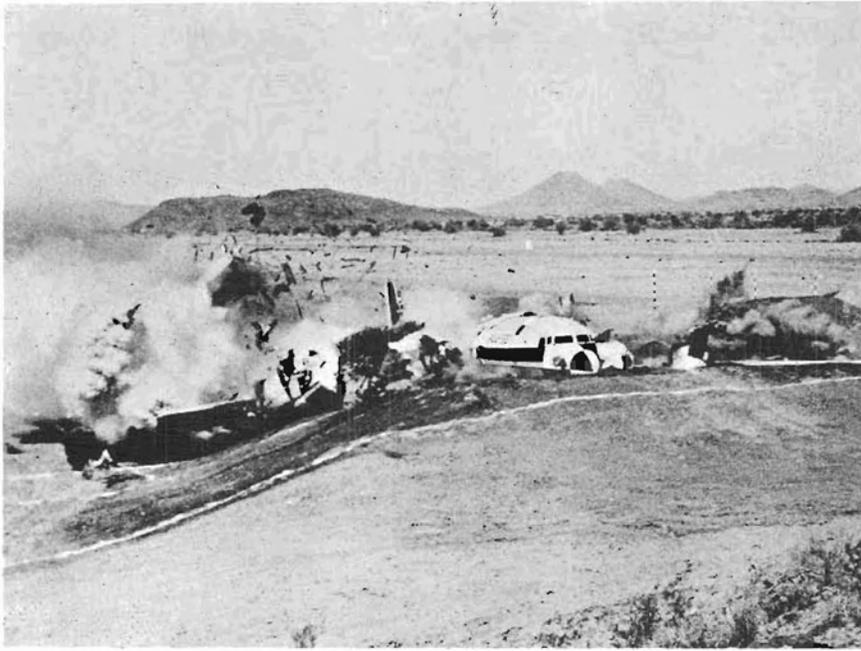
FIG. 24 IMPACT WITH 8 DEGREE IMPACT SLOPE

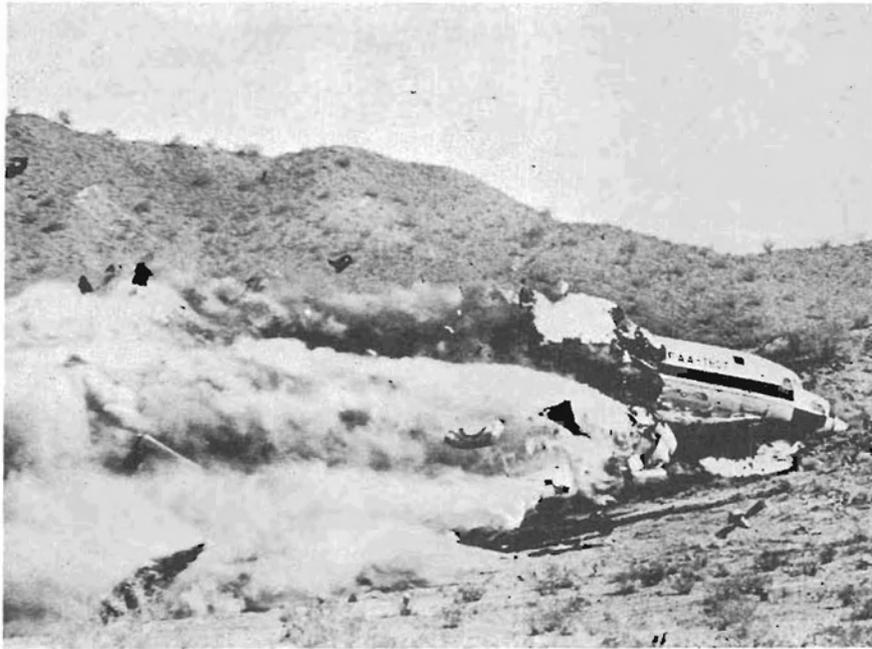
FIG. 26 IMPACT WITH SECOND HILL (20 DEGREE SLOPE)

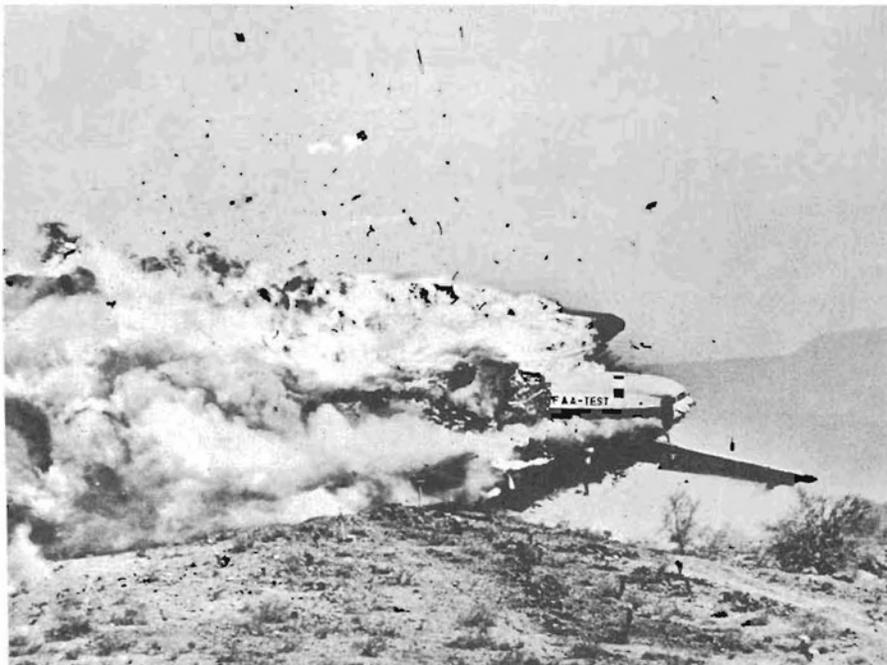
The aircraft bounced over the summit of the hill, as shown in Figure 27. Final impact occurred on the back side, at the foot of the hill. The main portion of the aircraft came to rest 860 feet from the point of initial contact with the main landing gear barriers. In Figure 28, the large section of the aft fuselage is shown lying on its left side. While passing over the summit of the hill, the left wing, torn completely free, flew ahead of the fuselage, as shown in Figure 27, and impacted approximately 50 feet ahead of the main fuselage. During this sequence, the wing rotated laterally 180 degrees and impacted in an inverted position. The right wing remained tied to the fuselage by the control wires and came to rest right side up in approximately its normal position. The bulk of the fuselage (aft section) came to rest at a 45-degree angle to the flight path and rolled over on its left side. The tail section of the aircraft broke partially

FIG. 27 AIRCRAFT BOUNCING OVER SECOND HILL

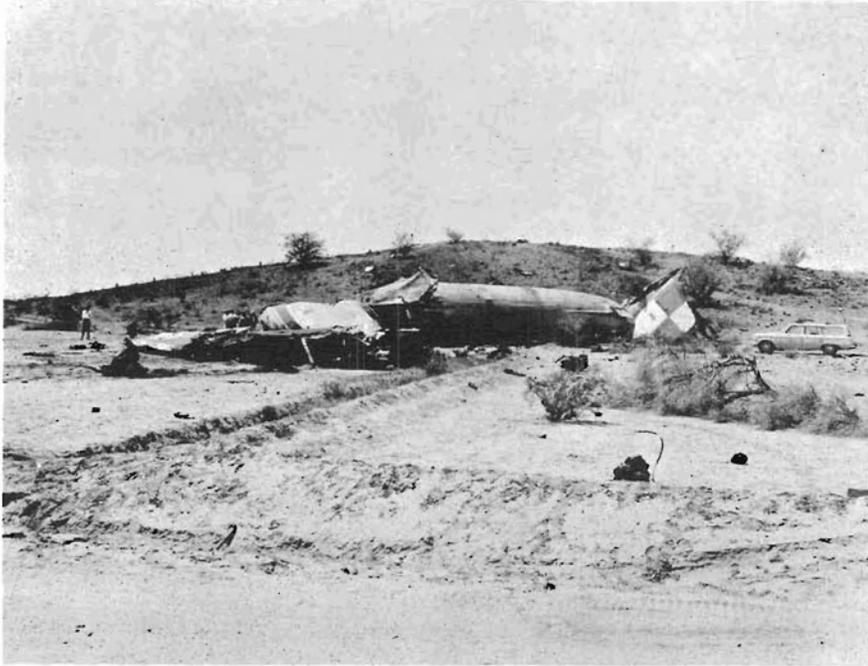
free of the main fuselage just behind the aft pressure bulkhead and rolled further to the left than the main fuselage, as shown in Figure 28. The wreckage distribution during the crash sequence has been plotted on a wreckage distribution chart, Figure 29. Although a large number of smaller parts were scattered over the crash course, most of the large pieces remained together during the entire sequence and came to rest in a small area on the center line of the original path. Sequence pictures of the crash are shown in Figures 30 and 31.

FIG. 28 FINAL POSITION OF FUSELAGE

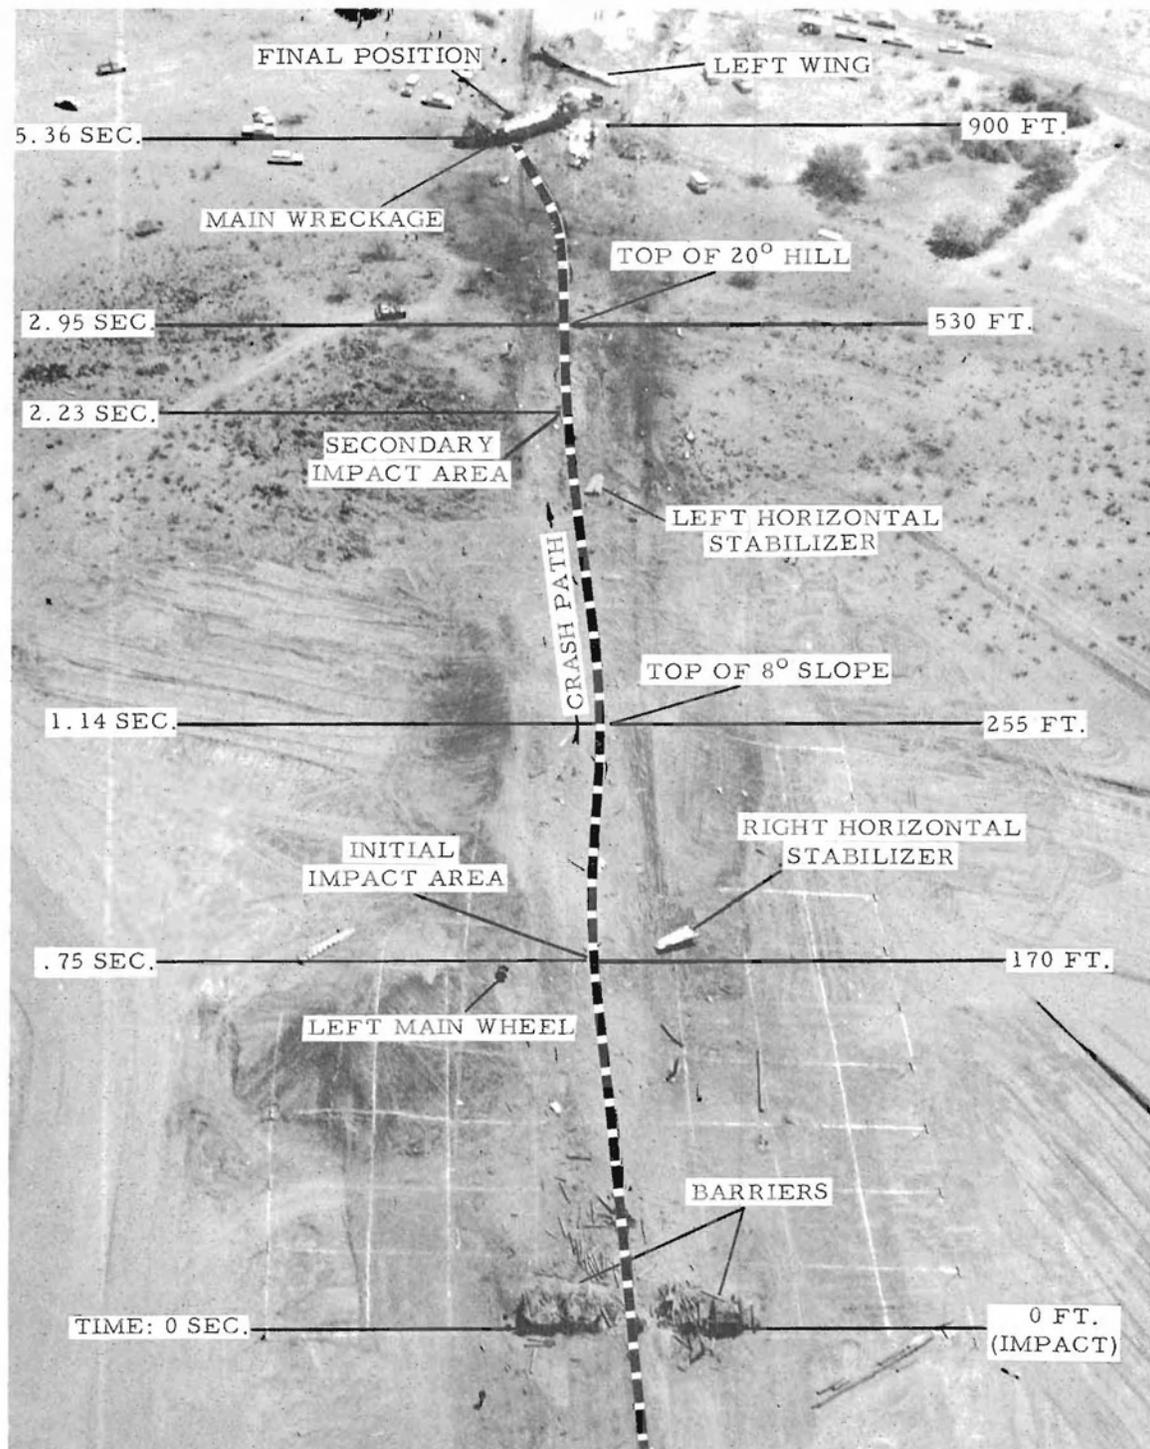
FIG. 29 WRECKAGE DISTRIBUTION PATTERN

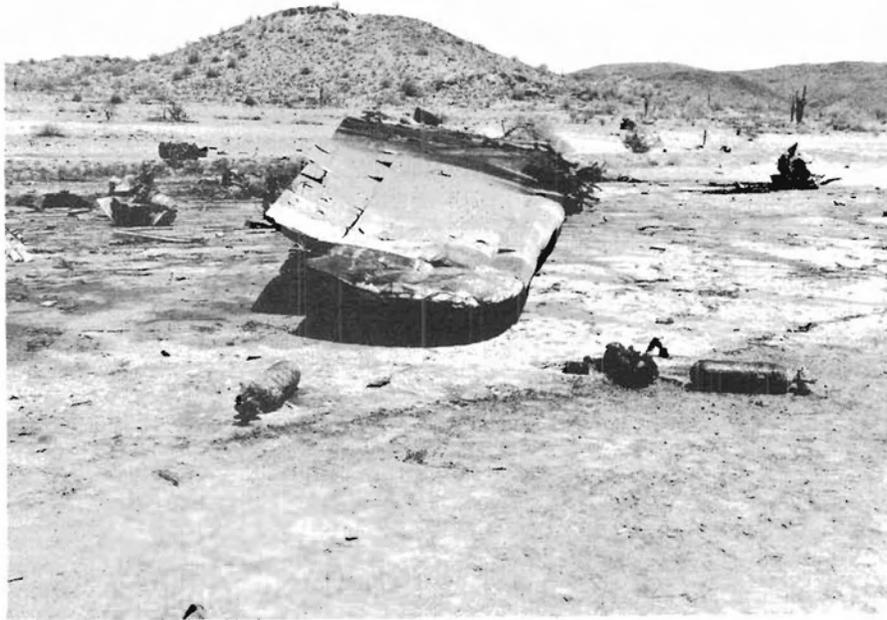
FIG. 32 POSTCRASH VIEW OF LEFT WING WHERE IT CAME TO REST LYING 50 FEET AHEAD OF MAJOR AIRCRAFT WRECKAGE

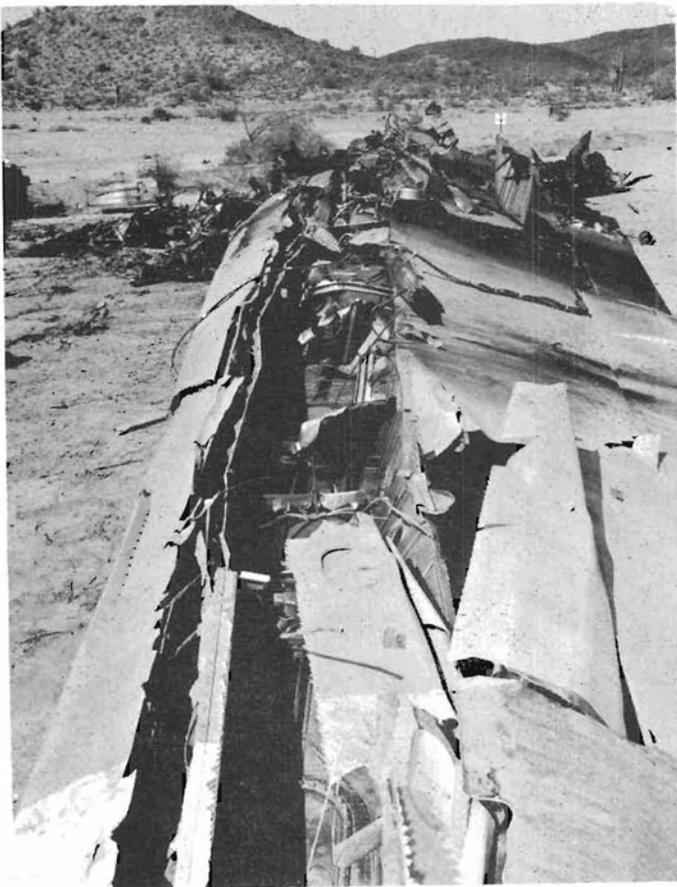
FIG. 33 SPANWISE SEPARATION OF UPPER SKIN ON LEFT WING AS VIEWED FROM WING TIP TOWARD WING ROOT AREA

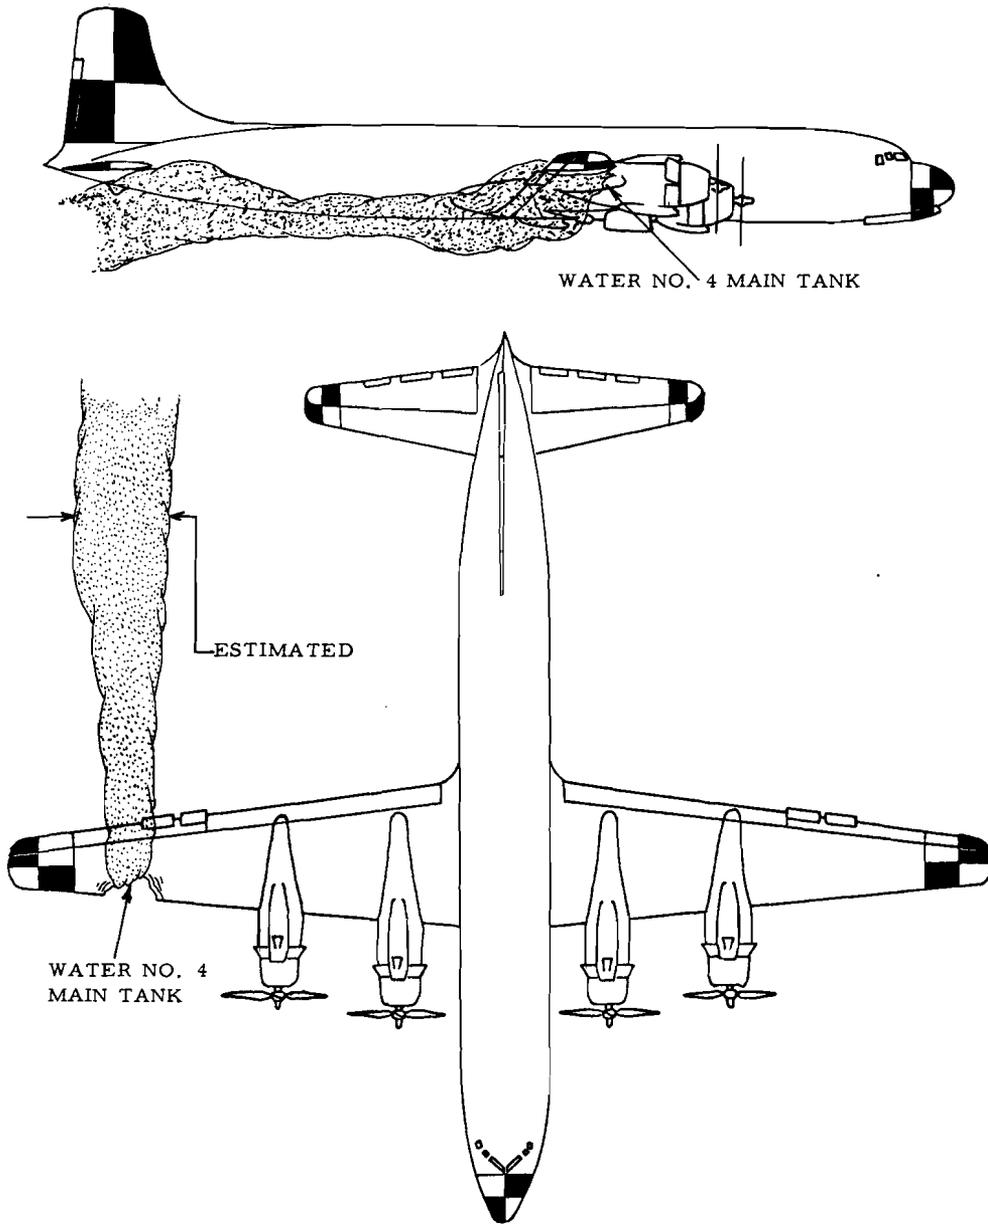
2. In crashes of aircraft with fuel tanks and structure similar to the DC-7 aircraft, the fuel spillage and spray patterns which result from fuel tank damage will be similar to that obtained in this test, and will, to a large extent, surround the aircraft, both while it is in motion and after it comes to rest.

FIG. 37 FUEL SPILLAGE PATTERN 2.00 SECOND AFTER INITIAL IMPACT

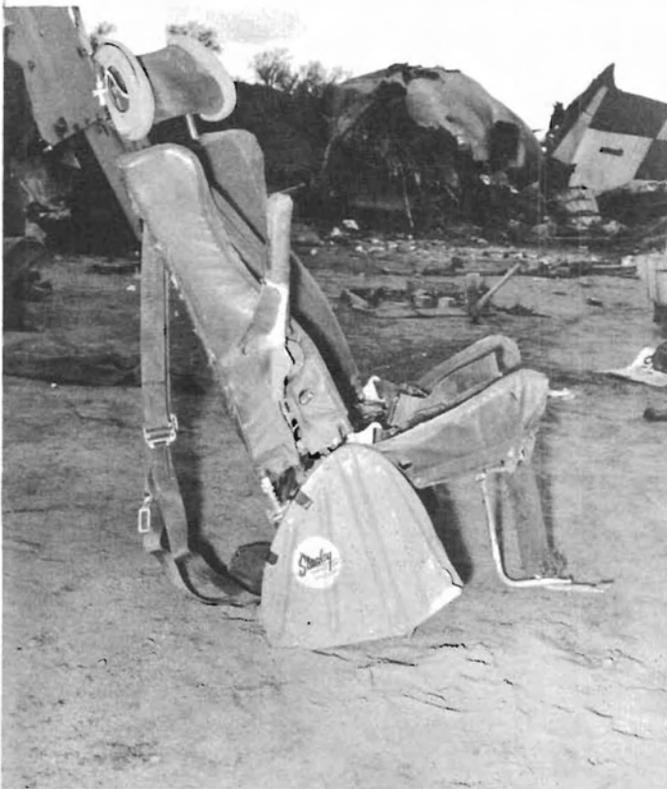
FIG. 44 RIGHT SIDE VIEW  
OF PILOT SEAT  
AFTER REMOVAL  
FROM WRECKAGE

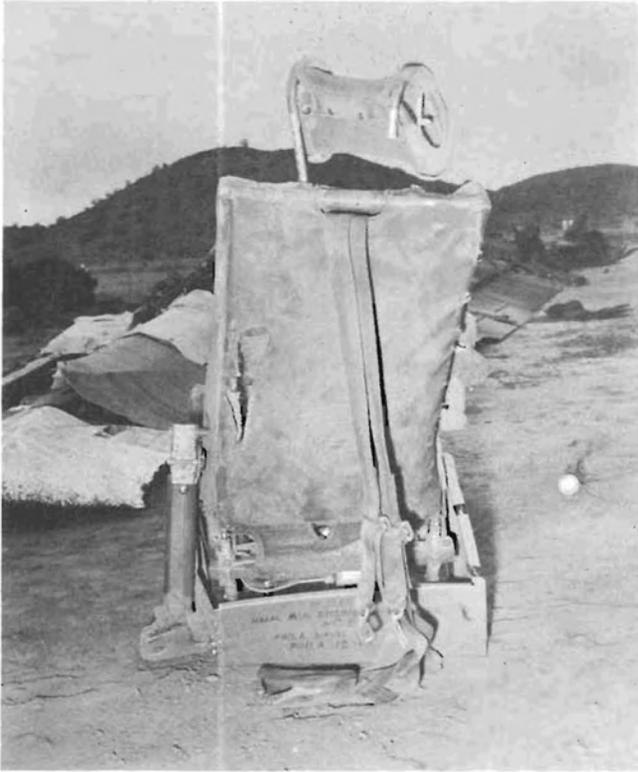
FIG. 46 REAR VIEW OF  
PILOT SEAT AFTER  
REMOVAL FROM  
WRECKAGE

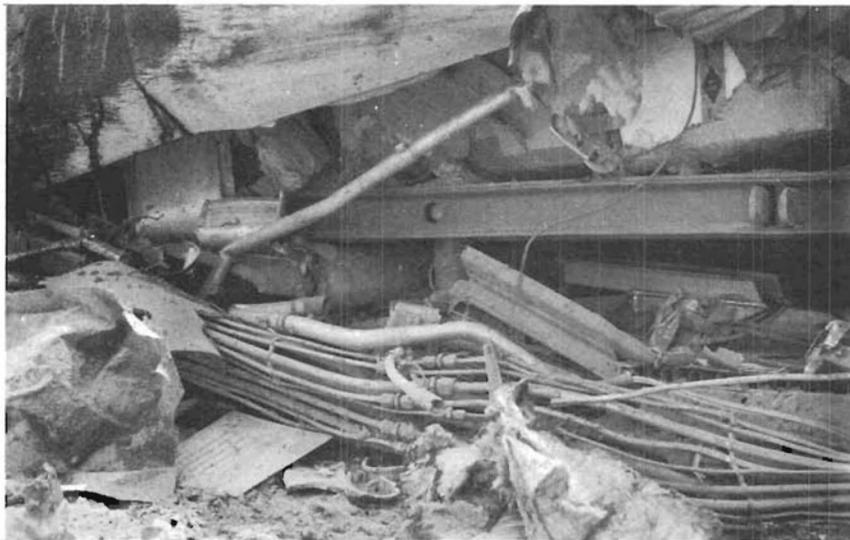
Figure 58 shows the understructure of the fuselage in the cargo area, which opened up and allowed the floor to drop to the ground. Although the aft portion of the aircraft rolled over onto its left side, the aircraft nose and cargo section remained upright.

FIG. 58 DEFORMATION ON LEFT SIDE OF FUSELAGE  
SHOWING CARGO PALLET INSTALLATION  
SEVERED FROM FUSELAGE FRAMING

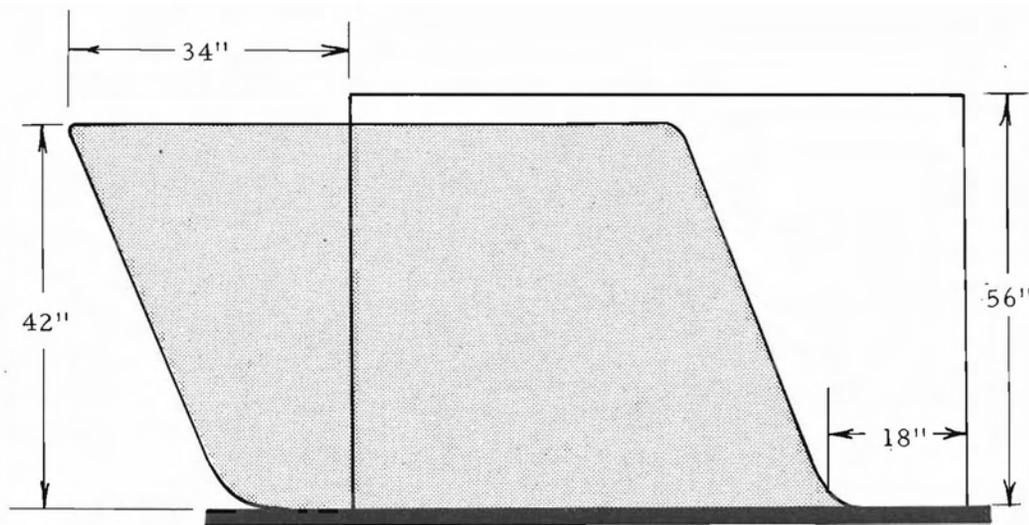
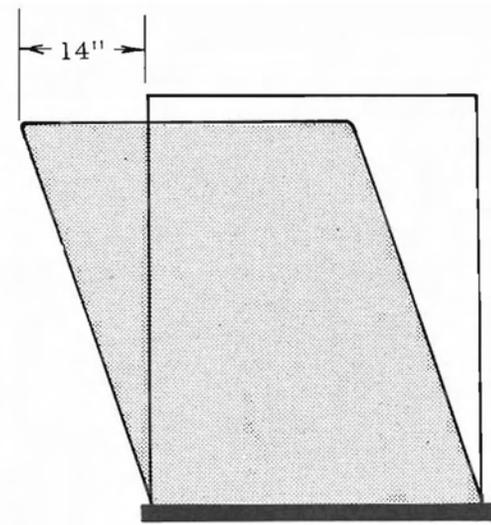
There was no evidence to indicate that any loads were applied to the cargo, cargo pallet or nylon net of the aft cargo experiment except the inertia loads of the cargo and pallet. The postcrash configuration of this cargo installation is shown in the sketch of Figure 61. Approximately one-fourth of the boxes of cargo used for this load suffered no damage whatsoever, while approximately one-half were torn but not destroyed. Only four boxes of cargo were completely ripped apart. One buckle on a load carrying strap, Figure 62, failed. Figure 63 shows the forward tiedown ring on the pallet which was deformed forward by the load applied to this strap.

FIG. 61 POSTCRASH POSITION OF SHIFTED CARGO

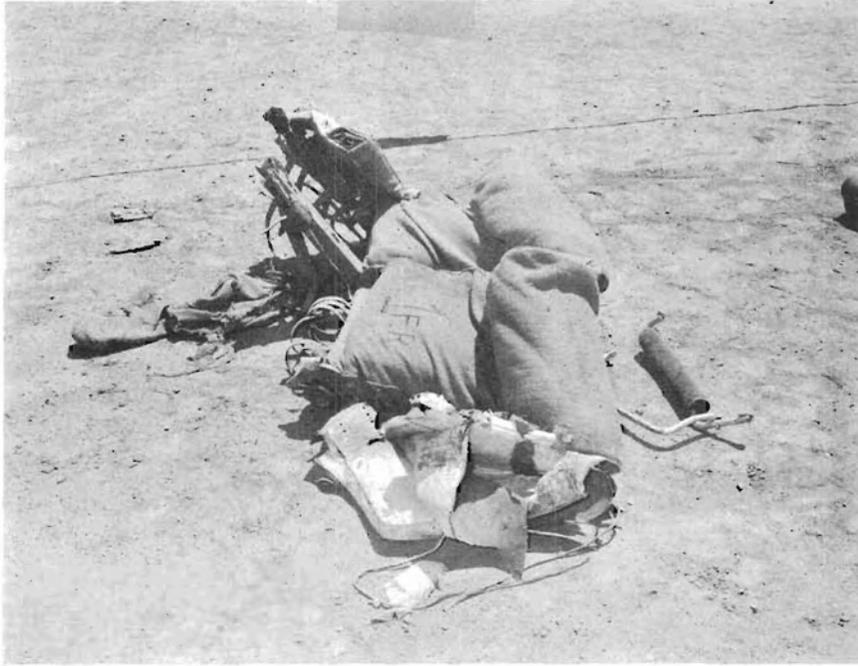
The two forward seats of this group of three were torn loose from their mountings and were found entangled in the wreckage of the forward fuselage section. The postcrash conditions of these seats is shown in Figures 66 and 67. The first seat was struck by the propeller blade from No. 3 engine. In addition, the fuselage broke just forward of the seat location and the walls of the fuselage, next to the seats, were buckled outward and crushed. The wall attachment for the forward seat pulled out of the wall fitting. The second seat ripped out the fitting and the intercostal to which it was attached.

FIG. 66 FORWARD SEAT OF FORWARD CABIN DC-7  
PASSENGER SEAT EXPERIMENT

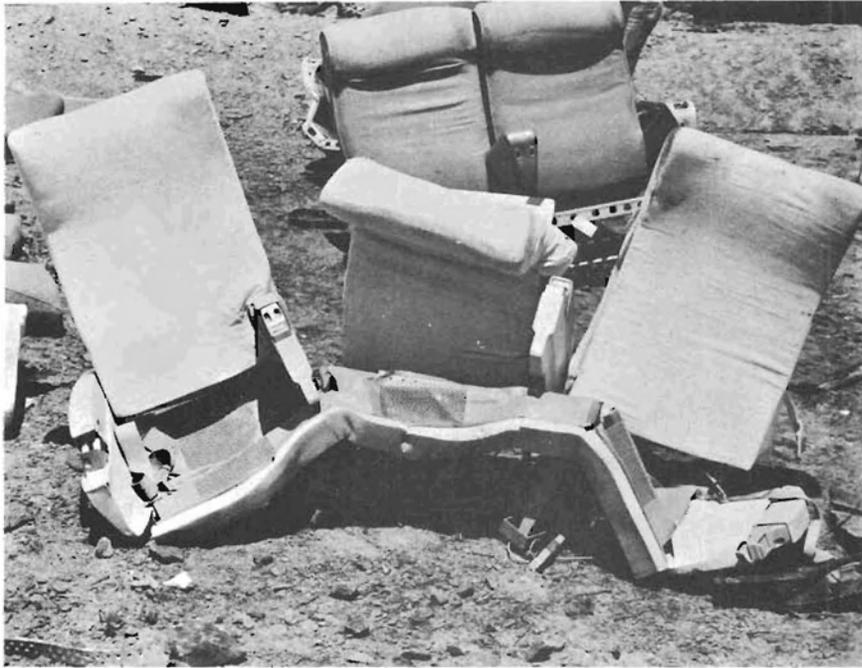
FIG. 72 FRONT VIEW OF OCCUPIED THREE PASSENGER FORWARD FACING SEAT AFTER REMOVAL FROM WRECKAGE

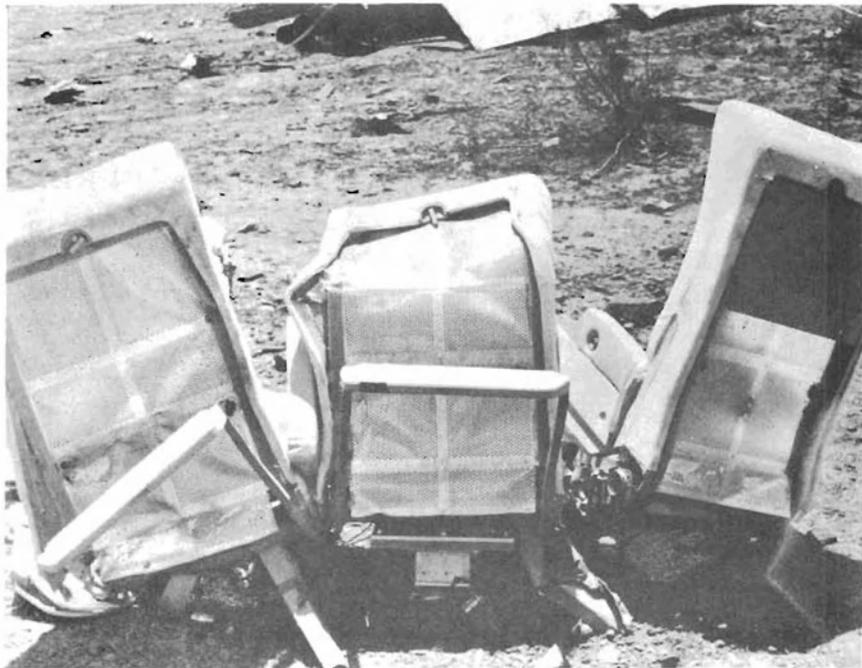
FIG. 73 REAR VIEW OF OCCUPIED THREE PASSENGER FORWARD FACING SEAT AFTER REMOVAL FROM WRECKAGE

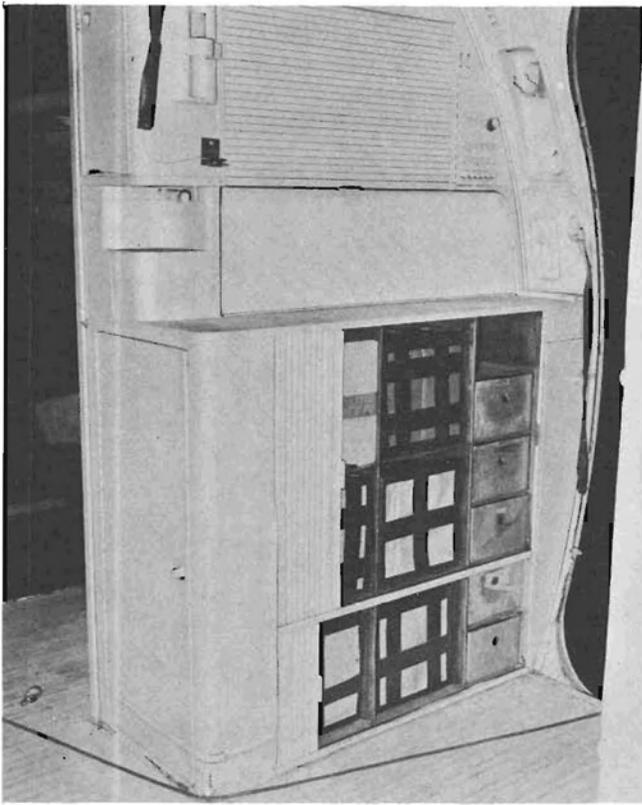
FIG. 80 GALLEY EQUIP-  
MENT EXPERI-  
MENT

The galley was located between fuselage station 660 and 780 on the left side of the airplane. (Reference Figure 21) The aft galley section was loaded with 410 pounds of simulated equipment, such as food containers and trays. No changes were made in the galley structure or in the methods of securing equipment in the galley for this test. Figure 80 shows the weighted boxes placed in the galley.

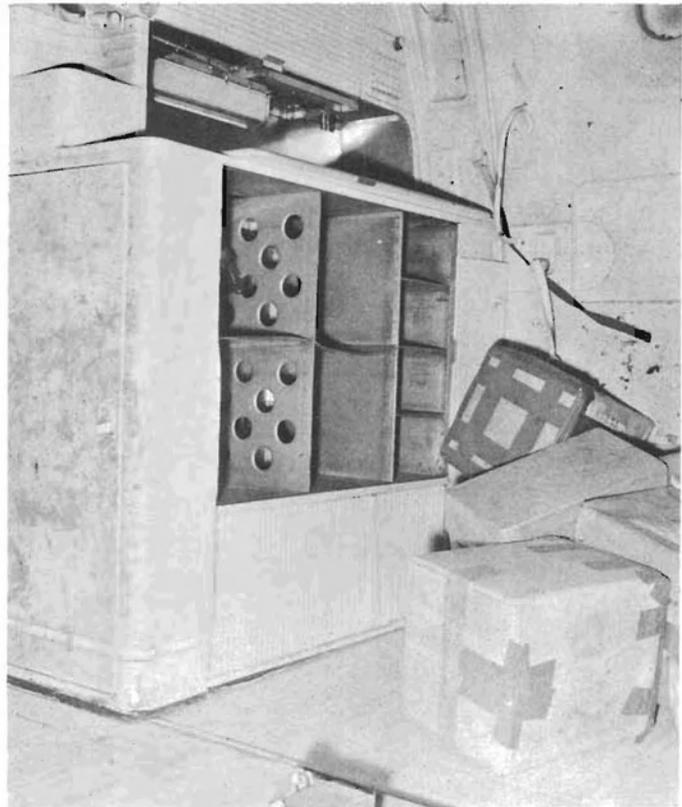
FIG. 81 GALLEY EXPERI-  
MENT AFTER  
CRASH  
(PICTURE ROTA-  
TED 90°  
COUNTERCLOCK-  
WISE)

The aft section of the galley remained in place but the flexible sliding door failed when the aircraft impacted the 8 degree slope allowing the simulated galley equipment to eject and impact against the bottom of the forward galley section. All of the equipment remained in the galley area with the exception of the flexible door which moved forward to fuselage station 570. The forward galley, which was not loaded, remained in place; however, the forward bulkhead was loosened during the crash. Figures 81 and 82 show the postcrash condition of the galley and the spilled equipment.

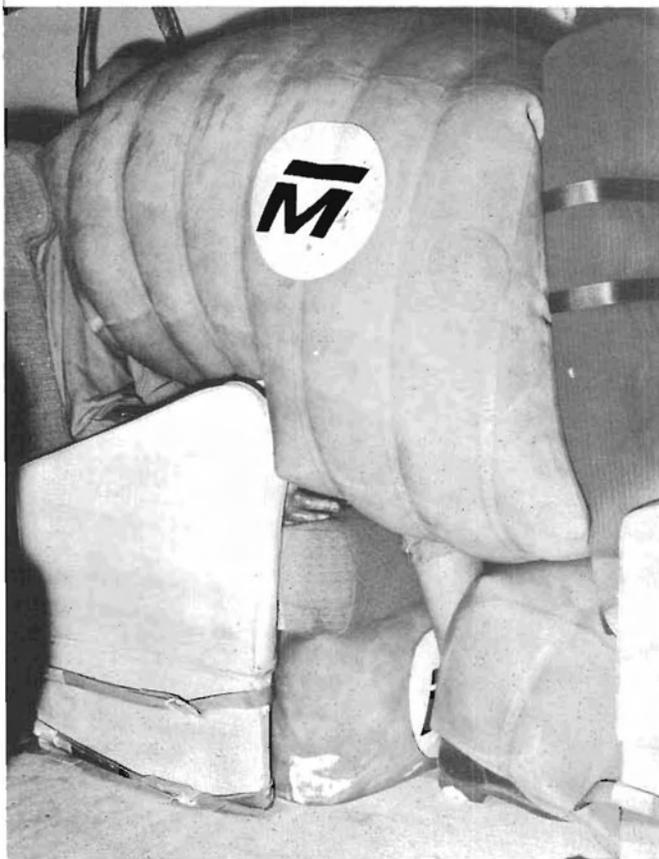
FIG. 83 VIEW SHOWING  
PASSENGER  
DUMMY CONTACT  
WITH AIRBAGS

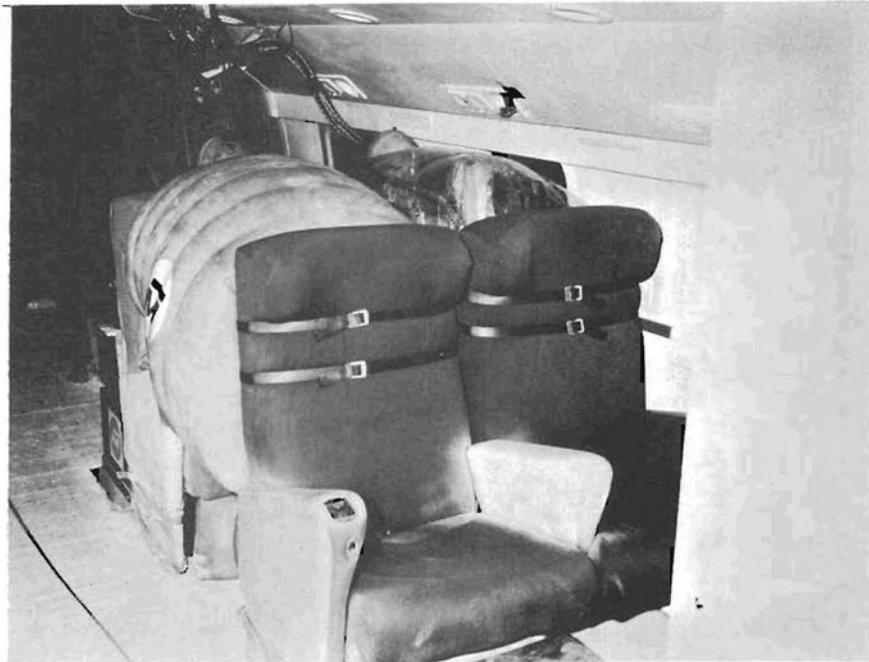
clear plastic bag. The top portion of the plastic bag can be seen in Figure 84. The DC-7 seats occupied by the dummies were installed at fuselage station 807.688. No changes were made in the structure of the seats or in the method of attaching these seats to the aircraft. Both seat occupants were 95th percentile anthropomorphic dummies. The dummy in the aisle seat was instrumented to record vertical and longitudinal accelerations in the pelvic region. The dummy restrained by the clear plastic bag was not instrumented.

FIG. 84 RUBBER AND CLEAR PLASTIC AIRBAGS

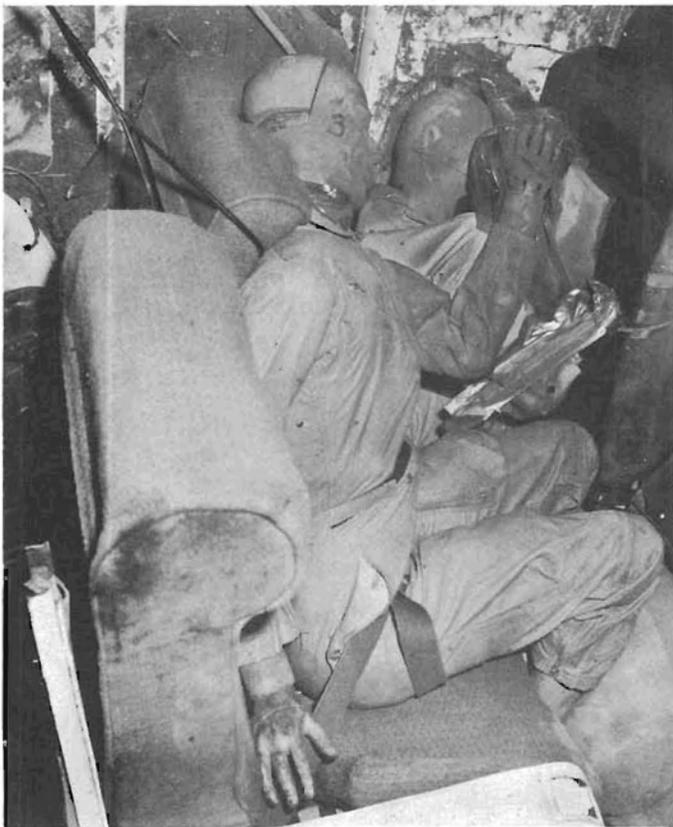
Both dummies remained in position in the aft seat, as shown in Figure 85. The lap belts were still attached and intact. The three rubber airbags that restrained the aisle dummy remained inflated. The two underseat bags restrained the dummy's feet in the normal position. The upper bag remained attached to the forward seat back, even though the seat back failed under the load applied by the dummy when the aircraft impacted the 8 degree slope. This failure allowed the chest bag to rotate out of position as shown in Figures 86 and 87.

Figure 88 is a postcrash rear view of the airbag experiment, showing the rotated bag lodged against the aft galley partition. The plastic airbag installed in front of the dummy next to the wall split along the inboard aft seam during impact. This 15-inch tear allowed rapid deflation and allowed the dummy's head to strike the back of the seat ahead. Figure 85 shows the dummy after the crash with his head positioned against the fitting box for the clear plastic bag. The occupied seat remained attached to the floor. The aft wall attachment held; but the forward wall fitting failed, allowing the forward seat structure next to the wall to deflect downward.

FIG. 85 POSTCRASH VIEW  
OF DUMMIES  
SHOWING CLEAR  
AIRBAG COLLAPSED  
IN FRONT OF  
HEAD OF DUMMY  
NEXT TO WALL

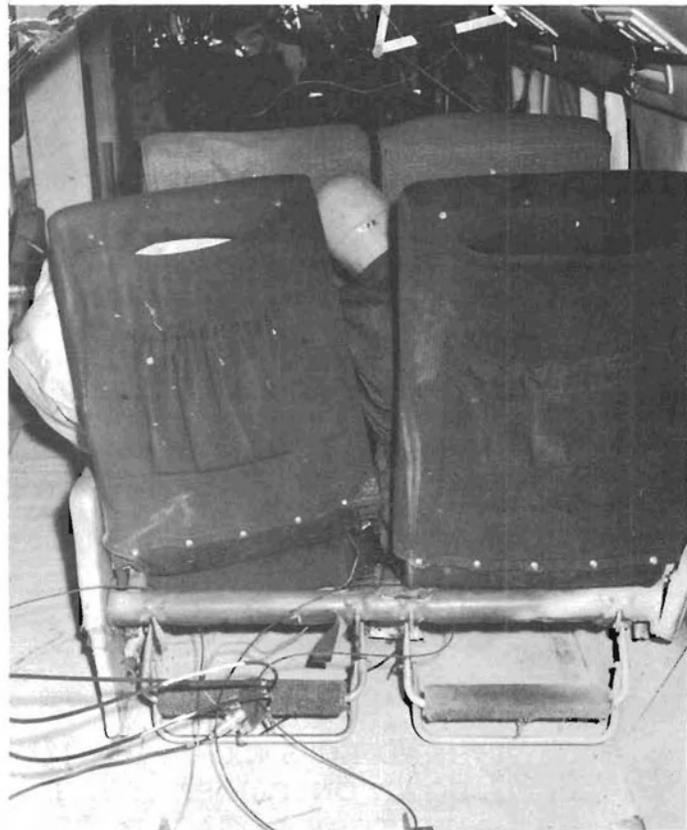
The seat was considerably deformed by the loading encountered during the crash. The forward wall attachment was bent upward, as the seat forward edge was forced downward. The forward edge of the seat contacted the floor and remained 1-1/2 to 2 inches from the floor. The aisle side of the seat collapsed due to the forward and downward loads, as shown in Figures 89 and 90. Both dummies remained in their seats throughout the crash even though the lap belt attachments for the aisle seat failed. The head of the aisle dummy struck the back of the seat in front of him causing a 3-inch deep dent in the metal structure which resulted in the loss of the dummy's head. (See Figure 91) Figure 92 shows that separation occurred between the seat back and the seat pan. The legs of both dummies extended under the forward seat. The legs of the aisle dummy extended under the seat up to his knees whereas the legs of the dummy next to the wall only extended under the forward seat midway between the ankles and the knees.

FIG. 89 POSTCRASH  
REAR VIEW OF  
AFT CABIN  
DC-7 PASSEN-  
GER SEAT  
EXPERIMENT  
(PICTURE ROTA-  
TED 90° CLOCK-  
WISE)

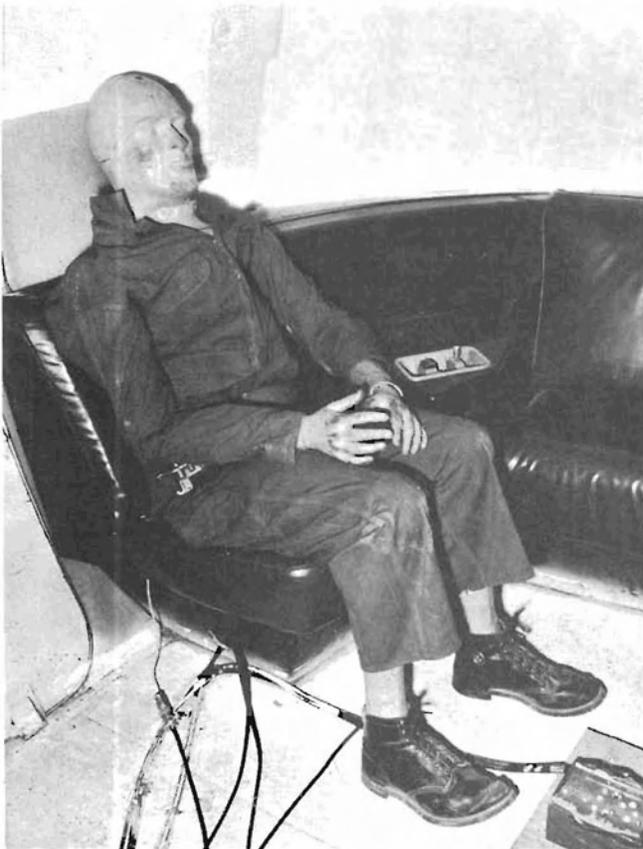
An unmodified DC-7 lounge seat on the right side of the aircraft at fuselage station 946.25 was used for this experiment. (Reference Figure 21) The existing lap belt, providing the only restraint, was connected to existing fasteners behind the lounge cushioning. Figure 93 shows this experiment with the occupant, a 95th percentile dummy, in place. A load link was installed to record lap belt force.

FIG. 93 VIEW LOOKING  
AFT AT DUMMY  
IN SIDE FACING  
LOUNGE SEAT
