DOT/FAA/AR-07/64

Teardown Evaluation of a 1975 Piper Navajo Chieftain Model PA31-350 Airplane

March 2008

Final Report

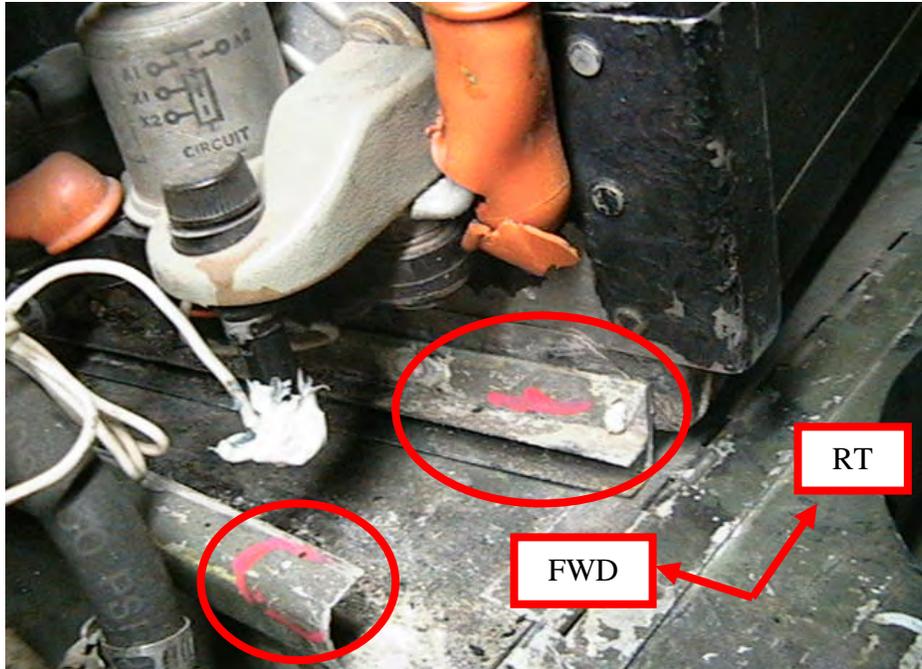
Figure 3 shows the location of the battery box assembly, and figure 4 shows corrosion of the battery box assembly as well as a 1-inch crack in the angle that retains the battery box, part number 53960-00. This defect is located at FS 2, WL 13, and body line (BL) 0. The location of the ELT antenna, part number 597 257, is shown in figure 5, while the ELT antenna, located at FS 261, WL 40, and RBL 6, is shown in figure 6. The wire connecting the antenna to the

Figure 4. Corrosion and Crack on the Battery Box FS 2, WL 13, and BL 0

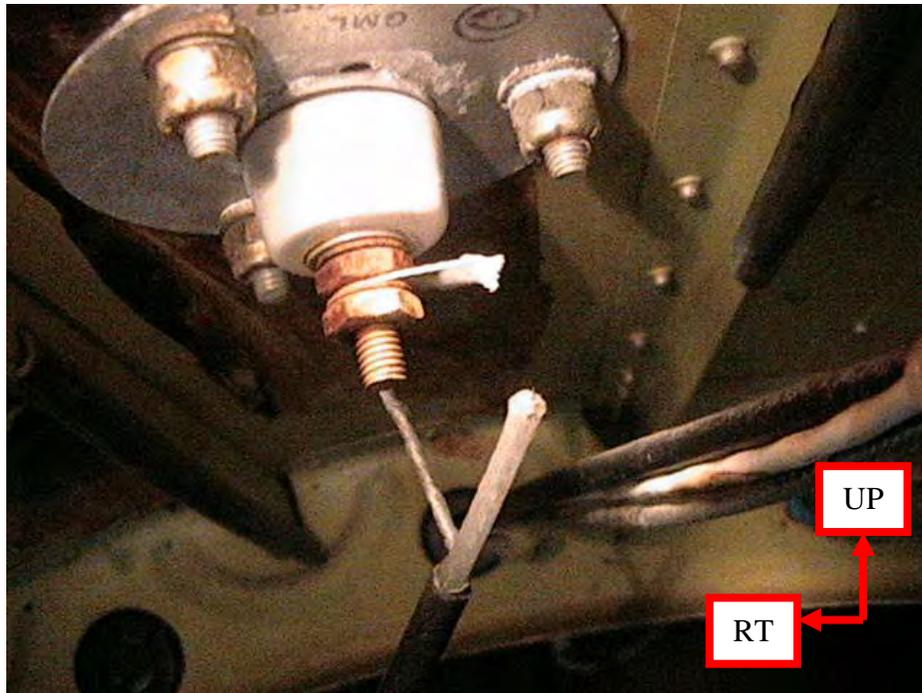
transmitter was severed, rendering the ELT system ineffective. Figure 7 shows the locations of the fuel gauge assemblies, part numbers 40648-02 and 40648-03. Wear was observed on the float arms, part number 54751-02, with a depth of 0.1 to 0.3 times the arm diameter, as shown in figure 8. The damage on the float arm shown in figure 9 is representative of all fuel gauge assemblies observed on this airplane. The wear locations coincide with the arm travel stops of the assemblies, implying damage due to repetitive contact. The location of an engine control cable, part number 24894-18, observed chafing of a fuel line, part number 23745-15, as shown in figure 10. Although this cable only moves inside a stationary housing, the contact between the housing and fuel line is inappropriate. The engine control cable assembly contacting the fuel line in the left nacelle at FS 110, WL 15, and LWS 64 shown in figure 11, as found on the airplane.

Figure 6. Severed ELT Antenna Wire FS 261, WL 40, and RBL 6

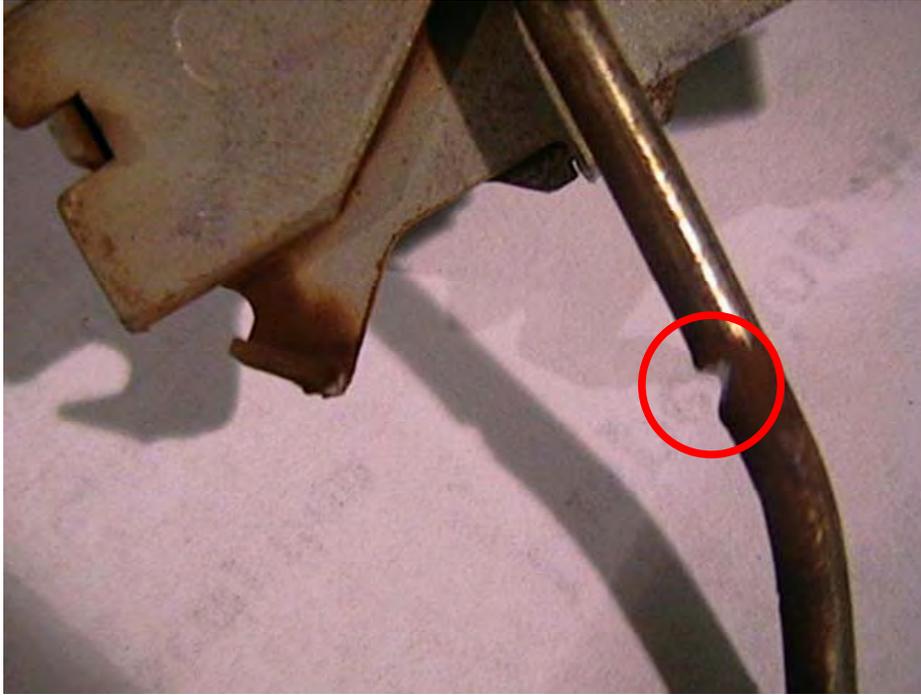
Figure 8. Worn Fuel Gauge Assembly Float Arms All Wing Fuel Cell Gauge Locations

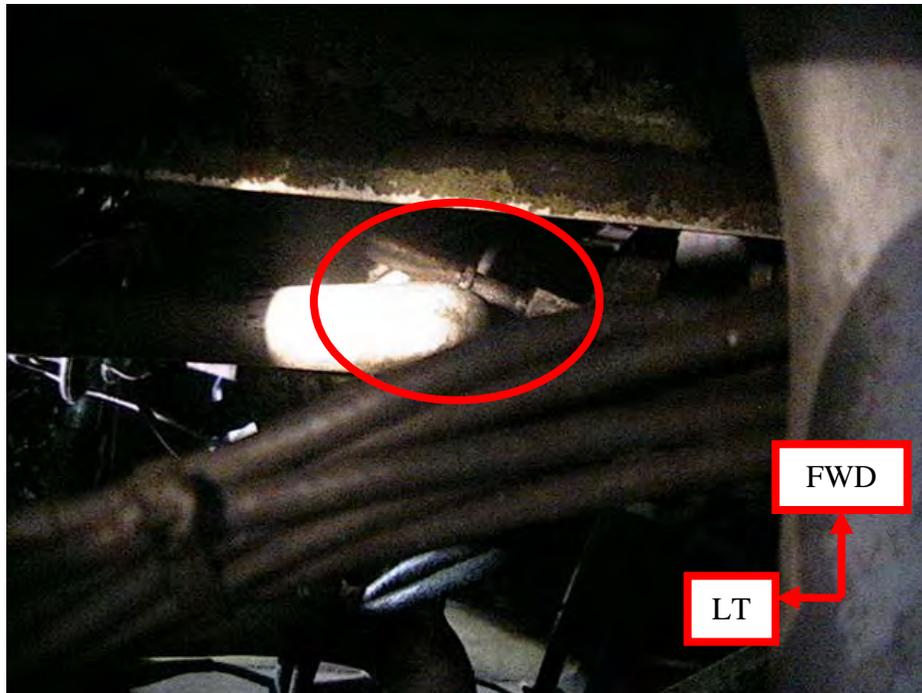
Figure 10. Contact Between Fuel Line and Engine Control Cable Assembly FS 110, WL 15, and LWS 64

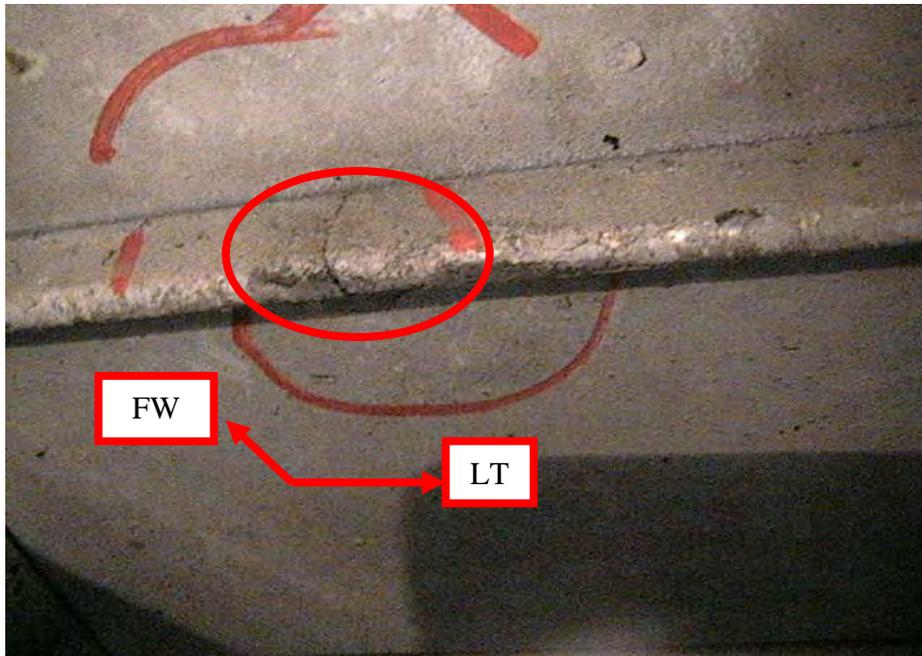
The locations of the right and left main landing gear wheel well ribs and stringers are shown in figures 11 and 12, respectively, and the damage to these areas at FS 150, WL 16, and RWS 39.5 to RWS 49, and LWS 39.5 to LWS 49 is shown in figures 13 and 14. Information obtained during the survey of the airplane maintenance records revealed numerous instances of the wheel brake assemblies contacting the damaged areas. Repairs have been performed in both the left and right main landing gear wheel wells to correct this issue; however, these repairs have also been damaged in the same manner. Figure 15 shows the location of the floor gusset plate, part number 41278-00, located at FS 28, WL 13, and RBL 12, and figure 16 shows cracking and damage at this location. Figure 17 illustrates the location of the lower center bulkhead assembly, part number 41233-03. Tearing past the stop drilled cracks on the left and right sides of the lower center bulkhead assembly at FS 162.6, WL 16, RBL 6, and LBL 6 was observed and is shown in figure 18.

Figure 13. Damaged and Cracked Right Wing Stringers in the Main Gear Wheel Well FS 50, WL 16, and RWS 39.5 to RWS 49

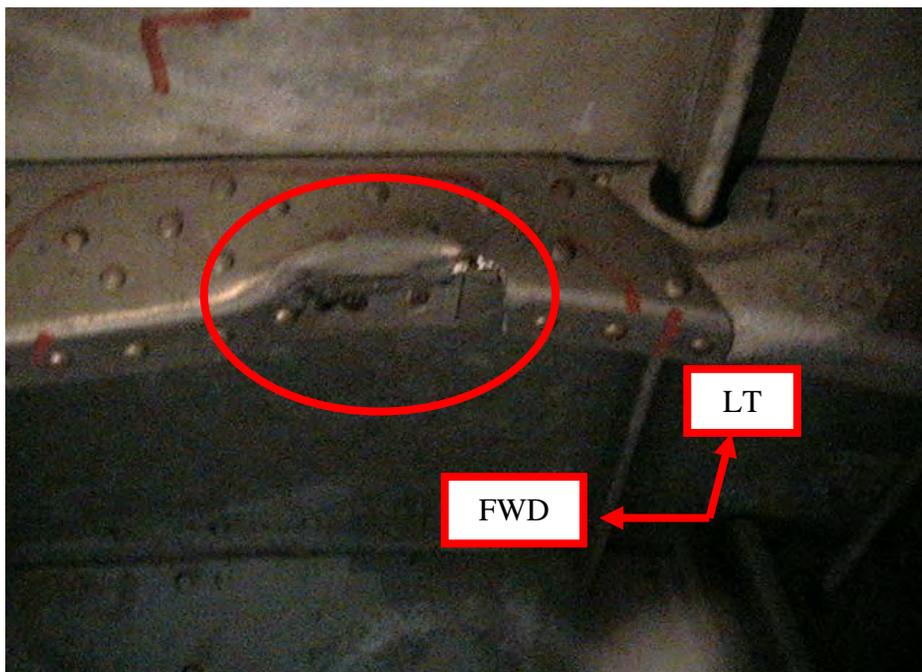
Figure 14. Damaged Left Wing Ribs in the Main Gear Wheel Well FS 150, WL 16, and LWS 39.5 to LWS 49

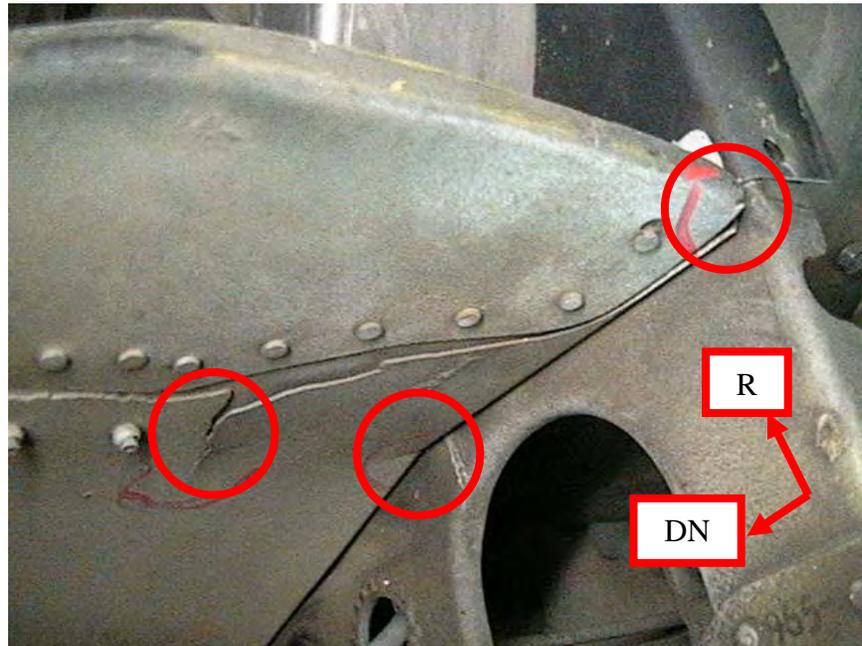
Figure 16. Cracks in the Floor Gusset Plate Assembly FS 28, WL 13, and RBL 12

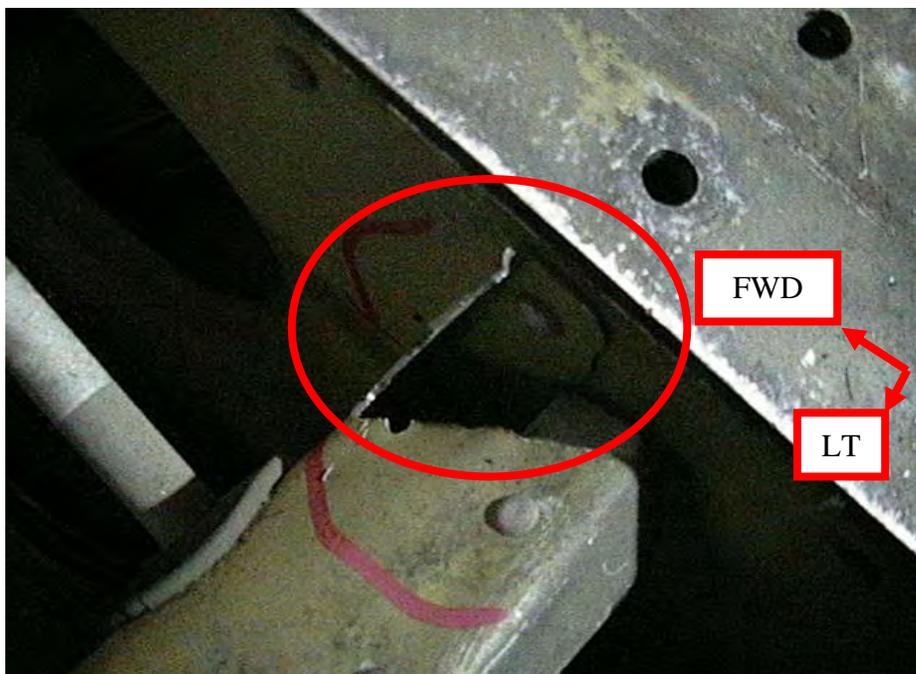
Figure 18. Torn Lower Center Bulkhead Assembly FS 162.6, WL 16, RBL 6, and LBL 6

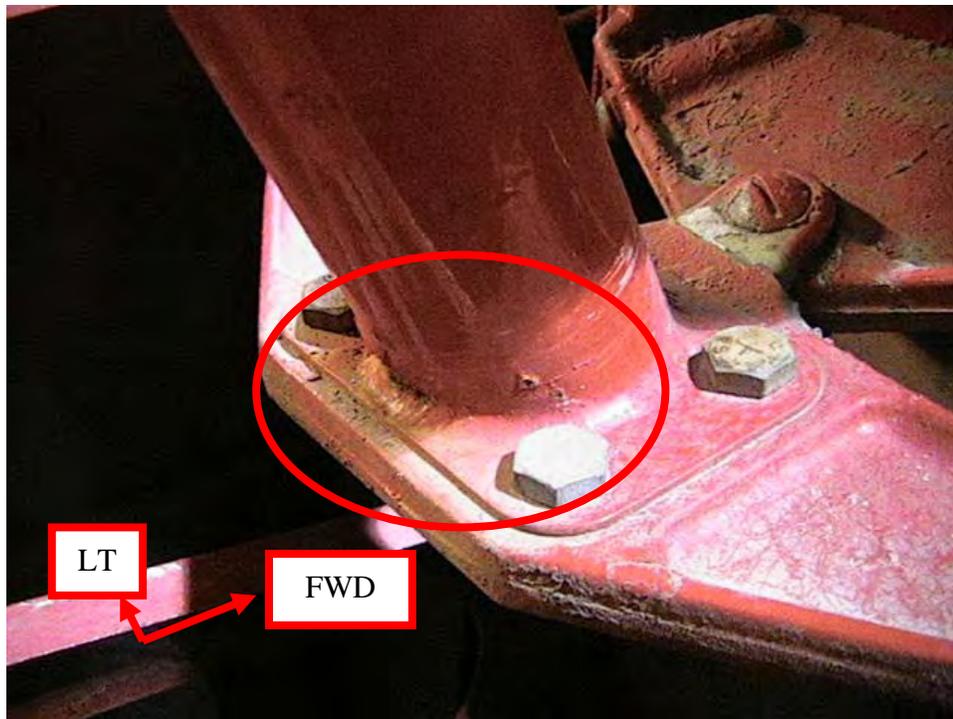
The location of the rudder torque tube, part number 40040-09, is shown in figure 19. Figure 20 shows corrosion of the rudder torque tube at FS 342.25, WL 20, and BL 0. Figure 21 shows the location of a chafed coaxial cable, while figure 22 shows chafing of the coaxial cable by the aileron trim tab control cables at FS 84, WL 17, and BL 0. The location of the nose landing gear oleo strut housing, part number 40273-00, is shown in figure 23. A 1-inch crack, located at FS 25, WL 32, and RBL 2, began near the steering stop, as shown in figure 24. The survey of the airplane maintenance records revealed that numerous reports have been made of similar damage fleet-wide due to improper towing procedures and exceeding the turn limitations of the airplane.

Figure 20. Corrosion on the Rudder Torque Tube FS 342.25, WL 20, and BL 0

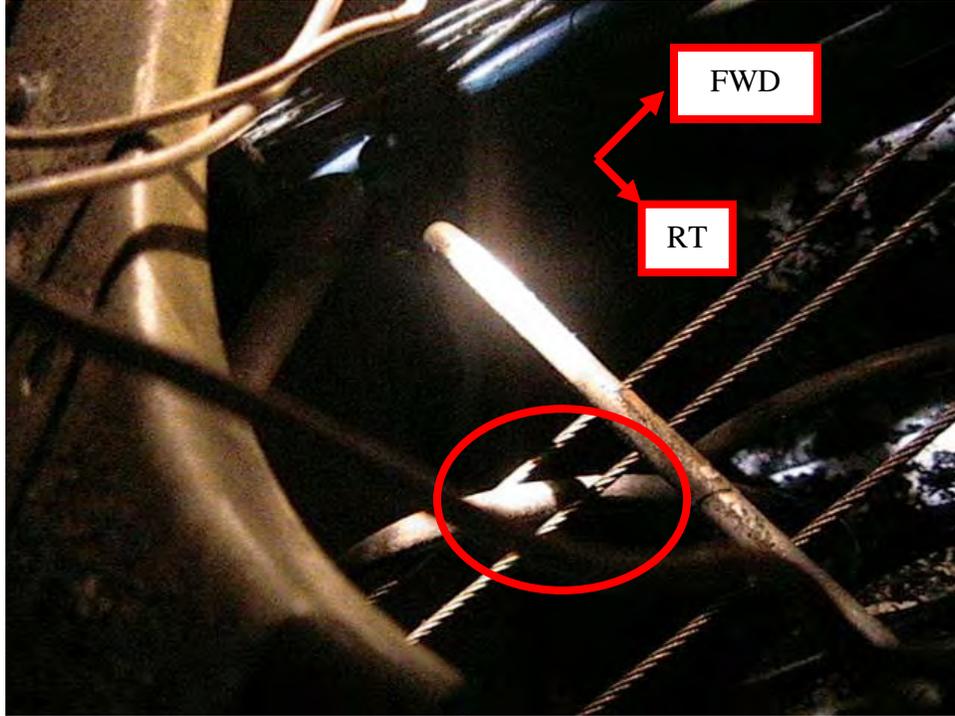
Figure 22. Chafing of a Coaxial Cable by Trim Tab Cables FS 84, WL 17, and BL 0

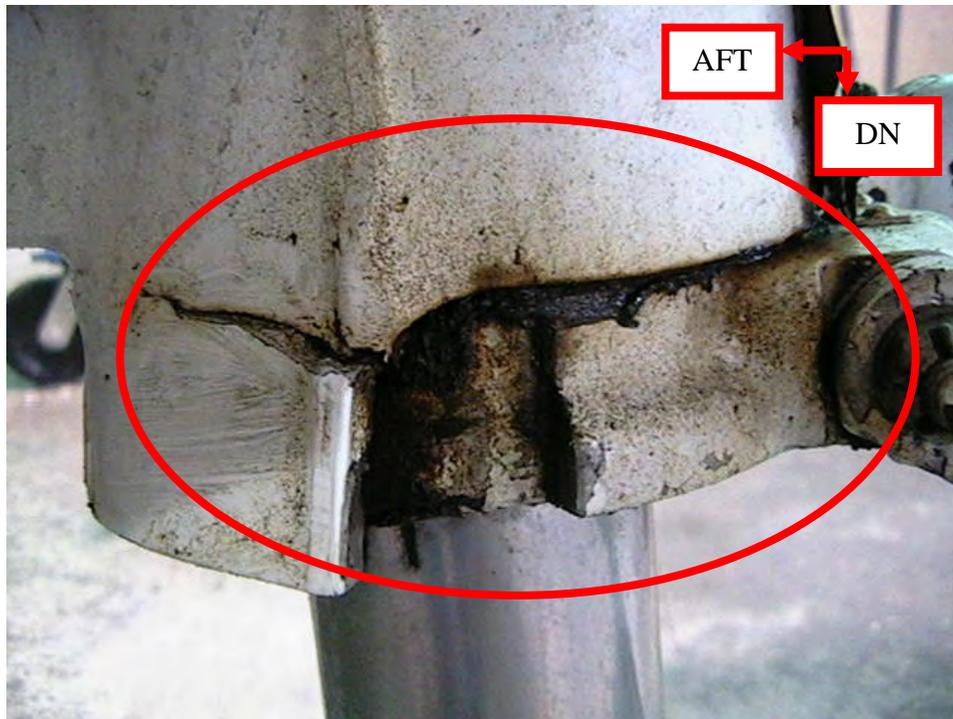
Figure 24. Nose Landing Gear Strut Housing Cracked FS 25, WL 32, and RBL 2

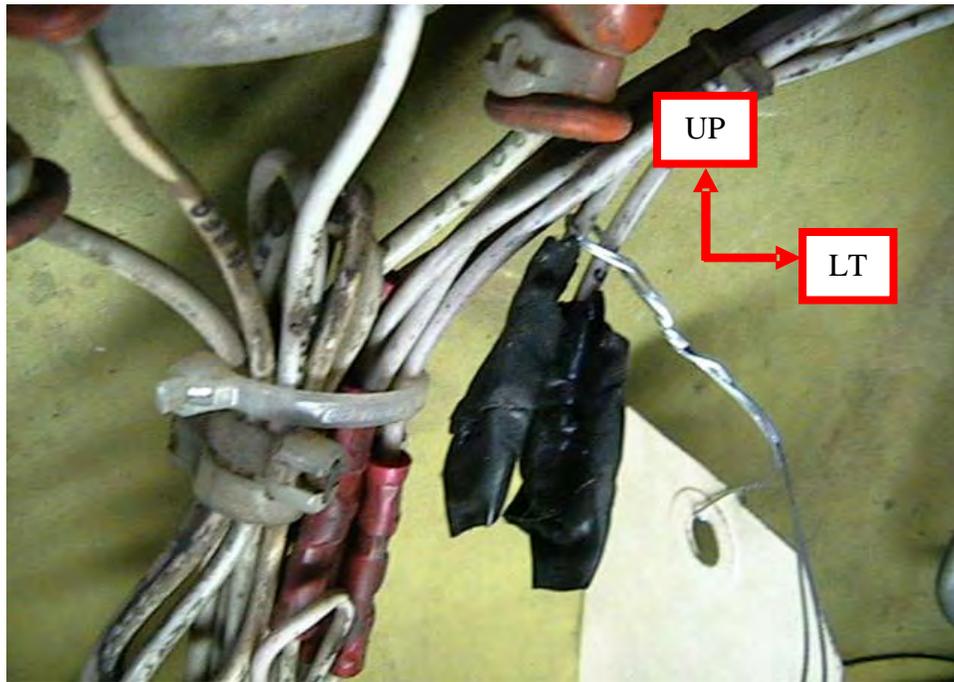
The defects observed in the nose compartment included improper termination, missing/damaged grommets, which resulted in chafed insulation, and overheating and cracking of the voltage clamper. Figure 25 shows an improper termination using electrical tape, while figure 26 shows a wire with the insulation cut near the termination point. A chafed wire due to a damaged

Figure 25. Improper Terminations in Nose Compartment FS 57, WL 8, and RBL 18

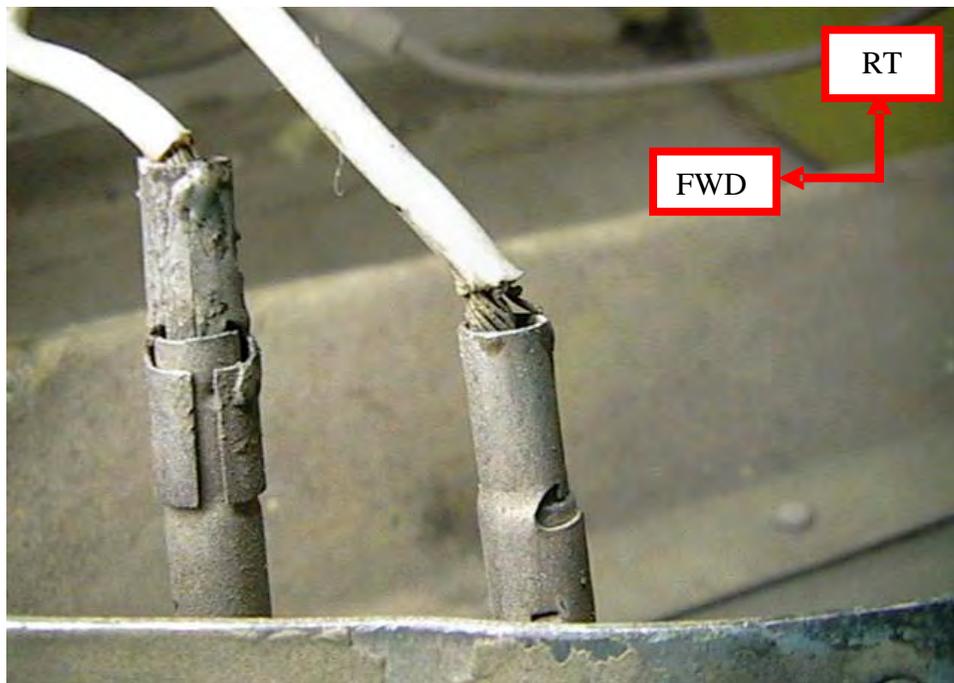
Figure 26. Cut Insulation at Terminations FS 24, WL 15, and LBL 18

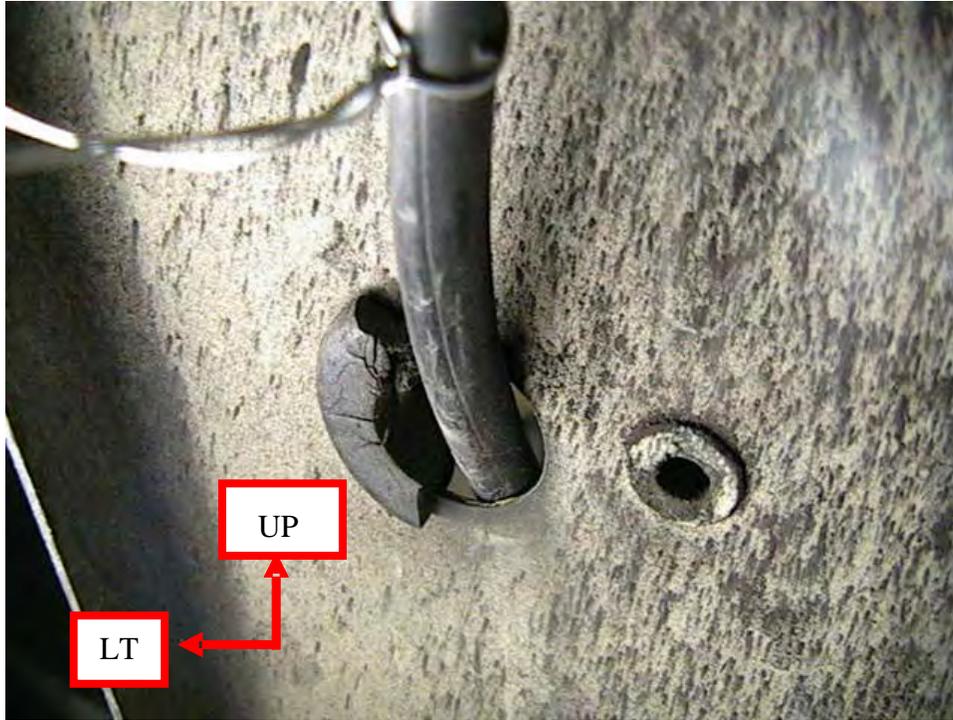
grommet is shown in figure 27. A cracked and overheated voltage clammer is shown in figure 28.

Figure 27. Damaged Grommet Resulting in Wire Chafing FS 35, WL 11, and RBL 18

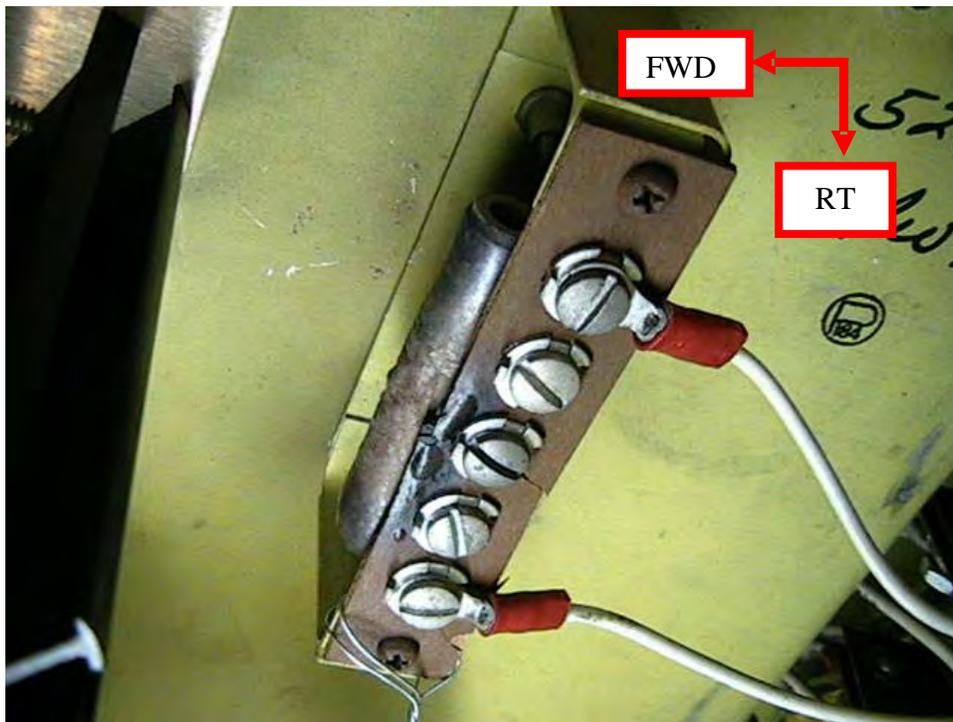
Figure 28. Cracked and Burnt Voltage Clamper FS 52, WL 0, and LBL 12

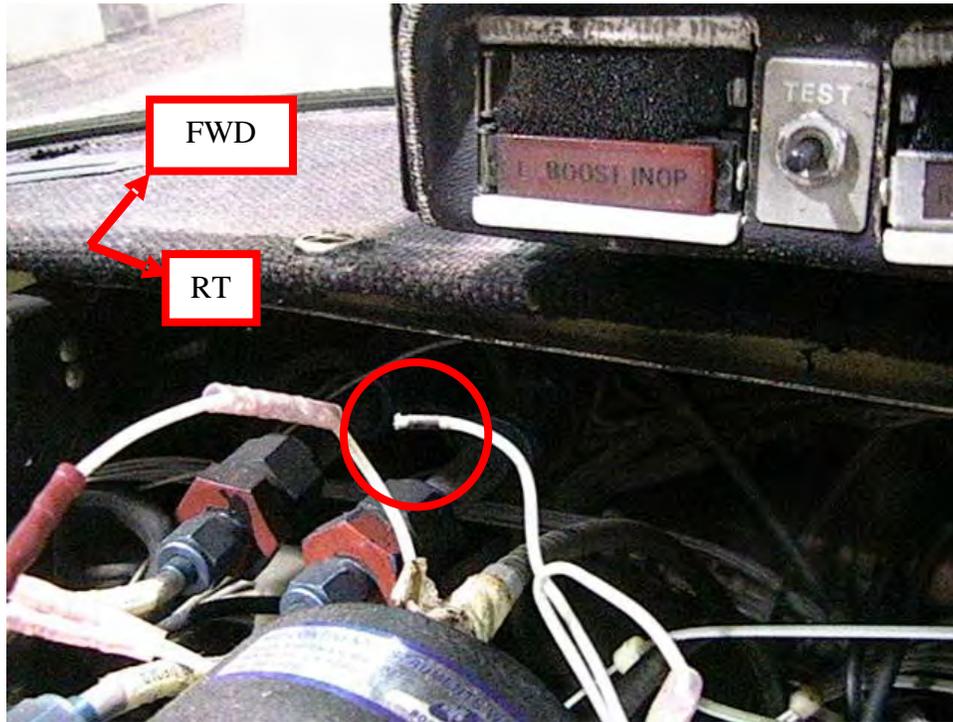
Most of the defects in the crew compartment were located forward of the instrument panel and consisted of improperly terminated wires and broken wires as shown in figures 29 and 30, respectively. Other defects observed included chafing of wires, resulting in exposed conductors and damaged insulation, as shown in figure 31.

Figure 29. Improper Wire Terminations FS 76, WL 24, and BL 0

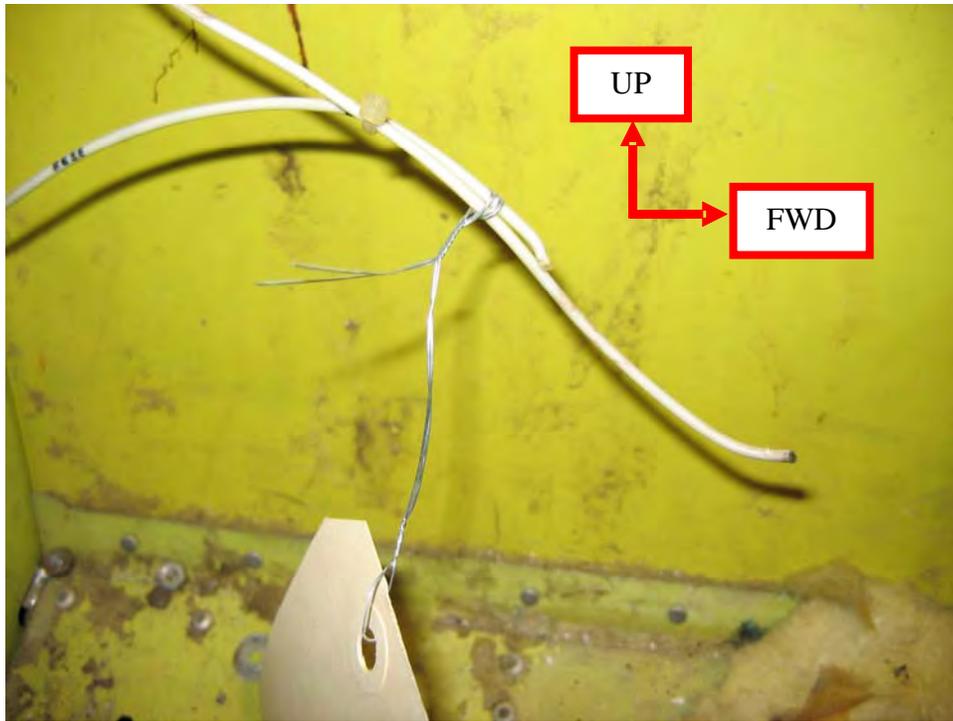
Figure 30. Broken Wire FS 116, WL 10, and LBL 20

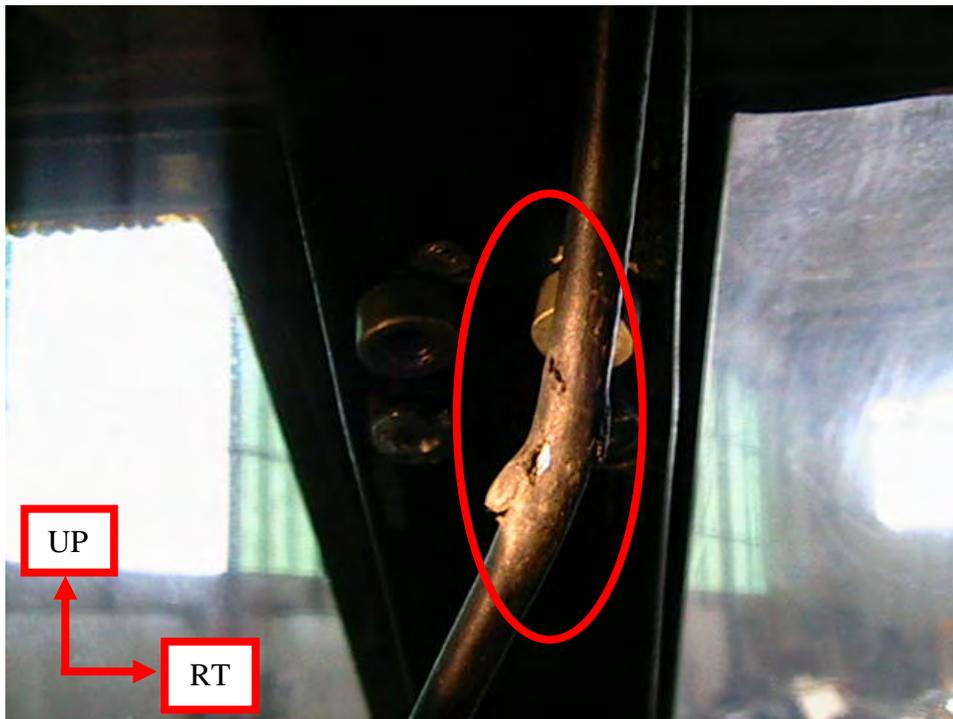
Figure 31. Damaged Wire and Insulation FS 70, WL 30, and BL 0

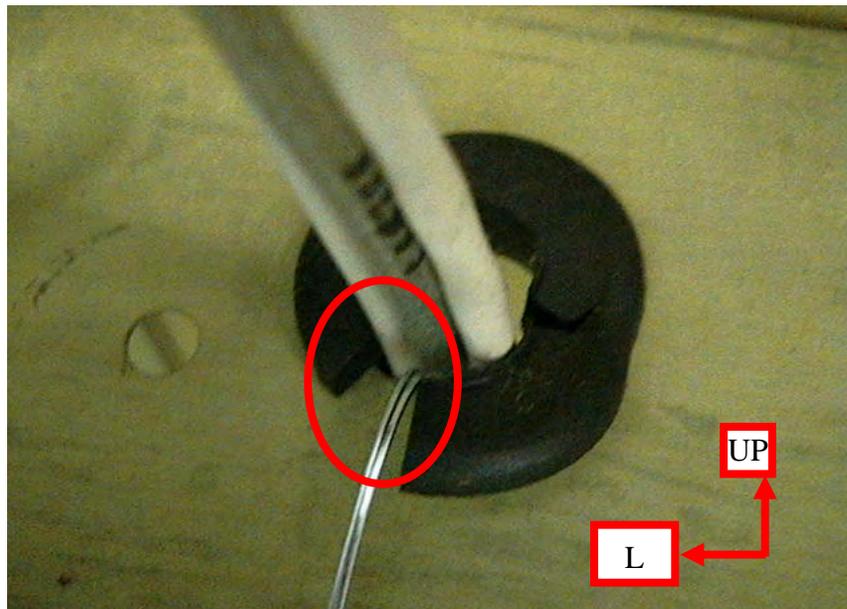
Wiring defects in the passenger compartment consisted of chafing and damage due to missing or deteriorated grommets in the structure as shown in figures 32 and 33, respectively. Figure 33 shows a missing grommet in a cabin frame. Eighteen instances of missing grommets in frames were noted on this airplane. A few additional defects including exceeding the wire bend radius and improper terminations were also noted.

Figure 32. Damaged Grommet in Cabin Frame FS 261, WL 21, and BL 0

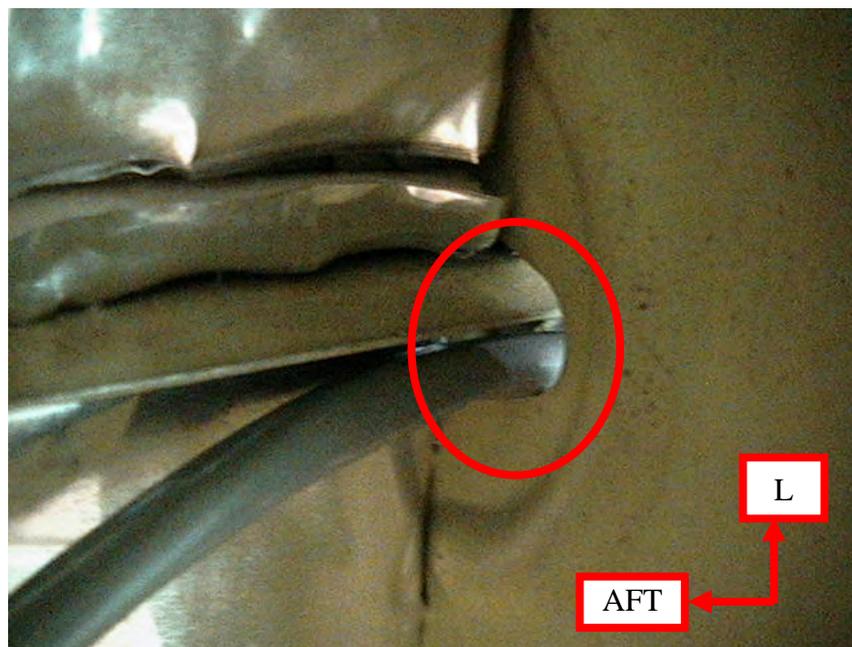
Figure 33. Missing Grommet in Cabin Frame

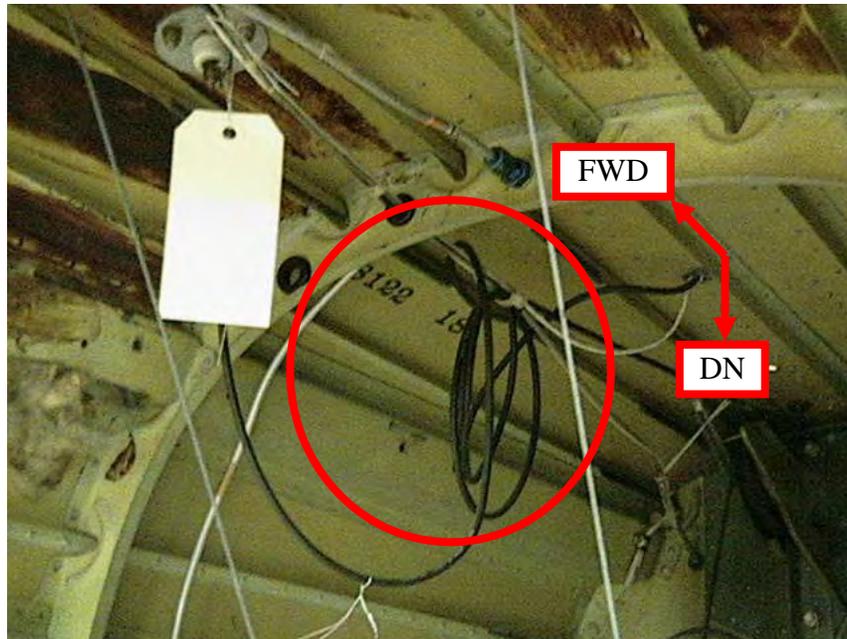
Findings in the empennage were limited to lack of support for wires and wire bundles, as shown in figure 34, and missing grommets that resulted in wire chafing, as shown in figure 35.

Figure 34. Improperly Supported Wires FS 298, WL 36, and BL 0

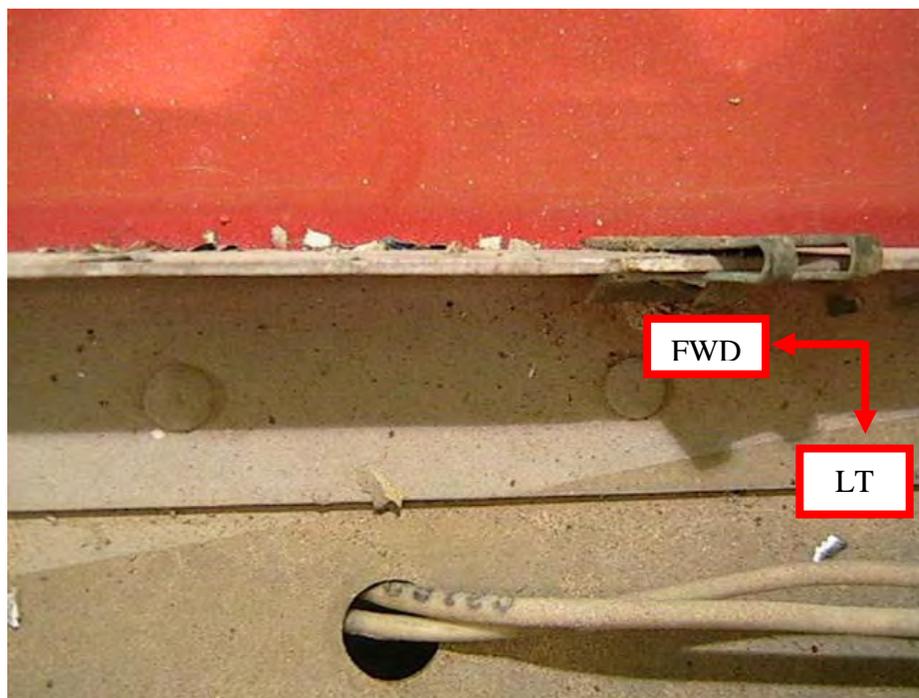
Figure 35. Chafing of Wires Due to Missing Grommet FS 311, WL 30, and BL 0

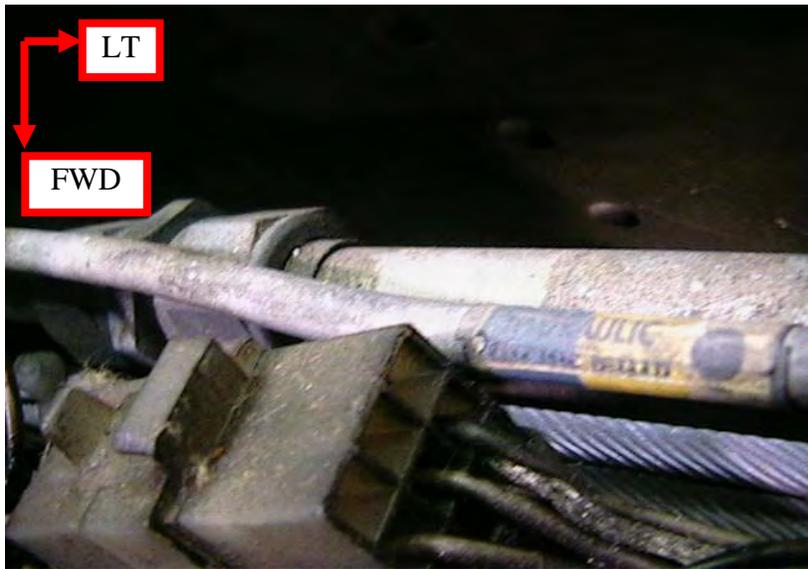
Installation defects were numerous in the left wing zone. Wiring defects observed in the left wing included chafing, overheating, exposed inner conductor, improper clamping of wire bundles, and missing grommets that led to the chafing of wires. Figure 36 shows a wire component chafing flammable fluid lines, while figure 37 shows an overheated wire. A wire with an exposed inner conductor is shown in figure 38. Examples of improper clamping and support of wires and wire bundles observed in the left wing are shown in figure 39. The line shown in figure 39 is a deactivated de-ice system line. Missing grommets in the fuel cells caused chafing of the fuel transmitter wire insulation.

Figure 36. Chafing of Fluid Tube by Wire Connector FS 104.5, WL 12, and LWS 40

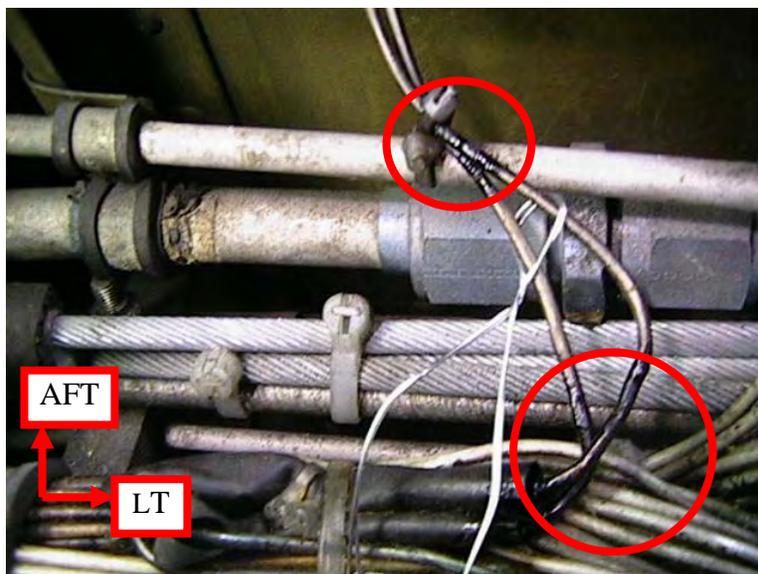
Figure 37. Overheated Wires FS 104.5, WL 12, and LWS 39

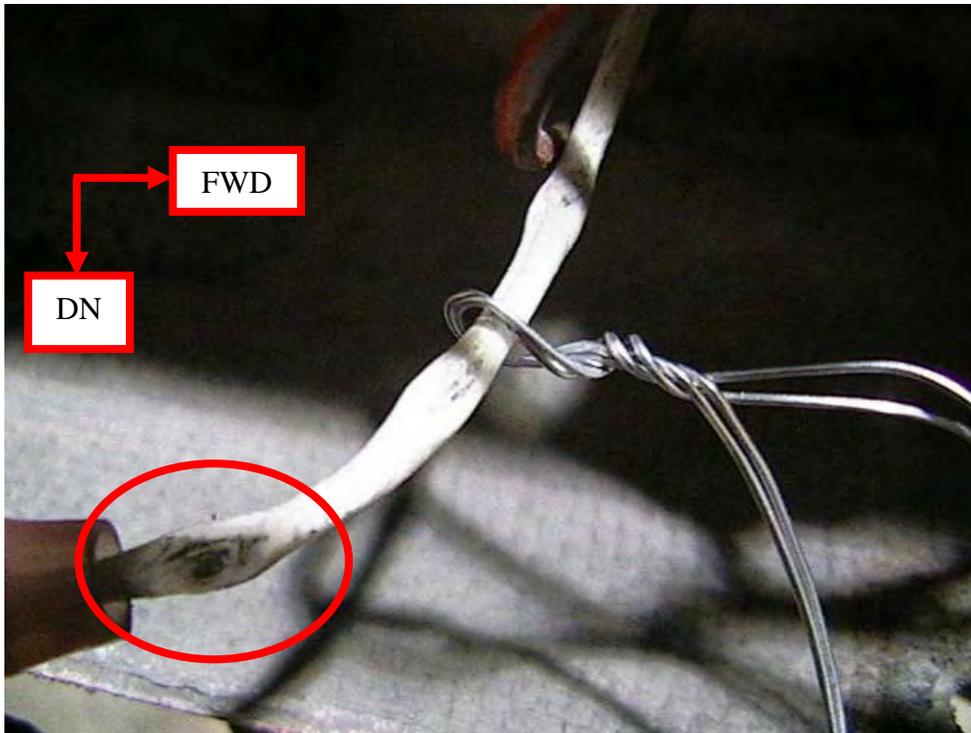
Figure 38. Exposed and Damaged Wire Inner Conductor FS 135, WL 0, and LWS 242

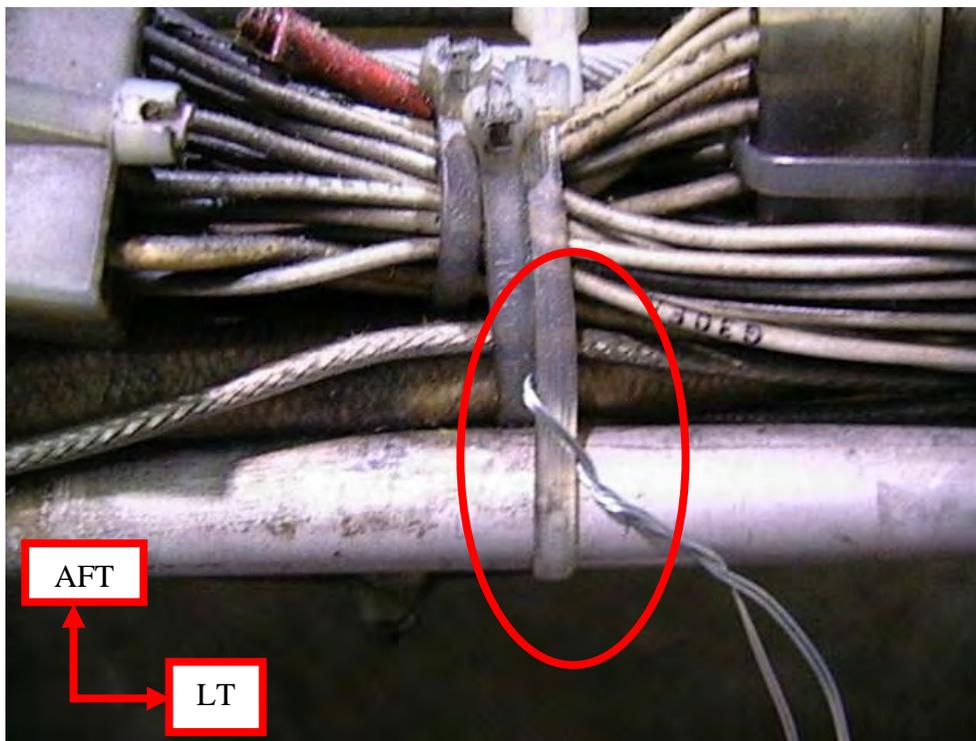
Figure 39. Improper Support of Wire Bundle to Fluid Tubing FS 106, WL 12, and LWS 45

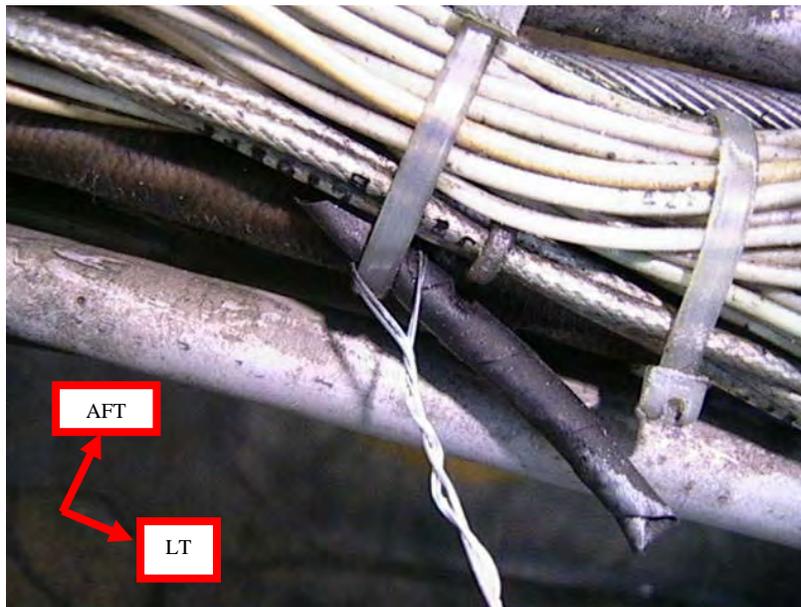
The inspection of the right wing revealed similar discrepancies noted during the inspection of the left wing. Wiring defects, such as improper termination, improper clamping, and missing grommets, were observed in the right wing. Figure 40 shows the improper termination of a wire, while figure 41 illustrates improper clamping of a wire. The right wing also was missing grommets in the fuel cells, which resulted in chafing of the fuel transmitter wire insulation.

Figure 40. Improper Wire Termination FS 105, WL 13, and RWS 51

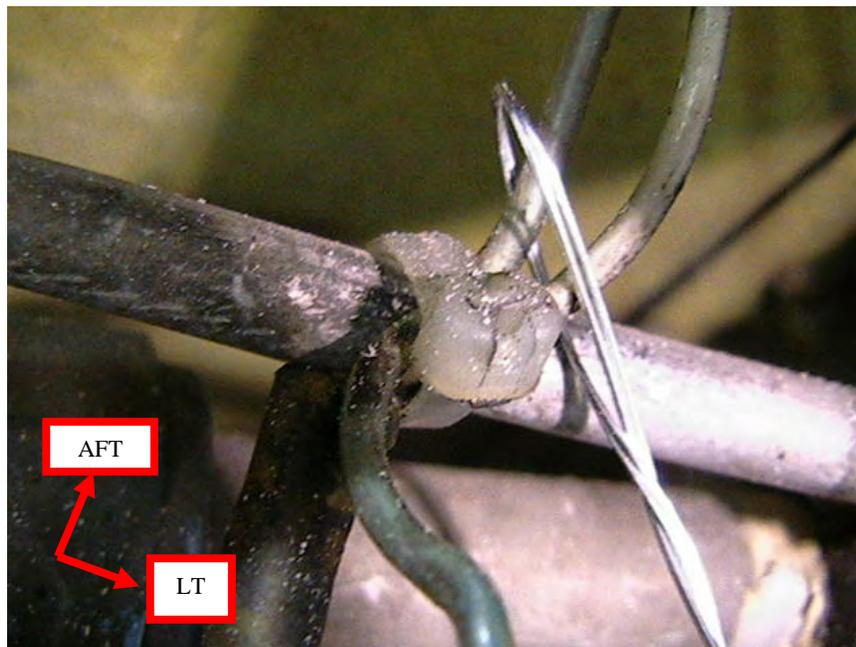
Figure 41. Improper Clamping/Support of Wire FS 105, WL 13, and RWS 36

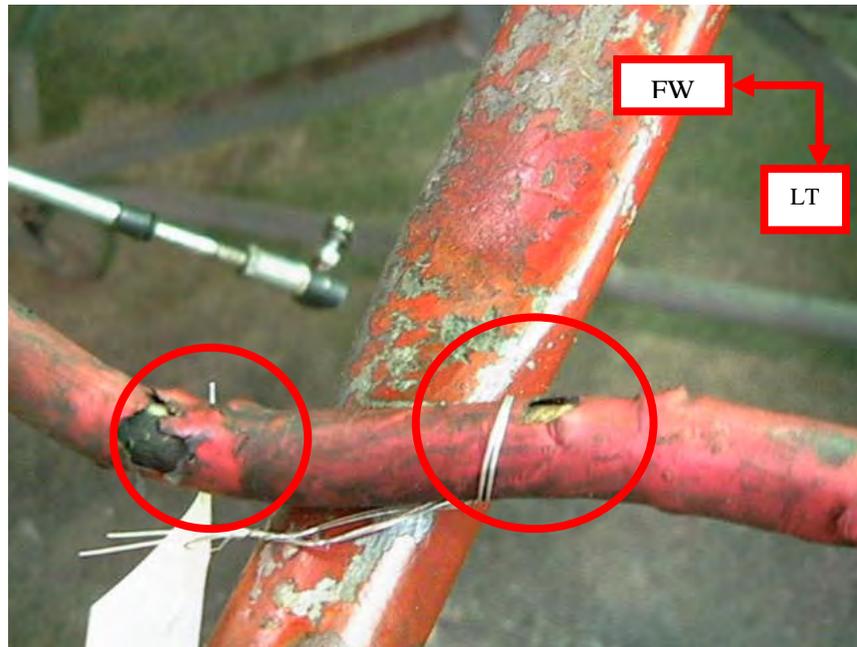
Defects in the left nacelle mainly consisted of damaged insulation due to abrasion and chemical damage, as shown in figures 42 and 43. Wires improperly stowed that led to chafing are shown in figure 44.

Figure 42. Damaged Insulation on the Starter Wire FS 87, WL 15, and LWS 77

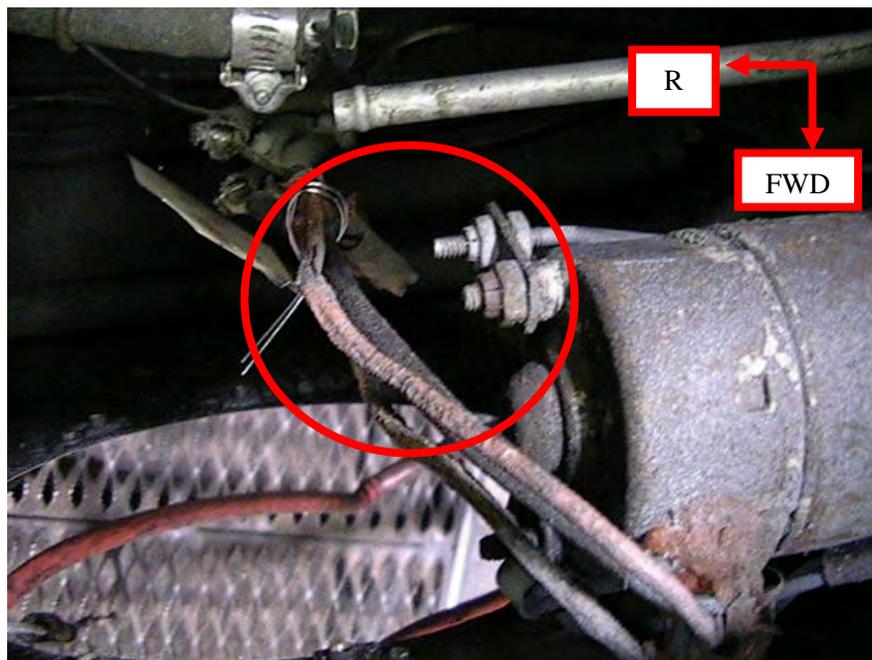
Figure 43. Chemically Damaged Cowl Flap Motor Wires FS 110, WL 0, and LWS 77

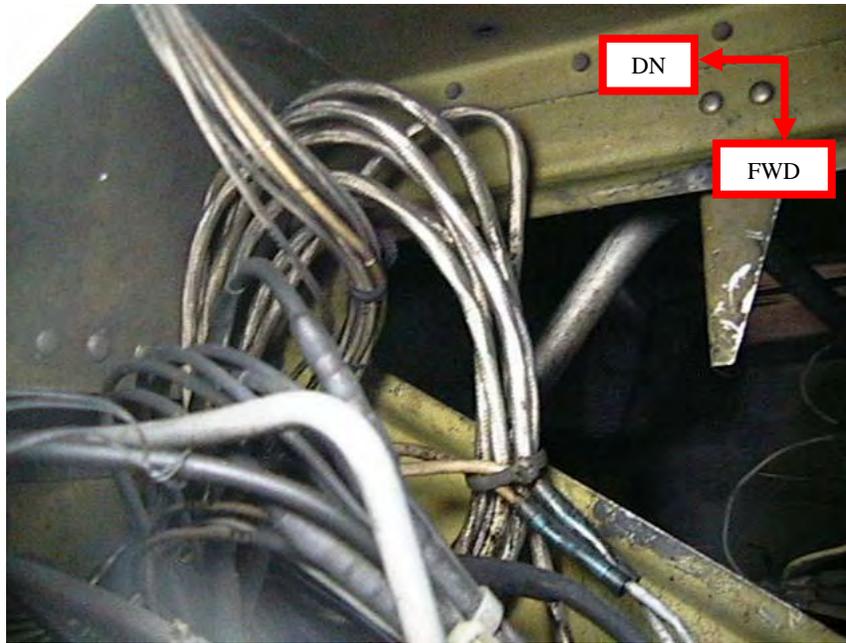
Figure 44. Insufficiently Stowed Wires FS 110, WL 6, and LWS 62

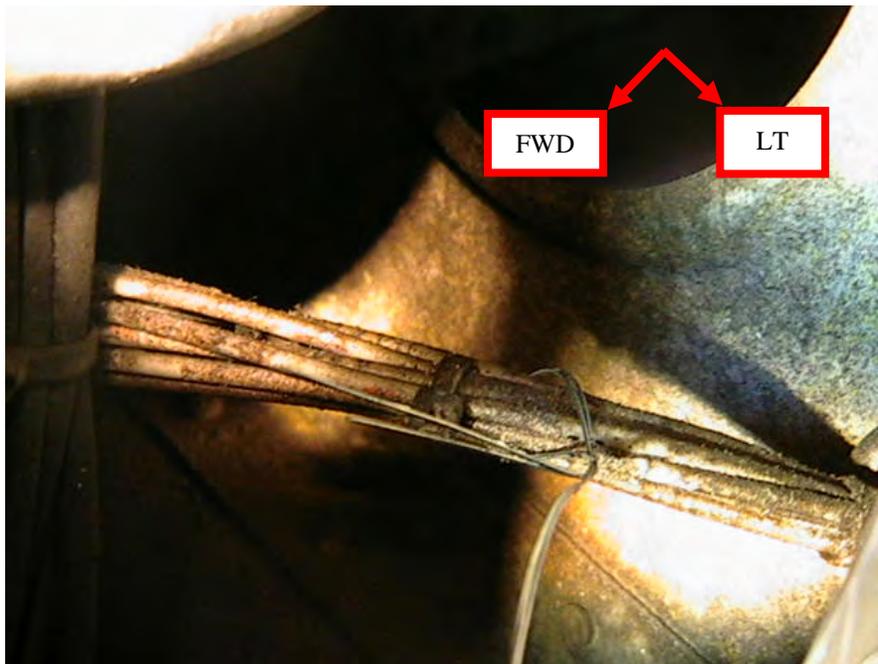
Similar to the findings in the left nacelle, the right nacelle defects included dirty/oily wires, as shown in figure 45, and insufficient support of wires and wire bundles, shown in figure 46. Figure 46 shows wires improperly supported on an air conditioner condenser line.

Figure 45. Dirty/Oily Wires FS 110, WL 0, and RWS 77

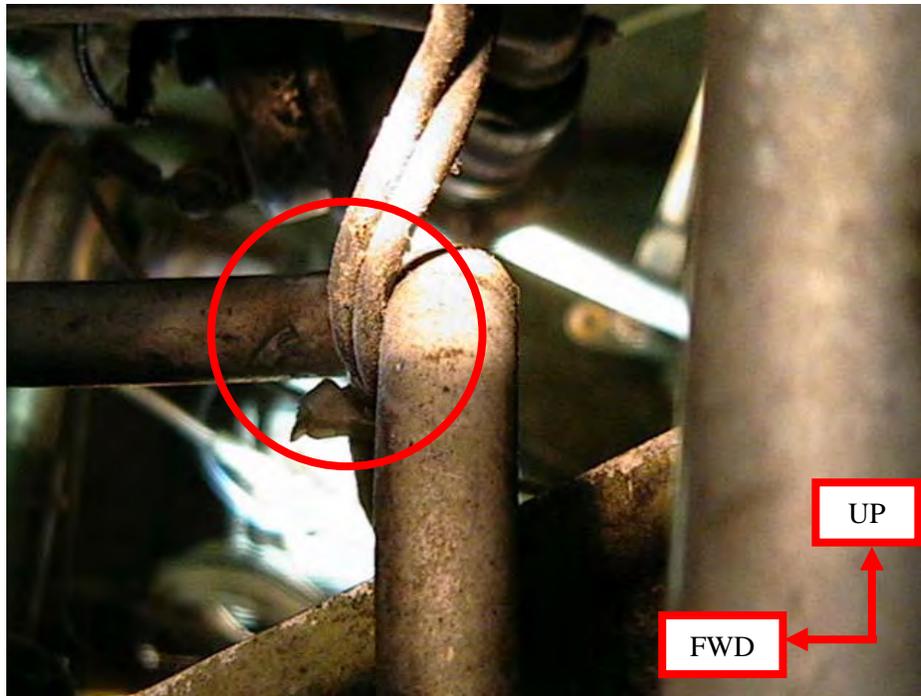
Figure 46. Poor/Improper Support of Wires FS 110, WL 0, and RWS 77
