DOT/FAA/AR-07/64

Teardown Evaluation of a 1975 Piper Navajo Chieftain Model PA31-350 Airplane

March 2008

Final Report

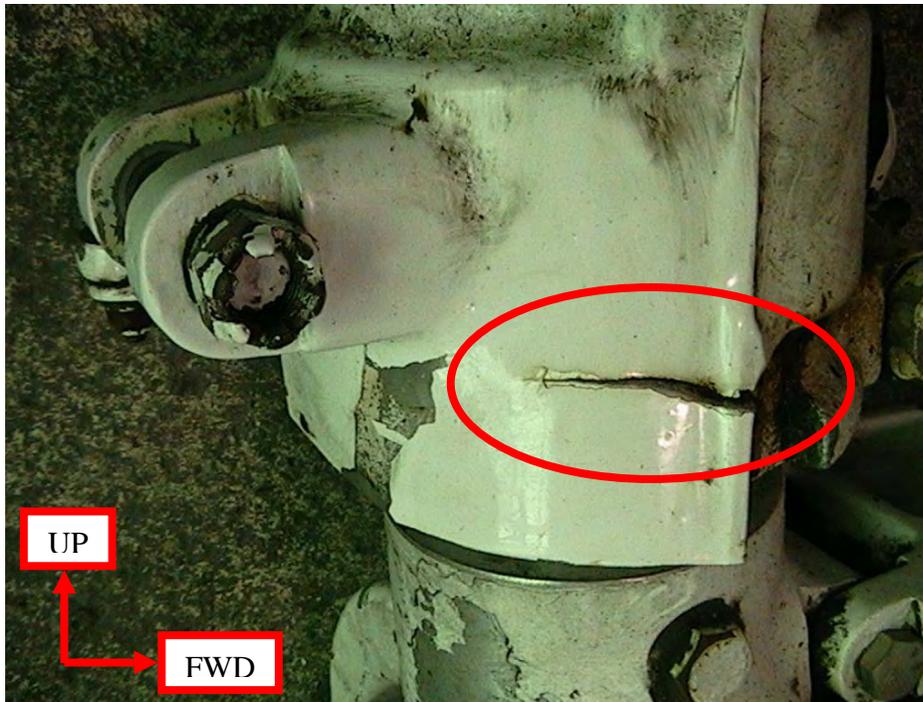
Name of Inspection	Discrepancy Reported
Landing gear strut housing attachment points	Nose landing gear housing is cracked
Rudder torque tube	Corrosion is completely through the tube

Figure 52. Crack in the Nose Landing Gear Strut Housing FS 25, WL 32, and RBL 2

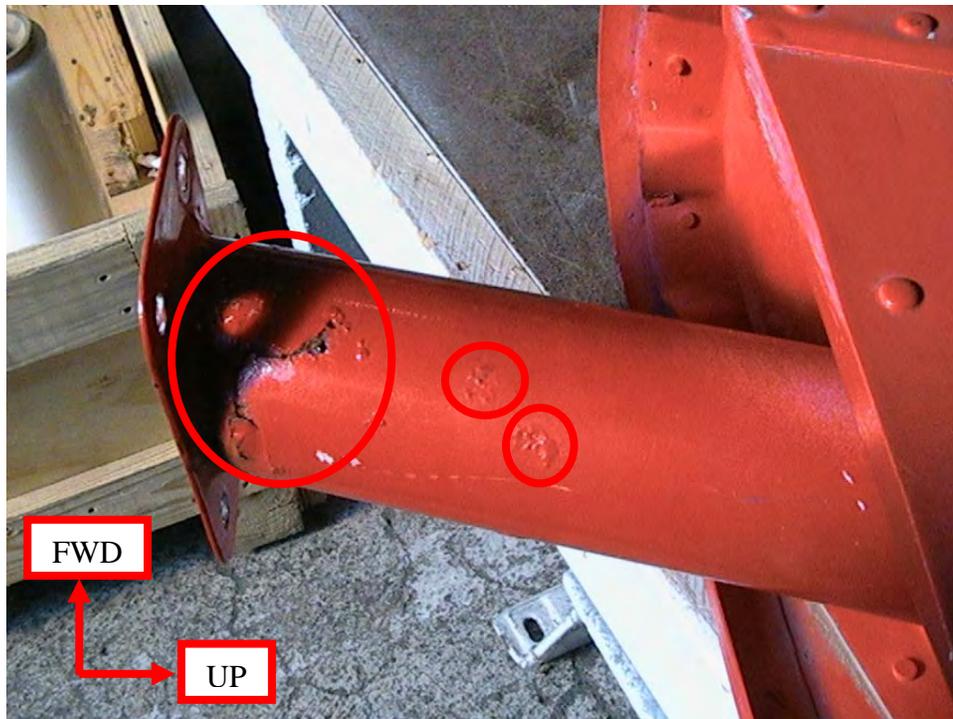
Visual testing is the original and most commonly used NDI method. It is the simplest to perform since it does not require additional equipment. The inspector simply looks at the inspection areas for surface damage. A ten power hand-held magnifying glass under a minimum 100-lumen light is often used to detect smaller flaws. Since paint is rarely removed from the inspection area, the inspector must decide whether a crack is in the paint only or if it extends into the underlying structure. The results of the visual airworthiness inspections are listed in table 19. In addition, these visual findings are shown in figures 51 through 55. Figure 51 is the global view of the nose landing gear strut assembly. Figure 52 shows a 1-inch crack on the nose landing gear strut housing. Figure 53 shows the location of the rudder torque tube. Corrosion, approximately 2 square inches, on the rudder torque tube can be seen in figures 54 and 55.

Figure 54. Corrosion on the Rudder Torque Tube FS 342.25, WL 20, and BL 0

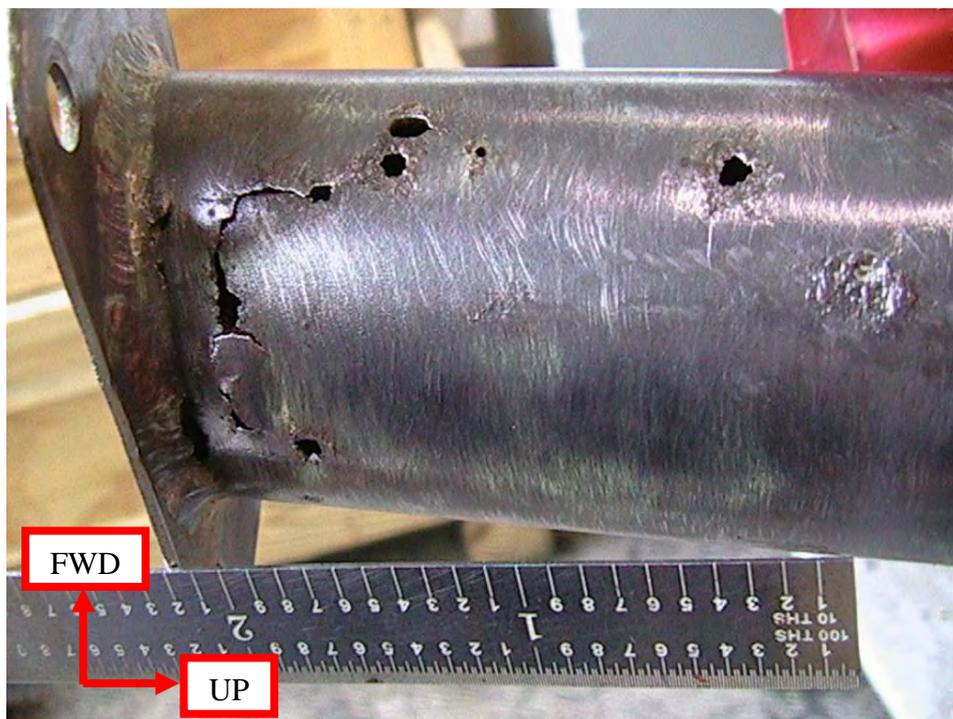
Figure 55. Corrosion on the Rudder Torque Tube After Paint Removal FS 342.25, WL 20, and BL 0

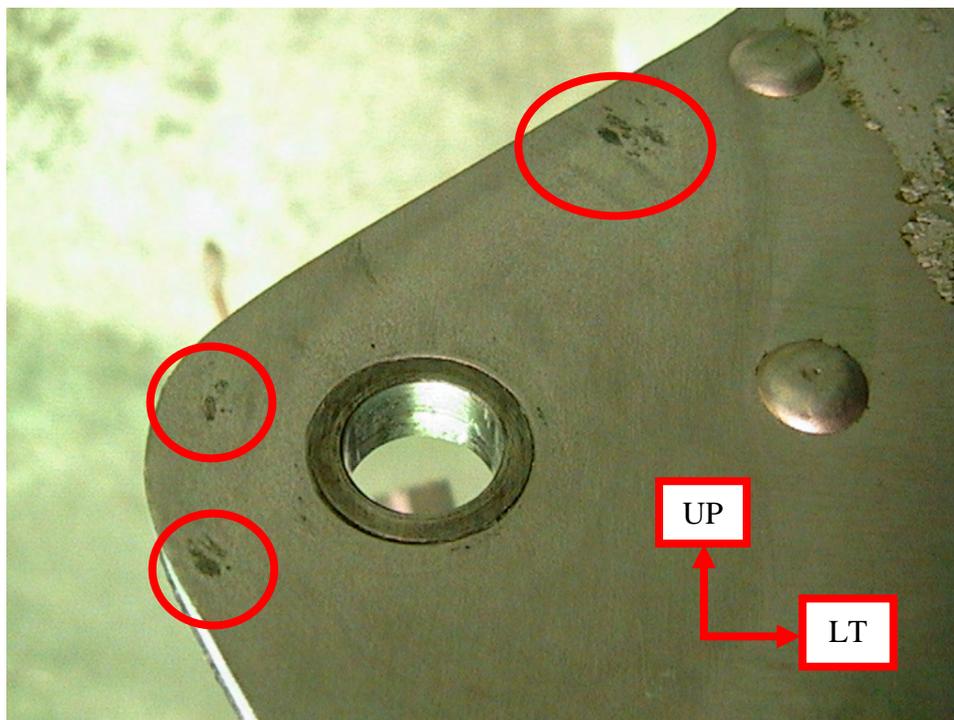
Penetrant inspections tend to take longer than visual or eddy current to perform since surfaces must be stripped of paint before this inspection can be conducted. A penetrating liquid is placed on the surface of the part, and this liquid penetrates into the cavity formed by a discontinuity, such as a crack, in the material. The surface liquid is then removed gently to avoid disturbing the penetrant that settled in the discontinuity. The liquid left in the cavity is brought back to the surface with the application of a developer. A black light is used to view the flaw if a fluorescent penetrant is used. Fluorescent penetrant is limited to surface flaws and requires about 20 minutes of inspection preparation. Table 20 shows the discrepancies of the liquid penetrant airworthiness inspections, which included the inspection of elevator hinges and attachment fittings. The corrosion findings from liquid penetrant are shown in figures 57 through 61. The global view of the liquid penetrant areas on the wing front and rear spar attachment points is shown in figure 57. The left wing fuselage attachment points with corrosion are shown in figures 58 and 59. Corrosion on the right wing fuselage attachment points is shown in figures 60 and 61.

Figure 58. Corrosion on the Left Wing Front Spar Wing Side Attachment Point WS 30

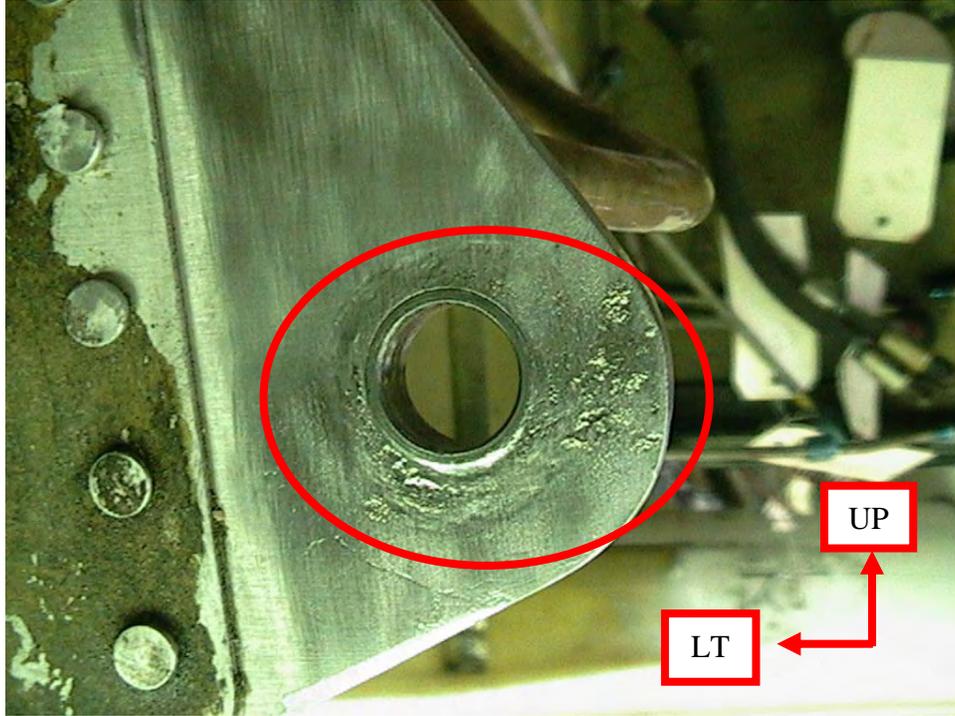
Figure 59. Corrosion on the Left Wing Rear Spar Wing Side Attachment Point WS 30

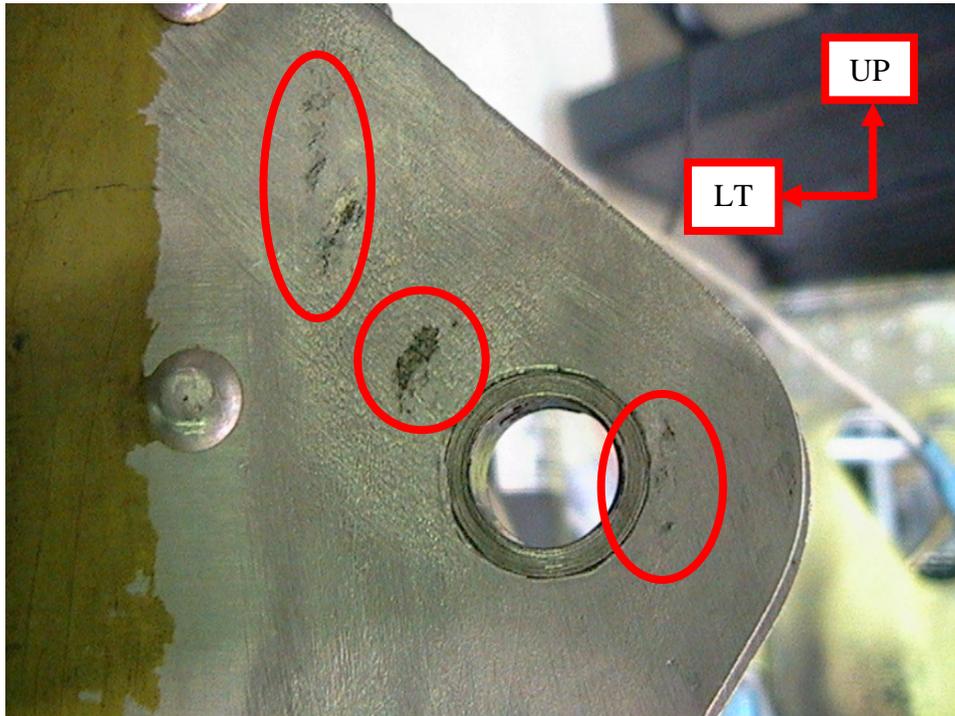
Figure 60. Corrosion on the Right Wing Front Spar Wing Side Attachment Point WS 30

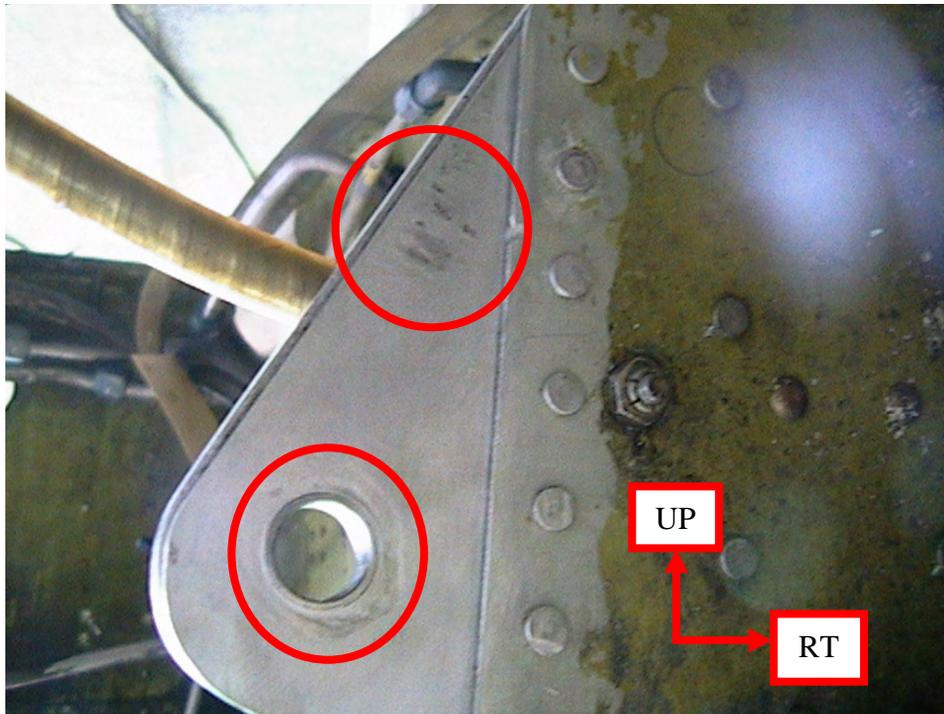
Figure 61. Corrosion on the Right Wing Rear Spar Wing Side Attachment Point WS 30

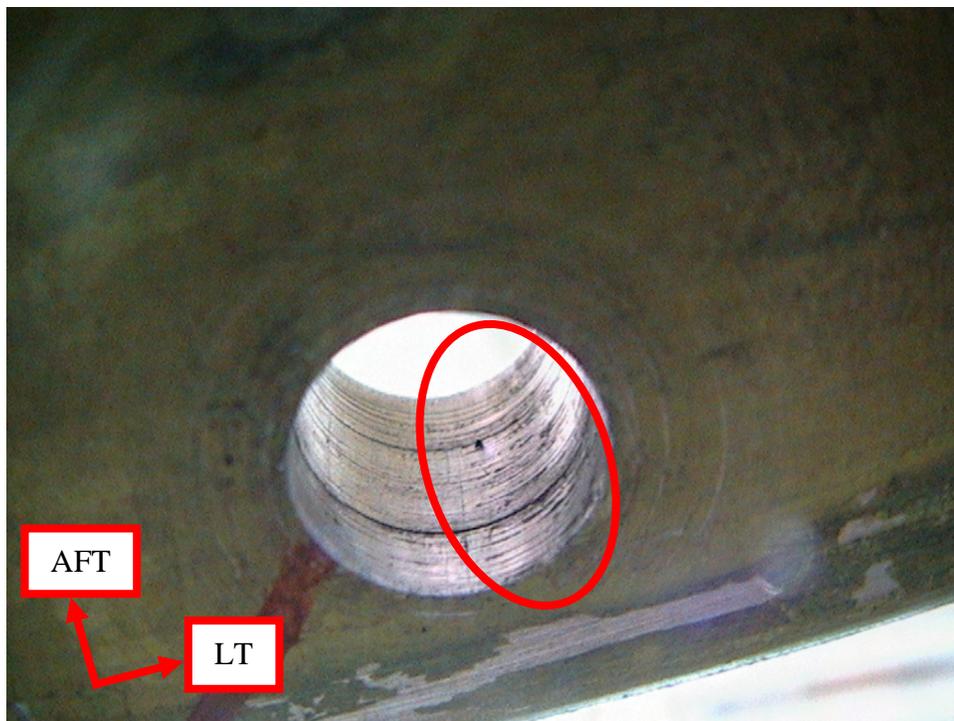
A majority of the airworthiness inspections were performed using the eddy-current method. Table 21 shows the results from the eddy-current airworthiness inspections. These eddy-current findings are shown in figures 64 through 69. The global view of the inspected area on the wing main spar splice attachment points is shown in figure 64. The left wing main spar splice attachment points with the gouge indications are shown in figures 65 and 66. Figure 67 shows the average gouges found on the left wing main spar splice attachment points. The right wing main spar splice attachment points with gouge indications are shown in figure 68. Figure 69 shows the average gouges found on the right wing main spar splice attachment points.

Figure 67. Gouges on the Left Wing Main Spar Splice Attachment Points BL 0 Through BL 6

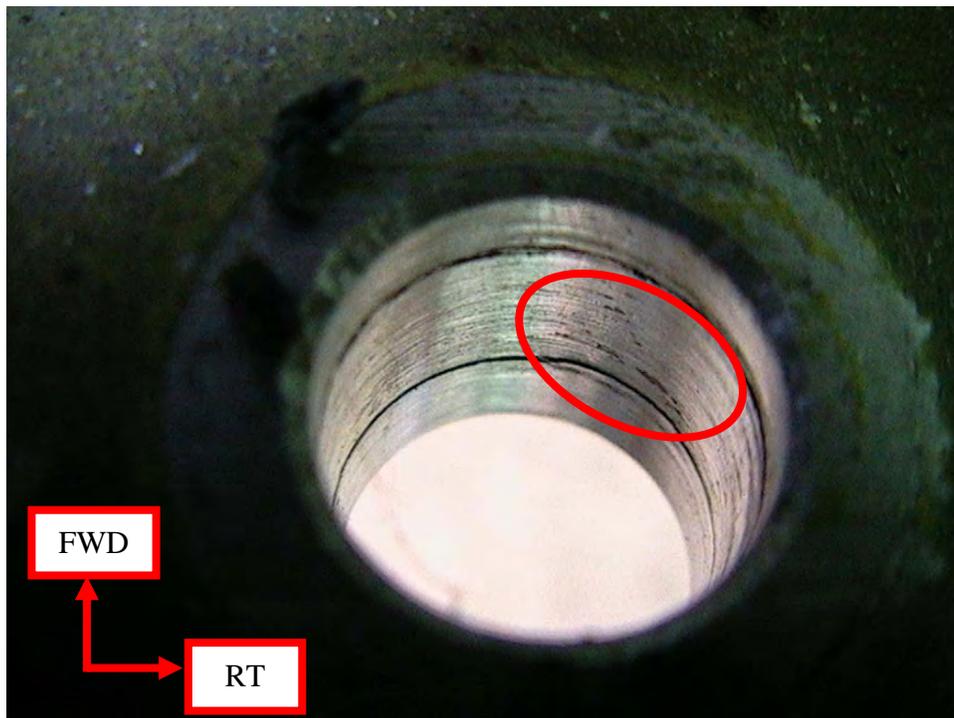
Figure 69. Gouges on the Right Wing Main Spar Splice Lower Attachment Points BL 0 Through BL 6

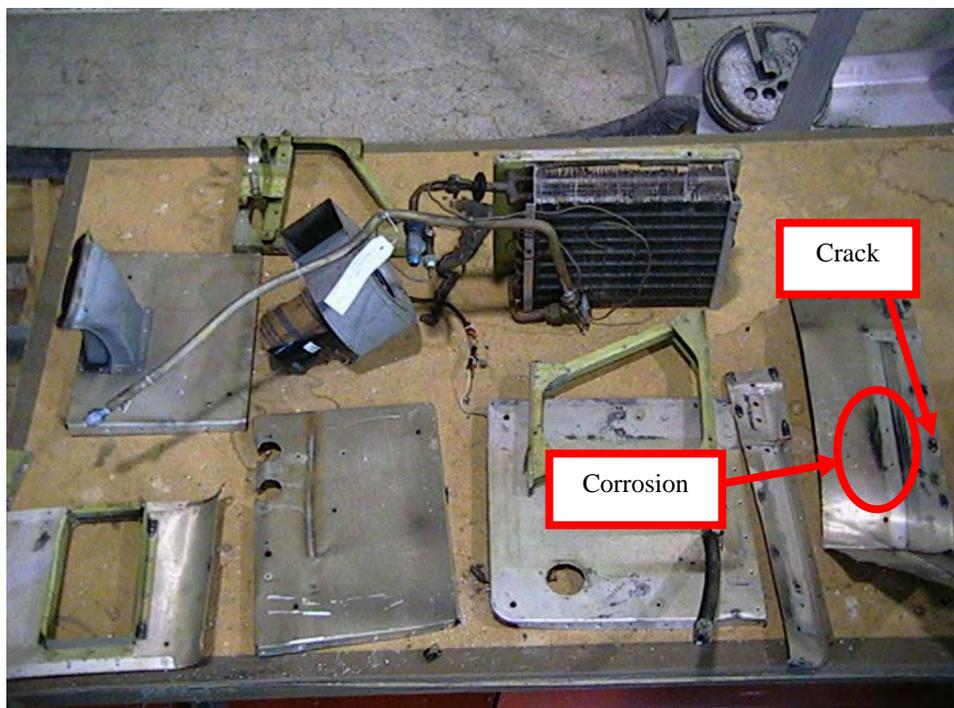
The teardown inspection of the air conditioning unit, shown in figure 70 before disassembly and figure 71 after disassembly, revealed a 0.5-inch crack in the frame mount hole and some minor corrosion. Several heat exchanger cooling fins had minor damage on the top and bottom end. No other defects beside normal wear were found on this unit.

Figure 71. Air Conditioning Unit Cracked and Corroded

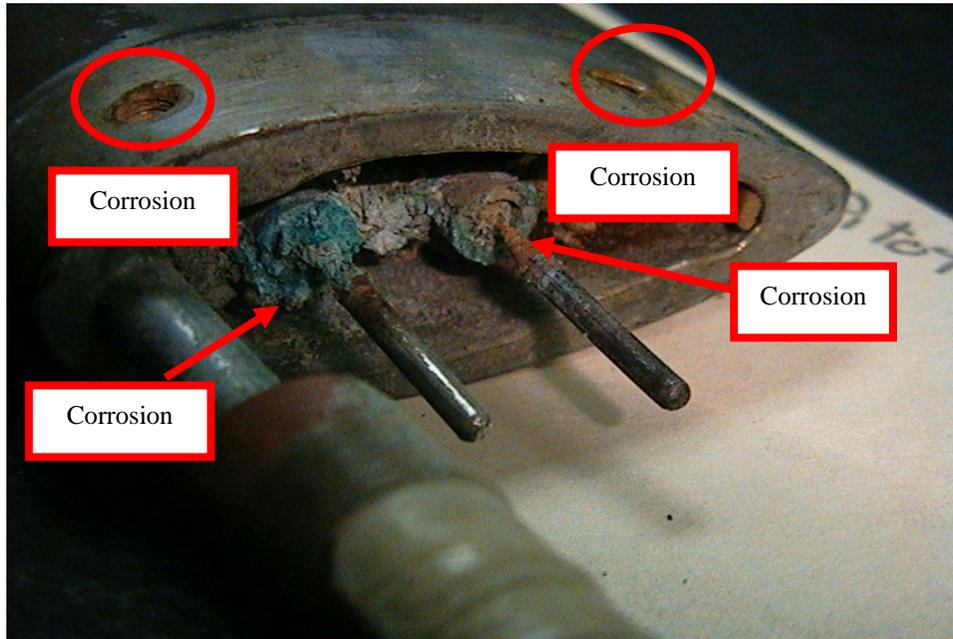
The inspections of the right pitot probe, shown in figure 72, revealed extensive galvanic corrosion around the element heating probe pins. This condition has the potential to inhibit the probe from heating, causing the probe to freeze in flight, which may result in false airspeed indications. There was also a small amount of corrosion found around the bolt attachment holes. Approximately 20% of the surface plating on the top side of the probe had deteriorated. This condition was attributed to possible high wind-speed environment for which the probe operates in.

Figure 72. Corrosion on Pitot Probe

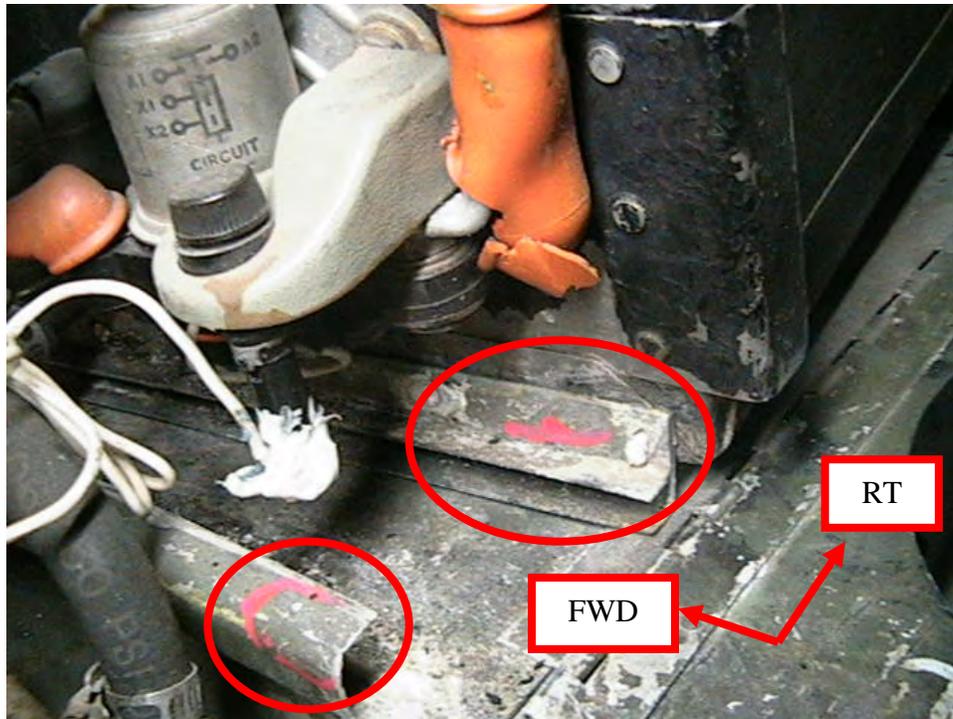
The hydraulic actuator, shown in figure 77 before disassembly and figure 78 after disassembly, revealed no defects during an extensive visual inspection. Figure 79 shows a hydraulic reservoir, and figure 80 shows a heat duct switch assembly. Both were visually inspected, resulting in no defects found. The inspection of the battery box, shown in figure 81, revealed a 0.5-inch crack and minor uniform surface corrosion.

Figure 81. Battery Box Cracked and Corroded

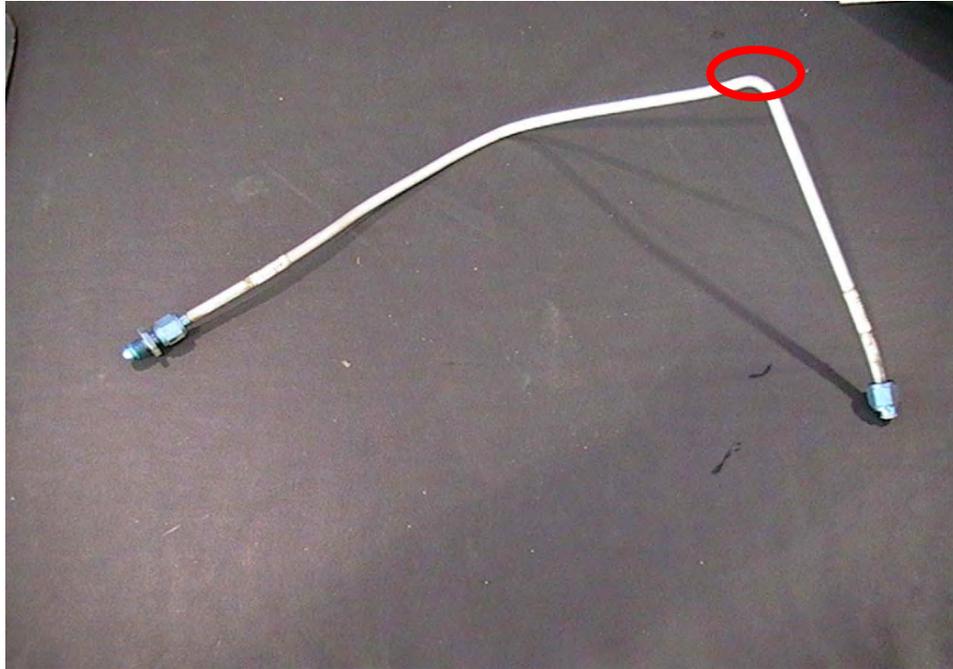
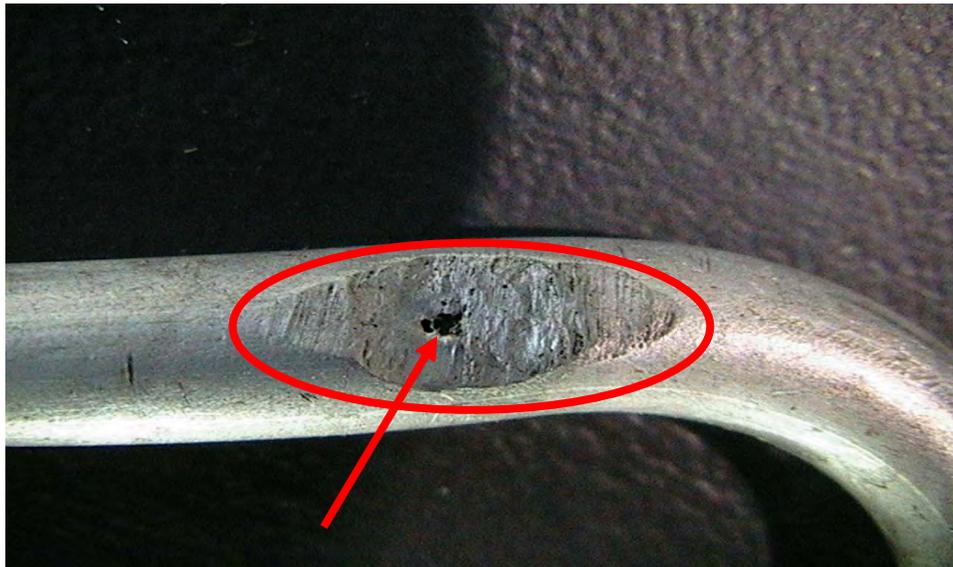
Two hundred and three lines, tubes, and hoses were visually inspected and leak checked during the teardown phase. The majority of findings were minor scratches, nicks, gouges, flared tube ends, and minor corrosion. One major finding, shown in figures 83 and 84, was a manifold pressure line with a small 1/16-inch-diameter hole causing it to fail the leak check. This pressure line had a small gouge surrounding the hole, measuring approximately 1 inch. This is indicative of a chafing condition.

Figure 83. Location of Hole in the Left Wing Manifold Pressure Line

Figure 84. Close-Up View of Hole in the Left Wing Manifold Pressure Line

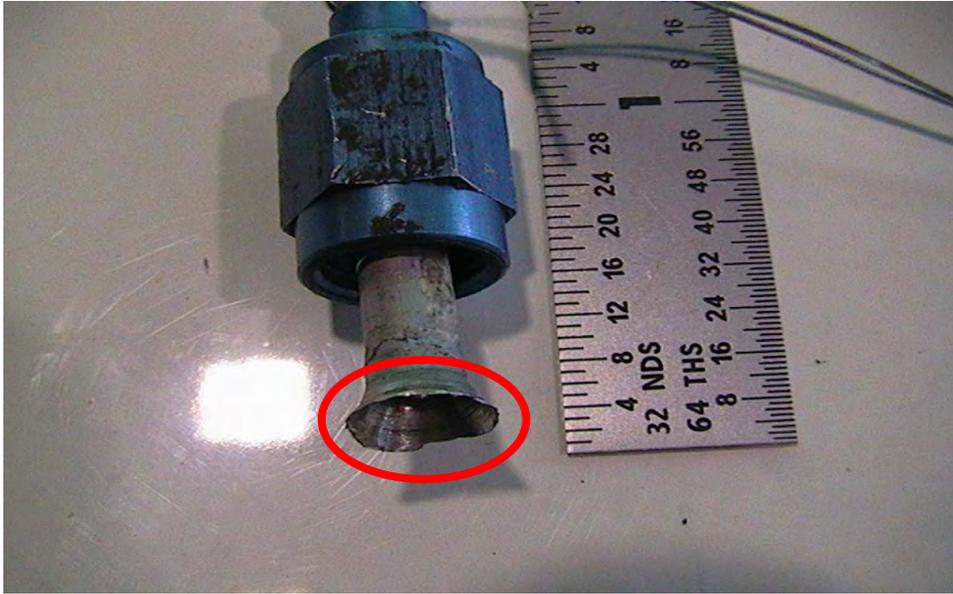
Figures 85 and 86 show two separate line fittings with flared ends, which could cause leaking. The line shown in figure 86 also had a small gouge on the b-nut, and figure 87 shows the pneumatic de-ice valve lower fitting with mild corrosion on the fitting threads. The overall condition of all tubes, fittings, and hoses inspected were classified as satisfactory. The majority of findings may be contributed to airplane normal wear and aging effects.

Figure 85. Upper Oil Pressure Line Fitting With Flared End

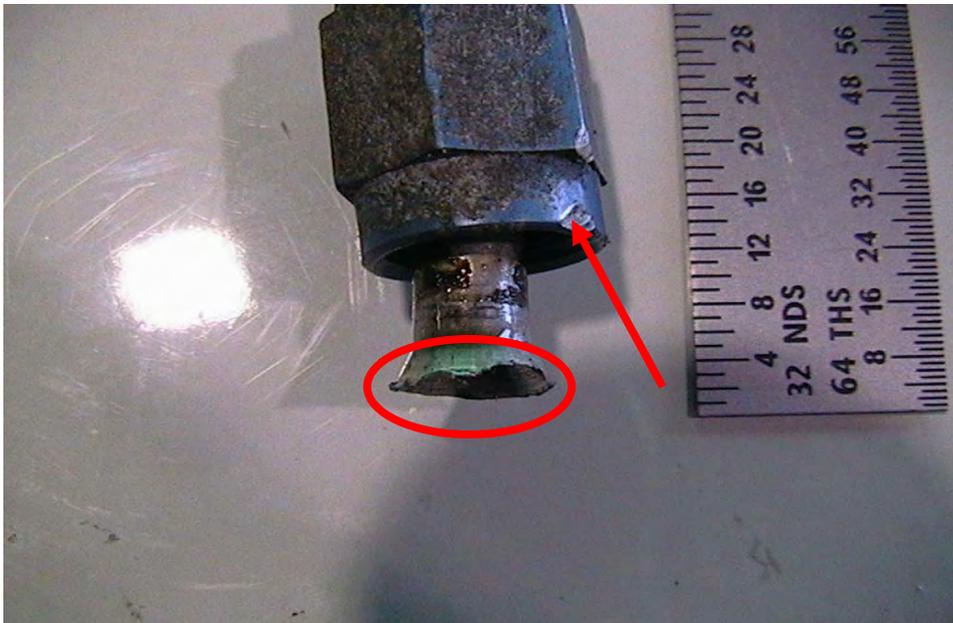
Figure 86. Lower Oil Pressure Line Fitting With Gouge and Flared End

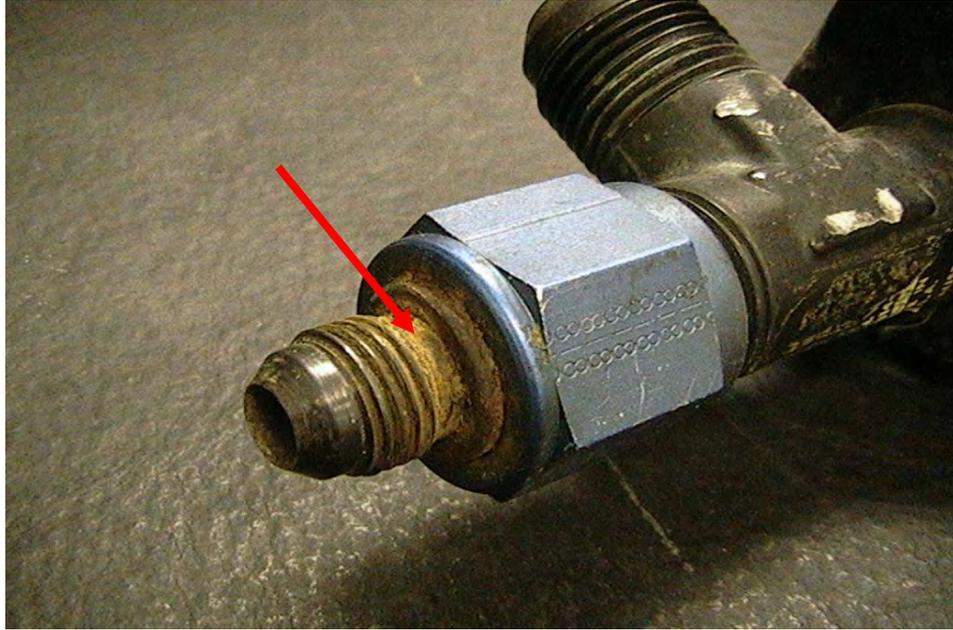
Figure 87. Corrosion on Pneumatic De-Ice Valve

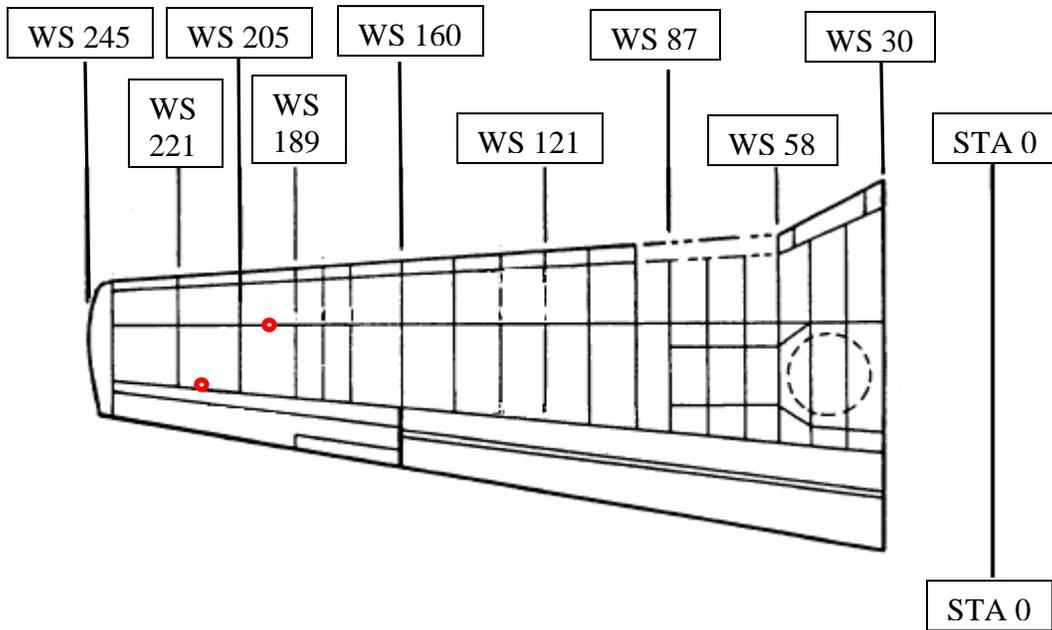
NDI Method	Indication	Location
Sliding probe	Crack	Left wing main spar lower cap WS 197.25
Sliding probe	Crack	Left wing rear spar lower cap WS 197.25
Sliding probe	Crack	Left wing rear spar upper cap WS 217

Figure 92. Left Wing Lower Surface NDI Indications

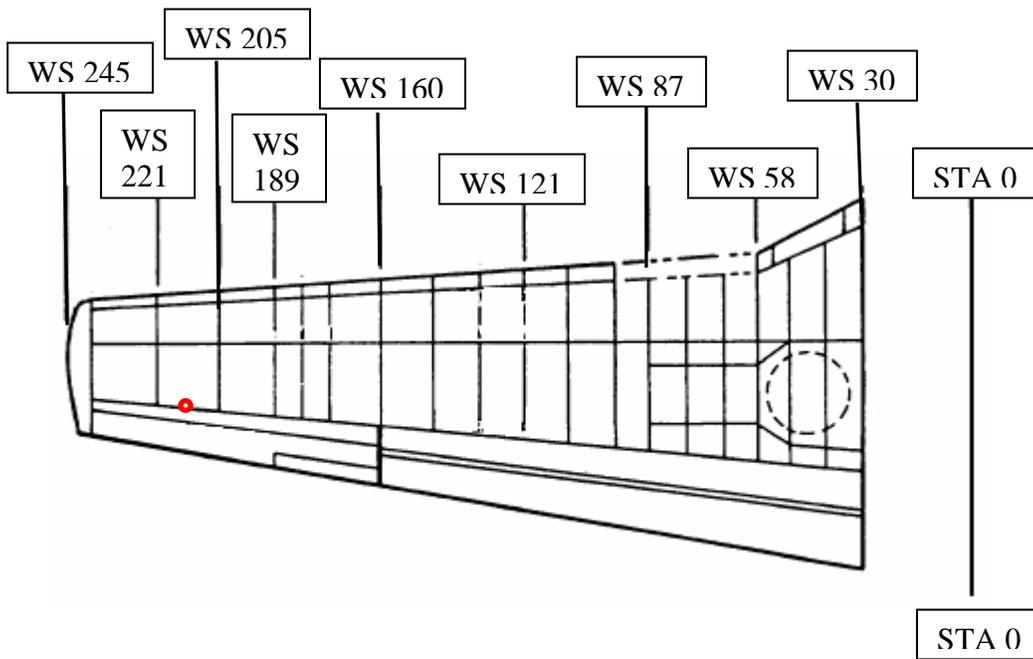
Figure 93. Left Wing Upper Surface NDI Indications

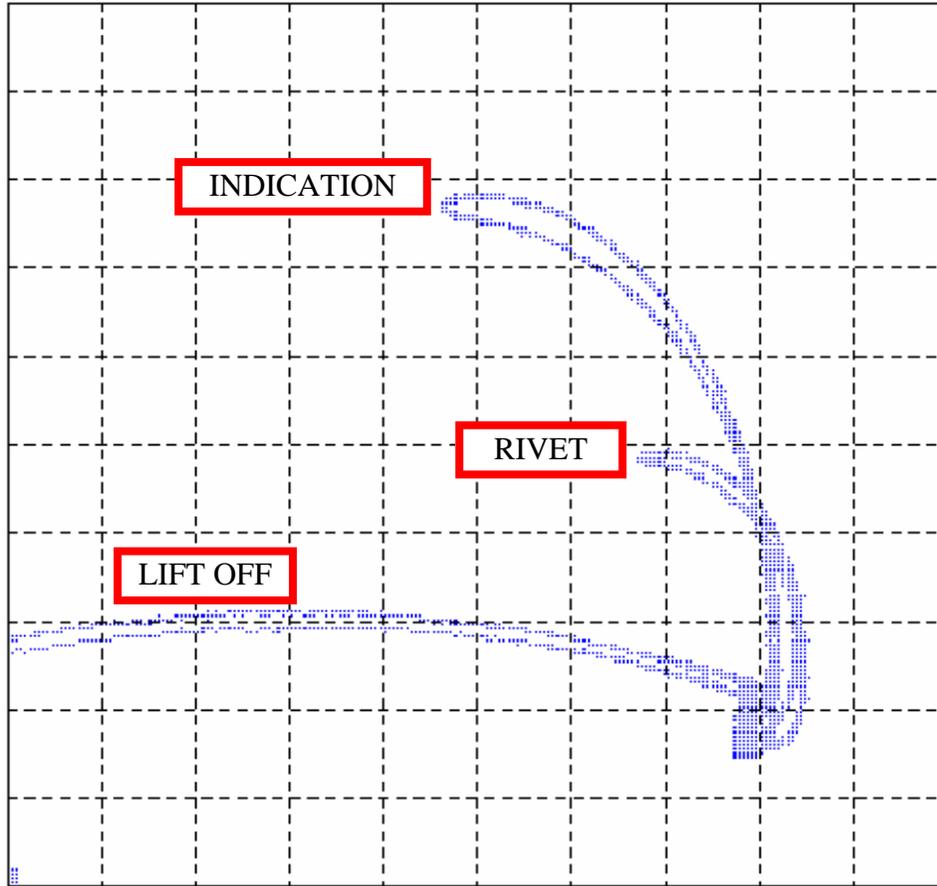
Figure 94. Left Wing Rear Spar Upper Cap WS 217 Indication Screen Display

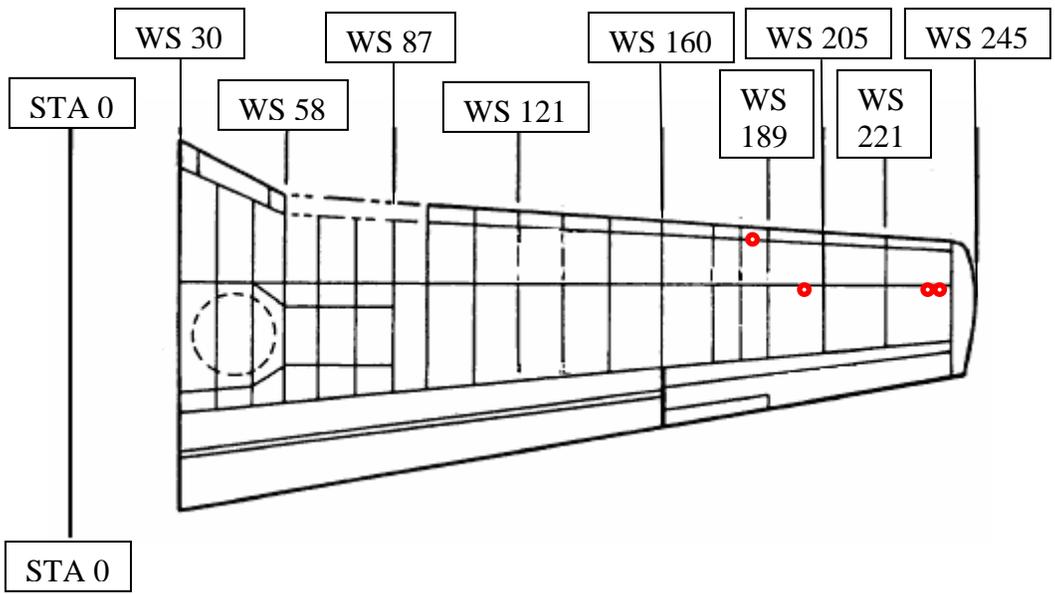
NDI Method	Indication	Location
Sliding probe	Crack	Right wing front spar lower cap WS 184.5
Sliding probe	Crack	Right wing main spar lower cap WS 198.5
Sliding probe	Crack	Right wing main spar lower cap WS 232.2
Sliding probe	Crack	Right wing main spar lower cap WS 233.5
Sliding probe	Crack	Right wing main spar upper cap WS 110

Figure 95. Right Wing Lower Surface NDI Indications

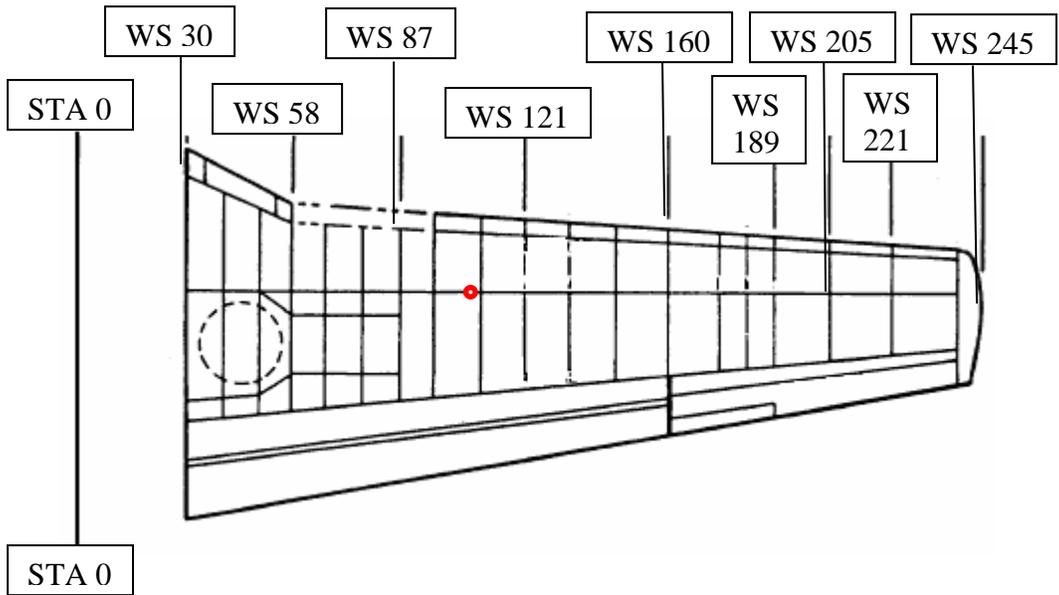
Figure 96. Right Wing Upper Surface NDI Indications

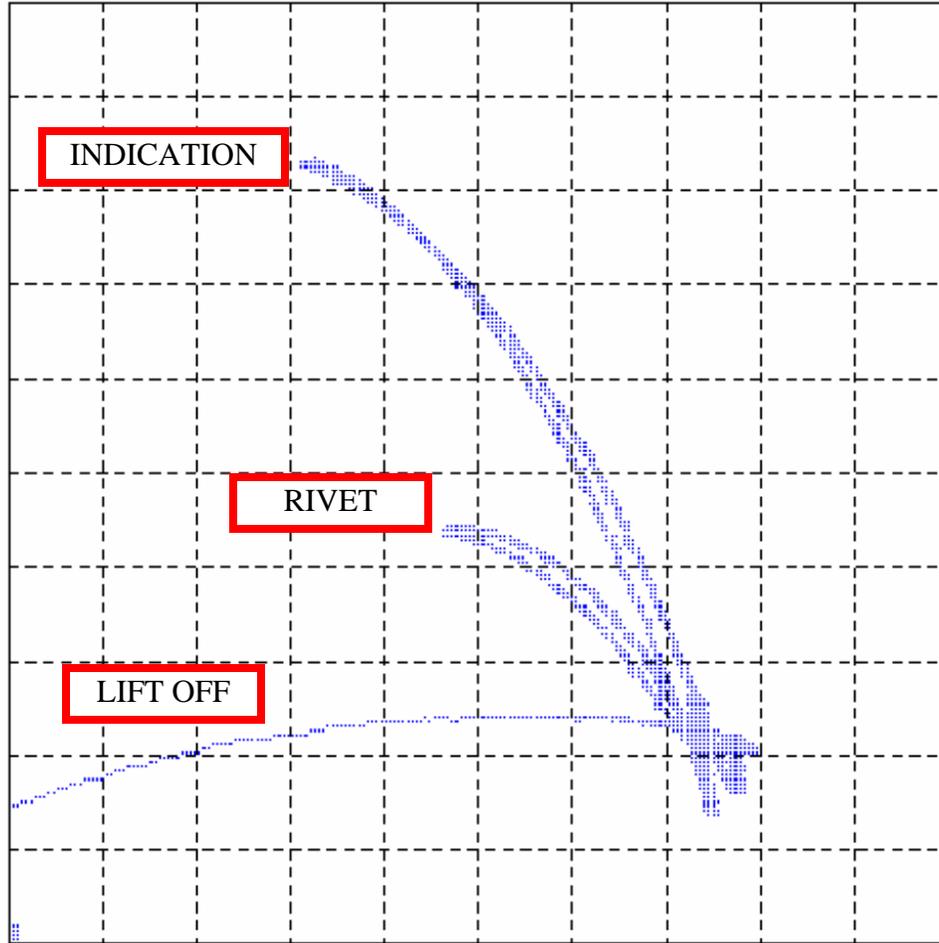
Figure 97. Right Wing Front Spar Lower Cap WS 184.5 Indication Screen Display

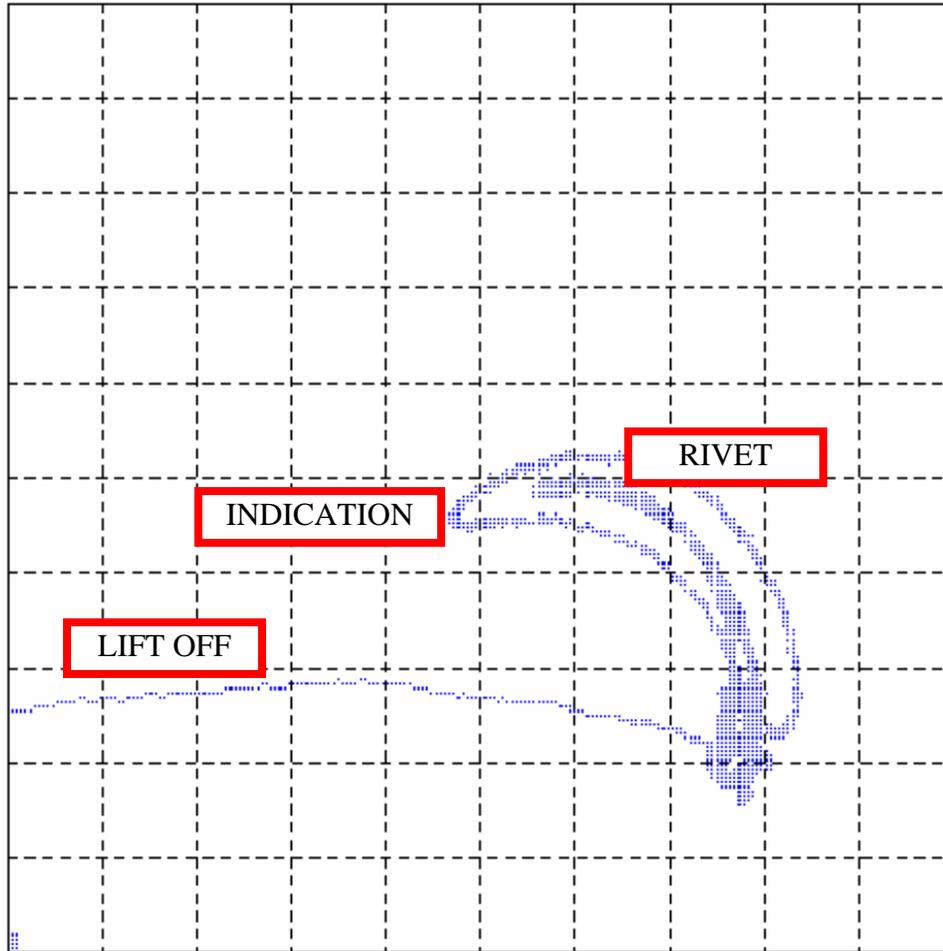
Figure 98. Right Wing Main Spar Lower Cap WS 232.2 Indication Screen Display

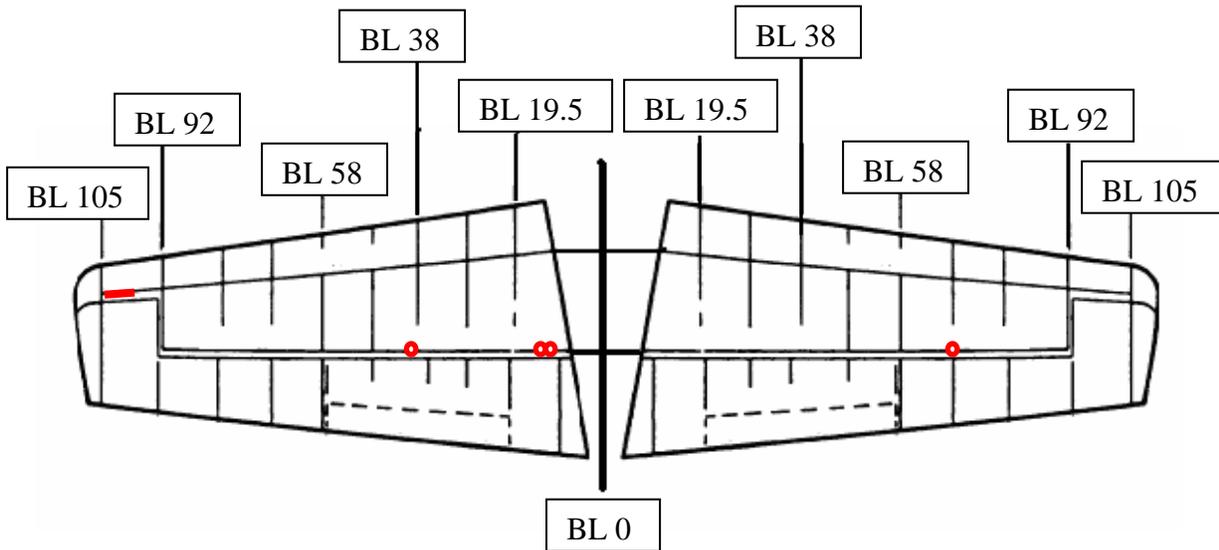
Method	Indication	Location
Sliding probe	Crack	Left horizontal stabilizer rear spar lower cap BL 12.5
Sliding probe	Crack	Left horizontal stabilizer rear spar lower cap BL 12.5
Sliding probe	Crack	Left horizontal stabilizer rear spar lower cap BL 39.5
Sliding probe	Crack	Right horizontal stabilizer rear spar lower cap BL 68
Sliding probe	Crack	Left horizontal stabilizer front spar lower cap BL 98-104.75
Sliding probe	Crack	Right horizontal stabilizer rear spar upper cap BL 34.5-37.25
Sliding probe	Crack	Right horizontal stabilizer rear spar upper cap BL 83.25-92
Sliding probe	Crack	Left horizontal stabilizer rear spar upper cap BL 90-92
Sliding probe	Crack	Left horizontal stabilizer front spar upper cap BL 100.25-104.75

Figure 99. Horizontal Stabilizer Lower Surface NDI Indications

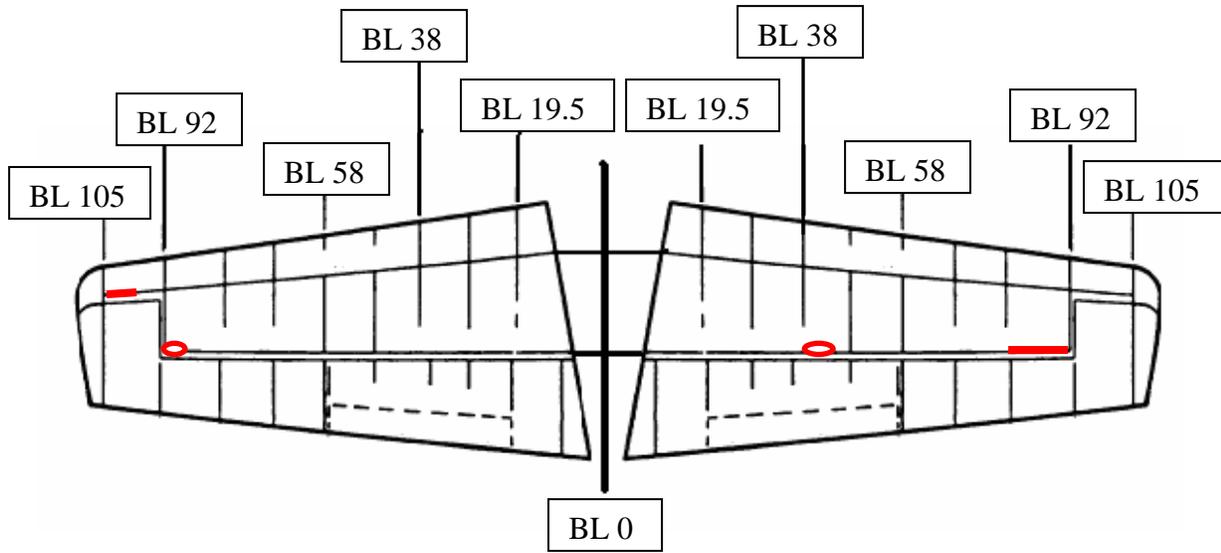
Figure 100. Horizontal Stabilizer Upper Surface NDI Indications

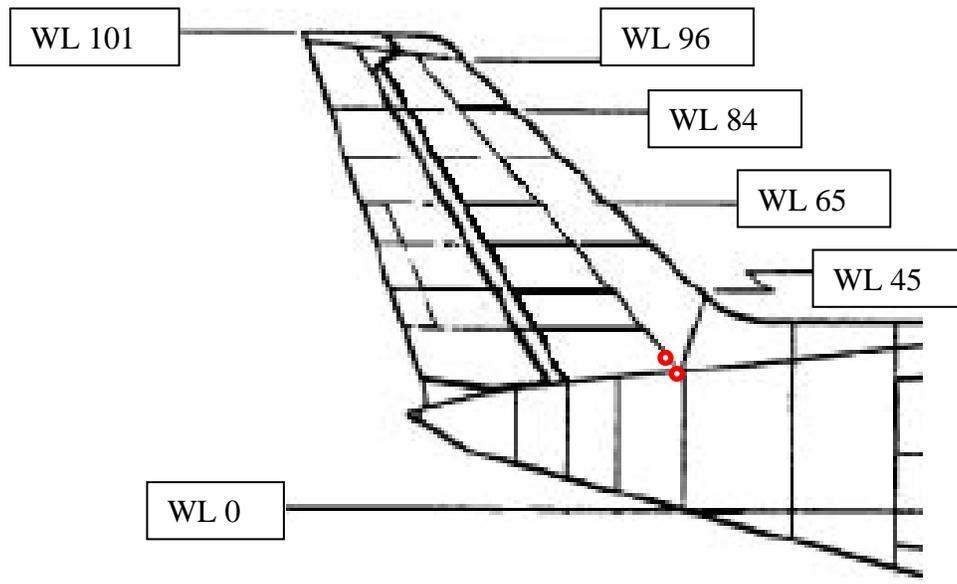
Method	Indications	Location
Sliding probe	Crack	Right vertical stabilizer front spar cap WL 24.25
Sliding probe	Crack	Right vertical stabilizer front spar cap WL 27.25

Figure 101. Vertical Stabilizer Right Side NDI Indications

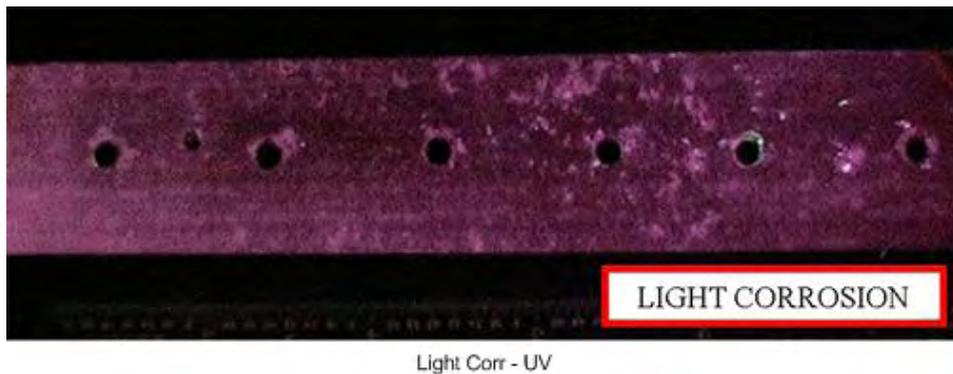
During the teardown evaluations, light and light-moderate corrosion was found to be widespread over the airplane. This is typical of an airplane of this age and operational environment history. Examples of light and light-moderate corrosion are shown in figures 102 through 105, as opposed to providing a photograph of each occurrence on the airplane.

Figure 102. Fluorescent Liquid Penetrant Indication of Light Corrosion

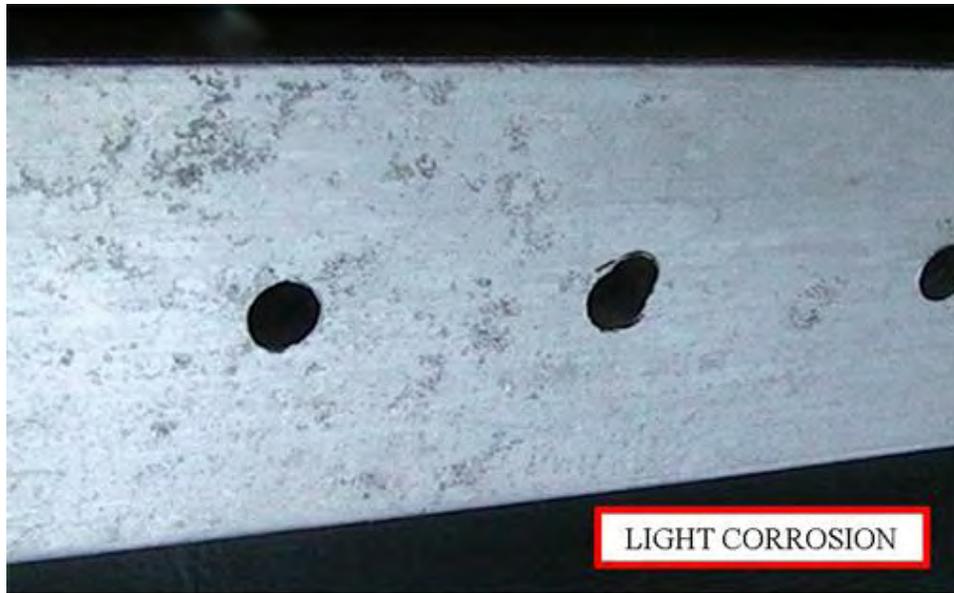
Light Corr Only - Macro

Figure 103. Light Corrosion Under Visible Light

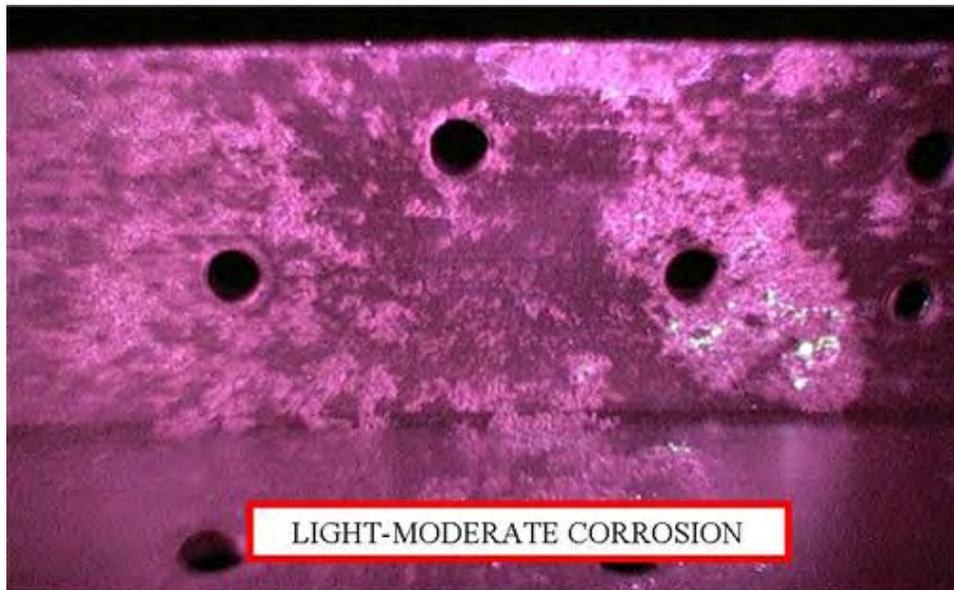
Light-Moderate Corr - UV

Figure 104. Fluorescent Liquid Penetrant Indication of Light-Moderate Corrosion

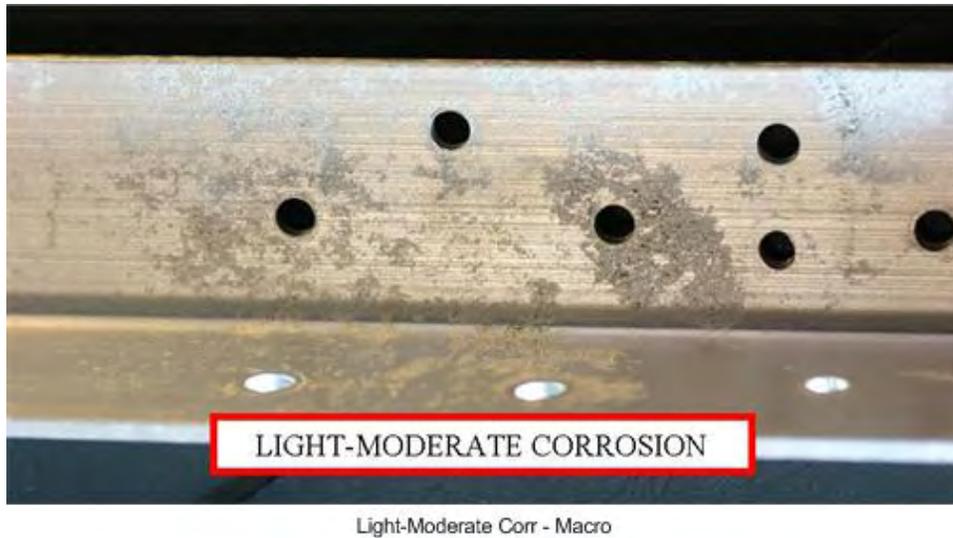
Figure 105. Light-Moderate Corrosion Under Visible Light
