DOT/FAA/AR-07/64

Teardown Evaluation of a 1975 Piper Navajo Chieftain Model PA31-350 Airplane

March 2008

Final Report

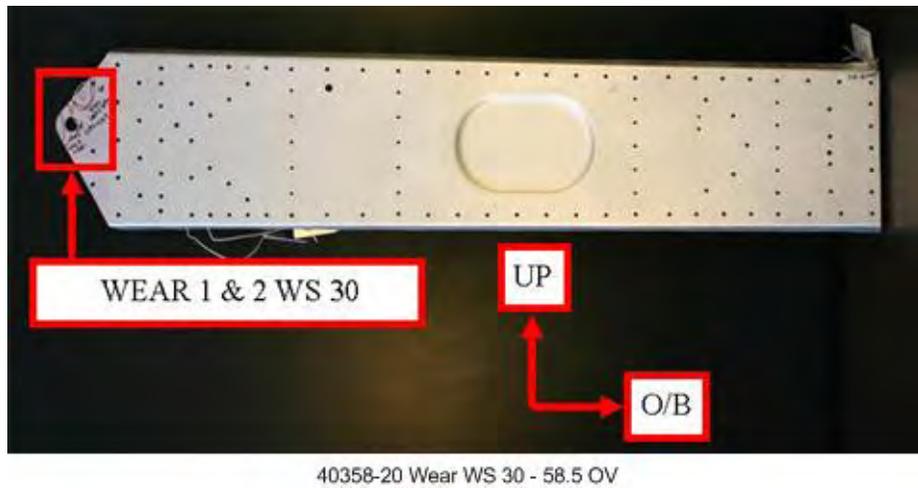
The structural stackup for the left wing front spar is shown in figure 106. All defects identified on the left wing front spar during the teardown evaluation are listed in table 28. Two areas of wear found on the left wing front spar attachment point is shown in figure 107, and macroscopic views of both areas are shown in figures 108 and 109. The maximum thickness loss due to these areas of wear was 2%. An additional area of wear was found on the left wing front spar web at WS 62.5, as shown in figure 110. A macroscopic view of this area of wear, which caused a maximum localized thickness loss of 83%, is shown in figure 111. One crack was found on the left wing front spar web at WS 147.5, as shown in figure 112. The fluorescent liquid penetrant indication is shown in figure 113. A microscopic view of this 0.233-inch crack is shown in figure 114.

Figure 107. Location of Wear 1 and 2 on the Left Wing Front Spar Attachment Point WS 30

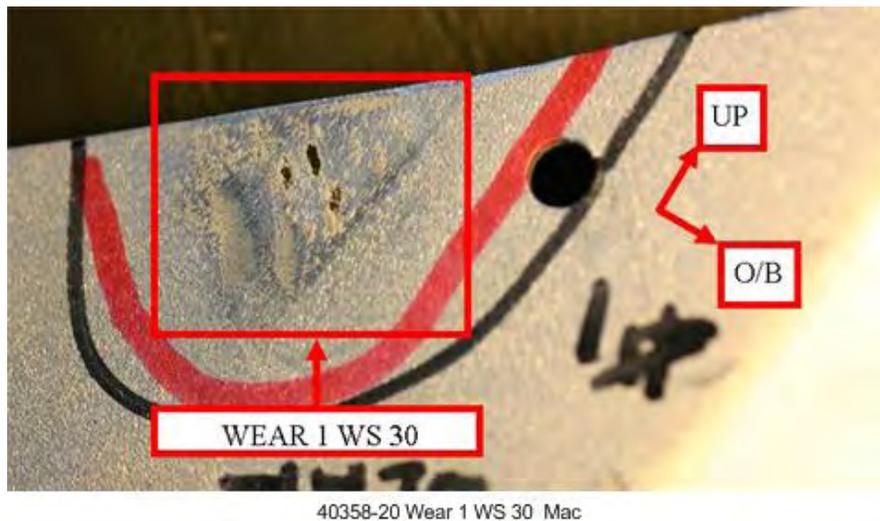
Figure 108. Macroscopic View of Wear 1 on the Left Wing Front Spar Attachment Point WS 30

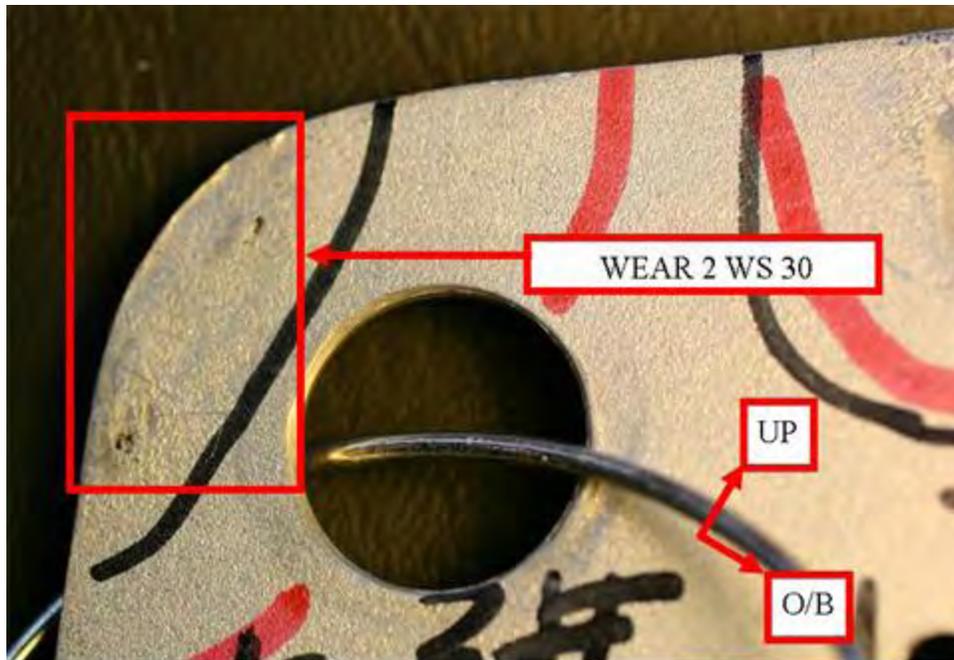
40358-20 Wear 2 WS 30 Mac

Figure 109. Macroscopic View of Wear 2 on the Left Wing Front Spar Attachment Point WS 30

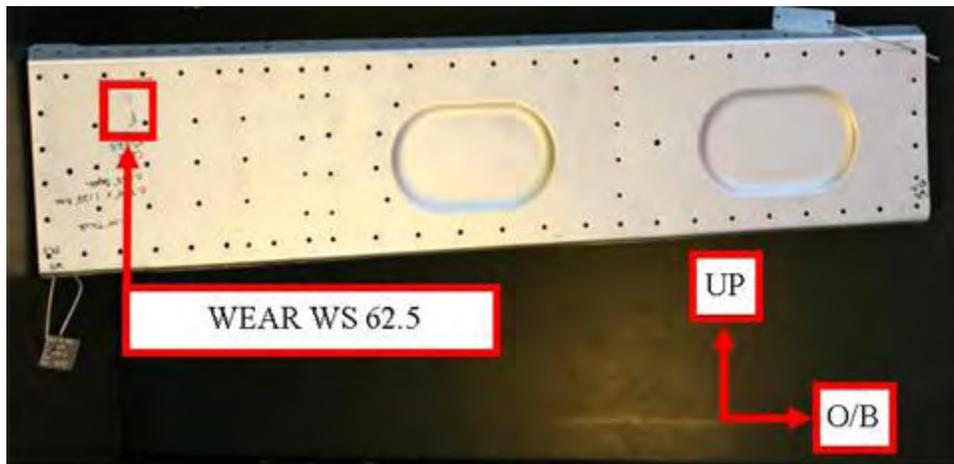
40358-12A Wear WS 59.5-87.5 OV

Figure 110. Location of Wear on the Left Wing Front Spar Web WS 62.5

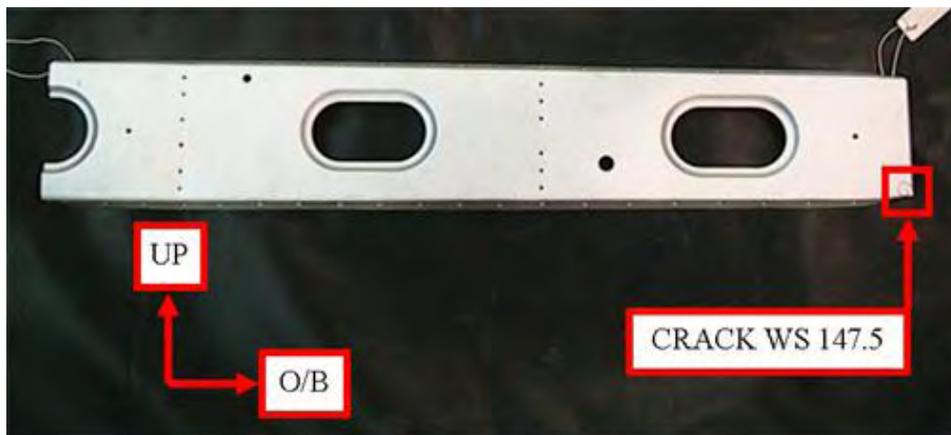
40358-12 CRK WS 116.5-147.5 OV

Figure 112. Location of Crack on the Left Wing Front Spar Web WS 147.5

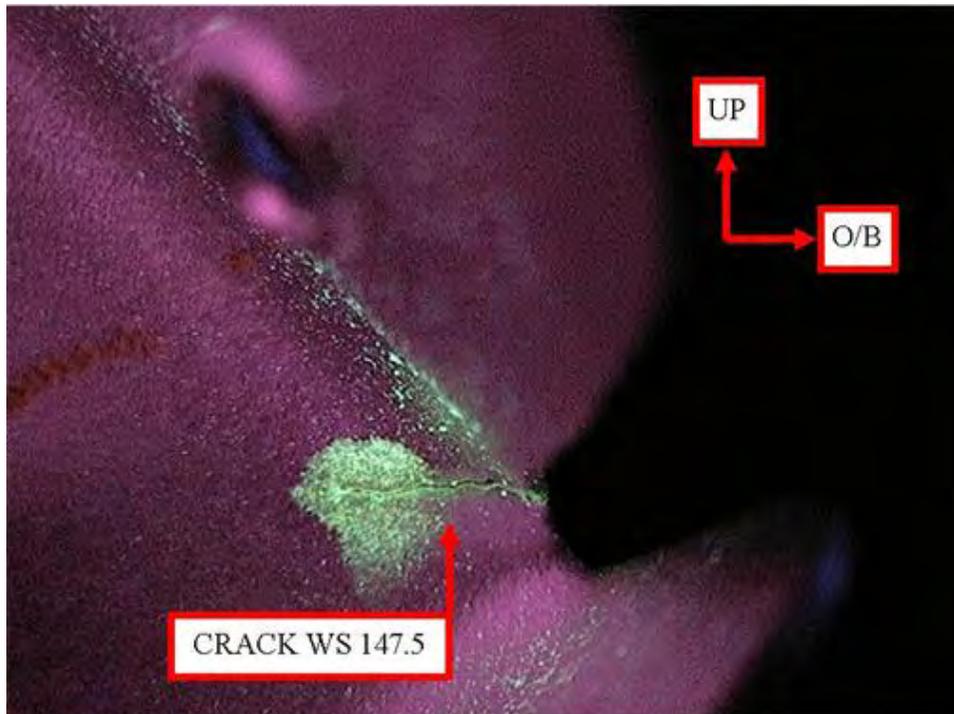
40358-12 CRK WS116.5-147.5 FLP

Figure 113. Fluorescent Liquid Penetrant Indication of Crack on the Left Wing Front Spar Web WS 147.5

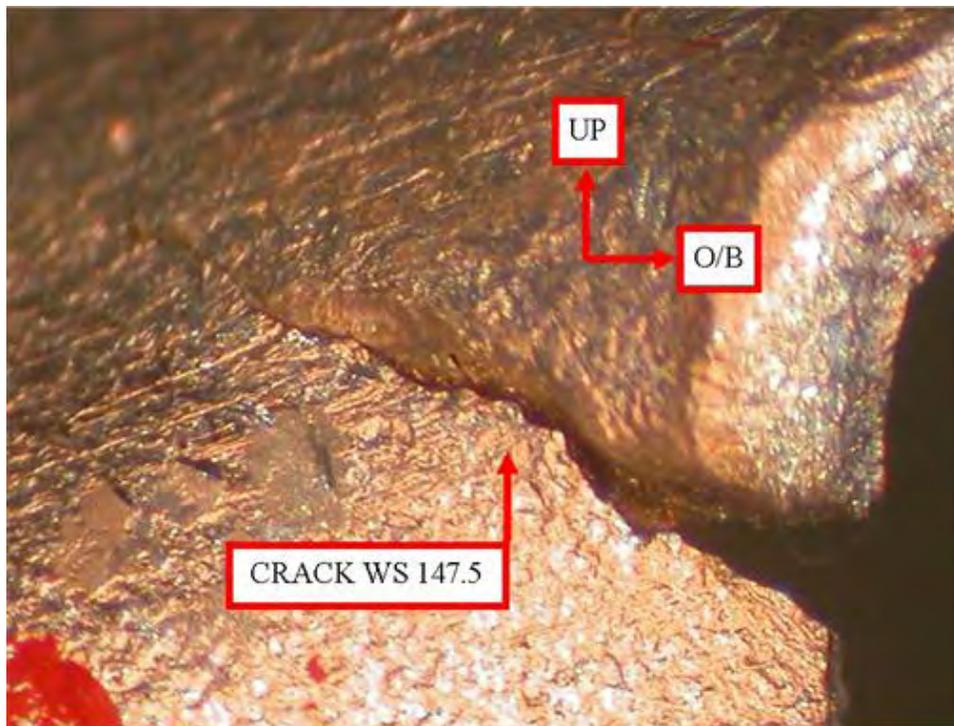
40358-12 CRK WS116.5-147.5 Mic

Figure 114. Microscopic View of Crack on the Left Wing Front Spar Web WS 147.5

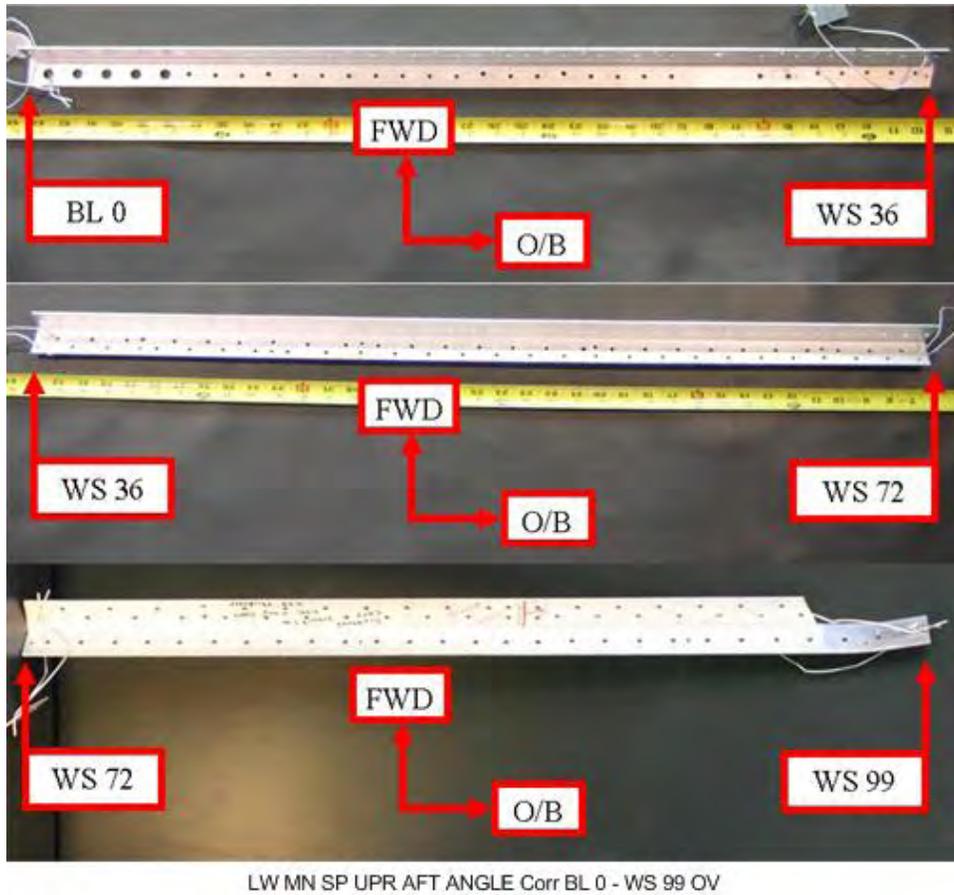
Examples of light and light-moderate corrosion are shown for reference in figures 102 through 105. Scattered light corrosion was identified on the left wing main spar upper aft reinforcement from BL 0 through WS 150. An overview of this area is shown in figure 116. Figure 117 shows an overview of the upper aft angle from BL 0 through WS 99. Scattered light-moderate corrosion was reported on the upper aft angle with a maximum localized thickness loss of 3%. Figure 118 shows the location of light corrosion observed on the upper forward angle at WS 27.25. This corrosion covered an area of 0.02 square inch and caused a maximum thickness loss of 1%.

Figure 117. Overview of Left Wing Main Spar Upper Aft Angle BL 0 Through WS 99

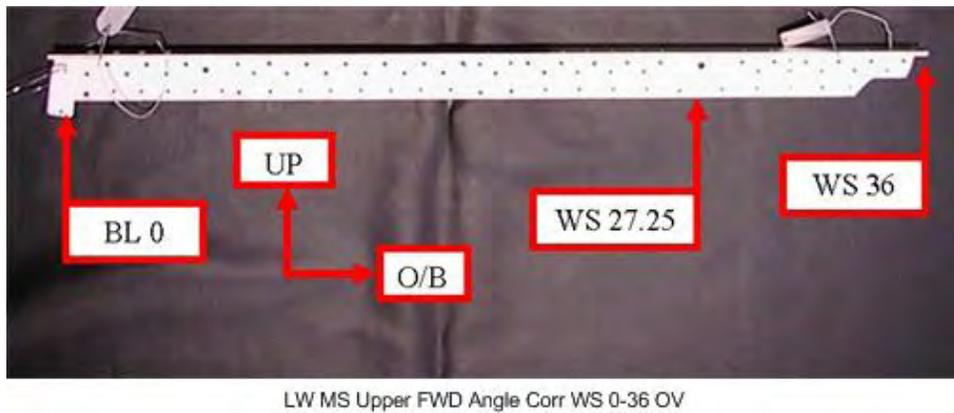
Figure 118. Location of Light Corrosion on the Left Wing Main Spar Upper Forward Angle WS 27.25

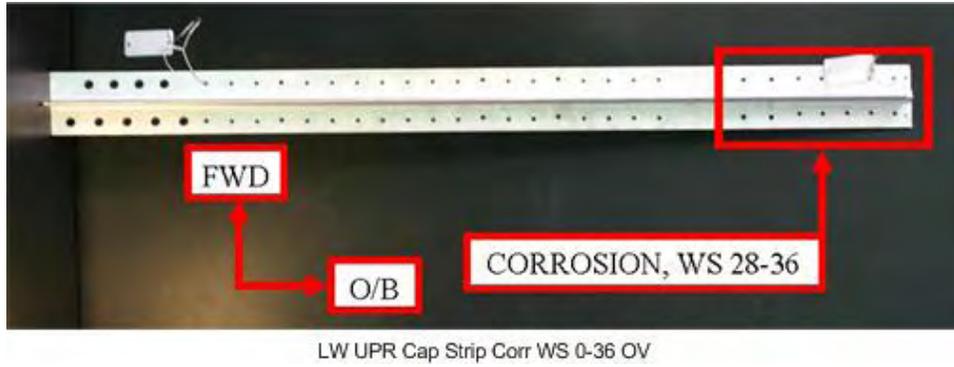
A 20-square-inch area of light-moderate corrosion was observed on the left wing main spar upper cap strip from WS 28 to 36. The location of this area of corrosion, which caused a localized thickness loss of 3.6% on the cap strip is shown in figure 119. Light corrosion, causing a thickness loss of less than 1% was noted scattered over the surface of the upper forward reinforcement from WS 36 to 108. An overview of this area is shown in figure 120. Another area of light corrosion was found scattered across the surface of the upper cap strip from WS 72 to 212.5, as shown in figure 121. This corrosion caused a maximum thickness loss of 1.5%.

Figure 119. Location of Light-Moderate Corrosion on the Left Wing Main Spar Upper Cap Strip WS 28 Through WS 36

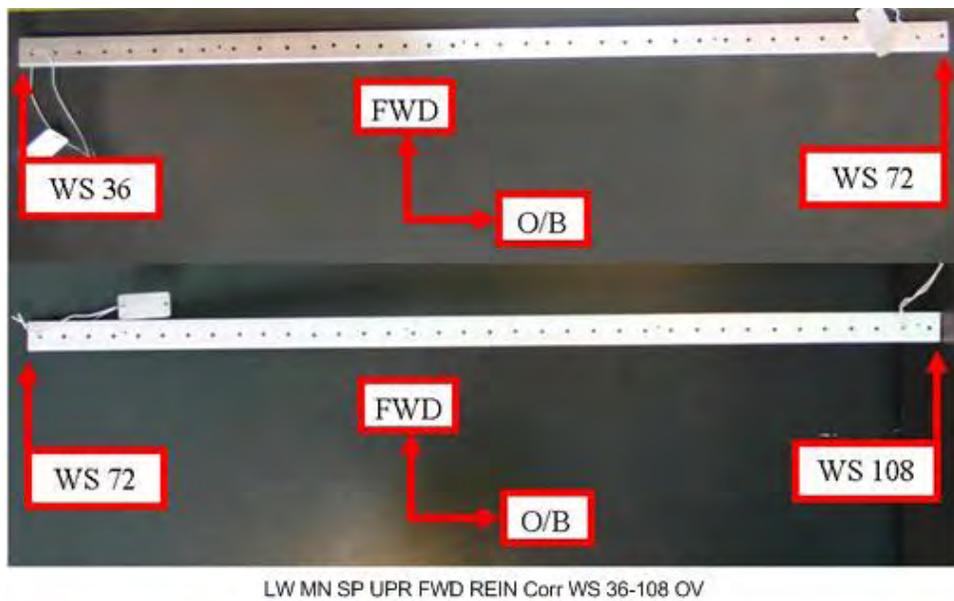
Figure 120. Overview of Left Wing Main Spar Upper Forward Reinforcement WS 36 Through WS 108

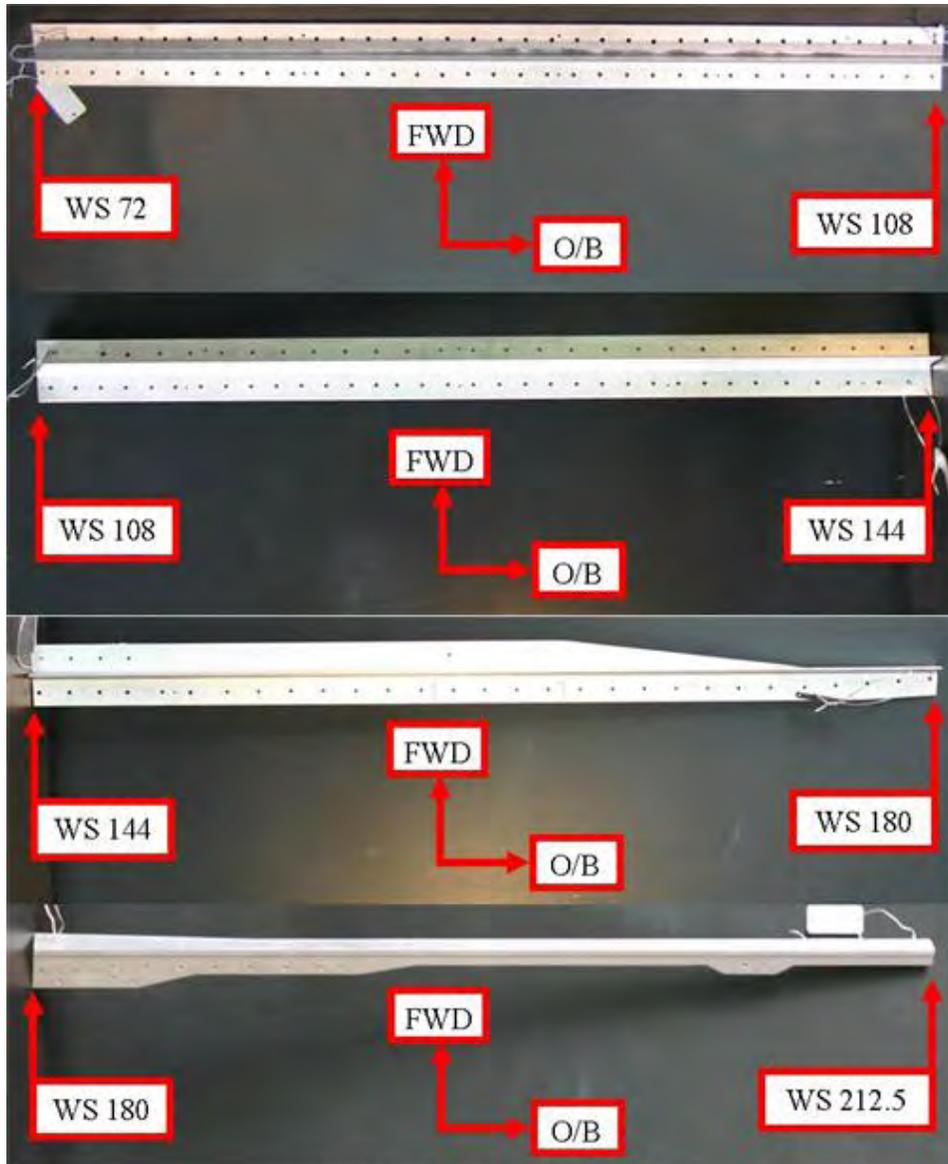
LW MN SP UPR CAP Corr WS 72-212.5 OV

Figure 121. Overview of Left Wing Main Spar Upper Cap Strip WS 72 Through WS 212.5

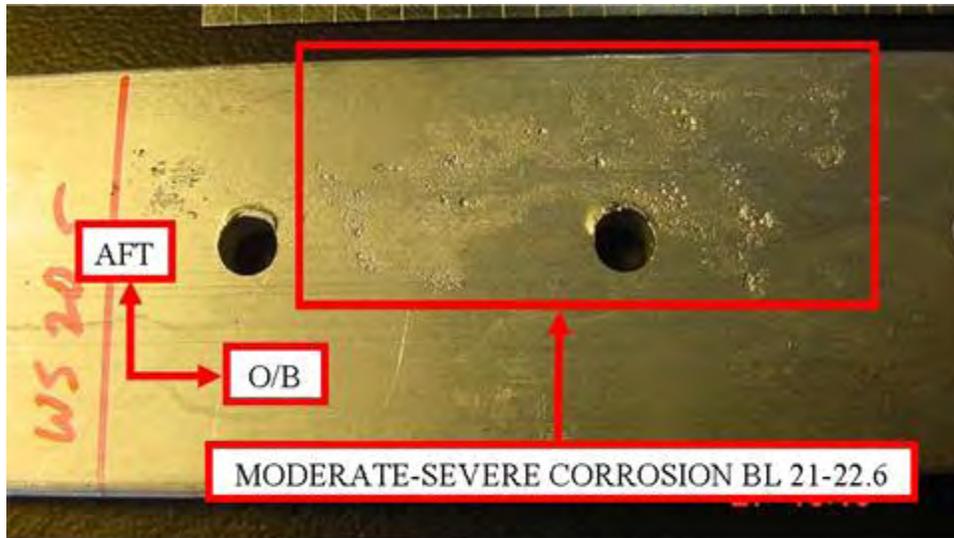
LW MS Sp LWR AFT REIN Corr BL21-22.6 Mac

Six areas of corrosion were documented on the left wing main spar lower aft reinforcement. The location of each area of corrosion is shown in figure 122. Scattered light to light-moderate corrosion was noted from BL 0 to WS 108, which caused a maximum localized thickness loss of 4%. A 1.5-square-inch area of moderate-severe corrosion was found from BL 21 to BL 22.6 and is shown in figure 123. This corrosion resulted in a 7.5% localized reduction in thickness. From WS 34.3 to WS 35, a 0.7-square-inch area of moderate corrosion, which caused a thickness loss of 6%, was recorded. A macroscopic view of this area of corrosion is shown in figure 124. Figure 125 shows a 0.9-square-inch area of moderate corrosion. This area of corrosion, located from WS 40.2 to WS 41.4, caused a maximum reduction in thickness of 6%. A 0.75-square-inch area of moderate-severe corrosion, shown in figure 126, was observed on the lower aft reinforcement. This area of corrosion, located from WS 56.9 to WS 57.9, caused a localized loss

Figure 123. Macroscopic View of Moderate-Severe Corrosion on the Left Wing Main Spar Lower Aft Reinforcement BL 21 Through BL 22.6

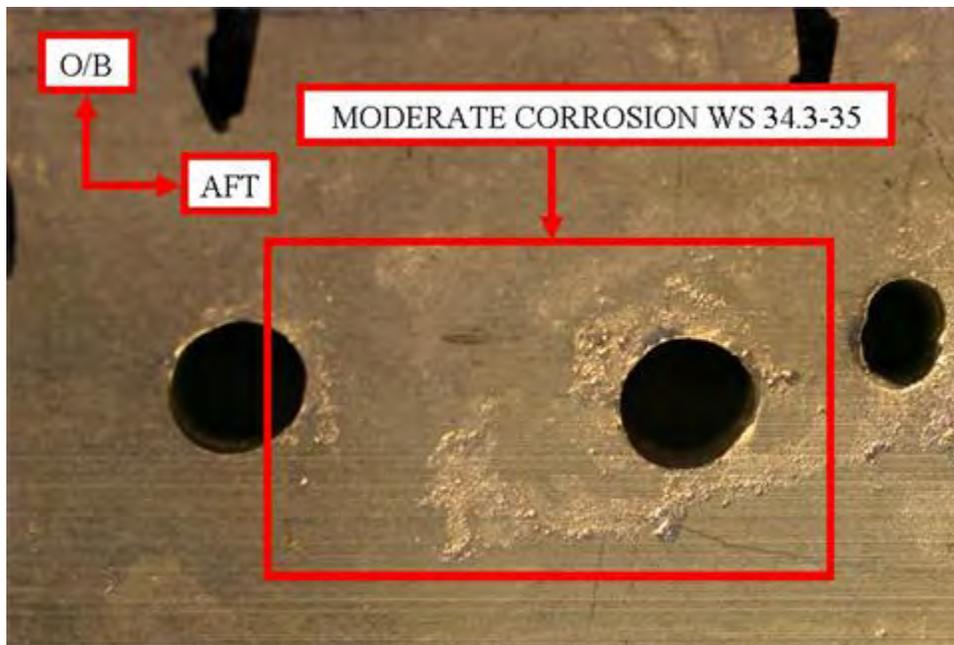
LW MS SP LWR AFT REIN Corr WS34.3-35 Mac

Figure 124. Macroscopic View of Moderate Corrosion on the Left Wing Main Spar Lower Aft Reinforcement WS 34.3 Through WS 35

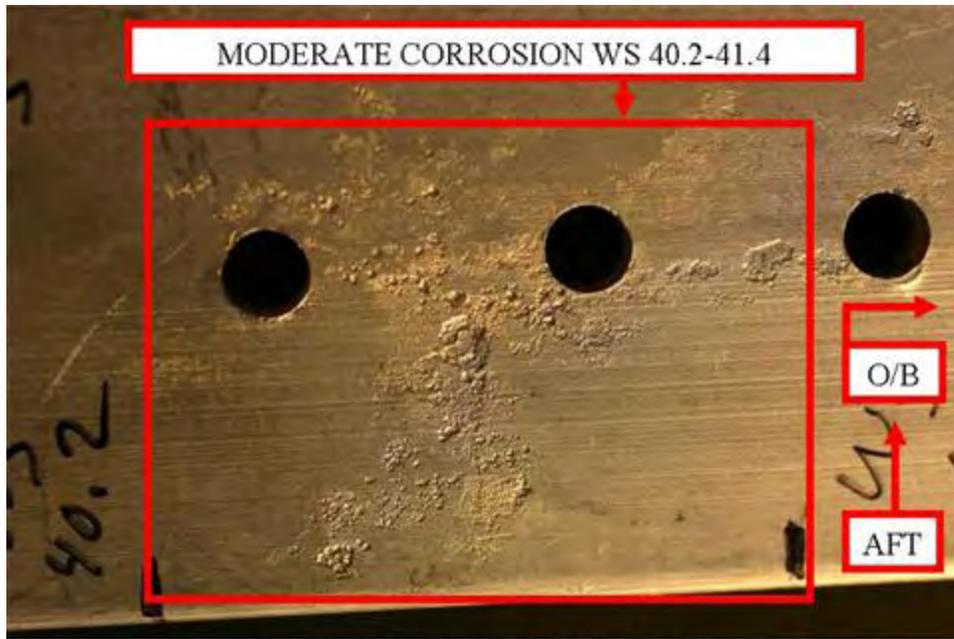
LW MN SP LWR AFT REIN Corr WS40.2-41.4 Mac

Figure 125. Macroscopic View of Moderate Corrosion on the Left Wing Main Spar Lower Aft Reinforcement WS 40.2 Through WS 41.4

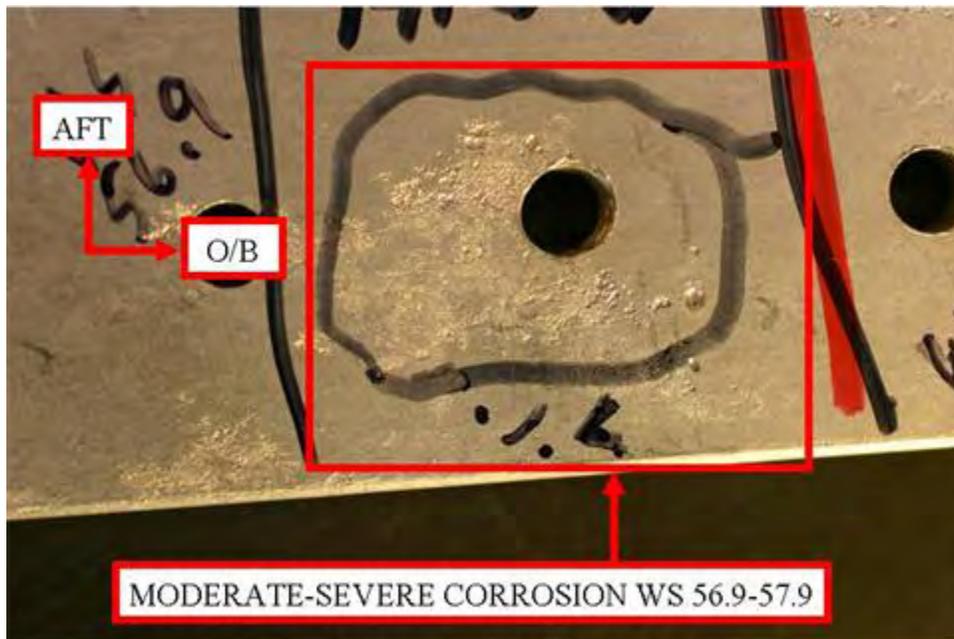
LW MN SP LWR AFT REIN Corr WS56.9-57.9 Mac

in thickness of 7%. Another area of moderate-severe corrosion, causing 7% thickness loss, was observed on the lower aft reinforcement from WS 62.25 to WS 63.25. Figure 127 shows this 0.5-square-inch area of corrosion.

Figure 126. Macroscopic View of Moderate-Severe Corrosion on the Left Wing Main Spar Lower Aft Reinforcement WS 56.9 Through WS 57.9

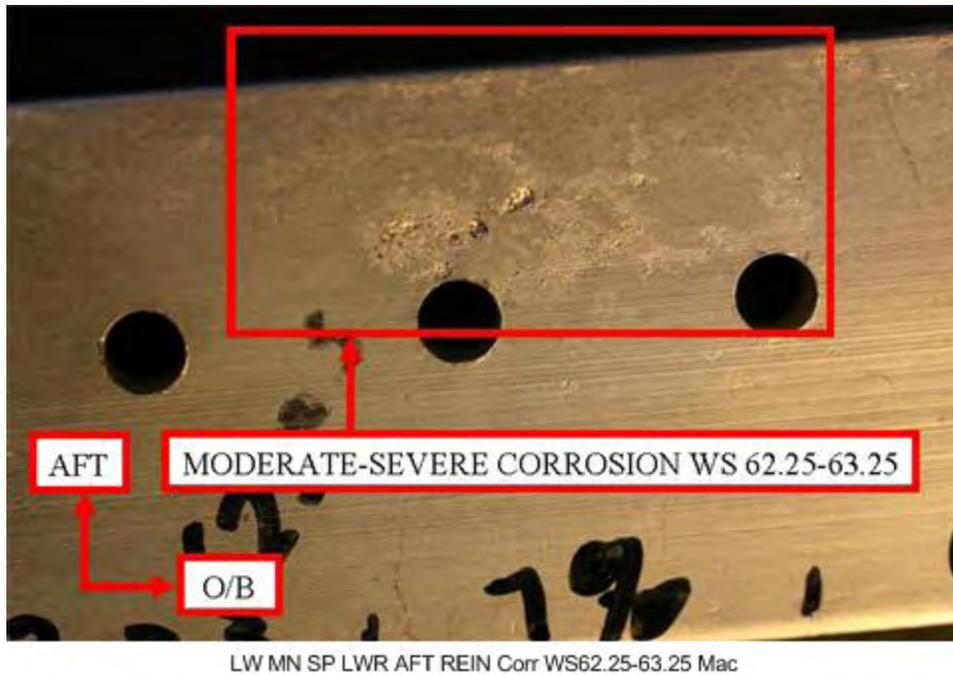
Figure 127. Macroscopic View of Moderate-Severe Corrosion on the Left Wing Main Spar Lower Aft Reinforcement WS 62.25 Through WS 63.25

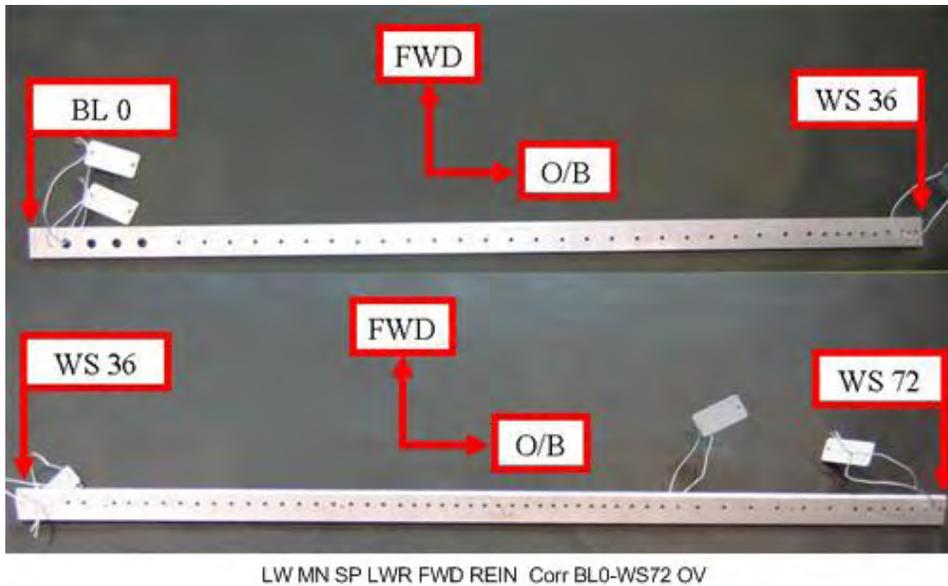
Figure 128 shows an overview of light scattered corrosion on the left wing main spar lower forward reinforcement from BL 0 to WS 72. This corrosion caused a maximum thickness loss of 1.4%. Light scattered corrosion, resulting in a reduction in thickness of 2%, was also observed on the left wing main spar lower aft angle from BL 0 to WS 72, as shown in figure 129. An area of moderate-severe corrosion, shown in figure 130, was also located on the lower aft angle from WS 52.5 to WS 58. This area covered 11-square inches and caused a maximum reduction in thickness of 9%. Light corrosion was also scattered across the surface of the main spar lower cap strip from WS 34.4 to WS 144, as shown in figure 131. An area of corrosion covering 6 square inches was noted on the lower cap strip around fastener holes from WS 168 to WS 174 and is shown in figure 132. Both areas of corrosion located on the left wing main spar lower cap strip were classified as light corrosion causing less than 1% localized thickness loss.

Figure 128. Overview of Left Wing Main Spar Lower Forward Reinforcement BL 0 Through WS 72

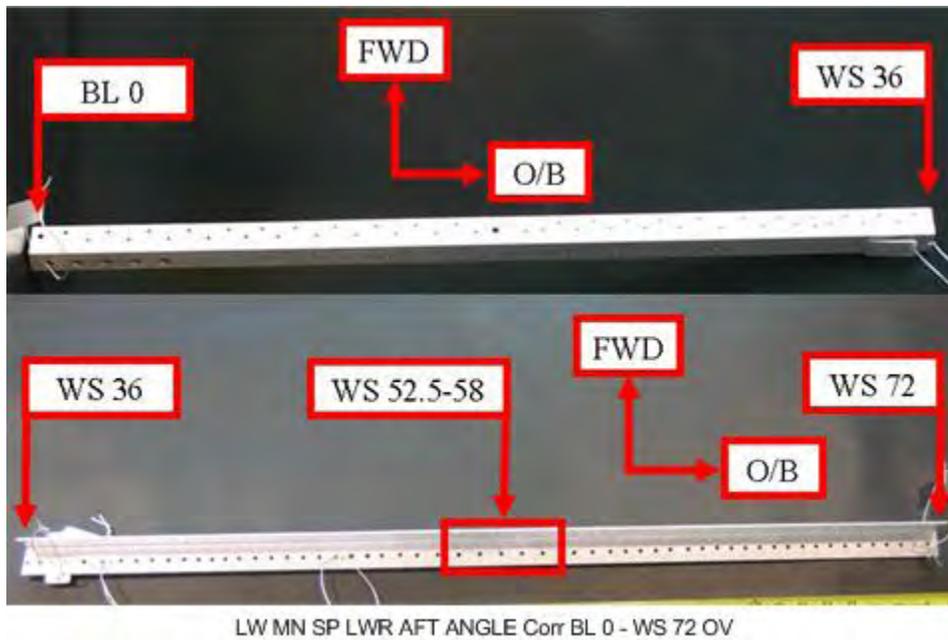
Figure 129. Location of Light Scattered Corrosion and Overview of Left Wing Main Spar Lower Aft Angle BL 0 Through WS 72

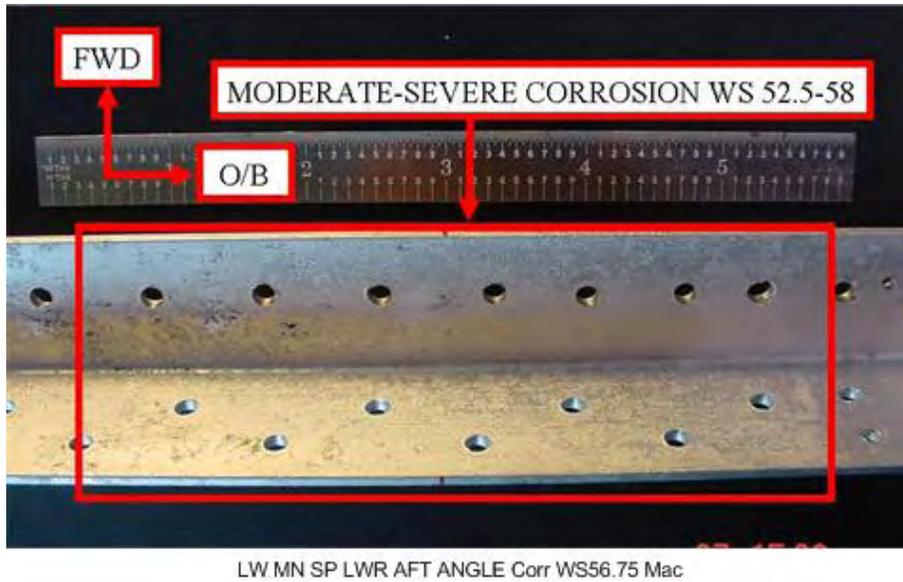
Figure 130. Macroscopic View of Moderate-Severe Corrosion on the Left Wing Main Spar Lower Aft Angle WS 52.5 Through WS 58

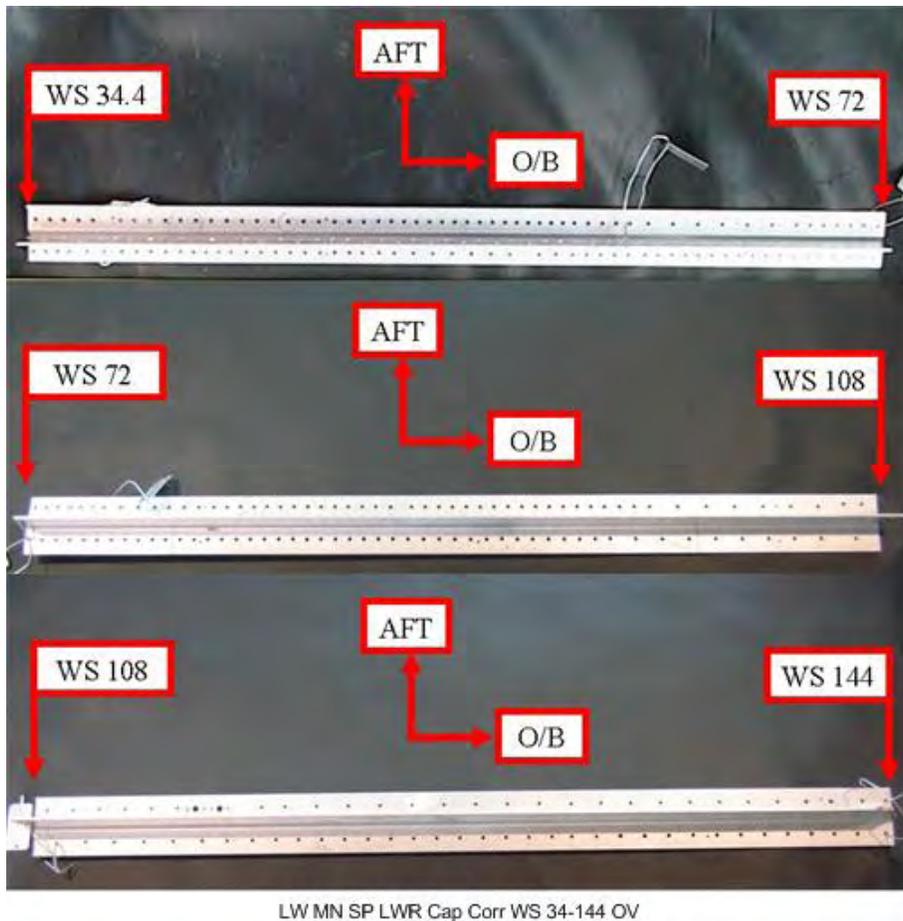
Left wing main spar lower cap strip, figure 131	Corrosion	WS 34.4 through WS 144	Scattered over entire part	Corrosion indication	Light corrosion less than 1 % thickness loss	103
	Corrosion	Around rivet holes WS 168 through WS 174	5.0 inches by 1.2 inches	Corrosion indication	Light corrosion less than 1% thickness loss	103

Figure 131. Overview of Left Wing Main Spar Lower Cap Strip WS 34.4 Through WS 144

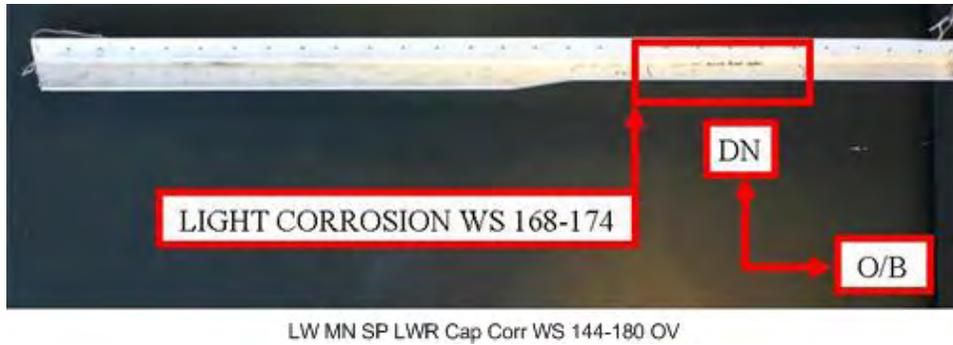
Figure 132. Location of Light Corrosion on the Left Wing Main Spar Lower Cap Strip Around Rivet Holes WS 168 Through WS 174

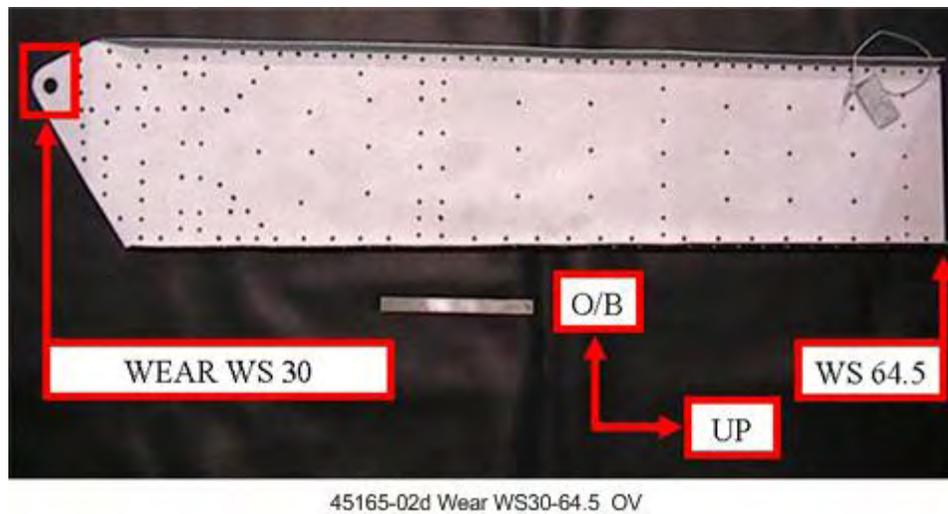
Figure 133 shows the structural stackup of the left wing rear spar, and table 30 provides detailed information on all defects found on the rear spar. Figure 134 shows the location of an area of wear observed on the left wing rear spar channel 1. Light-moderate corrosion, which resulted in a thickness loss of 3%, was found scattered across this channel from WS 30 to WS 64.5. The wear, shown in figure 135, caused a thickness loss of 3% and covered a surface area of 1.13 square inches. The location of a 0.293-inch-crack on the left wing rear spar web is shown in figure 136, while a macroscopic view of the crack is shown in figure 137. Figure 138 shows the fluorescent liquid penetrant indication of this crack, and figure 139 shows the microscopic view of this crack.

Figure 134. Location of Wear and Overview of Left Wing Rear Spar Channel 1 WS 30 Through WS 64.5

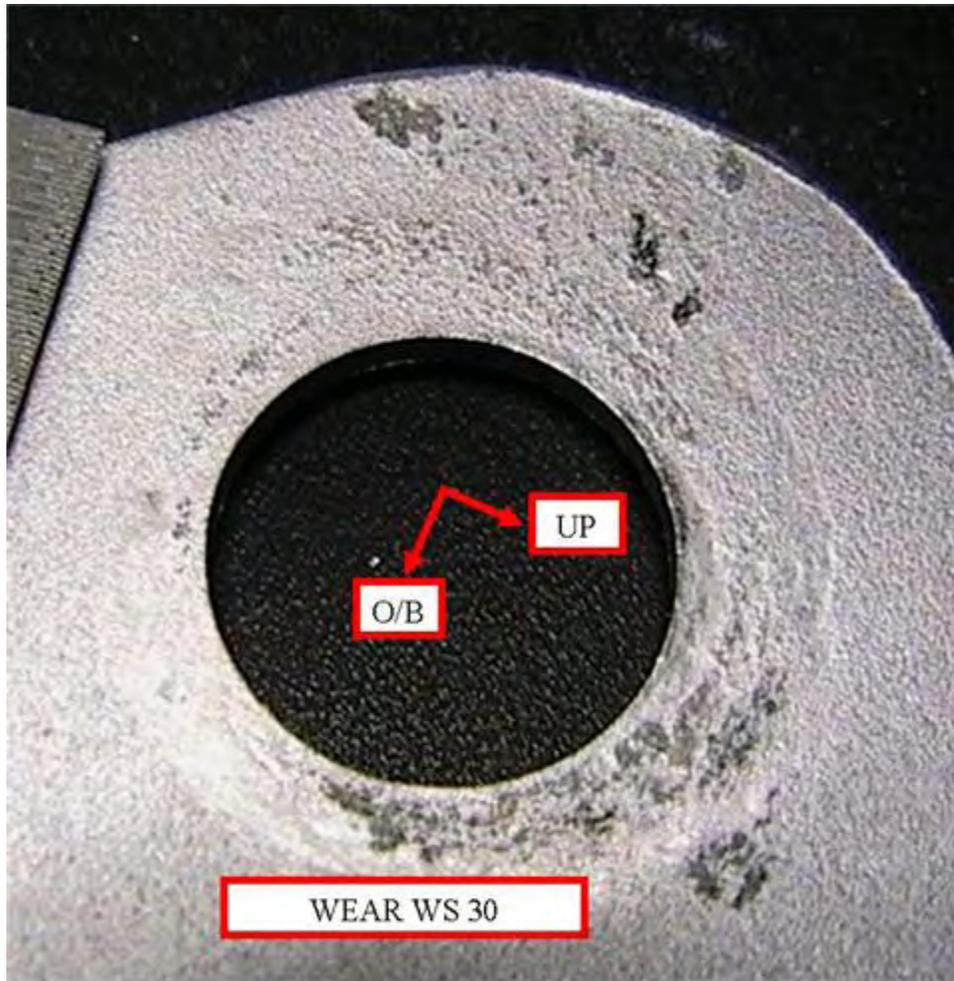
45165-02d Wear WS30-64.5 Mac

Figure 135. Macroscopic View of Wear on the Left Wing Rear Spar Channel 1 WS 30

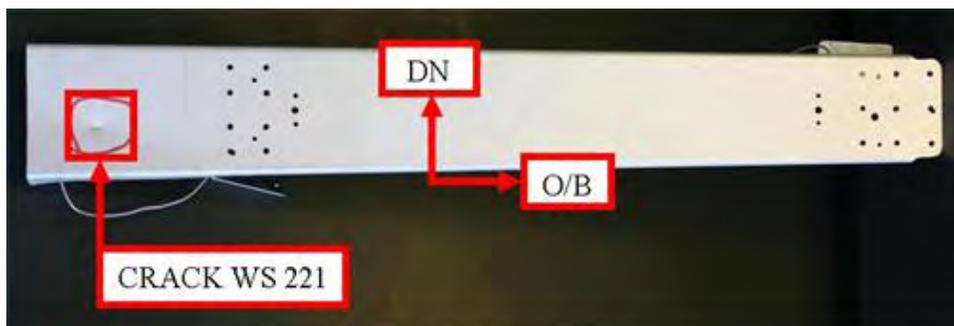
40362-30c CRK 219-242 OV

Figure 136. Location of Crack on the Left Wing Rear Spar WS 221

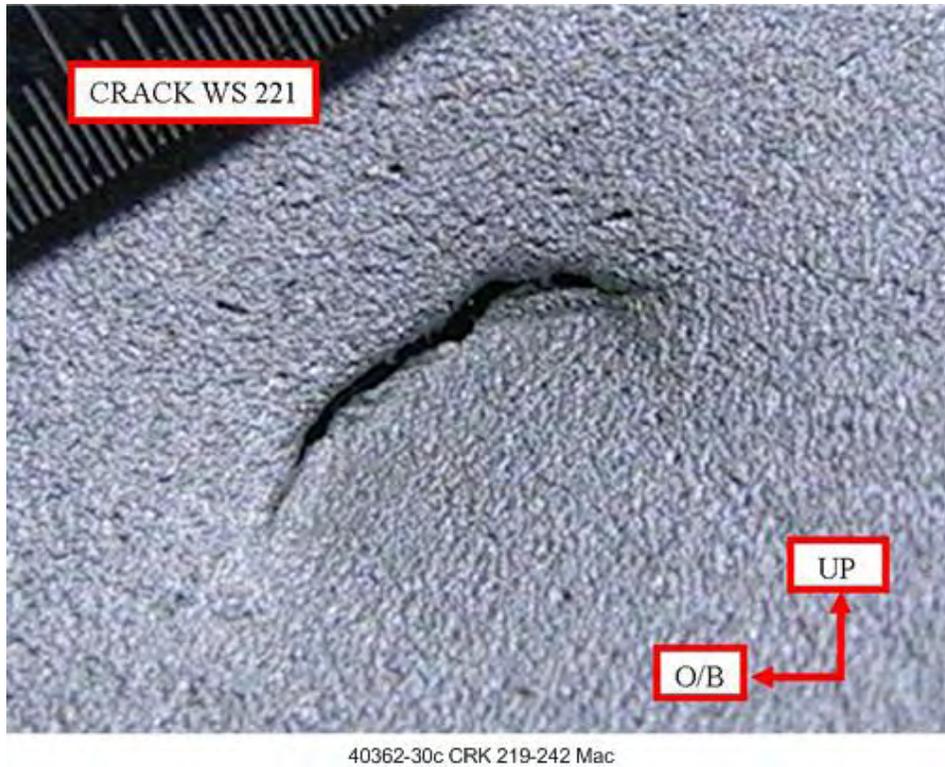
Figure 137. Macroscopic View of Crack on the Left Wing Rear Spar WS 221

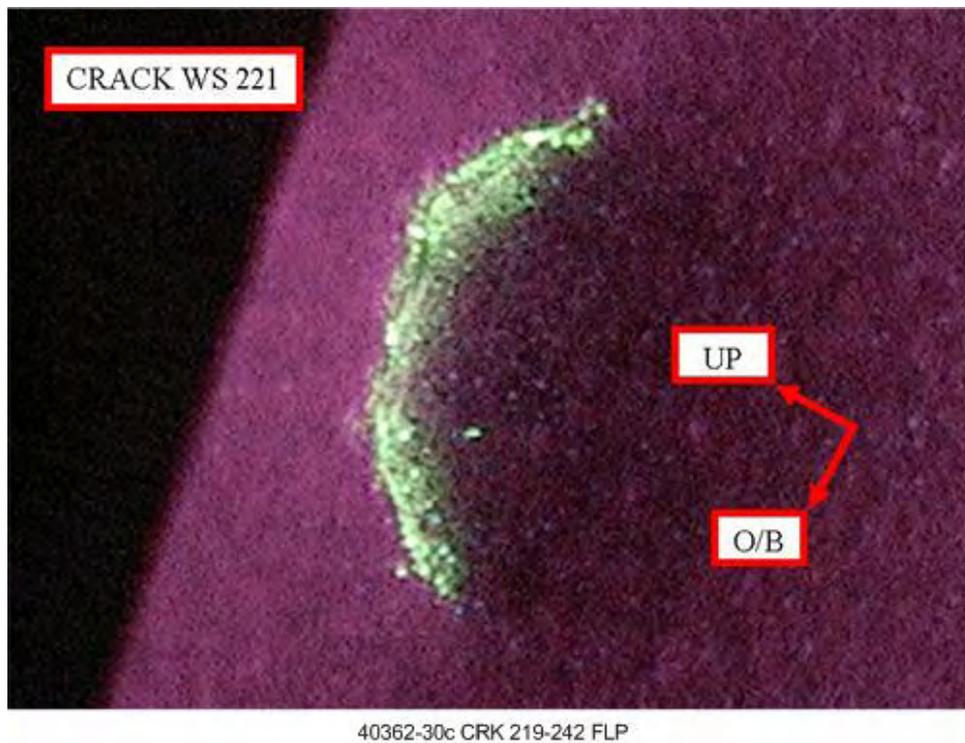
Figure 138. Fluorescent Liquid Penetrant Indication of Crack on the Left Wing Rear Spar WS 221

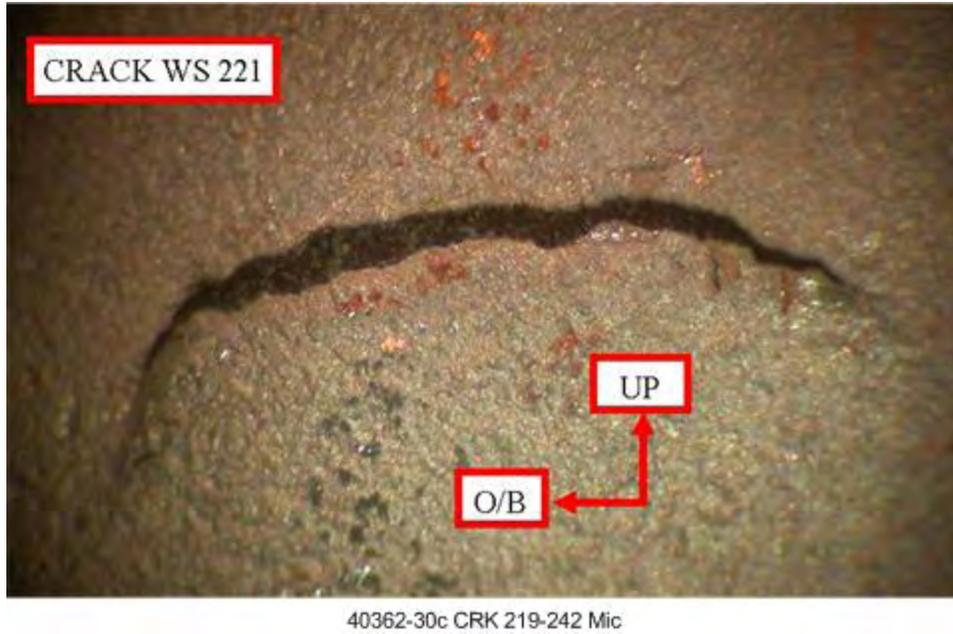
Figure 139. Microscopic View of Crack on the Left Wing Rear Spar WS 221

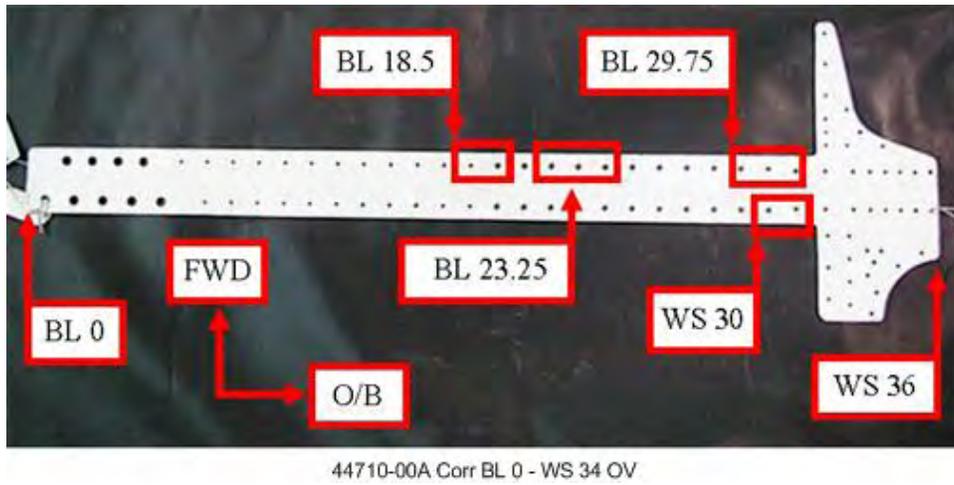
Figure 140 shows the location of light-moderate, moderate, and severe corrosion on the left wing plate wing panel reinforcement assembly, part number 44710-00A. A moderate area of corrosion, shown in figure 141, was identified at BL 18.5. This area of corrosion covered a surface area of 0.55 square inch and caused a localized reduction in thickness of 6%. One area of light-moderate corrosion was identified on the reinforcement assembly at BL 23.25, covered a surface area of 0.24 square inch, and resulted in a 3% maximum localized thickness loss. A 1.59-square-inch area of severe corrosion was found at BL 29.75 and is shown in figure 142. A maximum localized thickness loss of 12% was caused by this area of corrosion. Another area of severe corrosion was noted at WS 30, which caused a localized reduction in thickness of 13.5%. This area of corrosion, shown in figure 143, covered 0.86 square inch. The location of a crack found on the left wing aft main gear door hinge bracket, part number 40560-05, is shown in figure 144. This crack, measuring 0.273 inch in length, occurred at WS 30. A macroscopic view of this crack is shown in figure 145, and a microscopic view of the crack is shown in figure 146.

Figure 140. Locations of Light-Moderate, Moderate, and Severe Corrosion on the Left Wing Plate Wing Panel Reinforcement Assembly BL 0 Through WS 36

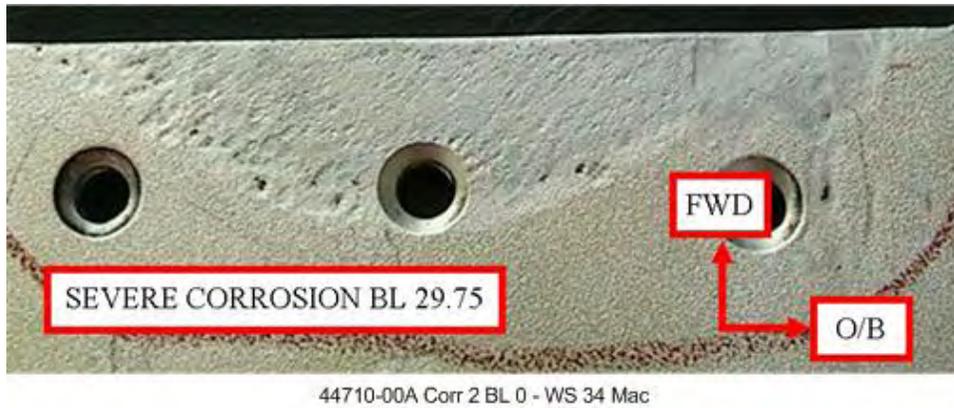
Figure 142. Macroscopic View of Severe Corrosion on the Left Wing Plate Wing Panel Reinforcement Assembly WS 29.75

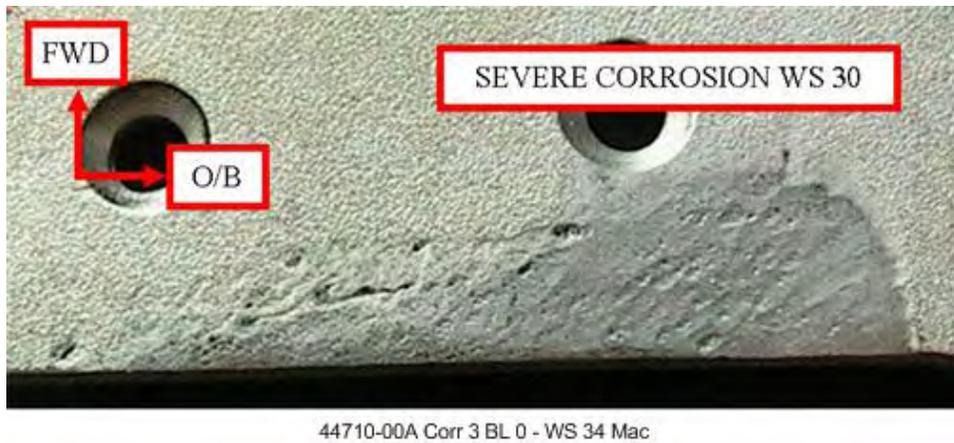
Figure 143. Macroscopic View of Severe Corrosion on the Left Wing Plate Wing Panel Reinforcement Assembly WS 30

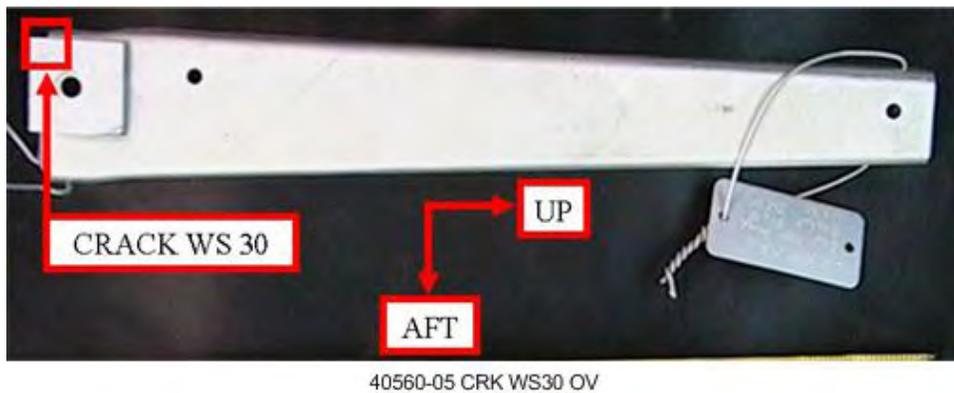
Figure 144. Location of Crack on the Left Wing Aft Main Gear Door Hinge Bracket WS 30

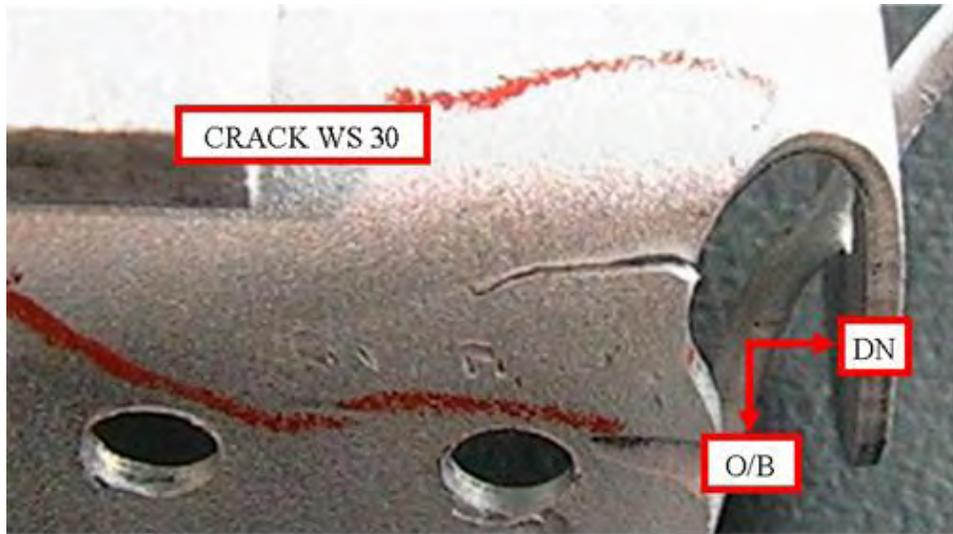
40560-05 CRK WS30 Mac

Figure 145. Macroscopic View of Crack on the Left Wing Aft Main Gear Door Hinge Bracket WS 30

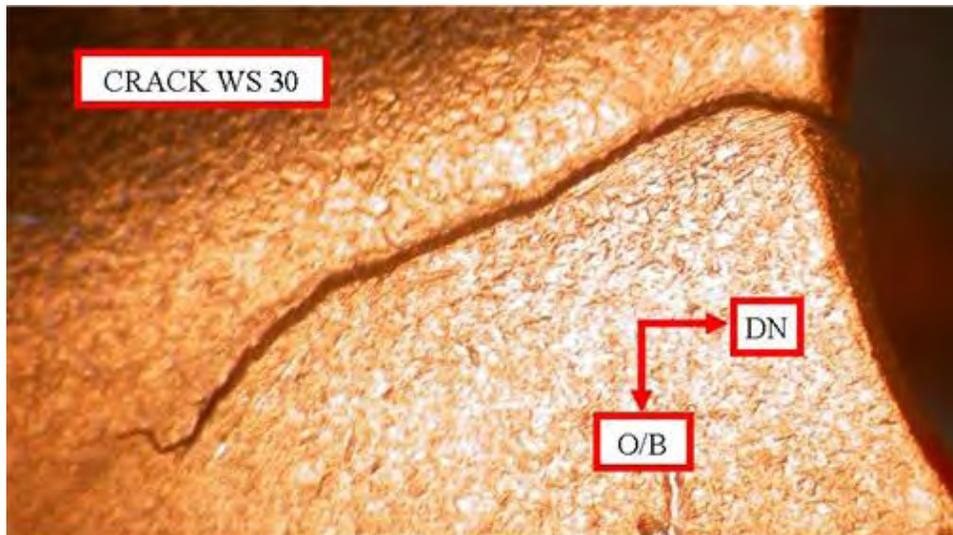
40560-05 CRK WS30 Mic

Figure 146. Microscopic View of Crack on the Left Wing Aft Main Gear Door Hinge Bracket WS 30

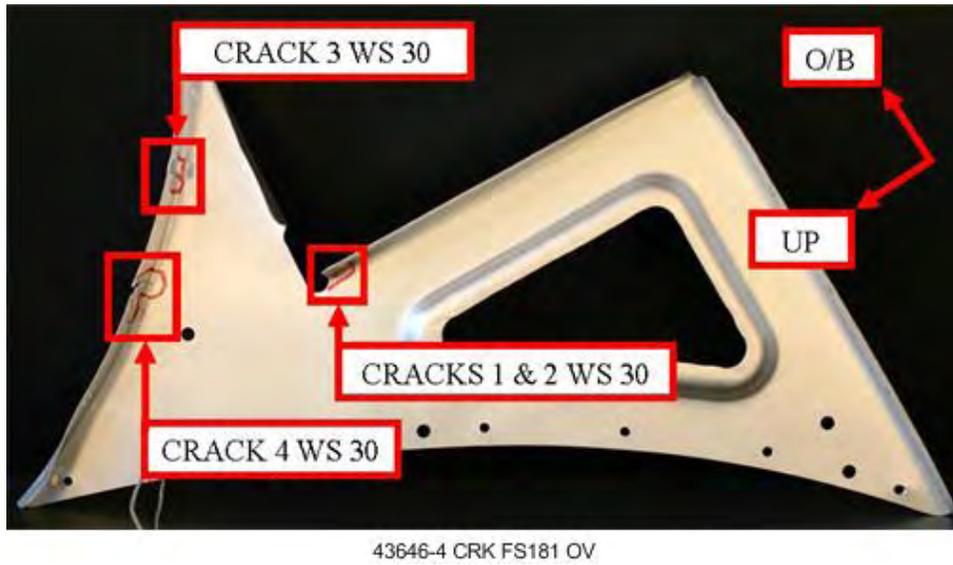
The location of four cracks on the left wing bulkhead wing fillet, part number 43646-04 located at WS 30 FS 181, is shown in figure 147. A macroscopic view of crack 1, measuring 0.423 inch, is shown in figure 148, while a microscopic view of this crack is shown in figure 149. Crack 2, which measures 0.226 inch, is shown macroscopically in figure 150 and microscopically in figure 151. Multiple cracks, grouped together and identified as crack 3, were found emanating from a fastener hole, as shown in figure 152. A microscopic view of these cracks, which measured 0.157 inch, is shown in figure 153. Multiple cracks, grouped together and identified as

Figure 147. Location of Cracks on the Left Wing Bulkhead Wing Fillet WS 30 FS 181
