DOT/FAA/AR-07/64

Teardown Evaluation of a 1975 Piper Navajo Chieftain Model PA31-350 Airplane

March 2008

Final Report

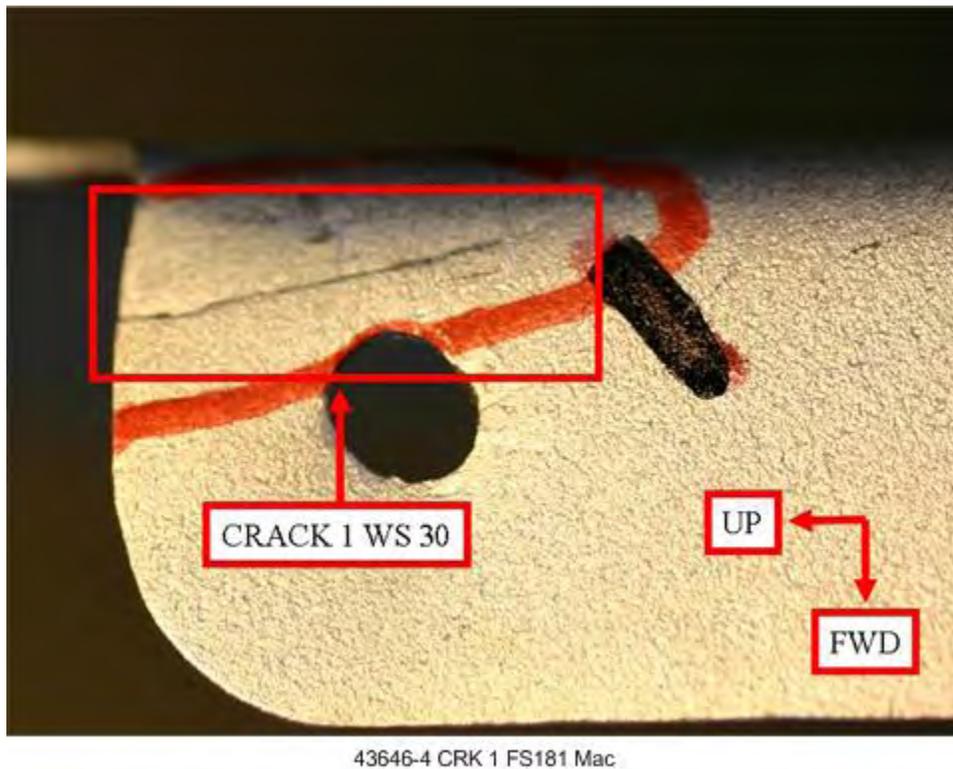
The location of four cracks on the left wing bulkhead wing fillet, part number 43646-04 located at WS 30 FS 181, is shown in figure 147. A macroscopic view of crack 1, measuring 0.423 inch, is shown in figure 148, while a microscopic view of this crack is shown in figure 149. Crack 2, which measures 0.226 inch, is shown macroscopically in figure 150 and microscopically in figure 151. Multiple cracks, grouped together and identified as crack 3, were found emanating from a fastener hole, as shown in figure 152. A microscopic view of these cracks, which measured 0.157 inch, is shown in figure 153. Multiple cracks, grouped together and identified as

Figure 148. Macroscopic View of Crack 1 on the Left Wing Bulkhead Wing Fillet WS 30 FS 181

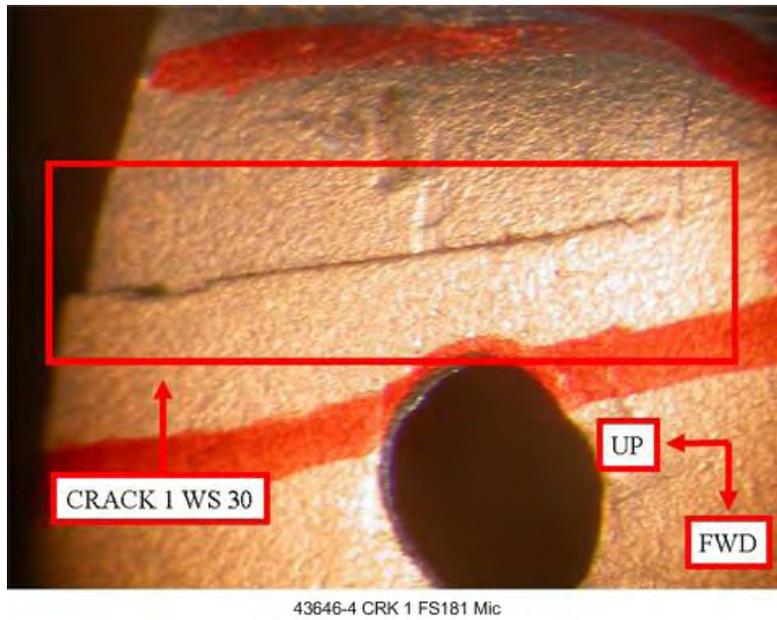
Figure 149. Microscopic View of Crack 1 on the Left Wing Bulkhead Wing Fillet
WS 30 FS 181

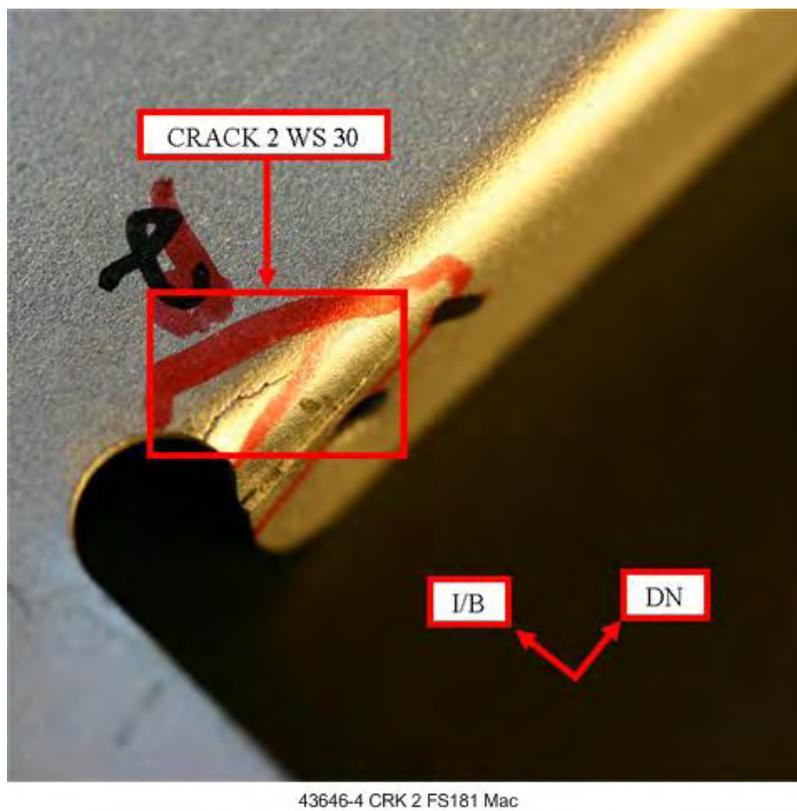
Figure 150. Macroscopic View of Crack 2 on the Left Wing Bulkhead Wing Fillet
WS 30 FS 181

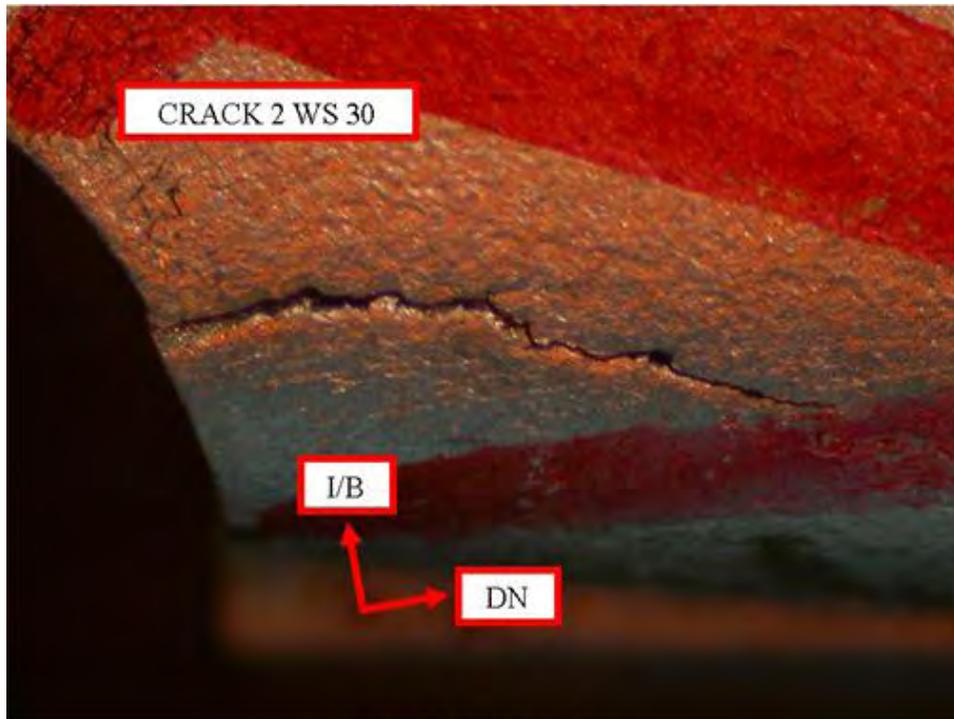
43646-4 CRK 2 FS181 Mic

Figure 151. Microscopic View of Crack 2 on the Left Wing Bulkhead Wing Fillet WS 30 FS 181

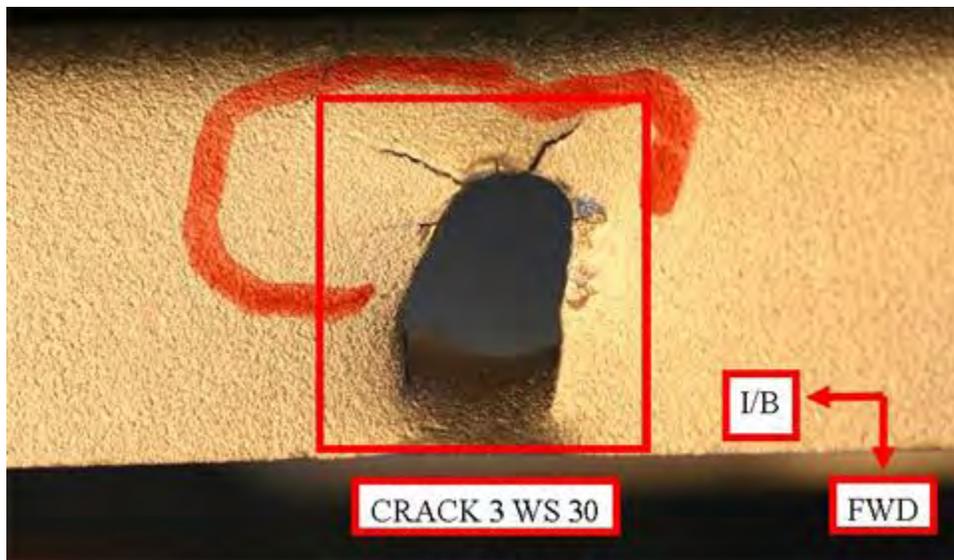
43646-4 CRK 3 FS181 Mac

Figure 152. Macroscopic View of Crack 3 on the Left Wing Bulkhead Wing Fillet WS 30 FS 181

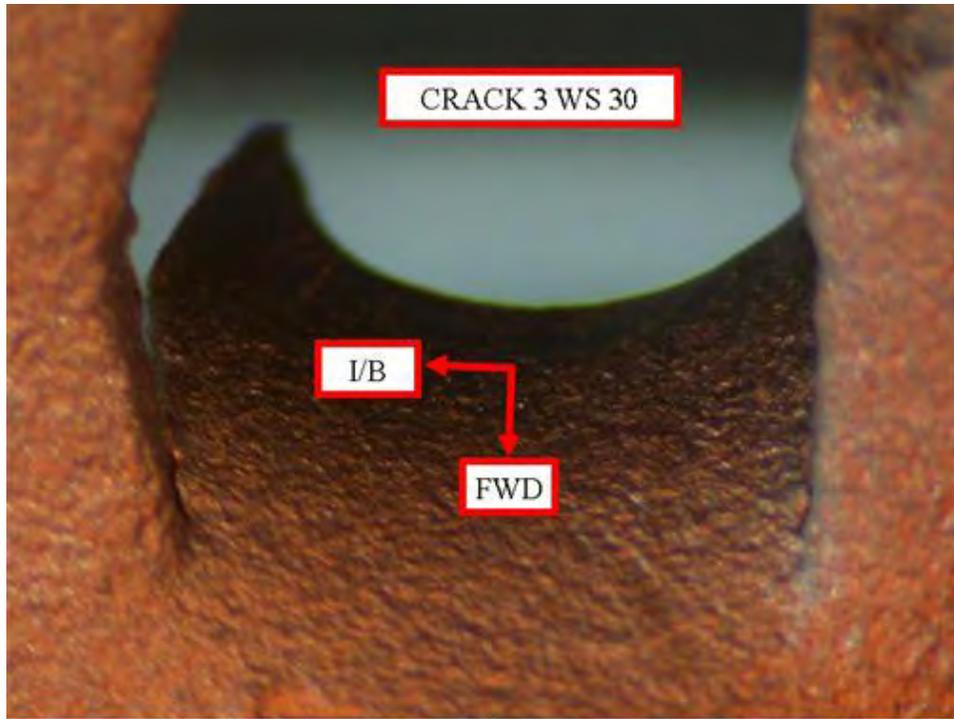
43646-4 CRK 3 FS181 Mic

Figure 153. Microscopic View of Crack 3 on the Left Wing Bulkhead Wing Fillet WS 30 FS 181

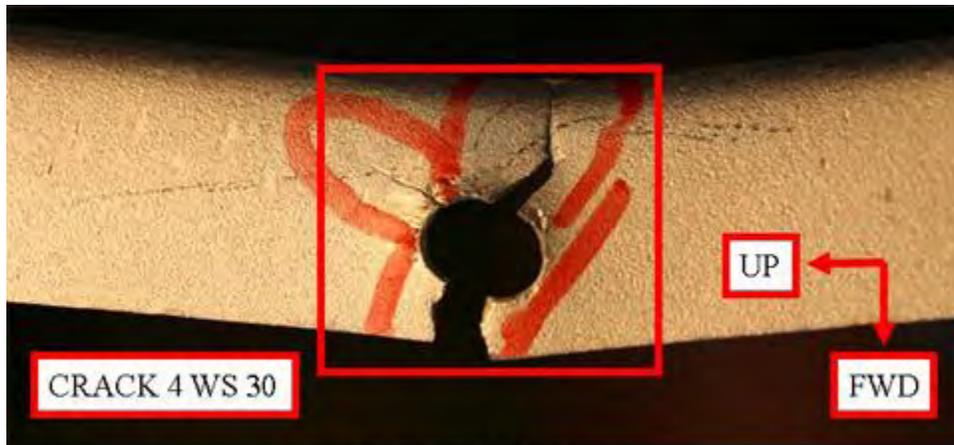
43646-4 CRK 4 FS181 Mac

crack 4, are shown macroscopically in figure 154. A microscopic view of these cracks, which measured 0.386 inch, is shown in figure 155.

Figure 154. Macroscopic View of Crack 4 on the Left Wing Bulkhead Wing Fillet WS 30 FS 181

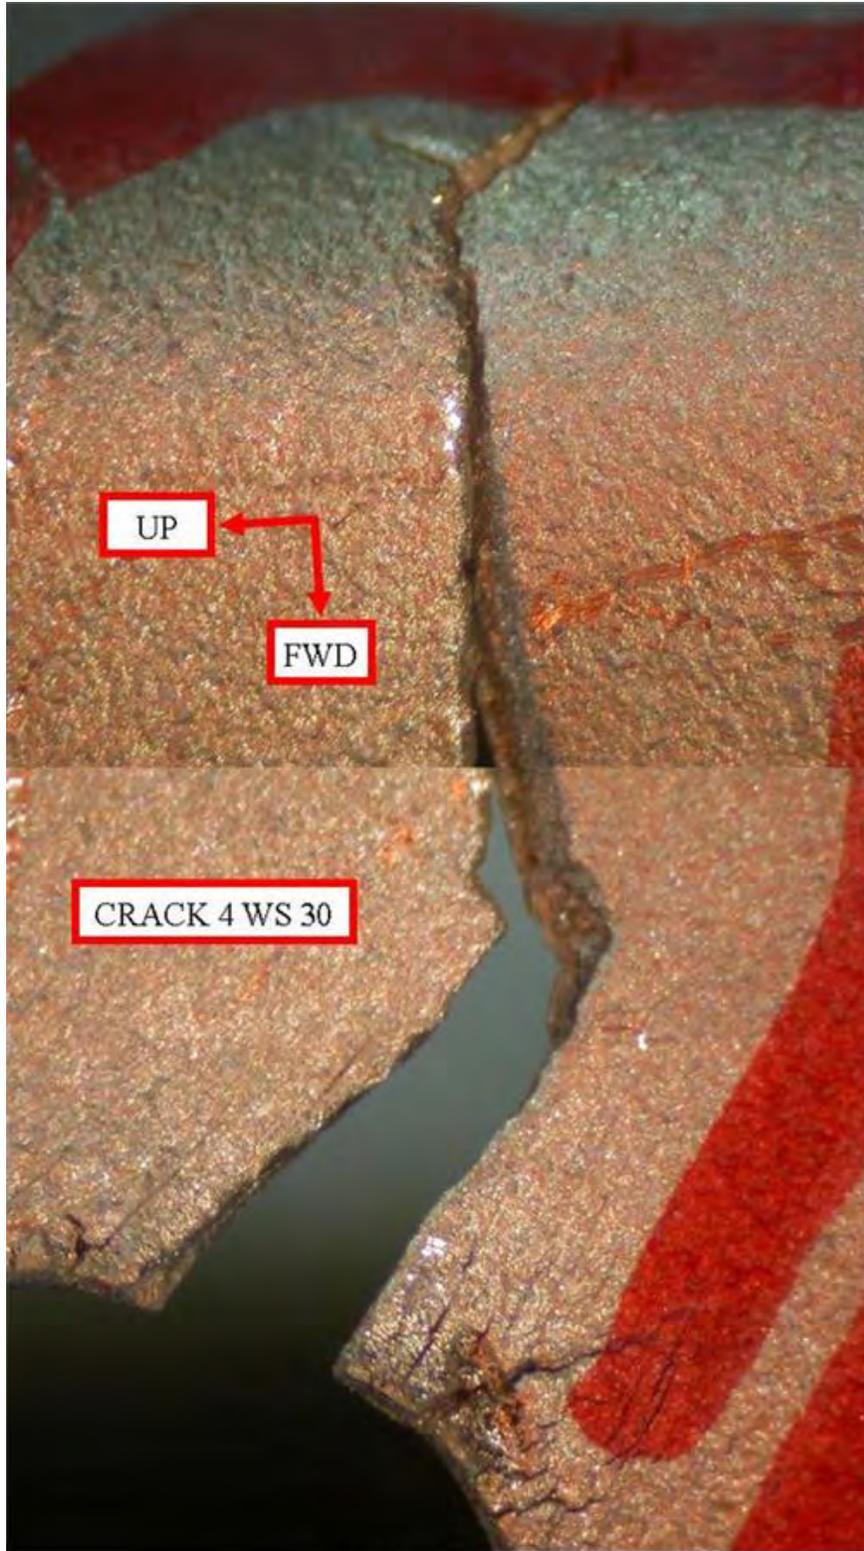
43646-4 CRK 4 FS181 Mic

Figure 155. Microscopic View of Crack 4 on the Left Wing Bulkhead Wing Fillet
WS 30 FS 181

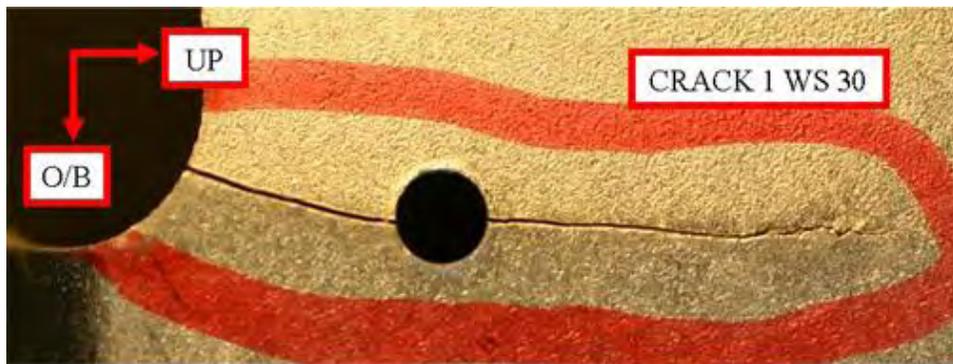
43649-004 CRK FS 191 Mac

The location of four cracks on the left wing bulkhead wing fillet at WS 30 FS 191.7, part number 43646-04, is shown in figure 156. A macroscopic view of crack 1, which originated from both sides of a fastener hole and grew to a final total length of 0.77 inch, is shown in figure 157. Figures 158 and 159 show microscopic views of both branches of the crack. The macroscopic view of multiple cracks, grouped together and identified as crack 2, is shown in figure 160. This crack also occurs on both sides of a fastener hole and has a total length of 0.756 inch. Microscopic views of this crack are shown in figures 161 and 162. Figure 163 provides the macroscopic view for cracks 3 and 4. A microscopic view of crack 3, which measured 0.349 inch, is shown in figure 164, and the microscopic view of crack 4, which measured 0.374 inch, is shown in figure 165.

Figure 157. Macroscopic View of Crack 1 on the Left Wing Bulkhead Wing Fillet WS 30 FS 191.7

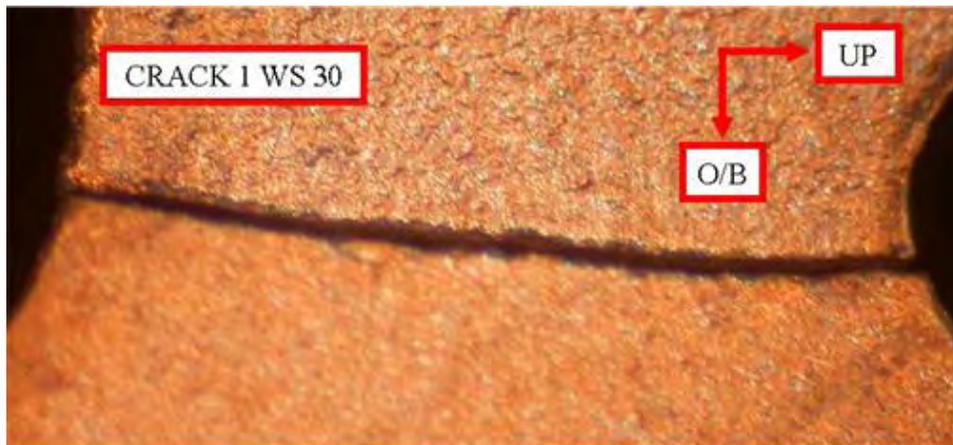
43649-004 CRK FS 191 Mic 1

Figure 158. Microscopic View of Crack 1 Branch 1 on the Left Wing Bulkhead Wing Fillet WS 30 FS 191.7

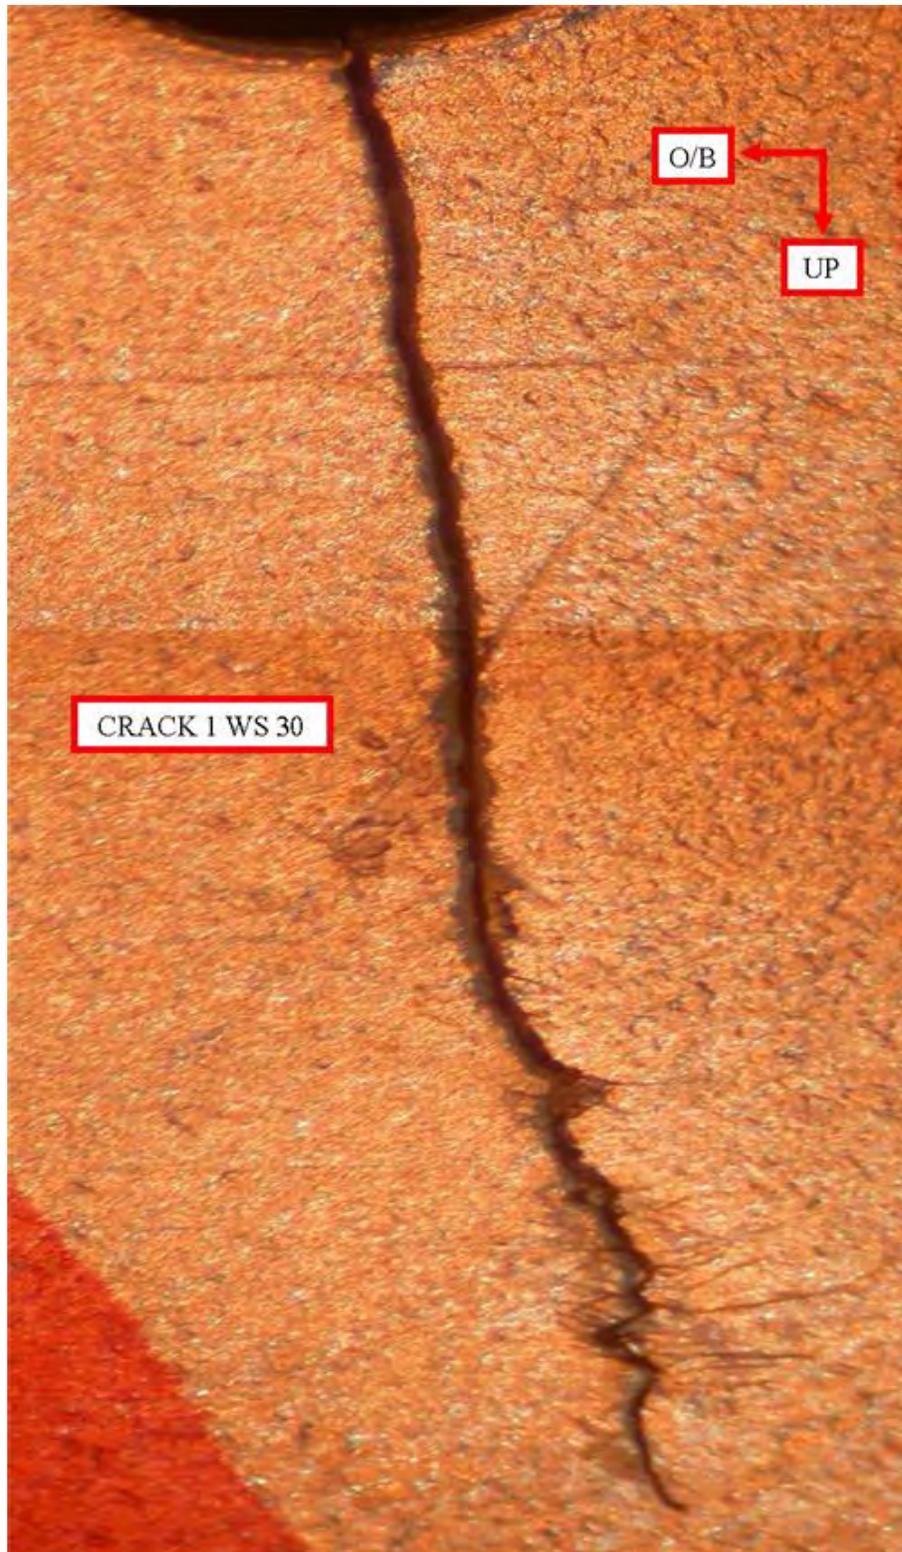
43649-004 CRK FS 191 Mic 2

Figure 159. Microscopic View of Crack 1 Branch 2 on the Left Wing Bulkhead Wing Fillet
WS 30 FS 191.7

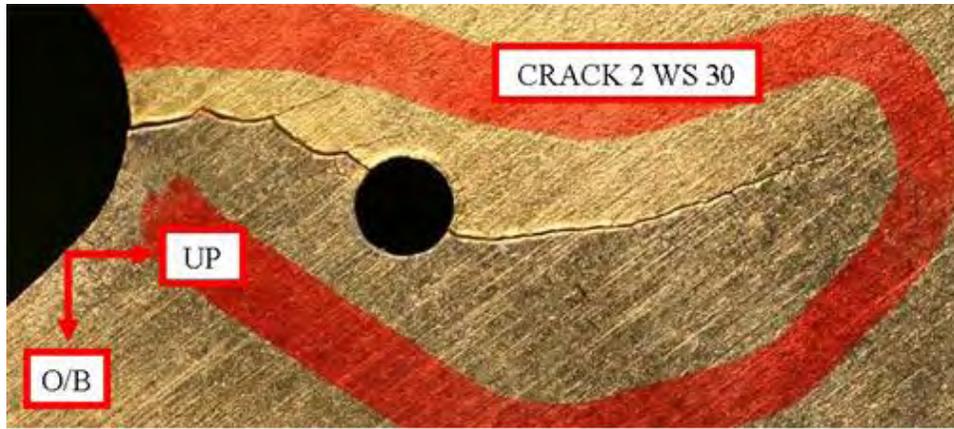
43649-004 CRK 2 FS 191 Mac

Figure 160. Macroscopic View of Crack 2 on the Left Wing Bulkhead Wing Fillet WS 30 FS 191.7

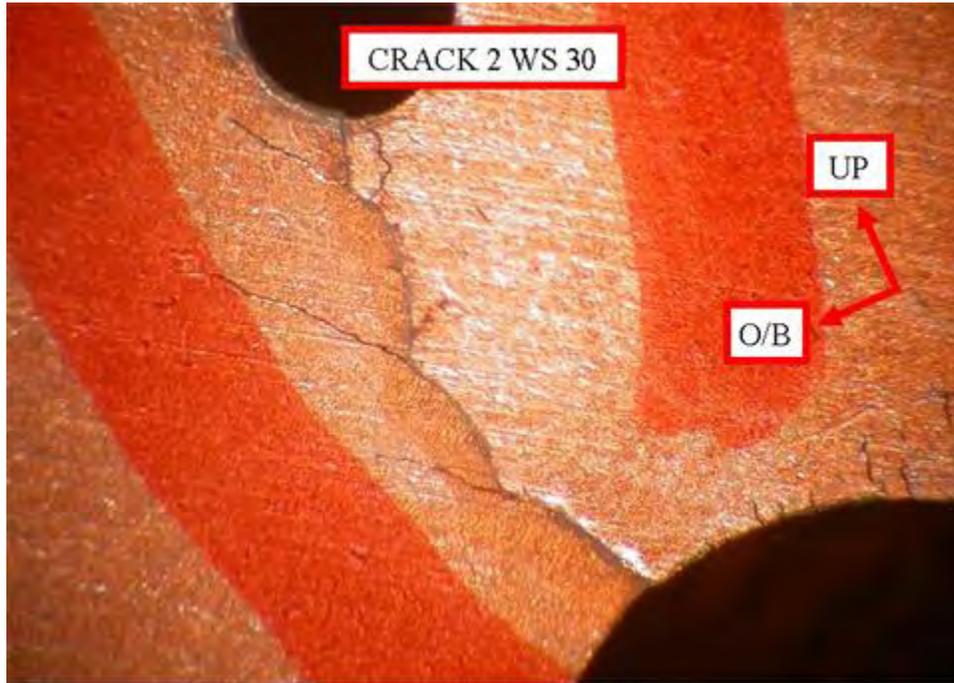
43649-004 CRK 2 FS 191 Mic 1

Figure 161. Microscopic View of Crack 2 Branch 1 on the Left Wing Bulkhead Wing Fillet WS 30 FS 191.7

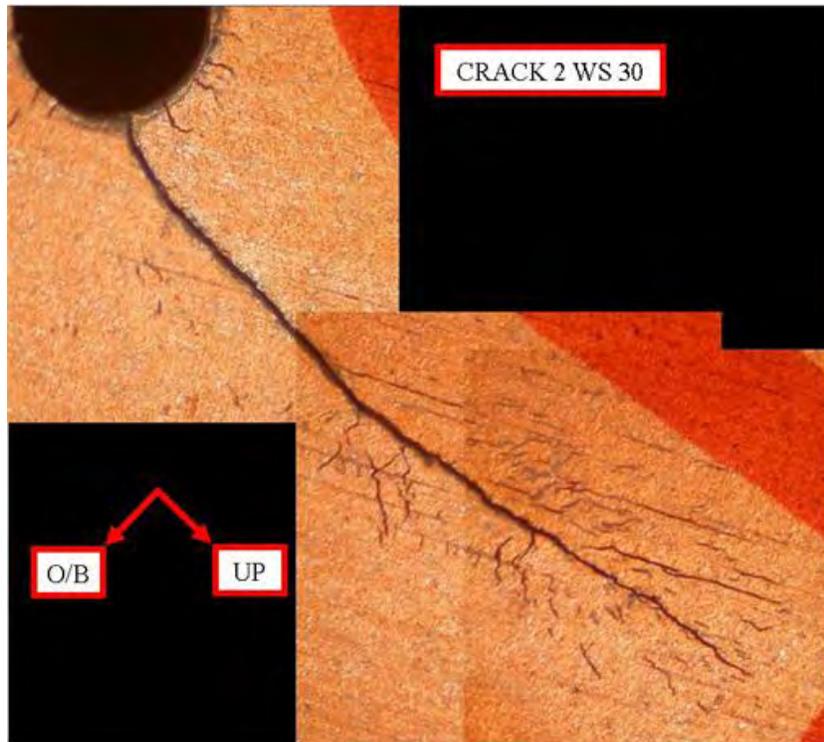
43649-004 CRK 2 FS 191 Mic 2

Figure 162. Microscopic View of Crack 2 Branch 2 on the Left Wing Bulkhead Wing Fillet WS 30 FS 191.7

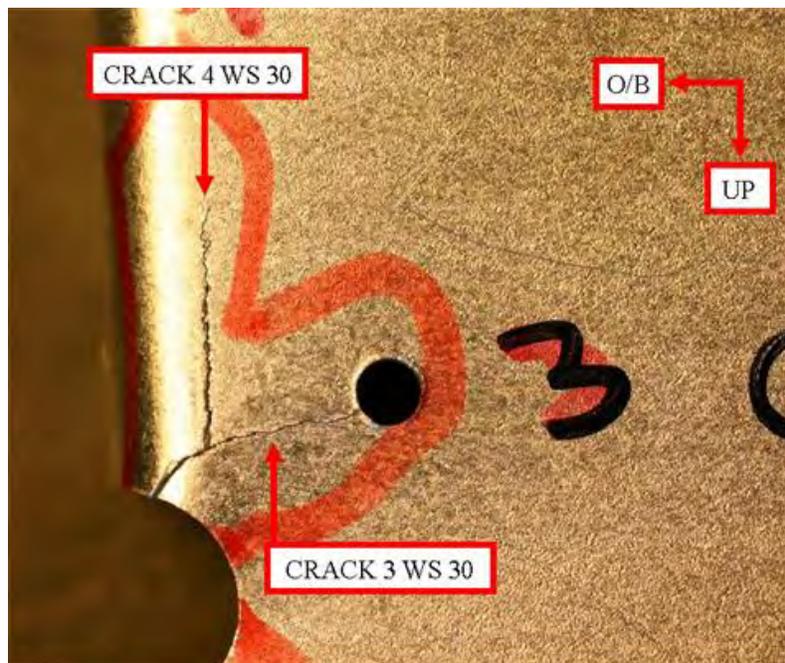
43649-004 CRK 3 and 4 FS 191 Mac

Figure 163. Macroscopic View of Cracks 3 and 4 on the Left Wing Bulkhead Wing Fillet WS 30 FS 191.7

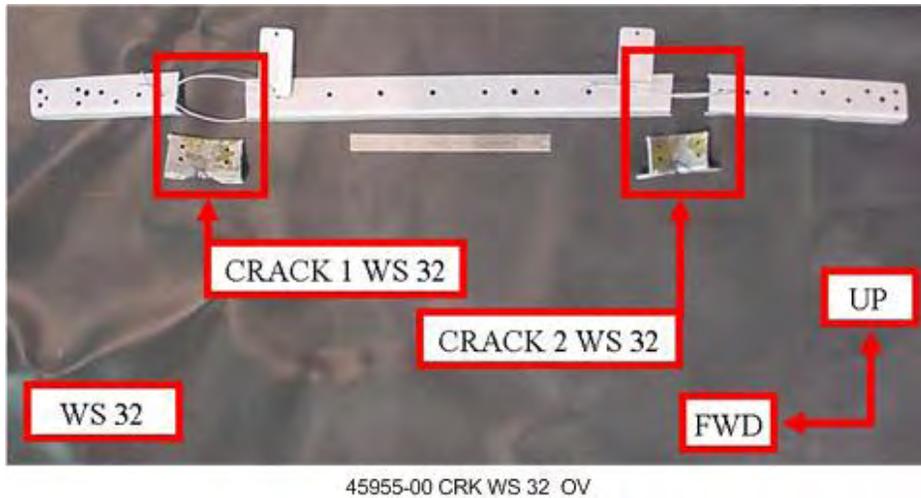
Figure 166 provides the location of crack 1 and 2 on the left wing main gear door angle, part number 45955-00, at WS 32. These cracks were identified during the inspections, and were removed prior to the fluorescent liquid penetrant process. Figure 167 shows a macroscopic view of crack 1, which measures 0.235 inch, and figure 168 shows a macroscopic view of crack 2, measuring 0.231 inch. The fracture face for crack 2 is shown in figure 169. From an analysis of the fracture faces for crack 1 and 2, it was determined that the failure mode for crack 2 was fatigue. The failure mode for crack 1 could not be determined due to extensive smearing of the fracture face.

Figure 166. Location of Cracks 1 and 2 on the Left Wing Main Gear Door Angle WS 32

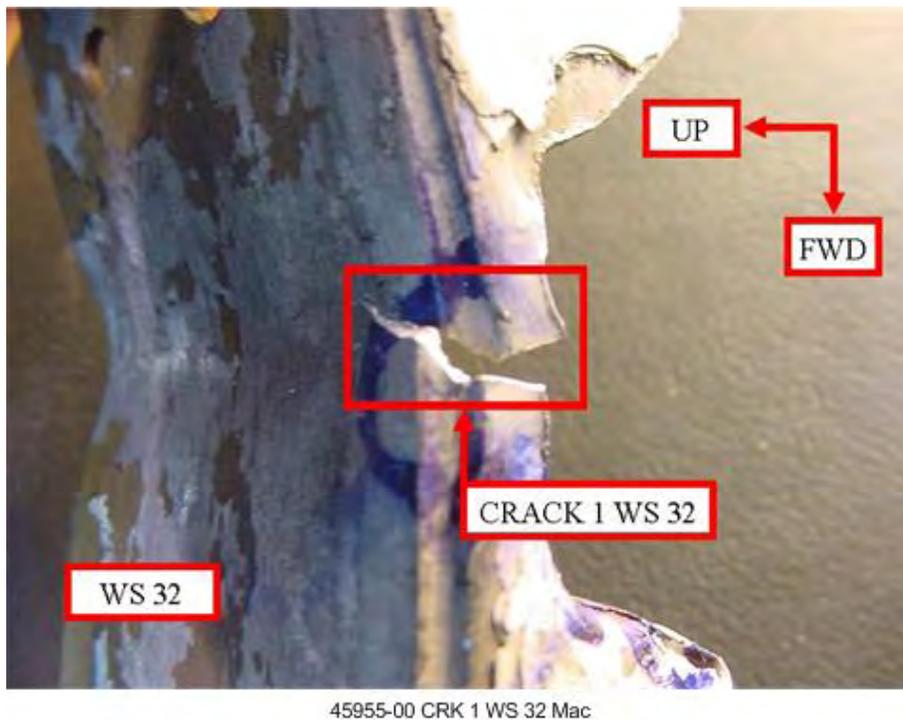
Figure 167. Macroscopic View of Crack 1 on the Left Wing Main Gear Door Angle WS 32

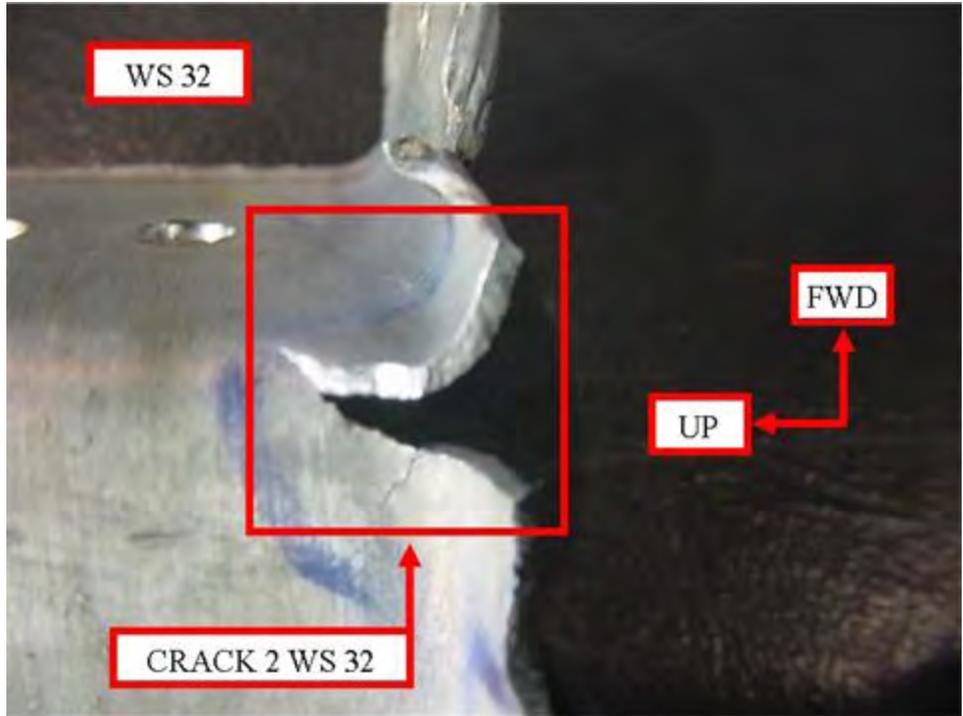
45955-00 CRK 2 WS 32 Mac

Figure 168. Macroscopic View of Crack 2 on the Left Wing Main Gear Door Angle WS 32

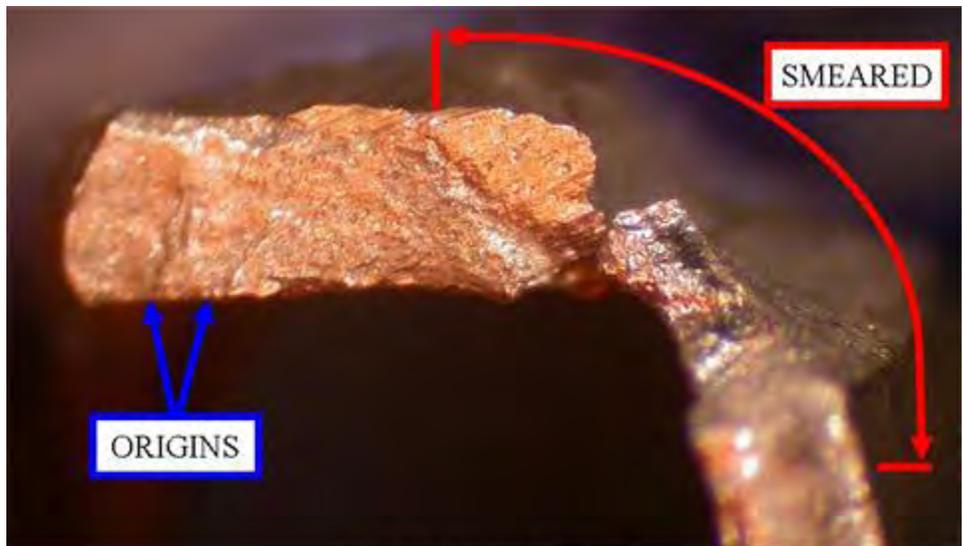
45955-00 CRK 2 WS 32 Frac

Figure 169. Fracture Face Crack 2 on the Left Wing Main Gear Door Angle WS 32

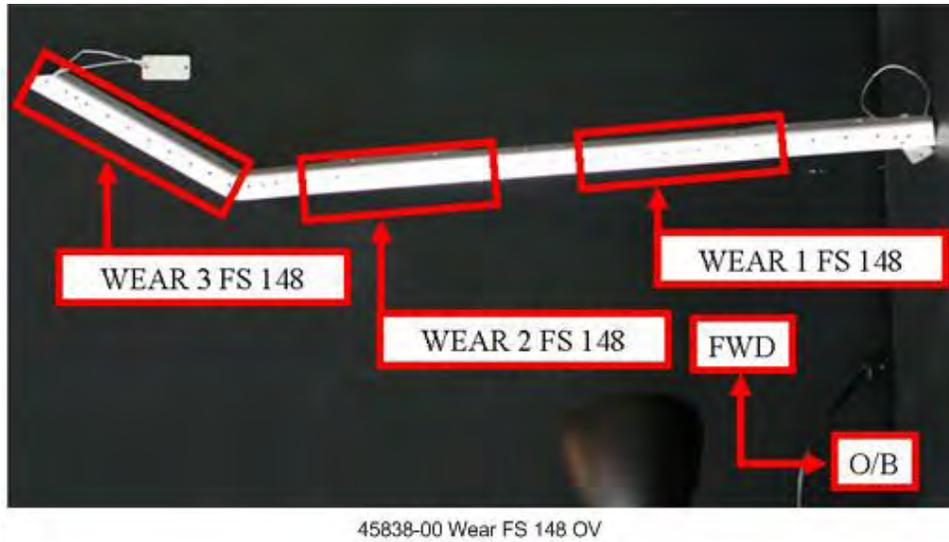
Figure 170 shows the location of three areas of wear on the left wing rear spar assembly lower aft angle, part number 45838-00. This entire part also had light scattered corrosion across its surface. Figure 171 shows a 2.47-square-inch area of wear, located at WS 38 FS 148. This area of wear resulted in a reduction in localized thickness of 54%. Another area of wear, identified as

Figure 170. Location of Wear 1, 2, and 3 and Overview of Left Wing Rear Spar Assembly Lower Aft Angle FS 148

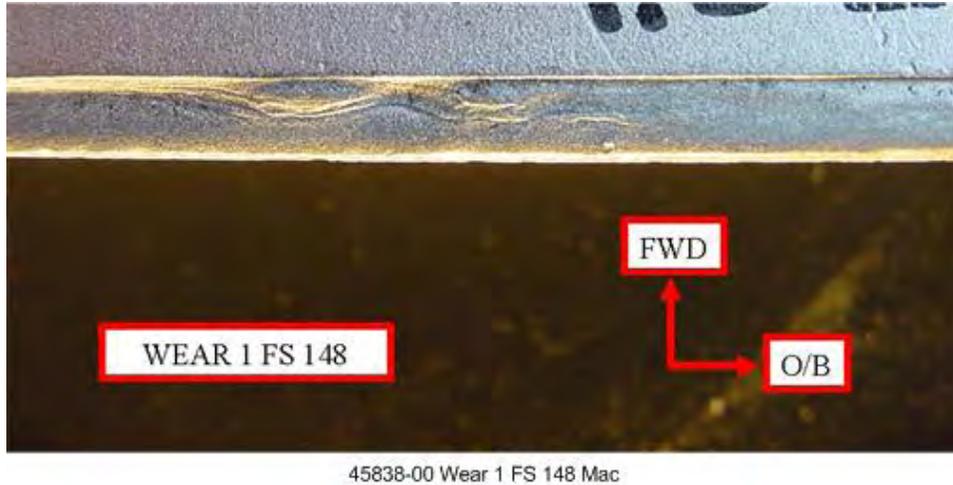
Figure 171. Macroscopic View of Wear 1 on the Left Wing Rear Spar Assembly Lower Aft Angle WS 38 FS 148

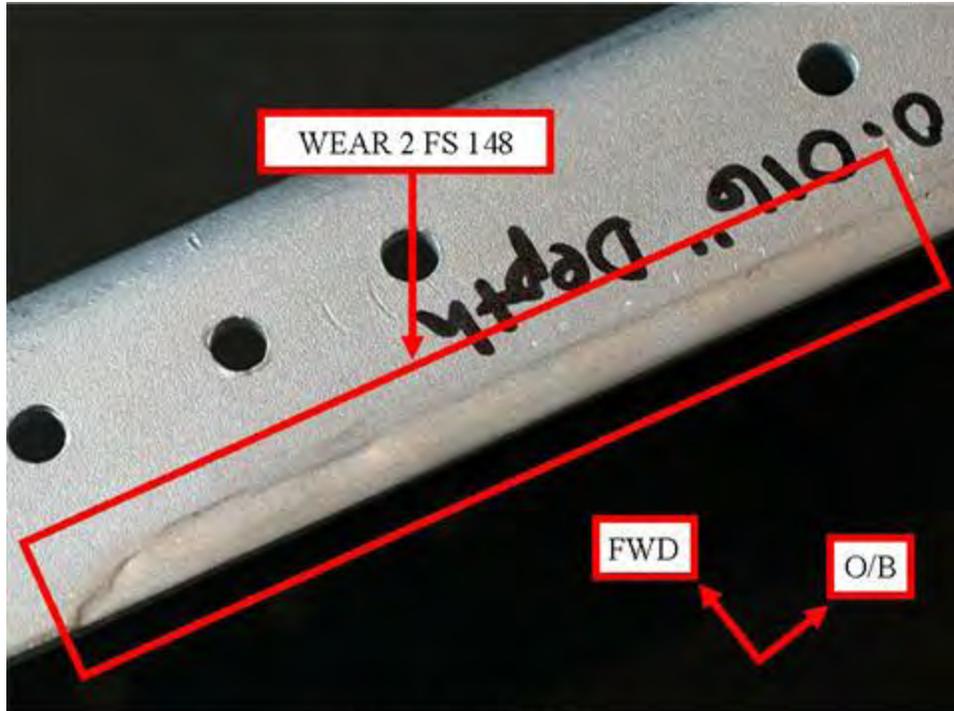
45838-00 Wear 2 FS 148 Mac

wear 2 and shown in figure 172, was located at WS 44 FS 148. This 0.9-square-inch area of wear resulted in a localized thickness loss of 17.7%. The final area of wear, documented on the lower aft angle, occurred at WS 64.5 FS 148, covered a surface area of 0.8 square inch, and caused a localized reduction in thickness of 32%. Wear 3 is shown in figure 173.

Figure 172. Macroscopic View of Wear 2 on the Left Wing Rear Spar Assembly Lower Aft Angle WS 44 FS 148

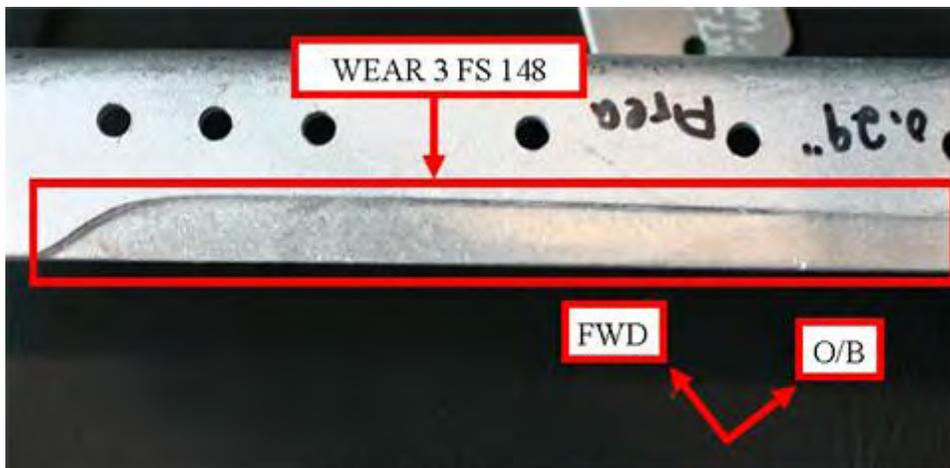
45838-00 Wear 3 FS 148 Mac

Figure 173. Macroscopic View of Wear 3 on the Left Wing Rear Spar Assembly Lower Aft Angle WS 64.5 FS 148

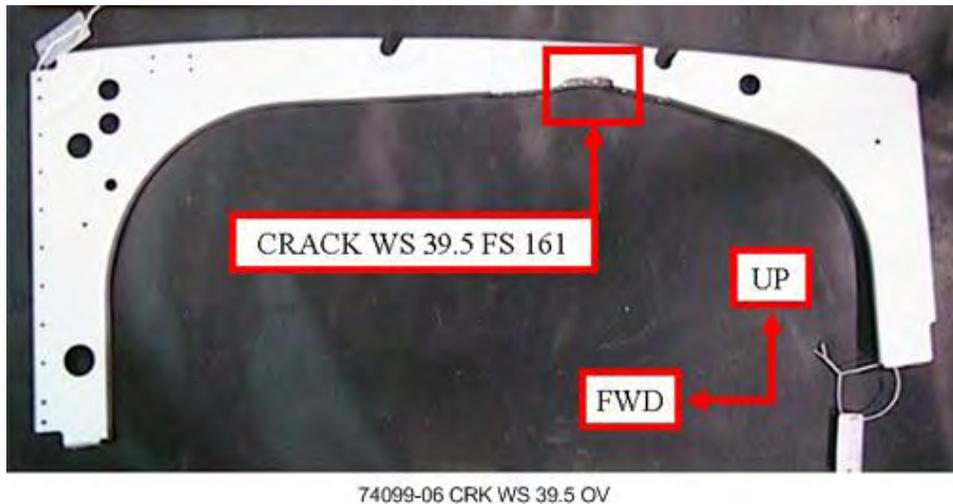
Figure 174 shows the location of a crack on the left wing rib assembly, part number 74099-06. A macroscopic view of the crack, which measures 1.525 inches and is located at WS 39.5 FS 161, is shown in figure 175, and the fluorescent liquid penetrant indication of this crack is shown in figure 176. Figure 177 shows a damaged section of the left wing rib, part number 40423-12. A macroscopic view of the damage to the left wing rib is shown in figure 178. The location of a

Figure 174. Location of Crack on the Left Wing Rib Assembly WS 39.5 FS 161

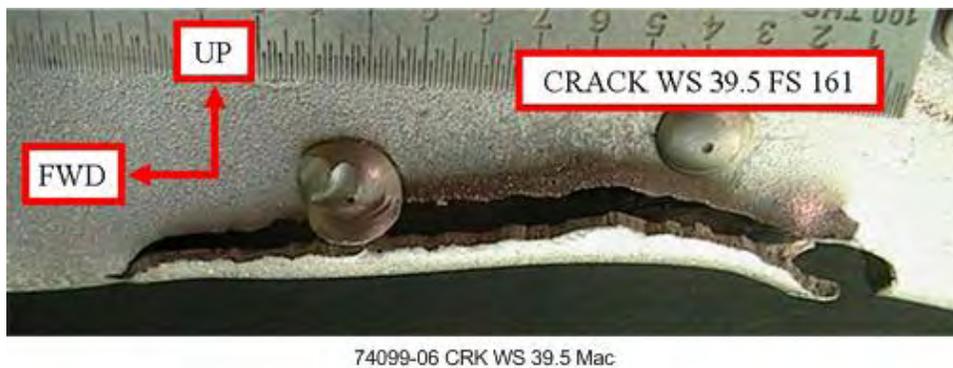
Figure 175. Macroscopic View of Crack on the Left Wing Rib Assembly WS 39.5 FS 161

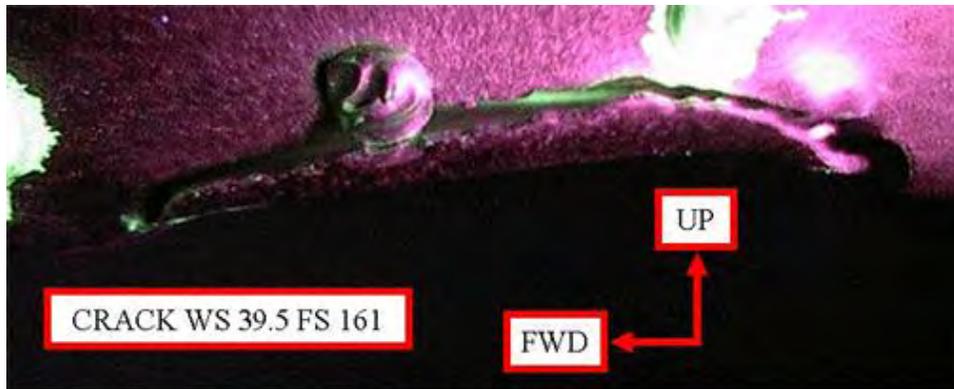
74099-06 CRK WS 39.5 FLP

Figure 176. Fluorescent Liquid Penetrant Indication of Crack on the Left Wing Rib Assembly WS 39.5 FS 161

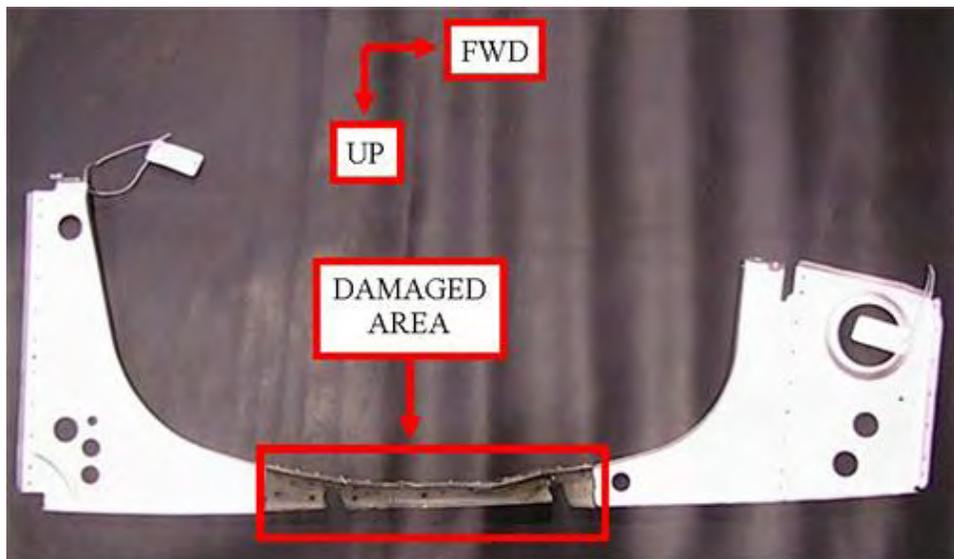
40423-12 Damage WS 49 OV

Figure 177. Overview of Damage on the Left Wing Rib WS 49

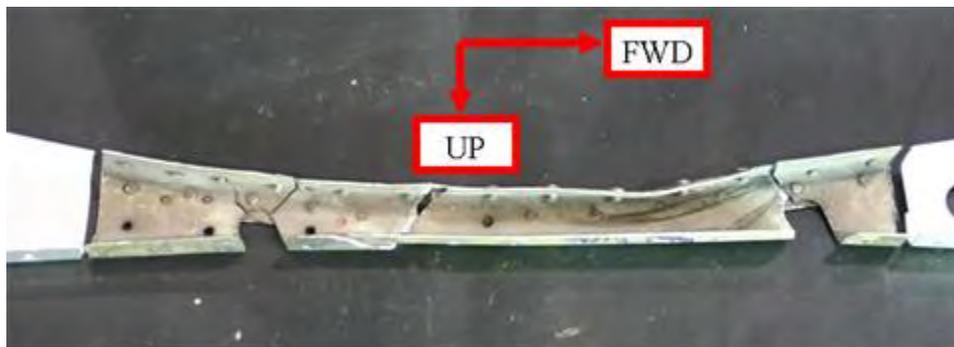
40423-12 Damage WS 49 Mac

Figure 178. Macroscopic View of the Damage on the Left Wing Rib WS 49

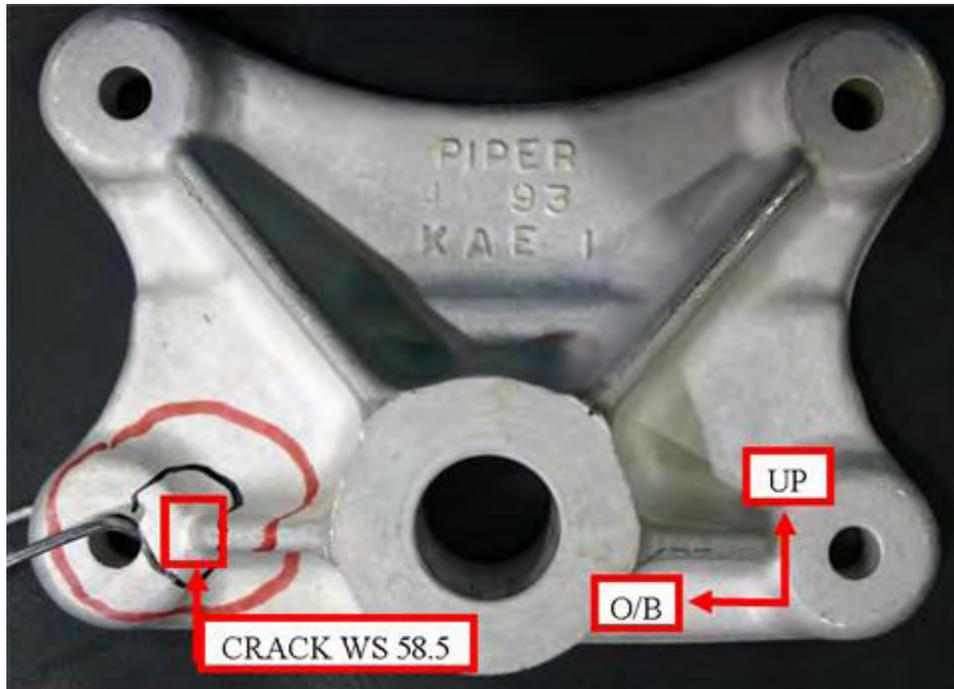
40294-00A CRK WS 58.5 OV

0.225-inch crack on the left wing main gear aft fitting assembly, part number 40294-00A, is shown in figure 179. A macroscopic view of this crack, which occurred at WS 58.5, is shown in figure 180, and the fluorescent liquid penetrant indication is shown in figure 181. Figure 182 shows the microscopic view of this crack. Light scattered corrosion was found on the left wing gear well plate 5, part number 40500-00 from WS 58.5 to WS 87.5. An overview providing the location of this corrosion, which caused a localized maximum thickness loss of 1.5%, is shown in figure 183.

Figure 179. Location of Crack on the Left Wing Main Gear Aft Fitting Assembly WS 58.5

Part Nomenclature	Revised Inspection	Location
LT wing main gear aft fitting	Remove paint and perform BHEC and LPI	Figure 179
LT wing trunnion landing gear aft	Remove paint and perform BHEC and LPI	Figure 198
RT Wing trunnion landing gear aft	Remove paint and perform BHEC and LPI	Figure 332

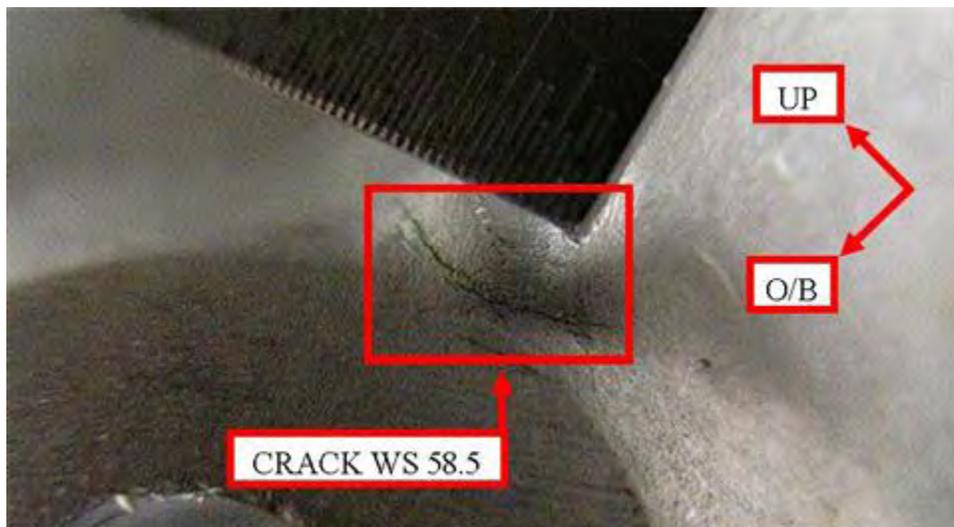
40294-00A CRK WS 58.5 Mac

Figure 180. Macroscopic View of the Left Wing Main Gear Aft Fitting Assembly WS 58.5

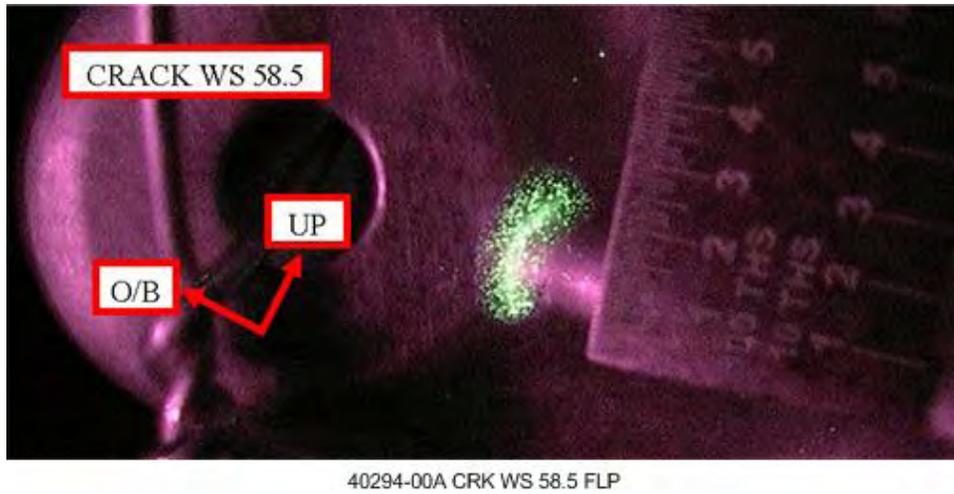
Figure 181. Fluorescent Liquid Penetrant Indication on the Left Wing Main Gear Aft Fitting Assembly WS 58.5

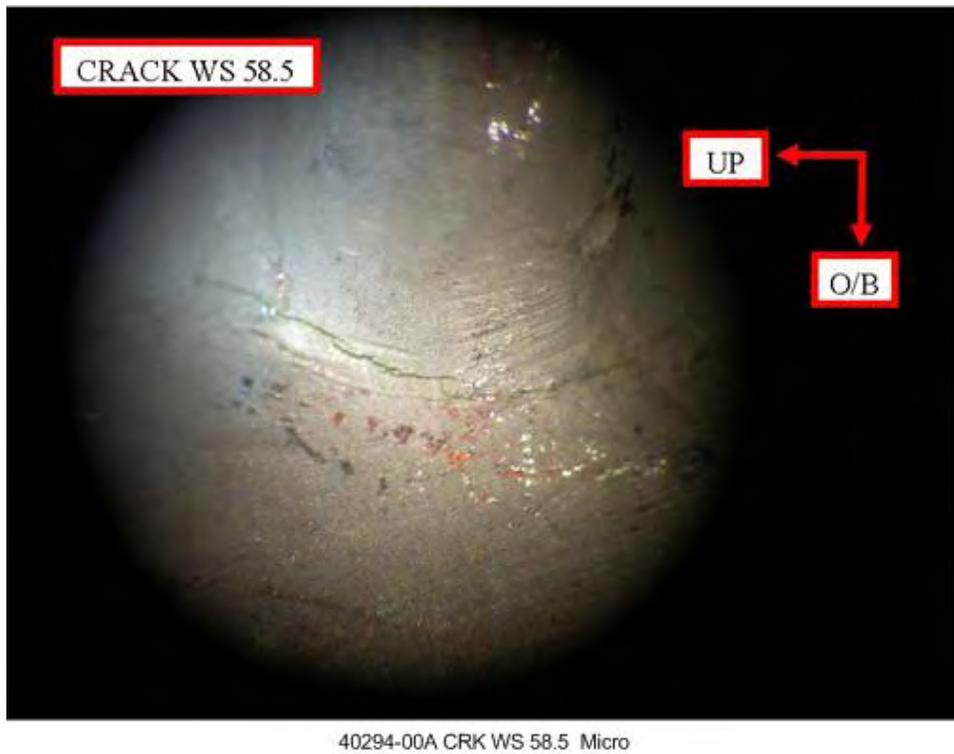
Figure 182. Microscopic View of Crack on the Left Wing Main Gear Aft Fitting Assembly WS 58.5

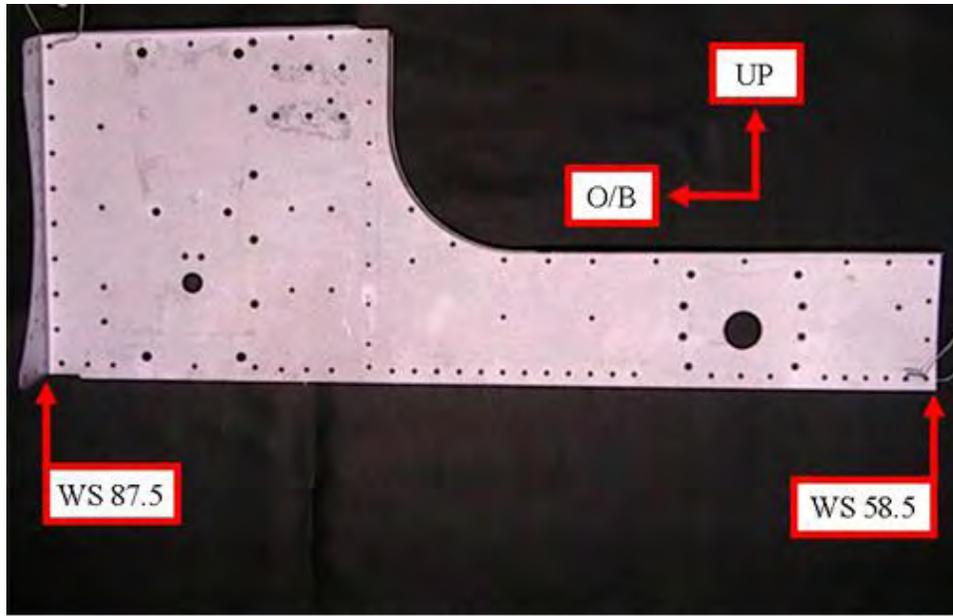
40500-00 Plate 5 Corr WS 58.5-87.5 OV

Part Name and Figure Number	Defect Type	Defect Location	Defect Extent	NDI Indication	Defect Classification	Defect Figure Number
Left wing gear well plate 5, figure 183	Corrosion	WS 58.5 through WS 87.5	Scattered over entire part	Corrosion indication	Light corrosion 1.5% thickness loss	103
Left nacelle front locker floor, figure 184	Corrosion	WS 65.25 through WS 83	17 inches by 4.5 inches	Corrosion indication	Light-moderate corrosion 3% thickness loss	105
	Corrosion	WS 66.75 through WS 77	10 inches by 2 inches	Corrosion indication	Light-moderate corrosion 3% thickness loss	105
	Crack	WS 73.5	0.65 inch	Crack indication	Surface	185
	Corrosion	WS 73.75 through WS 77	2.5 inches by 1.5 inches	Corrosion indication	Severe corrosion 15.6% thickness loss	186
	Corrosion	WS 74.5 through WS 76	1 inches by 2 inches	Corrosion indication	Severe corrosion 22% thickness loss	187
Left wing engine nacelle bulkhead assembly, figure 188	Corrosion	WS 65.69	33 inches by 12 inches inboard side of part	Corrosion indication	Light corrosion 2% thickness loss	103

Figure 183. Overview of Left Wing Gear Well Plate 5 WS 58.5 Through WS 87.5

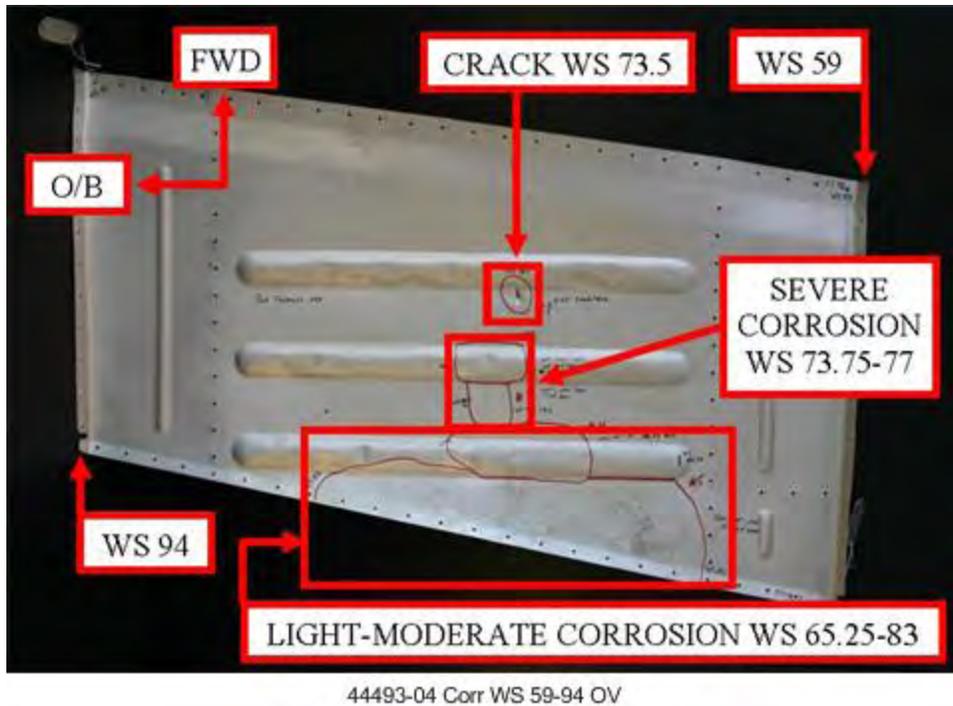
The location of a crack, light-moderate, and severe areas of corrosion found on the left nacelle front locker floor, part number 44493-04, is shown in figure 184. A 76.5-square-inch area of light-moderate corrosion, which caused a localized reduction in thickness of 3%, was located from WS 65.25 to WS 83, and an additional 20-square-inch area of light-moderate corrosion, also causing a thickness loss of 3%, was documented from WS 66.75 to WS 77. Figure 185 shows a macroscopic view of a 0.65-inch-long crack located at WS 73.5. The macroscopic view of a 3.75-square-inch area of severe corrosion, causing a localized reduction in thickness of 15.6%, is shown in figure 186. This area of corrosion was located from WS 73.75 to WS 77 on the locker floor. Another area of severe corrosion, located from WS 74.5 to WS 76, was documented on the front locker floor. This 2-square-inch area of corrosion, shown in figure 187, caused a localized reduction in thickness of 22%. Figure 188 shows an overview of scattered light corrosion on the left wing engine nacelle bulkhead assembly, part number 44437-04, located at WS 65.69. This corrosion resulted in a localized thickness loss of 2%.

Figure 184. Location of Crack, Light-Moderate, and Severe Corrosion on the Left Nacelle Front Locker Floor WS 59 Through WS 94
