DOT/FAA/AR-07/64

Teardown Evaluation of a 1975 Piper Navajo Chieftain Model PA31-350 Airplane

March 2008

Final Report

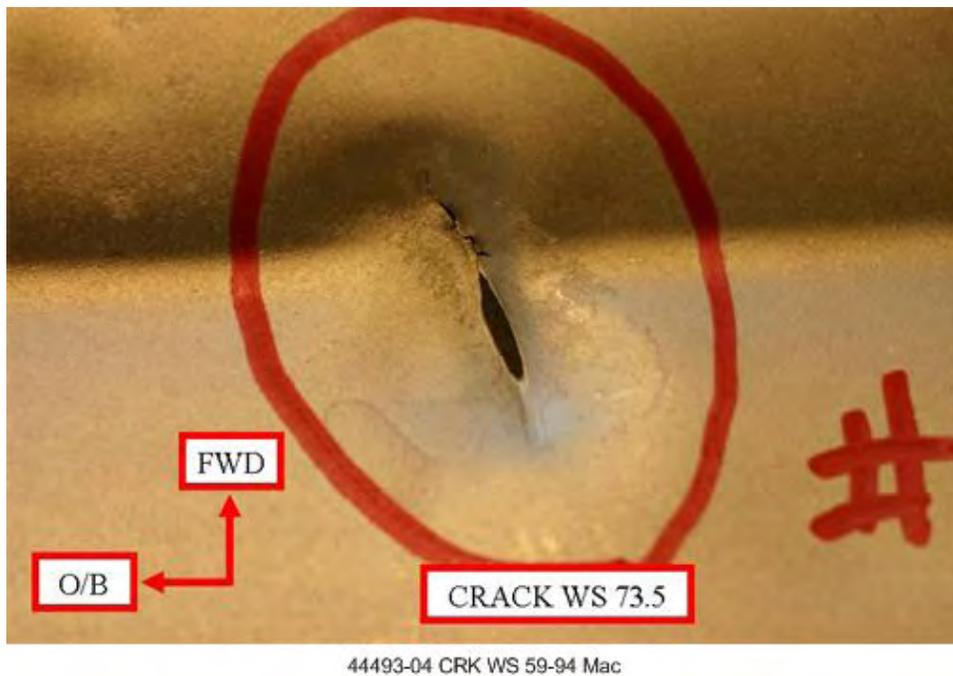
The location of a crack, light-moderate, and severe areas of corrosion found on the left nacelle front locker floor, part number 44493-04, is shown in figure 184. A 76.5-square-inch area of light-moderate corrosion, which caused a localized reduction in thickness of 3%, was located from WS 65.25 to WS 83, and an additional 20-square-inch area of light-moderate corrosion, also causing a thickness loss of 3%, was documented from WS 66.75 to WS 77. Figure 185 shows a macroscopic view of a 0.65-inch-long crack located at WS 73.5. The macroscopic view of a 3.75-square-inch area of severe corrosion, causing a localized reduction in thickness of 15.6%, is shown in figure 186. This area of corrosion was located from WS 73.75 to WS 77 on the locker floor. Another area of severe corrosion, located from WS 74.5 to WS 76, was documented on the front locker floor. This 2-square-inch area of corrosion, shown in figure 187, caused a localized reduction in thickness of 22%. Figure 188 shows an overview of scattered light corrosion on the left wing engine nacelle bulkhead assembly, part number 44437-04, located at WS 65.69. This corrosion resulted in a localized thickness loss of 2%.

Figure 185. Macroscopic View of Crack on the Left Nacelle Front Locker Floor WS 73.5

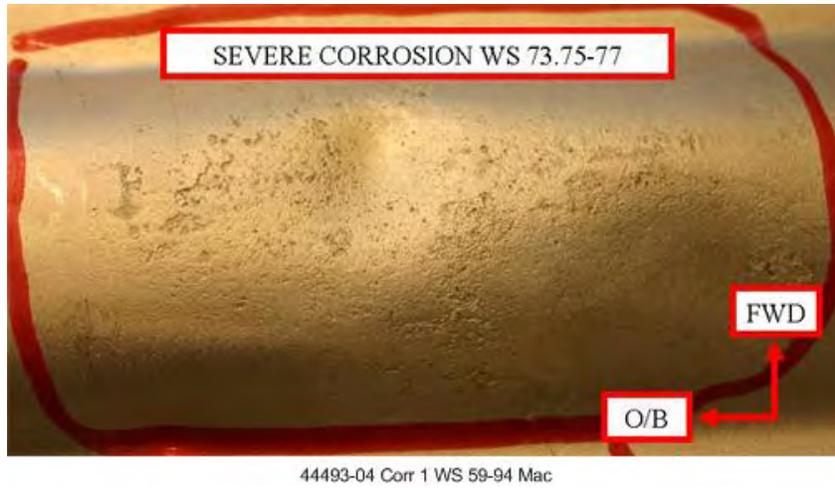
Figure 186. Macroscopic View of Severe Corrosion on the Left Nacelle Front Locker Floor WS 73.75 Through WS 77

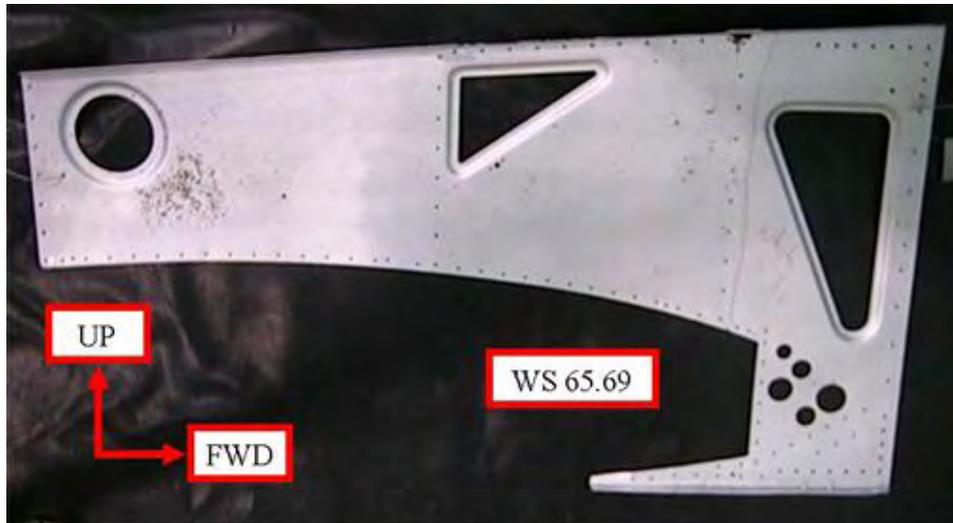
44437-04 Corr WS 65.69 OV

Figure 188. Overview of Left Wing Engine Nacelle Bulkhead Assembly WS 65.69

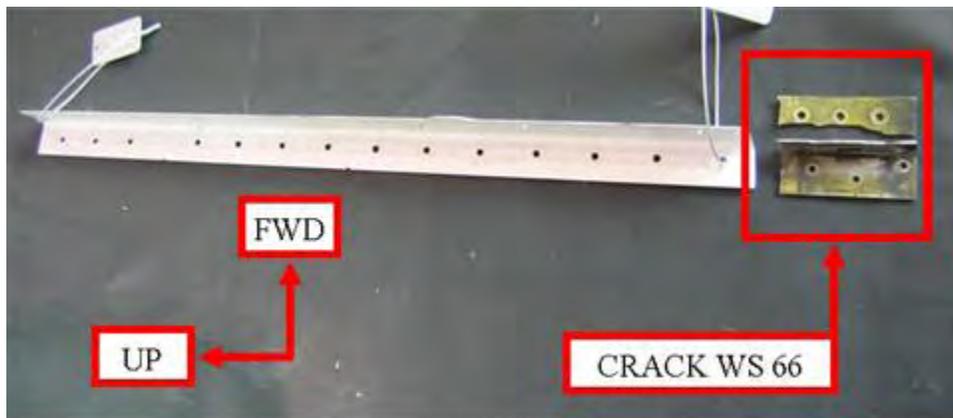
41632-00 CRK WS 66 OV

Left wing nacelle inboard angle longitudinal bulkhead, figure 189	Crack	WS 66	1.695 inches	Not inspected ¹	Fatigue	190 191 192
Left wing rear spar rib assembly, figure 193	Corrosion	WS 67.5	5.25 inches by 1 inch (both sides of part)	No indication	Light corrosion 1% thickness loss	103
Left wing bulkhead assembly rear spar main gear support, figure 194	Corrosion	WS 70	3 inches by 1.58 inches	Corrosion indication	Light corrosion 1.3% thickness loss	103
Left wing nacelle plate assembly firewall shear, figure 195	Wear	WS 72	1.245 inches by 0.304 inch	No indication	Wear 20% thickness loss	196
	Wear	WS 72	4 inches by 0.194 inch	No indication	Wear 25% thickness loss	197
Left wing trunnion landing gear aft, figure 198	Crack	WS 77.5	0.175 inch	Crack indication	Bend radii	199 200

The location of a crack in the left wing nacelle inboard angle longitudinal bulkhead, part number 41632-00, is shown in figure 189. A macroscopic view of this crack, which measures 1.695 inches, is shown in figure 190, and the fracture face of this crack, located at WS 66, is shown in figure 191. A fractograph, shown in figure 192, confirms the failure mode of this crack is fatigue. This fractograph provides a view of the fracture face features, in this case fatigue striations, and the crack growth direction.

Figure 189. Location of Crack on the Left Wing Nacelle Inboard Angle Longitudinal Bulkhead WS 66

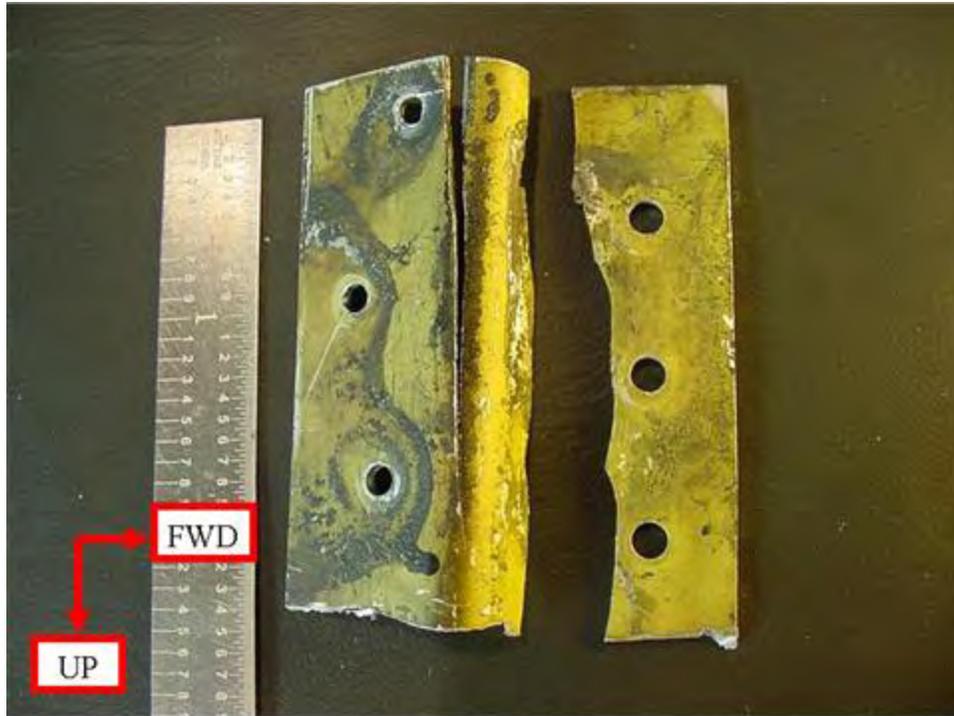
41632-00 CRK WS 66 Macro

Figure 190. Macroscopic View of Crack on the Left Wing Nacelle Inboard Angle Longitudinal Bulkhead WS 66

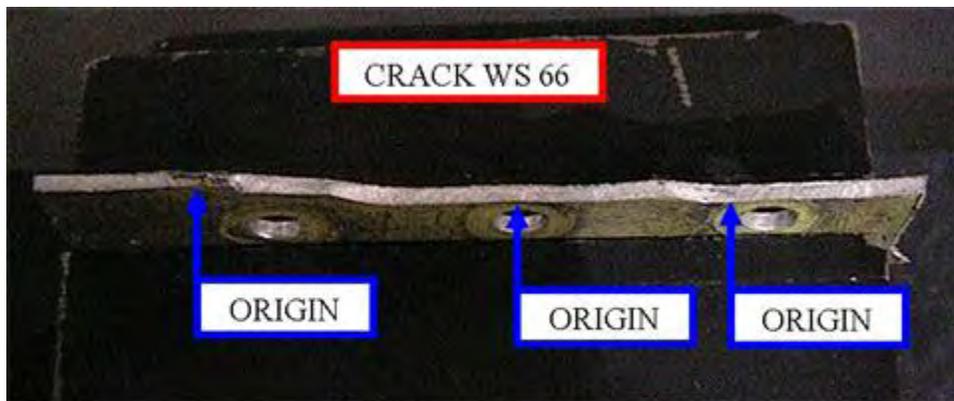
41632-00 CRK WS66 Frac

Figure 191. Fracture Face of Crack on the Left Wing Nacelle Inboard Angle Longitudinal Bulkhead WS 66

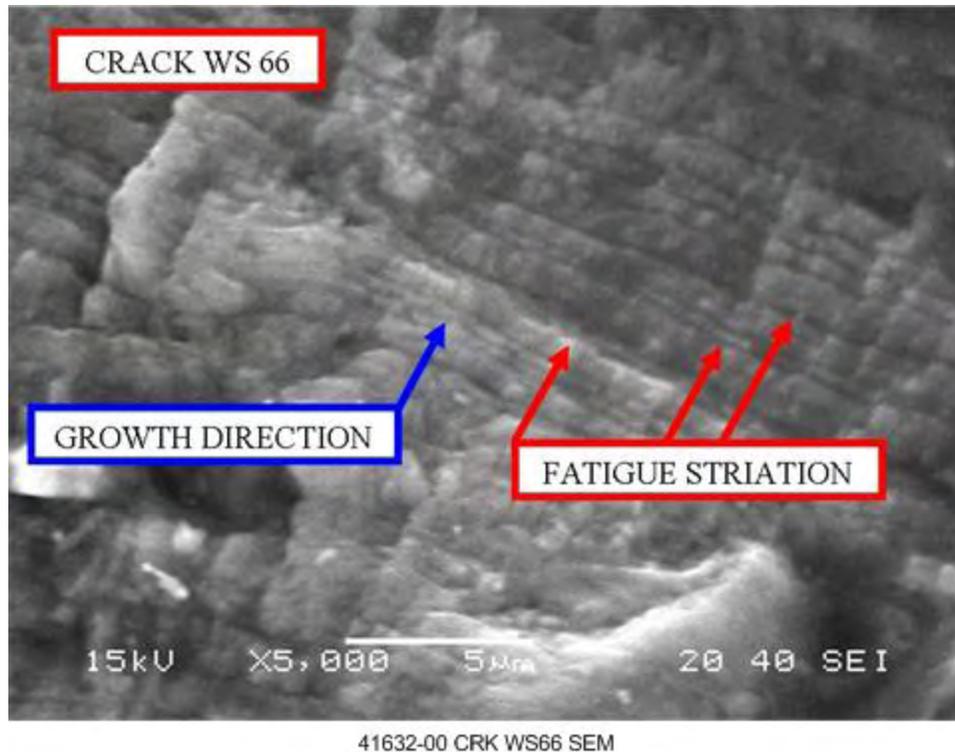
Figure 192. Fractograph of the Crack on the Left Wing Nacelle Inboard Angle Longitudinal Bulkhead WS 66

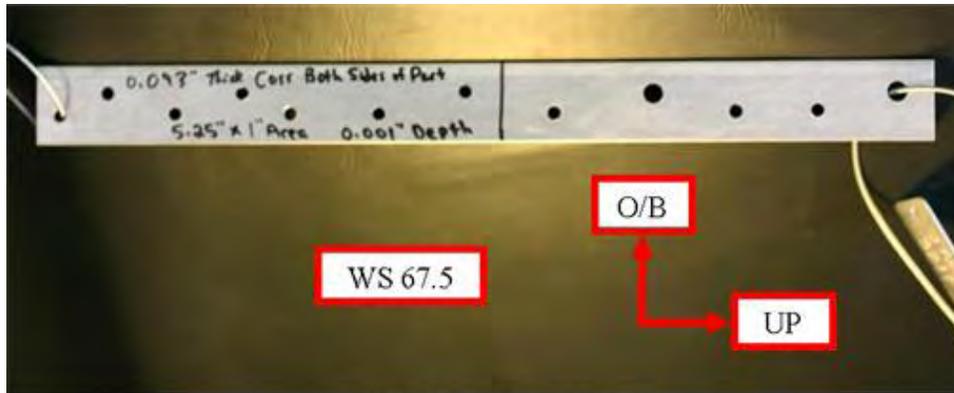
40419-24 Corr WS 67.5 OV

Figure 193 shows the location of light corrosion on the left wing rear spar rib assembly, part number 40419-24. This 5.25-square-inch area of corrosion, located at WS 67.5, caused a maximum thickness loss of 1%. An area of light corrosion, causing a maximum reduction in thickness of 1.3%, was observed on the left wing bulkhead assembly rear spar main gear support, part number 45501-00, at WS 70. Figure 194 shows the location of this 4.74-square-inch area of corrosion. Two areas of wear were observed on the left wing nacelle plate assembly firewall shear, part number 40671-00A, at WS 72, as shown in figure 195. A macroscopic view of wear 1, which covered a surface area of 0.38 square inch and caused a localized reduction in thickness of 20%, is shown in figure 196. Figure 197 shows a macroscopic view of wear 2, which covered a surface area of 0.78 square inch and resulted in a maximum thickness loss of 25%.

Figure 193. Location of Light Corrosion on the Left Wing Rear Spar Rib Assembly WS 67.5

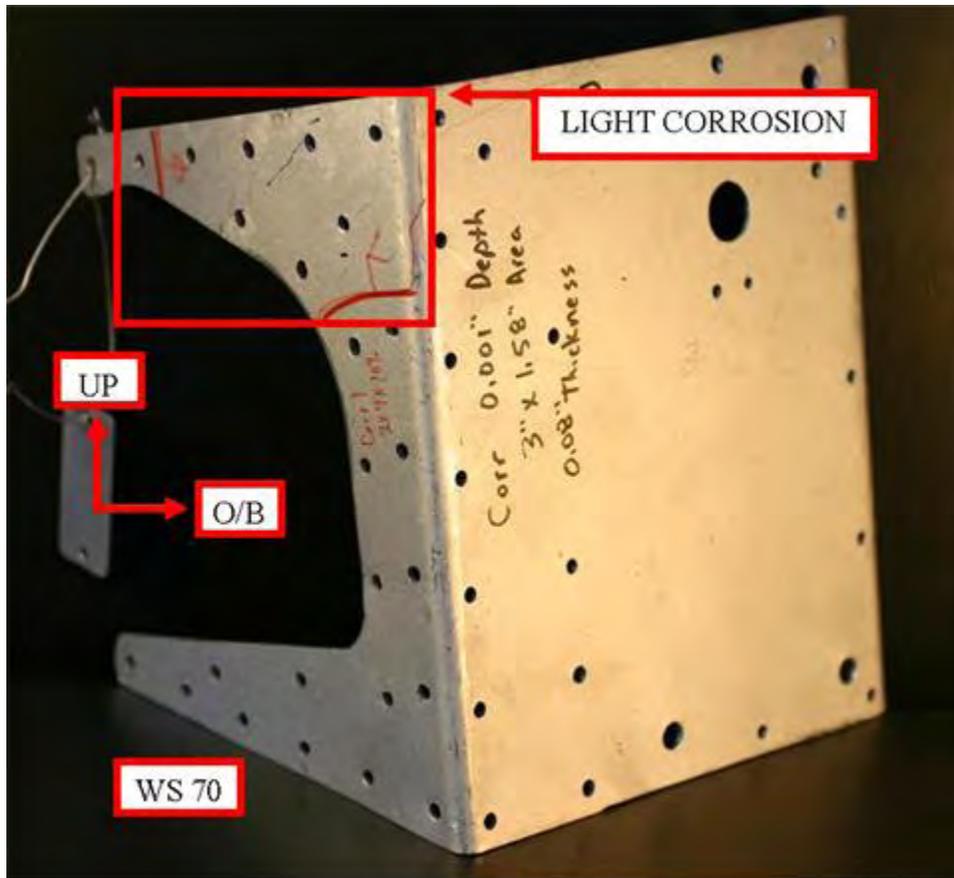
45501-00 Corr WS 70 OV

Figure 194. Location of Light Corrosion on the Left Wing Bulkhead Assembly Rear Spar Main Gear Support WS 70

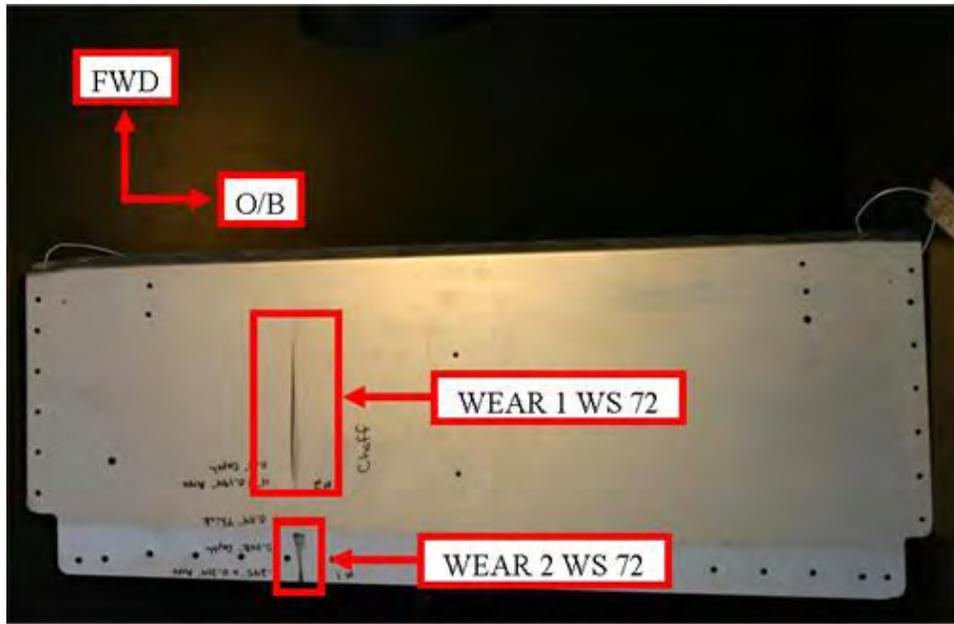
40671-00A Wear WS 72 OV

Figure 195. Location of Wear on the Left Wing Nacelle Plate Assembly Firewall Shear WS 72

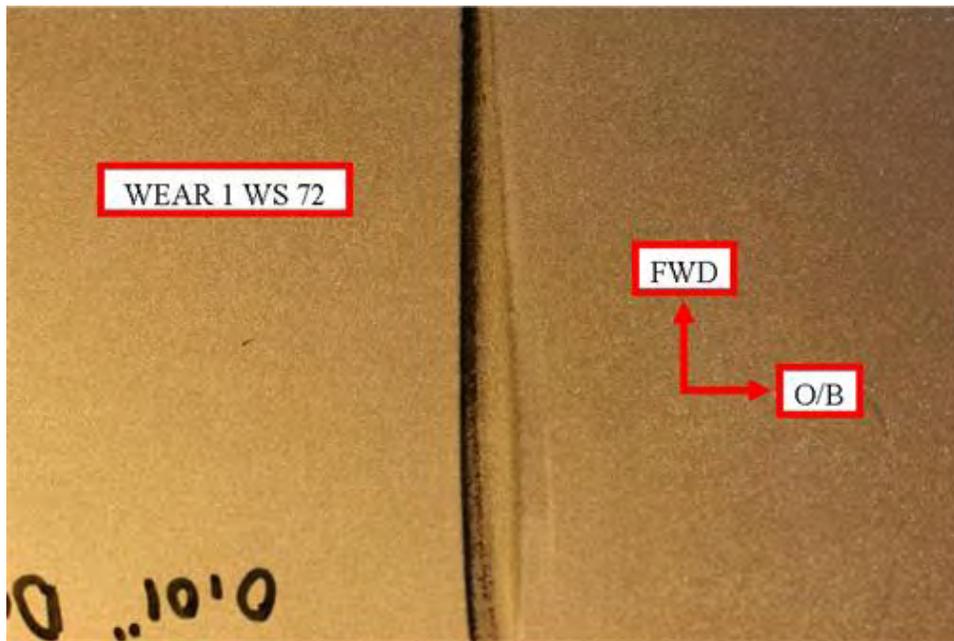
40671-00A Wear1 WS 72 Mac

Figure 196. Macroscopic View of Wear 1 on the Left Wing Nacelle Plate Assembly Firewall Shear WS 72

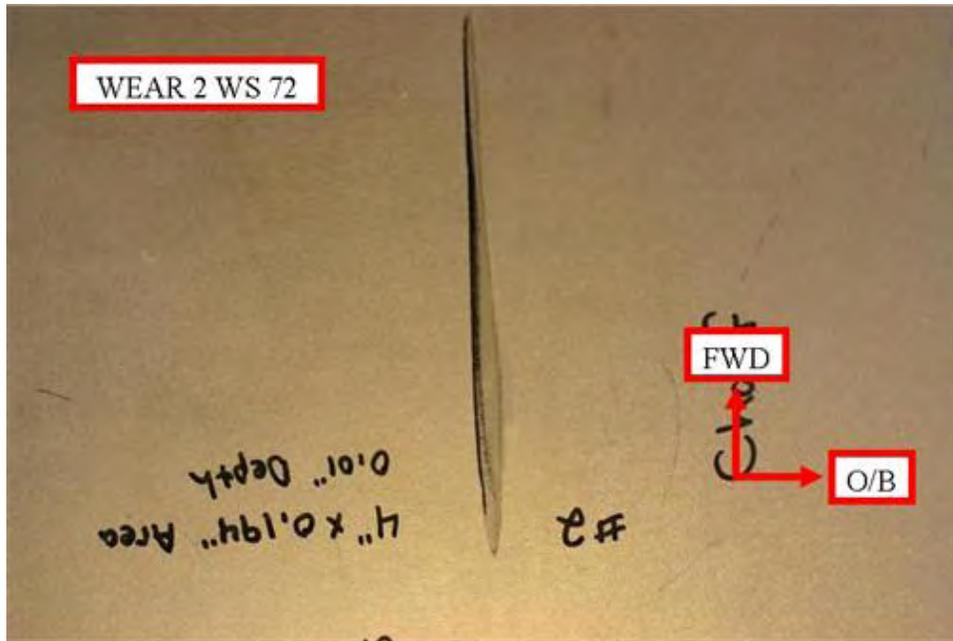
40671-00A Wear2 WS 72 Mac

Figure 197. Macroscopic View of Wear 2 on the Left Wing Nacelle Plate Assembly Firewall Shear WS 72

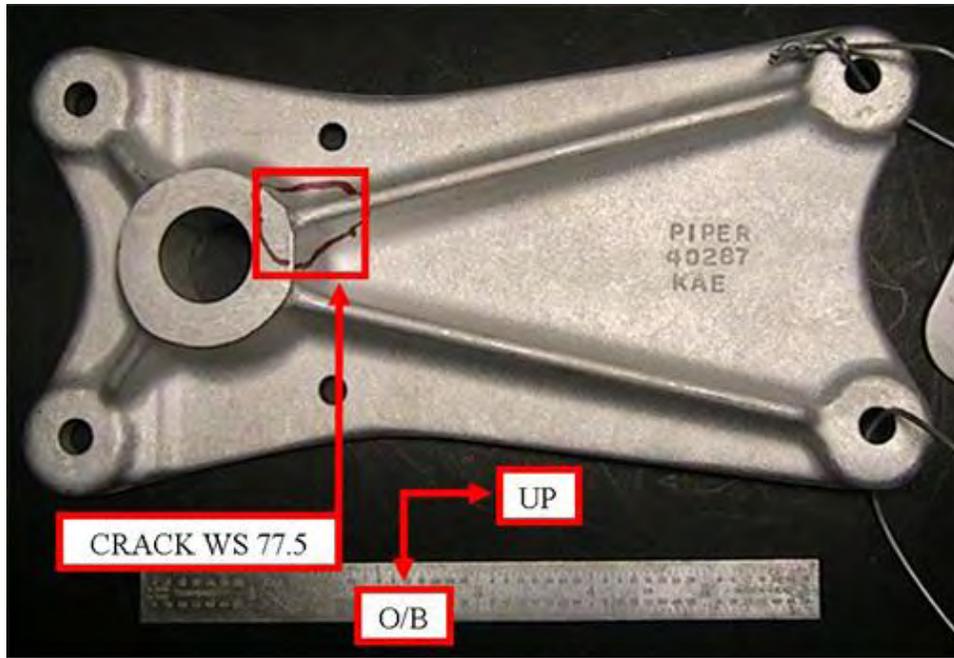
40288-00A CRK WS 77.5 OV

The location of a crack on the left wing trunnion landing gear aft, part number 40288-00A, is shown in figure 198. A macroscopic view of this crack, which measures 0.175 inches and occurred at WS 77.5, is shown in figure 199, and the fluorescent liquid penetrant indication is shown in figure 200. Figure 201 shows the location of a crack on the left wing nacelle air filter bracket, part number 44397-00, which measured 0.496 inch in length and was determined to be caused by fatigue. A macroscopic view of this crack is shown in figure 202, and the fracture face is shown in figure 203. Figure 204 shows the location of wear on the left wing plate assembly main spar rib attachment, part number 40456-02A, at WS 87. This area of wear, shown macroscopically in figure 205, covered a surface area of 2.1 square inches and resulted in a maximum reduction in localized thickness of 66%.

Figure 198. Location of Crack on the Left Wing Trunnion Landing Gear Aft WS 77.5

Part Nomenclature	Revised Inspection	Location
LT wing main gear aft fitting	Remove paint and perform BHEC and LPI	Figure 179
LT wing trunnion landing gear aft	Remove paint and perform BHEC and LPI	Figure 198
RT Wing trunnion landing gear aft	Remove paint and perform BHEC and LPI	Figure 332

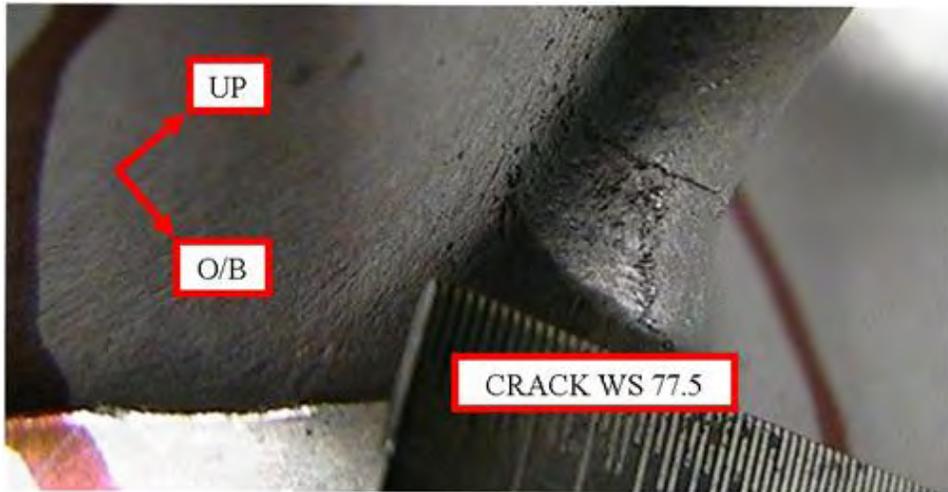
40288-00A CRK WS 77.5 Mac

Figure 199. Macroscopic View of Crack on the Left Wing Trunnion Landing Gear Aft WS 77.5

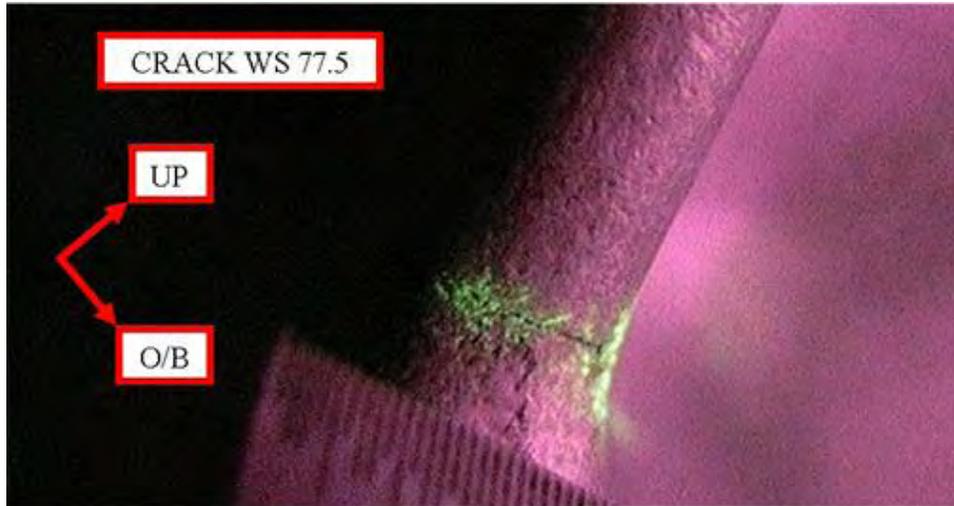
40288-00A CRK WS 77.5 FLP

Figure 200. Fluorescent Liquid Penetrant Indication of Crack on the Left Wing Trunnion Landing Gear Aft WS 77.5

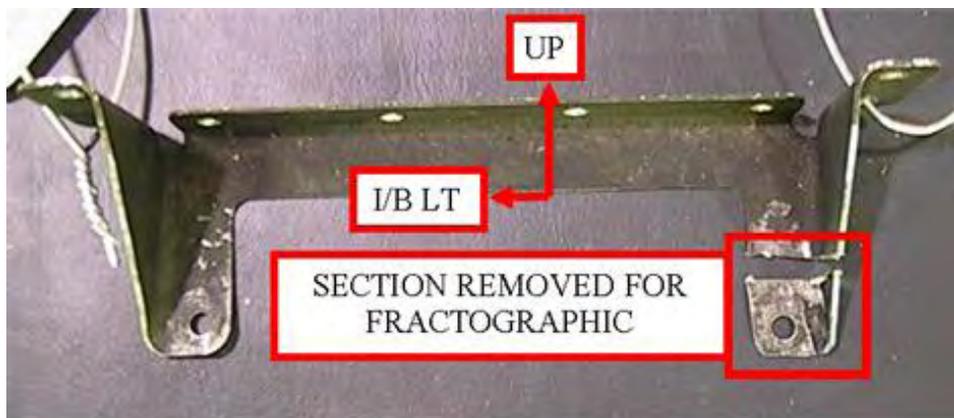
44397-00 CRK WS 85 OV

Part Name and Figure Number	Defect Type	Defect Location	Defect Extent	NDI Indication	Defect Classification	Defect Figure Number
Left wing nacelle air filter bracket, figure 201	Crack	WS 85	0.496 inch	Not inspected ¹	Fatigue	202 203
Left wing plate assembly main spar rib attach, figure 204	Wear	WS 87	0.941 inch by 2.23 inches	No indication	Wear 66% thickness loss	205
Left wing main spar rib attachment wing panel assembly (1 of 2), figure 206	Crack	WS 87.5	1.040 inches	Not inspected ¹	Failure mode undetermined due to extensive crack face smearing	207 208
Left wing main spar rib attachment wing panel assembly (2 of 2), figure 209	Crack	WS 87.5	0.904 inch	Not inspected ¹	Failure mode undetermined due to extensive crack face smearing	216
Left wing flap track, figure 111	Multiple cracks	WS 87.5	0.044 inch	Crack indication	Hole crack	212 213 214
Left wing rear spar assembly rib assembly, figure 215	Corrosion	WS 87.5	30 inches by 12 inches scattered inboard side of part	Corrosion indication	Light corrosion 2% thickness loss	103

Figure 201. Location of Left Wing Nacelle Air Filter Brack WS 85

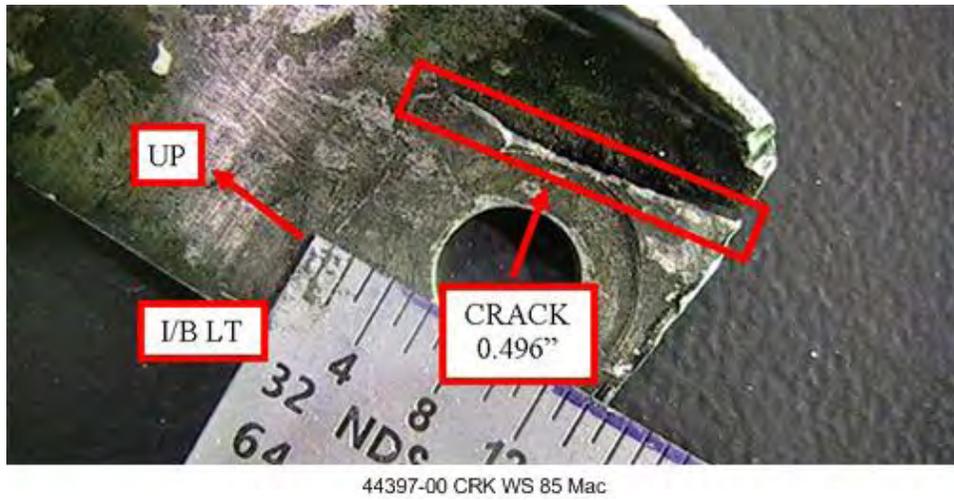
Figure 202. Macroscopic View of Crack on the Left Wing Nacelle Air Filter Bracket WS 85

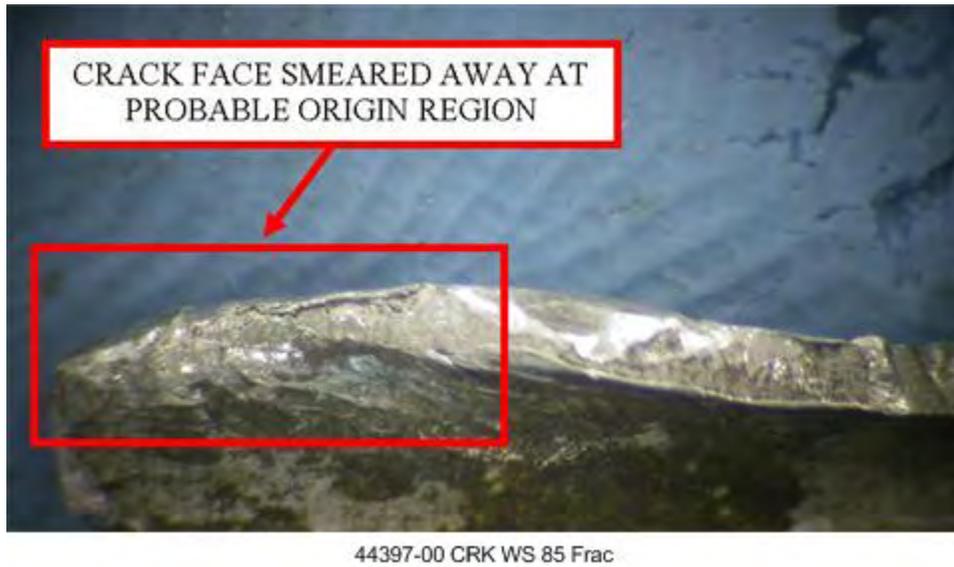
Figure 203. Fracture Face of Crack on the Left Wing Nacelle Air Filter Bracket WS 85

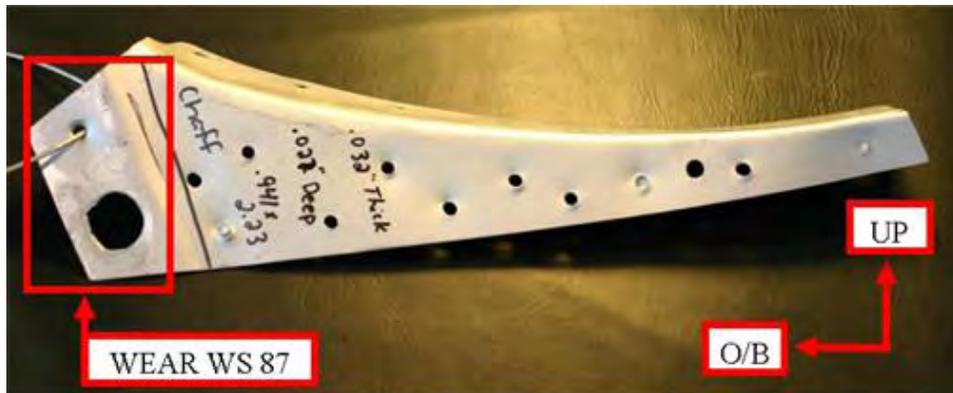
40456-02A Wear WS 87 OV

Figure 204. Location of Wear on the Left Wing Plate Assembly Main Spar Rib Attachment WS 87

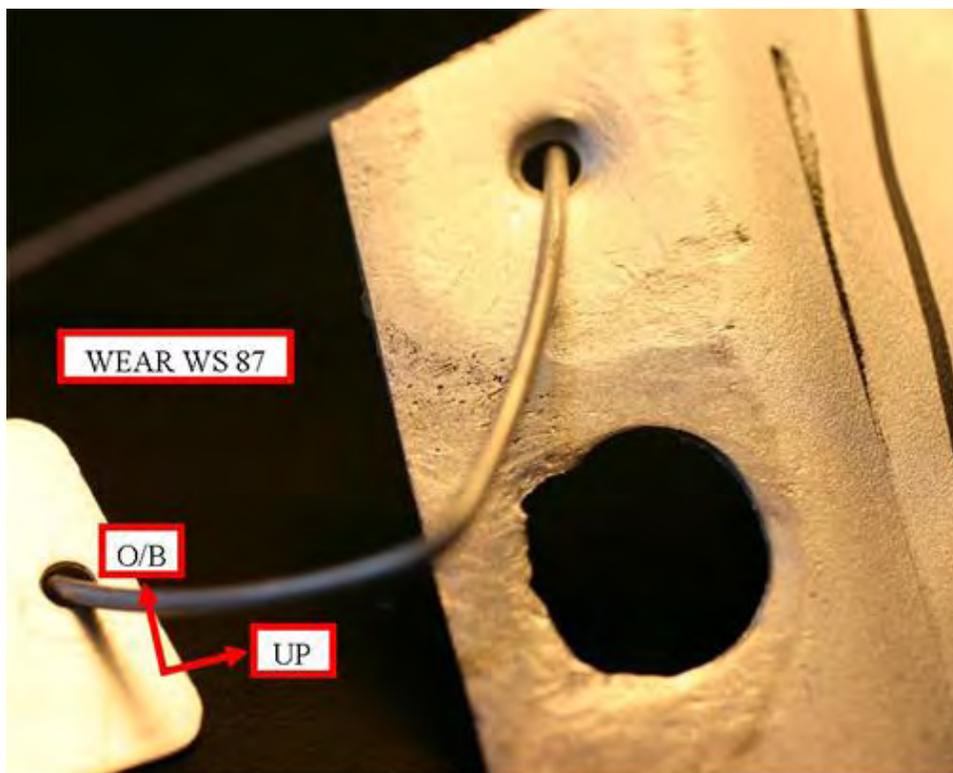
40456-02A Wear WS 87 Mac

Figure 205. Macroscopic View of Wear on the Left Wing Plate Assembly Main Spar Rib Attachment WS 87

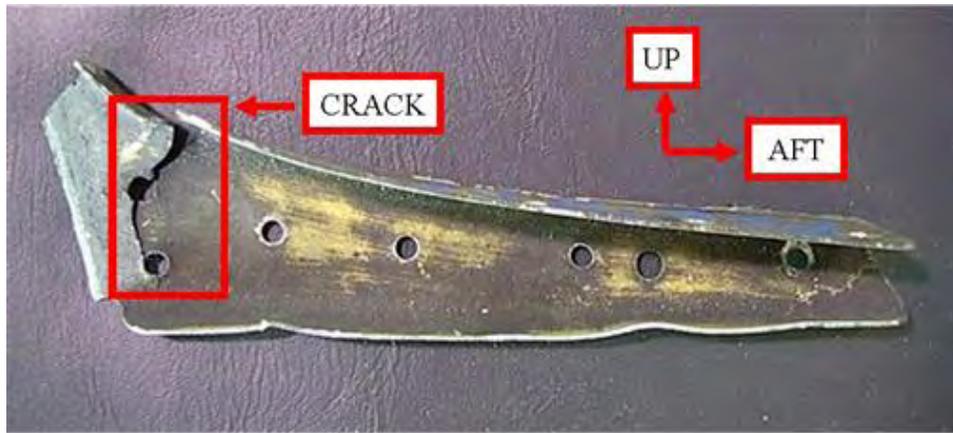
40456-02 (1 of 2) CRK WS 87 OV

Figure 206 shows the location of a 1.04-inch crack on the left wing main spar rib attachment wing panel assembly (1 of 2), part number 40456-02, at WS 87.5. A macroscopic view of this crack is shown in figure 207. The fracture face of this crack was examined; however, due to extensive crack face smearing, shown in figure 208, the failure mode could not be determined. A similar crack, measuring 0.904 inch, was identified on the left wing main spar rib attachment

Figure 206. Location of Crack on the Left Wing Main Spar Rib Attachment Wing Panel Assembly (1 of 2) WS 87.5

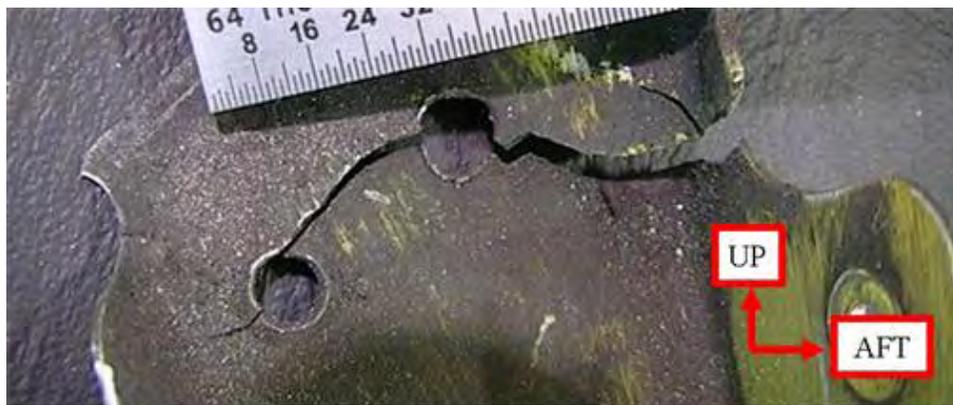
40456-02 (1 of 2) CRK WS 87 Mac

Figure 207. Macroscopic View of Crack on the Left Wing Main Spar Rib Attachment Wing Panel Assembly (1 of 2) WS 87.5

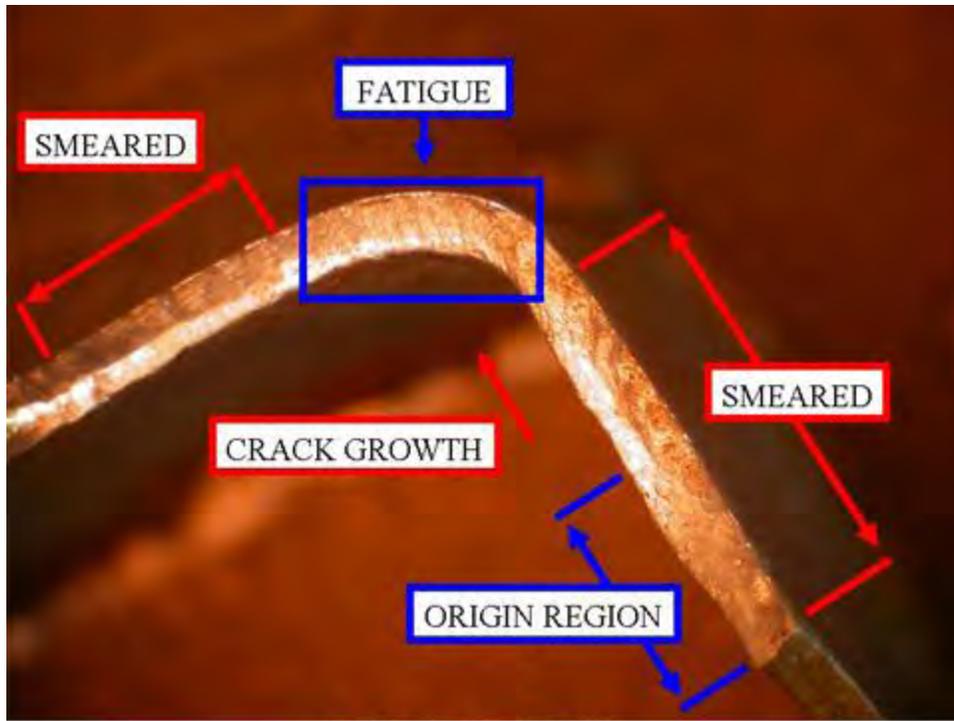
40456-02 (1 of 2) CRK WS 87 Frac

Figure 208. Fracture Face of Crack on the Left Wing Main Spar Rib Attachment Wing Panel Assembly (1 of 2) WS 87.5

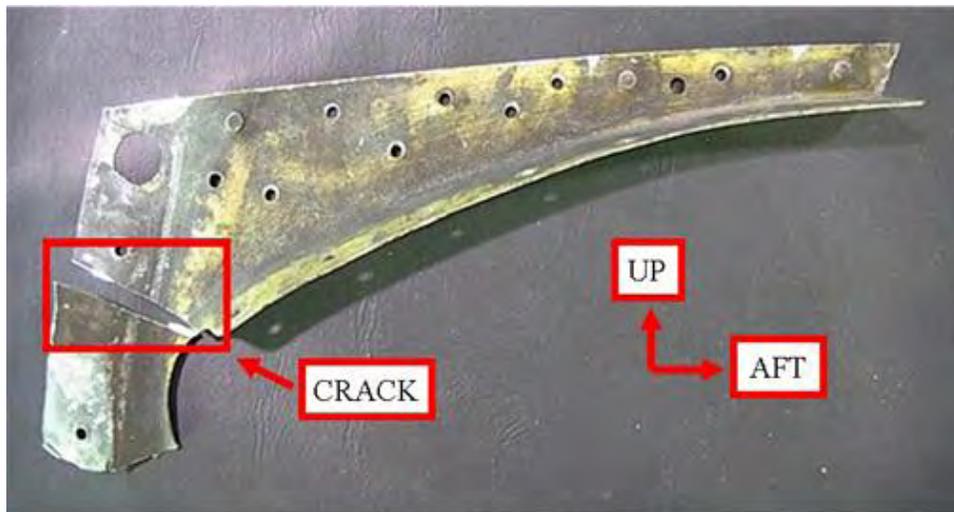
40456-02 (2 of 2) CRK WS 87.5 OV

wing panel assembly (2 of 2), part number 40456-02, at WS 87.5. The location of this crack is shown in figure 209, and a macroscopic view of the crack is shown in figure 210. As with the previous crack, extensive crack face smearing prevented identification of the failure mode. The location of cracks in the left wing flap track, part number 45809-10C, is shown in figure 211. A macroscopic view of these cracks, located at WS 87.5 and measuring 0.044 inch in length, is shown in figure 212. Figure 213 shows of the fluorescent liquid penetrant indication of these cracks. A microscopic view of the cracks on the flap track is shown in figure 214.

Figure 209. Location of Crack on the Left Wing Main Spar Rib Attachment Wing Panel Assembly (2 of 2) WS 87.5

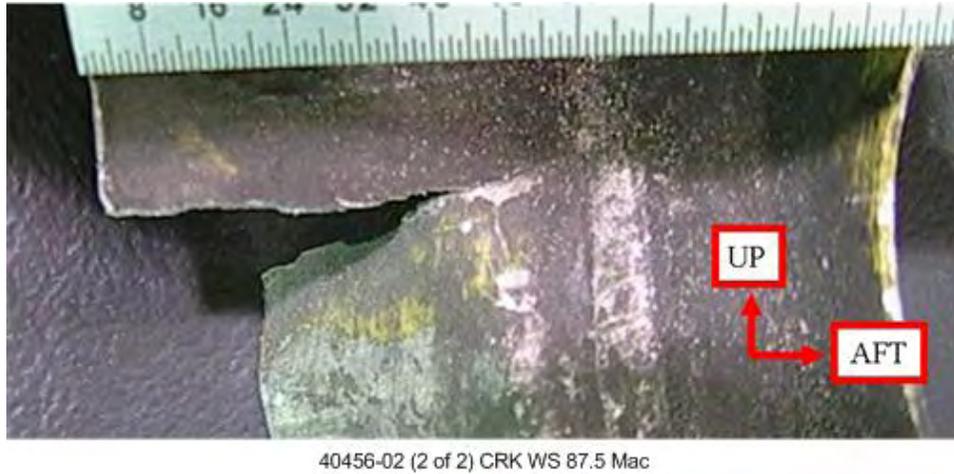
Figure 210. Macroscopic View of Crack on the Left Wing Main Spar Rib Attachment Wing Panel Assembly (2 of 2) WS 87.5

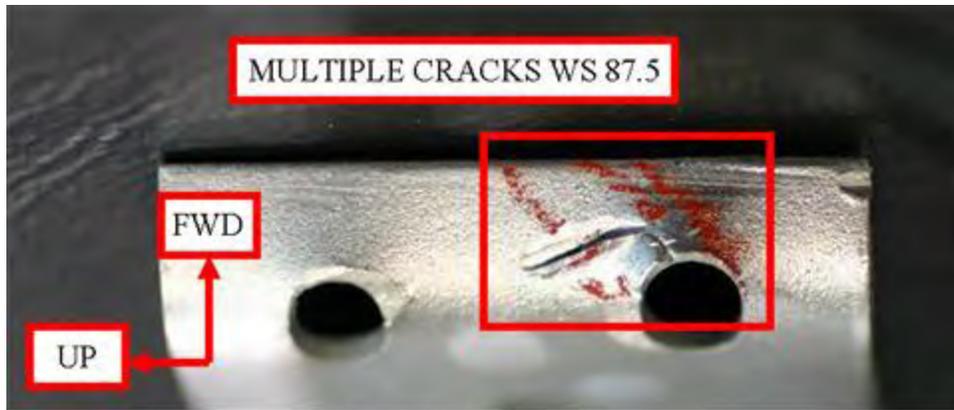
45809-10C CRK WS87.5 Mac

Figure 212. Macroscopic View of Cracks on the Left Wing Flap Track WS 87.5

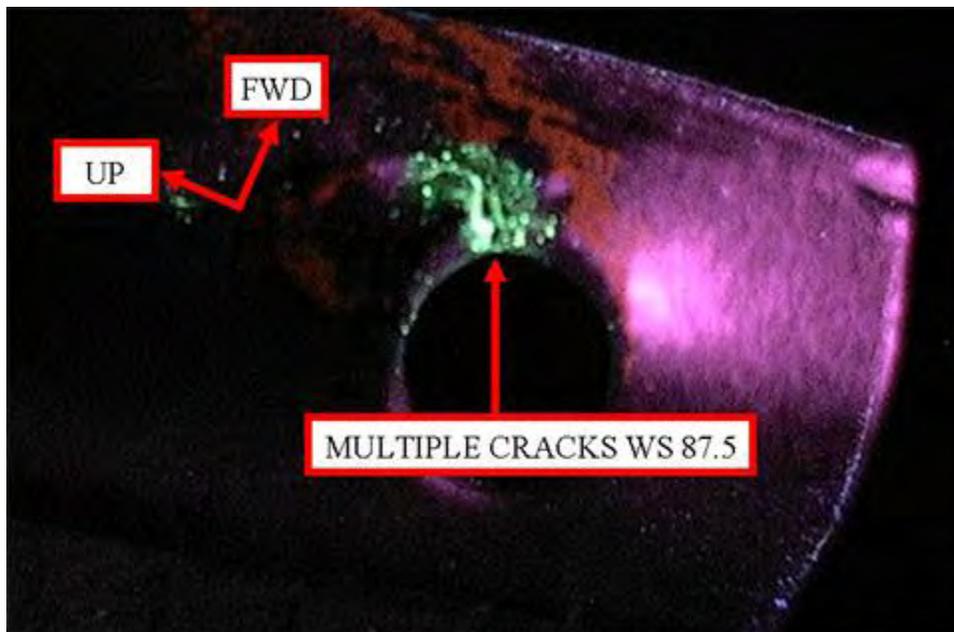
45809-10C CRK WS 87.5 FLP

Figure 213. Fluorescent Liquid Penetrant Indication of Cracks on the Left Wing Flap Track WS 87.5

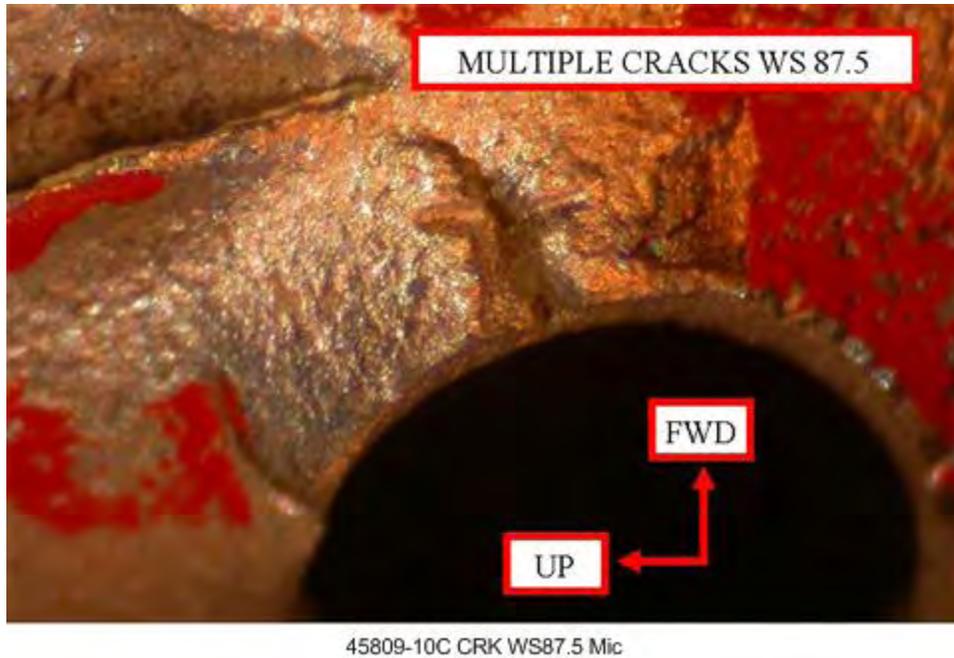
Figure 214. Microscopic View of Cracks on the Left Wing Flap Track WS 87.5

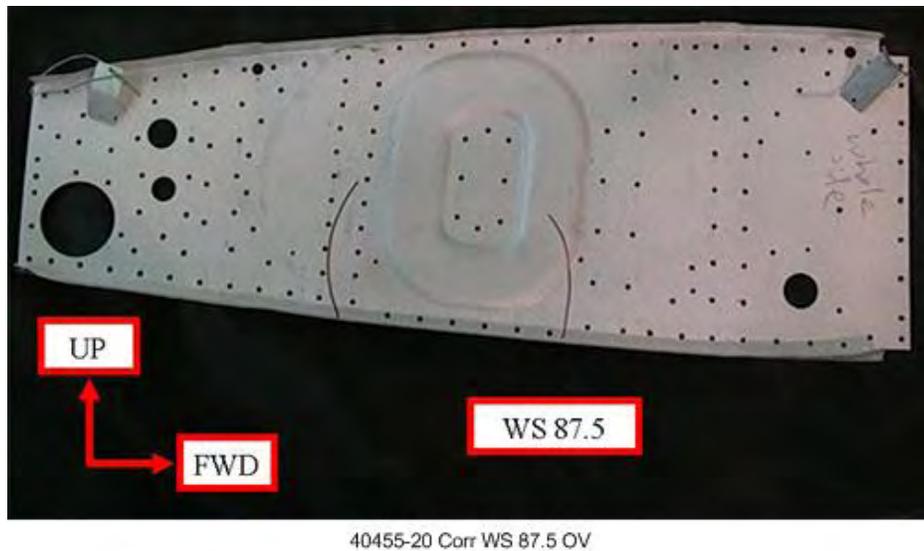
Figure 215 shows the location of light scattered corrosion on the left wing rear spar rib assembly, part number 40455-20. This light corrosion occurred at WS 87.5 and caused only a 2% localized thickness loss. Light scattered corrosion, causing a maximum thickness loss of 1%, was also observed on the left wing rear spar bulkhead assembly, part number 45501-00E. This area of corrosion, located at WS 87.5 FS 161, is shown in figure 216. Figure 217 also shows light scattered corrosion, resulting in a localized reduction in thickness of 2%, on the left wing rear spar rib assembly, part number 40455-22. This scattered corrosion was located at WS 87.5.

Figure 215. Location of Light Corrosion on the Left Wing Rear Spar Rib Assembly WS 87.5

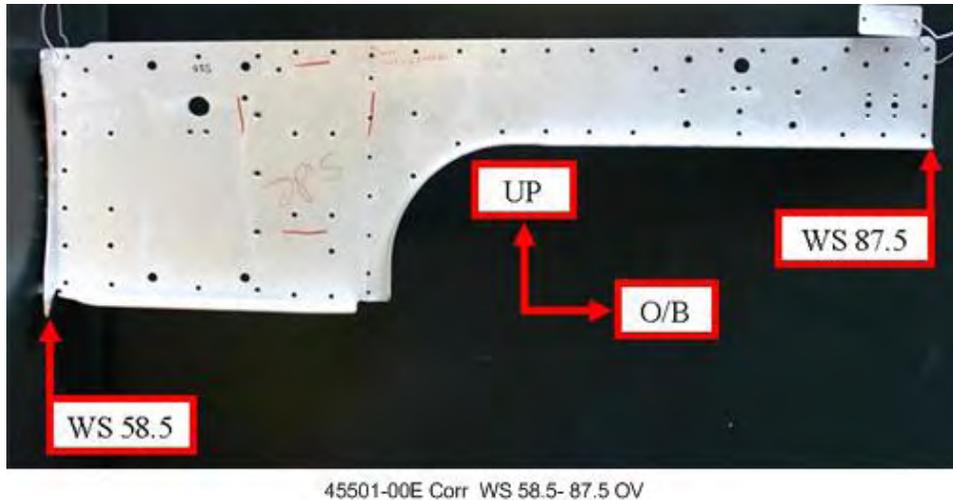
Left wing rear spar bulkhead assembly, figure 216	Corrosion	WS 87.5 FS 161	Scattered whole part	Corrosion indication	Light corrosion 1% thickness loss	103
Left wing rear spar rib assembly, figure 217	Corrosion	WS 87.5	Scattered whole part	No indication	Light corrosion 2% thickness loss	103
Left nacelle bulkhead longitudinal outboard, figure 218	Corrosion	WS 89 FS 154 through FS 185.5	Scattered inboard side of part	Corrosion indication	Light-moderate corrosion 3% thickness loss	105
	Crack	WS 89 FS 184	0.13 inch	Crack indication	Hole crack	219 220
	Crack	WS 89 FS 185.5	0.60 inch	Crack indication	Surface crack	221 222

Figure 216. Overview of Left Wing Rear Spar Bulkhead Assembly WS 87.5 FS 161

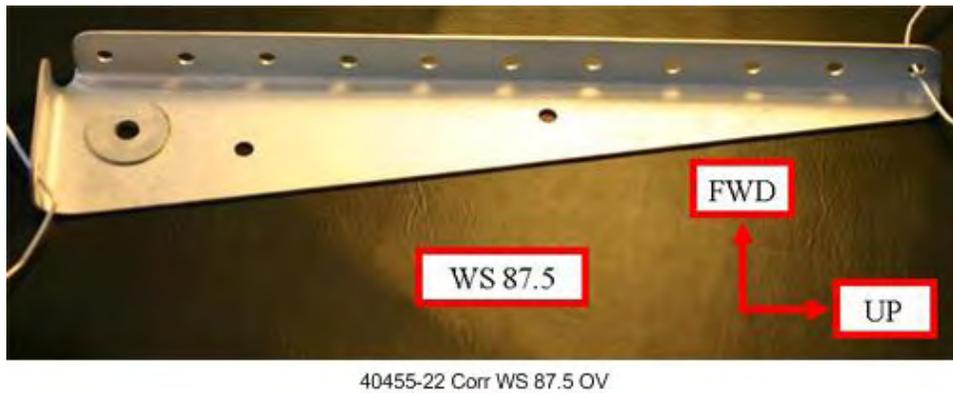
Figure 217. Overview of Left Wing Rear Spar Rib Assembly WS 87.5

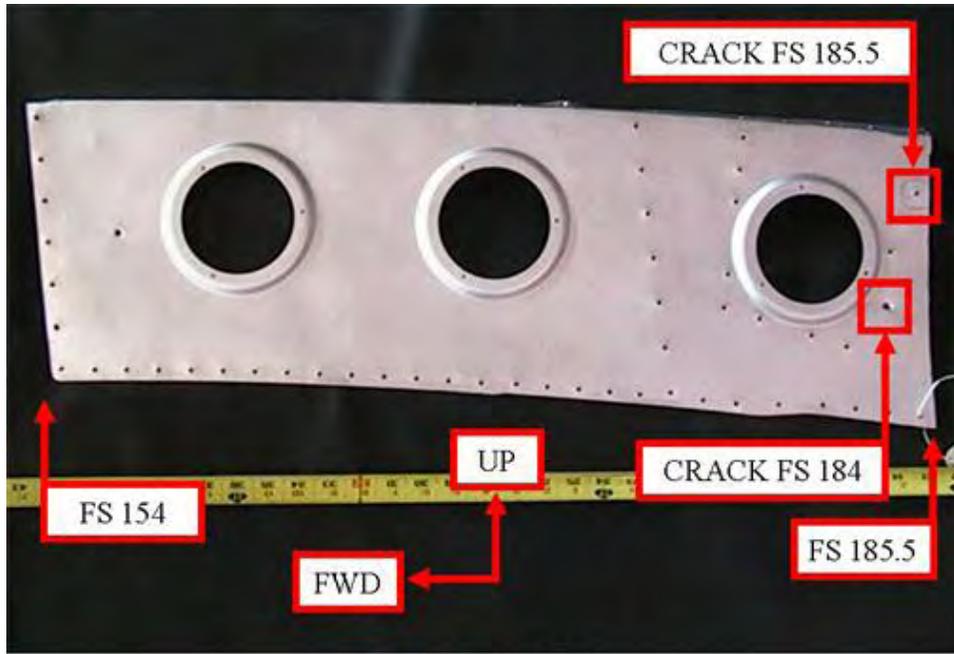
40455-22 Corr WS 87.5 OV

The location of two cracks and light-moderate corrosion on the left nacelle bulkhead longitudinal outboard, part number 44438-06A, is shown in figure 218. The light-moderate corrosion was scattered across the inboard side of the part and resulted in a maximum localized reduction in thickness of 3%. Figure 219 shows a macroscopic view of the 0.13-inch crack located at FS 184, and a microscopic view of the crack is shown in figure 220. A macroscopic view of the 0.60-inch crack, located at FS 185.5, is shown in figure 221, and a microscopic view is shown in figure 222. Figure 223 shows the location of cracks and light-moderate scattered corrosion on the left nacelle bulkhead longitudinal outboard, part number 44438-06B, which spans from WS 185.5 to FS 211.5. Light-moderate scattered corrosion was observed across the entire surface of this part, which resulted in a maximum localized reduction in thickness of 4%. A macroscopic view of multiple cracks emanating from a fastener hole at FS 207.5 is shown in figure 224, and a microscopic view of these cracks is shown in figure 225. The maximum length of these cracks was 0.195 inch.

Figure 218. Location of Cracks and Overview of Left Nacelle Bulkhead Longitudinal Outboard WS 89 FS 154 Through FS 185.5

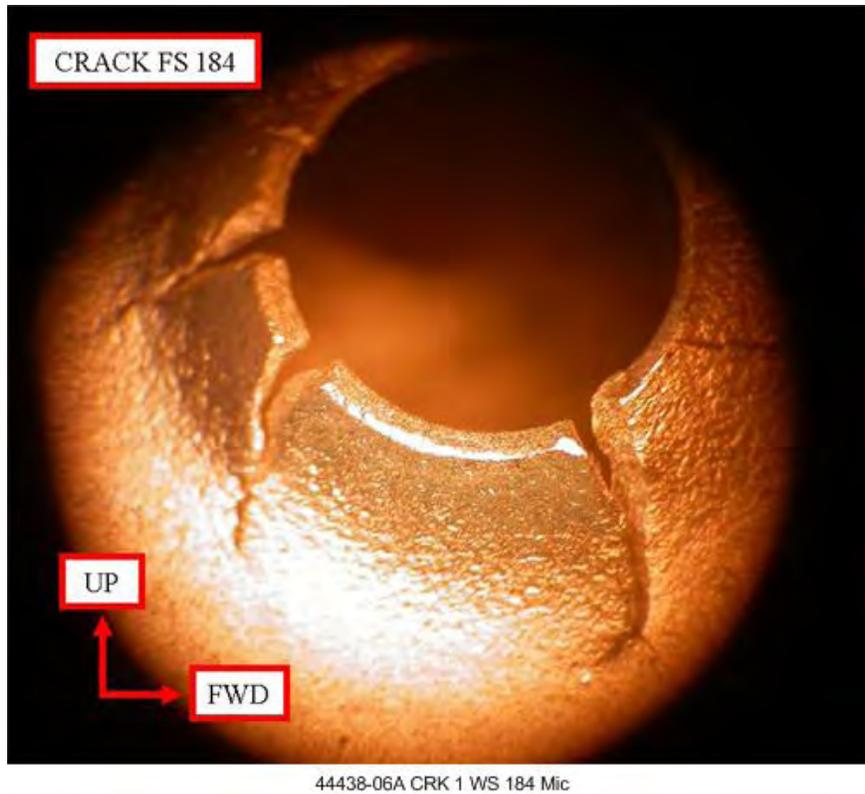
Figure 220. Microscopic View of Crack on the Left Nacelle Bulkhead Longitudinal Outboard WS 89 FS 184

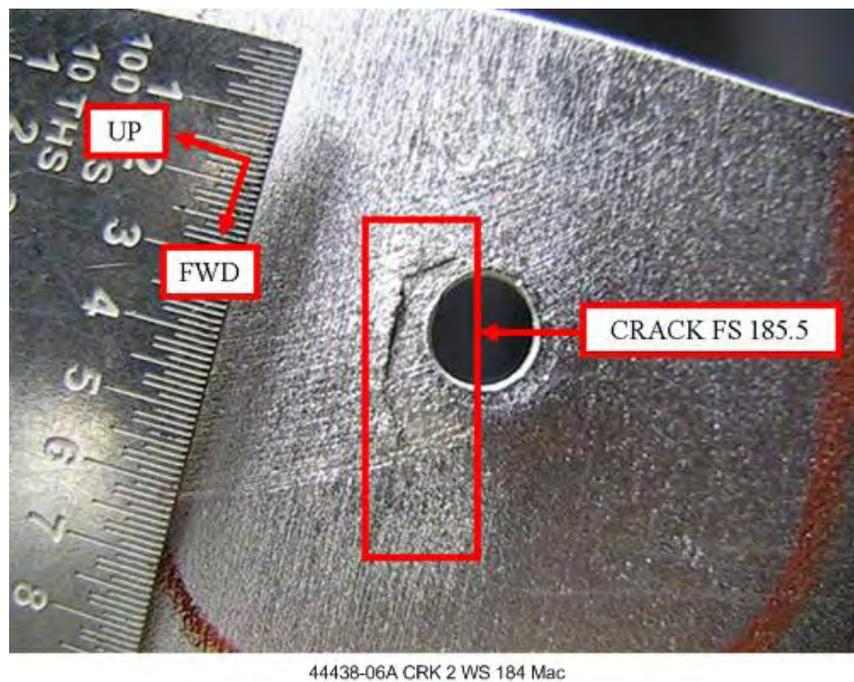
Figure 221. Macroscopic View of Crack on the Left Nacelle Bulkhead Longitudinal Outboard WS 89 FS 185.5

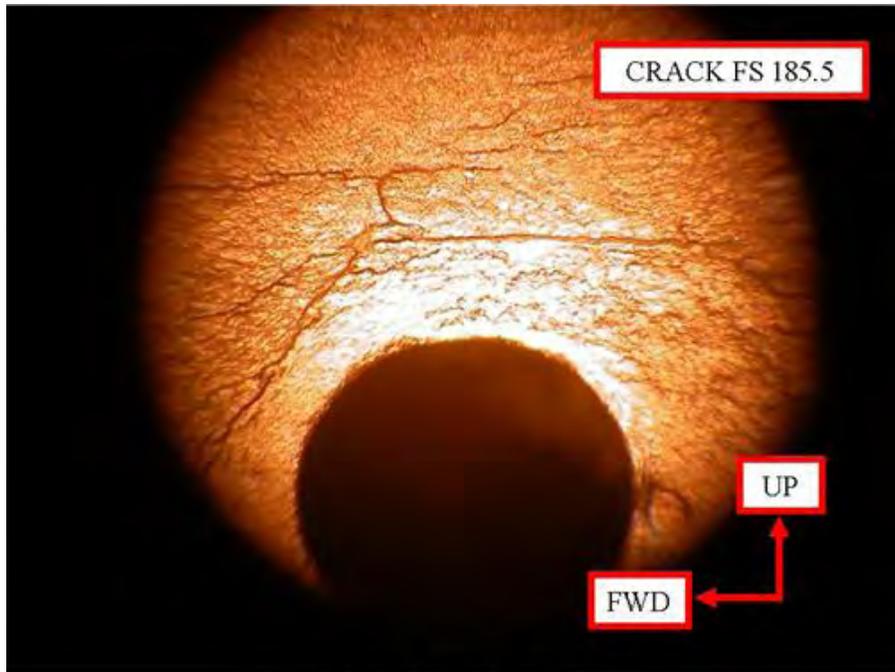
44438-06A CRK 2 WS 184 Mic

Figure 222. Microscopic View of Crack on the Left Nacelle Bulkhead Longitudinal Outboard WS 89 FS 185.5
