DOT/FAA/AR-07/64

Teardown Evaluation of a 1975 Piper Navajo Chieftain Model PA31-350 Airplane

March 2008

Final Report

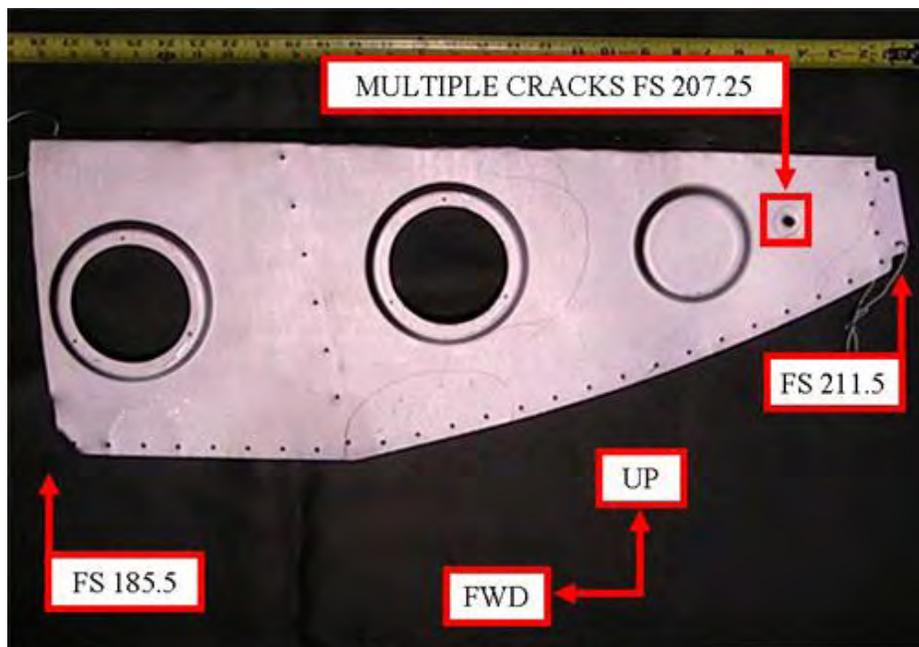
44438-06B CRK FS 185.5-211.5 OV

Part Name and Figure Number	Defect Type	Defect Location	Defect Extent	NDI Indication	Defect Classification	Defect Figure Number
Left nacelle bulkhead longitudinal outboard, figure 223	Corrosion	WS 89 FS 185 through FS 211.5	Scattered over entire part	Corrosion indication	Light-moderate corrosion 4% thickness loss	105
	Multiple cracks	WS 89 FS 207.25	0.195 inch	Crack indication	Hole crack	224 225
Left wing nacelle outboard angle-longitudinal bulkhead, figure 226	Corrosion	WS 89 FS 154 through FS 185.5	Scattered over entire part	Corrosion indication	Light-moderate corrosion 4% thickness loss	105
	Crack	WS 89 FS 177	0.211 inch	Crack indication	Surface crack	226 227
Left wing engine nacelle bulkhead assembly, figure 229	Corrosion	WS 89.31	32.5 inches by 12 inches inboard side of part	Corrosion indication	Light corrosion 2% thickness loss	103
Left wing aileron bracket front left, figure 230	Corrosion	WS 174.5	0.55 inch by 0.55 inch	No indication	Light corrosion 1.5% thickness loss	103

Figure 223. Location of Cracks and Overview Left Nacelle Bulkhead Longitudinal Outboard WS 89 FS 185.5 Through FS 211.5

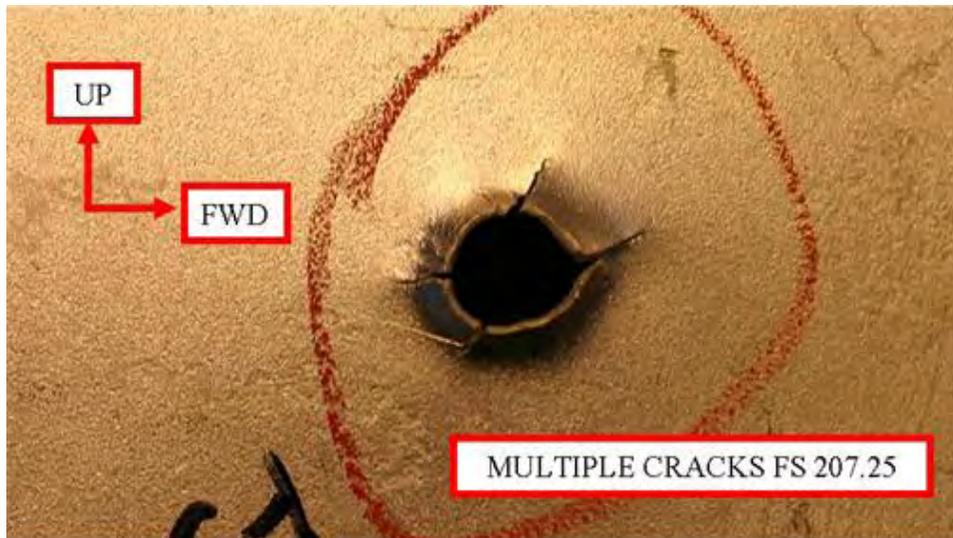
44438-06B CRK FS 185.5-211.5 Mac

Figure 224. Macroscopic View of Cracks on the Left Nacelle Bulkhead Longitudinal Outboard WS 89 FS 207.25

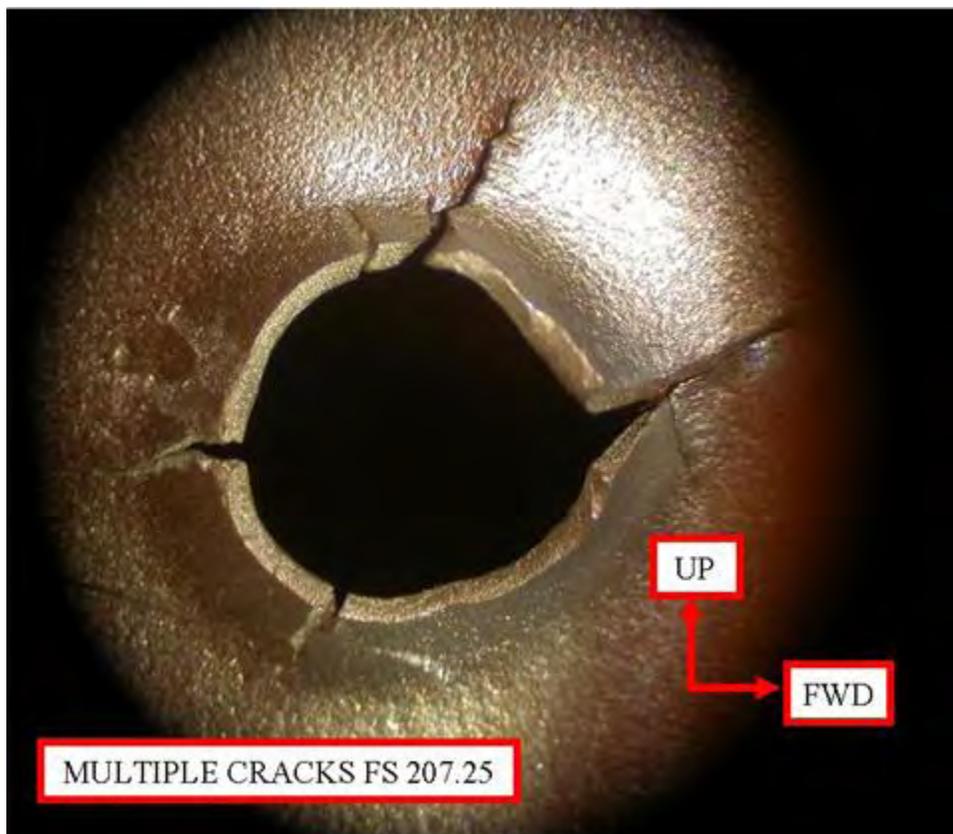
44438-06B CRK FS 185.5-211.5 Mic

The location of two cracks and light-moderate corrosion on the left nacelle bulkhead longitudinal outboard, part number 44438-06A, is shown in figure 218. The light-moderate corrosion was scattered across the inboard side of the part and resulted in a maximum localized reduction in thickness of 3%. Figure 219 shows a macroscopic view of the 0.13-inch crack located at FS 184, and a microscopic view of the crack is shown in figure 220. A macroscopic view of the 0.60-inch crack, located at FS 185.5, is shown in figure 221, and a microscopic view is shown in figure 222. Figure 223 shows the location of cracks and light-moderate scattered corrosion on the left nacelle bulkhead longitudinal outboard, part number 44438-06B, which spans from WS 185.5 to FS 211.5. Light-moderate scattered corrosion was observed across the entire surface of this part, which resulted in a maximum localized reduction in thickness of 4%. A macroscopic view of multiple cracks emanating from a fastener hole at FS 207.5 is shown in figure 224, and a microscopic view of these cracks is shown in figure 225. The maximum length of these cracks was 0.195 inch.

Figure 225. Microscopic View of Cracks on the Left Nacelle Bulkhead Longitudinal Outboard WS 89 FS 207.25

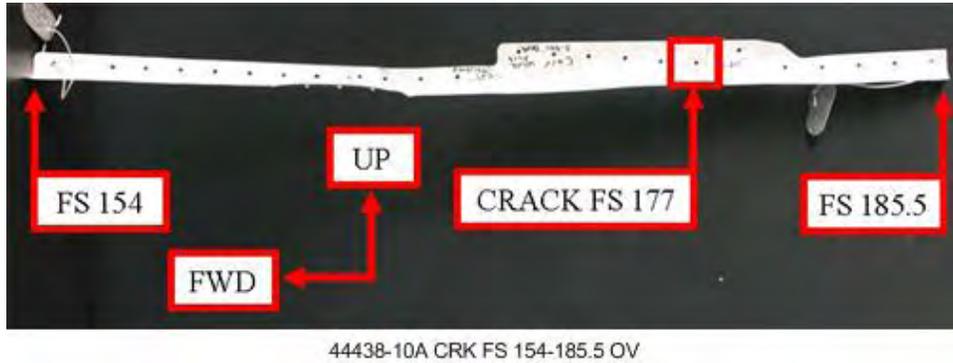
Figure 226 shows an overview of the location of a crack and light-moderate corrosion on the left wing nacelle outboard angle longitudinal bulkhead, part number 44438-10A. The light-moderate corrosion was scattered over the entire part and resulted in a maximum localized thickness loss of 4%. The macroscopic view of the 0.211-inch crack, located at WS 89 FS 177, is shown in figure 227, and a microscopic view of this crack is shown in figure 228.

Figure 226. Location of Crack and Overview of Light-Moderate Corrosion on the Left Wing Nacelle Outboard Angle—Longitudinal Bulkhead WS 89 FS 154 Through FS 185.5

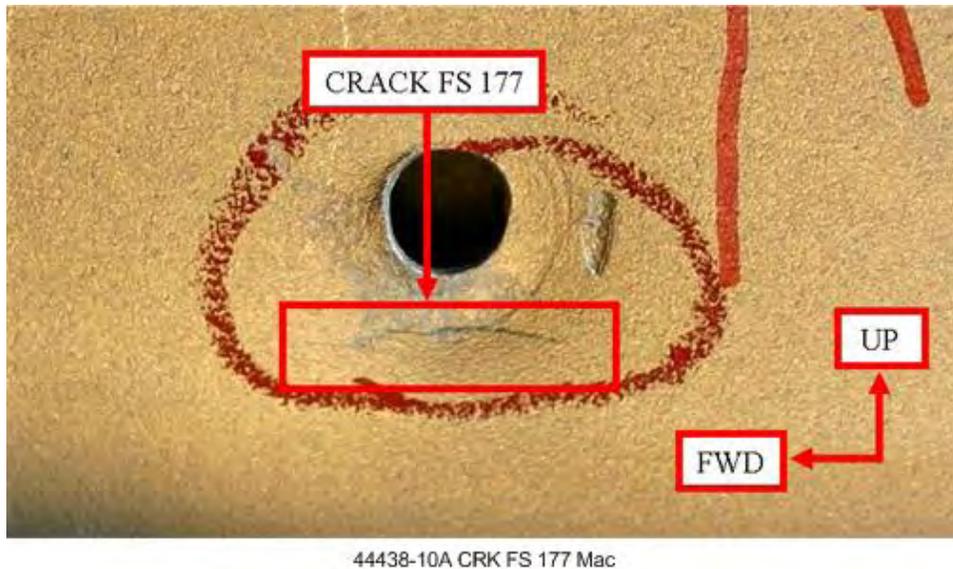
Figure 227. Macroscopic View of Crack on the Left Wing Nacelle Outboard Angle—Longitudinal Bulkhead WS 89 FS 177

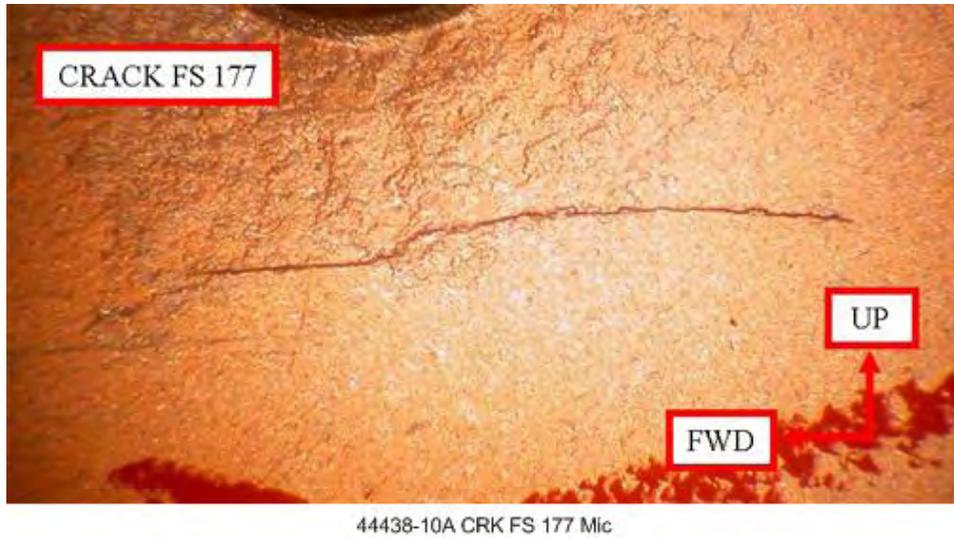
Figure 228. Microscopic View of Crack on the Left Wing Nacelle Outboard Angle—
Longitudinal Bulkhead WS 89 FS 177

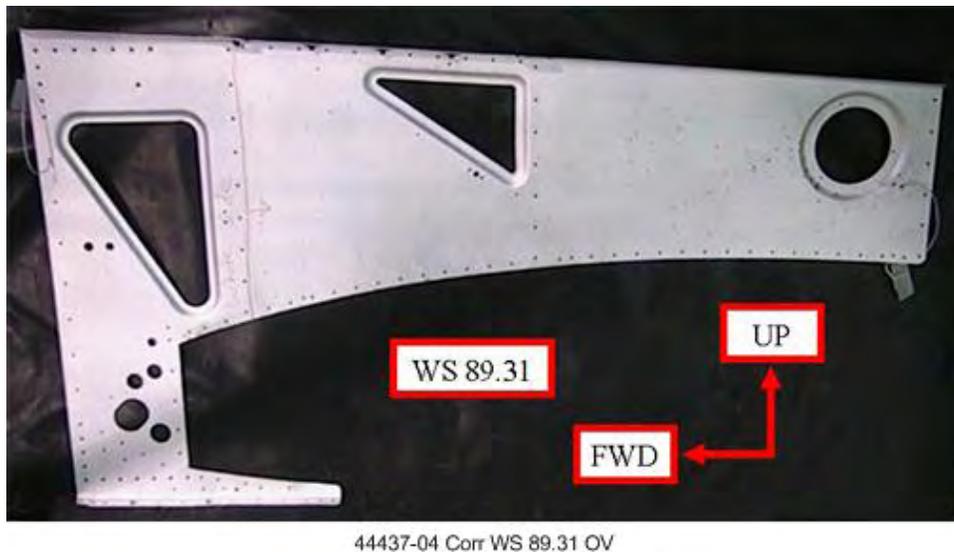
Figure 229 shows the location of light scattered corrosion on the left wing engine nacelle bulkhead assembly, part number 44437-04, at WS 89.31. This corrosion resulted in a maximum thickness loss of 2%. The location of light corrosion, resulting in a localized thickness loss of 1.5%, on the left wing aileron bracket front left, part number 40109-01, is shown in figure 230. The corrosion covered a surface area of 0.3 square inch at WS 174.5.

Figure 229. Location of Light Corrosion on the Left Wing Engine Nacelle Bulkhead
Assembly WS 89.31

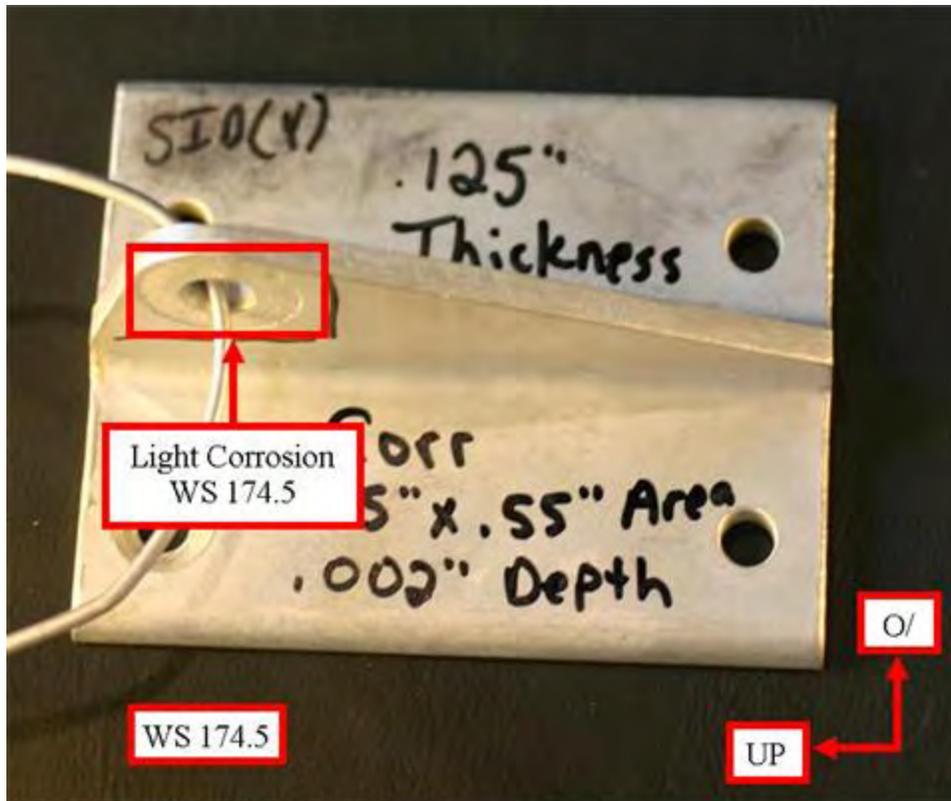
40109-01 Corr WS 174.5 OV

Figure 230. Location of Light Corrosion on the Left Wing Aileron Bracket Front Left WS 174.5

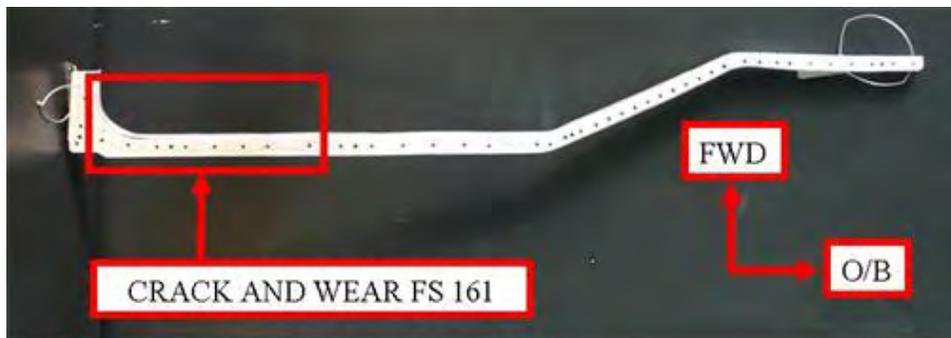
45838-00 CRK FS 161 OV

Left wing rear spar lower aft angle, figure 231	Crack	FS 161	3.5 inches	Crack indication	Surface crack	232
	Wear	FS 161	11 inches by 0.2 inch	No indication	Wear 100% thickness loss	233
Left wing rear spar lower fwd angle, figure 234	Wear	FS 167	22.75 inches by 0.211 inch	No indication	Wear 13% thickness loss	235

Figure 231 shows the location of a crack and an area of wear on the left wing rear spar lower aft angle, part number 45838-00, at FS 161. A macroscopic view of the 3.5-inch crack and 2.2-square-inch area of wear, resulting in areas of complete thickness loss, is shown in figure 232, and the fluorescent liquid penetrant indication is shown in figure 233. The location of a 4.75-square-inch area of wear on the left wing rear spar lower forward angle, part number 45824-00, is shown in figure 234. A macroscopic view of this area of wear, which caused a localized reduction in thickness of 13%, is shown in figure 235.

Figure 231. Location of Crack and Wear on the Left Wing Rear Spar Lower Aft Angle FS 161

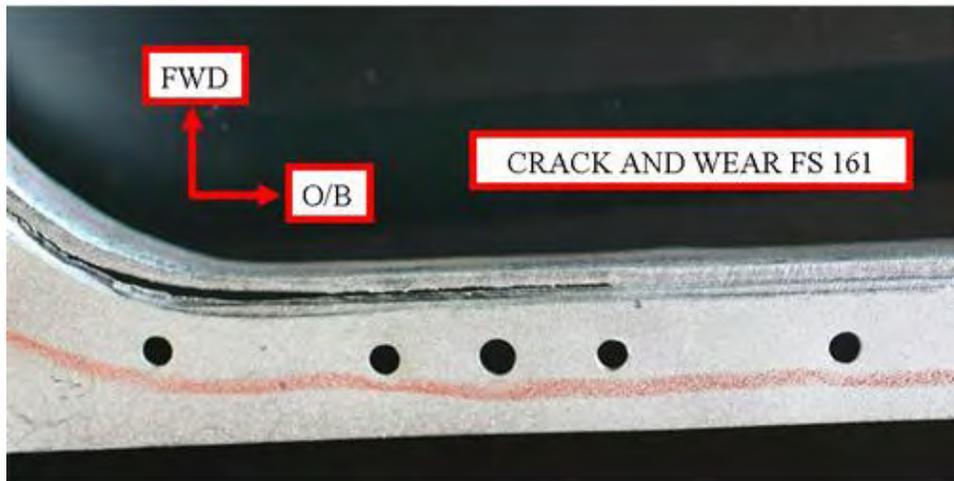
45838-00 CRK FS 161 Mac

Figure 232. Macroscopic View of Crack and Wear on the Left Wing Rear Spar Lower Aft Angle FS 161

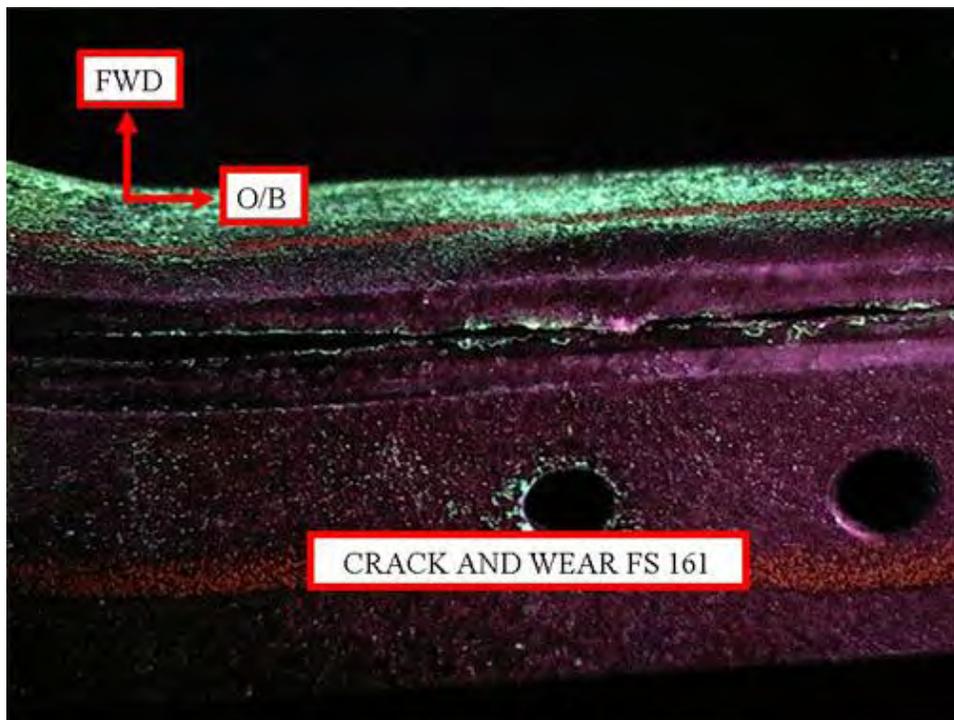
45838-00 CRK FS 161 FLP

Figure 233. Fluorescent Liquid Penetrant Indication of Crack and Wear on the Left Wing Rear Spar Lower Aft Angle FS 161

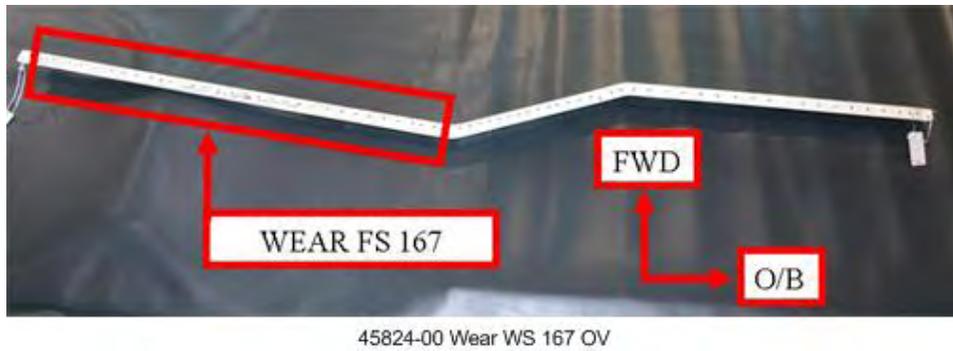
Figure 234. Location of Wear on the Left Wing Rear Spar Lower Forward Angle FS 167

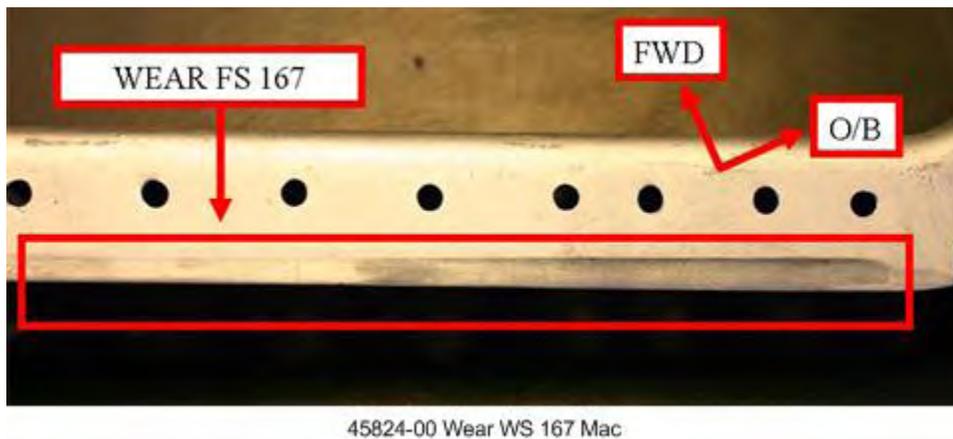
Figure 235. Macroscopic View of Wear on the Left Wing Rear Spar Lower Forward Angle FS 167

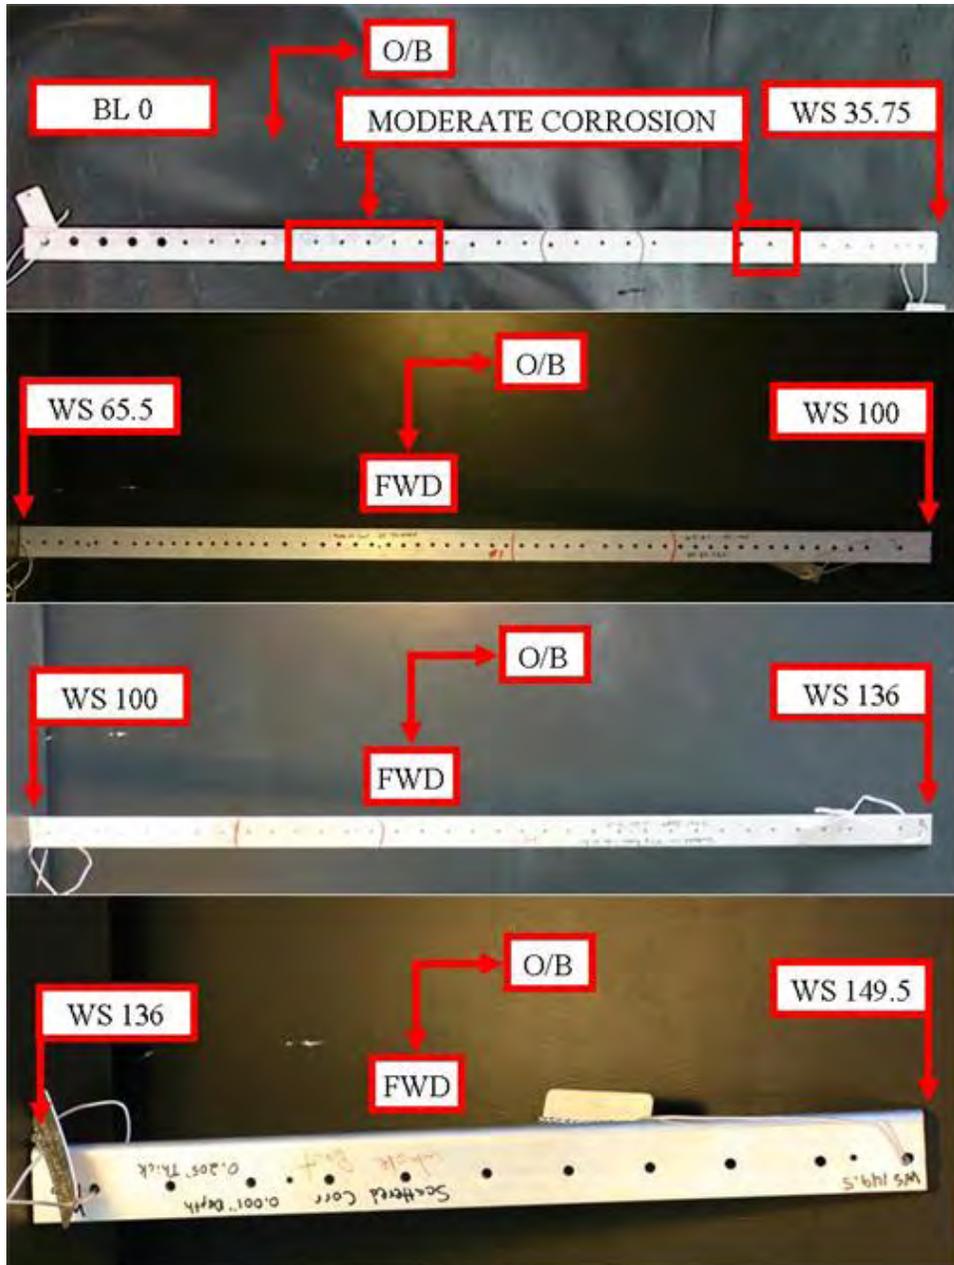
RW MN SP UPR AFT REIN Corr BL 0 - WS 149.5 OV

Figure 237 shows an overview of light corrosion scattered over the entire right wing main spar upper forward reinforcement from BL 0 to WS 129. This corrosion caused a localized reduction in thickness of only 1%. The location of scattered light corrosion and two areas of moderate corrosion on the right wing main spar upper aft reinforcement are shown in figure 238. The scattered light corrosion covered the surface of the aft reinforcement from WS 65.5 to WS 149.5 and caused a maximum localized thickness loss of less than 1%. A macroscopic view of a 9.75-square-inch area of moderate corrosion, located from BL 10.5 to 17, is shown in figure 239. Figure 240 shows a macroscopic view of another moderate area of corrosion, covering a surface area of 1.75 square inches, on the aft reinforcement, located from BL 27.5 to BL 29.25. Both areas of corrosion caused a maximum localized reduction in thickness of 5.5%.

Figure 238. Location of Moderate Corrosion and Overview of Right Wing Main Spar Upper Aft Reinforcement BL 0 Through WS 149.5

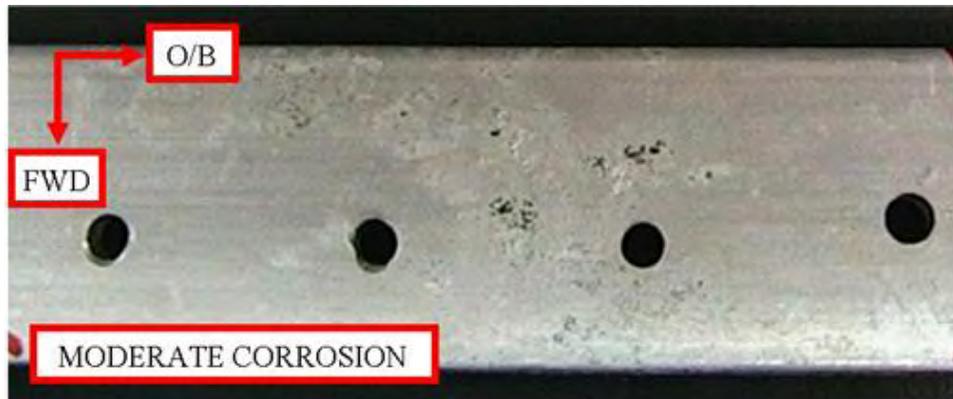
RW MN SP UPR AFT REIN Corr BL 0 -WS 35.75 Mac

Figure 239. Macroscopic View of Moderate Corrosion on the Right Wing Main Spar Upper Aft Reinforcement BL 10.5 Through BL 17

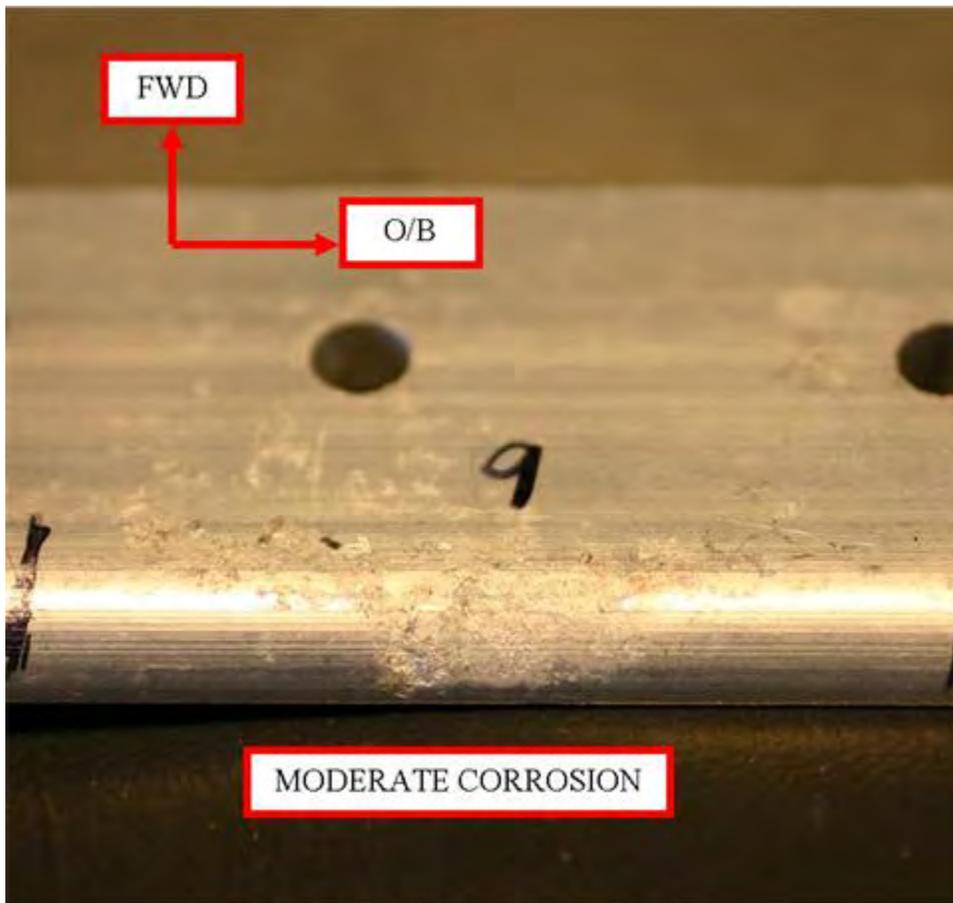
RW MS Upper Aft Reinforcement Corr BL 27.5-29.25 Mac

Figure 240. Macroscopic View of Moderate Corrosion on the Right Wing Main Spar Upper Aft Reinforcement BL 27.5 Through BL 29.25

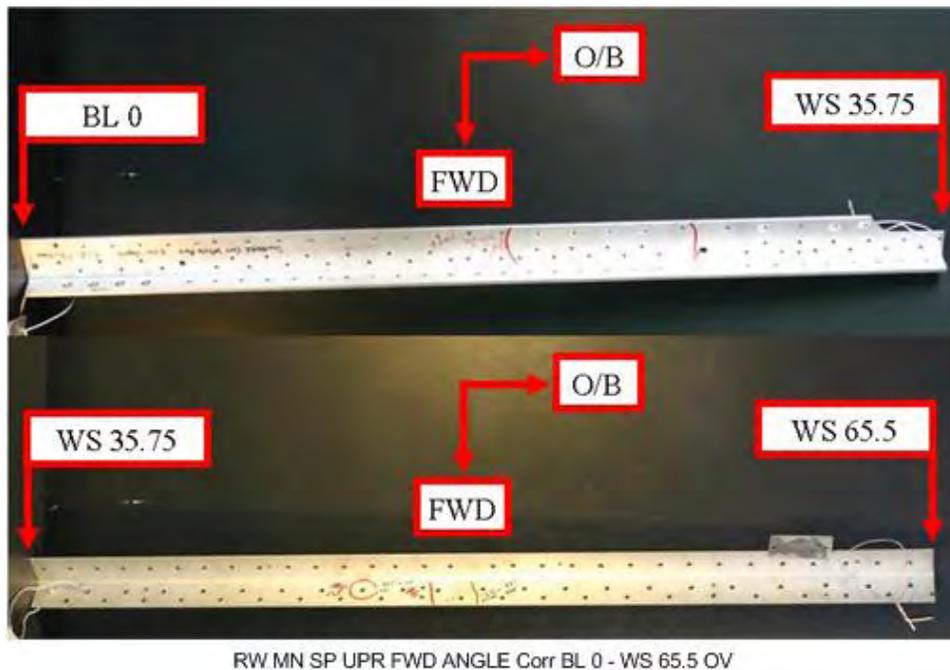
Figure 241 shows the location of light scattered corrosion on the right wing main spar upper forward angle from BL 0 to WS 65.5. This corrosion caused a localized thickness loss of 1%. The location of a 1.5-square-inch area of moderate-severe corrosion, located on the upper aft angle from WS 28.25 to WS 29.75, is shown in figure 242. A macroscopic view of the area of corrosion, which caused a maximum localized reduction in thickness of 9%, is shown in figure 243. The fluorescent liquid penetrant indication of this area of moderate-severe corrosion is shown in figure 244. The location of an area of light corrosion on the main spar upper cap strip is shown in figure 245. This 22.5-square-inch area of corrosion, located from WS 26.5 to WS 35.75, resulted in a maximum localized thickness loss of 3.8%. Figure 246 shows the location of a 2.59-square-inch area of light corrosion on the upper cap strip from WS 96.75 to WS 100, which caused a reduction in thickness of less than 1%.

Figure 241. Location of Light Corrosion on the Right Wing Main Spar Upper Forward Angle BL 0 Through WS 65.5

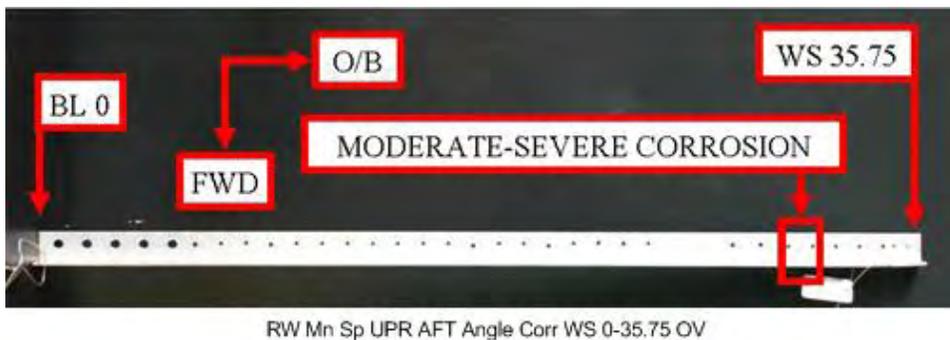
Figure 242. Location of Moderate-Severe Corrosion on the Right Wing Main Spar Upper Aft Angle WS 28.25 Through WS 29.75

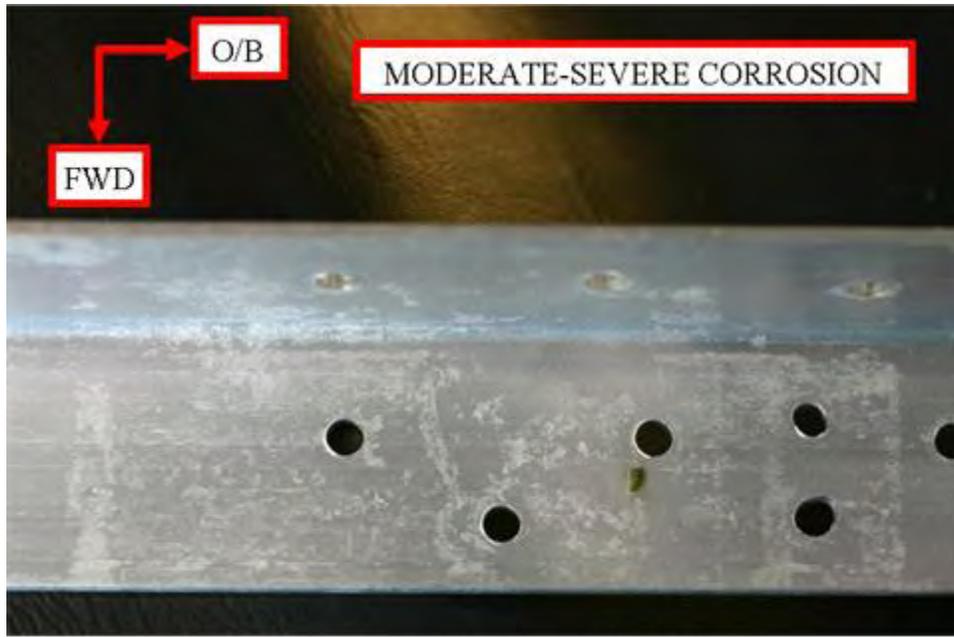
RW Mn Sp UPR AFT Angle Corr WS 0-35.75 Mac

Figure 243. Macroscopic View of Moderate-Severe Corrosion on the Right Wing Main Spar Upper Aft Angle WS 28.25 Through WS 29.75

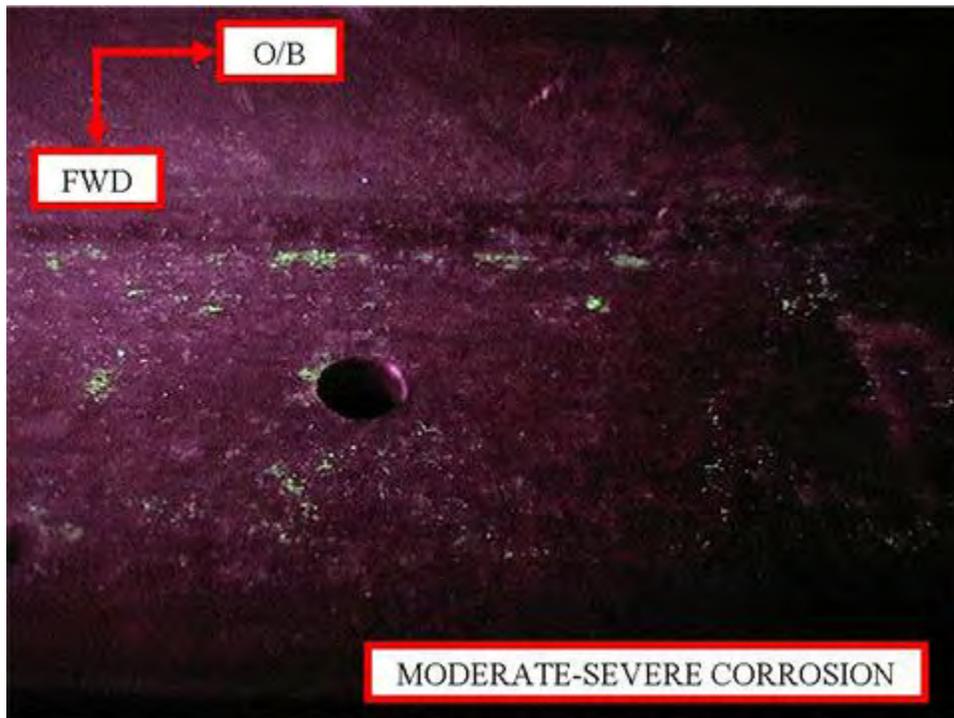
RW Mn Sp UPR AFT Angle Corr WS 0-35.75 FLP

Figure 244. Fluorescent Liquid Penetrant View of Moderate-Severe Corrosion on the Right Wing Main Spar Upper Aft Angle WS 28.25 Through WS 29.75

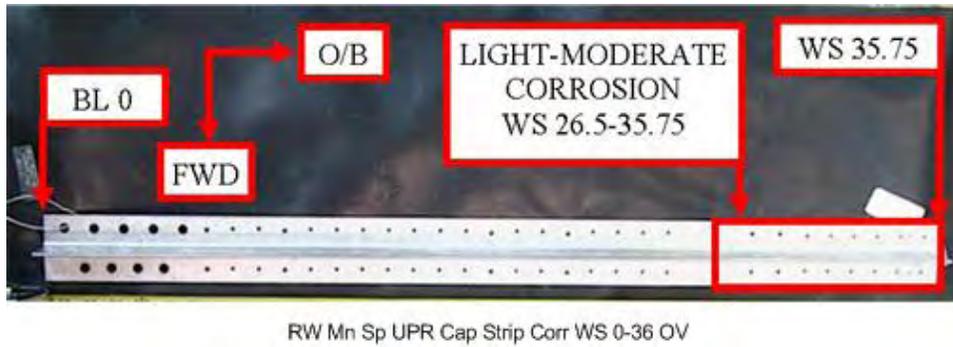
Figure 245. Location of Light-Moderate Corrosion on the Right Wing Main Spar Upper Cap Strip WS 26.5 Through WS 35.75

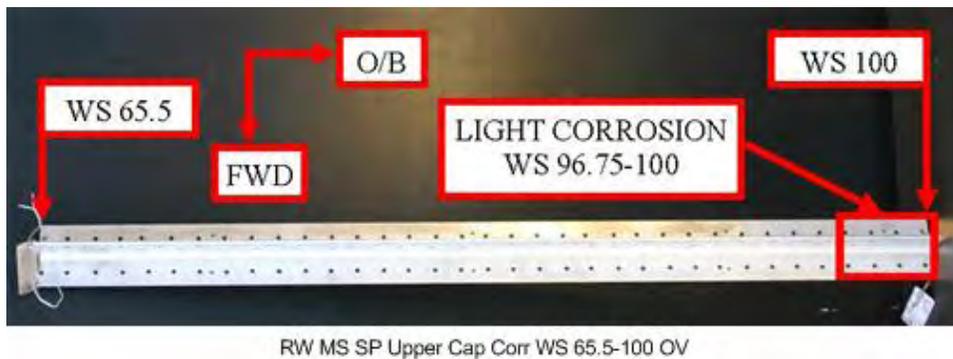
Figure 246. Location of Light Corrosion on the Right Wing Main Spar Upper Cap Strip WS 96.75 Through WS 100

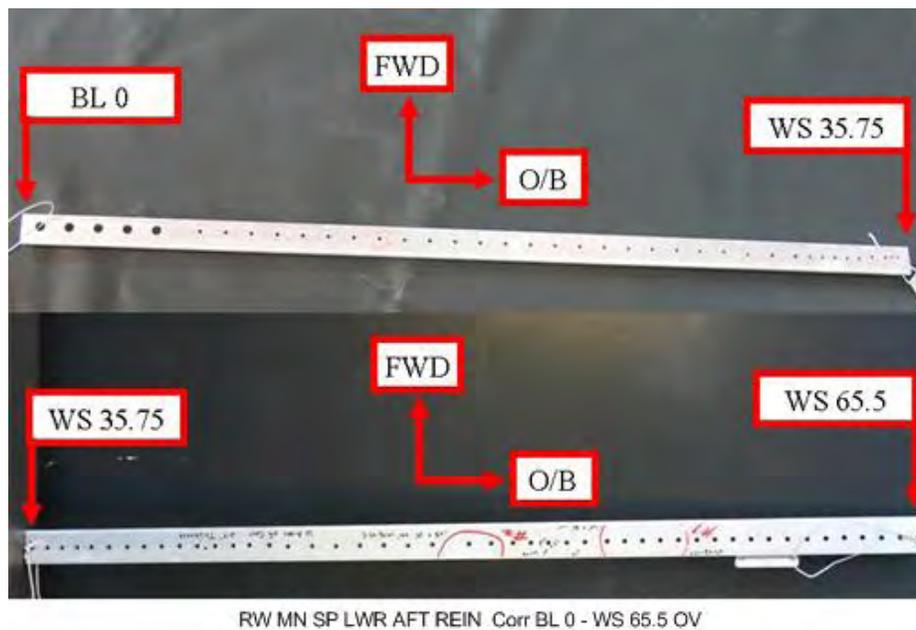
The location of scattered light-moderate corrosion, located from BL 0 to WS 100, on the lower cap strip is shown in figure 247. This scattered corrosion caused a maximum localized thickness loss of 4.5%. Scattered light corrosion was also found on the lower forward reinforcement from BL 0 to WS 100, as shown in figure 248. This corrosion caused a maximum localized thickness loss of less than 1%. Scattered light corrosion, which caused a localized reduction in thickness of 1.4%, was also found on the lower aft reinforcement, scattered from BL 0 to WS 65.5, as shown in figure 249.

Figure 249. Location of Light-Moderate Corrosion on the Right Wing Main Spar Lower Aft Reinforcement BL 0 Through WS 65.5

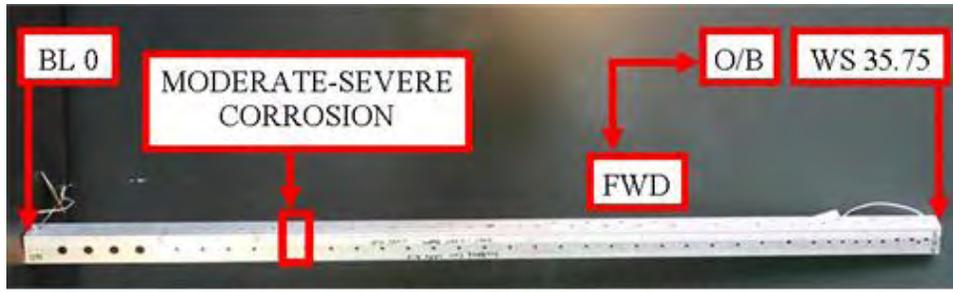
RW Main Spar LWR FWD Angle Corr BL 0 WS 35.5 OV

A 0.11-square-inch area of moderate-severe corrosion was observed on the right wing main spar lower forward angle from BL 13.75 to BL 14.5, as shown in figure 250. This area of corrosion, shown in figure 251, caused a maximum localized thickness loss of 7.3%. Scattered light-moderate corrosion and an area of wear were found on the main spar lower aft angle from BL 0 to WS 65.5, as shown in figure 252. The light-moderate corrosion was scattered across the surface of the part from BL 0 to WS 65.5 and caused a maximum reduction in thickness of 4.4%. The 0.53 square inch of wear, shown in figure 253, was located at BL 0 and caused a maximum thickness loss of 4.4%.

Figure 250. Location of Moderate-Severe Corrosion on the Right Wing Main Spar Lower Forward Angle BL 13.75 Through BL 14.5

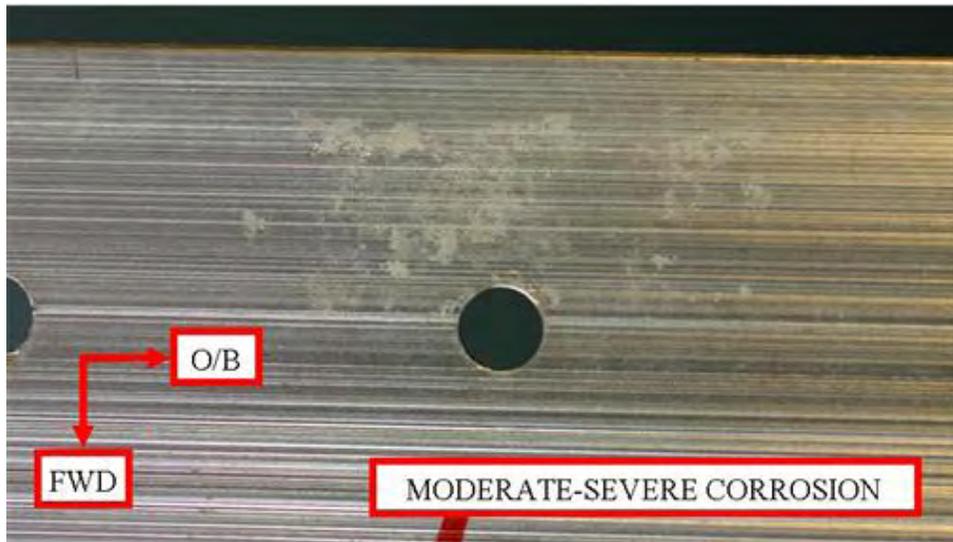
RW MN SP LWR FWD ANGLE Corr BL 13.75-14.5 Mac

Figure 251. Macroscopic View of Moderate-Severe Corrosion on the Right Wing Main Spar Lower Forward Angle BL 13.75 Through BL 14.5

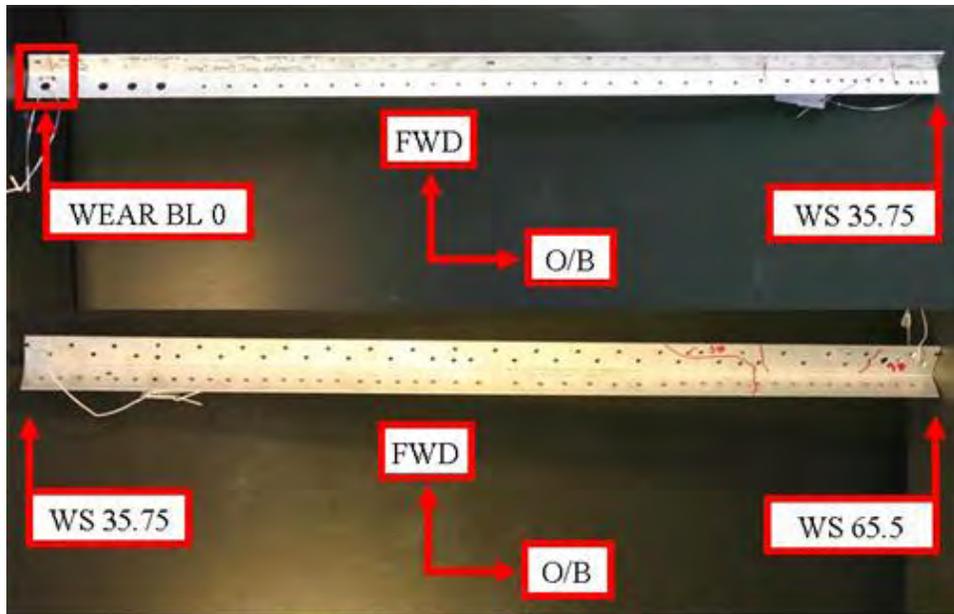
RW MN SP LWR AFT ANGLE Corr BL 0 - WS 65.5 OV

Figure 252. Location of Light-Moderate Corrosion and Wear on the Right Wing Main Spar Lower Aft Angle BL 0 Through WS 65.5

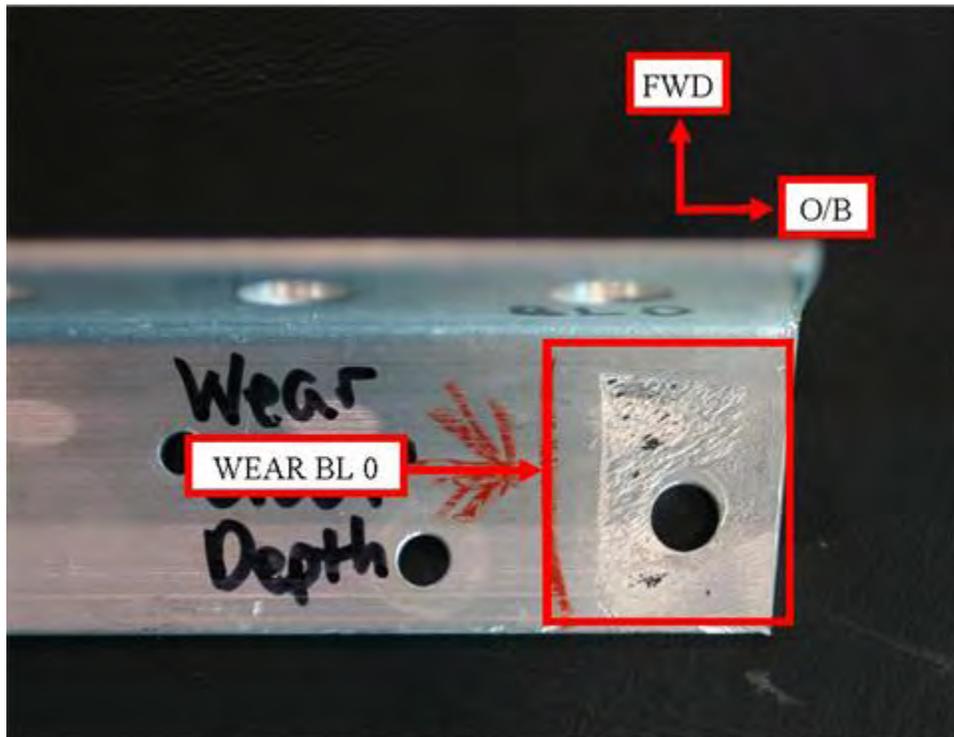
RW MN SP LWR Aft Angle Wear BL 0 Mac

Figure 253. Macroscopic View of Wear on the Right Wing Main Spar Lower Aft Angle BL 0

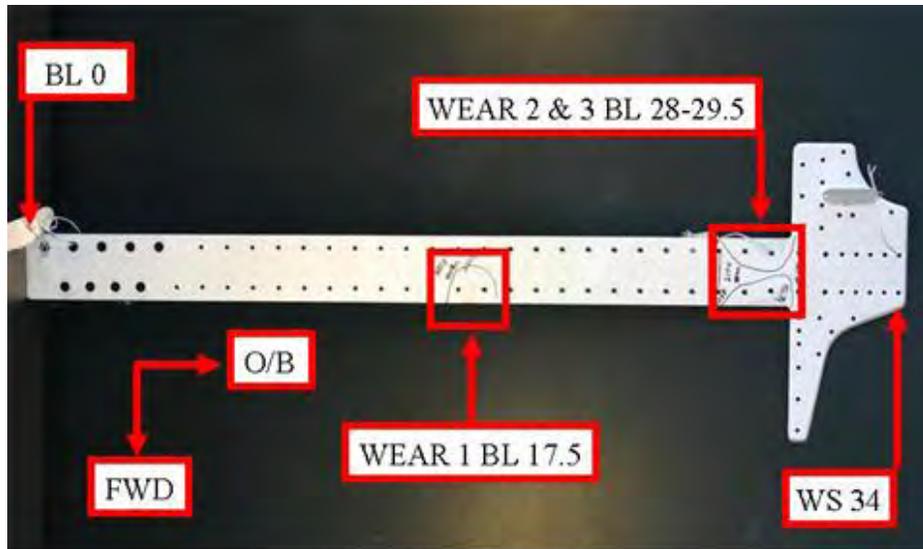
44710-01 Wear BL 0 - WS 34 OV

The location of three areas of wear that were observed on the right wing panel wing panel reinforcement assembly, part number 44710-01, is shown in figure 254. A macroscopic view of wear 1, located at BL 17.5, is shown in figure 255. This 0.87-square-inch area of wear resulted in a localized reduction in thickness of 6.7%. Figure 256 shows a macroscopic view of wear 2, which covered a surface area of 1.36 square inches from BL 28 to BL 29.5 and caused a maximum localized thickness loss of 9%. Wear 3 resulted in a 9% localized thickness loss, covered 1.22 square inches, and was located from BL 28 to BL 29.5, as shown in figure 257. Two cracks were documented on the right wing bulkhead wing fillet, part number 43646-5, located at WS 30 FS 181. The location of these two cracks is shown in figure 258, and figure 259 shows an overview of the section removed for fractographic analysis of these cracks. A macroscopic view of crack 1 is shown in figure 260. This crack measured 2.25 inches and the failure mode could not be determined due to extensive crack face smearing. A macroscopic view of crack 2, which measured 0.75 inches, is shown in figure 261. The failure mode of this crack could also not be determined.

Figure 254. Location of Wear on the Right Wing Panel—Wing Panel Reinforcement Assembly BL 0 Through WS 36

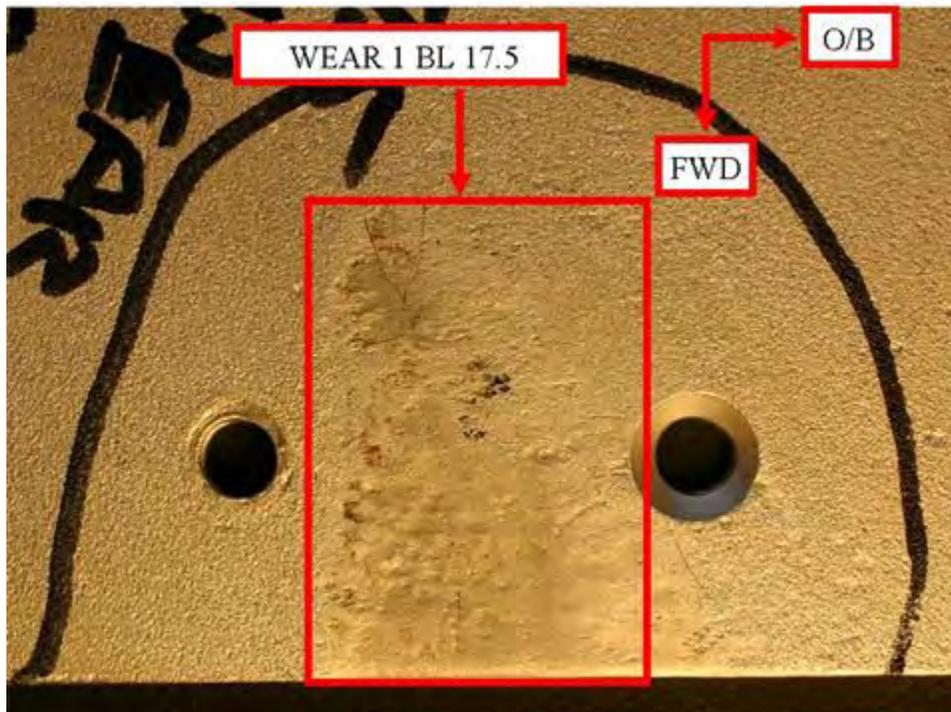
44710-01 Wear 1 BL17.5 Mac

Figure 255. Macroscopic View of Wear 1 on the Right Wing Panel—Wing Panel Reinforcement Assembly BL 17.5

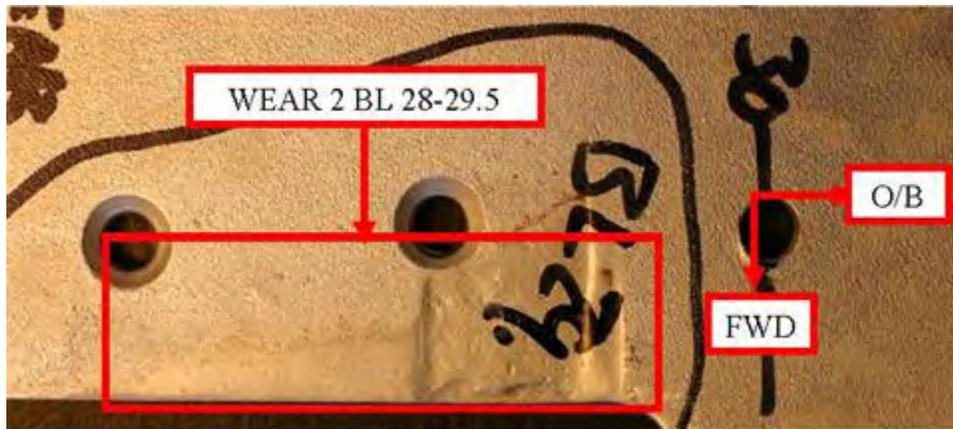
44710-01 Wear 2 BL28 -29.5 Mac

Figure 256. Macroscopic View of Wear 2 on the Right Wing Panel—Wing Panel Reinforcement Assembly BL 28 Through BL 29.5

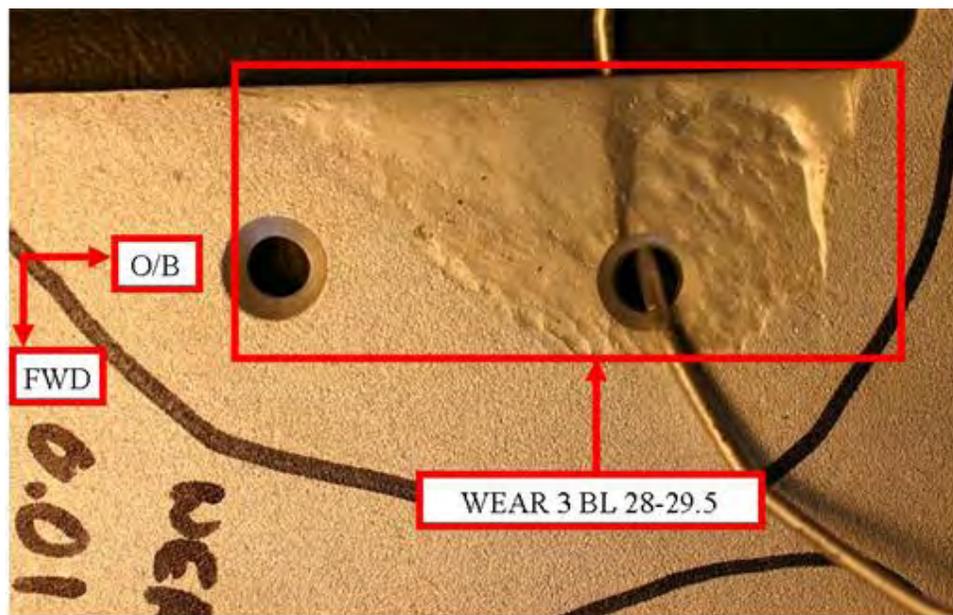
44710-01 Wear 3 BL28 -29.5 Mac

Figure 257. Macroscopic View of Wear 3 on the Right Wing Panel—Wing Panel Reinforcement Assembly BL 28 Through FS 29.5

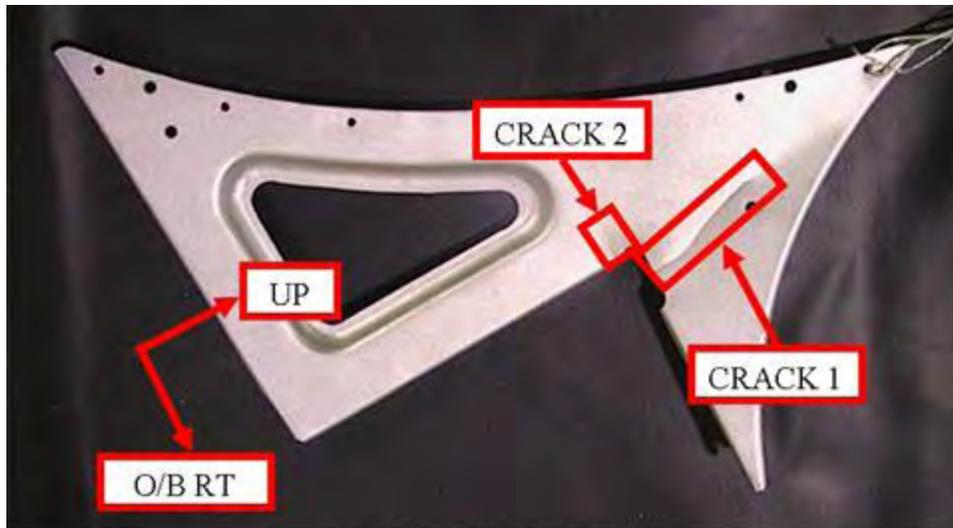
43646-5 CRK WS 30 FS 181 OV

Figure 258. Location of Cracks 1 and 2 on the Right Wing Bulkhead Wing Fillet WS 30 FS 181

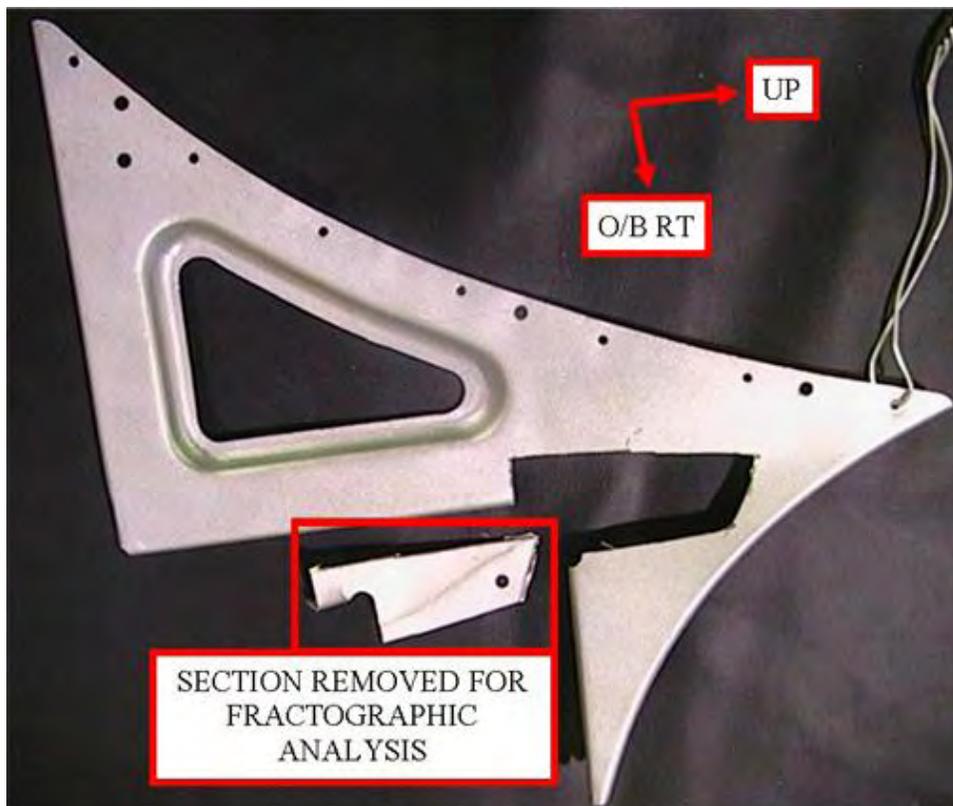
43646-5 CRK WS 30 FS 181 OV 2

Figure 259. Overview of Section of the Right Wing Bulkhead Wing Fillet Removed for Fractographic Analysis WS 30 FS 181

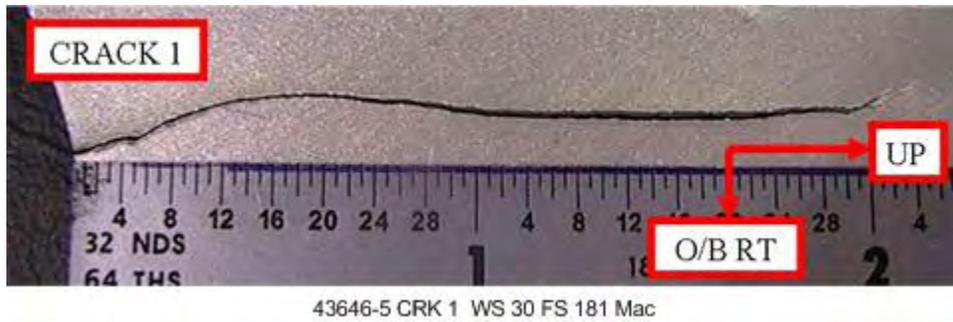
Figure 260. Macroscopic View of Crack 1 on the Right Wing Bulkhead Wing Fillet WS 30 FS 181

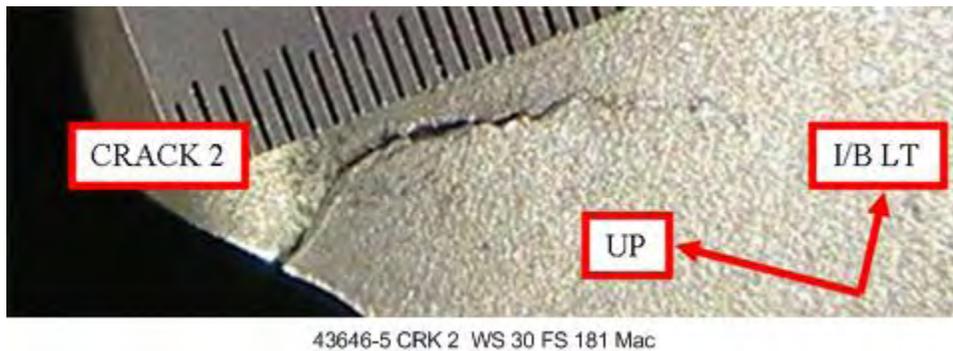
Figure 261. Macroscopic View of Crack 2 on the Right Wing Bulkhead Wing Fillet WS 30 FS 181
