DOT/FAA/AR-07/64

Teardown Evaluation of a 1975 Piper Navajo Chieftain Model PA31-350 Airplane

March 2008

Final Report

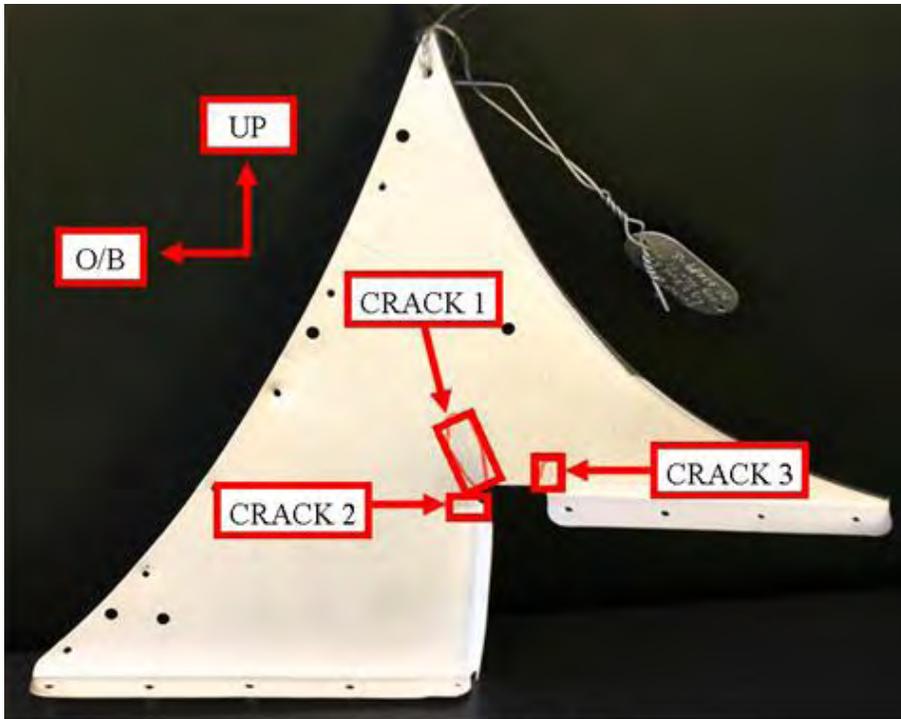
43646-5 CRK WS 30 FS 191.7 OV

The location of three cracks on the right wing bulkhead wing fillet, part number 43646-05, is shown in figure 262 at WS 30 FS 191.7. A macroscopic view of crack 1, which measured 1.075 inches, is shown in figure 263, and the fluorescent liquid penetrant indication is shown in figure 264. A microscopic view of crack 1 is shown in figure 265. A macroscopic view of crack 2 is shown in figure 266. The fluorescent liquid penetrant indication of crack 2 is shown in figure 267, and a microscopic view of crack 2, which measured 0.525 inch in length, is shown in figure 268. Crack 3, which measured 0.458 inch, is shown macroscopically in figure 269. The fluorescent liquid penetrant indication of crack 3 is shown in figure 270, and a microscopic view is shown in figure 271.

Figure 262. Location of Cracks 1, 2, and 3 on the Right Wing Bulkhead Wing Fillet WS 30 FS 191.7

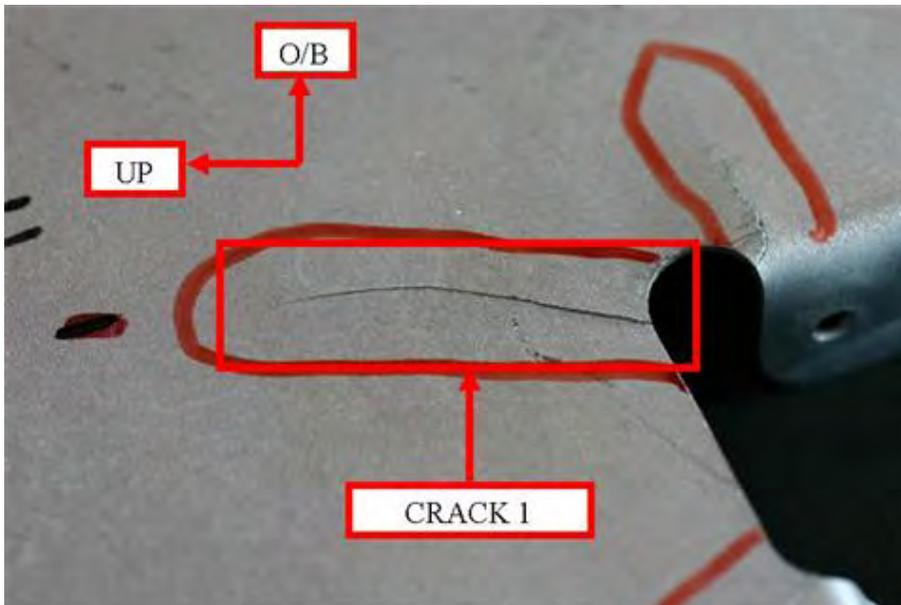
43646-5 CRK 1 WS 30 FS 191.7 Mac

Figure 263. Macroscopic View of Crack 1 on the Right Wing Bulkhead Wing Fillet WS 30 FS 191.7

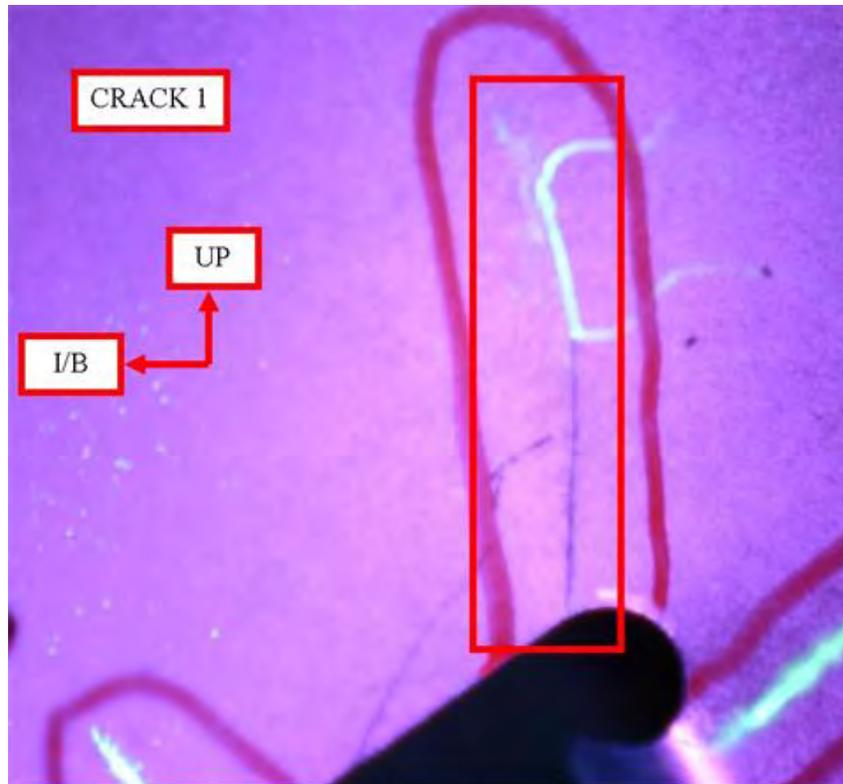
Figure 264. Fluorescent Liquid Penetrant Indication of Crack 1 on the Right Wing Bulkhead Wing Fillet WS 30 FS 191.7

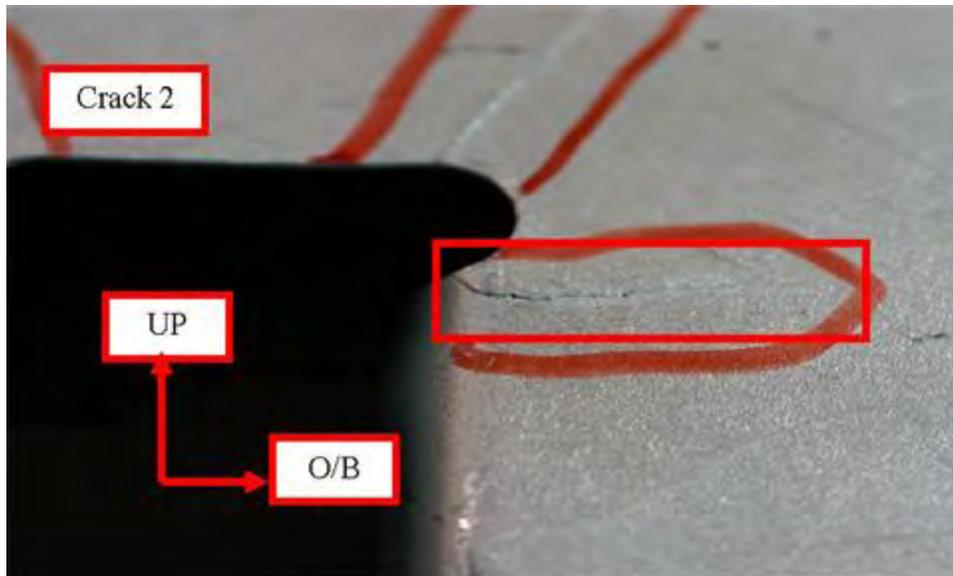
43646-5 CRK 2 WS 30 FS 191.7 Mac

Figure 266. Macroscopic View of Crack 2 on the Right Wing Bulkhead Wing Fillet WS 30 FS 191.7

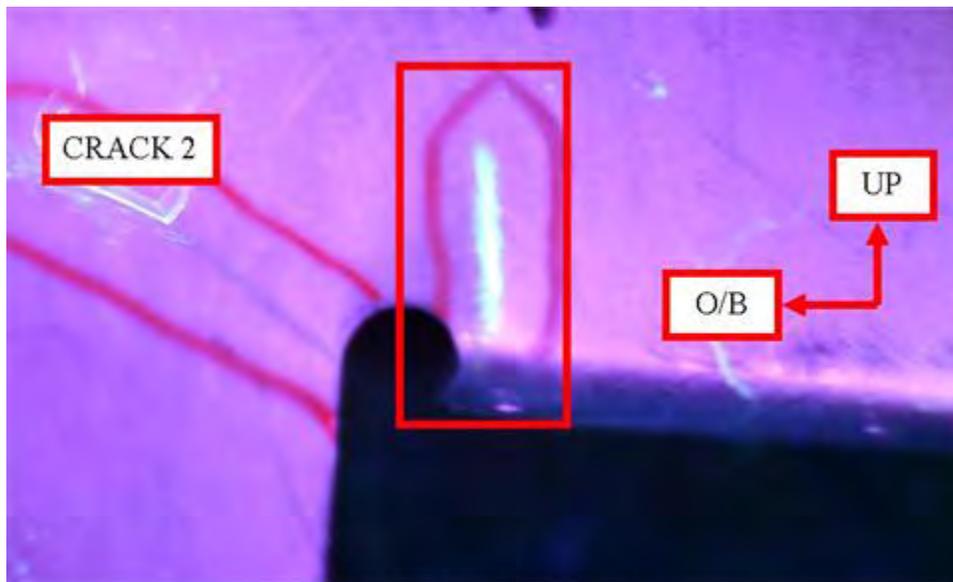
43646-5 CRK 2 WS 30 FS 191.7 Mac

Figure 267. Fluorescent Liquid Penetrant Indication of Crack 2 on the Right Wing Bulkhead Wing Fillet WS 30 FS 191.7

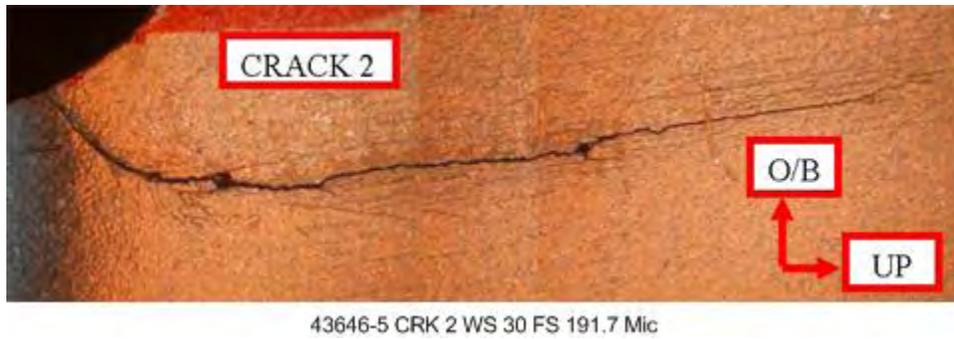
Figure 268. Microscopic View of Crack 2 on the Right Wing Bulkhead Wing Fillet WS 30 FS 191.7

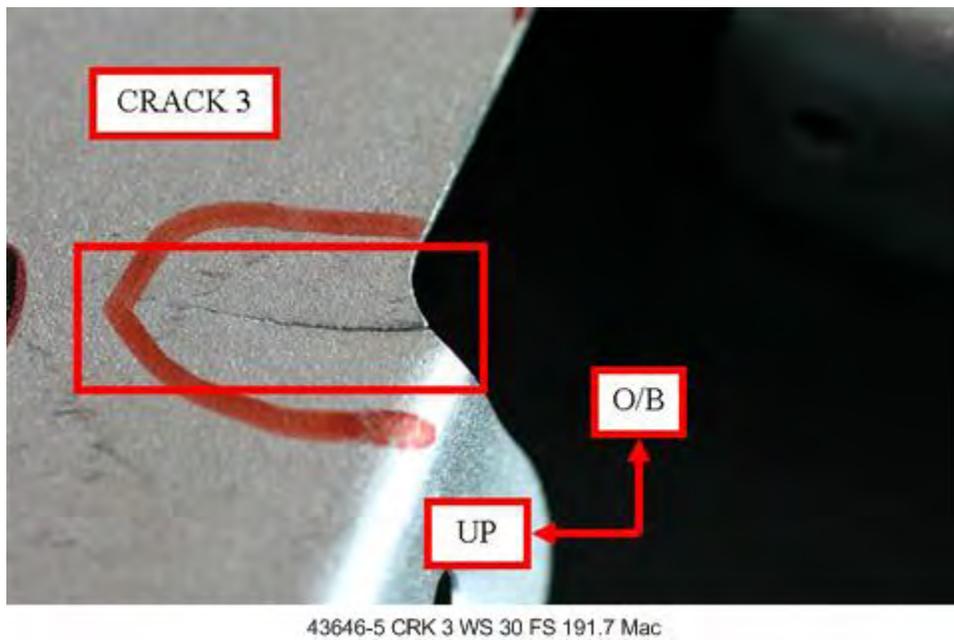
Figure 269. Macroscopic View of Crack 3 on the Right Wing Bulkhead Wing Fillet WS 30 FS 191.7

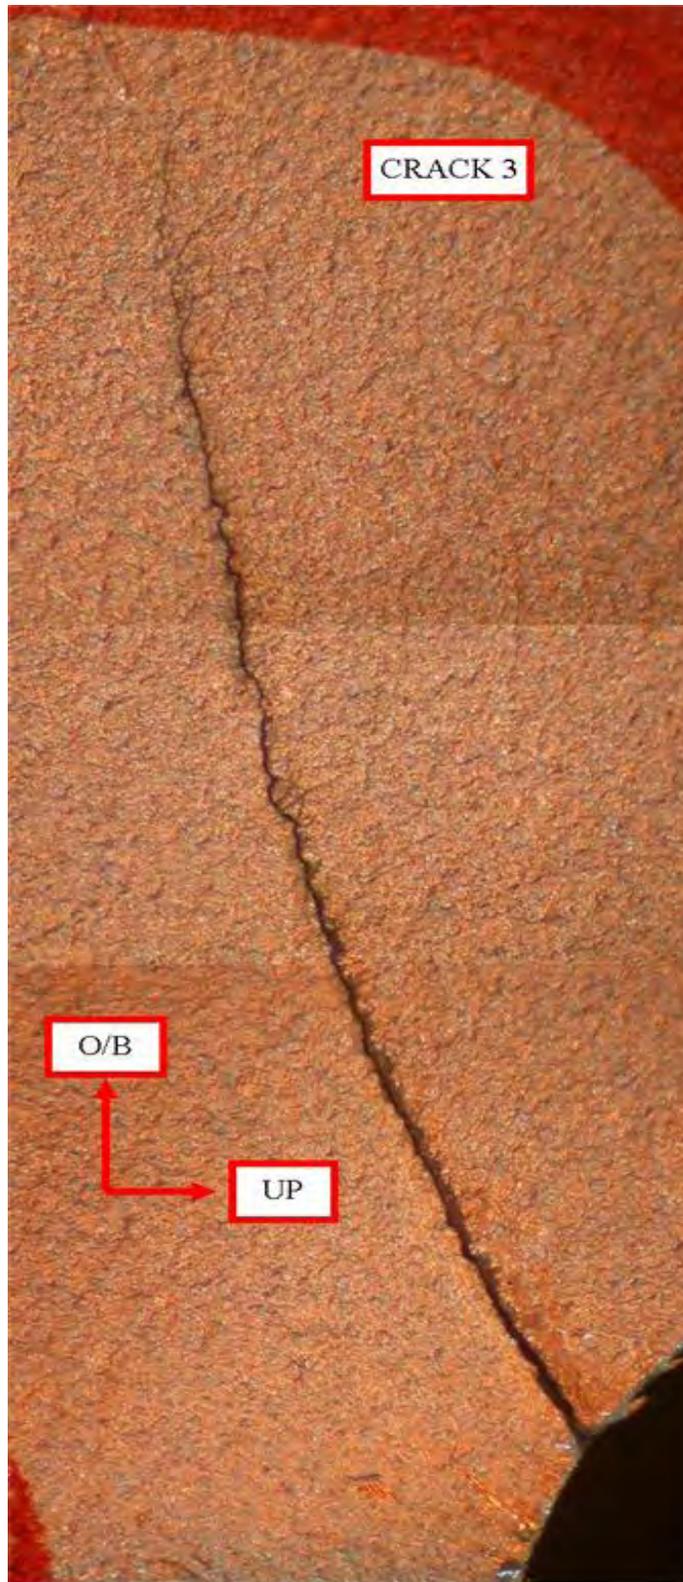
43646-5 CRK 3 WS 30 FS 191.7 Mic

Figure 271. Microscopic View of Crack 3 on the Right Wing Bulkhead Wing Fillet
WS 30 FS 191.7

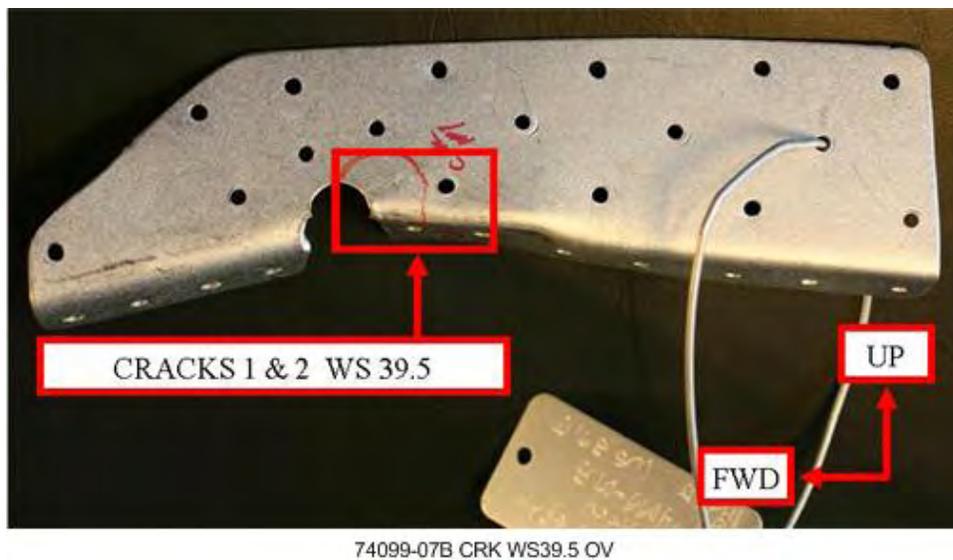
Figure 272 shows the location of two cracks on the right wing rear spar rib assembly at WS 39.5, part number 74099-07B. A macroscopic view of crack 1, which measures 0.216 inches, is shown in figure 273, and the fluorescent liquid penetrant indication is shown in figure 274. A microscopic view of crack 1 is shown in figure 275. A macroscopic view of crack 2 is shown in figure 276, and the fluorescent liquid penetrant indication of crack 2 is shown in figure 277. A microscopic view of this crack, which measured 1.09 inches, is shown in figure 278. An overview of damage observed on the right wing rear spar rib assembly WS 49, part number 40423-23A, is shown in figure 279. A close-up of this damage is shown in figure 280. Figure 281 shows the location of two cracks observed on the rear spar rib assembly WS 49. A macroscopic view of crack 1, which measures 0.244 inches, is shown in figure 282, and the fluorescent liquid penetrant indication of this crack is shown in figure 283. Figure 284 shows a macroscopic view of crack 2, and figure 285 shows the fluorescent liquid penetrant indication of this 0.242-inch crack.

Figure 272. Location of Cracks 1 and 2 on the Right Wing Rear Spar Rib Assembly WS 39.5

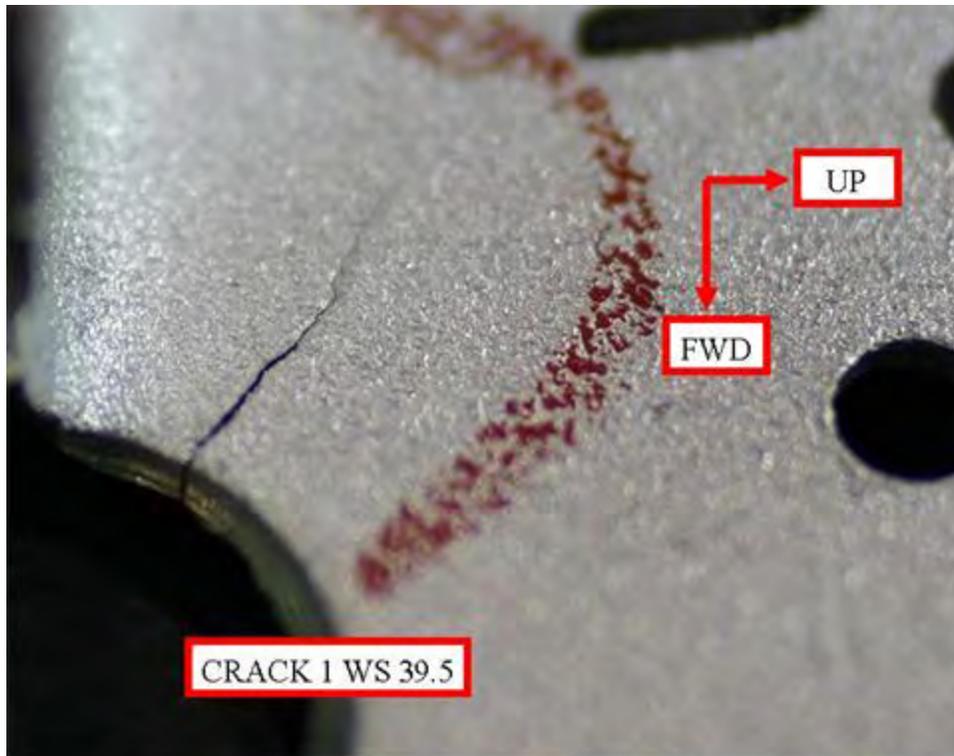
74099-07B CRK 1 WS39.5 Mac

Figure 273. Macroscopic View of Crack 1 on the Right Wing Rear Spar Rib Assembly WS 39.5

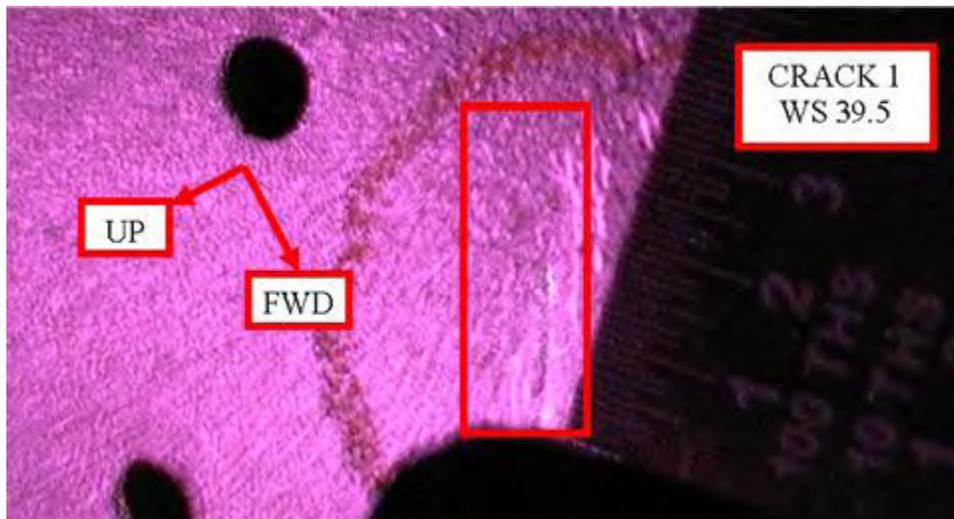
74099-07B CRK 1 WS39.5 FLP

Figure 274. Fluorescent Liquid Penetrant Indication of Crack 1 on the Right Wing Rear Spar Rib Assembly WS 39.5

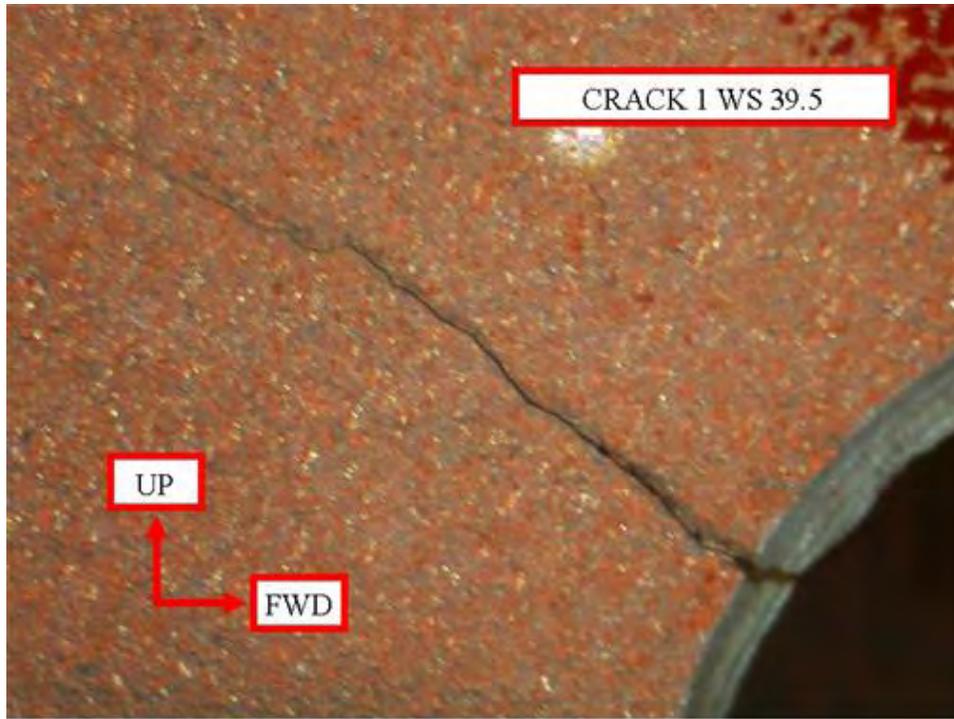
74099-07B CRK 1 WS39.5 Mic

Figure 275. Microscopic View of Crack 1 on the Right Wing Rear Spar Rib Assembly WS 39.5

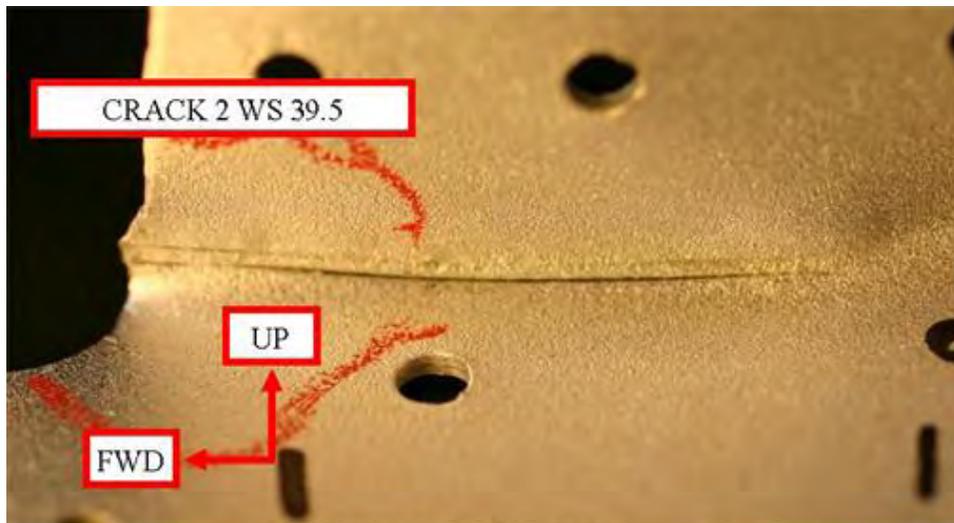
74099-07B CRK 2 WS39.5 Mac

Figure 276. Macroscopic View of Crack 2 on the Right Wing Rear Spar Rib Assembly WS 39.5

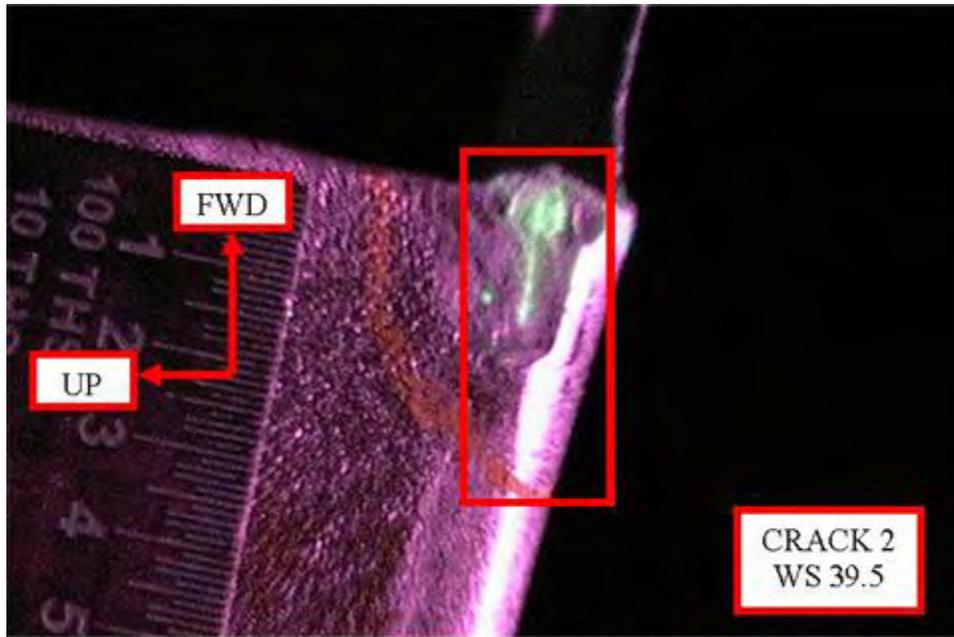
74099-07B CRK 2 WS39.5 FLP

Figure 277. Fluorescent Liquid Penetrant Indication of Crack 2 on the Right Wing Rear Spar Rib Assembly WS 39.5

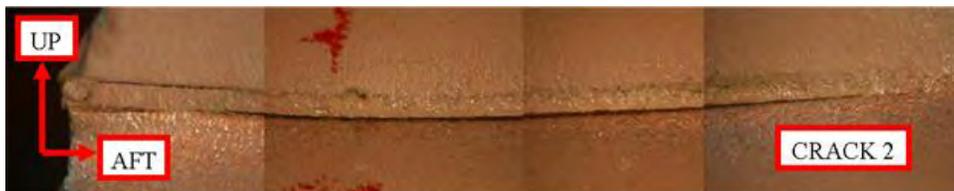
74099-07B CRK 2 WS39.5 Mic

Figure 278. Microscopic View of Crack 2 on the Right Wing Rear Spar Rib Assembly WS 39.5

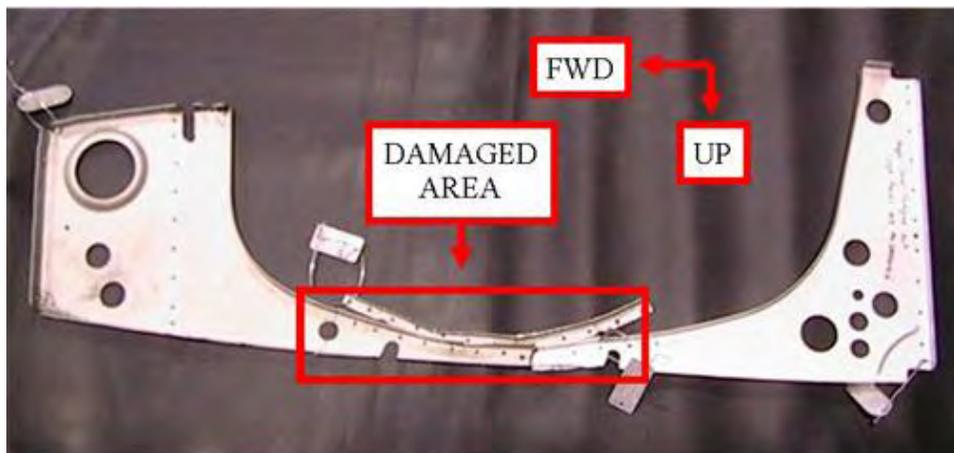
40423-23A Damage WS 49 OV

Figure 279. Overview of Damage on the Right Wing Rear Spar Rib Assembly WS 49

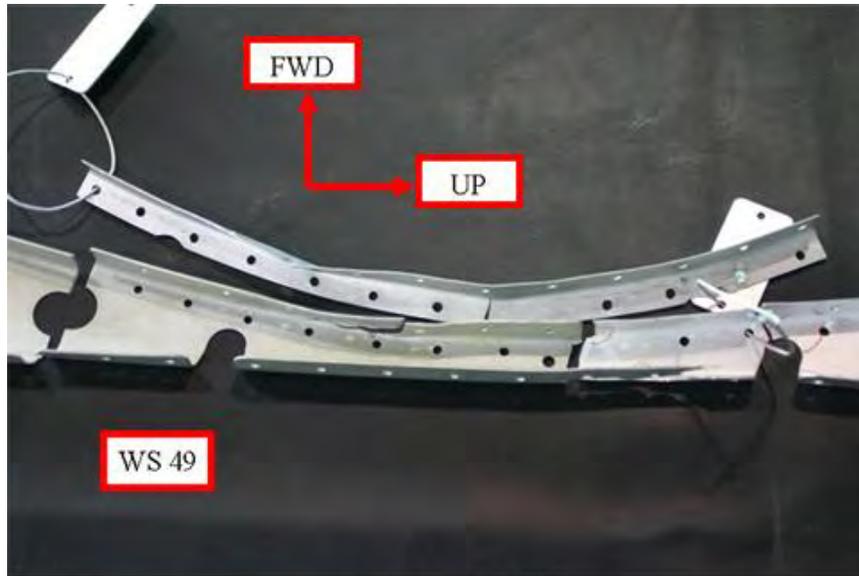
40423-23A Damage WS 49 Mac

Figure 280. Close-Up of Damage on the Right Wing Rear Spar Rib Assembly WS 49

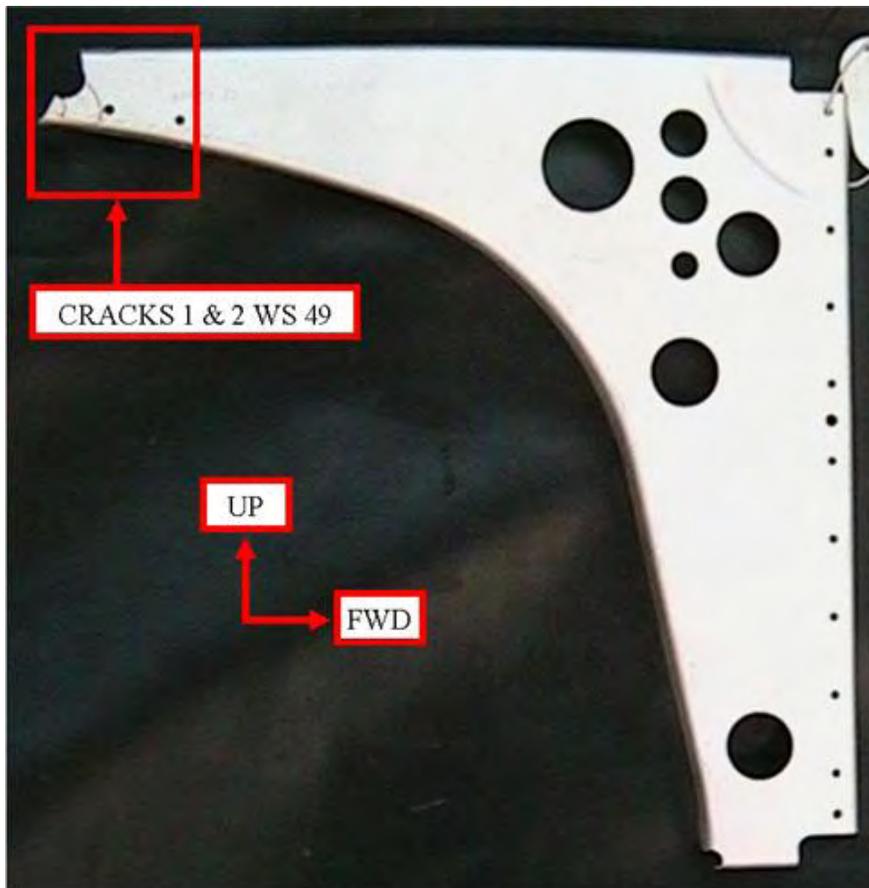
40423-23A CRK WS 49 OV 2

Figure 281. Location of Cracks 1 and 2 on the Right Wing Rear Spar Rib Assembly WS 49

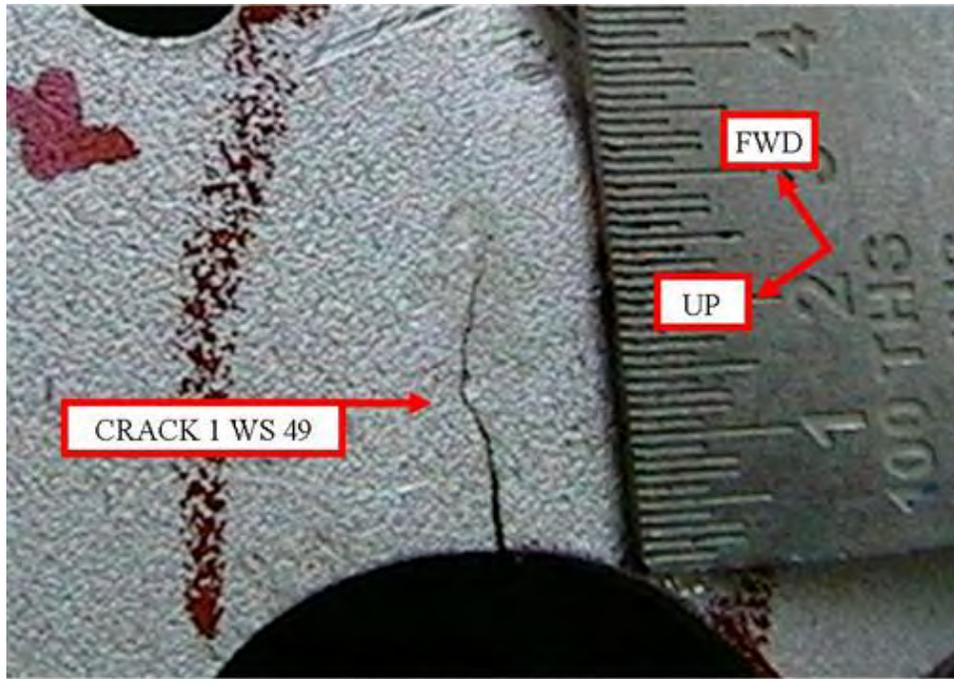
40423-23A CRK 1 WS 49 Mac

Figure 282. Macroscopic View of Crack 1 on the Right wing Rear Spar Rib Assembly WS 49

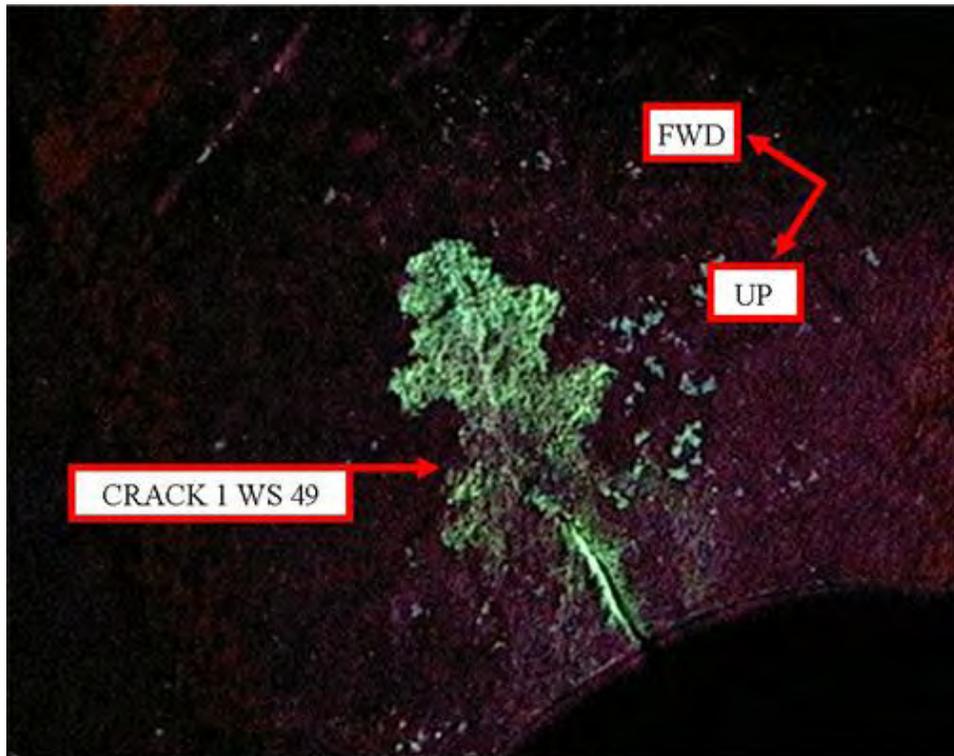
40423-23A CRK 1 WS 49 FLP

Figure 283. Fluorescent Liquid Penetrant Indication of Crack 1 on the Right Wing Rear Spar Rib Assembly WS 49

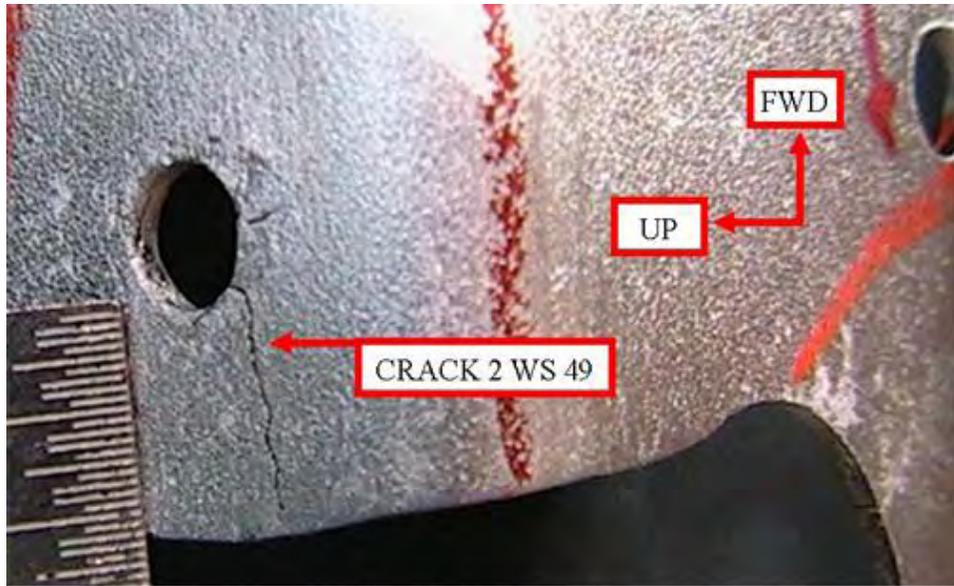
40423-23A CRK 2 WS 49 Mac

Figure 284. Macroscopic View of Crack 2 on the Right Wing Rear Spar Rib Assembly WS 49

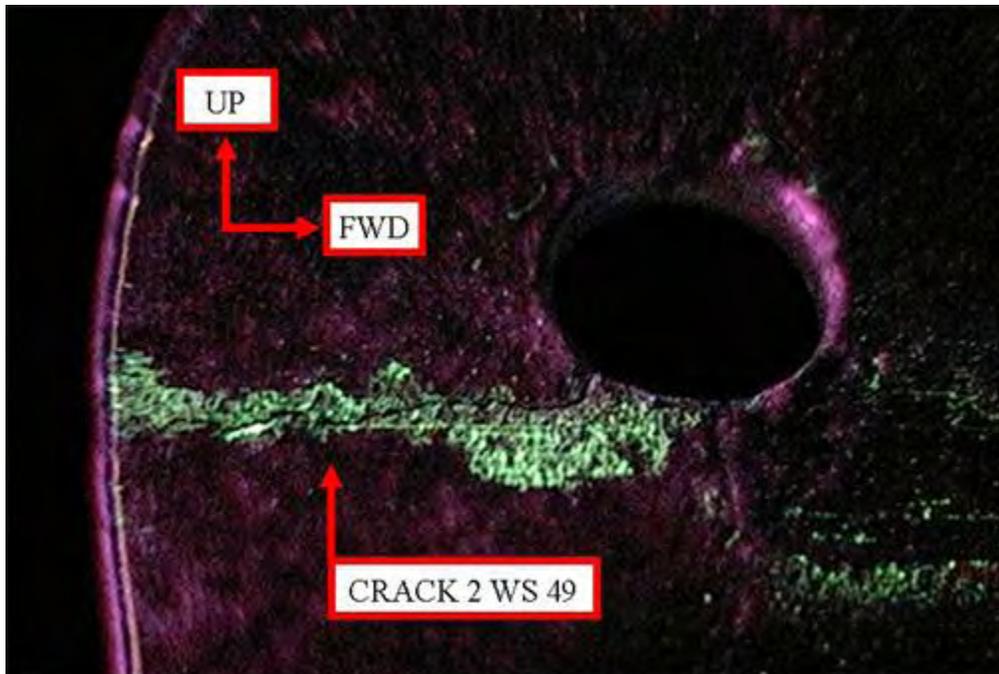
40423-23A CRK 2 WS 49 FLP

Figure 285. Fluorescent Liquid Penetrant Indication of Crack 2 on the Right Wing Rear Spar Rib Assembly WS 49

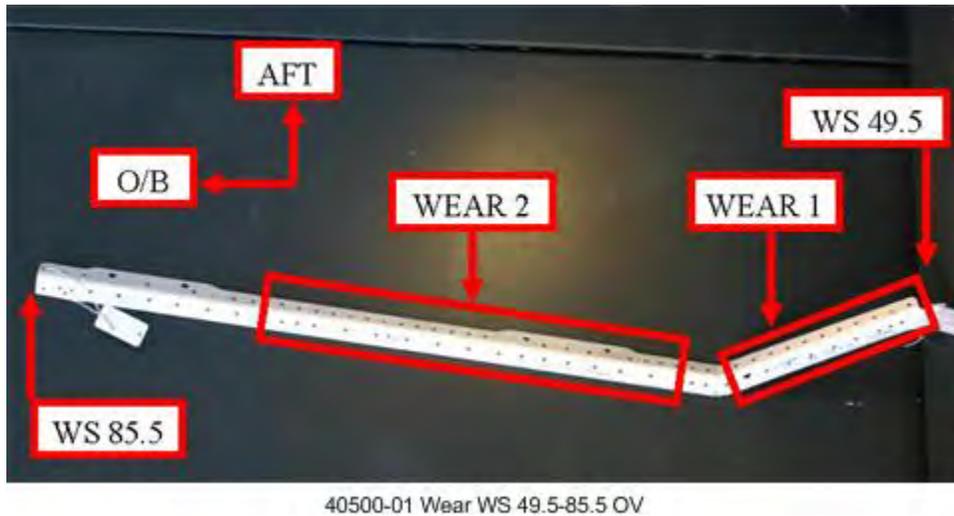
Figure 286 shows the location of wear 1 and 2 on the right wing rear spar main gear forward, part number 40500-01. Figure 287 shows a macroscopic view of wear 1. Wear 1, located from WS 49.5 to WS 59.25, covered a surface area of 2.54 square inches and caused a maximum reduction in thickness of 48%. Wear 2, shown macroscopically in figure 288, covered a surface area of 4.24 square inches and resulted in a maximum localized thickness loss of 21%. The location of two areas of wear on the right wing rear spar lower aft assembly, part number 45838-01, is shown in figure 289. The macroscopic view of both areas of wear are shown in figure 290. Wear 1 covered a surface area of 0.6 square inches and resulted in a localized reduction in thickness of 19.3%. Wear 2 encompassed an area of 4 square inches and caused a maximum localized thickness loss of 44%.

Figure 286. Location of Wear 1 and 2 on the Right Wing Rear Spar Assembly Main Gear Forward WS 49.5 Through WS 85.5

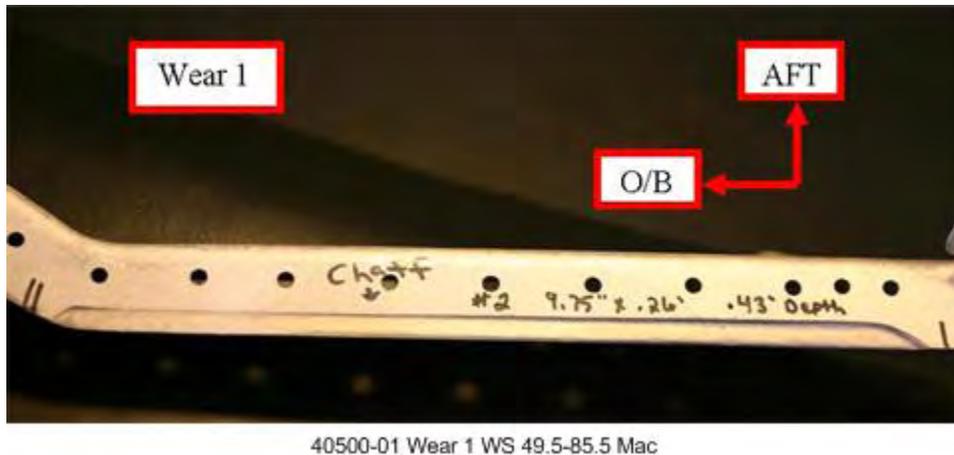
Figure 287. Macroscopic View of Wear 1 on the Right Wing Rear Spar Assembly Main Gear Forward WS 49.5 Through WS 59.25

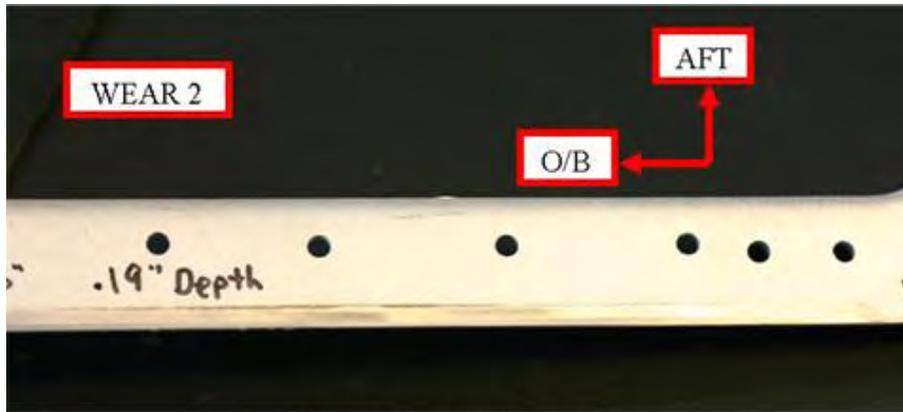
40500-01 Wear 2 WS 49.5-85.5 Mac

Figure 288. Macroscopic View of Wear 2 on the Right Wing Rear Spar Assembly Main Gear Forward WS 59 Through WS 85.5

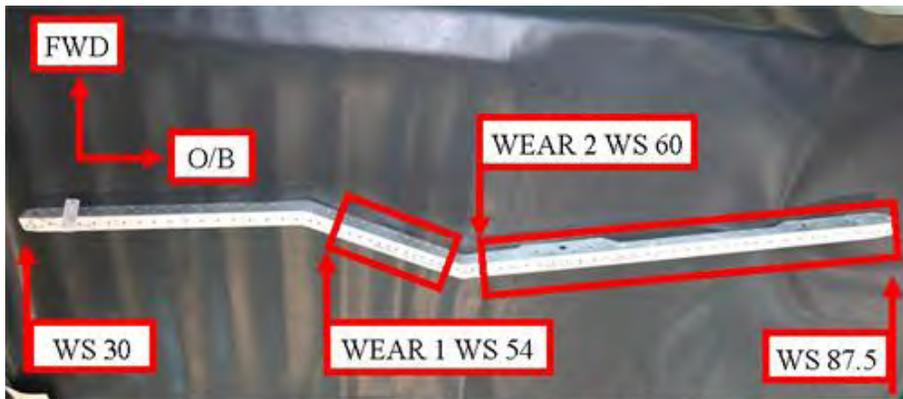
45838-01 Wear WS 30-87.5 OV

Figure 289. Location of Wear on the Right Wing Rear Spar Lower Aft Assembly WS 30 Through WS 87.5

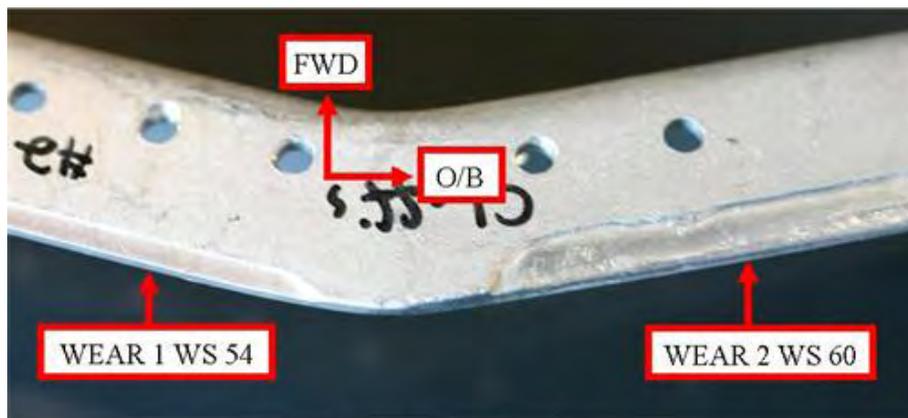
45838-01 Wear WS 30-87.5 Mac

Figure 290. Macroscopic View of Wear on the Right Wing Rear Spar Lower Aft Assembly WS 54 and WS 60

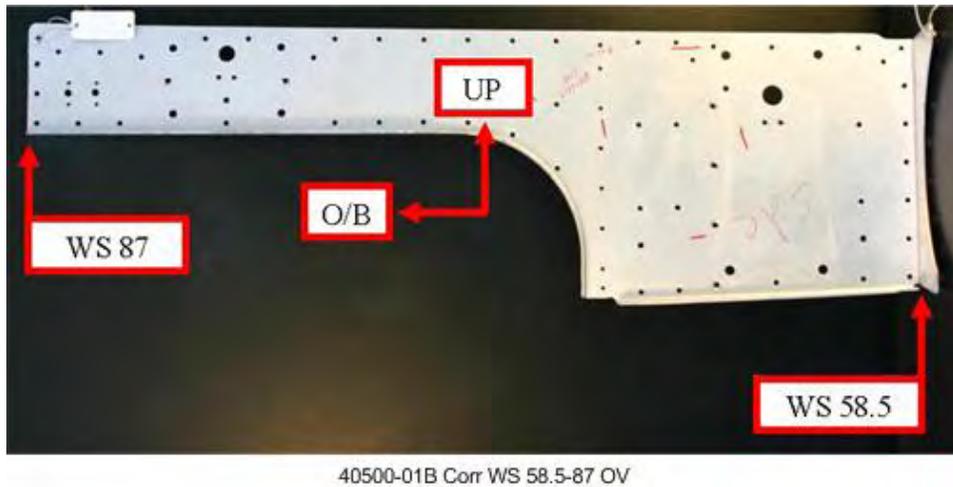
The location of light-moderate scattered corrosion on the right wing rear spar bulkhead assembly main gear support forward, part number 40500-01B, is shown in figure 291. This corrosion caused a maximum localized reduction in thickness of 2.5%. Figure 292 shows the location of a crack and an area of wear on the right wing nacelle inboard plate skin attachment, part number 41663-01A, at WS 60. Figure 293 shows a macroscopic view of the crack and area of wear, and figure 294 shows the fluorescent liquid penetrant indication. A microscopic view of the crack and area of wear, measuring 0.4 inches in length, is shown in figure 295. The location of the right wing inboard upper rivet of the engine attachment is shown in figure 296, and the fracture face of this rivet is shown in figure 297. A fractograph, showing fatigue striations, is shown in figure 298.

Figure 291. Location of Light-Moderate Corrosion on the Right Wing Rear Spar Bulkhead Assembly Main Gear Support Forward WS 58.5 Through WS 87

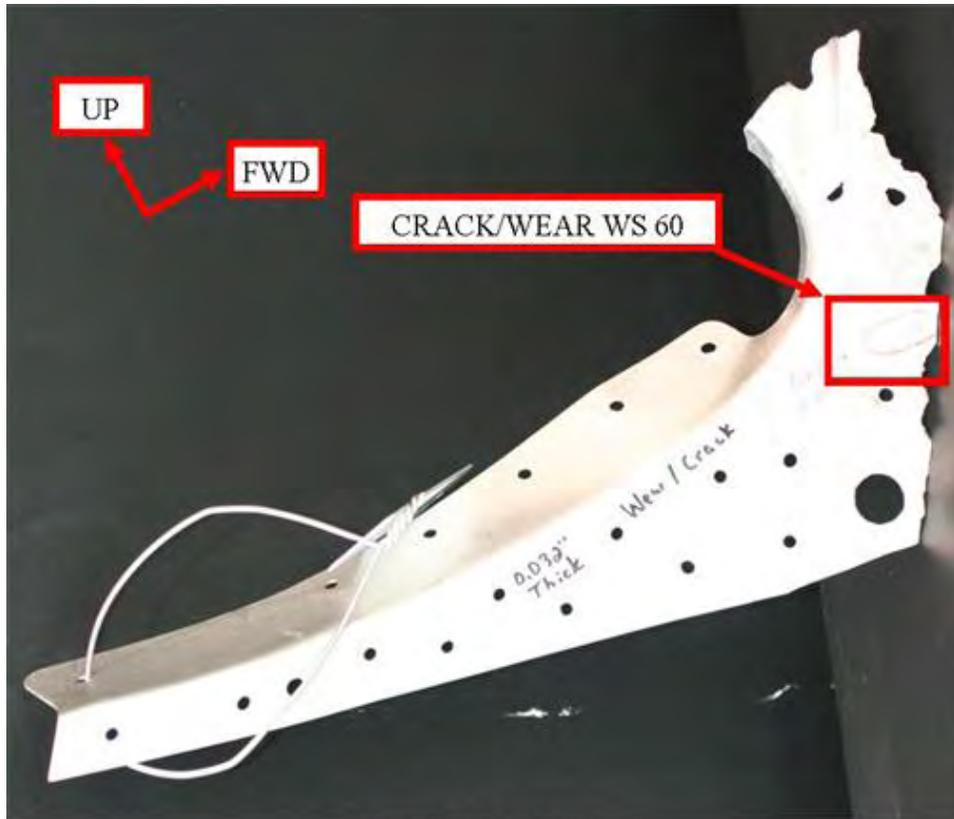
41663-01A CRK WS 60 OV

Figure 292. Location of Crack and Wear on the Right Wing Nacelle Inboard Plate Skin Attachment WS 60

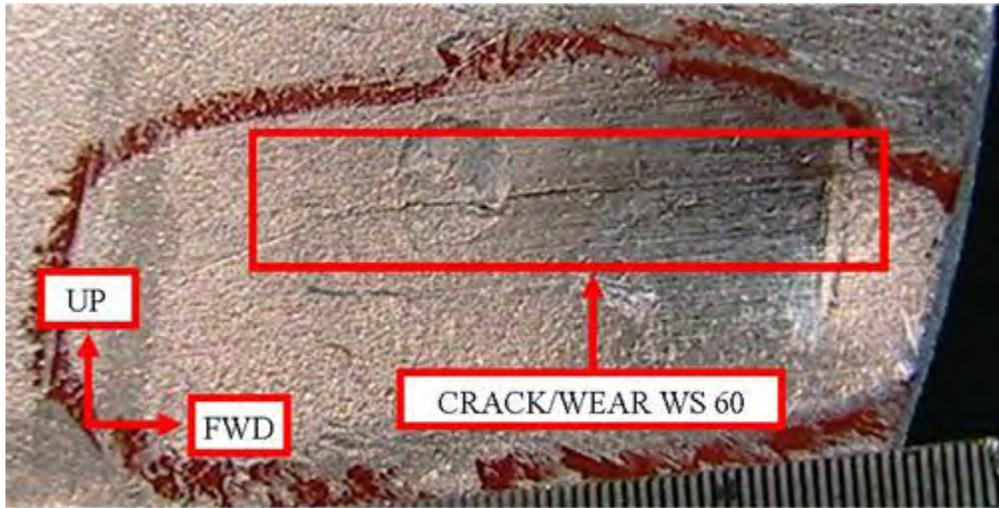
41663-01A CRK WS 60 Mac

Figure 293. Macroscopic View of Crack and Wear on the Right Wing Nacelle Inboard Plate Skin Attachment

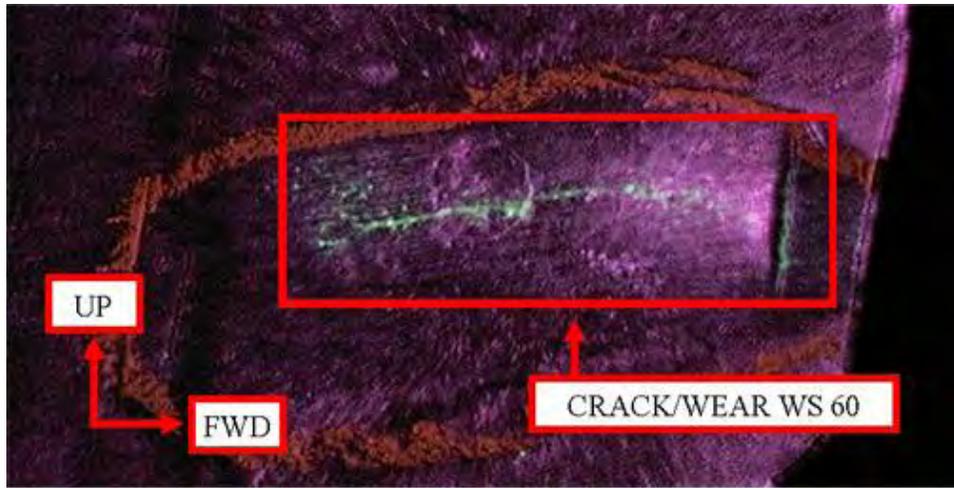
41663-01A CRK WS 60 FLP

Figure 294. Fluorescent Liquid Penetrant Indication of Crack and Wear on the Right Wing Nacelle Inboard Plate Skin Attachment WS 60

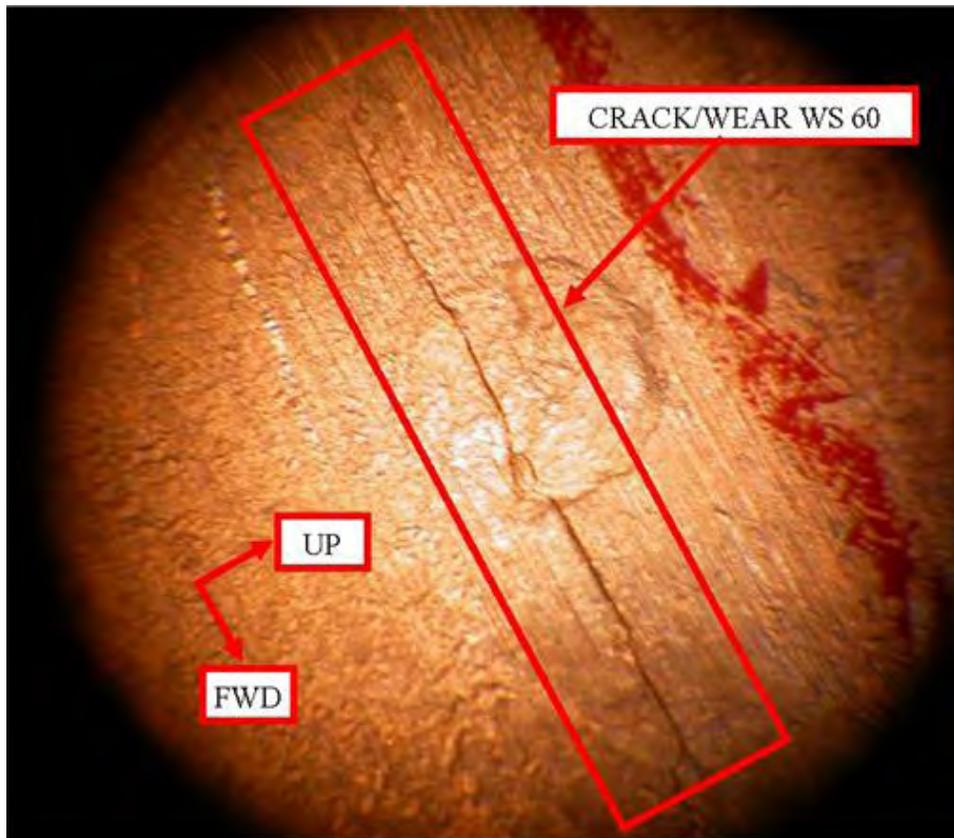
41663-01A CRK WS 60 Mic

Figure 295. Microscopic View of Crack and Wear on the Right Wing Nacelle Inboard Plate Skin Attachment WS 60

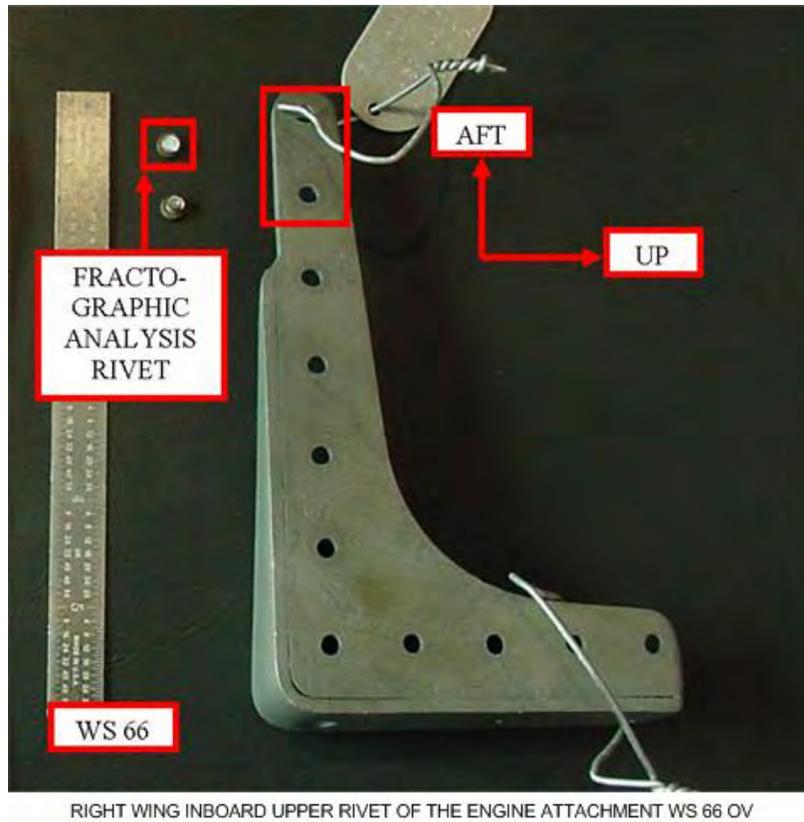
Figure 296. Location of Right Wing Inboard Upper Rivet of the Engine Attachment WS 66

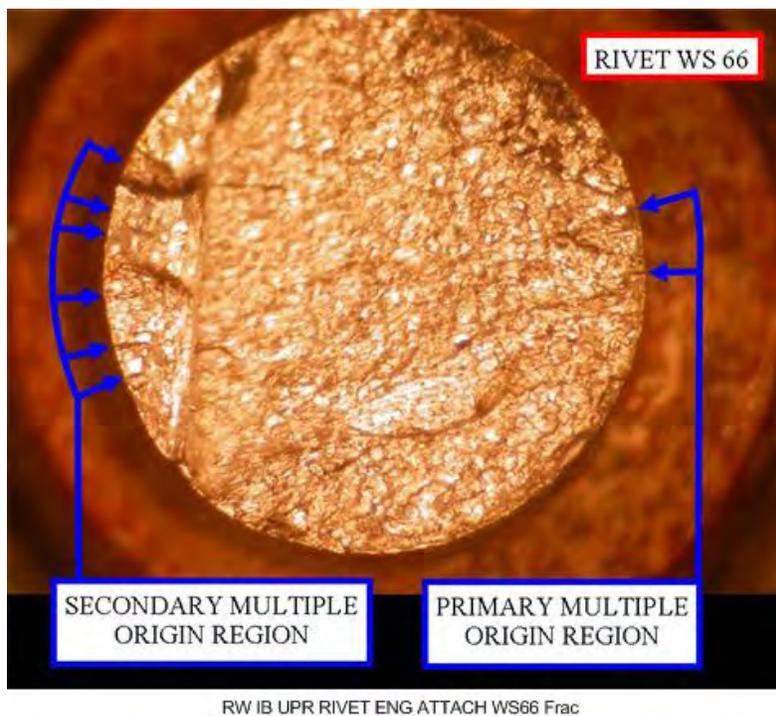
Figure 297. Fracture Face of Right Wing Inboard Upper Rivet of the Engine Attachment WS 66

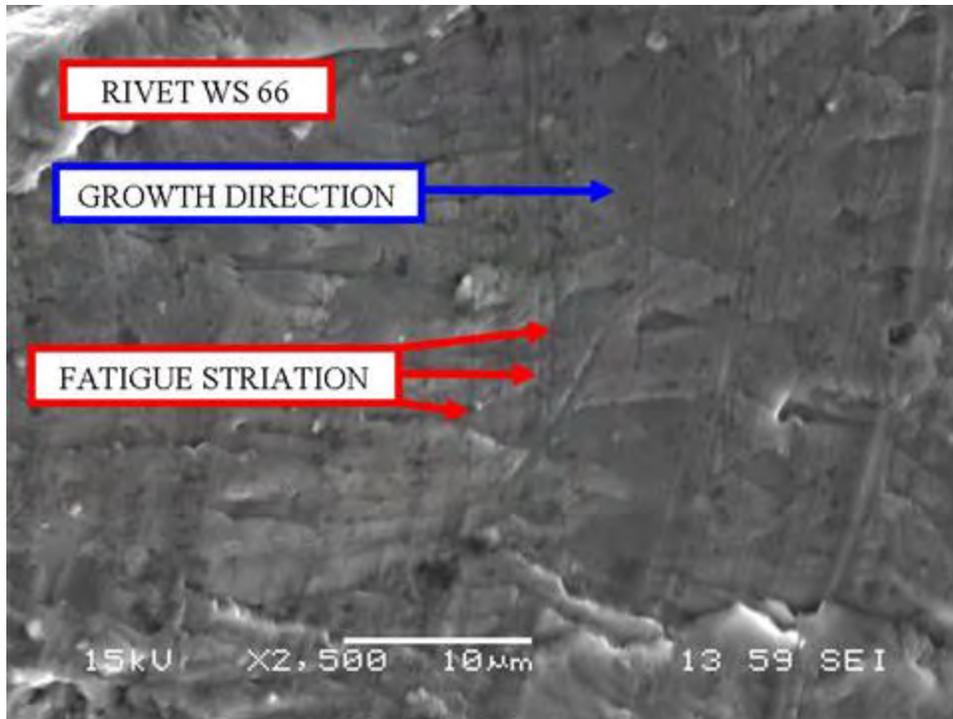
RW IB UPR RIVET ENG ATTACH WS66 Frac 2

Figure 298. Fractograph of Right Wing Inboard Upper Rivet of the Engine Attachment WS 66

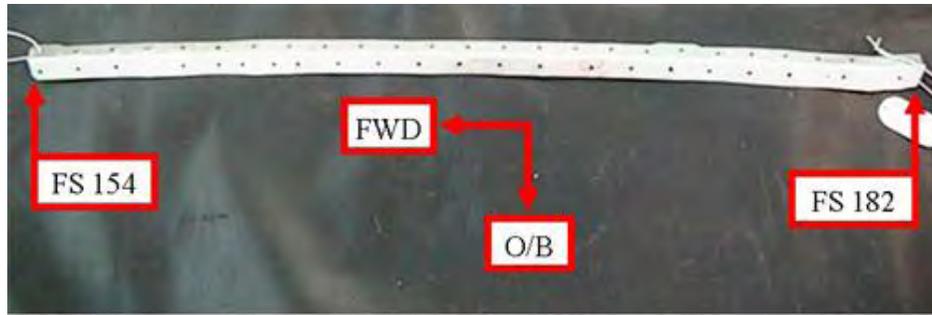
44437-07 Corr FS 154-182 OV

Figure 299 shows the location of light-moderate scattered corrosion observed on the right nacelle longitudinal inboard bulkhead aft piece, part number 44437-07, and figure 300 shows the location of five cracks found on the bulkhead aft piece. A macroscopic view of crack 1, which measured 0.369 inches in length, is shown in figure 301, and the fluorescent liquid penetrant indication is shown in figure 302. Figure 303 shows a microscopic view of crack 1, which was located at WS 66 FS 160.25 on the nacelle longitudinal inboard bulkhead aft piece. Figure 304 provides a macroscopic view of crack 2, which measured 0.608 inches in length and was located at WS 66 FS 161.25. The fluorescent liquid penetrant indication is shown in figure 305, and a microscopic view of this crack is shown in figure 306. A macroscopic view of crack 3, which measured 0.127 inch in length, on the right wing nacelle longitudinal inboard bulkhead aft piece is shown in figure 307. The fluorescent liquid penetrant indication of crack 3 is shown in figure 308, and a microscopic view of this crack is shown in figure 309. Figure 310 shows a macroscopic view of crack 4 at WS 66 FS 171.25, and figure 311 shows the fluorescent liquid penetrant indication of this 0.318-inch crack. Figure 312 shows a microscopic view of crack 4 on the inboard bulkhead aft piece. Crack 5, which measured 0.133 inches, is shown macroscopically in figure 313, and the fluorescent liquid penetrant indication is shown in figure 314. A microscopic view of crack 5, which was located at WS 66 FS 179.25 on the longitudinal inboard bulkhead aft piece, is shown in figure 315.

Figure 299. Location of Light-Moderate Corrosion on the Right Nacelle Longitudinal Inboard Bulkhead Aft Piece WS 66 FS 154 Through FS 182
