DOT/FAA/AR-07/64

Teardown Evaluation of a 1975 Piper Navajo Chieftain Model PA31-350 Airplane

March 2008

Final Report

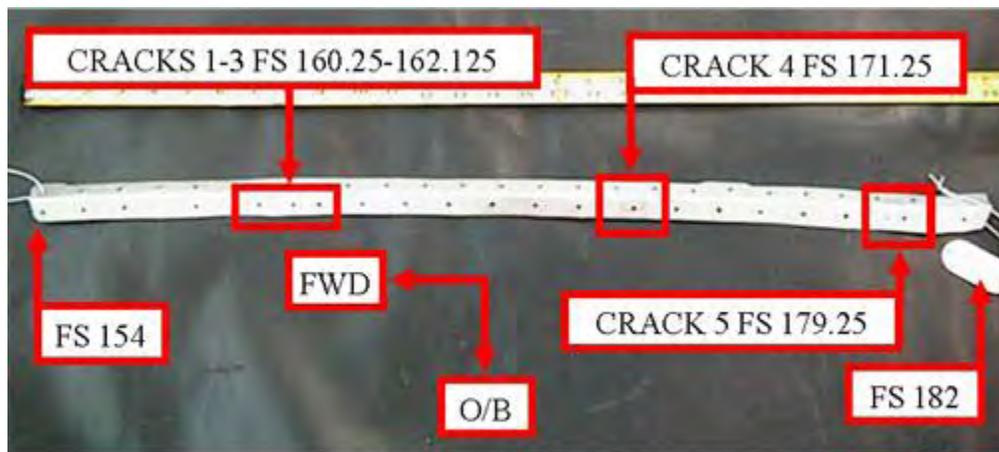
44437-07 CRK FS154-182 OV

Figure 299 shows the location of light-moderate scattered corrosion observed on the right nacelle longitudinal inboard bulkhead aft piece, part number 44437-07, and figure 300 shows the location of five cracks found on the bulkhead aft piece. A macroscopic view of crack 1, which measured 0.369 inches in length, is shown in figure 301, and the fluorescent liquid penetrant indication is shown in figure 302. Figure 303 shows a microscopic view of crack 1, which was located at WS 66 FS 160.25 on the nacelle longitudinal inboard bulkhead aft piece. Figure 304 provides a macroscopic view of crack 2, which measured 0.608 inches in length and was located at WS 66 FS 161.25. The fluorescent liquid penetrant indication is shown in figure 305, and a microscopic view of this crack is shown in figure 306. A macroscopic view of crack 3, which measured 0.127 inch in length, on the right wing nacelle longitudinal inboard bulkhead aft piece is shown in figure 307. The fluorescent liquid penetrant indication of crack 3 is shown in figure 308, and a microscopic view of this crack is shown in figure 309. Figure 310 shows a macroscopic view of crack 4 at WS 66 FS 171.25, and figure 311 shows the fluorescent liquid penetrant indication of this 0.318-inch crack. Figure 312 shows a microscopic view of crack 4 on the inboard bulkhead aft piece. Crack 5, which measured 0.133 inches, is shown macroscopically in figure 313, and the fluorescent liquid penetrant indication is shown in figure 314. A microscopic view of crack 5, which was located at WS 66 FS 179.25 on the longitudinal inboard bulkhead aft piece, is shown in figure 315.

Figure 300. Location of Cracks on the Right Nacelle Longitudinal Inboard Bulkhead Aft Piece WS 66 FS 154 Through FS 182

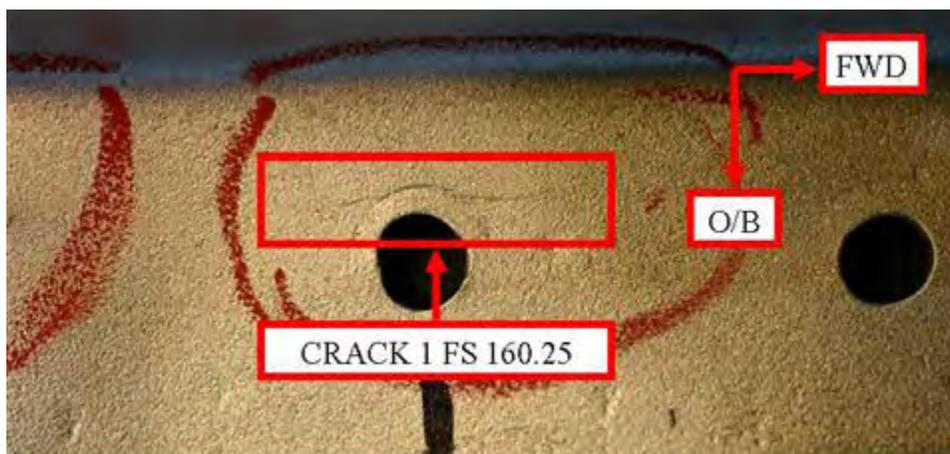
44437-07 CRK 1 FS154-182 Mac

Figure 301. Macroscopic View of Crack 1 on the Right Nacelle Longitudinal Inboard Bulkhead Aft Piece WS 66 FS 160.25

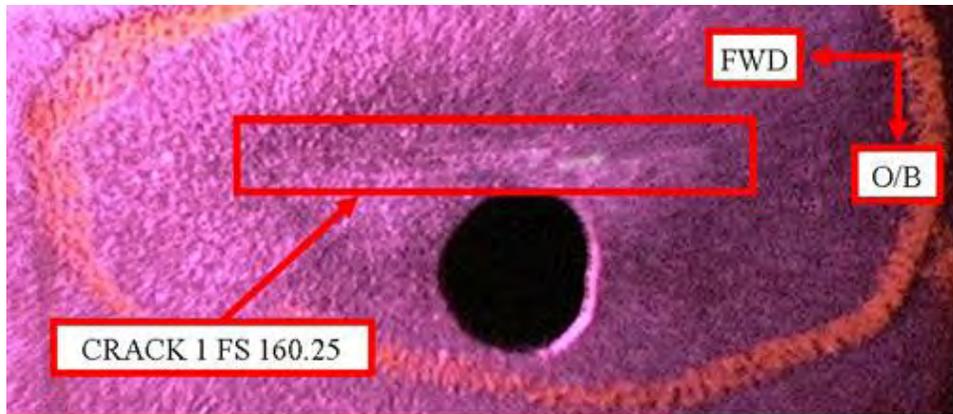
44437-07 CRK 1 FS154-182 FLP

Figure 302. Fluorescent Liquid Penetrant of Crack 1 on the Right Nacelle Longitudinal Inboard Bulkhead Aft Piece WS 66 FS 160.25

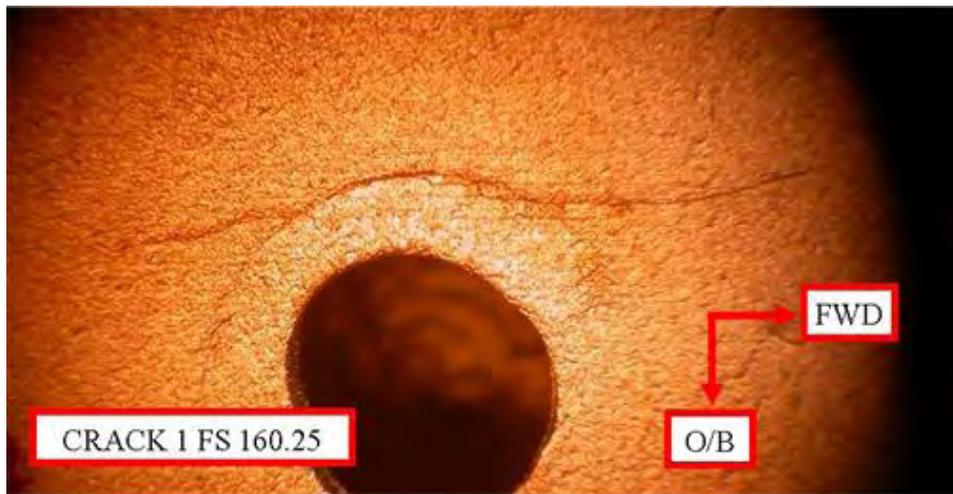
44437-07 CRK 1 FS154-182 Mic

Figure 303. Microscopic View of Crack 1 on the Right Nacelle Longitudinal Inboard Bulkhead Aft Piece WS 66 FS 160.25

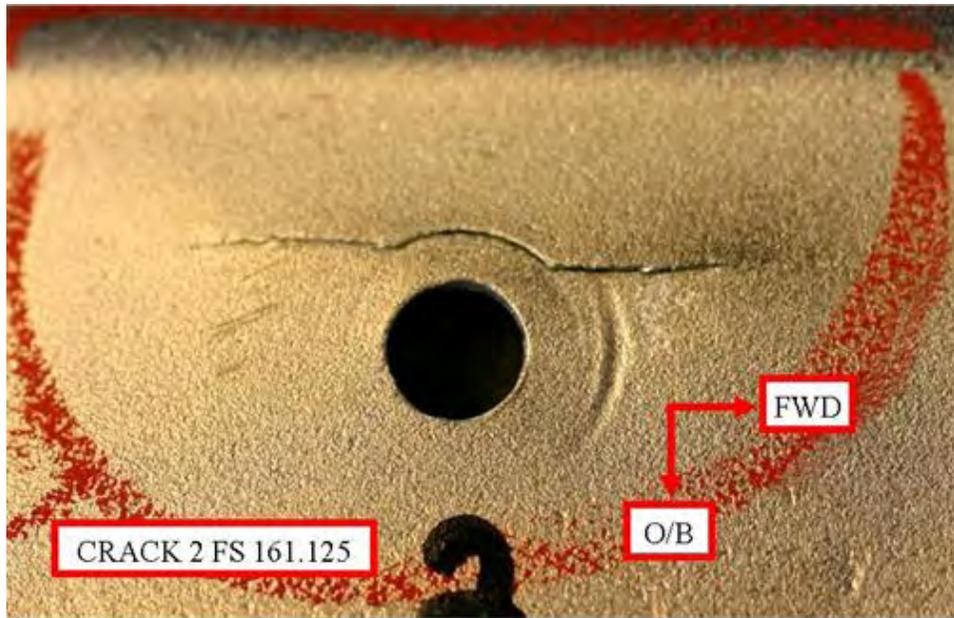
44437-07 CRK 2 FS154-182 Mac

Figure 304. Macroscopic View of Crack 2 on the Right Nacelle Longitudinal Inboard Bulkhead Aft Piece WS 66 FS 161.25

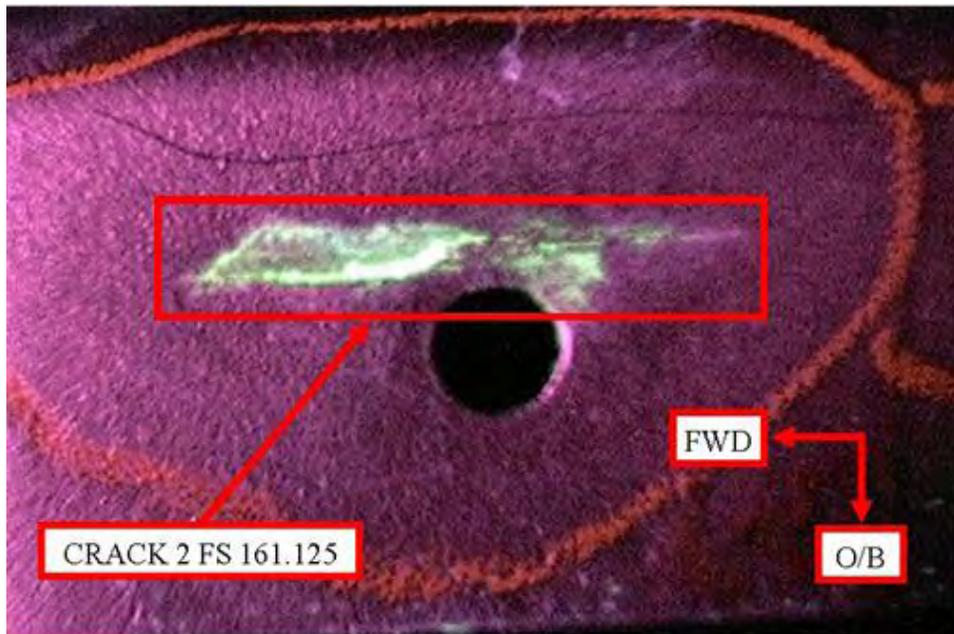
44437-07 CRK 2 FS154-182 FLP

Figure 305. Fluorescent Liquid Penetrant Indication of Crack 2 on the Right Nacelle Longitudinal Inboard Bulkhead Aft Piece WS 66 FS 161.25

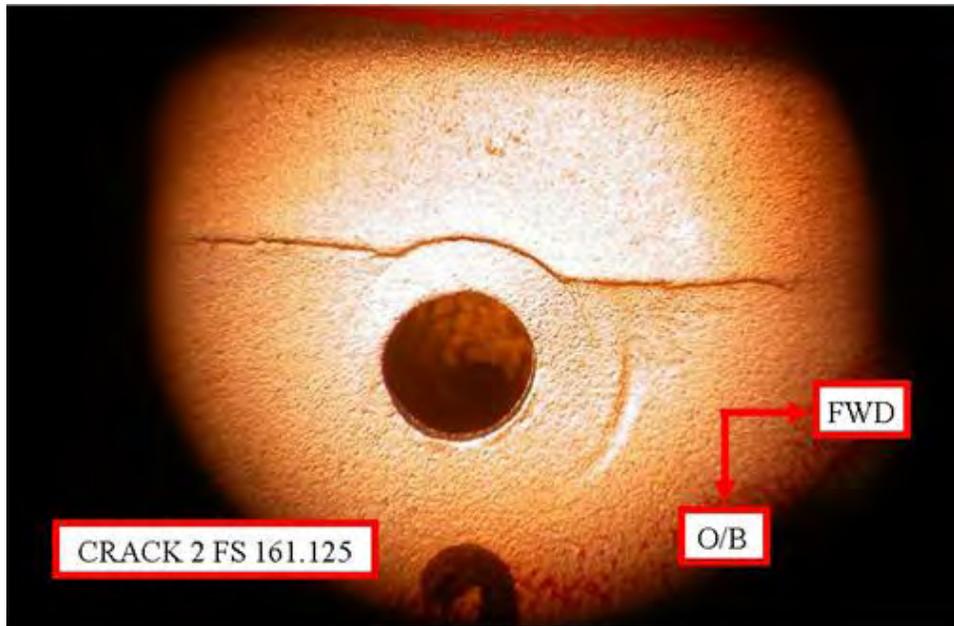
44437-07 CRK 2 FS154-182 Mic

Figure 306. Microscopic View of Crack 2 on the Right Nacelle Longitudinal Inboard Bulkhead Aft Piece WS 66 FS 161.25

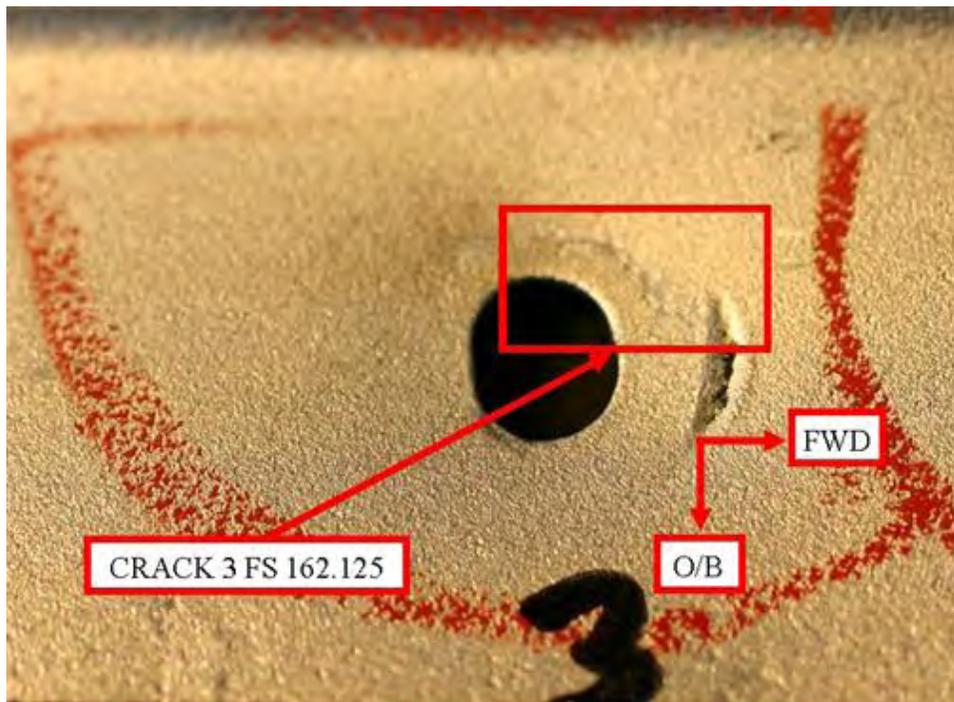
44437-07 CRK 3 FS154-182 Mac

Figure 307. Macroscopic View of Crack 3 on the Right Nacelle Longitudinal Inboard Bulkhead Aft Piece WS 66 FS 162.125

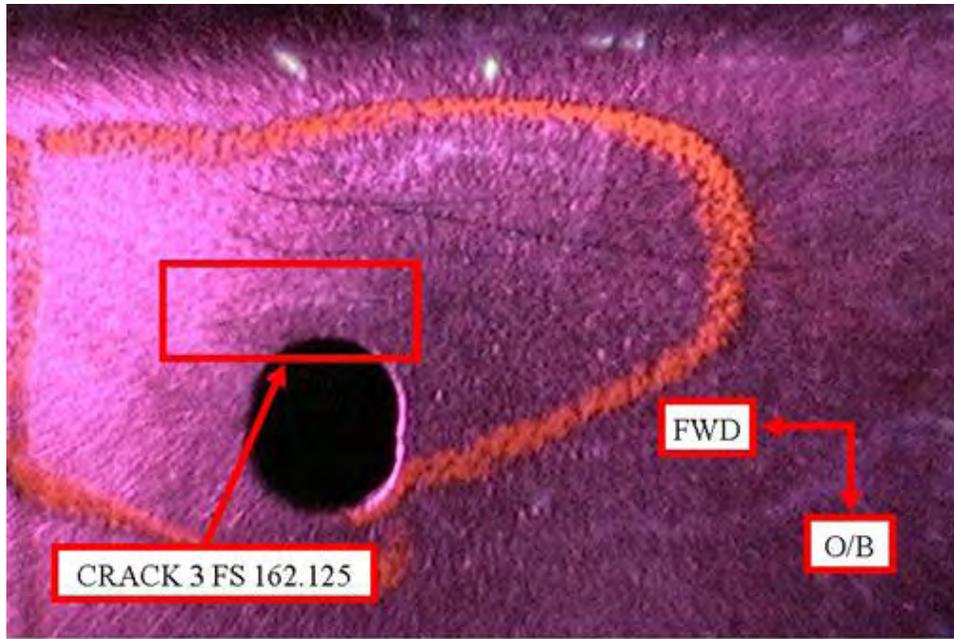
44437-07 CRK 3 FS154-182 FLP

Figure 308. Fluorescent Liquid Penetrant Indication of Crack 3 on the Right Nacelle Longitudinal Inboard Bulkhead Aft Piece WS 66 FS 162.125

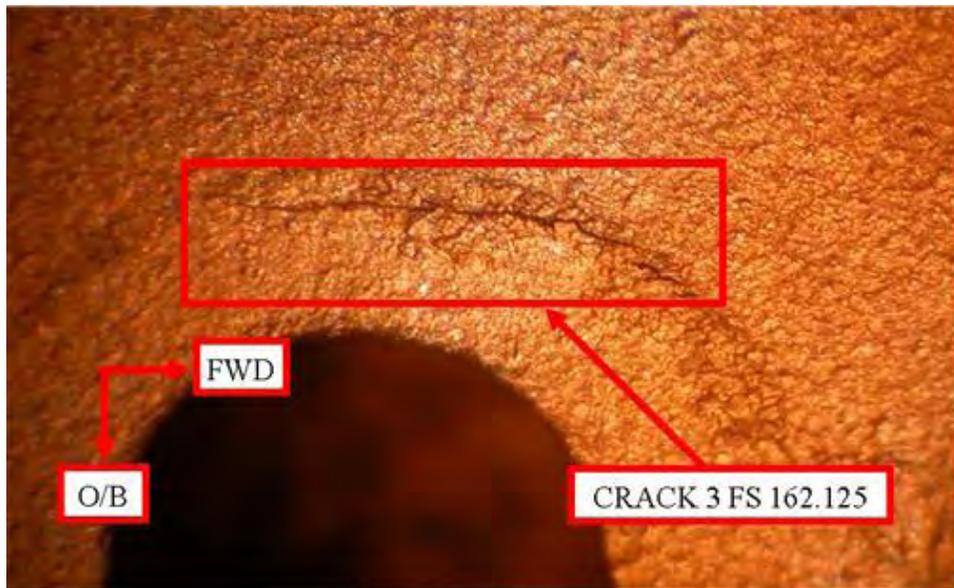
44437-07 CRK 3 FS154-182 Mic

Figure 309. Microscopic View of Crack 3 on the Right Nacelle Longitudinal Inboard Bulkhead Aft Piece WS 66 FS 162.125

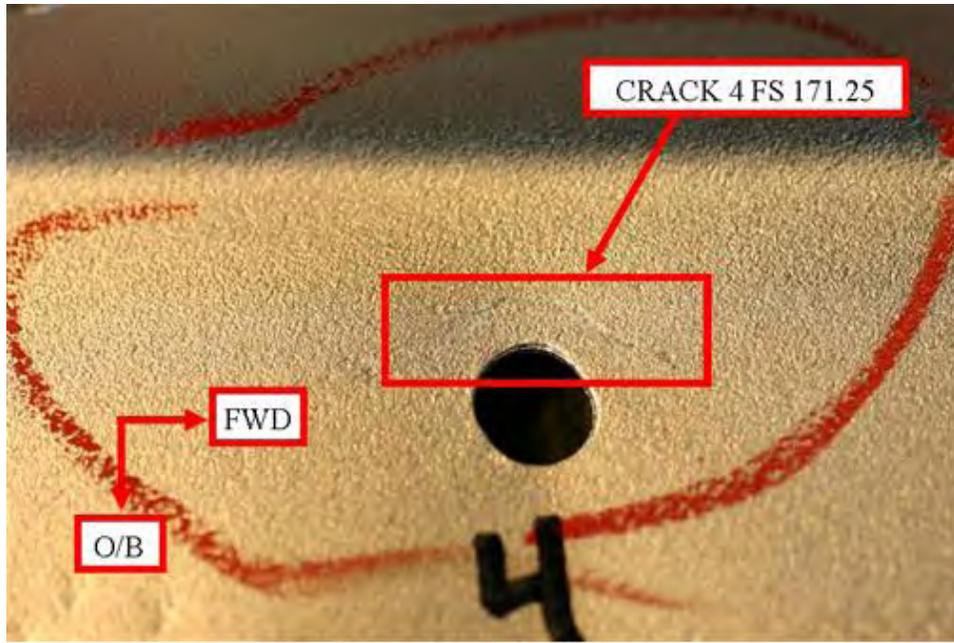
44437-07 CRK 4 FS154-182 Mac

Figure 310. Macroscopic View of Crack 4 on the Right Nacelle Longitudinal Inboard Bulkhead Aft Piece WS 66 FS 171.25

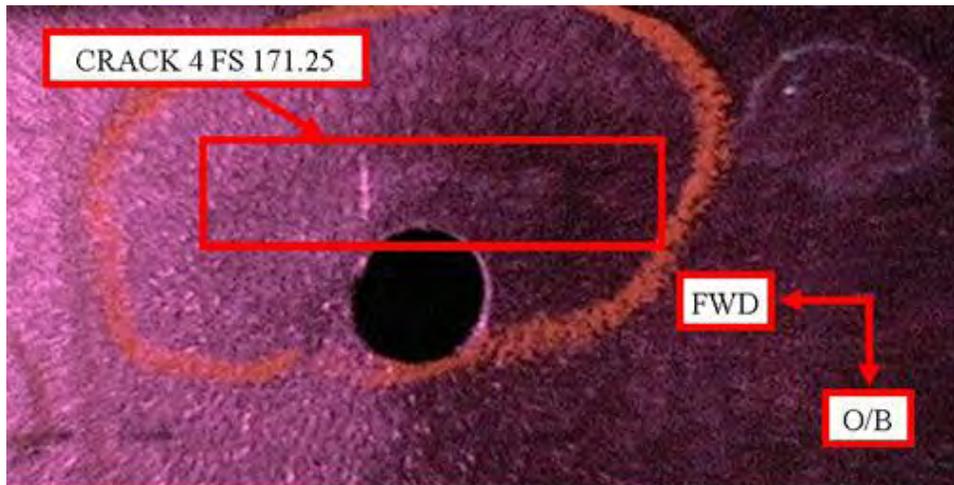
44437-07 CRK 4 FS154-182 FLP

Figure 311. Fluorescent Liquid Penetrant Indication of Crack 4 on the Right Nacelle Longitudinal Inboard Bulkhead Aft Piece WS 66 FS 171.25

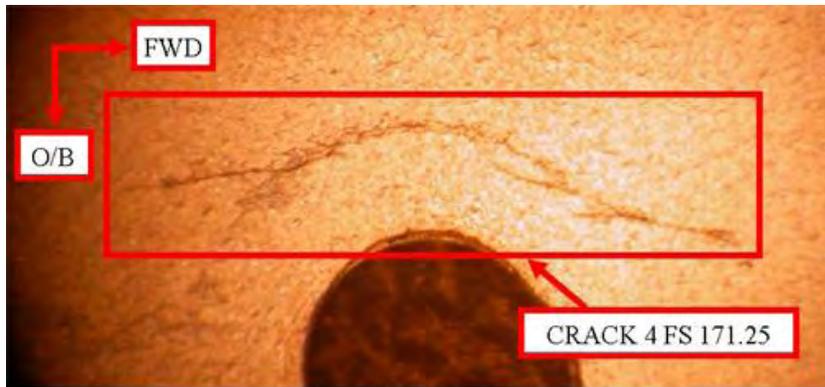
44437-07 CRK 4 FS154-182 Mic

Figure 312. Microscopic View of Crack 4 on the Right Nacelle Longitudinal Inboard Bulkhead Aft Piece WS 66 FS 171.25

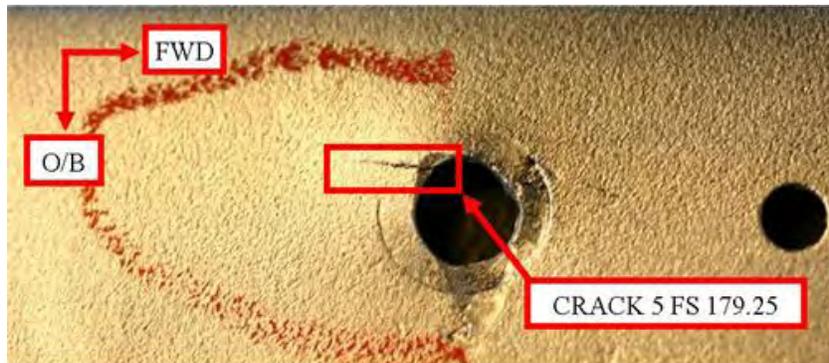
44437-07 CRK 5 FS154-182 Mac

Figure 313. Macroscopic View of Crack 5 on the Right Nacelle Longitudinal Inboard Bulkhead Aft Piece WS 66 FS 179.25

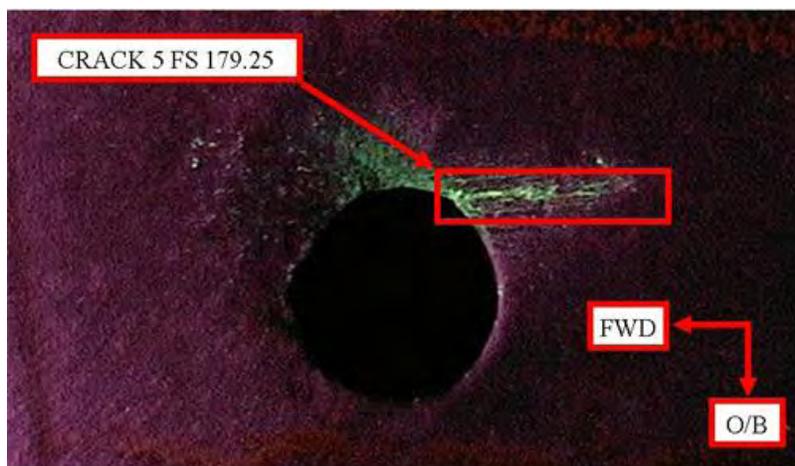
44437-07 CRK 5 FS154-182 FLP

Figure 314. Fluorescent Liquid Penetrant Indication of Crack 5 on the Right Nacelle Longitudinal Inboard Bulkhead Aft Piece WS 66 FS 179.25

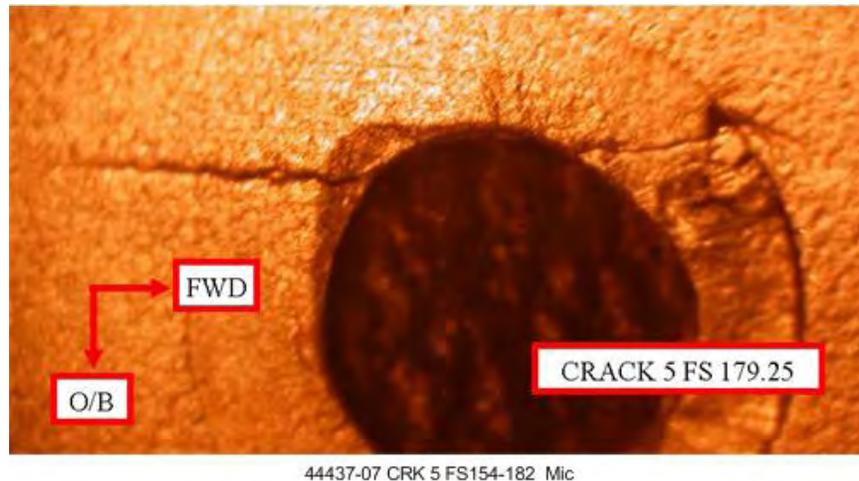
Figure 315. Microscopic View of Crack 5 on the Right Nacelle Longitudinal Inboard Bulkhead Aft Piece WS 66 FS 179.25

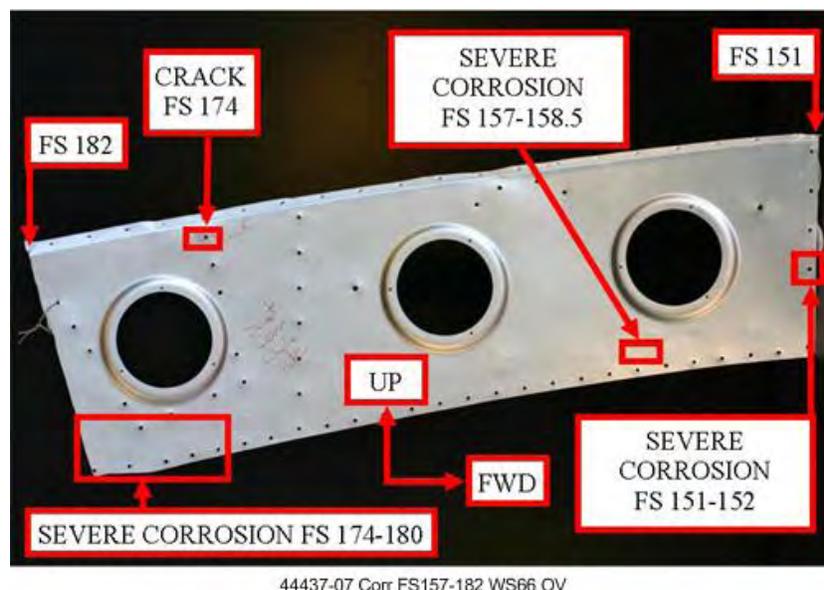
The location of a crack and three areas of severe corrosion are shown in figure 316 on the right nacelle inboard longitudinal bulkhead, part number 44437-07. Figure 317 shows a macroscopic view of severe corrosion located at WS 66 FS 151 to FS 152. This 1.25-square-inch area of corrosion caused a localized reduction in thickness of 22%. Another area of severe corrosion, located at WS 66 FS 157 to FS 158.5, is shown macroscopically in figure 318. This area of corrosion also caused a localized thickness loss of 22%. Figure 319 shows another area of severe corrosion on the right nacelle inboard longitudinal bulkhead at WS 66 FS 174 to FS 180. This 15-square-inch area of corrosion caused a maximum localized thickness loss of 22%. Figure 320 shows a macroscopic view of a 0.385-inch-crack located at WS 66 FS 174 on the nacelle inboard bulkhead, and figure 321 shows a microscopic view of this crack.

Figure 316. Location of Crack and Severe Corrosion on the Right Nacelle Inboard Bulkhead WS 66 FS 151 Through FS 182

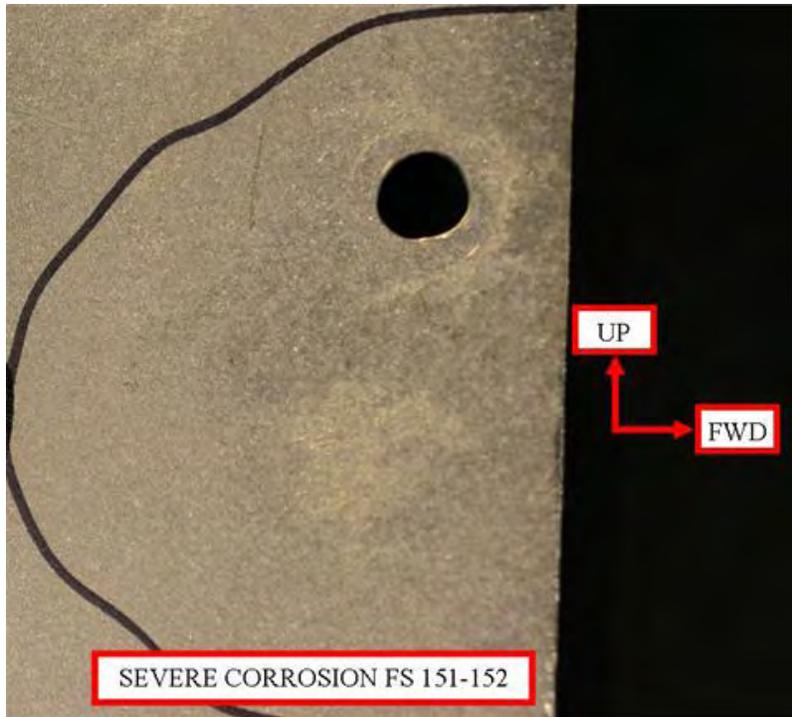
44437-07 Corr 1 FS157-182 WS66 Mac

Figure 317. Macroscopic View of Severe Corrosion on the Right Nacelle Inboard Longitudinal Bulkhead WS 66 FS 151 Through FS 152

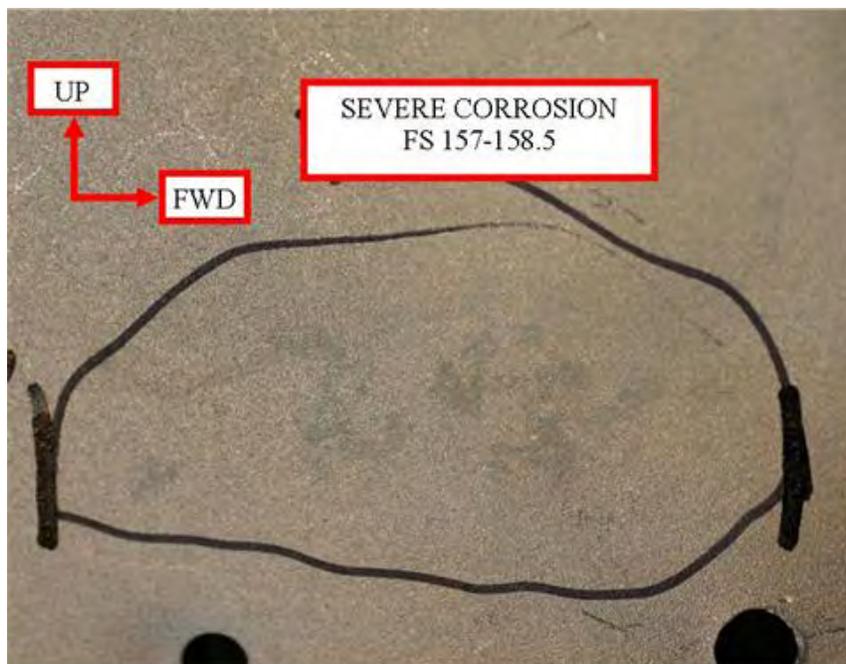
44437-07 Corr 2 FS157-182 WS66 Mac

Figure 318. Macroscopic View of Severe Corrosion on the Right Nacelle Inboard Longitudinal Bulkhead WS 66 FS 157 Through FS 158.5

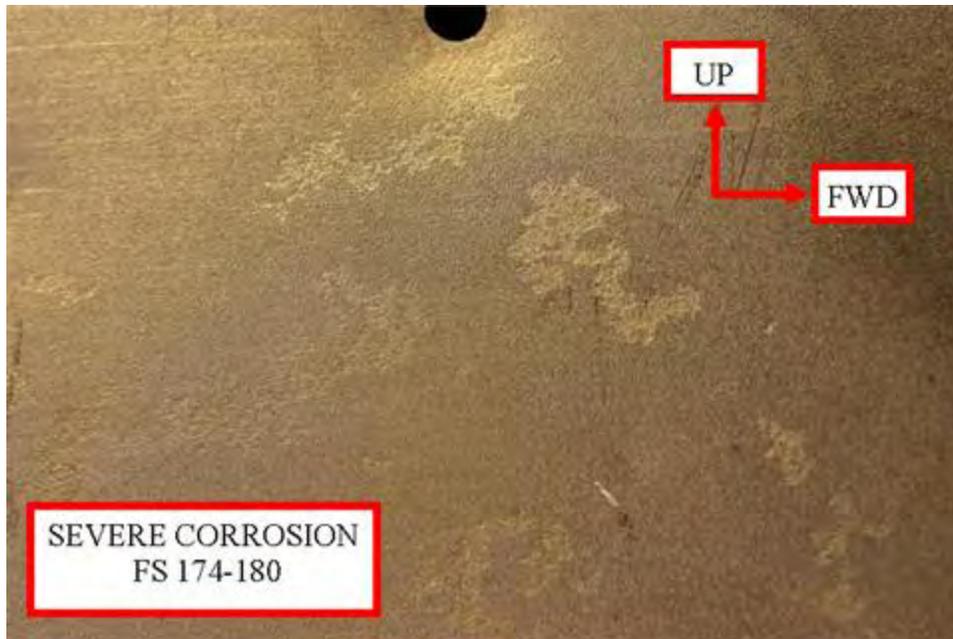
44437-07 Corr 3 FS157-182 WS66 Mac

Figure 319. Macroscopic View of Severe Corrosion on the Right Nacelle Inboard Longitudinal Bulkhead WS 66 FS 174 Through FS 180

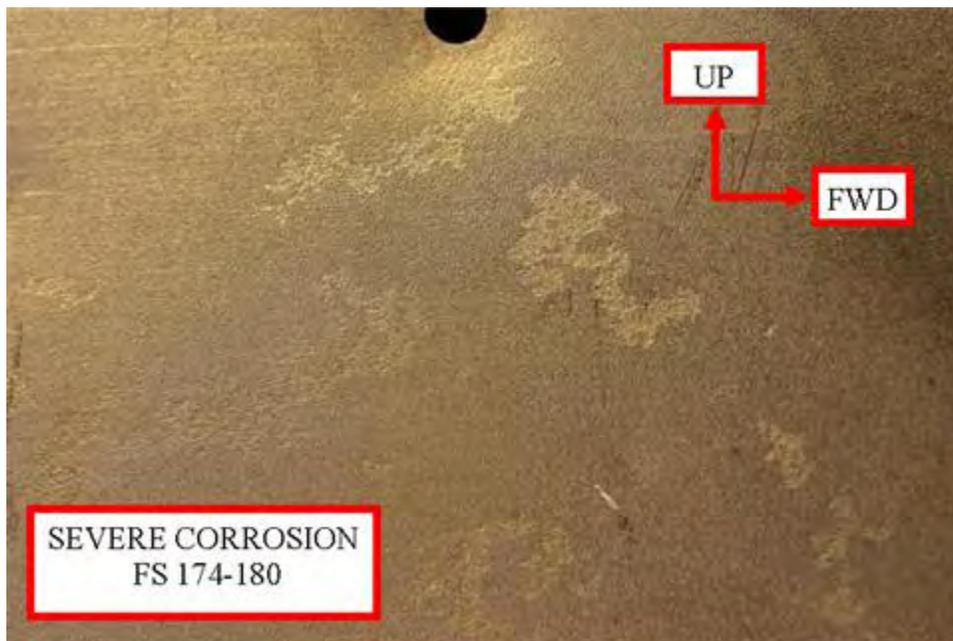
44437-07 Corr 3 FS157-182 WS66 Mac

Figure 320. Macroscopic View of Crack on the Right Nacelle Inboard Longitudinal Bulkhead WS 66 FS 174

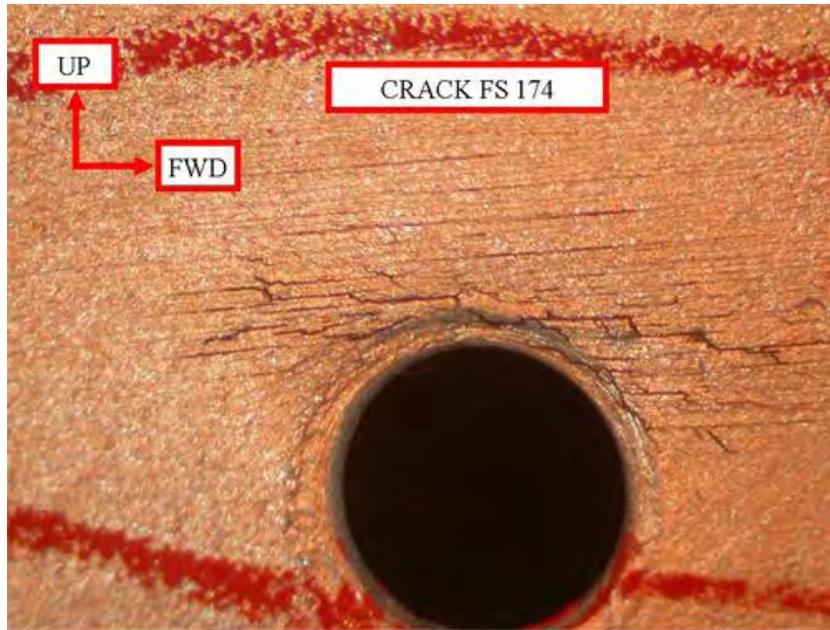
44437-07 CRK FS157-182 WS66 Mic

Figure 321. Microscopic View of Crack on the Right Nacelle Inboard Longitudinal Bulkhead WS 66 FS 174

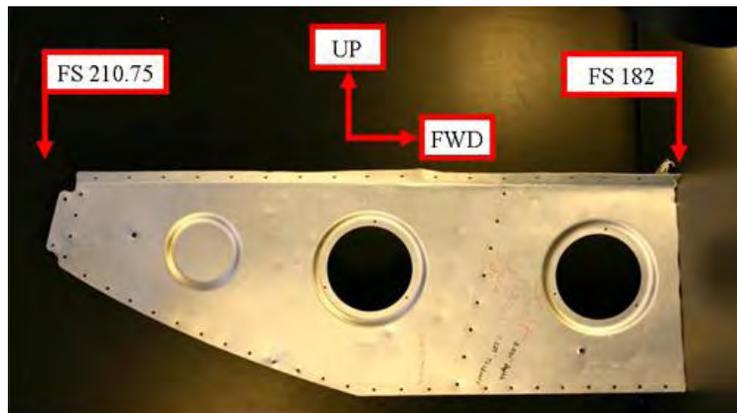
44437-07 Corr FS 182-210.75 WS 66 OV

Figure 322 shows the location of light-moderate corrosion on the right nacelle bulkhead longitudinal inboard, part number 44437-07. This corrosion caused a localized reduction in thickness of 4%. The location of light-moderate scattered corrosion on the right wing nacelle bulkhead assembly, part number 44474-06A, is shown in figure 323. This corrosion caused a maximum localized thickness loss of 3%. Figure 324 shows the location of a 0.21-inch-crack on the right wing nacelle torque tube bracket assembly, part number 41815, located from WS 66 to WS 89 FS 111.5. A macroscopic view of this crack is shown in figure 325, and the fluorescent liquid penetrant indication of this crack is shown in figure 326. A microscopic view of the crack on the torque tube bracket is shown in figure 327.

Figure 322. Location of Light-Moderate Corrosion on the Right Nacelle Bulkhead Longitudinal Inboard WS 66 FS 182 Through FS 210.75

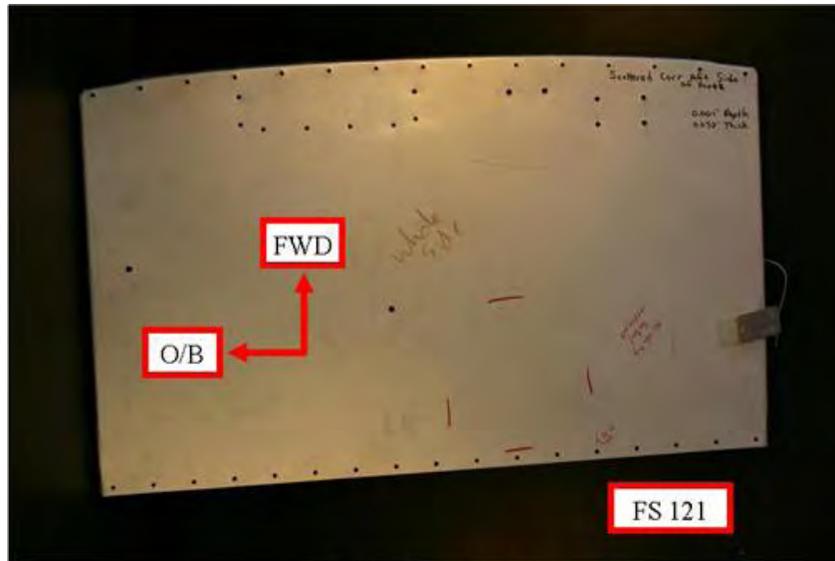
44474-06A Corr FS 121 OV

Figure 323. Location of Light-Moderate Corrosion on the Right Wing Nacelle Bulkhead Assembly WS 66 Through WS 89 FS 121

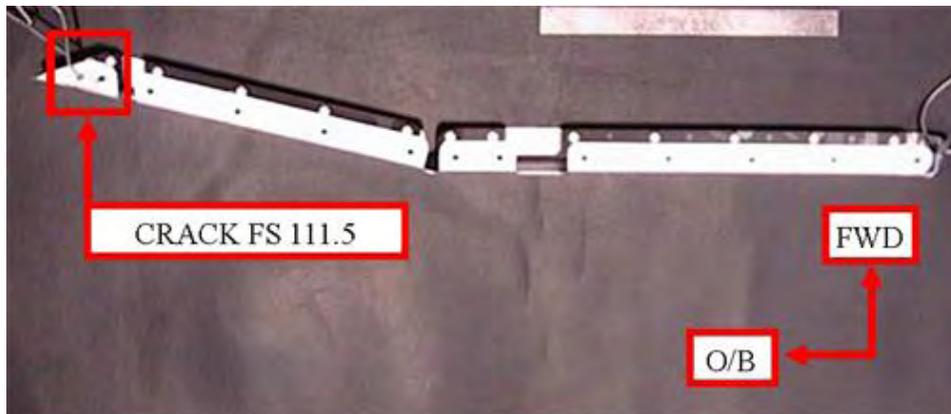
41815 CRK FS 111.5 OV

Figure 324. Location of the Crack on the Right Wing Nacelle Torque Tube Bracket Assembly WS 66 Through WS 89 FS 111.5

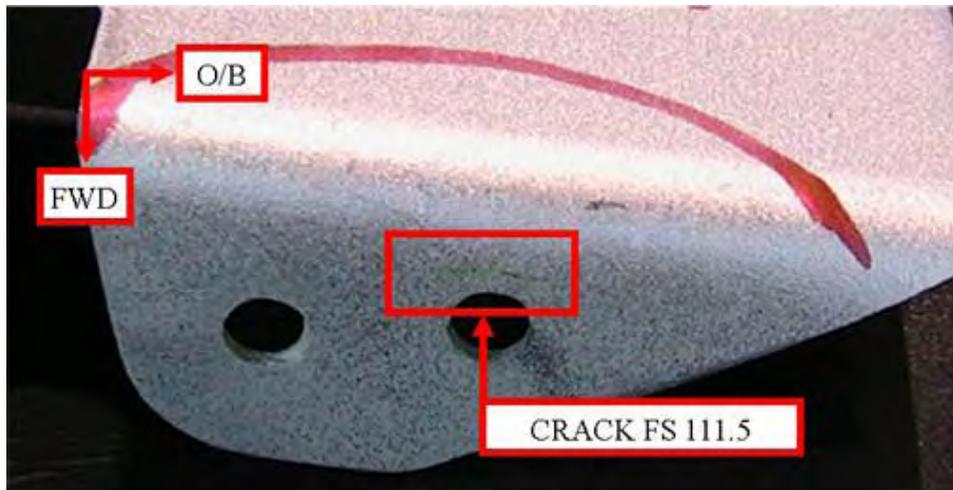
41815 CRK FS 111.5 Mac

Figure 325. Macroscopic View of Crack on the Right Wing Nacelle Torque Tube Bracket Assembly FS 111.5

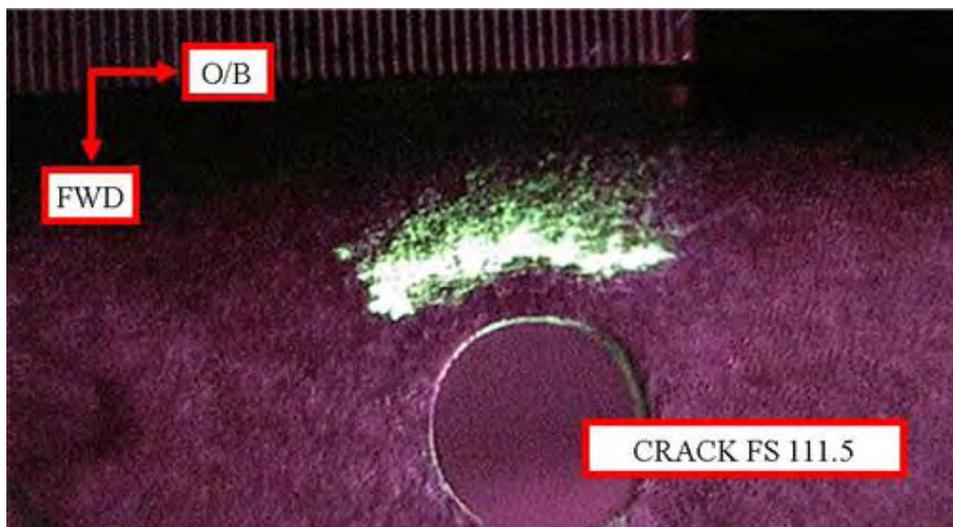
41815 CRK FS 111.5 FLP

Figure 326. Fluorescent Liquid Penetrant Indication on the Right Wing Nacelle Torque Tube Bracket Assembly FS 111.5

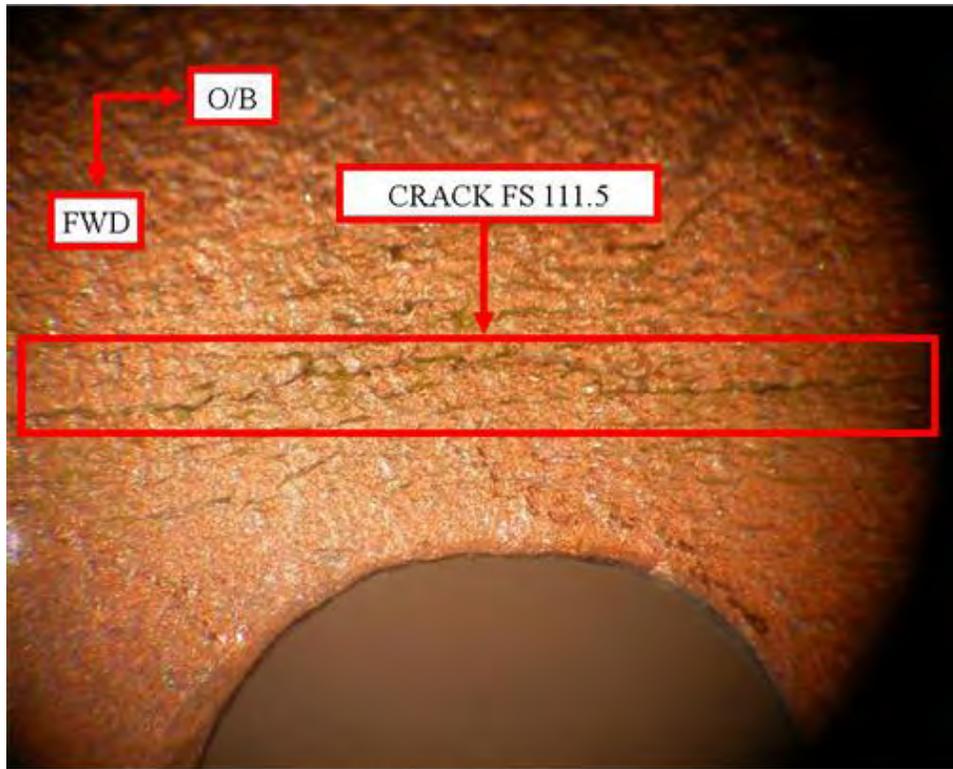
41815 CRK FS 111.5 Mic

Figure 327. Microscopic View of Crack on the Right Wing Nacelle Torque Tube Bracket Assembly FS 111.5

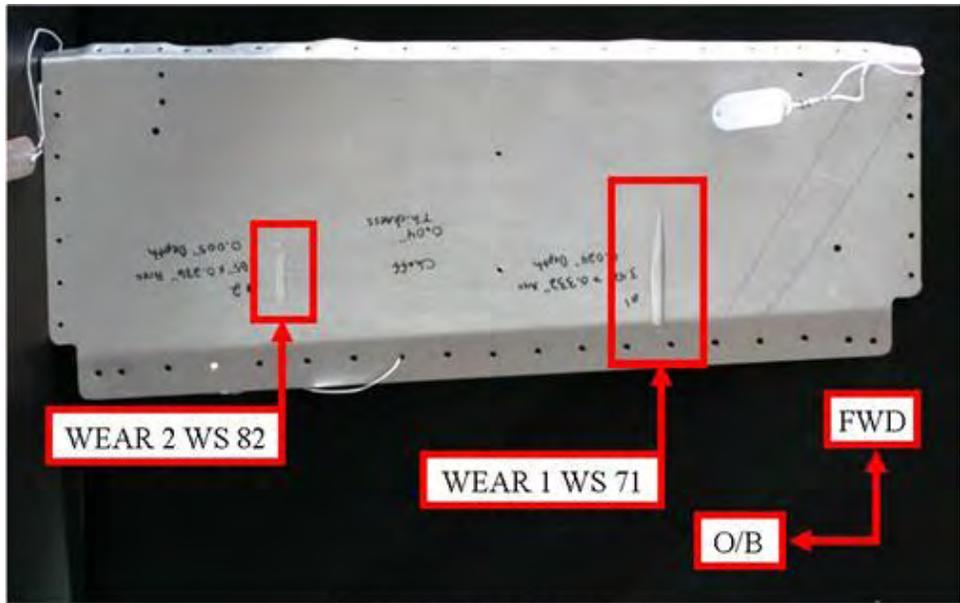
40671-01A Wear FS 111.5-121 OV

The location of two areas of wear on the right wing nacelle plate assembly firewall shear, part number 40671-01A, is shown in figure 328. A macroscopic view of wear 1 is shown in figure 329. This 1.14-square-inch area of wear was located at WS 71 and caused a maximum reduction in thickness of 60%. Figure 330 shows a macroscopic view of wear 2 on the firewall shear at WS 82. This 0.44-square-inch area of corrosion caused a maximum thickness loss of 12.5%. Figure 331 shows the location of two cracks on the right wing trunnion landing gear aft, part number 40288-00A, at WS 77.5. A macroscopic view of crack 1, measuring 0.210 inch, is shown in figure 332, and the fluorescent liquid penetrant indication of this crack is shown in figure 333. Figure 334 shows a macroscopic view of crack 2, and figure 335 shows the fluorescent liquid penetrant indication for this 0.172-inch-long crack. A microscopic view of crack 2 is shown in figure 336.

Figure 328. Location of Wear 1 and 2 on the Right Wing Nacelle Plate Assembly Firewall Shear WS 71 and WS 82

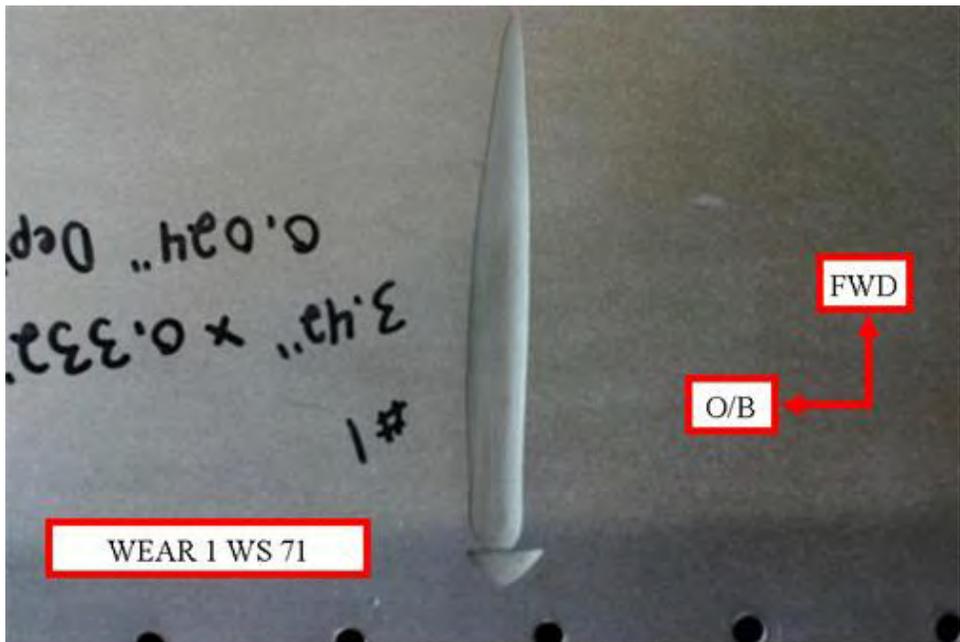
40671-01A Wear 1 FS 111.5-121 Mac

Figure 329. Macroscopic View of Wear 1 on the Right Wing Nacelle Plate Assembly Firewall Shear WS 71

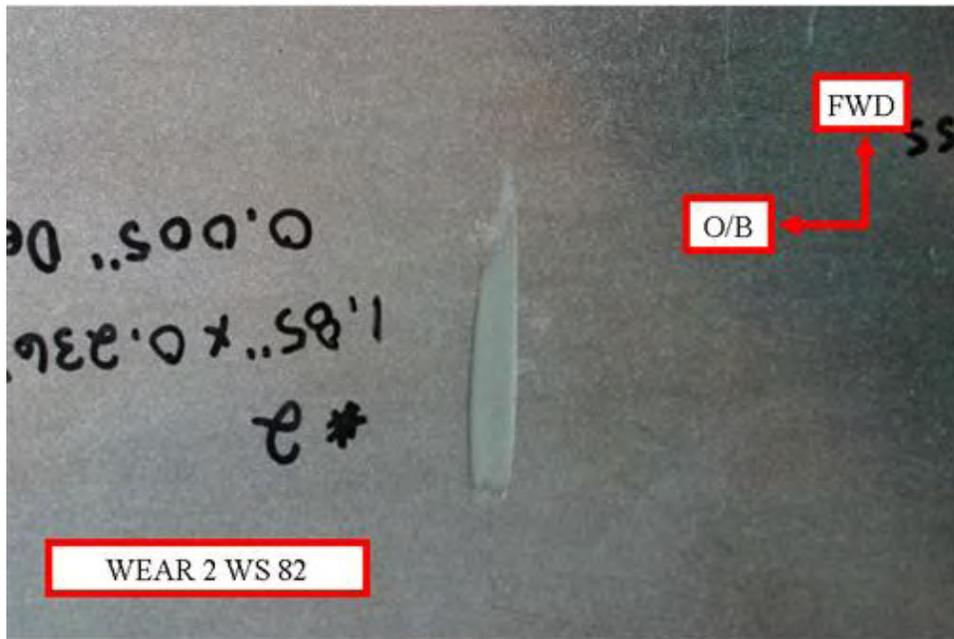
40671-01A Wear 2 FS 111.5-121 Mac

Figure 330. Macroscopic View of Wear 2 on the Right Wing Nacelle Plate Assembly Firewall Shear WS 82

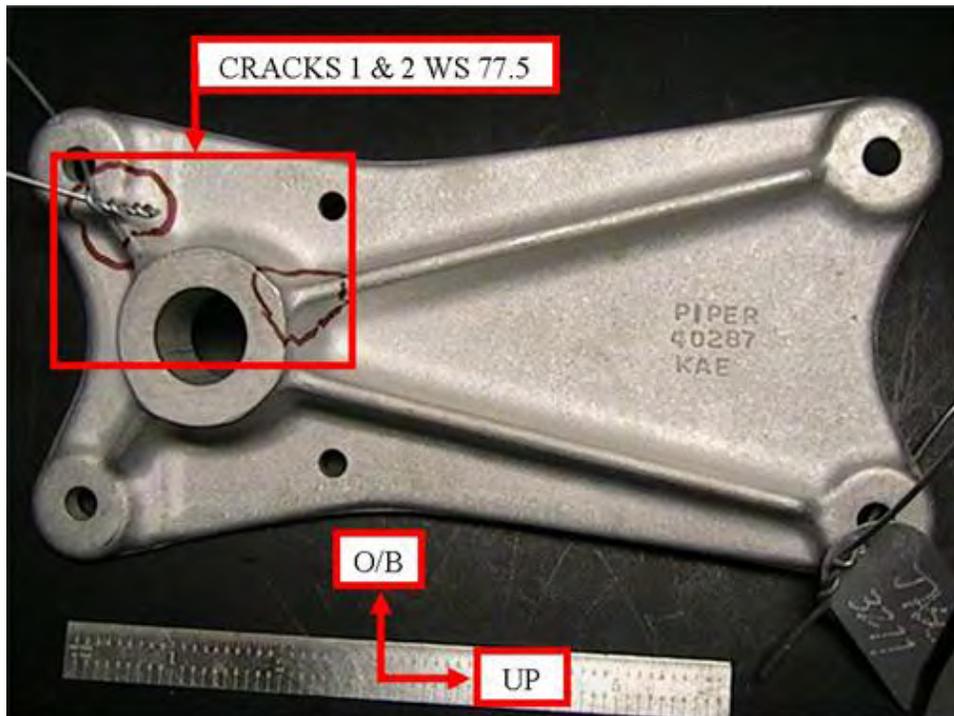
40288-00A CRK WS 77.5 OV

Figure 331. Location of Cracks 1 and 2 on the Right Wing Trunnion Landing Gear Aft WS 77.5

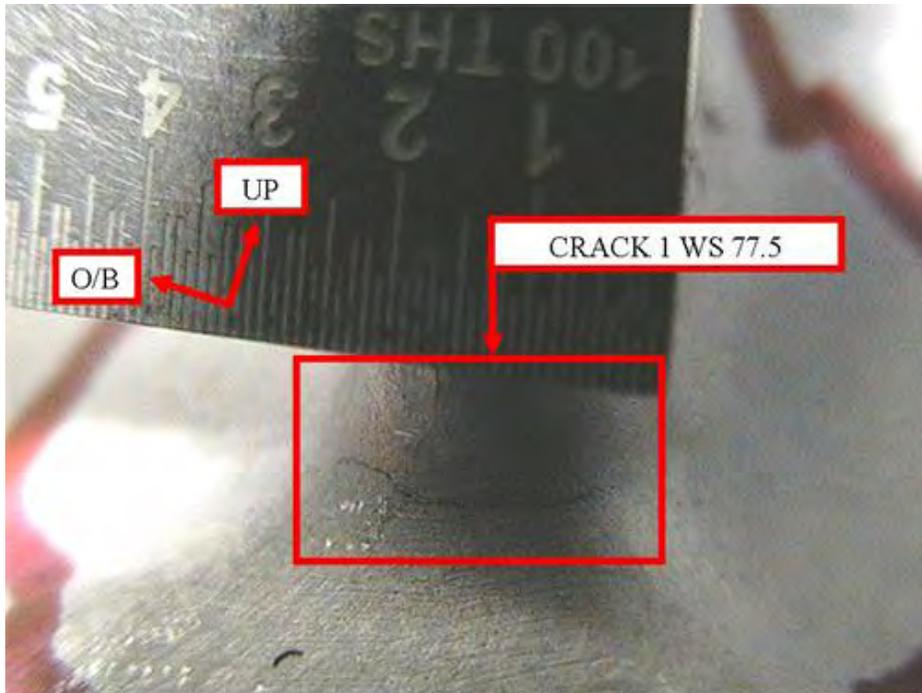
40288-00A CRK 1 WS 77.5 Mac

Figure 332. Macroscopic View of Crack 1 on the Right Wing Trunnion Landing Gear Aft WS 77.5

Part Nomenclature	Revised Inspection	Location
LT wing main gear aft fitting	Remove paint and perform BHEC and LPI	Figure 179
LT wing trunnion landing gear aft	Remove paint and perform BHEC and LPI	Figure 198
RT Wing trunnion landing gear aft	Remove paint and perform BHEC and LPI	Figure 332

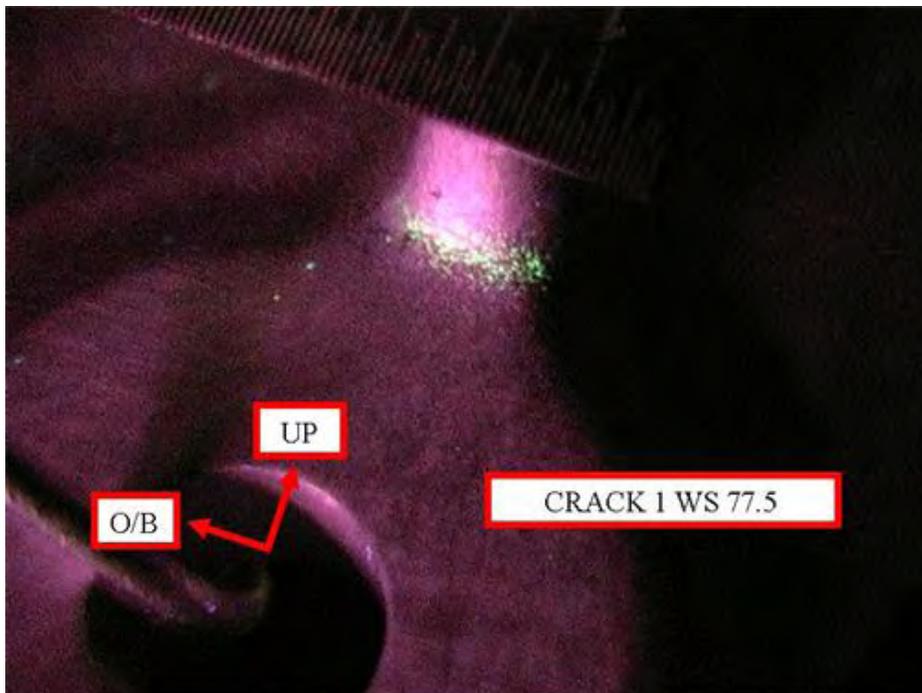
40288-00A CRK 1 WS 77.5 FLP

Figure 333. Fluorescent Liquid Penetrant Indication of Crack 1 on the Right Wing Trunnion Landing Gear Aft WS 77.5

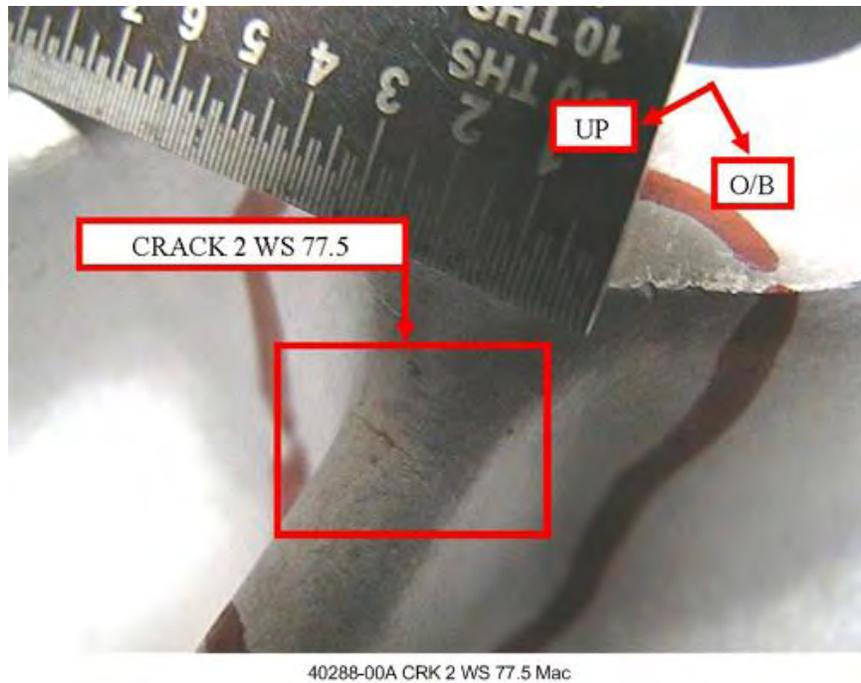
Figure 334. Macroscopic View of Crack 2 on the Right Wing Trunnion Landing Gear Aft WS 77.5

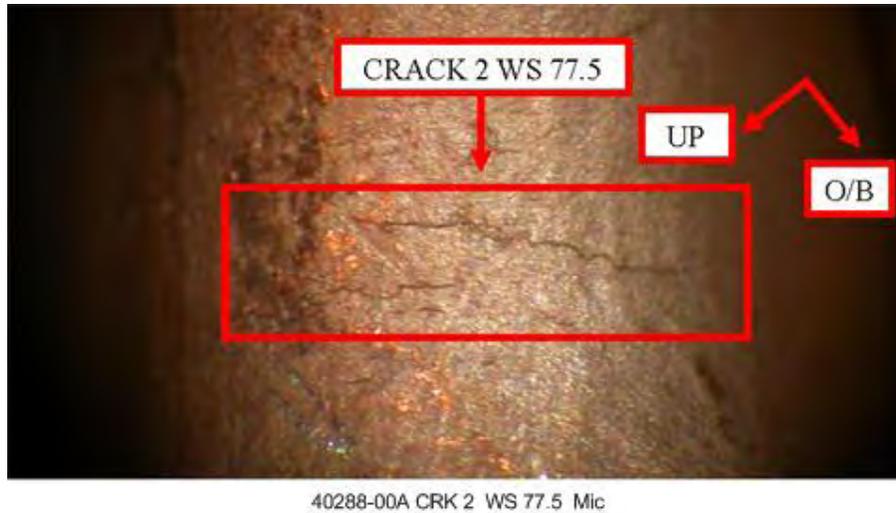
Figure 336. Microscopic View of Crack 2 on the Right Wing Trunnion Landing Gear Aft WS 77.5

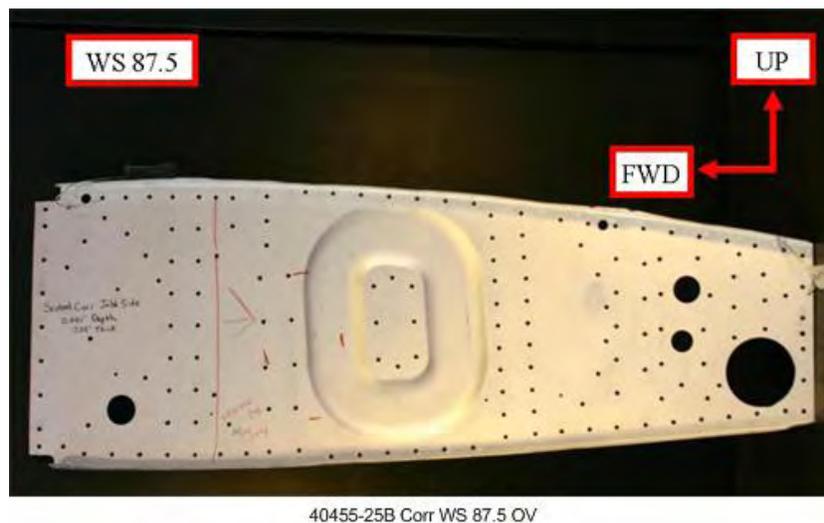
The location of light scattered corrosion, causing a maximum thickness loss of 2%, on the right wing rear spar rib assembly, part number 40455-25B, is shown in figure 337 at WS 87.5. Figure 338 shows the location of a crack and light-moderate scattered corrosion on the right wing nacelle outboard longitudinal bulkhead, part number 44437-07. The light-moderate corrosion was scattered at WS 89 FS 182.25 to FS 210.75 and resulted in a maximum reduction in thickness of 4%. A macroscopic view of the 2.29-inch crack located at WS 89 FS 210.75 is shown in figure 339. The location of a 0.047-inch crack on the right wing flap track, part number 45381-15B, is shown in figure 340, and a macroscopic view of this crack is shown in figure 341. The fluorescent liquid penetrant indication of this crack, located at WS 147.5, is shown in figure 342. Figure 343 shows the location of light scattered corrosion on the right aileron hinge, part number 45384-00. This corrosion caused a localized thickness loss of less than 1%.

Figure 337. Location of Light Corrosion on the Right Wing Rear Spar Rib Assembly WS 87.5

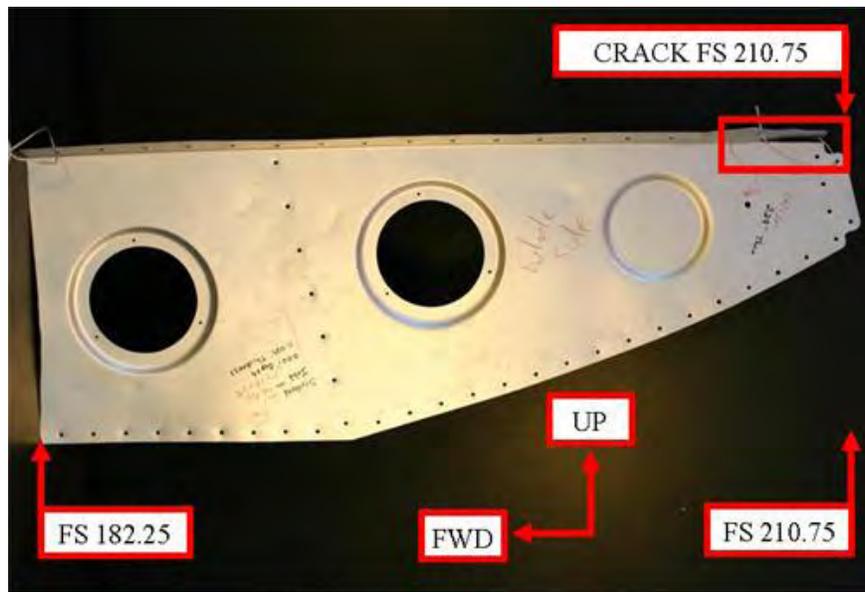
44437-07 Corr FS 182.25-210.75 WS 89 OV

Figure 338. Location of Crack and Overview of Right Wing Nacelle Outboard Longitudinal Bulkhead WS 89 FS 182.25 Through FS 210.75
