DOT/FAA/AR-07/64

Teardown Evaluation of a 1975 Piper Navajo Chieftain Model PA31-350 Airplane

March 2008

Final Report

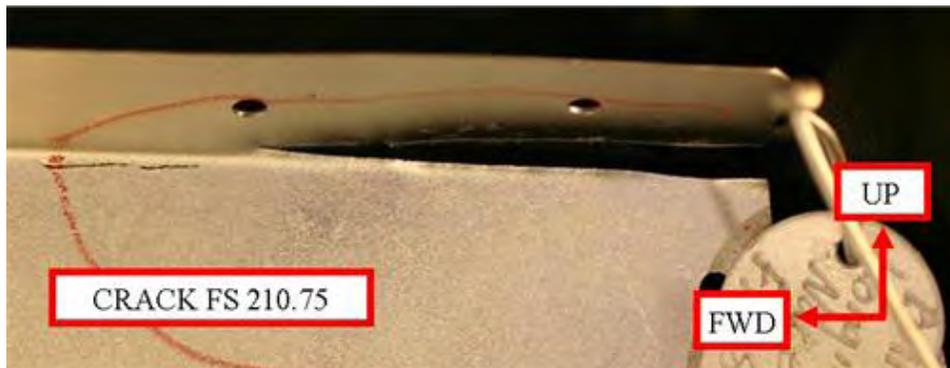
44437-07 CRK FS 182.25-210.75 WS 89 Mac

Figure 339. Macroscopic View of Crack on the Right Wing Nacelle Outboard Longitudinal Bulkhead WS 89 FS 210.75

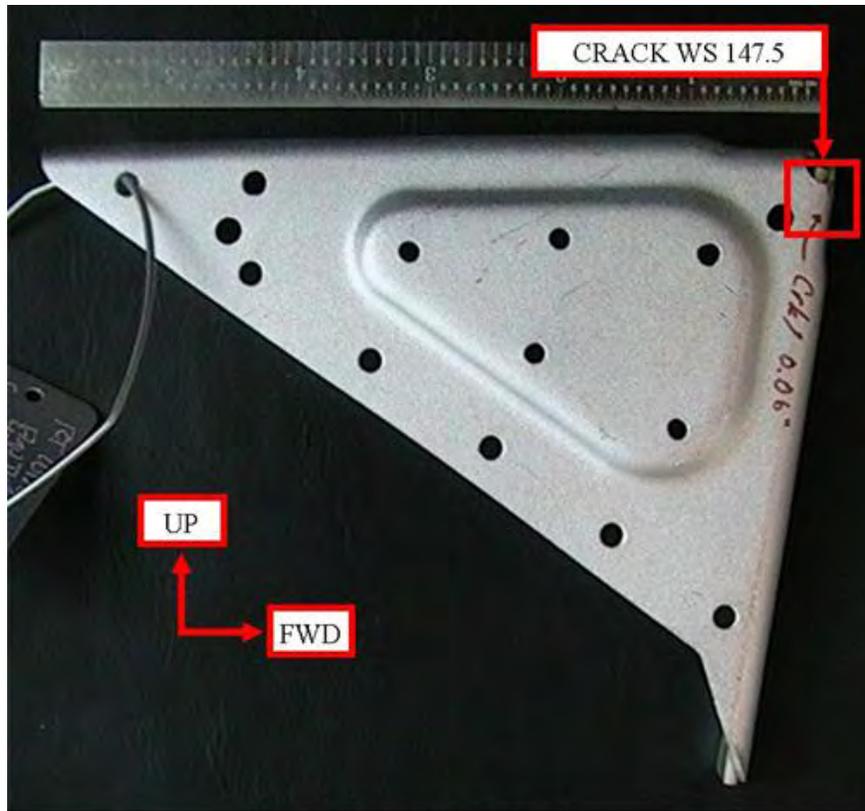
45351-15B CRK WS147.5 OV

Figure 340. Location of Crack on the Right Wing Flap Track WS 147.5

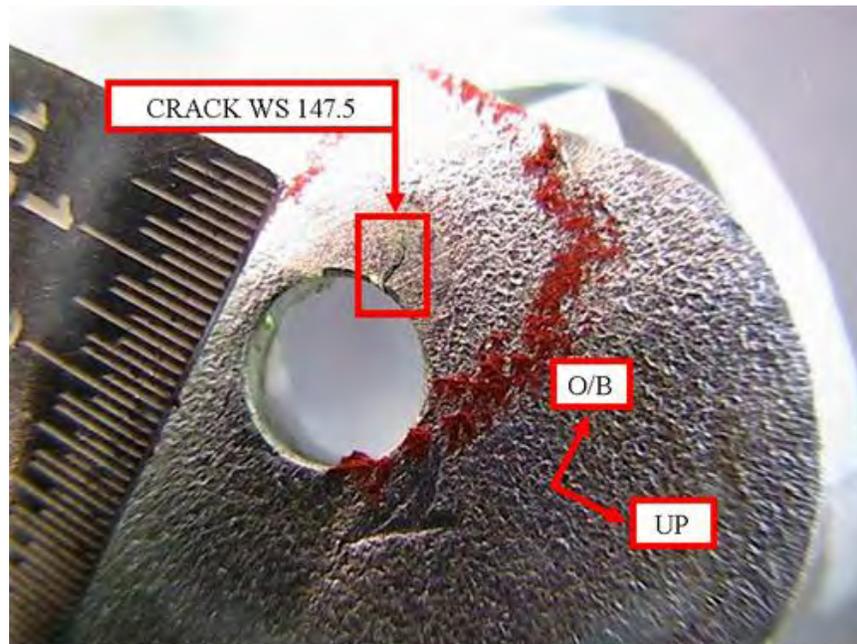
45381-15B CRK WS 147.5 Mac

Figure 341. Macroscopic View of Crack on the Right Wing Flap Track WS 147.5

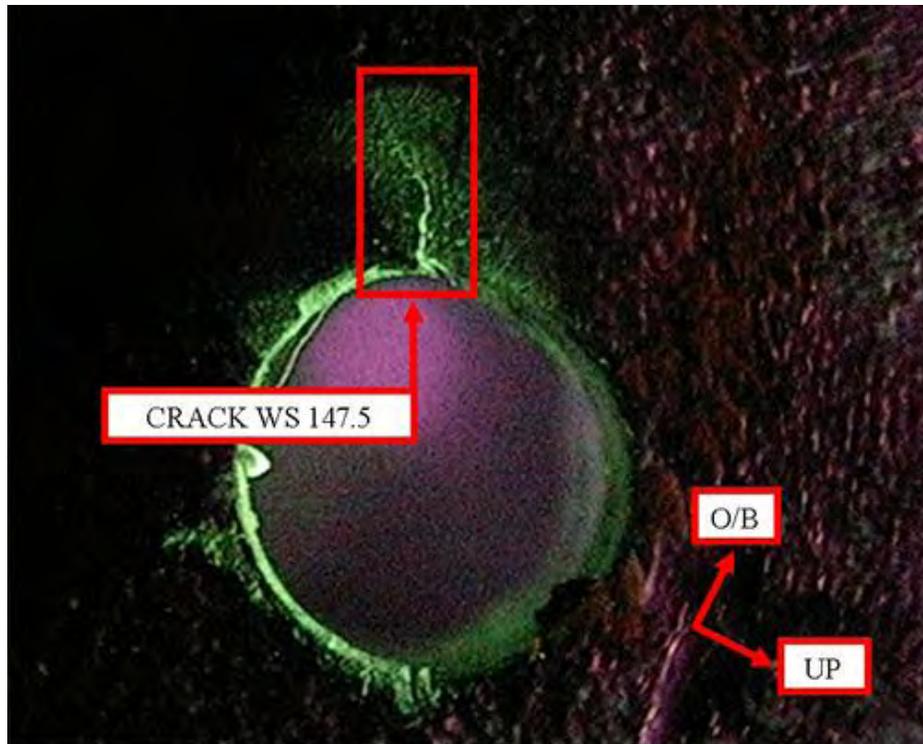
45381-15B CRK WS 147.5 FLP

Figure 342. Fluorescent Liquid Penetrant Indication of the Crack on the Right Wing Flap Track WS 147.5

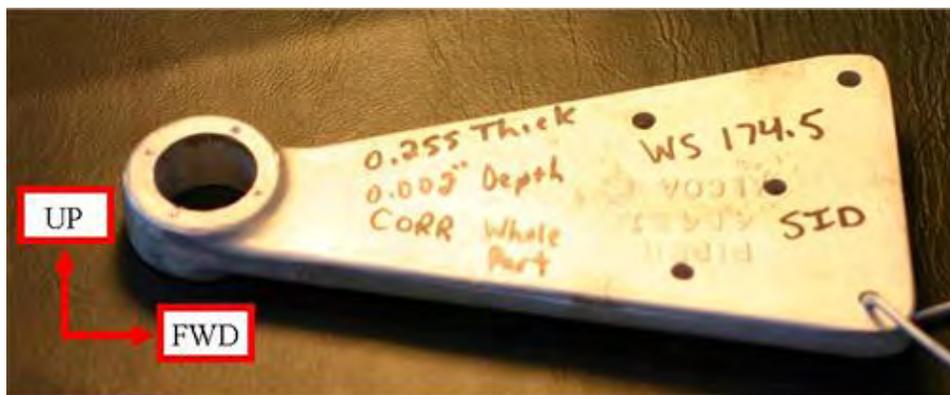
45384-00 Corr WS 174.5 OV

Figure 343. Location of Light Corrosion on the Right Aileron Hinge WS 174.5

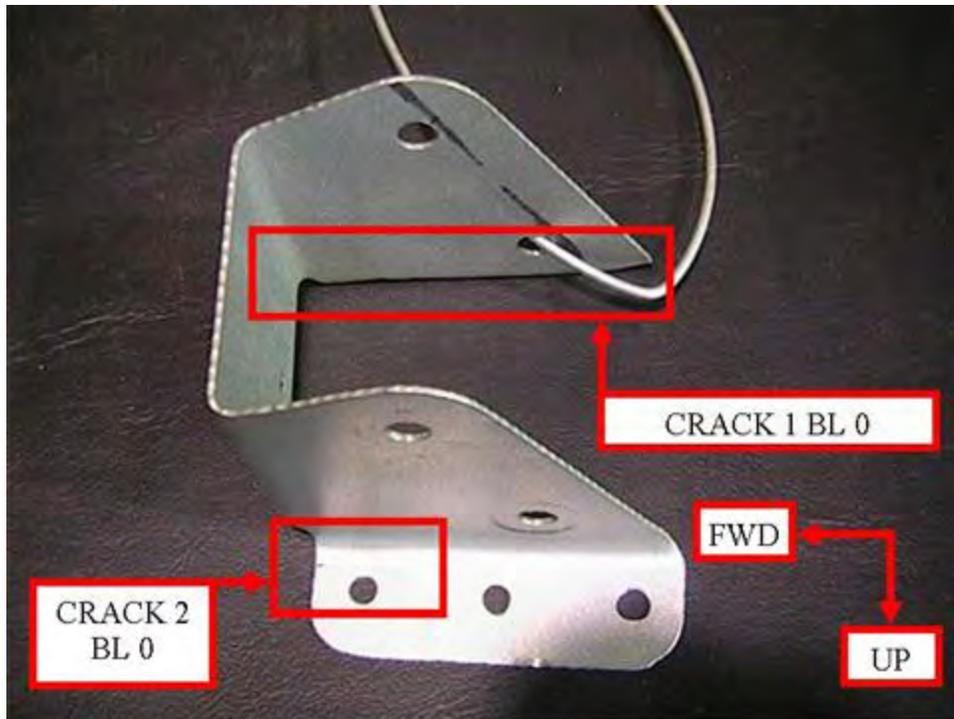
40908 CRK BL0 OV

Figure 344 shows the location of two cracks on the windshield bracket, part number 40908, at BL 0. A macroscopic view of crack 1, which measured 1.685 inches, is shown in figure 345, and the fracture face is shown in figure 346. This fracture face shows crack face characteristics typical of fatigue. Figure 347 shows a macroscopic view of crack 2 on the windshield bracket, and the fracture face is shown in figure 348. Through analysis of the crack face, it was determined that this 0.461-inch crack was caused by fatigue. The location of light-moderate corrosion on the fuselage lower forward skin, part number 40887-6, is shown in figure 349. This 147-square-inch area of corrosion was located from FS 2 to FS 23 and caused a maximum reduction in thickness of 5%. The location of multiple cracks on the stiffener angle, part number 44717-5, is shown in figure 350. These cracks measured 0.03 inch each and had grown only about 10% through the thickness of the part. A microscopic view of these cracks, which occurred at FS 2, are shown in figure 351.

Figure 344. Location of Crack 1 and 2 on the Windshield Bracket BL 0

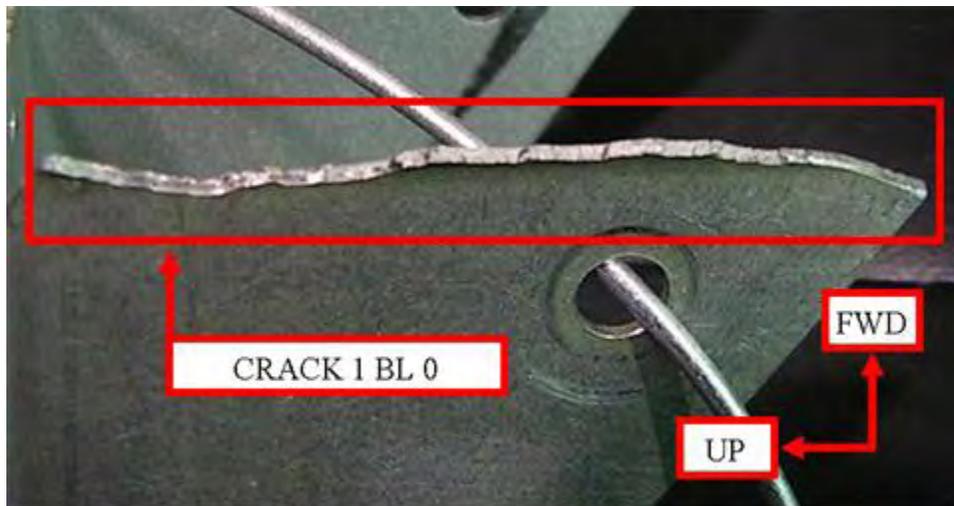
40908 CRK 1 BL0 Mac

Figure 345. Macroscopic View of Crack 1 on the Windshield Bracket BL 0

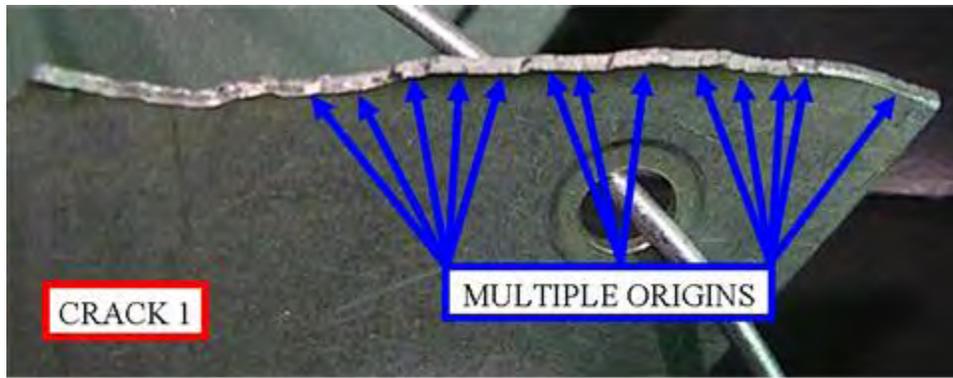
40908 CRK 1 BL0 Frac

Figure 346. Fracture Face of Crack 1 on the Windshield Bracket BL 0

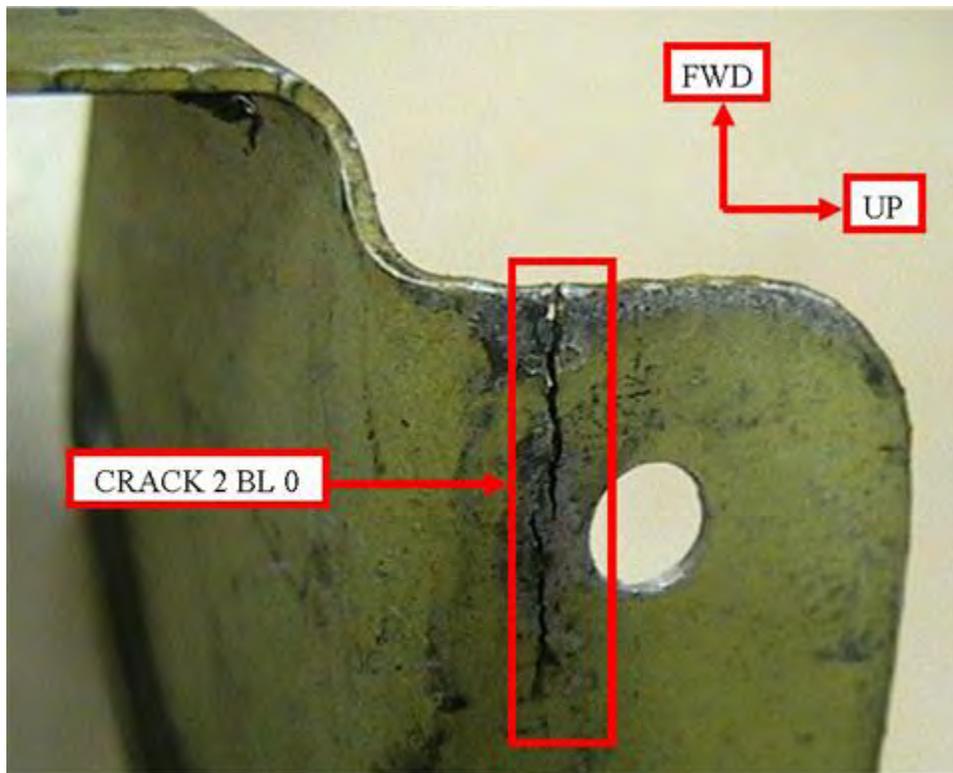
40908 CRK 2 BL0 Mac

Figure 347. Macroscopic View of Crack 2 on the Windshield Bracket BL 0

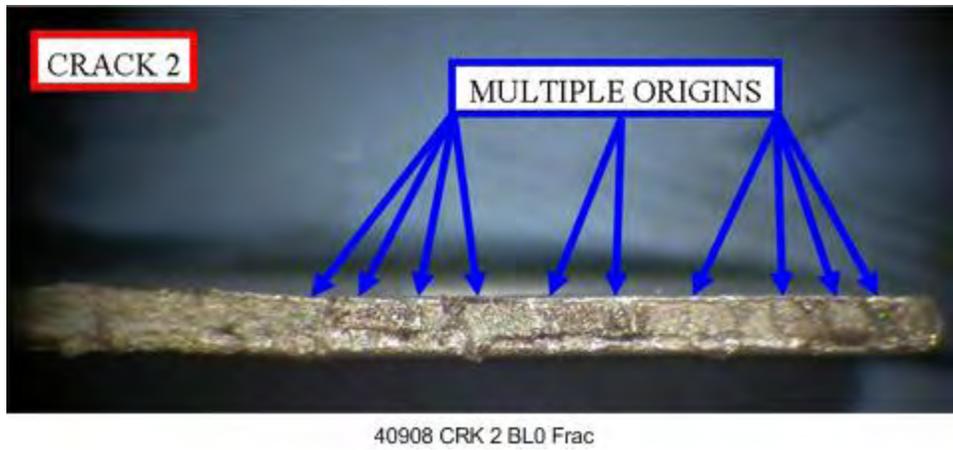
Figure 348. Fracture Face of Crack 2 on the Windshield Bracket BL 0

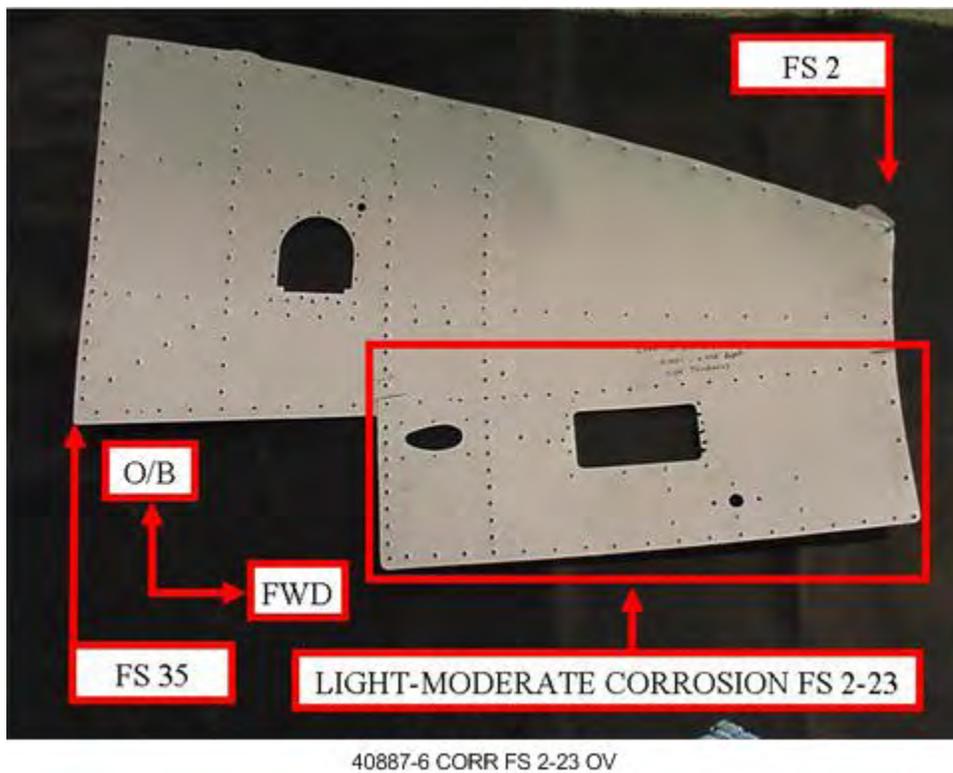
Figure 349. Location of Light-Moderate Corrosion on the Fuselage Lower Forward Skin FS 2 Through FS 23

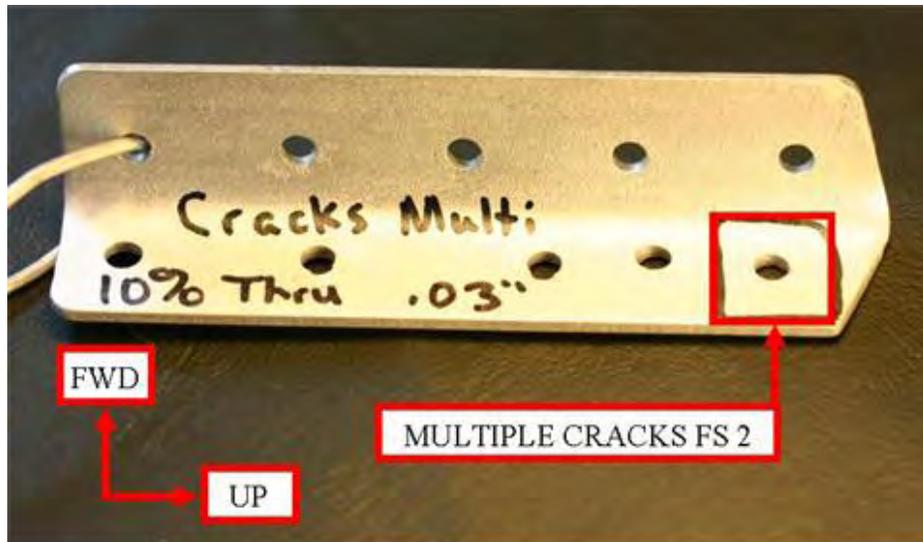
44717-5 CRK FS2 OV

Figure 350. Location of Multiple Cracks on the Stiffener Angle FS 2

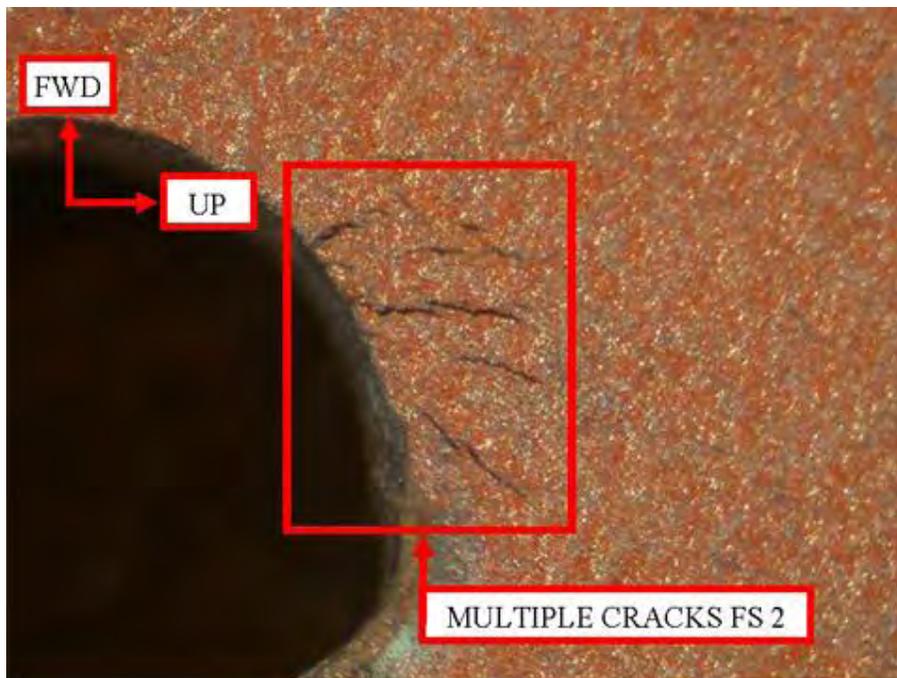
44717-5 MULTI CRKS FS2 Mic

Figure 351. Microscopic View of Multiple Cracks on the Stiffener Angle FS 2

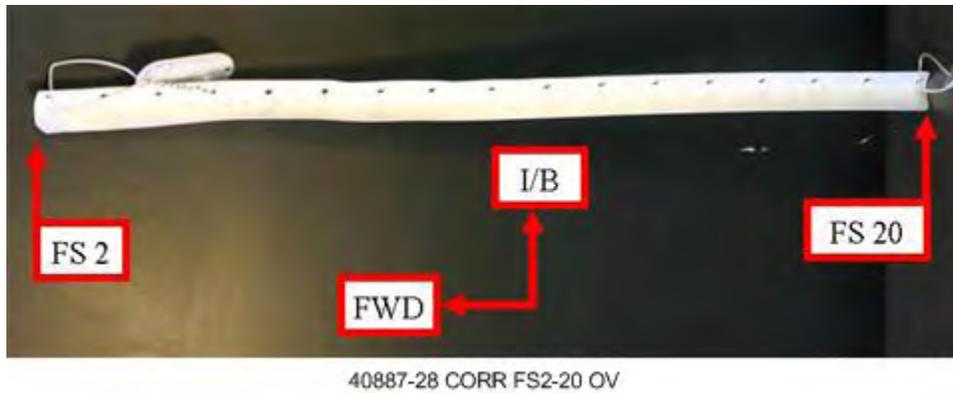
Figure 352 shows the location of severe corrosion on the lower forward fuselage right side skin angle attachment, part number 40887-28, from FS 2 to FS 20. This 9.64-square-inch area of corrosion caused a maximum localized thickness loss of 15.6%. Figure 353 shows a macroscopic view of this area of corrosion. The location of a 0.341-inch-long crack on the battery box, part number 53959-000, is shown in figure 354 at FS 2. Figure 355 shows a macroscopic view of this crack, while a microscopic view is shown in figure 356.

Figure 352. Location of Severe Corrosion on the Lower Forward Fuselage Right Side Skin Angle Attachment FS 2 Through FS 20

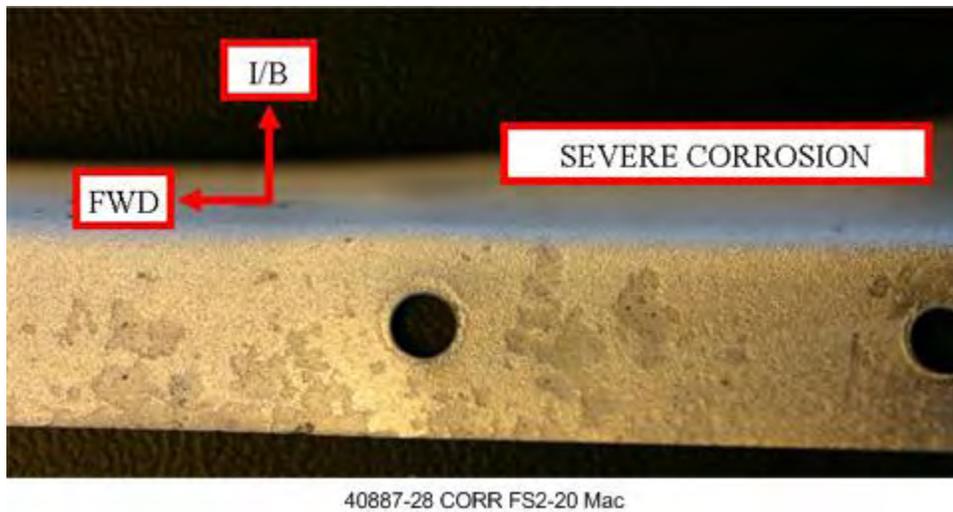
Figure 353. Macroscopic View of Severe Corrosion on the Lower Forward Fuselage Right Side Skin Angle Attachment FS 2 Through FS 20

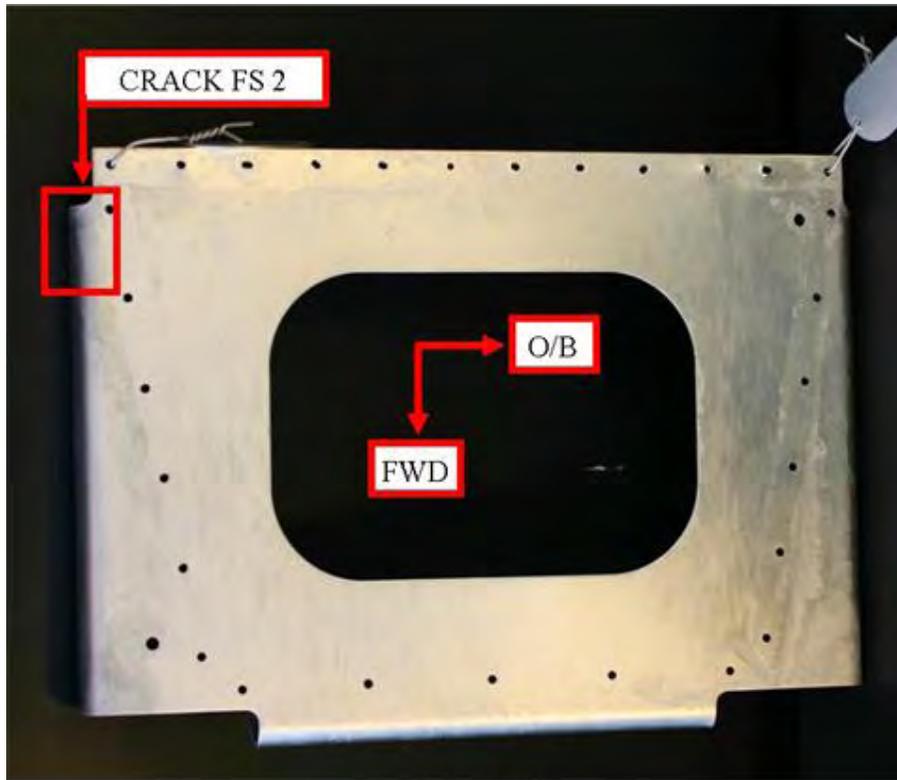
53959-00 CRK FS2 OV

Figure 354. Location of Crack on the Battery Box FS 2

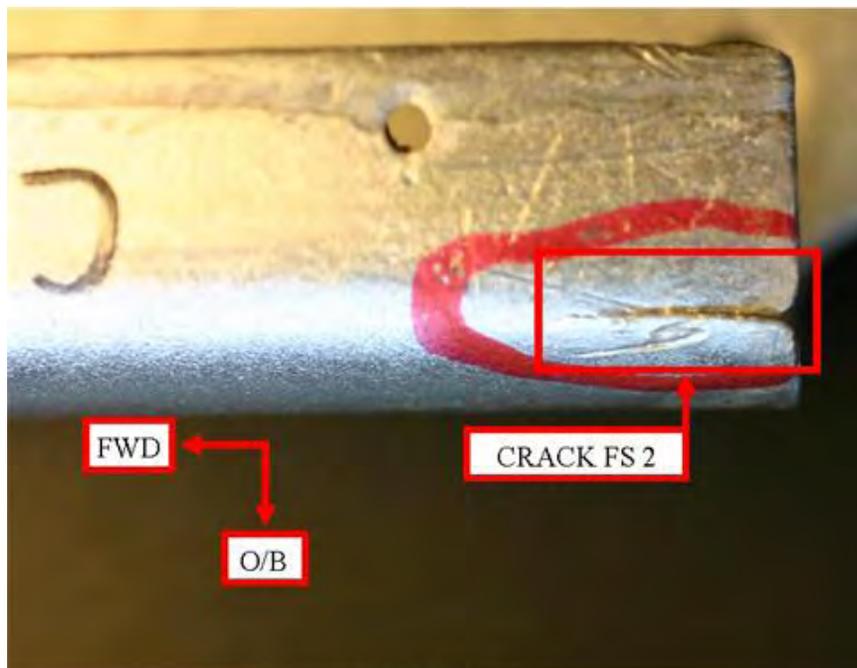
53959-00 CRK FS2 Mac

Figure 355. Macroscopic View of the Crack on the Battery Box FS 2

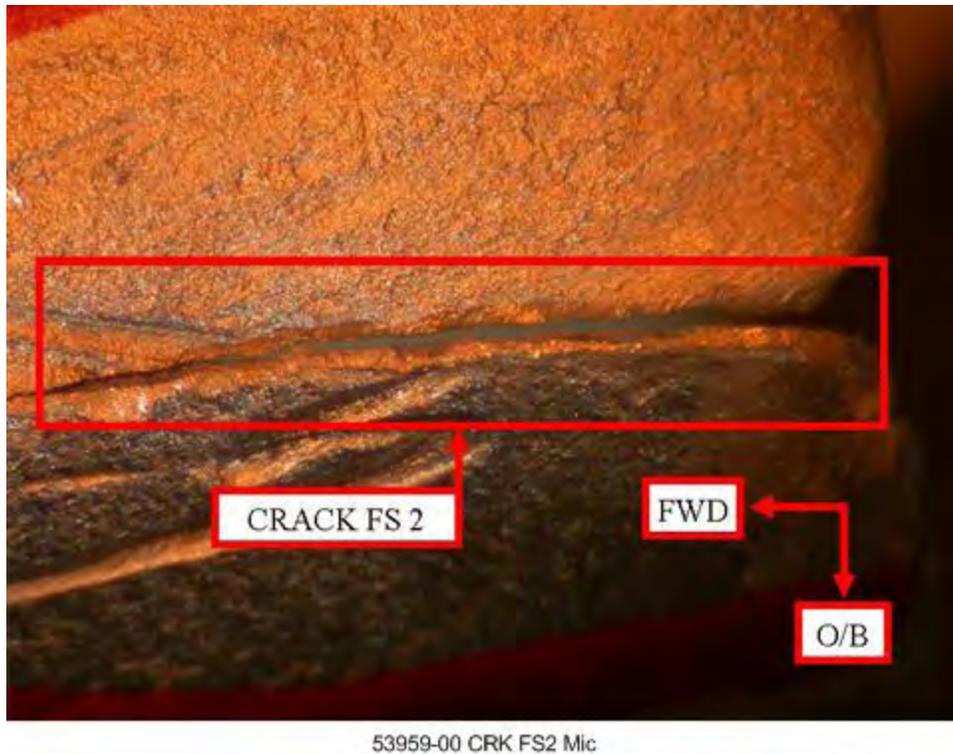
Figure 356. Microscopic View of Crack on the Battery Box FS 2

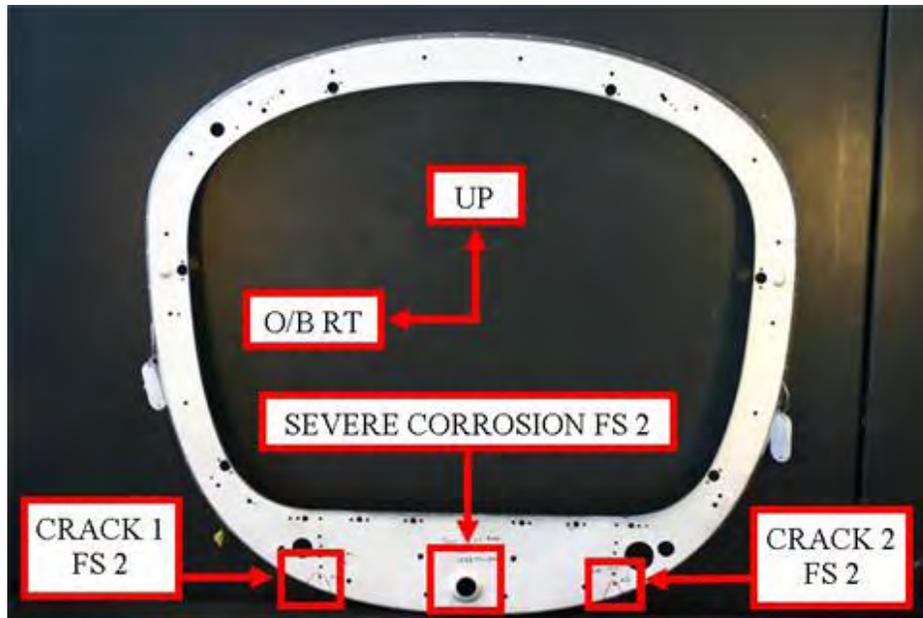
71790-02 CRK FS2 OV

Figure 357 shows the location of two cracks and one 13-square-inch area of severe corrosion on the bulkhead assembly, part number 71790-2. A macroscopic view of the severe corrosion, located at FS 2, is shown in figure 358. This area of corrosion caused a localized reduction in thickness of 22%, which is categorized as severe corrosion. Figure 359 shows a macroscopic view of crack 1, which measured 0.836 inch and was located at FS 2. The fluorescent liquid penetrant indication is shown in figure 360, and a microscopic view of crack 1 is shown in figure 361. Figure 362 shows a macroscopic view of crack 2 on the bulkhead assembly, located at FS 2. The fluorescent liquid penetrant indication is shown in figure 363. A microscopic view of crack 2, which measures 0.545 inch in length and also occurs at FS 2, is shown in figure 364. Figure 365 shows the location of an 11.69-square-inch area of light-moderate corrosion, located from FS 2 to FS 15.25 on the right fuselage upper angle longitudinal beam assembly, part number 44877-01A. This area of corrosion caused a localized reduction in thickness of 4.2%.

Figure 357. Location of Two Cracks and Severe Corrosion on the Bulkhead Assembly FS 2

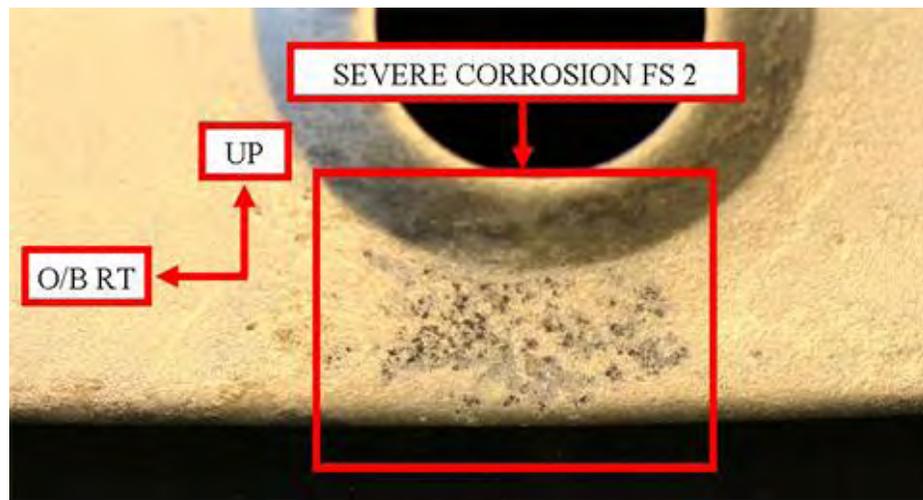
71790-02 CORR FS2 Mac

Figure 358. Macroscopic View of Severe Corrosion on the Bulkhead Assembly FS 2

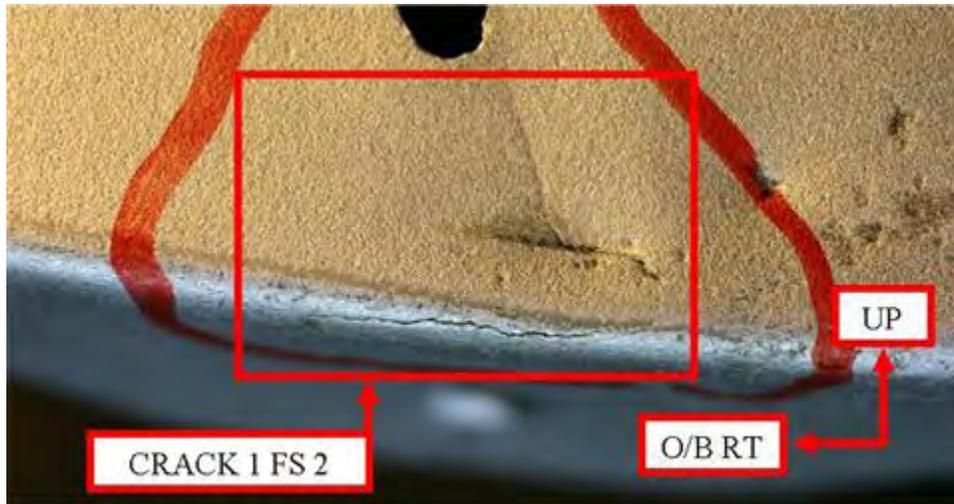
71790-02 CRK 1 FS2 Mac

Figure 359. Macroscopic View of Crack 1 on the Bulkhead Assembly FS 2

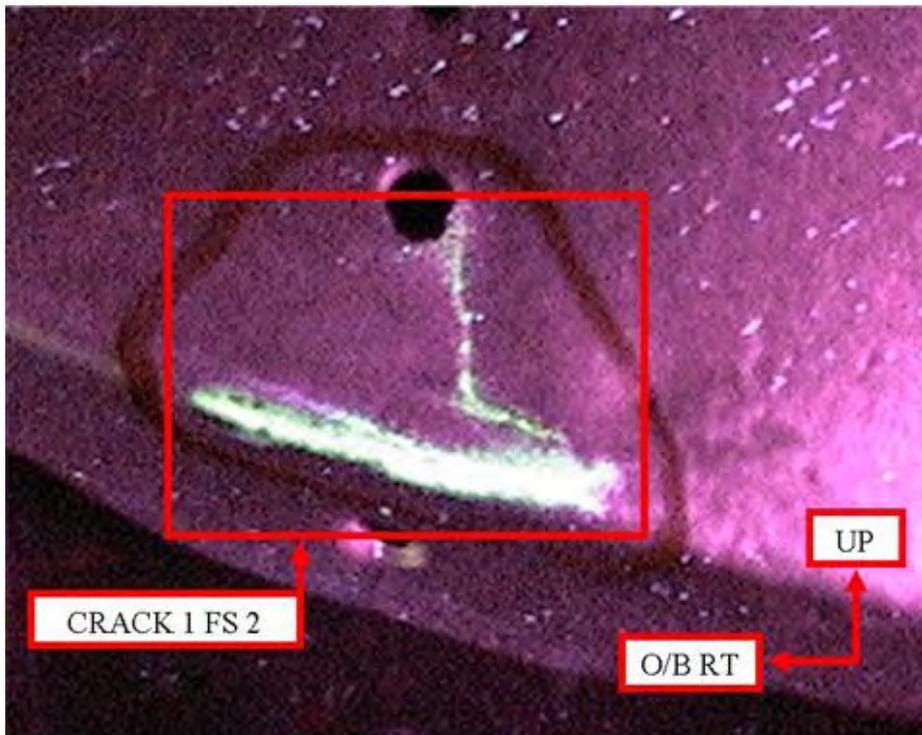
71790-02 CRK 1 FS2 FLP

Figure 360. Fluorescent Liquid Penetrant Indication of Crack 1 on the Bulkhead Assembly FS 2

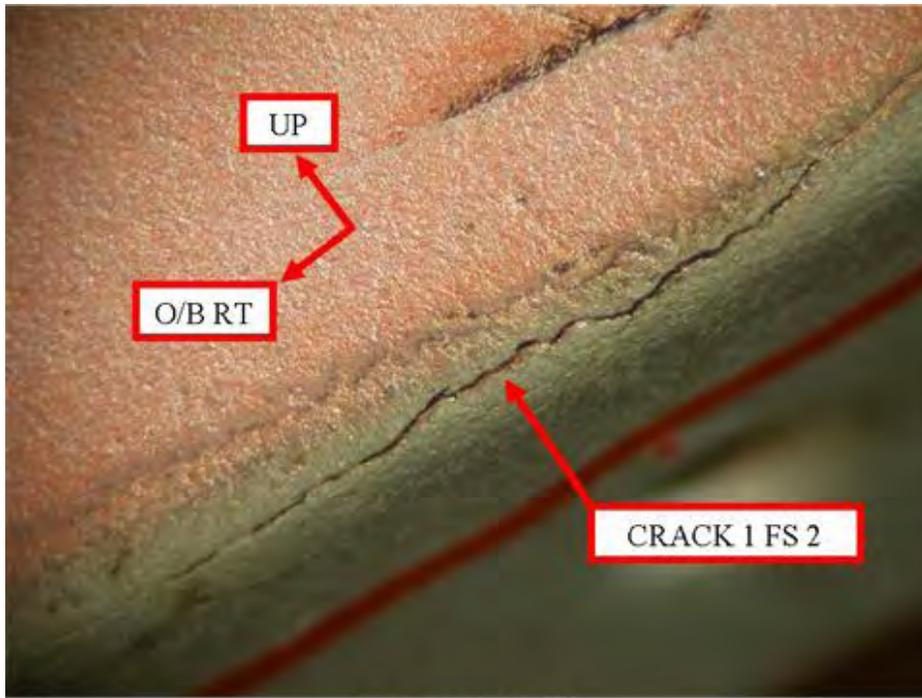
71790-02 CRK 1 FS2 Mic

Figure 361. Microscopic View of Crack 1 on the Bulkhead Assembly FS 2

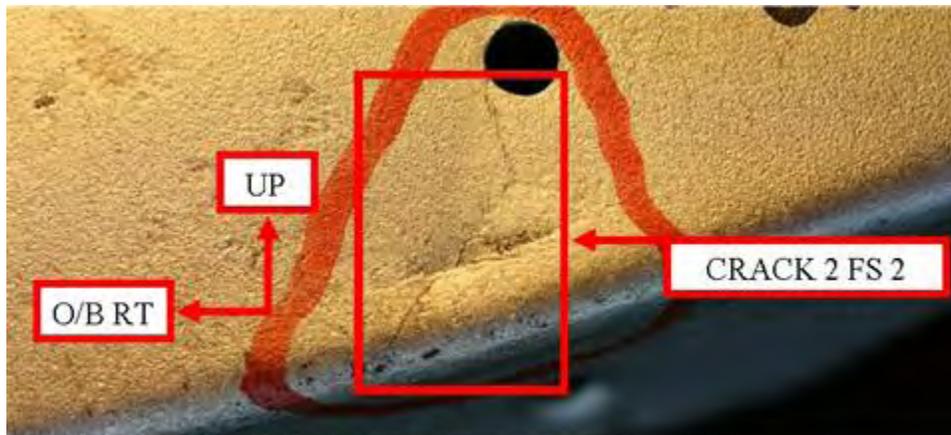
71790-02 CRK 2 FS2 Mac

Figure 362. Macroscopic View of Crack 2 on the Bulkhead Assembly FS 2

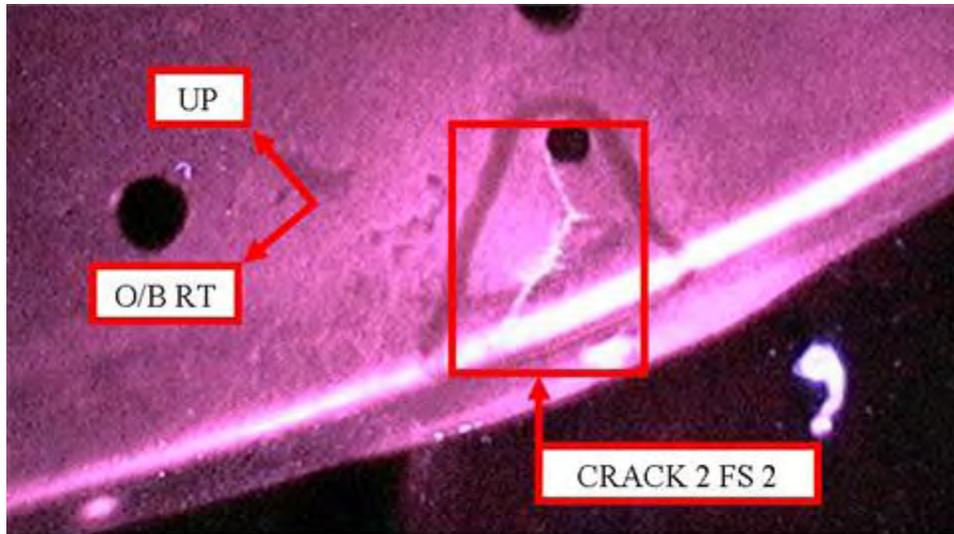
71790-02 CRK 2 FS2 FLP

Figure 363. Fluorescent Liquid Penetrant Indication of Crack 2 on the Bulkhead Assembly FS 2

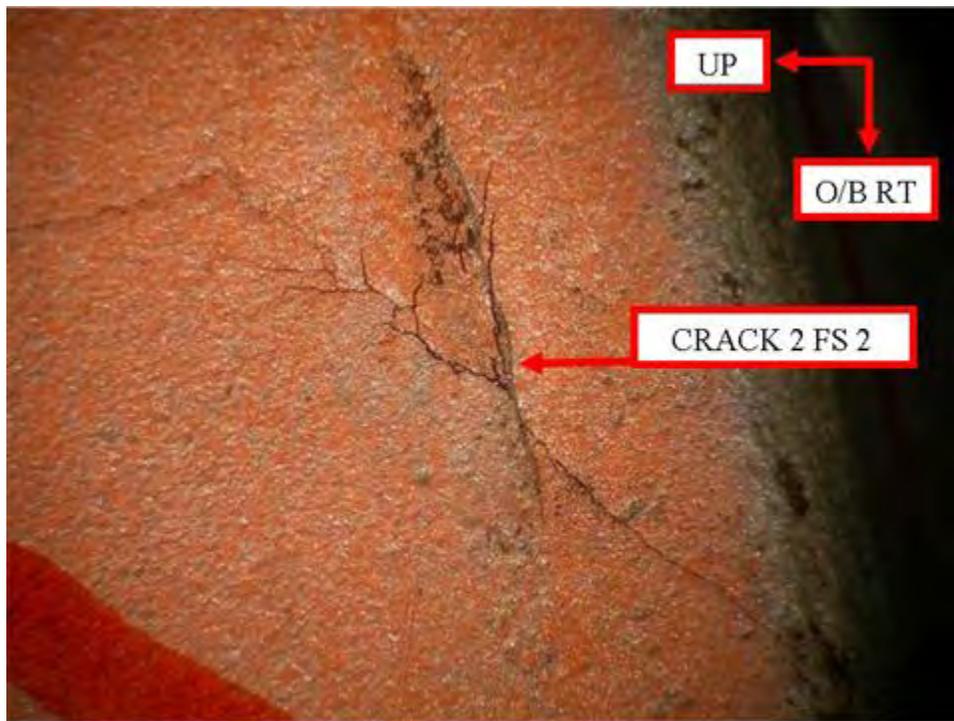
71790-02 CRK 2 FS2 Mic

Figure 364. Microscopic View of Crack 2 on the Bulkhead Assembly FS 2

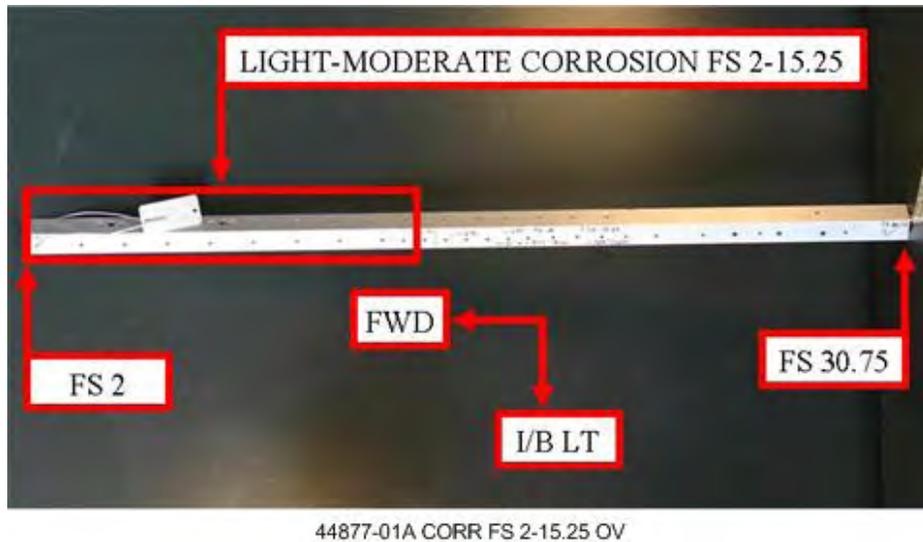
Figure 365. Location of Light-Moderate Corrosion on the Right Fuselage Upper Angle Longitudinal Beam Assembly FS 2 Through FS 15.25

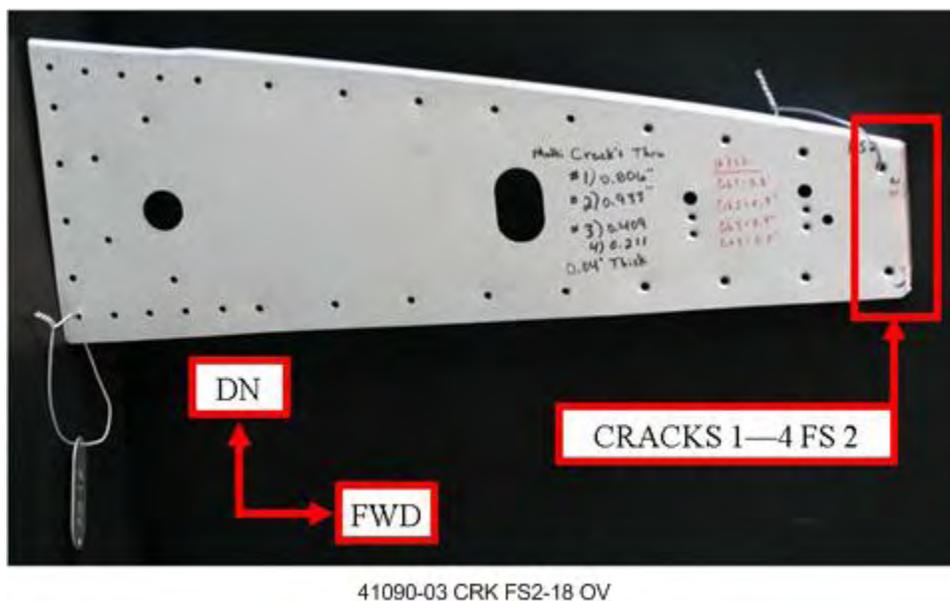
The location of four cracks on the fuselage web-beam assembly lower forward frame right side, part number 41090-03, is shown in figure 366 at FS 2. A macroscopic view of crack 1, which measured 0.806 inch, is shown in figure 367. A macroscopic view of crack 2, which measured 0.933 inch and occurred at FS 2, is shown in figure 368. Figure 369 shows a macroscopic view of crack 3 on the fuselage web-beam, and figure 370 shows the fluorescent liquid penetrant indication of this 0.409-inch crack. A macroscopic view of crack 4, which measures 0.211 inch, is shown in figure 371, and the fluorescent liquid penetrant indication for crack 4 is shown in figure 372.

Figure 366. Location of Cracks on the Fuselage Web-Beam Assembly Lower Forward Frame Right Side FS 2

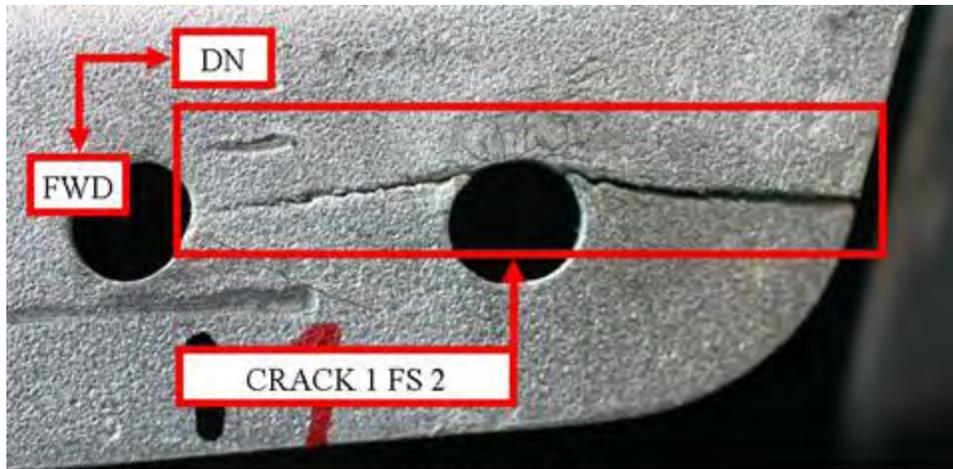
41090-03 CRK 1 FS2 Mac

Figure 367. Macroscopic View of Crack 1 on the Fuselage Web-Beam Assembly Lower Forward Frame Right Side FS 2

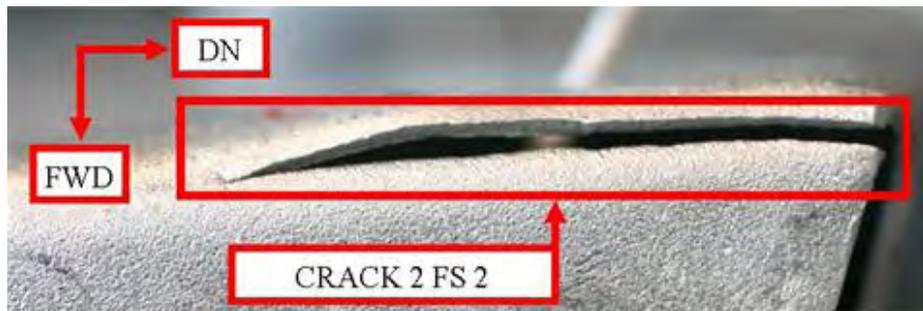
41090-03 CRK 2 FS2 Mac

Figure 368. Macroscopic View of Crack 2 on the Fuselage Web-Beam Assembly Lower Forward Frame Right Side FS 2

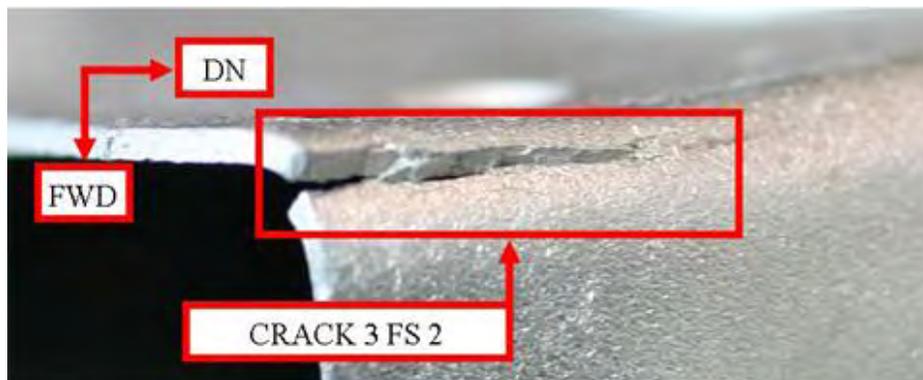
41090-03 CRK 3 FS2 Mac

Figure 369. Macroscopic View of Crack 3 on the Fuselage Web-Beam Assembly Lower Forward Frame Right Side FS 2

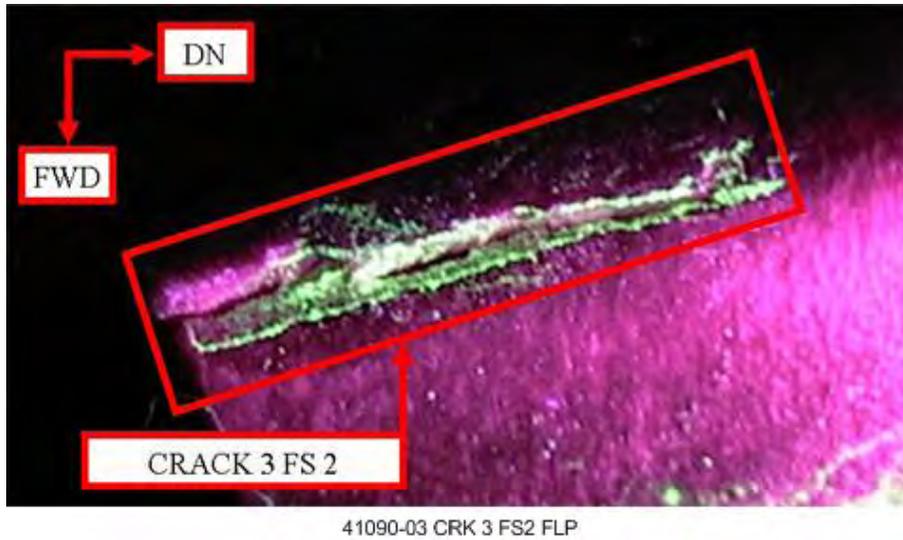
Figure 370. Fluorescent Liquid Penetrant Indication of Crack 3 on the Fuselage Web-Beam Assembly Lower Forward Frame Right Side FS 2

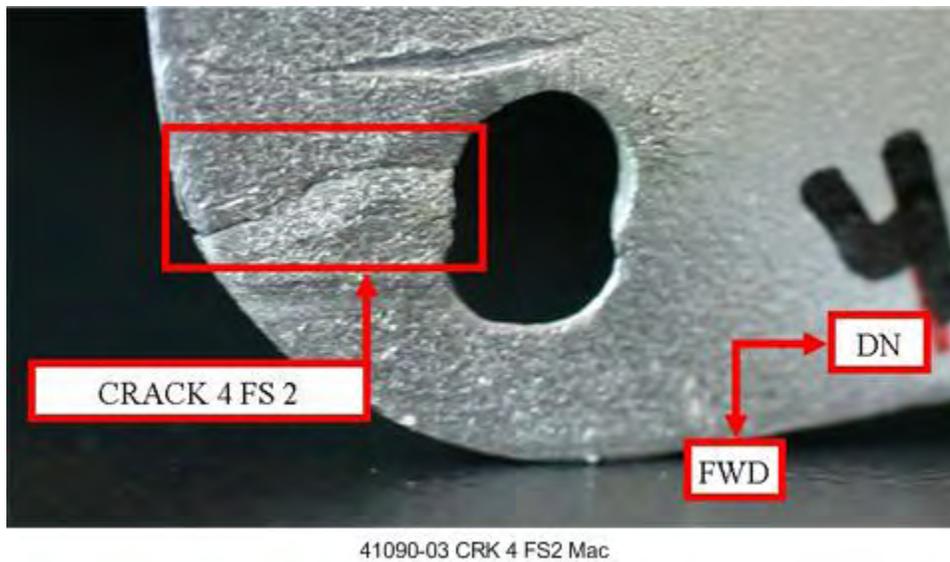
Figure 371. Macroscopic View of Crack 4 on the Fuselage Web-Beam Assembly Lower Forward Frame Right Side FS 2

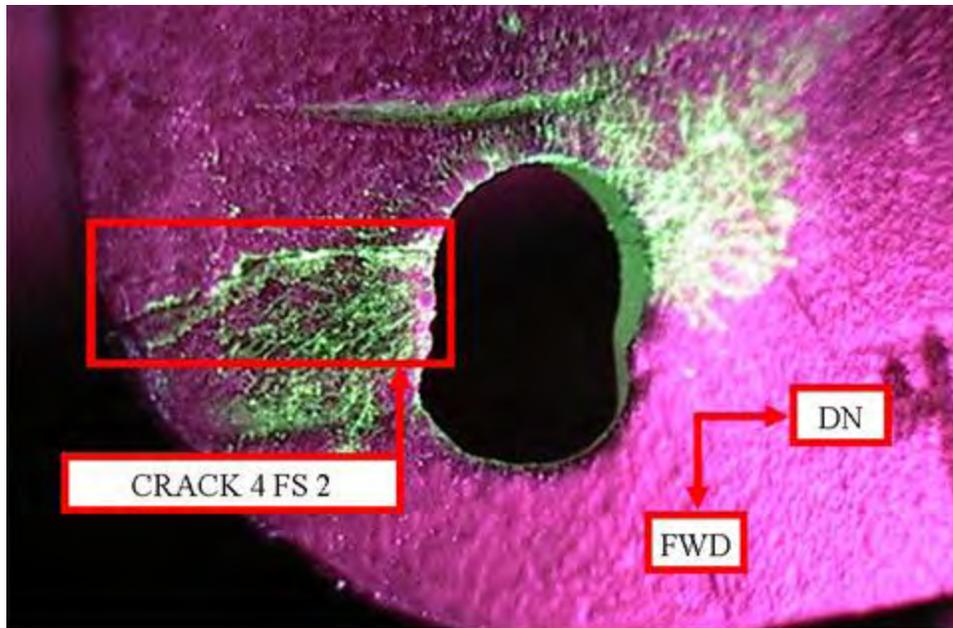
41090-03 CRK 4 FS2 FLP

Figure 372. Fluorescent Liquid Penetrant Indication of Crack 4 on the Fuselage Web-Beam Assembly Lower Forward Frame Right Side FS 2

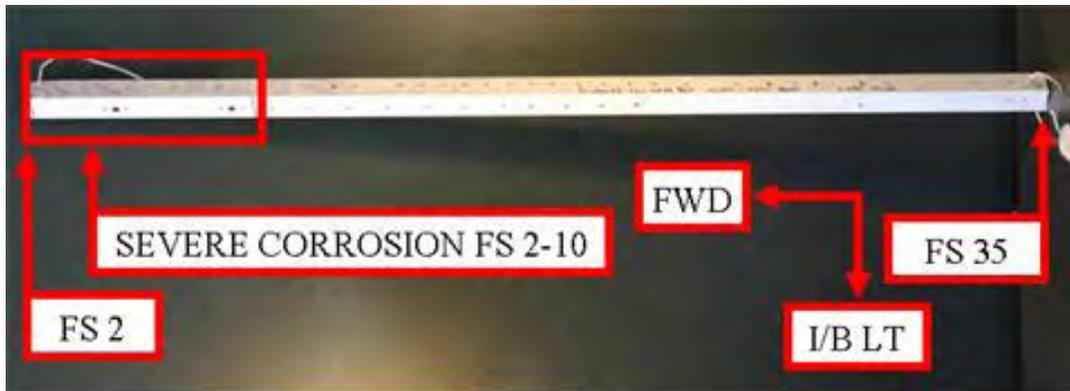
44877-00 Corr FS 2-10 OV

Figure 373 shows the locations of a 12-square-inch area of severe corrosion and light scattered corrosion on the fuselage left upper angle 1 longitudinal beam assembly, part number 44877-00. The light scattered corrosion occurred from FS 10 to FS 35 and caused a maximum localized thickness loss of 2%. A macroscopic view of the severe corrosion that occurred from FS 2 to FS 10 is shown in figure 374. This area of corrosion caused a localized reduction in thickness of 12%. An overview of light-moderate scattered corrosion and the location of three cracks on the fuselage left lower forward web, part number 41090-02, are shown in figure 375. Light-moderate corrosion was found scattered across the web from FS 2 to FS 18 and caused a localized reduction in thickness of 2.5%. A macroscopic view of crack 1, which measured 0.096 inch and occurred at FS 2, is shown in figure 376, and a microscopic view of crack 1 is shown in figure 377. Figure 378 shows a macroscopic view of crack 2, which measured 0.76 inch and was located at FS 2 on the fuselage left lower forward web. Figure 379 shows the fluorescent liquid penetrant indication of crack 2, and figure 380 shows a microscopic view of this crack. A macroscopic view of crack 3 is shown in figure 381, and a microscopic view of this 0.221-inch-crack is shown in figure 382.

Figure 373. Location of Severe Corrosion on the Fuselage Left Upper Angle 1 Longitudinal Beam Assembly FS 2 Through FS 35

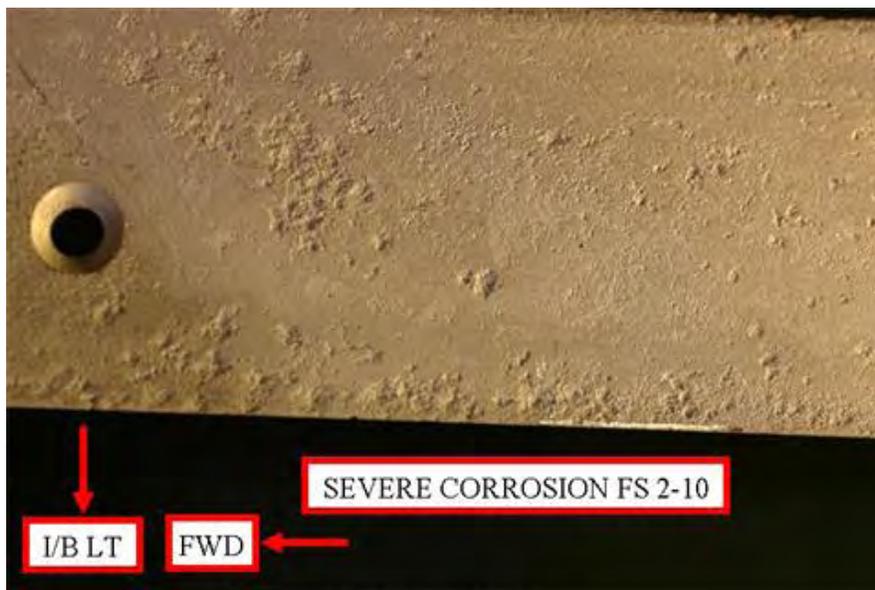
44877-00 Corr FS 2-10 Mac

Figure 374. Macroscopic View of Severe Corrosion on the Fuselage Left Upper Angle 1 Longitudinal Beam Assembly FS 2 Through FS 10

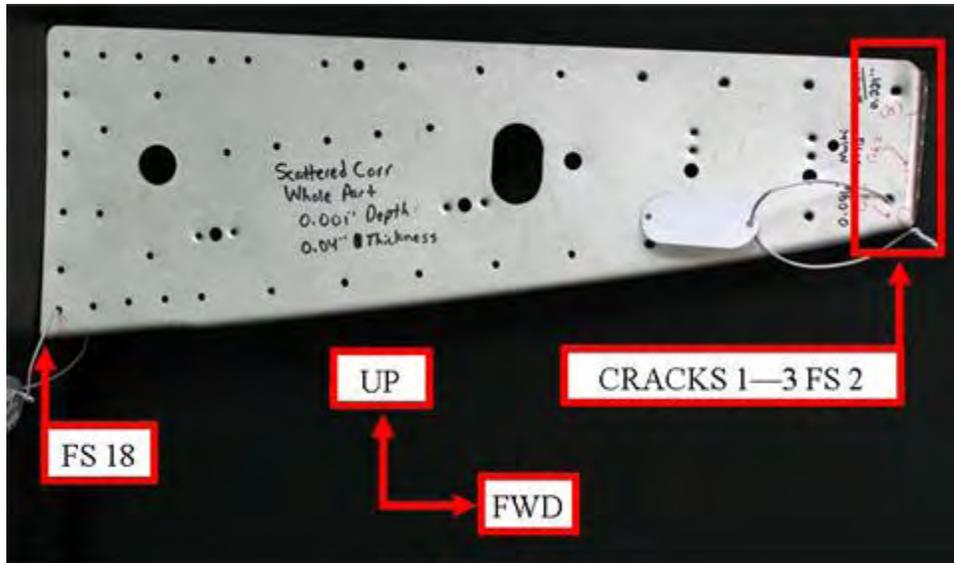
41090-02 CRK FS2 OV

Figure 375. Location of Three Cracks and Overview of Fuselage Left Lower Forward Web FS 2 Through FS 18

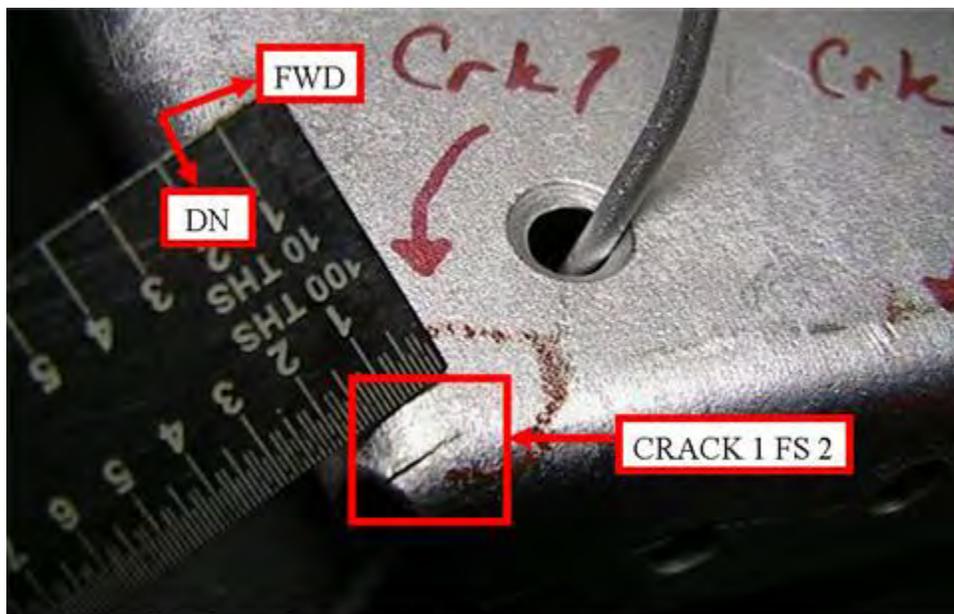
41090-02 CRK 1 FS2 Mac

Figure 376. Macroscopic View of Crack 1 on the Fuselage Left Lower Forward Web FS 2
