DOT/FAA/AR-07/64

Teardown Evaluation of a 1975 Piper Navajo Chieftain Model PA31-350 Airplane

March 2008

Final Report

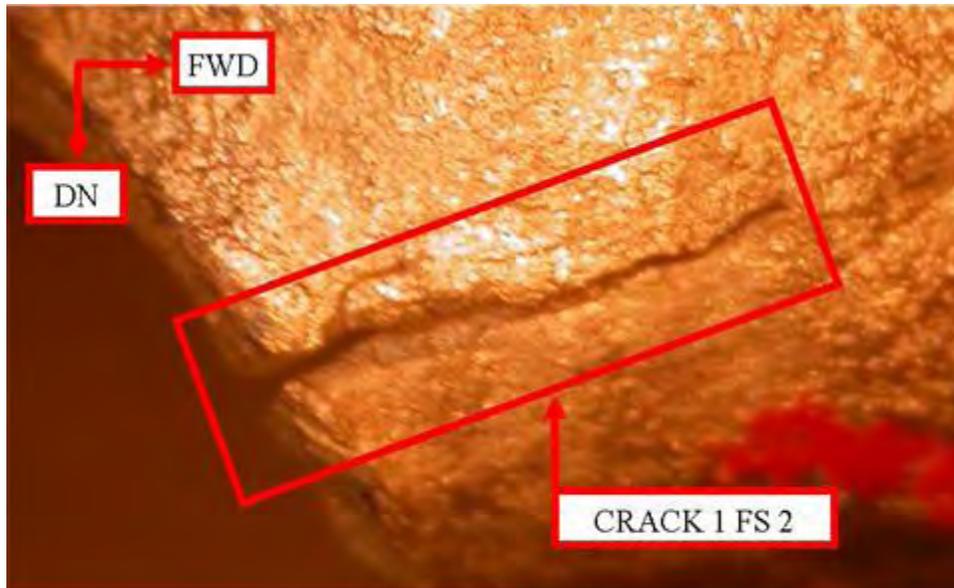
41090-02 CRK 1 FS2 Mic

Figure 373 shows the locations of a 12-square-inch area of severe corrosion and light scattered corrosion on the fuselage left upper angle 1 longitudinal beam assembly, part number 44877-00. The light scattered corrosion occurred from FS 10 to FS 35 and caused a maximum localized thickness loss of 2%. A macroscopic view of the severe corrosion that occurred from FS 2 to FS 10 is shown in figure 374. This area of corrosion caused a localized reduction in thickness of 12%. An overview of light-moderate scattered corrosion and the location of three cracks on the fuselage left lower forward web, part number 41090-02, are shown in figure 375. Light-moderate corrosion was found scattered across the web from FS 2 to FS 18 and caused a localized reduction in thickness of 2.5%. A macroscopic view of crack 1, which measured 0.096 inch and occurred at FS 2, is shown in figure 376, and a microscopic view of crack 1 is shown in figure 377. Figure 378 shows a macroscopic view of crack 2, which measured 0.76 inch and was located at FS 2 on the fuselage left lower forward web. Figure 379 shows the fluorescent liquid penetrant indication of crack 2, and figure 380 shows a microscopic view of this crack. A macroscopic view of crack 3 is shown in figure 381, and a microscopic view of this 0.221-inch-crack is shown in figure 382.

Figure 377. Microscopic View of Crack 1 on the Fuselage Left Lower Forward Web FS 2

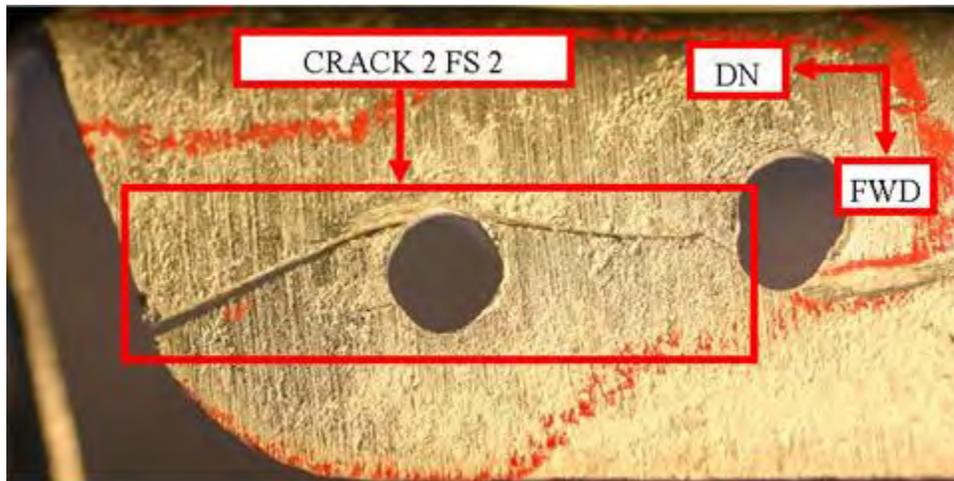
41090-02 CRK 2 FS2 Mac

Figure 378. Macroscopic View of Crack 2 on the Fuselage Left Lower Forward Web FS 2

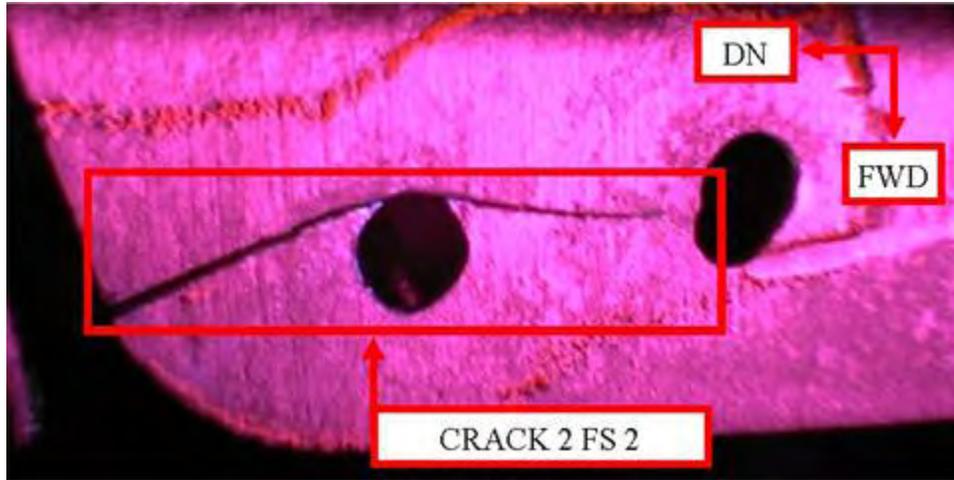
41090-02 CRK 2 FS2 FLP

Figure 379. Fluorescent Liquid Penetrant Indication of Crack 2 on the Fuselage Left Forward Web FS 2

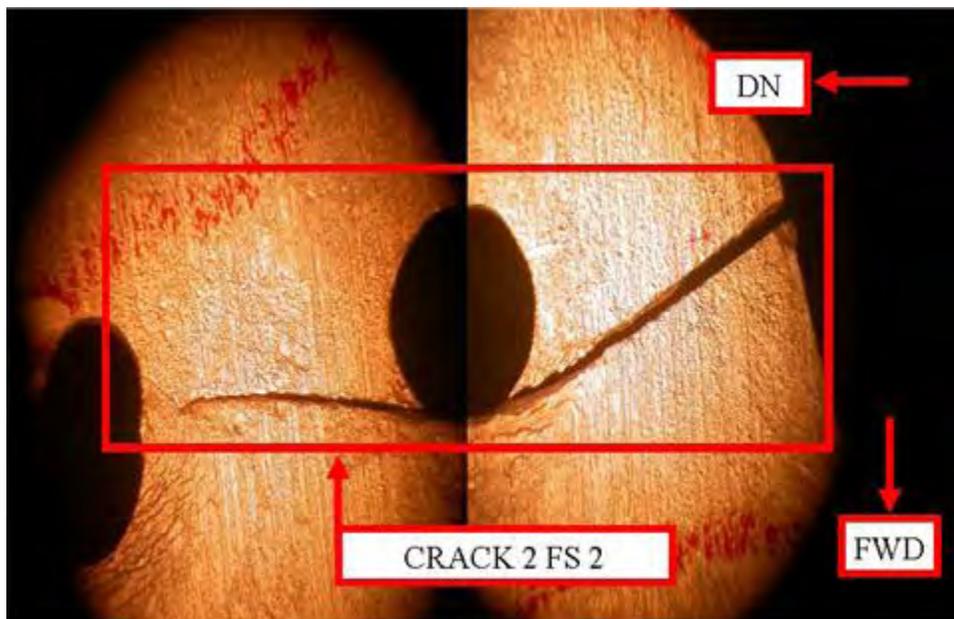
41090-02 CRK 2 FS2 Mic

Figure 380. Microscopic View of Crack 2 on the Fuselage Left Lower Forward Web FS 2

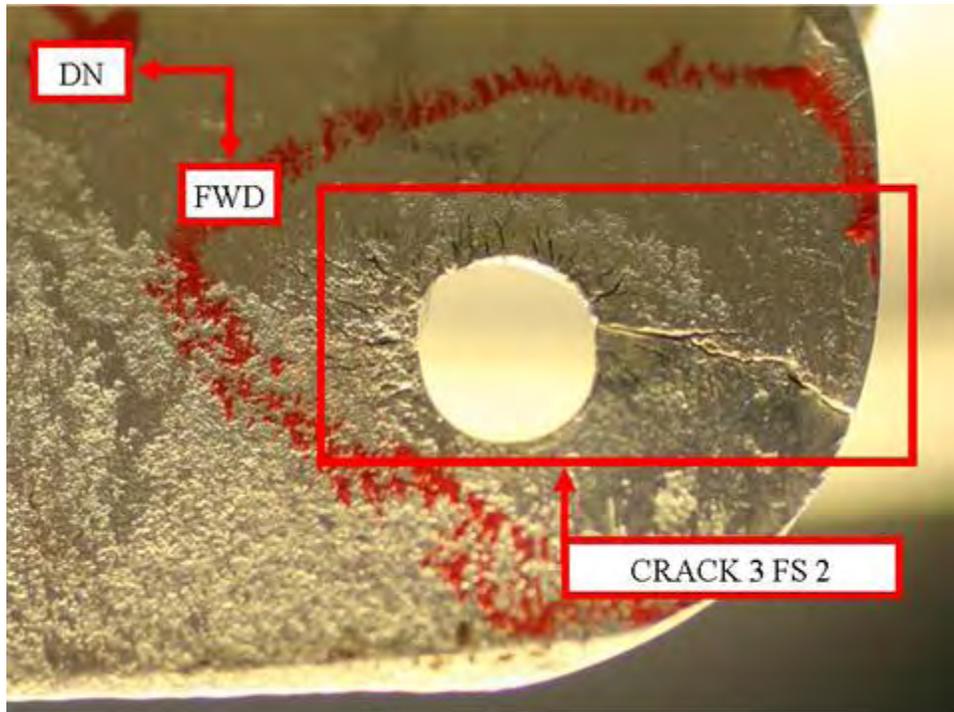
41090-02 CRK 3 FS2 Mac

Figure 381. Macroscopic View of Crack 3 on the Fuselage Left Lower Forward Web FS 2

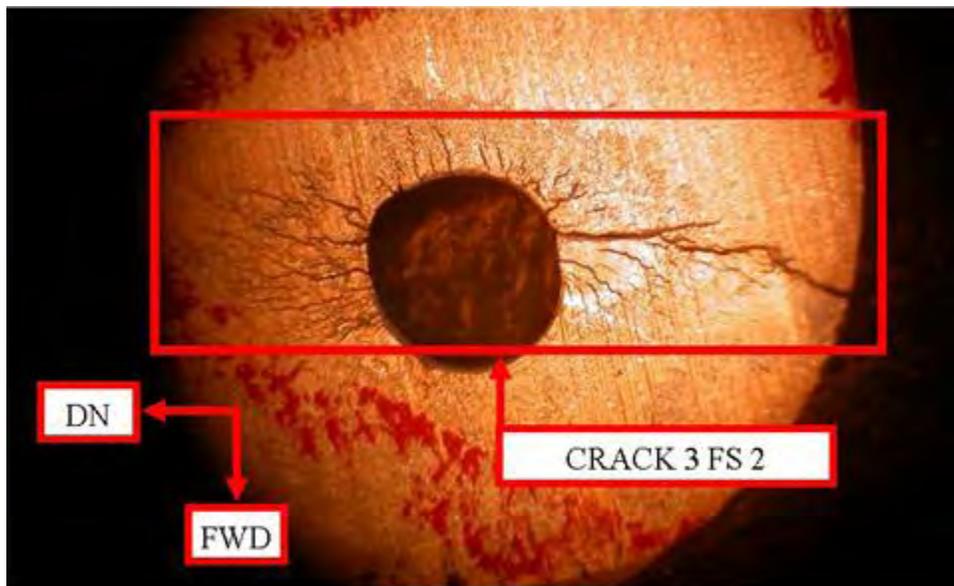
41090-02 CRK 3 FS2 Mic

Figure 382. Microscopic View of Crack 3 on the Fuselage Left Lower Forward Web FS 2

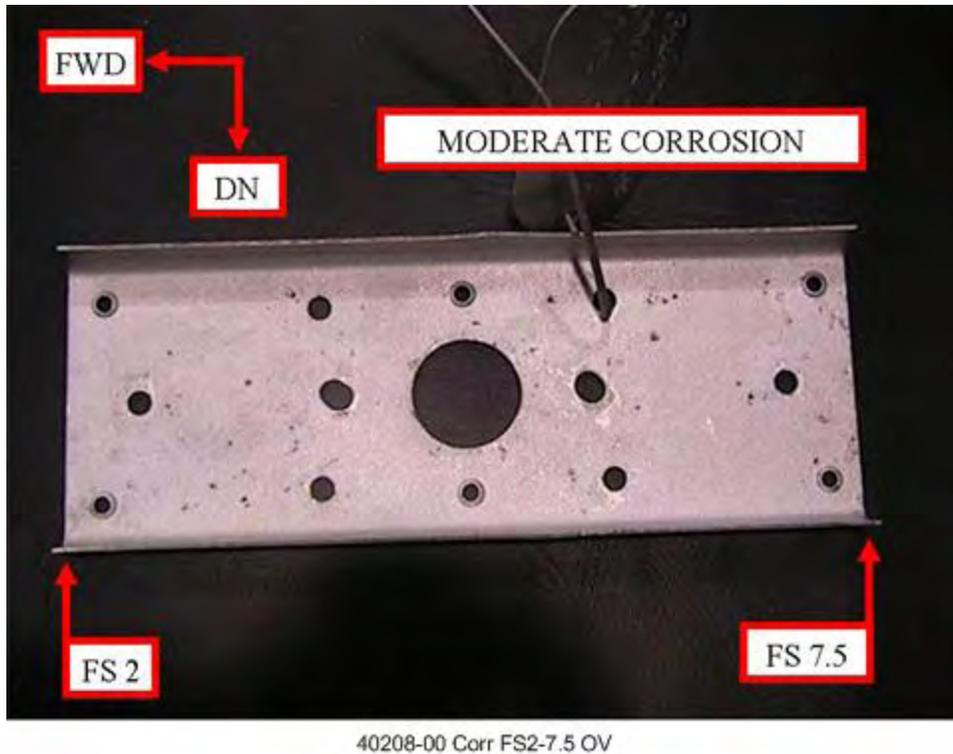
Figure 383 shows the location of an 11-square-inch area of moderate corrosion on the baggage compartment door lock bracket, part number 40208-00. This area of corrosion caused a maximum localized reduction in thickness of 6%. A macroscopic view of a segment of this area of corrosion is shown in figure 384. Figure 385 shows the location of cracks 1 and 2 on the fuselage lower plate assembly, part number 44814-00 from FS 18 to FS 28.62. A macroscopic view of crack 1, which measured 0.570 inch and is located at FS 22, is shown in figure 386, and a picture of the fracture face is shown in figure 387. Figure 388 shows a macroscopic view of crack 2, which measured 0.668 inch and was located at FS 27, and the fracture face is shown in figure 389 for crack 2. The failure mode for both cracks was determined to be fatigue.

Figure 383. Location of Moderate Corrosion on the Baggage Compartment Door Lock Bracket FS 2 Through FS 7.5

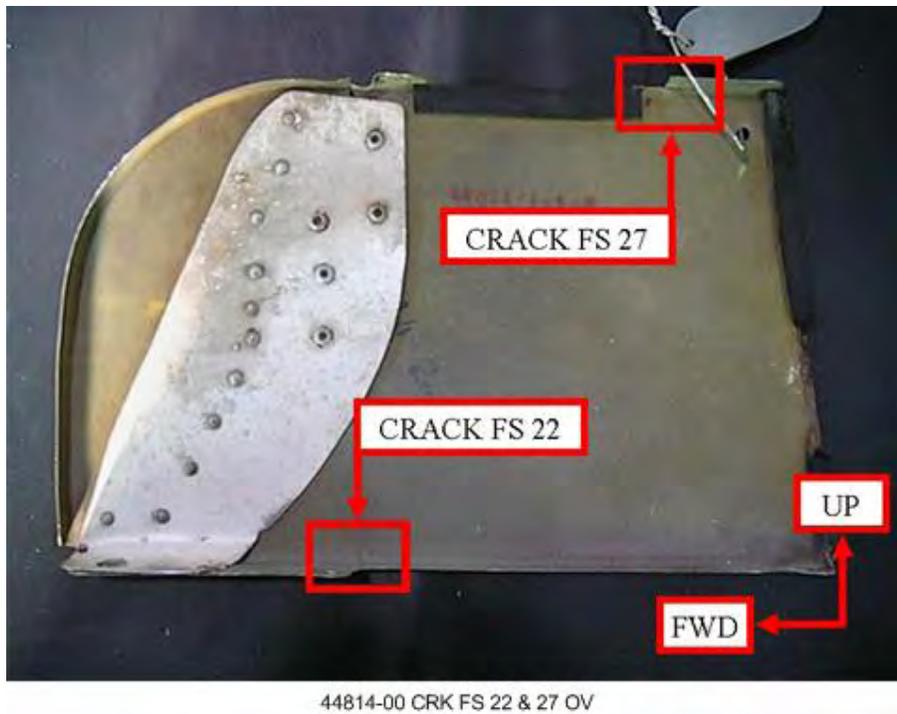
Figure 385. Location of Cracks 1 and 2 on the Fuselage Lower Plate Assembly FS 18 Through FS 28.62

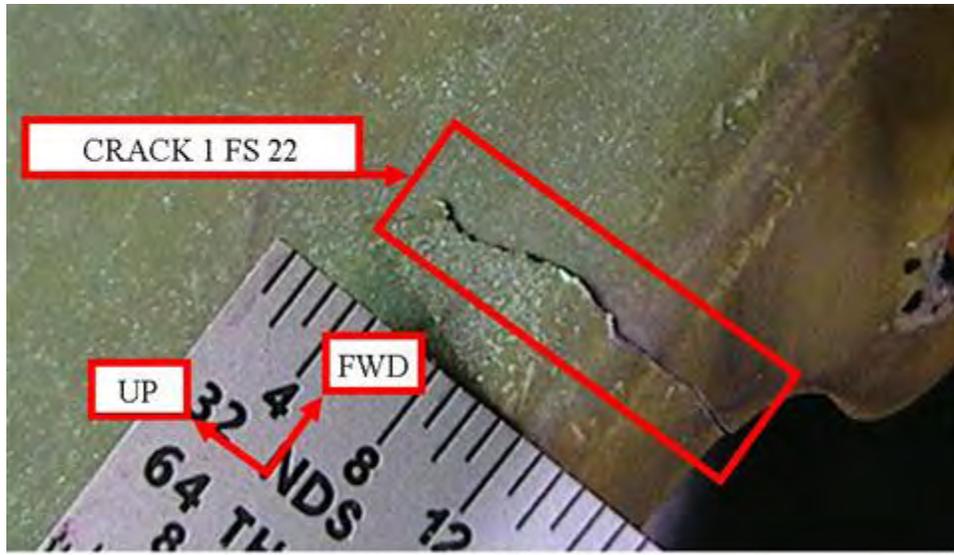
44814-00 CRK 1 FS22 Mac

Fuselage lower plate assembly, figure 386	Crack	FS 22	0.570 inch	Not inspected ¹	Fatigue	387 388
	Crack	FS 27	0.668 inch	Not inspected ¹	Fatigue	389 390

Figure 386. Macroscopic View of Crack 1 on the Fuselage Lower Plate Assembly FS 22

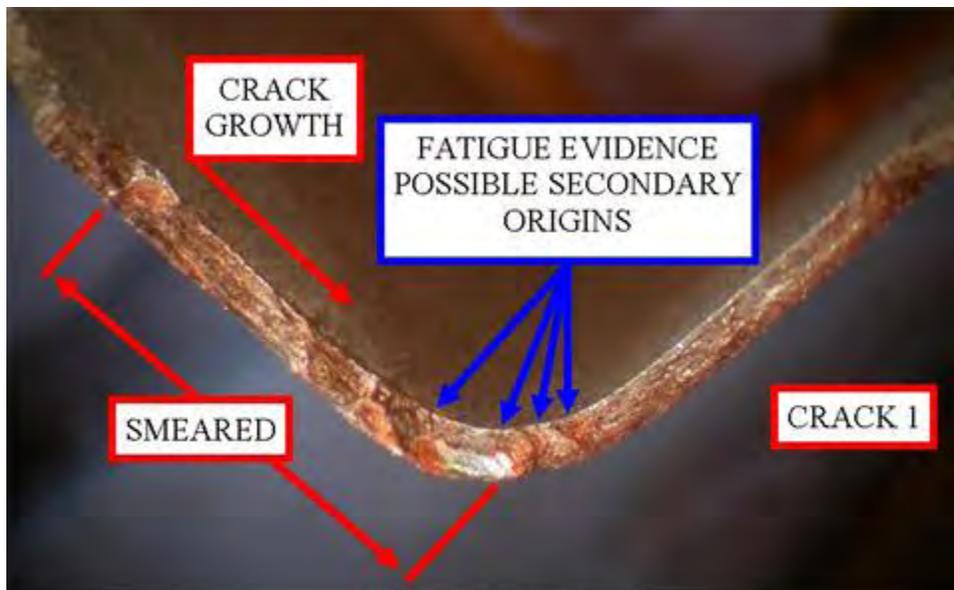
44814-00 CRK 1 FS22 Frac

Figure 387. Fracture Face of Crack 1 on the Fuselage Lower Plate Assembly FS 22

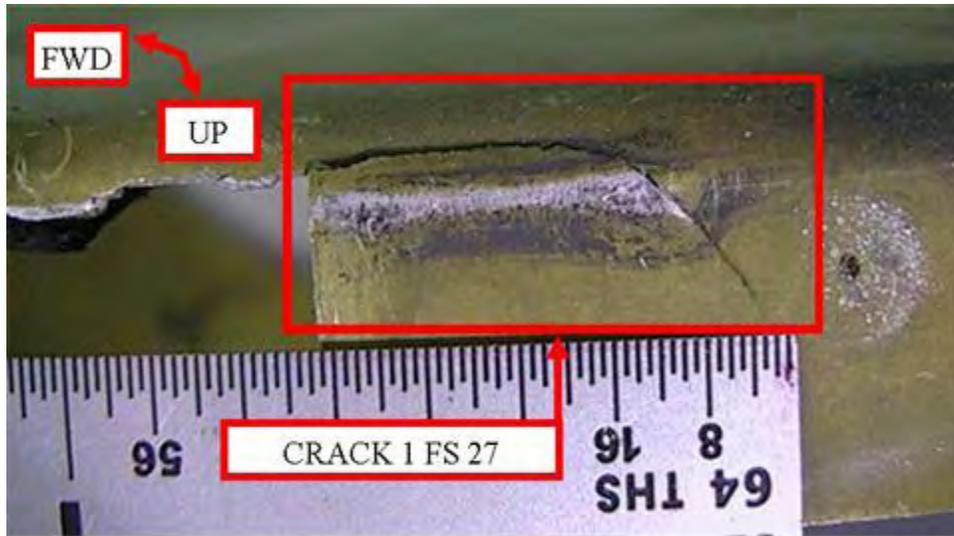
44814-00 CRK 2 FS27 Mac

Figure 388. Macroscopic View of Crack 2 on the Fuselage Lower Plate Assembly FS 27

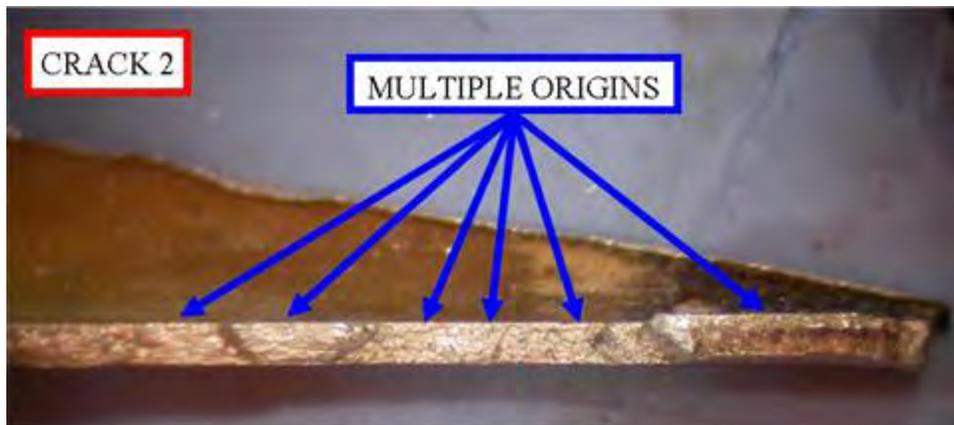
44814-00 CRK 2 FS27 Frac

Figure 389. Fracture Face of Crack 2 on the Fuselage Lower Plate Assembly FS 27

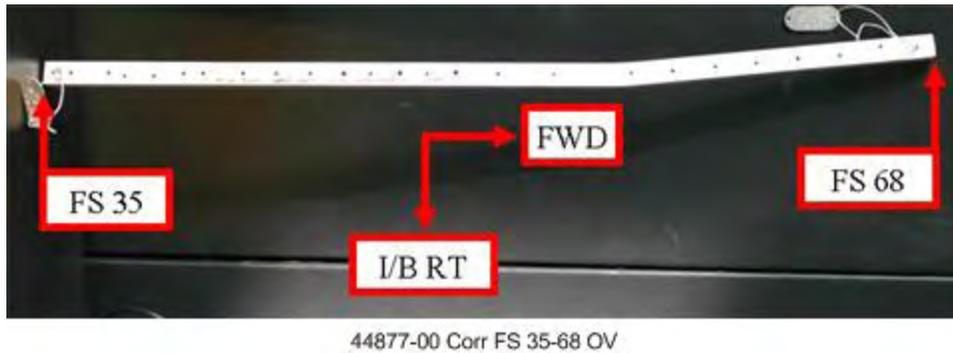
Figure 390 shows an overview of light scattered corrosion on the fuselage upper left angle 2 beam assembly, part number 44877-00, from FS 35 to FS 68. The corrosion was categorized as light corrosion because it caused a maximum thickness loss of only 2%. The location of an 8.25-square-inch area of light corrosion is shown in figure 391 on the fuselage upper right angle B longitudinal beam assembly, part number 44877-01B. This corrosion was located from FS 57 to FS 61.75 and caused a maximum localized reduction in thickness of 1%.

Figure 390. Overview of Fuselage Upper Left Angle 2 Beam Assembly FS 35 Through FS 68

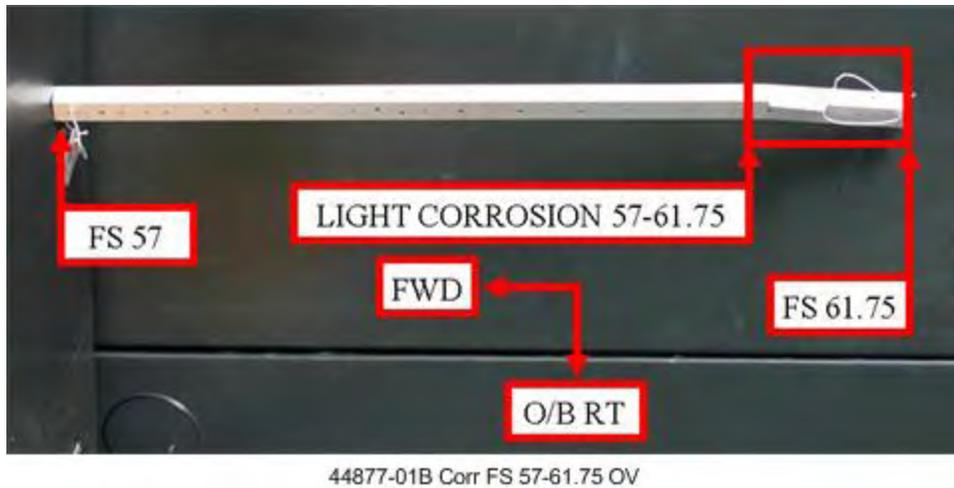
Figure 391. Location of Light Corrosion on the Fuselage Upper Right Angle B Longitudinal Beam Assembly FS 57 Through FS 61.75

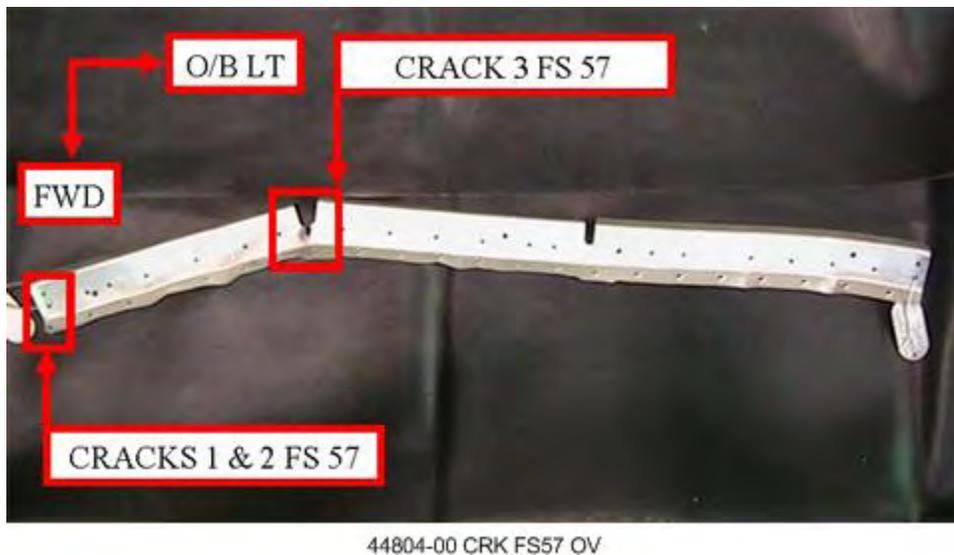
The location of three cracks on the left floorboard support channel, part number 44804-00, is shown in figure 392. A macroscopic view of crack 1, which measured 0.09 inch in length, is shown in figure 393, and a microscopic view of this crack is shown in figure 394. Crack 2, which measured 0.156 inch, is shown macroscopically in figure 395 and microscopically in figure 396. A macroscopic view of crack 3 is shown in figure 397. This 1.25-inch crack was analyzed, but due to extensive crack face smearing, the failure mode could not be determined.

Figure 392. Location of Three Cracks on the Left Floorboard Support Channel FS 57

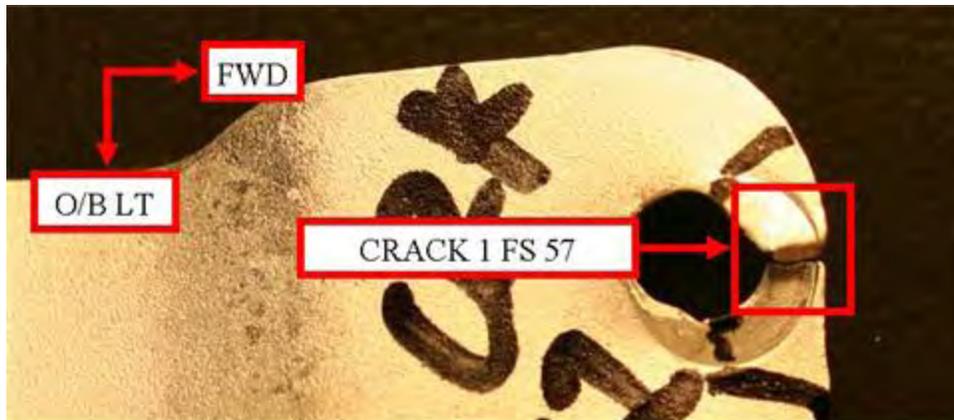
44804-00 CRK 1 FS57 Mac

Figure 393. Macroscopic View of Crack 1 on the Left Floorboard Support Channel FS 57

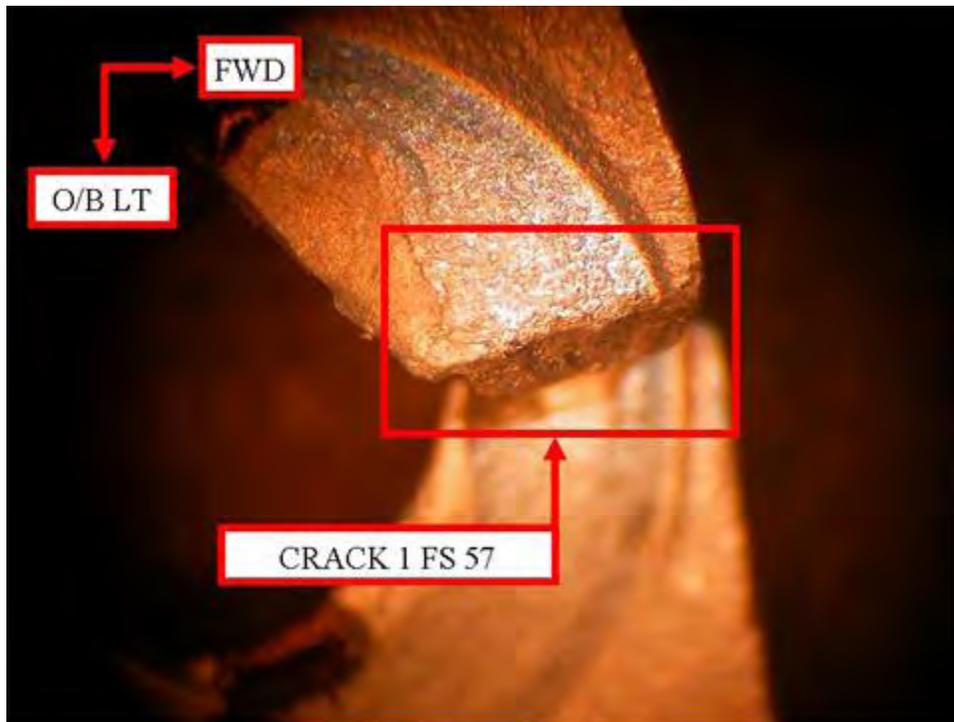
44804-00 CRK 1 FS57 Mic

Figure 394. Microscopic View of Crack 1 on the Left Floorboard Support Channel FS 57

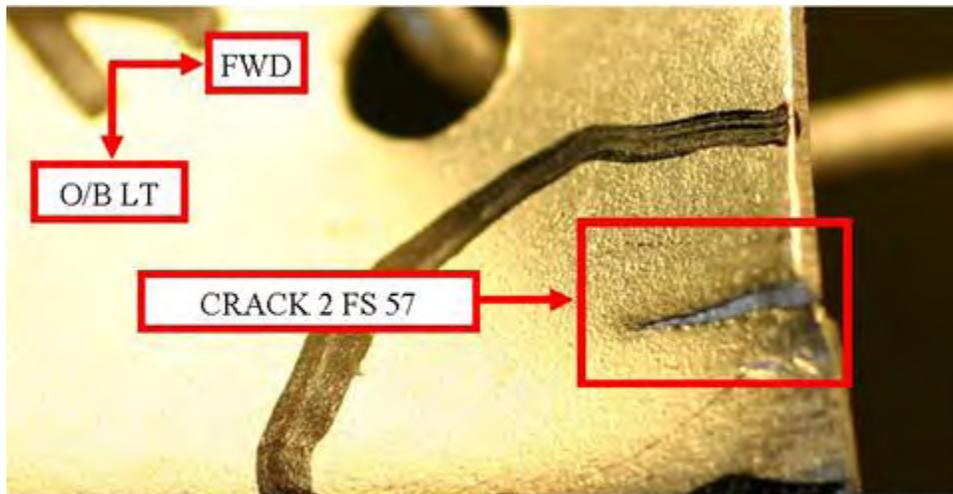
44804-00 CRK 2 FS57 Mac

Figure 395. Macroscopic View of Crack 2 on the Left Floorboard Support Channel FS 57

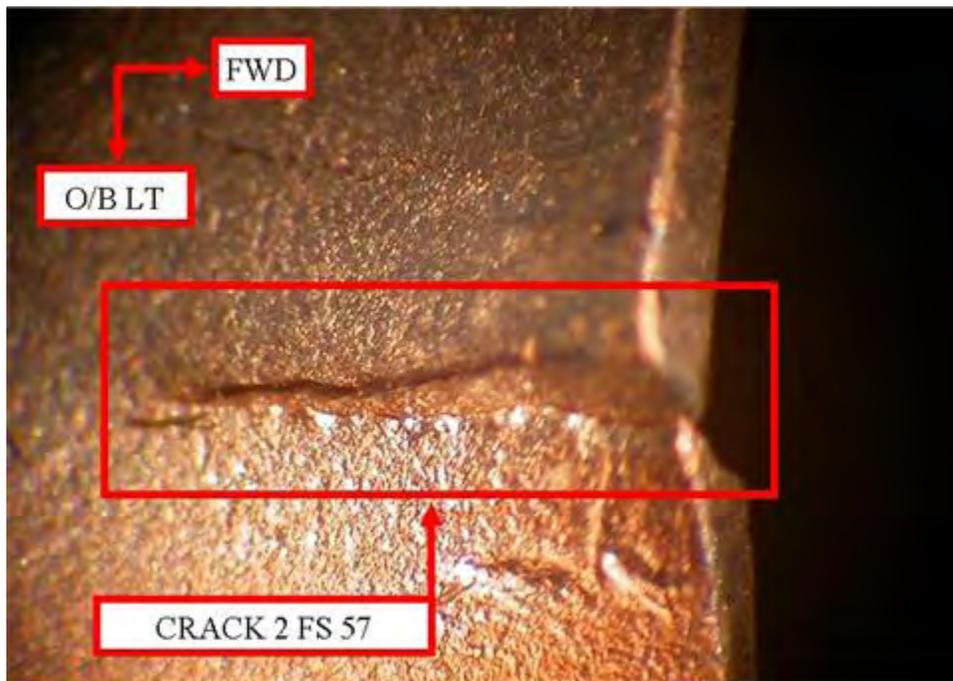
44804-00 CRK 2 FS57 Mic

Figure 396. Microscopic View of Crack 2 on the Left Floorboard Support Channel FS 57

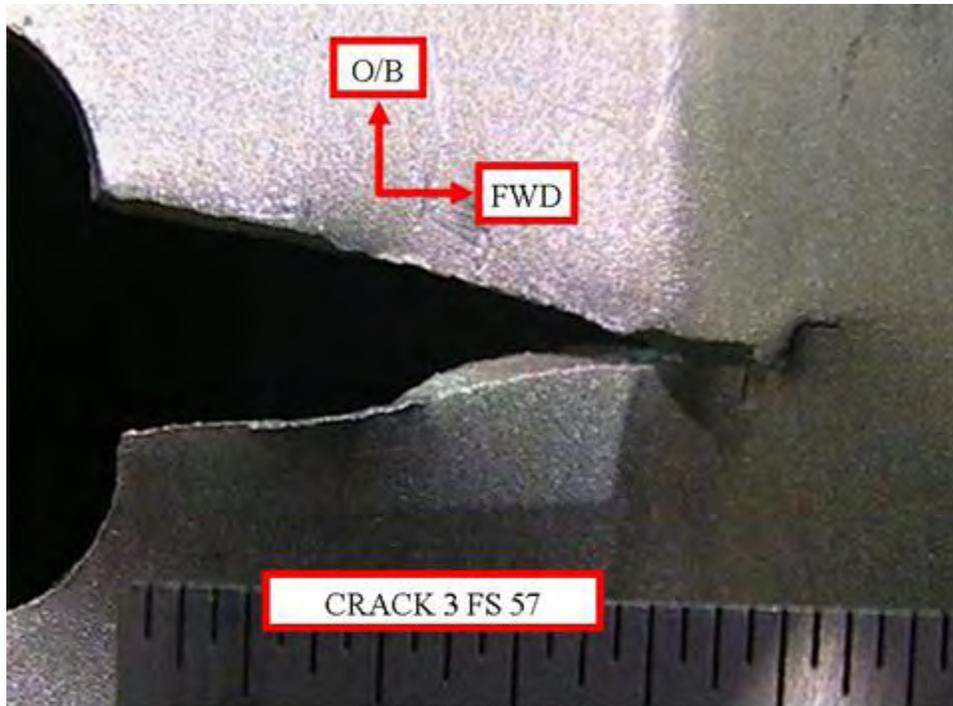
44804-00 CRK 3 FS57 Mac

Figure 397. Macroscopic View of Crack 3 on the Left Floorboard Support Channel FS 57

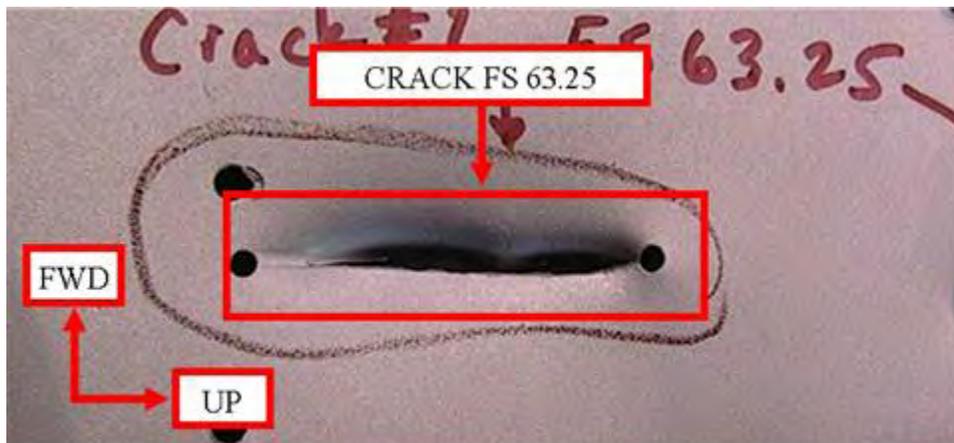
52118-00 CRK FS63.25 Mac

The location of a 1.691-inch crack on the fuselage upper forward skin, part number 52118-00, is shown in figure 398, and a macroscopic view of this crack is shown in figure 399. Figure 400 shows the location of a 0.262-inch crack on the fuselage bulkhead assembly, part number 40962-3. A macroscopic view of this crack, which occurs at FS 66.5, is shown in figure 401. The location of three areas of damage on the fuselage bulkhead assembly, located at FS 87.5, is shown in figure 402. Figure 403 shows a macroscopic view of damage 1 and 2 on the bulkhead assembly, part number 52157-6. Damage 1, which covered a surface area of 0.24 square inch, and damage 2, which covered 0.1 square inch, both resulted in localized areas of complete thickness loss. A macroscopic picture of damage 3 is shown in figure 404. This damage covered a surface area of 0.07 square inch and caused a maximum localized reduction in thickness of 100%. The fluorescent liquid penetrant indication for this damage is shown in figure 405.

Figure 399. Macroscopic View of the Crack in the Fuselage Upper Forward Skin FS 63.25

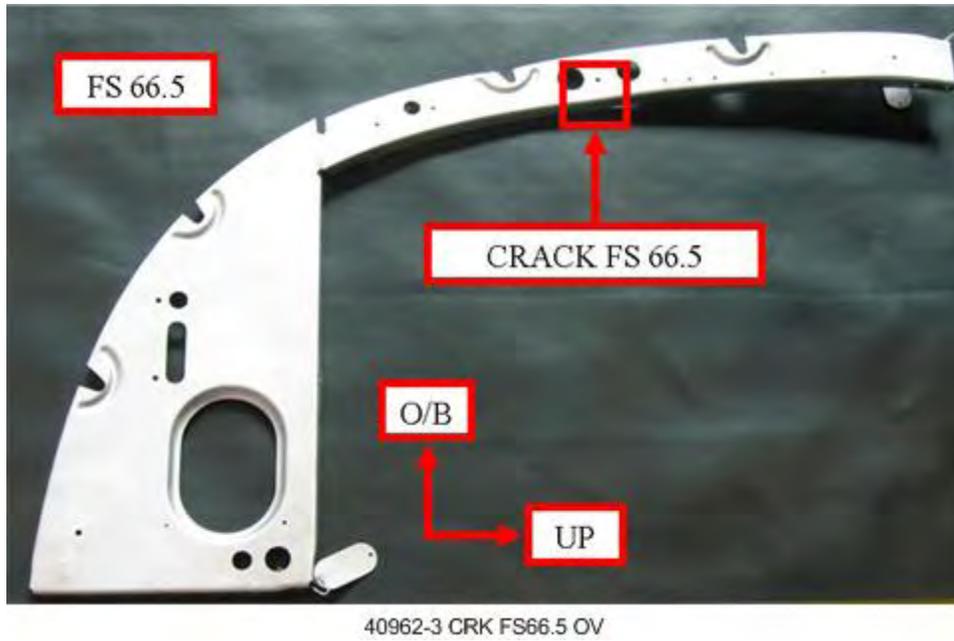
Figure 400. Location of Crack on the Fuselage Bulkhead Assembly FS 66.5

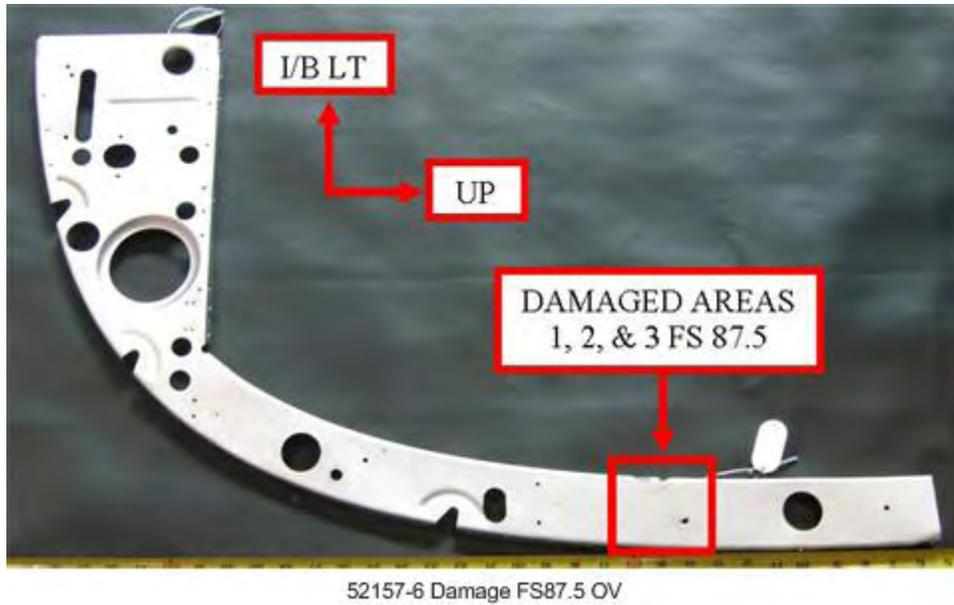
Figure 402. Location of Three Areas of Damage on the Fuselage Bulkhead Assembly FS 87.5

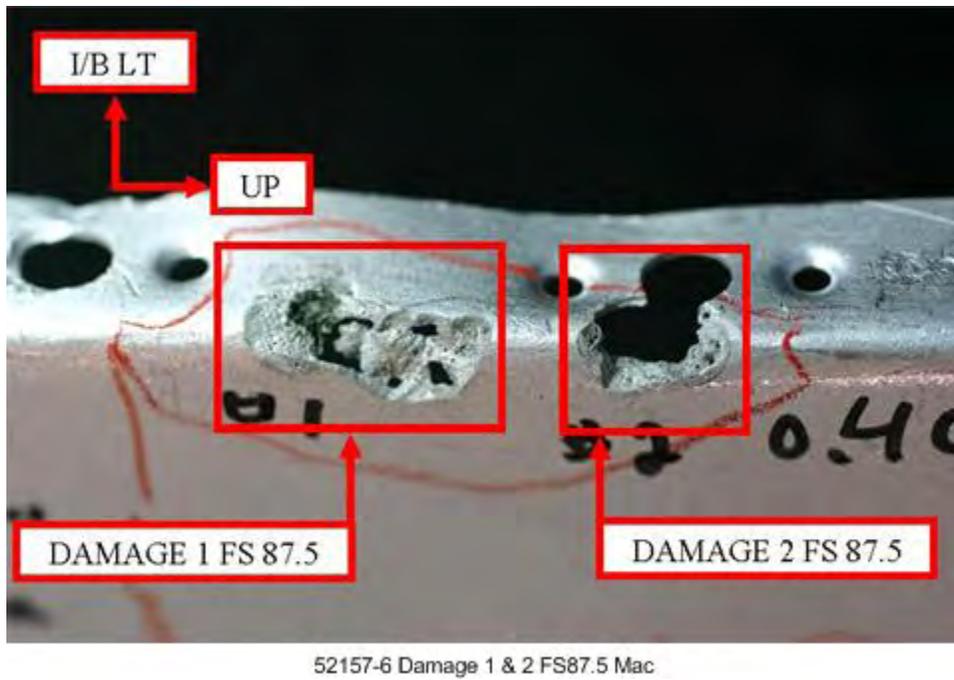
Fuselage bulkhead assembly, figure 403	Damage	FS 87.5	0.693 inch by 0.34 inch	Indication	Damage 100% thickness loss	404
	Damage	FS 87.5	0.408 inch by 0.25 inch	Indication	Damage 100% thickness loss	404
	Damage	FS 87.5	0.354 inch by 0.21 inch	Indication	Damage 100% thickness loss	405 406

Figure 403. Macroscopic View of Damage 1 and 2 on the Fuselage Bulkhead Assembly FS 87.5

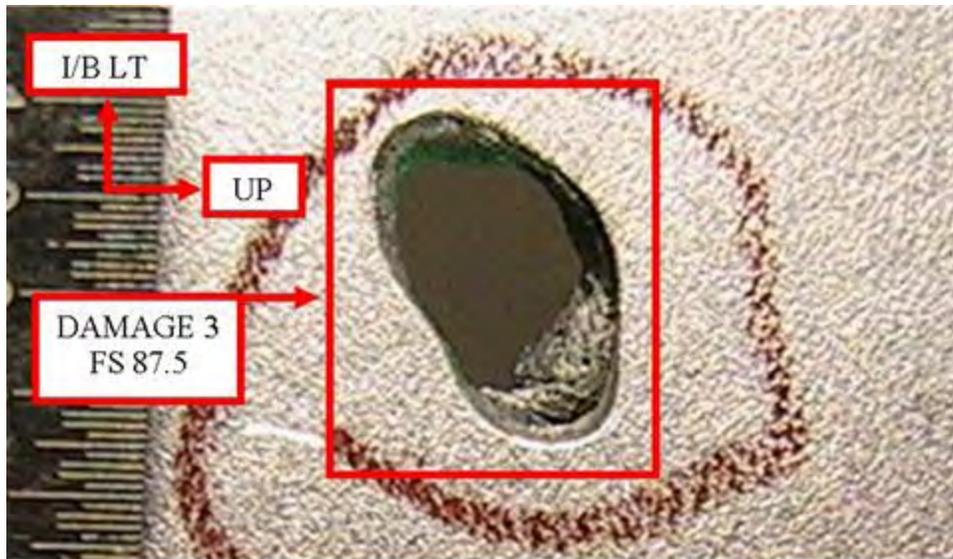
52157-6 Damage 3 FS87.5 Mac

Figure 404. Macroscopic View of Damage 3 on the Fuselage Bulkhead Assembly FS 87.5

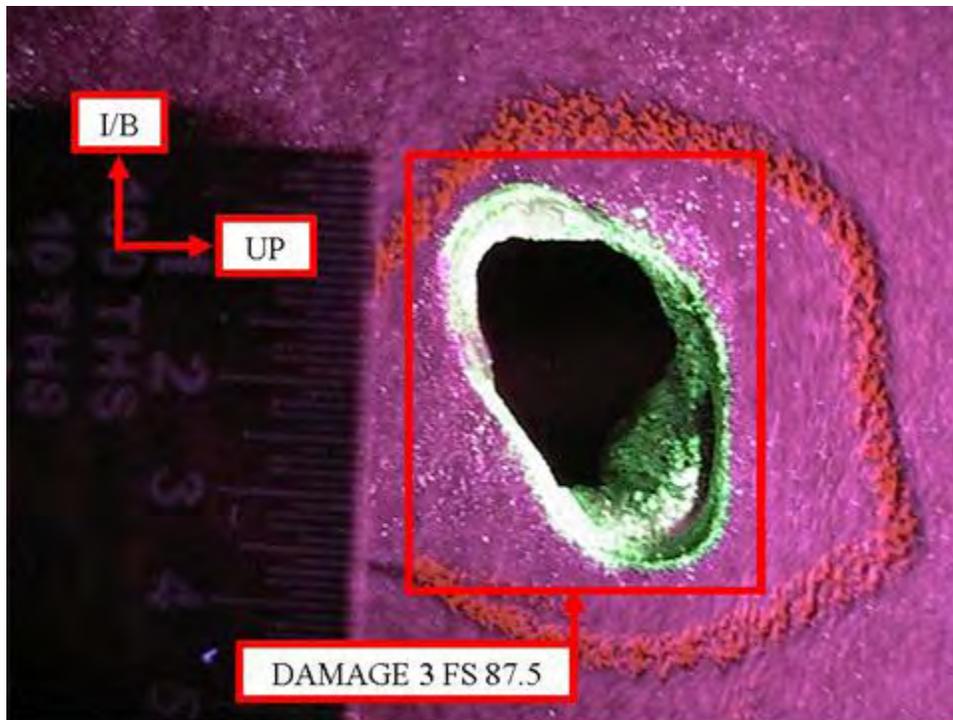
52157-6 Damage 3 FS87.5 FLP

Figure 405. Fluorescent Liquid Penetrant Indication of Damage 3 on the Fuselage Bulkhead Assembly FS 87.5

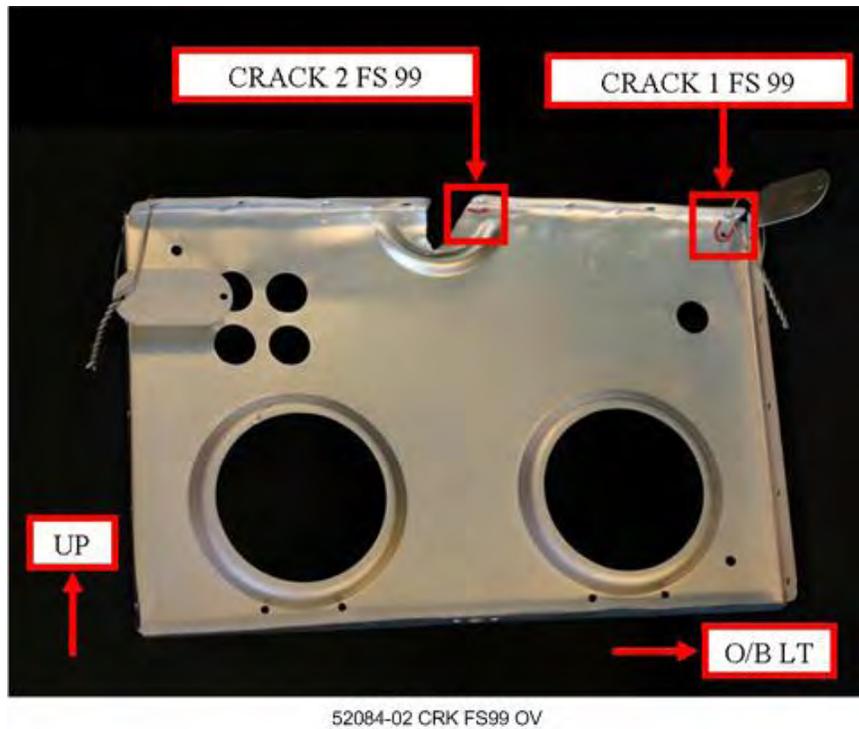
The location of two cracks on the bulkhead assembly, part number 52084-002, located at FS 99 is shown in figure 406. Crack 1, which measured 0.436 inch in length, is shown macroscopically in figure 407 and microscopically in figure 408. A macroscopic view of crack 2 is shown in figure 409. This crack, which measured 0.196 inch, is shown microscopically in figure 410. The location of a 0.12-inch crack on the center fuselage right stringer, part number 52080-05, is shown in figure 411. This crack, located at FS 102.25 is shown macroscopically in figure 412. The fluorescent liquid penetrant indication for this crack is shown in figure 413, and a microscopic view of the crack is shown in figure 414.

Figure 406. Location of Cracks 1 and 2 on the Bulkhead Assembly FS 99

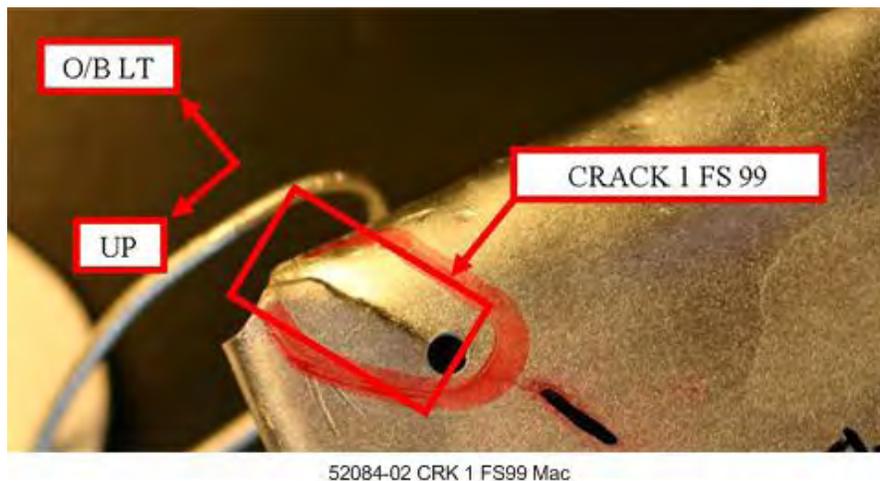
Part Name and Figure Number	Defect Type	Defect Location	Defect Extent	NDI Indication	Defect Classification	Defect Figure Number
Bulkhead assembly, figure 407	Crack	FS 99	0.436 inch	Crack indication	Bend radii	408 409
	Crack	FS 99	0.196 inch	Crack indication	Bend radii surface crack	410 411
Center fuselage right stringer, figure 412	Crack	FS 102.25	0.12 inch	Crack indication	Bend radii surface crack	413
						414
						415

Figure 407. Macroscopic View of Crack 1 on the Bulkhead Assembly FS 99

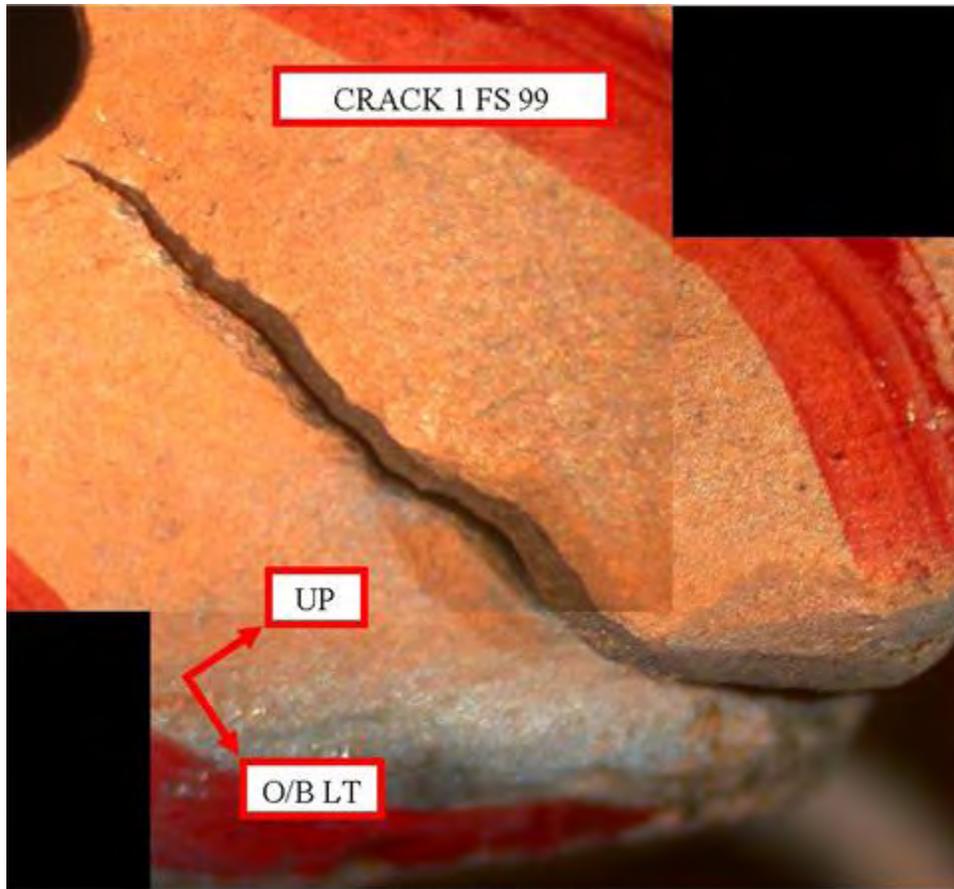
52084-02 CRK 1 FS99 Mic

Figure 408. Microscopic View of Crack 1 on the Bulkhead Assembly FS 99

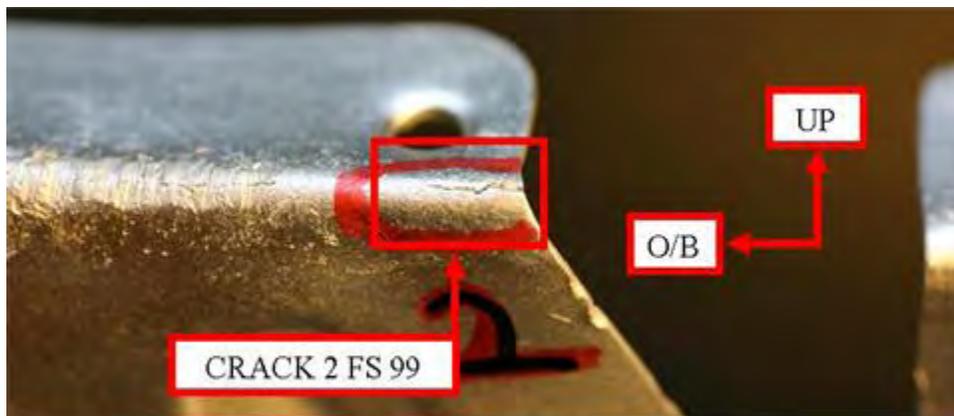
52084-02 CRK 2 FS99 Mac

Figure 409. Macroscopic View of Crack 2 on the Bulkhead Assembly FS 99

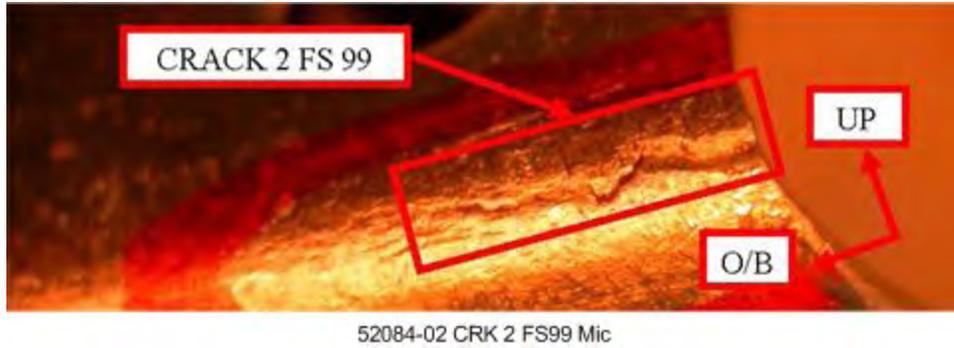
Figure 410. Microscopic View of Crack 2 on the Bulkhead Assembly FS 99

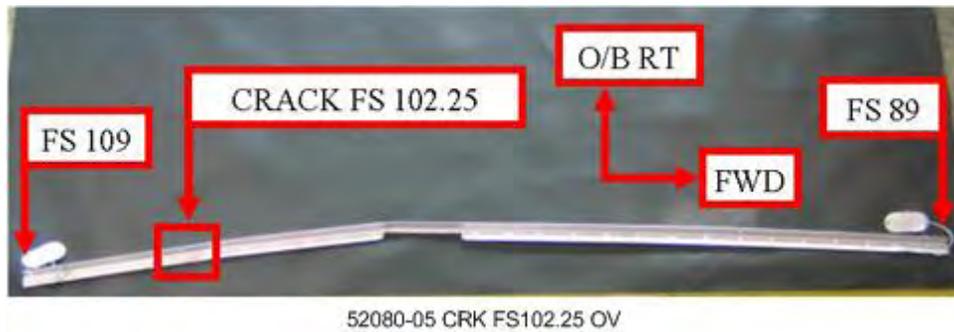
Figure 411. Location of Crack on the Center Fuselage Right Stringer FS 89 Through FS 109

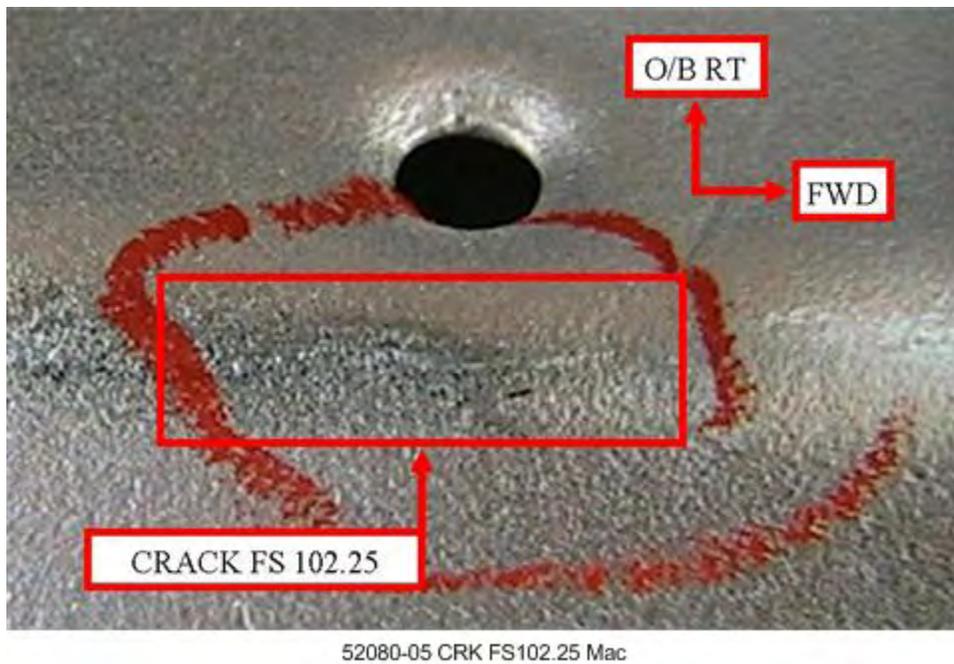
Figure 412. Macroscopic View of Crack on the Center Fuselage Right Stringer at FS 102.25

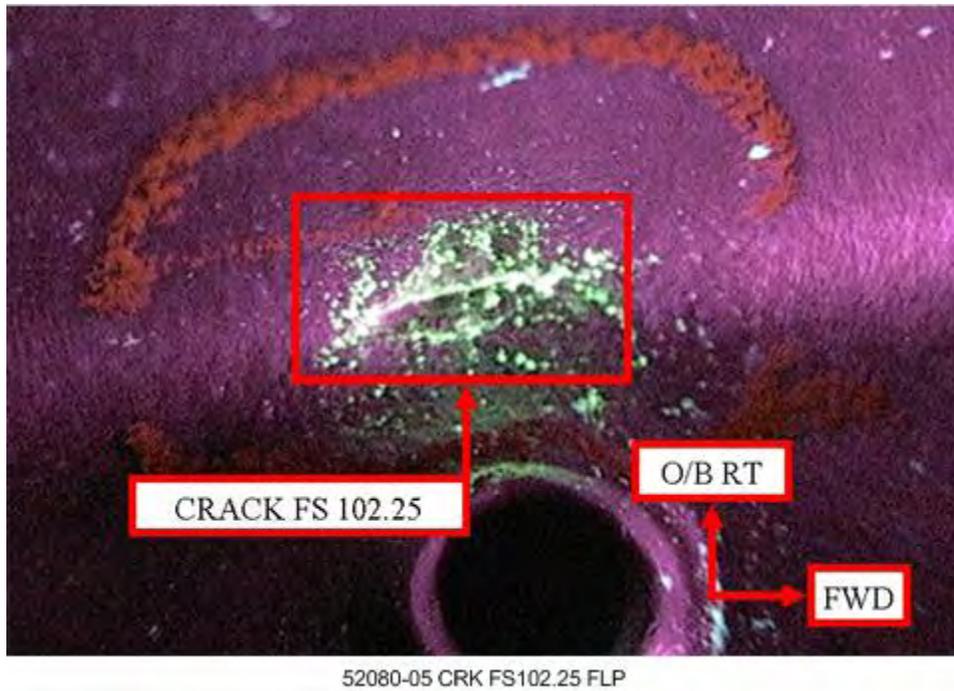
Figure 413. Fluorescent Liquid Penetrant Indication of the Crack on the Center Fuselage Right Stringer FS 102.25

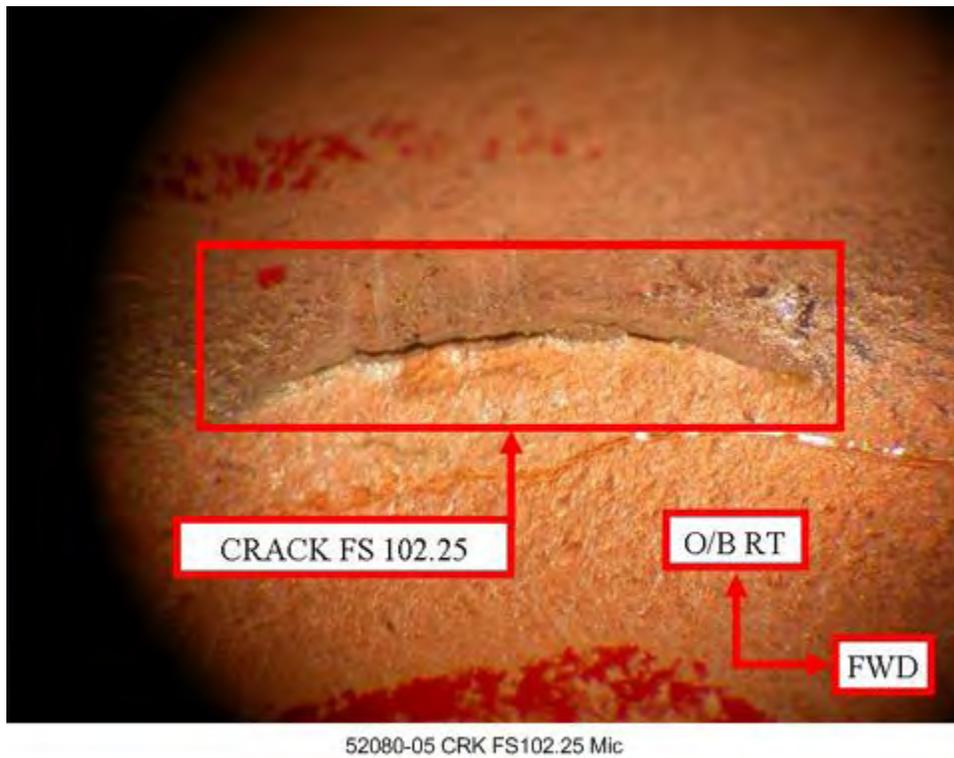
Figure 414. Microscopic View of the Crack on the Center Fuselage Right Stringer FS 102.25

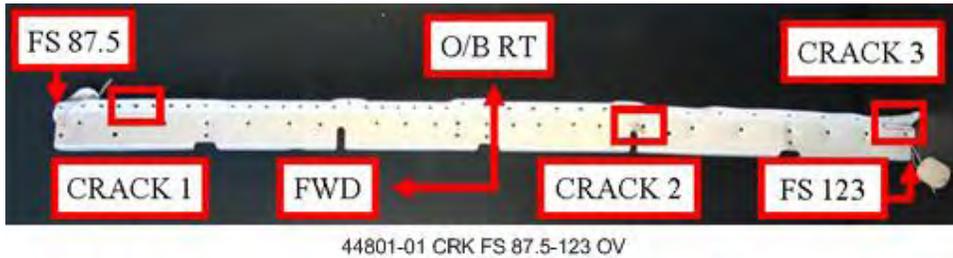
Figure 415 shows the location of three cracks on the right floorboard channel, part number 44801-01. A macroscopic view of crack 1 on the right floorboard channel is shown in figure 416. This crack, which was located at FS 91.5, measured 0.045 inch in length. A macroscopic view of crack 2 is shown in figure 417, which measured 0.097 inch and was located at FS 112. Figure 418 shows a macroscopic view of crack 3, which was located at FS 123 and measured 1.1605 inch in length.

Figure 415. Location of Three Cracks on the Right Floorboard Channel FS 87.5 Through FS 123

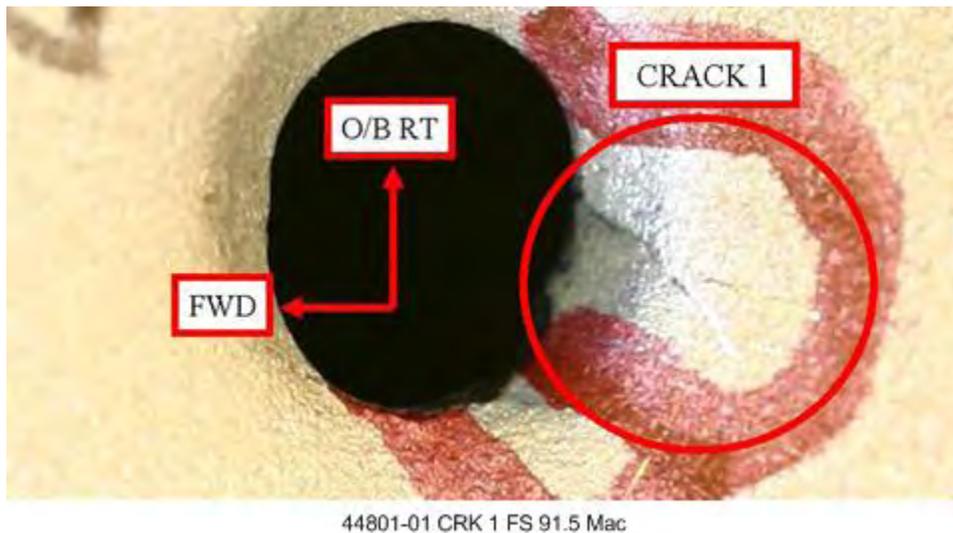
Figure 416. Macroscopic View of Crack 1 on the Right Floorboard Channel FS 91.5
