DOT/FAA/AR-07/64

Teardown Evaluation of a 1975 Piper Navajo Chieftain Model PA31-350 Airplane

March 2008

Final Report

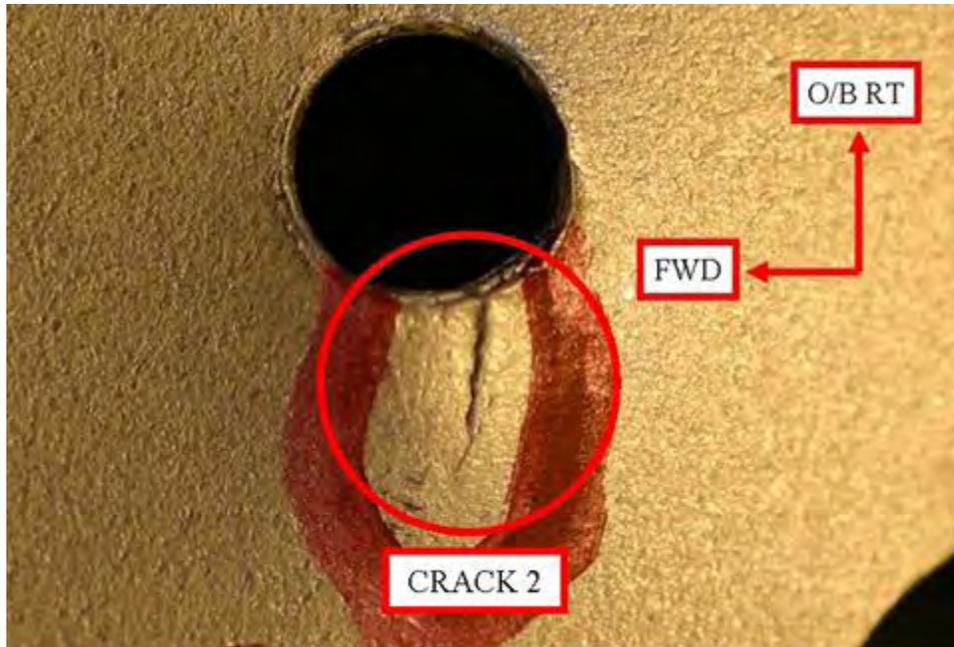
44801-01 CRK 2 FS 112 Mac

Figure 417. Macroscopic View of Crack 2 on the Right Floorboard Channel FS 112

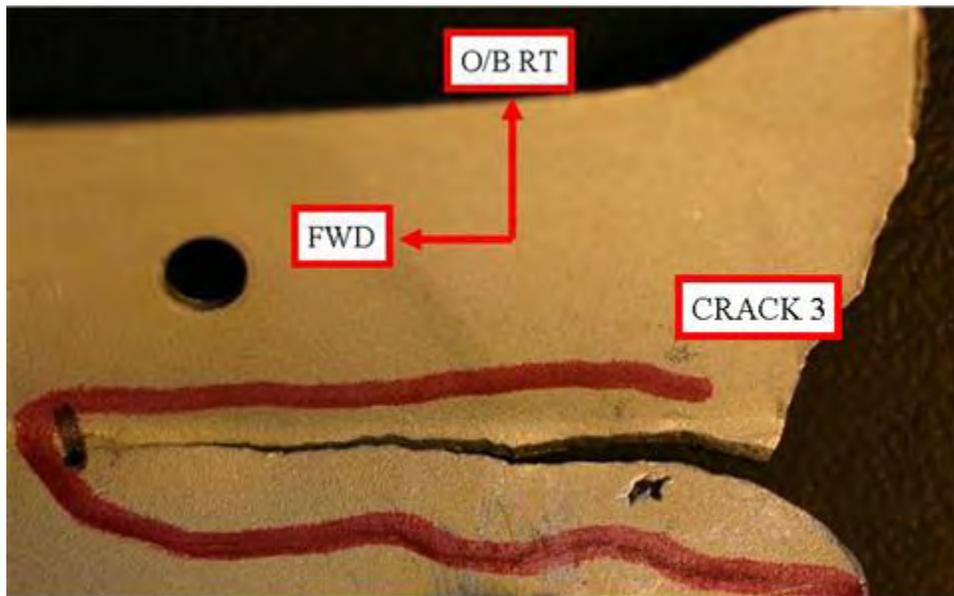
44801-01 CRK 3 FS 123 Mac

Figure 418. Macroscopic View of Crack 3 on the Right Floorboard Support FS 123

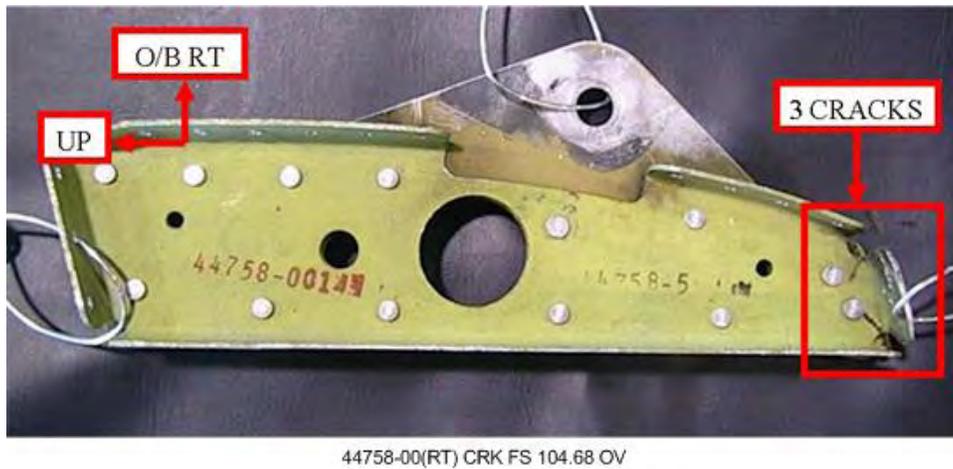
The location of three cracks on the right front spar attachment, part number 44758-01, is shown in figure 419. Figure 420 shows a macroscopic view of cracks 1 and 2 at FS 104.31. Figure 421 shows a fracture face picture of crack 1, which measured 0.353 inch, on the right front spar attachment, and figure 422 shows a fracture face picture for the 0.310-inch crack, identified as crack 2. Figure 423 shows a macroscopic view of crack 3, which measured 0.112 inch. From the fatigue striations evident on the fracture faces of cracks 1 and 2, it was determined that the failure mode for all three cracks was fatigue.

Figure 419. Location of Three Cracks on the Right Front Spar Attachment FS 104.31

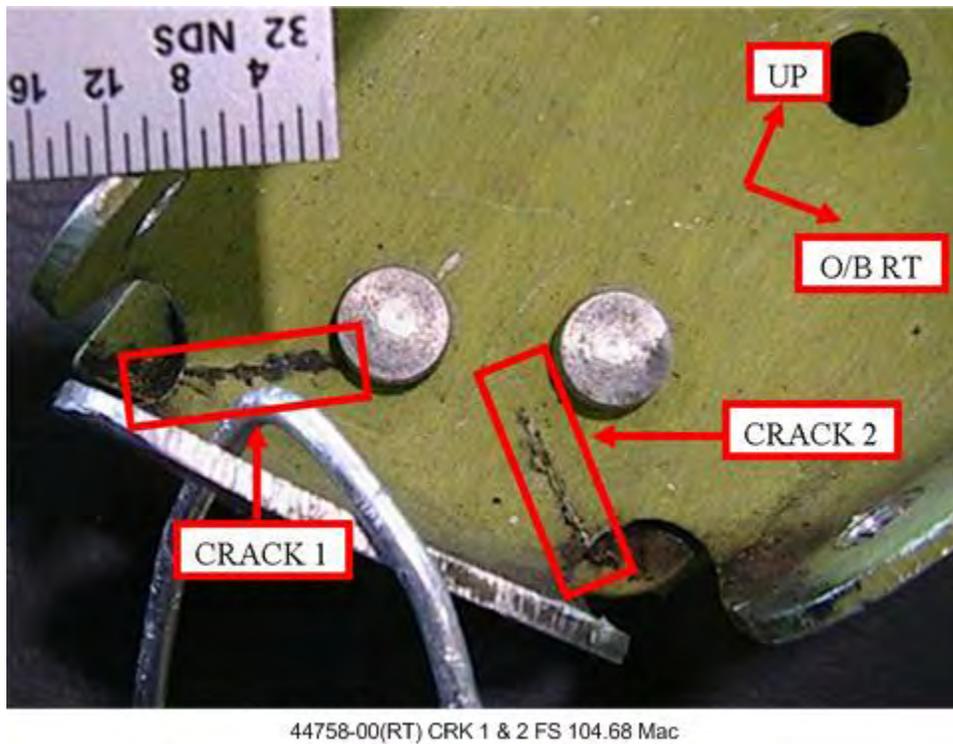
Figure 420. Macroscopic View of Cracks 1 and 2 on the Right Front Spar Attachment FS 104.31

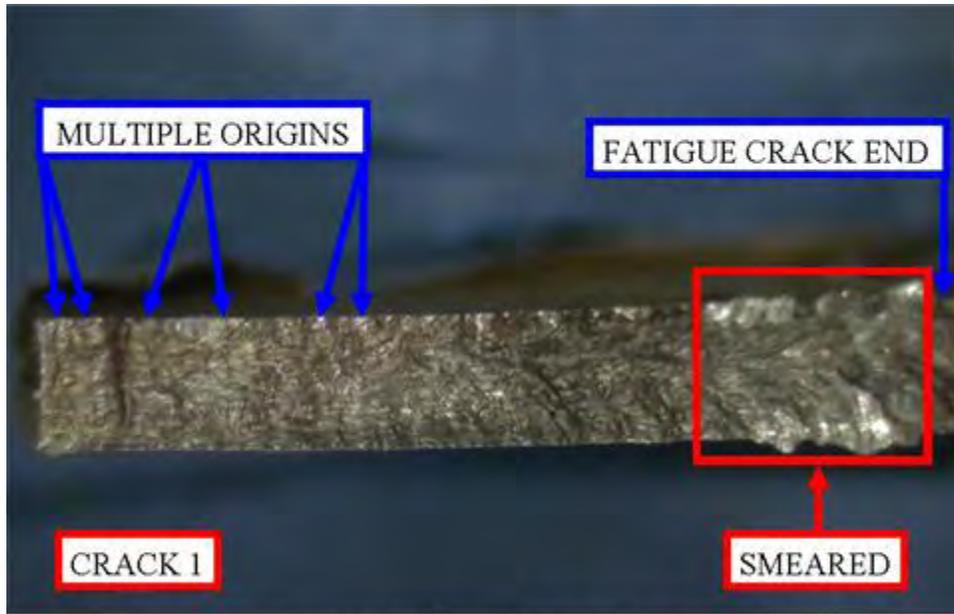
44758-01 CRK 1 FS 104.31 Frac

Figure 421. Fracture Face of Crack 1 on the Right Front Spar Attachment FS 104.31

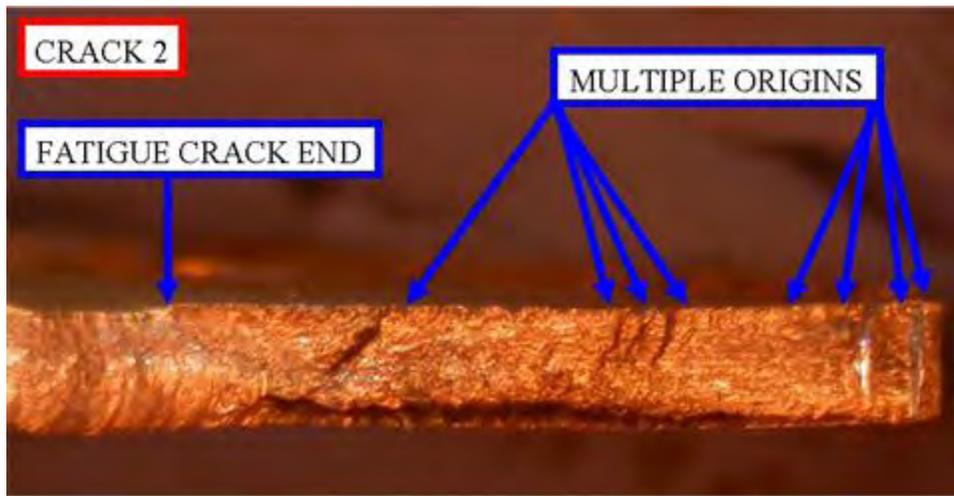
44758-01 CRK 2 FS 104.31 Frac

Figure 422. Fracture Face of Crack 2 on the Right Front Spar Attachment FS 104.31

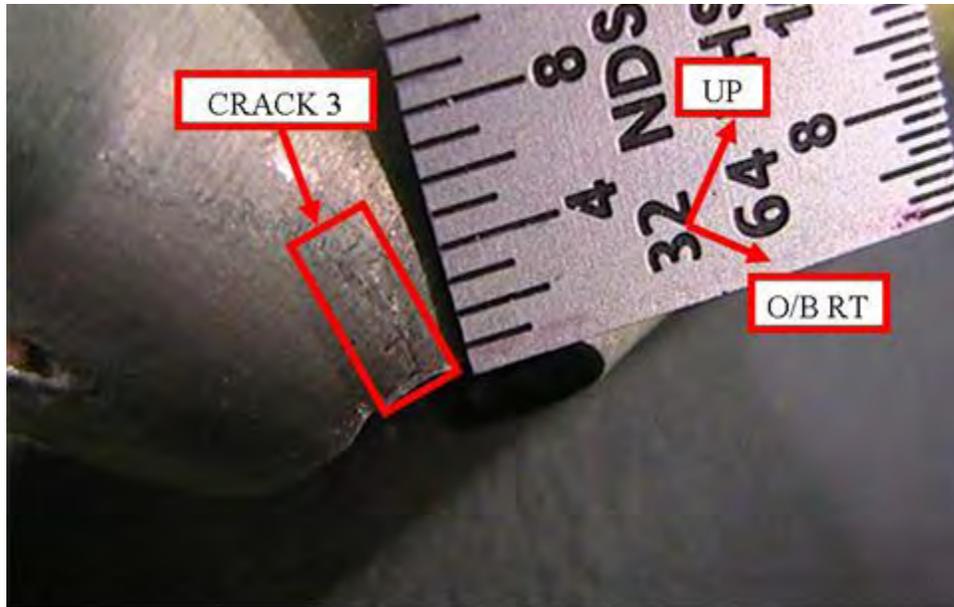
44758-00 CRK 3 FS 104.68 Mac

Figure 423. Macroscopic View of Crack 3 on the Right Front Spar Attachment FS 104.31

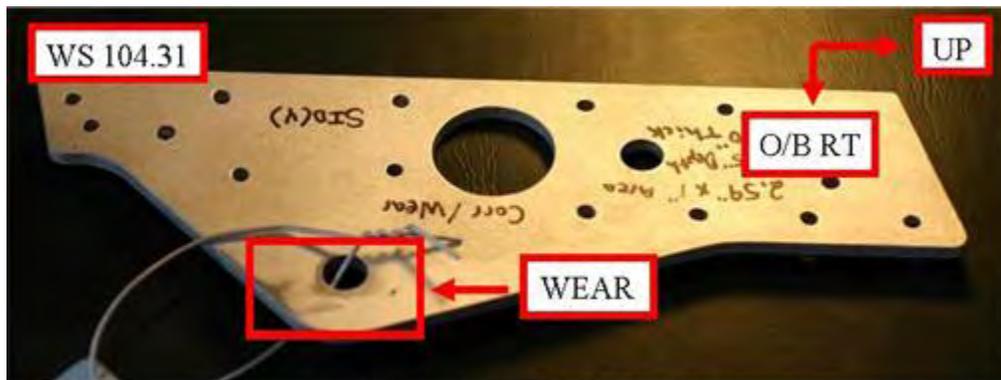
44758-1(RT) Wear FS 104.31 2 of 3 OV

Figure 424 shows the location of wear on the right front spar attachment 2 of 3 (B), part number 44758-01. A macroscopic view of the wear is shown in figure 425. This area of wear covered a surface area of 2.59 square inches and caused a localized reduction in thickness of 28%. The location of a similar area of wear on the left front spar attachment 2 of 3 (B) is shown in figure 426. A macroscopic view of this 2.97-square-inch area of corrosion, which caused a maximum localized thickness loss of 28%, is shown in figure 427.

Figure 424. Location of Wear on the Right Front Spar Attachment 2 of 3 (B) FS 104.31

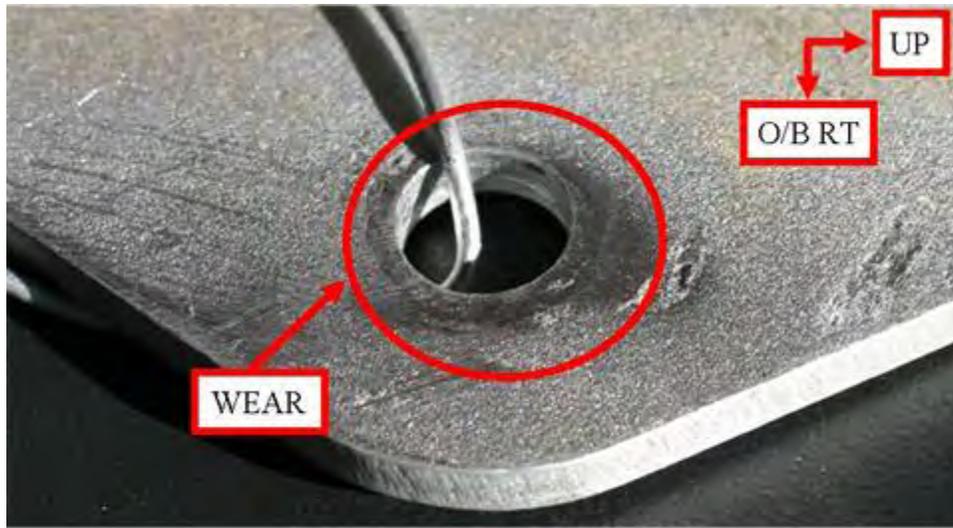
44758-1(RT) Wear FS 104.31 2 OF 3 Mac

Figure 425. Macroscopic View of Wear on the Right Front Spar Attachment 2 of 3 (B) FS 104.31

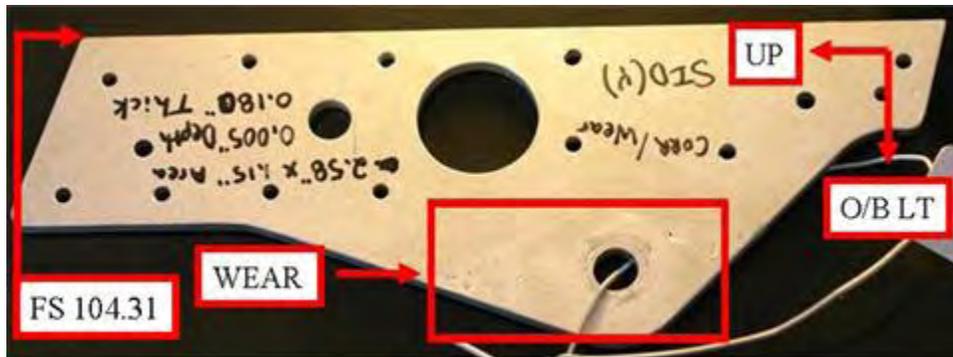
44758-00(LT) Wear FS 104.31 2 of 3 OV

Figure 426. Location of Wear on the Left Front Spar Attachment 2 of 3 (B) FS 104.31

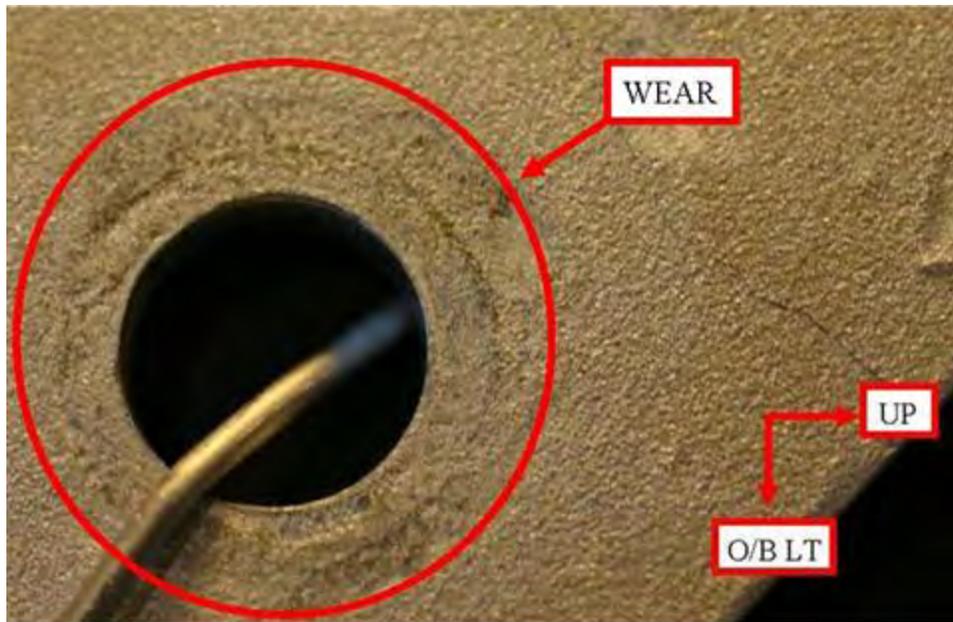
44758-00(LT) Wear FS 104.31 2 of 3 Mac

Figure 427. Macroscopic View of Wear on the Left Front Spar Attachment 2 of 3 (B) FS 104.31

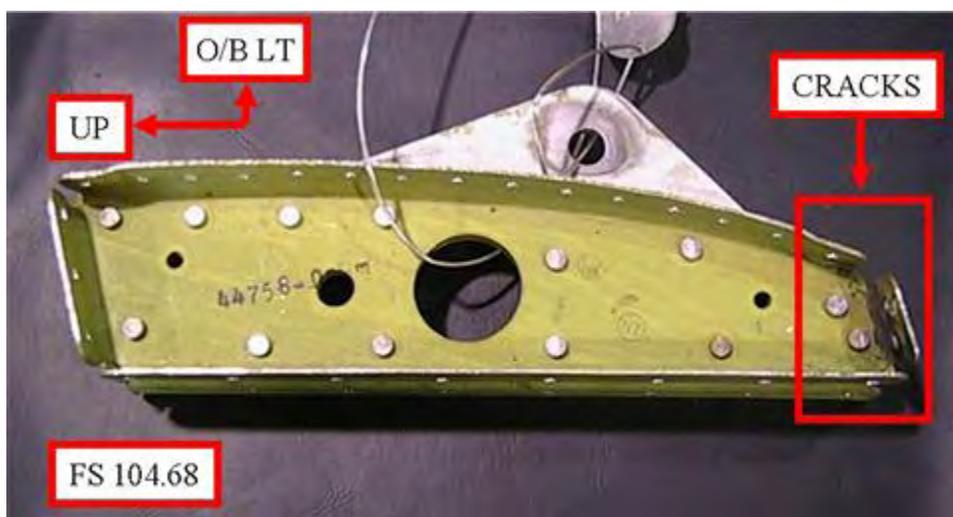
44758-01(LT) CRK FS 104.68 OV

The location of three cracks on the left front spar attachment is shown in figure 428. A macroscopic view of crack 1, which measured 1 inch, is shown in figure 429, and the fracture face of crack 1 is shown in figure 430. A fractograph of this crack, located at FS 104.68, is shown in figure 431, which shows crack face characteristics typical of fatigue. A macroscopic view of crack 2, which measured 0.334 inch, on the left front spar attachment, part number 44758-00, is shown in figure 432. A macroscopic view of crack 3, which measured 0.25 inch, is shown in figure 433. All three cracks were determined to be caused by fatigue.

Figure 428. Location of Three Cracks on the Left Front Spar Attachment FS 104.68

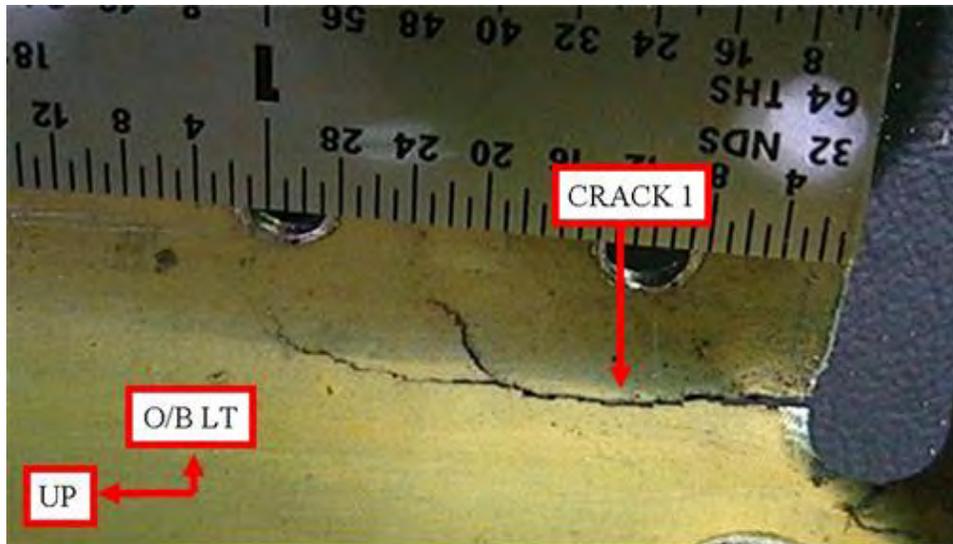
44758-01(LT) CRK 1 FS 104.68 Mac

Figure 429. Macroscopic View of Crack 1 on the Left Front Spar Attachment FS 104.68

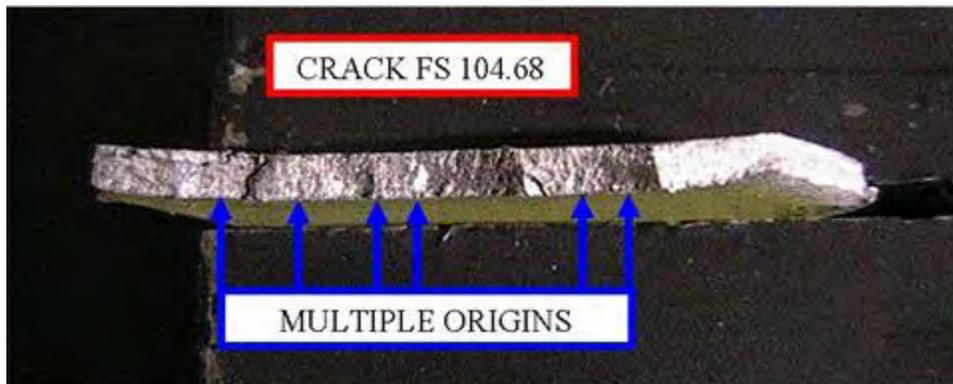
44758-01(LT) CRK 1 FS 104.68 Frac

Figure 430. Fracture Face of Crack 1 on the Left Front Spar Attachment FS 104.68

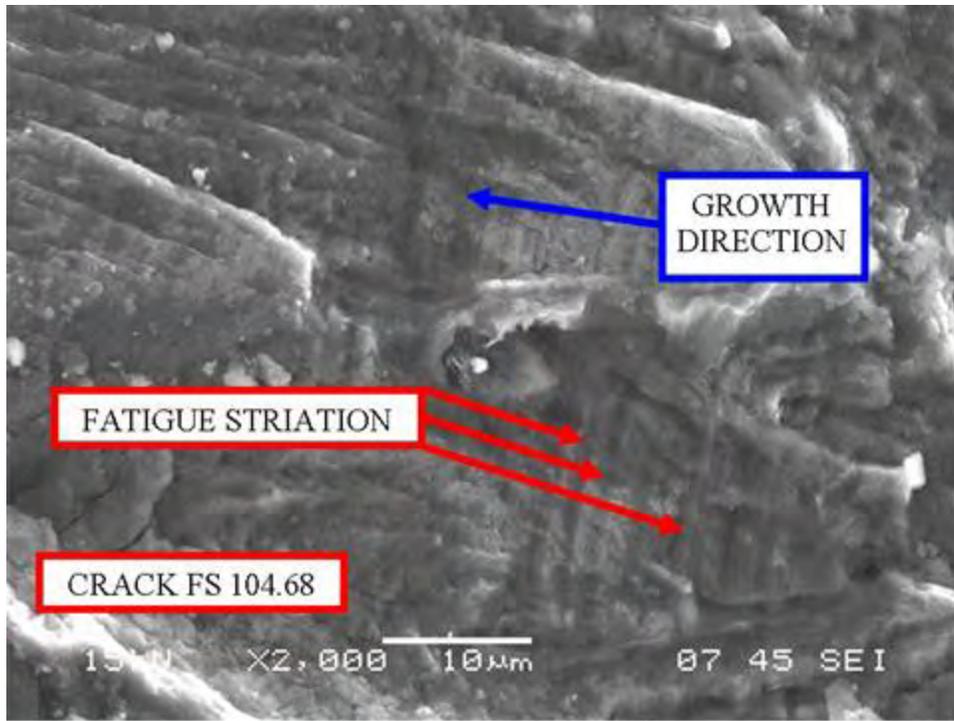
44758-01(LT) CRK 1 FS 104.68 SEM

Figure 431. Fractograph of Crack 1 on the Left Front Spar Attachment FS 104.68

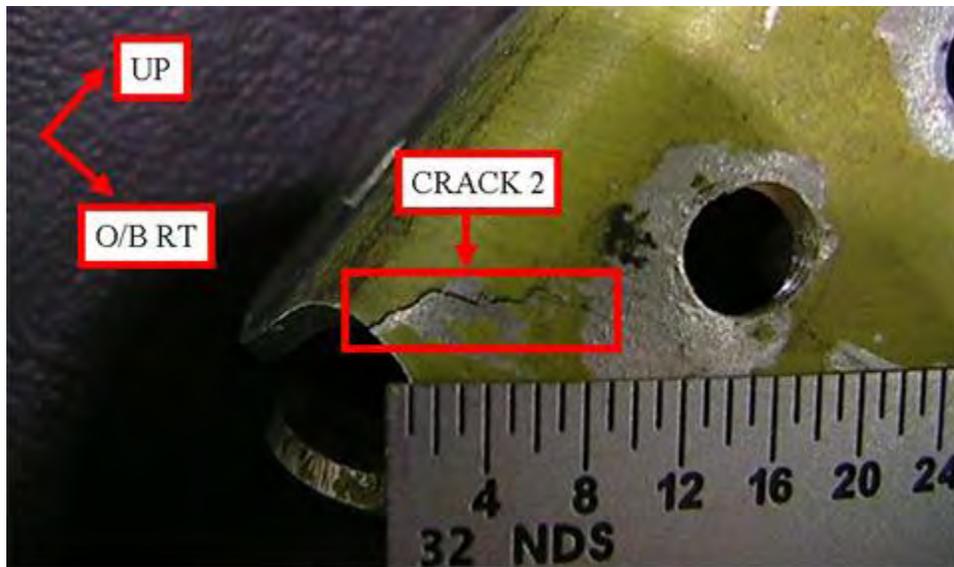
44758-01(LT) CRK 2 FS 104.68 Mac

Figure 432. Macroscopic View of Crack 2 on the Left Front Spar Attachment FS 104.68

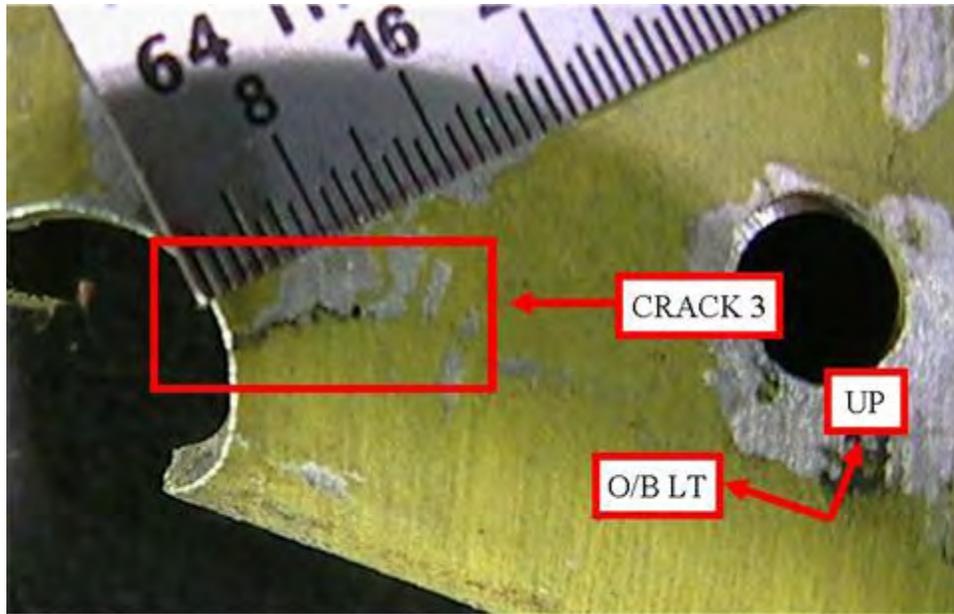
44758-01(LT) CRK 3 FS 104.68 Mac

Figure 433. Macroscopic View of Crack 3 on the Left Front Spar Attachment FS 104.68

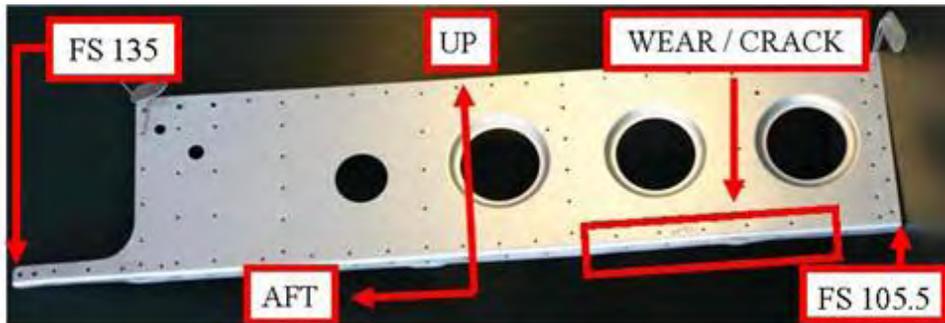
44877-2 Wear / CRK FS106-120 OV

Figure 434 shows the location of a 0.223-inch crack and a 126-square-inch area of wear, which resulted in a localized maximum thickness loss of 100% on the left lower forward longitudinal frame beam assembly, part number 44877-2. The wear, which stretched from FS 106 to FS 120, and the crack, which was located at FS 112, are shown macroscopically in figure 435, and microscopically in figure 436.

Figure 434. Location of Crack and Wear on the Left Lower Forward Longitudinal Frame Beam Assembly FS 105.5 Through FS 135

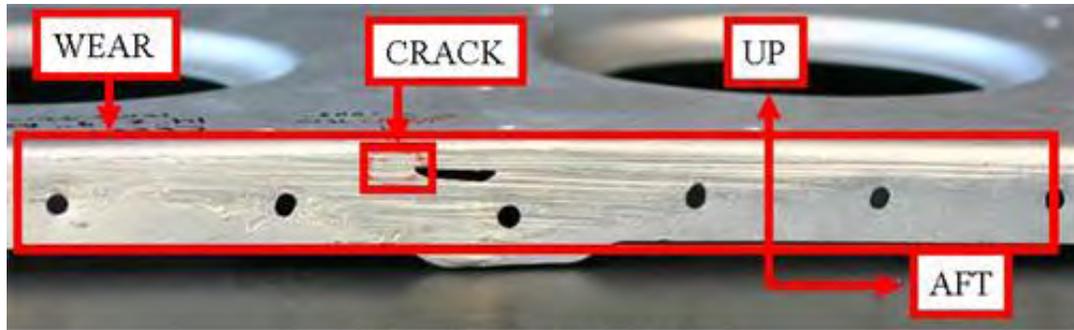
44877-2 Wear & CRK FS106-120 Mac

Figure 435. Macroscopic View of Crack and Wear on the Left Lower Forward Longitudinal Frame Beam Assembly FS 106 Through FS 120

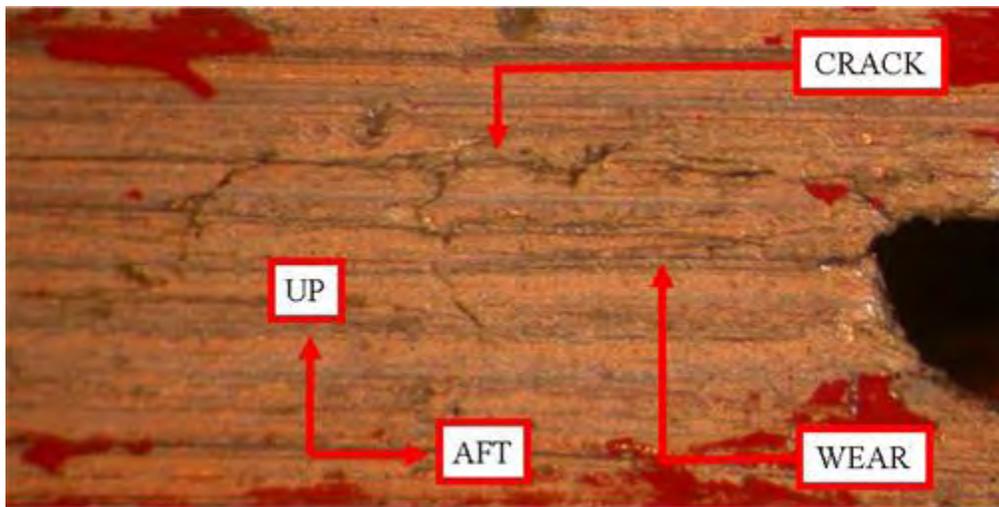
44877-2 CRK FS 112 Mic

Figure 436. Microscopic View of Crack and Wear on the Left Lower Forward Longitudinal Frame Beam Assembly FS 112

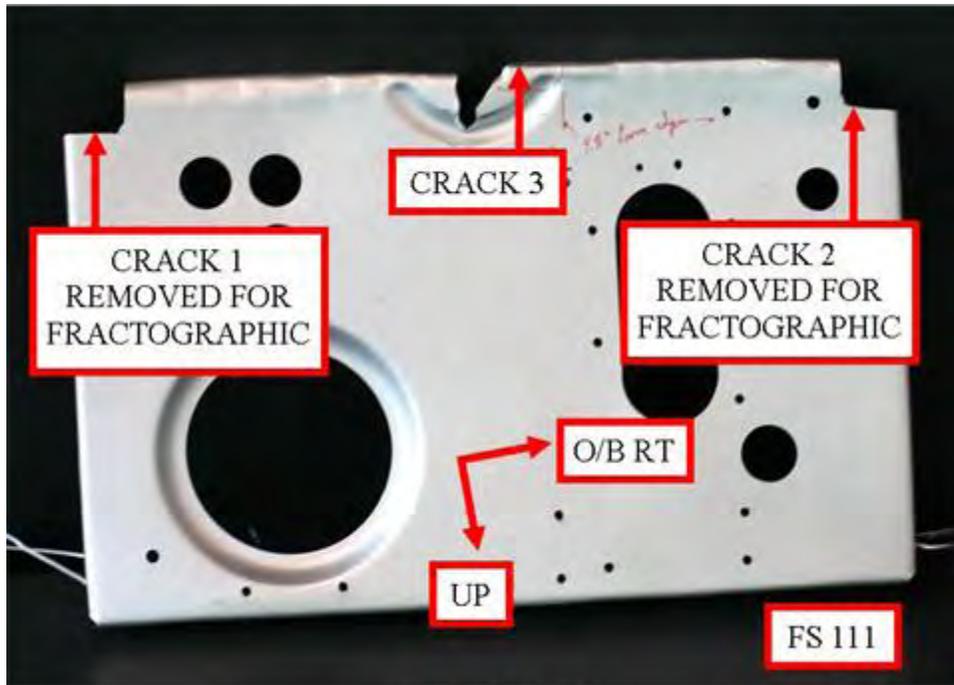
52190-05 CRK FS 111 OV

The location of three cracks on the bulkhead assembly lower forward left frame, part number 52190-05 is shown in figure 437. A macroscopic view of crack 1, which was located at FS 111 and measured 0.289 inches in length, is shown in figure 438. A macroscopic view of crack 2, which measured 0.375 inch, is shown in figure 439. Crack 3, which measured 0.336 inches and was located at FS 111, is shown macroscopically in figure 440 and microscopically in figure 441. Cracks 1 and 2 were opened for fractographic analysis but, due to extensive crack face smearing, a failure mode could not be obtained.

Figure 437. Location of Three Cracks in the Bulkhead Assembly Lower Forward Left Frame FS 111

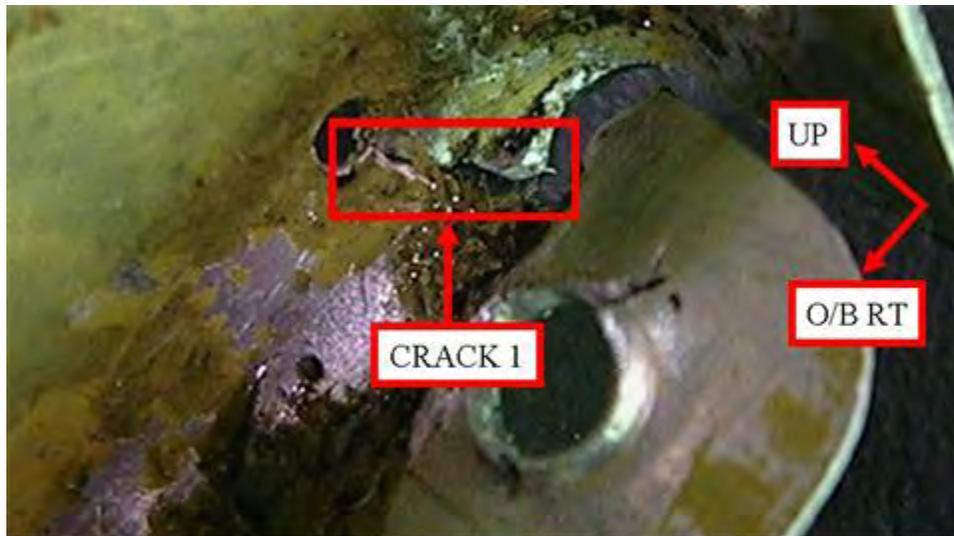
52190-05 CRK 1 FS 111 Mac

Figure 438. Macroscopic View of Crack 1 on the Bulkhead Assembly Lower Forward Left Frame FS 111

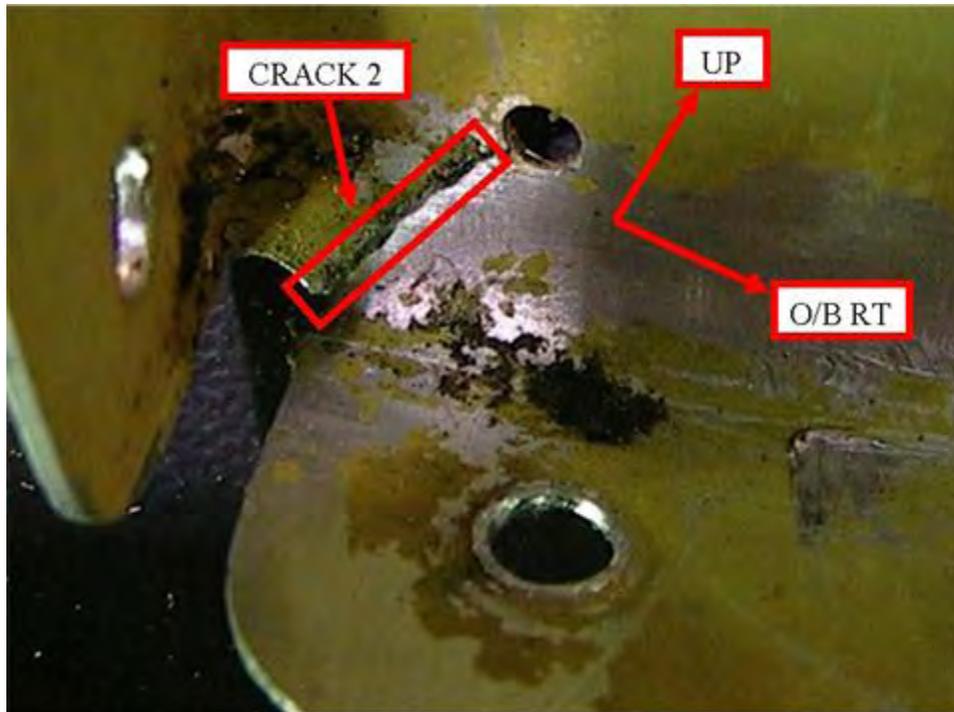
52190-05 CRK 2 FS 111 Mac

Figure 439. Macroscopic View of Crack 2 on the Bulkhead Assembly Lower Forward Left Frame FS 111

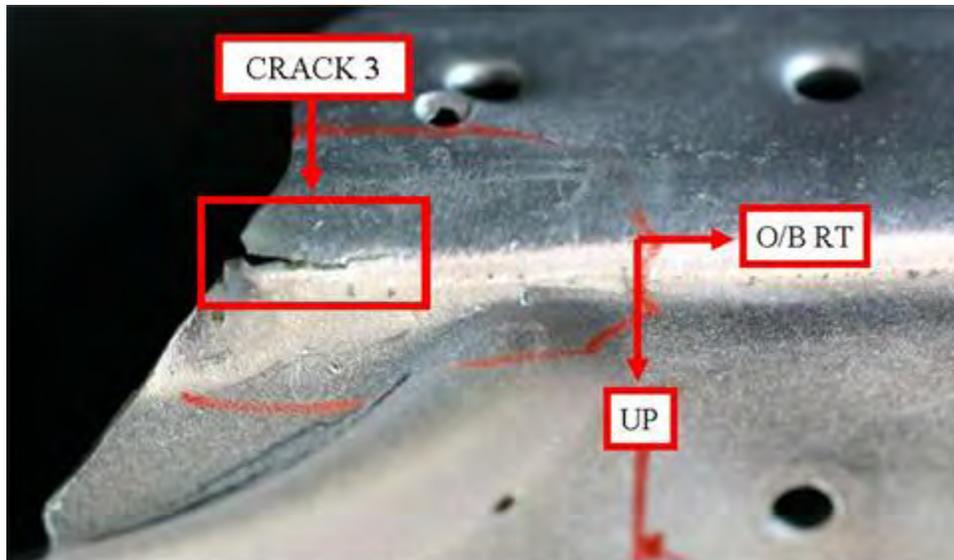
52190-05 CRK 3 FS 111 Mac

Figure 440. Macroscopic View of Crack 3 on the Bulkhead Assembly Lower Forward Left Frame FS 111

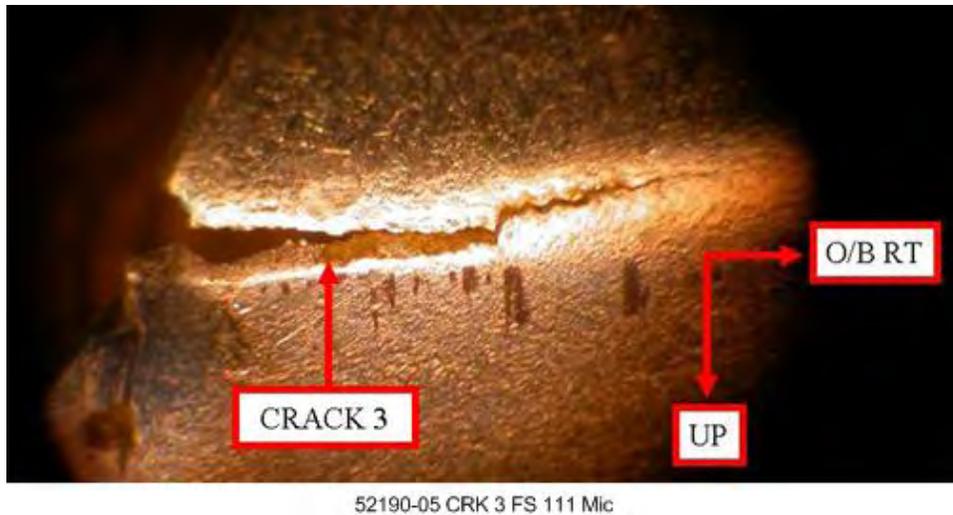
Figure 441. Microscopic View of Crack 3 on the Bulkhead Assembly Lower Forward Left Frame FS 111

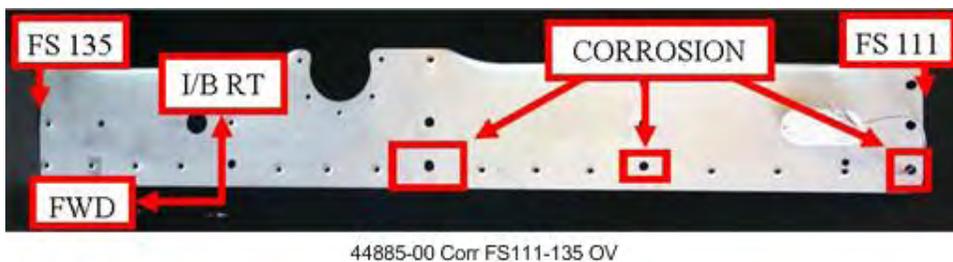
The location of areas of moderate, moderate-severe, and severe corrosion on the left inboard floorboard support, part number 44885-00, is shown in figure 442. A macroscopic view of a 0.17-square-inch area of moderate-severe corrosion, located at FS 111, is shown in figure 443. This area of corrosion resulted in a maximum reduction in thickness of 9.3%. Figure 444 shows a macroscopic view of corrosion on the floorboard support at FS 118. This 0.32-square-inch area of corrosion caused a maximum localized thickness loss of 6.2%, which is classified as moderate corrosion. Figure 445 shows a macroscopic view of 1.87-square-inch area of severe corrosion, which caused a maximum localized thickness loss of 25%. This area of corrosion was located at FS 123.

Figure 442. Location of Moderate, Moderate-Severe, and Severe Corrosion on the Left Inboard Floorboard Support FS 111 Through FS 135

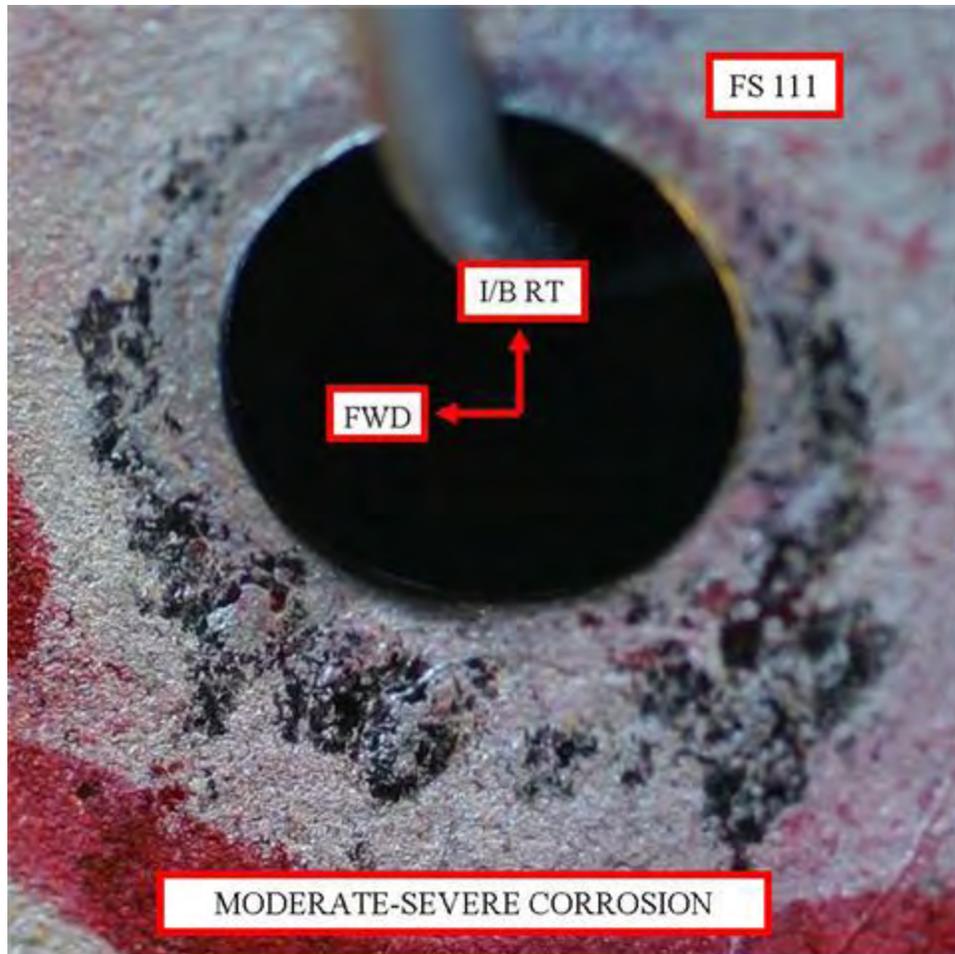
44885-00 Corr FS111 Mac

Figure 443. Macroscopic View of Moderate-Severe Corrosion on the Left Inboard Floorboard Support FS 111

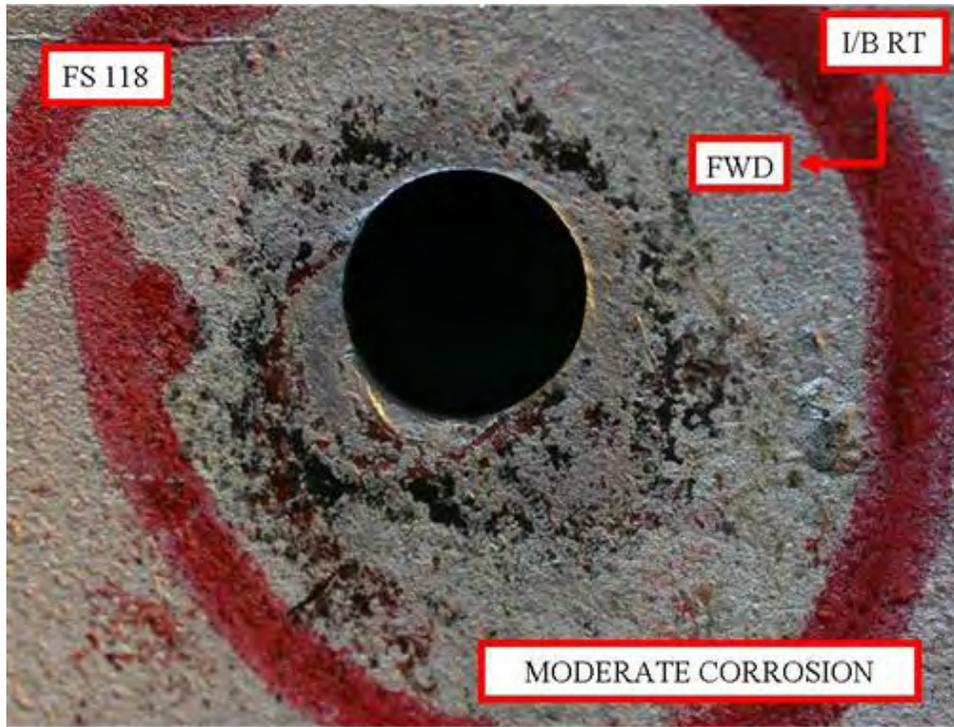
44885-00 Corr 2 FS118 Mac

Figure 444. Macroscopic View of Moderate Corrosion on the Left Inboard Floorboard Support FS 118

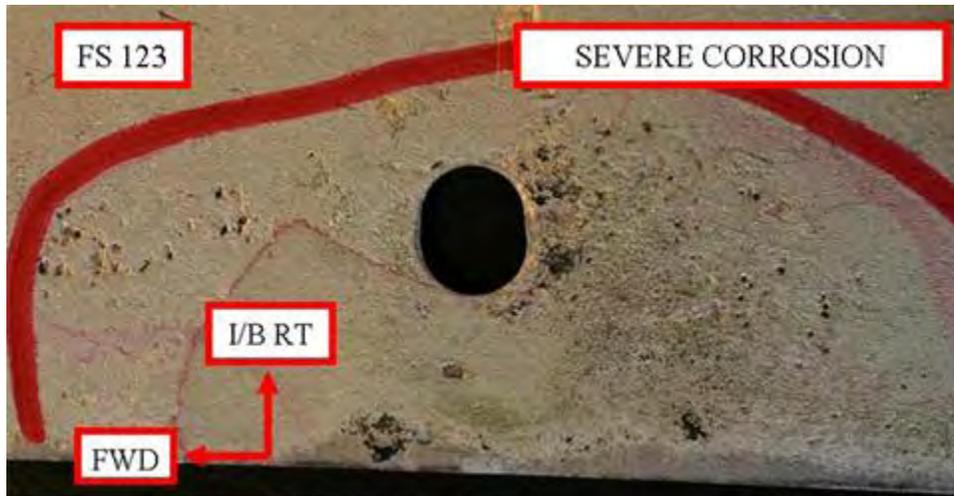
44885-00 Corr 3 FS123 Mac

Figure 445. Macroscopic View of Severe Corrosion on the Left Inboard Floorboard Support FS 123

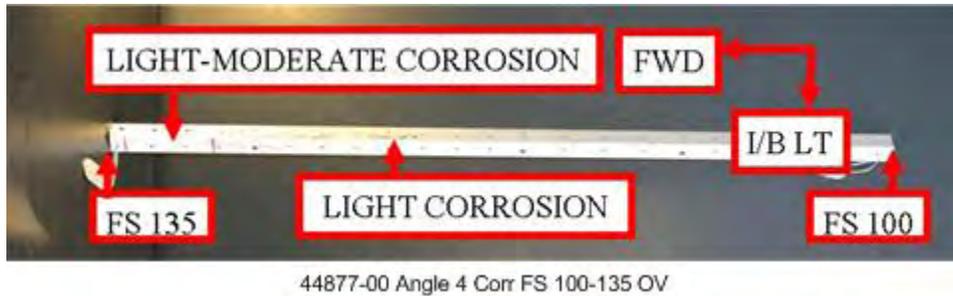
Figure 446 shows the location of light and light-moderate corrosion on the fuselage upper left angle 4 longitudinal beam assembly, part number 44877-00, at FS 115.5 and FS 129.5. The light corrosion covered a surface area of 0.56 square inch and resulted in a localized thickness loss of 1%, and the light-moderate corrosion covered a surface area of 1.125 square inches and resulted in a reduction in localized thickness of 4%. The location of a 0.274-inch crack on the fuselage lower forward stringer, part number 52080-09, is shown in figure 447, and a macroscopic view of this crack is shown in figure 448. The fracture face of this crack, located at FS 122, is shown in figure 449. The failure mode for this crack was determined to be overload from analysis of this fracture face.

Figure 446. Location of Light and Light-Moderate Corrosion on the Fuselage Upper Left Angle 4 Longitudinal Beam Assembly FS 115.5 and FS 129.5

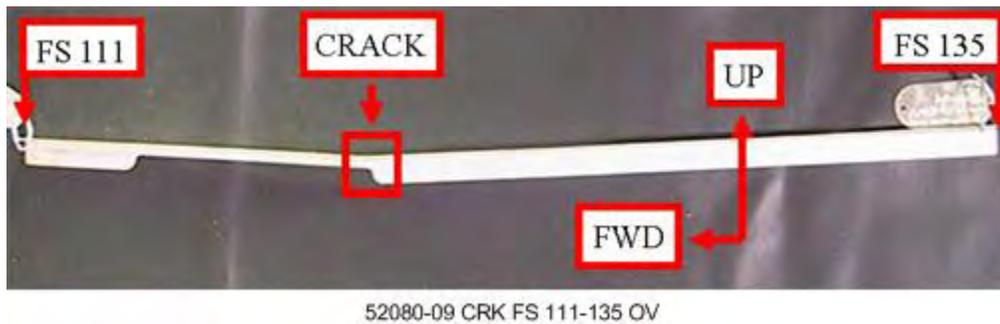
Figure 447. Location of Crack on the Fuselage Lower Forward Stringer FS 122

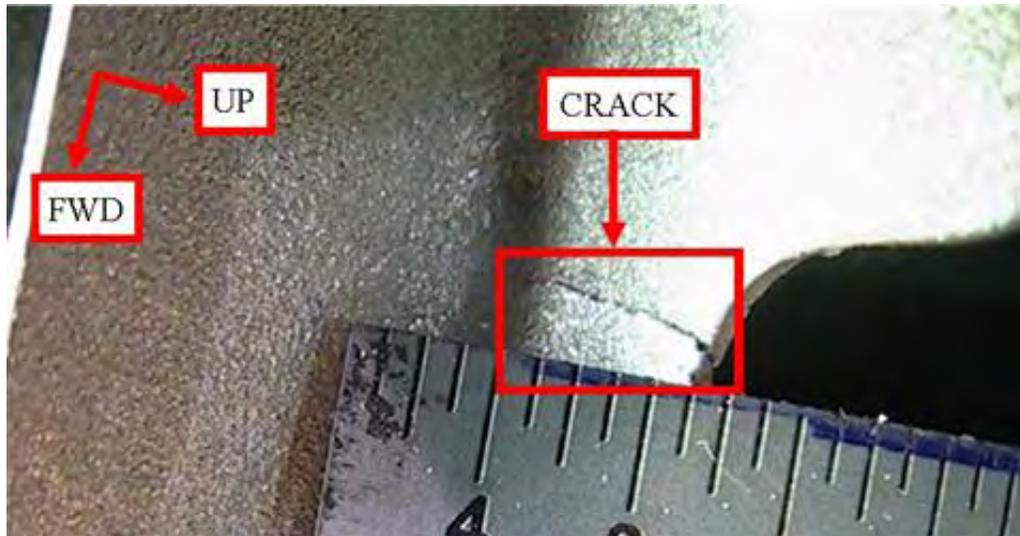
52080-09 CRK FS 111-135 Mac

Figure 448. Macroscopic View of Crack on the Fuselage Lower Forward Stringer FS 122

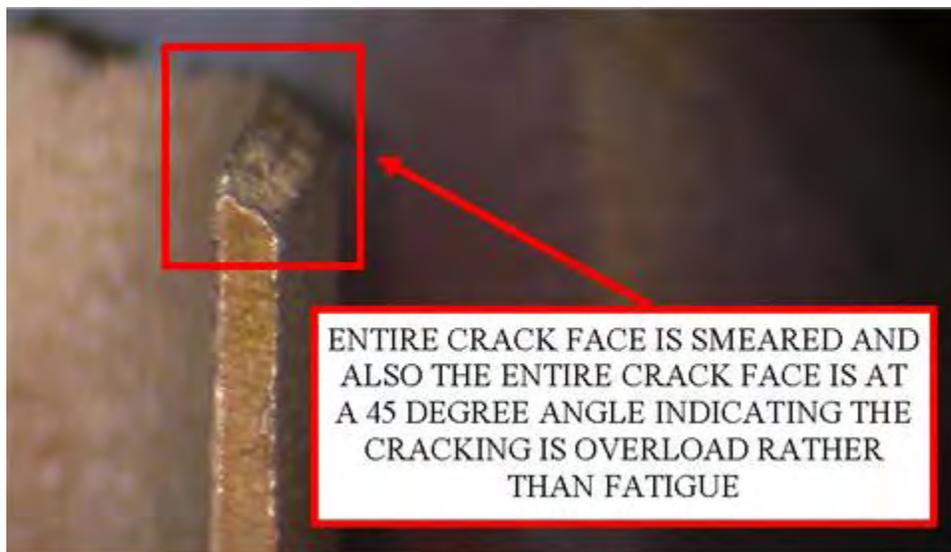
52080-09 CRK FS 111-135 Frac

Figure 449. Fracture Face of Crack on the Fuselage Lower Forward Stringer FS 122

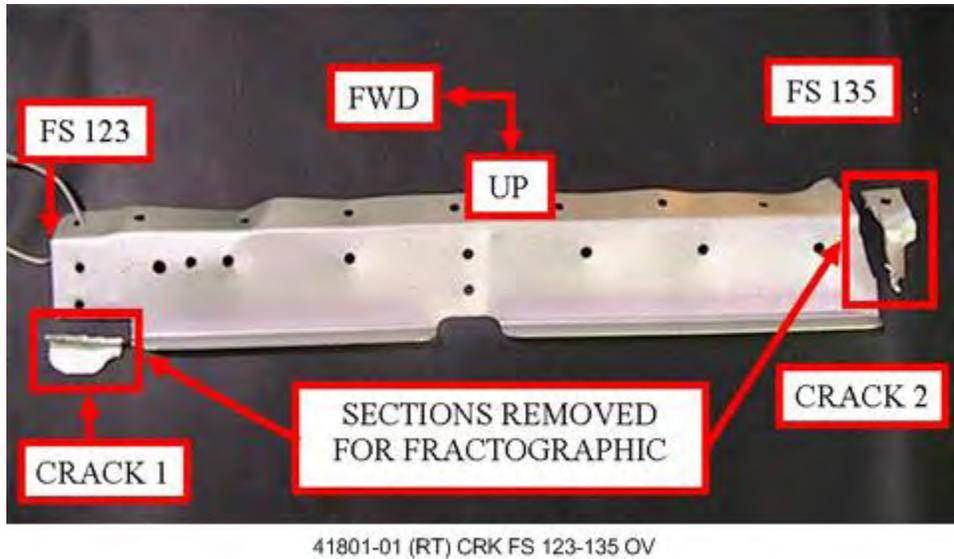
Figure 450 shows the location of two cracks on the fuselage right floorboard channel support, part number 44801-01. A macroscopic view of crack 1, which is located at FS 123 and measured 0.738 inch, is shown in figure 451. Figure 452 shows a macroscopic view of a 1.297-inch crack, crack 2, at FS 135. Both crack faces were analyzed; however, due to extensive crack face smearing, the failure mode of both cracks could not be determined. Figure 453 shows the location of a 2.14-square-inch area of light-moderate corrosion on the fuselage longitudinal beam lower right frame, part number 44877-03. This corrosion caused a maximum reduction in thickness of 2.5%.

Figure 450. Location of Cracks 1 and 2 on the Fuselage Right Floorboard Channel Support FS 123 Through FS 135

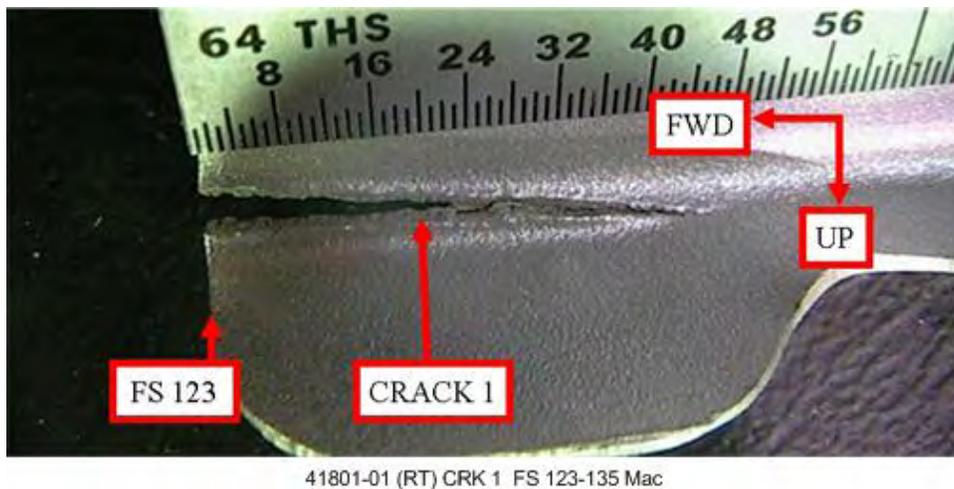
Figure 451. Macroscopic View of Crack 1 on the Fuselage Right Floorboard Channel Support FS 123

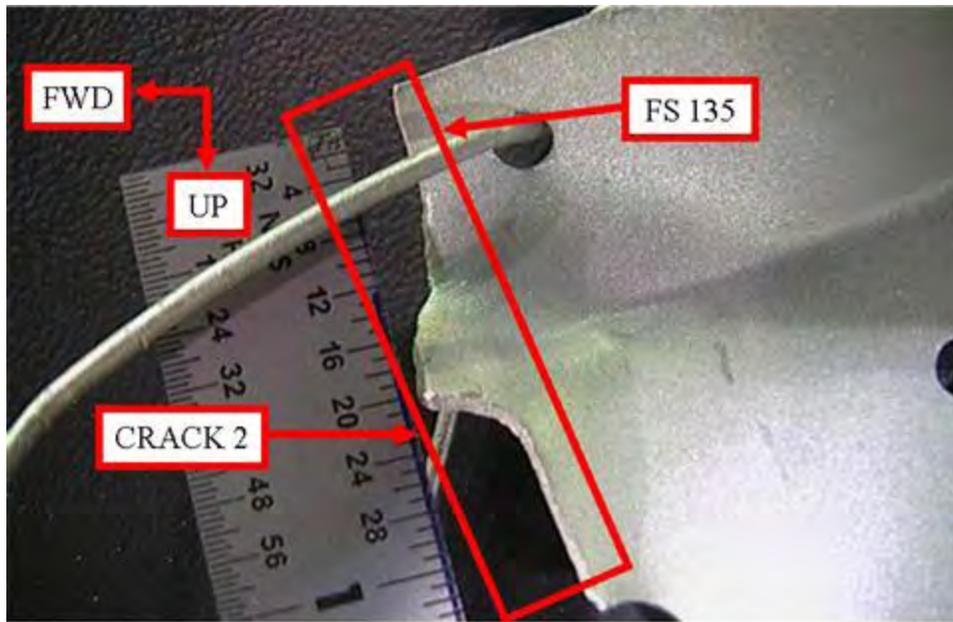
41801-01 (RT) CRK 2 FS 123-135 Mac

Figure 452. Macroscopic View of Crack 2 on the Fuselage Right Floorboard Channel Support FS 135

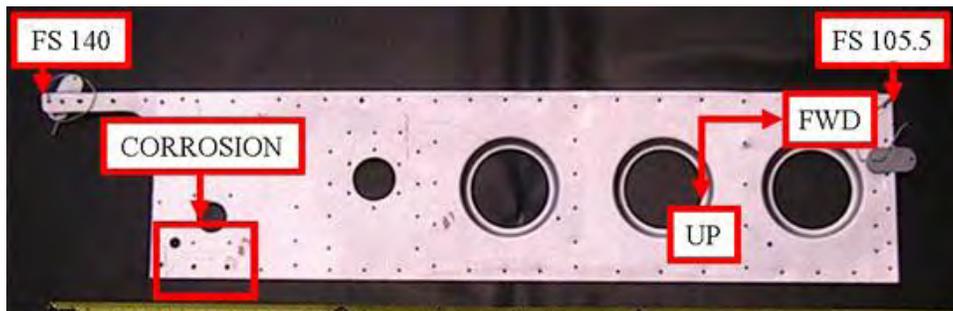
44877-03 (RT) Corr FS105.5-140 OV

Figure 453. Location of Light-Moderate Corrosion on the Fuselage Longitudinal Beam Lower Right Frame FS 130.75 Through FS 133

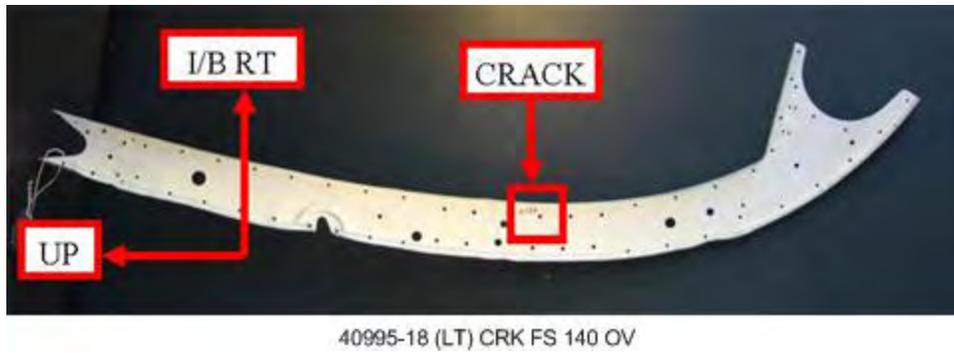
The location of a crack on the left center body bulkhead at FS 140, part number 40995-18, is shown in figure 454. A macroscopic view of this 0.072-inch crack is shown in figure 455. Figure 456 shows the location of an area of severe corrosion and an area of wear on the right center body bulkhead FS 140, part number 40995-17. A macroscopic view of the area of severe corrosion, located at FS 140, is shown in figure 457. This corrosion covered a surface area of 0.11 square inch and caused a maximum reduction in thickness of 12.5%. A macroscopic view of a 0.14-square-inch area of wear is shown in figure 458. This wear occurred at FS 140 and caused a localized reduction in thickness of 7.5%.

Figure 454. Location of Crack on the Left Center Body Bulkhead FS 140

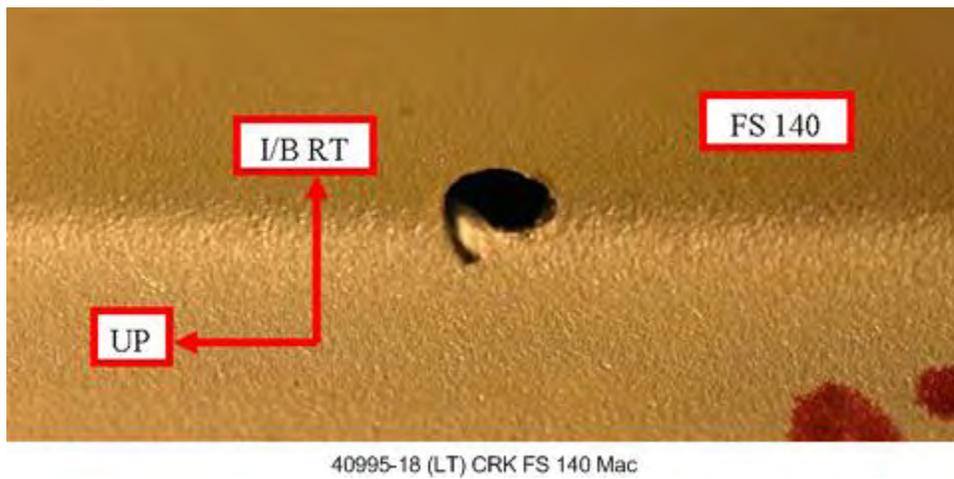
Figure 455. Macroscopic View of Crack on the Left Center Body Bulkhead FS 140
