DOT/FAA/AR-07/64

Teardown Evaluation of a 1975 Piper Navajo Chieftain Model PA31-350 Airplane

March 2008

Final Report

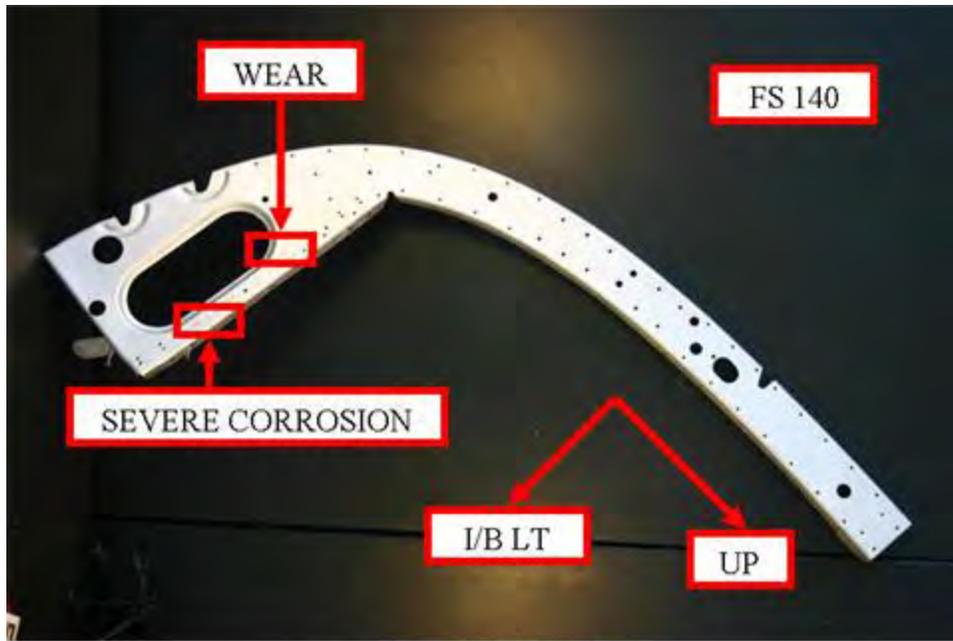
40995-17 (RT) Corr FS140 OV

Figure 456. Location of Severe Corrosion and Wear on the Right Center Body Bulkhead FS 140

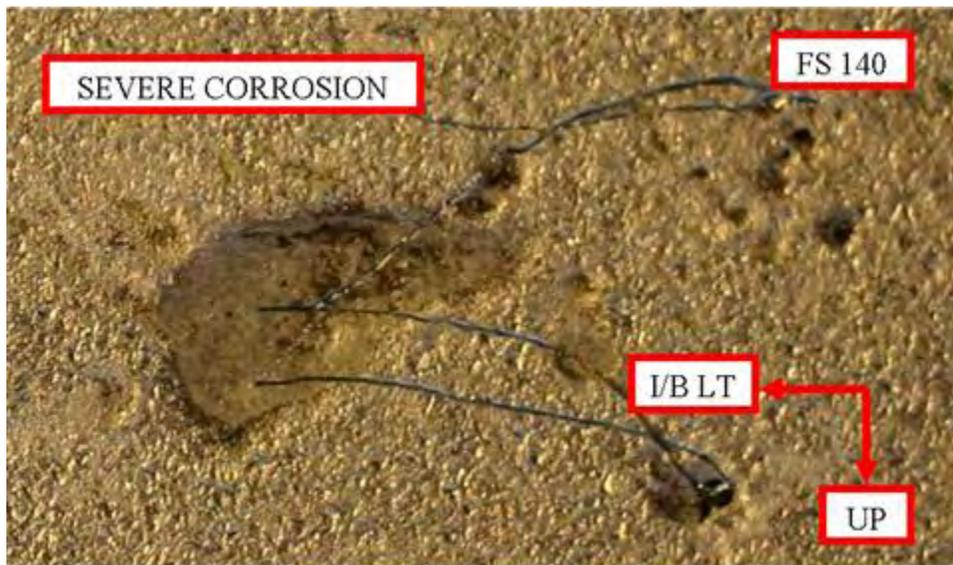
40995-17 (RT) Corr FS140 Mac

Figure 457. Macroscopic View of Severe Corrosion on the Right Center Body Bulkhead FS 140

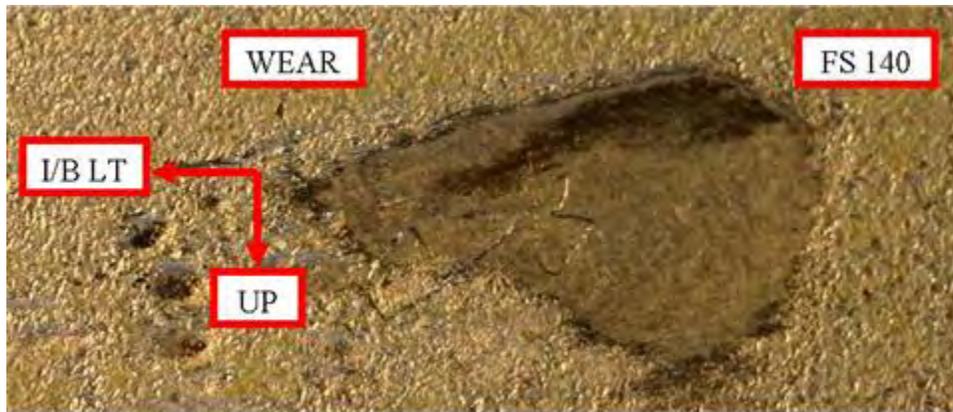
40995-17 (RT) Wear FS140 Mac

Figure 458. Macroscopic View of Wear on the Right Center Body Bulkhead FS 140

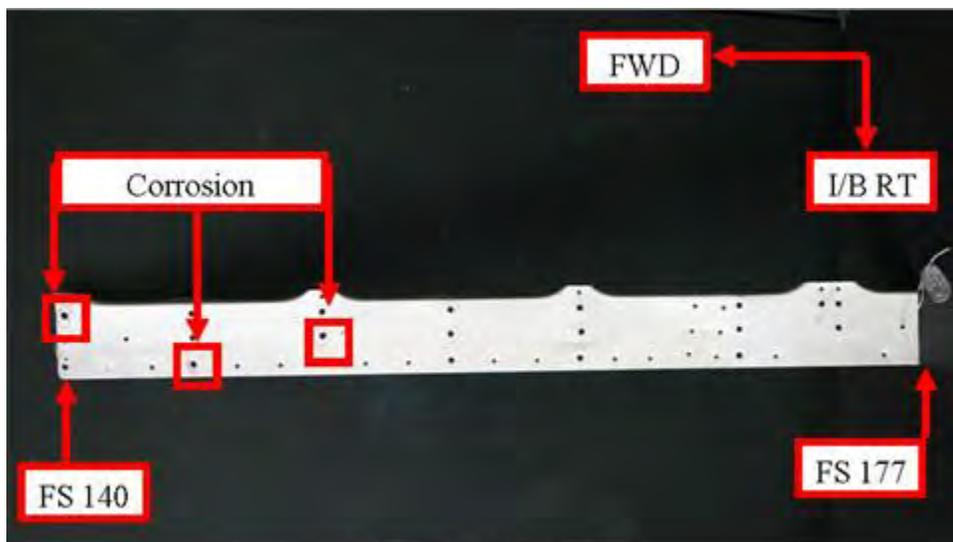
41614-00 Corr FS140-177 OV

The location of light-moderate, moderate-severe, and severe corrosion identified on the left floorboard support, part number 41614-00, is shown in figure 459. Figure 460 shows a macroscopic view of a 0.23-square-inch area of corrosion located at FS 140. The maximum localized reduction in thickness caused by this area of corrosion was 18%. A macroscopic view of a 0.04-square-inch area of moderate-severe corrosion, located at FS 146, is shown in figure 461. This area of corrosion caused a localized thickness loss of 9.4%. A 0.07-square-inch area of light-moderate corrosion that caused a localized thickness loss of 3% was noted on the floorboard support at FS 151.

Figure 459. Location of Light-Moderate, Moderate-Severe, and Severe Corrosion on the Left Floorboard Support FS 140 Through FS 177

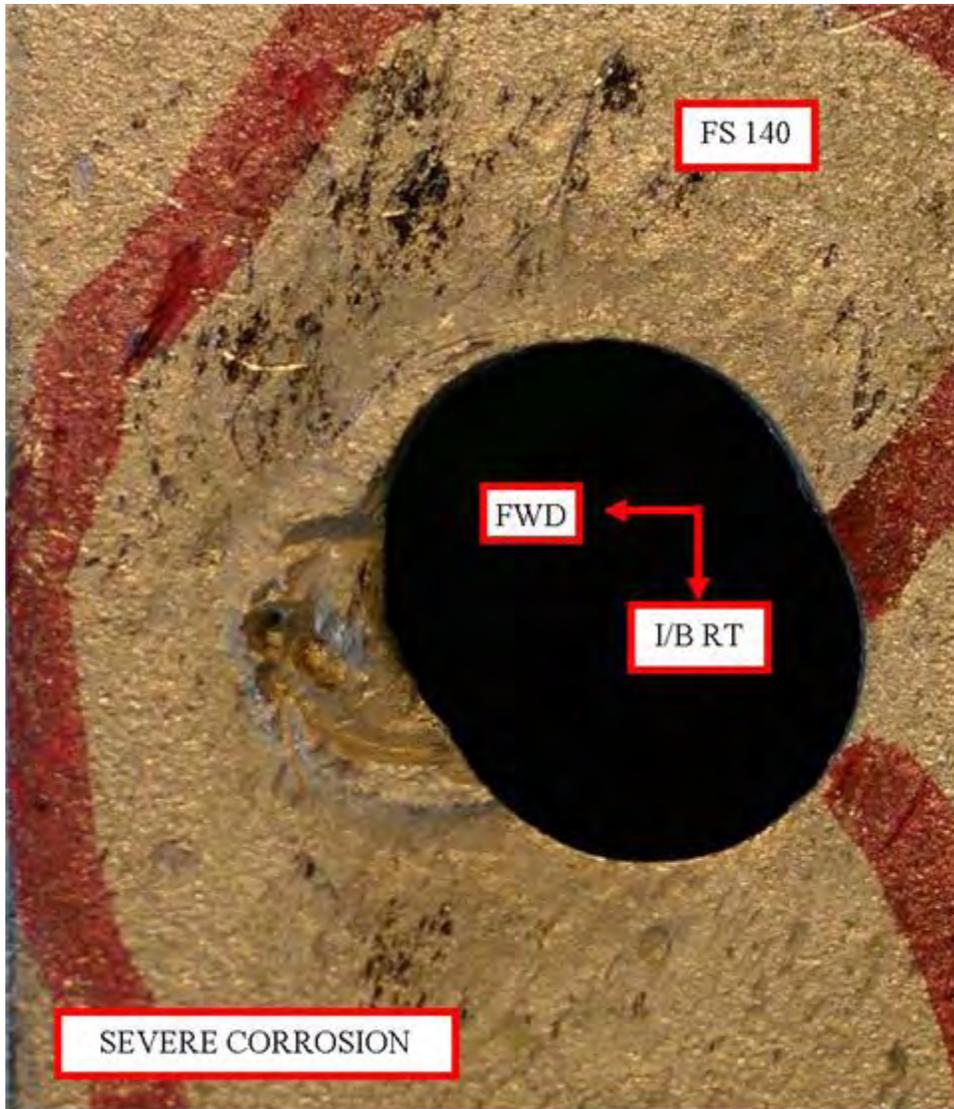
41614-00 Corr 1 FS140-177 Mac

Figure 460. Macroscopic View of Severe Corrosion on the Left Floorboard Support FS 140

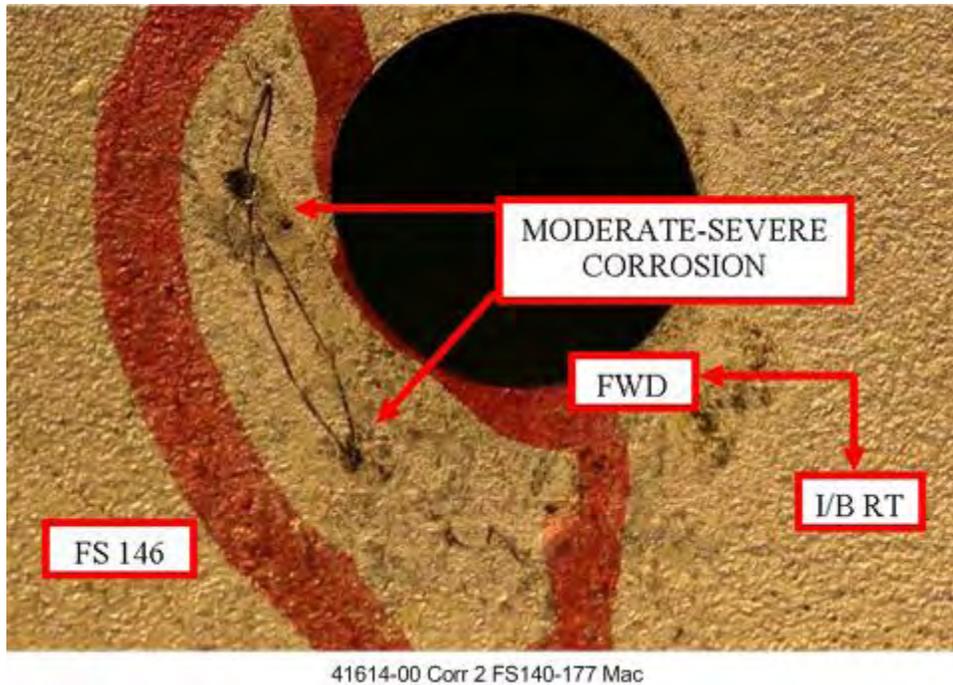
Figure 461. Macroscopic View of Moderate-Severe Corrosion on the Left Floorboard Support FS 146

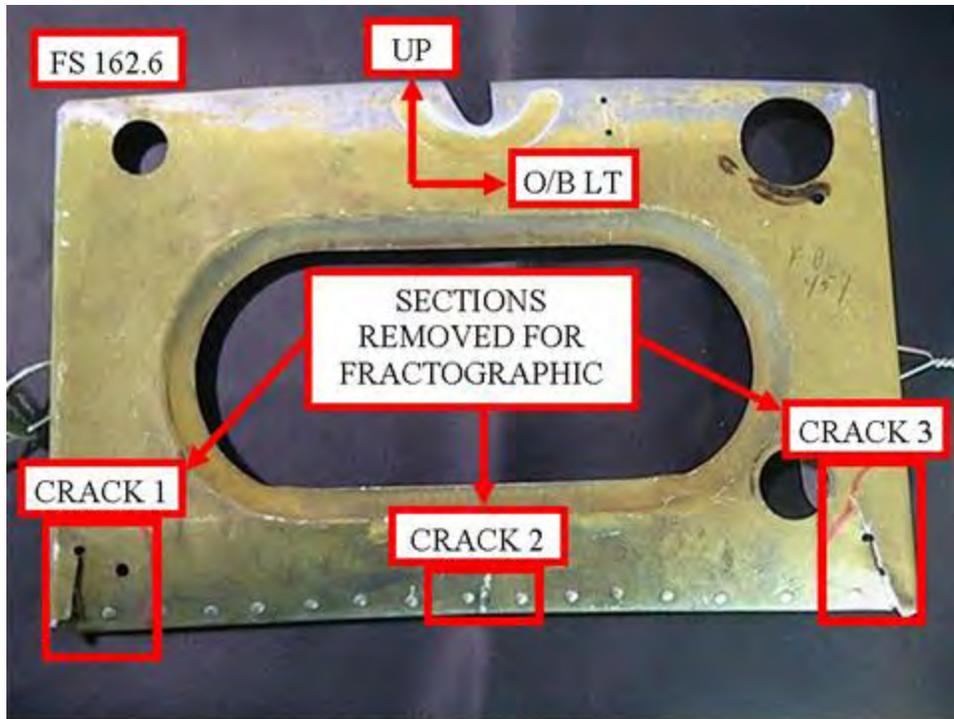
41233-05 CRK FS 162.6 OV

The location of three cracks on the fuselage bottom bulkhead assembly, part number 41233-05, is shown in figure 462. A macroscopic view of crack 1, located at FS 162.6, is shown in figure 463. The fracture face of this 1.514-inch crack is shown in figure 464. A macroscopic view of crack 2, which measured 0.642 inch in length, is shown in figure 465. A fracture face of this crack is shown in figure 466. A macroscopic view of crack 3, which measured 1.804 inches in length and occurred at FS 162.6, is shown in figure 467, and the fracture face is shown in figure 468. From the fracture face characteristics, it was determined that all three cracks were caused by fatigue; however, significant crack face smearing was also observed.

Figure 462. Location of Three Cracks on the Fuselage Bottom Bulkhead Assembly FS 162.6

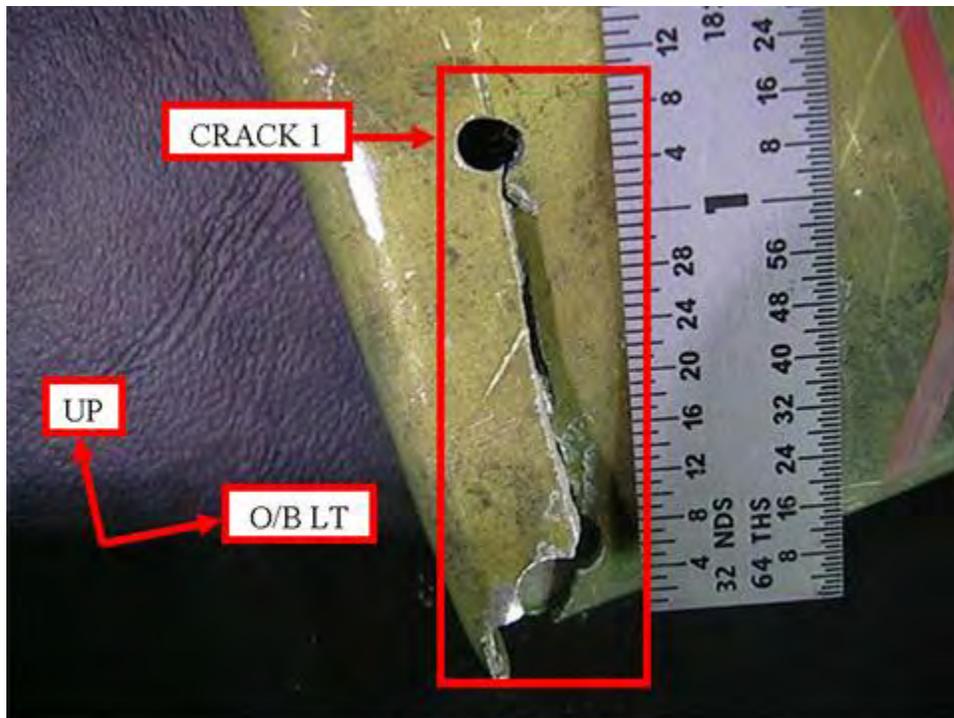
41233-05 CRK 1 FS 162.6 Mac

Figure 463. Macroscopic View of Crack 1 on the Fuselage Bottom Bulkhead Assembly FS 162.6

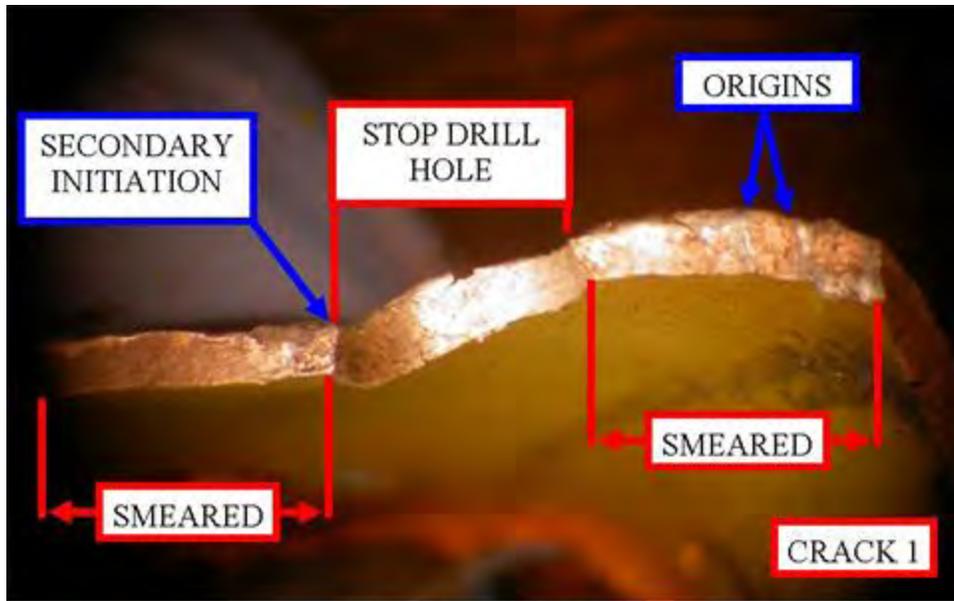
41233-05 CRK 1 FS 162.6 Frac

Figure 464. Fracture Face of Crack 1 on the Fuselage Bottom Bulkhead Assembly FS 162.6

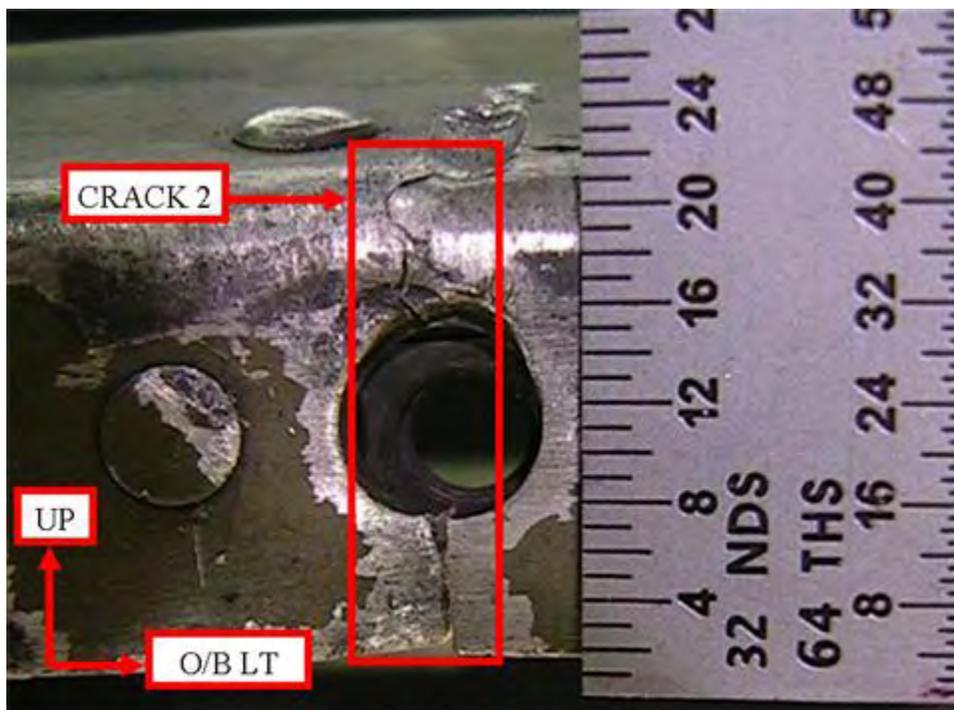
41233-05 CRK 2 FS 162.6 Mac

Figure 465. Macroscopic View of Crack 2 on the Fuselage Bottom Bulkhead Assembly FS 162.6

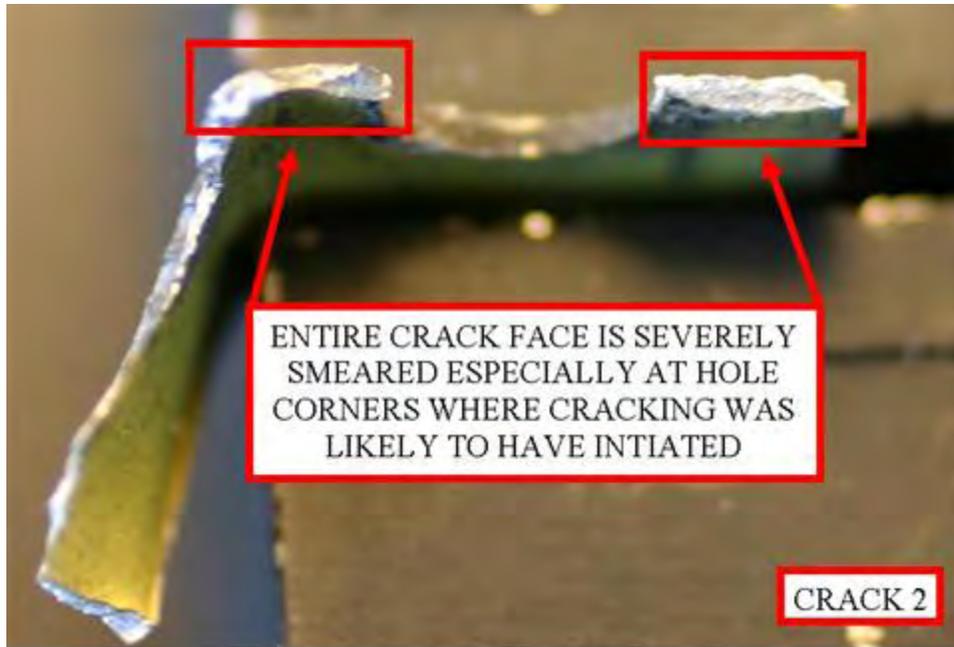
41233-05 CRK 2 FS 162.6 Frac

Figure 466. Fracture Face of Crack 2 on the Fuselage Bottom Bulkhead Assembly FS 162.6

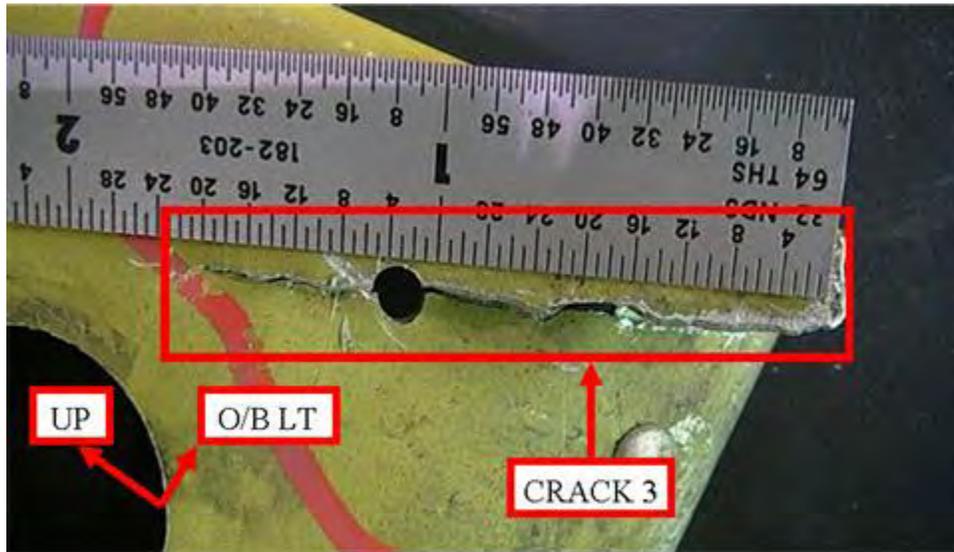
41233-05 CRK 3 FS 162.6 Mac

Figure 467. Macroscopic View of Crack 3 on the Fuselage Bottom Bulkhead Assembly FS 162.6

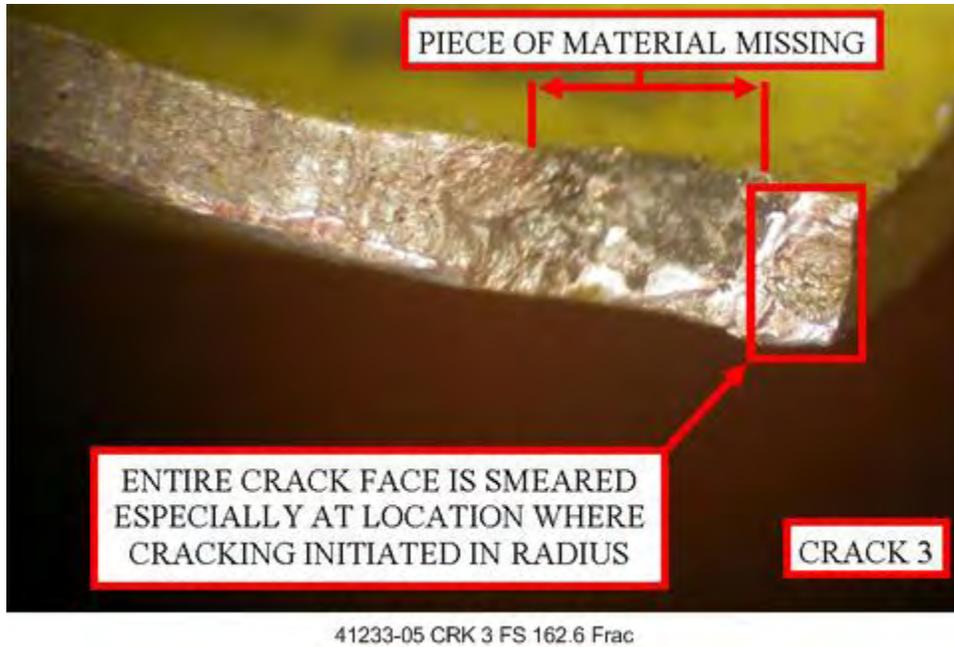
Figure 468. Fracture Face of Crack 3 on the Fuselage Bottom Bulkhead Assembly FS 162.6

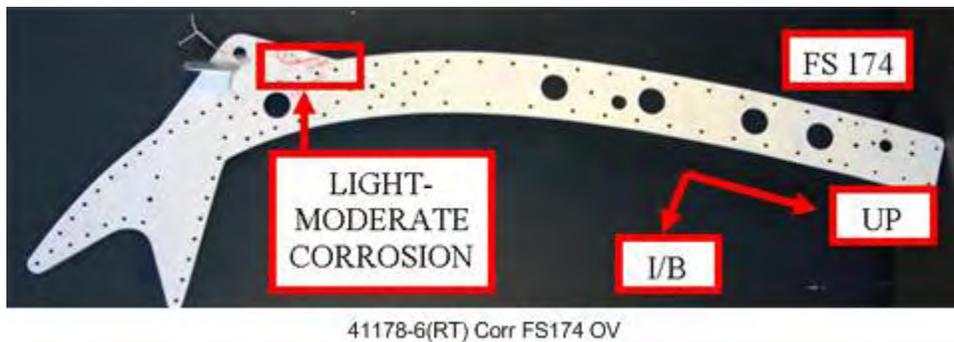
Figure 469 shows the location of a 0.62-square-inch area of light-moderate corrosion on the center body right, part number 41178-6. This area of corrosion caused a localized thickness loss of 3% and occurred at FS 174. The location of a 0.77-square-inch area of light corrosion, resulting in a maximum reduction in thickness of 2%, is shown in figure 470 on the center body left, part number 41178-6. Light scattered corrosion, shown in figure 471, was found scattered across the fuselage right longitudinal beam assembly, part number 41119, from FS 174 to FS 203. This corrosion caused a maximum reduction in thickness of 1%.

Figure 469. Location of Light-Moderate Corrosion on the Center Body Right FS 174

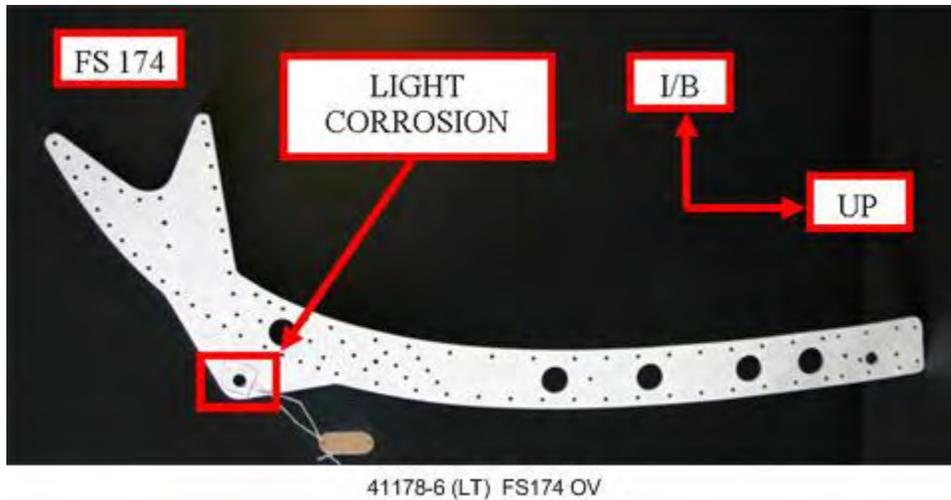
Figure 470. Location of Light Corrosion on the Center Body Left FS 174

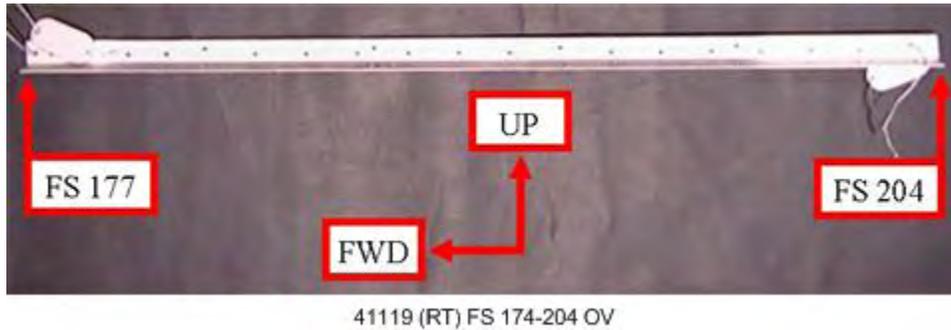
Figure 471. Location of Light Scattered Corrosion on the Fuselage Right Longitudinal Beam Assembly FS 174 Through FS 204

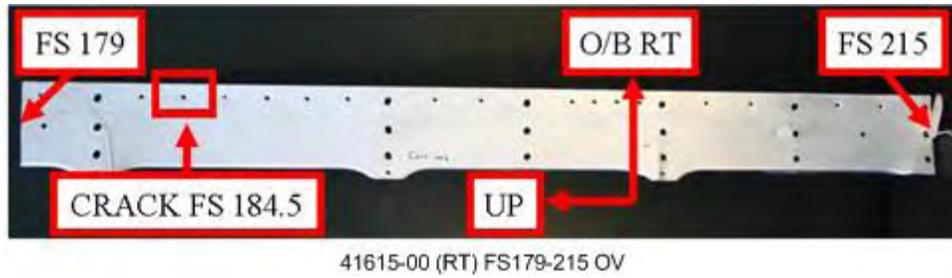
Figure 472 shows the location of a crack and moderate corrosion on the right floorboard support, part number 41615-00. A macroscopic view of the moderate corrosion, which covered 129.5 square inches from FS 179 to FS 215 and caused a localized reduction in thickness of 6.3%, is shown in figure 473. A macroscopic view of the 0.054-inch crack, located at FS 184.5, is shown in figure 474, while a microscopic view of this crack is shown in figure 475. The location of scattered light-moderate corrosion on the fuselage right longitudinal bulkhead outboard angle, part number 44437-07, is shown in figure 476. This area of scattered corrosion occurred from FS 182.25 to FS 210.75 and caused a maximum reduction in thickness of 4%.

Figure 472. Location of Crack and Moderate Corrosion on the Right Floorboard Support FS 179 Through FS 215

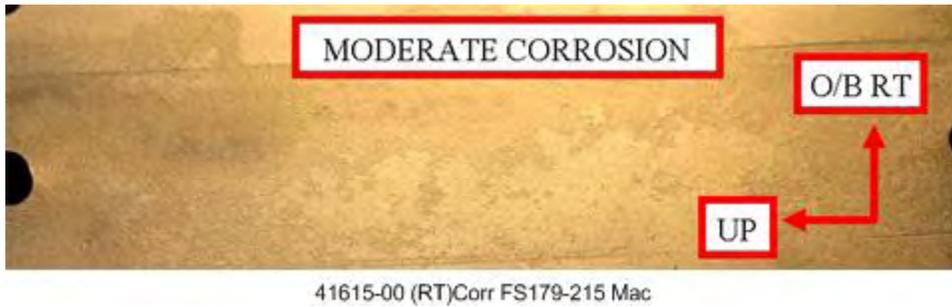
Figure 473. Macroscopic View of Moderate Corrosion on the Right Floorboard Support FS 179 Through FS 215

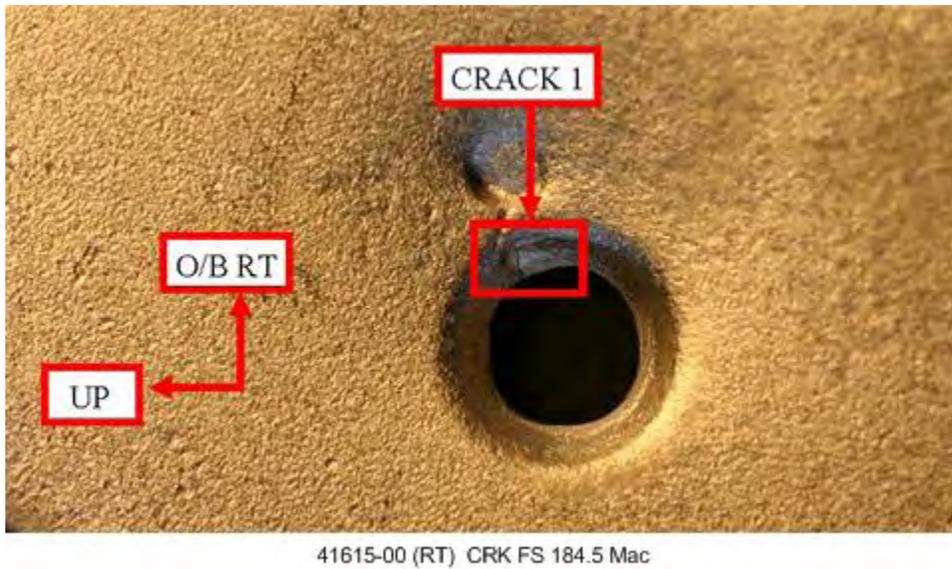
Figure 474. Macroscopic View of Crack on the Right Floorboard Support FS 184.5

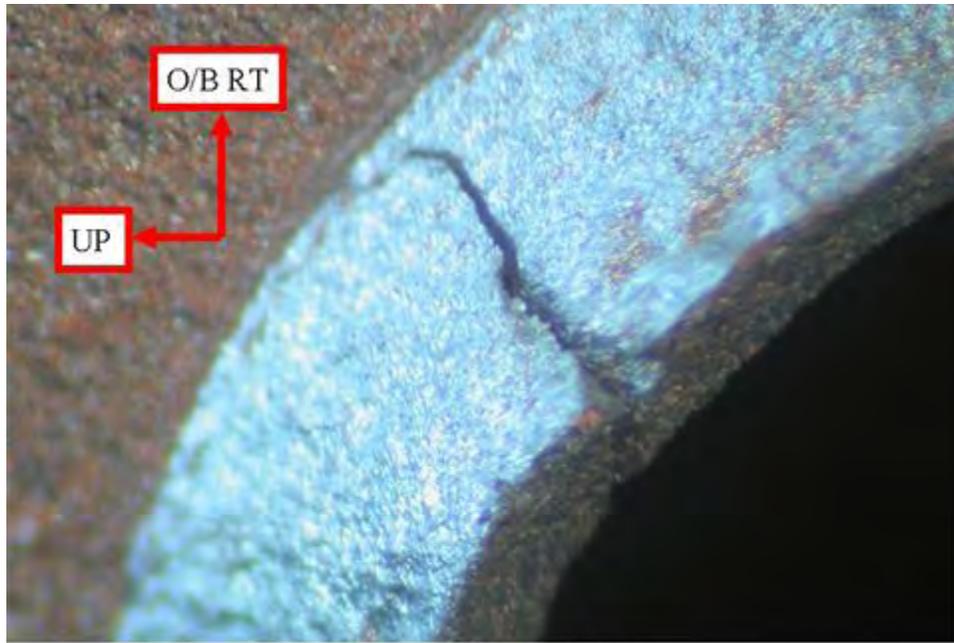
41615-00 (RT) CRK FS179-215 Mic

Figure 475. Microscopic View of Crack on the Right Floorboard Support FS 184.5

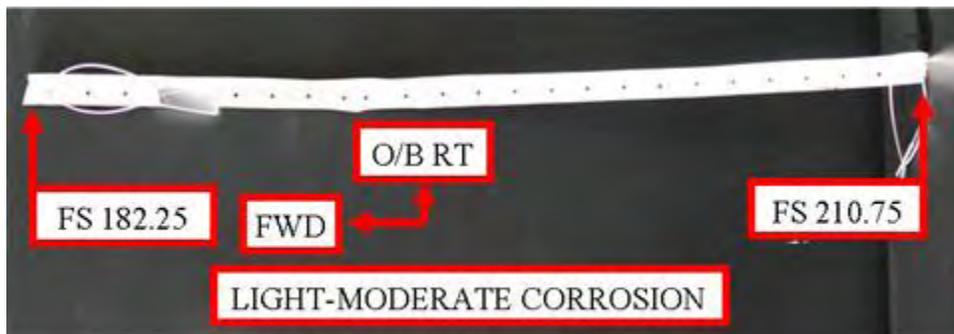
44437-07 FS182.25-210.75 Ov

Figure 476. Location of Light-Moderate Scattered Corrosion on the Fuselage Right Longitudinal Bulkhead Outboard Angle FS 182.25 Through FS 210.75

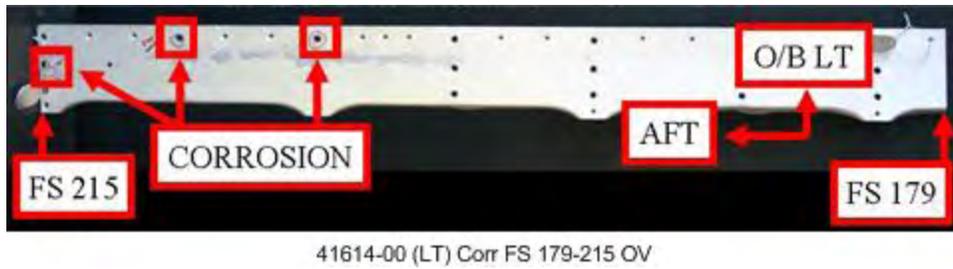
Figure 477 shows the location of moderate, moderate-severe, and severe corrosion on the left floorboard support, part number 41614-00. A macroscopic view of a 0.27-square-inch area of severe corrosion, located at FS 204.5, is shown in figure 478. This area of corrosion caused a maximum reduction in thickness of 22%. Figure 479 shows a 0.05-square-inch area of moderate corrosion that caused a localized thickness loss of 6.3% and was located at FS 210. A macroscopic view of a 0.01-square-inch area of moderate-severe corrosion is shown in figure 480. This area of corrosion caused a maximum localized reduction in thickness of 9.4%.

Figure 477. Location of Moderate, Moderate-Severe, and Severe Corrosion on the Left Floorboard Support FS 179 Through FS 215

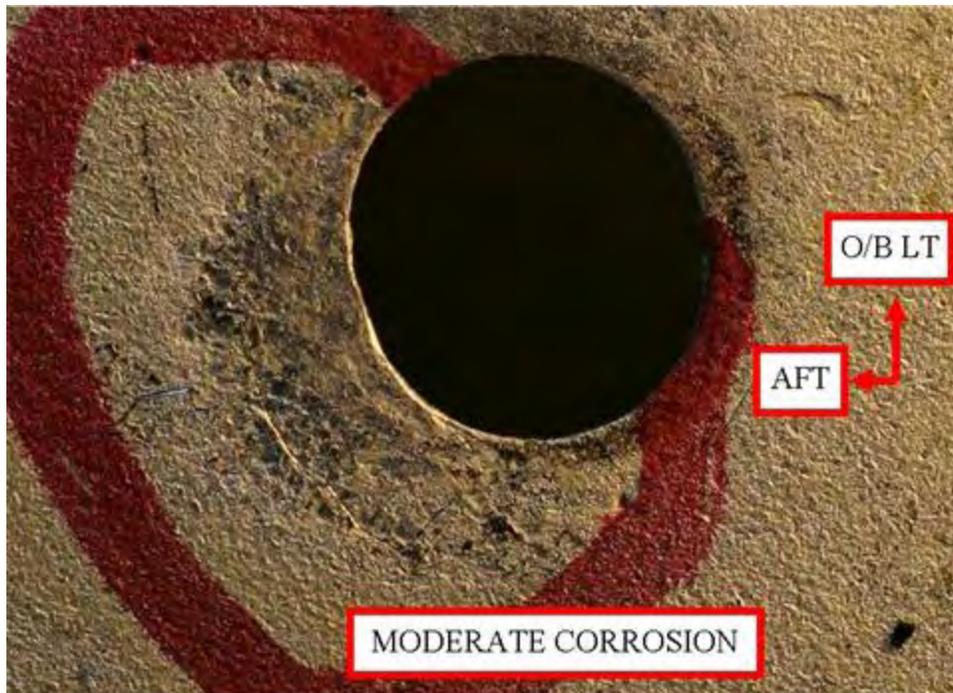
41614-00 (LT) Corr 2 FS179-215 Mac

Figure 479. Macroscopic View of Moderate Corrosion on the Left Floorboard Support FS 210

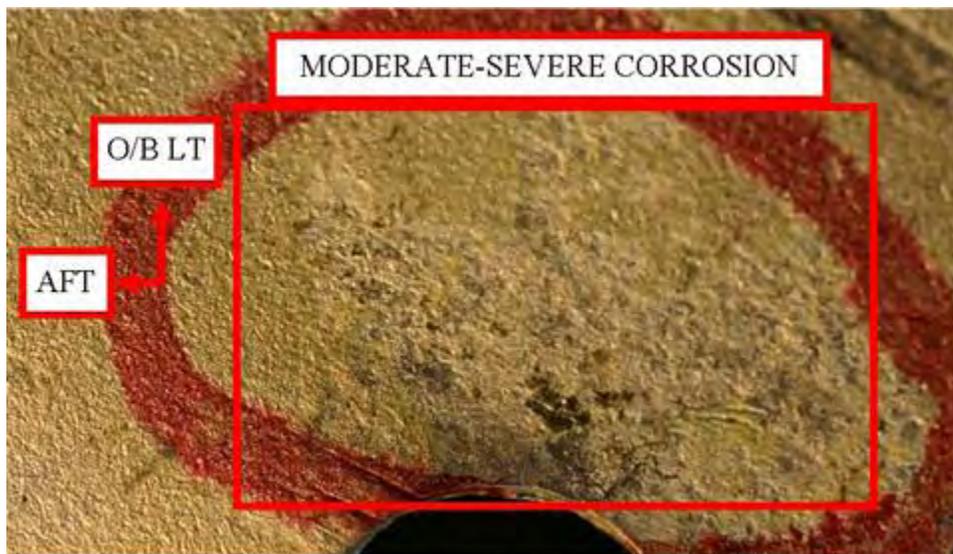
41614-00 (LT) Corr 3 FS179-215 Mac

Figure 480. Macroscopic View of Moderate-Severe Corrosion on the Left Floorboard Support FS 215

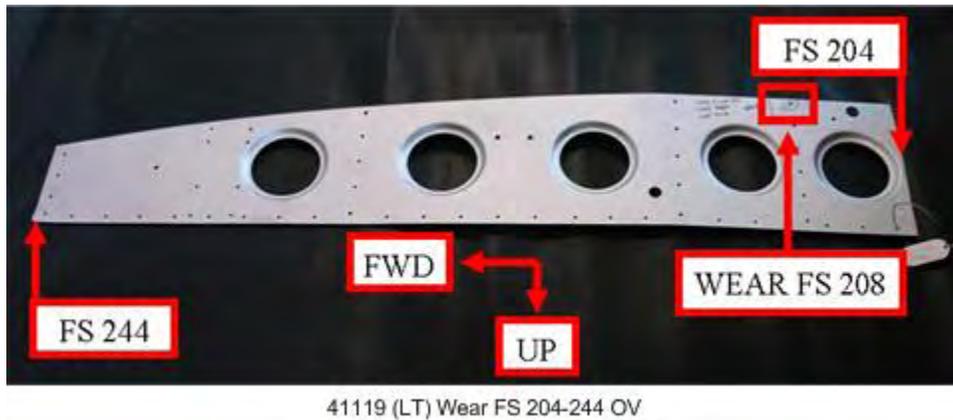
The location of a 0.69-square-inch area of wear on the left longitudinal beam assembly, part number 41119, is shown in figure 481. This area of wear, located at FS 208, caused a reduction in thickness of 12.5% locally, as shown in figure 482. Figure 483 shows the location of scattered light corrosion on the fuselage right beam assembly longitudinal, part number 41119. This location was scattered across the surface of the part from FS 204 to FS 244 and caused a localized reduction in thickness of 1%. The location of a crack and light corrosion on the fuselage left beam assembly lower rear frame, part number 41119-08, is shown in figure 484. The light corrosion covered a surface area of 105 square inches from FS 213.5 to FS 228.5 and resulted in a thickness loss of 2%. A macroscopic view of the 1.59-inch crack, located at FS 220.5, is shown in figure 485.

Figure 481. Location of Wear on the Left Longitudinal Beam Assembly FS 204 Through FS 244

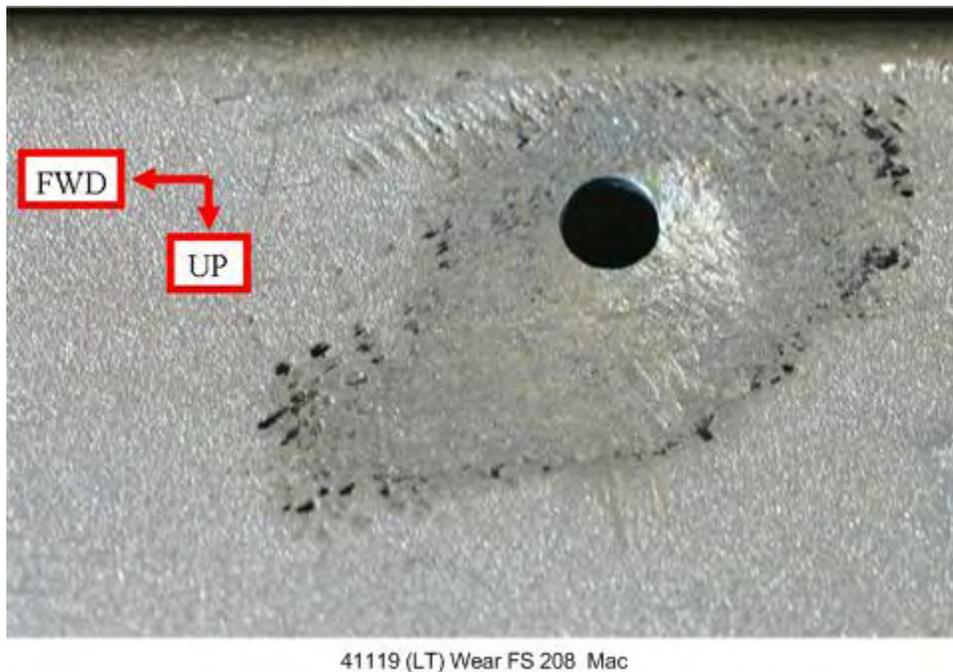
Figure 482. Macroscopic View of Wear on the Left Longitudinal Beam Assembly FS 208

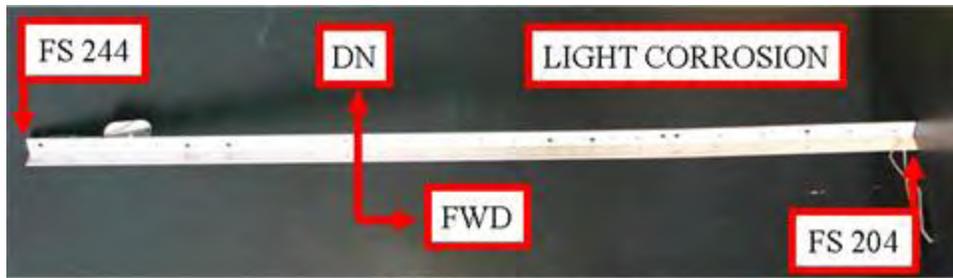
41119 (RH) Corr FS 204-244 OV

Figure 483. Location of Light Scattered Corrosion on the Fuselage Right Beam Assembly Longitudinal FS 204 Through FS 244

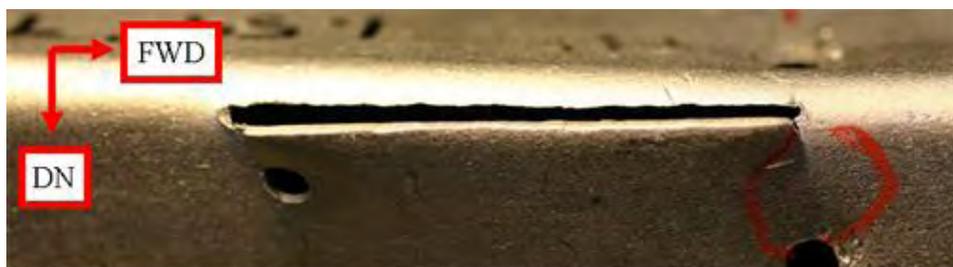
41119-08 (LT) CRK FS198.5-228 Mac

Figure 485. Macroscopic View of Crack on the Fuselage Left Beam Assembly Lower Rear Frame FS 220.5

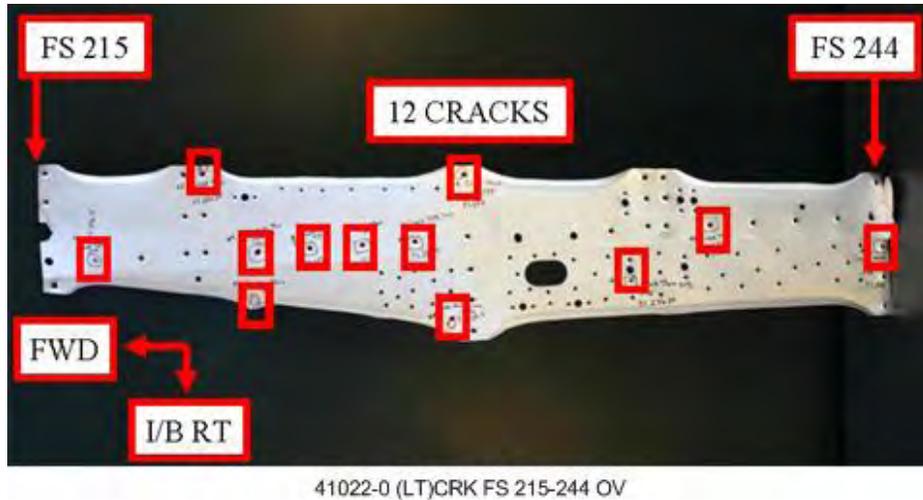
The location of 12 cracks on the left inboard floorboard support assembly, part number 41022-0, is shown in figure 486. A macroscopic view of crack 1, which measures 0.014 inch and is located at FS 216.5, is shown in figure 487, and a microscopic view of this crack is shown in figure 488. Figure 489 shows a macroscopic view of crack 2, which measured 0.215 inch and was located at FS 220.5. A microscopic view of crack 2 is shown in figure 490. Figure 491 shows a macroscopic view of crack 3, which measured 0.508 inch and was located at FS 222, and a microscopic view of this crack is shown in figure 492. A macroscopic view of crack 4 was located at FS 222, and is shown in figure 493. A microscopic view of this 0.157-inch crack is shown in figure 494.

Figure 486. Location of 12 Cracks on the Left Inboard Floorboard Assembly FS 215 Through FS 244

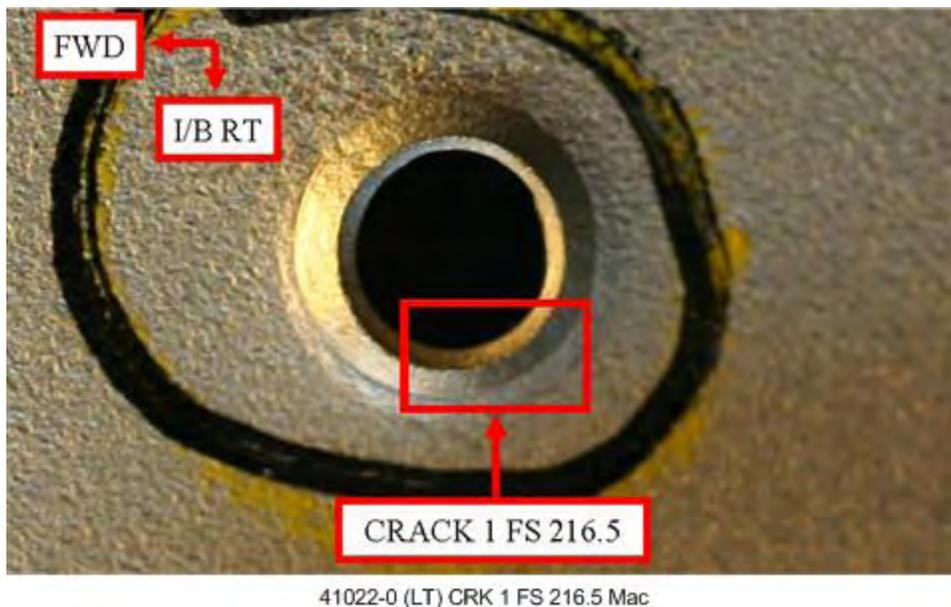
Figure 487. Macroscopic View of Crack 1 on the Left Inboard Floorboard Support Assembly FS 216.5

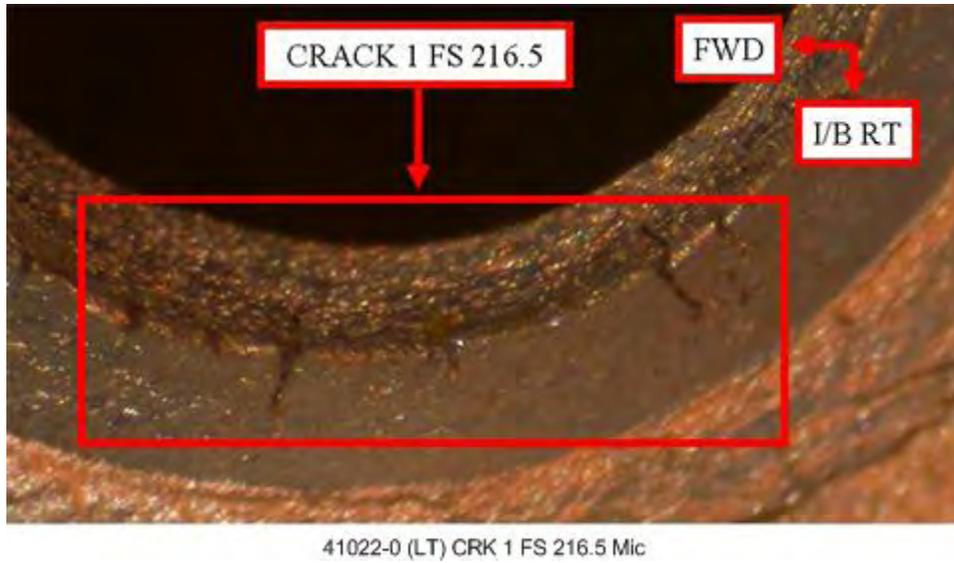
Figure 488. Microscopic View of Crack 1 on the Left Inboard Floorboard Support Assembly FS 216.5

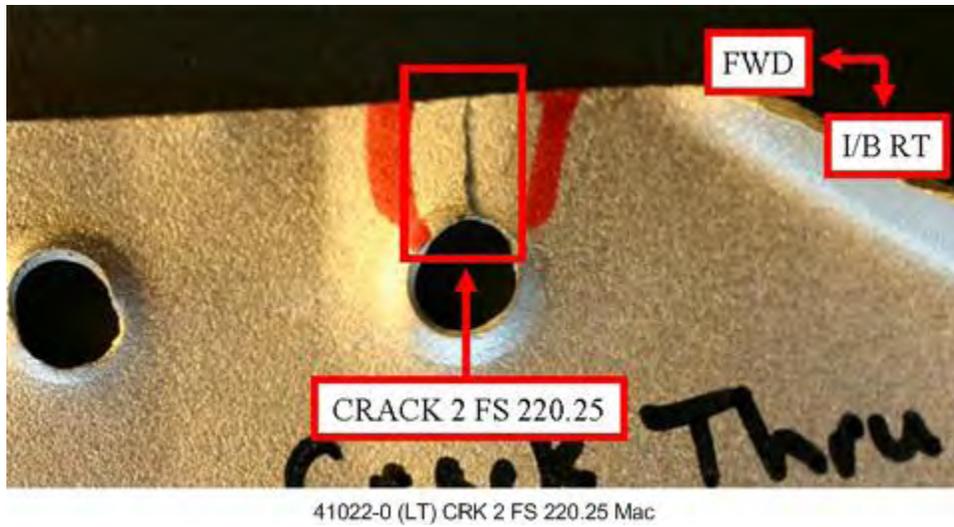
Figure 489. Macroscopic View of Crack 2 on the Left Inboard Floorboard Support Assembly FS 220.25

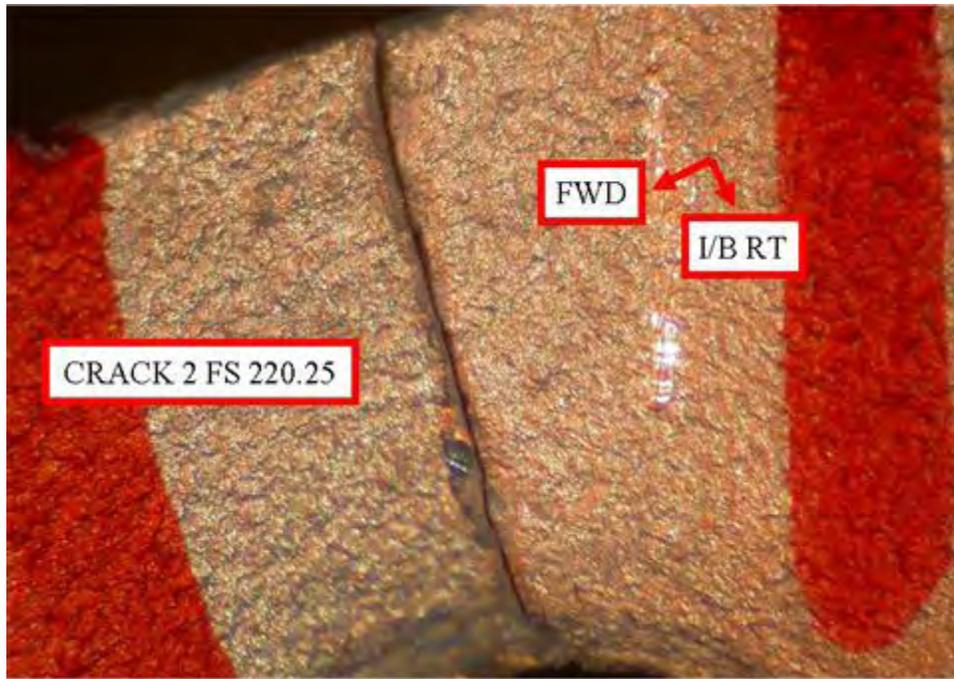
41022-0 (LT) CRK 2 FS 220.25 Mic

Figure 490. Microscopic View of Crack 2 on the Left Inboard Floorboard Support Assembly FS 220.25

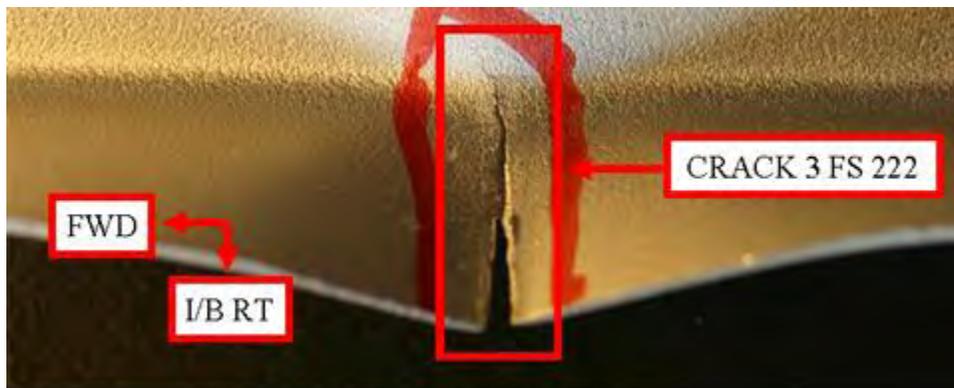
41022-0 (LT) CRK 3 FS 222 Mac

Figure 491. Macroscopic View of Crack 3 on the Left Inboard Floorboard Support Assembly FS 222

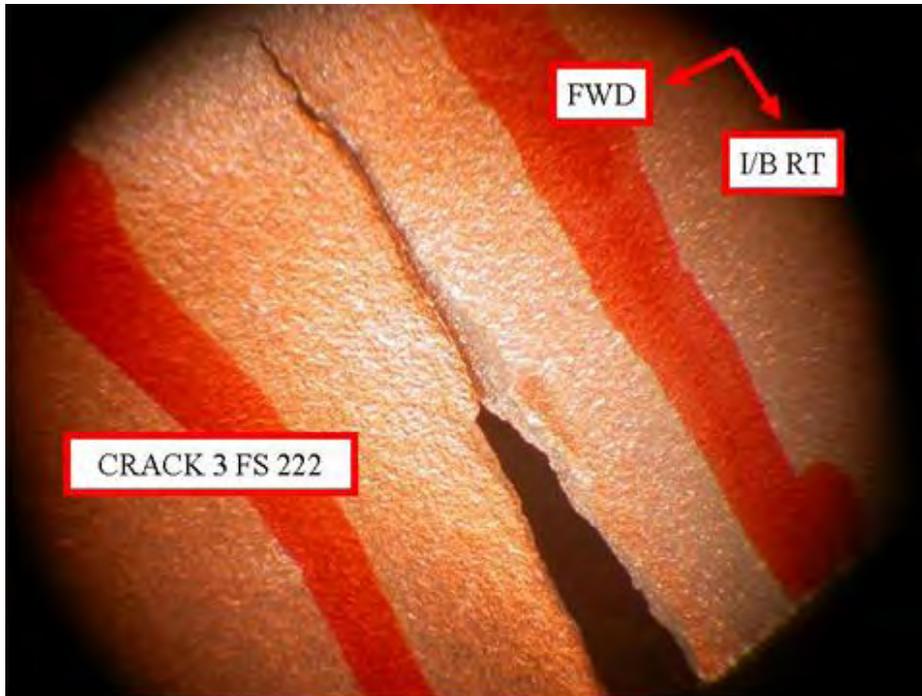
41022-0 (LT) CRK 3 FS 222 Mic

Figure 492. Microscopic View of Crack 3 on the Left Inboard Floorboard Support Assembly FS 222

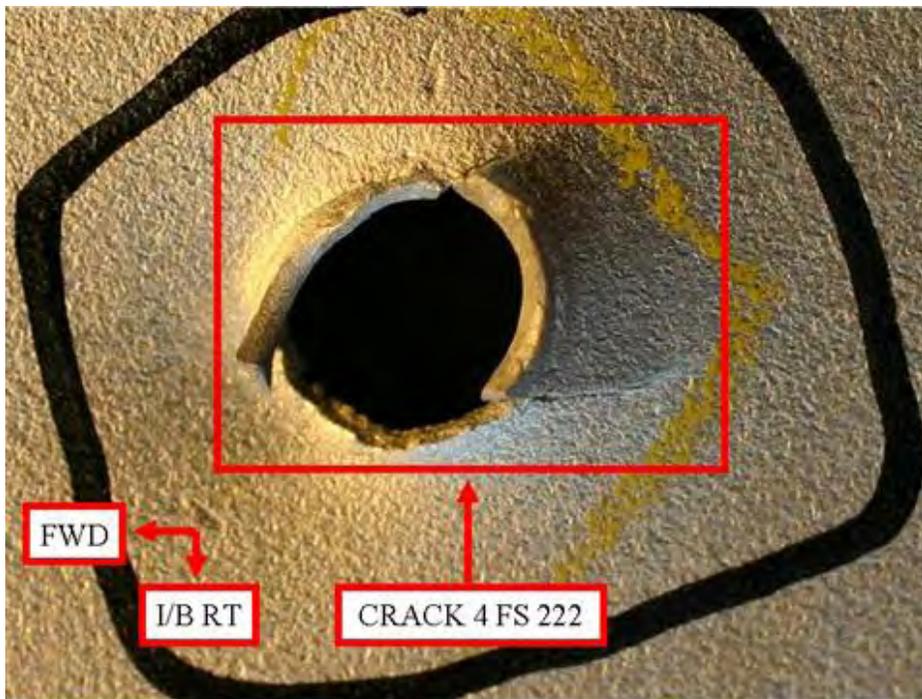
41022-0 (LT) CRK 4 FS 222 Mac

Figure 493. Macroscopic View of Crack 4 on the Left Inboard Floorboard Support Assembly FS 222

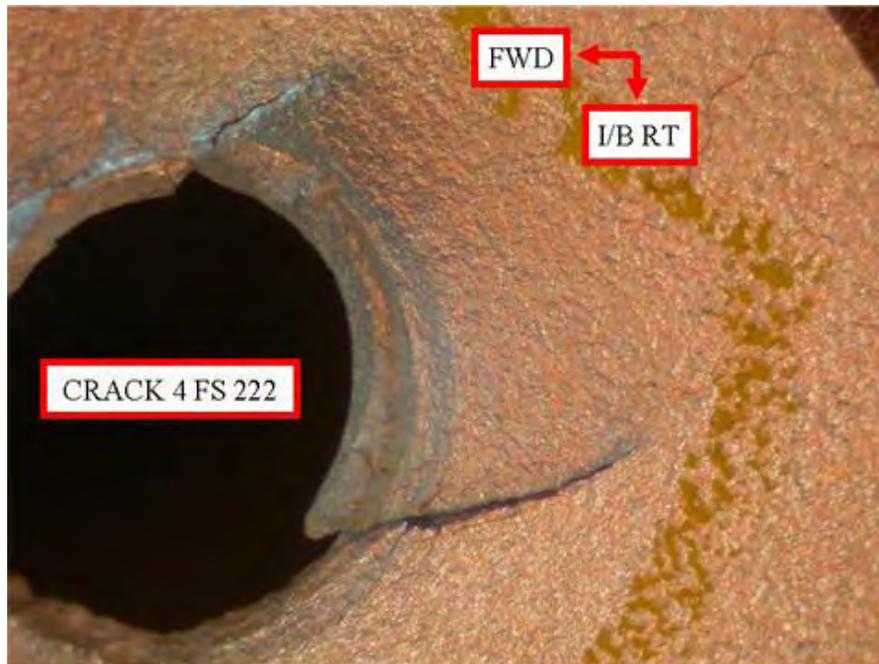
41022-0 (LT) CRK 4 FS 222 Mic

Figure 494. Microscopic View of Crack 4 on the Left Inboard Floorboard Support Assembly FS 222

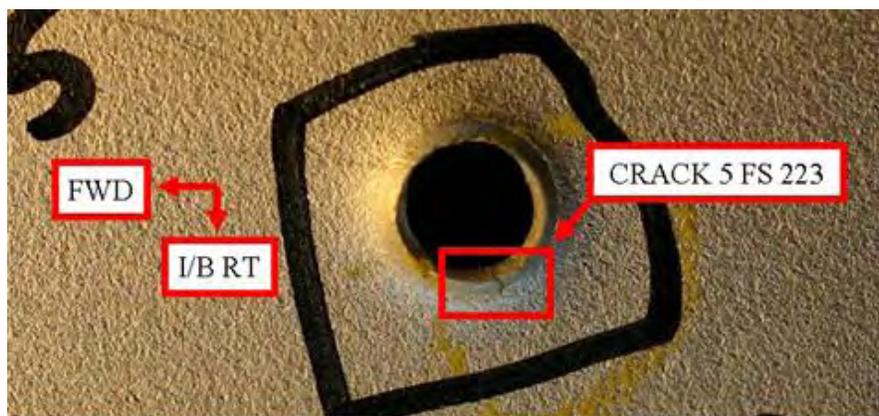
41022-0 (LT) CRK 5 FS 223 Mac

A macroscopic view of crack 5 on the left inboard floorboard assembly, which measured 0.03 inch and was located at FS 223, is shown in figure 495, and figure 496 shows a microscopic view of crack 5. Crack 6, which measures 0.036 inch and was located at FS 225, is shown macroscopically in figure 497 and microscopically in figure 498. Figure 499 shows a macroscopic view of crack 7. This crack measured 0.166 inch and was located at FS 227.5. A microscopic view of crack 7 is shown in figure 500. Multiple cracks grouped together and identified as crack 8 measured 0.26 inch in length and occurred at FS 229.5. A macroscopic view of crack 8 is shown in figure 501, and a microscopic view is shown in figure 502.

Figure 495. Macroscopic View of Crack 5 on the Left Inboard Floorboard Support Assembly FS 223

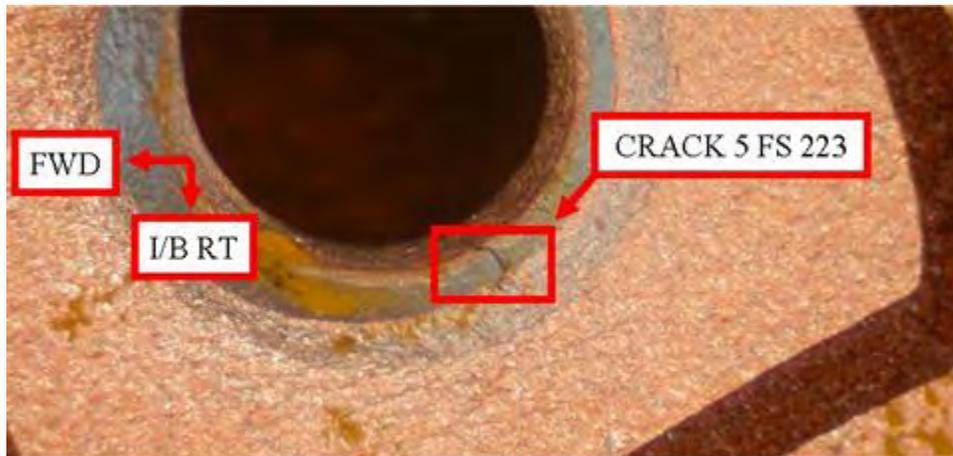
41022-0 (LT) CRK 5 FS 223 Mic

Figure 496. Microscopic View of Crack 5 on the Left Inboard Floorboard Support Assembly FS 223
