DOT/FAA/AR-07/64

Teardown Evaluation of a 1975 Piper Navajo Chieftain Model PA31-350 Airplane

March 2008

Final Report

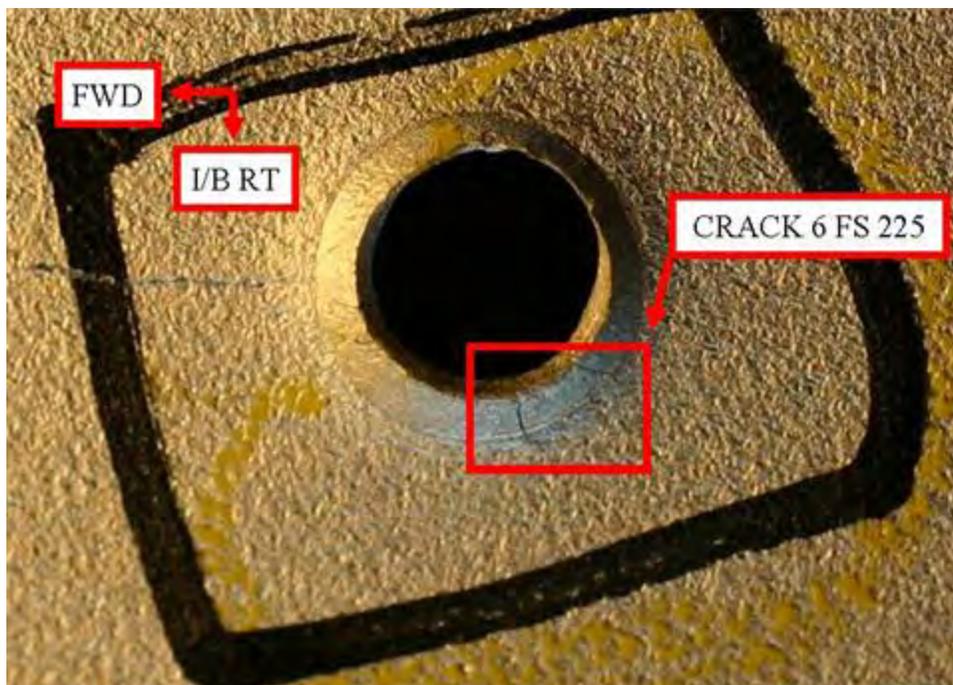
41022-0 (LT) CRK 6 FS 225 Mac

Figure 497. Macroscopic View of Crack 6 on the Left Inboard Floorboard Support Assembly FS 225

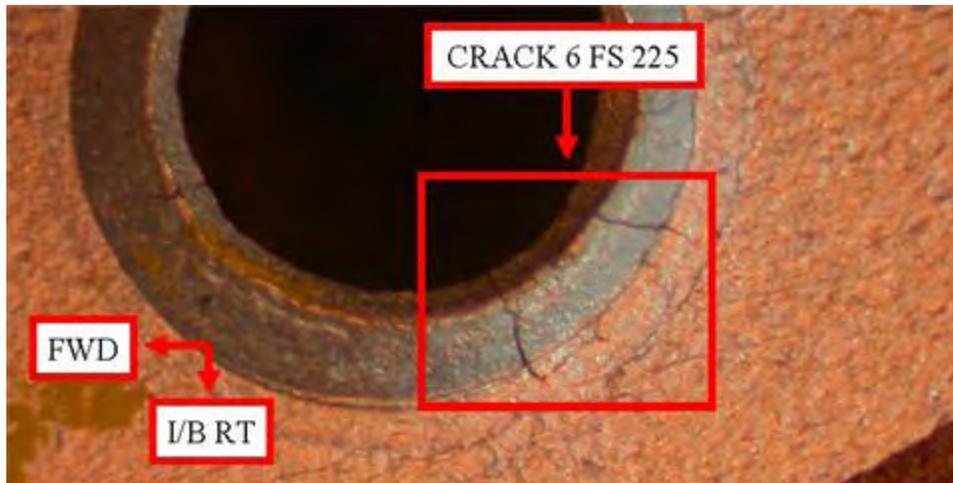
41022-0 (LT) CRK 6 FS 225 Mic

Figure 498. Microscopic View of Crack 6 on the Left Inboard Floorboard Support Assembly FS 225

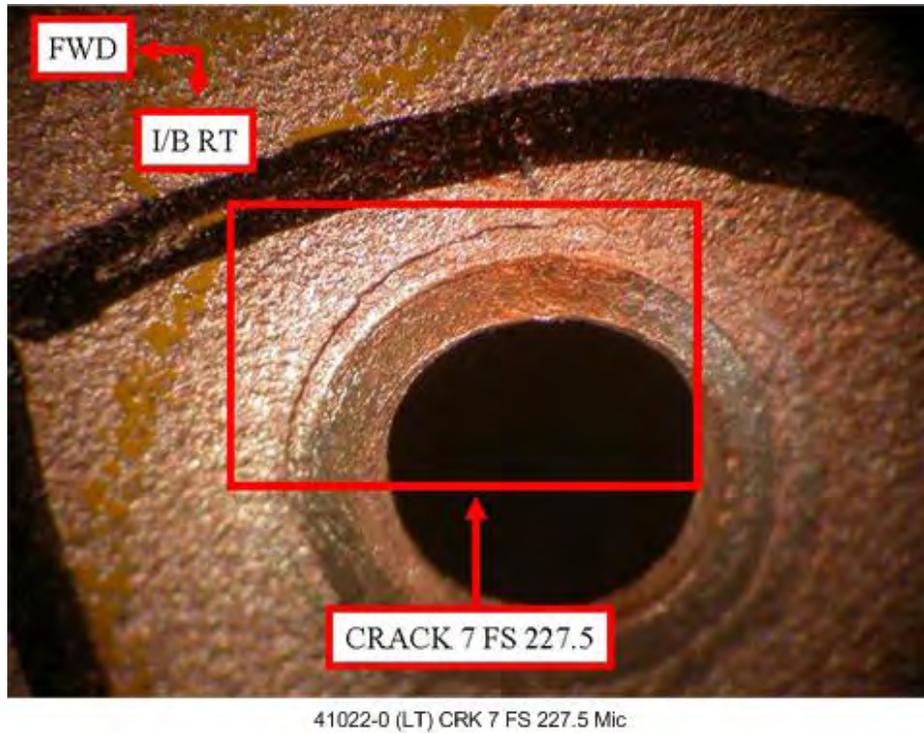
A macroscopic view of crack 5 on the left inboard floorboard assembly, which measured 0.03 inch and was located at FS 223, is shown in figure 495, and figure 496 shows a microscopic view of crack 5. Crack 6, which measures 0.036 inch and was located at FS 225, is shown macroscopically in figure 497 and microscopically in figure 498. Figure 499 shows a macroscopic view of crack 7. This crack measured 0.166 inch and was located at FS 227.5. A microscopic view of crack 7 is shown in figure 500. Multiple cracks grouped together and identified as crack 8 measured 0.26 inch in length and occurred at FS 229.5. A macroscopic view of crack 8 is shown in figure 501, and a microscopic view is shown in figure 502.

Figure 500. Microscopic View of Crack 7 on the Left Inboard Floorboard Support Assembly FS 227.5

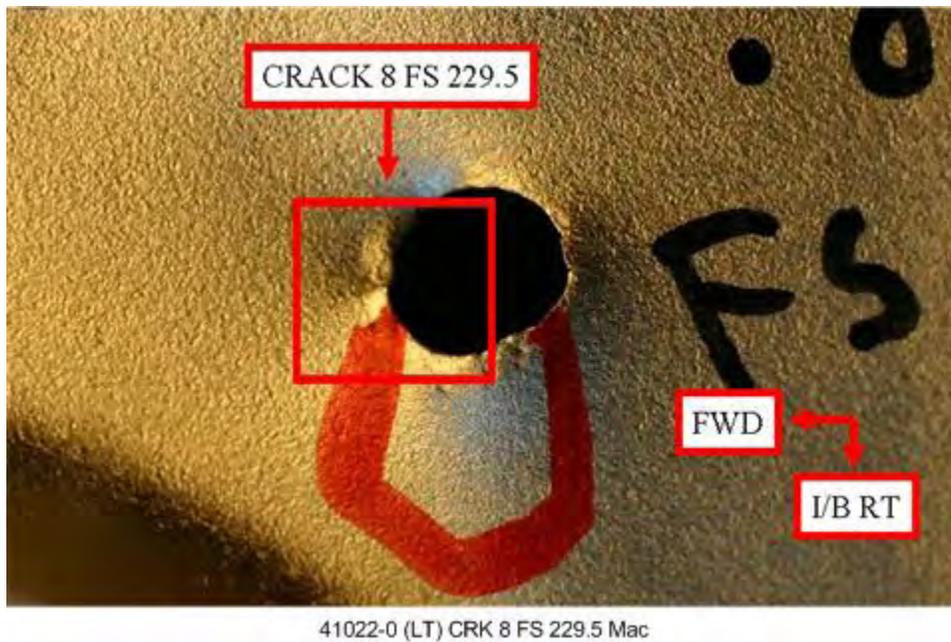
Figure 501. Macroscopic View of Crack 8 on the Left Inboard Floorboard Support Assembly FS 229.5

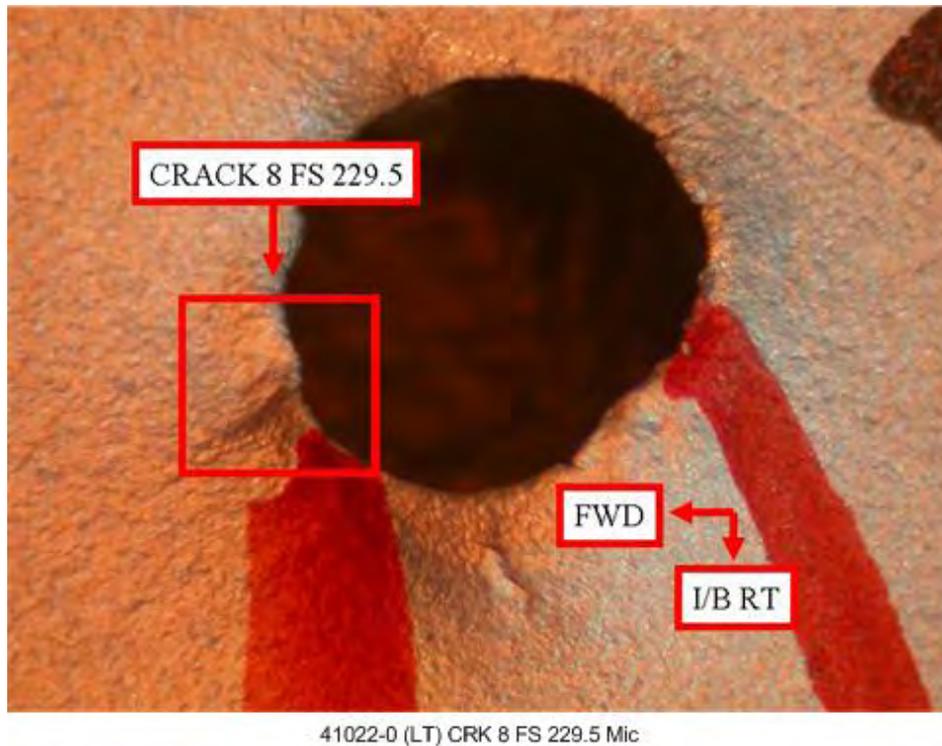
Figure 502. Microscopic View of Crack 8 on the Left Inboard Floorboard Support Assembly FS 229.5

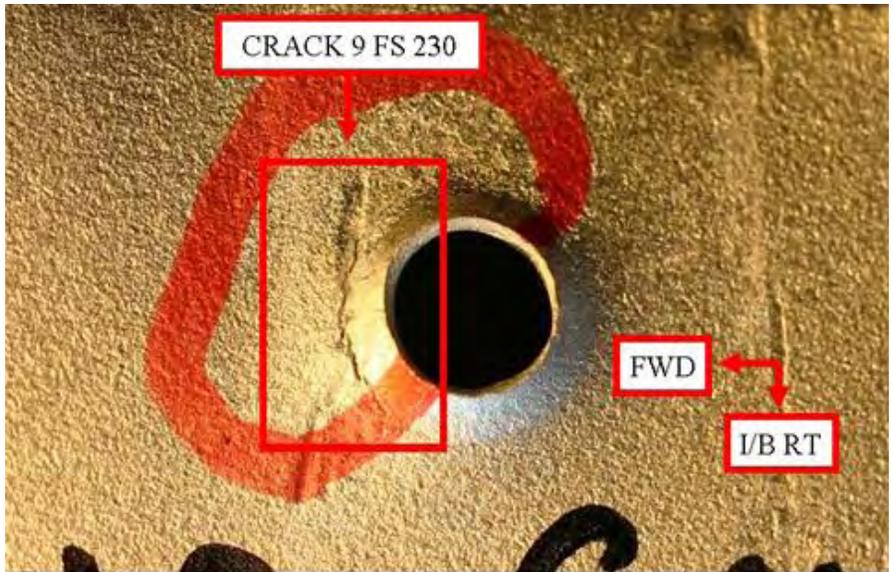
41022-0 (LT) CRK 9 FS 230 Mac

Figure 503 shows a macroscopic view of crack 9 on the left inboard floorboard support assembly, and figure 504 shows a microscopic view of this crack. Crack 9 measured 0.249 inch and occurred at FS 230. Crack 10, which is shown macroscopically in figure 505, measured 0.142 inch in length and occurred at FS 236.25. A microscopic view of crack 10 is shown in figure 506. Figure 507 shows a macroscopic view of crack 11, and figure 508 provides a microscopic view of this 0.31-inch crack located at FS 238. Multiple cracks grouped together and identified as crack 12 are shown macroscopically in figure 509 and microscopically in figure 510. The longest of these cracks measured 0.038 inch and occurred at FS 244.

Figure 503. Macroscopic View of Crack 9 on the Left Inboard Floorboard Support Assembly FS 230

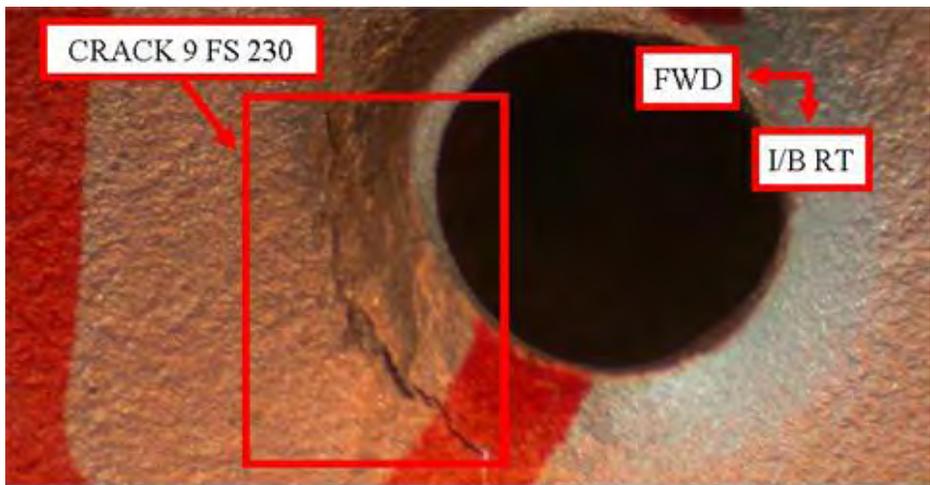
41022-0 (LT) CRK 9 FS 230 Mic

Figure 504. Microscopic View of Crack 9 on the Left Inboard Floorboard Support Assembly FS 230

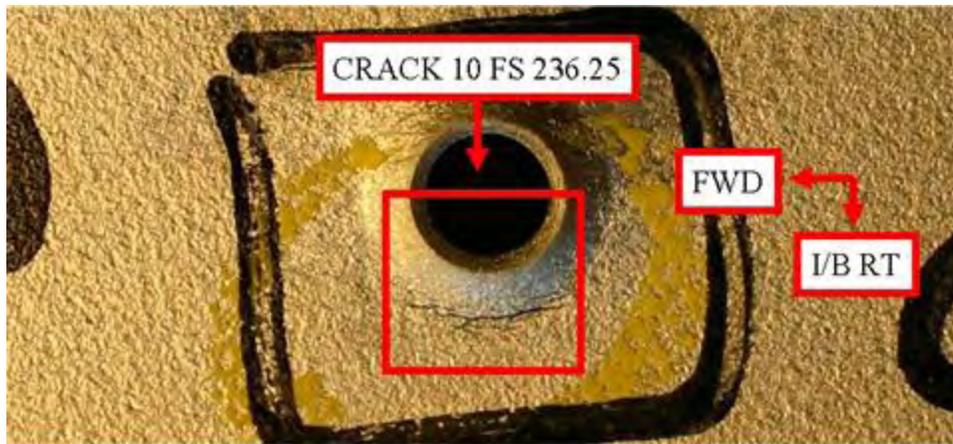
41022-0 (LT) CRK 10 FS 236.25 Mac

Figure 505. Macroscopic View of Crack 10 on the Left Inboard Floorboard Support Assembly FS 236.25

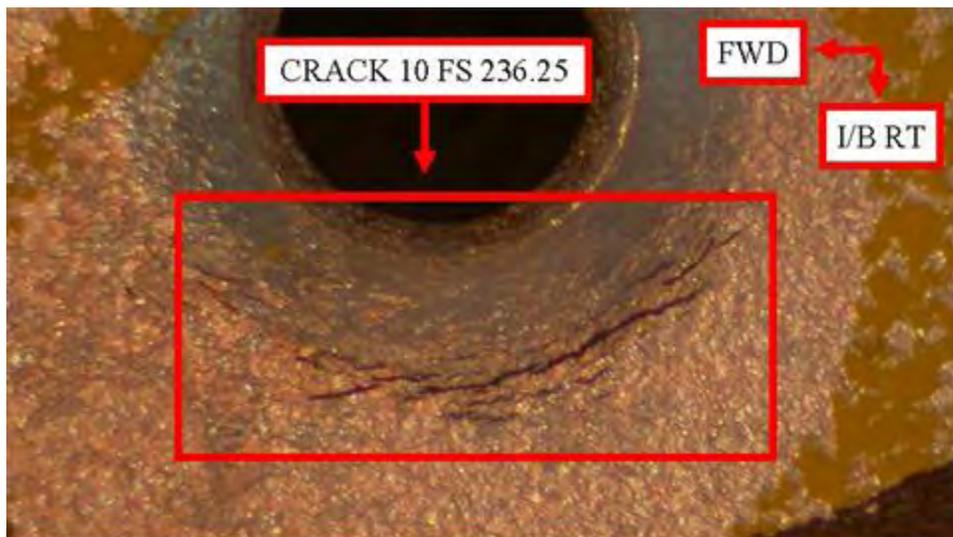
41022-0 (LT) CRK 10 FS 236.25 Mic

Figure 506. Microscopic View of Crack 10 on the Left Inboard Floorboard Support Assembly FS 236.25

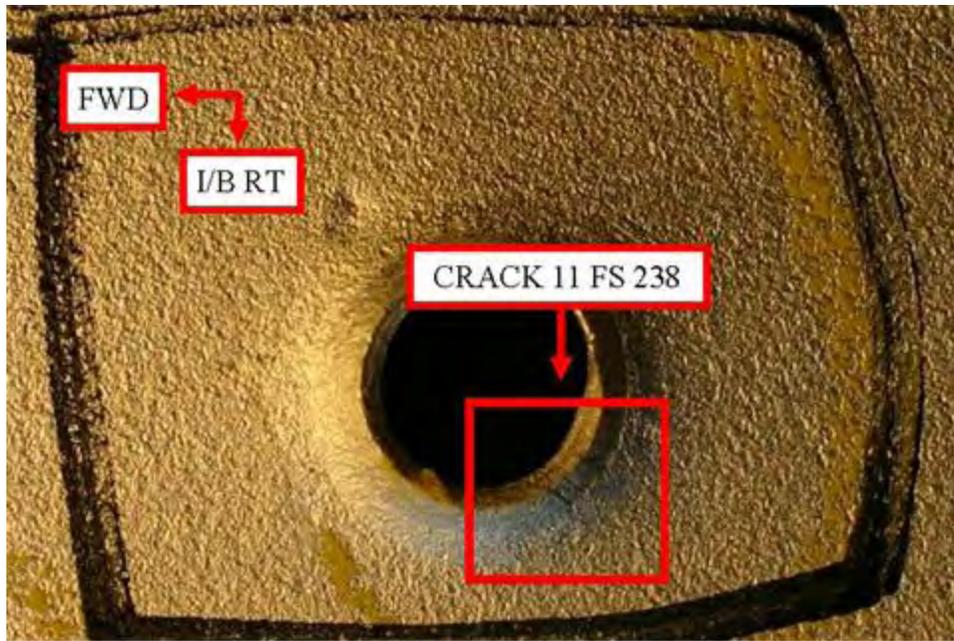
41022-0 (LT) CRK 11 FS 238 Mac

Figure 507. Macroscopic View of Crack 11 on the Left Inboard Floorboard Support Assembly FS 238

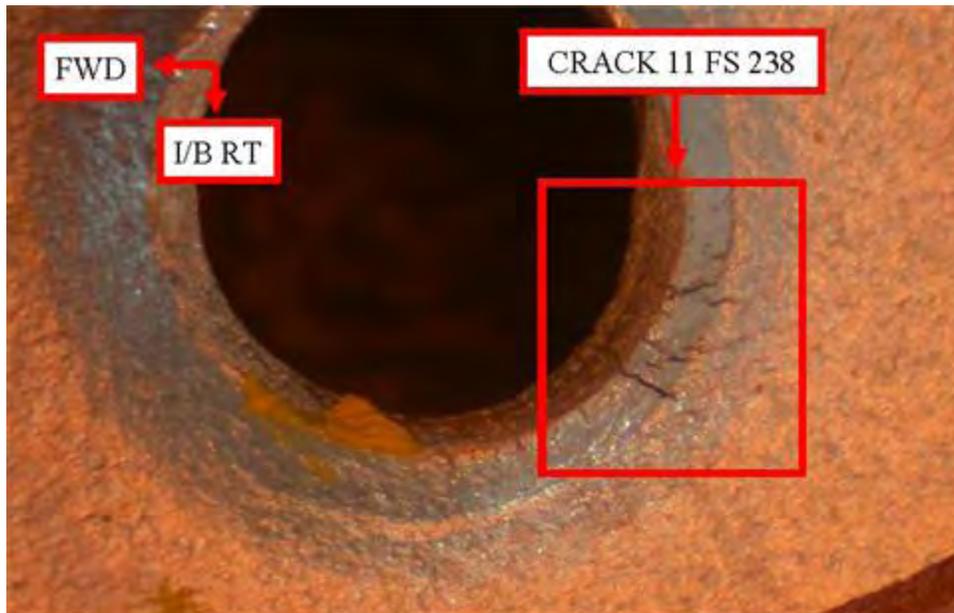
41022-0 (LT) CRK 11 FS 238 Mic

Figure 508. Microscopic View of Crack 11 on the Left Inboard Floorboard Support Assembly FS 238

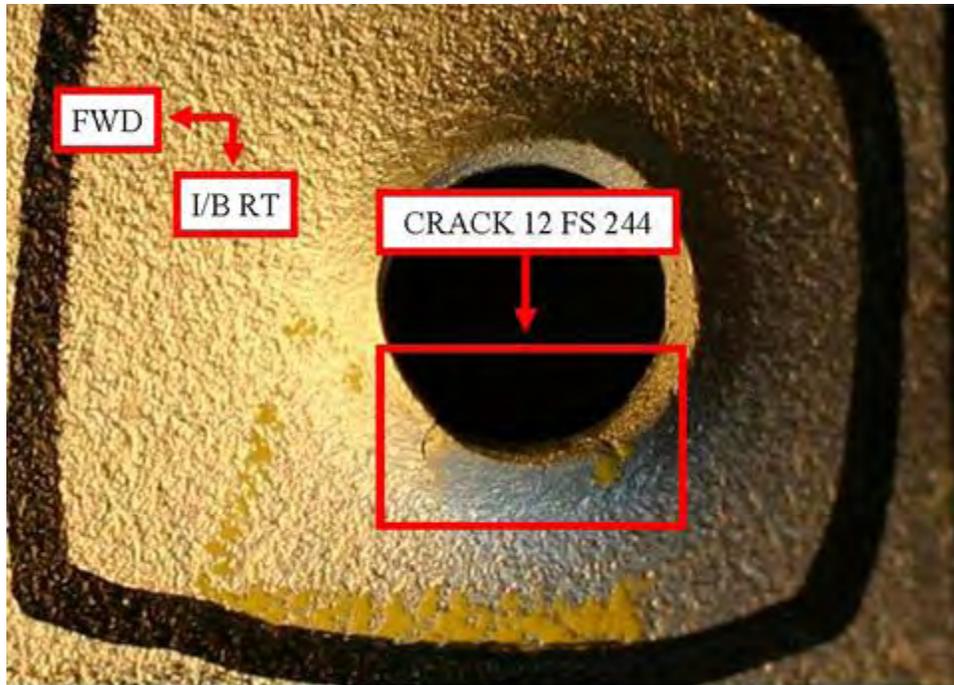
41022-0 (LT) CRK 12 FS 244 Mac

Figure 509. Macroscopic View of Crack 12 on the Left Inboard Floorboard Support Assembly FS 244

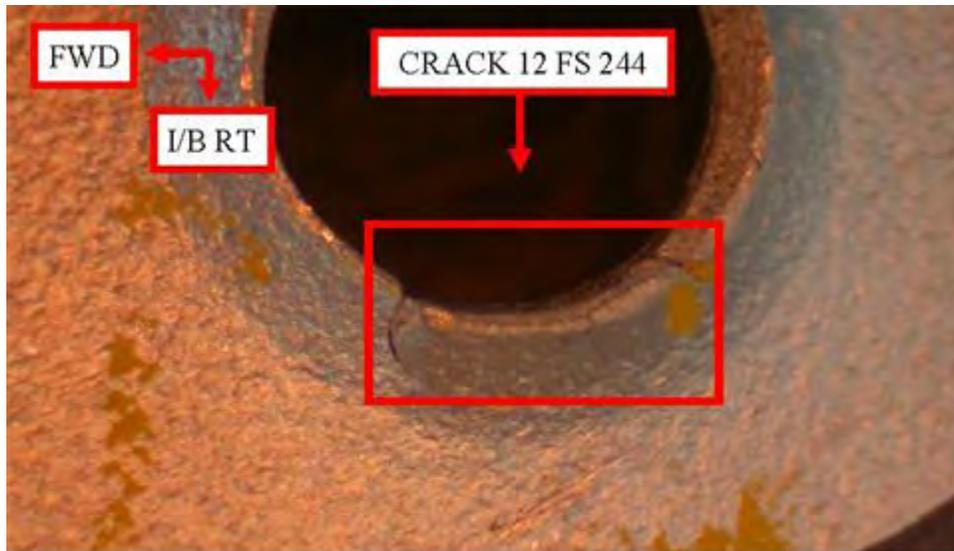
41022-0 (LT) CRK 12 FS 244 Mic

Figure 510. Microscopic View of Crack 12 on the Left Inboard Floorboard Support Assembly FS 244

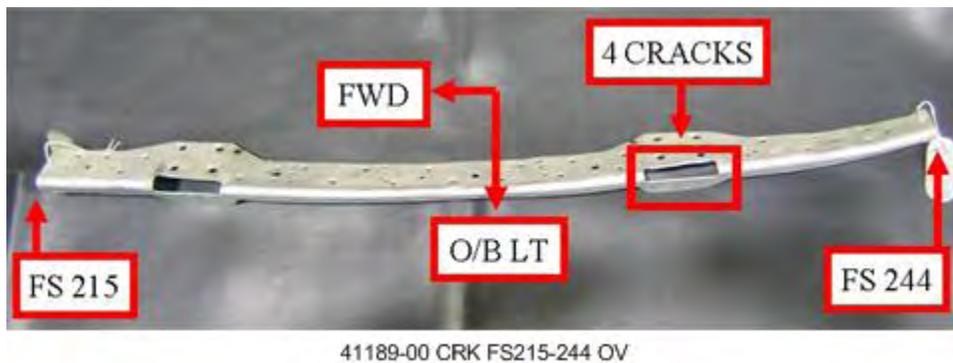
During the teardown evaluation, four cracks were identified on the door sill support aft body, part number 41189-00. The location of these cracks is shown in figure 511. A macroscopic view of crack 1, which measured 0.409 inch and was located at FS 236, is shown in figure 512. Figure 513 shows a macroscopic view of crack 2. Crack 2 was also located at FS 236 and measured 0.437 inch in length. A macroscopic view of crack 3 is shown in figure 514. Crack 3 measured 0.428 inch in length and occurred at FS 237.5. Crack 4 measured 0.267 inch and was located at FS 237.5. A macroscopic view of crack 4 is shown in figure 515. All four cracks were examined in an effort to determine failure mode, but due to extensive crack face smearing, the failure mode could not be determined. Figure 516 shows the location of light-moderate scattered corrosion on the fuselage center body angle, part number 41119-010. This corrosion was scattered across the entire surface of the part and caused a maximum localized thickness of 3.2%.

Figure 511. Location of Four Cracks on the Door Sill Support Aft Body FS 215 Through FS 244

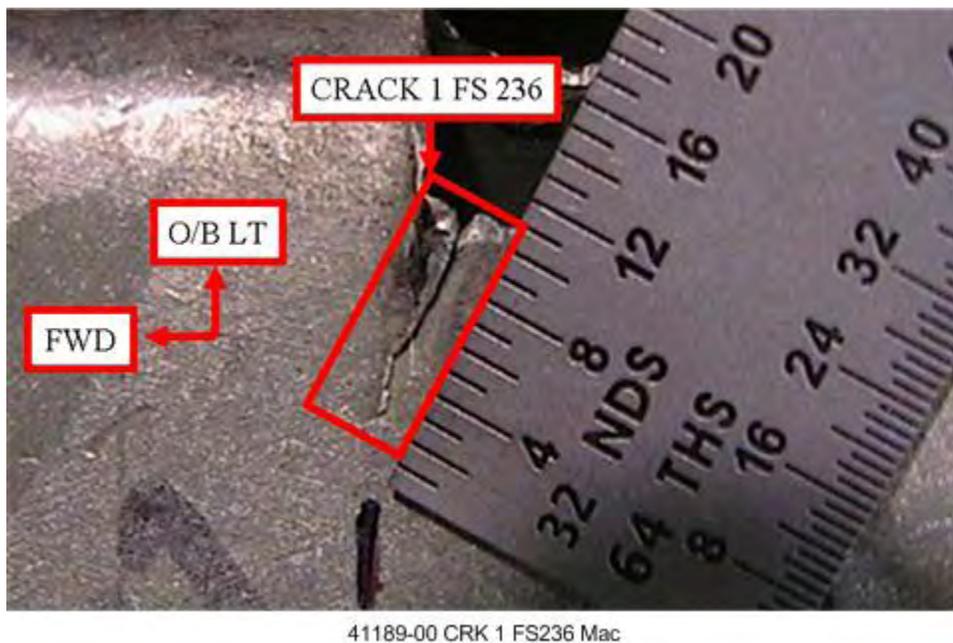
Figure 512. Macroscopic View of Crack 1 on the Door Sill Support Aft Body FS 236

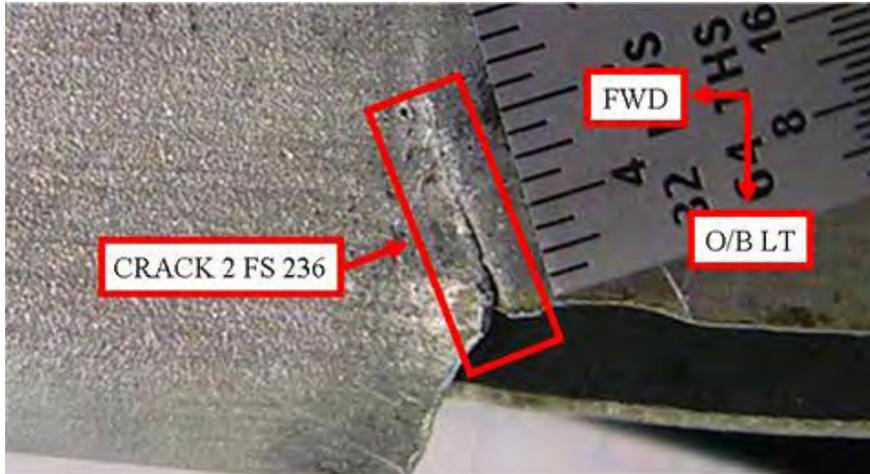
41189-00 CRK 2 FS236 Mac

Figure 513. Macroscopic View of Crack 2 on the Door Sill Support Aft Body FS 236

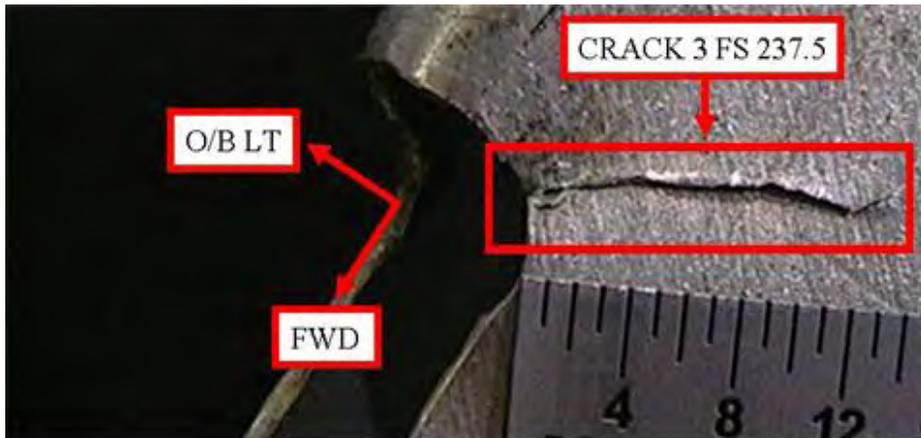
41189-00 CRK 3 FS237.5 Mac

Figure 514. Macroscopic View of Crack 3 on the Door Sill Support Aft Body FS 237.5

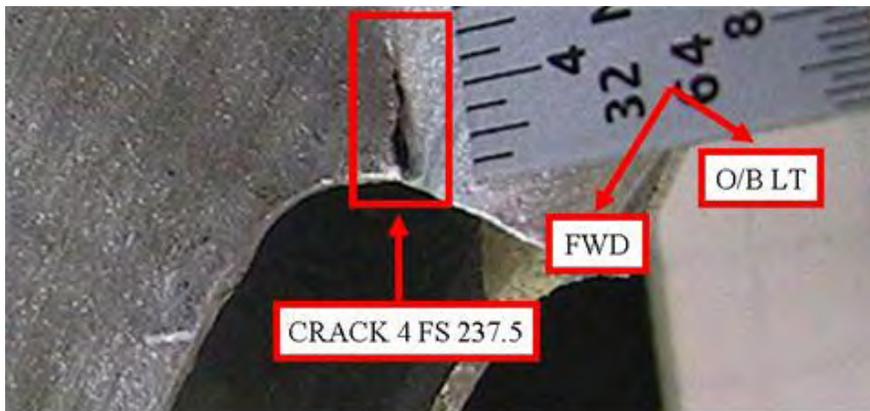
41189-00 CRK 4 FS237.5 Mac

Figure 515. Macroscopic View of Crack 4 on the Door Sill Support Aft Body FS 237.5

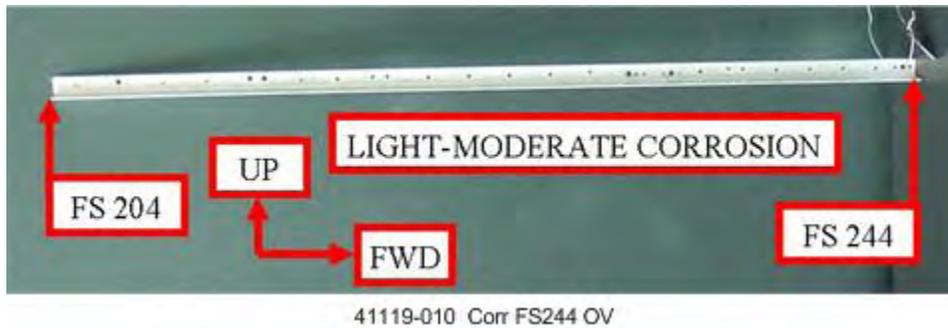
Figure 516. Location of Light-Moderate Scattered Corrosion on the Fuselage Center Body Angle FS 204 Through FS 244

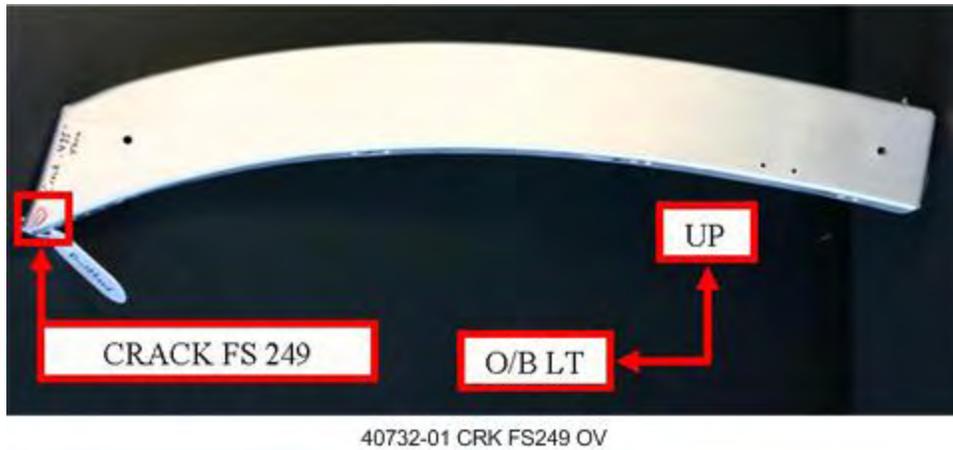
The location of a crack on the bulkhead right aft fuselage, part number 40732-01, is shown in figure 517. This crack measured 0.435 inch and was located at FS 249. A macroscopic view of this crack is shown in figure 518, and a microscopic view of this crack is shown in figure 519. The location of a 1.66-inch crack on the oxygen bottle bracket assembly, part number 52820-008, is shown in figure 520. A macroscopic view of this crack that was located at FS 296 is shown in figure 521. The fracture face of this crack is shown in figure 522, and a fractograph of the crack face, showing defined fatigue striations and crack growth direction, is shown in figure 523.

Figure 517. Location of Crack on the Bulkhead Right Aft Fuselage FS 249

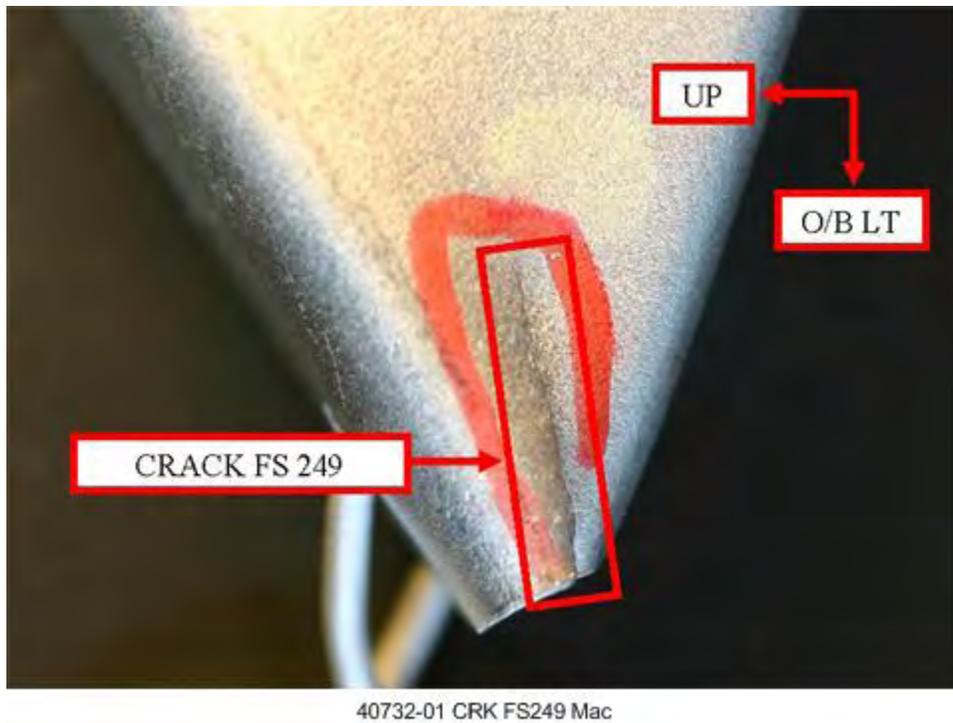
Figure 518. Macroscopic View of Crack on the Bulkhead Right Aft Fuselage FS 249

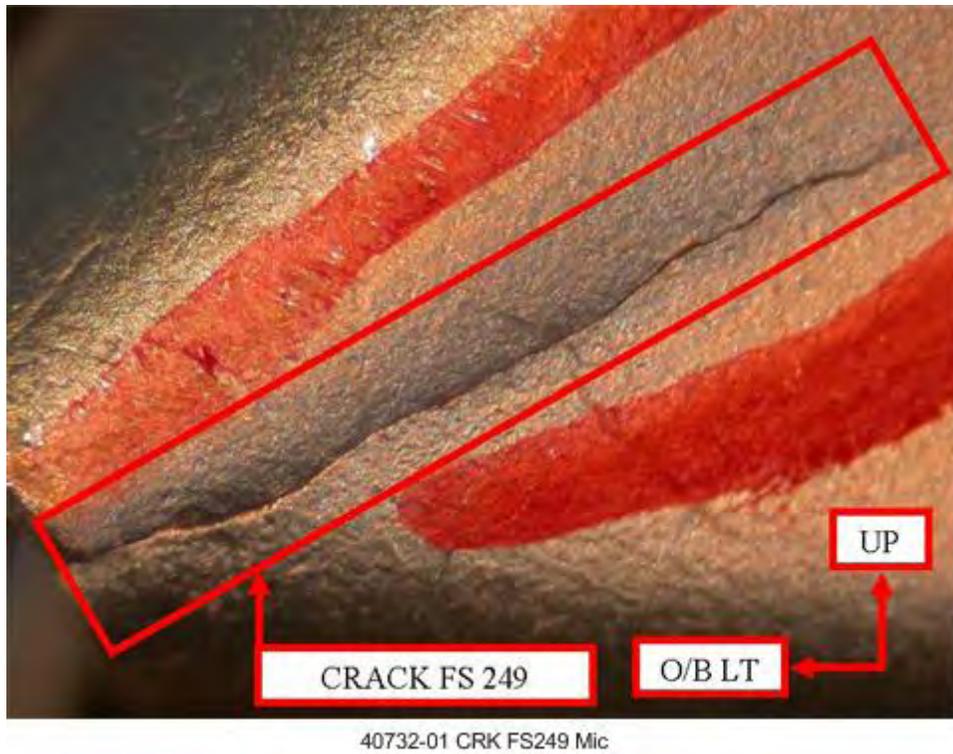
Figure 519. Microscopic View of Crack on the Bulkhead Right Aft Fuselage FS 249

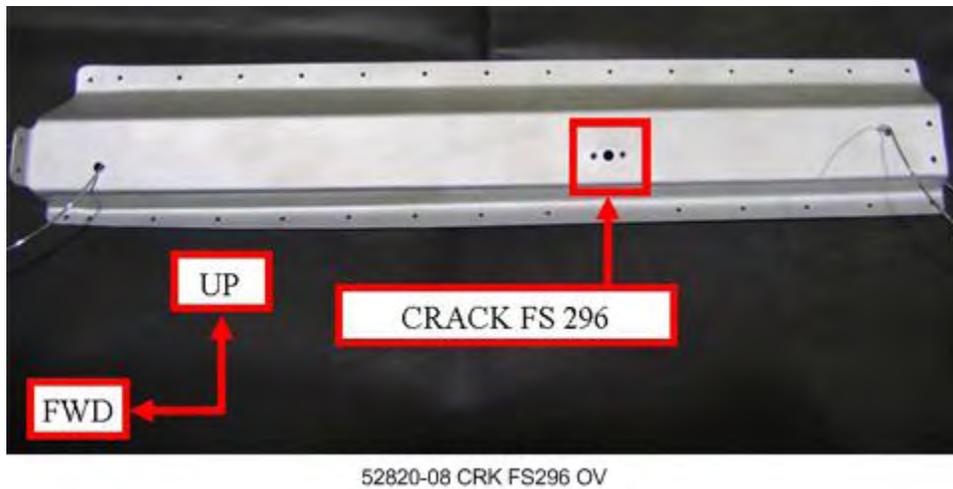
Figure 520. Location of Crack on the Oxygen Bottle Bracket Assembly FS 296

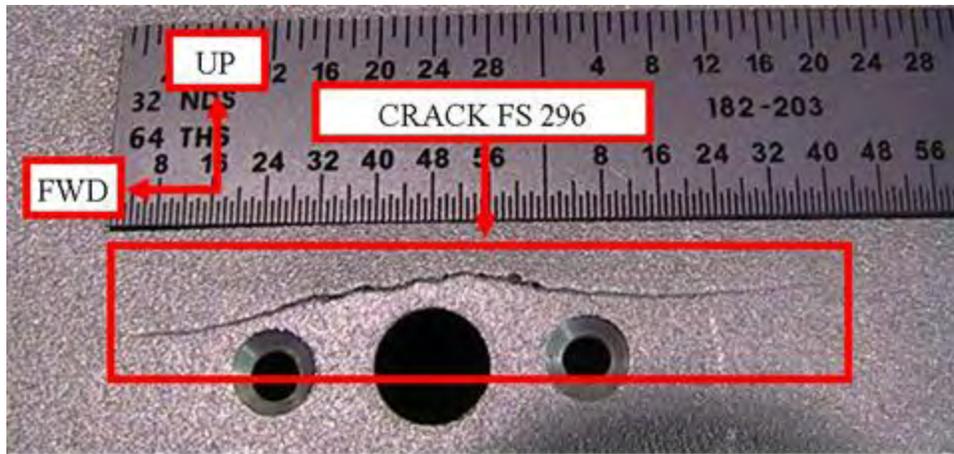
52820-08 CRK FS296 Mac

Figure 521. Macroscopic View of Crack on the Oxygen Bottle Bracket Assembly FS 296

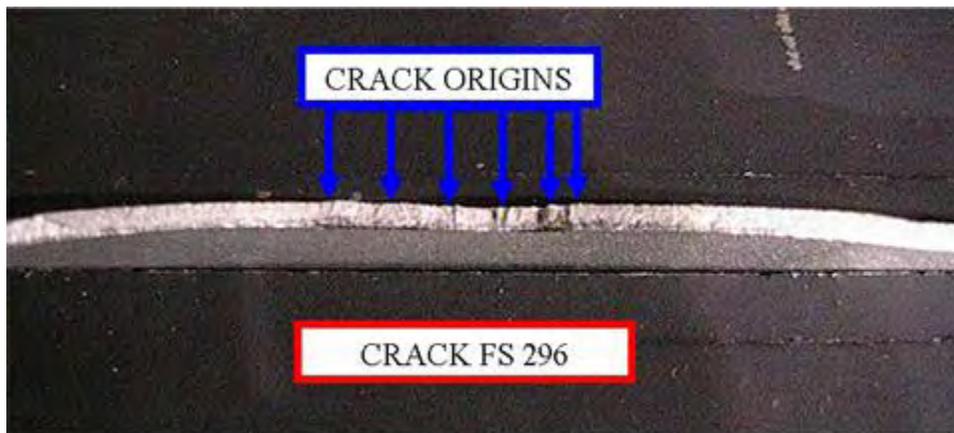
52820-08 CRK FS296 Frac

Figure 522. Fracture Face of Crack on the Oxygen Bottle Bracket Assembly FS 296

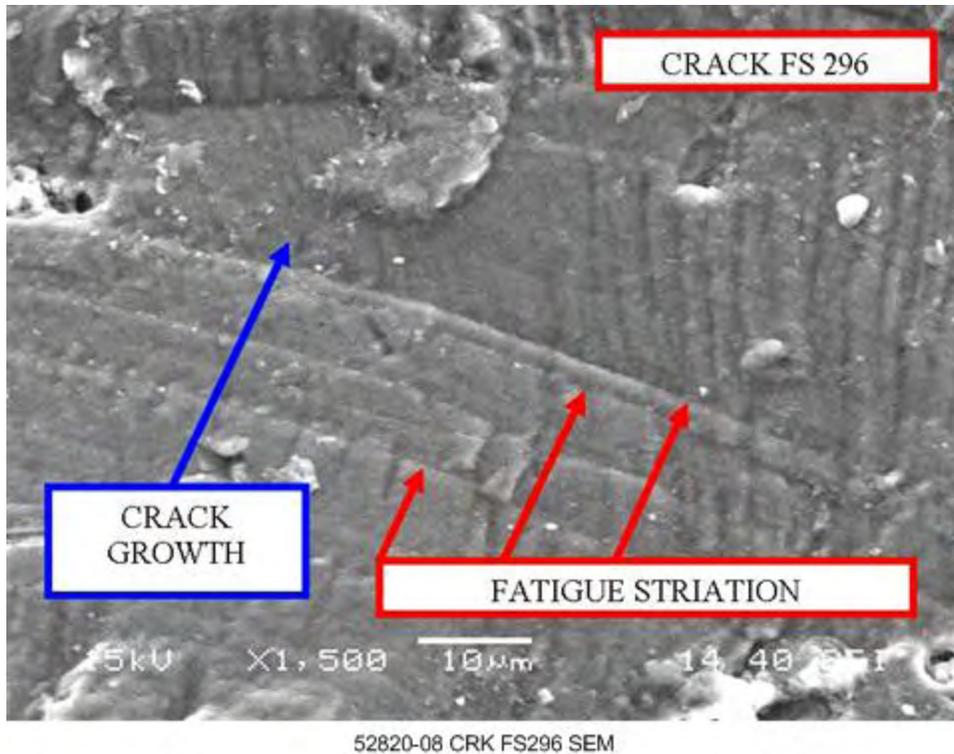
Figure 523. Fractograph of the Crack on the Oxygen Bottle Bracket Assembly FS 296

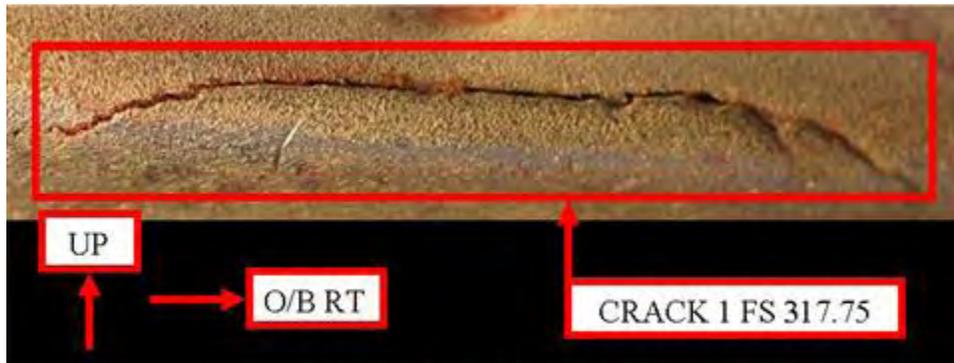
40682-08(1 of 2) CRK 1 FS317.75 Mac

The location of three cracks on the aft fuselage bulkhead assembly (1 of 2), part number 40682-08, is shown in figure 524. Figure 525 shows a macroscopic view of crack 1, which measured 1.165 inches and was located at FS 317.75. A macroscopic view of crack 2, which measured 0.75 inch and was located at FS 317.75, is shown in figure 526, and figure 527 shows a macroscopic view of crack 3. Crack 3 measured 0.55 inch and was also located at FS 317.75.

Figure 525. Macroscopic View of Crack 1 on the Aft Fuselage Bulkhead Assembly (1 of 2) FS 317.75

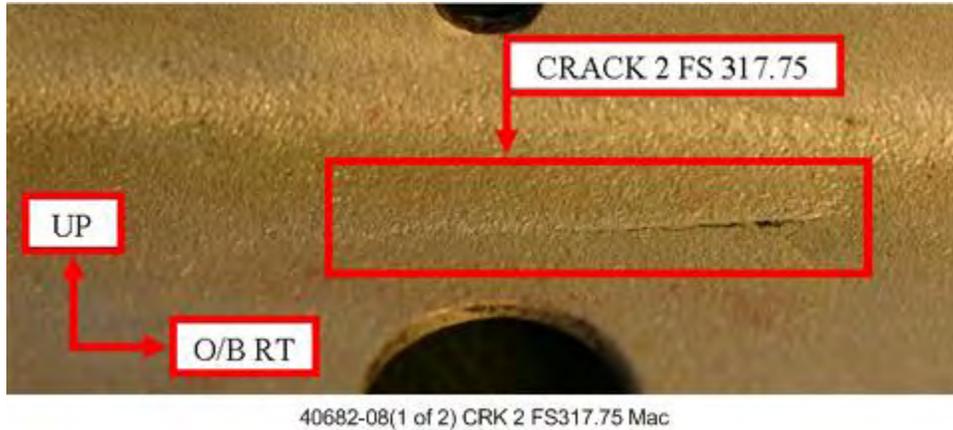
Figure 526. Macroscopic View of Crack 2 on the Aft Fuselage Bulkhead Assembly (1 of 2) FS 317.75

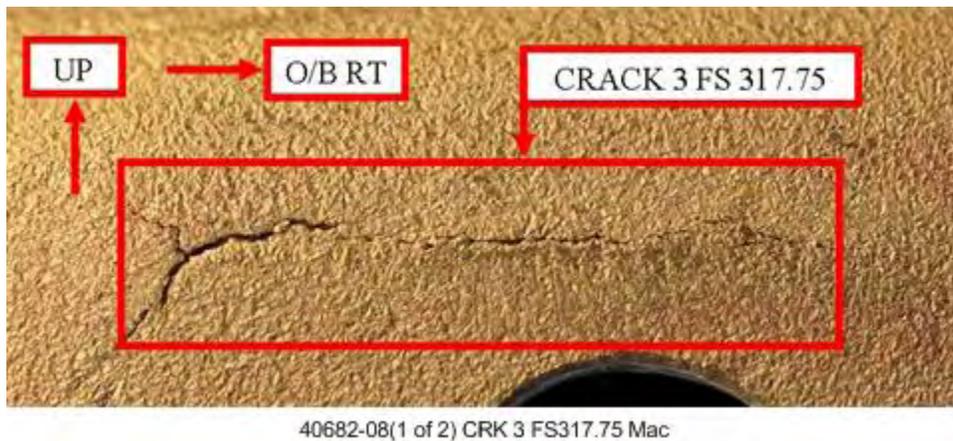
Figure 527. Macroscopic View of Crack 3 on the Aft Fuselage Bulkhead Assembly (1 of 2) FS 317.75

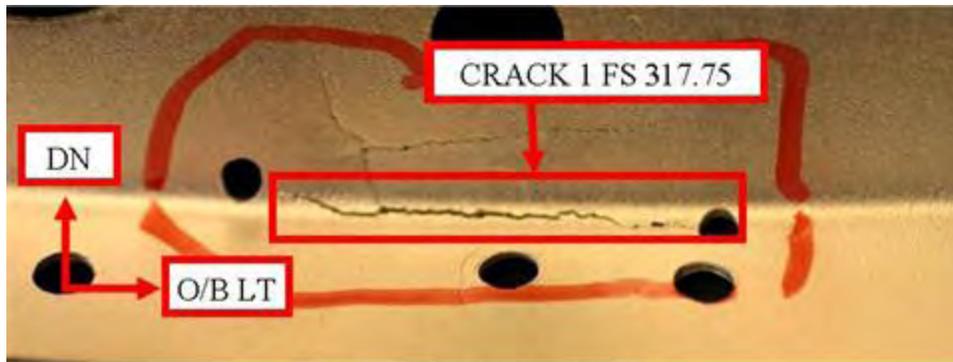
40682-08(2 of 2) CRK 1 FS317.75 Mac

Figure 528 shows the location of two cracks on the aft fuselage bulkhead assembly (2 of 2) at FS 317.75, part number 40682-08. A macroscopic view of crack 1, which measures 1.138 inches, is shown in figure 529. Figure 530 shows a macroscopic view of crack 2, which measures 1.192 inches. Figure 531 shows the location of a 0.48-inch crack on the aft fuselage bulkhead assembly, part number 40682-4. A macroscopic view of this crack is shown in figure 532, and a microscopic view of the crack is shown in figure 533.

Figure 529. Macroscopic View of Crack 1 on the Aft Fuselage Bulkhead Assembly (2 of 2) FS 317.75

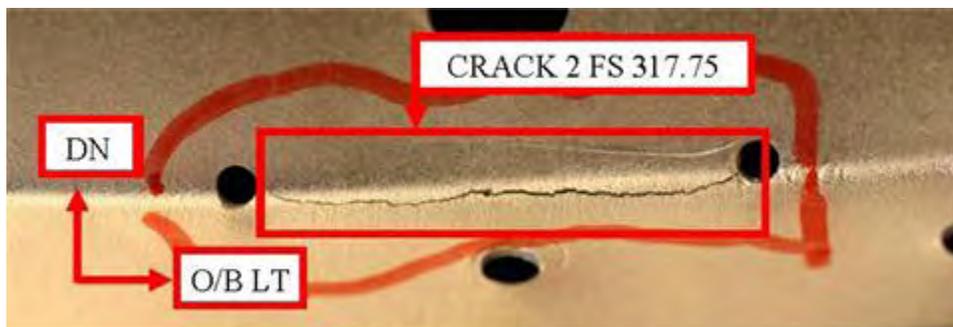
40682-08(2 of 2) CRK 2 FS317.75 Mac

Figure 530. Macroscopic View of Crack 2 on the Aft Fuselage Bulkhead Assembly (2 of 2) FS 317.75

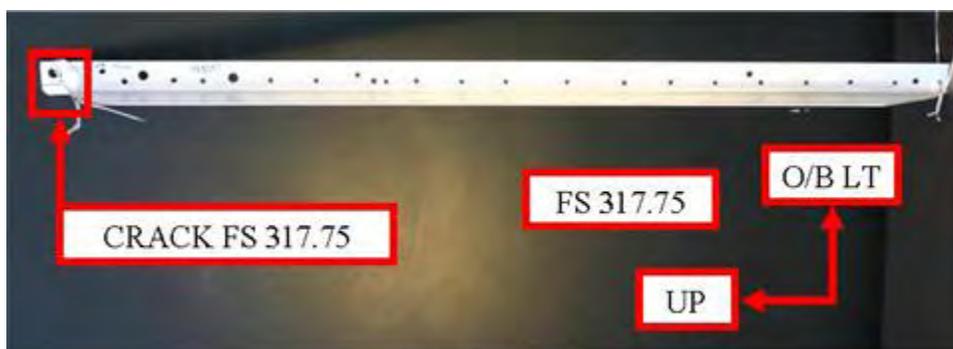
40682-4 CRK FS317.5 OV

Figure 531. Location of a Crack on the Aft Fuselage Bulkhead Assembly FS 317.75

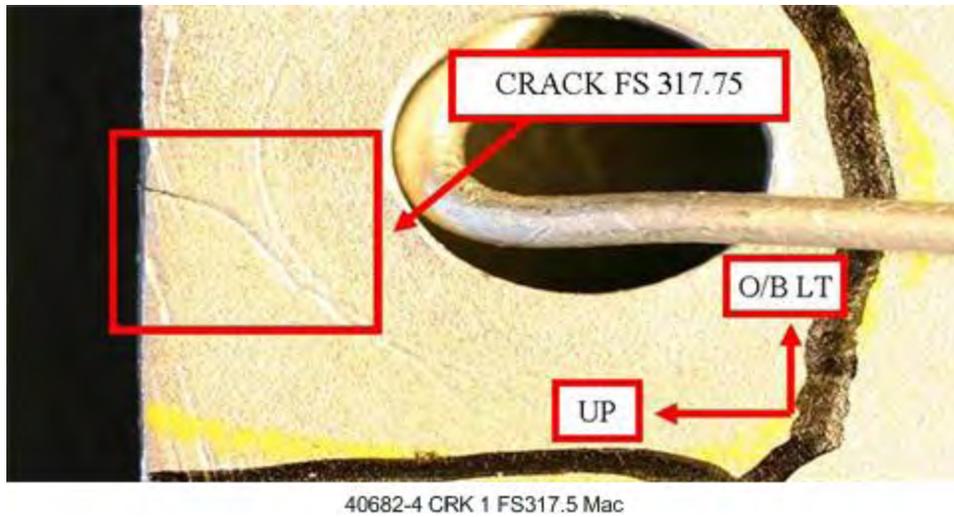
Figure 532. Macroscopic View of a Crack on the Aft Fuselage Bulkhead Assembly FS 317.75

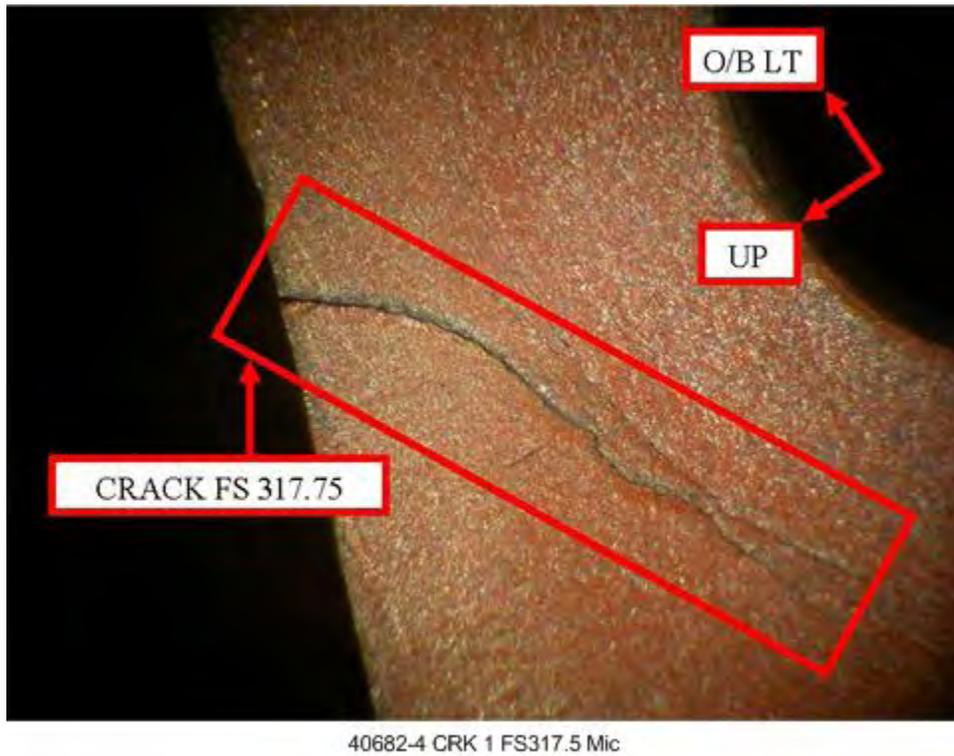
Figure 533. Microscopic View of a Crack Aft Fuselage Bulkhead Assembly FS 317.75

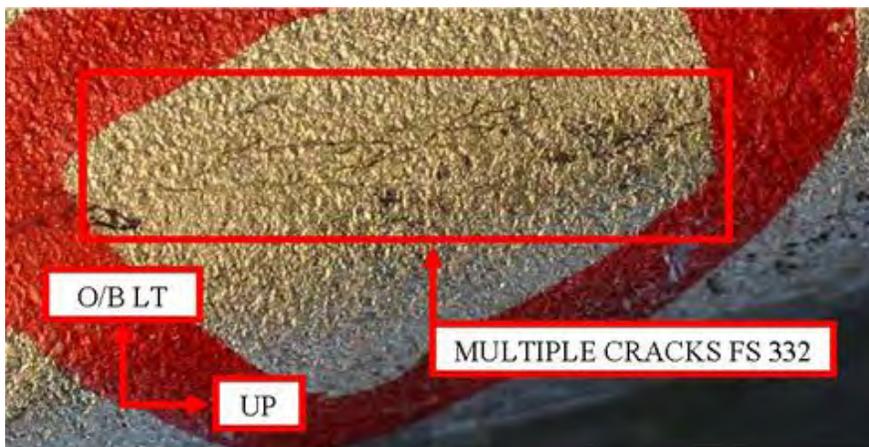
40655-00 (1 of 5) CRK FS 332 Mac

Figure 534 shows the location of multiple part-through cracks on the fuselage bulkhead assembly, part number 40655-00. These cracks, which are shown macroscopically in figure 535 had a maximum length of 0.305 inch and were located at FS 332. A microscopic view of these cracks is shown in figure 536. The location of multiple part-through cracks on the bulkhead assembly, part number 40639-004, is shown in figure 537. These cracks had a maximum length of 0.437 inch and were located at FS 342.25. A macroscopic view of these cracks is shown in figure 538, and a microscopic view is shown in figure 539.

Figure 535. Macroscopic View of Cracks on the Fuselage Bulkhead Assembly FS 332

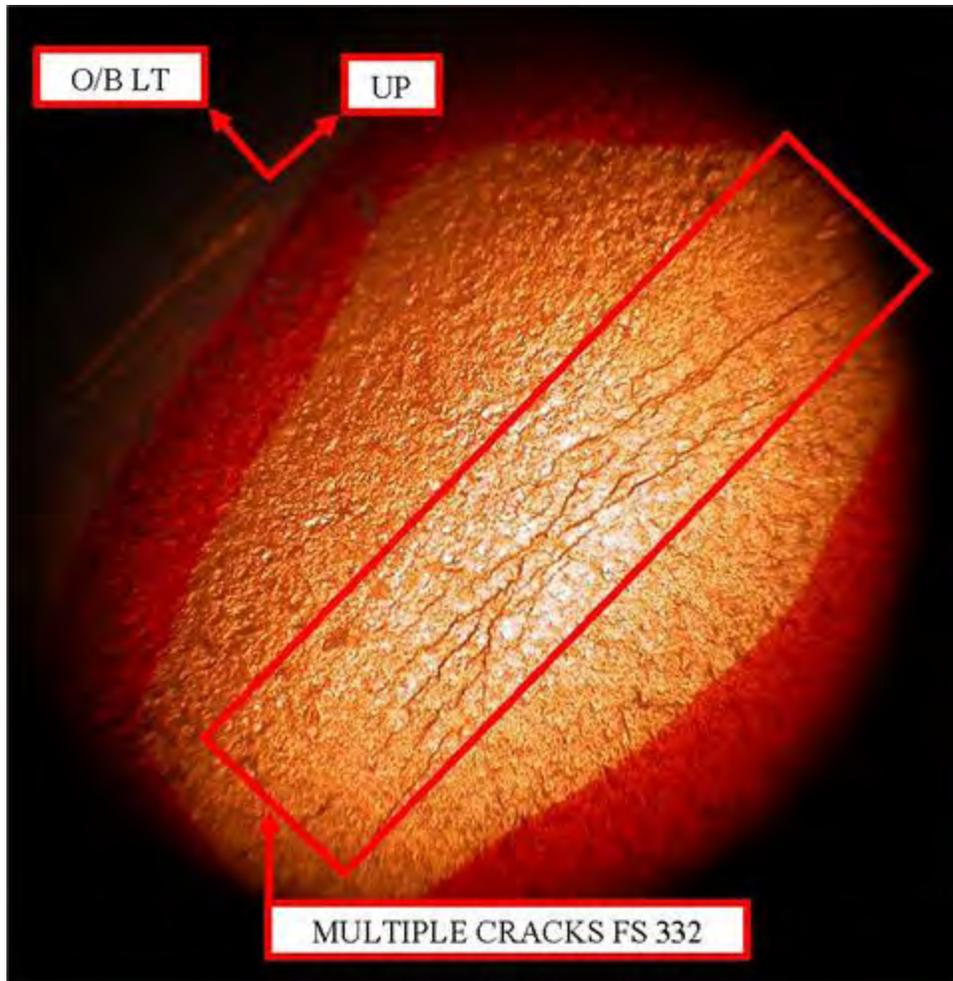
40655-00 (1 of 5) CRK FS 332 Mic

Figure 536. Microscopic View of Cracks on the Fuselage Bulkhead Assembly FS 332

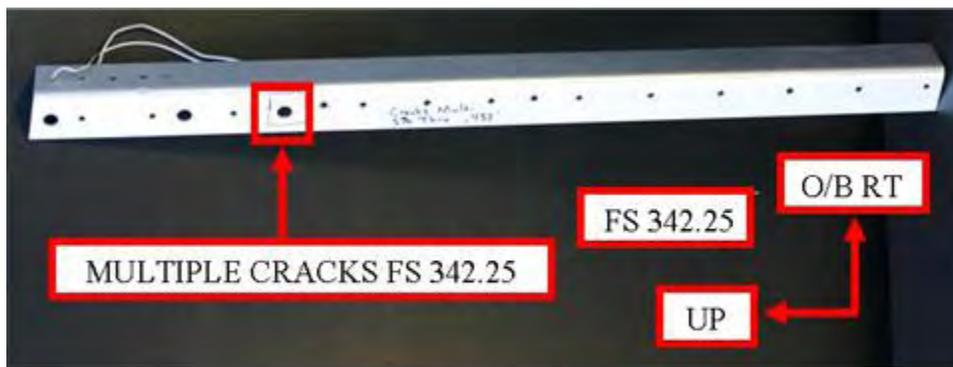
40639-04 CRK FS342.25 OV

Figure 537. Location of Multiple Cracks on the Bulkhead Assembly FS 342.25

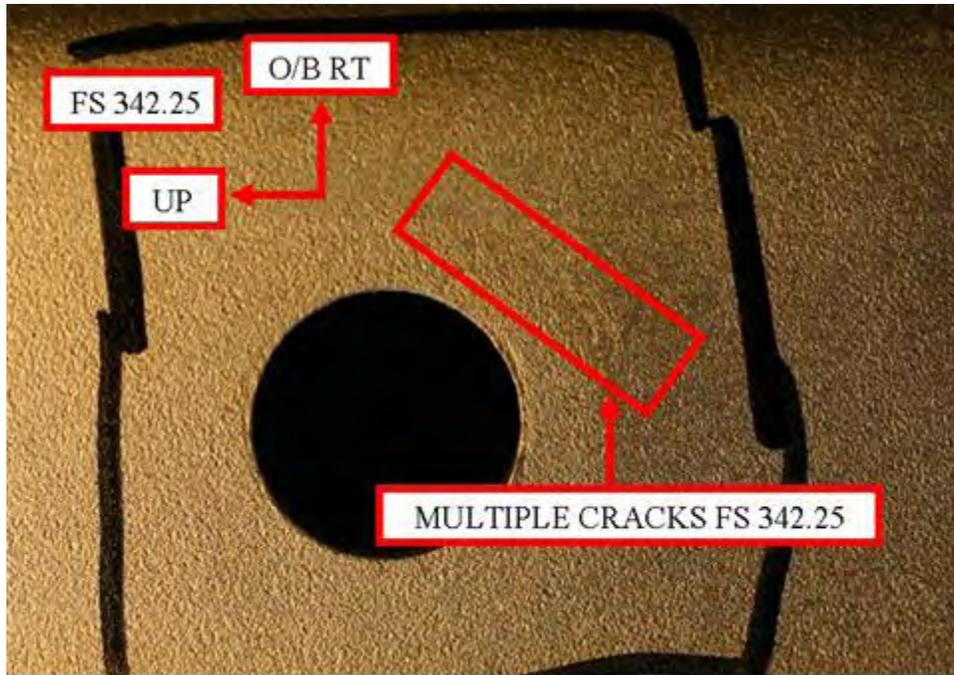
40639-04 CRK FS342.25 Mac

Figure 538. Macroscopic View of Multiple Cracks on the Bulkhead Assembly FS 342.25

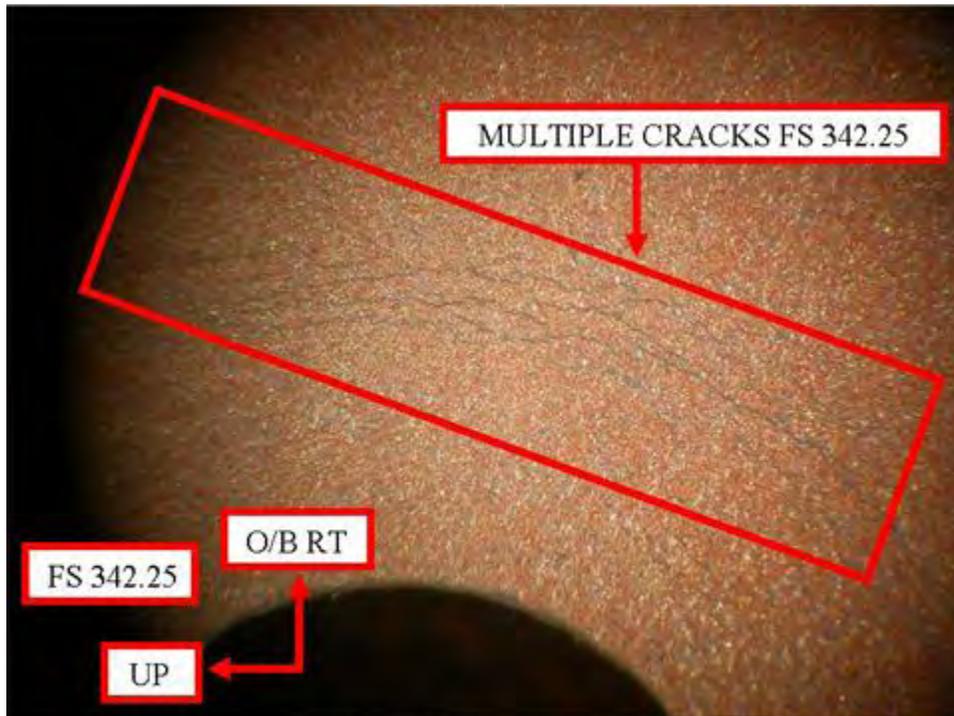
40639-04 CRK FS342.25 Mic

Figure 539. Microscopic View of Multiple Cracks on the Bulkhead Assembly FS 342.25
