DOT/FAA/AR-07/64

Teardown Evaluation of a 1975 Piper Navajo Chieftain Model PA31-350 Airplane

March 2008

Final Report

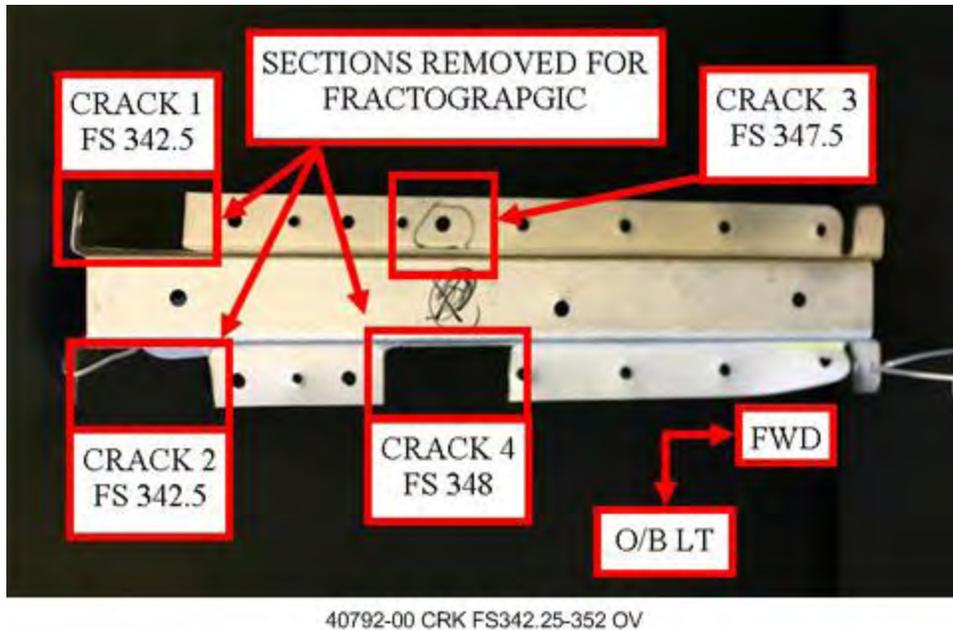
The location of four cracks found on the aft body lower channel, part number 40792-00, is shown in figure 540. A macroscopic view of crack 1, which was located at FS 342.25 and measured 0.906 inch, is shown in figure 541, and the fracture face is shown in figure 542. Figure 543 shows a macroscopic view of crack 2, which measures 0.931 inch in length and is located at FS 342.25. The fracture face of crack 2 is shown in figure 544. Crack 3, which measured 0.337 inch and was located at FS 347.5, is shown macroscopically in figure 545. A macroscopic view of crack 4, which measured 1.044 inches and was located at FS 348, is shown in figure 546, and figure 547 shows the fracture face for crack 4. From the fracture face photographs for cracks 1, 2, and 4, it was determined that these cracks were caused by fatigue.

Figure 540. Location of Four Cracks on the Aft Body Lower Channel FS 342.25 Through FS 352

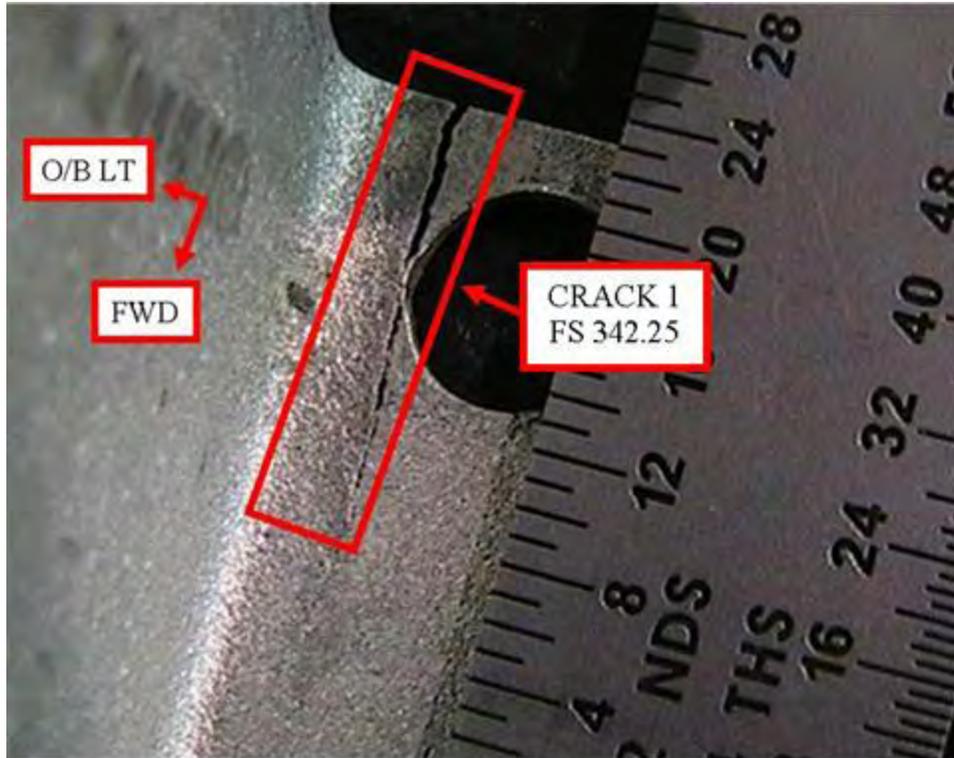
40792-00 CRK 1 FS342.25-352 Mac

Figure 541. Macroscopic View of Crack 1 on the Aft Body Lower Channel FS 342.25

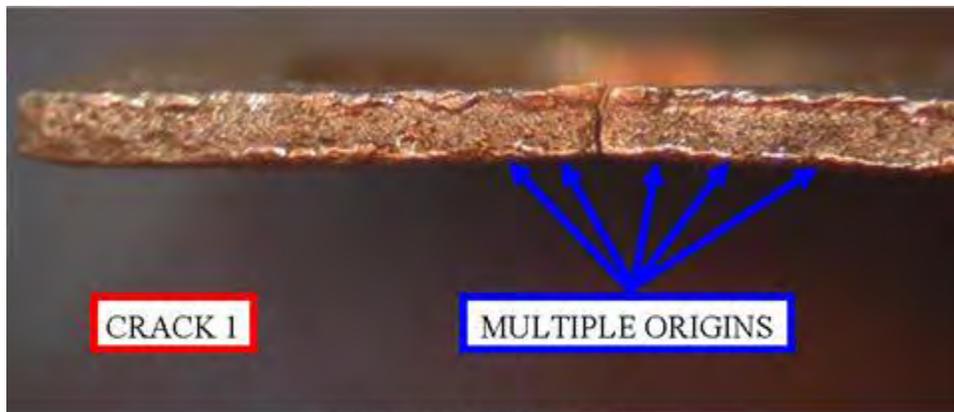
40792-00 CRK 1 FS342.25-352 Frac

Figure 542. Fracture Face of Crack 1 on the Aft Body Lower Channel FS 342.25

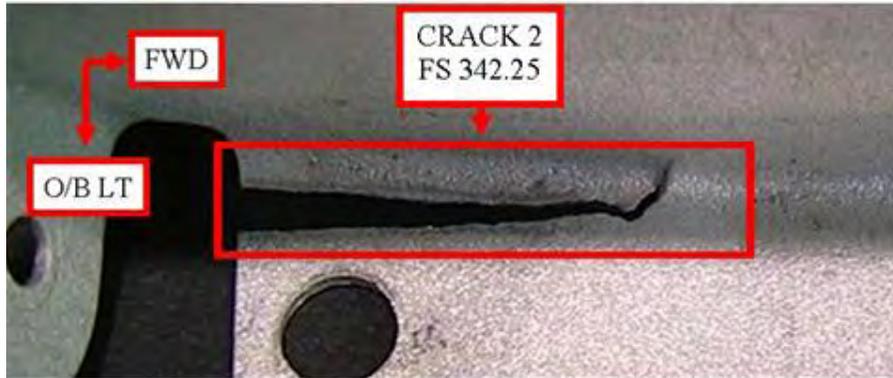
40792-00 CRK 2 FS342.25-352 Mac

Figure 543. Macroscopic View of Crack 2 on the Aft Body Lower Channel FS 342.25

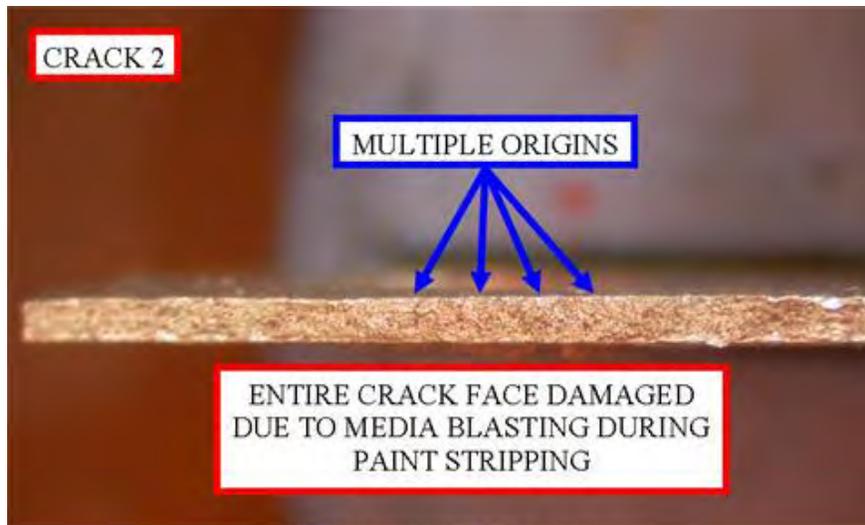
40792-00 CRK 2 FS342.25-352 Frac

Figure 544. Fracture Face of Crack 2 on the Aft Body Lower Channel FS 342.25

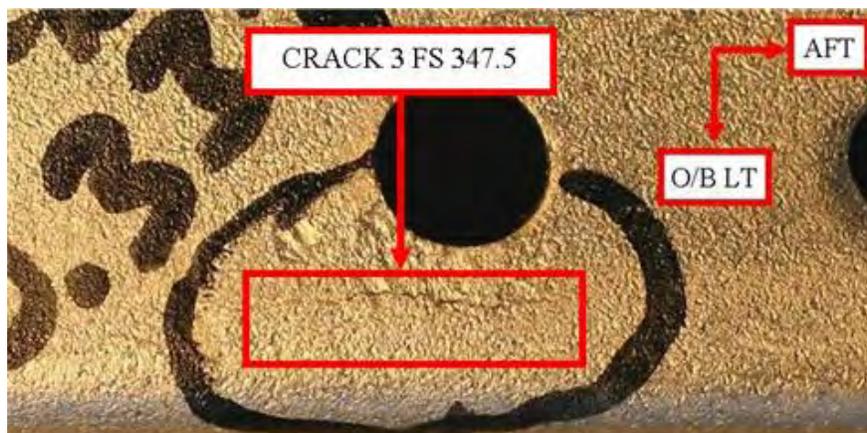
40792-00 CRK 3 FS342.25-352 Mac

Figure 545. Macroscopic View of Crack 3 on the Aft Body Lower Channel FS 347.5

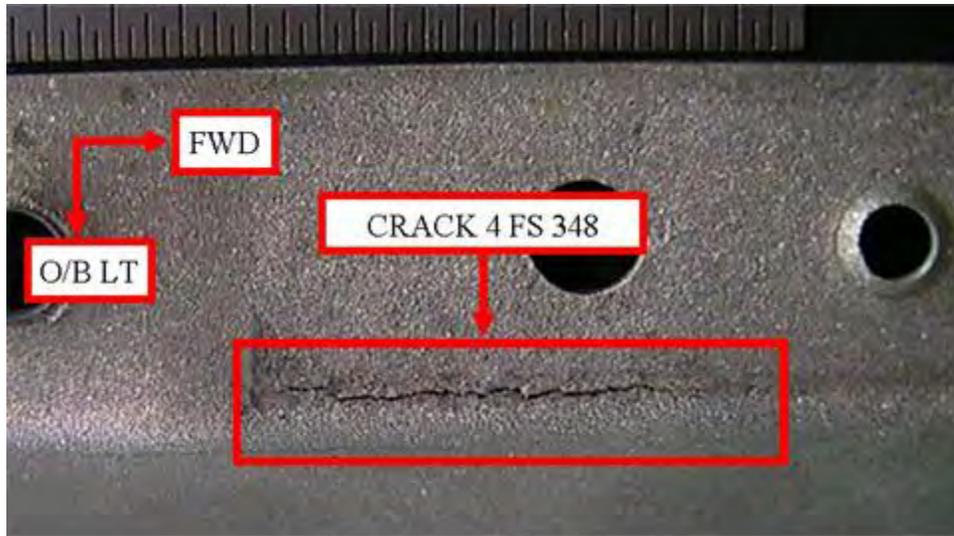
40792-00 CRK 4 FS342.25-352 Mac

Figure 546. Macroscopic View of Crack 4 on the Aft Body Lower Channel FS 348

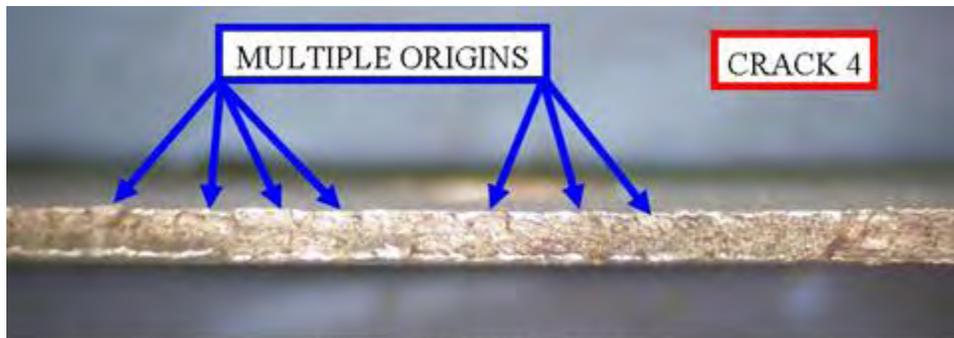
40792-00 CRK 4 FS342.25-352 Frac

Figure 547. Fracture Face of Crack 4 on the Aft Body Lower Channel FS 348

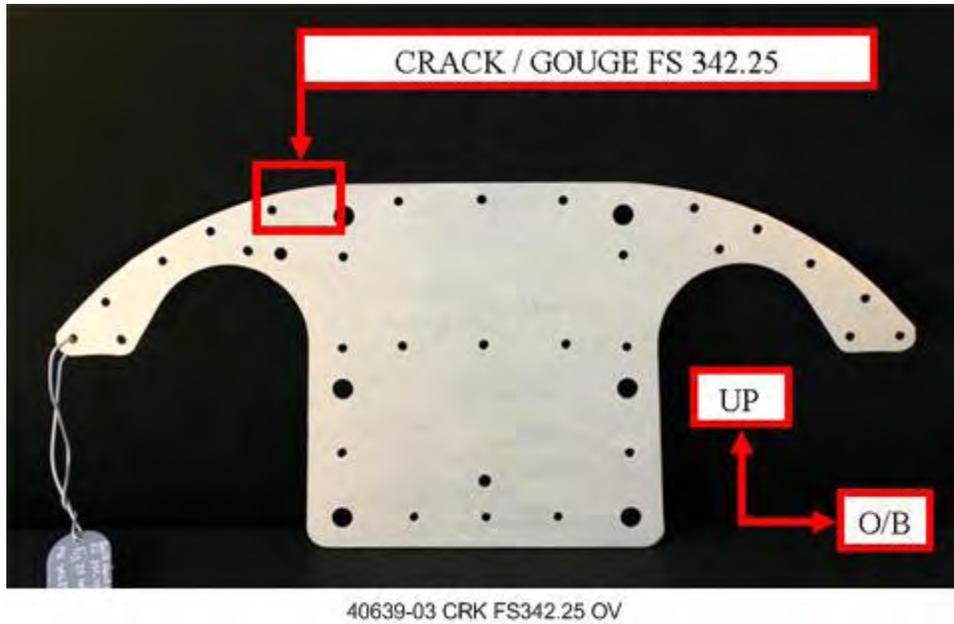
The location of a gouge and a crack on the bulkhead assembly, part number 40639-03, at FS 342.25, is shown in figure 548. A macroscopic view of the 0.12-square-inch gouge and 0.058-inch crack is shown in figure 549. This gouge caused a localized thickness loss of 8%. A microscopic view of the crack is shown in figure 550.

Figure 548. Location of Gouge and Crack on the Bulkhead Assembly FS 342

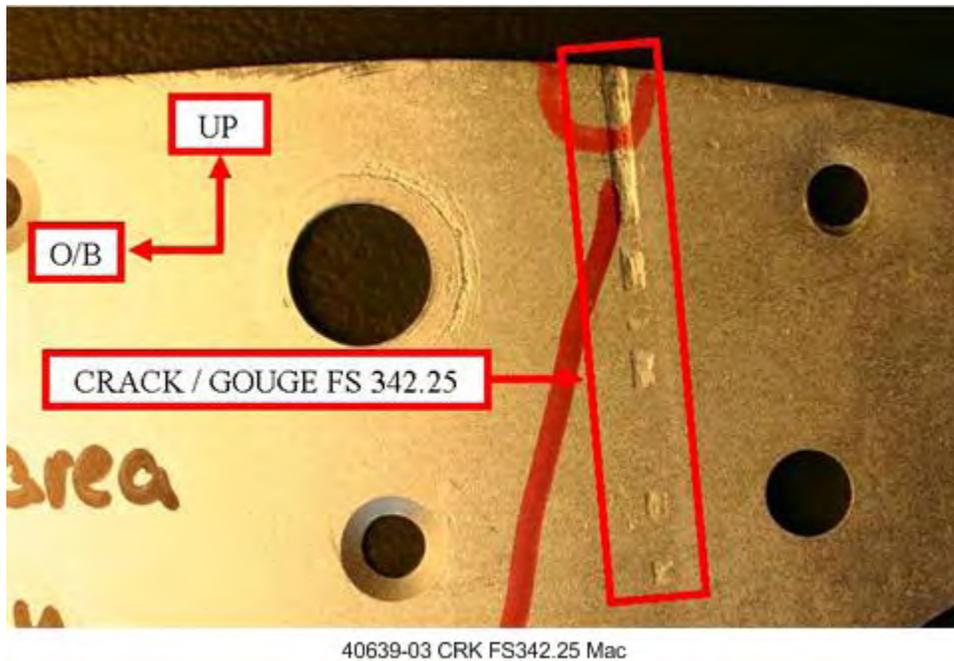
Figure 549. Macroscopic View of Crack and Gouge on the Bulkhead Assembly FS 342.25

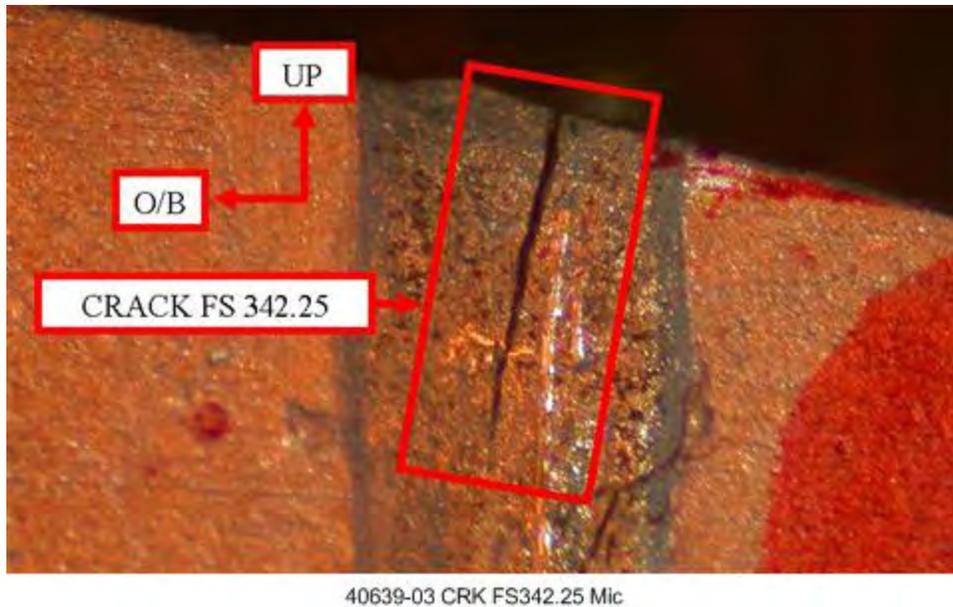
Figure 550. Microscopic View of Crack on the Bulkhead Assembly FS 342.25

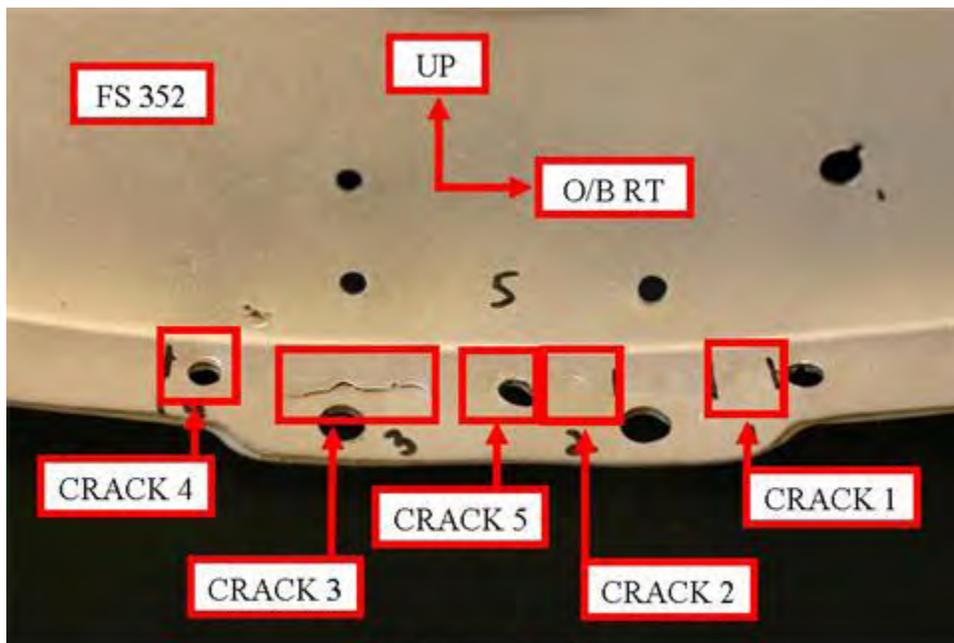
40638-00 CRK FS352 Mac

An overview of the location of five cracks on the fuselage bulkhead assembly, part number 40638-00, at FS 352, is shown in figure 551, and a detailed overview is shown in figure 552. A macroscopic view of crack 1, which measured 0.105 inch, is shown in figure 553. A macroscopic view of crack 2, which measured 0.189 inch in length, is shown in figure 554. A microscopic view of crack 2 is shown in figure 555. Figure 556 shows a macroscopic view of crack 3, which measured 0.9875 inch, and figure 557 shows a microscopic view of this crack. Crack 4, which measured 0.1095 inch in length, is shown macroscopically in figure 558 and microscopically in figure 559. Figure 560 shows a macroscopic view of crack 5, and figure 561 shows a microscopic view of this 0.14-inch-long crack.

Figure 552. Location of Five Cracks on the Fuselage Bulkhead Assembly FS 352

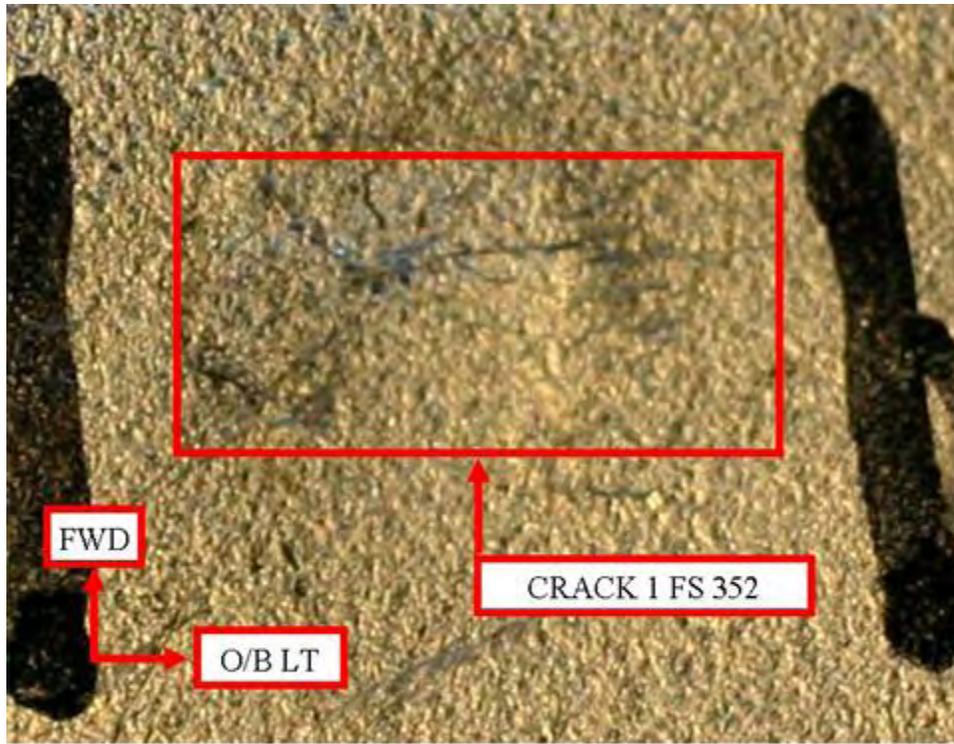
40638-00 CRK 1 FS352 Mac

Figure 553. Macroscopic View of Crack 1 on the Fuselage Bulkhead Assembly FS 352

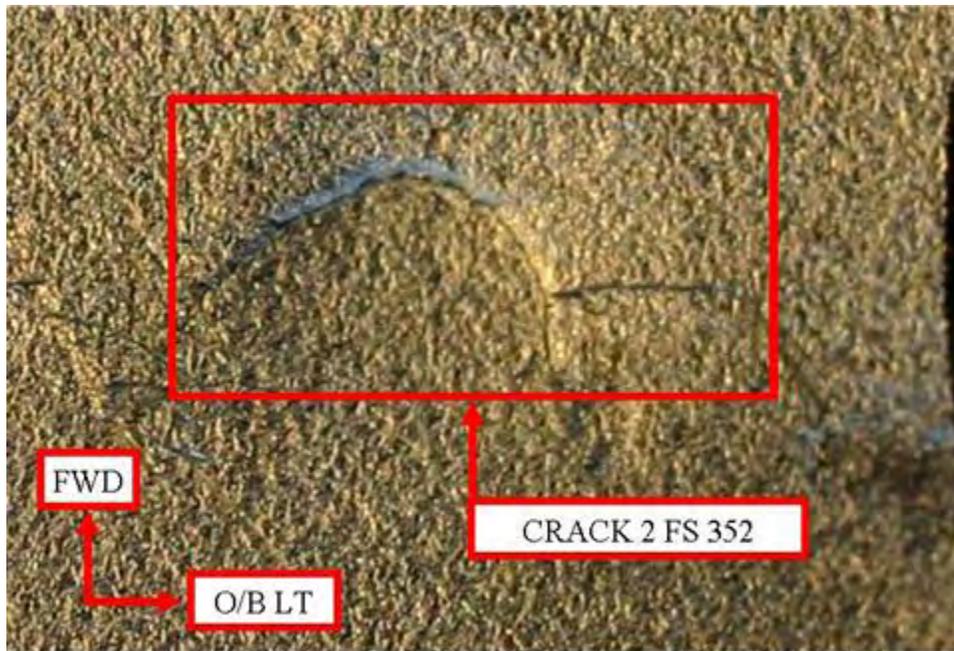
40638-00 CRK 2 FS352 Mac

Figure 554. Macroscopic View of Crack 2 on the Fuselage Bulkhead Assembly FS 352

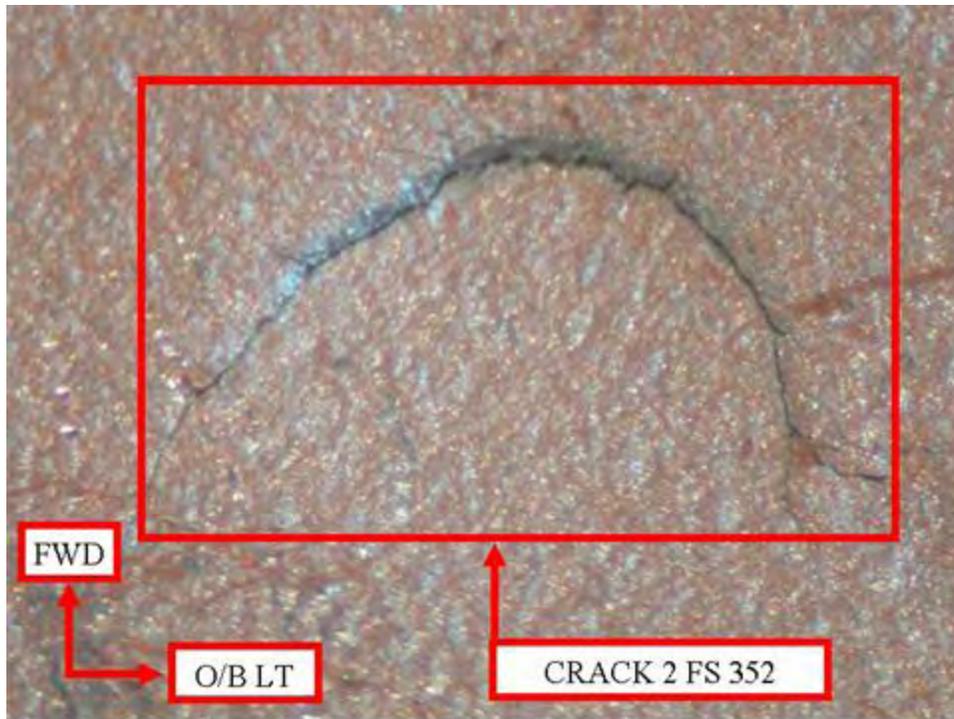
40638-00 CRK 2 FS352 Mic

Figure 555. Microscopic View of Crack 2 on the Fuselage Bulkhead Assembly FS 352

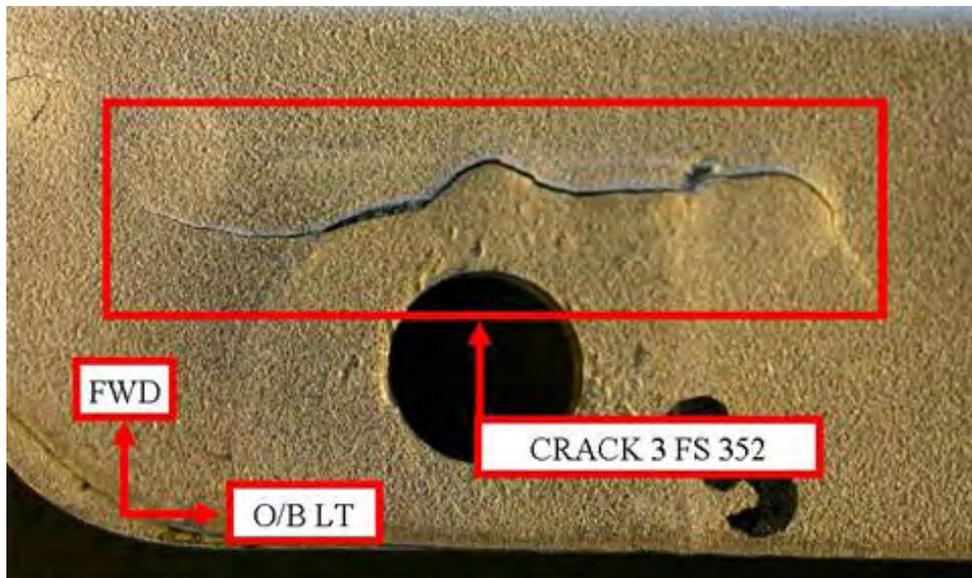
40638-00 CRK 3 FS352 Mac

Figure 556. Macroscopic View of Crack 3 on the Fuselage Bulkhead Assembly FS 352

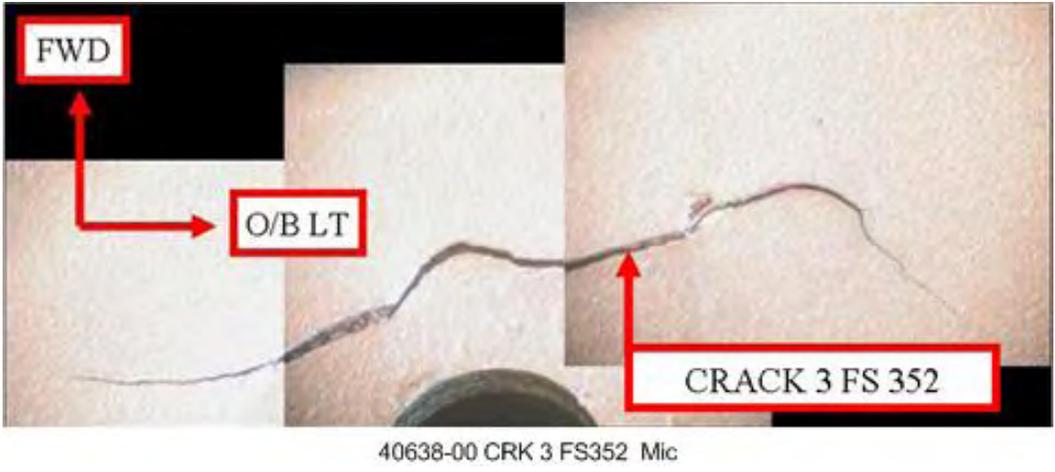
Figure 557. Microscopic View of Crack 3 on the Fuselage Bulkhead Assembly FS 352

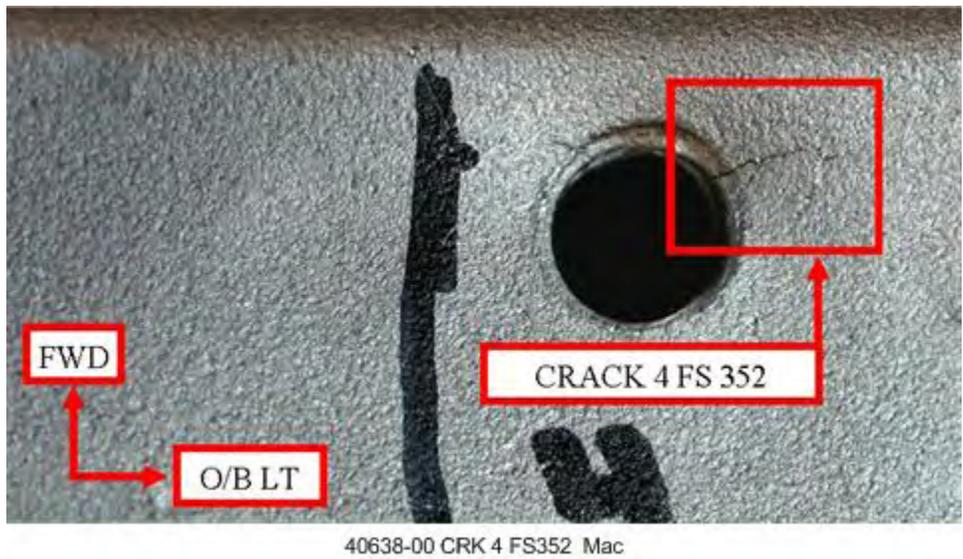
Figure 558. Macroscopic View of Crack 4 on the Fuselage Bulkhead Assembly FS 352

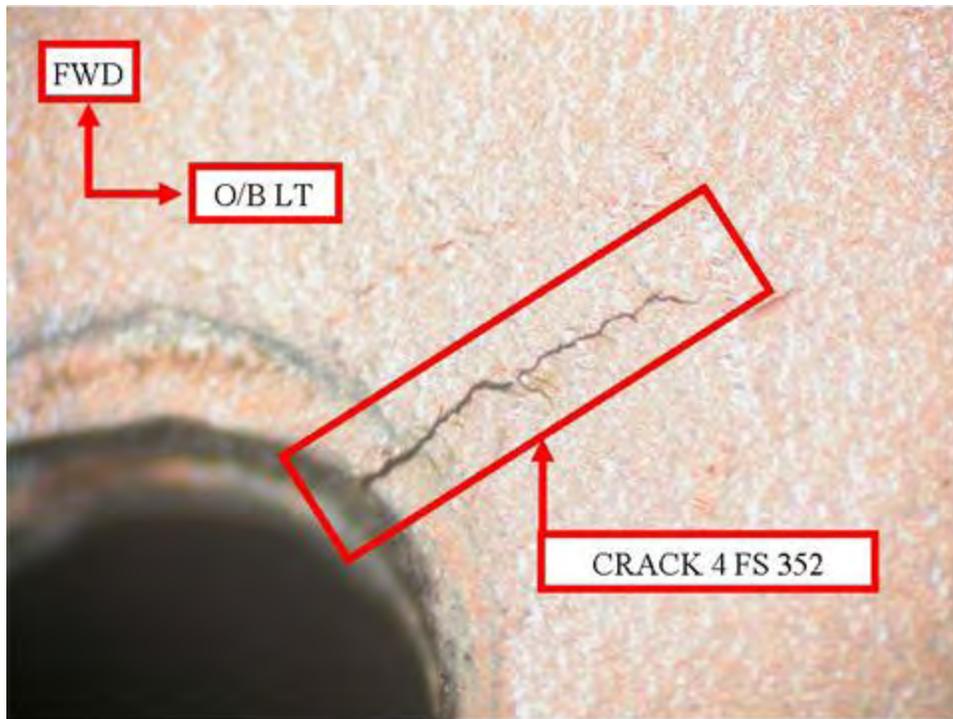
40638-00 CRK 4 FS352 Mic

Figure 559. Microscopic View of Crack 4 on the Fuselage Bulkhead Assembly FS 352

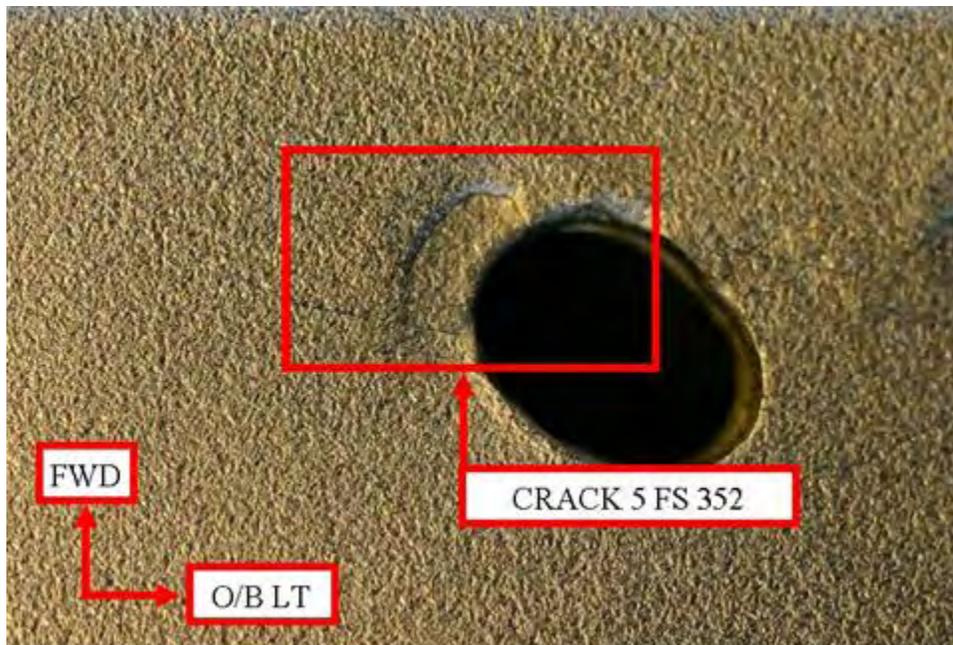
40638-00 CRK 5 FS352 Mac

Figure 560. Macroscopic View of Crack 5 on the Fuselage Bulkhead Assembly FS 352

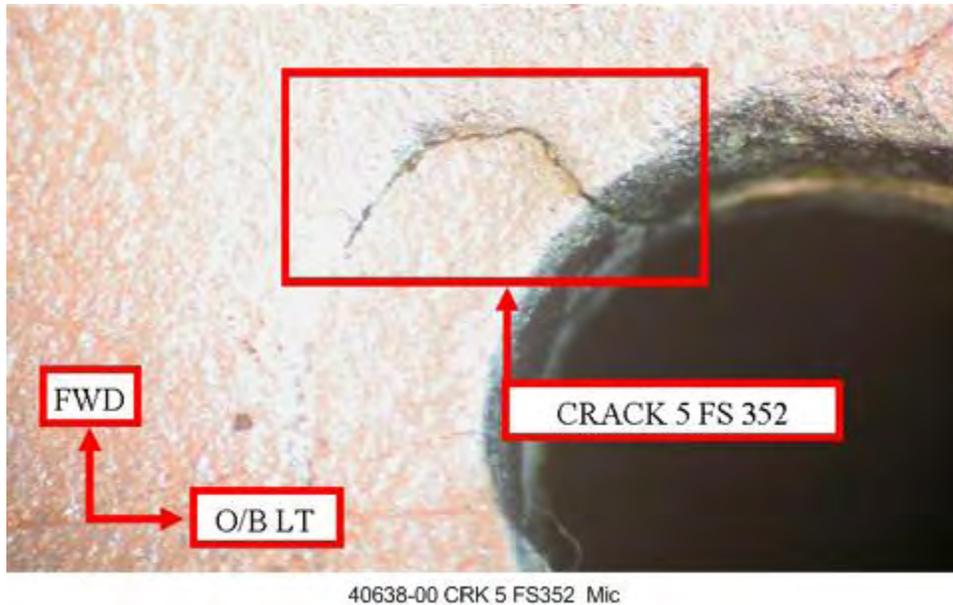
Figure 561. Microscopic View of Crack 5 on the Fuselage Bulkhead Assembly FS 352

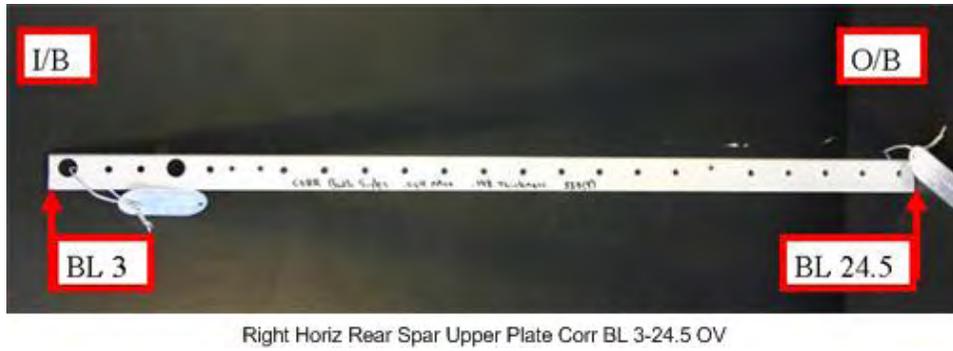
Figure 565. Location of Light Corrosion on the Right Horizontal Stabilizer Rear Spar Upper Plate BL 3 Through BL 24.5

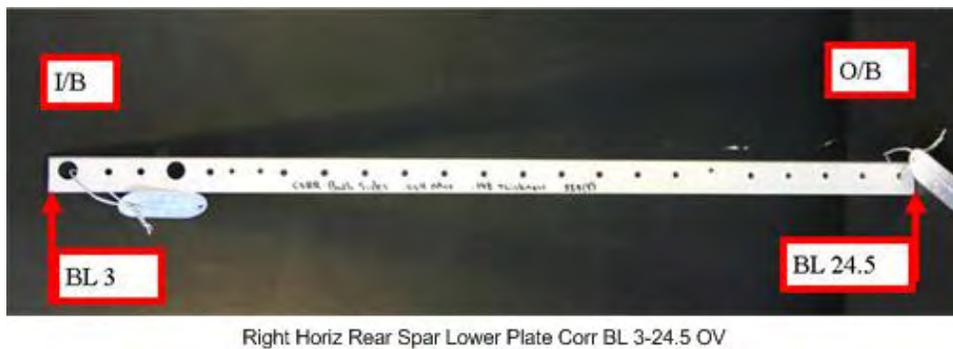
Figure 566. Location of Light Corrosion on the Right Horizontal Stabilizer Rear Spar Lower Plate BL 3 Through BL 24.5

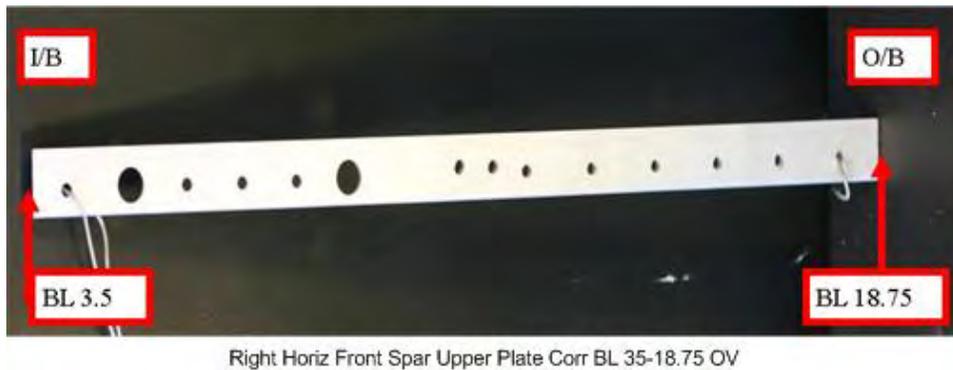
Figure 567. Location of Light Corrosion on the Right Horizontal Stabilizer Front Spar Upper Plate BL 3.5 Through BL 18.75

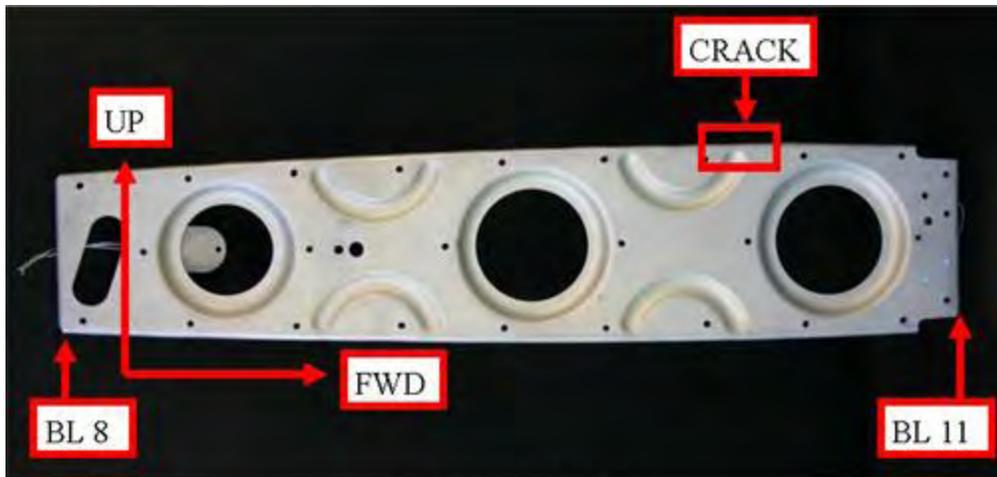
42230-2 CRK BL 8-11 OV

The location of a crack on the left horizontal stabilizer rib, part number 42270-2, is shown in figure 568. A macroscopic view of this 0.089-inch crack that is located at BL 11 is shown in figure 569. Figure 570 shows the location of a 0.026-inch crack at BL 12.6 on the right horizontal stabilizer gusset-front spar, part number 40170-15. A macroscopic view of this crack is shown in figure 571, and the fluorescent liquid penetrant indication is shown in figure 572.

Figure 568. Location of Crack on the Left Horizontal Stabilizer Rib BL 8 Through BL 11

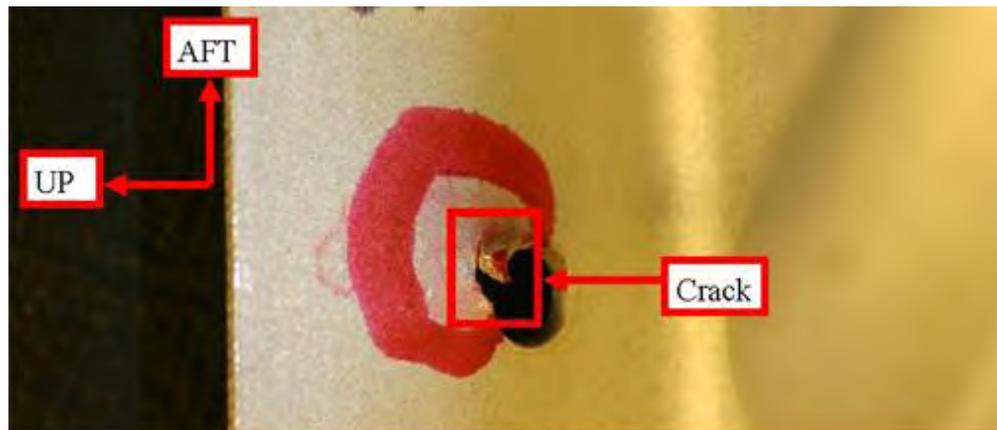
42230-2 CRK BL 8-11 Mac

Figure 569. Macroscopic View of Crack on the Left Horizontal Stabilizer Rib BL 11

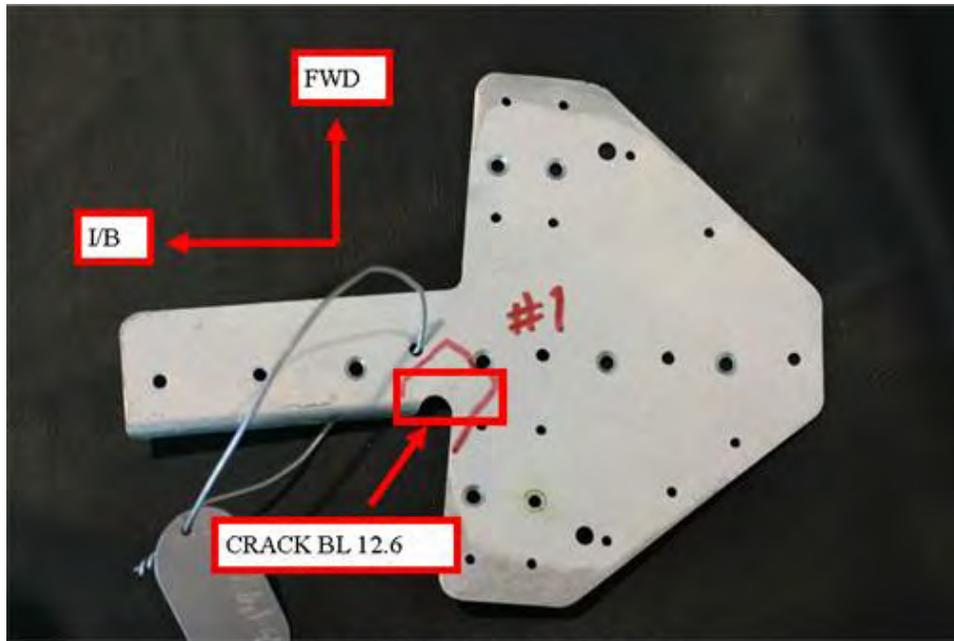
RT Hor FT SP Upper Gusset CRK BL 12.6 OV

Figure 570. Location of Crack on the Right Horizontal Stabilizer Gusset—Front Spar BL 12.6

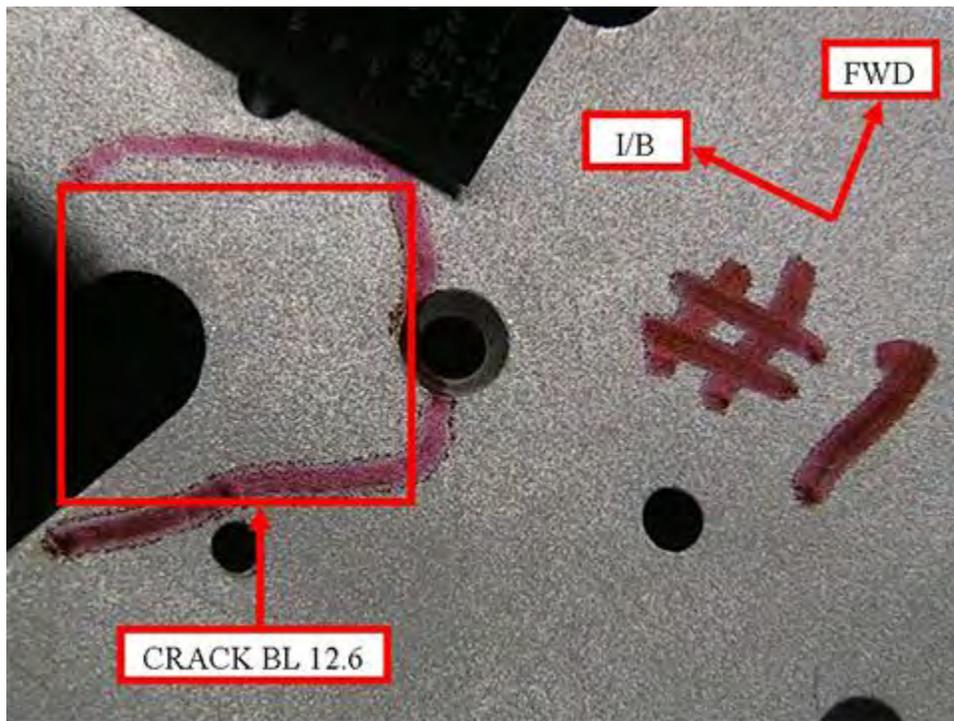
RT Hor FT SP Upper Gusset CRK BL 12.6 Mac

Figure 571. Macroscopic View of Crack on the Right Horizontal Stabilizer Gusset—Front Spar BL 12.6

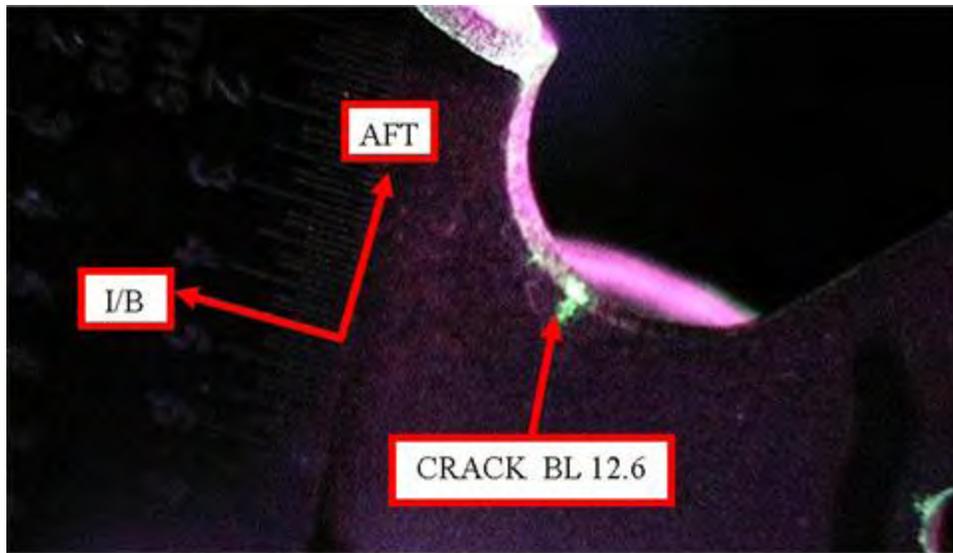
RT Hor FT SP Upper Gusset CRK BL 12.6 FLP

Figure 572. Fluorescent Liquid Penetrant Indication of Crack on the Right Horizontal Stabilizer Gusset—Front Spar BL 12.6

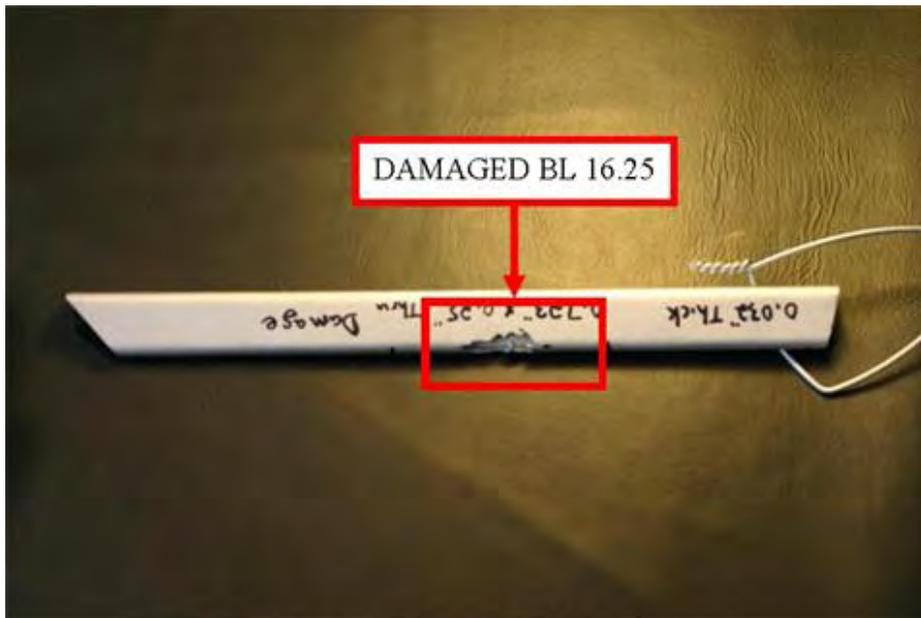
RH STRINGER Damage BL 16.25 OV

Figure 573 shows the location of damage on the right horizontal stabilizer stringer. A macroscopic view of the 0.18-square-inch area of damage that caused areas of complete localized thickness loss is shown in figure 574. The location of multiple cracks on the right horizontal stabilizer leading-edge skin assembly, part number 40155-15, is shown in figure 575. A macroscopic view of these cracks, which measure 0.106 inch in length and are located at BL 18.5, are shown in figure 576.

Figure 573. Location of Damage on the Right Horizontal Stabilizer Stringer BL 16.25

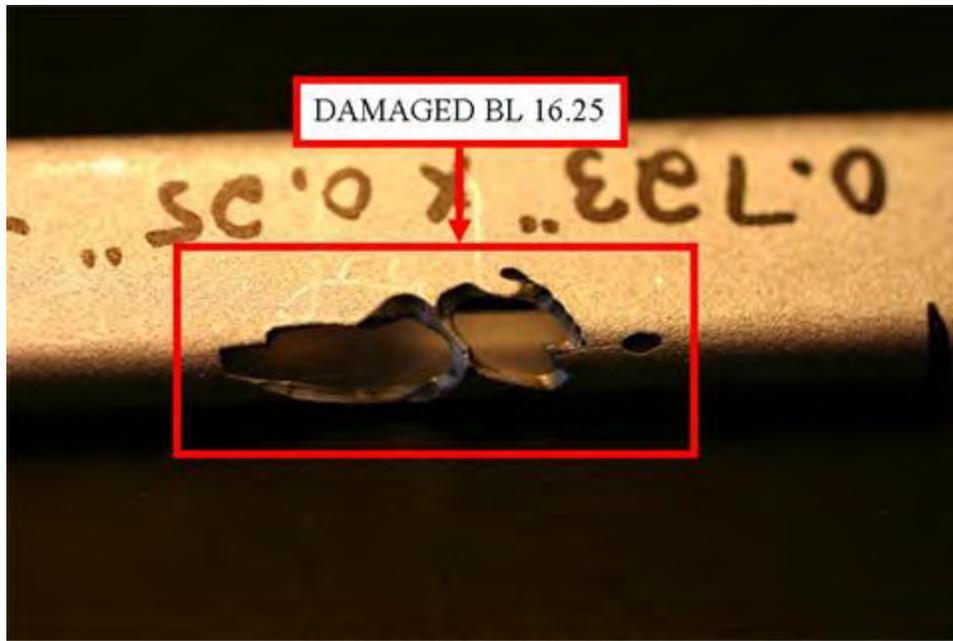
RH STRINGER Damage BL 16.25 Mac

Figure 574. Macroscopic View of Severe Damage on Right Horizontal Stabilizer Stringer BL 16.25

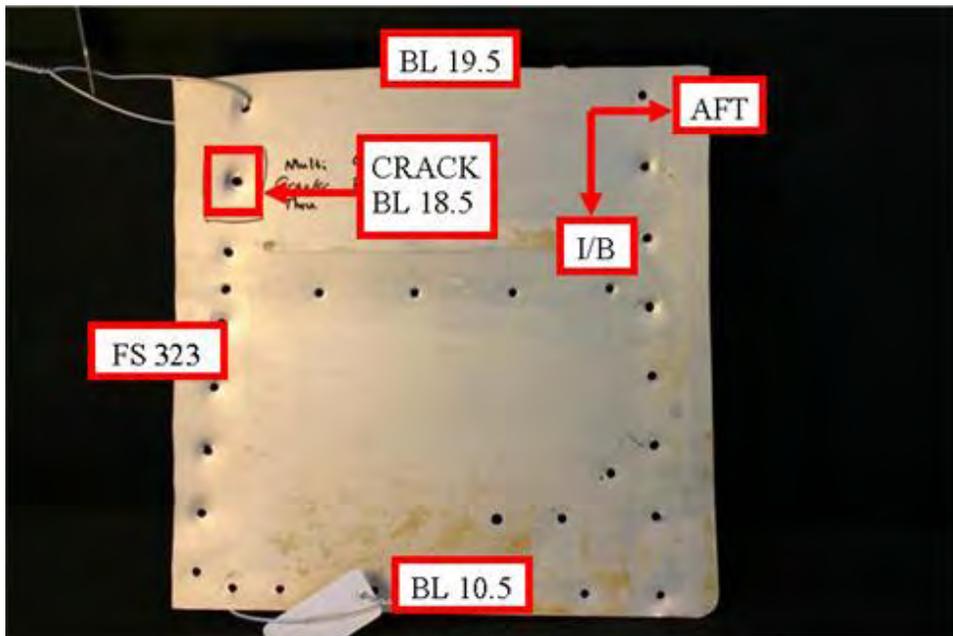
40155-15 CRK BL10.5-19.5 OV

Figure 575. Location of Multiple Cracks on the Right Horizontal Stabilizer Leading-Edge Skin Assembly BL 18.5

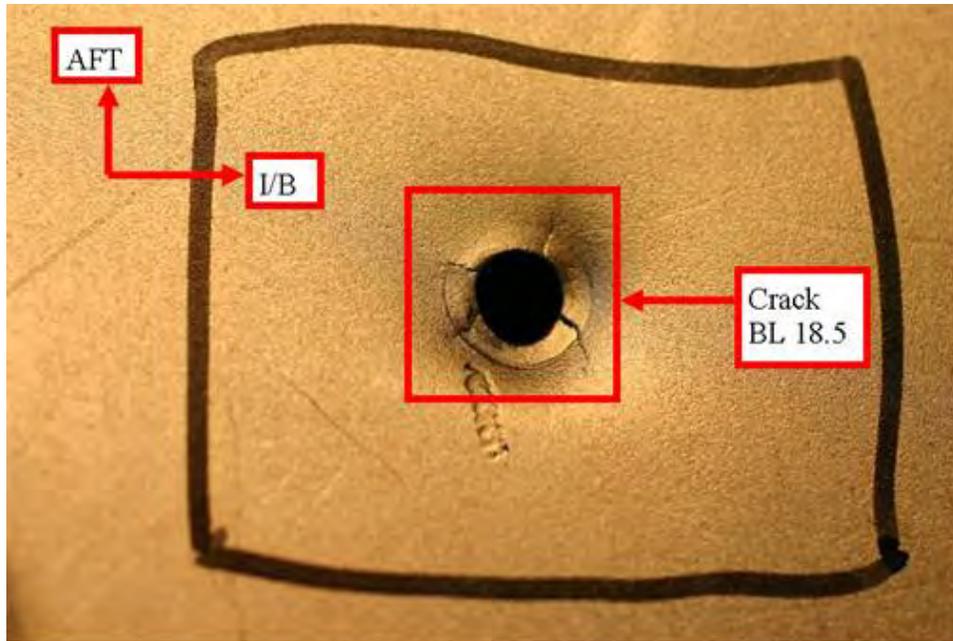
40155-15 CRK BL10.5-19.5 Mac

Figure 576. Macroscopic View of Multiple Cracks on the Right Horizontal Stabilizer Leading-Edge Skin Assembly BL 18.5

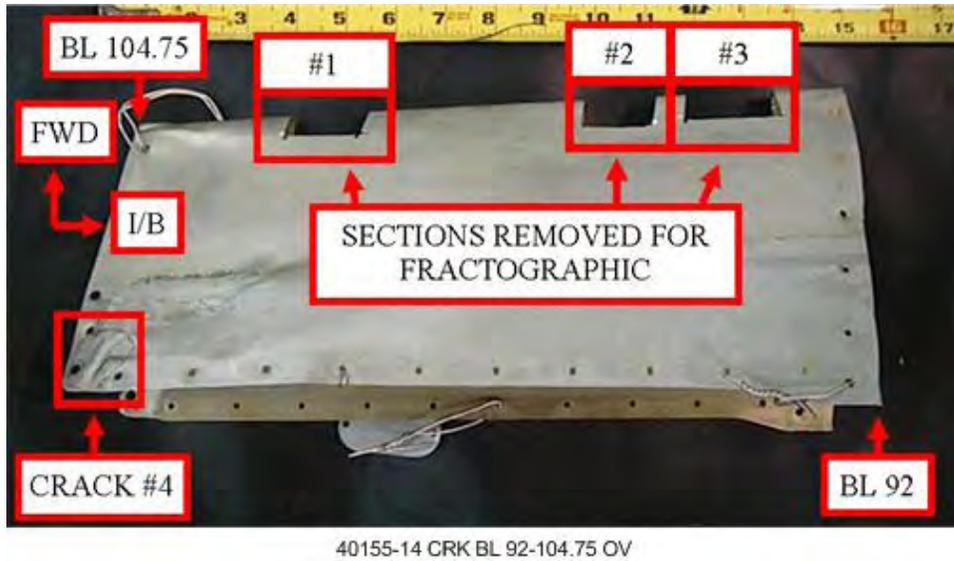
Figure 577 shows the location of four cracks on the left horizontal stabilizer leading-edge skin, part number 40155-14. Figure 578 shows a macroscopic view of crack 1, which measured 0.599 inch and was located at BL 94. A macroscopic view of crack 2, which measured 0.524 inch and was located at BL 96, is shown in figure 579. Figure 580 shows a macroscopic view of crack 3, which measured 0.549 inch and was located at BL 100. Cracks 1 through 3 were caused by a puncture to the leading-edge skin. Crack 4, which is shown macroscopically in figure 581, was located at BL 104.75 and measured 0.313 inch in length. The fluorescent liquid penetrant indication is shown in figure 582. A macroscopic view of crack 4 is shown in figure 583.

Figure 577. Location of Cracks on the Left Horizontal Stabilizer Leading-Edge Skin BL 92 Through BL 104.75

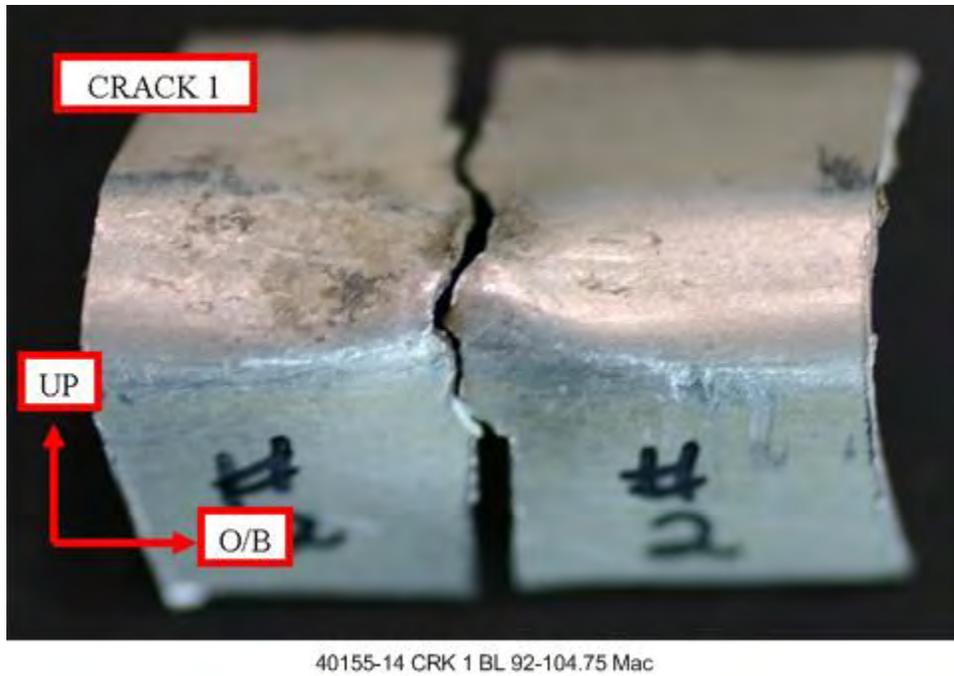
Figure 578. Macroscopic View of Crack 1 on the Left Horizontal Stabilizer Leading-Edge Skin BL 94

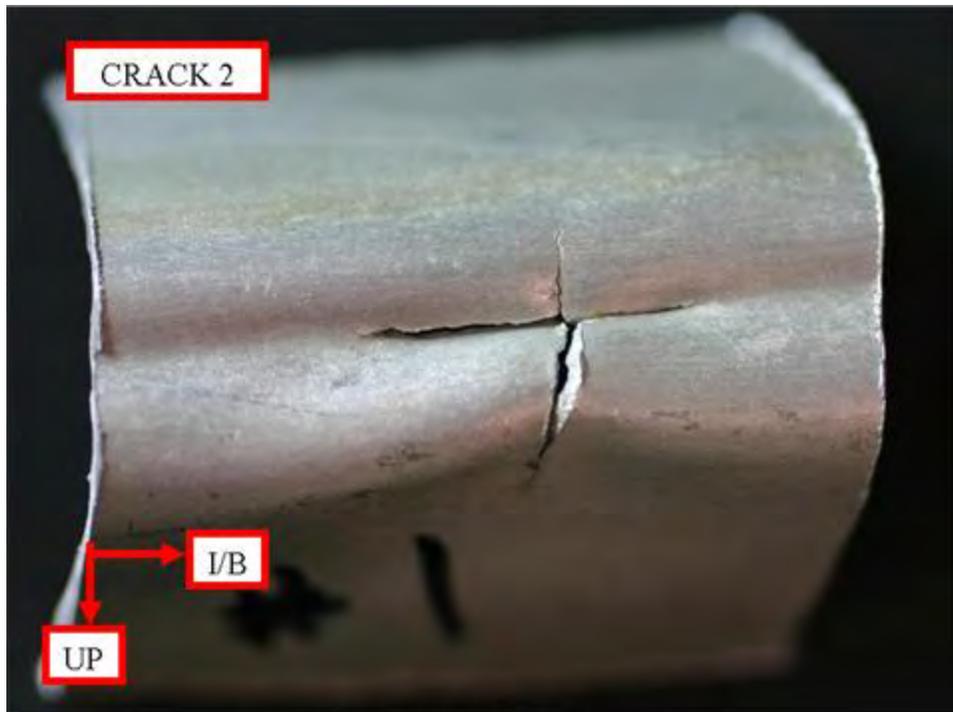
40155-14 CRK 2 BL 92-104.75 Mac

Figure 579. Macroscopic View of Crack 2 on the Left Horizontal Stabilizer Leading-Edge Skin BL 96

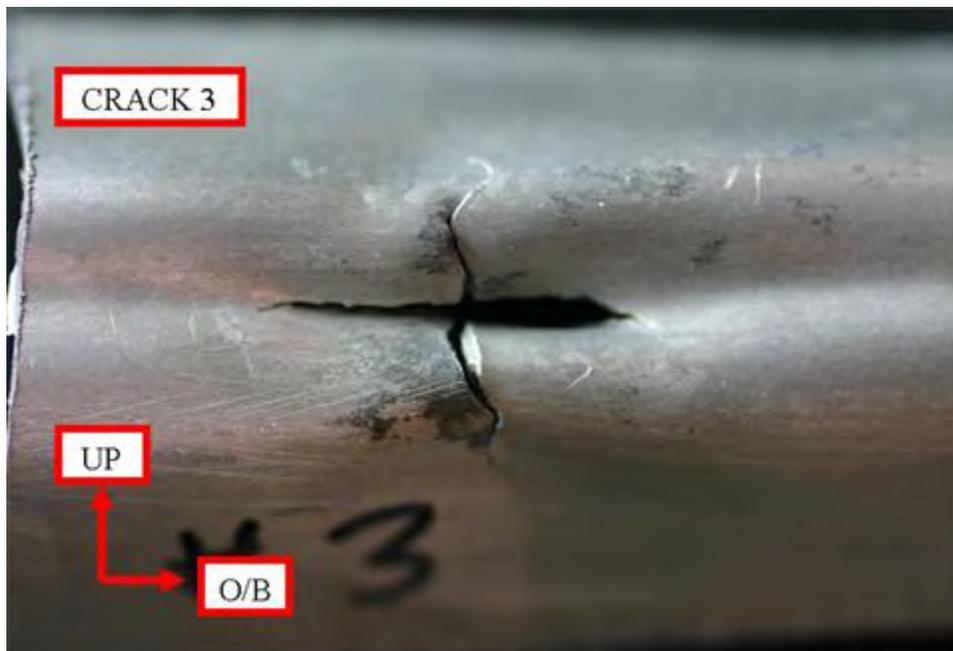
40155-14 CRK 3 BL 92-104.75 Mac

Figure 580. Macroscopic View of Crack 3 on the Left Horizontal Stabilizer Leading-Edge Skin BL 100

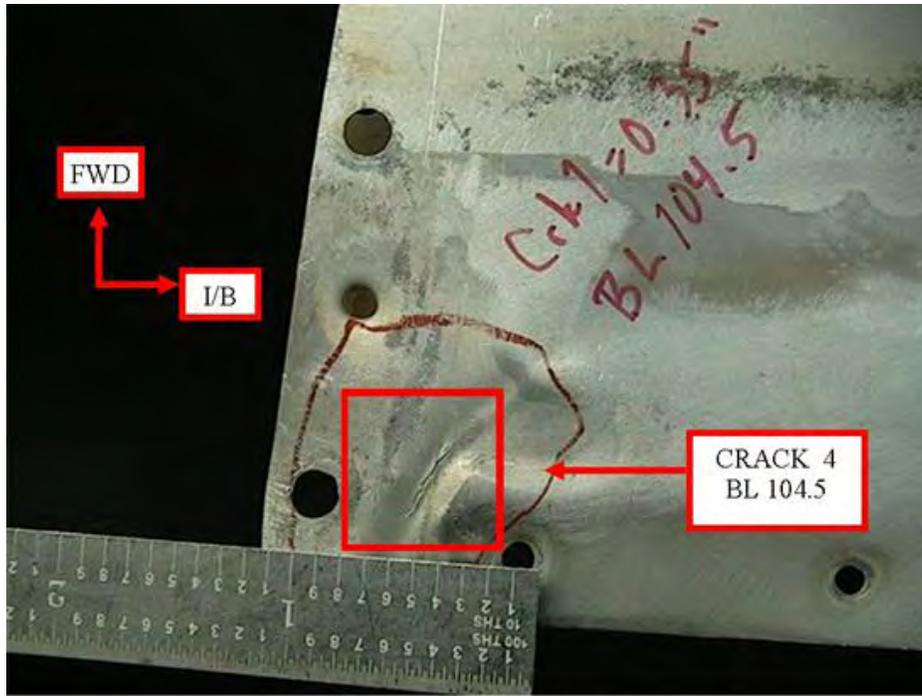
Figure 581. Macroscopic View of Crack 4 on the Left Horizontal Stabilizer Leading-Edge Skin BL 104.75
