DOT/FAA/AR-07/64

Teardown Evaluation of a 1975 Piper Navajo Chieftain Model PA31-350 Airplane

March 2008

Final Report

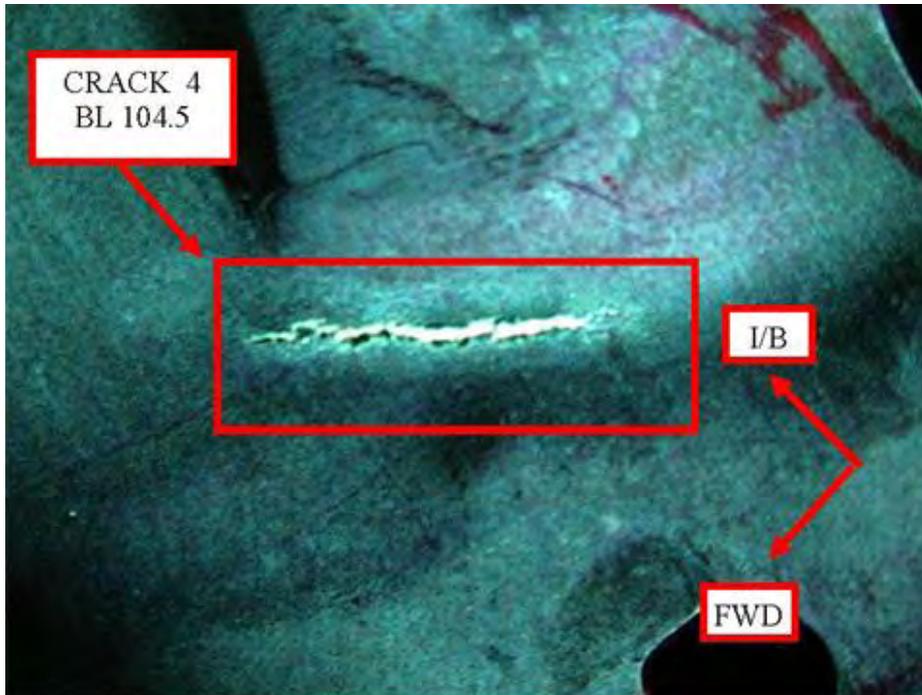
Figure 582. Fluorescent Liquid Penetrant Indication of Crack 4 on the Left Horizontal Stabilizer Leading-Edge Skin BL 104.5

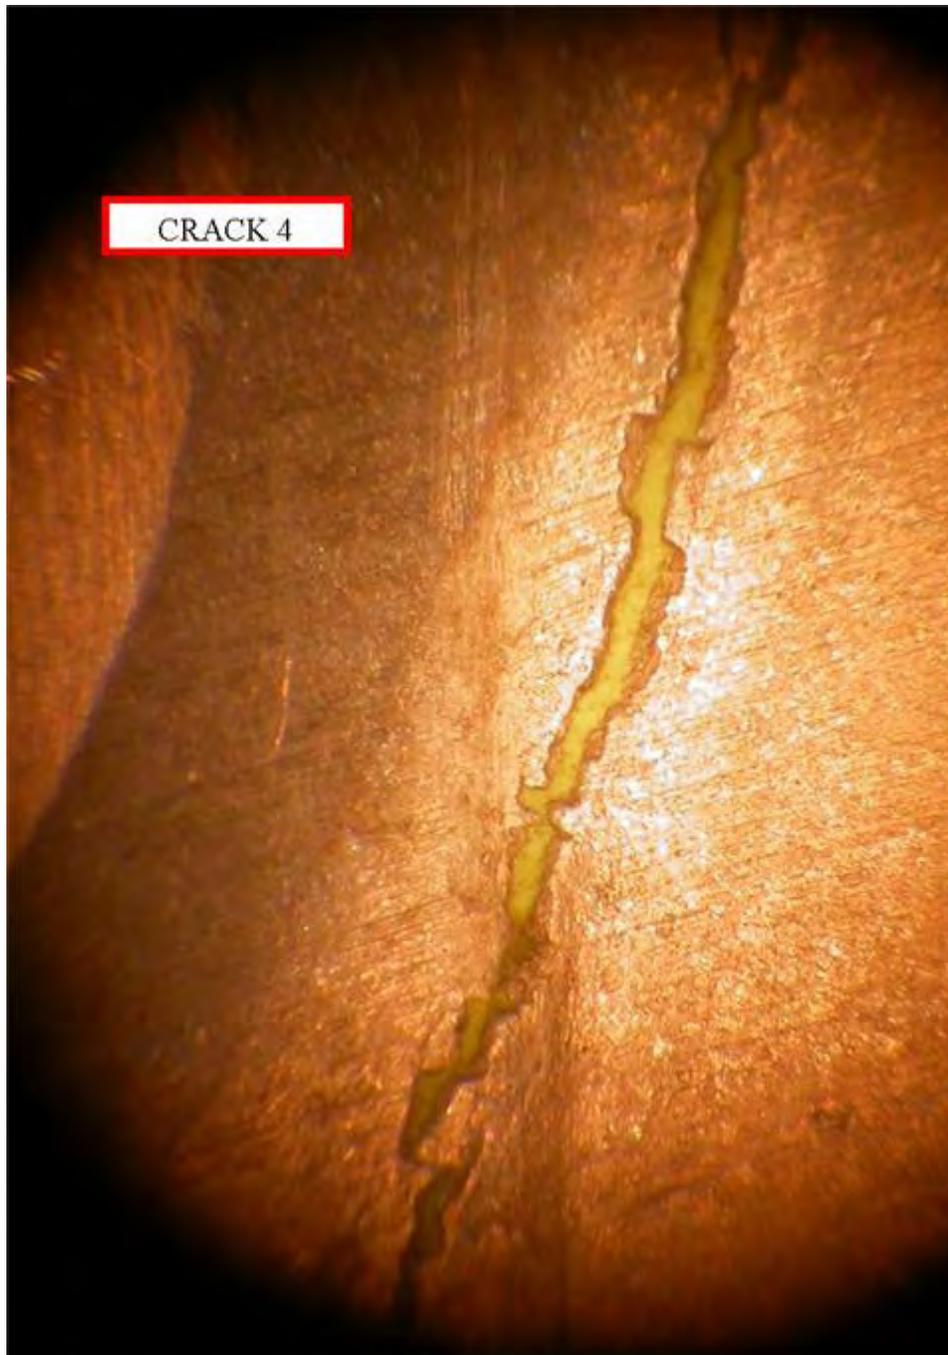
40155-14 CRK 4 BL 92-104.75 Mic

Figure 577 shows the location of four cracks on the left horizontal stabilizer leading-edge skin, part number 40155-14. Figure 578 shows a macroscopic view of crack 1, which measured 0.599 inch and was located at BL 94. A macroscopic view of crack 2, which measured 0.524 inch and was located at BL 96, is shown in figure 579. Figure 580 shows a macroscopic view of crack 3, which measured 0.549 inch and was located at BL 100. Cracks 1 through 3 were caused by a puncture to the leading-edge skin. Crack 4, which is shown macroscopically in figure 581, was located at BL 104.75 and measured 0.313 inch in length. The fluorescent liquid penetrant indication is shown in figure 582. A macroscopic view of crack 4 is shown in figure 583.

Figure 583. Microscopic View of Crack 4 on the Left Horizontal Stabilizer Leading-Edge Skin at BL 104.5

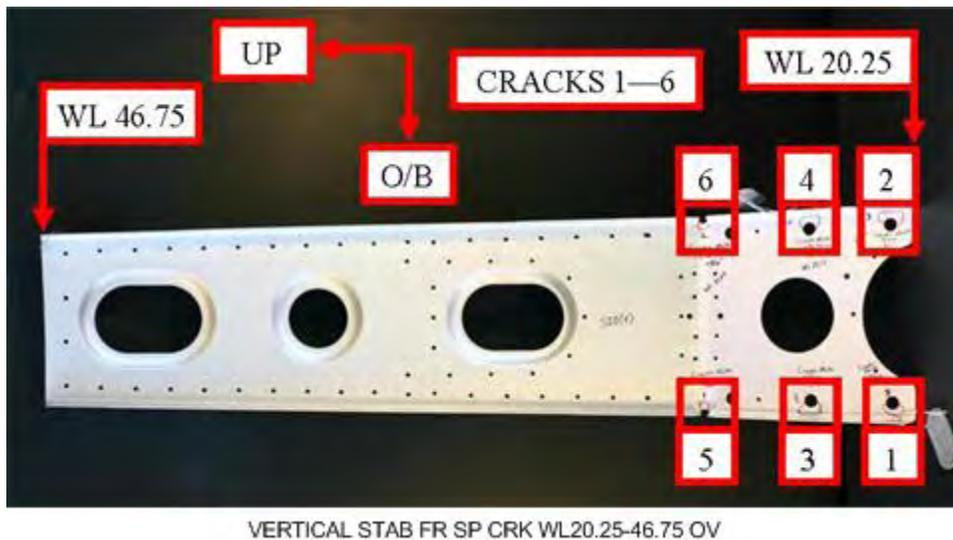
Figure 585 shows the location of six areas of cracking on the vertical stabilizer front spar from WL 20.25 to WL 46.75. A macroscopic view of crack 1, which measured 0.70 inch and was located at WL 21, is shown in figure 586, and a microscopic view of this cracks is shown in figure 587. Crack 2 located at WL 21, which measured 0.810 inch, is shown macroscopically in figure 588 and microscopically in figure 589. A macroscopic view of crack 3, which measured 0.373 inch and was located on the front spar at WL 23.75, is shown in figure 590. A microscopic view of this crack is shown in figure 591. Crack 4, which is located at WL 23.75 on the front spar, measured 0.340 inch and is shown macroscopically in figure 592. A microscopic view of crack 4 is shown in figure 593.

Figure 585. Location of Six Cracks on the Vertical Stabilizer Front Spar WL 20.25 Through WL 46.75

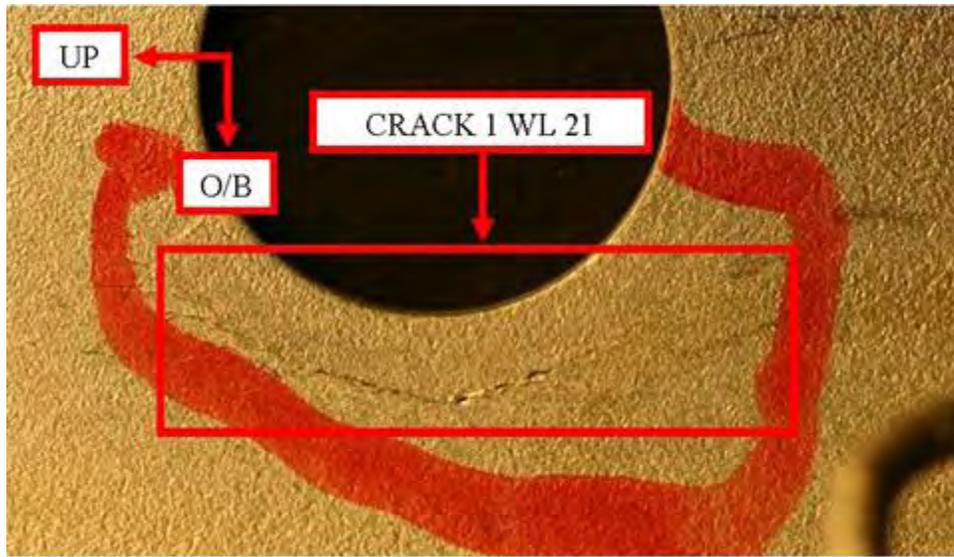
VERTICAL STAB FR SP WL21 CRK1 Mac

Figure 586. Macroscopic View of Crack 1 on the Vertical Stabilizer Front Spar WL 21

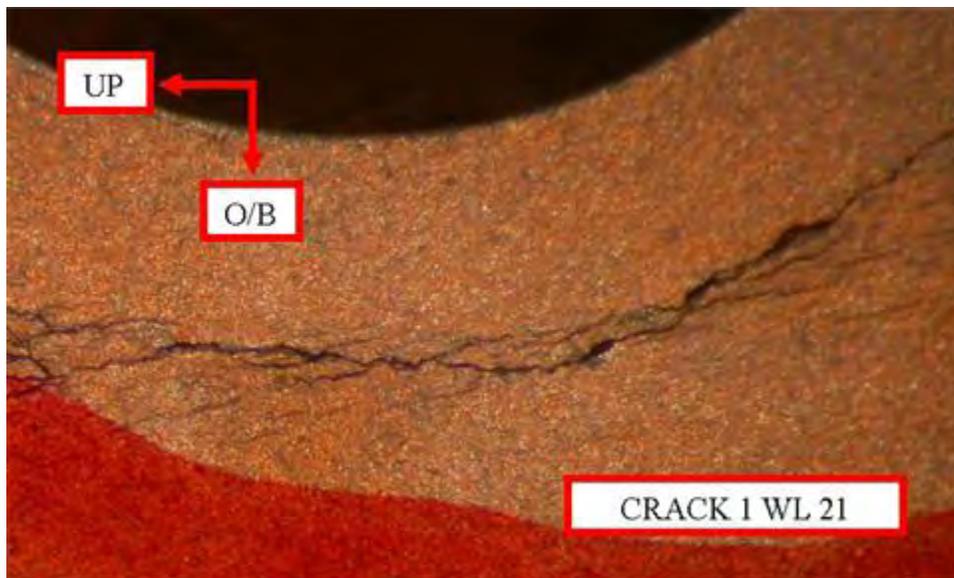
VERTICAL STAB FR SP WL21 CRK1 Mic

Figure 587. Microscopic View of Crack 1 on the Vertical Stabilizer Front Spar WL 21

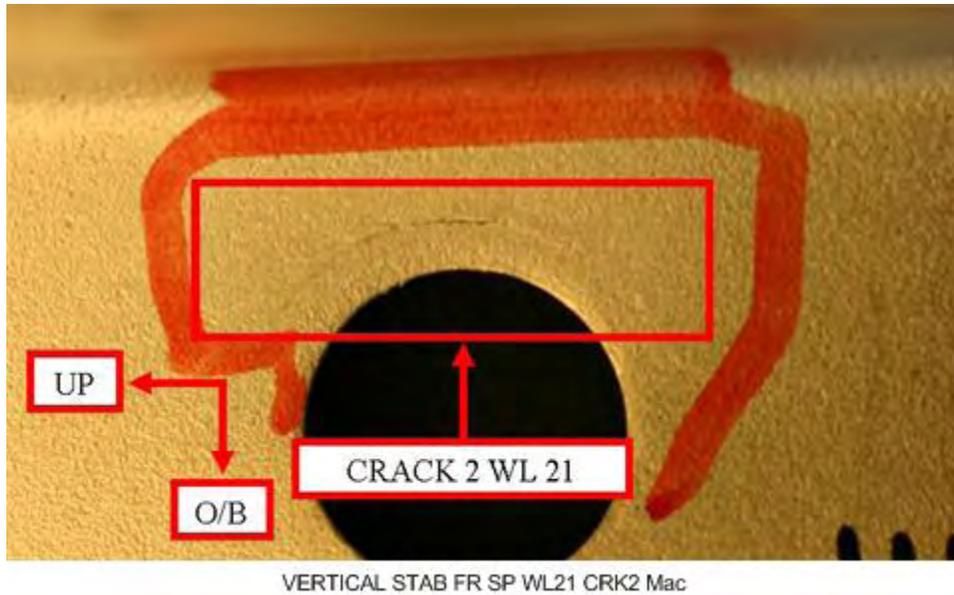
Figure 588. Macroscopic View of Crack 2 on the Vertical Stabilizer Front Spar WL 21

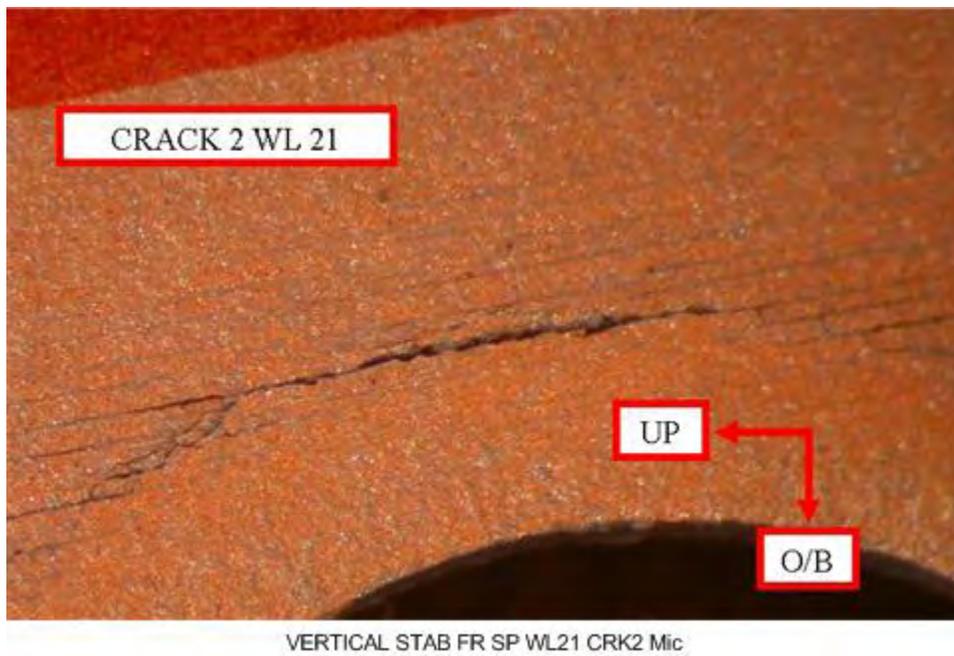
Figure 589. Microscopic View of Crack 2 on the Vertical Stabilizer Front Spar WL 21

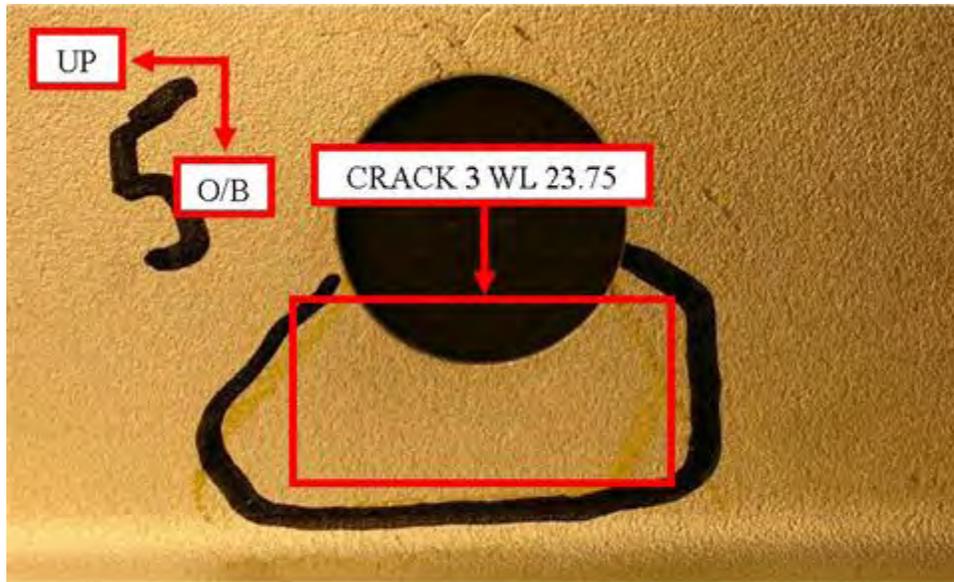
VERTICAL STAB FR SP WL21 CRK3 Mac

Figure 590. Macroscopic View of Crack 3 on the Vertical Stabilizer Front Spar WL 23.75

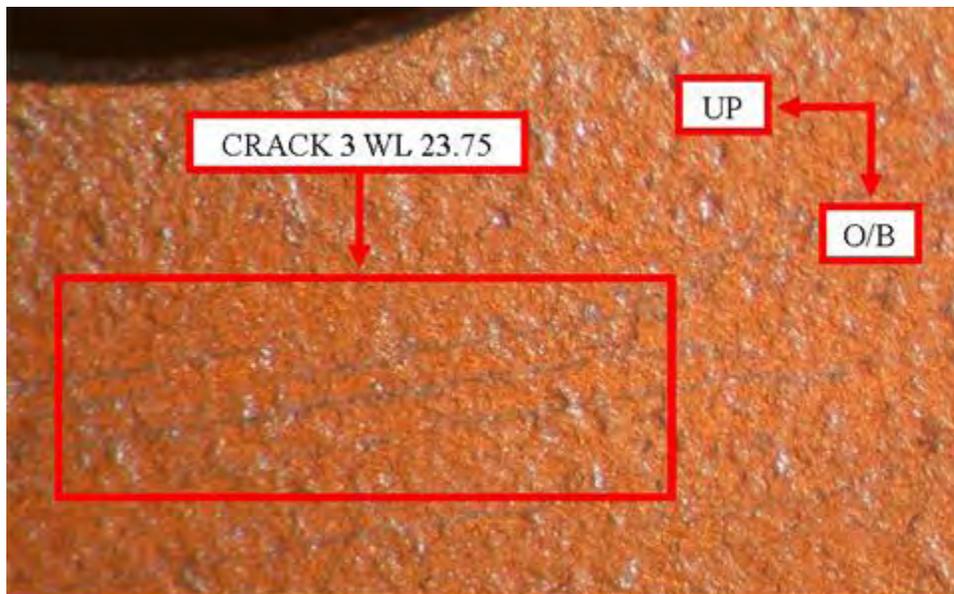
VERTICAL STAB FR SP WL21 CRK3 Mic

Figure 591. Microscopic View of Crack 3 on the Vertical Stabilizer Front Spar WL 23.75

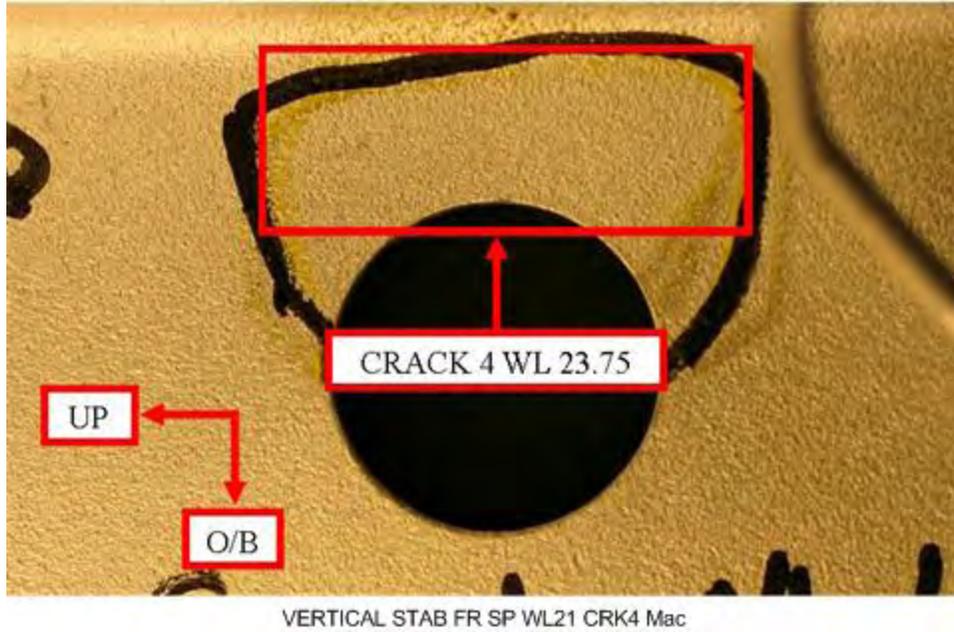
Figure 592. Macroscopic View of Crack 4 on the Vertical Stabilizer Front Spar WL 23.75

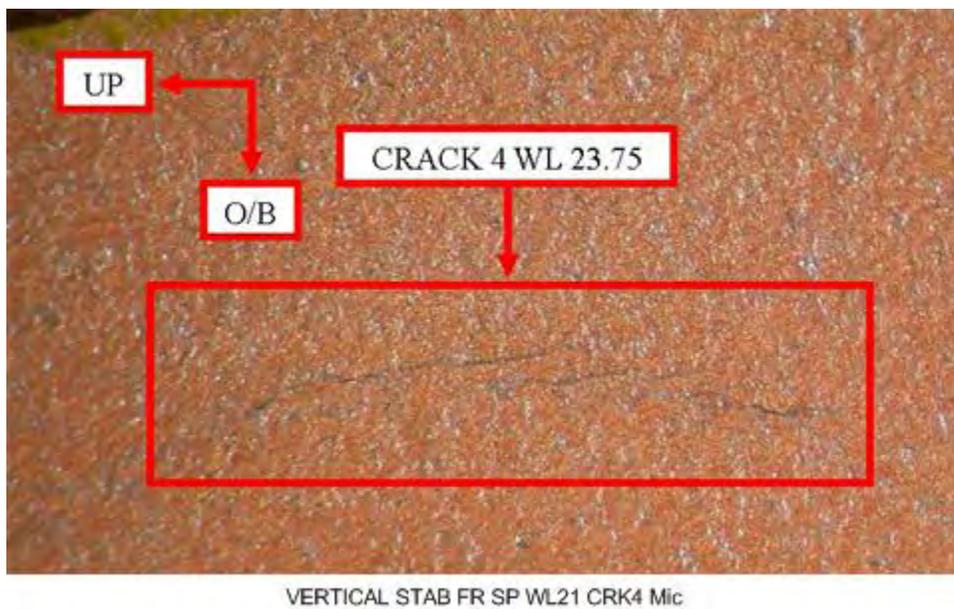
Figure 593. Microscopic View of Crack 4 on the Vertical Stabilizer Front Spar WL 23.75

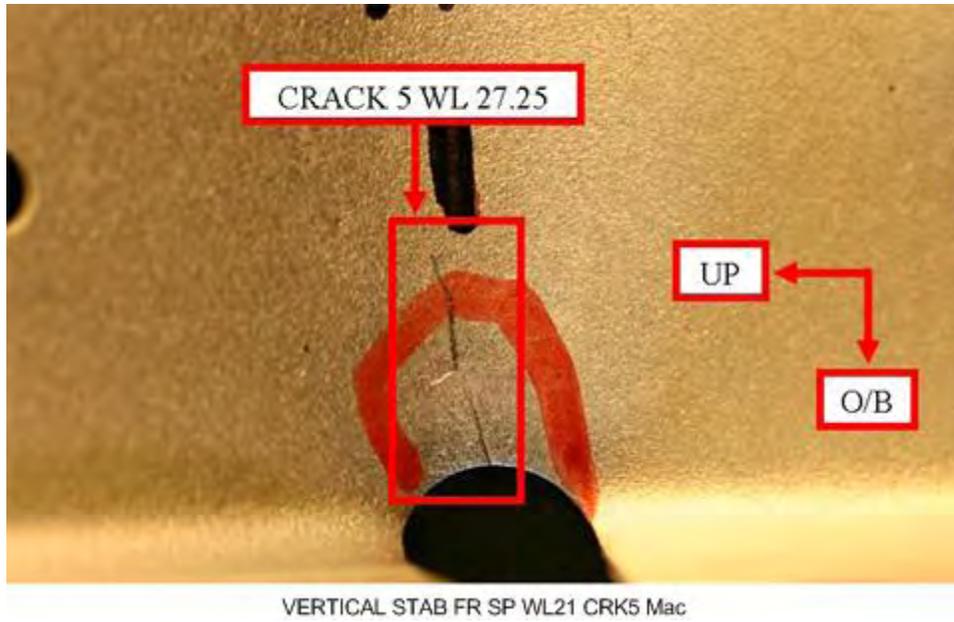
Crack 5, which measured 0.138 inch and was located at WL 27.25 on the vertical stabilizer front spar, is shown macroscopically in figure 594. A microscopic view of crack 5 is shown in figure 595. Figure 596 shows a macroscopic view of crack 6, which was located at FS 27.25. This 0.086-inch crack is also shown microscopically in figure 597.

Figure 594. Macroscopic View of Crack 5 on the Vertical Stabilizer Front Spar WL 27.25

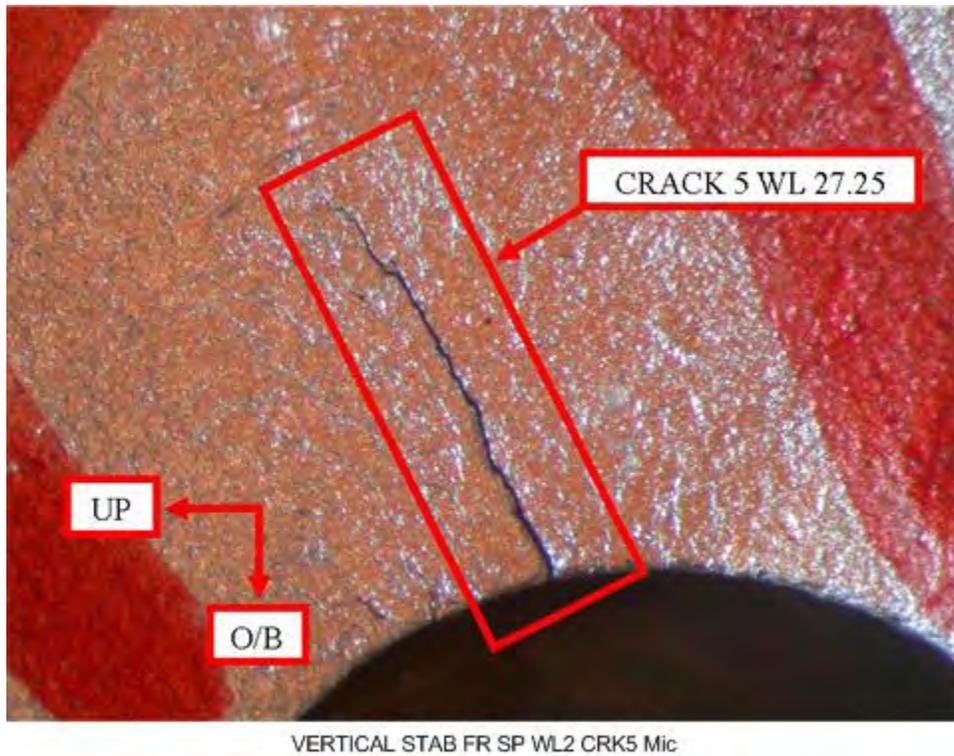
Figure 595. Microscopic View of Crack 5 on the Vertical Stabilizer Front Spar WL 27.25

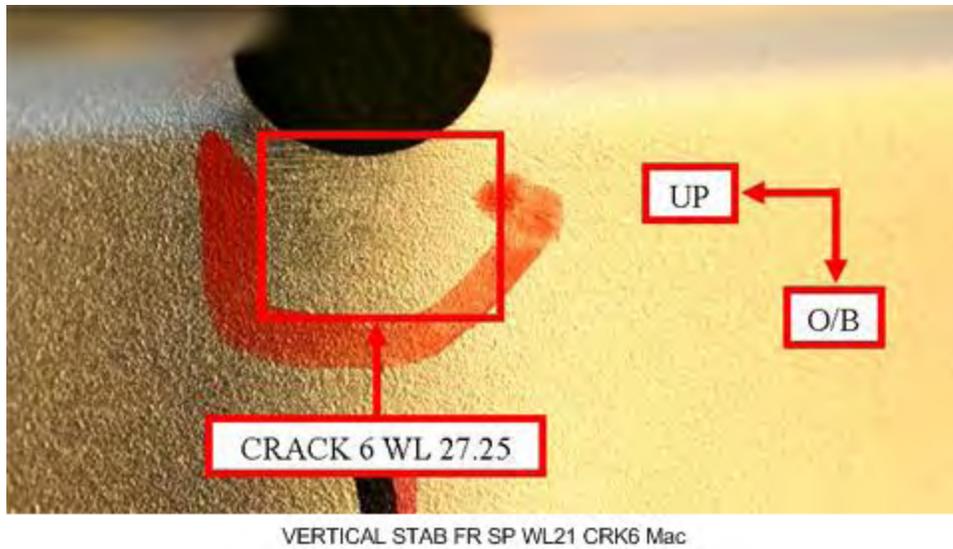
Figure 596. Macroscopic View of Crack 6 on the Vertical Stabilizer Front Spar WL 27.25

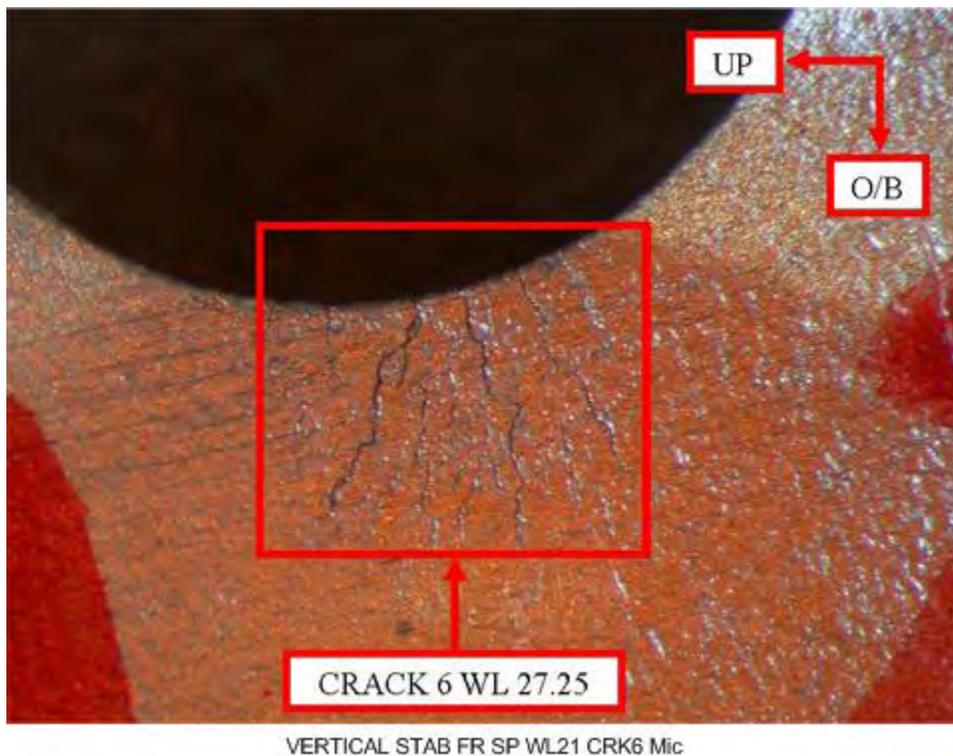
Figure 597. Microscopic View of Crack 6 on the Vertical Stabilizer Front Spar WL 27.25

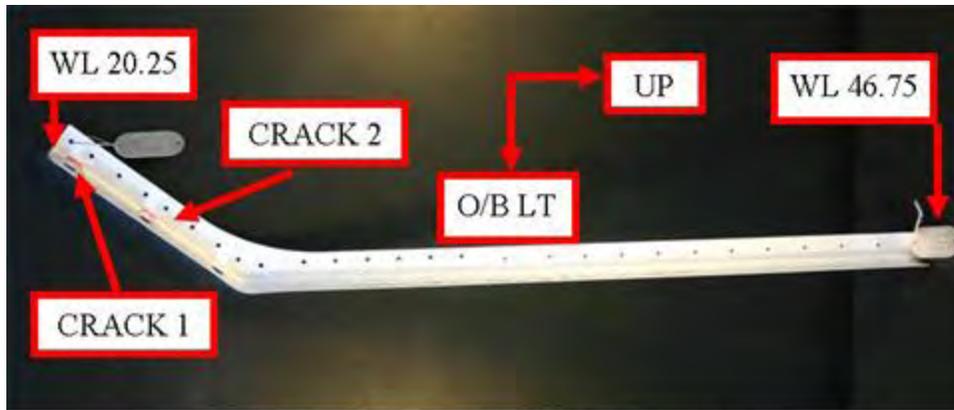
VERTICAL STAB FR SP LEFT ANGLE #1 WL20.25 OV

The location of two cracks on the vertical stabilizer front spar left angle is shown in figure 598. Crack 1, which is shown macroscopically in figure 599, was located at WL 20.5 and measured 0.692 inch. A microscopic view of this crack is shown in figure 600. Figure 601 shows a macroscopic view of crack 2, which measured 0.35 inch and was located at WL 23 on the front spar left angle. This crack is shown microscopically in figure 602.

Figure 598. Location of Two Cracks on the Vertical Stabilizer Front Spar Left Angle WL 20.25 Through WL 46.75

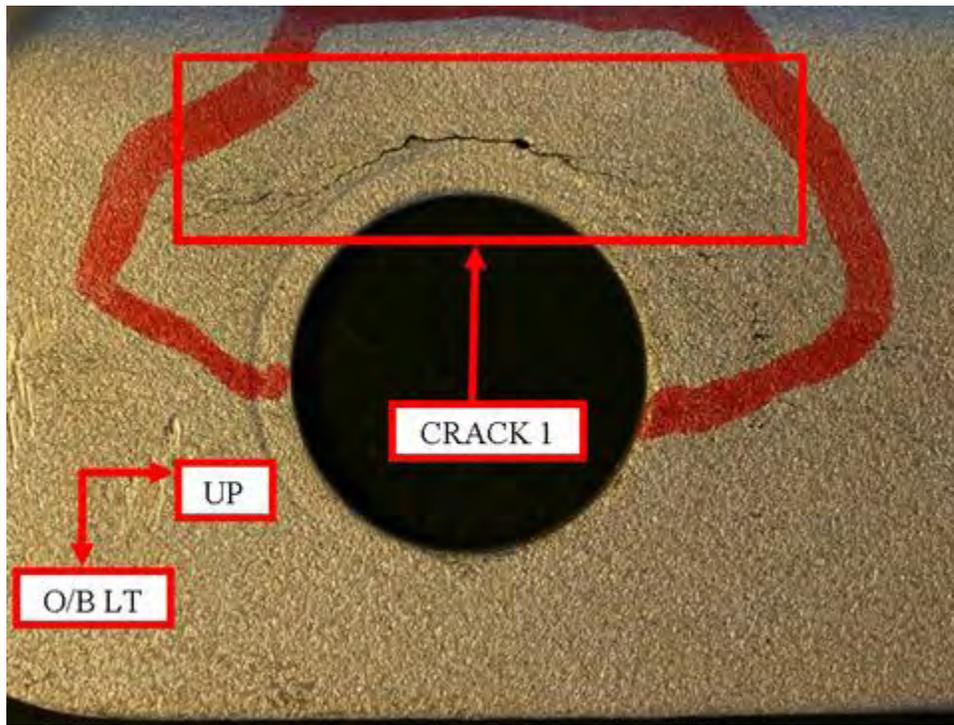
VERTICAL STAB FR SP LT ANGLE #1 WL20.25 CRK1 Mac

Figure 599. Macroscopic View of Crack 1 on the Vertical Stabilizer Front Spar Left Angle WL 20.25

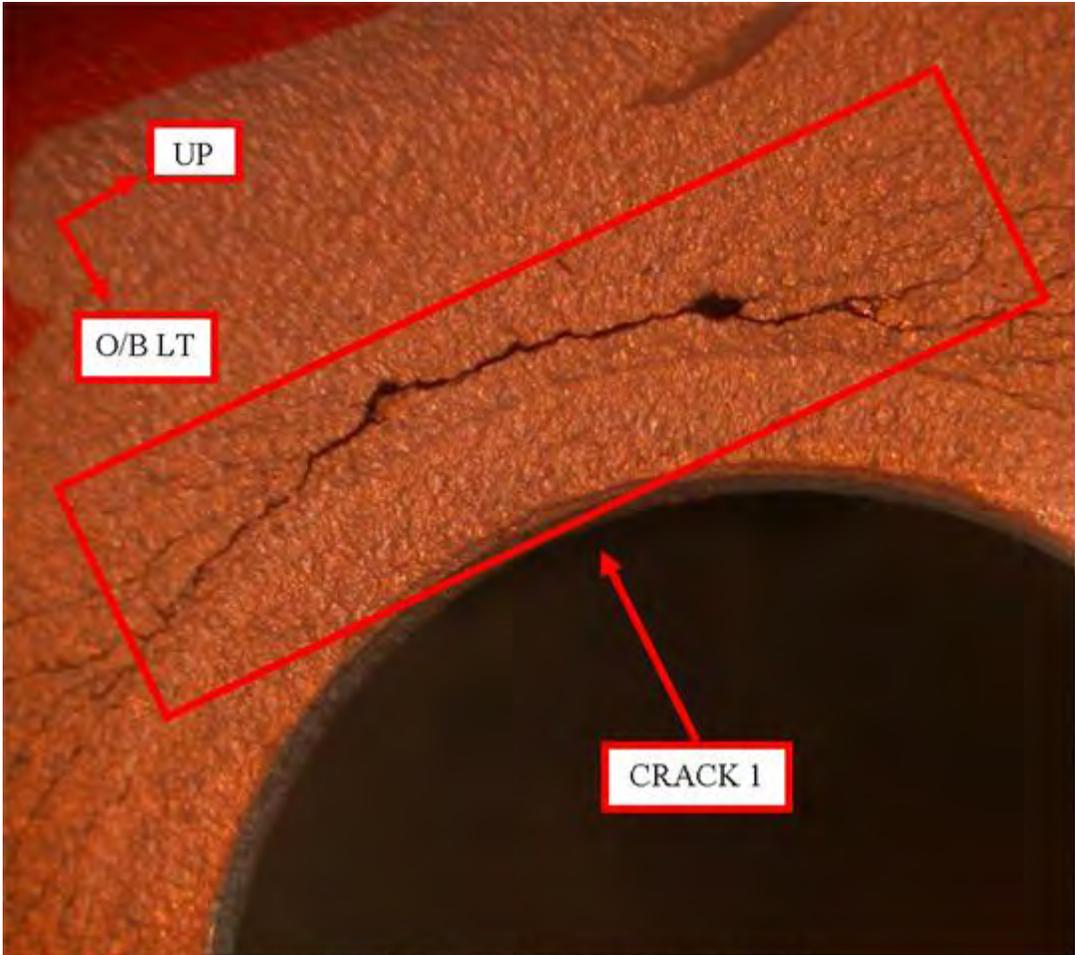
VERTICAL STAB FR SPAR LT ANGLE #1 WL20.25 CRK1 Mic

Figure 600. Microscopic View of Crack 1 on the Vertical Stabilizer Front Spar Left Angle WL 20.25

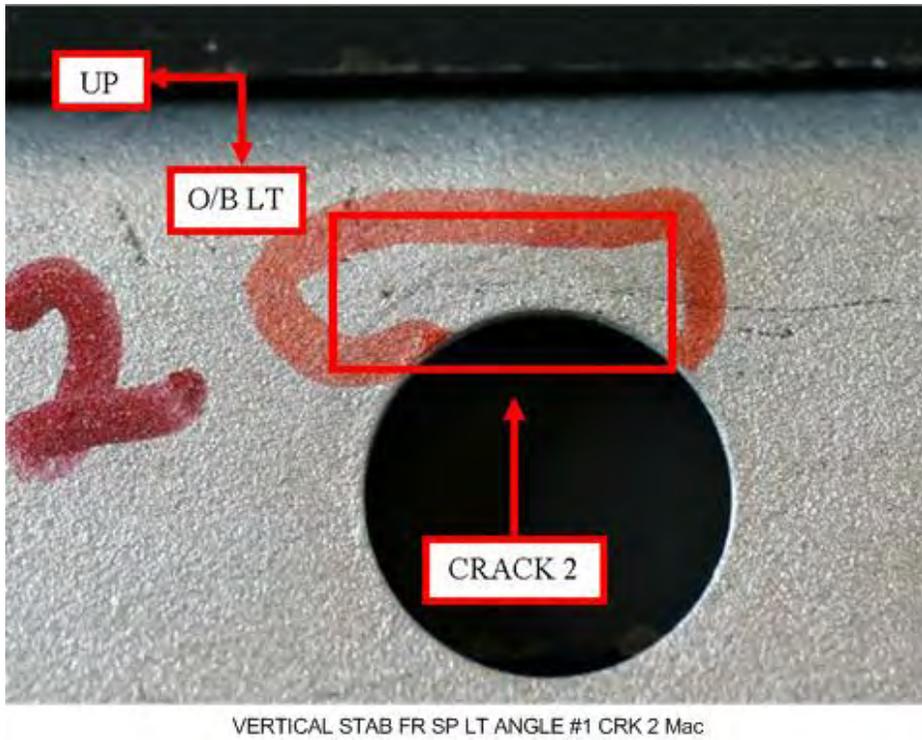
Figure 601. Macroscopic View of Crack 2 on the Vertical Stabilizer Front Spar Left Angle WL 23

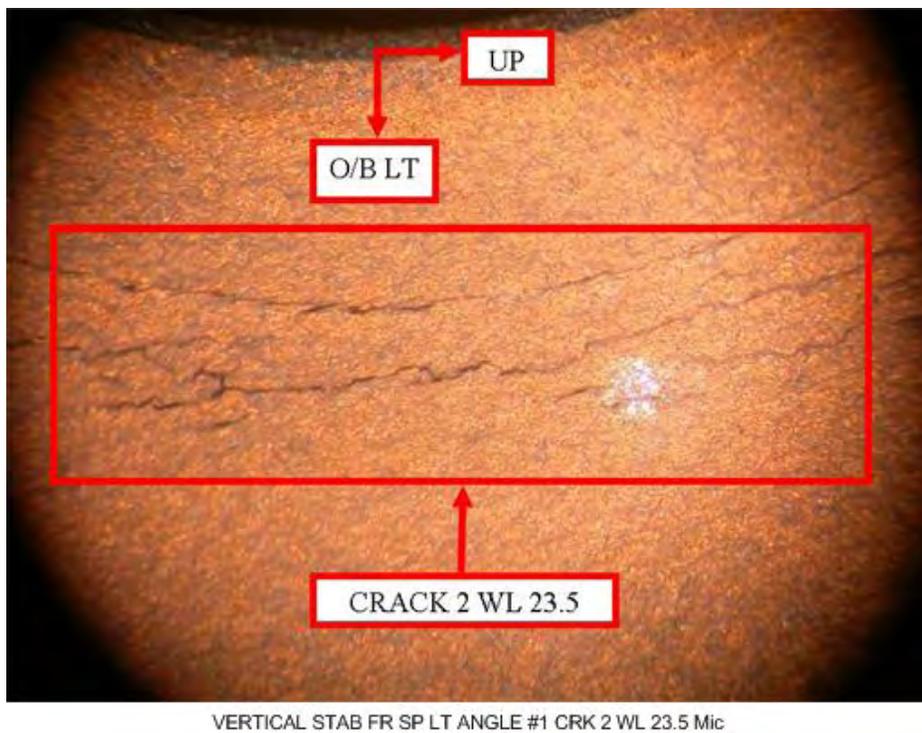
Figure 602. Microscopic View of Crack 2 on the Vertical Stabilizer Front Spar Left Angle WL 23.5

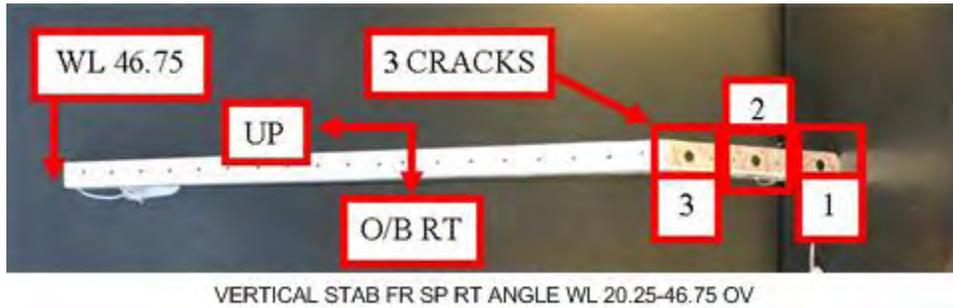
Figure 603 shows the location of three cracks on the vertical stabilizer front spar right angle. Crack 1, which measured 0.602 inch and was located at WL 20.25, is shown macroscopically in figure 604 and microscopically in figure 605. Figure 606 shows a macroscopic view of crack 2 at WL 23.5, and a microscopic view of this 0.414-inch crack is shown in figure 607. A macroscopic view of crack 3, which measured 0.40 inch and was located at WL 26.5, is shown in figure 608. Figure 609 shows a microscopic view of this crack.

Figure 603. Location of Three Cracks on the Vertical Stabilizer Front Spar Right Angle WL 20.25 Through WL 46.75

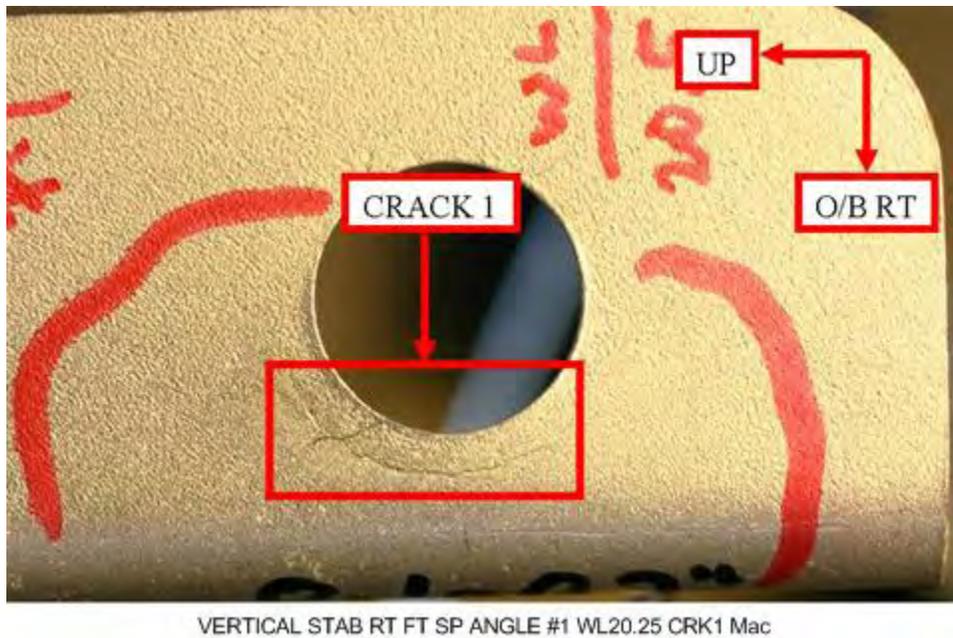
Figure 604. Macroscopic View of Crack 1 on the Vertical Stabilizer Front Spar Right Angle WL 20.25

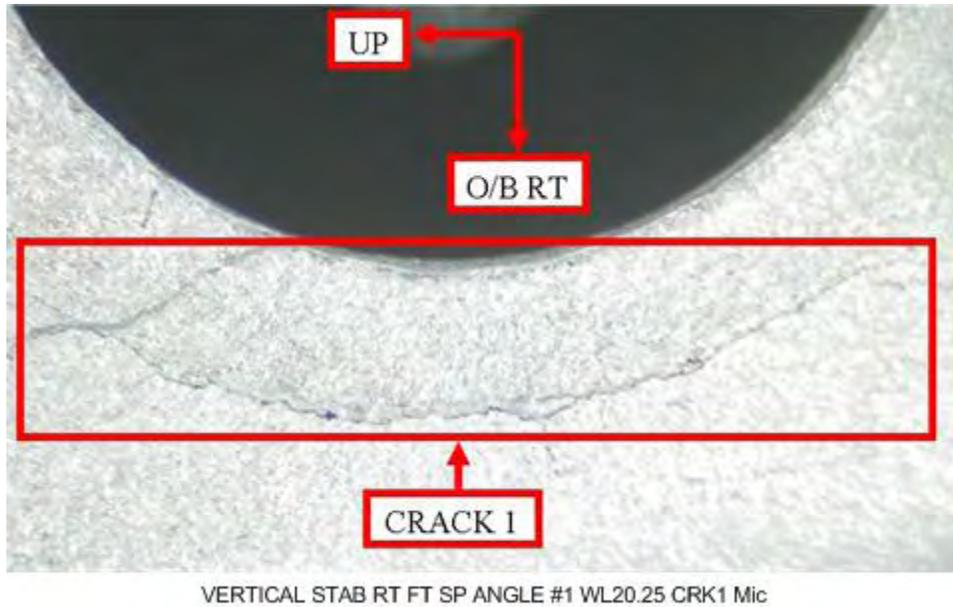
Figure 605. Microscopic View of Crack 1 on the Vertical Stabilizer Front Spar Right Angle WL 20.25

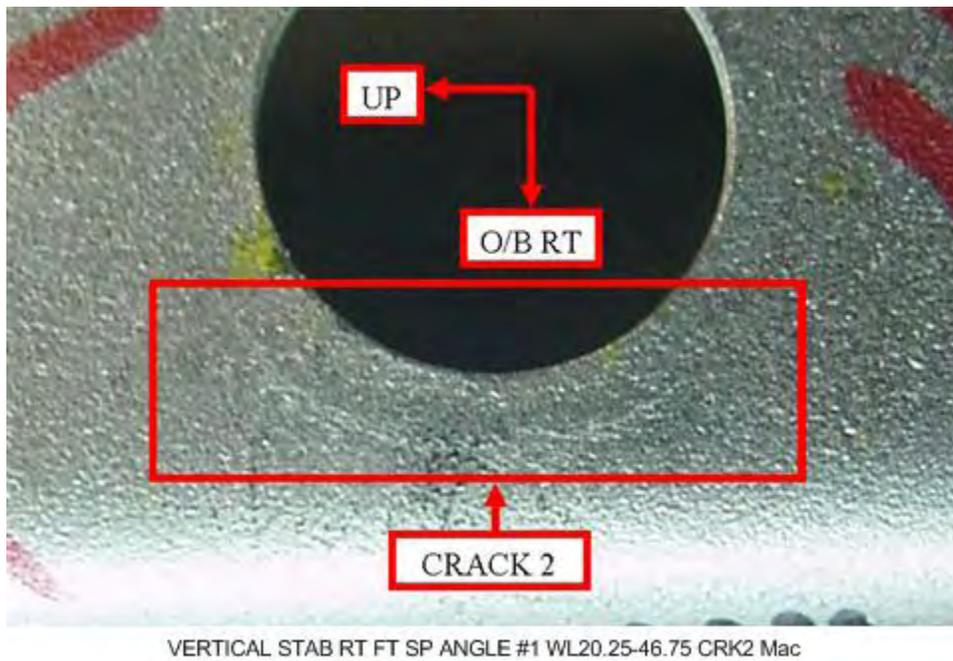
Figure 606. Macroscopic View of Crack 2 on the Vertical Stabilizer Front Spar Right Angle WL 23.5

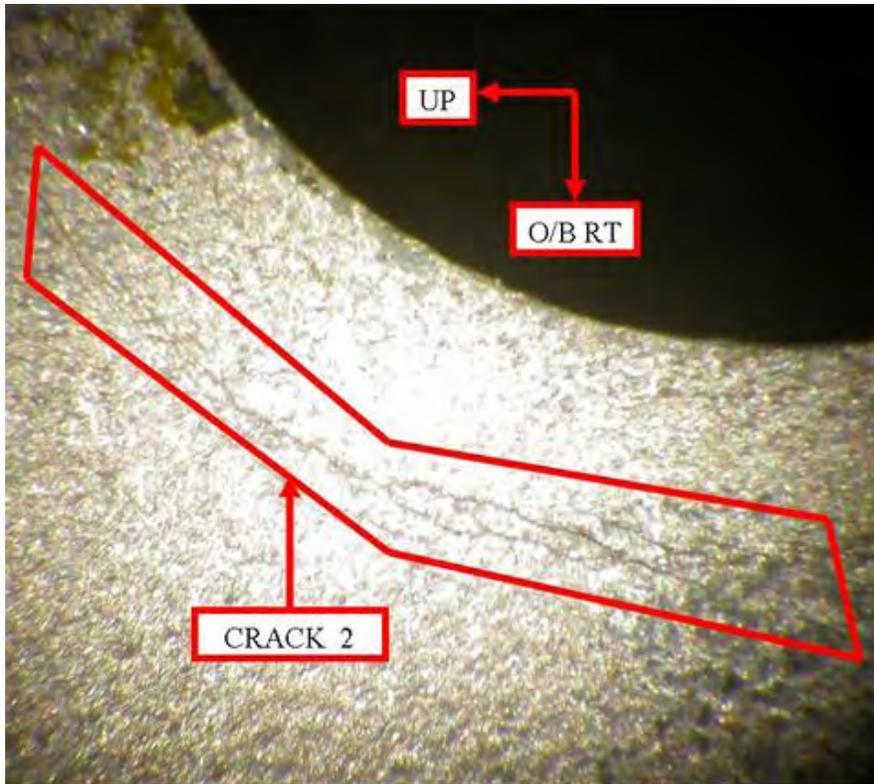
VERTICAL STAB RT FR SP ANGLE #1 WL20.25-46.75 CRK2 Mic

Figure 607. Microscopic View of Crack 2 on the Vertical Stabilizer Front Spar Right Angle WL 23.5

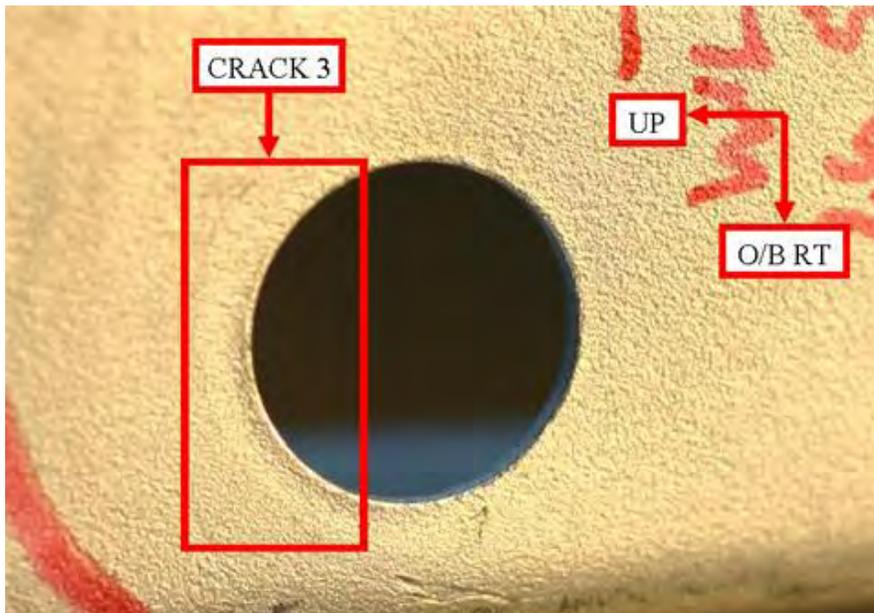
VERTICAL STAB RT FR SP ANGLE #1 WL20.25-46.75 CRk3 Mac

Figure 608. Macroscopic View of Crack 3 on the Vertical Stabilizer Front Spar Right Angle WL 26.5

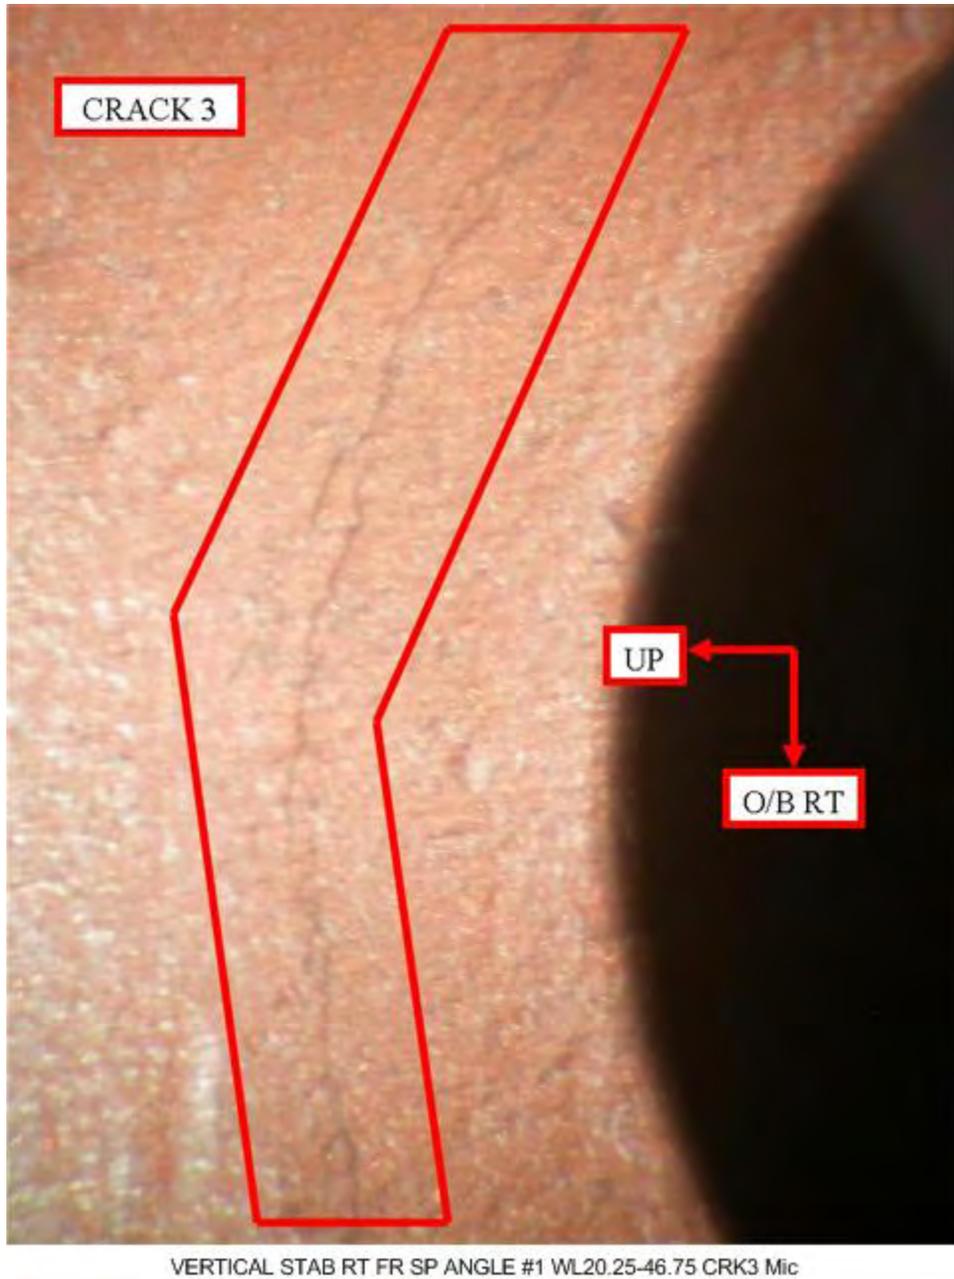
VERTICAL STAB RT FR SP ANGLE #1 WL20.25-46.75 CRK3 Mic

Figure 609. Microscopic View of Crack 3 on the Vertical Stabilizer Front Spar Right Angle WL 26.5

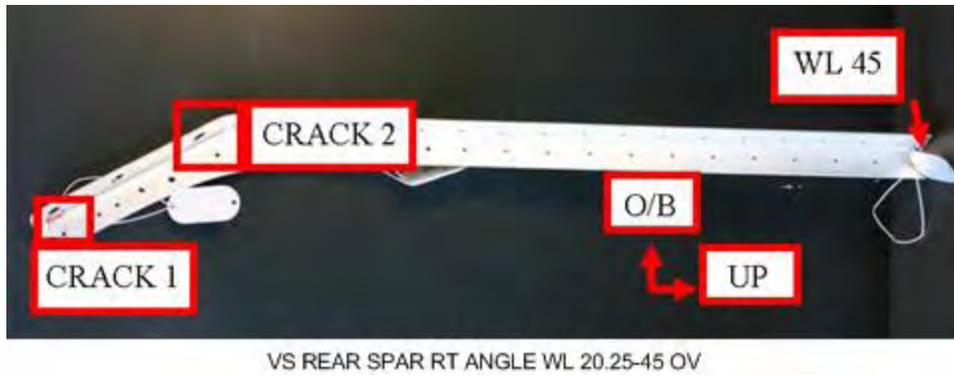
The location of two cracks on the vertical stabilizer rear spar right angle is shown in figure 611. A macroscopic view of multiple cracks grouped together and identified as crack 1 is shown in figure 612. The maximum length of this group of 5% through-the-thickness cracks is 0.335 inch. A microscopic view of crack 1, which is located on the rear spar right angle at WL 20.25, is shown in figure 613. Another cluster of 5% through-the-thickness cracks, crack 2, were identified at WL 24.75 and had a length of 0.497 inch. A macroscopic view of crack 2 is shown in figure 614, and a microscopic view is shown in figure 615.

Figure 611. Location Two Cracks on the Vertical Stabilizer Rear Spar Right Angle WL 20.25 Through WL 45

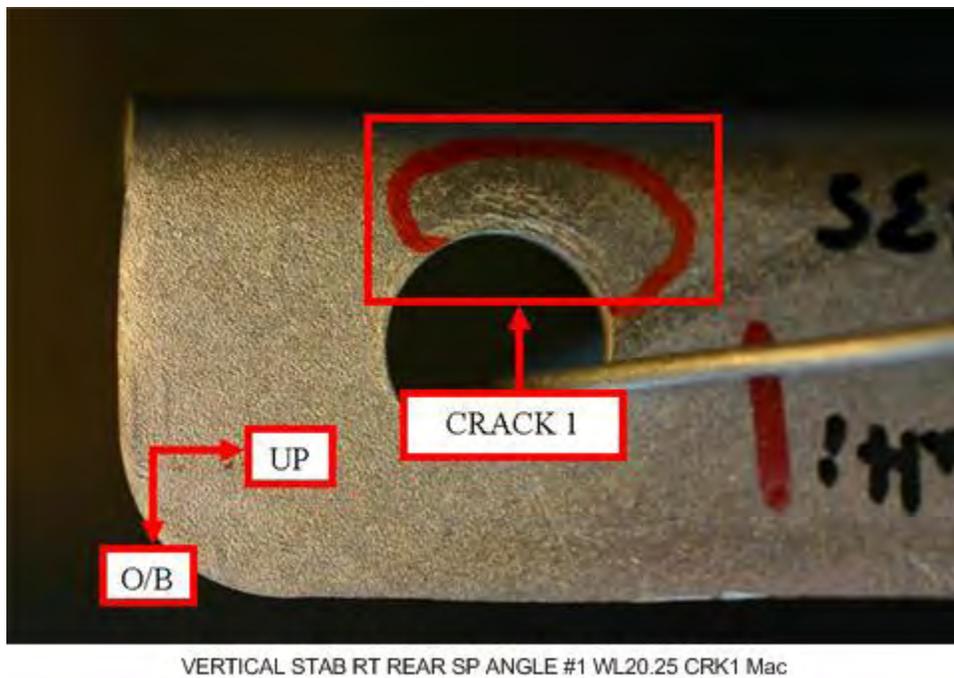
Figure 612. Macroscopic View of Crack 1 on the Vertical Stabilizer Rear Spar Right Angle WL 20.25

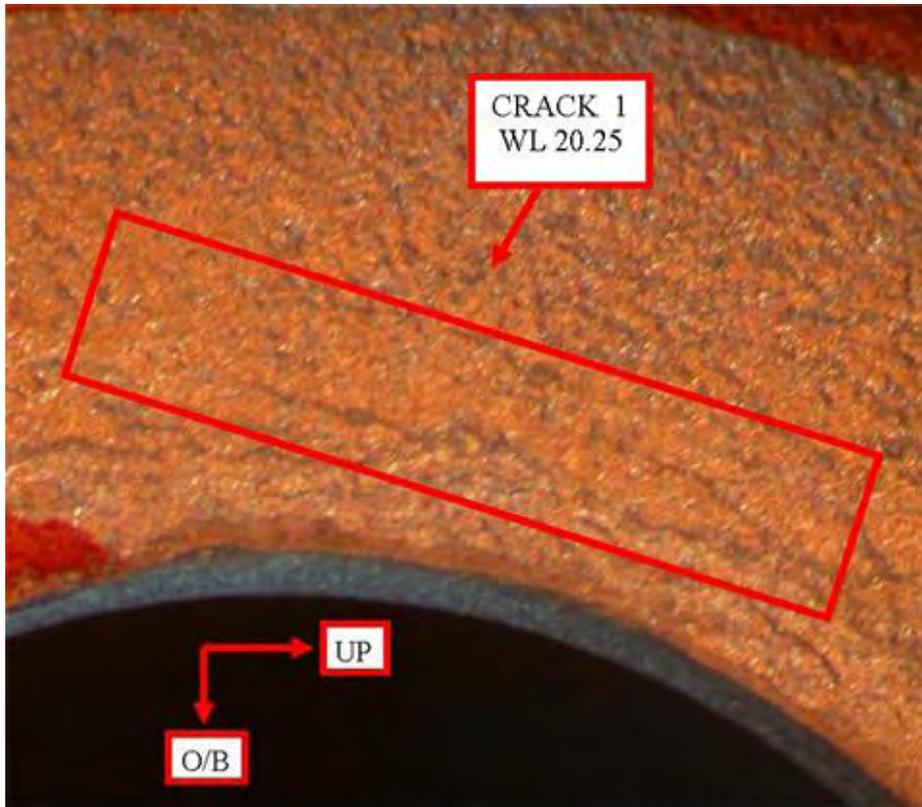
VERTICAL STAB RT REAR SP ANGLE CRK1 WL 20.25 MIC

Figure 613. Microscopic View of Crack 1 on the Vertical Stabilizer Rear Spar Right Angle WL 20.25

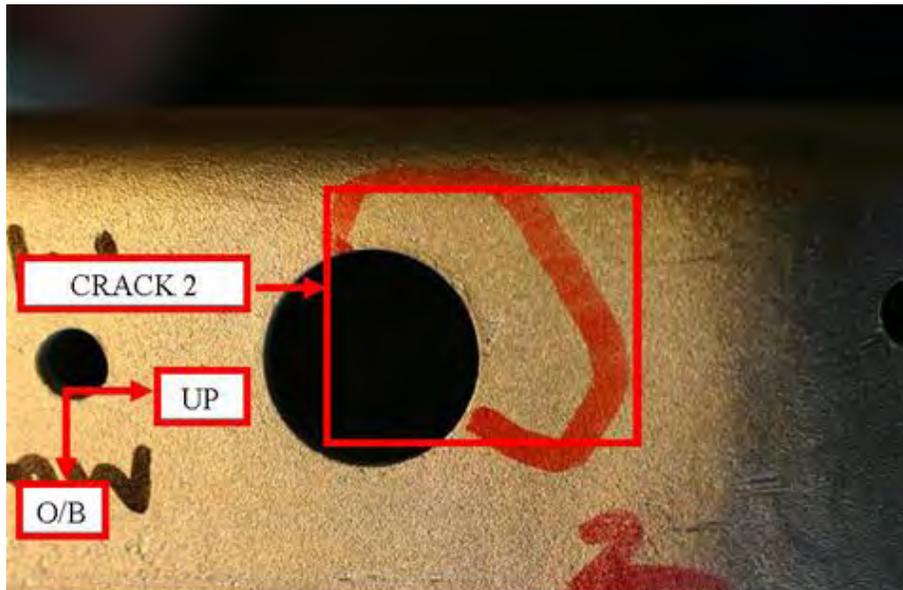
VERTICAL STAB RT REAR SP ANGLE #1 WL24.75 CRK2 Mac

Figure 614. Macroscopic View of Crack 2 on the Vertical Stabilizer Rear Spar Right Angle WL 24.75

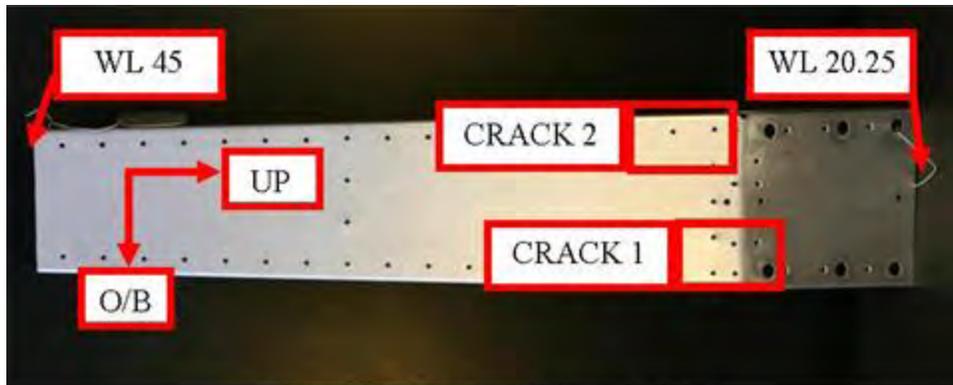
VERTICAL STAB REAR SPAR WL 20.25-45 OV

Figure 616 shows the location of two cracks on the vertical stabilizer rear spar at WL 26. Crack 1, which is shown macroscopically in figure 617, measured 0.102 inch. The fluorescent penetrant indication for crack 1 is shown in figure 618. A microscopic view of this crack is shown in figure 619. A macroscopic view of crack 2 is shown in figure 620. The fluorescent liquid penetrant indication for this 0.203-inch crack is shown in figure 621. A microscopic view is shown in figure 622.

Figure 616. Location of Two Cracks on the Vertical Stabilizer Rear Spar WL 20.25 Through WL 45

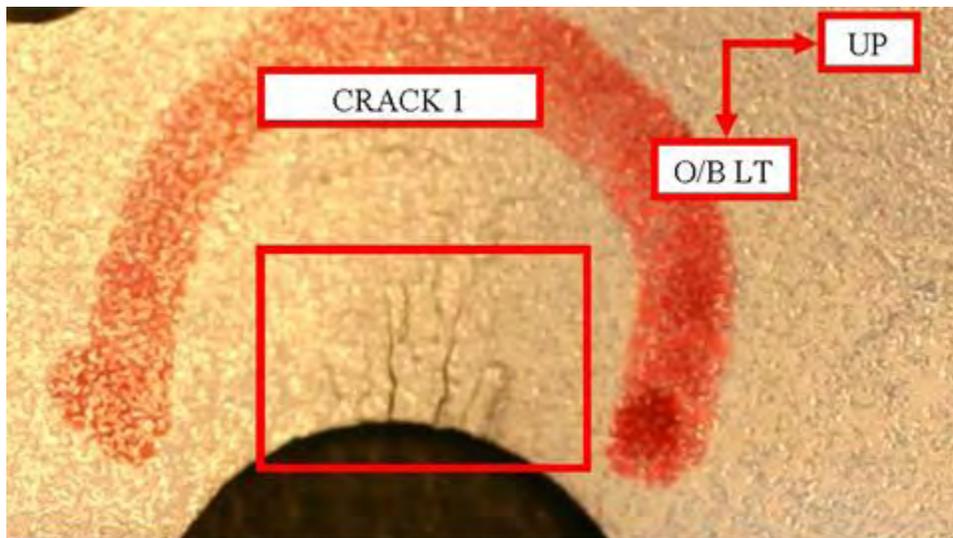
VERTICAL STAB REAR SP WL26 CRK1 Mac

Figure 617. Macroscopic View of Crack 1 on the Vertical Stabilizer Rear Spar WL 26
