DOT/FAA/AR-07/64

Teardown Evaluation of a 1975 Piper Navajo Chieftain Model PA31-350 Airplane

March 2008

Final Report

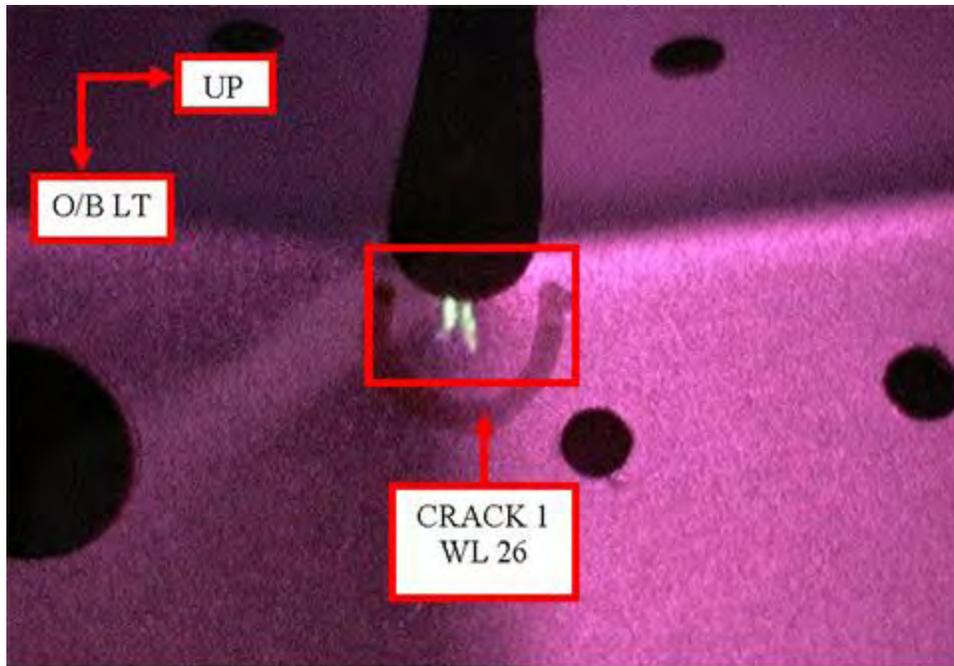
VERTICAL STAB REAR SP WL26 CRK 1 FLP

Figure 618. Fluorescent Liquid Penetrant Indication of Crack 1 on the Vertical Stabilizer Rear Spar WL 26

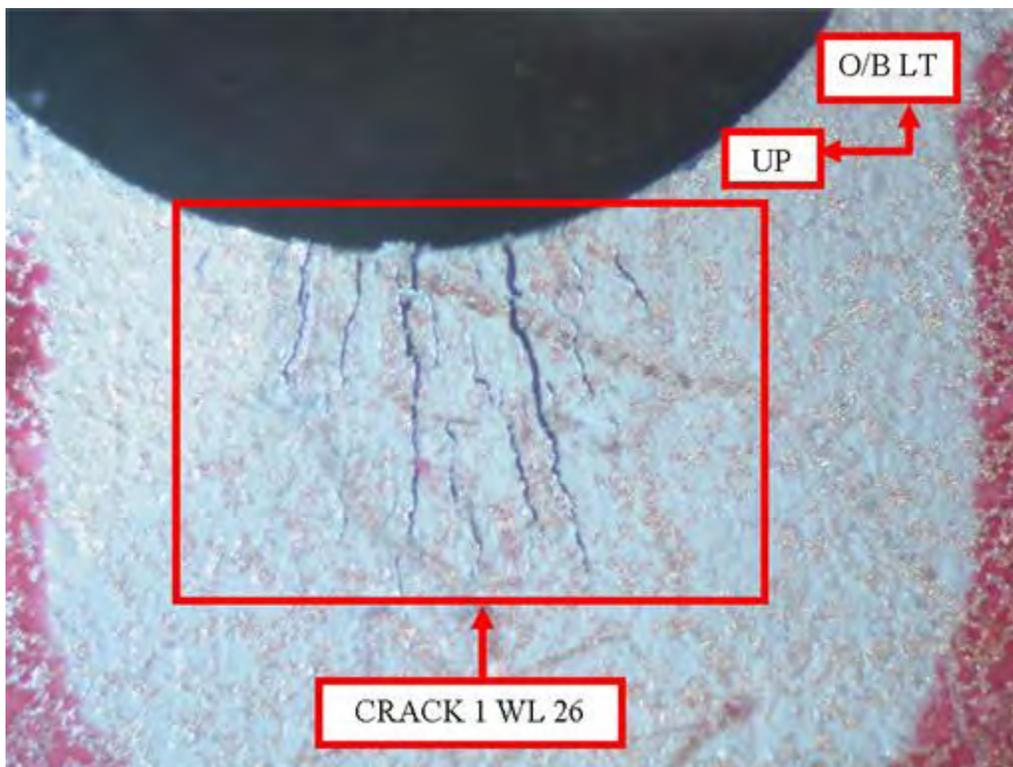
VERTICAL STAB REAR SP WL 26 CRK 1 MIC

Figure 619. Microscopic View of Crack 1 on the Vertical Stabilizer Rear Spar WL 26

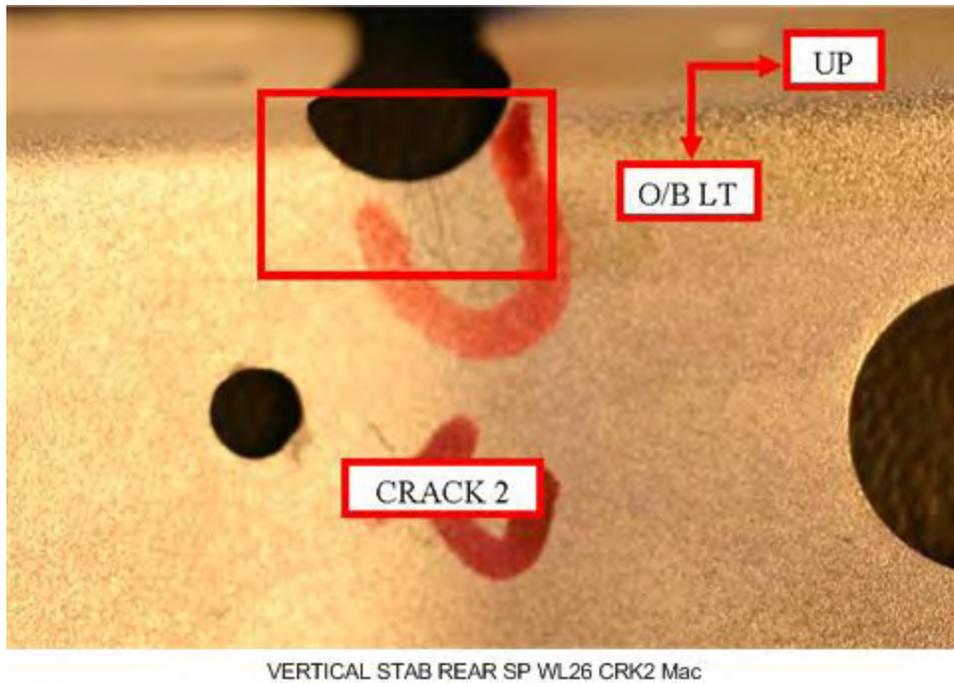
Figure 620. Macroscopic View of Crack 2 on the Vertical Stabilizer Rear Spar WL 26

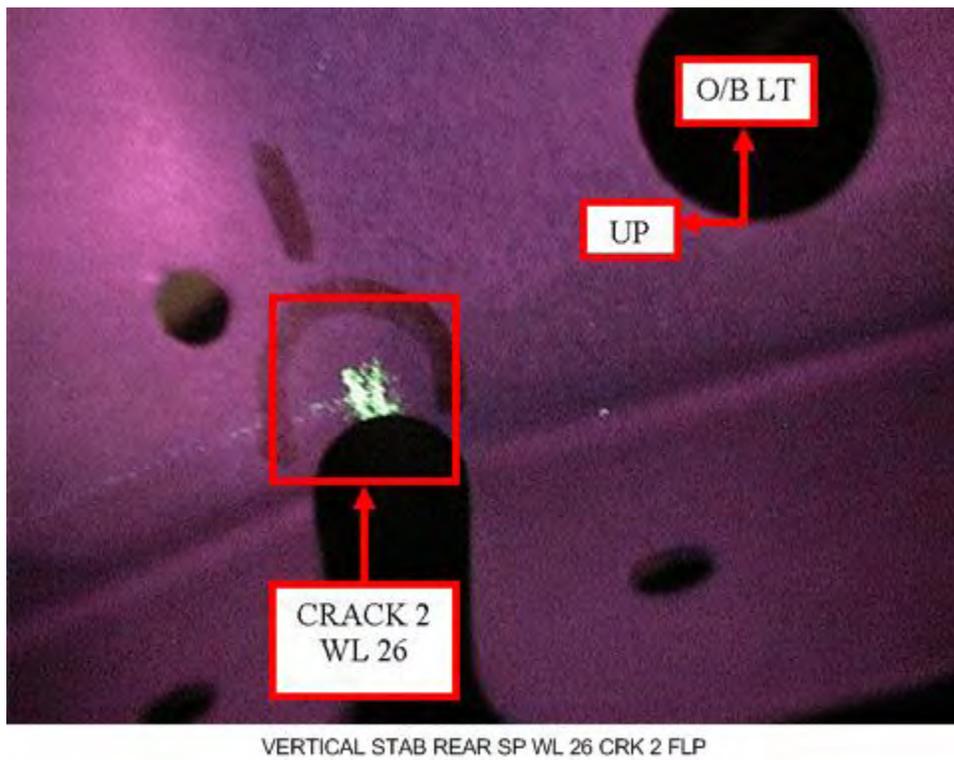
Figure 621. Fluorescent Liquid Penetrant Indication of Crack 2 on the Vertical Stabilizer Rear Spar WL 26

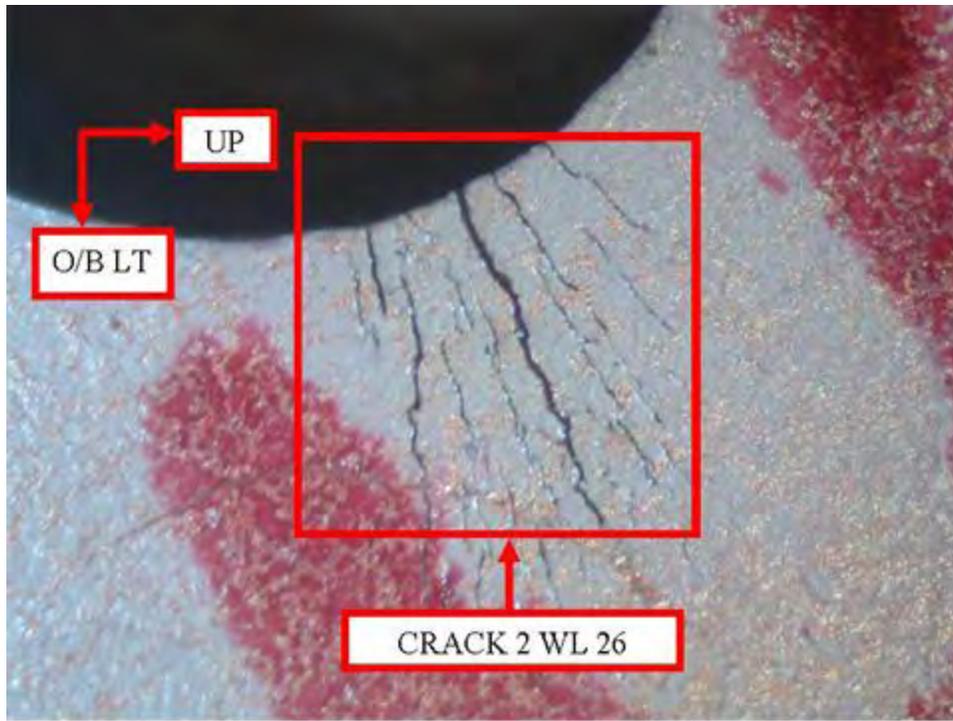
VERTICAL STAB REAR SP WL 26 CRK 2 MIC

Figure 622. Microscopic View of Crack 2 on the Vertical Stabilizer Rear Spar WL 26

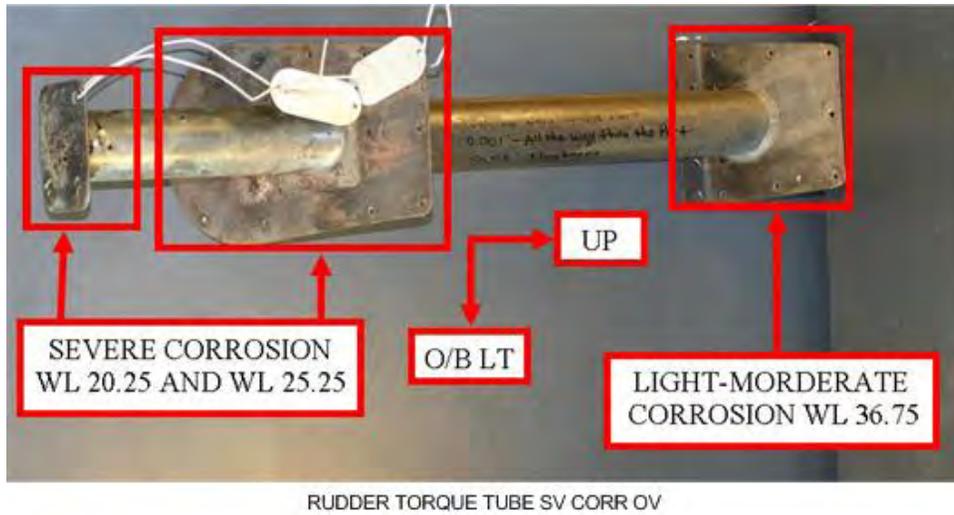
The location of light-moderate and severe corrosion on the rudder torque tube assembly, part number 40040-09, is shown in figure 623. A 14-square-inch area of light-moderate corrosion was located at WL 36.75 and caused a localized thickness loss of 4%, and an area of severe corrosion, located at WL 20.25 and shown macroscopically in figure 624, caused areas of complete localized thickness loss. This corrosion covered a surface area of 3.375 square inches. Another area of severe corrosion, covering a surface area of 24-square-inches and resulting in a localized reduction in thickness of 40%, was observed at WL 25.25 and is shown microscopically in figure 625.

Figure 623. Location of Light-Moderate and Severe Corrosion on the Rudder Torque Tube Assembly WL 20.25 Through WL 36.75

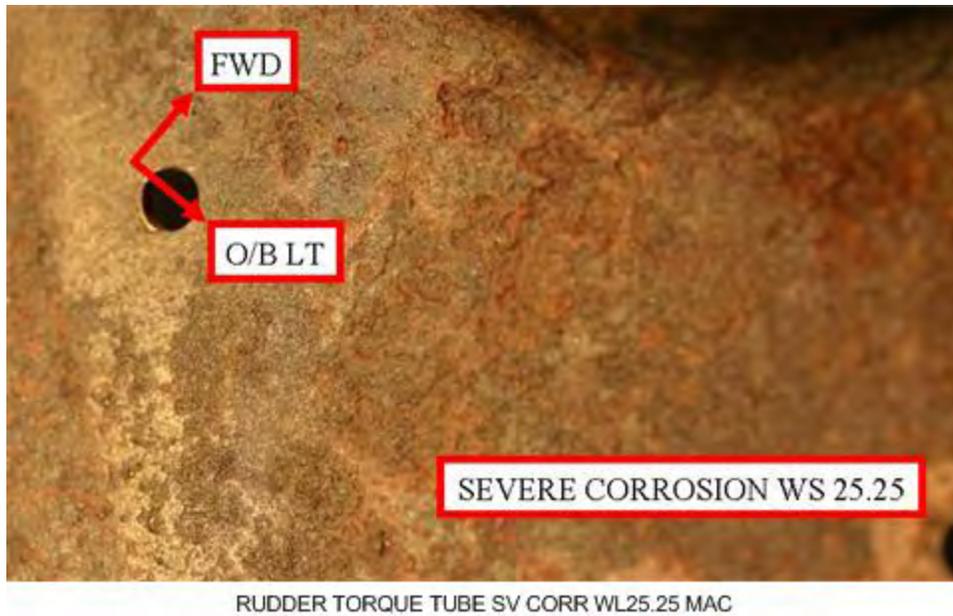
Figure 625. Microscopic View of Severe Corrosion on the Rudder Torque Tube Assembly WL 25.25

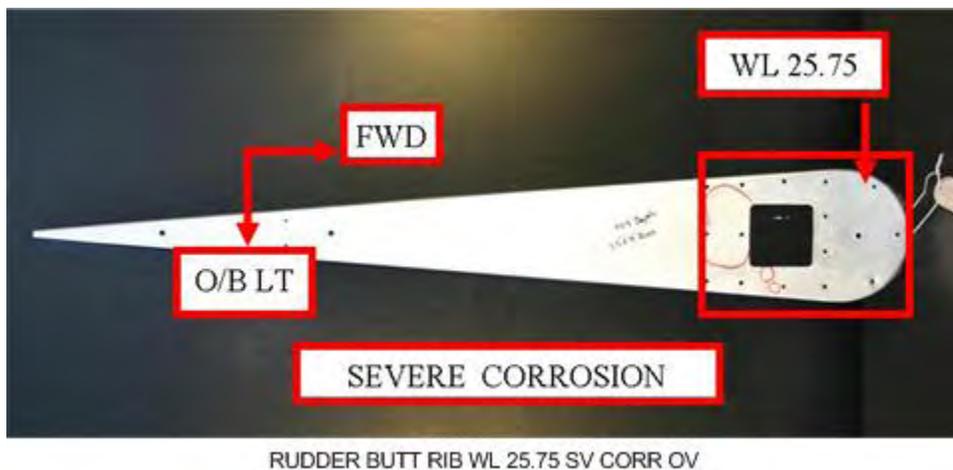
The location of severe corrosion on the rudder butt rib, part number 40039-00, is shown in figure 626. This 30-square-inch area of corrosion, shown macroscopically in figure 627, was located at WL 25.75 and caused a maximum reduction in thickness of 15.6%. The location of a 30-square-inch area of light-moderate corrosion on the rudder horn, part number 40253-00, is shown in figure 628. This corrosion caused a localized thickness loss of 2.7%. Figure 629 shows the location of a group of cracks on the vertical stabilizer left side gusset, part number 40170-16. A macroscopic view of this 0.054-inch crack is shown in figure 630, and a microscopic view is shown in figure 631 at WL 27.

Figure 626. Location of Severe Corrosion on the Rudder Butt Rib WL 25.75

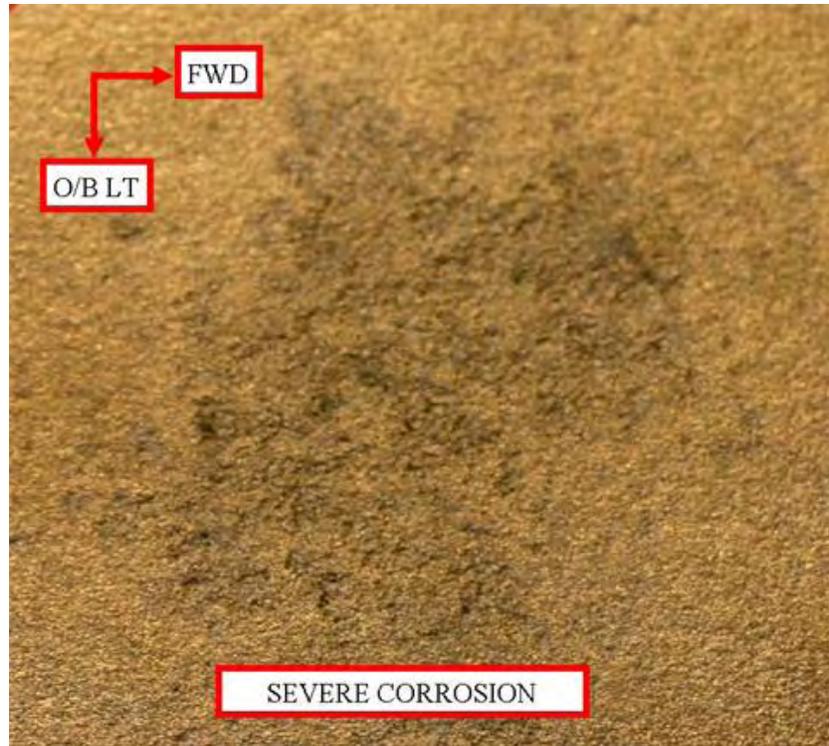
RUDDER BUTT RIB WL 25.75 SV CORR MAC

Figure 627. Macroscopic View of Severe Corrosion on the Rudder Butt Rib WL 25.75

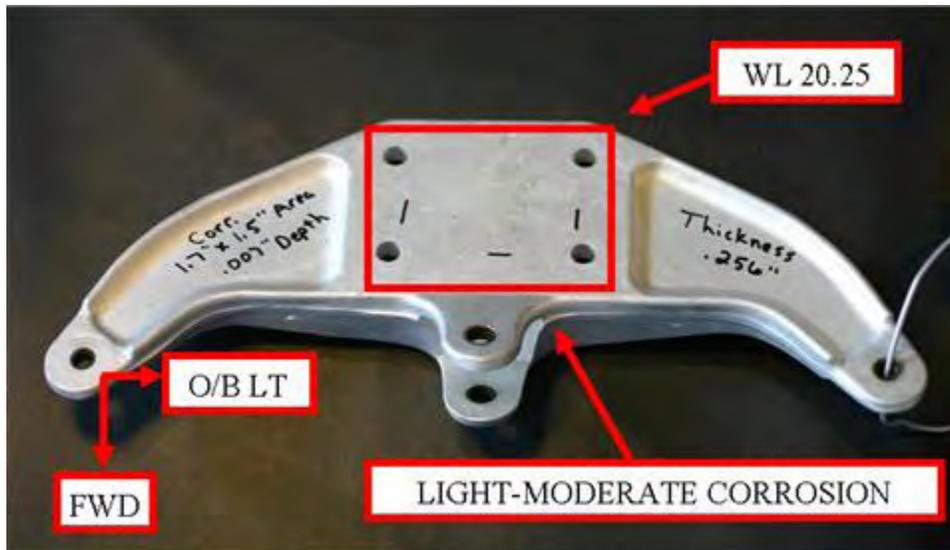
RUDDER HORN WL 20.25 LM CORR OV

Figure 628. Location of Light-Moderate Corrosion on the Rudder Horn WL 20.25

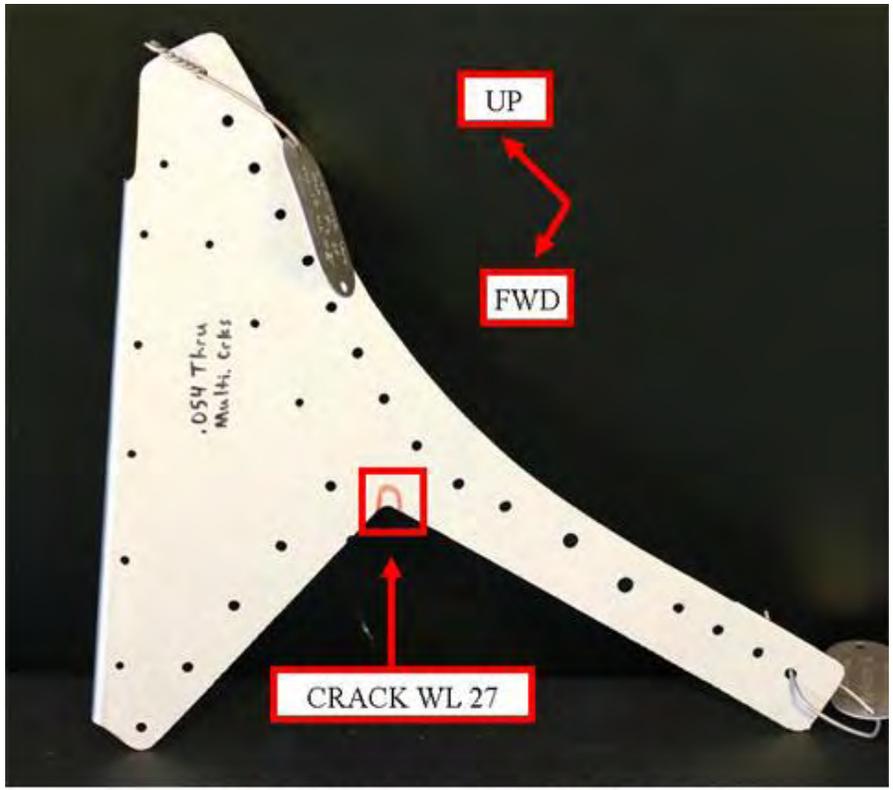
VERTICAL STAB LT SIDE GUSSET WL 20.25-31.75 OV

Figure 629. Location of Cracks on the Vertical Stabilizer Left Side Gusset WL 20.25 Through WL 31.75

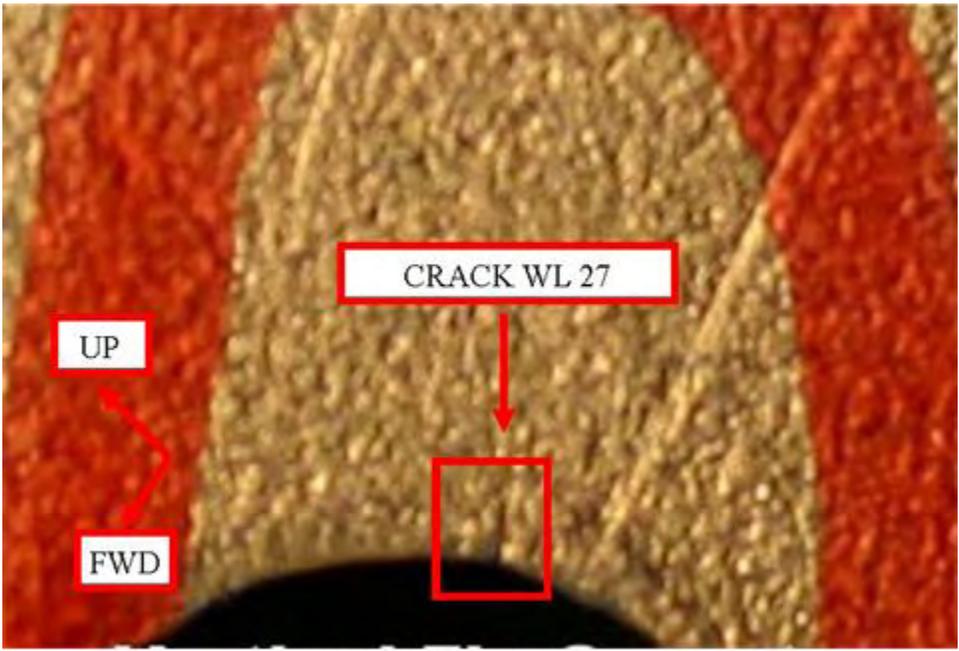
VERTICAL STAB LT SIDE GUSSET WL 27 CRK MAC

Figure 630. Macroscopic View of Crack on the Vertical Stabilizer Left Side Gusset WL 27

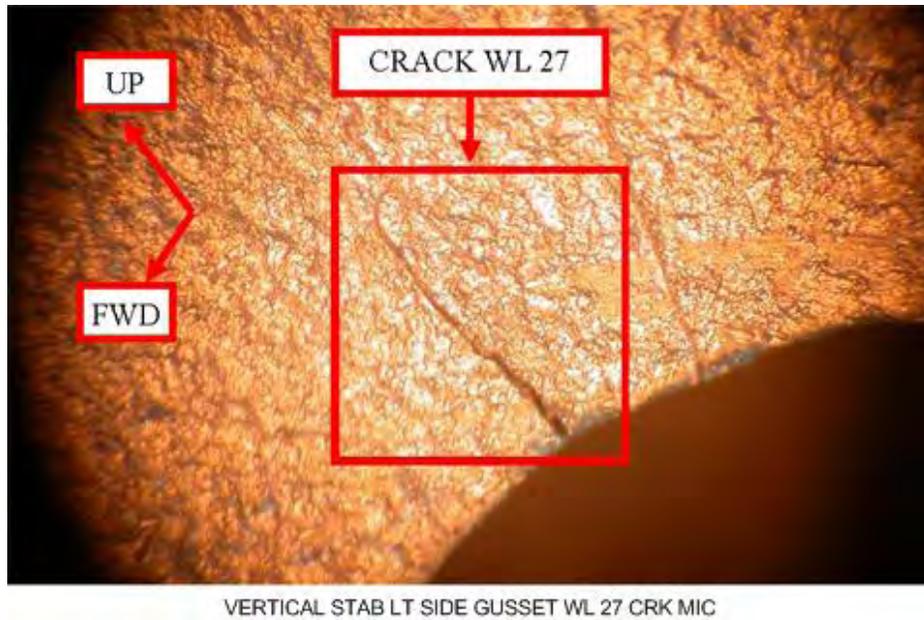
Figure 631. Microscopic View of Crack on the Vertical Stabilizer Left Side Gusset WL 27

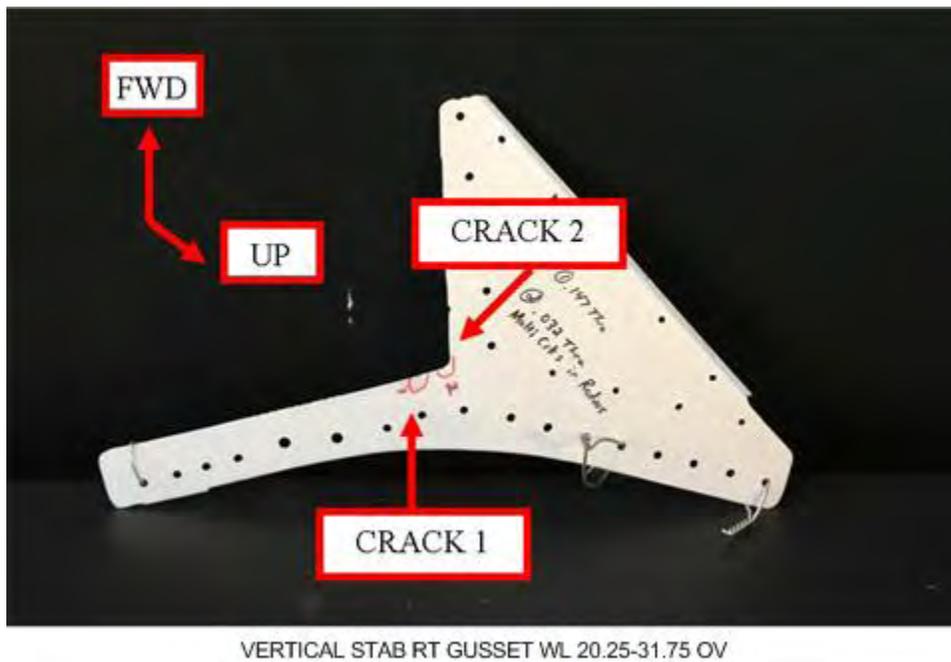
Figure 632 shows the location of two cracks on the right rear vertical stabilizer gusset, part number 40170-15. A macroscopic view of crack 1, which measured 0.147 inch, and crack 2, which measured 0.032 inch, is shown in figure 633. The fluorescent liquid penetrant indications for both cracks is shown in figure 634. A microscopic view of crack 1 is shown in figure 635. A microscopic view of crack 2, which was located at WL 27, is shown in figure 637.

Figure 632. Location of Two Cracks on the Right Rear Vertical Stabilizer Gusset WL 20.25 Through WL 31.75

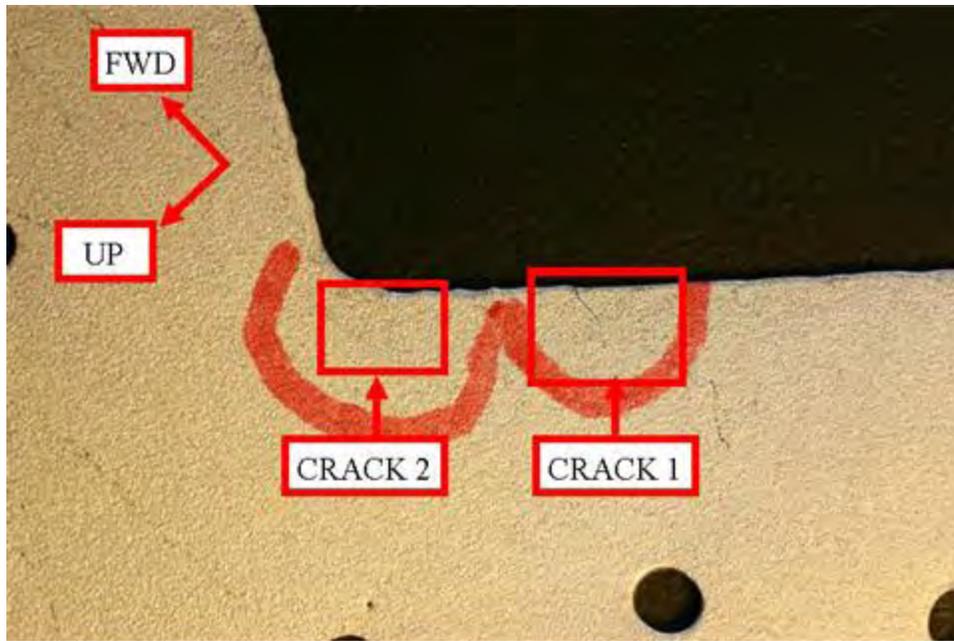
VERTICAL STAB GUSSET Rt WL27 CRK1&2 MAC

Figure 633. Macroscopic View of Cracks 1 and 2 on the Right Rear Vertical Stabilizer Gusset WL 27

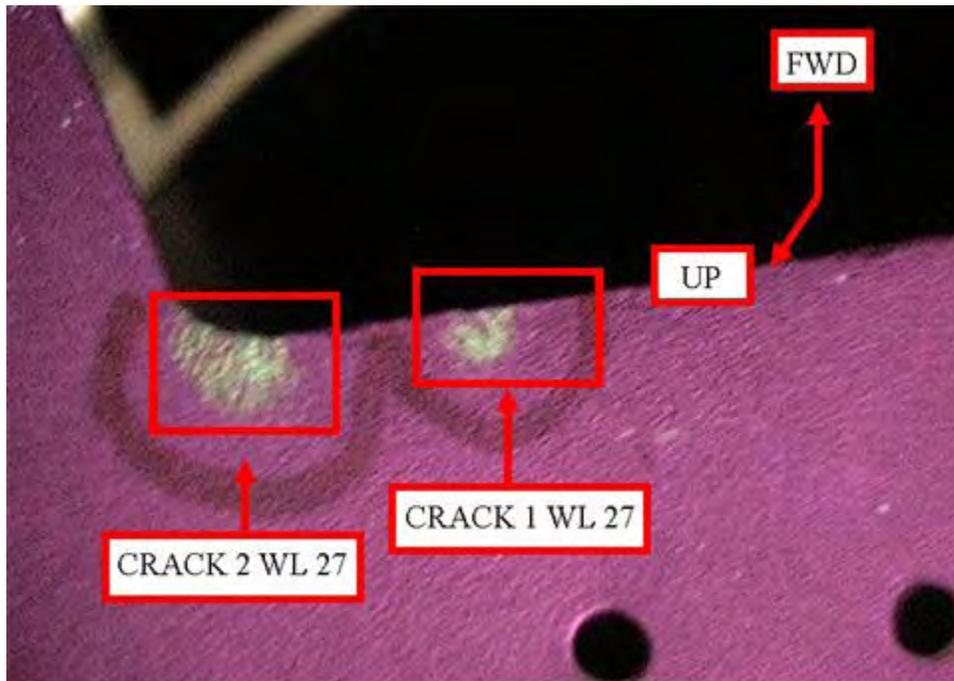
VERTICAL STAB RT GUSSET WL 27 FLP

Figure 634. Fluorescent Liquid Penetrant Indication on the Right Rear Vertical Stabilizer Gusset WL 27

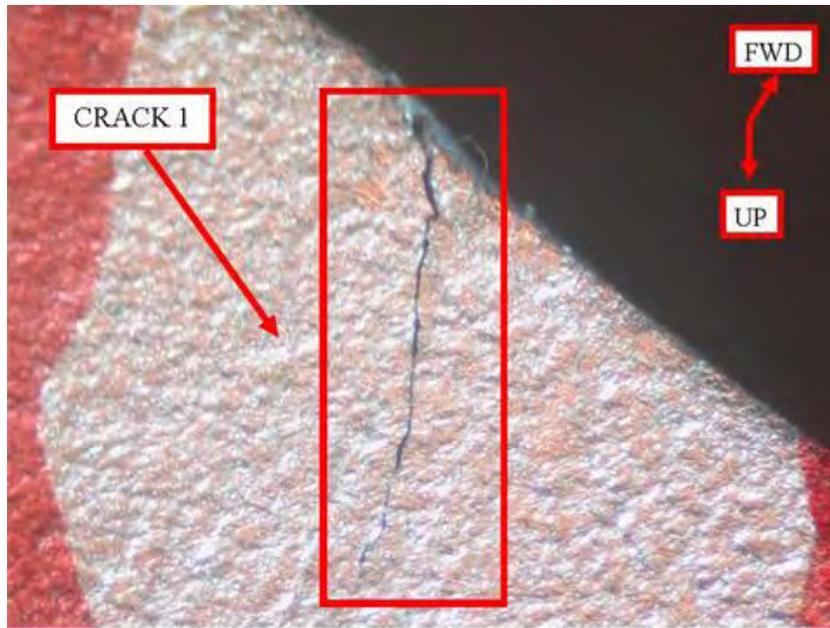
VERTICAL STAB RT GUSSET CRK 1 WL 27 MIC

Figure 635. Microscopic View of Crack 1 on the Right Rear Vertical Stabilizer Gusset WL 27

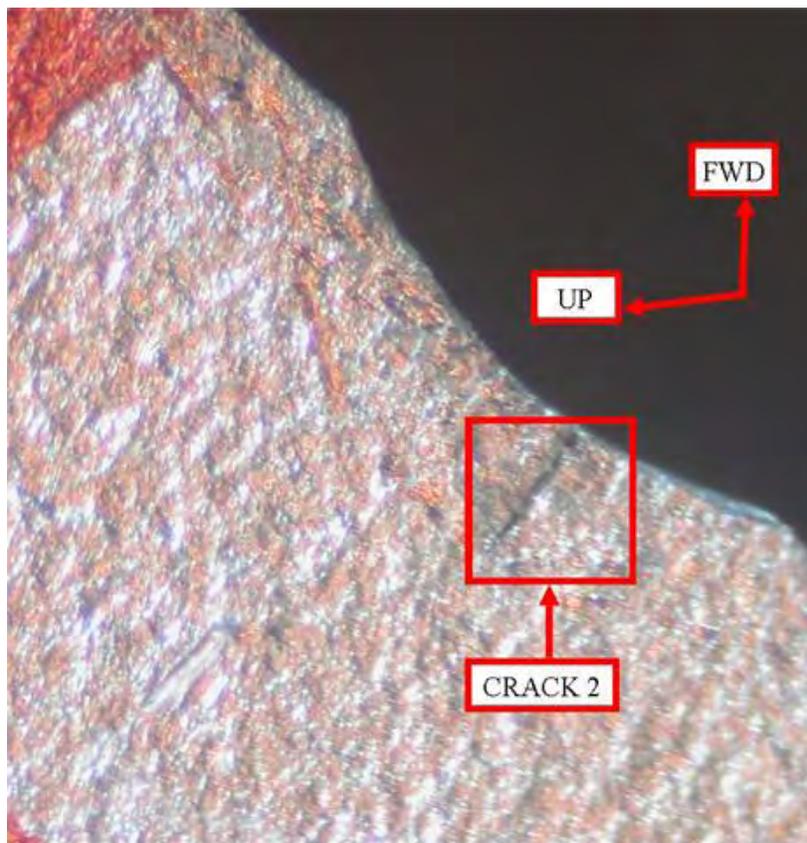
VERTICAL STAB RT GUSSET WL27 CRK2 MIC

Figure 636. Microscopic View of Crack 2 on the Right Rear Vertical Stabilizer Gusset WL 27

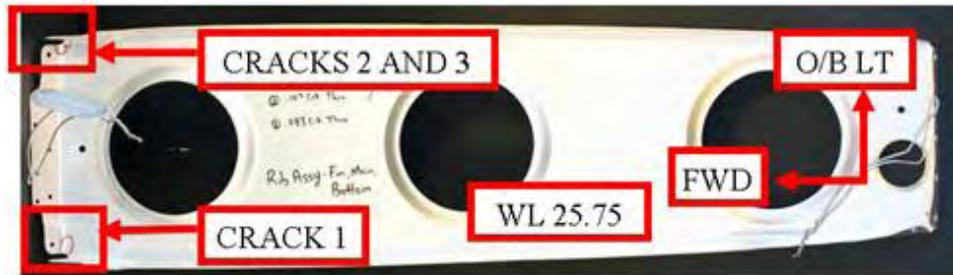
VERTICAL STAB MAIN BOTTOM RIB WL25.75 OV

The location of three cracks on the vertical stabilizer main bottom rib assembly, part number 44294-00, is shown in figure 637 at WL 25.75. A macroscopic view of crack 1 is shown in figure 638, and a microscopic view of this 0.397-inch crack is shown in figure 639. Figure 640 shows a macroscopic view of cracks 2 and 3 on the main bottom rib assembly. A microscopic view of crack 2, which measured 0.107 inch, and crack 3, which measured 0.083 inch is shown in figure 641.

Figure 637. Location of Three Cracks on the Vertical Stabilizer Main Bottom Rib Assembly WL 25.75

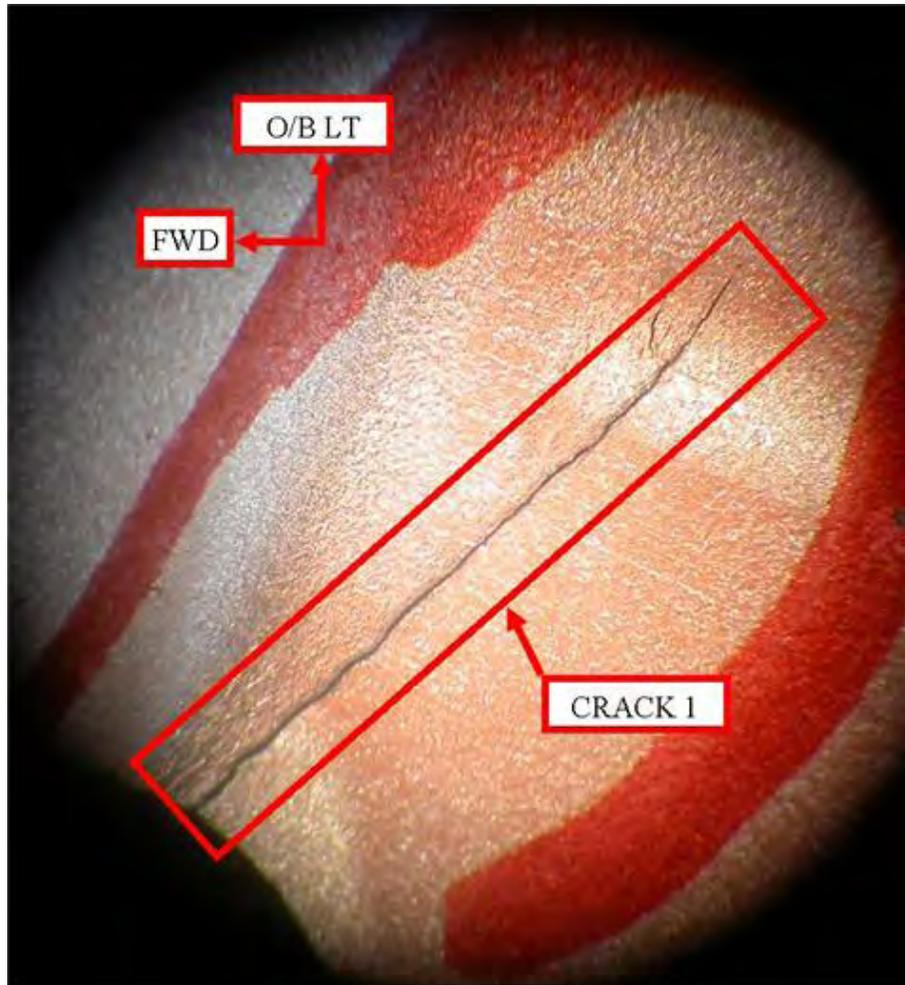
VERTICAL STAB MAIN BOTTOM RIB WL25.27 CRK1 MIC

Figure 639. Microscopic View of Crack 1 on the Vertical Stabilizer Main Bottom Rib Assembly WL 25.75

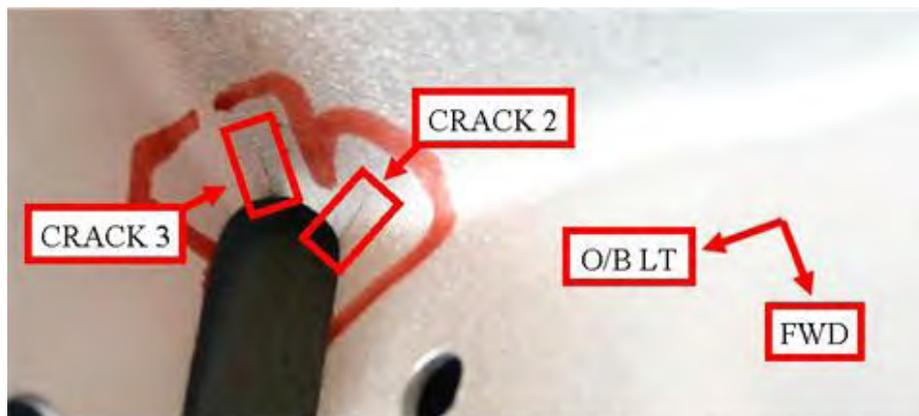
VERTICAL STAB MAIN BOTTOM RIB WL25.75 CRK2&3 MAC

Figure 640. Macroscopic View of Cracks 2 and 3 on the Vertical Stabilizer Main Bottom Rib Assembly WL 25.75

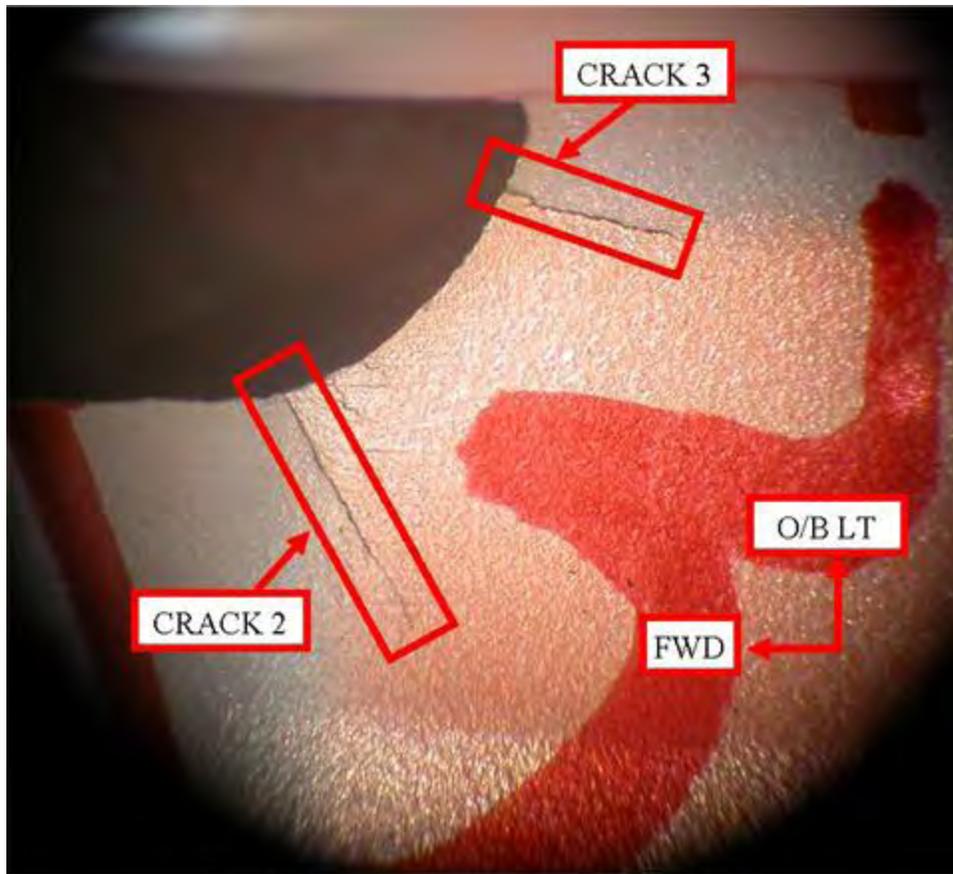
VERTICAL STAB MAIN BOTTOM RIB WL25.75 CRK 2&3 MIC

Figure 641. Microscopic View of Cracks 2 and 3 on the Vertical Stabilizer Main Bottom Rib Assembly WL 25.75

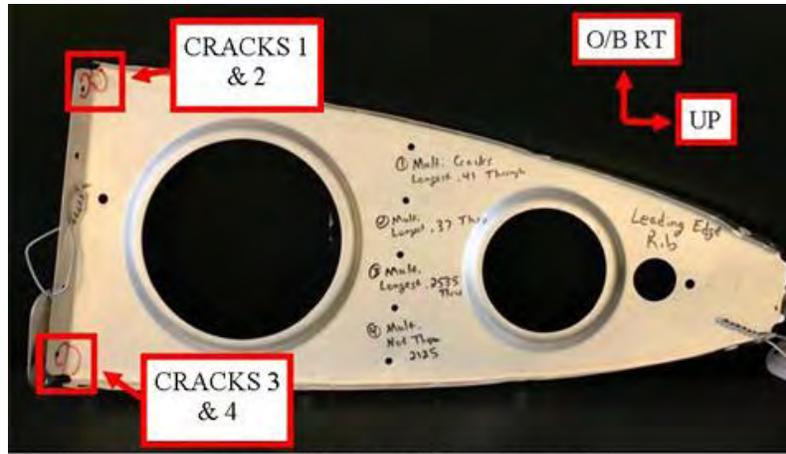
VERTICAL STAB LE RIB WL30.125-44.75 OV

The location of four cracks on the vertical stabilizer leading-edge rib, part number 40096-00, is shown in figure 642 at WL 30.125. A macroscopic view of cracks 1 and 2 is shown in figure 643. Figure 644 shows a microscopic view of crack 1, which measures 0.410 inch, and figure 645 shows a microscopic view of crack 2, which measures 0.370 inch. A macroscopic view of cracks 3 and 4 is shown in figure 646. A microscopic view of crack 3, which measures 0.2535 inch, is shown in figure 647. Figure 648 shows a 0.2125-inch crack, crack 4, microscopically.

Figure 642. Location of Four Cracks on the Vertical Stabilizer Leading-Edge Rib WL 30.125 Through WL 44.75

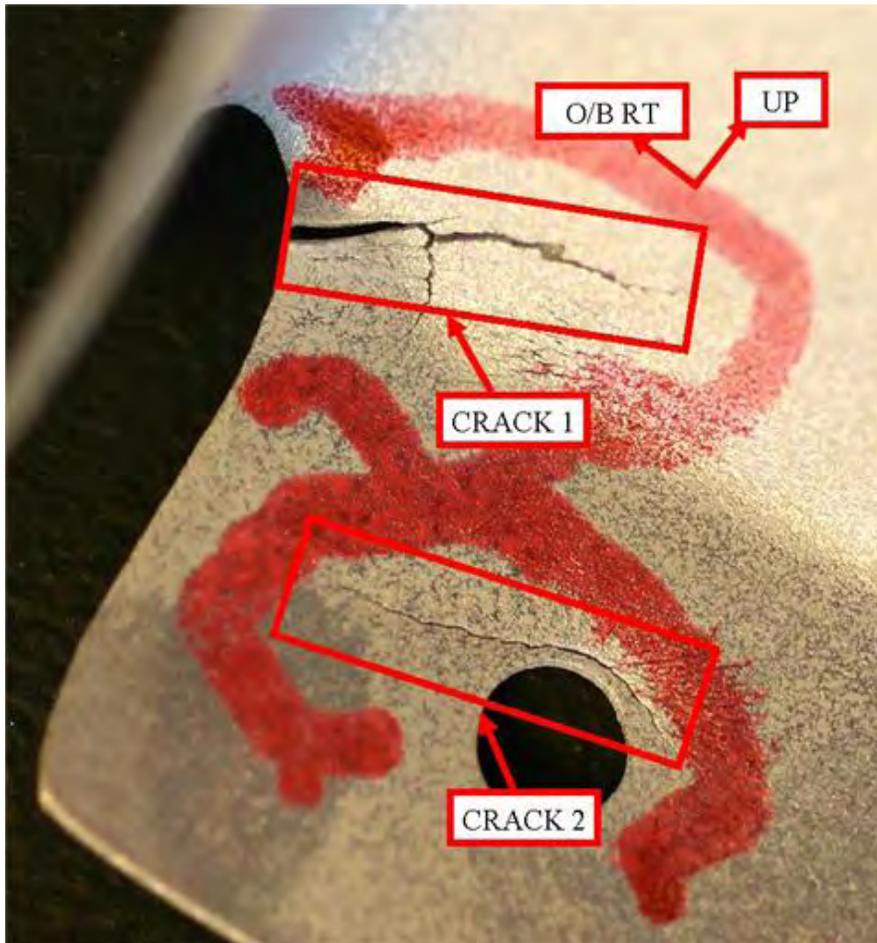
VERTICAL STAB LE Rib WL30.125 Crk1-2 MAC

Figure 643. Macroscopic View of Cracks 1 and 2 on the Vertical Stabilizer Leading-Edge Rib WL 30.125

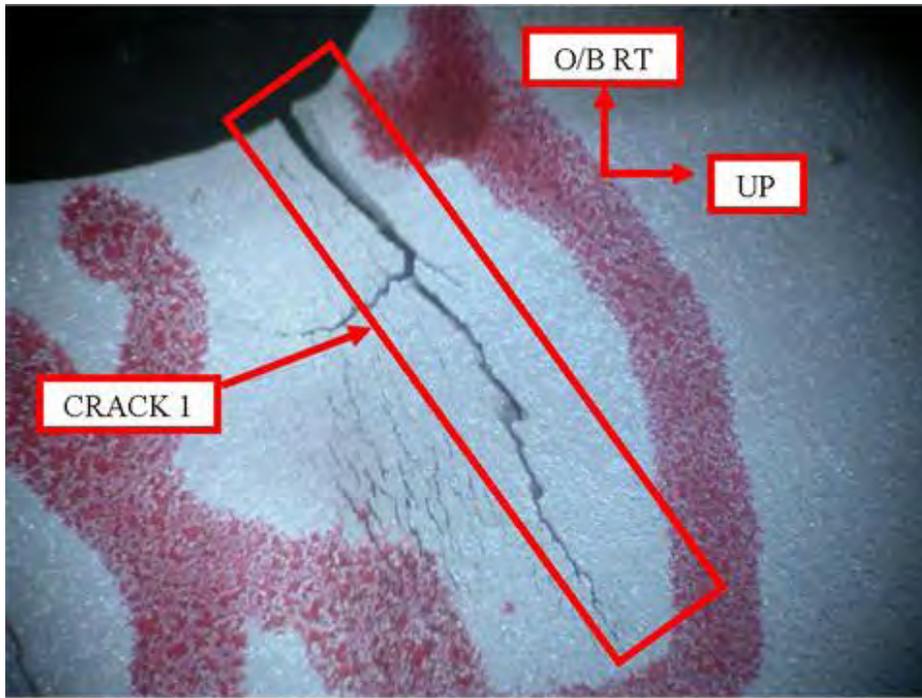
VERTICAL STAB LE RIB WL30.125 CRK1 MIC

Figure 644. Microscopic View of Crack 1 on the Vertical Stabilizer Leading-Edge Rib WL 30.125

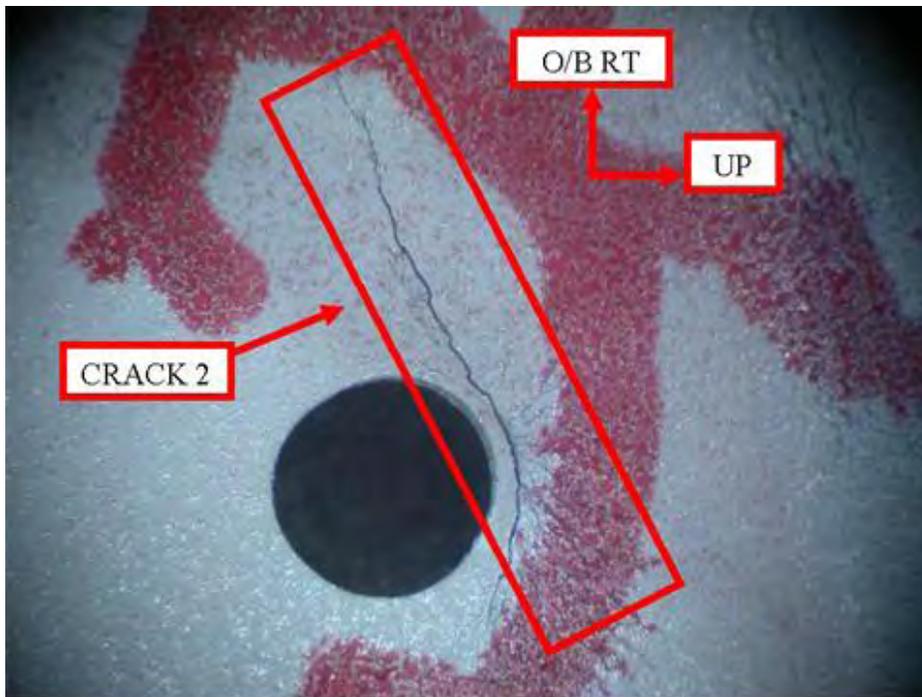
VERTICAL STAB LE RIB CRK 2 MIC

Figure 645. Microscopic View of Crack 2 on the Vertical Stabilizer Leading-Edge Rib WL 30.125

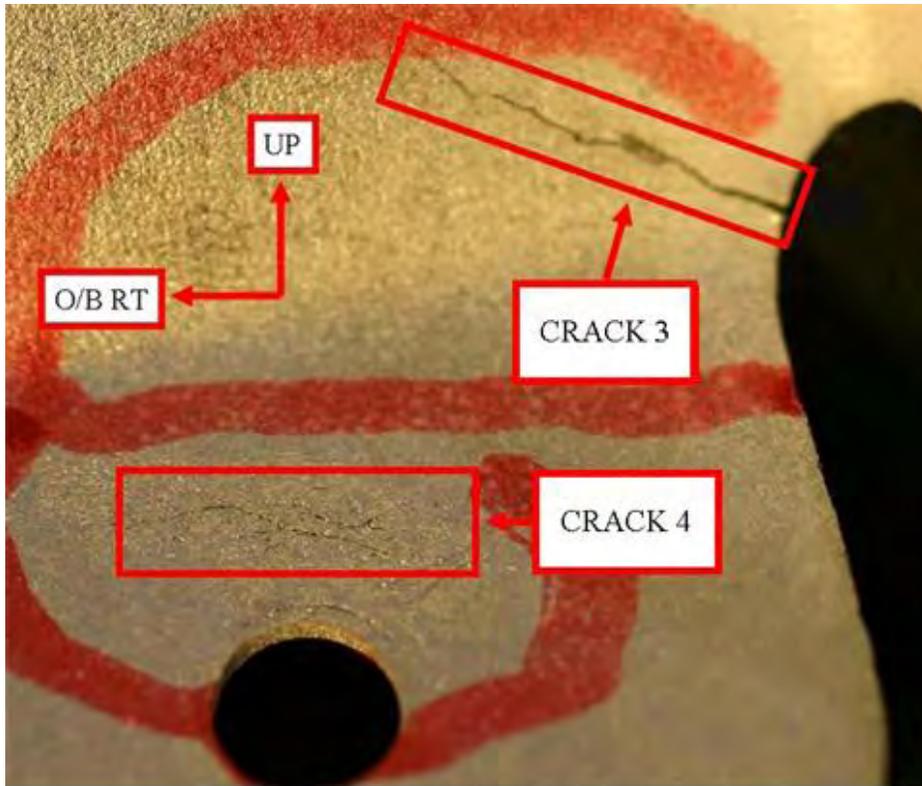
VERTICAL STAB LE RIB CRK 3&4 MAC

Figure 646. Macroscopic View of Cracks 3 and 4 on the Vertical Stabilizer Leading-Edge Rib WL 30.125

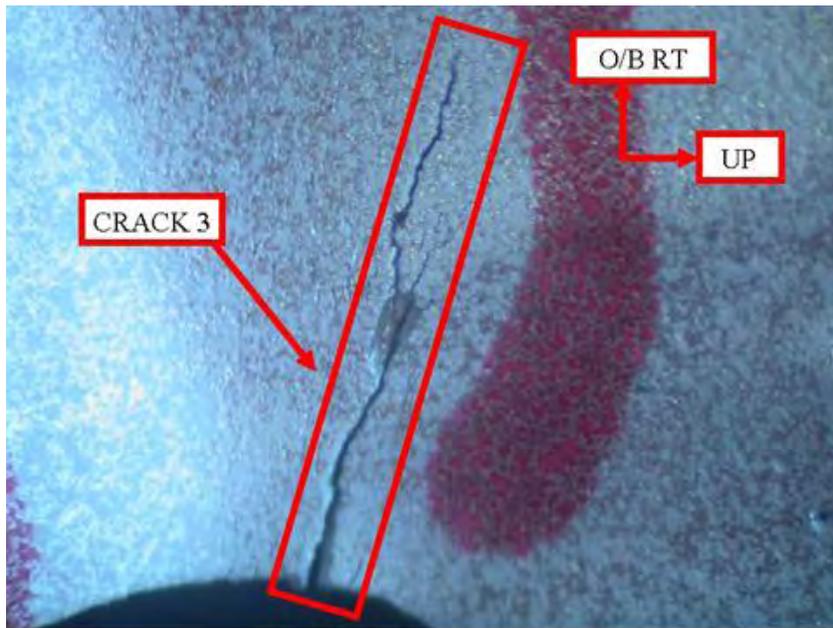
VERTICAL STAB LE RIB CRK 3 MIC

Figure 647. Microscopic View of Crack 3 on the Vertical Stabilizer Leading-Edge Rib WL 30.125

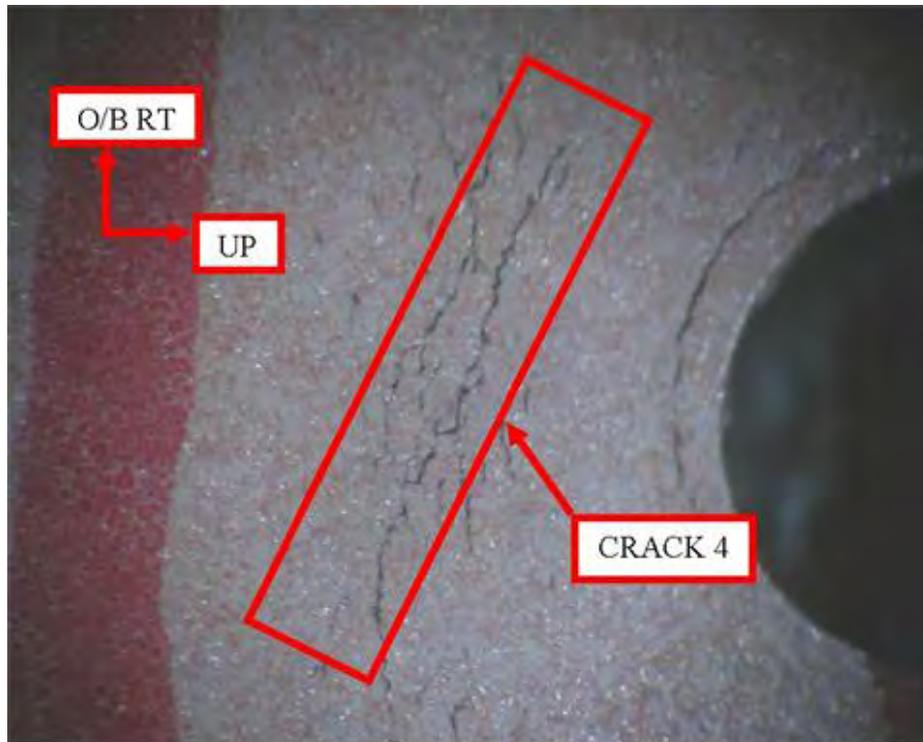
VERTICAL STAB LE RIB CRK 4 MIC

Figure 648. Microscopic View of Crack 4 on the Vertical Stabilizer Leading-Edge Rib WL 30.125

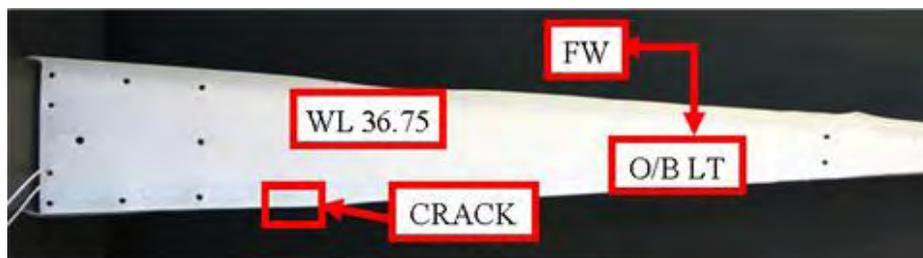
RUDDER MAIN RIB WL36.75 OV

The location of a 0.047-inch crack on the main rudder rib, part number 40078-3, is shown in figure 649. This crack, which was located at WL 36.75, is shown macroscopically in figure 650. The location of a hole in the weld bead of the rudder lower hinge assembly, part number 51109-04, is shown in figure 651, and a macroscopic view of the 0.085-inch-diameter inclusion is shown in figure 652. Figure 653 shows the location of a similar hole in a weld bead, with a diameter of 0.055 inch, in the rudder upper hinge, part number 51108-04. A microscopic view of this inclusion, located at WL 82.5, is shown in figure 654. The location of multiple cracks grouped together and identified as a single crack on the rudder leading-edge upper skin, part number 40046-04, is shown in figure 655. A macroscopic view of this crack group is shown in figure 656. The maximum length of the crack was measured as 0.042 inch and was located at WL 96. A microscopic view of this crack group is shown in figure 657.

Figure 649. Location of Crack on the Main Rudder Rib WL 36.75

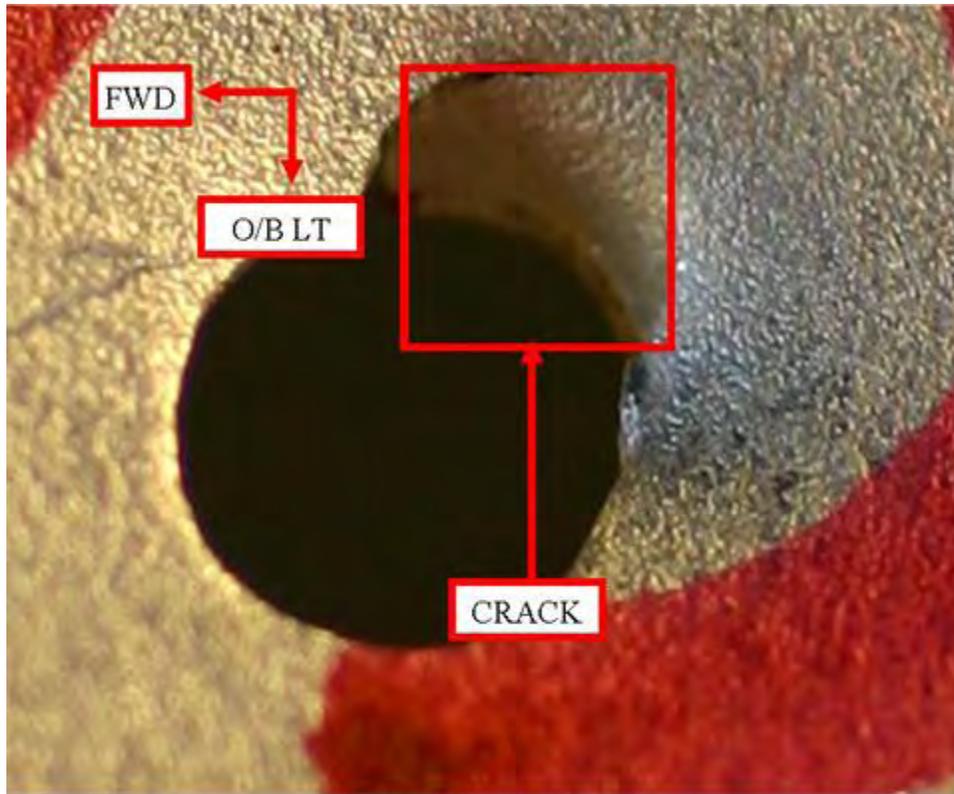
RUDDER MAIN RIB CRK MAC

Figure 650. Macroscopic View of Crack on the Main Rudder Rib WL 36.75

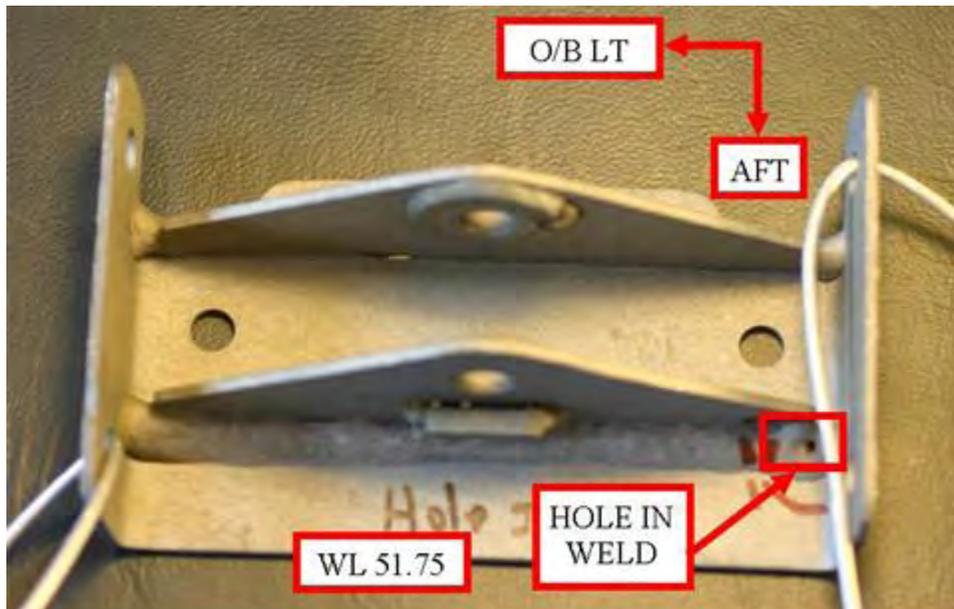
RUDDER LWR HINGE WL51.75 OV

Figure 651. Location of Hole in the Weld Bead on the Rudder Lower Hinge Assembly WL 51.75

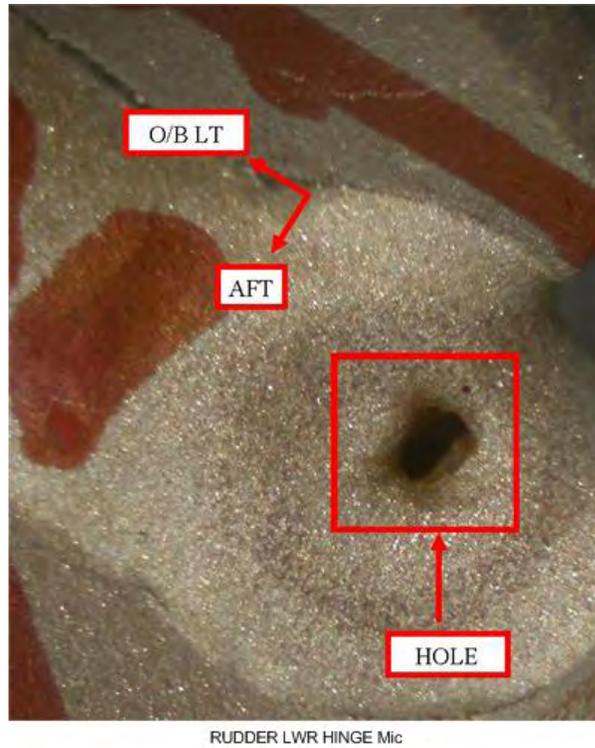
Figure 652. Macroscopic View of Hole in the Weld Bead on the Rudder Lower Hinge Assembly WL 51.75

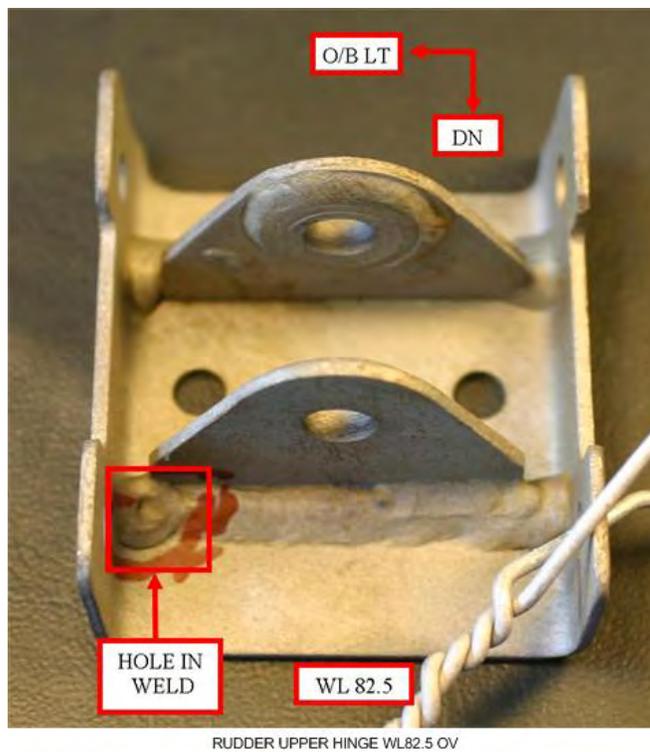
Figure 653. Location of Hole in the Weld Bead on the Rudder Upper Hinge WL 82.5
