DOT/FAA/AR-07/64

Teardown Evaluation of a 1975 Piper Navajo Chieftain Model PA31-350 Airplane

March 2008

Final Report

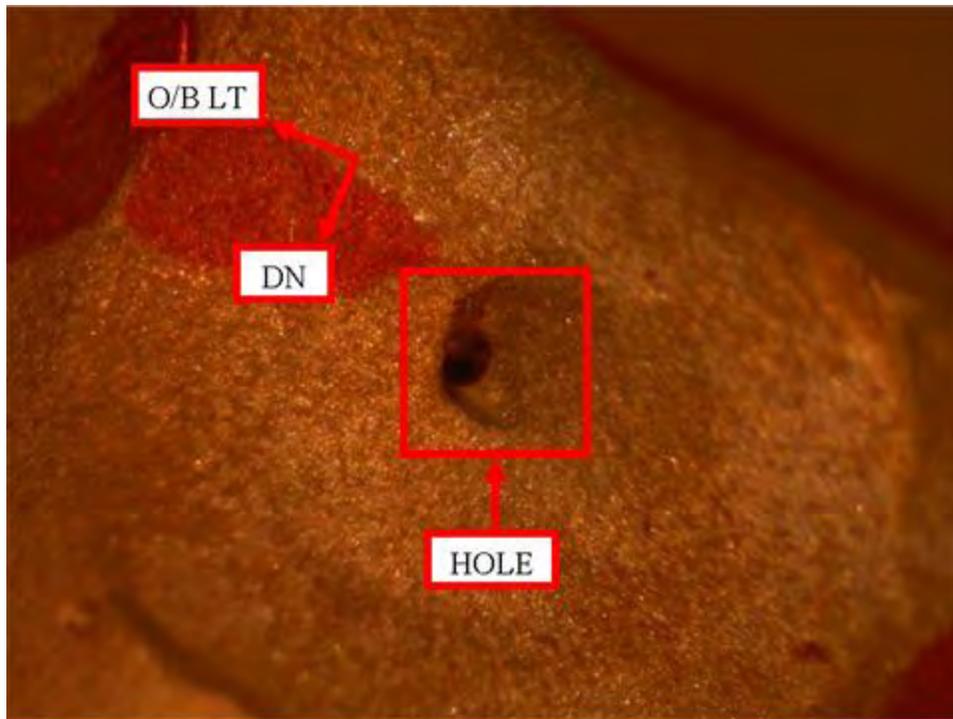
RUDDER UPPER HINGE Mac

Figure 654. Macroscopic View of Hole in the Weld Bead on the Rudder Upper Hinge WL 82.5

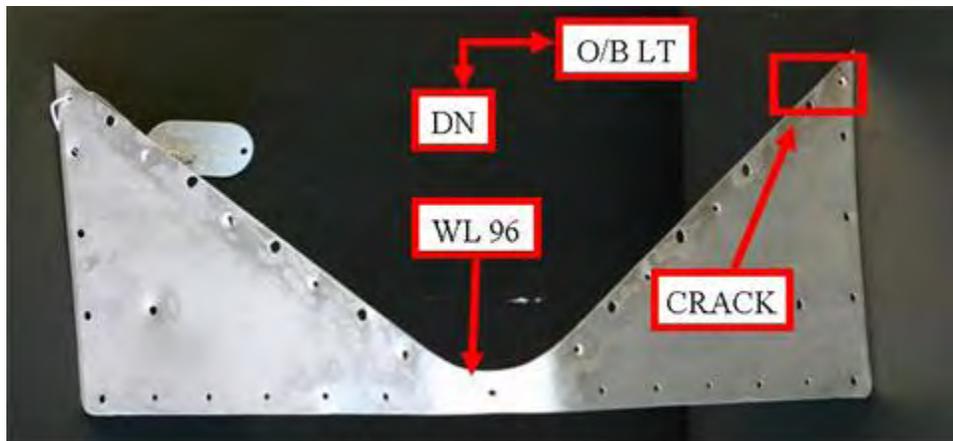
RUDDER LE UPPER SKIN WL96 OV

Figure 655. Location of Crack on the Rudder Leading-Edge Upper Skin WL 96

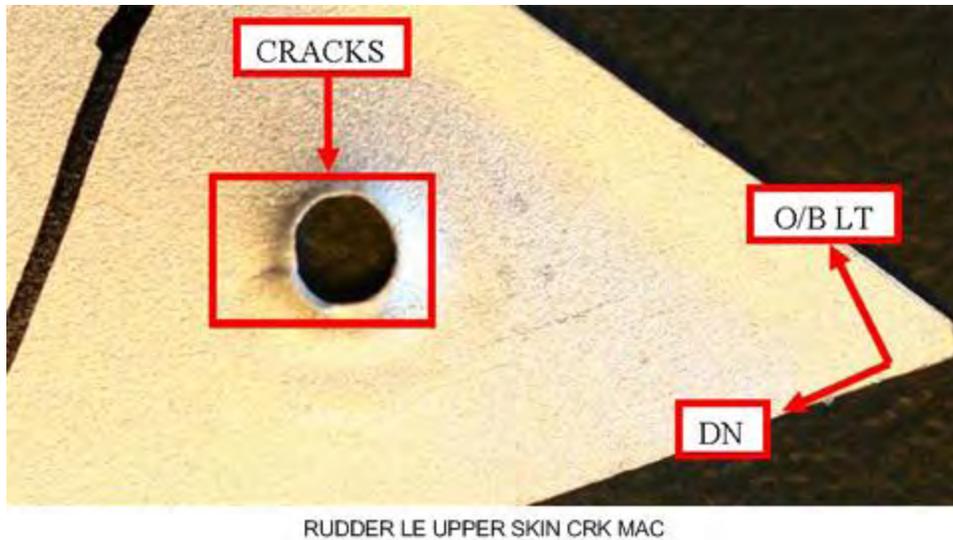
Figure 656. Macroscopic View of Crack on the Rudder Leading-Edge Upper Skin WL 96

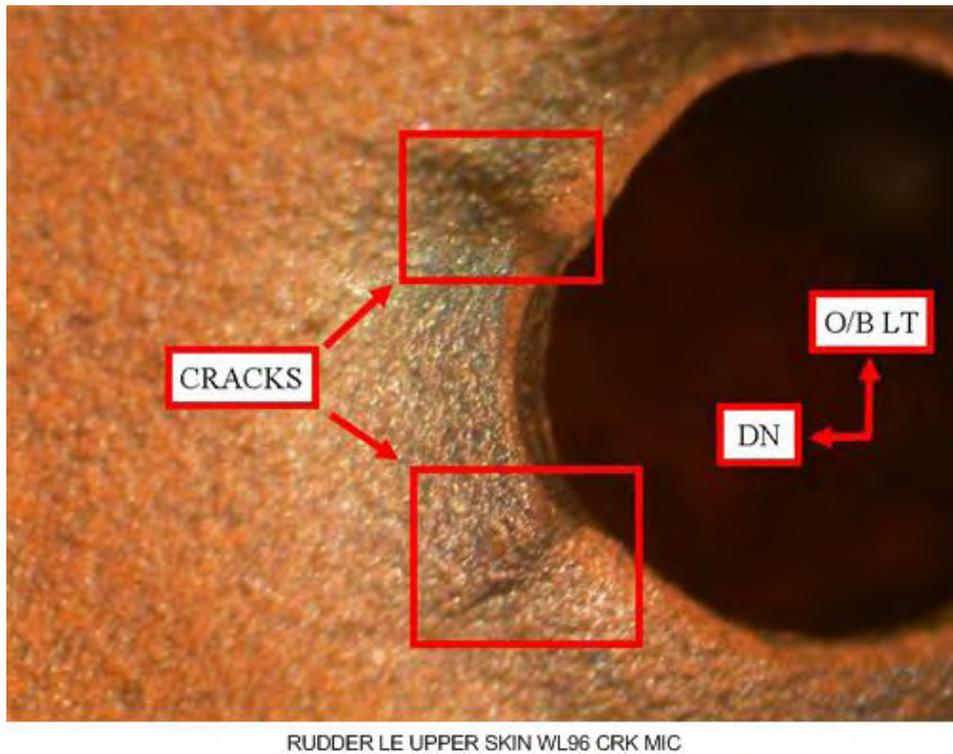
The location of a 0.047-inch crack on the main rudder rib, part number 40078-3, is shown in figure 649. This crack, which was located at WL 36.75, is shown macroscopically in figure 650. The location of a hole in the weld bead of the rudder lower hinge assembly, part number 51109-04, is shown in figure 651, and a macroscopic view of the 0.085-inch-diameter inclusion is shown in figure 652. Figure 653 shows the location of a similar hole in a weld bead, with a diameter of 0.055 inch, in the rudder upper hinge, part number 51108-04. A microscopic view of this inclusion, located at WL 82.5, is shown in figure 654. The location of multiple cracks grouped together and identified as a single crack on the rudder leading-edge upper skin, part number 40046-04, is shown in figure 655. A macroscopic view of this crack group is shown in figure 656. The maximum length of the crack was measured as 0.042 inch and was located at WL 96. A microscopic view of this crack group is shown in figure 657.

Figure 657. Microscopic View of Cracks on the Rudder Leading-Edge Upper Skin WL 96

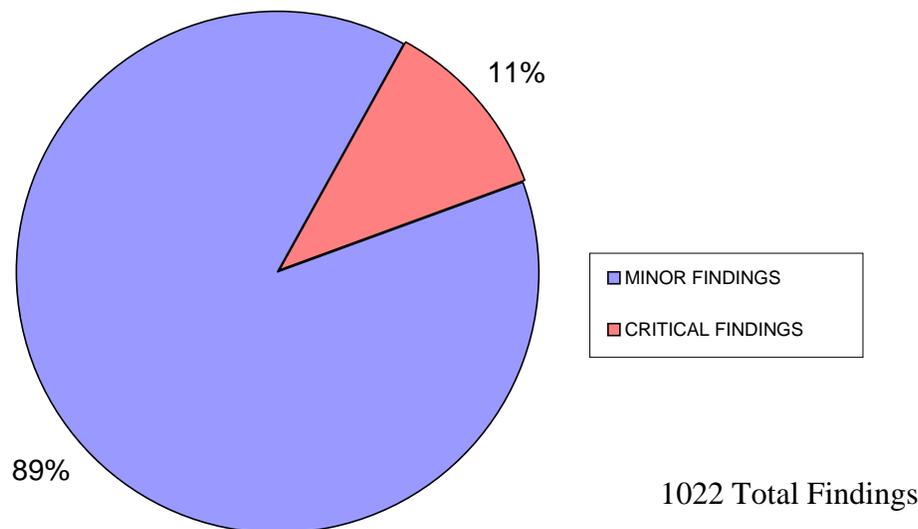
During the intrusive visual inspections, 1022 findings were documented; some were minor findings, and others were critical findings. Critical findings included exposed shields, exposed inner conductors, damaged inner conductions, heat-damaged wires, spliced inner conductors exposed, cold solder joints, exposed solder joints, loose or broken terminals, and contact arcing or fretting. Of the 1022 findings documented during the intrusive visual inspections, 117 were categorized as critical findings, as shown in figure 658. Figure 659 shows a breakdown of wiring findings by finding code. Eighteen percent of the wiring findings were rubbing/chafing of the outer insulation, with an additional eighteen percent classified as fluid contamination and another 17 percent identified as brittle and cracking insulation. Figure 660 shows the intrusive wiring visual inspection of findings by airplane systems. Twenty-two percent of the findings were related to the heater-ventilating and deicing system, and fifteen percent were part of the airplane power system. Another fifteen percent of the findings were related to the landing gear system.

Figure 658. Critical Versus Minor Findings From the Intrusive Wiring Visual Inspections

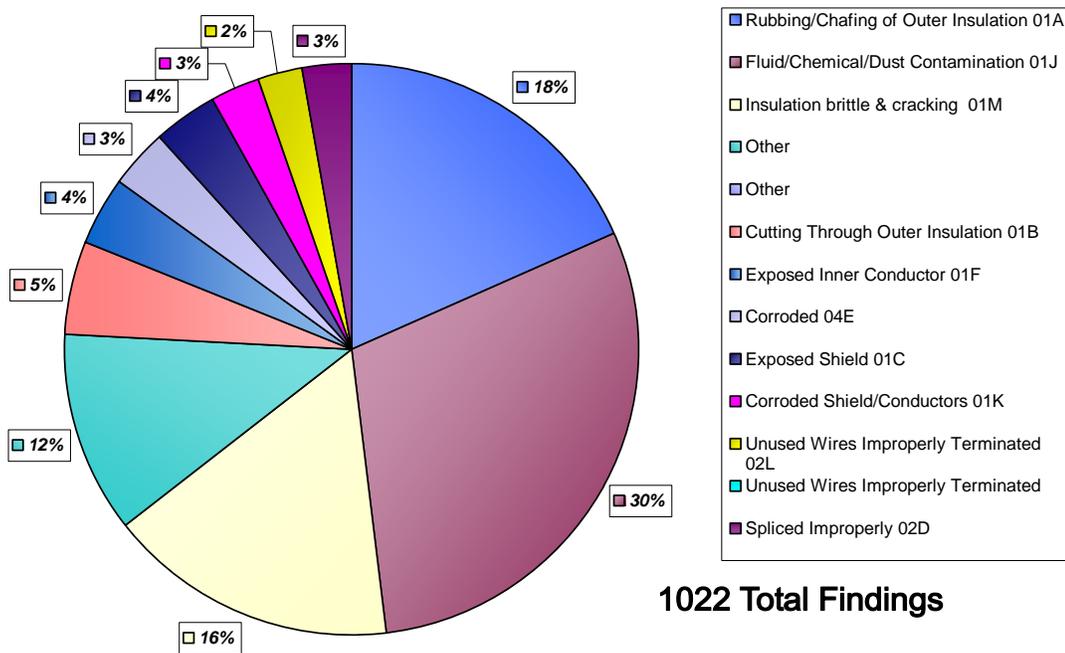
Figure 659. Breakdown of Wiring Findings by Finding Code

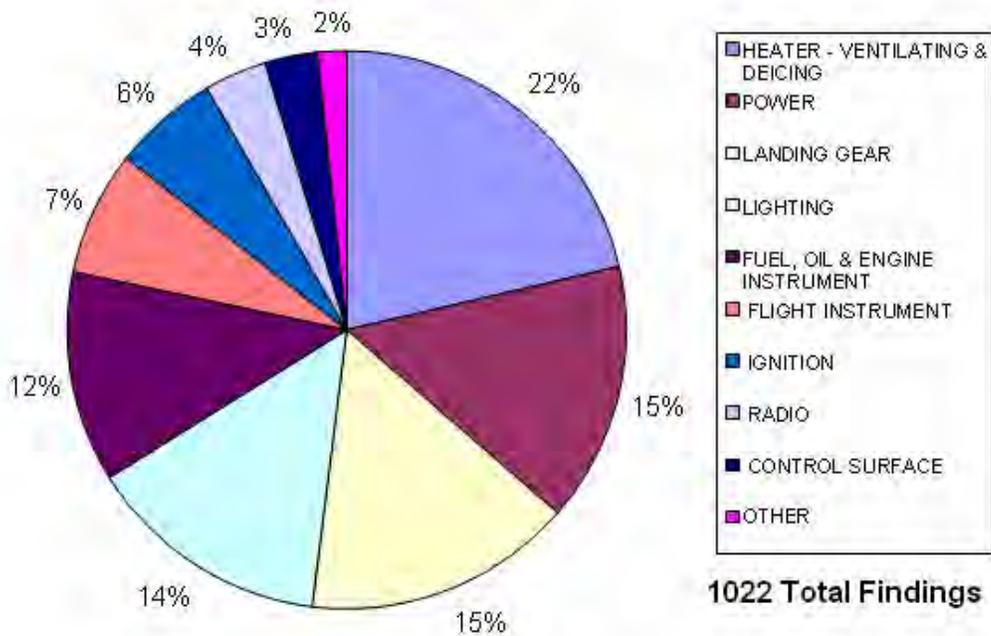
Figure 660. Intrusive Wiring Visual Inspection Findings by Airplane System

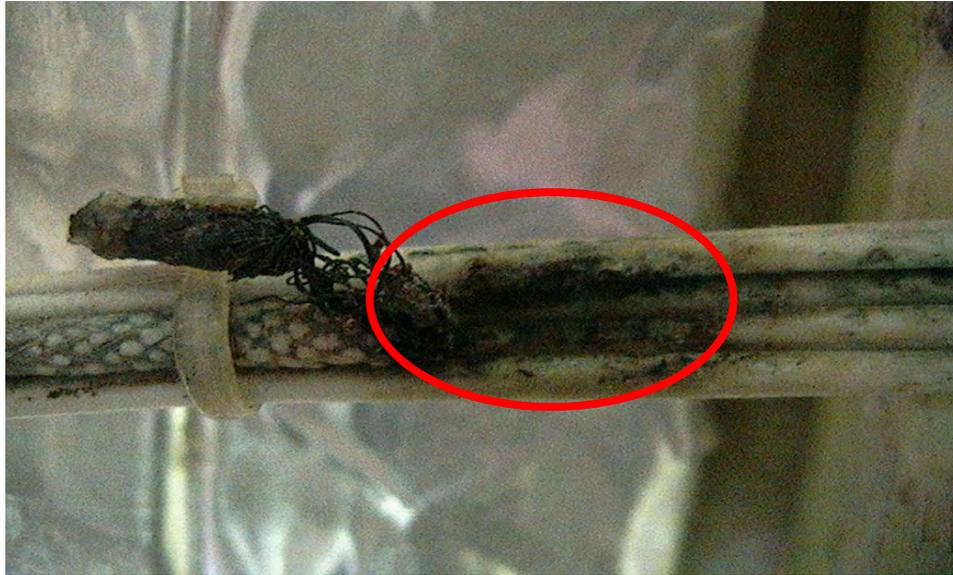
Examples of the more common wiring findings are shown in figures 661 to 670. Figure 661 shows heat-damaged insulation, and figure 662 shows the cracked insulation. Figure 663 shows broken outer insulation due to chafing of the wires. Figure 664 shows an example of a corroded terminal. An exposed inner conductor due to improper splicing is shown in figure 665. An example of a damaged terminal is shown in figure 666. A connector with fluid contamination is shown in figure 667. Contact arcing fretting is shown in figure 668. A worn and brittle shrink wrapping is shown in figure 669. Figure 670 shows brittle and broken pilot yoke interphone insulation.

Figure 661. Heat-Damaged Insulation

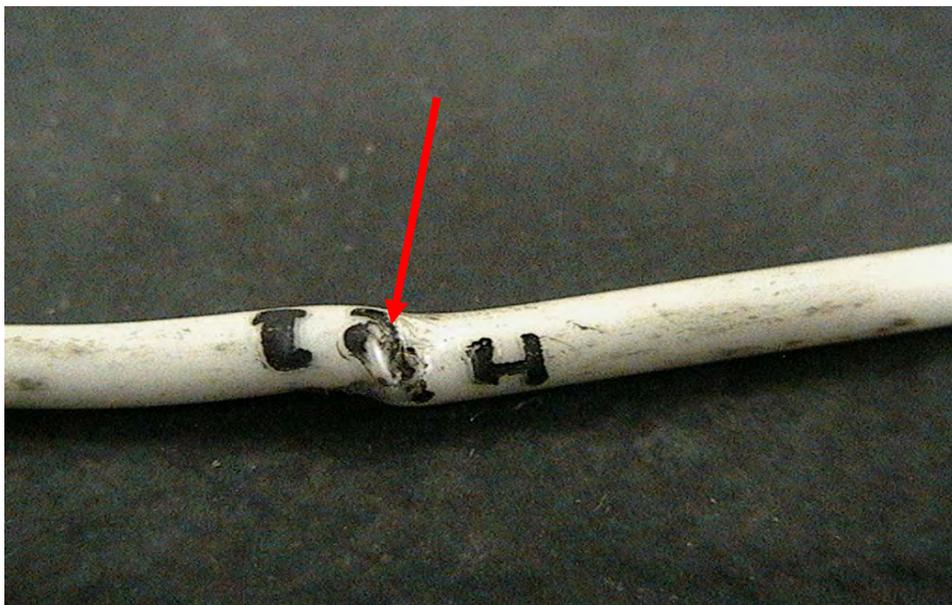
Figure 662. Cracked Insulation

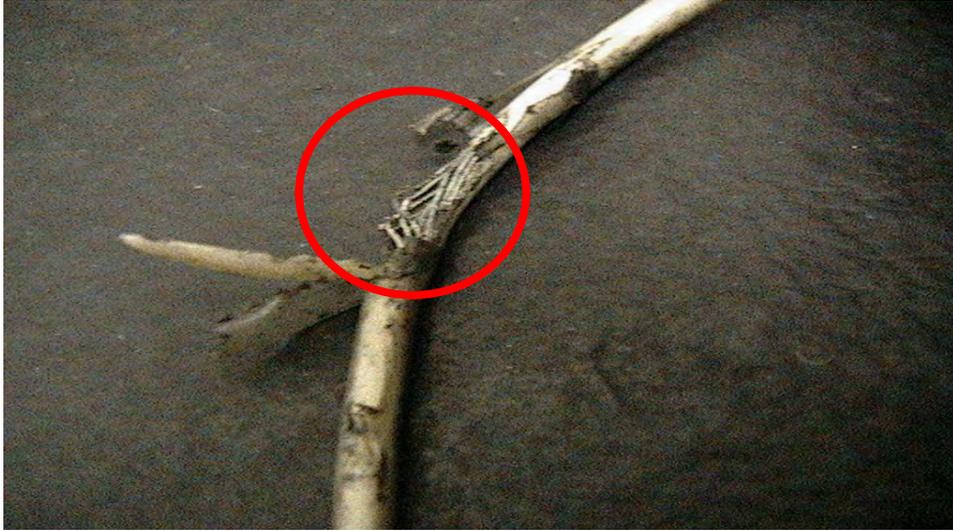
Figure 663. Insulation Broken Due to Chafing

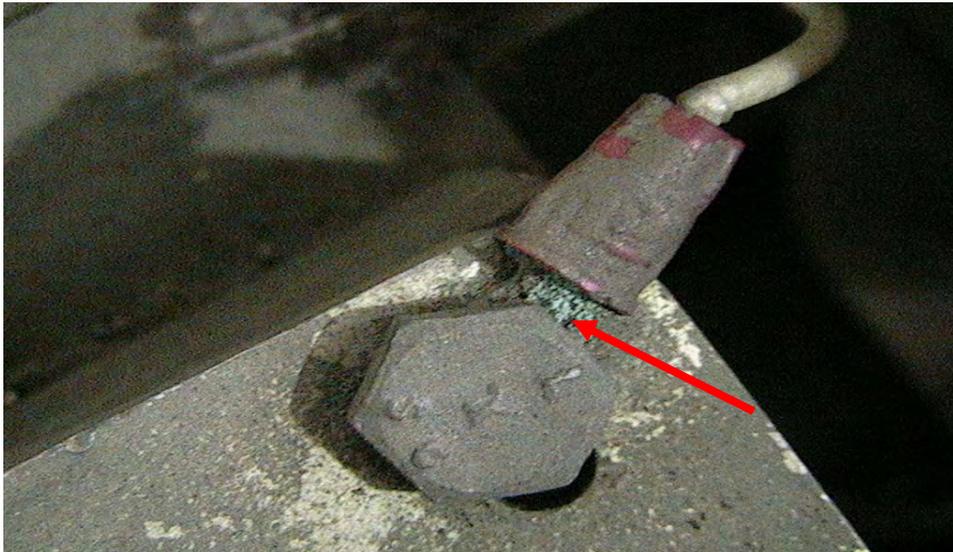
Figure 664. Corroded Terminal

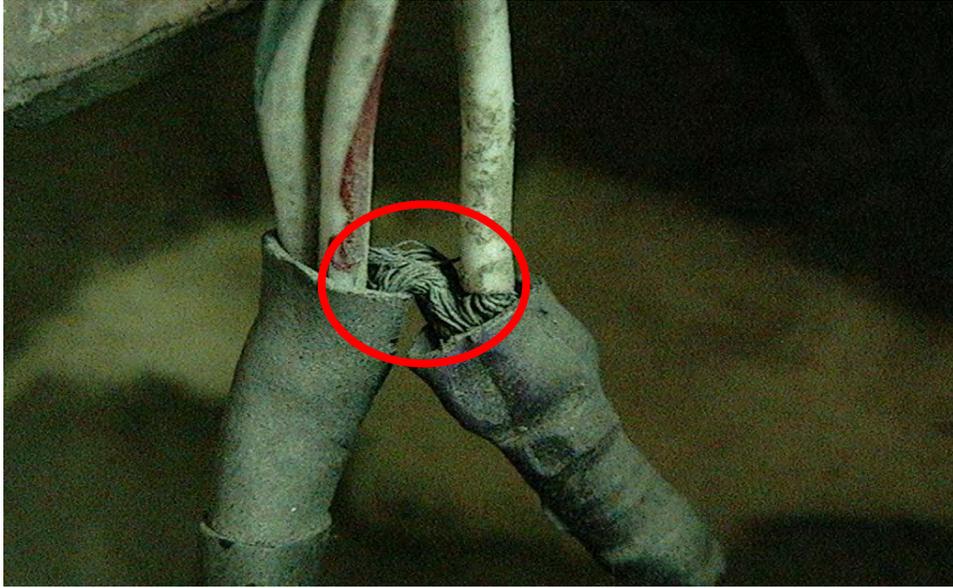
Figure 665. Inner Conductor Exposed Due to Improper Splicing

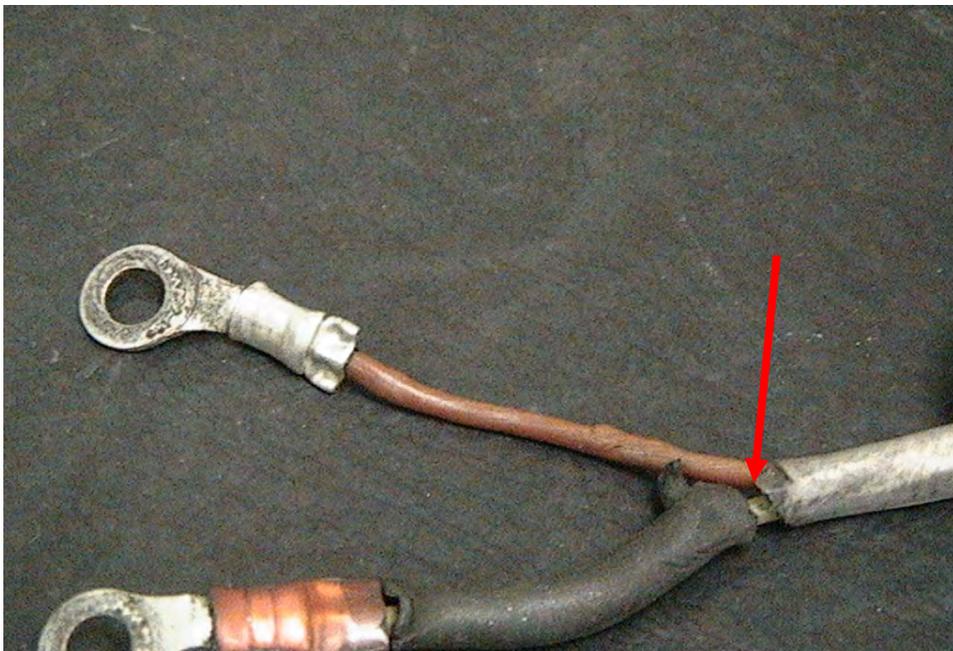
Figure 666. Damaged Terminal Insulation

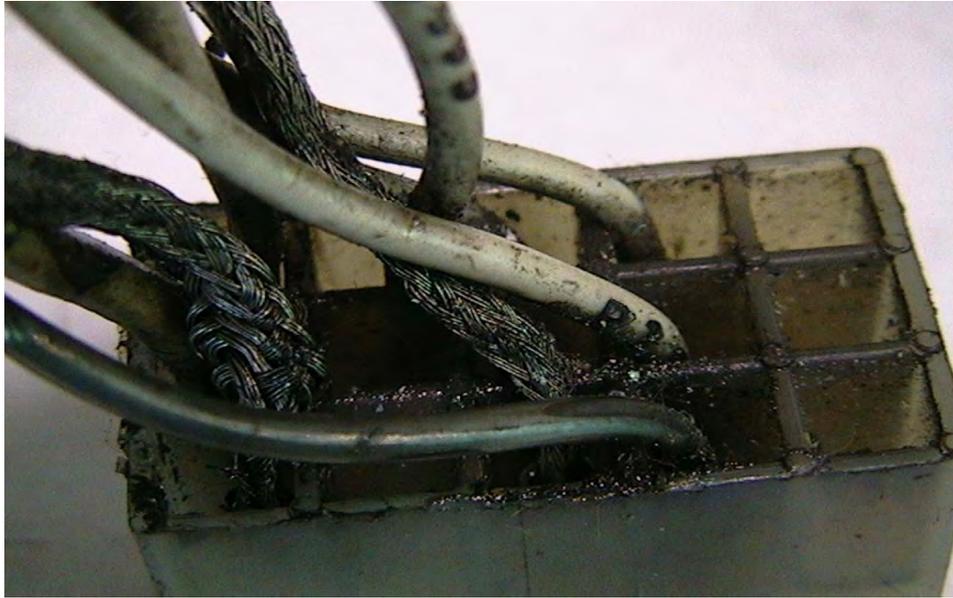
Figure 667. Fluid Contamination on Connector

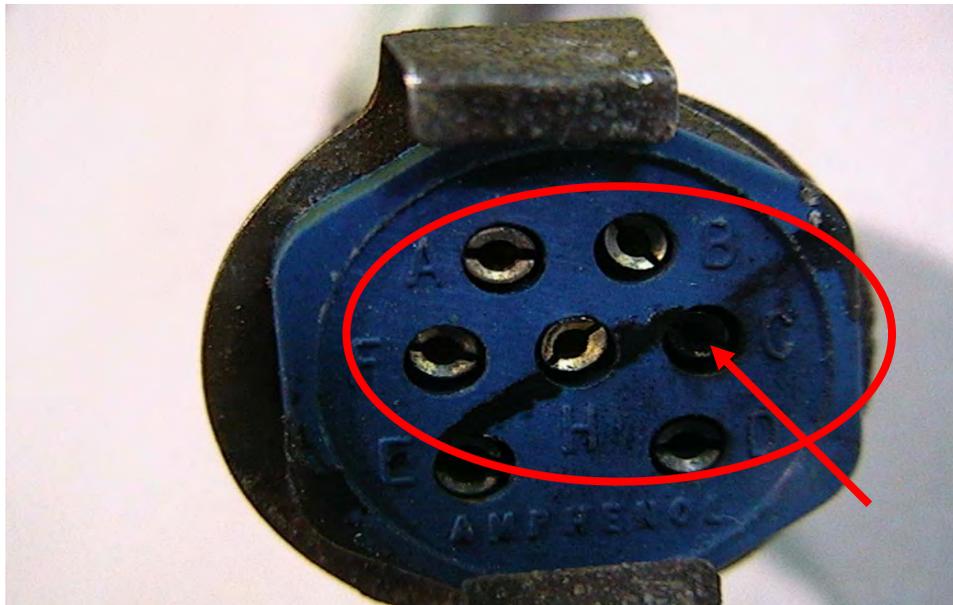
Figure 668. Contact Arcing Fretting

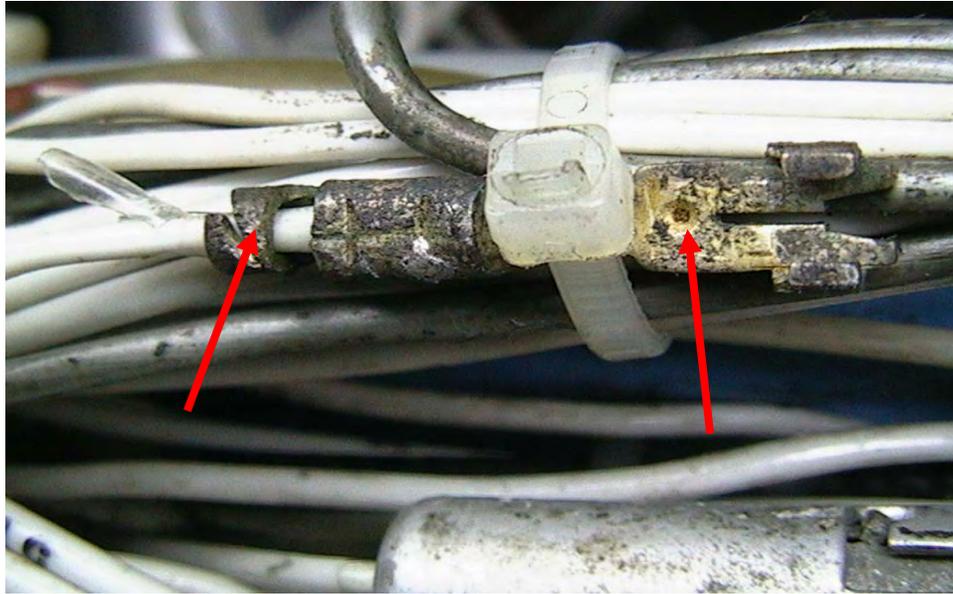
Figure 669. Shrink Wrap Worn and Brittle

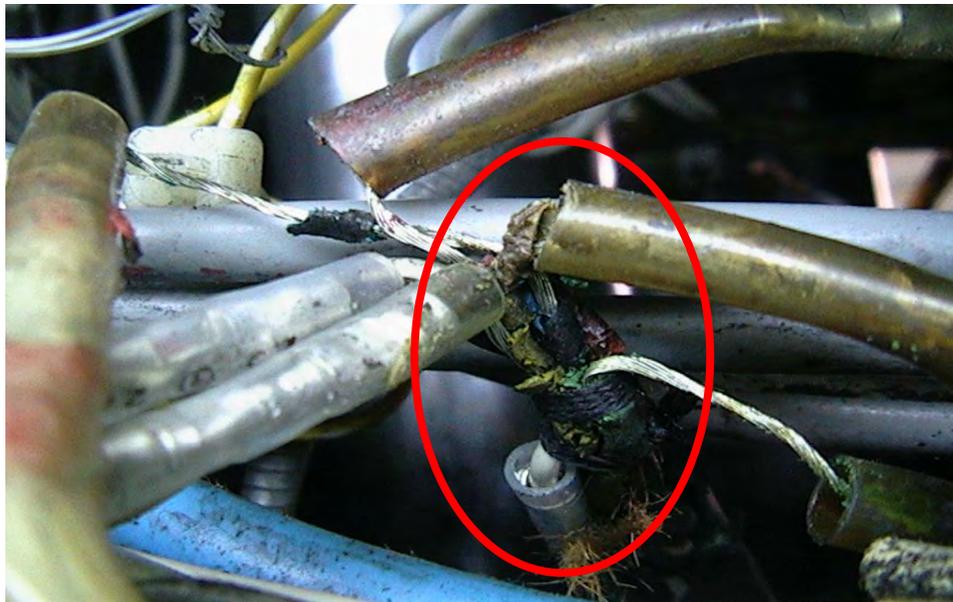
Figure 670. Pilot Yoke Interphone Insulation Brittle and Broken

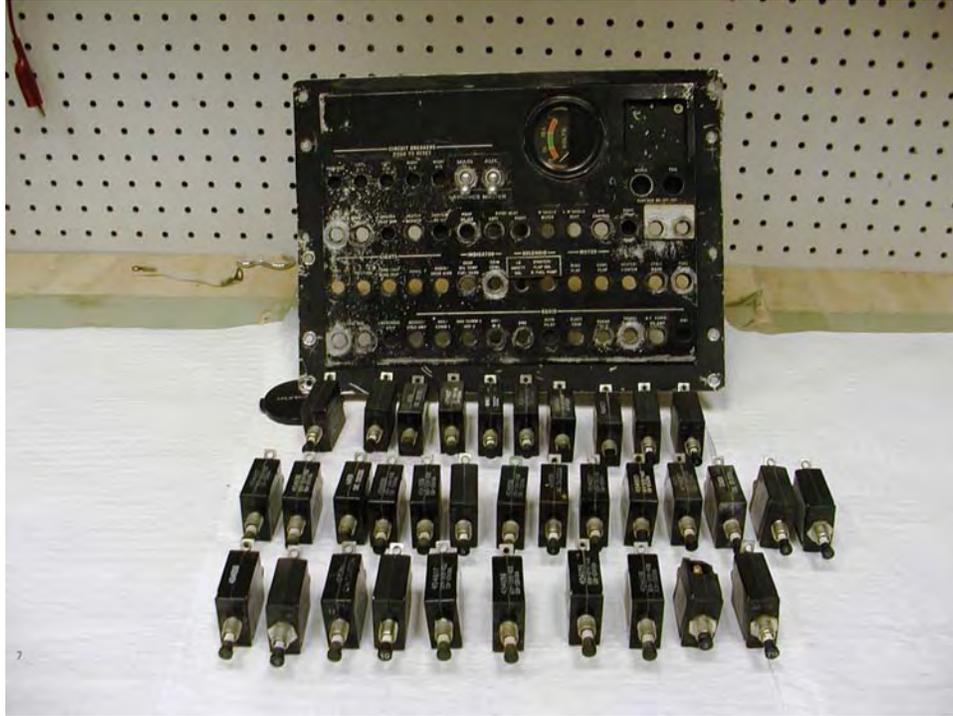
Figure 671. Circuit Breaker Panel and Removed Circuit Breakers

Circuit breakers are specifically designed to protect airplane wiring. A circuit breaker will trip off when the current going through it exceeds its rating, which provides primary electrical protection. The functionality of each of the Piper Navajo Chieftain circuit breakers was tested during the initial operational checks. The circuit breakers were then removed from the airplane and tested in the laboratory to verify current trip time specifications. Figure 671 shows the circuit breaker panel and the removed circuit breakers that were tested.

As seen in table 47, for 200% overload, the initial test (test 1) shows that 6 out of 29 (20.5%) of the functional breakers failed to trip within the specified time of 22 seconds. Three (10%) of the circuit breakers had open-circuit faults, a failure in a safe manner, which was also considered nonfunctional when calculating the percent of circuit breakers out-of-spec. As seen in table 48, for 300% overload, the initial test (test 1) shows that 3 out of the 24 (12.5%) functional circuit breakers failed to trip within the specified time of 6 seconds. After test 4, 5 out of 28 (18%) functional circuit breakers (a few began to work when cycled) failed to meet timing specifications, and at the end of the tenth test only one out of 28 (4%) of the circuit breakers did not meet specifications. Five out of 28 (18%) had open-circuit faults (test 1), which is a failure in a safe manner.

Table 46 provides a list of circuit breakers subjected to testing. The table includes the manufacturer's part number, the current rating of the circuit breaker, the condition of the breaker, and what system the circuit breaker was used for. Even though there were 35 circuit breakers on the panel, only 33 were tested because two circuit breakers (numbers 26 and 33) were defective and did not function.
