DOT/FAA/AR-98/22

FAA T53-L-13L Turbine Fragment Containment Test

June 1998

Final Report

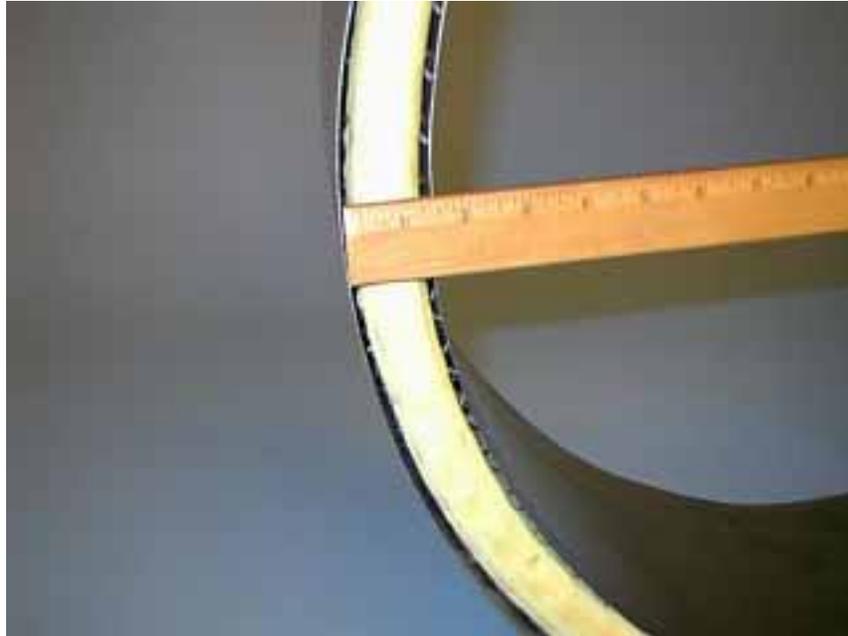
FIGURE 1. CONTAINMENT RING SECTION

The containment ring was developed and fabricated by Pepin Associates Inc. The ring was fabricated with a 0.014-inch titanium inner and outer sleeve. One-inch-thick Kevlar 29 ballistic fabric made up the primary structure of the containment ring. The ring was strengthened with titanium rods which were inserted through the fabric and laser welded to the inner and outer sleeves (figure 1). The ring weighed approximately 25 lbs. The containment ring was installed on the test engine and loosely connected to the engine case. The ring was centered on the second stage power turbine.

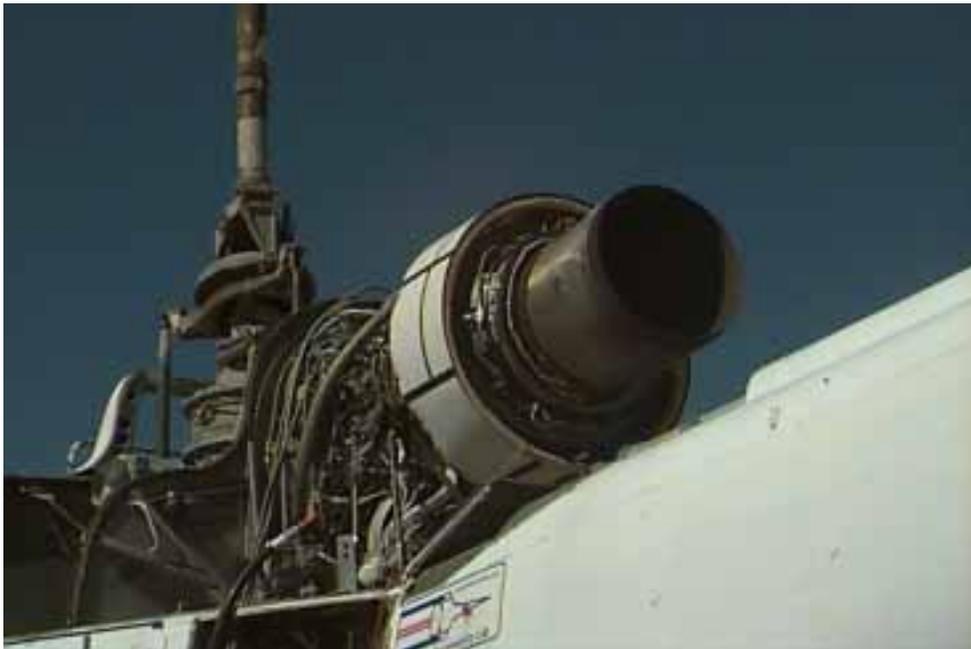
FIGURE 2. PRETEST INSTALLATION

The T53 engine was then installed in an UH-1 Huey helicopter (figure 2). The helicopter was mounted on two 2-foot-thick cement blocks and cabled down to three 1-foot-thick cement blocks (figure 3). The rotor head was removed to simplify the test setup and preparation. The engine was remotely started and operated. An emergency shutoff valve was located near the engine interface.

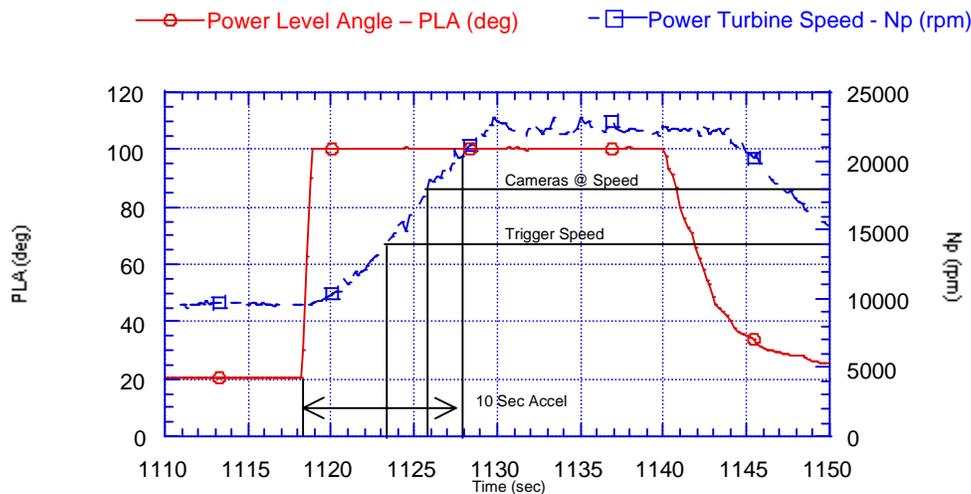
FIGURE 4. ENGINE ACCELERATION CALIBRATION

Even though the disk was notched, there was no way of determining exactly when or at what speed the disk would fail. To capture the event on high-speed film, a speed trigger circuit was used. There were approximately 8 seconds of film at a camera speed of 4000 pictures per second, 2.5 seconds of which were used as the cameras came up to speed. Prior to installing the test engine, a second engine was tested to determine the power turbine acceleration time from idle to maximum (figure 4). Multiple runs were conducted, and it was determined that the acceleration from idle to maximum was approximately 10 seconds. Idle speed was approximately 10,400 rpm and maximum was 22,500 rpm. Based on the engine acceleration times and the target rupture speed (20,400 rpm) and considering the camera time required to come to speed, a trigger speed of 14,000 rpm was chosen.

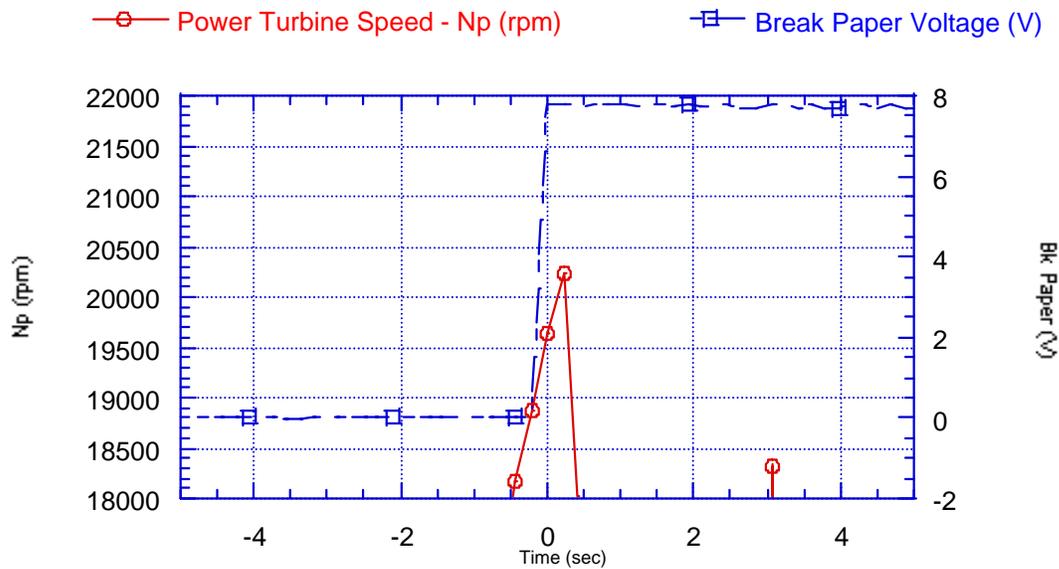
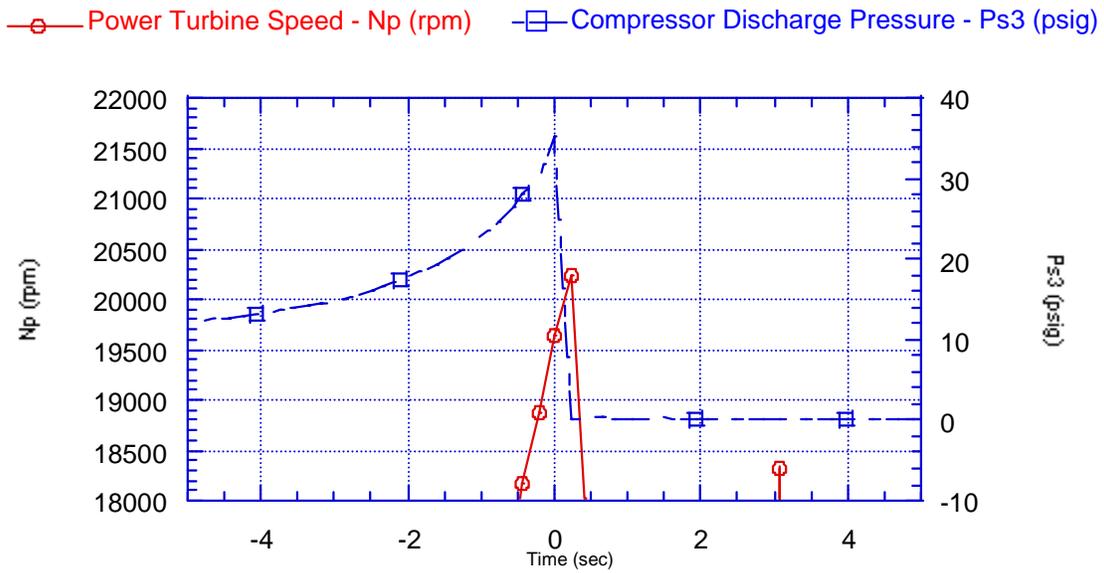
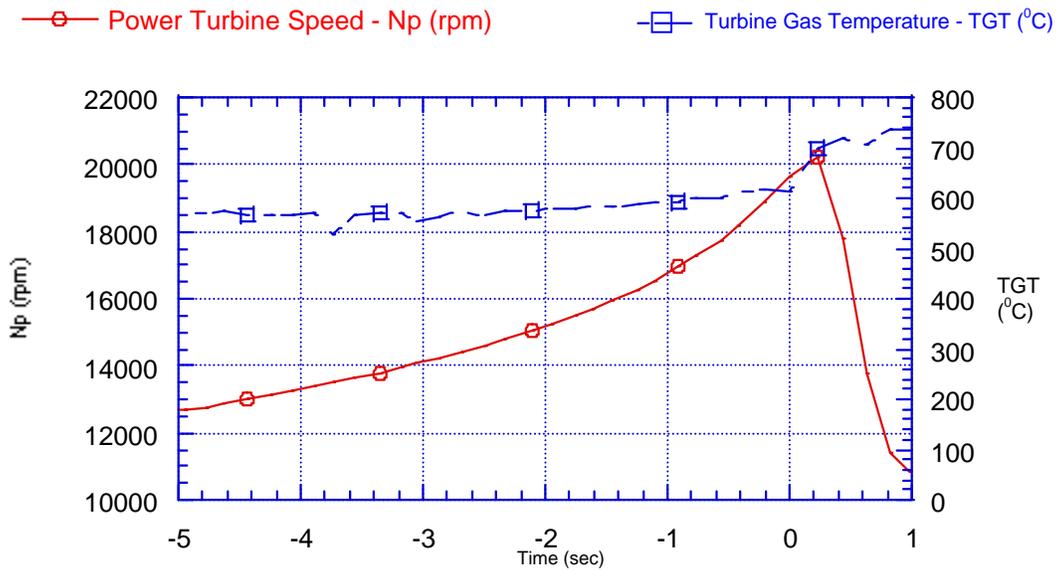
The test was completed as planned. The cameras were triggered as N_p passed through 14,000 rpm. The disk released at 19,629 rpm. Test data are provided in figures 5 through 7. The disk ruptured into three nearly equal sections that were contained by the containment ring. The outer titanium shell split due to the tensile load resulting from the disk fragments pulling the Kevlar into a triangular shape. All three disk fragments penetrated the engine combustor case. The fuel lines located between the containment ring and combustor case were penetrated, resulting in a small fire. Secondary blade fragments exited the engine exhaust nozzle and a few fragments
