Evaluation of Wind-Loading on Airport Signs

Keith Bagot

June 2000

DOT/FAA/AR-TN00/32

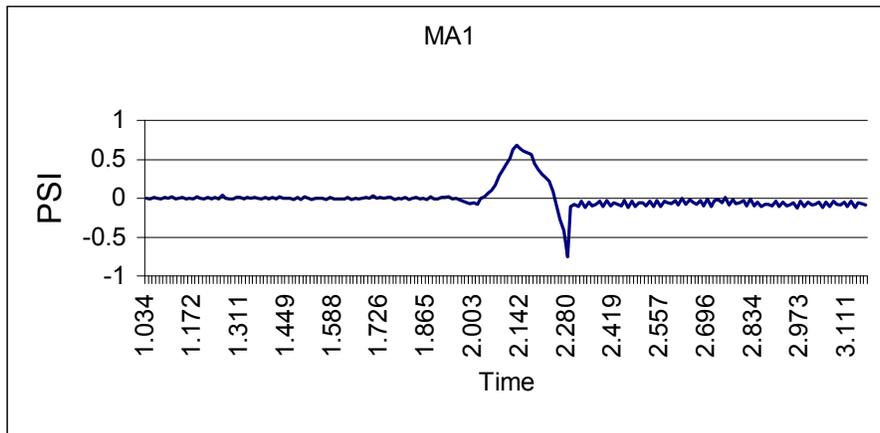
FIGURE 13. PRESSURE GAUGE ON SIGN FACE, MA1

The data also showed that the sign failed at the frangible point (couplings) under a load of only approximately 0.62 psi; which is less than the minimum frangibility requirements of the Advisory Circular. Moreover, the failure appeared to occur within the elastic limits of the laboratory tested couplings. It should be noted that the loading was applied to the sign over a time frame of less than 0.05 second, almost 200 times faster than in the laboratory tests. Although the measured wind speed was only 14.95 and 19.43 mph respectively, the data are considered to be unreliable since it was measured with a mechanical device that is not capable of providing accurate measurements over such a short period of time.

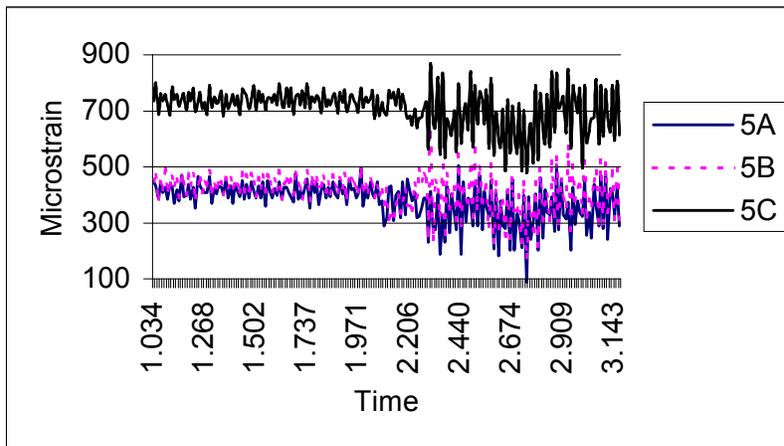
FIGURE 17. STRAIN GAUGE CLUSTER ON SIGN FACE, 5A, B, C

The sign was installed and data were collected for 3 months before the first sign was destroyed by the jet blast of a B747-200 which rotated adjacent to the sign. The sign failed at the frangible couplings as intended. The sign couplings broke between 2.12 and 2.13 seconds into the incident, which was consistent with the data obtained from the strain gauges on each of the couplings (MA1 and MA2). The force (from the wind) increased for 0.7 second; however, during the first 0.12 second of increased wind velocity, the measured force on coupling MA1 rose to 3,000 ft-lb. and dropped to zero. Similar conditions were observed on coupling MA1, 2248 ft-lb. and dropping to zero, within one hundredth of a second. Readings from the pressure and strain gauge clusters on the face (5A, B, C and 10A, B, C) of the sign did not record any significant change during the event.
