Shearographic Inspection of a Boeing 737

July 1992

DOT/FAA/CT-TN92/19

An inspection for disbonds was conducted on a Boeing 737-200 aircraft at the carrier's repair station at Winston-Salem, NC, from August 21 to 23, 1991. The inspection concentrated on comparing the effectiveness of shearography with currently mandated methods in detecting disbonds in the fuselage.

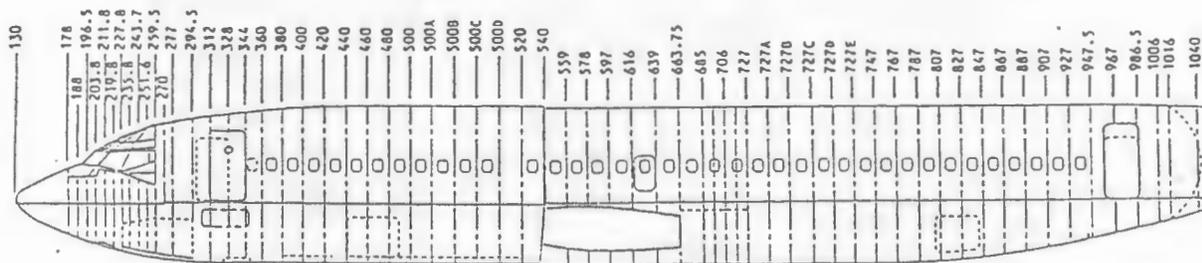
Figure 3 Body Station Template for Recording Inspection Results

The inspection was performed in accordance with a procedure jointly prepared by the FAA Technical Center and the Volpe center (see Appendix B). Data were recorded on a Body Station Template (Figure 3) by referring to the Boeing Structural Repair Manual (Appendix C).
