Mark 20 Category II/III Instrument Landing System Operational Test and Evaluation, Functional and Performance Test Report

DOT/FAA/CT-TN95/44

U.S. Department of Transportation
Federal Aviation Administration
Technical Center
Atlantic City Airport, NJ 08405

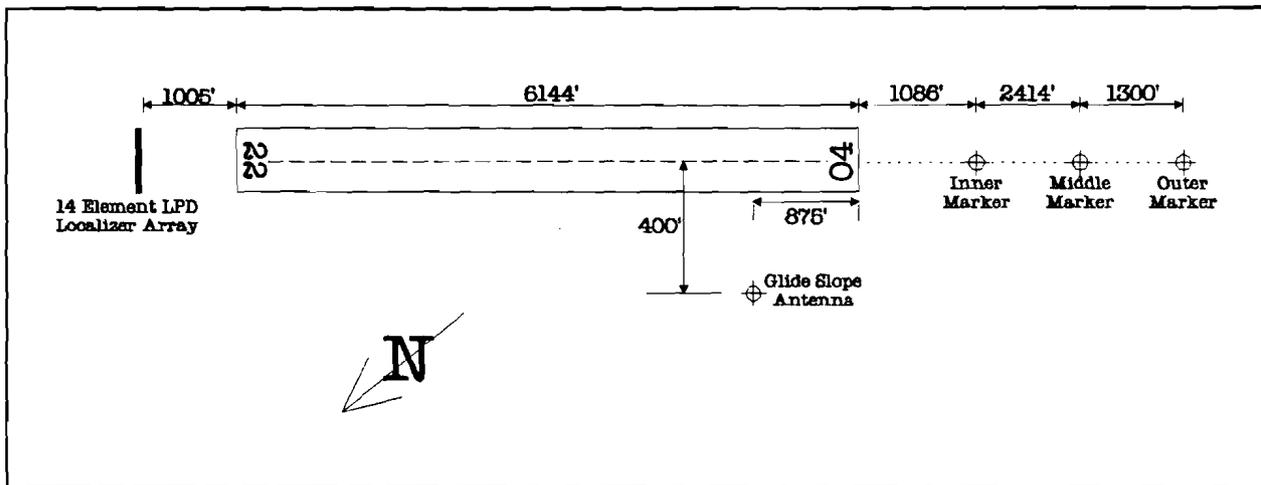
FIGURE 1. MARK 20 ILS OT&E TEST SETUP

antenna array, and an RF distribution and combining unit. The glide slope antenna array is set back 875 feet from the threshold of ACY runway 04 with a Northwest offset of 400 feet from the runway centerline (figure 1).

The marker beacons are a VHF system consisting of an inner marker, middle marker, and outer marker. Each marker beacon includes a single transmitter, single monitor, and a single Yagi antenna element for the inner and middle marker, and a dual Yagi antenna configuration for the outer marker. Each marker beacon is configurable to perform as an inner, middle, or outer marker. The inner, middle, and outer marker antennas are located 1,086 feet, 3,500 feet, and 4,800 feet from the ACY runway 04 threshold, respectively. Due to property restraints, the outer marker was not positioned in a normal operating location. The inner marker is located on the extended runway centerline, the middle marker is offset by 15 feet, and the outer marker 41 feet, both to the Northwest side of the extended centerline (figure 1).

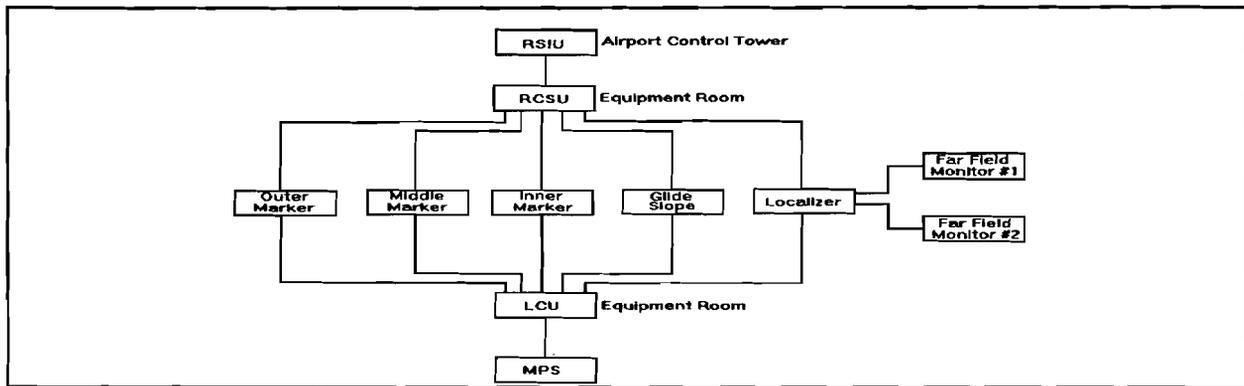
FIGURE 2. RCSU AND LCU TO SUBSYSTEM CONNECT DIAGRAM

The Remote Indication and Control Equipment (RICE) consists of an RCSU and an RSIU. The RCSU is directly connected to the localizer, glide slope, and each marker beacon (figure 2). Through this connection, transmitter and monitor information for each subsystem is updated constantly at the RCSU. On/off, reset, and FFM bypass control are also provided at the RCSU. The RSIU provides category of operation indication, localizer, glide slope, and marker beacon transmitter status, interlock control and display, and FFM status and bypass control. Power and ILS status are provided to the RSIU from the RCSU. In an operational environment, the RCSU would be located in the airport tower equipment room and the RSIU in the airport control tower cab.

The LCU provides a communications link between the Mark 20 and its associated Maintenance Processing System (MPS). The LCU is directly connected to the localizer, glide slope, and each marker beacon (figure 2). This connection is distinct and separate from the connection from the subsystems to the RCSU. The decoder module running the MPS was developed by FAA/UNISYS and tested by ACN-100D during integration testing at the FAA Technical Center. The MPS is a remote system that is used to monitor all National Airspace System (NAS) facilities that have Remote Maintenance System (RMS) capabilities. Remote control of each subsystem is provided directly from the LCU. An operational LCU would usually be located in the airport tower equipment room. For test purposes, the LCU was located in room 306 of building 301 at the FAA Technical Center.

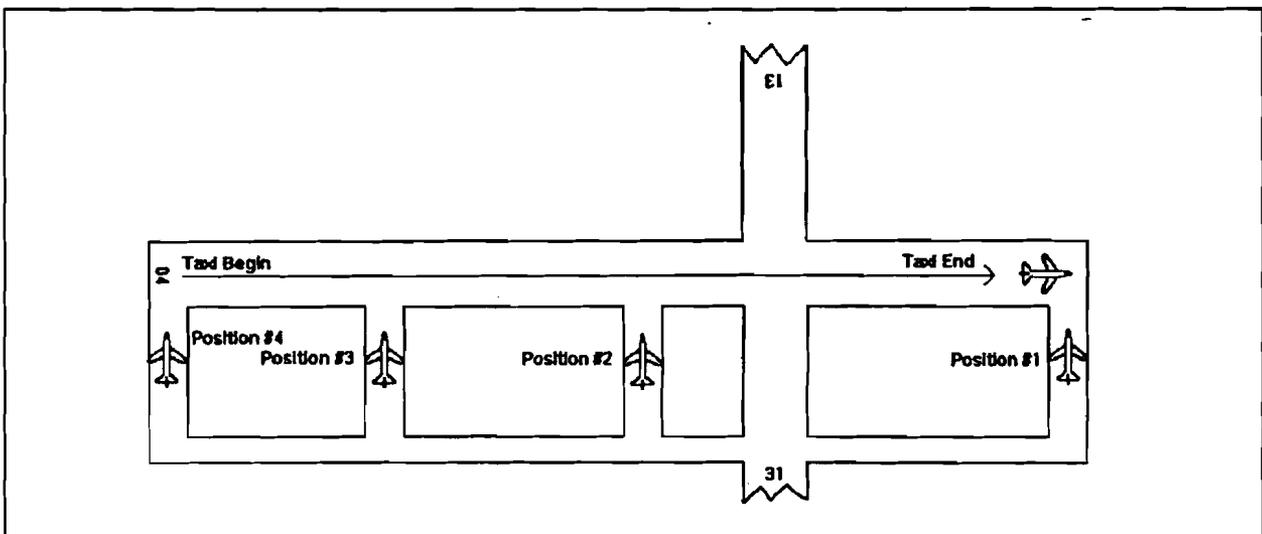
FIGURE 3. LOCATIONS OF B727 WHILE AIRBORNE LOCALIZER APPROACH AND FAR FIELD MONITOR DATA WAS COLLECTED

Localizer approach data was collected by a Convair 580 with a Boeing 727 (B727) located at various test locations along the runway, including the ILS critical area. An approach was flown and airborne data collected while the B727 taxied from the threshold to the stop end of runway 04. A handwritten log was generated to note the time that the B727 had arrived or departed a test location. The test locations are shown in figure 3. The recorded DDM measurements for each FFM are plotted versus time and compared to flight measurements collected while the B727 was located at that position. Any abnormal disturbances discovered in the airborne data that is caused by the presence of the B727, should also be detected by the FFM in higher than normal DDM readings and the appropriate indication at the RSIU.

Table 6 indicates the position of the B727 during testing. Figures 10 and 11 contain DDM values measured by each FFM versus time. FFM 1 is located at the inner marker and FFM 2 at the middle marker. The data collected indicate that minimal interference was detected by the FFMs. The large DDM spikes at 0921.45 and 0954.38 are when the B727 was at the stop end of runway 04 and turning to face the taxiway. The spikes, however, were not of sufficient magnitude to put the FFM into alarm. (The FFM alarm settings were set to ± 0.009 DDM and the spikes were only -0.004 and -0.005 DDM for FFM 1 and 2, respectively.) Airborne data collected indicates that no effect on provided guidance was caused by the presence of the B727 in positions 1, 2, 3, or 4 (figure 3).

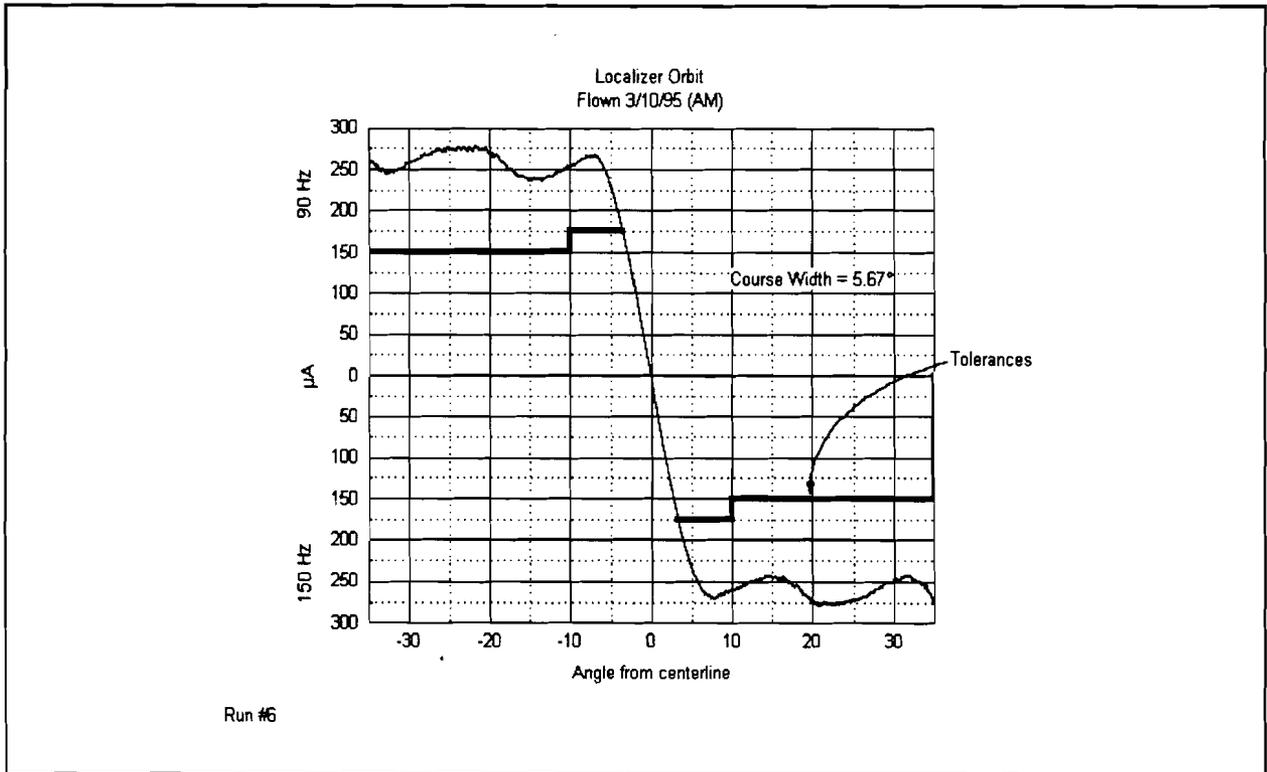
FIGURE 5. LOCALIZER ORBIT

FAA Technical Center flight evaluations met CAT II/III flight inspection criteria. Figure 4 shows a localizer approach. Figure 5 shows a localizer orbit. Figure 6 shows a glide slope approach. Figure 7 shows a glide slope level run.
