DOT/FAA/RD-91/1

Composite Profiles of Helicopter Mishaps at Heliports and Airports

January 1992

Final Report

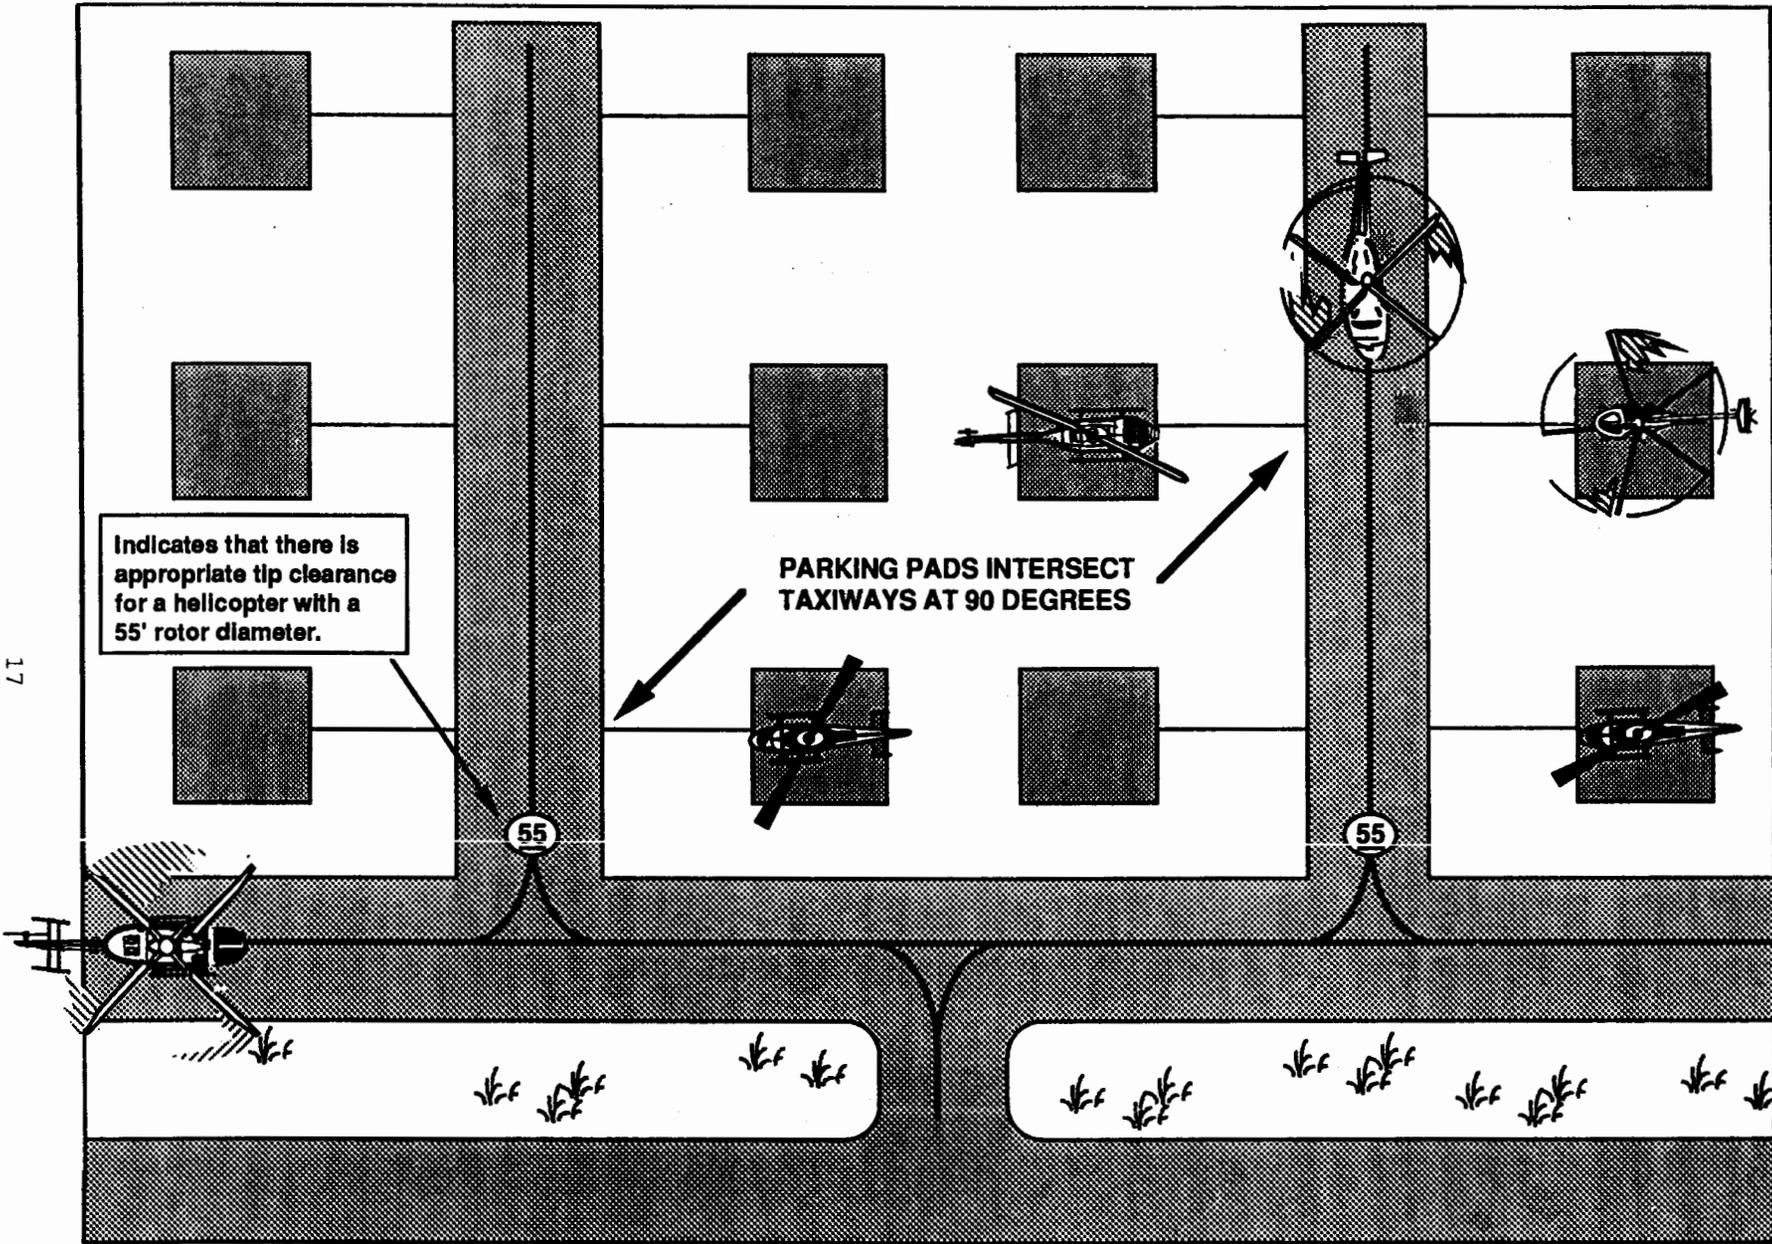
FIGURE 7 IMPROVED HELIPAD AND TAXI LANE ALIGNMENT

Parking Area Layout - The parking area design contributed to this particular mishap. The parking pads were designed to intersect the taxi lane at a 45 degree angle. Therefore, the pilot in this case would have had to look over his right shoulder to insure that no other aircraft was taxiing down the taxi lane from his right. Placing the parking pads at a 90 degree angle to the taxi lane is preferable in order to provide maximum visibility to the pilot. Figure 7 depicts the heliport with design improvements that enhance safety.

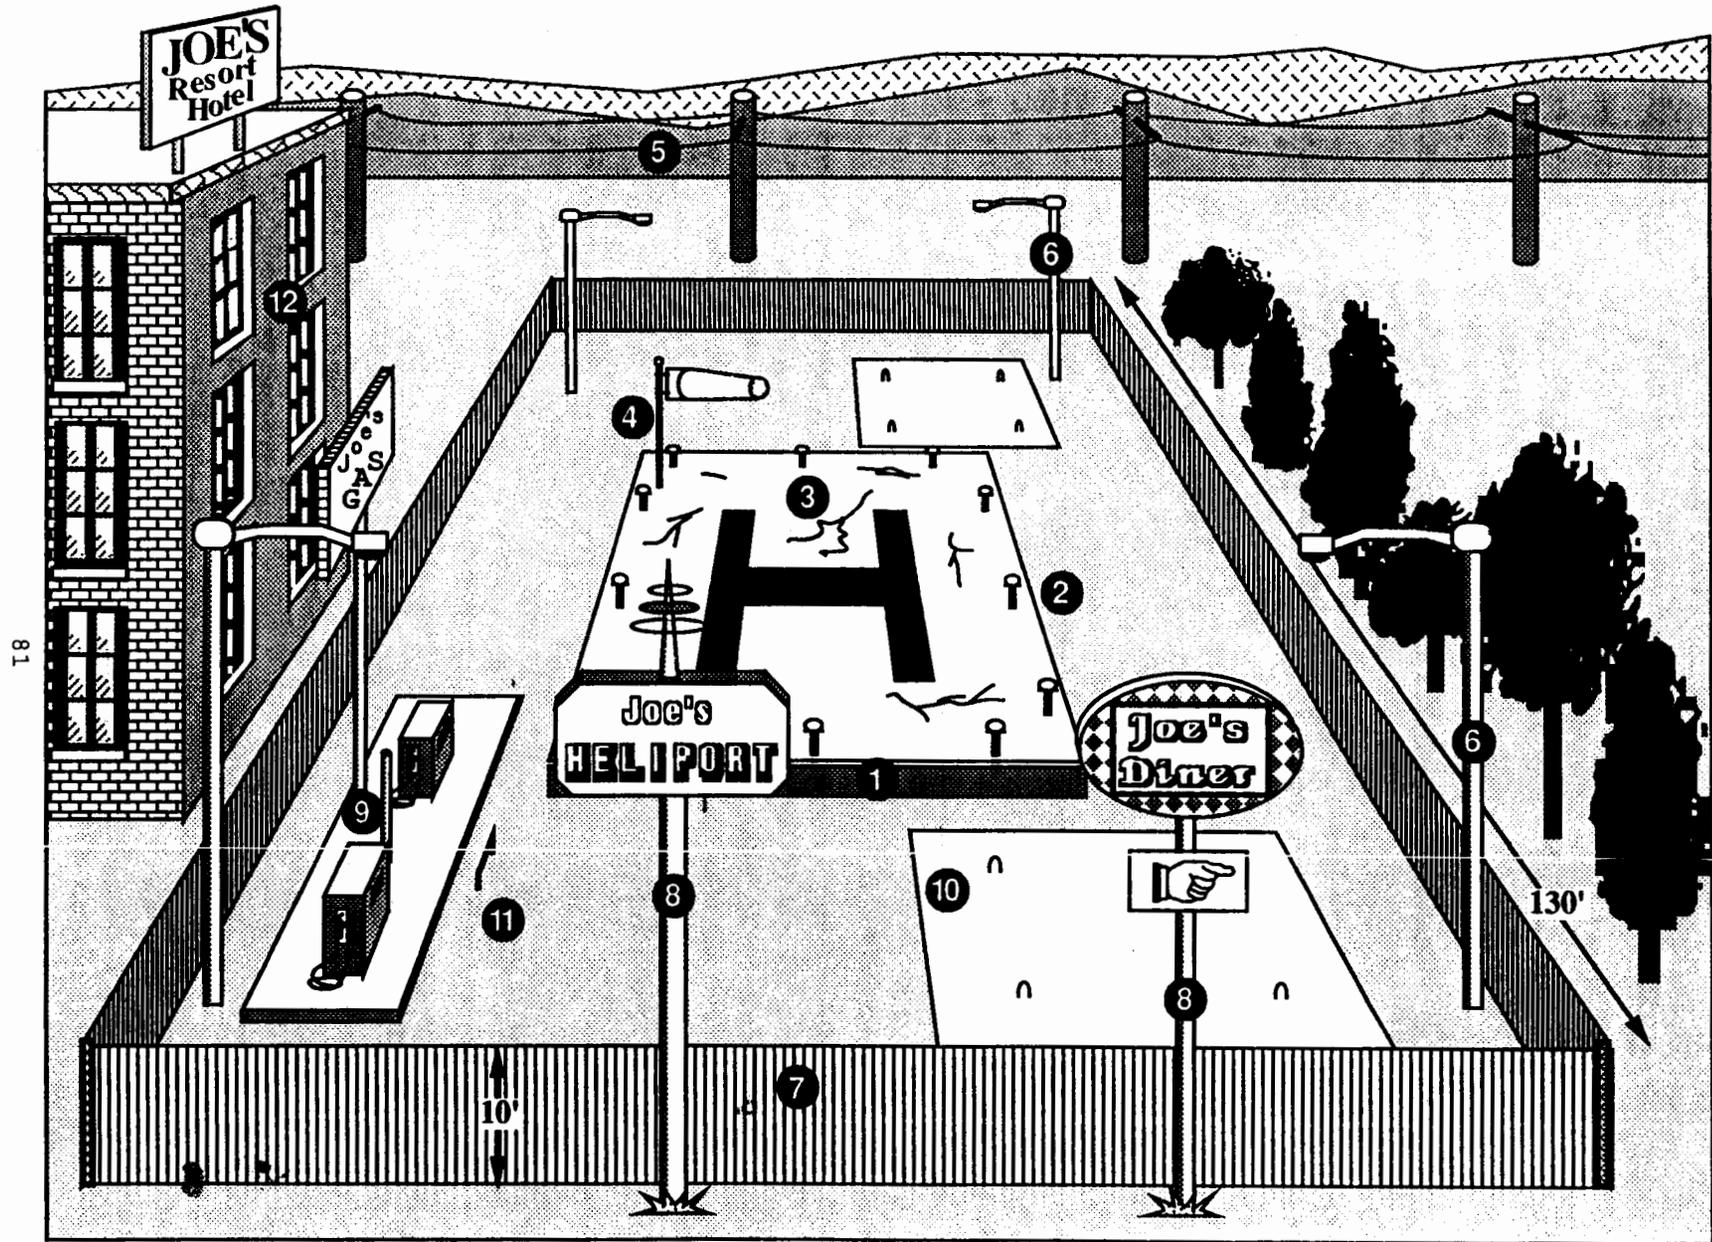
FIGURE 35 PROPOSED HELIPORT DESIGN

Figure 35 is a diagram that was submitted with the heliport approval application. Your assistant has numbered the design features that she thinks may be safety hazards. She also developed table 2 which includes the corresponding number of the items, as well as the items themselves that are of concern to her. Your task is to fill in the description column in table 2 for those items that you feel represent safety hazards. You must also fill out the recommendation letter (figure 36) that your company will send to the county commission. The correct answers are provided in appendix A and appendix B. Good luck!!
