DOT/FAA/AR-00/18

Development of Supplemental Inspection Report for the Fairchild Metro SA226 and SA227 Airplane

April 2000

Final Report

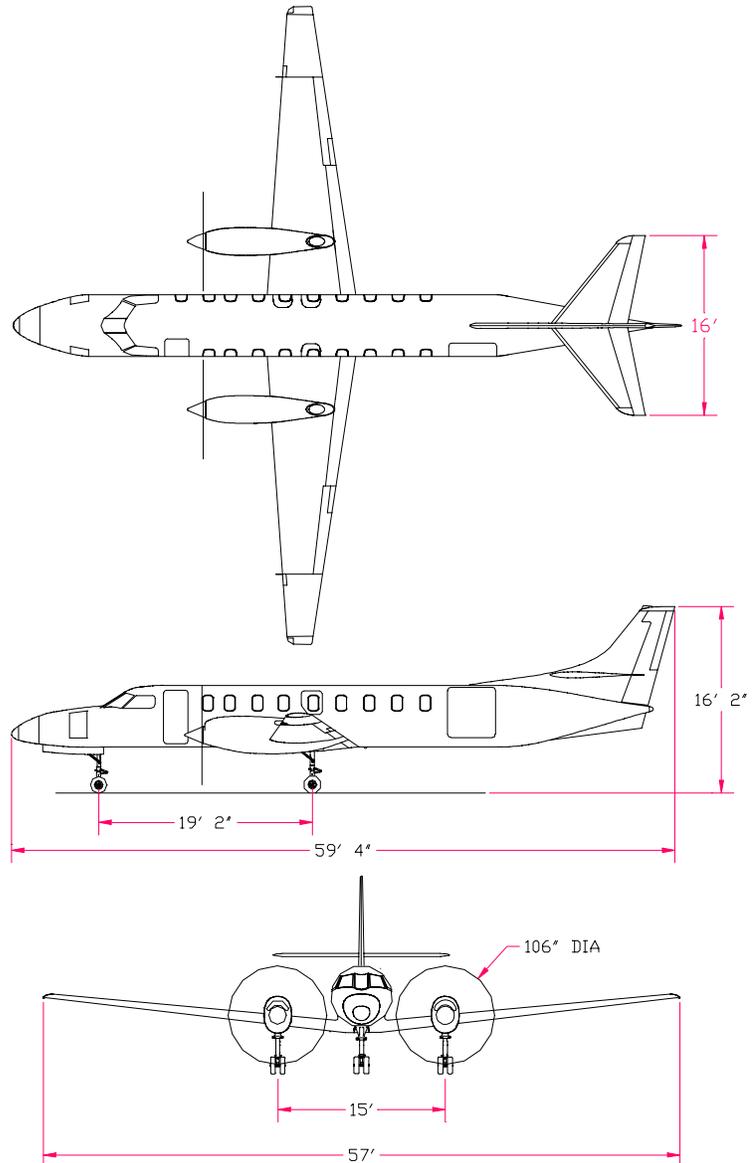
DATA		
<u>BASIC DIMENSIONS</u>		
LENGTH		59' 0"
HEIGHT		16' 8"
SPAN		57' 2"
<u>WING DATA</u>		
AREA:		
WING (TOTAL)		308.1 SQ FT
AILERON (TOTAL)		14.12 SQ FT
FLAP SLOTTED (TOTAL)		40.66 SQ FT
AIRFOIL:		
ROOT	NACA65 A215	
TIP	MODIFIED NACA64 A415	
ASPECT RATIO, AR		10.59
MAC		72.3 IN
SWEEP AT QUARTER CHORD		0.9 DEG
TAPER RATIO		.257
DIHEDRAL (WRP AT 32% CHORD)		5 DEG
ANGLE OF INCIDENCE:		
ROOT		+1 DEG
TIP		-2.69 DEG
GEOMETRIC TWIST		-3.69 DEG
<u>POWERPLANT DATA</u>		
ENGINES:		
TWO AIRESEARCH TPE331-12UA-701G (MAX CONT.)		1100 SHP
PROPELLERS:		
TWO 4 BLADED FULL FEATHERING		106 IN DIA
<u>LANDING GEAR DATA</u>		
MAIN GEAR (DUAL WHEELS)		
TOTAL STRUT STROKE		10 IN
TIRE (TUBELESS)		19.5 X 6.75-8, PLY RATING=10
WHEEL		18 X 5.5
NOSE GEAR (DUAL WHEELS)		
TOTAL STRUT STROKE		8 IN
TIRE (TUBELESS)		18 X 4.4, PLY RATING=10
WHEEL		18 X 4.4
<u>SPECIFICATIONS</u>		
WEIGHTS:		
TAKEOFF WEIGHT		16,500 LBS
EMPTY WEIGHT		8,680 LBS
LANDING WEIGHT		15,675 LBS

ZERO FUEL WEIGHT		14,500 LBS
<u>PERFORMANCE</u>		
SPEEDS:		
$V_{10}=V_C$		248 KNOTS, CAS
V_A		311 KNOTS, CAS
MAX. OPERATING ALTITUDE		25,000 FT
<u>EMPENNAGE DATA</u>		
HORIZONTAL TAIL:		
AREA, TOTAL (INCLUDING FUSELAGE)		75,970 SQ FT
AREA, STABILIZERS (TOTAL)		54.7 SQ FT
AREA, ELEVATORS (TOTAL)		21.27 SQ FT
AIRFOIL SECTION:		
ROOT	MODIFIED NACA66A009	
TIP	MODIFIED NACA63A009	
INCIDENCE	VARIABLE	
DIHEDRAL		0 DEG
VERTICAL TAIL:		
AREA, TOTAL (INCLUDING DORSAL)		56.0 SQ FT
AREA, (VERTICAL STABILIZER)		24.036 SQ FT
AREA, RUDDER		19.38 SQ FT
AREA, DORSAL FIN		10.583 SQ FT
AIRFOIL SECTION		
ROOT	MODIFIED NACA66A009	
TIP	MODIFIED NACA63A009	
AREA, VENTRAL		5.48 SQ FT

FIGURE 1. SA227 BASIC GEOMETRY

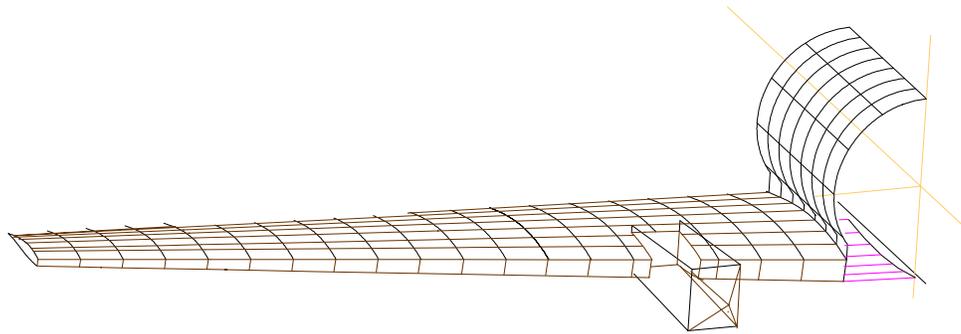
The wing finite element model shown in figure 2 was used to analyze the SA227 wing [1]. The results were checked during the SA227 wing static test [2] and shown to be within about 1% of the measured stress for the more heavily loaded portions of the wing. The finite element model was therefore used as an aid for selecting critical PSE areas and determining stress at locations on the wing other than strain gage locations.

FIGURE 2. SA227 WING FINITE ELEMENT MODEL

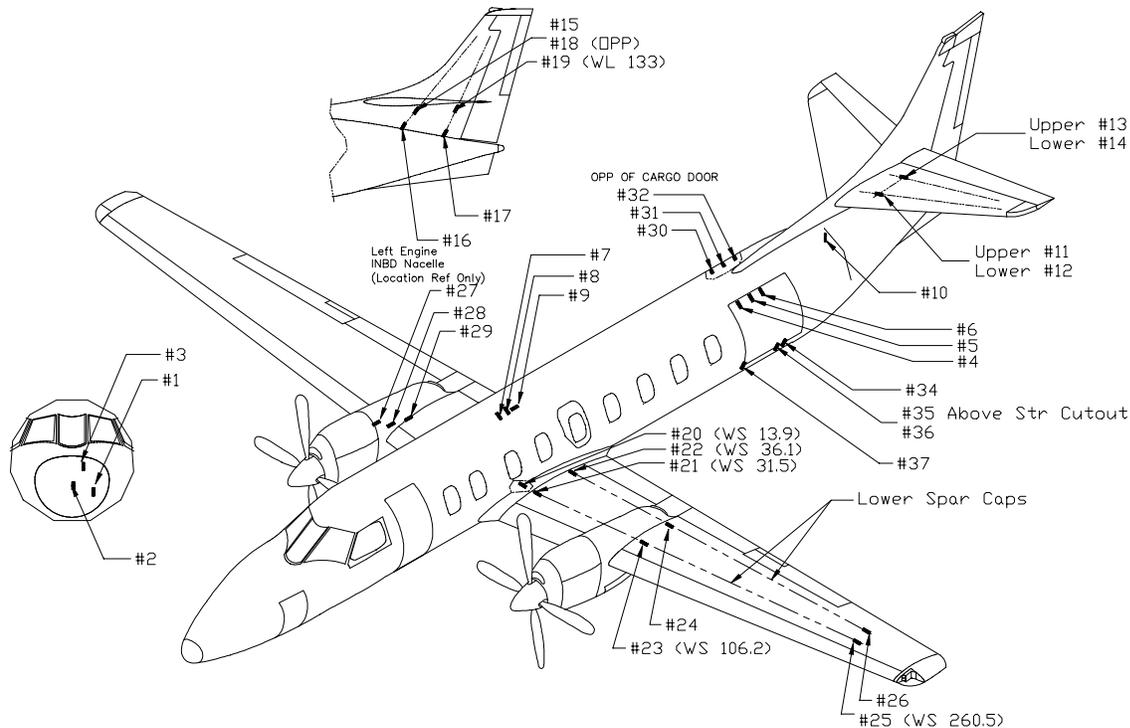
In support of the SID program, an SA227-DC aircraft was instrumented to measure strains at numerous locations during typical flight maneuvers. The details and results of these flight tests were reported at length in reference 3. Figure 3 shows the strain gage locations.

FIGURE 3. STRAIN GAGE LOCATIONS

Figure 3 in section 2.2.2.1 showed the locations of strain gages used to measure stresses on the aircraft during typical flight maneuvers. This data was used to help transform flight loads to stresses at critical areas of the principal structural elements. Further discussion of the methods and results of the strain survey is available in reference 3.

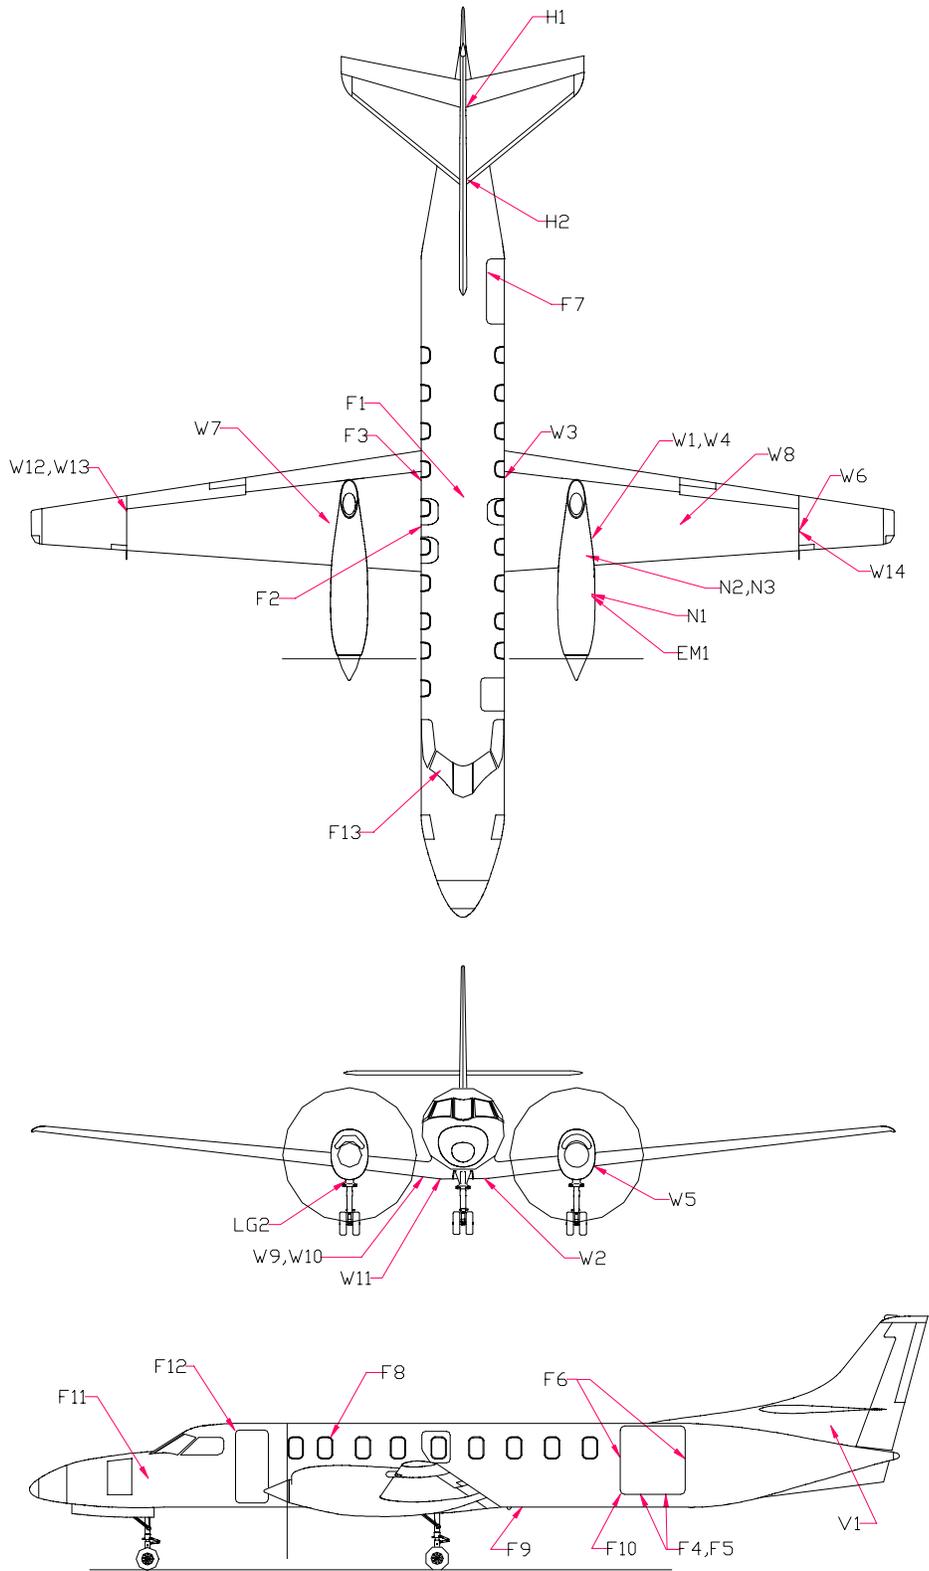
Table 4 presents the PSE critical areas selected for damage tolerance analysis. Figure 4 shows the locations of the critical areas. They are also depicted in reference 3.

FIGURE 4. LOCATIONS OF CRITICAL AREAS

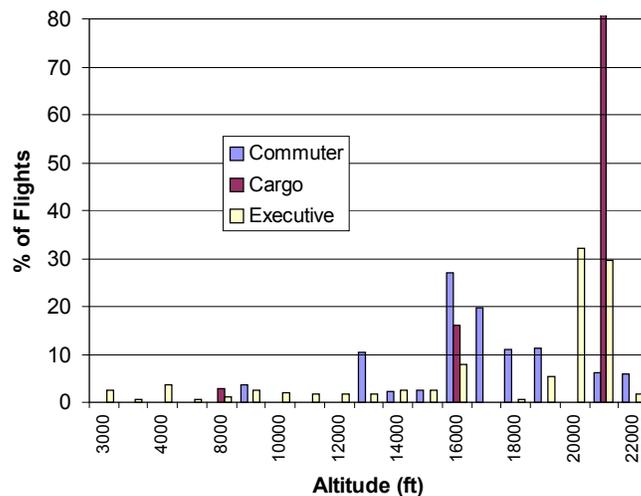
FIGURE 5. CRUISE ALTITUDE FREQUENCIES

The surveys covered a total of 70 aircraft and 871 flights: 32 aircraft and 535 flights with two commuter operators, 31 aircraft and 248 flights with a cargo operator, and 7 aircraft and 190 flights with an executive operator. Table 5 and figures 5 and 6 summarize the findings of the surveys. The complete set of data is provided in reference 3.

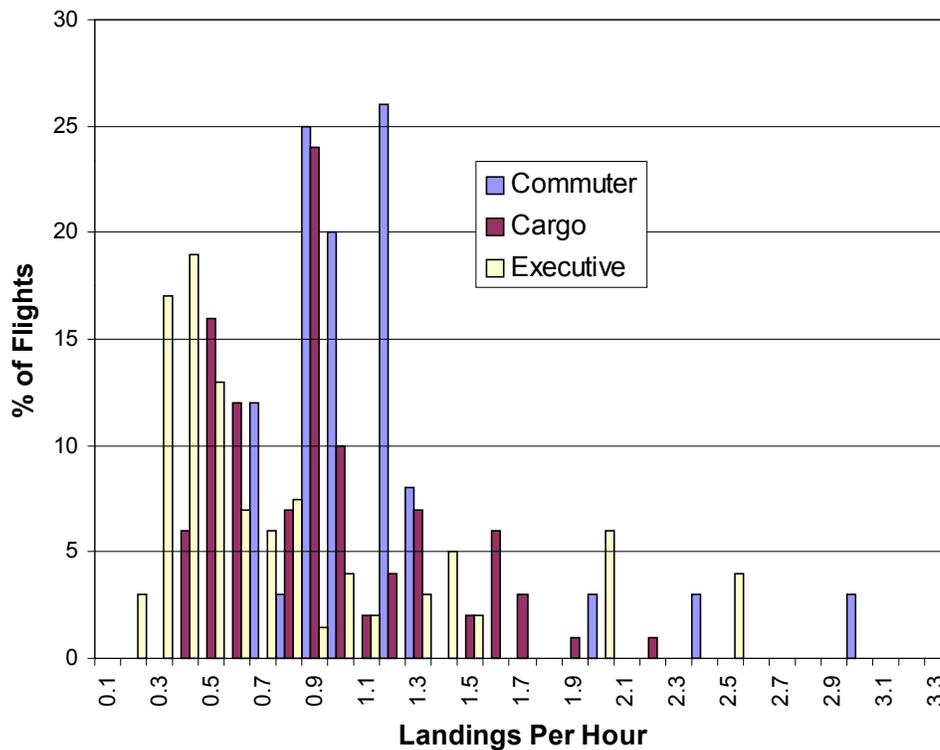
FIGURE 6. LANDINGS PER HOUR DISTRIBUTION

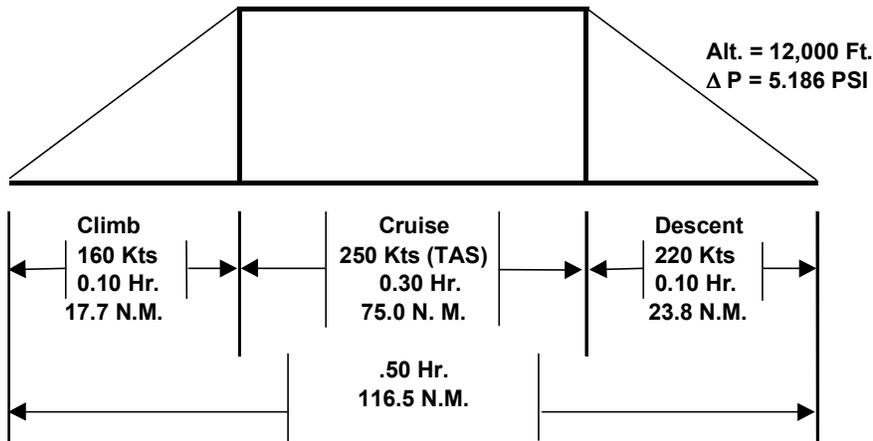
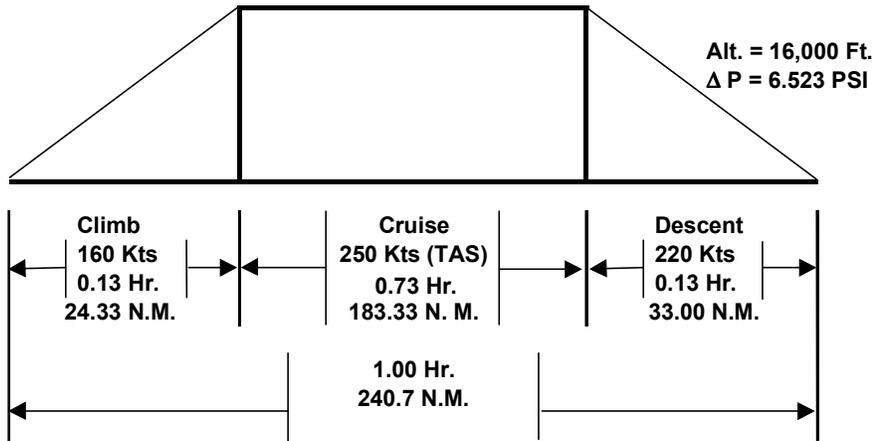
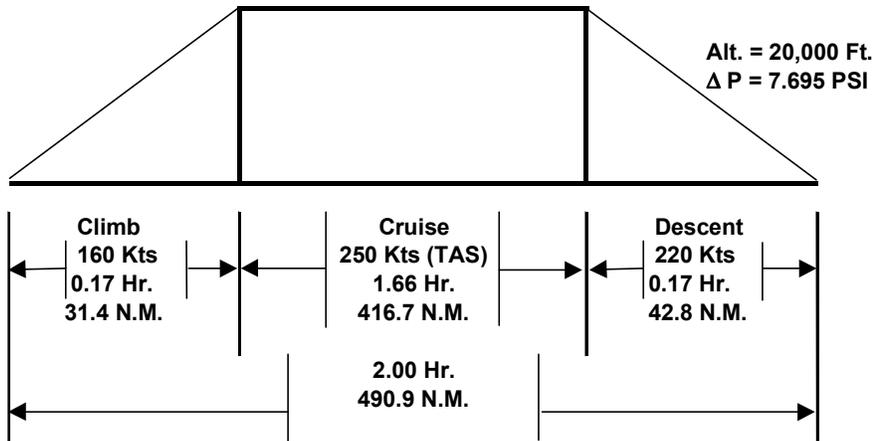
After reviewing the flight length, cruise altitude, and takeoff weight data of surveyed aircraft, three profiles were developed to represent flights typical of the three types of operation (commuter, cargo, executive). Table 6 shows the mission parameters and figure 7 illustrates the flight profiles.

FLIGHT PROFILE - COMMUTER

FLIGHT PROFILE - CARGO

FLIGHT PROFILE - EXECUTIVE

FIGURE 7. SA227 FLIGHT PROFILES

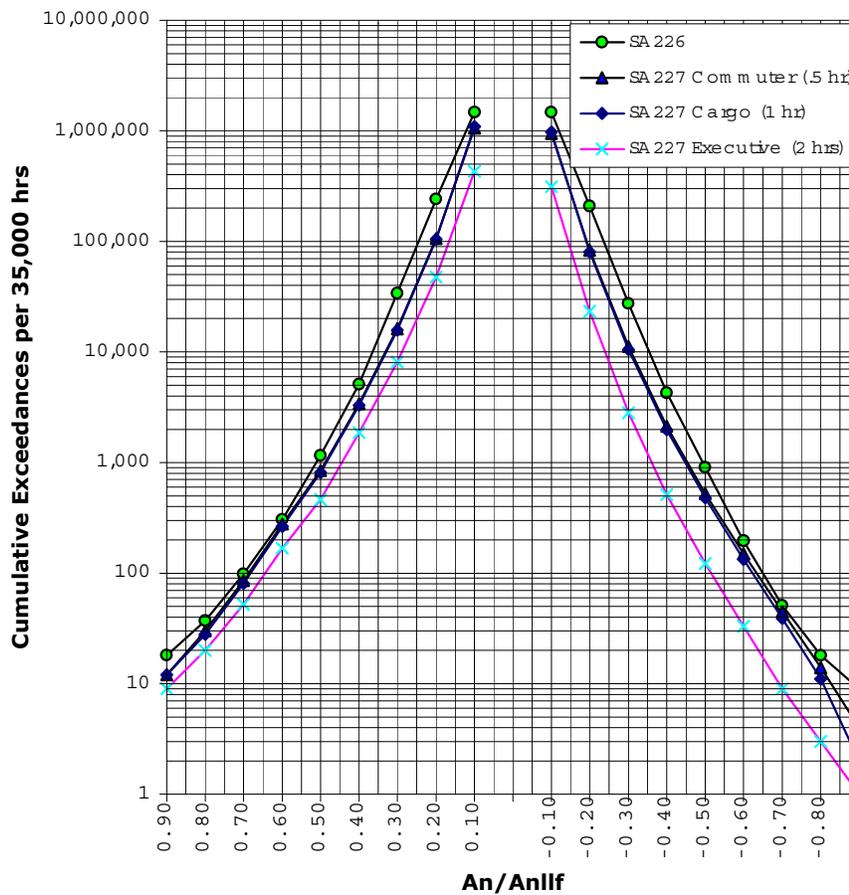
Figure 8 shows the gust and maneuver load spectra for the SA226 and each of the three SA227 mission profiles.

FIGURE 8. GUST AND MANEUVER LOAD SPECTRA

While performing the crack growth analyses it was noticed that the gust and maneuver spectra had the most effect on the rate of growth; whereas the landing and taxi spectra had relatively little effect.

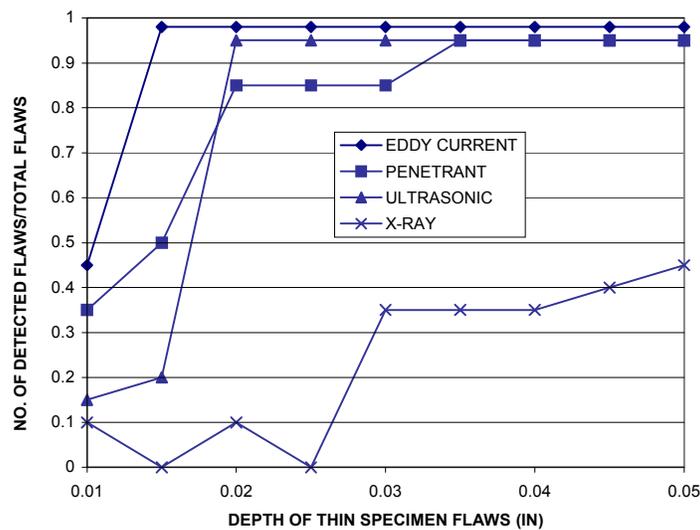
Figure 9, reproduced from reference 12 page 4-85, shows probability of detection for uncovered flaws in thin aluminum. Table 11 lists quoted minimum detectable crack sizes from specific installations in the Cessna 402 [13]. Reference 14 gives the following formula for detectable crack size of surface eddy-current probes: Detectable Crack Length = (Fastener Head DIA – Fastener Shank DIA) / 2 + Coil DIA

FIGURE 9. SAMPLE CRACK DETECTION PROBABILITY CURVES

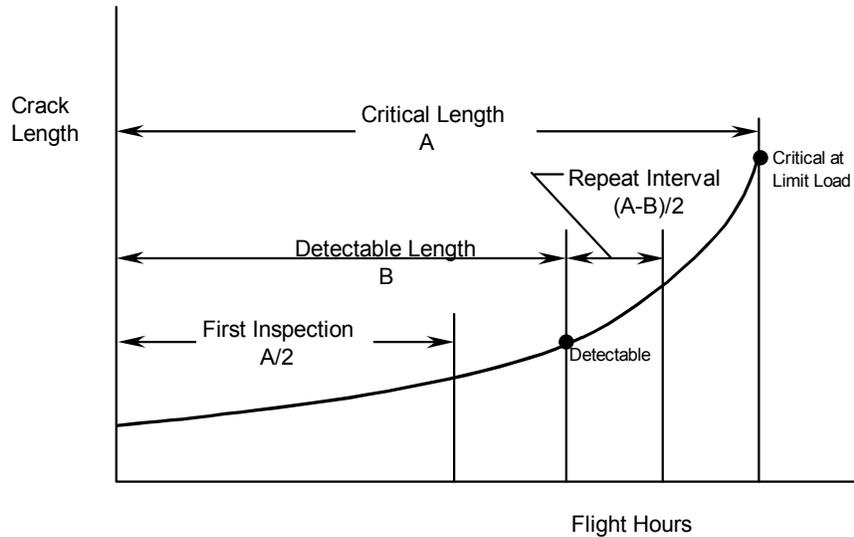
The recommended repeat inspection intervals for each PSE are presented in the SA226 and SA227 SID [16]. Figure 10 summarizes how the inspection intervals were obtained based on crack growth analysis. Scatter factors of 2 are assumed.

FIGURE 10. INSPECTION INTERVAL AND CRACK GROWTH CURVE RELATIONSHIP

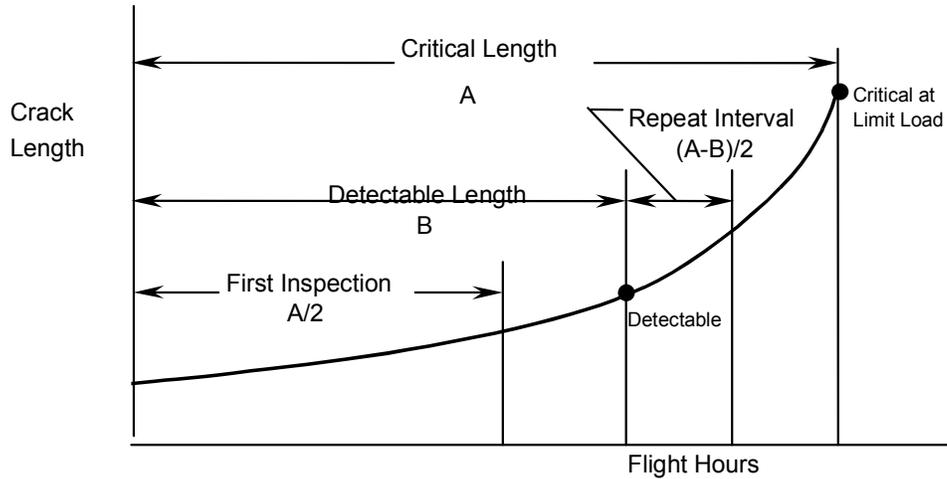
Initial inspections were based on the shorter of analytical crack growth curves, fatigue test results, or service experience. Where analytical crack growth was used, the initial inspection was set at $c_{crit}/2$, where c_{crit} is the crack size at which the structure can no longer support limit load. The initial crack size was assumed to be 0.05 inch in most cases. Figure 2 shows a typical crack growth curve and the inspection intervals determined therefrom.

Figure 2. Typical Crack Growth Curve

A very important part of the SID program is selecting and evaluating state-of-the-art nondestructive inspection (NDI) methods applicable to each PSE and determining a minimum detectable cracks length, c_{det} , for each NDI method. The minimum detectable crack length is used in conjunction with the critical crack length, c_{crit} , to define the life interval for the crack to grow from c_{det} to c_{crit} . This interval, $(c_{crit}-c_{det})/2$, is used to define the repeat inspection frequency for the SID program's required inspections. The threshold inspection generally occurs at $c_{crit}/2$. For a given NDI method and PSE, c_{det} corresponds to a crack size with 90% probability of detection. An example of repeat and initial inspection interval determination is shown in Figure 2.

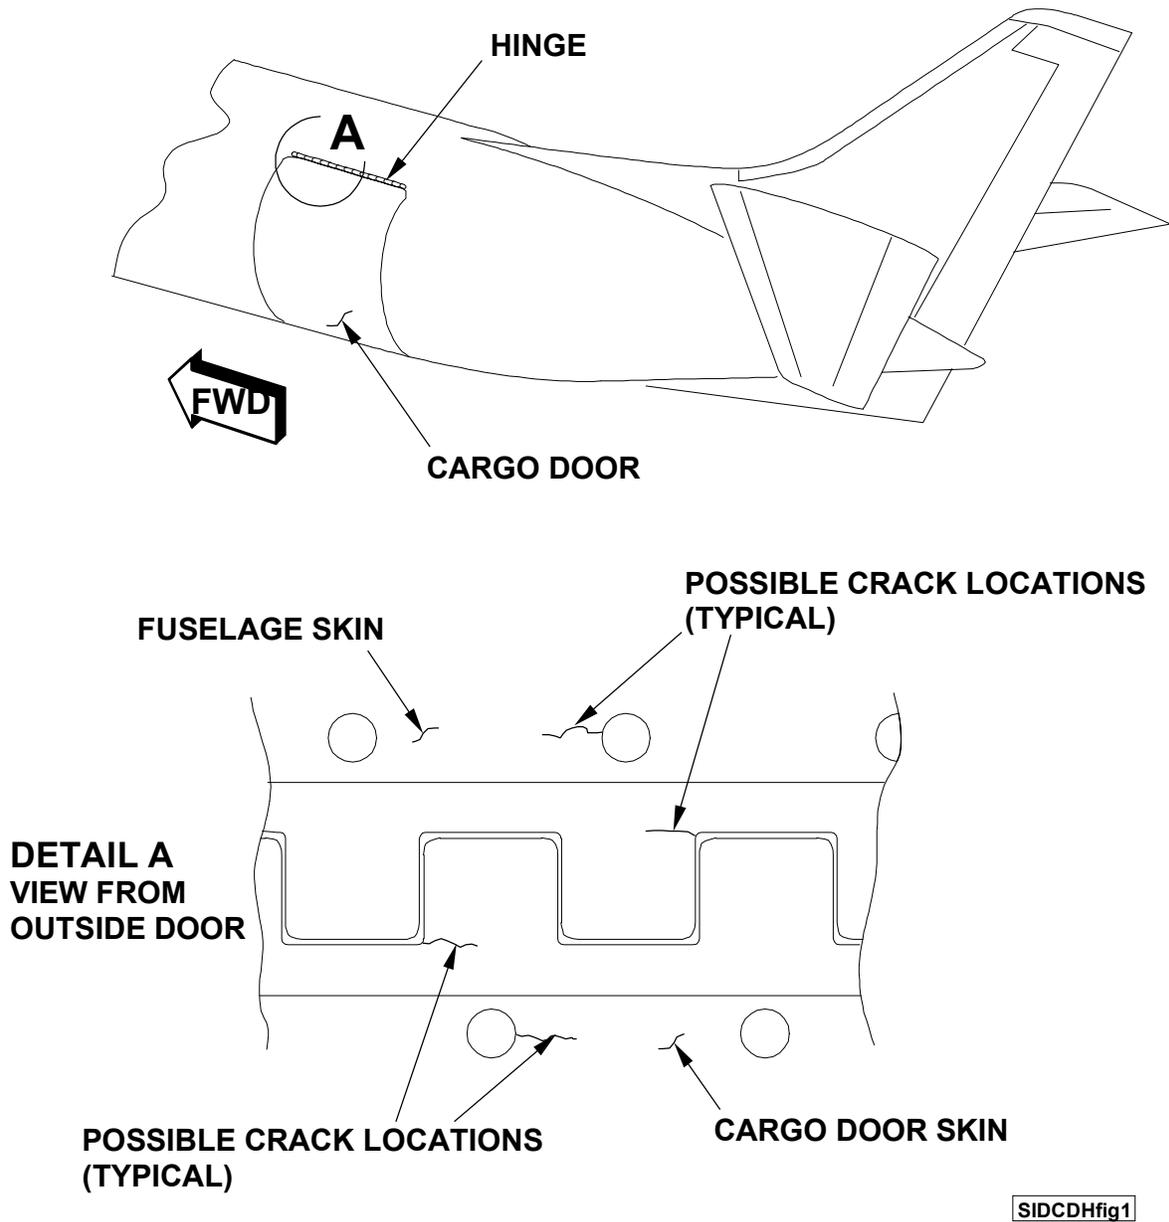
SIDCDHfig1

1. Adhere to procedures for Eddy-Current Inspection given in the SA226/227/227CC Structural Repair Manual, Chapter 51-30-07.
2. Refer to Figure 1. Inspect the hinge tabs and around fastener holes along the length of the hinge. Inspect the top piece (on fuselage) and bottom piece (on cargo door). Observe the phase and amplitude changes on the instrument.
3. Cracks are most likely to occur near the ends of the hinge.
4. If an indication is noted, carefully repeat the inspection pass in the opposite direction to verify the indication.
5. All cracks detected shall be reported to Fairchild Service Engineering. Report the location, direction, and length of each crack.

Figure 1. SA226/SA227 Cargo Door Hinge

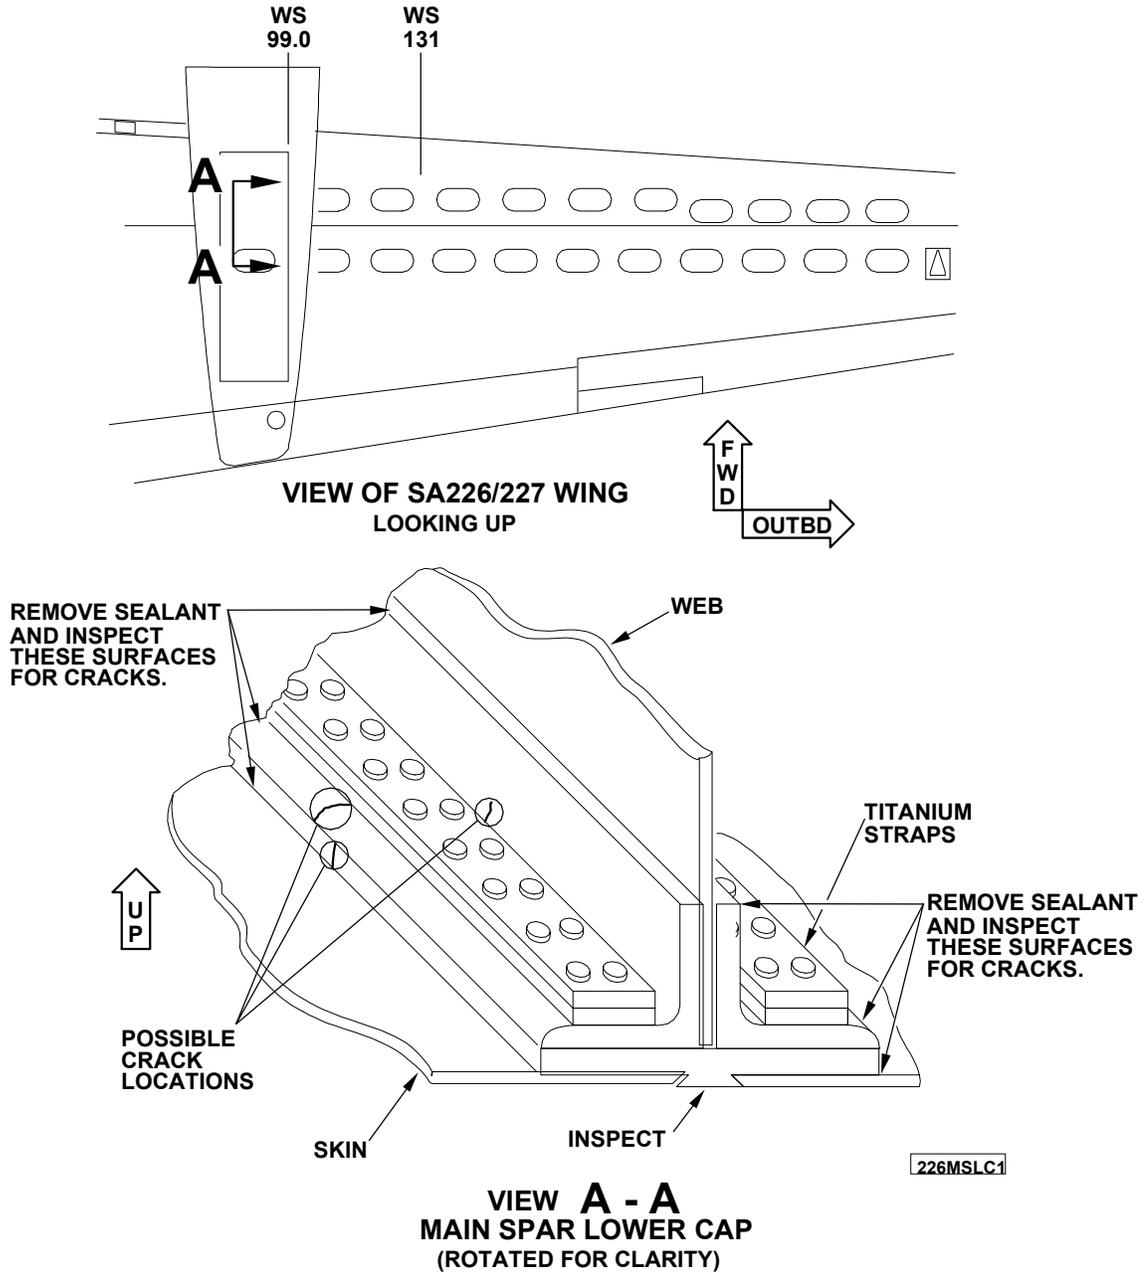
FIGURE 1. SA226/227 WING MAIN SPAR LOWER CAP WS 99

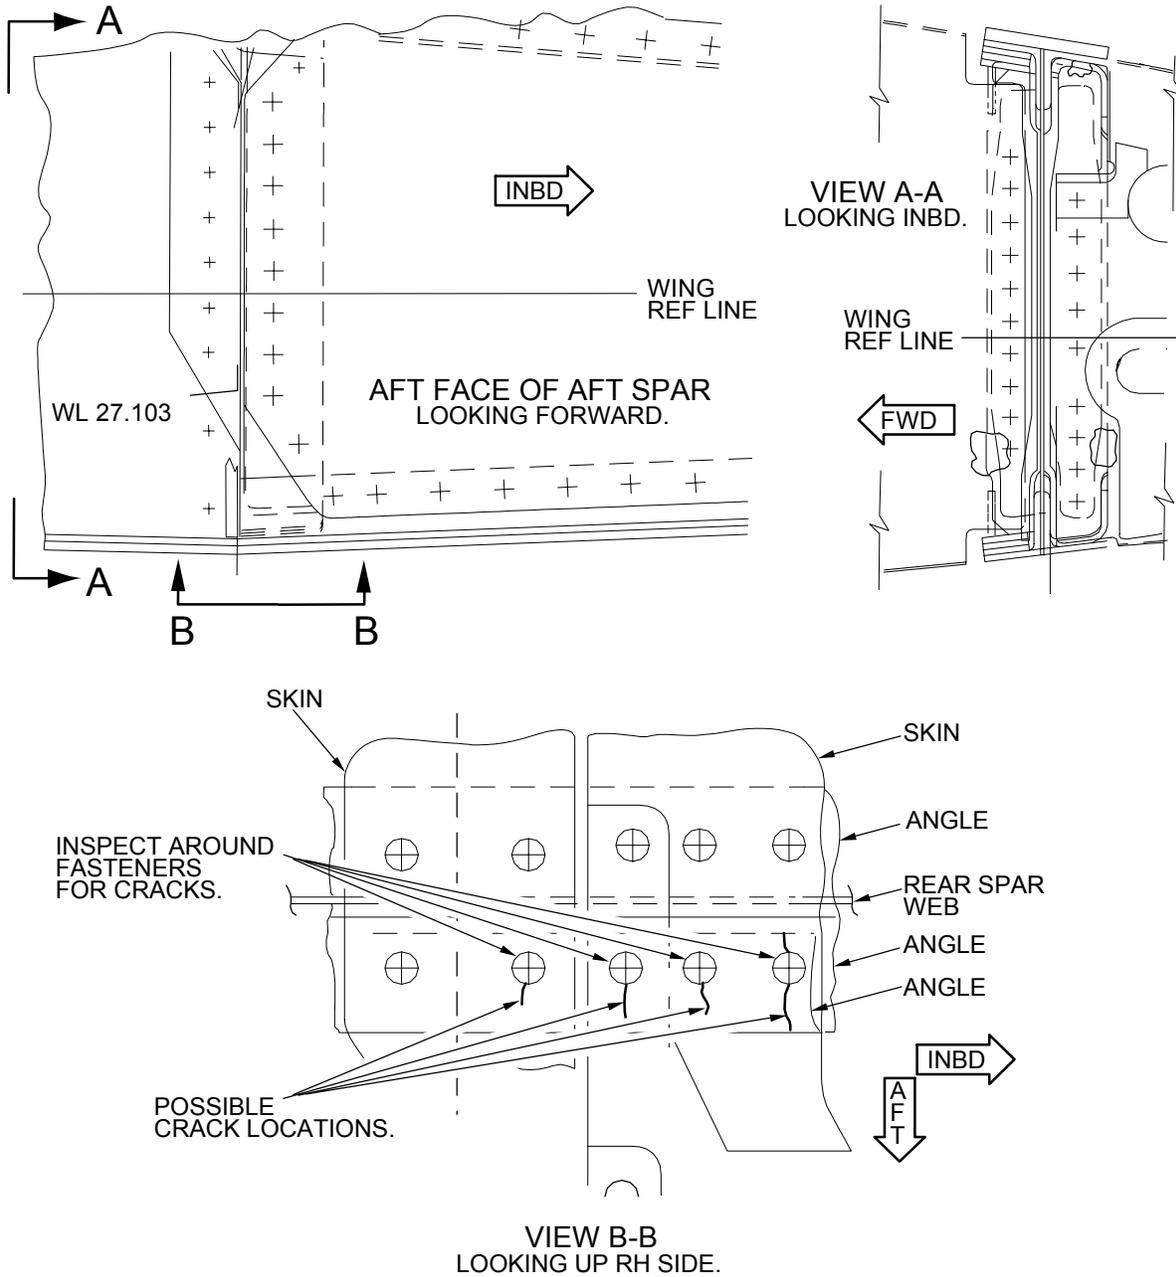
226RSLC1

1. Adhere to procedures for Eddy-Current Inspection given in the SA226/227 Structural Repair Manual, Chapter 51-30-07.
2. Refer to Figure 1. Inspect aft aluminum spar cap angle around the fastener holes between stations 24 and 27, left and right wing. Observe the phase and amplitude changes on the instrument.
3. If an indication is noted, carefully repeat the inspection pass in the opposite direction to verify the indication.
4. All cracks detected shall be reported to Fairchild Service Engineering. Report the location, direction, and length of each crack.

SA226 WING REAR SPAR LOWER CAP AT WS 27
 FIGURE 1

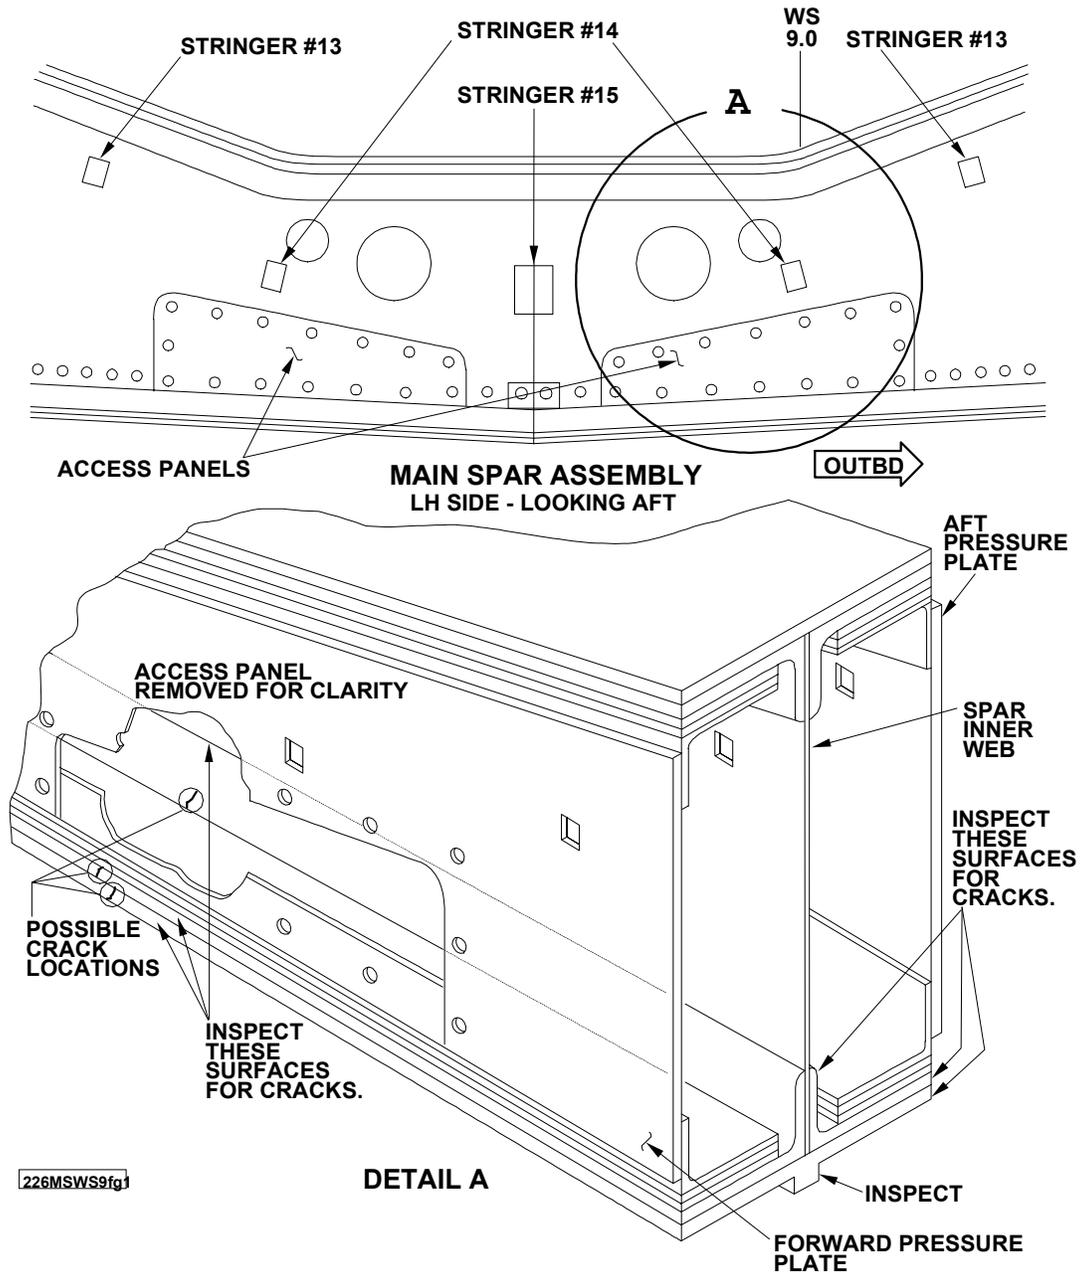
Figure 1. SA226 Main Spar at WS 9.0

1. If the forward and aft pressure plates do not have access panels installed at station 9, accomplish Fairchild Service Bulletin 226-57-006 (T) and (TB), 226-57-007 (AT), or 226-57-008 (TC).
2. Gain access to the main spar lower cap at station 9 by removing access panels on forward and aft pressure plates.
3. Inspect left and right wing. Refer to Section IV (NDI Inspection), Supplemental Inspection Number 57-10-02 for specific inspection instructions.
4. Reseal in accordance with SRM 51-30-03
5. Close out access panels in accordance with the Maintenance Manual.

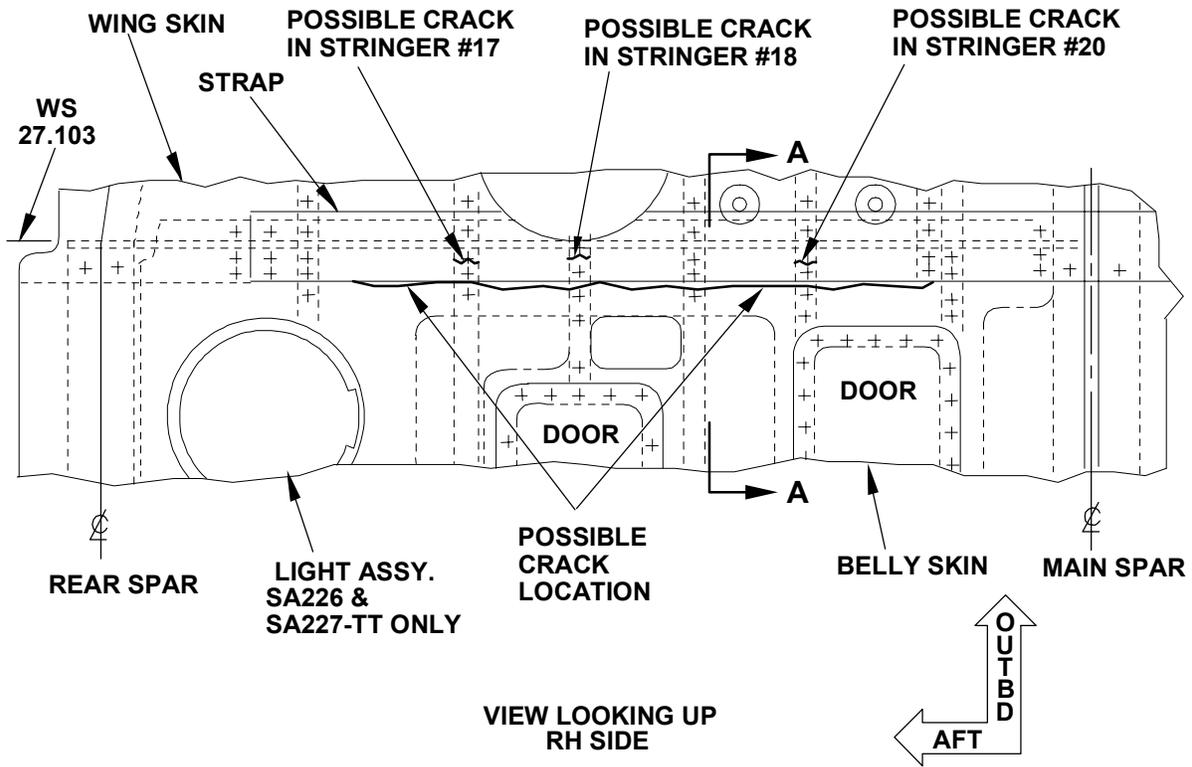
SID\ws27f1-1

1. Adhere to procedures for Eddy-Current Inspection given in the SA226/227 Structural Repair Manual, Chapter 51-30-07.
2. Refer to Figure 1, Sheets 1 and 2. Inspect the outside surface of the belly skin just inboard of the splice strap at WS 27, left and right side, from main spar to rear spar.
3. Inspect the inside surface of the belly skin around the fastener holes in the splice just inboard of WS 27, left and right side, from main spar to rear spar. Refer to Figure 1, Sheet 2.
4. Inspect stringers 16 through 21 around the fastener holes just inboard of the rib at WS 27, left and right side. Refer to Figure 1, Sheets 1 and 2.
5. If an indication is noted, carefully repeat the inspection pass in the opposite direction to verify the indication.
6. All cracks detected shall be reported to Fairchild Service Engineering. Report the location, direction, and length of each crack.

Figure 1. SA226/SA227 Lower Wing Skin Splice at WS 27 (Sheet 1)

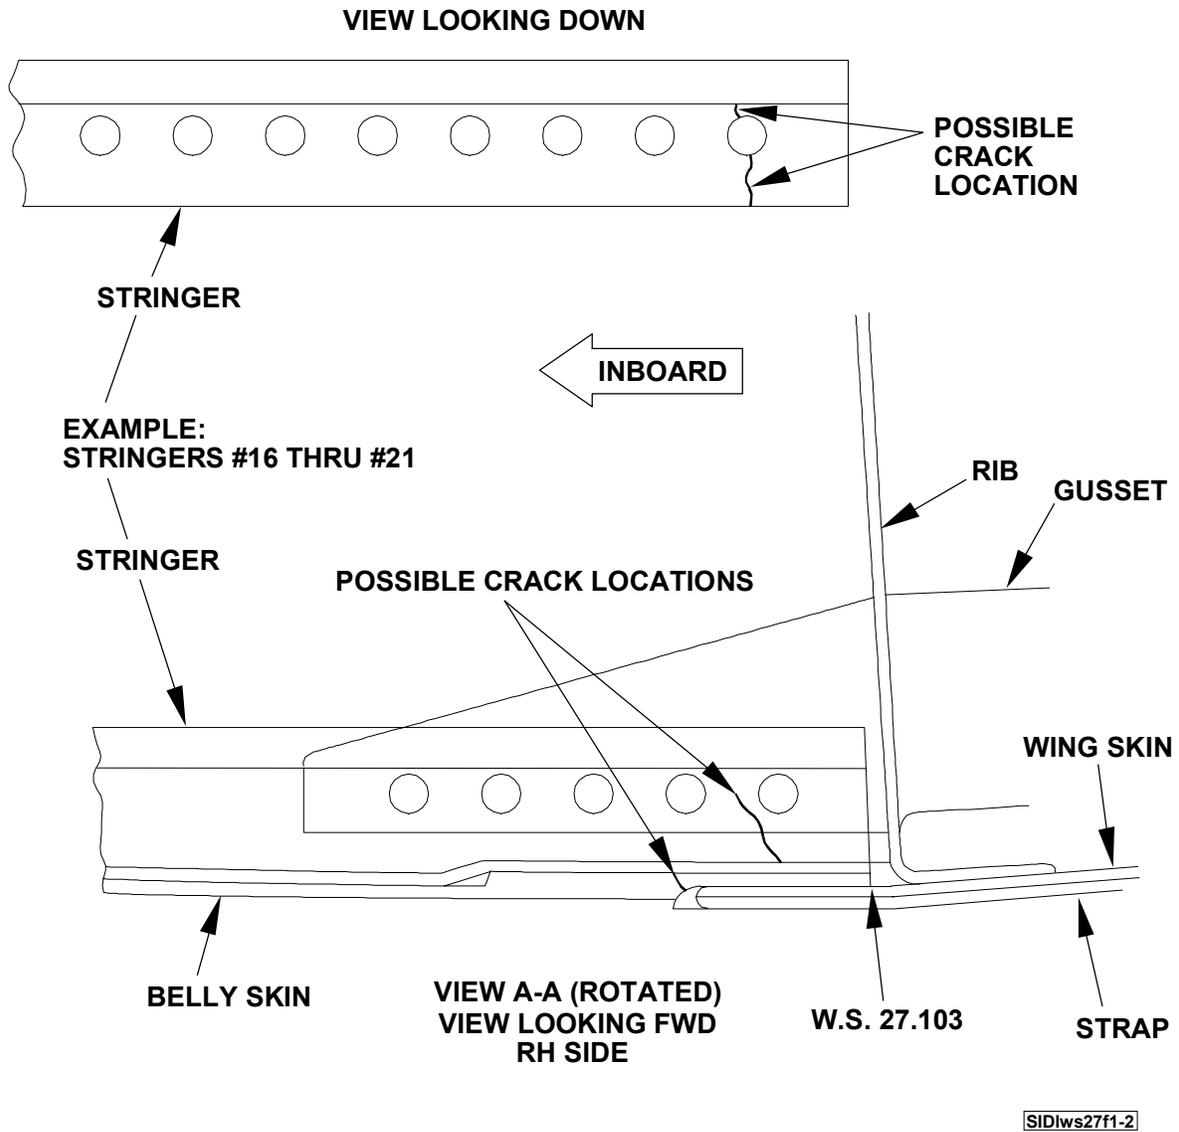
Figure 1. SA226/SA227 Lower Wing Skin Splice at WS 27 (Sheet 2)

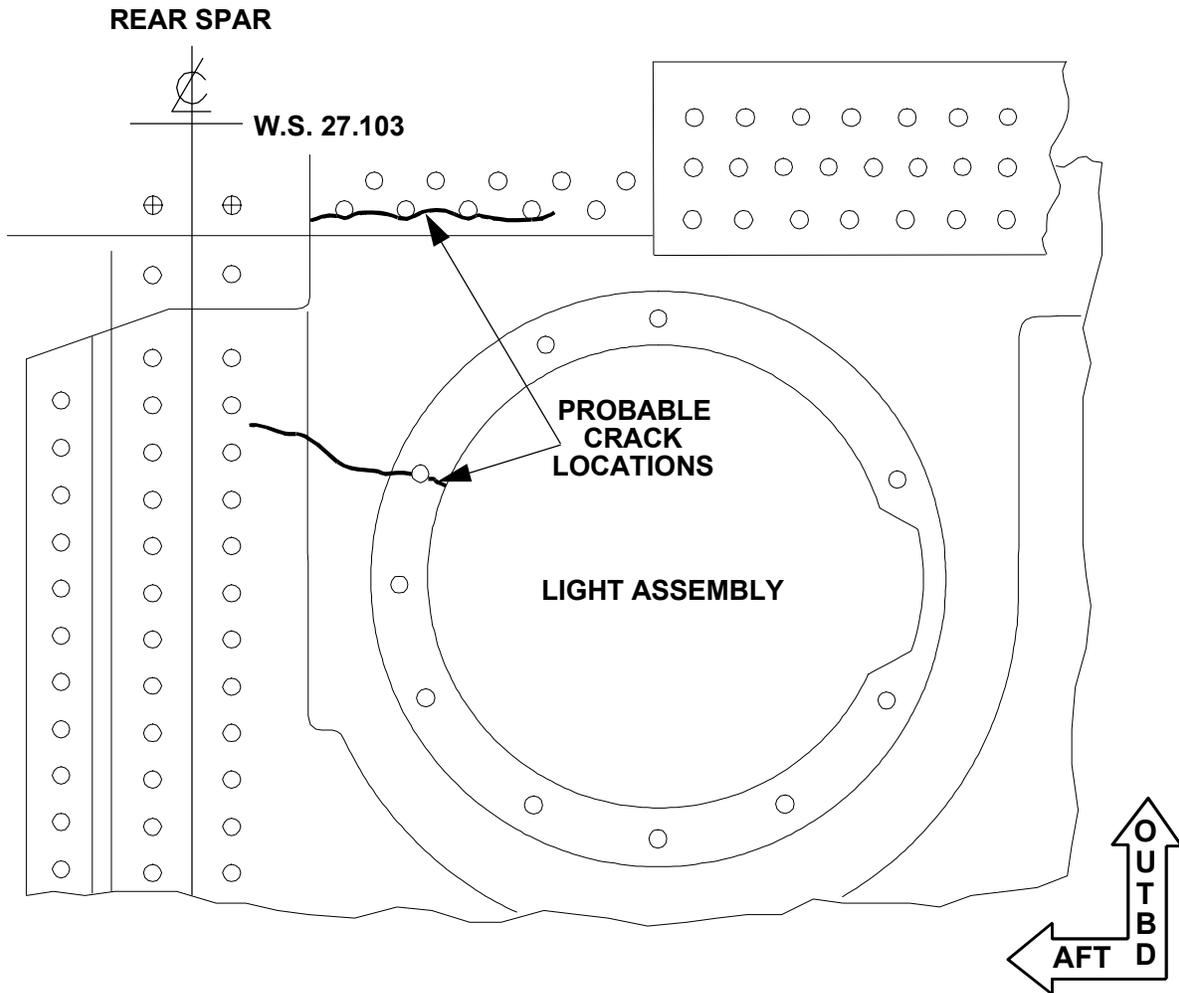
SID226WLCf1

1. Adhere to procedures for Eddy-Current Inspection given in the SA226/227 Structural Repair Manual, Chapter 51-30-07.
2. Refer to Figure 1. Inspect belly skin around landing light cutout and at splice of belly skin to center wing skin. Observe the phase and amplitude changes on the instrument.
3. If an indication is noted, carefully repeat the inspection pass in the opposite direction to verify the indication.
4. All cracks detected shall be reported to Fairchild Field Support Engineering. Report the location, direction, and length of each crack.

Figure 1. SA226/SA227 Wing Center Section Skin at Landing Light Cutout

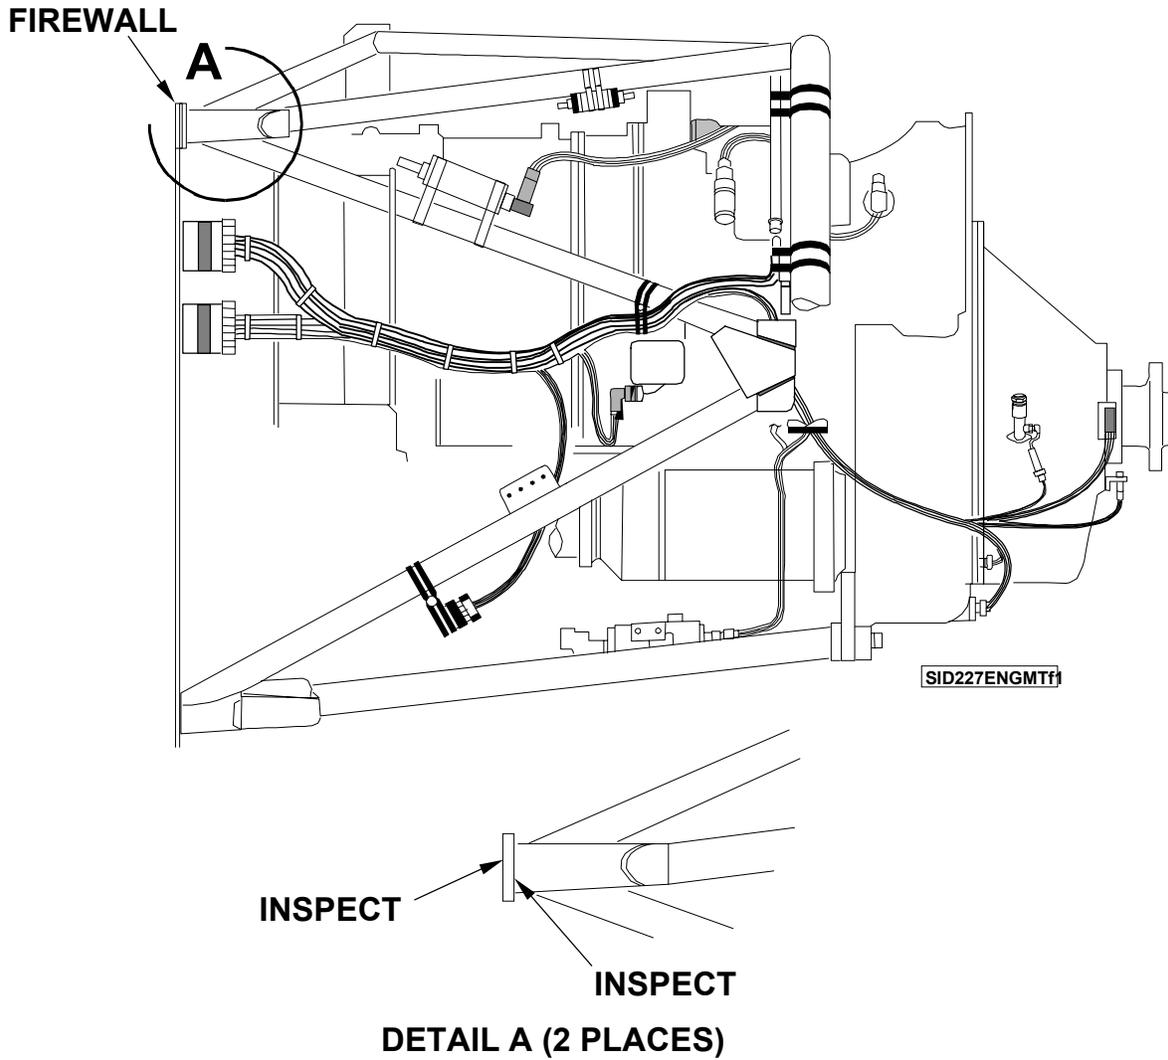
LH/RH ENGINE

Figure 1. SA227 Engine Mount at Firewall
