# **A Preliminary Examination of the Effectiveness of Hand-Held Extinguishers Against Hidden Fires in the Cabin Overhead Area of Narrow-Body and Wide-Body Transport Aircraft**

July 2007

DOT/FAA/AR-TN04/33

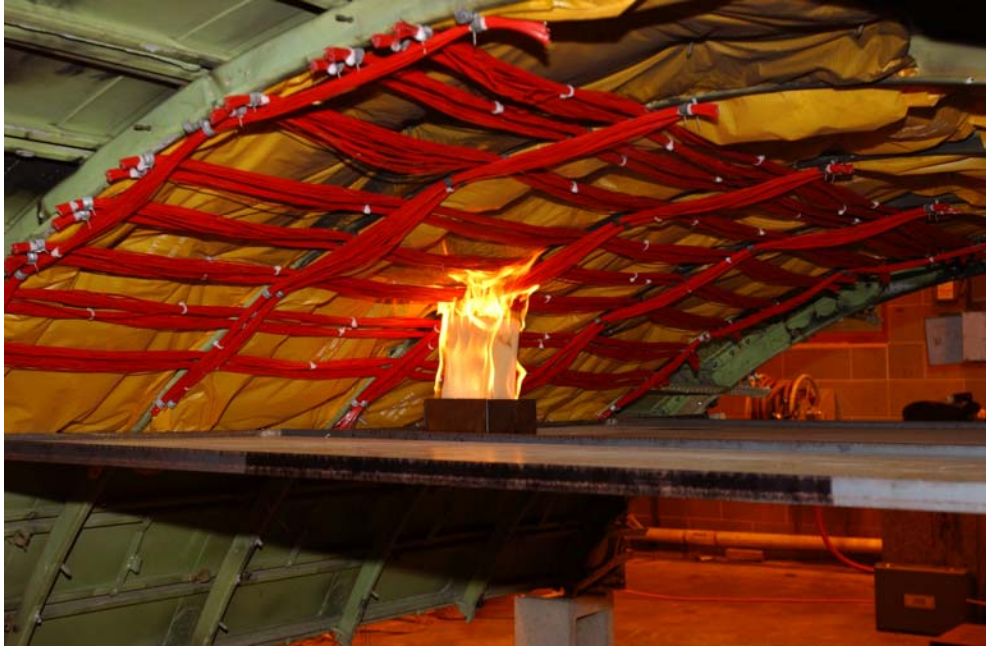
Figure 1. Wiring Test in a Simulated Cabin Overhead Area

Current Federal Aviation Administration (FAA) research is aimed at the development of more stringent fire test methods for materials located in hidden areas such as the ceiling overhead areas, cheek areas, and electronics and electrical (E/E) bays. This research targets the flammability of materials such as ducts, wires, panel closeouts, clamps, and other hardware located in the hidden and inaccessible areas to upgrade these materials to an equivalent level of fire resistance as recently adopted for thermal acoustic insulation [1]. The objective is to passively reduce the likelihood of an in-flight fire from occurring by substantially improving the fire resistance of materials in hidden areas. The research is coordinated with a subgroup of the International Aircraft Materials Fire Test Working Group, a government/industry group chaired by the FAA. Full-scale tests have been completed in which various types of wiring insulation were evaluated against a realistic fire threat (figure 1) [2].

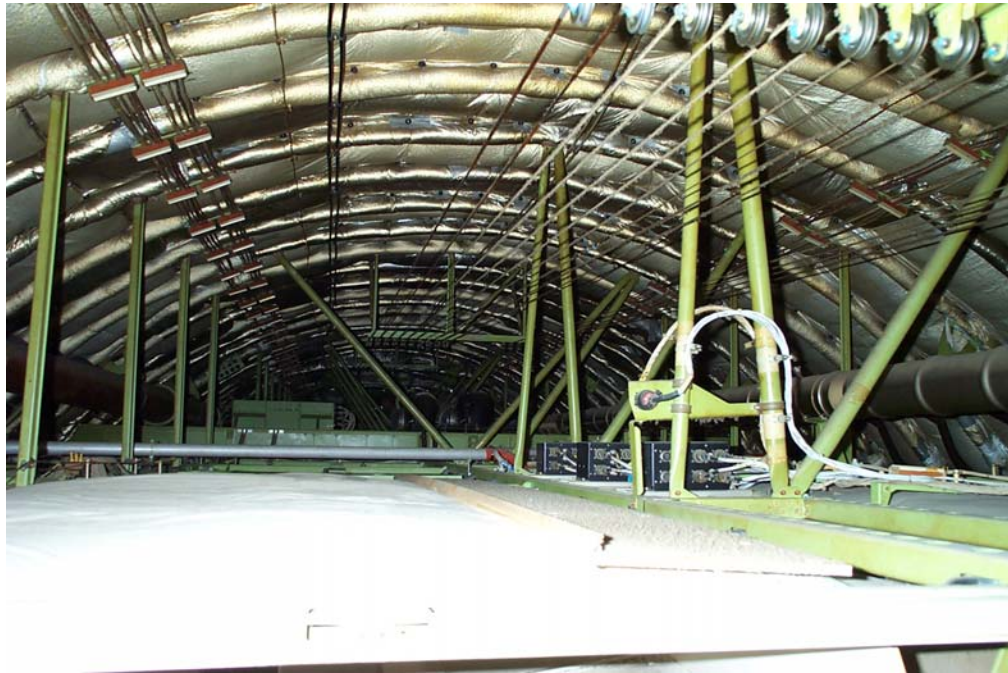
Figure 4. B-747SP Wide-Body Aircraft Aft Cabin Overhead Area

Although a majority of the cabin overhead volume is devoid of combustible materials, the periphery contains insulation blankets and adjacent wire bundles. There are also several wire bundles that run along the centerline, just above the ceiling panels. The aft overhead section of the B-747SP wide-body aircraft is shown in figure 4.

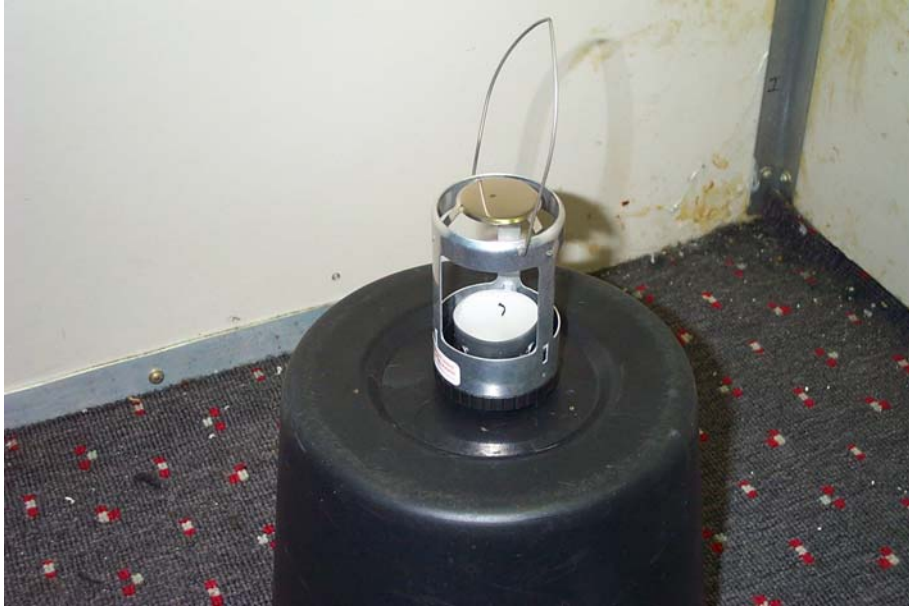
Figure 5. Candle Lanterns Used in Cabin Overhead Area Tests

Since the B-747SP was an operational test aircraft, as opposed to a true fire test article, care had to be taken not to cause damage to the interior during live fire tests. To create a realistic yet safe fire scenario, small candle lanterns were incorporated to measure the range and volume of fire extinguishant. The candles were paraffin-based discs, enclosed in a protective metal shroud to prevent wax spillage and ignition in the event that the candle tips over (figure 5). The candle lanterns were equipped with glass cylinders that shrouded the flames, making it somewhat difficult to extinguish them. For this reason, the glass shrouds were removed for all tests performed in the cabin overhead area. Once lit, the candle lanterns could burn continuously for 4 hours, making them ideal for this type of hidden space test.

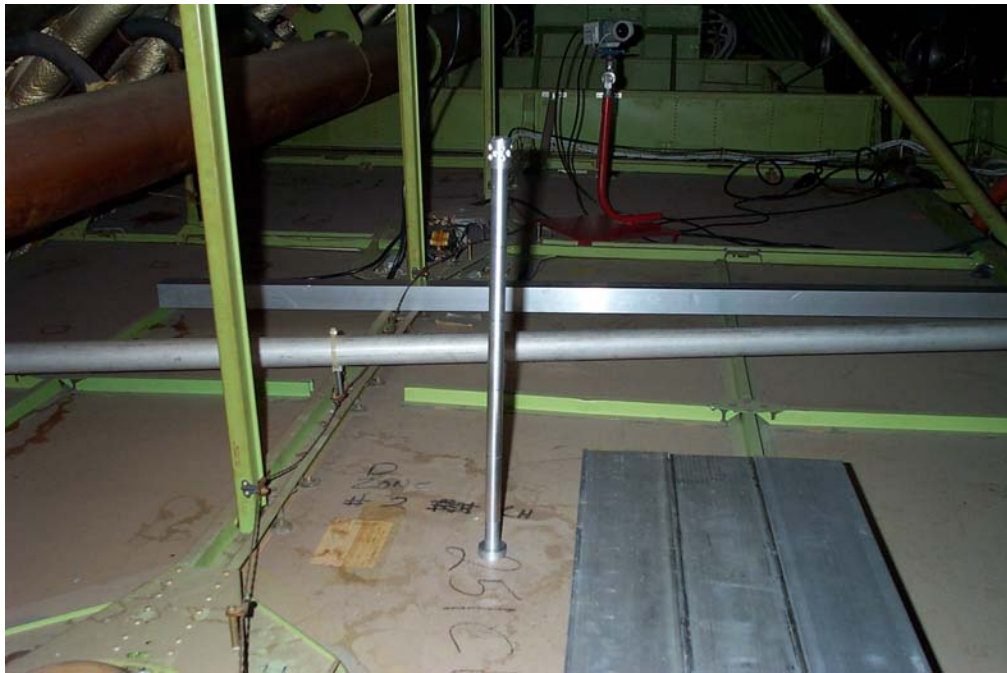
Figure 7. Ceiling-Mounted Port Extension Tube Mounted in Cabin Ceiling

To use the available extinguishing agent most efficiently, the initial ceiling-mounted port was designed to extend above the cabin ceiling to promote extinguishing agent transport to the combustible materials near the crown of the aircraft. The port and discharge head contained a series of threaded extension tubes, each measuring approximately 6 inches long. When five extension tubes were used in conjunction with the head, the discharge point was situated 30 inches above the cabin ceiling. The discharge head was designed to propel the agent radially (figures 7 and 8).

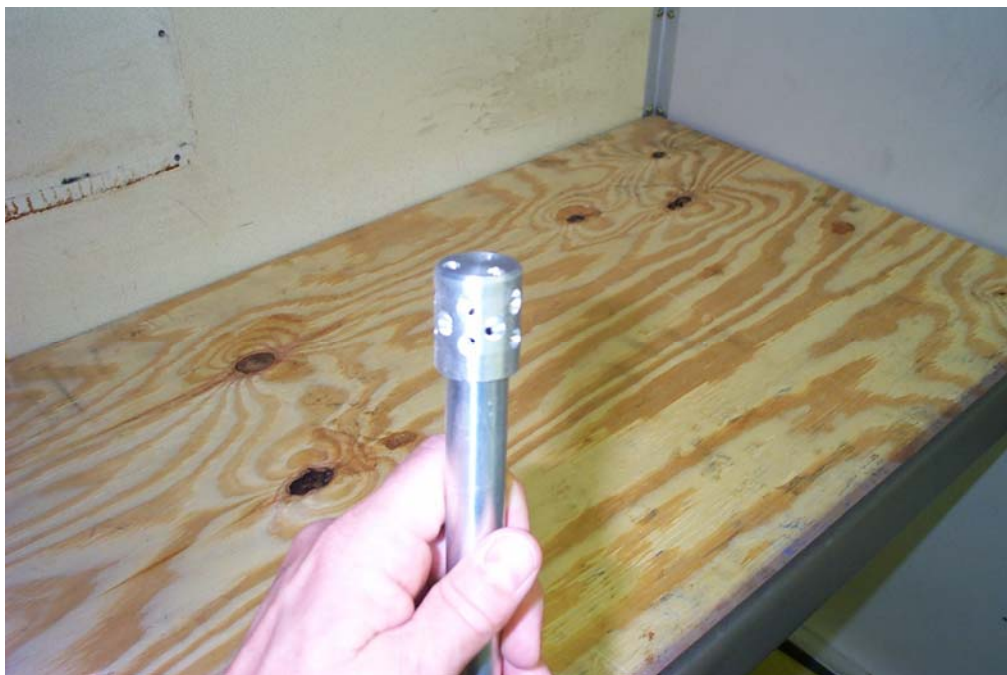
Figure 8. Ceiling-Mounted Port Prototype Discharge Head

Test 2 was run using the prototype discharge head (figure 8) attached to the end of the ceiling-mounted port. This configuration provided extinguishment of four of the six candles, a much better result than test 1. Although the overall thrust of the extinguisher was restricted with this design, it did convey the extinguishing agent far enough radially to give this outcome.

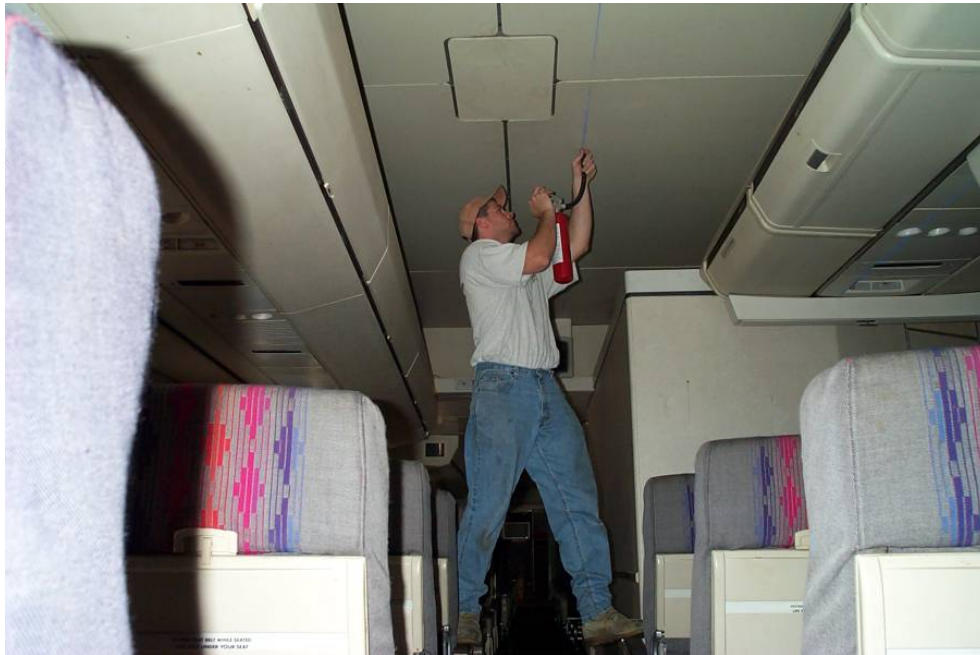
Figure 9. Extinguishing Agent Discharged Through the Port in the Wide-Body Aircraft

The ceiling-mounted port and associated tubes and head were centered over the left aisle, just aft of the crew rest area, which was converted into a control room for these tests. Cameras were mounted in the cabin overhead area to capture the sequence of events during extinguishing agent discharge. One important note was that all extinguishers incorporated a flexible discharge hose, allowing the extinguisher to remain perfectly upright during discharge. This enabled full expulsion of the extinguisher contents, which would not be possible otherwise, since the extinguisher would need to be held horizontally to engage the ceiling-mounted port. Also of note was the requirement that the person discharging the extinguishing agent needed to stand on the armrests of the seats to reach the ceiling-mounted port (figure 9).

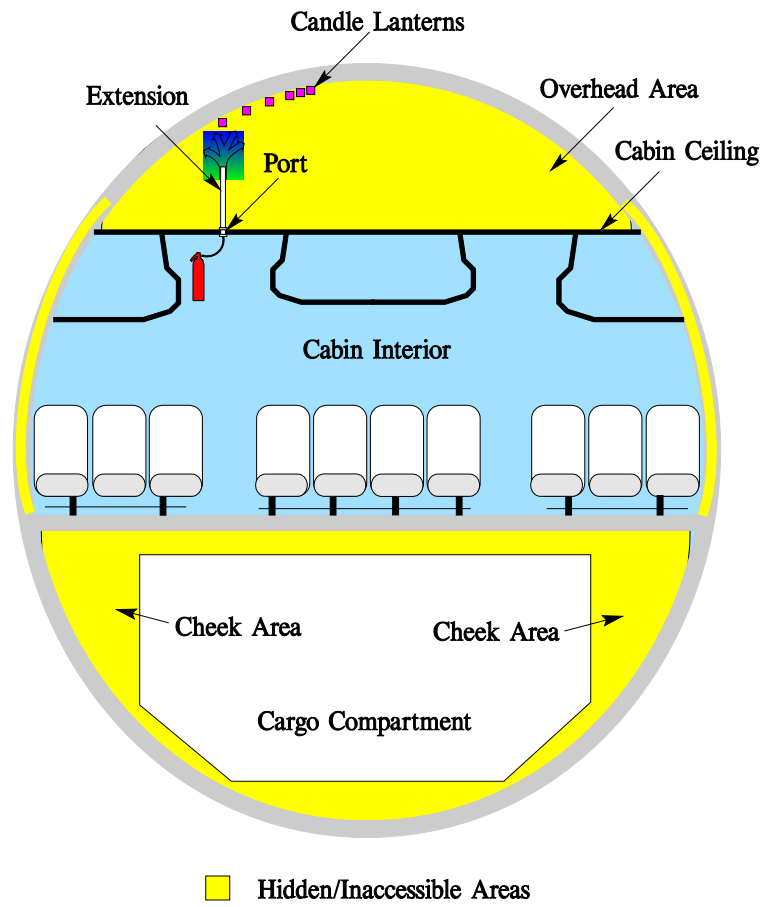
Figure 11. Cutaway Schematic of the Modified Candle Lantern Test Configuration

Using this arrangement, the candles were hung closer to the discharge head, perpendicular to the axis of the aircraft (figures 11 and 12). The distance from the first candle situated directly over the port to the last candle was approximately 42 inches.

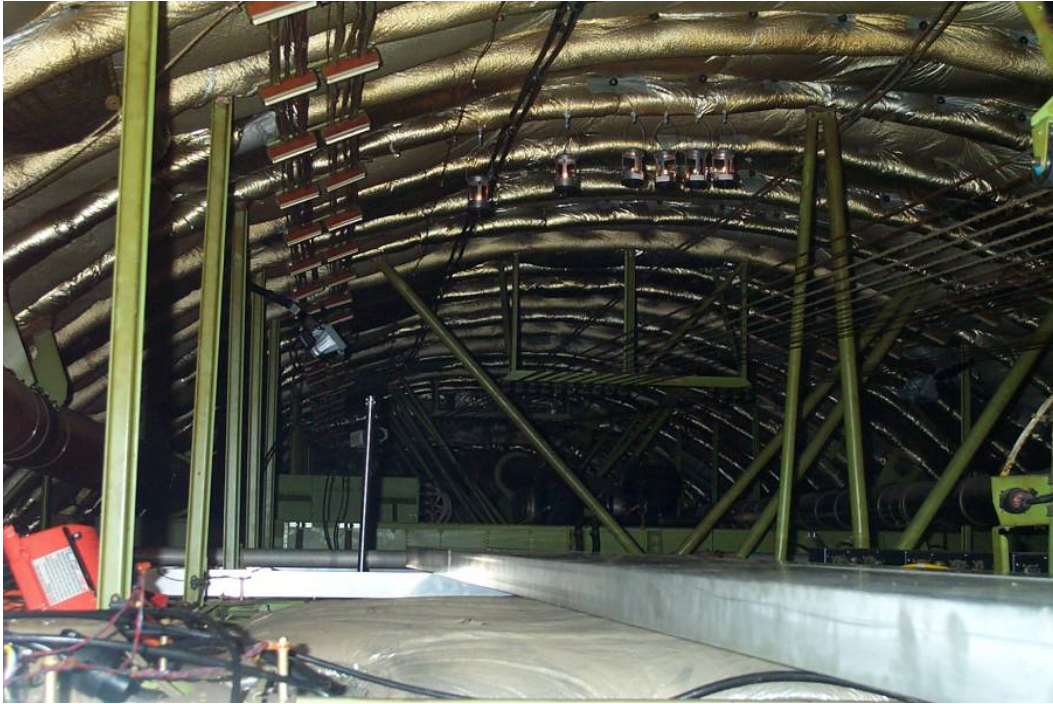
Figure 12. Modified Candle Lantern Test Configuration in Cabin Overhead Area

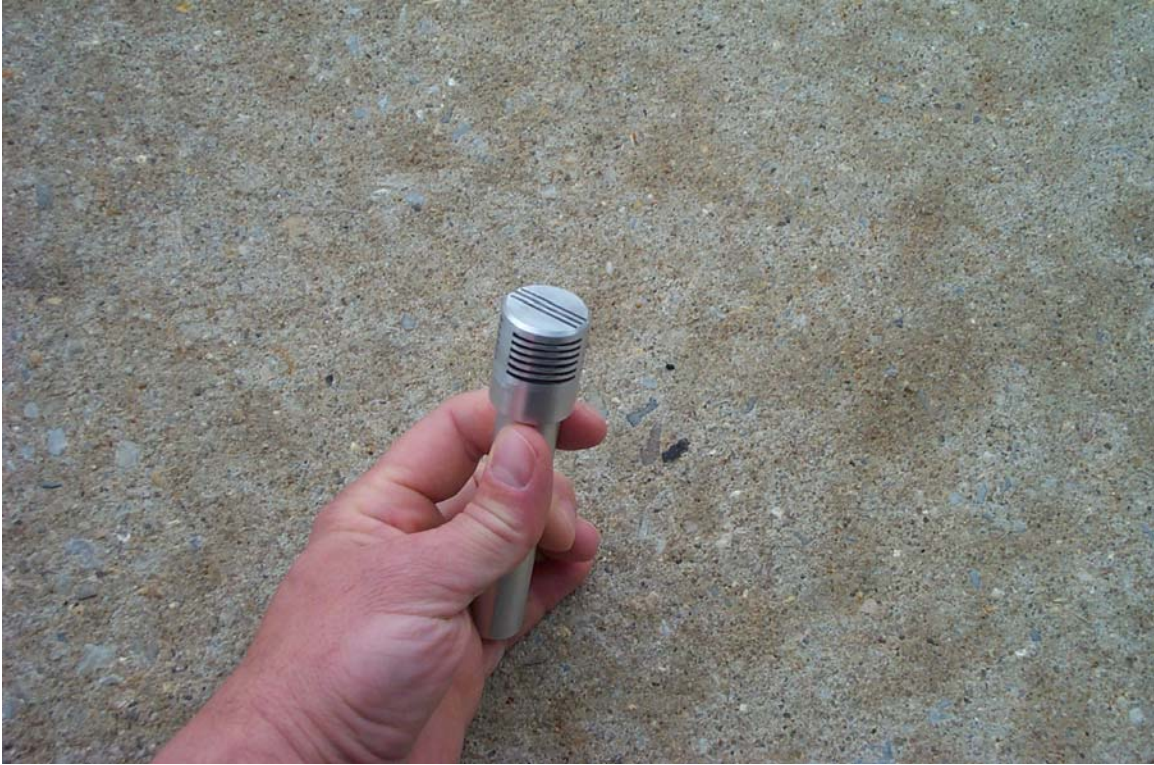
Figure 13. Grill Design Discharge Head

As a result, a second discharge head was designed and fitted to the ceiling-mounted port. The new discharge head featured a grill design and was much less restrictive than the previous discharge head with holes (figure 13).

During test 3, the prototype discharge head was replaced with the grilled design discharge head (figure 13). In earlier wide-body aircraft tests, this grill discharge head proved to be less restrictive, giving a slight advantage in performance over the prototype discharge head. However, the wide-body aircraft tests were run with the candle lanterns mostly vertical in relation to the discharge head, whereas the narrow-body aircraft tests were run with the candles nearly horizontal to the discharge head. Following full discharge, only three of the six candles were extinguished. Although the grill discharge head was less restrictive, it appeared slightly vertically biased, allowing more vertical discharge than radial. Given this characteristic, the

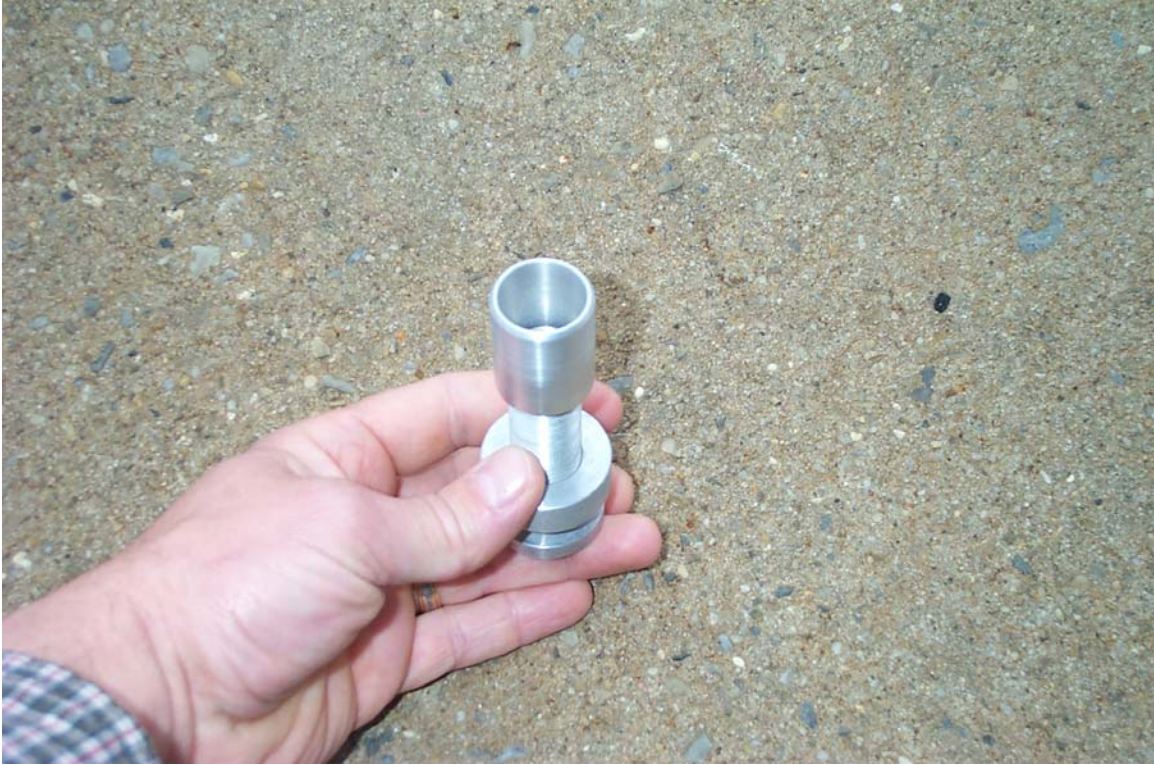
Figure 14. Feedthrough Design Discharge Head

To substantiate this theory, in test 5, a feedthrough design discharge head was attached to the end of the ceiling-mounted port (figure 14). This, again, resulted in five of the six candle lanterns being extinguished. In this case, the nonextinguished lantern was farthest from the discharge location, indicating good upward thrust, but slightly reduced radial range.

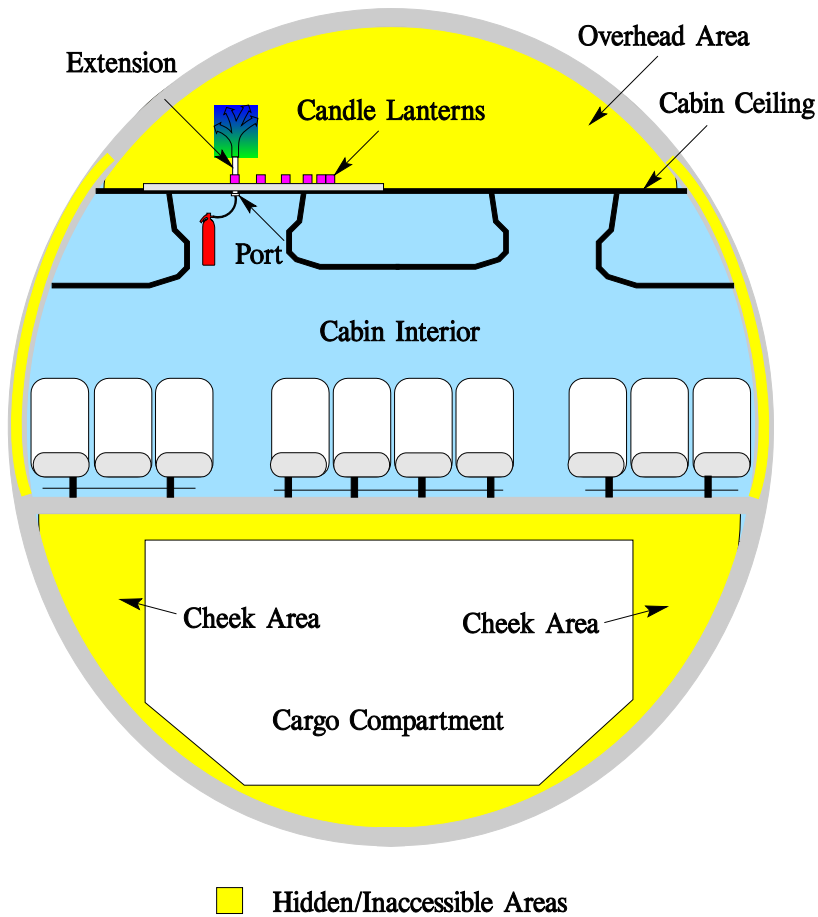
Figure 15. Candle Lanterns Located Directly Above Ceiling Panel

The last test in this series (test 7) used the feedthrough discharge head in conjunction with one 6-inch extension. This resulted in extinguishing all six candle lanterns. Although this result was promising, it was important to consider that the actual location of a fire may not be precisely known, and that optimization based on a specific fire location may yield misleading results. It is entirely possible that a fire could also occur directly on the top surface of the ceiling panels, either directly as the result of a wire bundle fire in this area or indirectly from a wire bundle fire above that had produced flaming drips to the ceiling surface below. For this reason, an additional candle lantern test scenario was devised in which the lanterns were placed just slightly above the ceiling panel (figure 15).

For this configuration, the six candle lanterns were placed on top of a section of aluminum frame, directly underneath the previous positions near the crown. The candle lanterns were placed on top of the aluminum frame, approximately 4 inches above the ceiling panel.

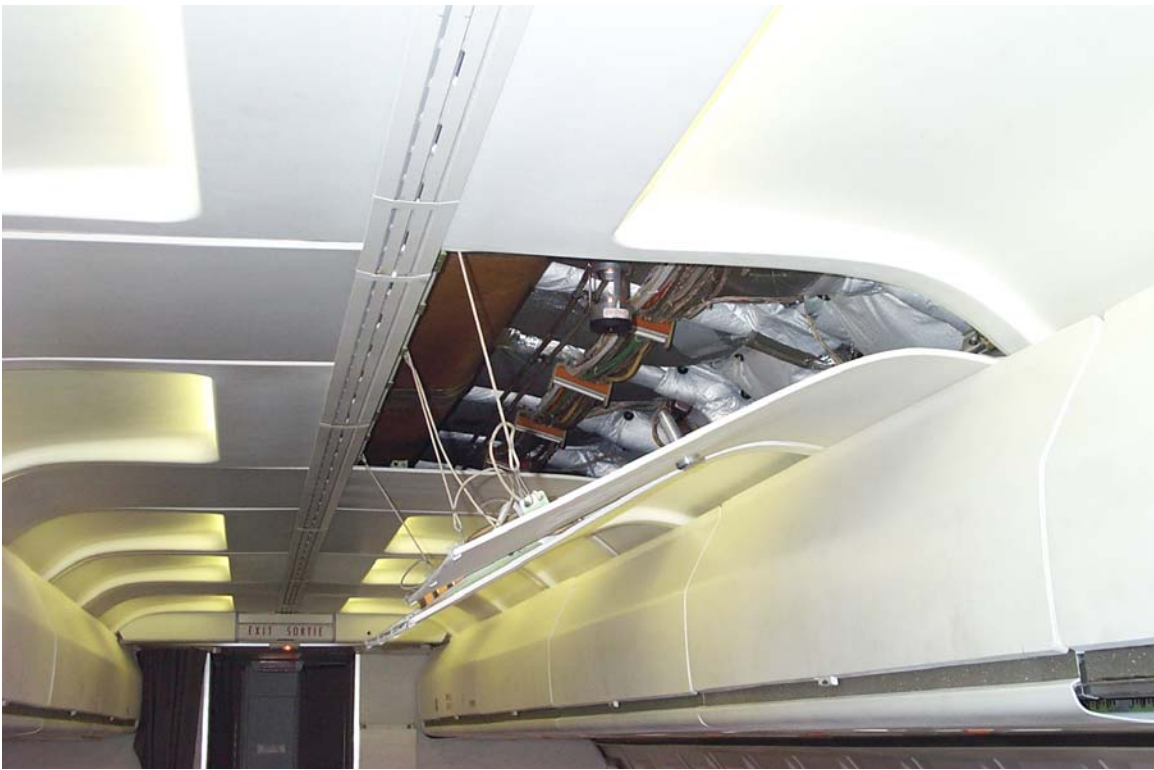
Figure 17. Narrow-Body Aircraft Showing Cabin Overhead Area Access

During the pretest inspection of the narrow-body aircraft, it was determined that the cabin overhead panels could be unfastened and rotated downward, giving nearly unlimited access to the cabin overhead area (figure 17). Although the locking mechanism for the panels was hidden in the overhead stowage bins and was somewhat difficult to activate, it became much easier to perform once the operator became familiar with it. This was a significant finding in that, given the proper training, a fire in the hidden overhead area of this type of aircraft with this particular panel attachment scheme could easily be accessed and extinguished. This was not true for the wide-body aircraft, in which the ceiling height was much greater and the ceiling panels were significantly larger.

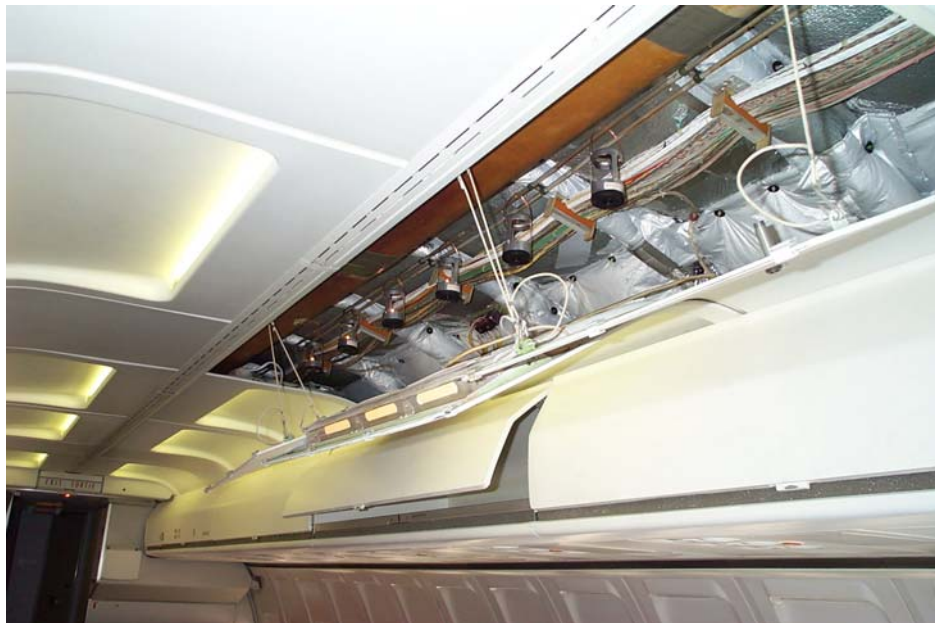
Figure 19. Narrow-Body Aircraft Test Configuration Showing Location of Candle Lanterns

Since the cabin overhead area of the narrow-body aircraft was relatively small and cluttered in comparison with the wide-body aircraft, there were only a few possibilities in terms of the location of the candle lantern fire sources. As such, the lanterns were hung from a hydraulic line that was mounted to the fuselage formers in the cabin overhead area (figure 18). This resulted in the lanterns being very close to a large wire bundle that ran forward to aft, which was a realistic simulation in terms of fire location (figure 19). The ceiling-mounted port was installed 15 inches from the centerline of the aircraft, which was approximately aligned with the candle lanterns.

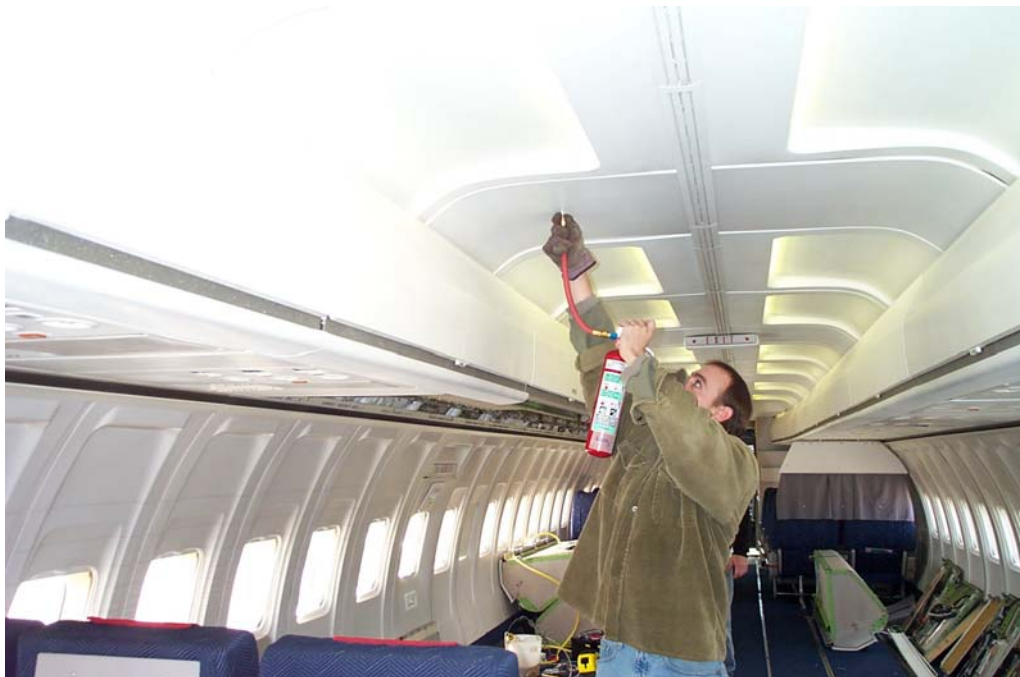
Figure 21. Halon 1211 Discharged Through Ceiling-Mounted Port

After lighting all six candle lanterns, the ceiling panels were quickly reinstalled to their proper position. The 2.5-lb Halon 1211 extinguisher was then fully discharged through the ceiling-mounted port, followed by a brief 1-minute settling period to allow the extinguishing agent to fully disperse in the cabin overhead area (figure 21). The ceiling panels were then unfastened to allow inspection of the candle lanterns. This procedure was followed for all tests.
