**DOT/FAA/TC-12/28**

# **Airport Surface Event Analysis for Airport Design January 2006—September 2011**

Final Report

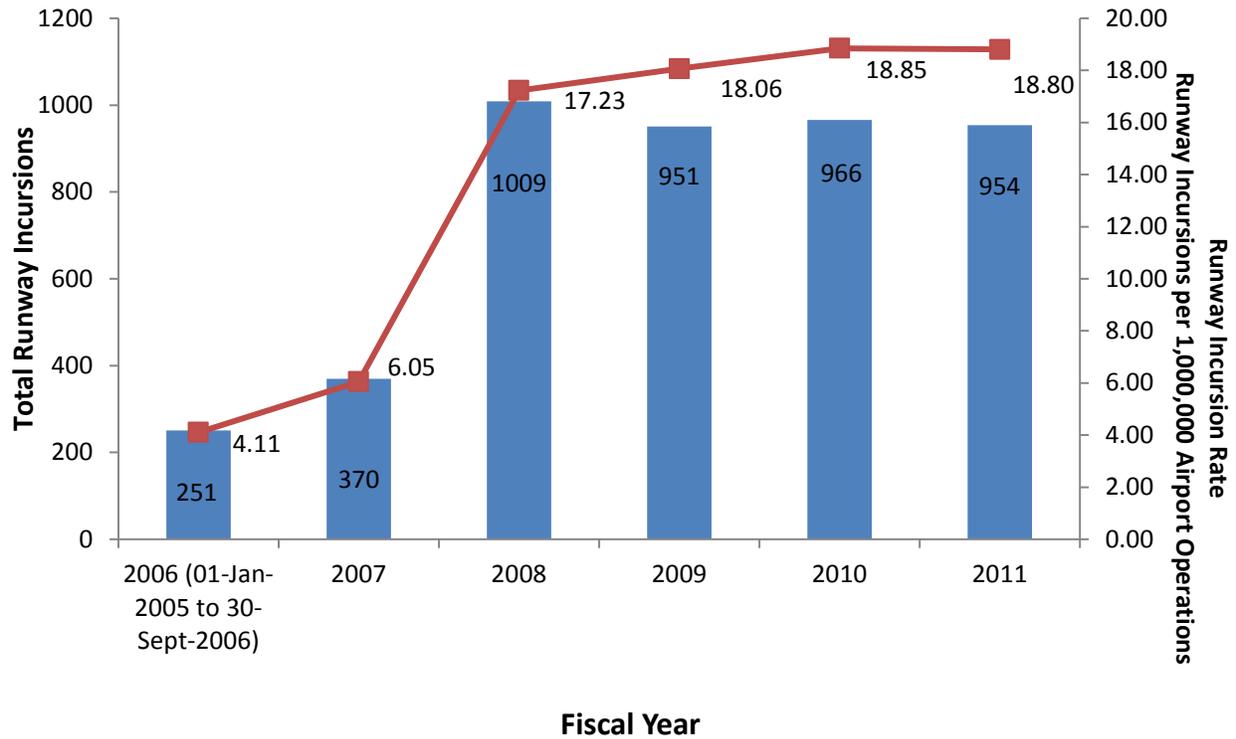
Figure 1 shows that the runway incursion rate increased significantly between 2007 and 2008 because of the FAA’s adoption of ICAO’s more restrictive definition. The red trend line in figure 1 depicts the percentage of runway incursions per 1million airport operations. The trend has remained steady from fiscal year (FY) 2008 through FY 2011.

Figure 1. Runway Incursions by Year

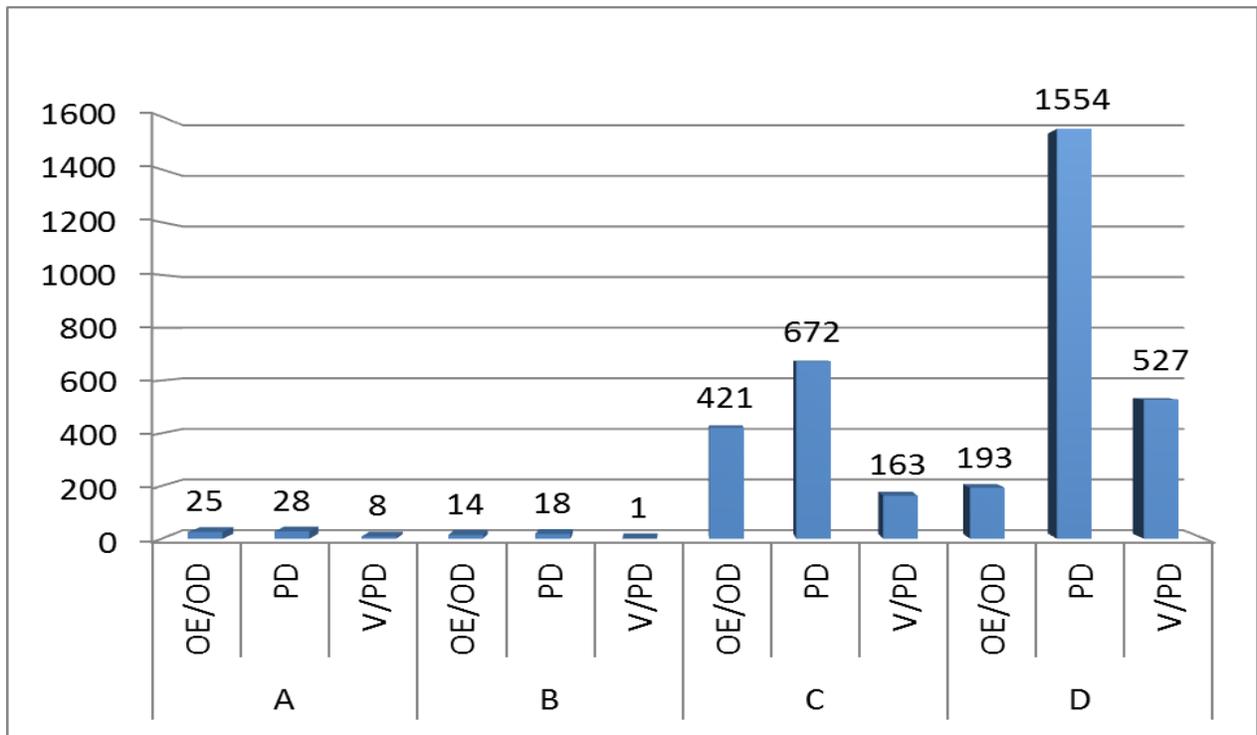
Figure 2 shows the PDs in Category D are the most prevalent type of runway incursion. Although Category C and D incursions are far more common than other incursions, the safety implications are less severe than Category A and B incursions. There have been 94 Category A and B incursions from 2006 through November 2010.

(OE/OD = Operational error/deviation, PD = Pilot deviation, and V/PD = Vehicle/pedestrian deviation)<sup>1</sup>

Figure 2. Runway Incursions by Category and Occurrence Type

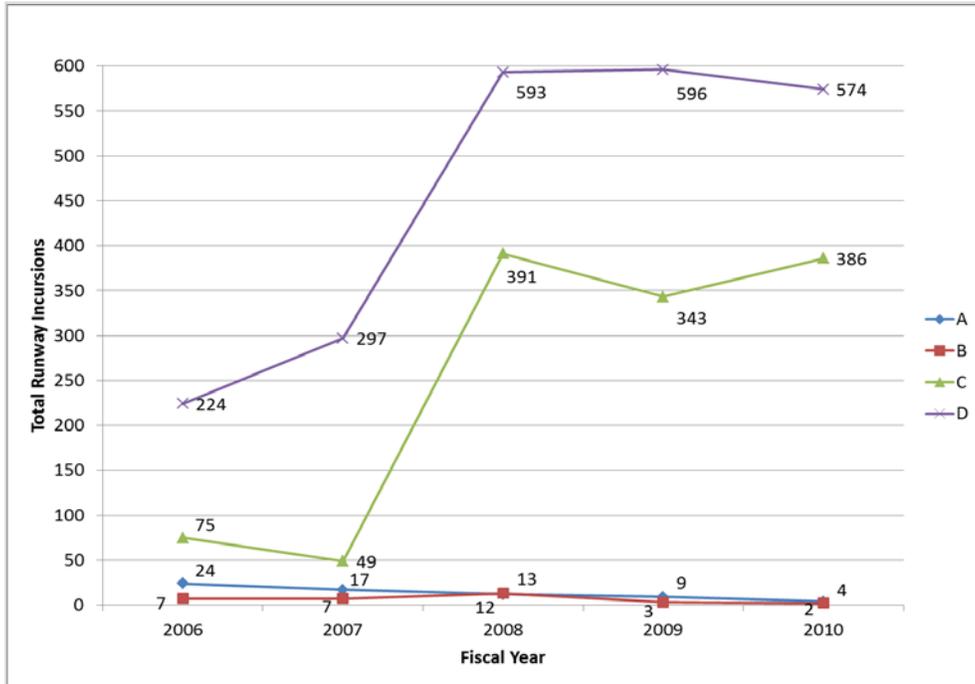
Figure 3 shows that the number of Category A runway incursions has decreased steadily since 2006, with only two Category A incursions in 2010. The number of Category B runway incursions has decreased since 2008. In 2008, the number of Category C and D runway incursions increased because of the stricter ICAO definition; however, occurrences in those categories remained relatively constant from 2008 through 2010.

Figure 3. Runway Incursions by Severity Category

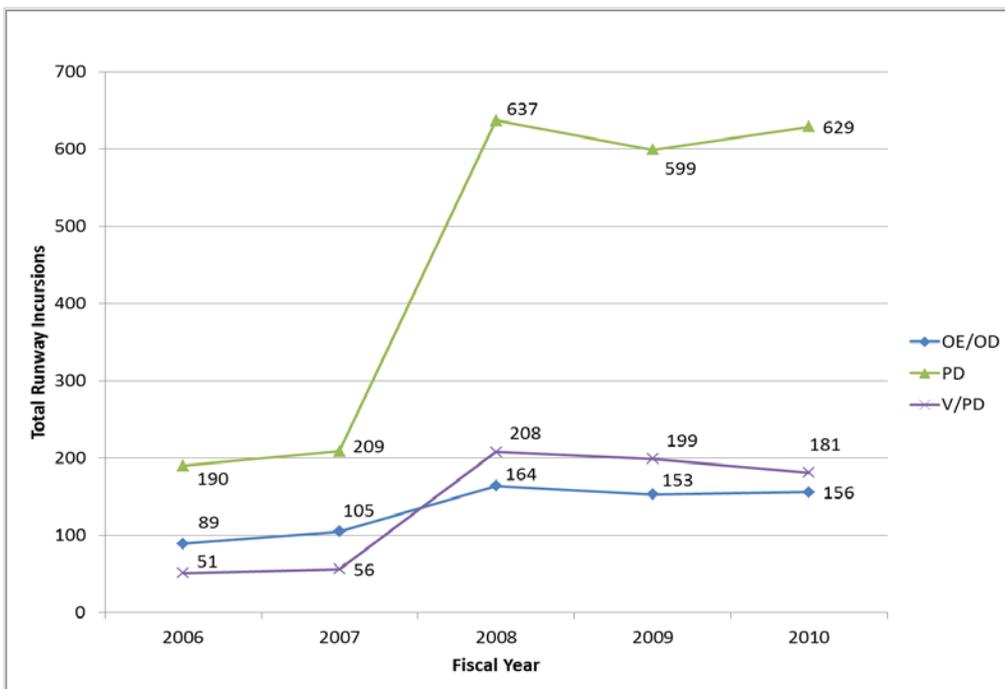
Figure 4 shows PDs are the most common type of runway incursions. All runway incursion types have remained relatively steady from 2008 to 2010.

Figure 4. Runway Incursions by Occurrence Type

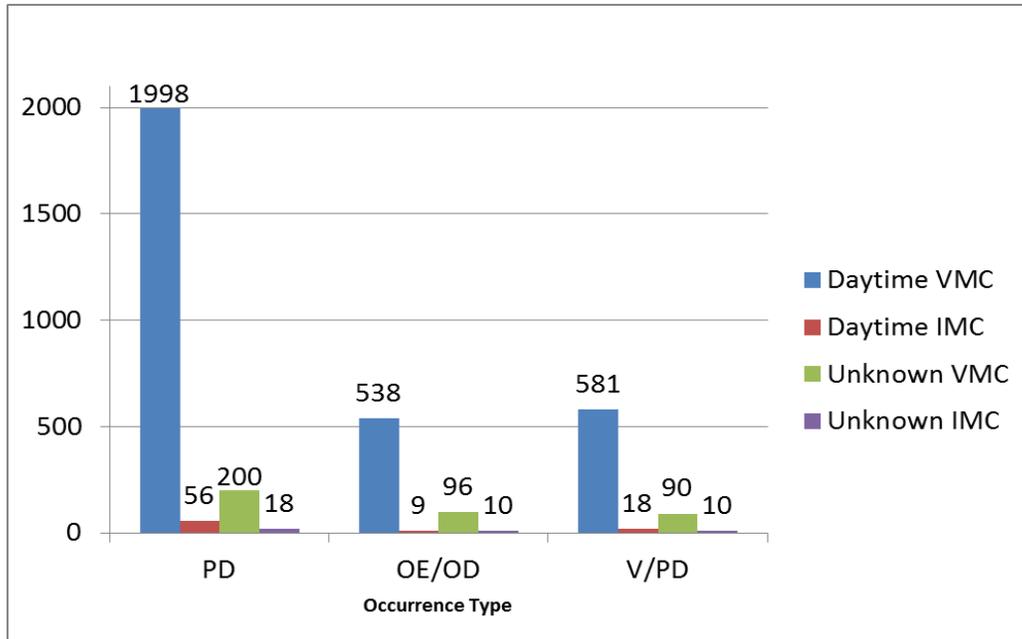
Figure 5 shows PDs occurring in daytime visual meteorological conditions (VMC) are the most common. The highest number of OE/OD and V/PD runway incursions occurred during daytime VMC as well. Because not all incursion reports identified the time of day, the time of day in many reports was categorized as unknown.

Figure 5. Runway Incursions by Occurrence Type and Weather Conditions

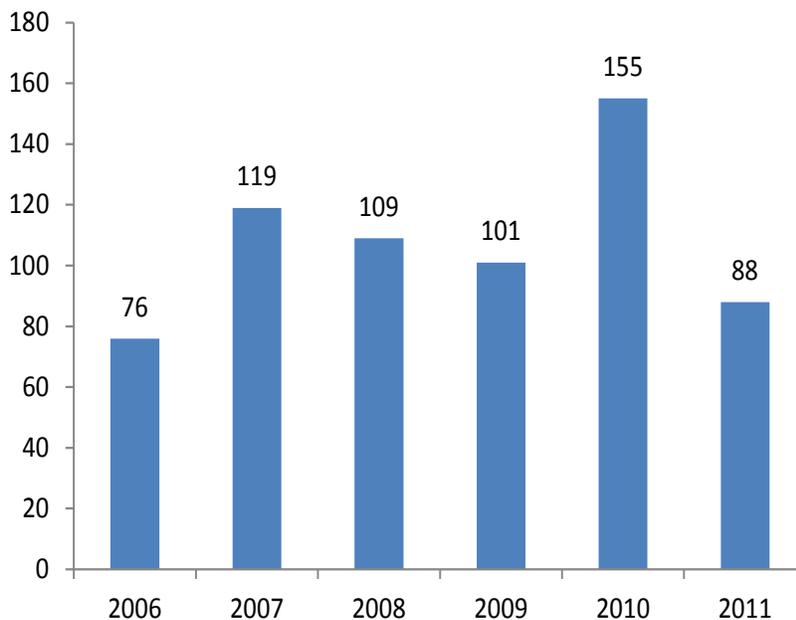
Figure 6 shows the taxiway incursion rate has remained relatively steady since 2007, with a slightly increasing trend for 2010. It should be noted the number of taxiway incursions is incomplete for 2011, as the scope of this review ended on September 30, 2011. The number of taxiway incursions is much lower than the number of runway incursions. Taxiway incursions

may likely be underreported because many of the wrong turns common on taxiways cause no conflict with other aircraft or vehicles.

Figure 6. Taxiway Incursions by Year

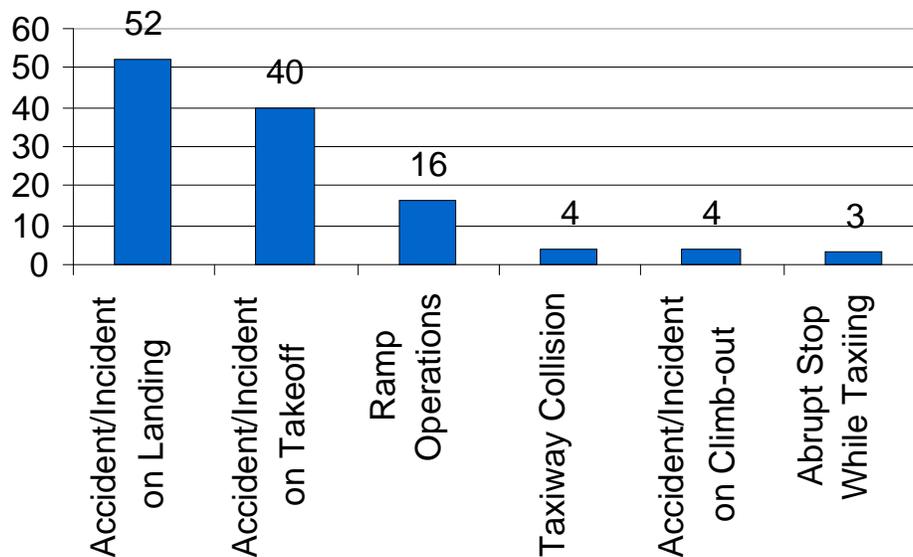
The FAA Office of Airports expressed interest in the types of events that cause injuries and fatalities at airports. Figure 7 shows the top six occurrence types that resulted in fatalities or injuries for the data collection period.

Figure 7. Number of Occurrences With Fatalities or Injuries

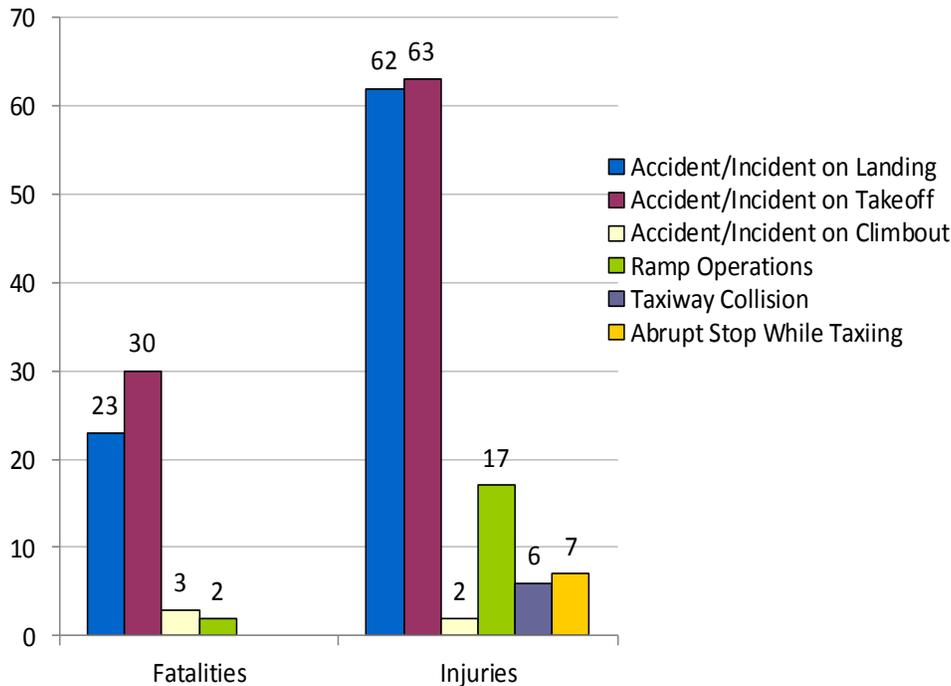
Figure 8 shows that the majority of fatalities and injuries occurred during accidents and incidents during the takeoff phase for the data collection period. The majority of these accidents and incidents were caused by a loss of aircraft control or mechanical failure.

Figure 8. Fatalities and Injuries by Phase of Flight
