Impact and Penetration of Thin Aluminum 2024 Flat Panels at Oblique Angles of Incidence

*Charles R. Ruggeri, Duane M. Revilock, and J. Michael Pereira
Glenn Research Center, Cleveland, Ohio*

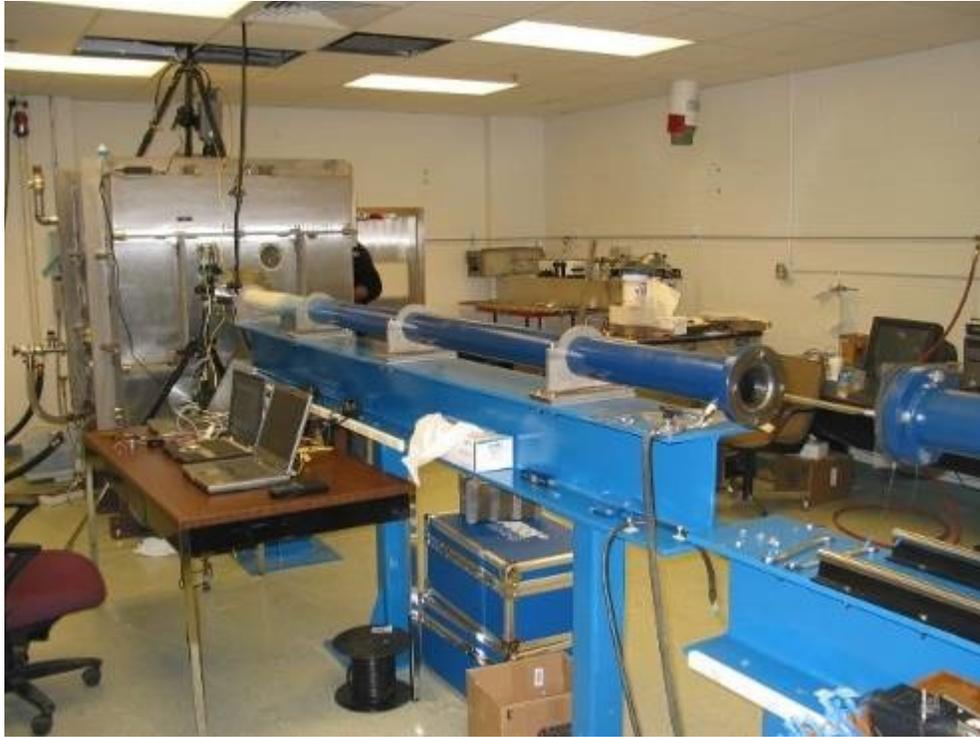
Figure 3.—Gas gun connected to the vacuum chamber.

The projectiles were accelerated with a helium filled gas gun connected to a vacuum chamber, shown in Figure 3. The gun barrel had a length of 3.7 m (12 ft) and a bore of 50.8 mm (2.0 in.). The pressure vessel was made up of sections as shown in Figure 4, with a total volume of 11.2 L (681 in.³). The projectile was carried down the gun barrel in a cylindrical polycarbonate sabot shown in Figure 5. The gun barrel protruded into the vacuum chamber which held the fixture for the specimens. The sabot was stopped at the end of the gun barrel by a stopper plate with a through-hole large enough to allow the projectile to pass through. This stopper system was designed such that the bottom of the sabot, which incorporated o-rings, remained in the gun barrel and formed a seal which prevented the gas pressure behind the sabot from affecting the pressure in the vacuum chamber.

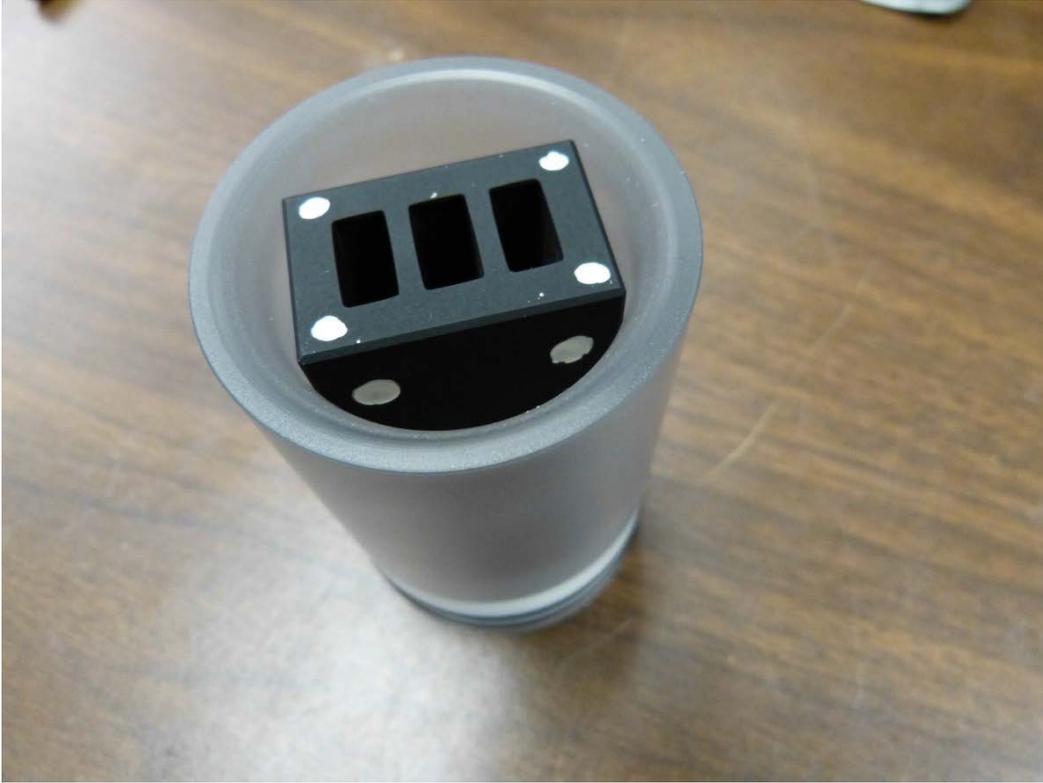
Figure 5.—Projectile in polycarbonate sabot.

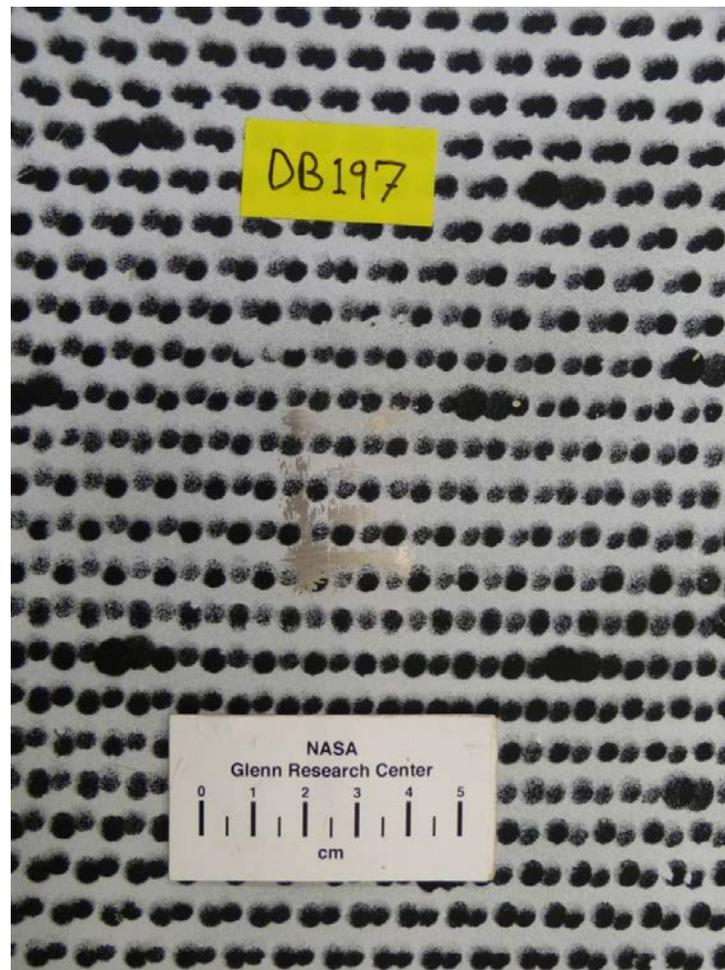
Figure A2.—Front (left) and back side views of impacted panel in test DB197.

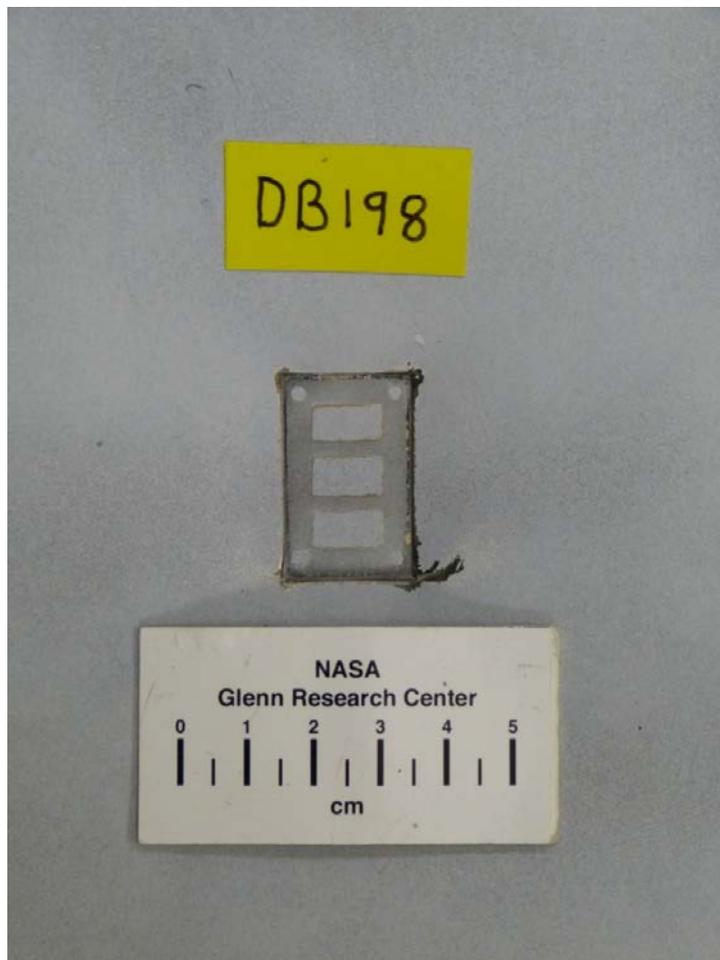
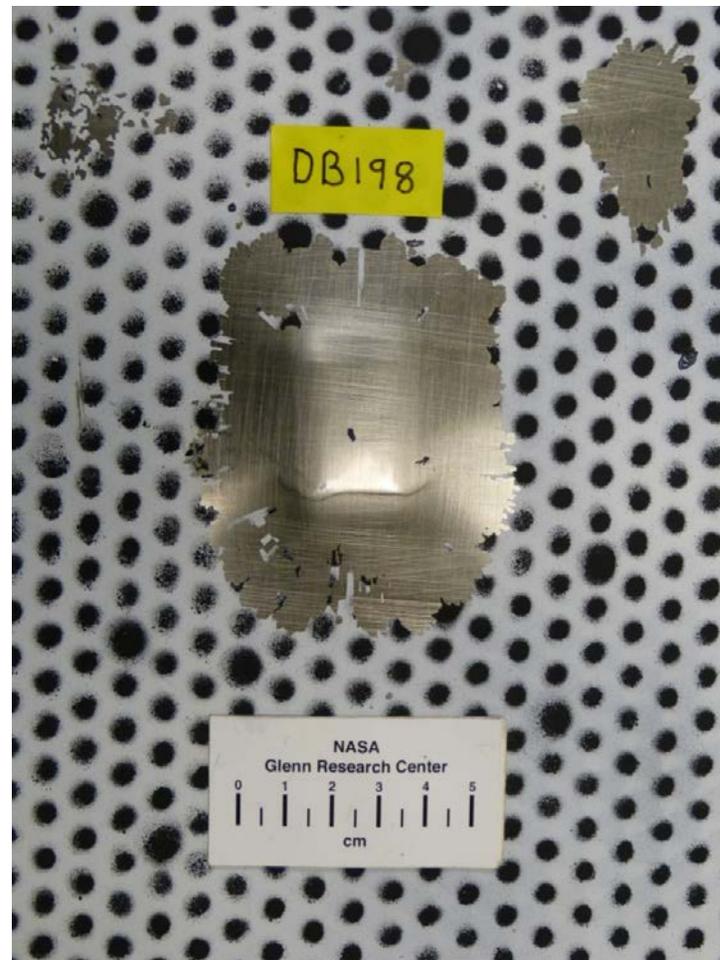
Figure A7.—Front (left) and back side views of impacted panel in test DB198.

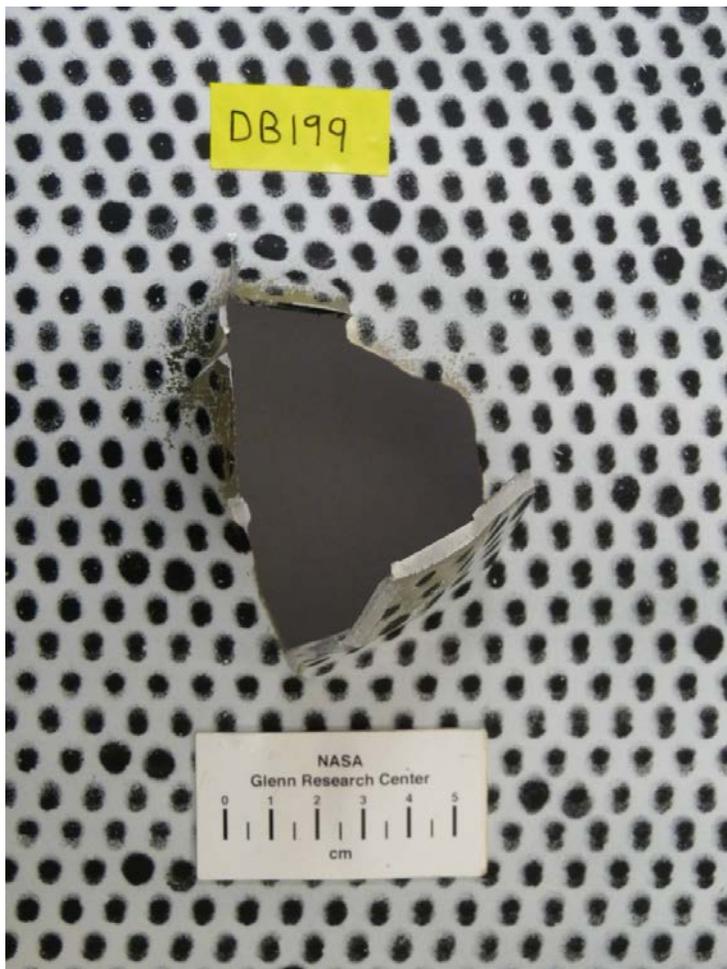
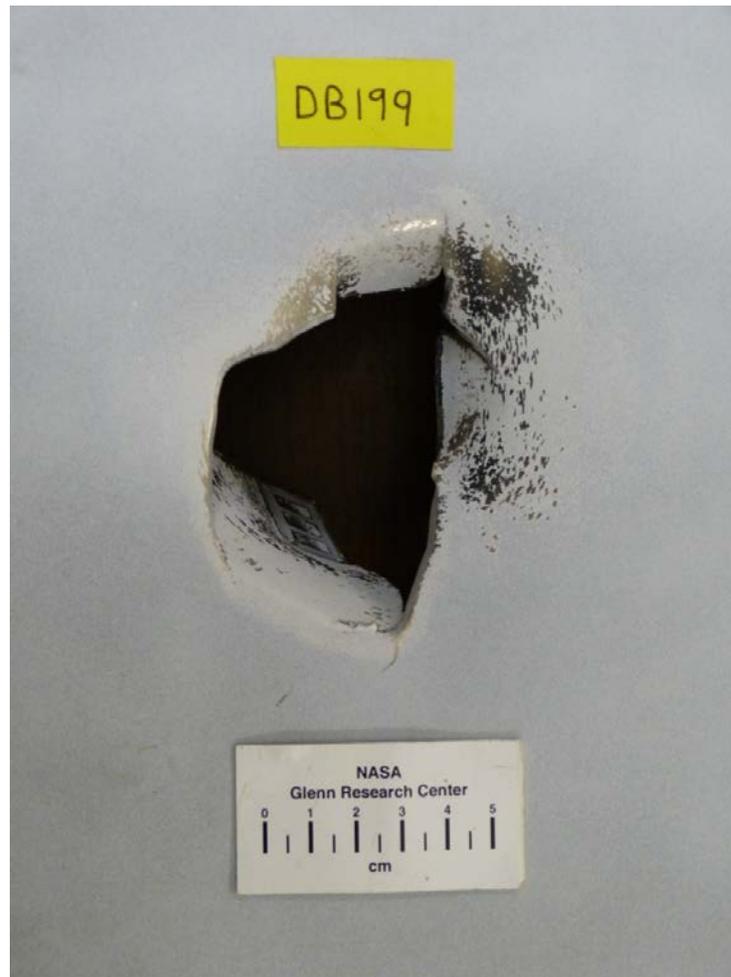
Figure A8.—Front (left) and back side views of impacted panel in test DB199.

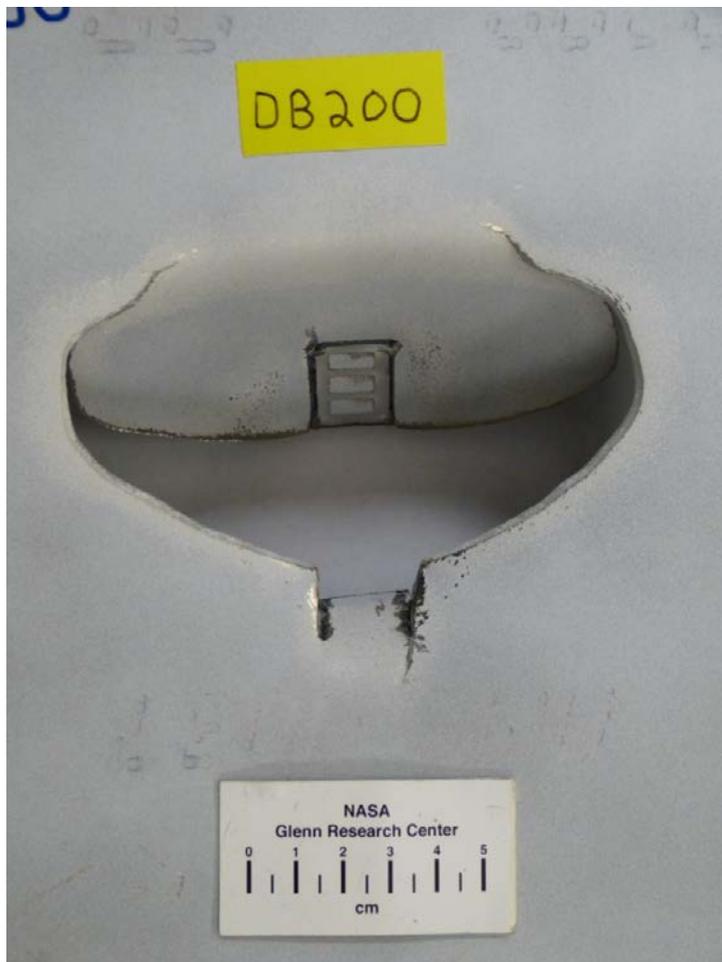
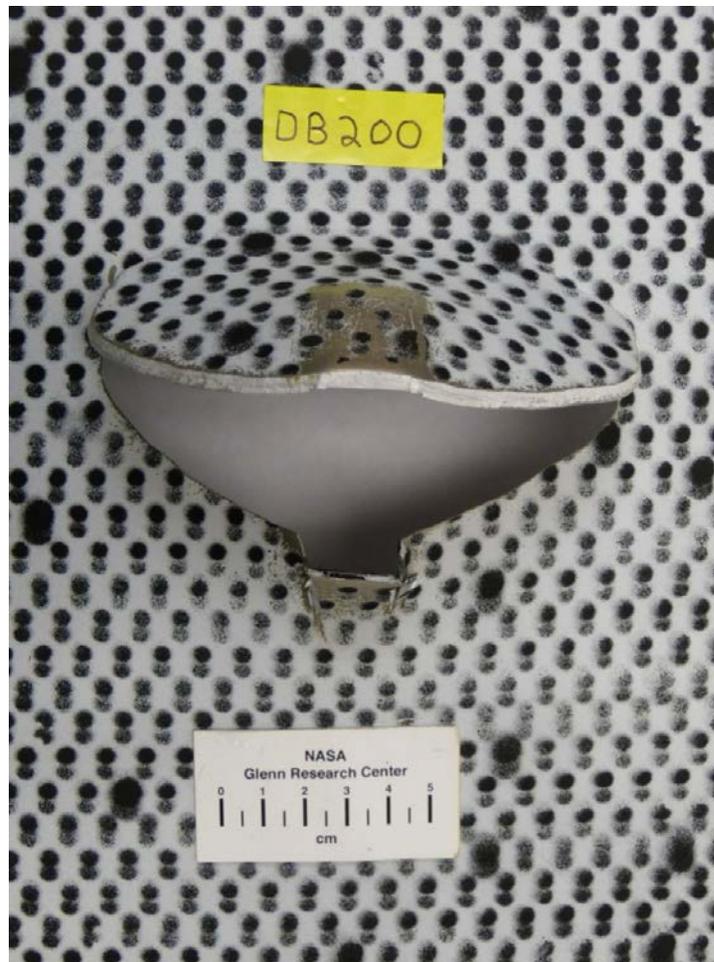
Figure A11.—Front (left) and back side views of impacted panel in test DB200.

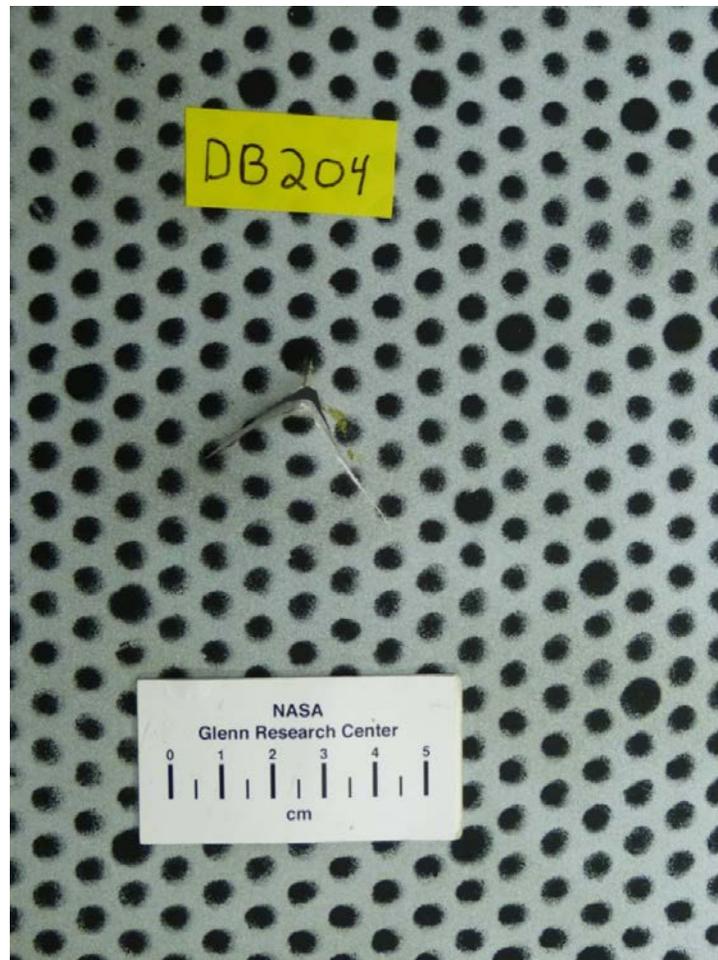
Figure A21.—Front (left) and back side views of impacted panel in test DB204.

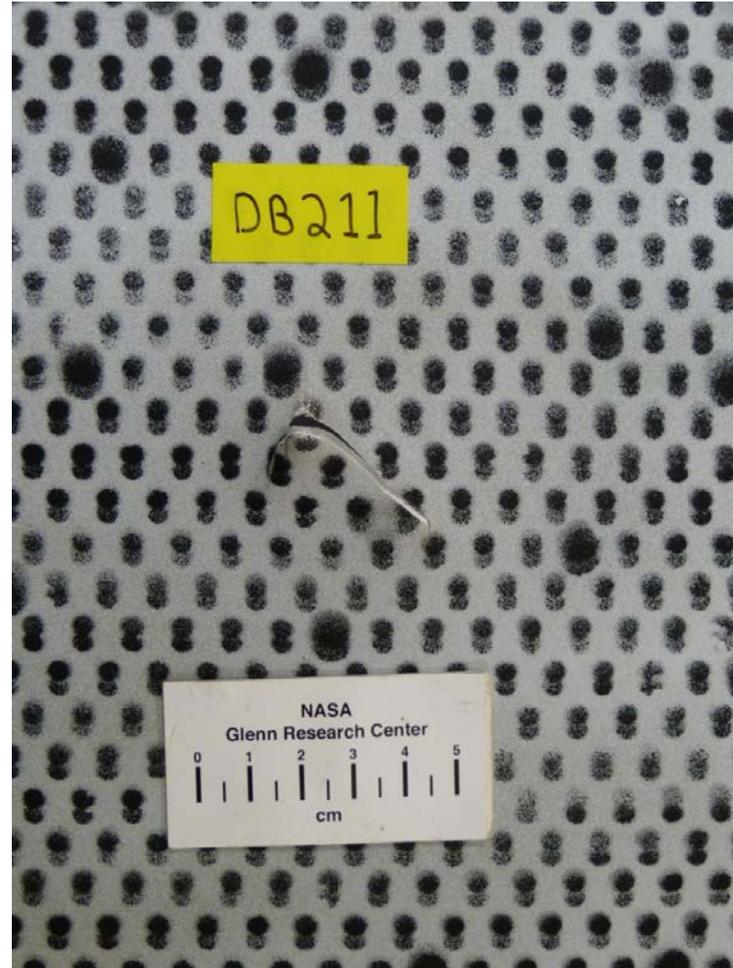
Figure A45.—Front (left) and back side views of impacted panel in test DB211.

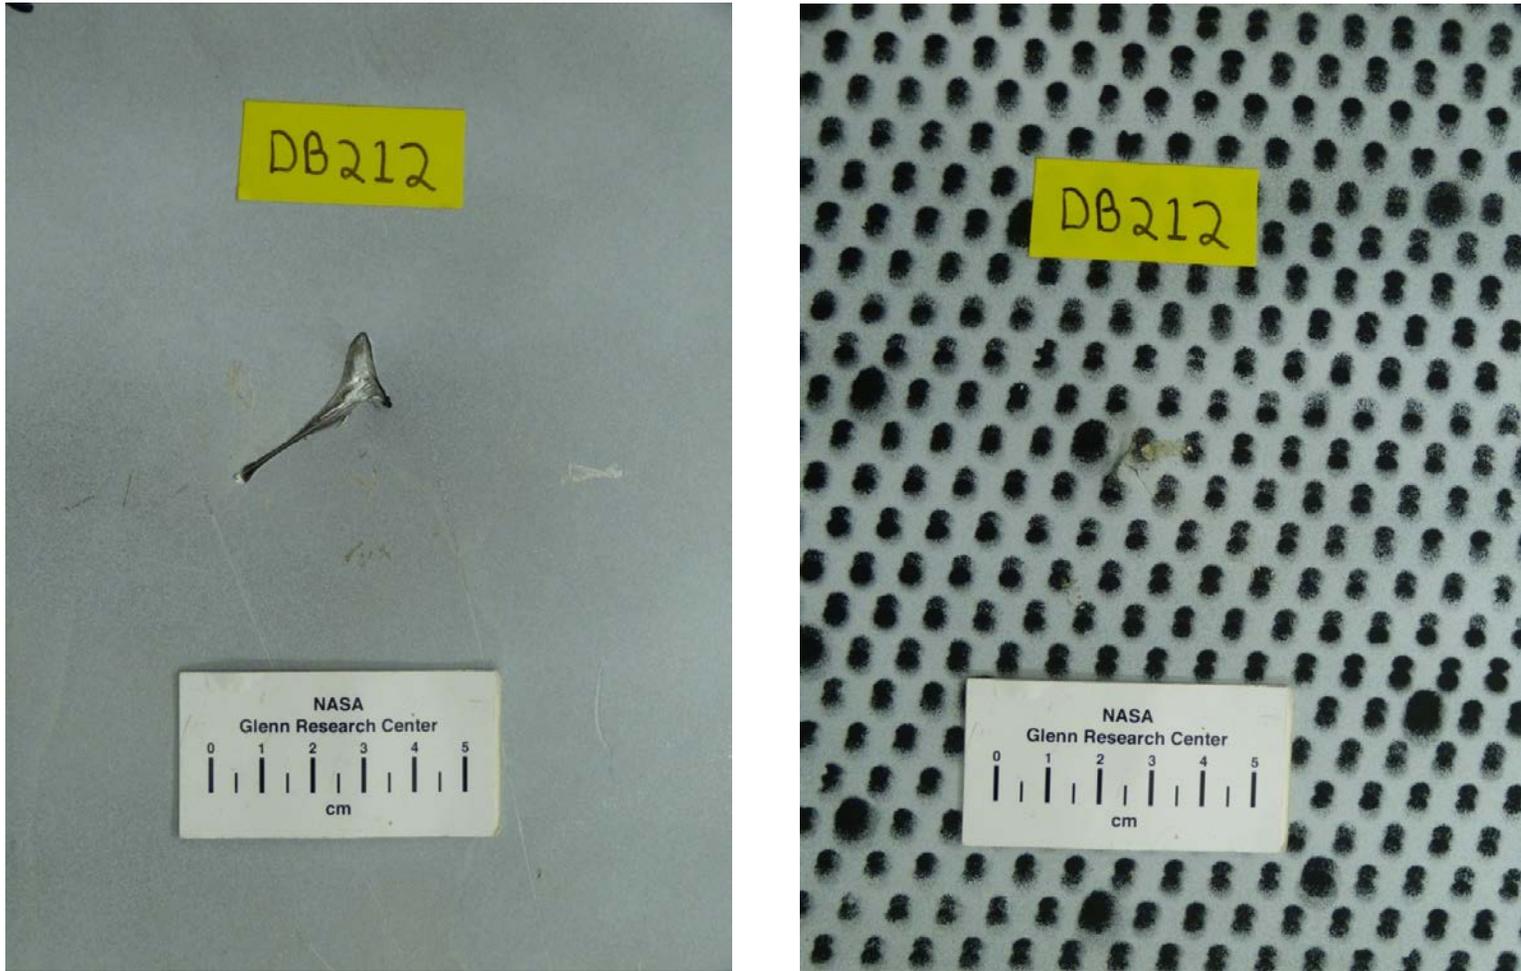
Figure A50.—Front (left) and back side views of impacted panel in test DB212.

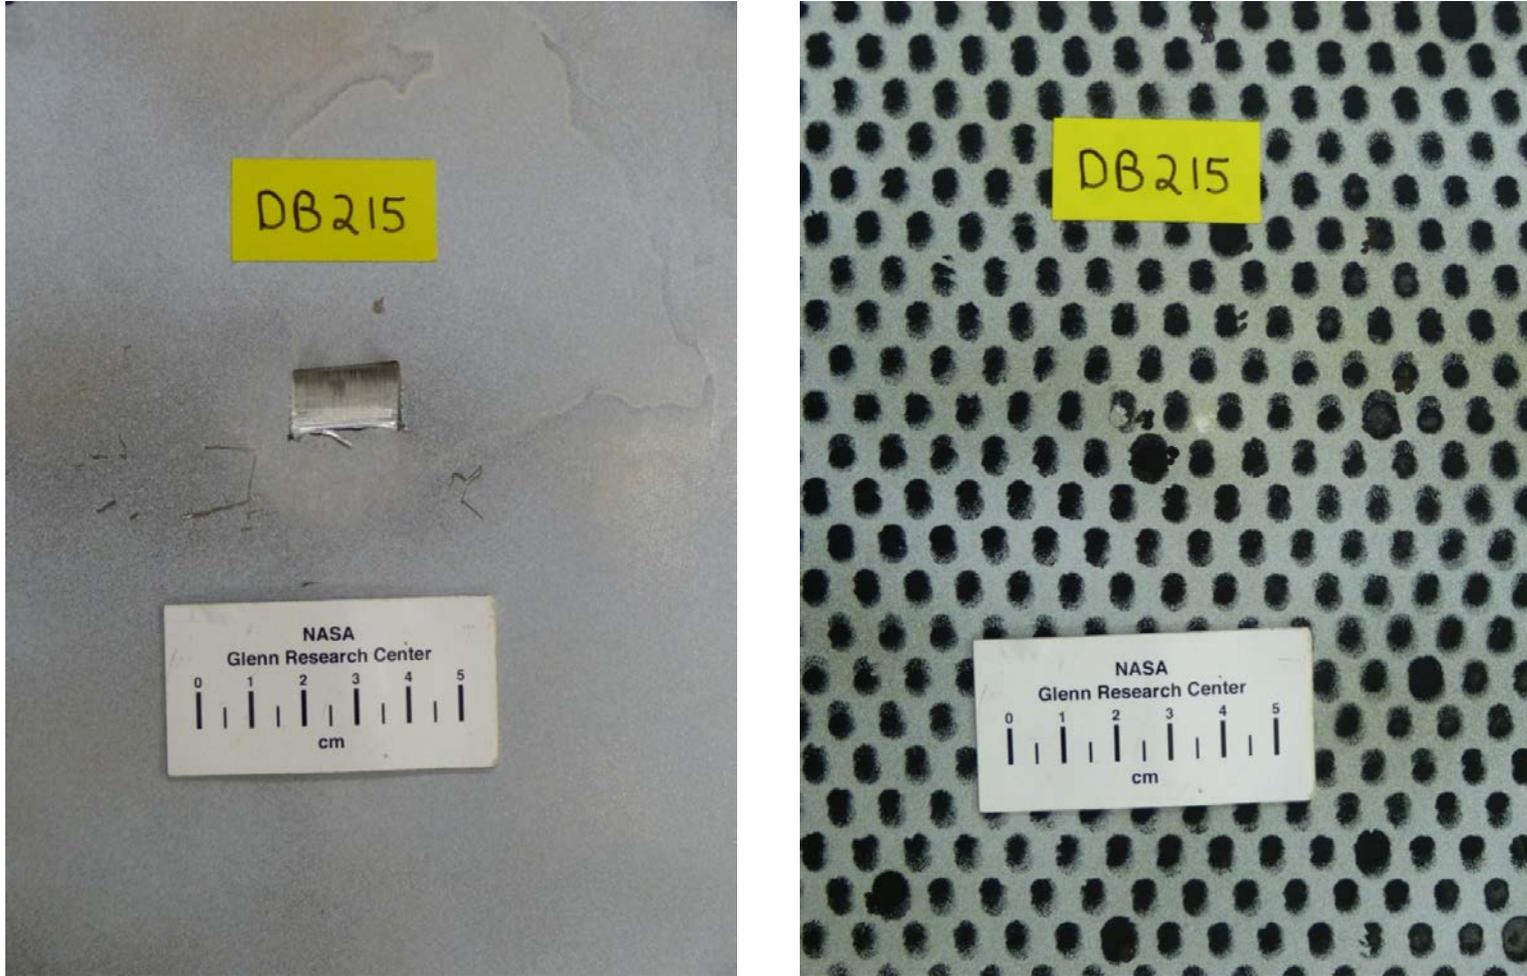
Figure A62.—Front (left) and back side views of impacted panel in test DB215.

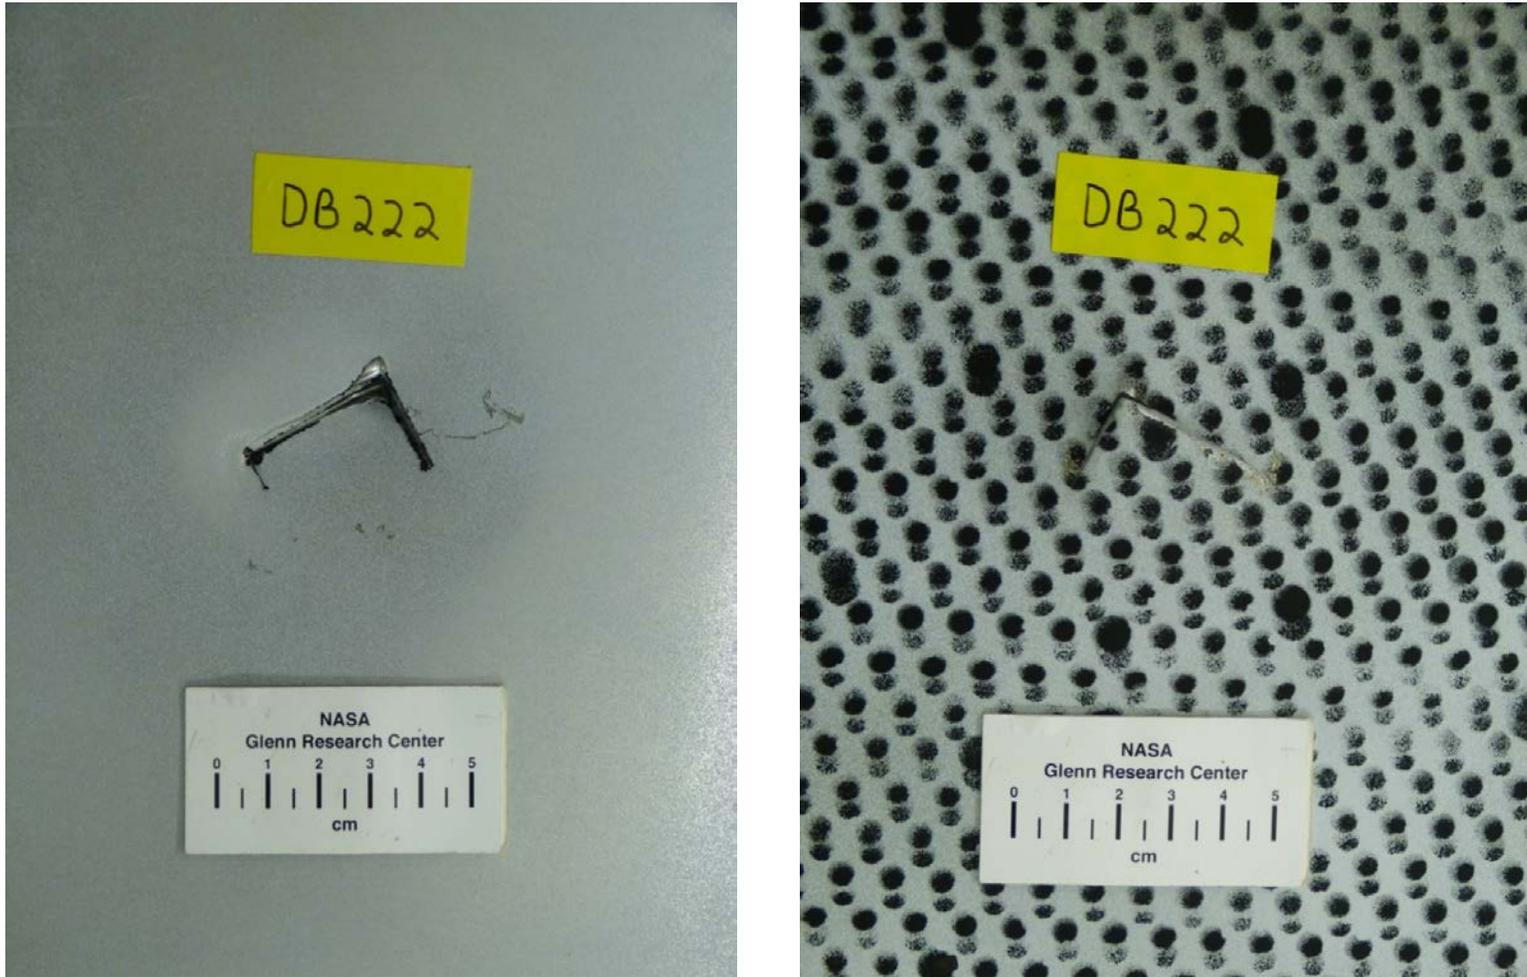
Figure A93.—Front (left) and back side views of impacted panel in test DB222.

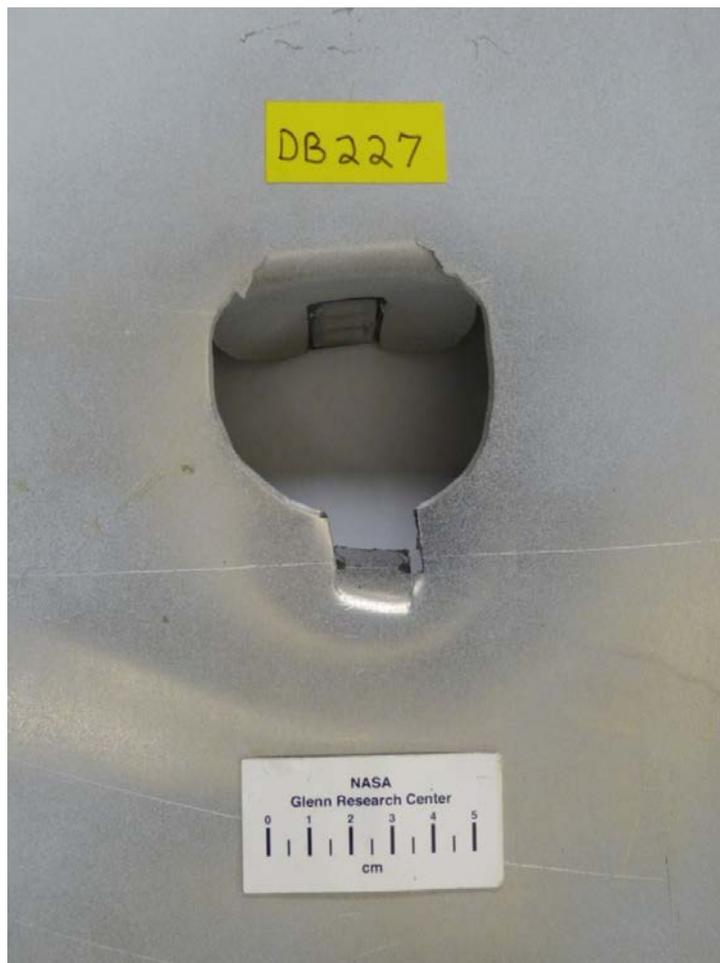
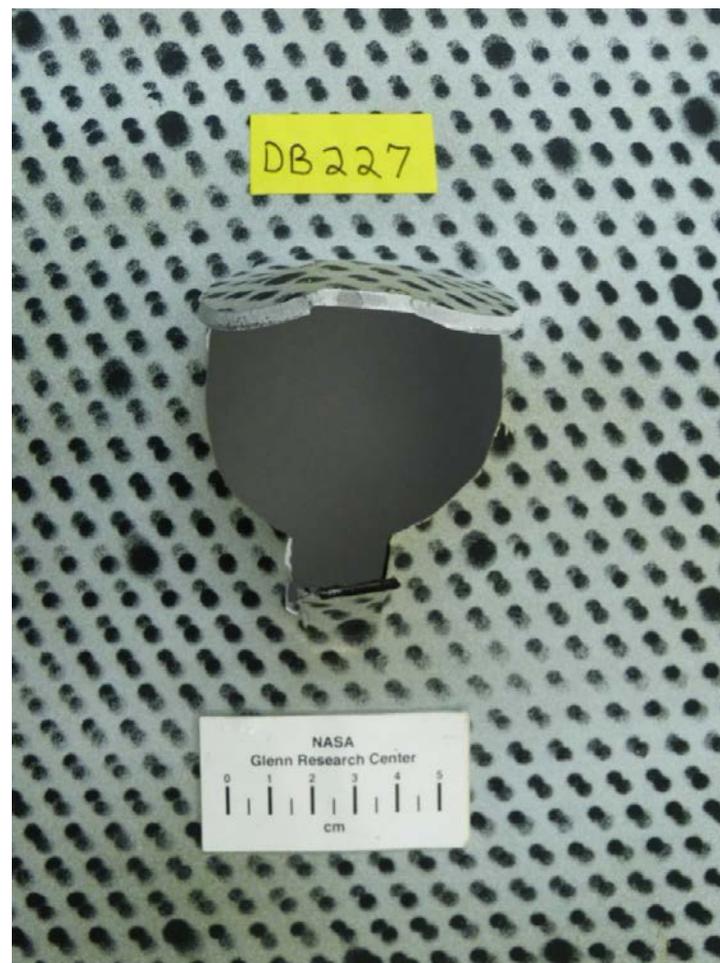
Figure A120.—Front (left) and back side views of impacted panel in test DB227.

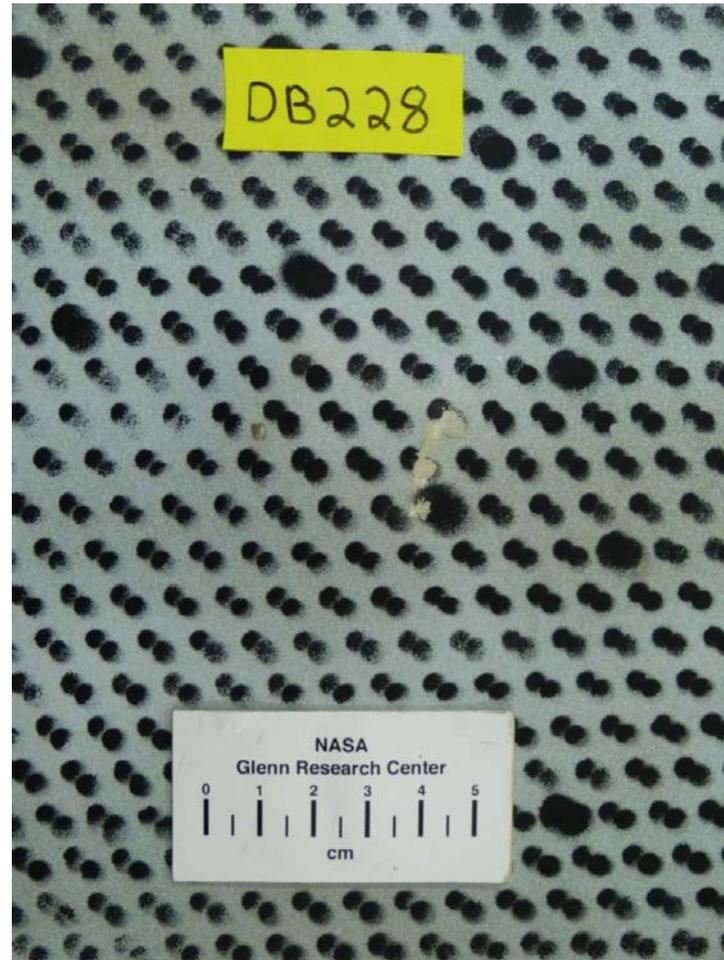
Figure A125.—Front (left) and back side views of impacted panel in test DB228.
