**DOT/FAA/TC-16/31**

# **A Study into the Structural Factors Influencing the Survivability of Occupants in Airplane Accidents**

September 2016

Final Report

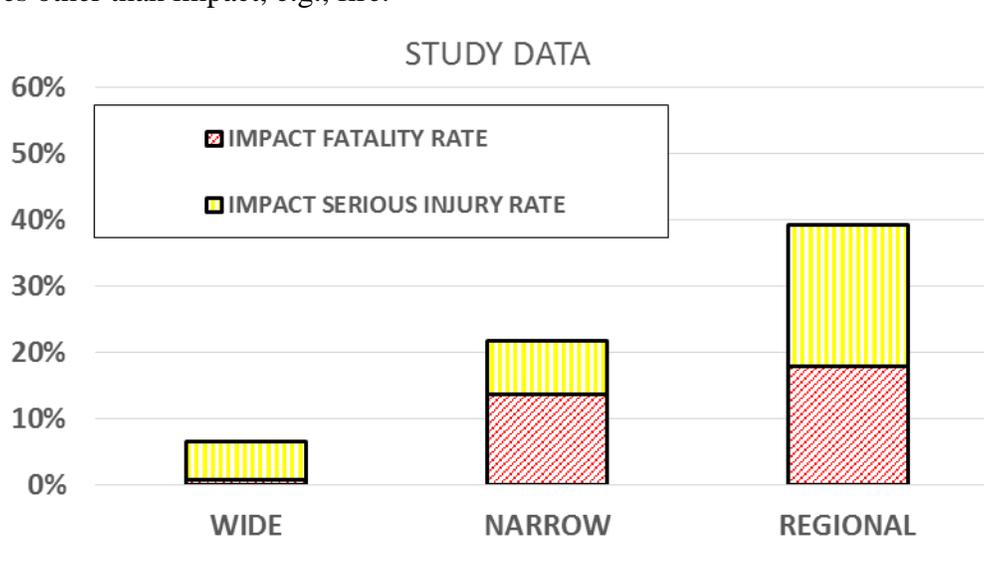
An indication of the survivability in an airplane accident may be measured by the occupant injury and fatality rate. Figure 5 shows the proportion of occupants sustaining fatal and serious impact injuries, based on the accidents selected for analysis in this study, for wide body, narrow body and regional airplanes. It should be noted that these data exclude occupant fatal and serious injuries from causes other than impact, e.g., fire.

Figure 5. Proportion of Occupants sustaining Fatal and Serious Impact Injuries – by Airplane Category based on the Study Data

Figure 5 shows that the larger airplanes have a better survival rate than the smaller airplanes. In order to gain more confidence in any conclusions derived from the data analysed, additional accident information was added to the data set. The accident data used was based on an earlier study carried out for the Authorities (reference 26). This additional data was for nine accidents that occurred over the period 1985 to 1990. The number of occupants, impact fatalities and impact serious injuries for all data (study data and the additional data) are shown in table 2.

It would appear from figure 5 and figure 6 that the wide body airplanes have a lower proportion of fatal and serious impact injuries than the narrow body and regional airplanes, suggesting that accidents to the larger airplanes are likely to be more survivable. While it is also likely that narrow body airplanes have a lower proportion of injuries than regional airplanes, there are insufficient data to be conclusive in this respect.
